The physical vulnerability of urban areas facing the threat of inundation from lahars and flash floods: application to the case study of Arequipa, Peru

THESE

présentée pour obtenir le grade de
DOCTEUR D'UNIVERSITE
Spécialité : Volcanologie

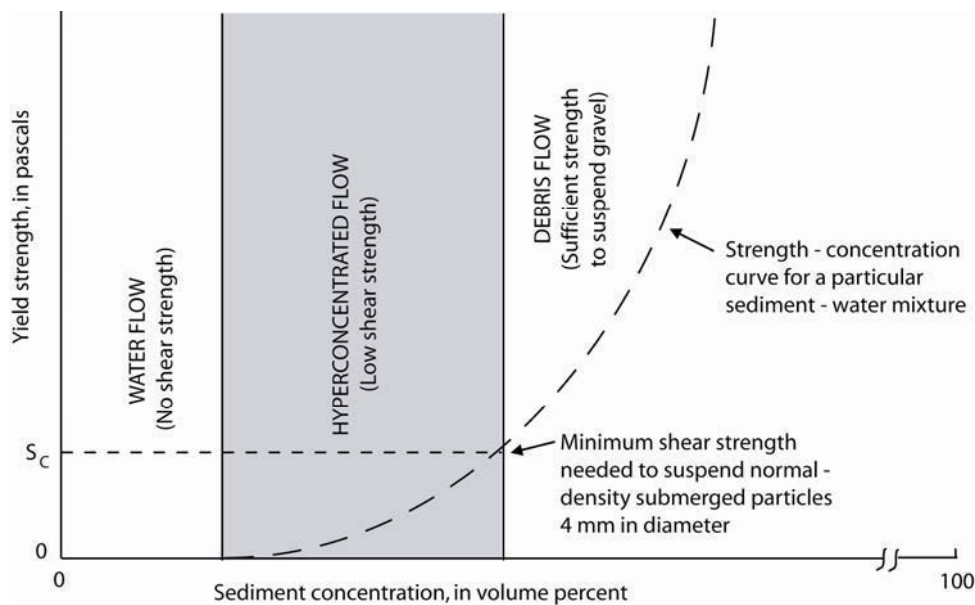
Figure 1: Yield strength of sediment-water mixtures as a function of suspended sediment concentration. Definitions based on an idealised yield-strength curve of poorly-sorted sediment-water mixture (from Pierson, 2005)

Rock debris in a lahar can range in size from clay particles (>0.003 mm) to blocks several tens of metres in maximum dimension. Volcanic debris flows and hyperconcentrated flows contain a high concentration of rock debris which gives the flow an internal strength capable of carrying large boulders as well as other objects such as cars, parts of buildings, and water tanks. Such flows also exert high impact forces against objects in their paths (Figure 1). As flows dilute and become hyperconcentrated they lack internal strength which causes the mixture of rock debris and water to take on different flow properties.

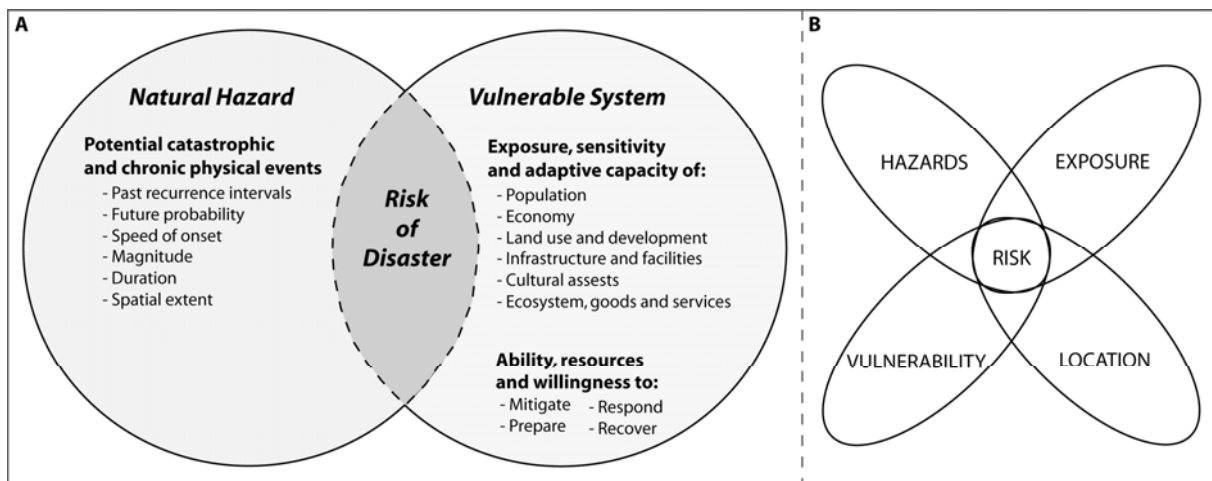
Figure 3: The elements and processes which contribute to risk. A: defines the risk of disaster as a function of natural hazards and the vulnerable human-environmental systems, of which are made up from many and varying elements (from Wood and Salard., 2009). B: A sketch showing a more simplistic approach to the main elements which contribute to risk, such as hazards, exposure and location (accessed from <http://water.usgs.gov/wid/html/HRDS.html>).

A natural hazard (or a natural event) however, only becomes a disaster due to the vulnerability and/or lack of resilience of a community. Chester (1993, p. 232) describes this situation “without people there can be no natural hazards; they are an artifice of the interaction between people and nature. In general, the greater the population density and the higher the economic development, the more severe will be the losses once an eruption occurs.” The type/s of interactions between the hazard and the vulnerable system are illustrated in Figure 3.

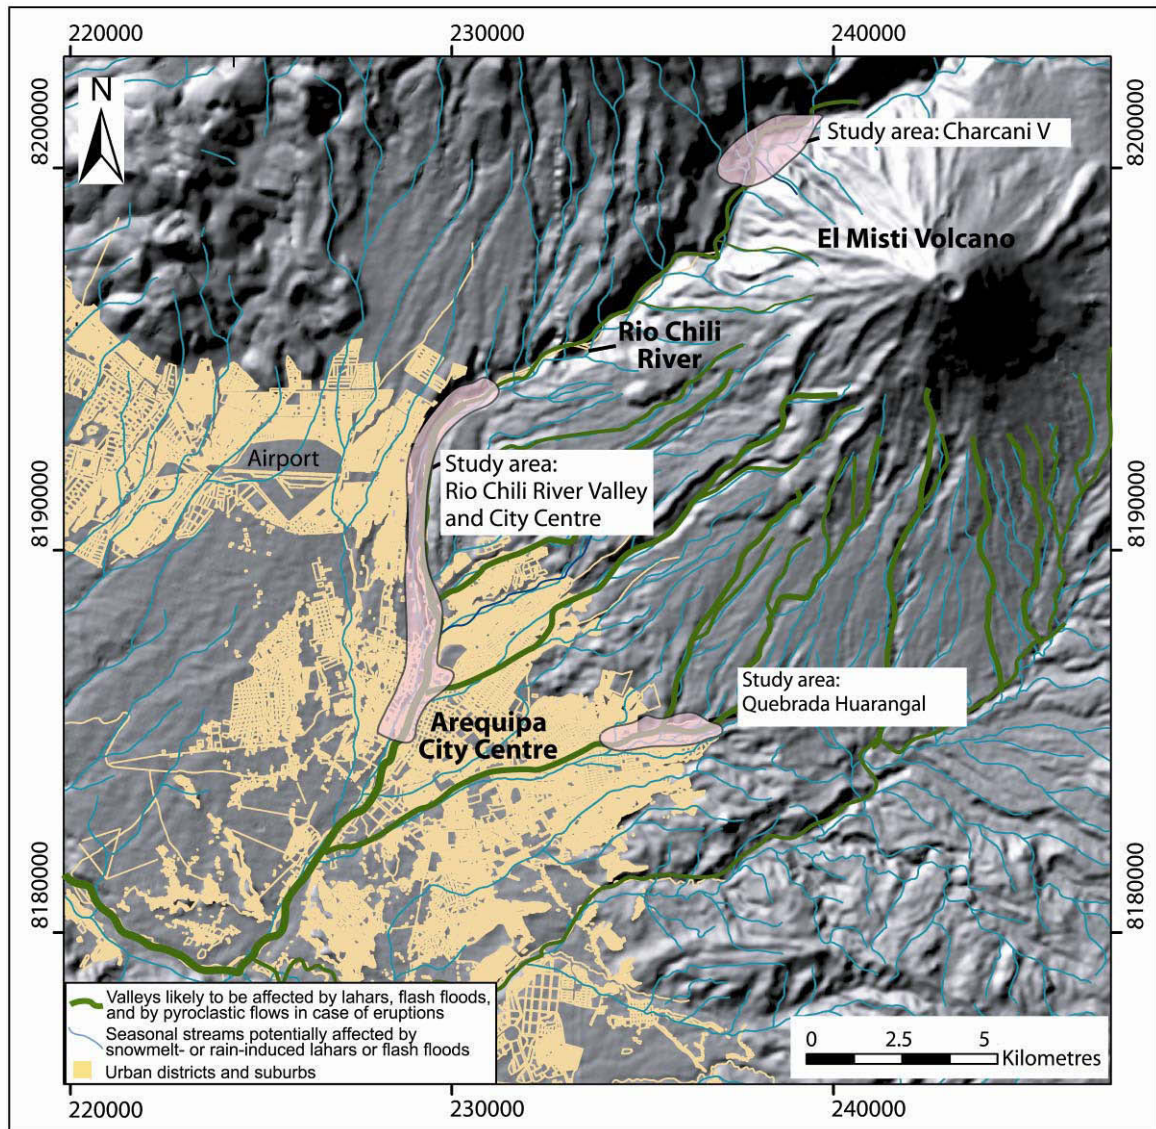
Figure 12: El Misti mass flow hazard-zone map showing areas likely to be affected by lahars and flash floods during eruptions, and seasonal streams potentially affected by snowmelt- or rainfall-induced lahars or flash floods (based on Thouret et al., 2001 and Delaite et al., 2005). Areas chosen for this project are highlighted.

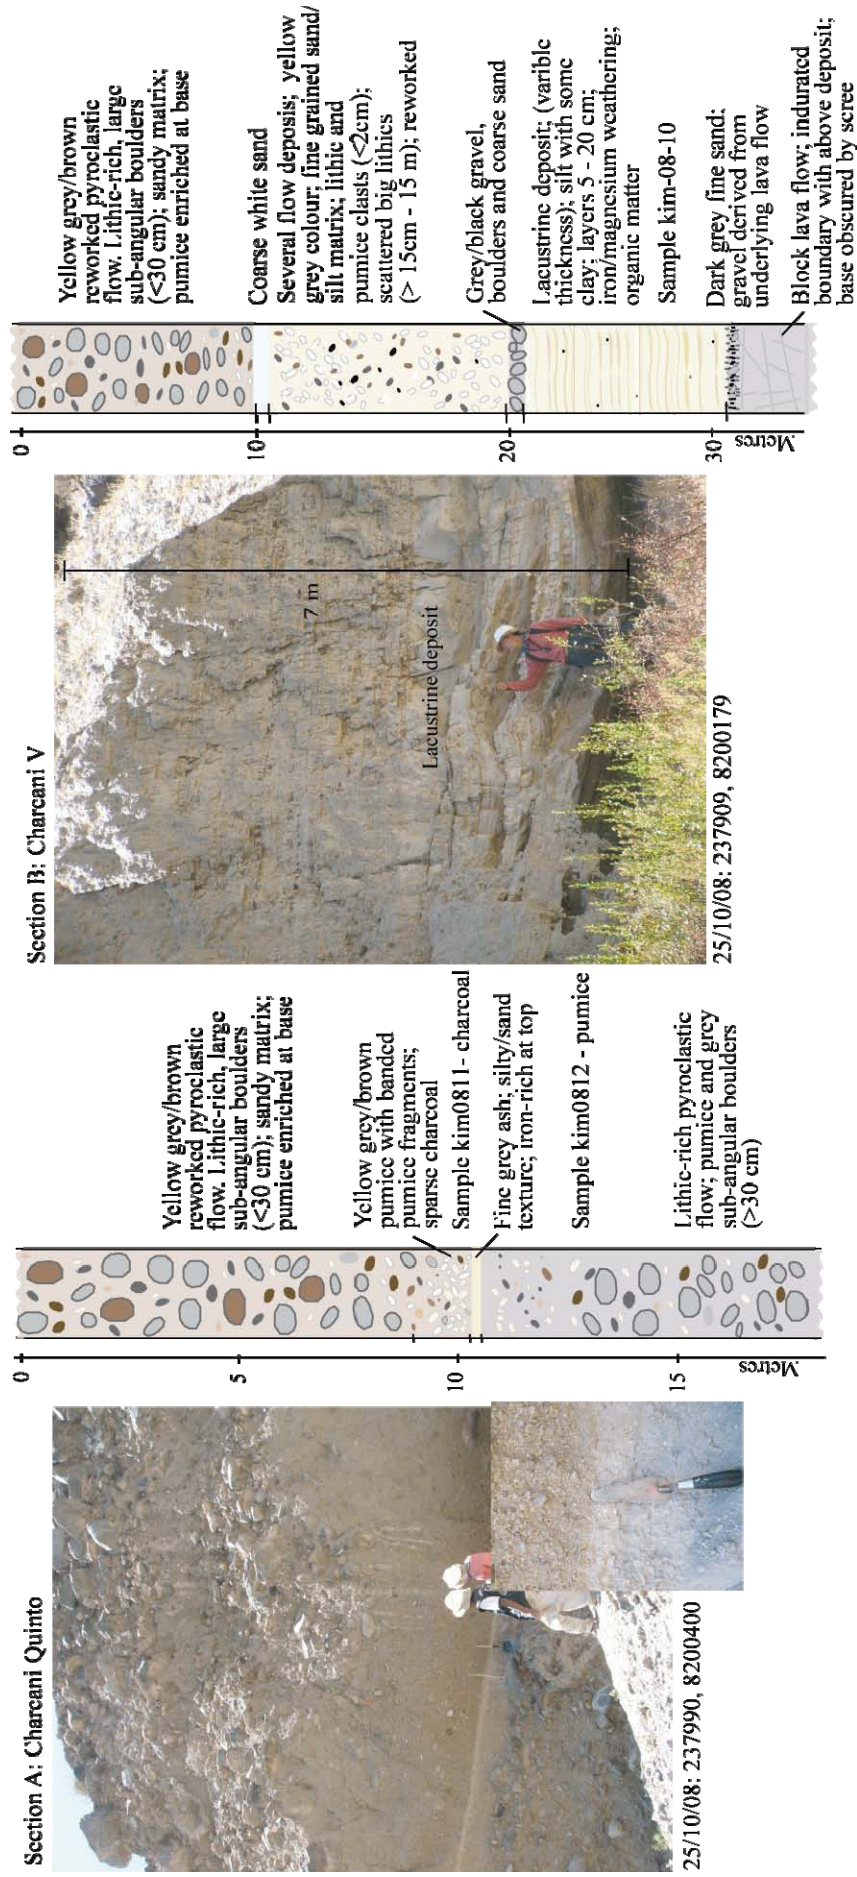
Figure 2.3: Stratigraphy of lahar and pyroclastic deposits located near the Charcani Quinto power station (location of sections can be found in Figure 2.1). Section A: the location where a charcoal sample was taken for ¹⁴C dating (inset image). Section B: thick lacustrine sediments in the upper Rio Chili Canyon.

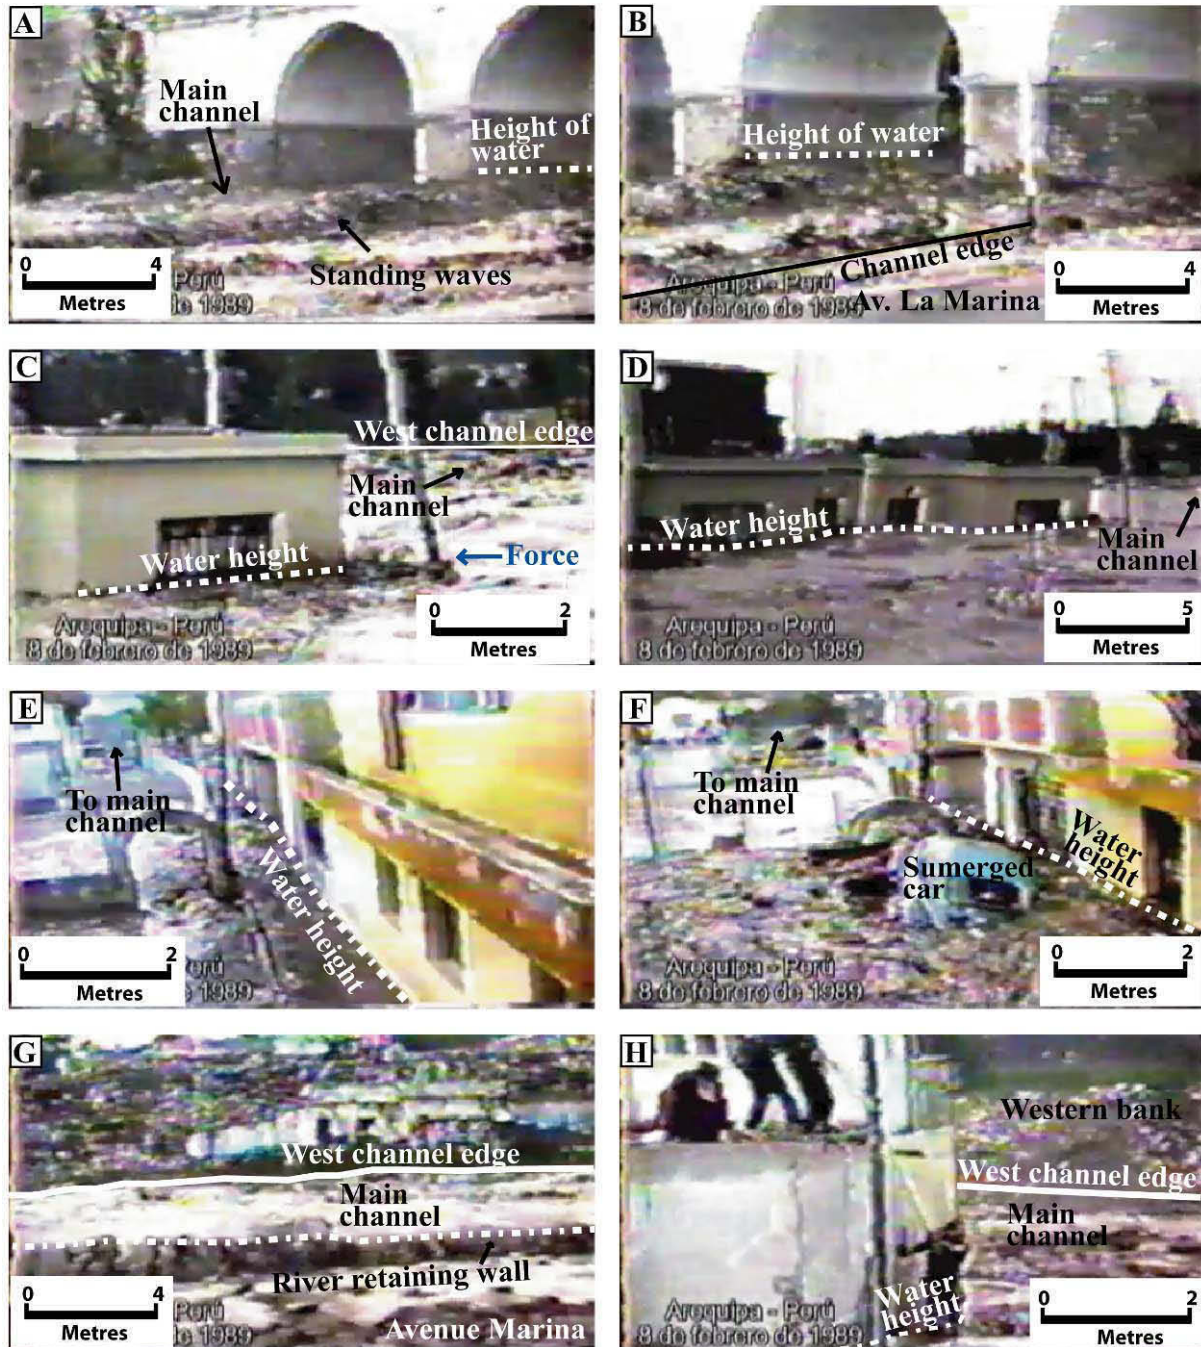
Figure 2.7: Frames taken from film footage showing the events and damage caused by the 8-9 February 1989 flood in Arequipa. A and B: Flow in and around the Puente Grau Bridge in the centre of the city. C and D: the flow height around a house on the eastern side of the Rio Chili, downstream of the Puente Grau Bridge. E and F: An increase in flow depth can be observed between the two snapshots. A car has also been carried away by the flow. G and H: the flow within the Rio Chili channel can be observed. The height of the flow is above the retaining walls which are usually 3.5 m above normal flow. The effects of the flow on buildings can also be observed in snapshot H. Snapshots are obtained from unedited film from the local regional TV channel (Channel 8) viewed on “Youtube”.

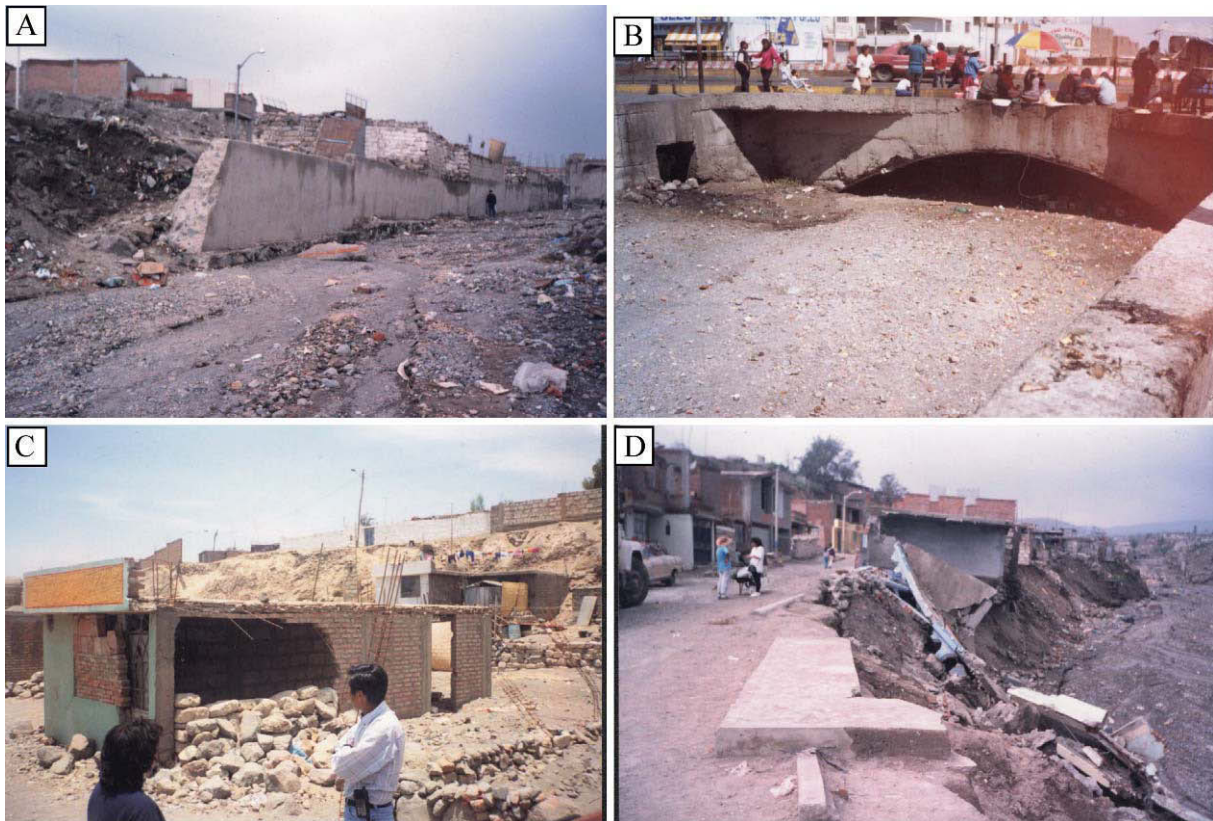
Figure 2.10: A: Destruction of a retaining wall. B: Inundation of Puente Avenue Jesus from Quebrada Mariano Melgar. C: A house damaged by the hyperconcentrated flow debris in the district of Mariano Melgar. D: Houses collapsed into Quebrada Mariano Melgar after channels were undermined by the hyperconcentrated flow. Photographs obtained from Victor Rodriguez.

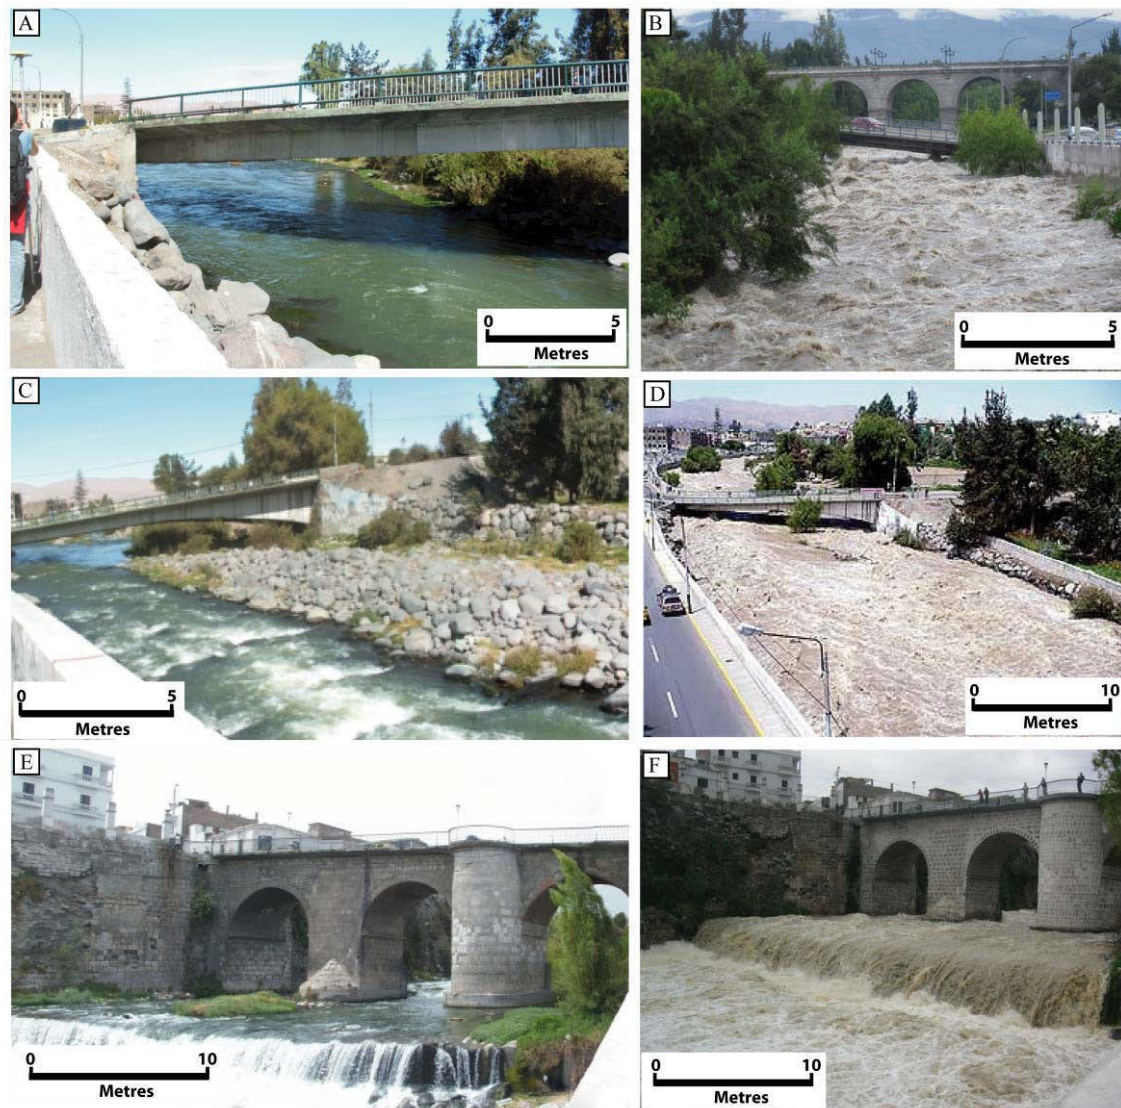
Figure 2.14: Before and after photographs of the flooding in the Rio Chili – before photos are taken in 2007 and 2008, and after photos were taken on 23 February 2011 (obtained from GrupoRPP www.rpp.com.pe). A and C show the channel and bridge height of Puente Grau during normal river flow while B and D show the height of the flow (just under the bridge deck) and absence of terraces as can be viewed in C. E and F are downstream of Puente Bolognesi, again the absence of islands can be noted in F. Also the level of the river is noticeably higher in F than E.

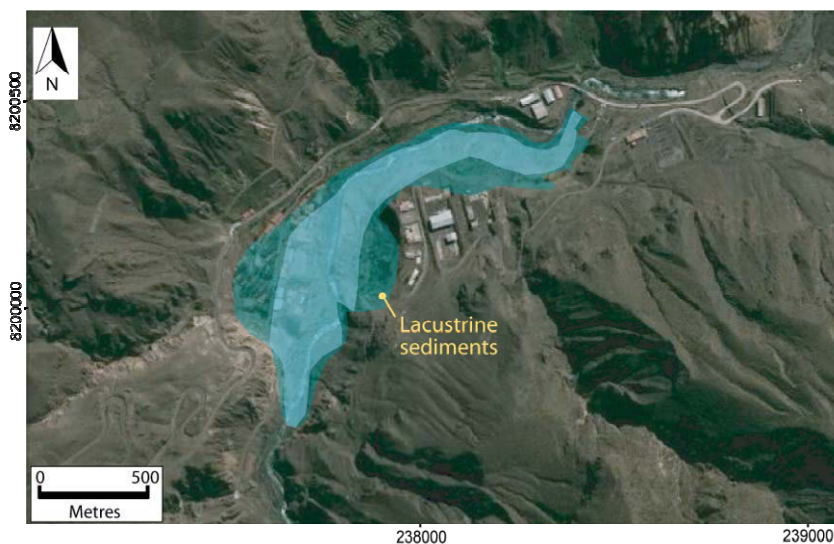
Figure 2.17: area where a lake could form in the upper Rio Chili canyon (near Charcani V). The lighter blue represents the likely area where a smaller lake would form, the darker blue representing the likely area flooded by a moderate sized lake. Image from Google Earth.

From the analysis of the geomorphology near where the lacustrine deposits are located, the area covered by a potential lake can be approximated (Figure 2.17). A small (light blue) and moderate (darker blue) sized lake outline, based on lacustrine outcrops and canyon landforms, is shown in Figure 2.17.

The surface area represented by the smaller lake is approximately 0.32 km^2 while the larger is 0.58 km^2 . The volume of water held can be determined from the approximated depth of the lake. The depth of the lake is approximated because the thickness of the lacustrine deposit alone does not represent how deep the lake would have been. The size and depth of the lake is related to the sediment supply and a balance between water supply and loss through evaporation. These variables also control the sedimentation rate (related to the thickness of the deposit). Cross-sections through the basin indicated that there is an elevation difference of approximately 5-10 m from the current river level to the edge of the small lake, and 15-20 m different for the larger lake. Therefore the estimated volume of water that could be stored is between 1.6 and $11.6 \times 10^6 \text{ m}^3$.

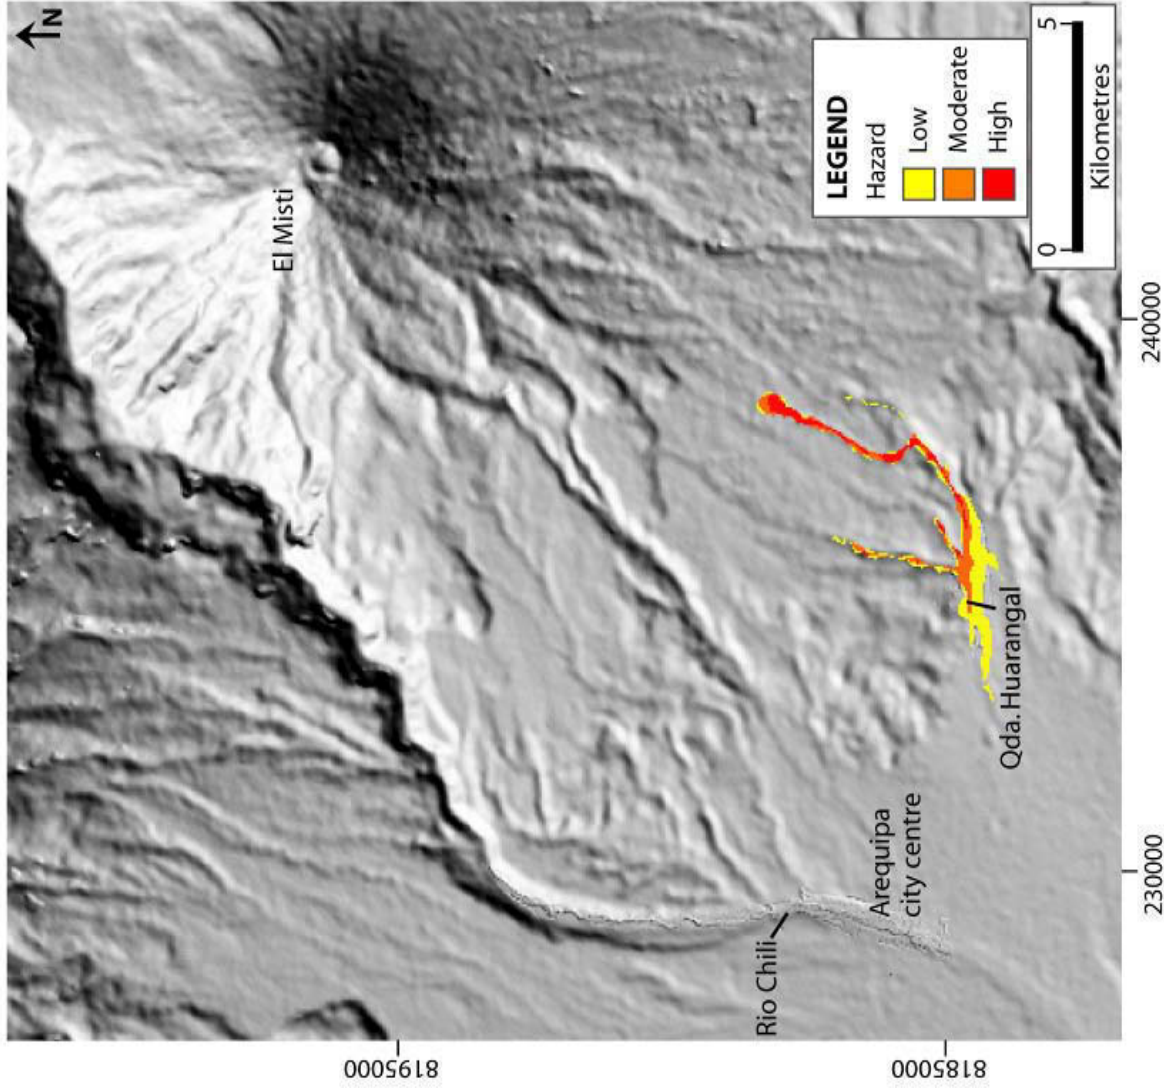
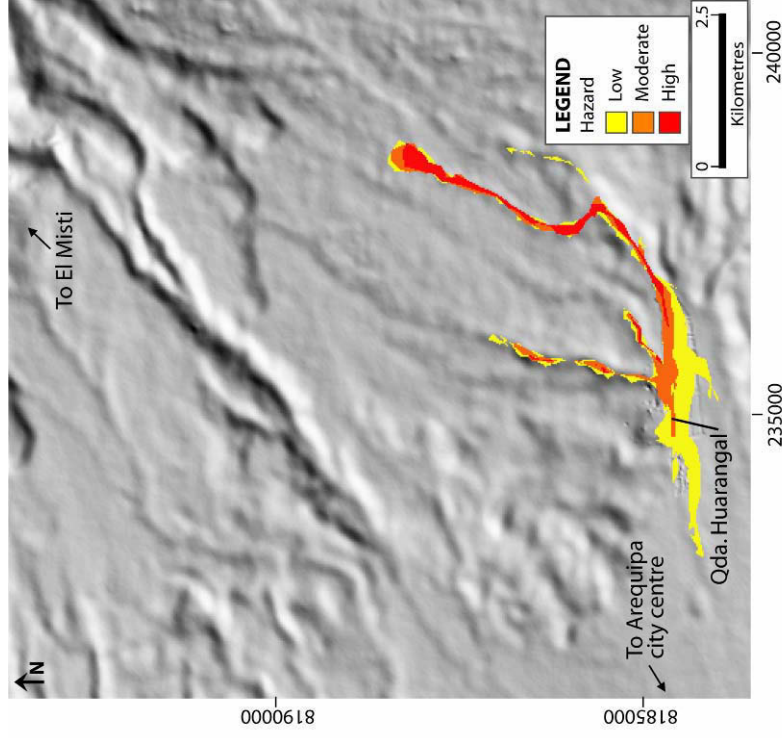
Figure 3.14: Hazard map for the Quebrada Huarangal fan derived from Titan2D simulations on a 10 m DEM. Volumes from $0.5 \times 10^6 \text{ m}^3$ to $11 \times 10^6 \text{ m}^3$ were modelled using an internal friction angle of 30° , a basal friction angle of 12° and a solid ratio of 0.40. A close up of the inundation zones and largest volume flows inundate the populated areas of the fan.

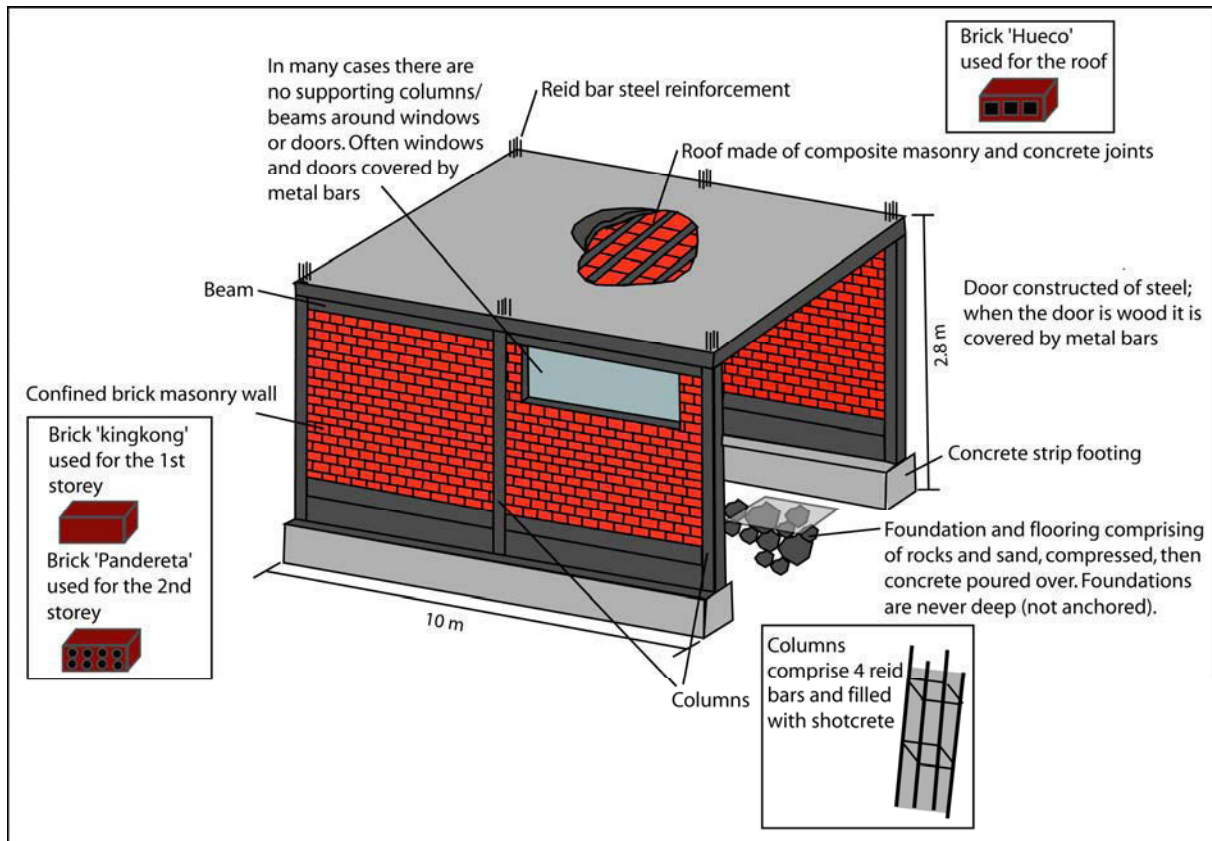
Figure 4.11: Typical structure of a confined masonry building as observed in Arequipa. Three different types of bricks are used in construction with subsequent storeys constructed using pandereta (modified from Loaiza and Blondet, 2003a).

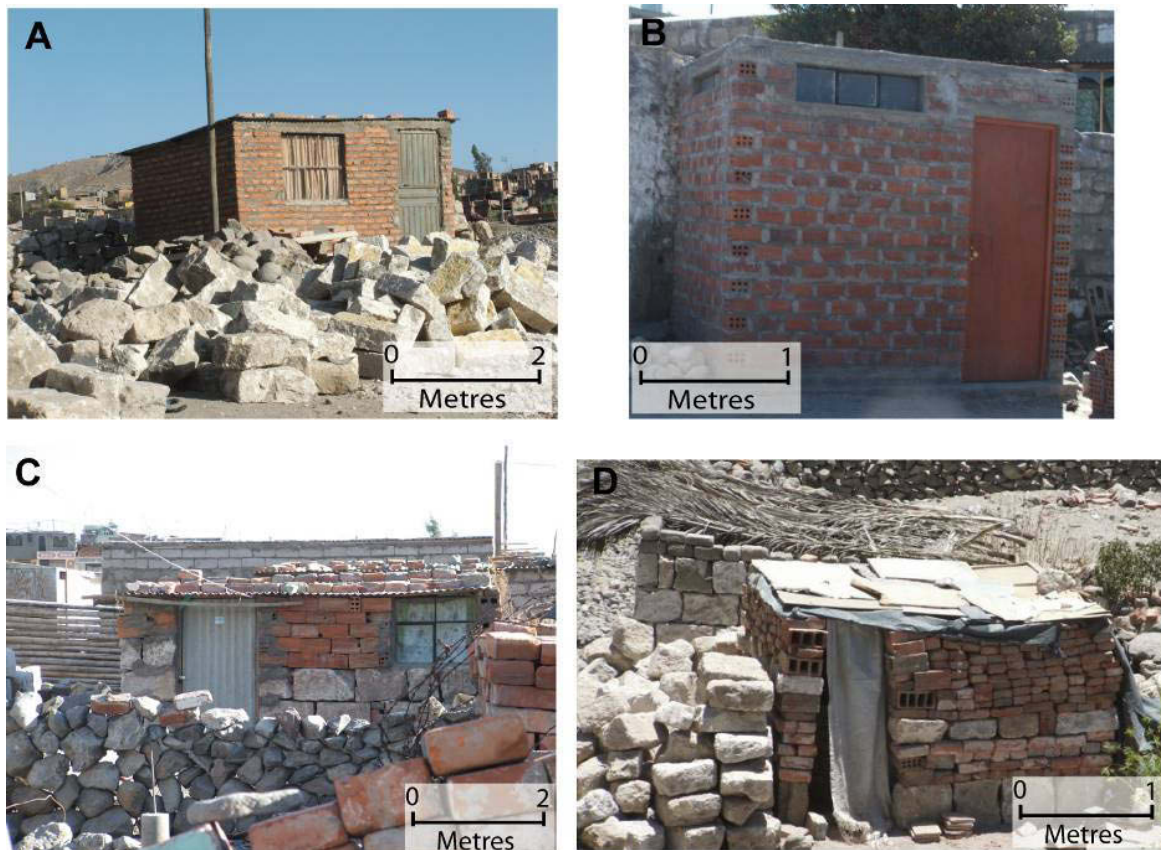
Figure 4.12: Unconfined masonry dwellings in Arequipa. Dwellings **A** and **B** are constructed of red clay brick with mortar, whereas dwellings **C** and **D** are constructed from a mixture of ignimbrite and red clay brick with no mortar.

Unconfined red clay brick masonry is common in the margins of Arequipa city, on the tilled agricultural terraces of the Río Chili Valley, and on the Huarangal fan (Figure 4.12). Buildings are either rectangular or square in shape, with a typical length of 9 m, width of 8 m and one storey high (typically 3-4 m in height). Normally they comprise one door or window opening per wall. Typical houses have a good wall density with only 2-7% of voids a typical thickness of 150-250 mm (Loaiza and Blondet, 2003a,b).

There are two types of unconfined red brick masonry – those with mortar (e.g. Figure 4.12 A and B) and those without (e.g. Figure 4.12, C and D). Both types do not possess reinforced columns as confined masonry does; buildings with mortar have very vulnerable wall corners or junctions, and in the case of structures with no mortar, all parts of the building are vulnerable. Figure 4.12 (A and B) shows a building where bricks and mortar are well bonded but there are no lateral supporting beams. The roof is a concrete and masonry composite; there is no mortar or lateral and horizontal reinforcement. There is one window and door and the corrugated iron roof is held in place with loose bricks. In Figure 4.12 (C and D) the dwelling has been constructed from ignimbrite blocks and an assortment of red clay bricks, but there is no mortar between bricks, or lateral or horizontal confinement. The dwelling in Figure 4.12 D is lacking windows, the door is made from fabric, and the roof consists of plastic with wooden sheets strewed across. In each case, the buildings have a shallow foundation often without a rubble stone strip footing, and many cases without a floor or a foundation at all. These buildings have little regard to construction principles (especially those without mortar) and reinforcement.

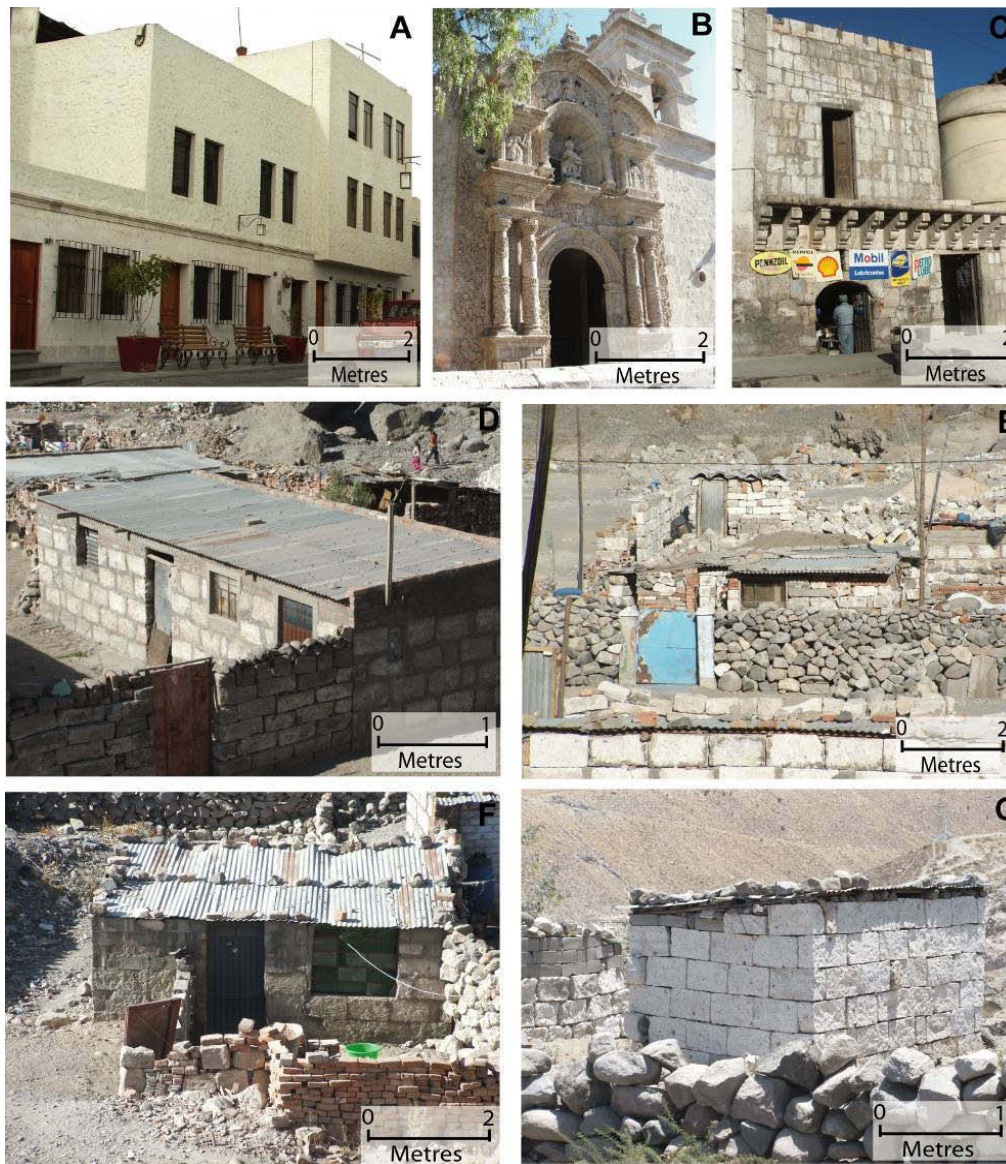
Figure 4.13: The range of ignimbrite block construction in Arequipa. **A:** New, well built and finished ignimbrite private dwellings **B:** An example of a ignimbrite church, the San Juan Bautista. **C:** A business building constructed from ignimbrite blocks. Behind this store private dwellings were being (re)constructed with ignimbrite. **D:** An ignimbrite block masonry dwelling within Quebrada Huarangal. **E:** and **F:** Similar dwellings situated within Quebrada Huarangal. **G:** A dwelling on the southern bank of Quebrada Huarangal.

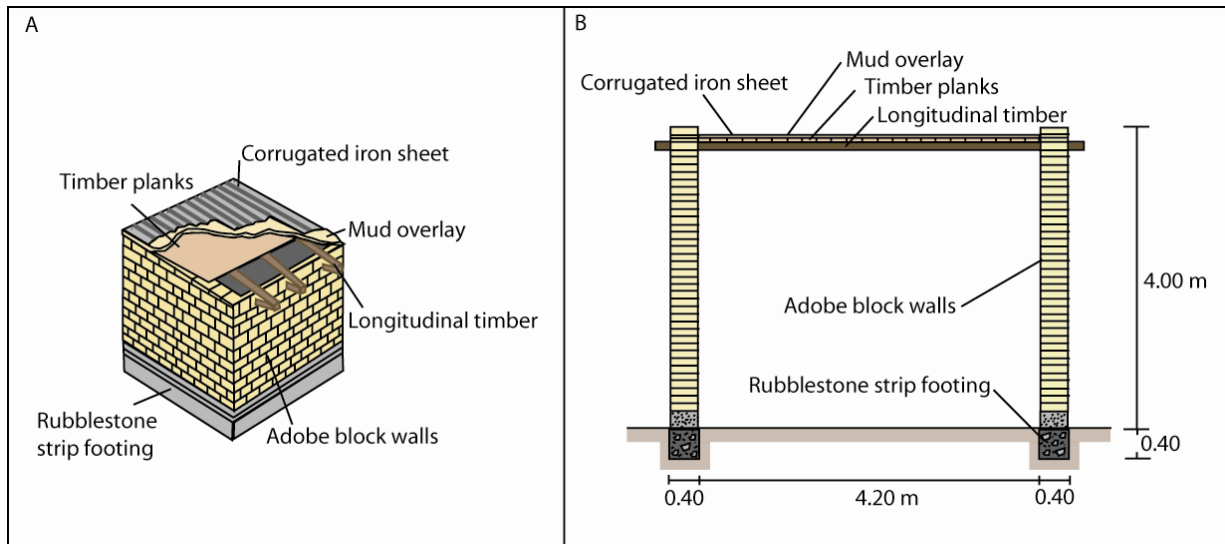
Figure 4.14: Typical adobe structure as observed in Arequipa. **A:** The main constructional materials used in adobe buildings (dimensions of the house are the same as in **B**). **B:** Structural components of adobe construction (modified from Loaiza et al., 2003c)

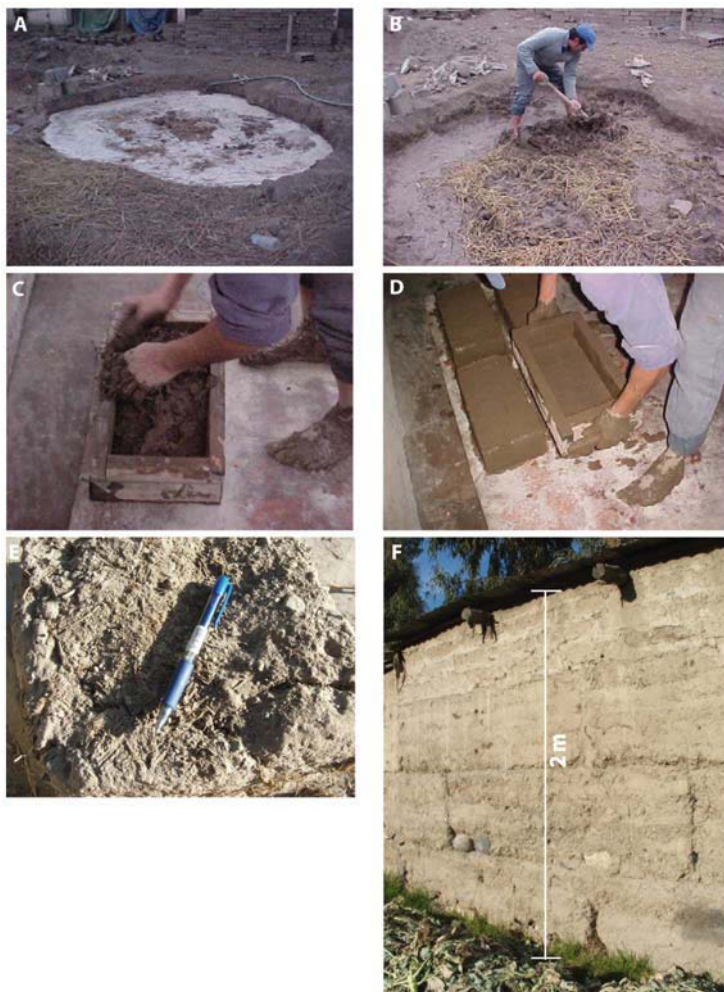
Figure 4.15: Making adobe bricks – **A:** a big pit is made and water added to make the ‘mud’, mud is then scooped up (**B**) and put into moulds (**C**), bricks are then turned out (**D**) and left to dry (photos obtained from Victor Rodriguez). **E:** An adobe brick from Arequipa – note the muddy texture with bits of straw. **F:** An adobe dwelling on the lower terrace side of the western side of the Río Chili in the city centre.

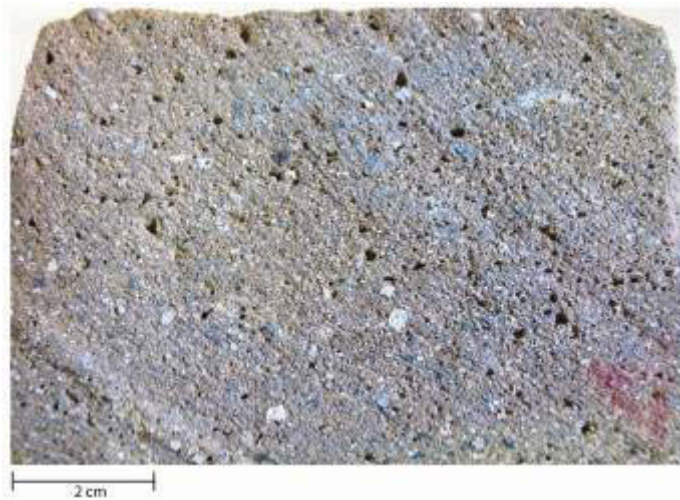
Figure 4.17: Red clay brick sourced from handmade brick factory in Quebrada Huarangal, Arequipa.

The red clay brick (Figure 4.17) is comprised of reddish orange brown clay (derived from the weathered Pichu Pichu debris-avalanche deposit that outcrops east of the city) mixed with very fine light grey sand derived from volcanic ash. The raw clay fragment is a weathered clay loam soil, with a moderate fine-medium sub-angular blocky to granular texture. There are few very small to small stones and common roots. Coarse grains correspond to volcanic components including andesitic lava, pumice or ignimbrite fragments and free crystals such as feldspar, quartz and biotite.

The texture of the brick is very coarse with many natural voids due to either loss of organic material once fired, or air bubbles formed during the mixing process. Individual grains present in the sample are up to 1 cm in size with the majority of visible grains 1-2 mm in size. A darker red tinge is visible on the outer edge of the brick as a result of the firing process.

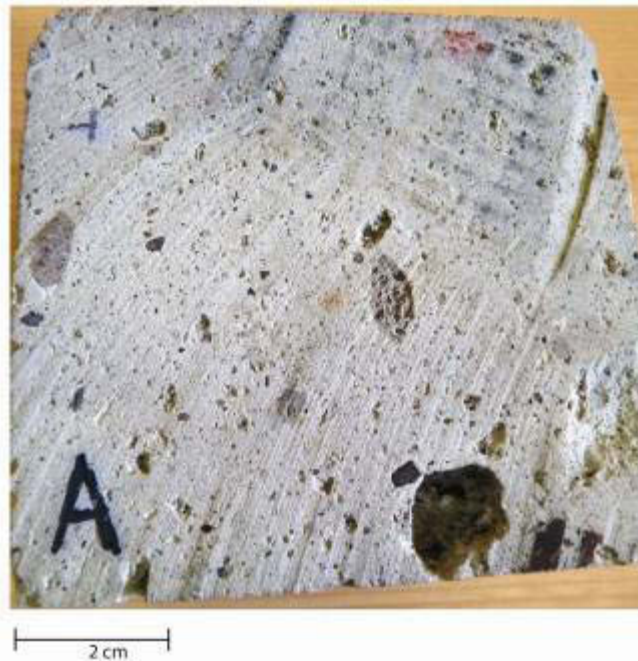
Figure 4.18: Ignimbrite block sourced from a brick factory in Arequipa.

Ignimbrite blocks (Figure 4.18) were collected in the field and subjected to various geotechnical tests (Chapter 1). Two main quarries are utilised for ignimbrite building stone in Arequipa, with the majority of ignimbrite blocks quarried from the white unit of the 1.65-Ma-old Arequipa Airport Ignimbrite (AAI), a whitish lithic-rich massive lapilli-tuff (Paquereau Lebti et al., 2006).

The non welded ignimbrite shows a vapour-phase facies, and is called ‘Sillar’ locally (Degg and Chester, 2005). The indurated block consists of a white to grey ashy matrix with grey to yellow fibrous pumice, which is fragile and highly vesiculated. Fragile weathered pumice, some of which are as large as 3 cm, can lead to large voids forming within the building material (see the bottom right corner of Figure 4.18). The brick is also rich in small lithic fragments (up to 25%) consisting of sub-rounded oxidised andesite fragments of free crystals of plagioclase, biotite, and magnetite and of glass (e.g. obsidian) (Vatin-Perignon et al., 1996). The texture of the brick is smooth and is reasonably hard apart from softer areas and pitting caused by the high vesiculated and fragile pumice.

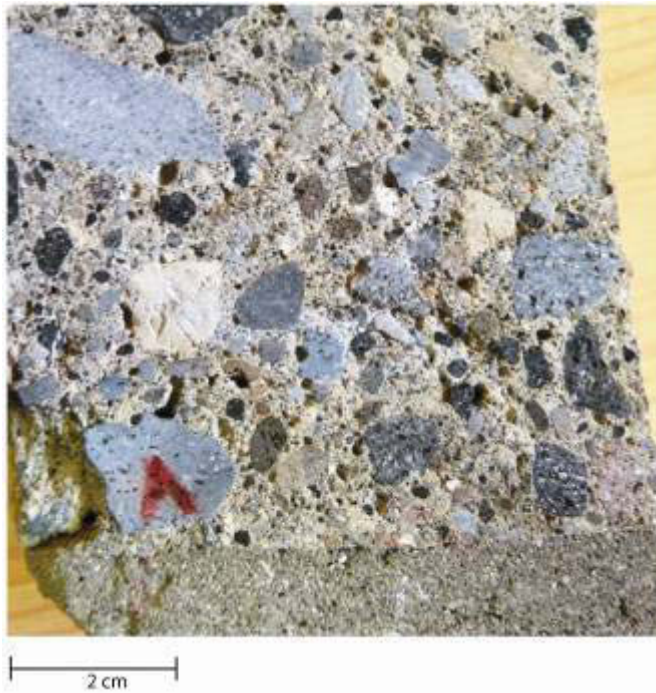
Figure 4.19: Concrete block sourced from a disused building in Arequipa. Note the concrete stucco facing to the bottom of the image.

Concrete blocks (Figure 4.19) were collected in the field and subjected to various laboratory tests (Chapter 1).

The concrete block is a breccia, comprising a multitude of different clasts within a very fine cream matrix (a microbreccia itself), which also includes smaller broken fragments. Sub-rounded to angular basaltic-andesite, andesite, and dacite clasts are common with some ignimbrite, and red-clay brick fragments. Individual clasts are up to 5 cm across in length, with 0.5 cm clasts the most common. Small (<1 mm) holes are present throughout the block where smaller clasts have fallen out, organic material has been lost, or where the concrete has not been mixed thoroughly. The outer, non-cut, edge of the block is rough and uneven. The concrete stucco layer is medium to coarse-grained grey sand with a yellow painted outer layer.

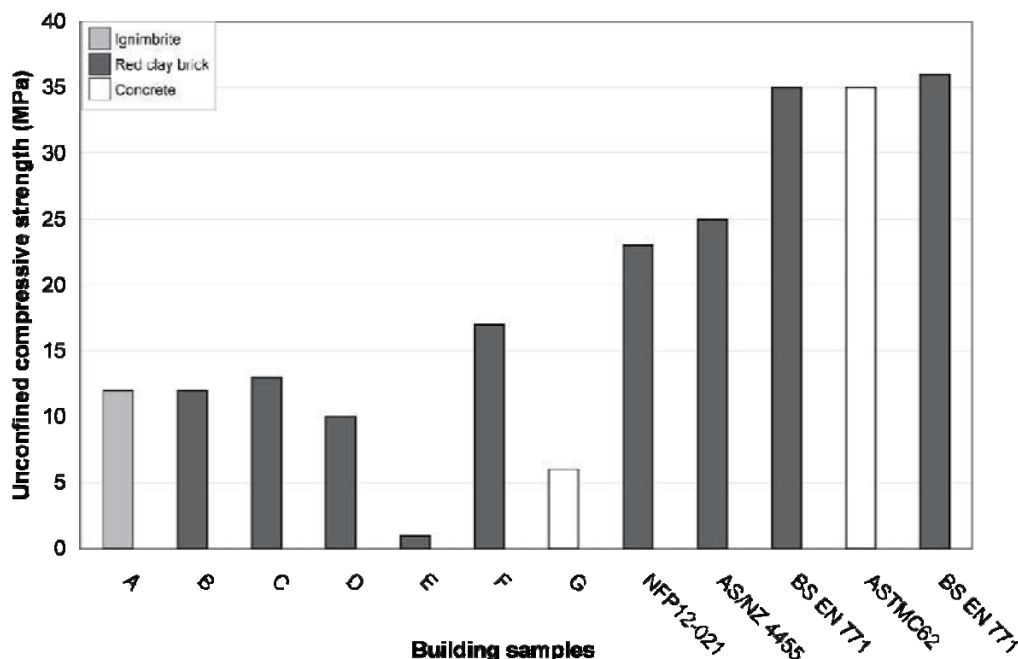
Figure 4.20: Unconfined compressive strength of samples of building material (red clay brick, ignimbrite and concrete block) collected in Arequipa. The strength of these building materials is less than the normal requirements stipulated in building codes from other countries. BS-EN-771 – British Building Code, ASTM C62 – American Building Code, AS/NZ 4455 Australian/New Zealand Building Code and NFP12-021 – French Building Code.

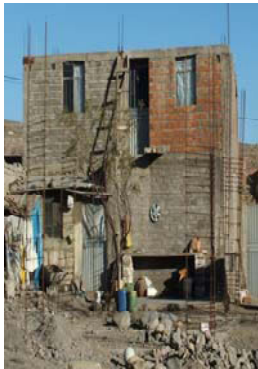
Type F		
<i>Structure:</i>	Confined masonry The same structural components as Type A buildings, however the structure is <u>degraded and unstable</u> . The building is often unfinished or constructed poorly, or has been damaged (e.g. earthquake) and not remedied.

<i>Height:</i>	1-2 storeys.	
<i>Floor:</i>	Same as A.	
<i>Roof:</i>	Roofing is the same as Type A or constructed of corrugated iron. The overall quality is poorer than that of Types A-C. The corrugated iron roofing is often held in place by objects such as rocks and pieces of wood if not nailed in place.	
<i>Openings:</i>	Windows are often small and few with aluminium or wood framing. It is not uncommon for the windows to have no glass or to be boarded up. Security bars not as common as buildings of Types A-C. Doors are constructed of mainly tin/aluminium, and are somewhat flimsy and with or without security.	
<i>Maintenance:</i>	Ground floor and 1st storey constructed from brick with no stucco or paint. Overall long-term evolution of the structure will be negative, and the environment and building are not well kept.

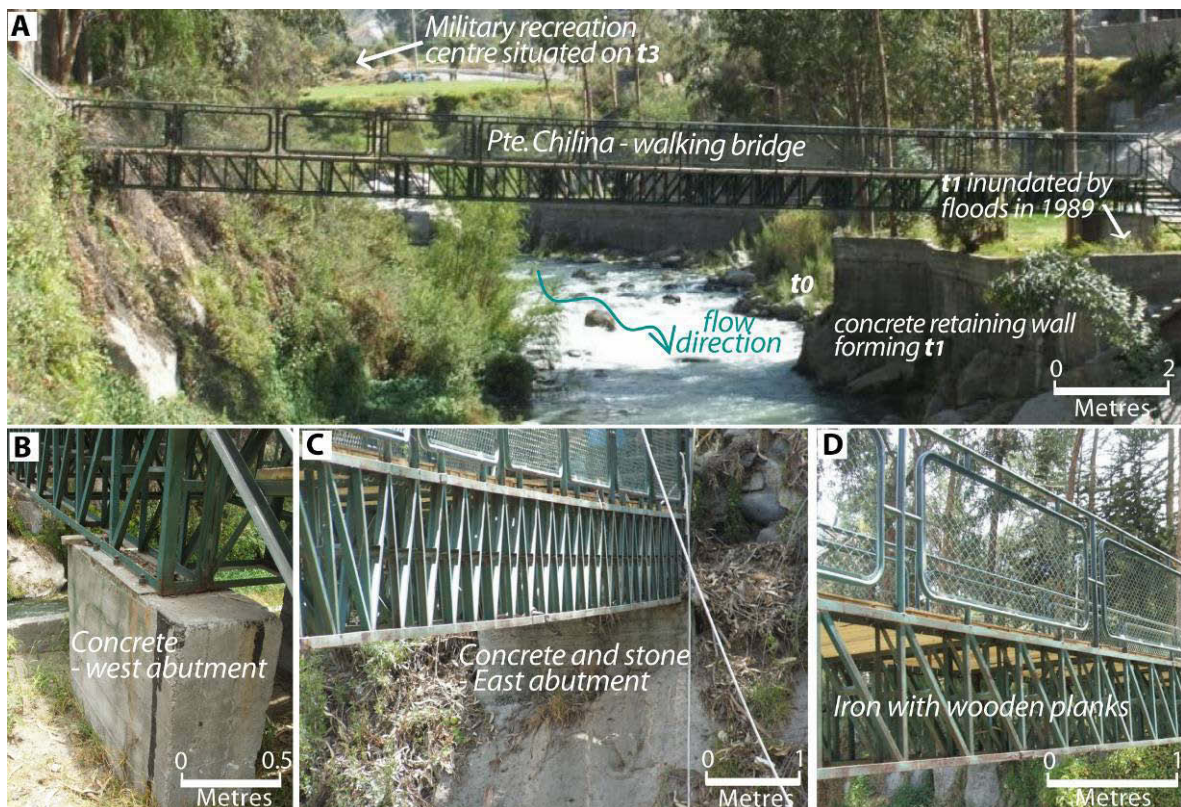
Figure 4.38: *A: Looking upstream at the Chilina Walking Bridge. This bridge connects private land from one side of the river to the other. B: Reinforced cast in-situ concrete east abutment; the steel truss is bolted onto the concrete. C: Reinforced cast in-situ concrete west abutment built flush into the river bank. D: The steel frame truss with wooden plank bridge span.*
