The physical vulnerability of urban areas facing the threat of inundation from lahars and flash floods: application to the case study of Arequipa, Peru

THESE

présentée pour obtenir le grade de
DOCTEUR D'UNIVERSITE
Spécialité : Volcanologie

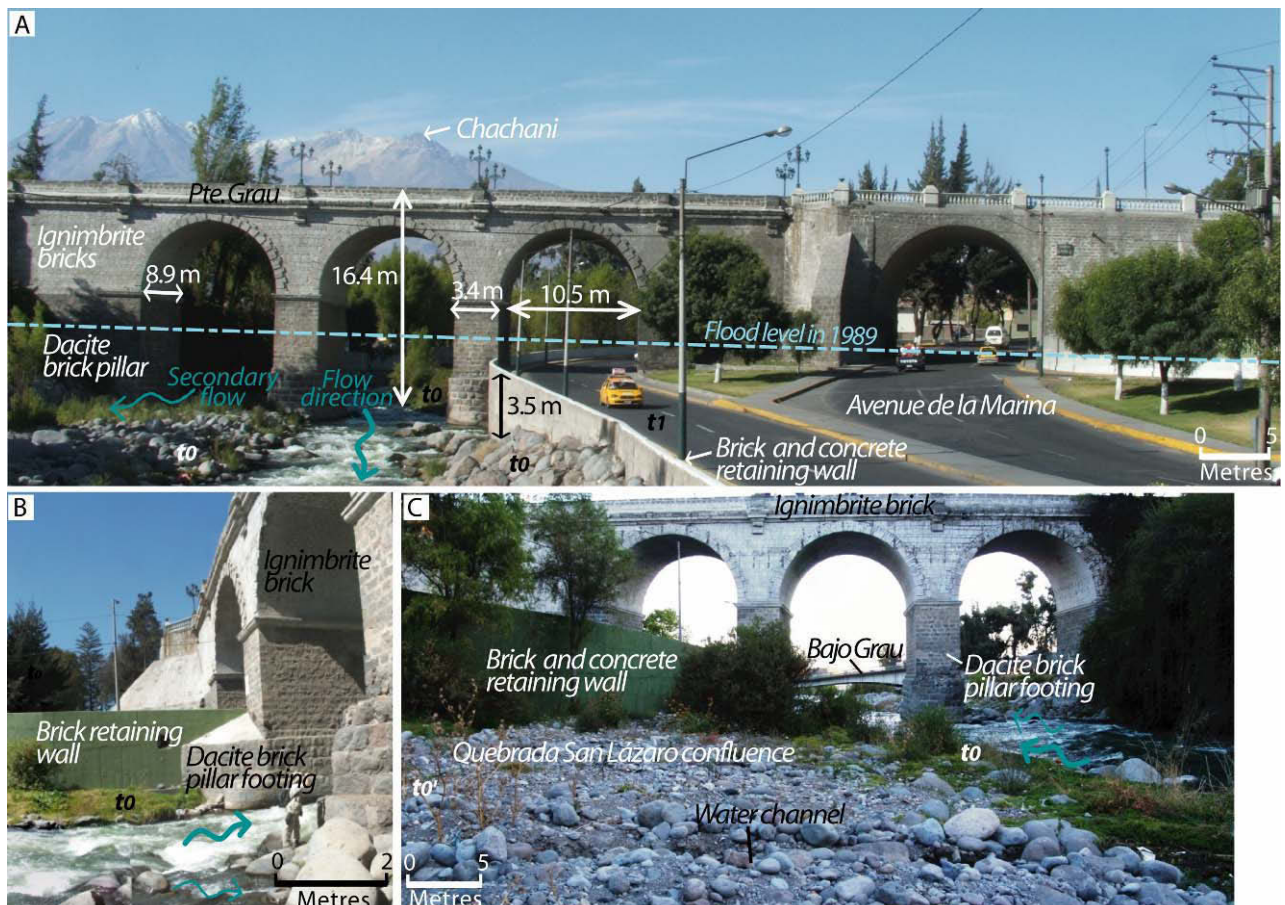
Figure 4.40: The iconic colonial-style ignimbrite masonry multiple span arch bridge ‘Puente Grau’. Note the gradient of the road sloping away from the river. **A:** Downstream view of the bridge crossing the Río Chili. **B:** Upstream view of the large pillars and footings constructed from dacite lava masonry from the western side of the river. **C:** The upstream view of the bridge, from the eastern side, at the confluence with Quebrada San Lázaro.

This is the main, and iconic, bridge of Arequipa City with construction beginning in 1884 and completed by 1898 (Zamacolya and Auregui, 1958) (Figure 4.40). This is a major bridge in Arequipa with heavy vehicular traffic in one direction connecting the historical part of the city in the city centre with communities on the west side of the river, such as Yanahuara.

The bridge is a closed spandrel, stone masonry, multiple span arch in the 'Centro Histórico' part of Arequipa (Young, C; 2009, pers. comm.). The bridge was constructed in a similar manner to the ancient Roman bridges – a stone pier supporting a cut stone arch with bossed facing stones. The stone walls have buttresses to hold back the soil that supports the roadway. There is also a water main connected to the upstream side of the bridge.

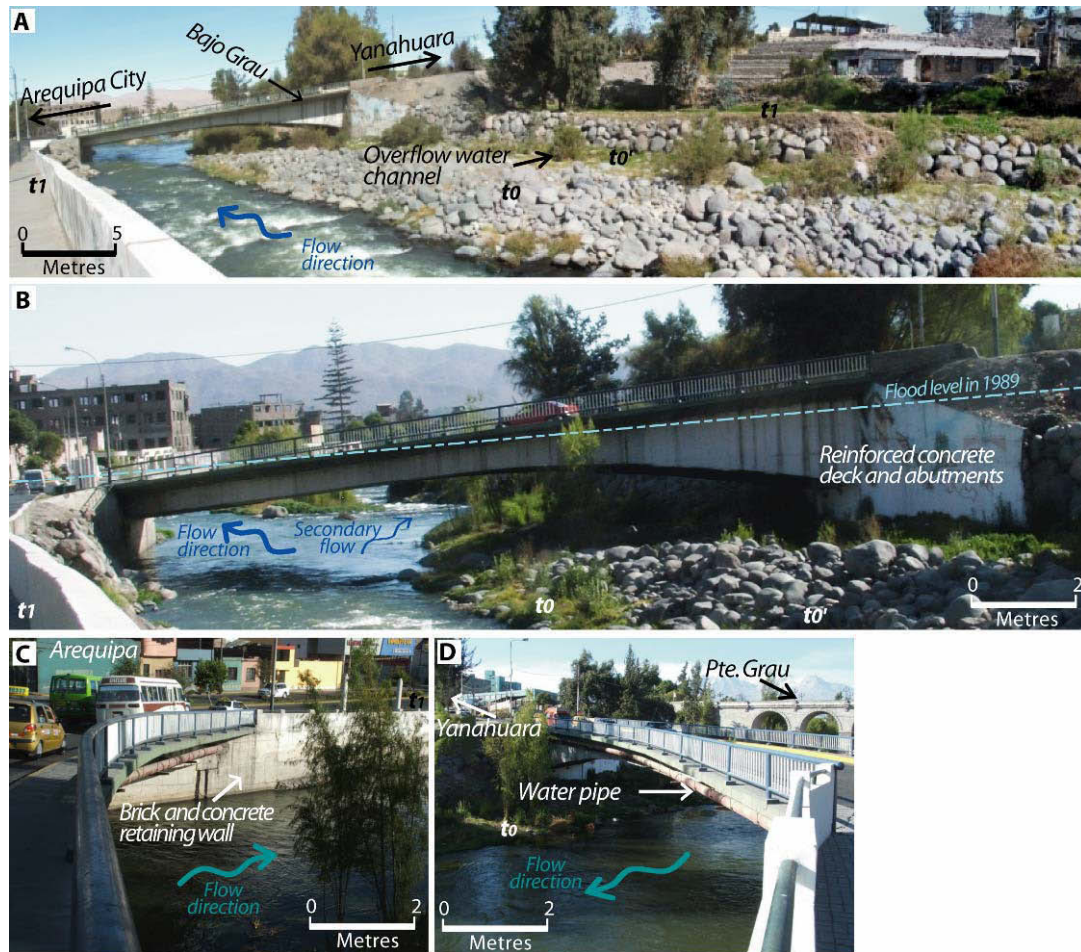
Figure 4.41: *A: Puente Bajo Grau, a one-way bridge connecting the Yanahuara district on the western side of the Río Chili River with the city centre. Note the different terraces on the western channel edge. B: Downstream view of Bajo Grau showing the slope of the bridge deck to the east. C: Curvature of the bridge to the south directing one-way traffic onto Avenue de la Marina. D: View of the bridge westwards towards Yanahuara, face-on to traffic, and Pte. Grau in the background. Note the pipe running under the bridge deck.*

Bajo Grau was constructed in 1989 and is a relatively new bridge compared to others in the region (Figure 4.41). It is a single span cast in-situ reinforced concrete structure with a single half arch of the bridge (Figure 4.41, A – to the right of the image) cast in place and the deck elements may have been precast.

When the bridge was in construction in 1989 it was flooded and was also instrumental in causing flooding to the adjacent road and properties on the east bank (Chapter 2). Water was redirected and debris piled up behind the bridge causing it to be overtopped and forcing the flow through the eastern channel bank where flow heights of 4-5 m were recorded on the lower terrace (t1).

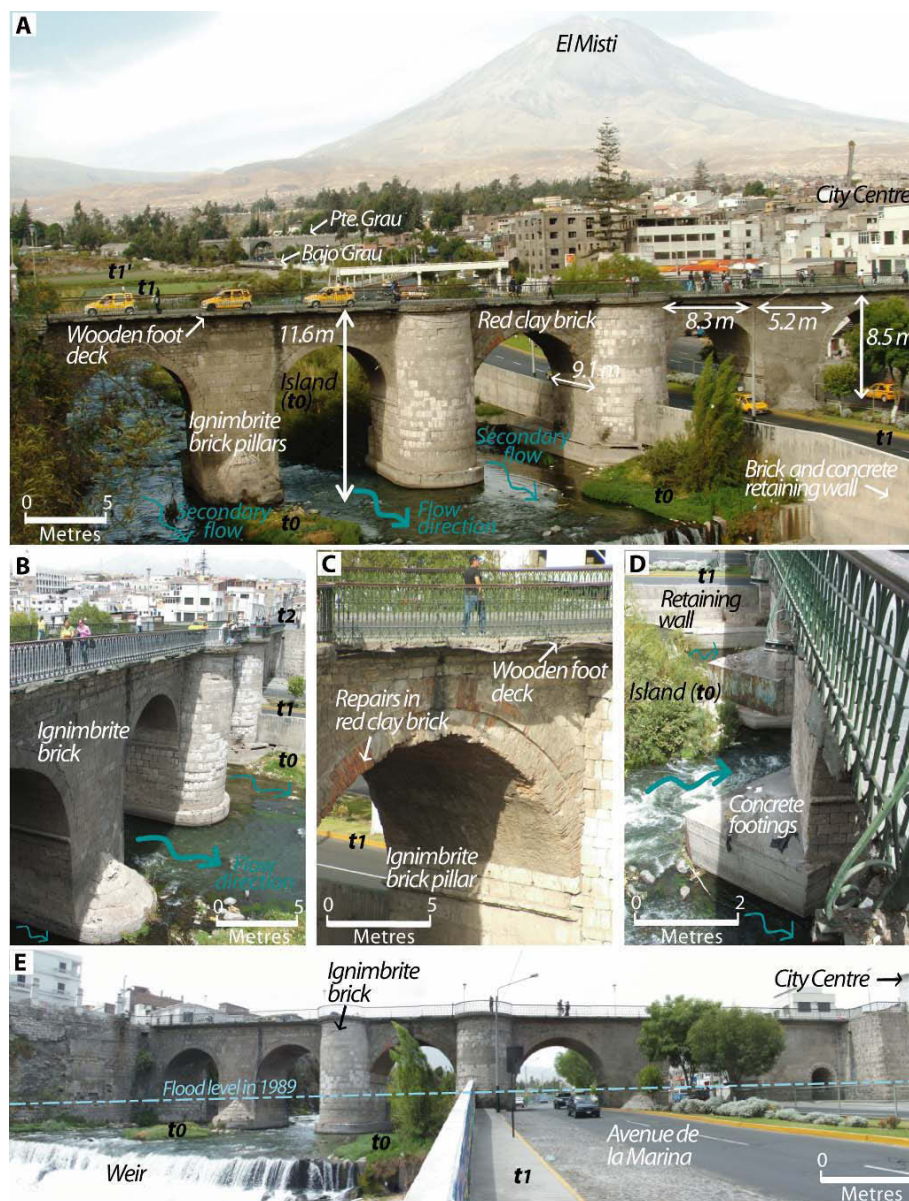
Figure 4.42: A: Downstream view of the bridge and its five arches over the river and highway. B: Downstream view of the bridge. C: Damage and poor repair of the river arch closest to the road, and the uneven footpath which is constructed from wood. D: The large pillars of the upstream side of bridge. E: Downstream view of the bridge at road level, the weir is on the left side of the photograph.

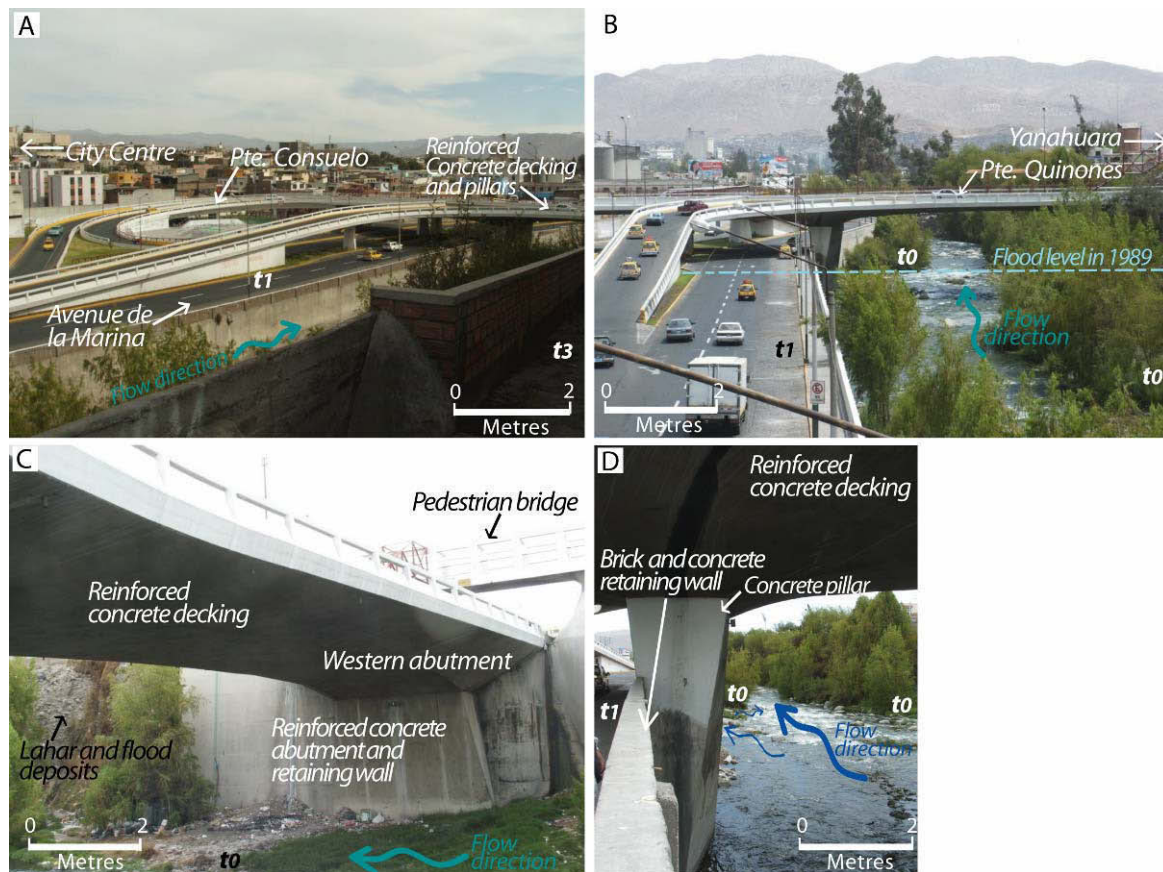
Figure 4.43: *A: Looking downstream to Pte. Quiñones and Pte Consuelo. B: Looking downstream at Pte. Quiñones. C: The western abutment of Pte. Quiñones. D: The middle pier between the Río Chili and Avenida de la Marina on the eastern side of Río Chili*

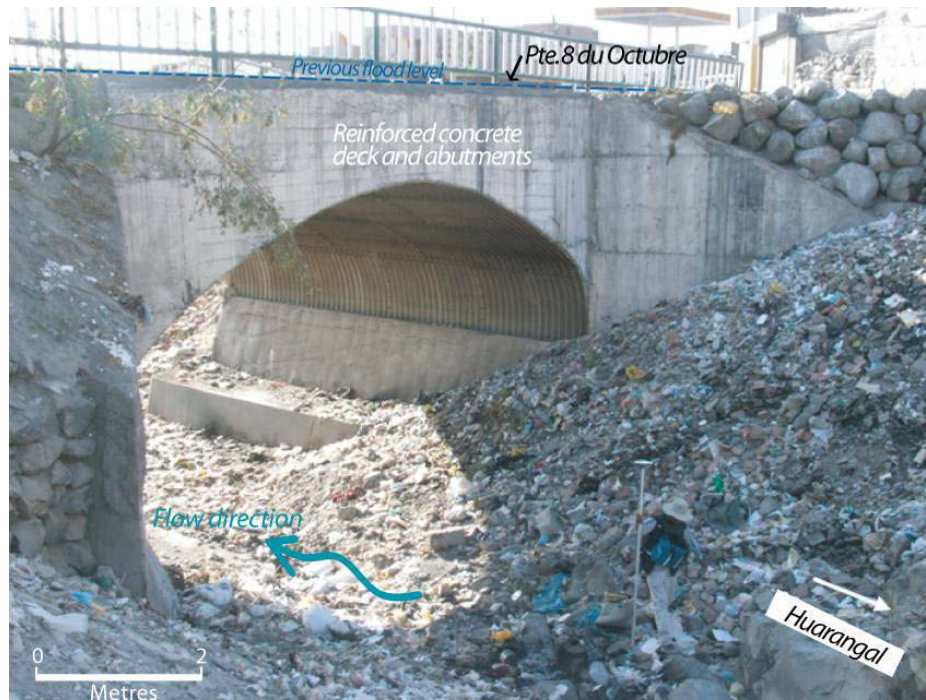
Figure 4.44: Upstream of Pte. 8 du Octubre in Huarangal. Of note is the amount of debris (including sediment, rock, building materials, rubbish) present in the channel. The GPS antenna is 2 m in height.

Located at the western extremity of the Huarangal fan area, this bridge is a single span, semi arch, reinforced cast in-situ concrete structure (Figure 4.44).

This bridge has an exceptionally low deck height of ~4.5 m with a clearing of <2 m above the detritus. This Quebrada is used as a dumpsite and contains a lot of artificial debris in the channel, which would add to sediment in a flow.

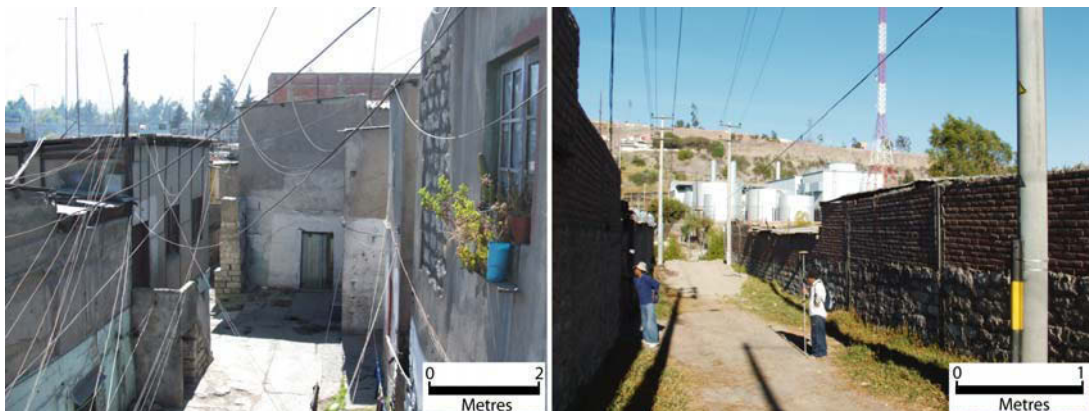
Figure 4.46: *The majority of power is distributed overhead in Arequipa where lines are held up by reinforced concrete and wooden power poles.*

Information of the location of the powerlines in Arequipa could not be obtained, however the majority of power is distributed by overhead lines as evidenced by notes and photographs taken in the field (Figure 4.46). Power poles constructed from reinforced concrete line the main, and most minor, roads within Arequipa. Wooden power poles support the lines on smaller roads, lanes, and rural areas (if power is accessible). Power is passed from building to building on wooden poles as can be seen in the figure below; notably the lines can be chaotically distributed within dense urban areas. The 2007 census determined that 21% of private dwellings within the Arequipa province are without electricity (INEI, 2008).

A sustained flow can result in power poles being pushed over and therefore cutting the power supply. A snapshot taken from video footage of the 1989 hyperconcentrated flow event (Chapter 2) show a reinforced concrete power pole in the city centre being forced over by the strength of the flow. The impact from debris in the flow also threatens the stability of power poles. The variables to power pole strength include construction material and quality, height and width of pole, line load and the foundation depth and quality. The failure of just one pole can result in power outages across a city block or even further afield. As discussed earlier, power supply is an essential and critical element not only for the population but in emergency response. For the vulnerability assessment the distribution of powerlines will be assumed to

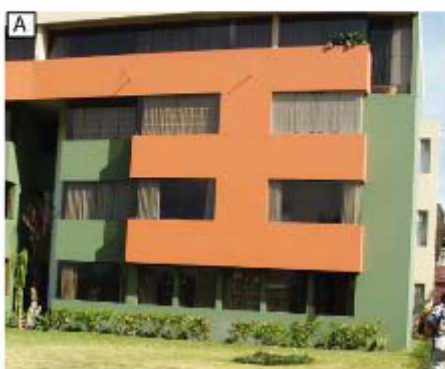
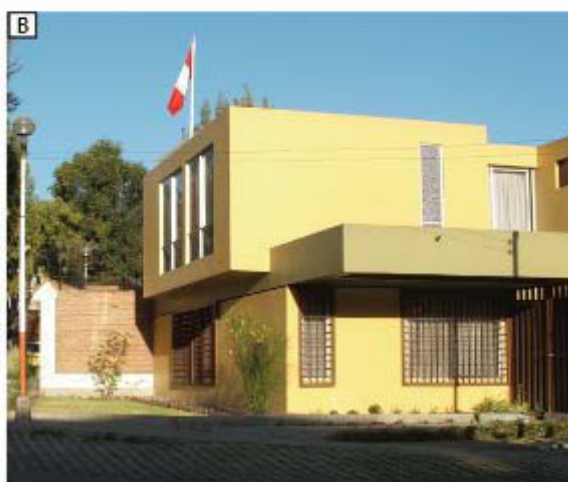
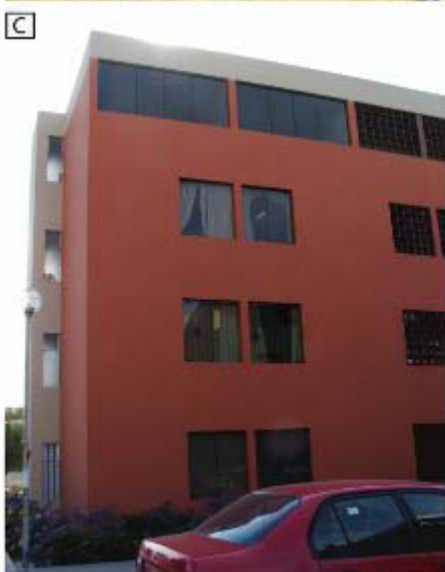
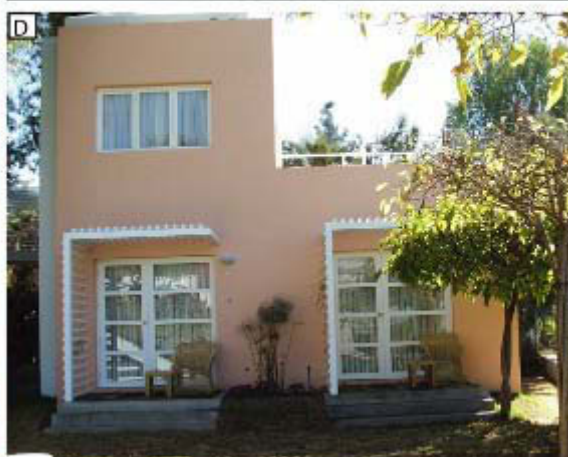
House Type A

- Unconfined masonry panels (unreinforced perforated clay bricks or concrete blocks).
- Cast-in-situ reinforced concrete frames (horizontal and vertical).
- Roof is mostly flat or pitched, reinforced concrete slabs.
- Large glass windows throughout, often aluminium framing secured with steel bars.
- Door generally solid and wooden consisting of steel security screen/bars.
- Building well finished. Painted, fenced, security, well-kept.

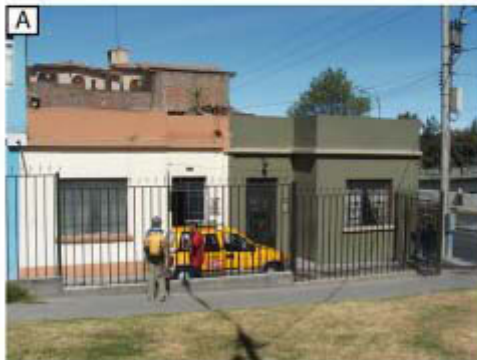
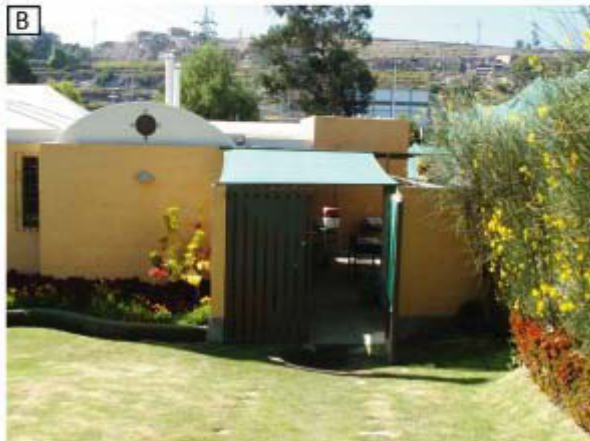
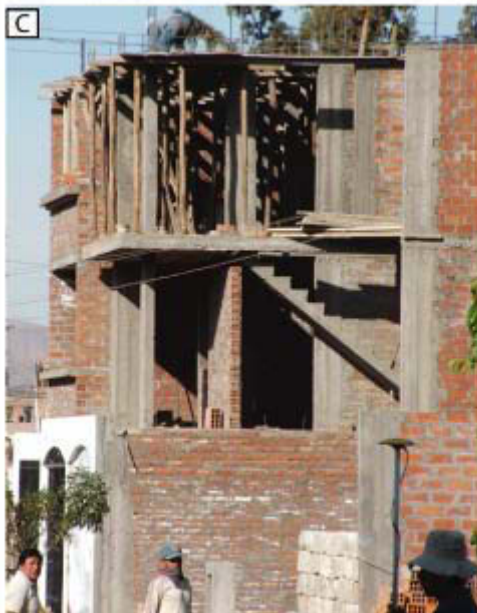
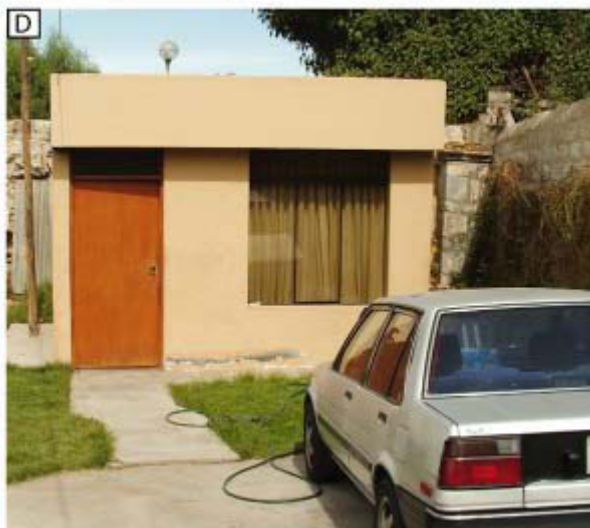
House Type B

- Same structural components as Type A, however structure not complete (even though occupied).
- Often the ground floor is completed.
- Windows, doors and roofs the same as Type A buildings.
- The evolution of the structure is positive.
- House well finished (less so that type A however) with positive evolution.

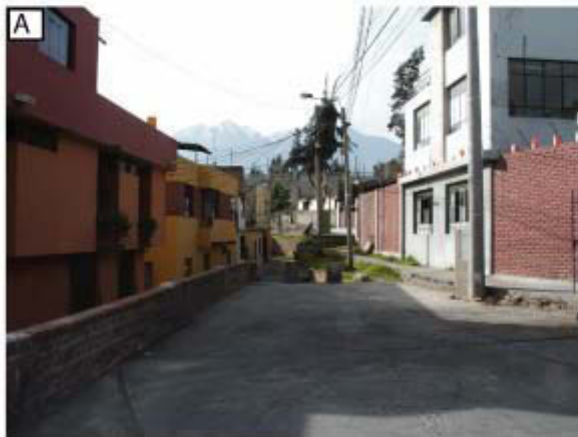
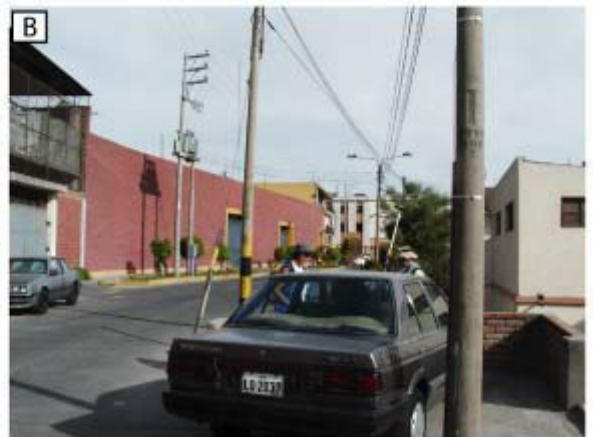
House Type C

- Same structural components as Type A , however vertical extension unfinished, and some material is unstable.
- Windows, doors and roofs often the same as Type A buildings. Roofs maybe be constructed with corrugated iron.
- Overall long-term evolution will be positive, however environment and building not well kept.

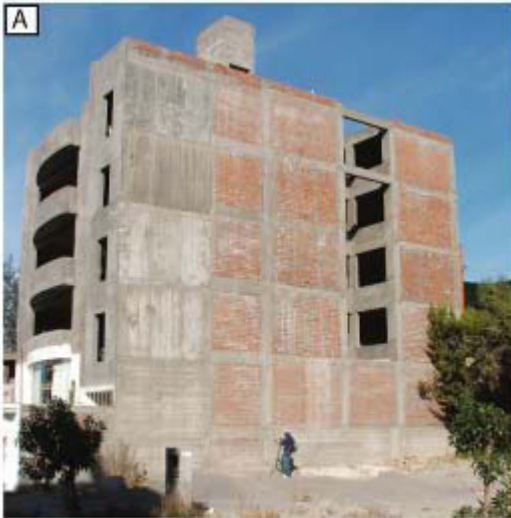
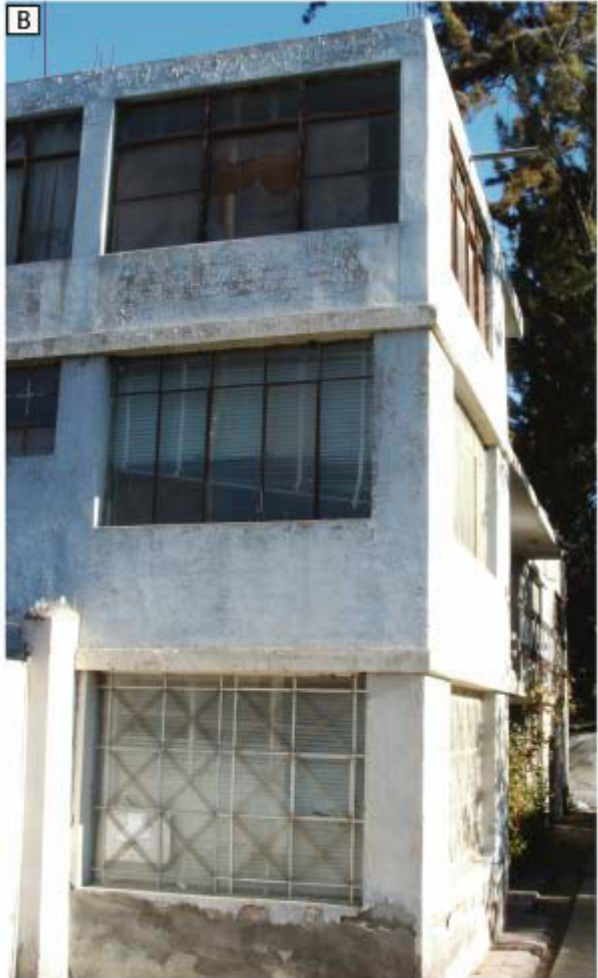
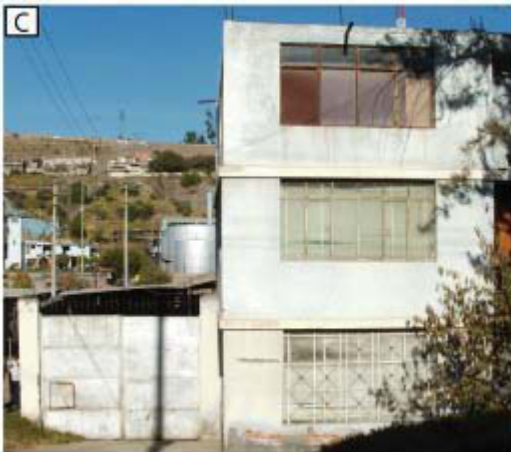
House Type D

- Same structural components as Type A buildings, however building characteristics similar to Type B with incremental and unfinished construction practices.
- 2-4 storeys.
- Vertical extension unfinished and some material that has been used are unstable

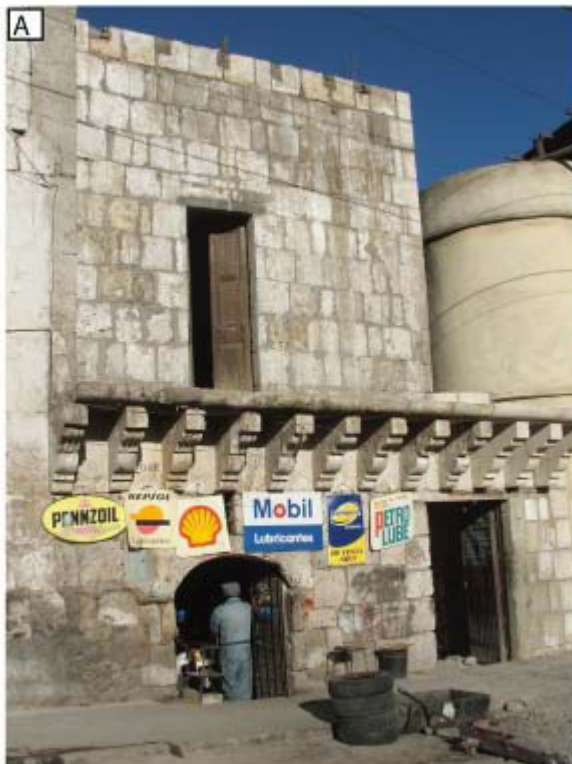
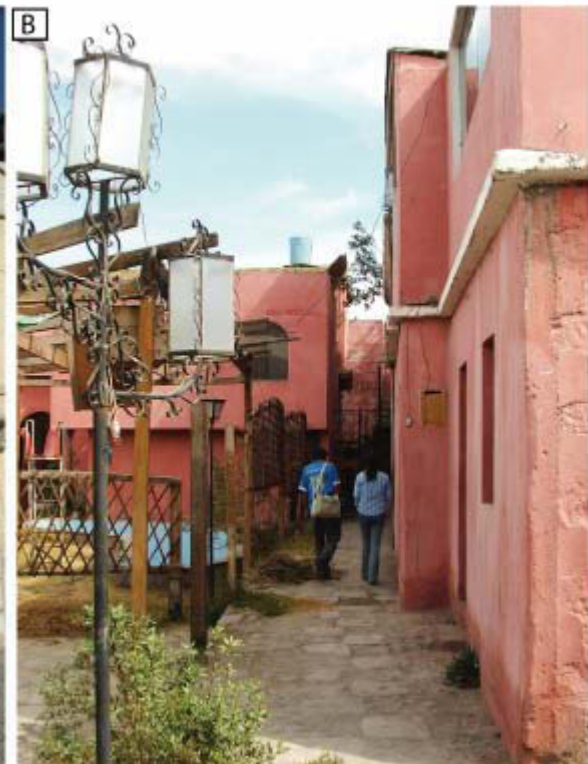
House Type E

- Building is typically colonial style and constructed from ignimbrite brick and/or adobe.
- First storey of building similar to Types B and C.
- The upkeep of the building is poor and can appear 'shabby'. Parts of the building are likely to be unstable.
- Windows tend to be smaller than newer houses constructed in Types A-C.

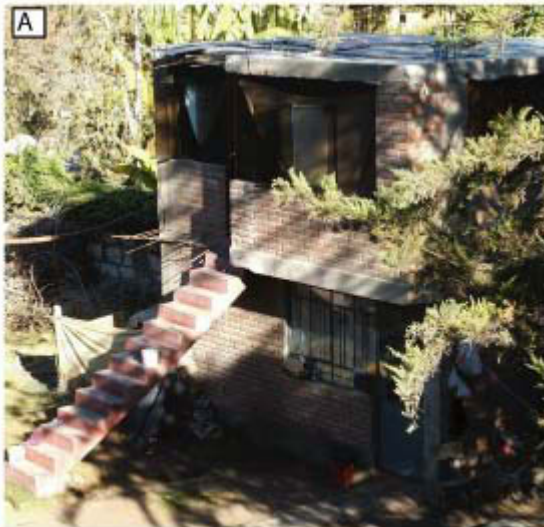
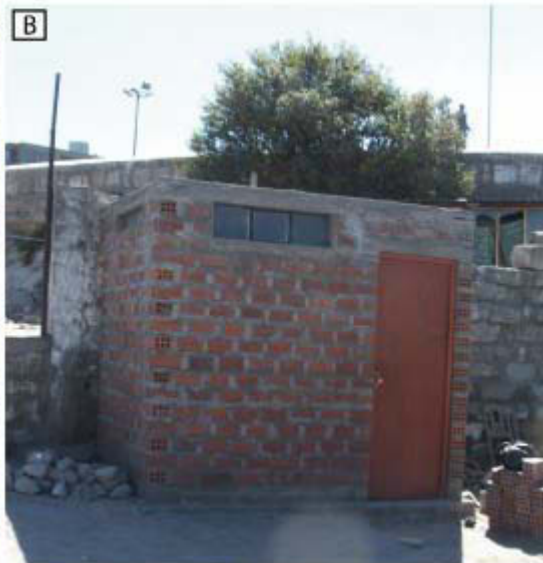
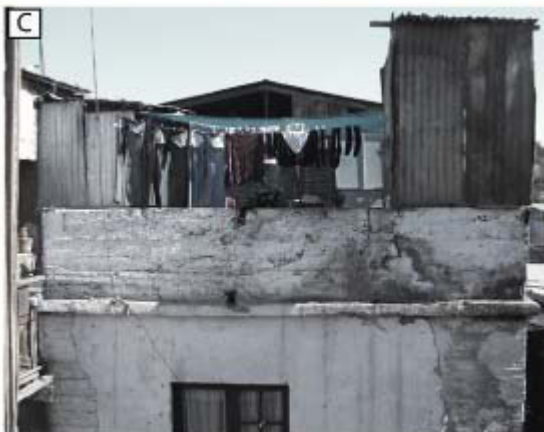
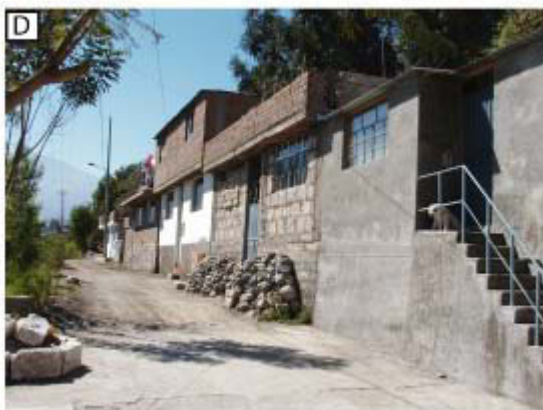
House Type F

- Same structural components as Type A.
- Structure is degraded and unstable, often unfinished or constructed poorly, or damaged (earthquake) and not remedied.
- Windows often small and few, with aluminium or wood framing.
- Doors are mainly tin/aluminium, somewhat flimsy, with or without security.
- Roofs maybe be the same as type A or constructed of corrugated iron. Corrugated iron often held in place by rocks and wood.
- Environment and building not well kept, overall long-term evolution will be negative.

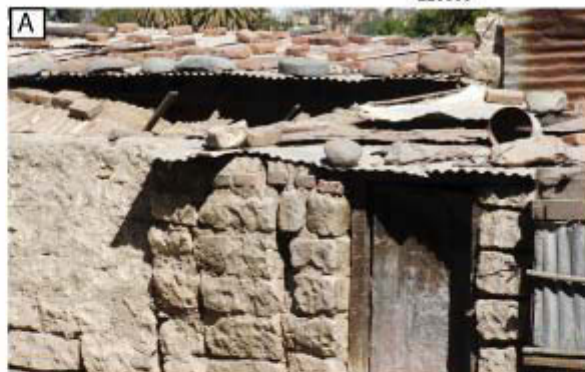
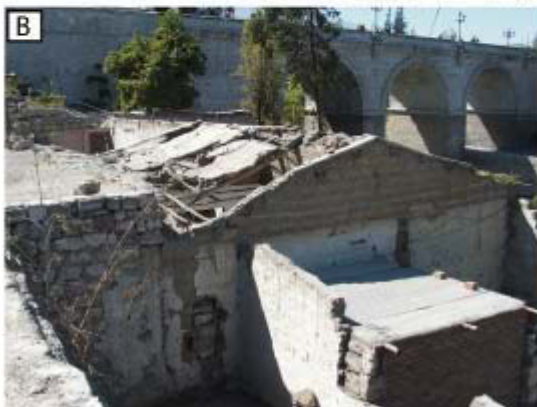
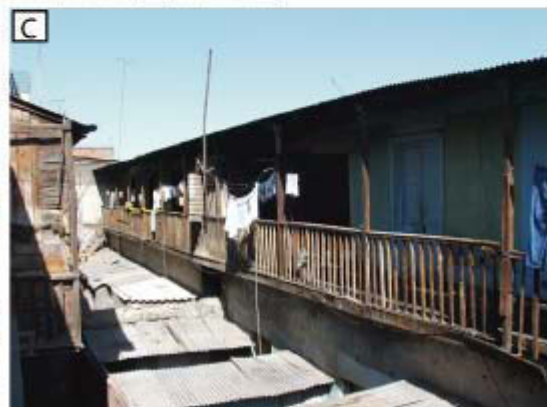
House Type G

- Building comprises of an old base constructed from stones and ignimbrite.
- Walls are ignimbrite, brick or adobe.
- The building is not confined by either reinforced horizontal or vertical cast-in-situ concrete, and in many cases appear quite unstable.
- Roofs typically constructed with corrugated iron placed on wooden rafters and held in place by rocks, bricks, wood etc. in some cases they are nailed into place.

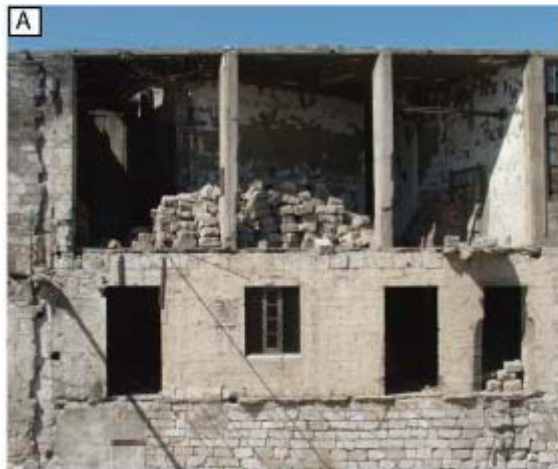
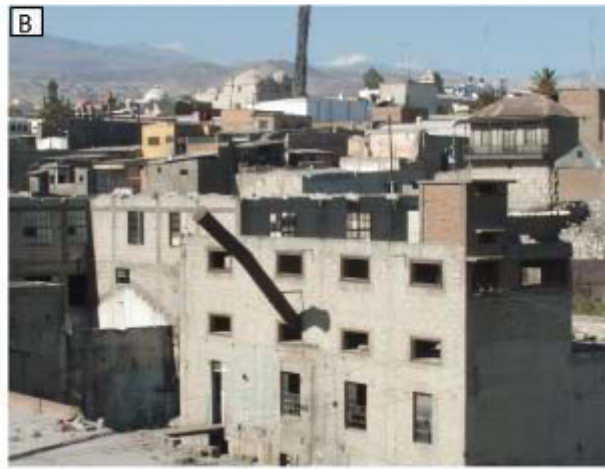
House Type I

- Abandoned and destroyed housing.
- Some destroyed in the 2001 earthquake and never rebuilt or cleared.
- Unsafe, unstable with squatters.
