Socio-cultural characteristics and policies vis-à-vis seismic risk reduction through post-quake rural reconstruction : a case study of Azad Jammu and Kashmir, Pakistan

THÈSE / UNIVERSITÉ DE BRETAGNE OCCIDENTALE

DOCTEUR DE L'UNIVERSITÉ DE BRETAGNE OCCIDENTALE

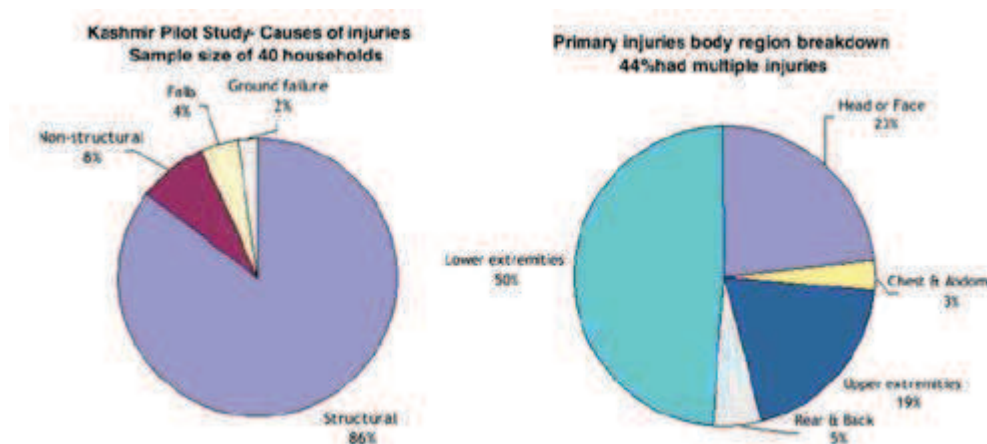
Figure 4.19 — : Data on causes and types of injuries from pilot study of survivors of Kashmir earthquake (Source : [Spence, 2007])

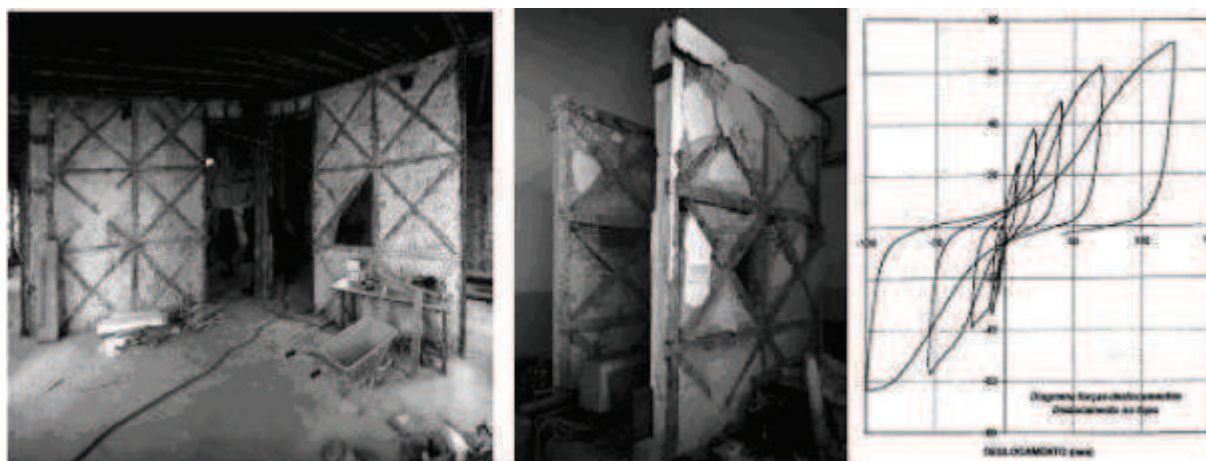
Figure 5.15 — Left : 18th Century building in central Lisbon showing "Pombalino gaiola" construction, 2003. Centre : Gaiola wall sections from a late 18th or early 19th C. building after having been tested. Right : Hysteresis diagram from one of the wall tests of the walls in both left figures ([Langenbach, 2007])

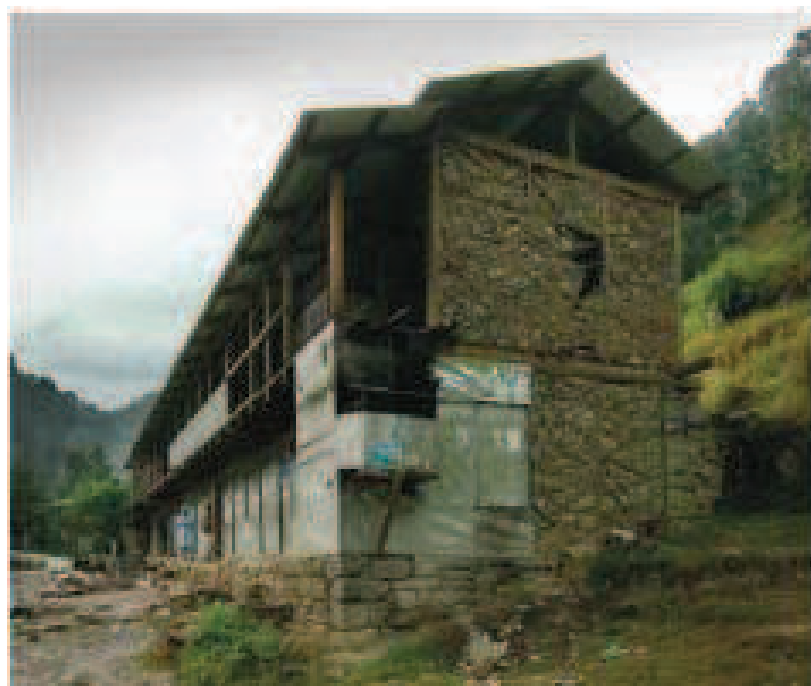
Figure 5.16 — Minor damage was observed in this building after the earthquake. Photo
Source : [Langenbach, 2009]

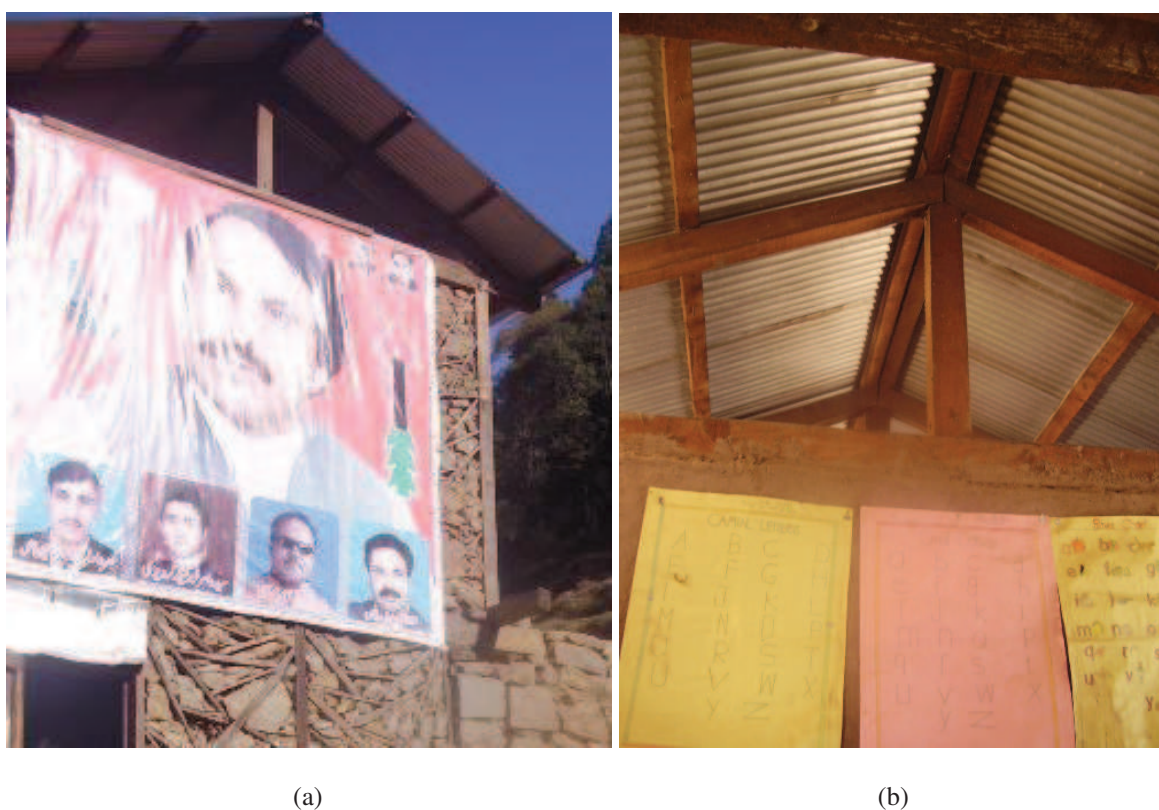
Figure 5.22 — Outside and inside views of the roof. it is not only open to the outside ; also it decreases the inner temperature because of its height. Source : S. Abidi

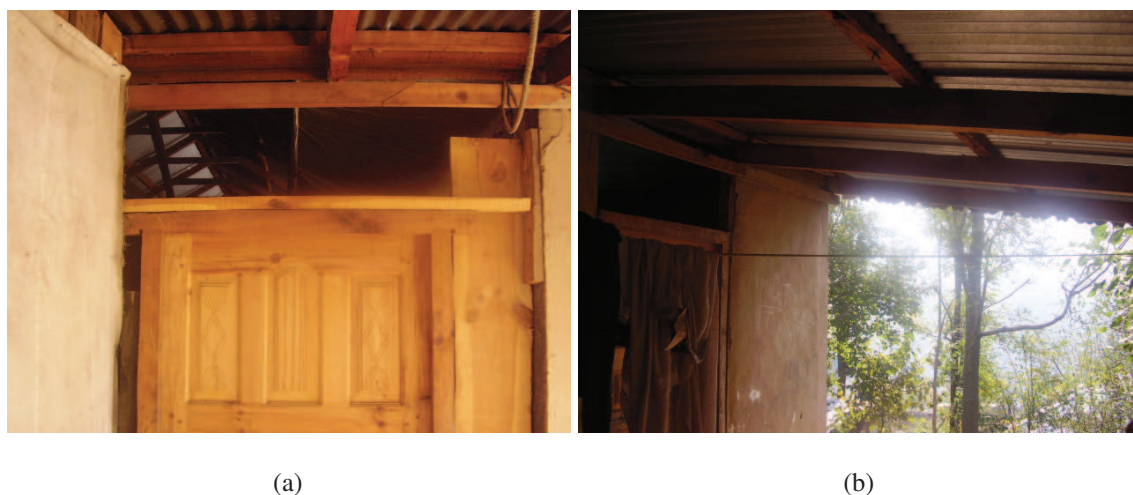
Figure 5.25 — : Opening above the doors. Source : S. Abidi.

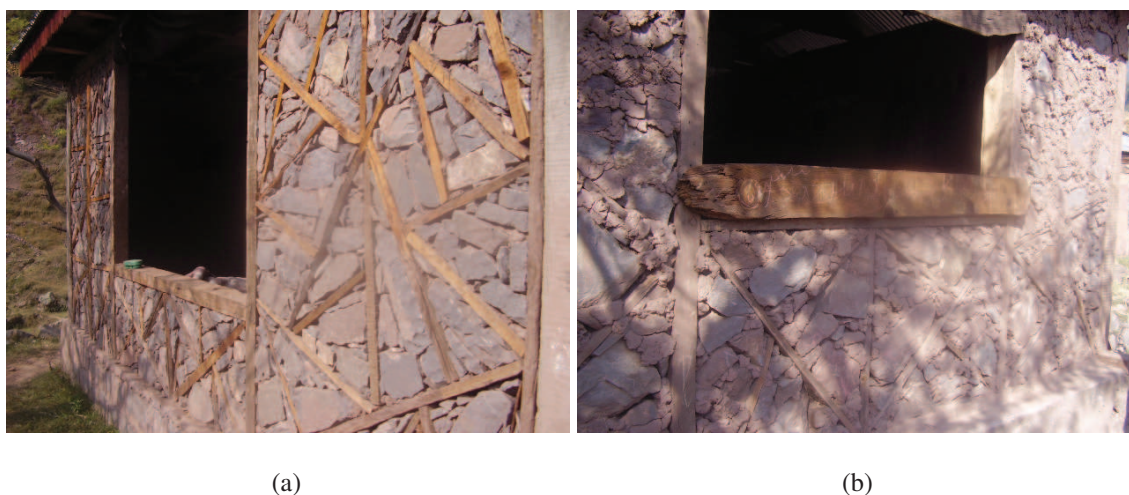
Figure 5.26 — Exposed dhajji walls. Source : S. Abidi.

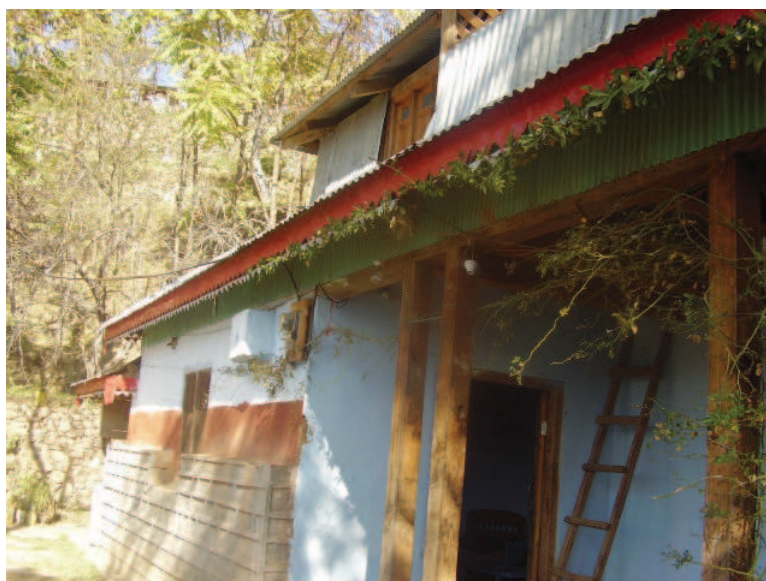
Figure 5.35 — Concrete blocks are not part of the structure. Source : S. Abidi.

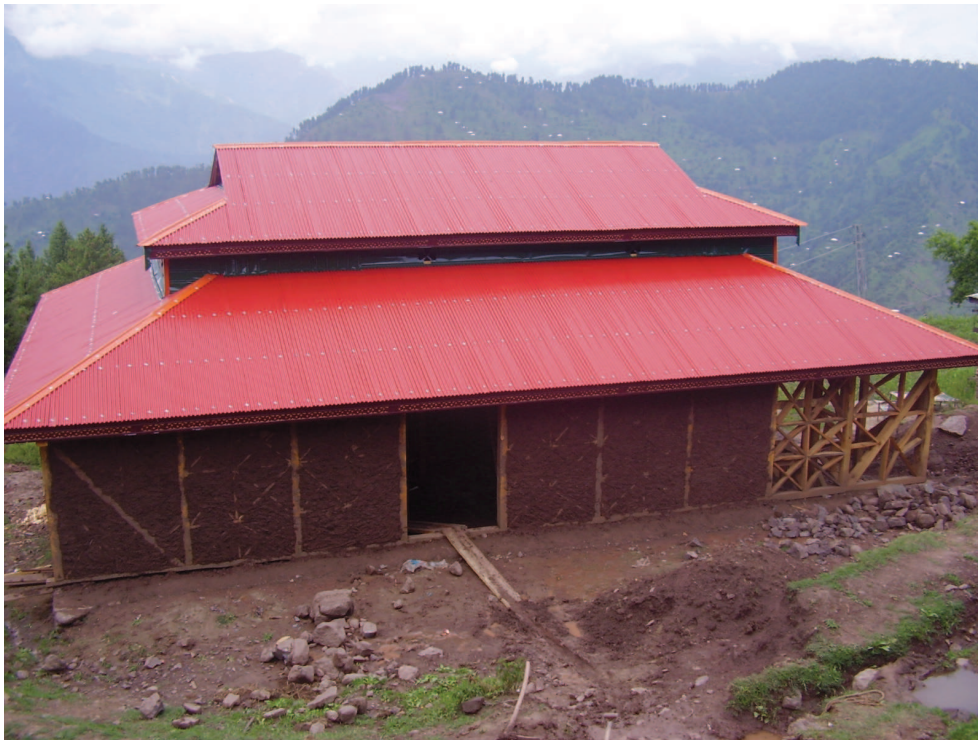
Figure 6.1 — A type of tower roof. Source : S. Abidi

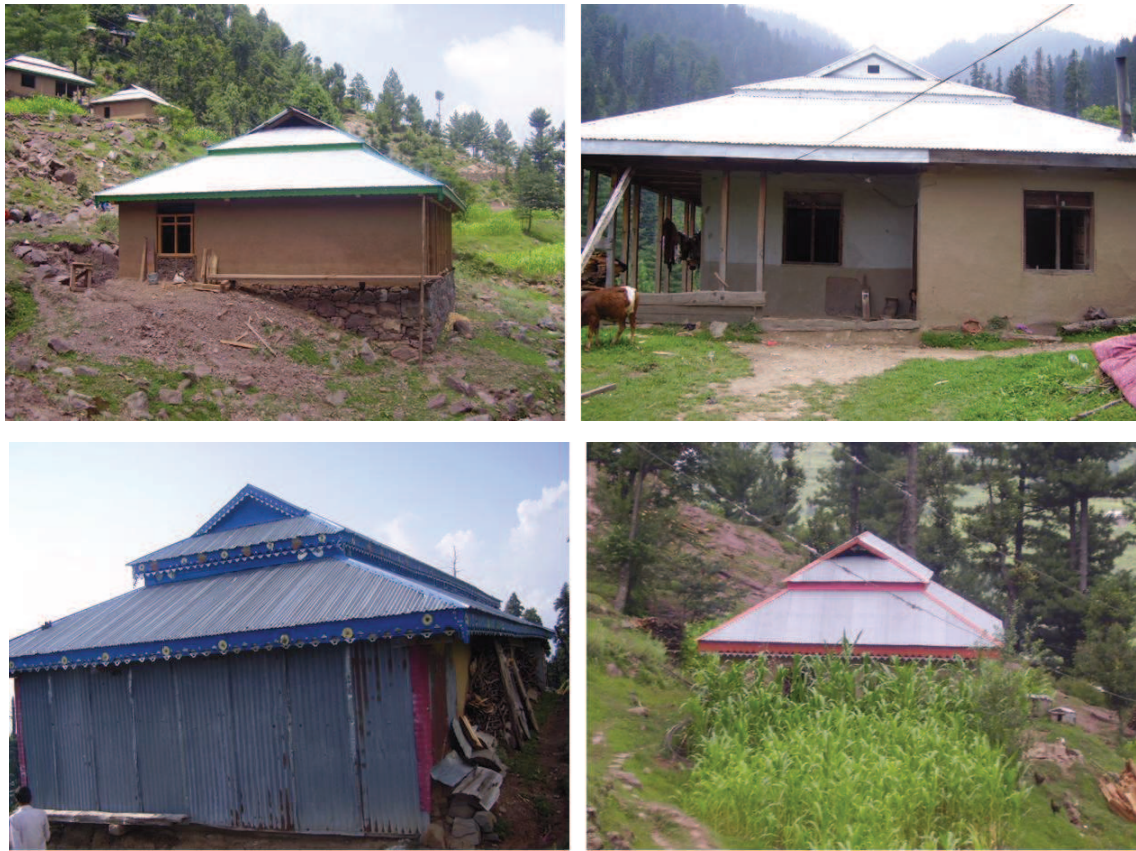
Figure 6.31 — Negligible break dutch gable roof. Source : S. Abidi

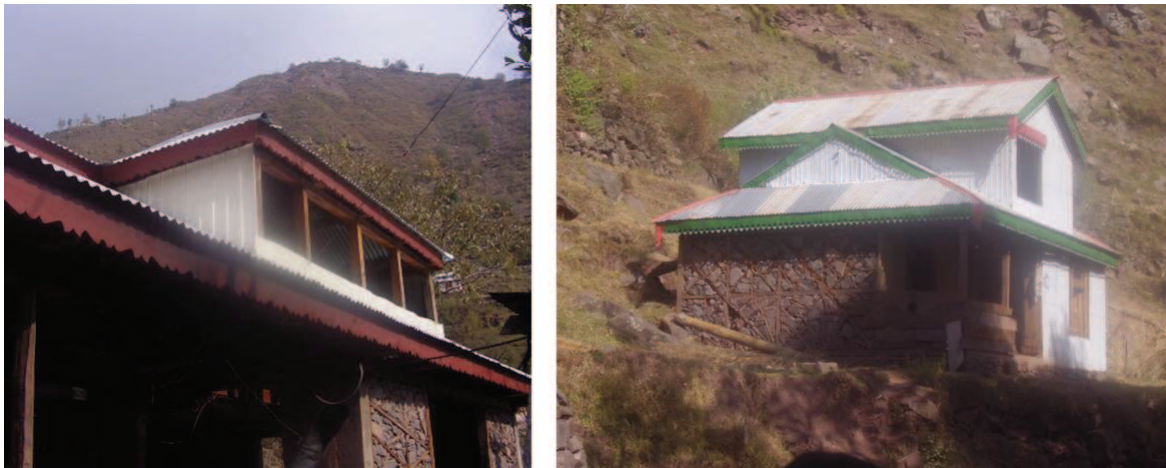
Figure 6.46 — Tower roof houses showing dhajji dewari on ground floor. the upper structure is covered with CGI sheets and is distinctly framed out of ground floor. Source : S. Abidi

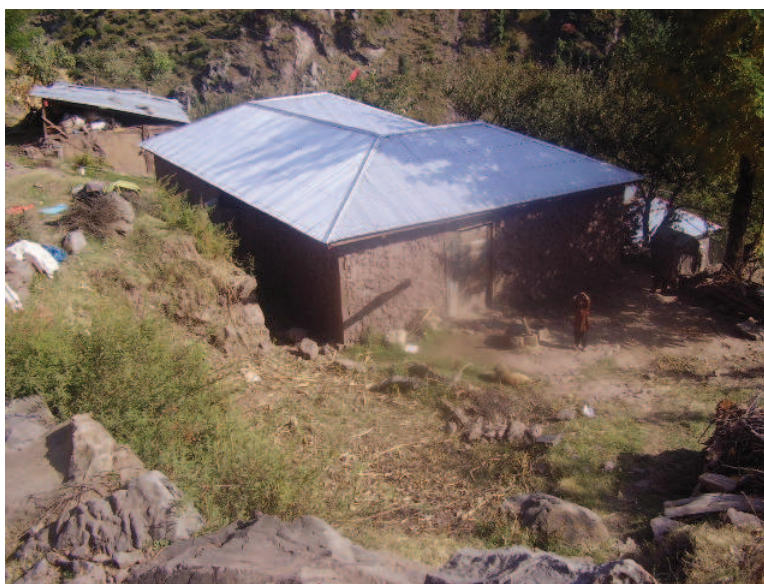
Figure 6.52 — A reconstructed single storey house truly following erra’s guidelines. source : S. Abidi

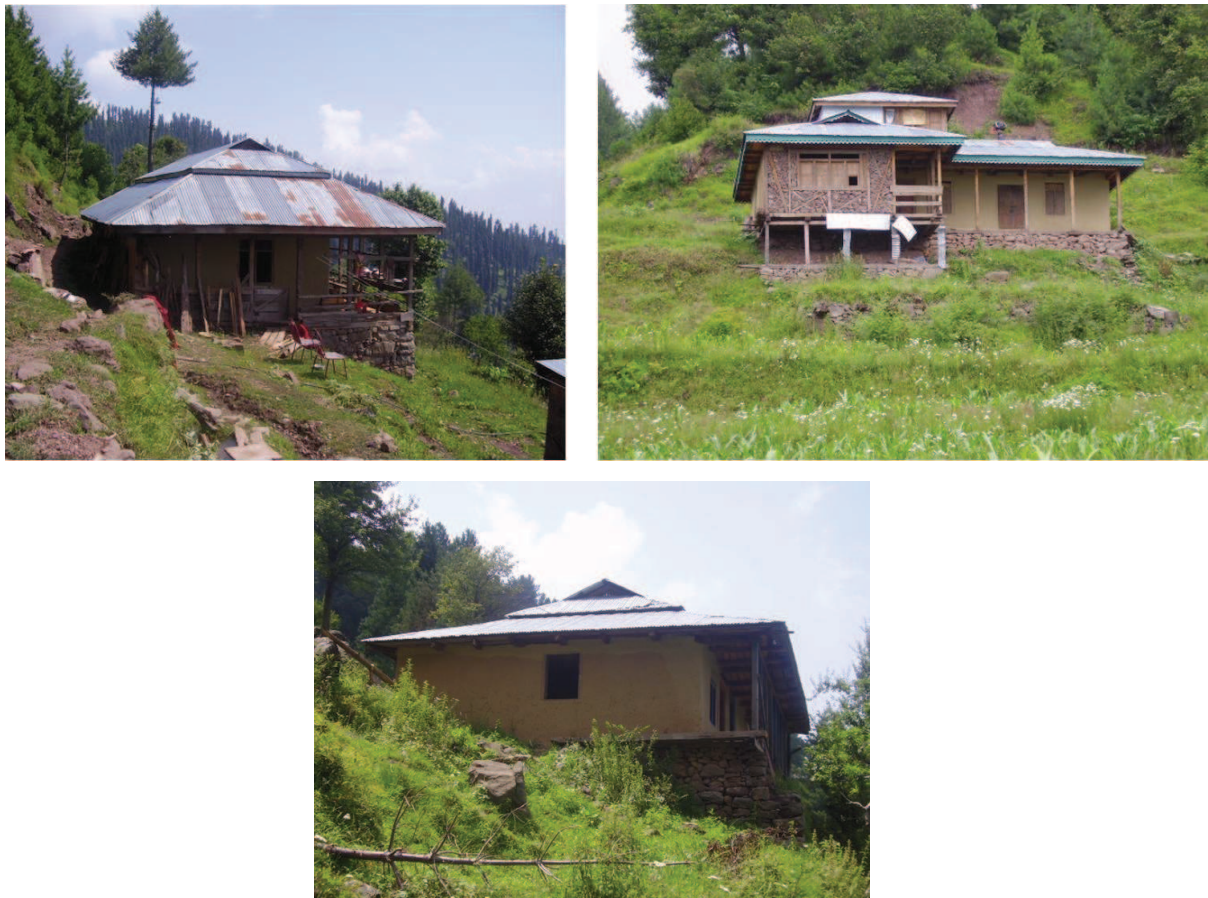
Figure 6.83 — People have built on hazardous sites. Source : S. Abidi.

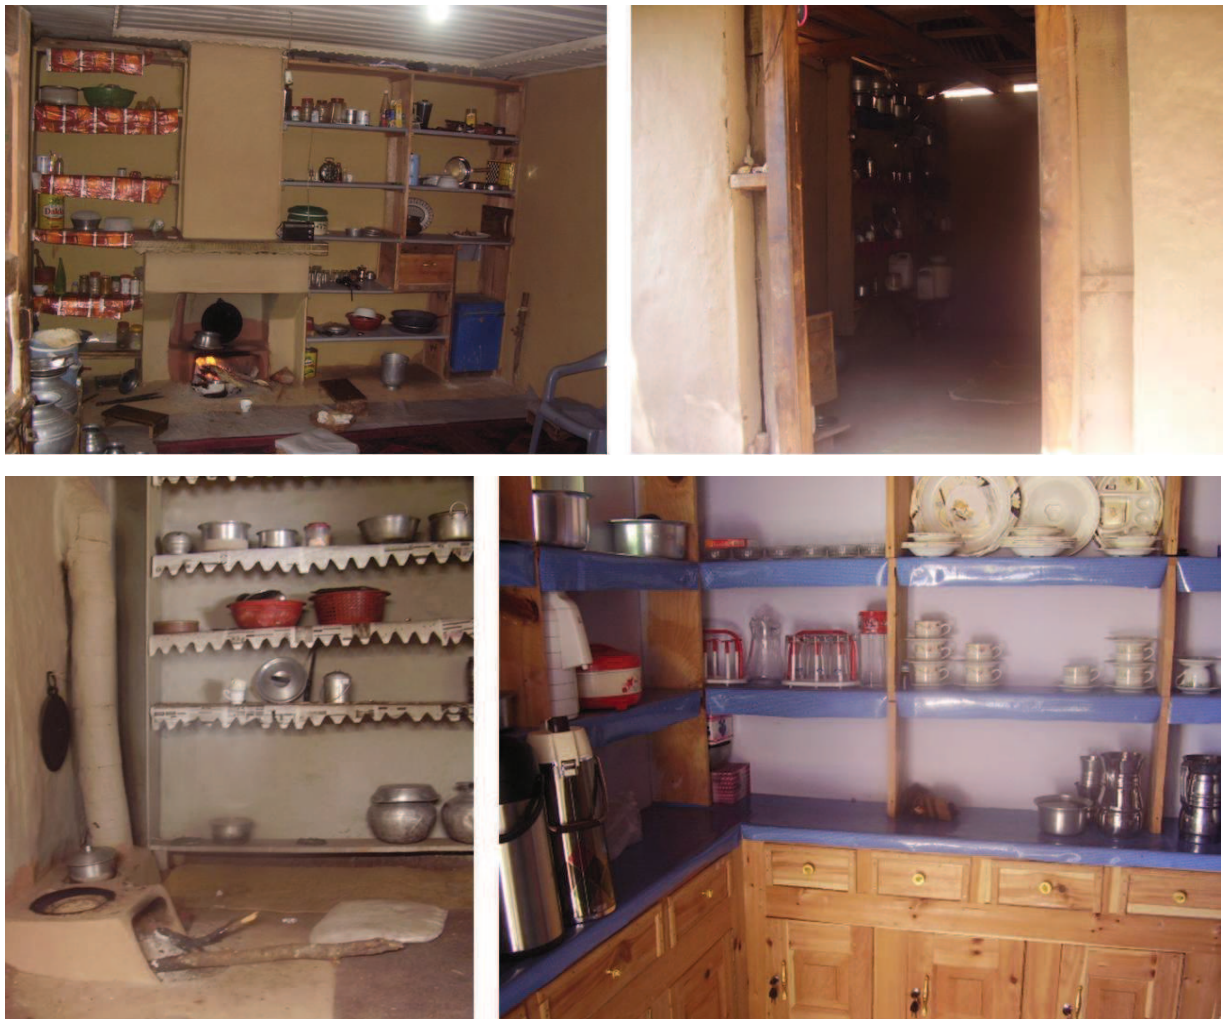
Figure 7.8 — Wooden Cupboards fixed on the walls can affect the performance of dhajji under earthquake. Source : S. Abidi

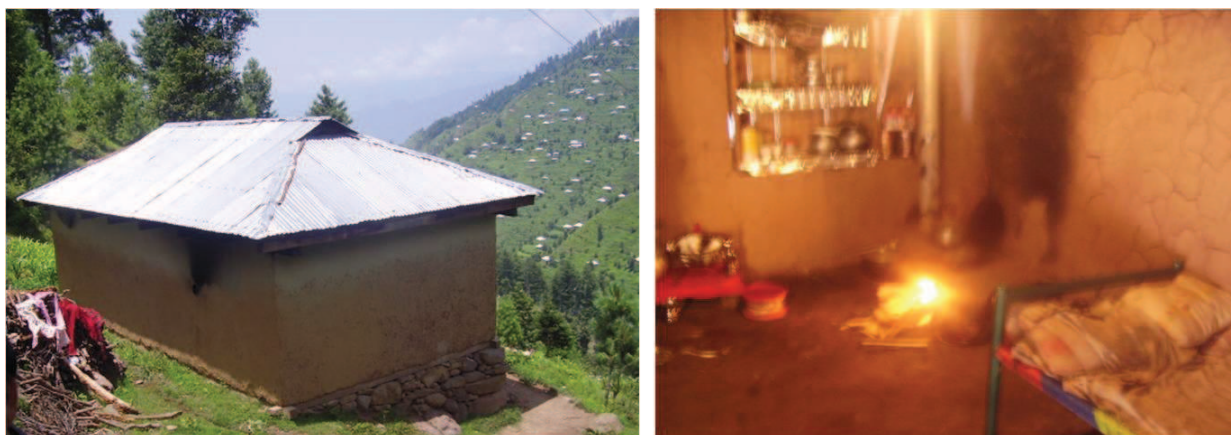
Figure 7.9 — Smoke Stains are evident on the inner and outer sides of the wall. Source : S. Abidi

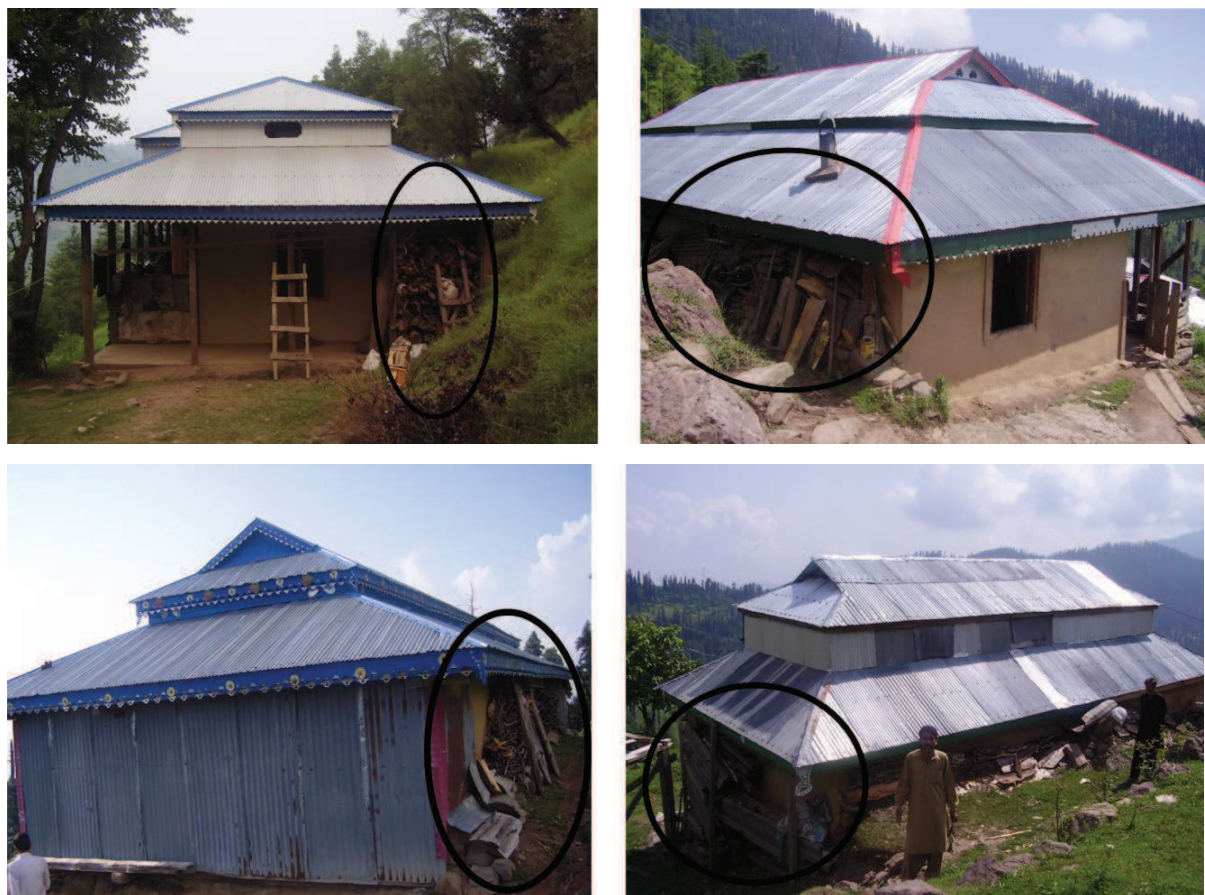
Figure 7.16 — Timber is stored beside the dhajji wall hence making the structure susceptible.

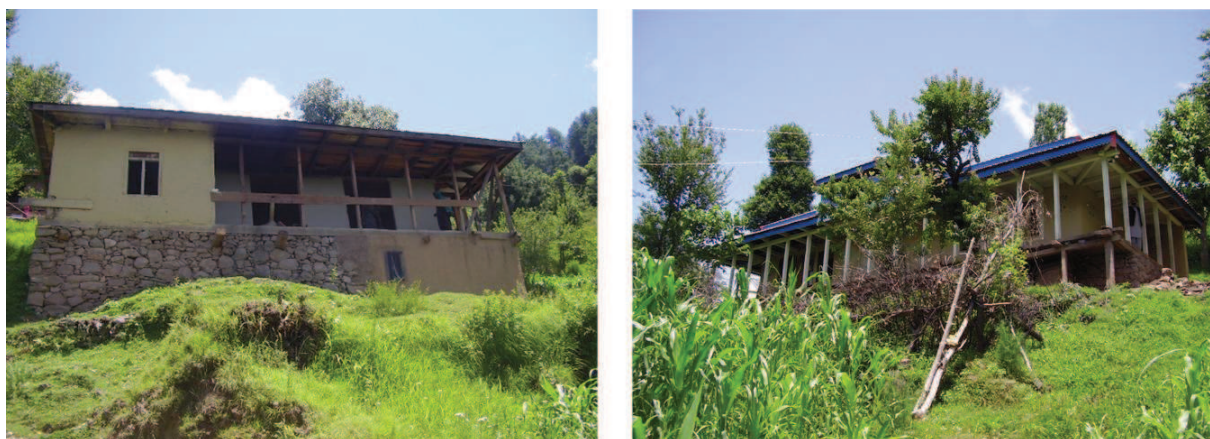
Figure 7.24 — Issues of the sight in reconstructed houses. Source : S. Abidi

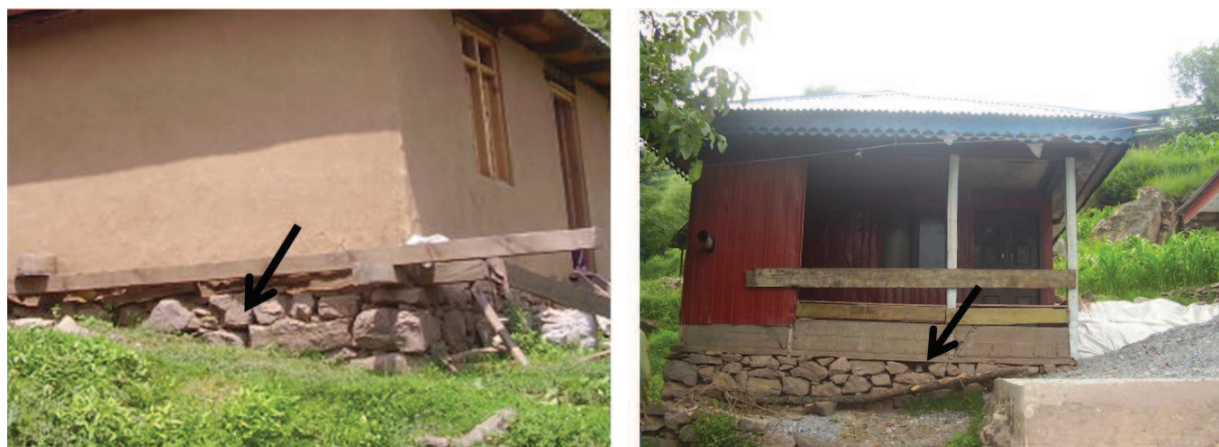
Figure 7.29 — During surveys, gaps were found in the plinth. Source : S. Abidi.

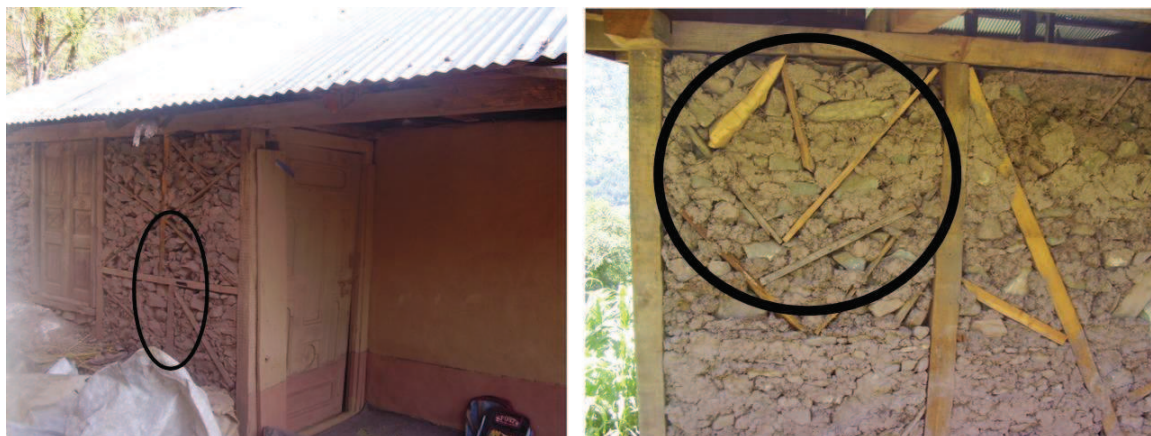
Figure 7.34 — Left : Discontinuous stud ; Right : No connection between bracings. Source : S. Abidi

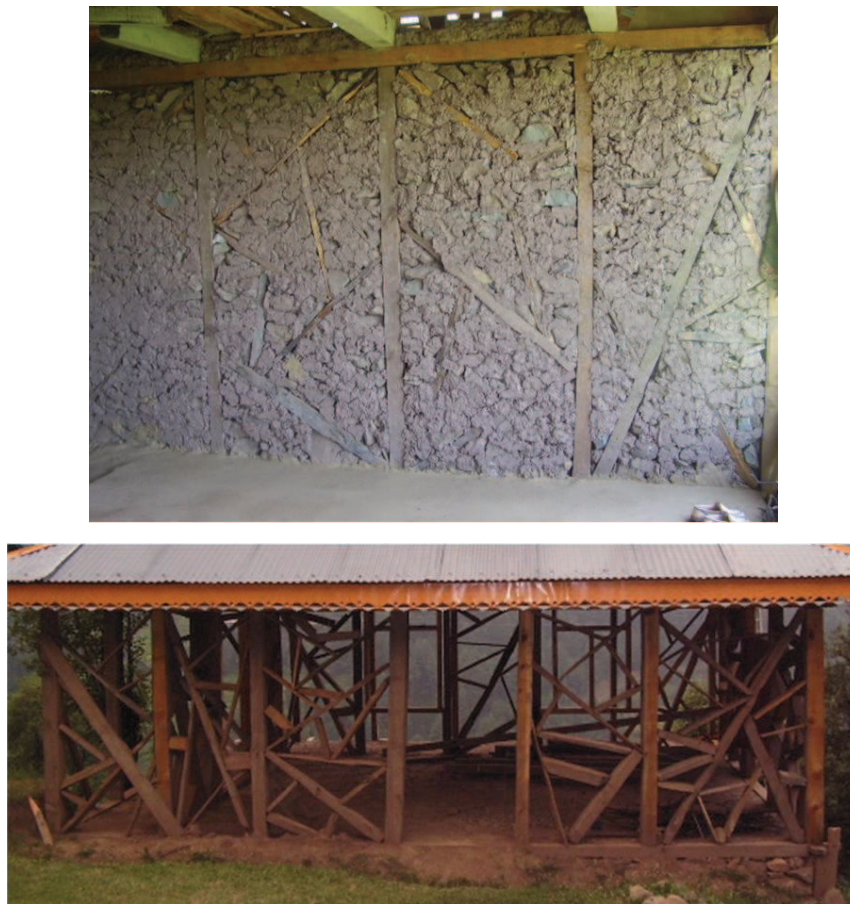
Figure 8.23 — Retaining wall and bracing members issues. Source : S. Abidi

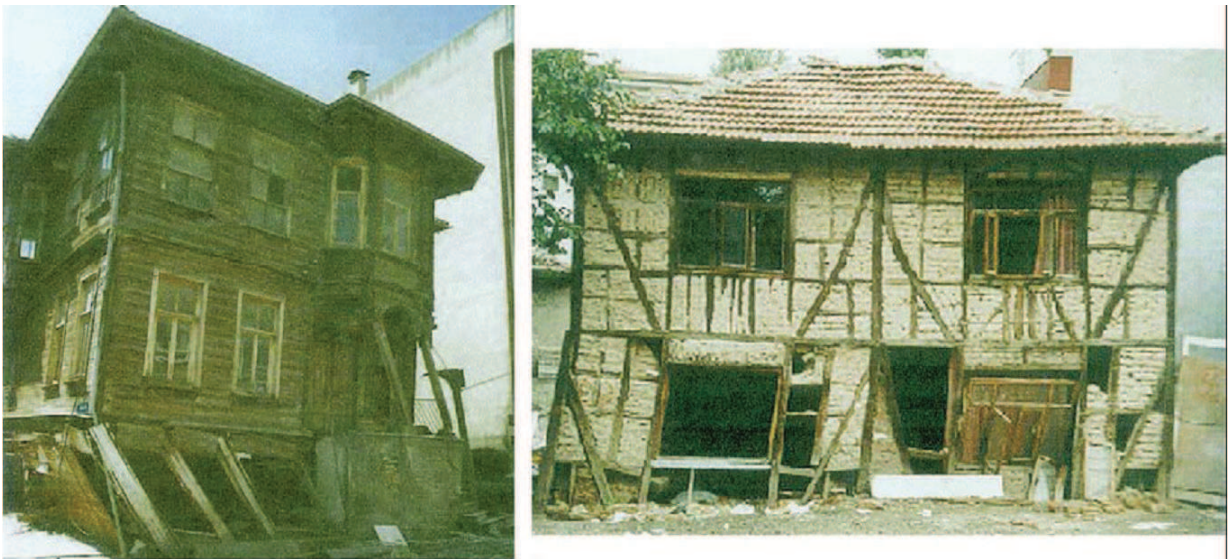
Figure 8.28 — Heavily damaged traditional wooden buildings due to soft storey. Left : Large laterally displaced traditional building ([Bayulke, 2004]) ; Right : Laterally displaced traditional building ([et al, 1999])

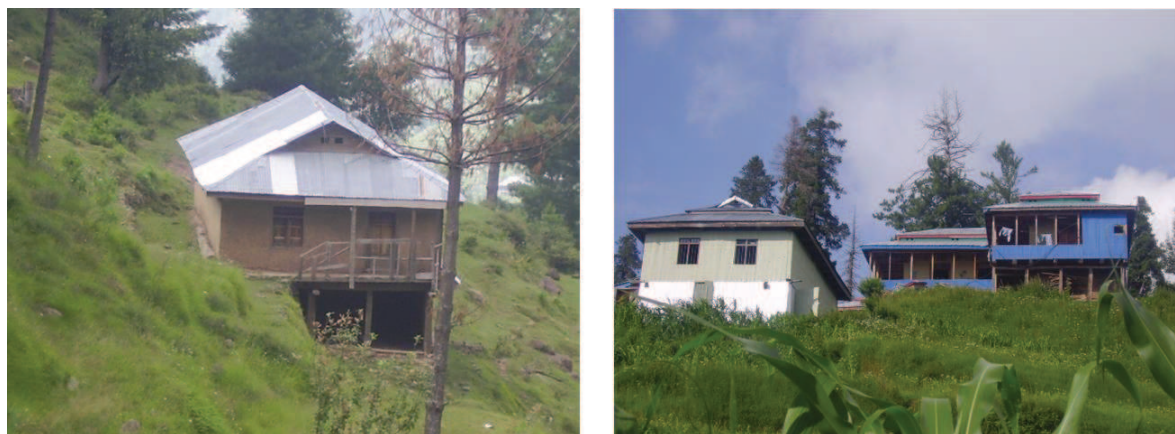
Figure 8.29 — Soft storey houses found in AJK. Source : S. Abidi
