Influence of casting defects on the fatigue behaviour of an A357-T6 aerospace alloy

Itziar Serrano Munoz

Itziar Serrano Munoz. Influence of casting defects on the fatigue behaviour of an A357-T6 aerospace alloy. Materials. INSA de Lyon, 2014. English. NNT : 2014ISAL0117 . tel-01175494

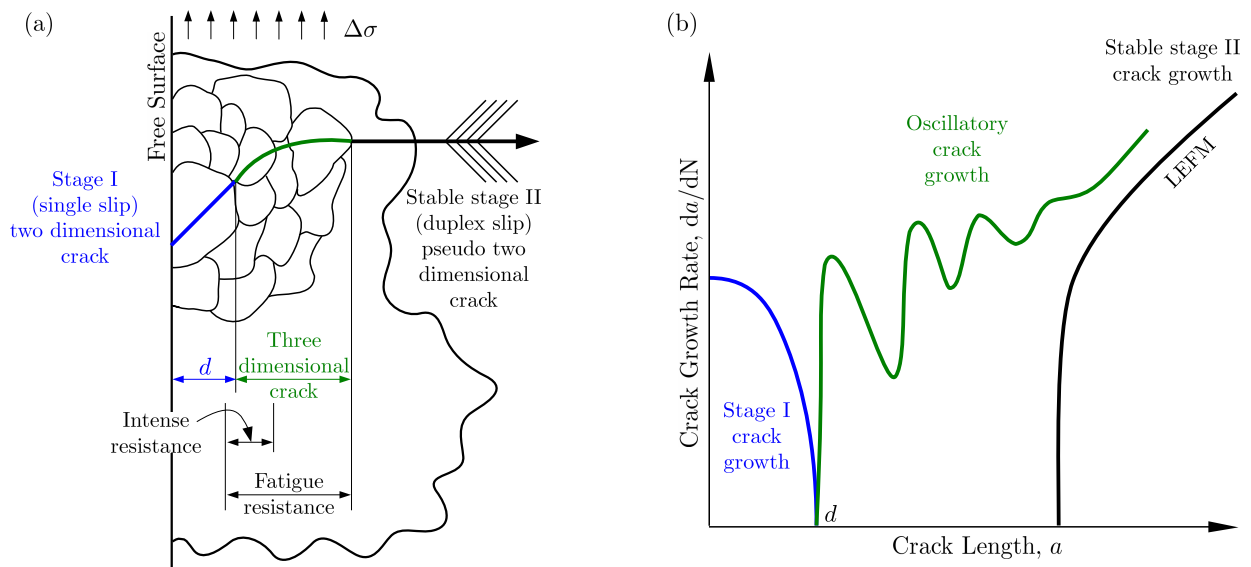
Fig. 2.3: (a) Schematic illustration of the fatigue resistance indicated in terms of difficulty for an initial stage I shear crack to become a stage II, tensile opening mode crack [MIL 93]. (b) Schematic illustration of oscillatory crack growth where d corresponds to the first microstructural barrier (able to arrest the crack) that opposing propagation [MIL 93].

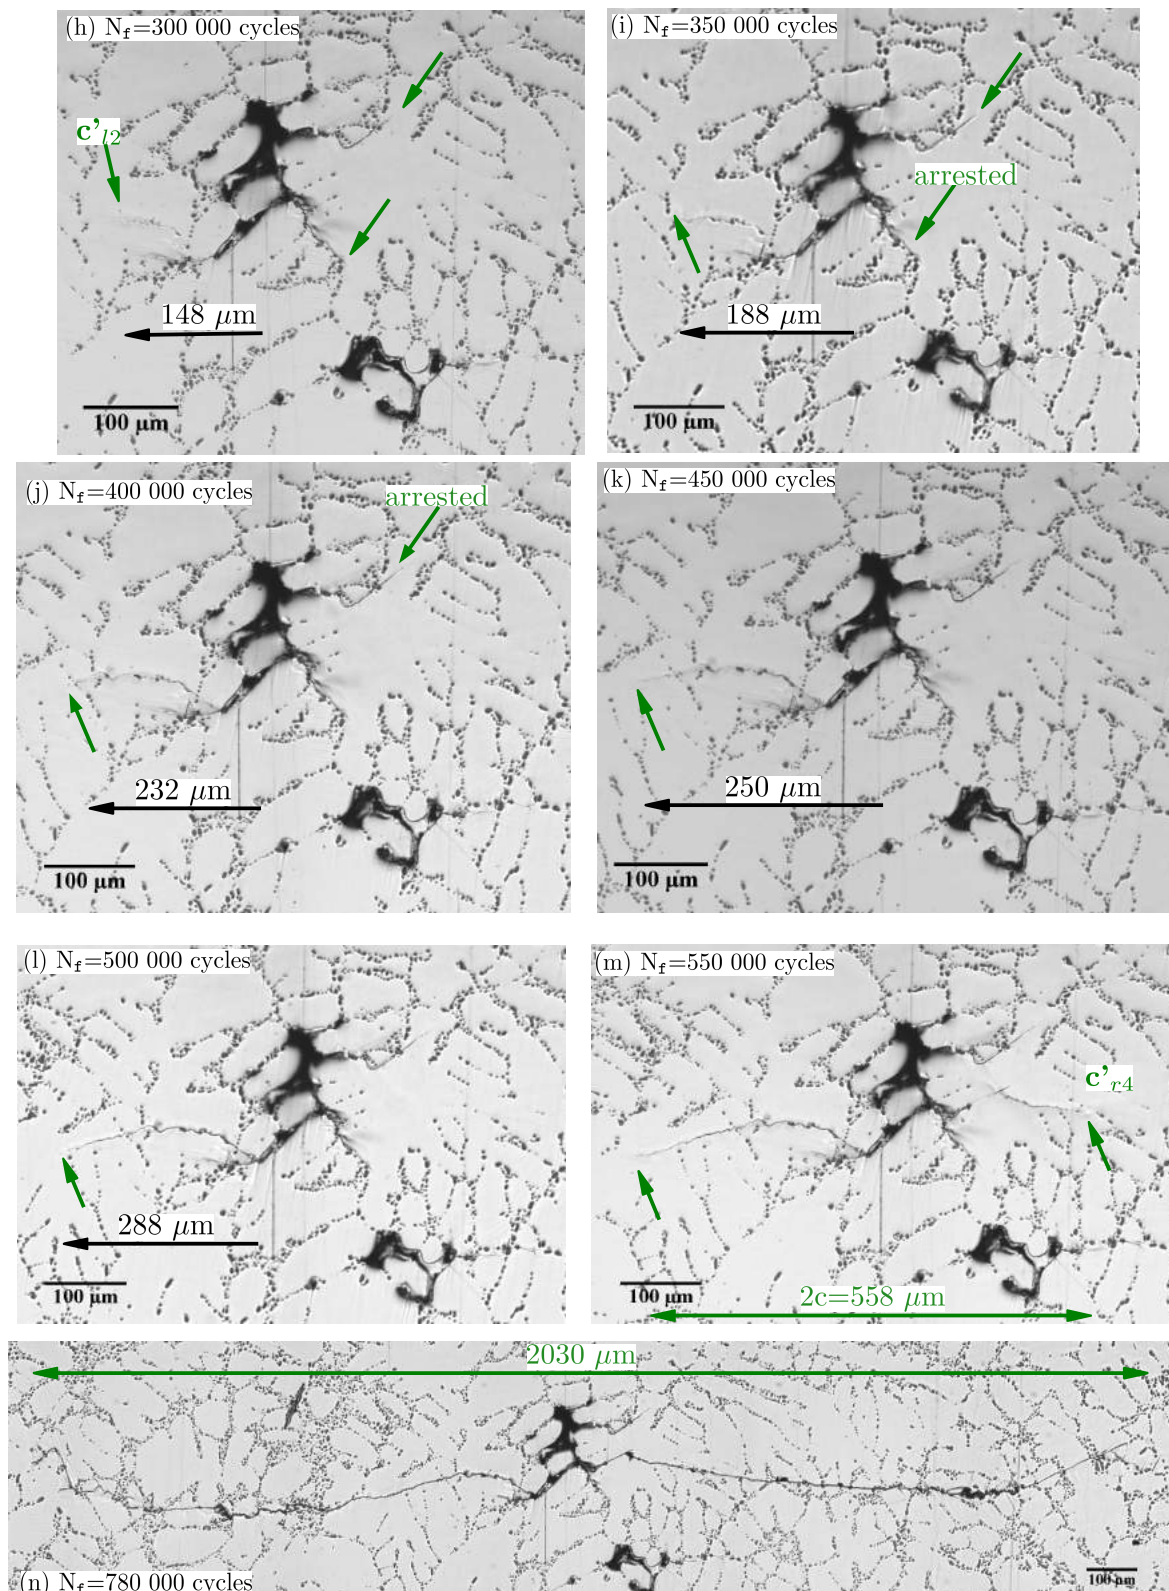
Fig. 2.21: (h)-(m) The same as the previous image but showing the crack progression between 300 000 and 550 000 cycles. This latter stage (m) presents the merging of the crack on the right side of the pore. (n) Optical image of the last stage (780 000 cycles).

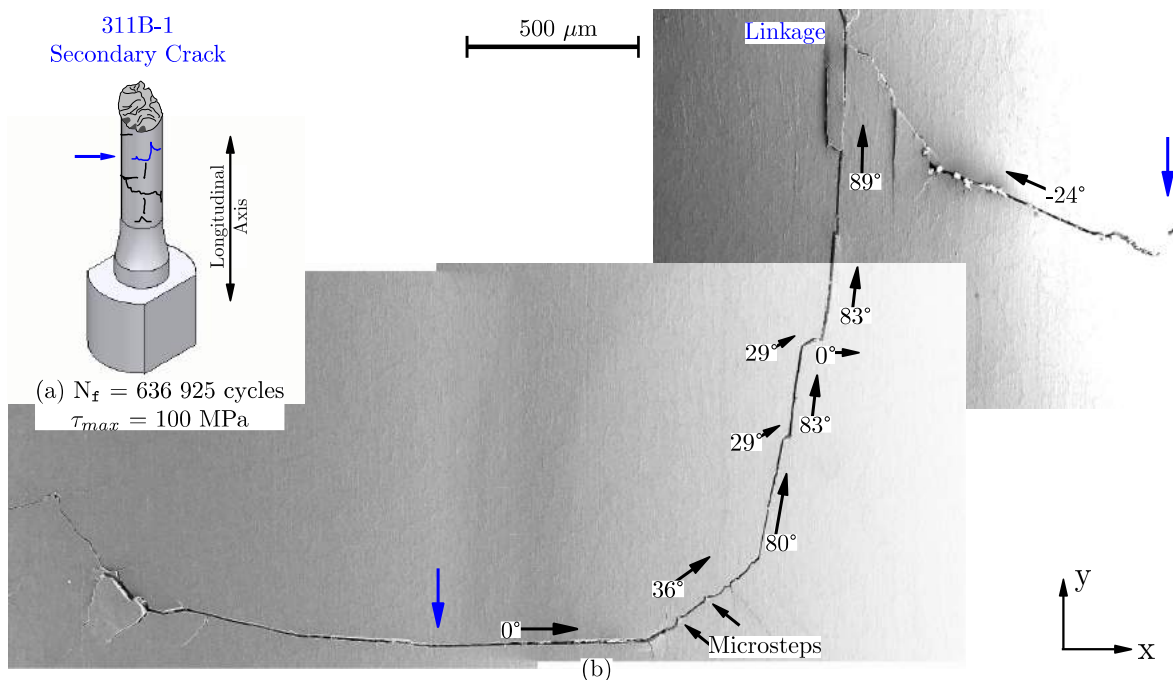
Fig. 2.46: (a) Schematic illustration of one half of the fractured gage showing the location of 311B-1 secondary crack. (b) SEM image of this crack where the two blue arrows indicate the presumed locations of the nucleation sites.

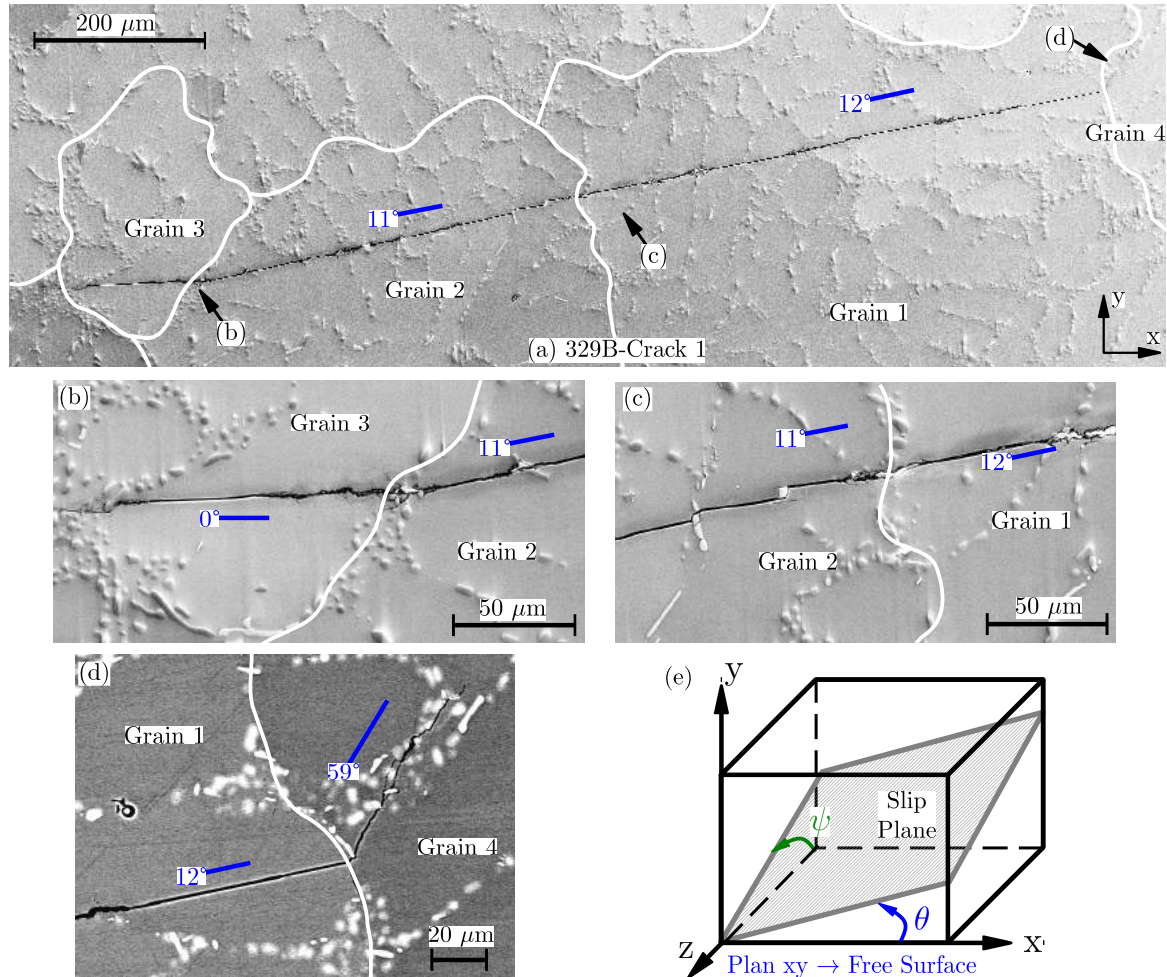
Fig. 2.57: (a) SEM observation showing propagation of 329B-Crack 1 through four different grains. The white lines indicate the approximate location of the grain boundaries. (b) Higher magnification of the crack crossing between Grain 2 and Grain 3. (c) The same as before but for Grain 1 and Grain 2. (d) BSE image of the crossing between Grain 1 and Grain 4. (e) Schematic illustration of the θ and ψ angle.

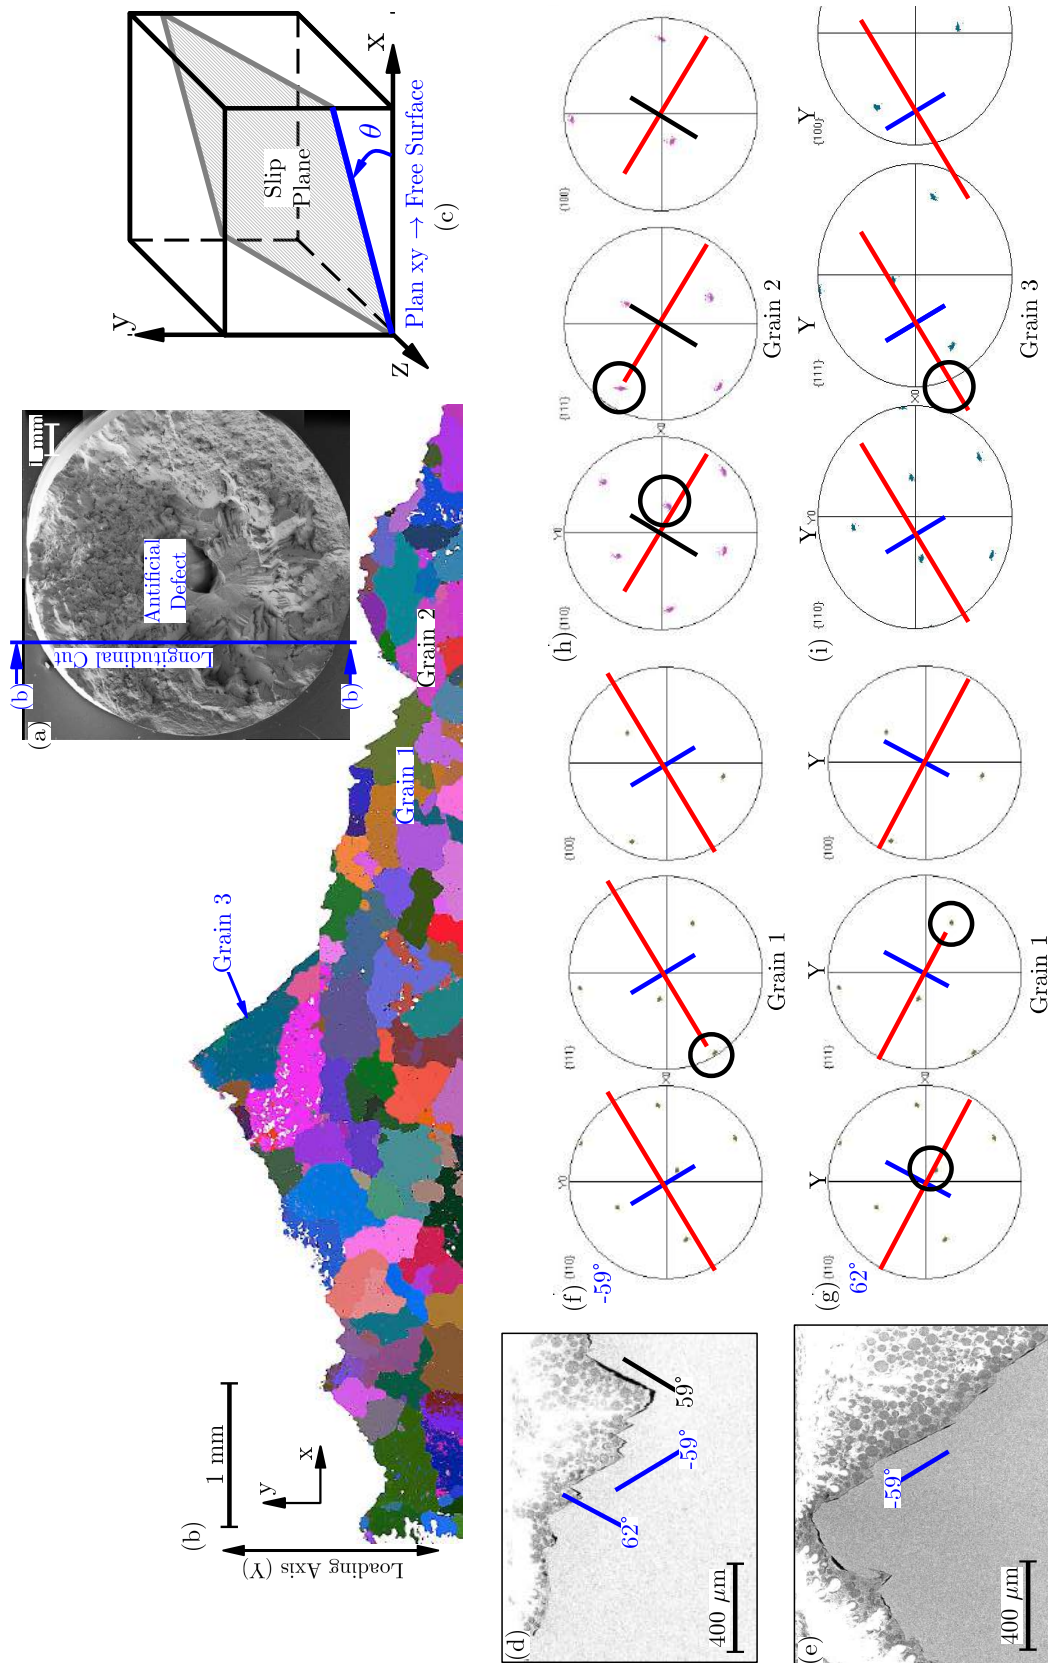
Fig. 3.11: (a) Fracture surface of the upper half of CTIF-131.104 specimen (cycled in ambient air) indicating the approximate location of the longitudinal cut. (b) EBSD Euler map of the longitudinal cut performed on the lower half which shows grain distribution along the internal crack. Only the grains exhibiting crystallographic propagation are labelled. (c) Schematic illustration of the θ angle which indicates the trace orientation. (d) SEM image showing the direction of crack propagation within Grain 1 and Grain 2. (e) Same as before but for the case of Grain 3. (f)-(i) Surface trace analysis on $\{111\}$, $\{110\}$, $\{100\}$ stereographic projection pole-figures. $\{111\}$ family is the only one that always shows interceptions with the normals.

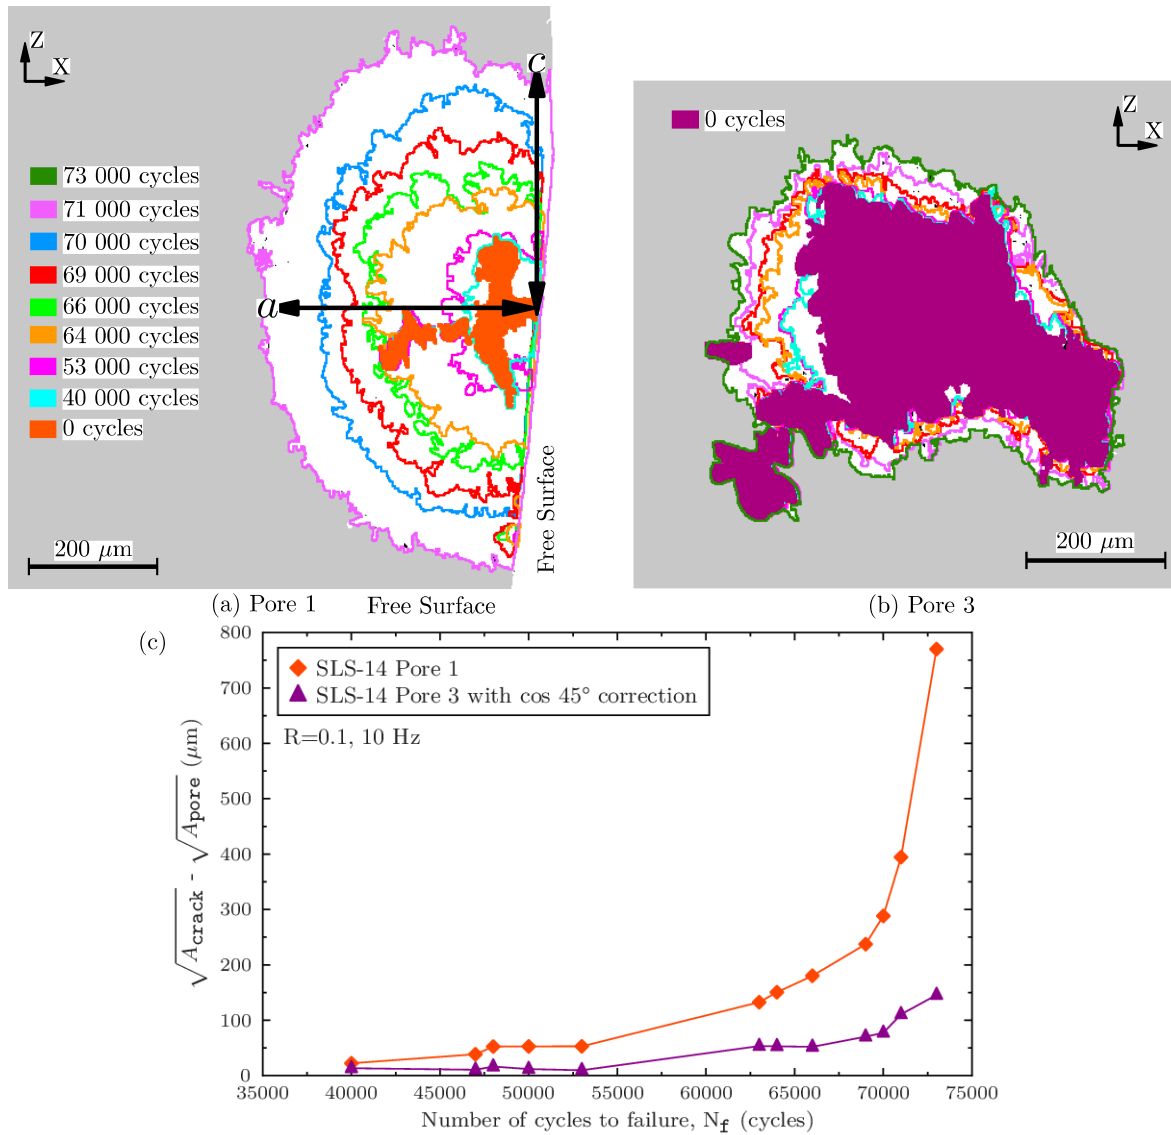
Fig. 3.19: SLS-14 specimen cycled at $\sigma_{max} = 230 \text{ MPa}$. (a) Y (loading direction) projection of the main growth stages for the crack nucleated at Pore 1 (some stages omitted for clarity). (b) Same as before but for the case of the internal Pore 3. (c) Plot of the crack propagation ($\sqrt{A_{crack}} - \sqrt{A_{pore}}$) against the number of cycles (N_f) for these two pores.

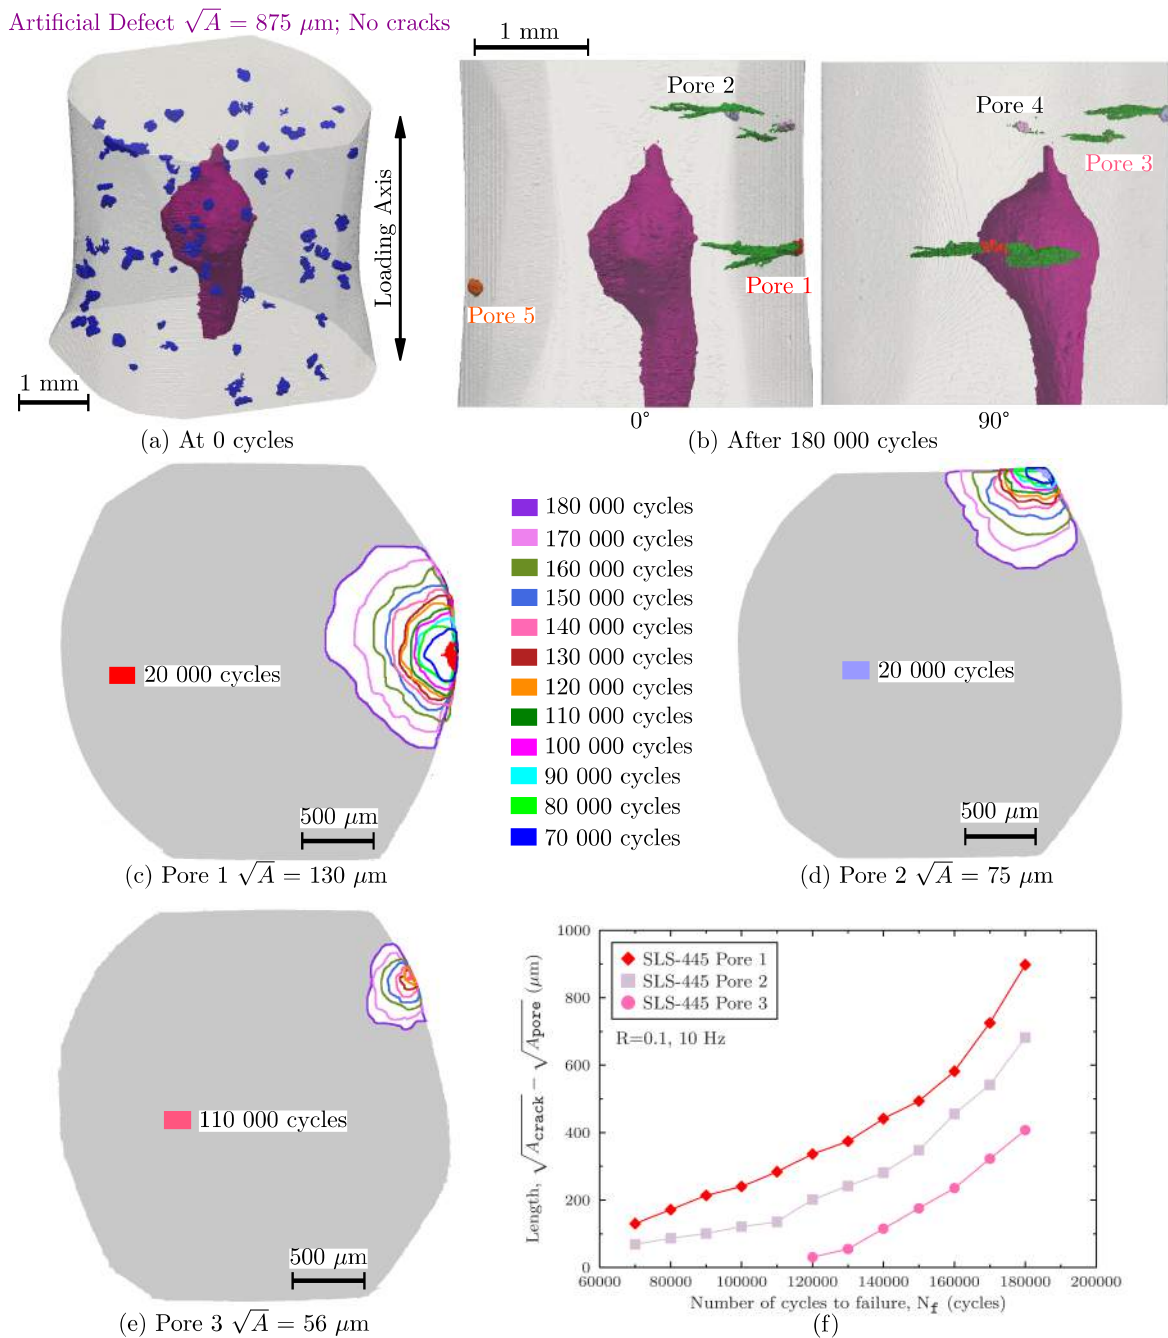
Fig. 3.20: (a) Defect distribution at 0 cycles within SLS-445 specimen gage. The artificial defect is presented in dark magenta and the microporosities in blue. The fatigue testing parameters are $N_f = 190\,000$ cycles and $\sigma_{\max} = 140$ MPa. (b) 3D rendering after 180 000 cycles at 0° and 90° only showing the five pores which nucleated a surface crack. (c) Y projection of the main growth stages for the crack nucleated at Pore 1. (d) For the case of Pore 2 and (e) for Pore 3. (f) Plot of the crack propagation ($\sqrt{A_{\text{crack}}} - \sqrt{A_{\text{pore}}}$) against the number of cycles (N_f) for these three pores.

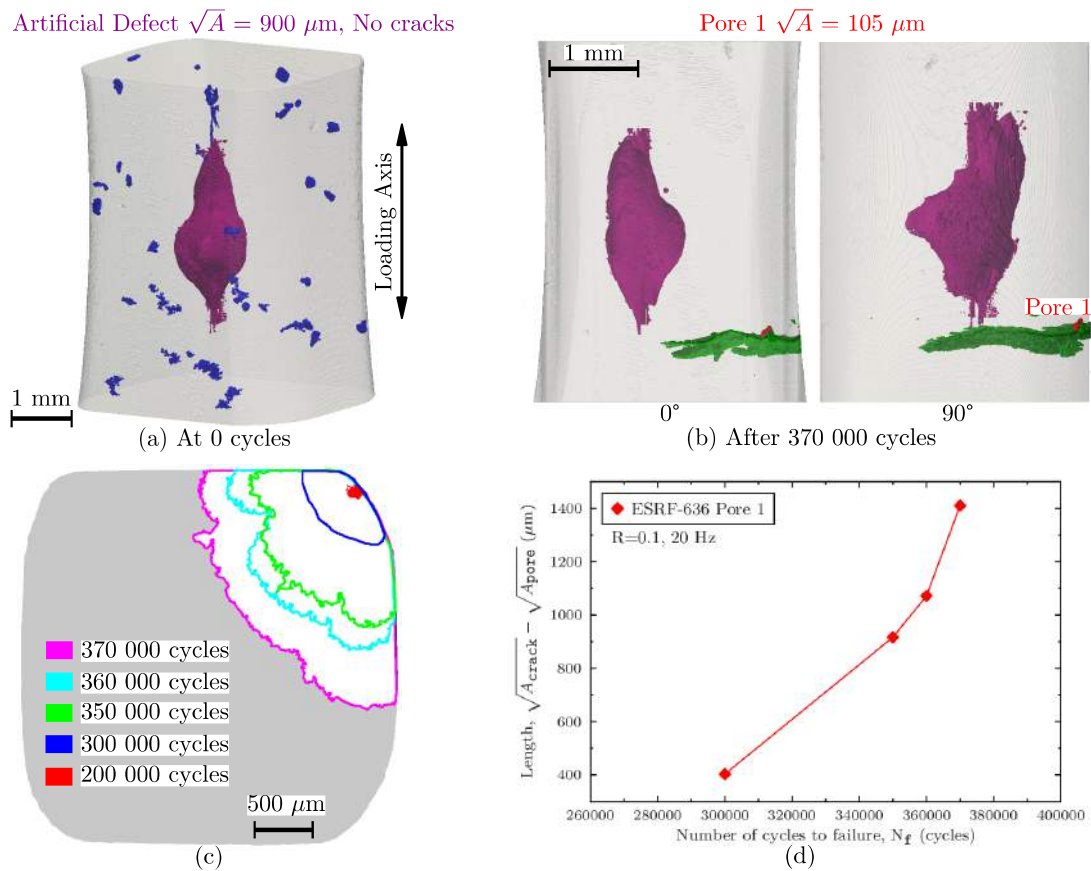
Fig. 3.21: (a) 3D rendering at 0 cycles of the defect population within the gage of ESRF-636 specimen. (b) 3D renderings at 0° and 90° after 370 000 cycles showing the surface crack (in green) formed at Pore 1. The fatigue testing parameters are $N_f = 370\,000$ cycles and $\sigma_{\max} = 105$ MPa. (c) Y projection of the main growth stages for this crack. (d) Plot of the crack propagation ($\sqrt{A_{\text{crack}}} - \sqrt{A_{\text{pore}}}$) against the number of cycles (N_f) for Pore 1.

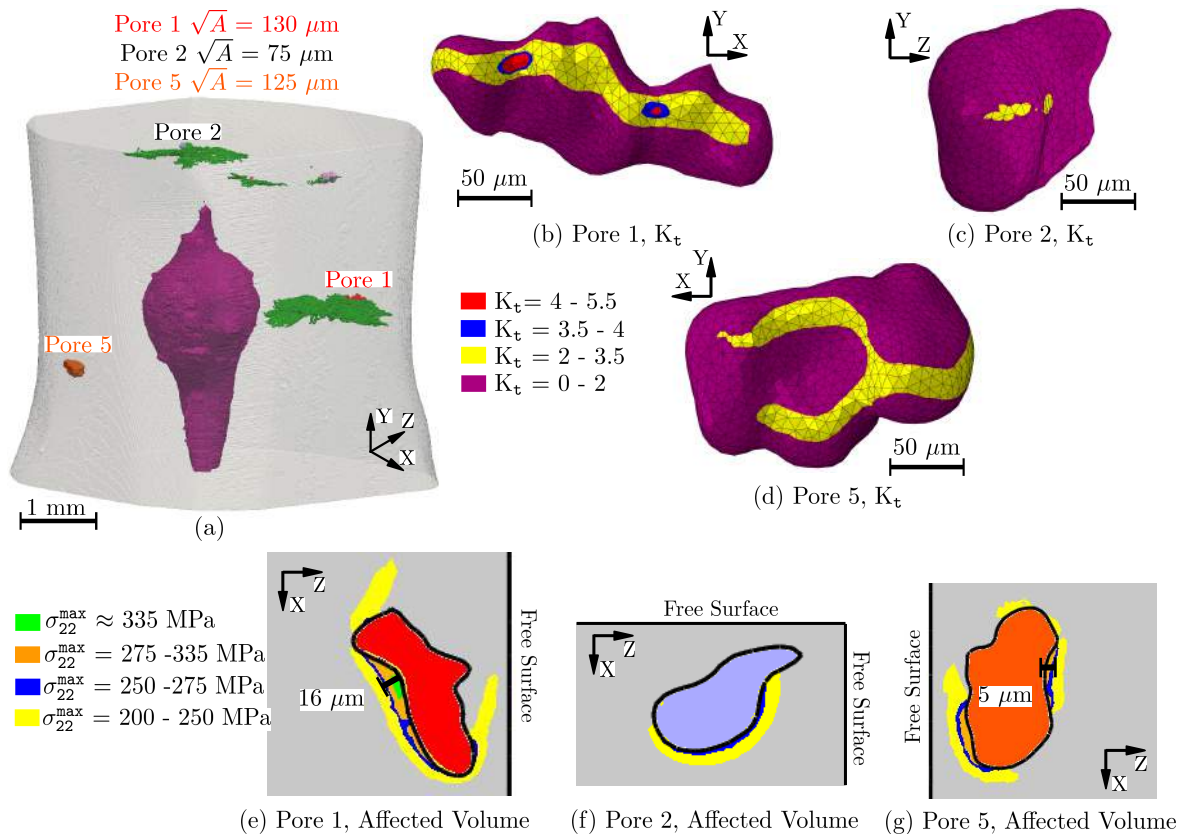
Fig. 3.28: (a) 3D rendering of SLS-445 specimen showing the artificial defect (in darkmagenta, $\sqrt{A} = 875 \mu\text{m}$) and the pores which nucleated surface cracks. The fatigue testing parameters are $N_f = 190\,000$ cycles, $\sigma_{\text{max}} = 140 \text{ MPa}$. (b) K_t evaluation for Pore 1 (crack nucleation after 20 000 cycles). (c) K_t evaluation for Pore 2 (crack nucleation after 20 000 cycles). (d) K_t evaluation for Pore 5 (crack nucleation after 170 000 cycles). (e) Slice performed along the middle plane perpendicular to the loading direction for Pore 1 and showing elasto-plastic results. (f) Same as before but for Pore 2 and (g) Pore 5. It must be noted that the values obtained within the ligament, between the free surface and the pore, are not taken into account.

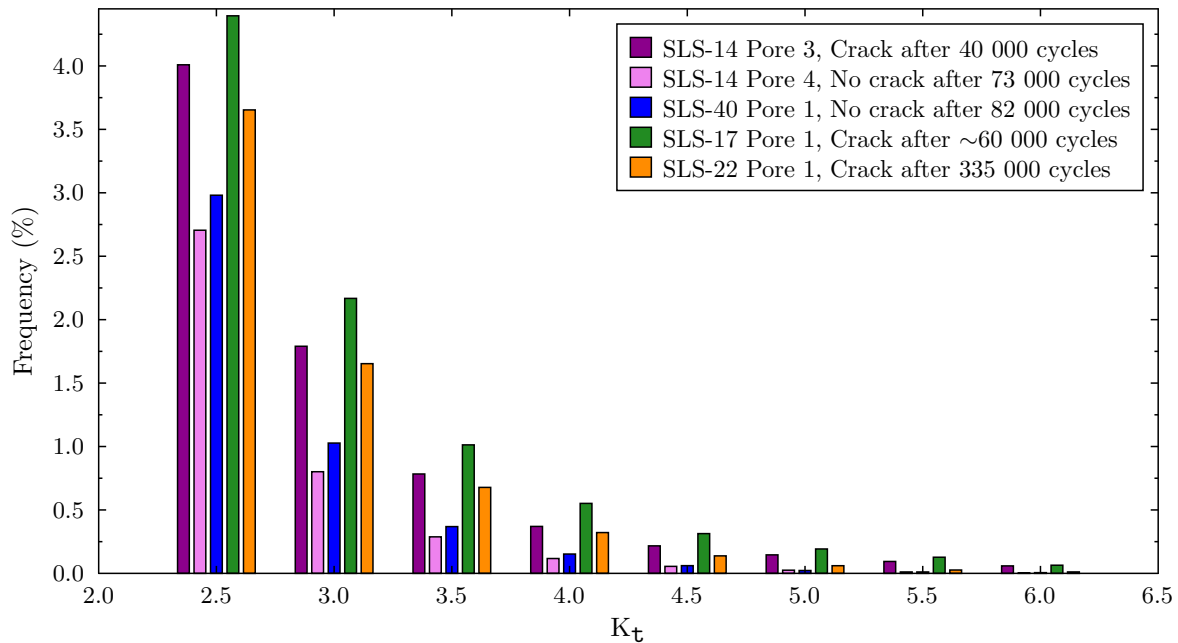
Fig. 3.32: Histogram showing the frequency of counts against the different K_t values obtained over the surface of natural internal defects.

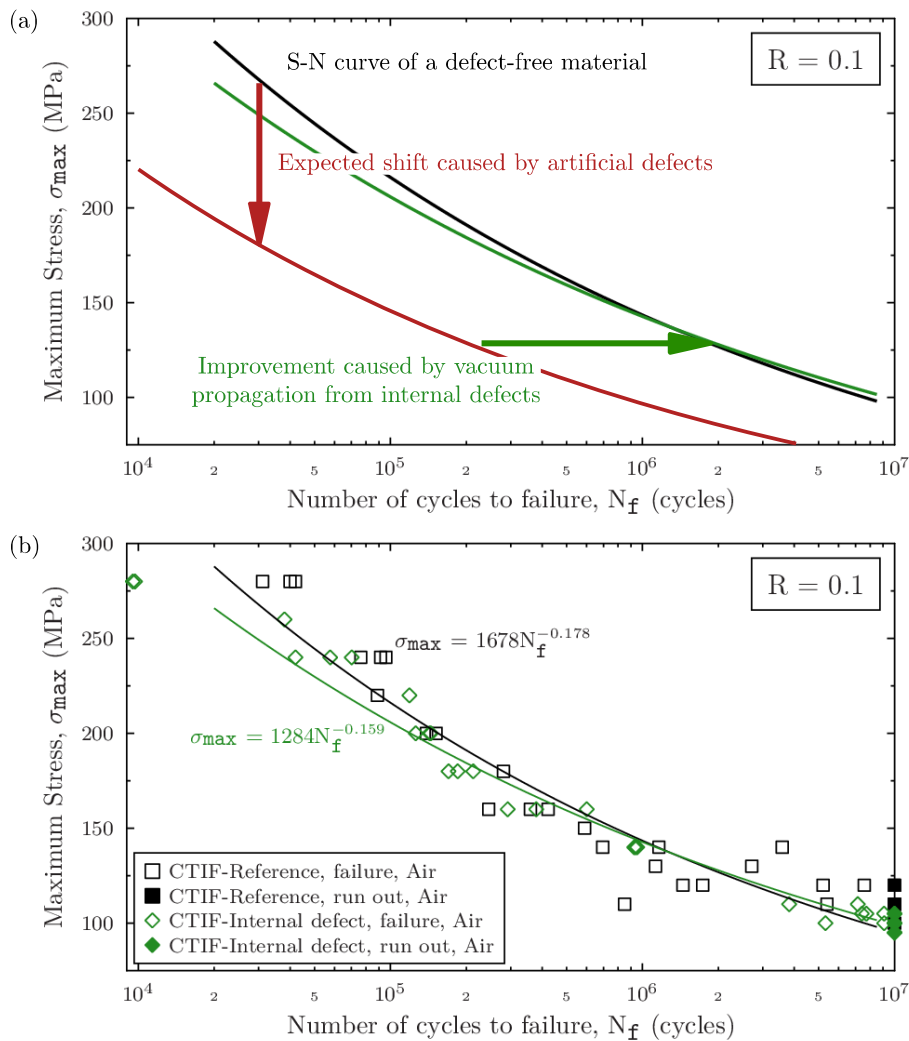
Fig. 3.36: (a) S-N curve showing the expected shifts produced by the cycling of $\varnothing_{eq} \approx 2$ mm internal artificial defect in different environments (air and vacuum). (b) S-N curves for the reference material (which is considered to be defect-free at the surface) and specimens containing internal artificial defects of $\varnothing_{eq} \approx 2$ mm cycled in ambient air.
