Strengthening of corroded reinforced concrete (RC) beams with near surface mounted (NSM) technique using carbon fiber polymer (CFRP) rods: an experimental and finite element (FE) modelling study

THÈSE

DOCTORAT DE L'UNIVERSITÉ DE TOULOUSE

Belal ALMASSRI

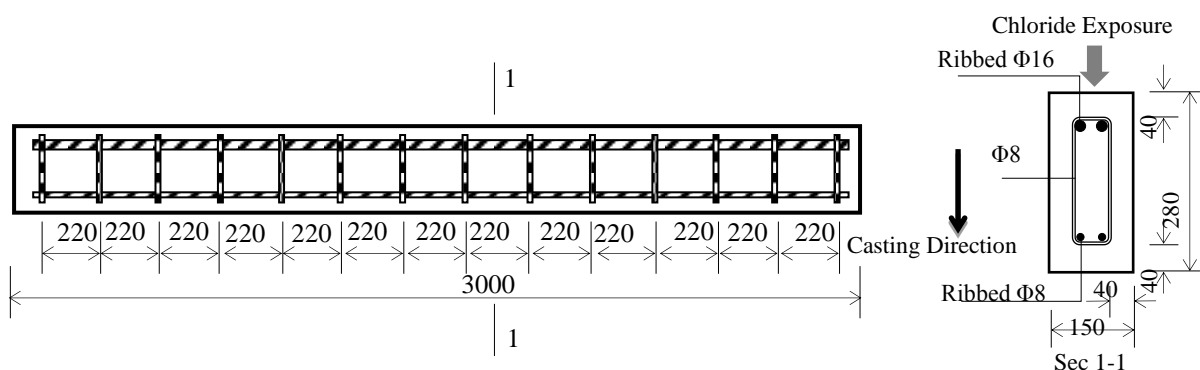
Figure I- 2 plan de ferraillement des poutres de type A. Toutes les dimensions sont en mm

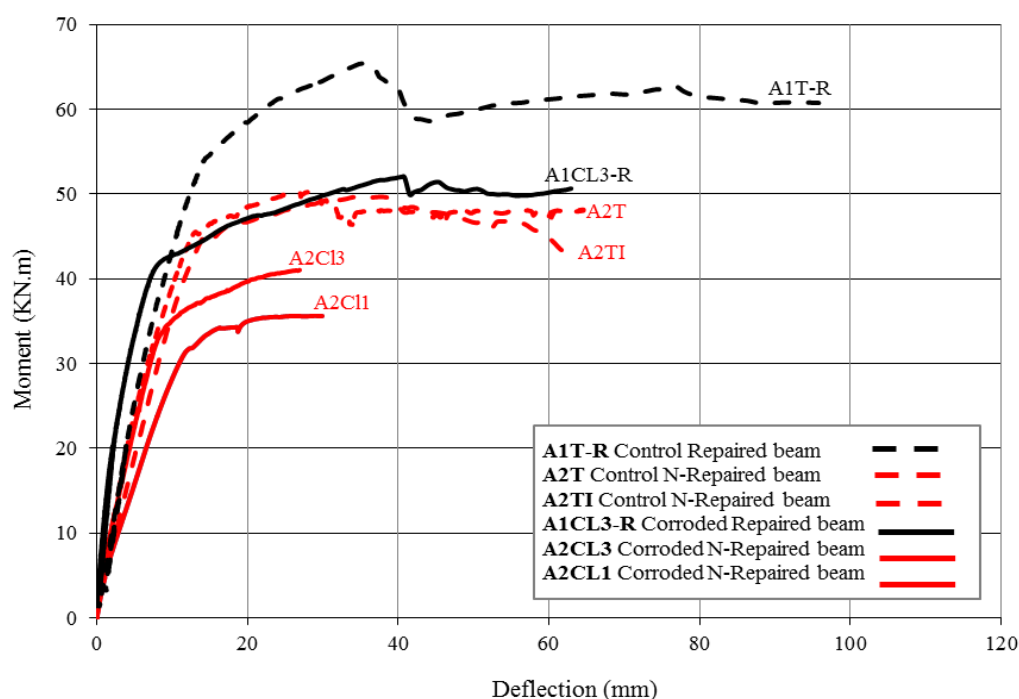
Figure I- 3 comparaison entre les réponses en flexion 3 points des différentes poutres (A2T, A2TI, A1T-R, A2CL3, A1CL3-R and A2CL1)

mécanique par couplage de deux poutres A et B, la face tendue des poutres de type A correspondait à la face supérieure et les poutres A ont été coulées dans cette configuration pour faciliter leur mise en œuvre. Les poutres ont été testées en flexion 3 points avant et après le renforcement par la technique NSM afin d'évaluer le changement dans les raideurs en flexion. Les cartes de fissuration résultant du processus de corrosion ont également été tracées avant la réparation. Après réparation, les deux poutres ont été testées jusqu'à rupture. Les résultats expérimentaux ont montré que la technique NSM est capable de restaurer la capacité initiale d'une poutre significativement dégradée par une corrosion à long terme. La figure I-3 montre les comparaisons entre les poutres témoins réparées ou non et les poutres corrodées réparées ou non. L'insertion d'un jonc de carbone de 6 mm par la technique NSM dans une poutre témoin (A1T-R) augmente significativement sa capacité ultime (A2T et A2TI). La poutre corrodée réparée (A1CL3-R) qui présente une perte de diamètre maximale de 38% retrouve une capacité portante au moins égale à celle des poutres témoins non réparées et une capacité portante significativement supérieure à celle des poutres corrodées non-réparées A2CL1 et A2CL3 avec un accroissement du moment de 17 kN.m et 11 kN.m respectivement.

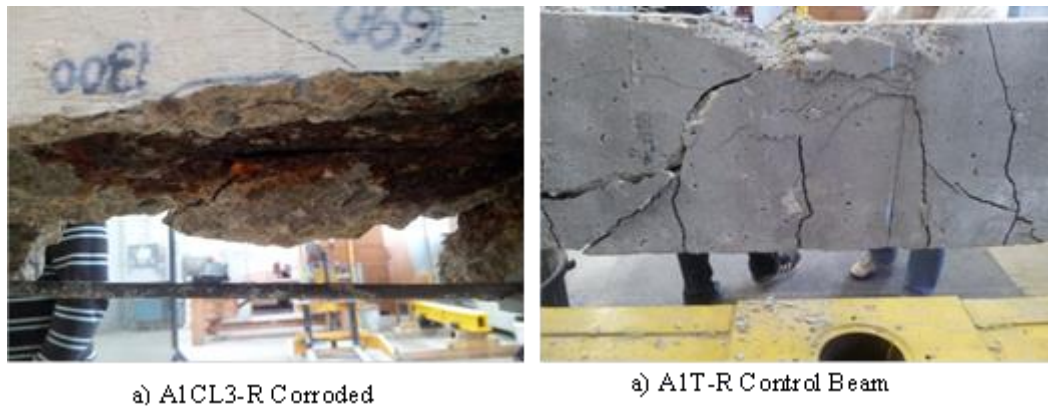
Figure I- 4 faciès de rupture des deux poutres réparées en flexion par la technique NSM

niveau des fissures de corrosion. Le mode de ruine obtenu sur la poutre corrodée réparée (A1CL3-R) (figure I-4) est différent de celui obtenu sur les poutres corrodées non réparées (A2CL1 et A2CL3) qui ont péri par une rupture fragile des armatures tendues au niveau de piqures de corrosion sévères. La rupture de la poutre corrodée réparée (A1CL3-R) intervient suivant un mode non-conventionnel dû à l'existence d'un plan de rupture généré par les fissures de corrosion. Ce plan de rupture est parallèle à la surface tendue du béton mais situé au niveau des armatures tendues.

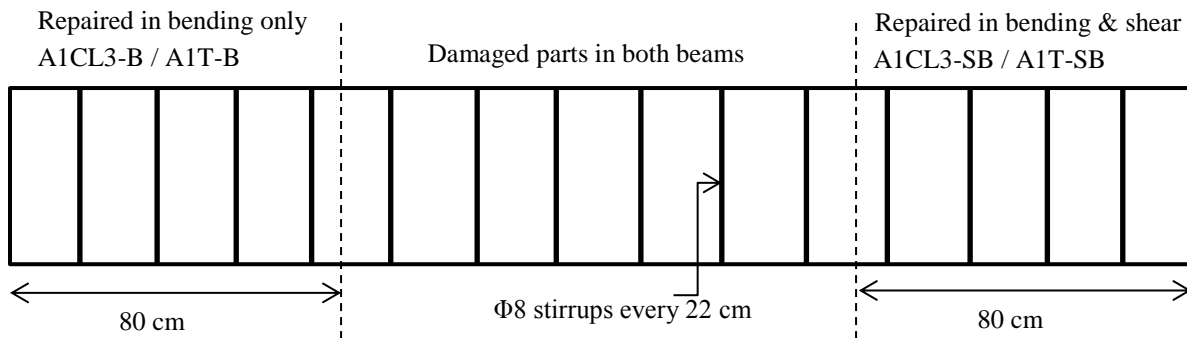
Figure I- 5 schéma de découpe des poutres longues A1CL3-R et A1T permettant d'obtenir 4 poutres courtes (A1CL3-B , A1CL3-SB, A1T-B, A1T-SB) correspondant aux extrémités peu sollicitées lors de la flexion

Le second chapitre s'intéresse au comportement mécanique en flexion 3 points après réparation de quatre poutres courtes (2 corrodées et 2 témoins) qui sont réparées ou renforcées par des joncs de carbone insérés par la technique NSM en flexion mais également vis-à-vis de l'effort tranchant pour deux d'entre elles. Les quatre poutres courtes sont obtenues par sciage en trois parties des deux poutres longues (A1CL3-R et A1T-R) étudiées au chapitre 1. La partie centrale endommagée lors des essais de flexion présentés au chapitre 1 est éliminée et il reste les deux extrémités de longueur 800 mm peu sollicitées lors de la flexion (figure I-5).

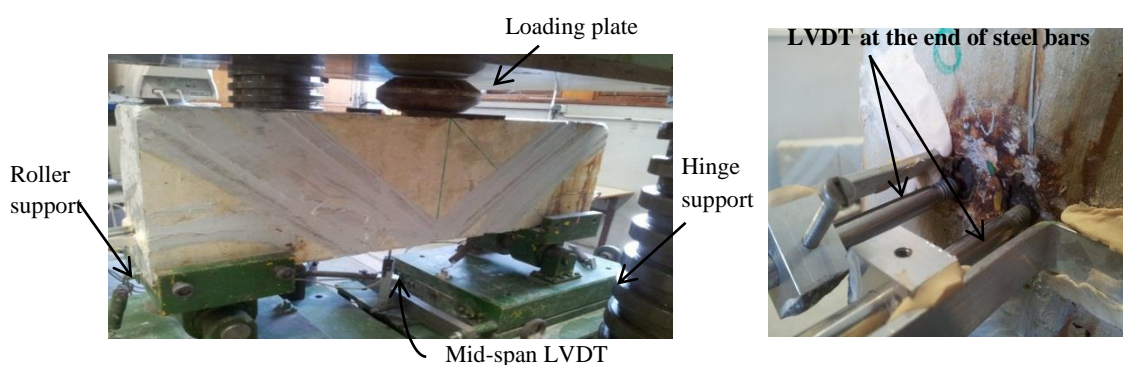
Figure I- 6 Vue de la réparation vis à vis de l'effort tranchant et de l'instrumentation permettant de mesurer le glissement des armatures longitudinales sur appuis

des LVDT (linear variable differential transducers) installés à chaque extrémité de barres. Un autre LVDT a été utilisé pour mesurer la flèche à mi-portée (figure I-6).

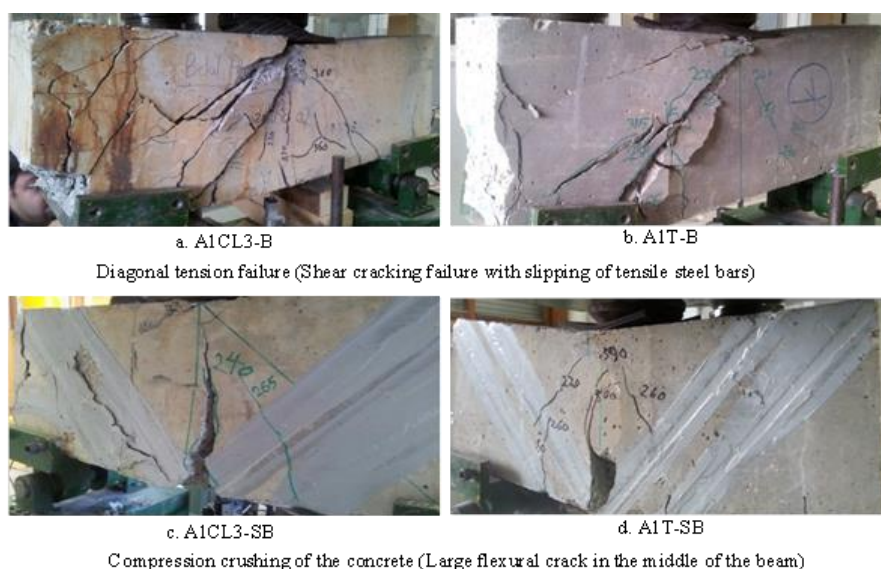
Figure I- 7 modes de ruine des quatre poutres courtes

Les résultats expérimentaux montrent que le mode de rupture obtenu pour les poutres non renforcées vis à vis de l'effort tranchant (poutre corrodée A1CL3-B et témoin A1T-B) a été par la formation d'une fissure inclinée de cisaillement d'effort tranchant, alors que les poutres renforcées vis-à-vis de l'effort tranchant (poutre corrodée A1CL3-SB et témoin A1T-SB) ont montrés un mode de rupture différent par excès de compression sur la fibre comprimée précédée de la formation de fissures de flexion largement ouvertes à mi-portée comme le montre la figure I-7.

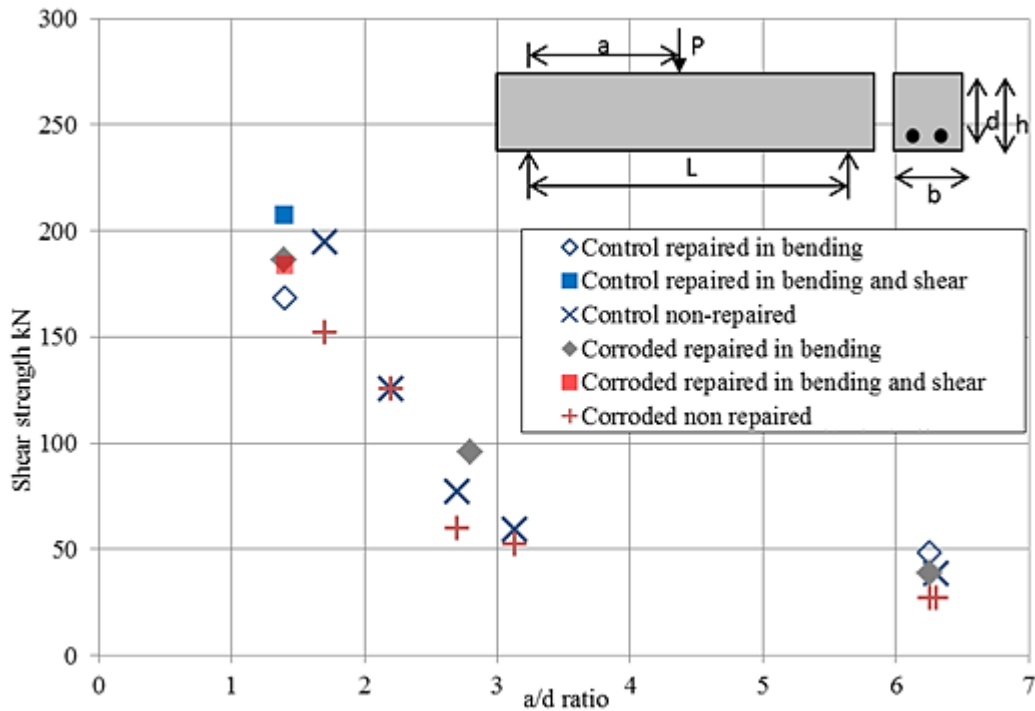
Figure I- 8 influence du ratio a/d sur la capacité portante des poutres

On ne constate pas d'effet significatif de la réparation vis-à-vis de l'effort tranchant de la poutre corrodée dans le cas d'un ratio (a/d) plus petit que 2 (figure I-8). Même en présence de corrosion des armatures et avec un renforcement vis-à-vis de l'effort tranchant et du moment de flexion, on constate qu'il y a toujours un comportement fortement influencé par le rapport (a/d) avec une transition entre un comportement piloté par la flexion ou le cisaillement aux alentours de 2.5-3

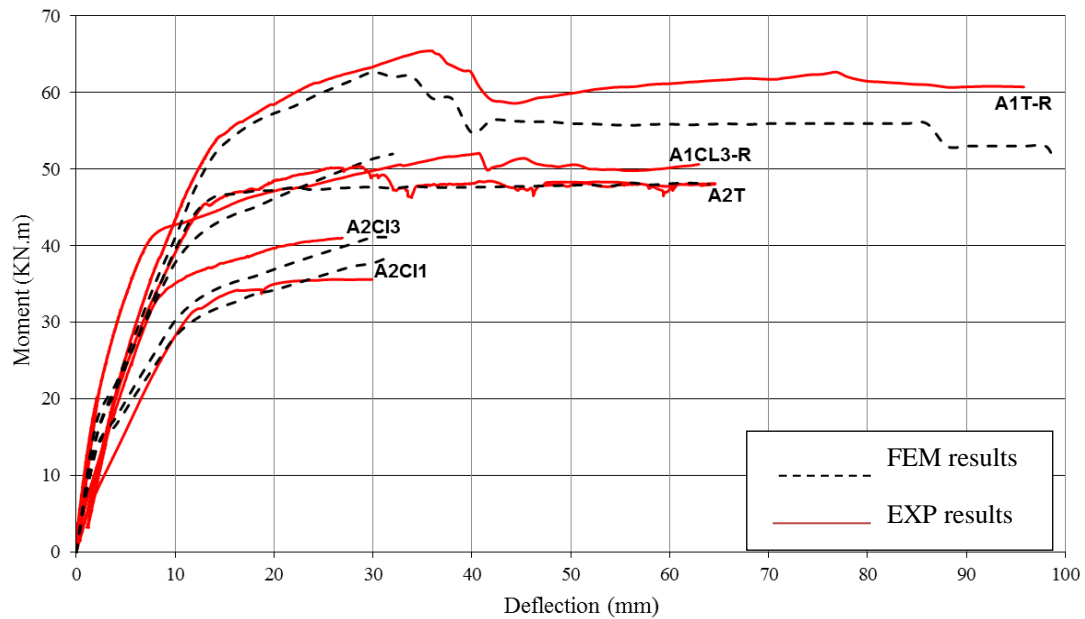
Figure I- 9 comparaison entre les résultats expérimentaux et la modélisation EF 2D utilisant le code FEMIX

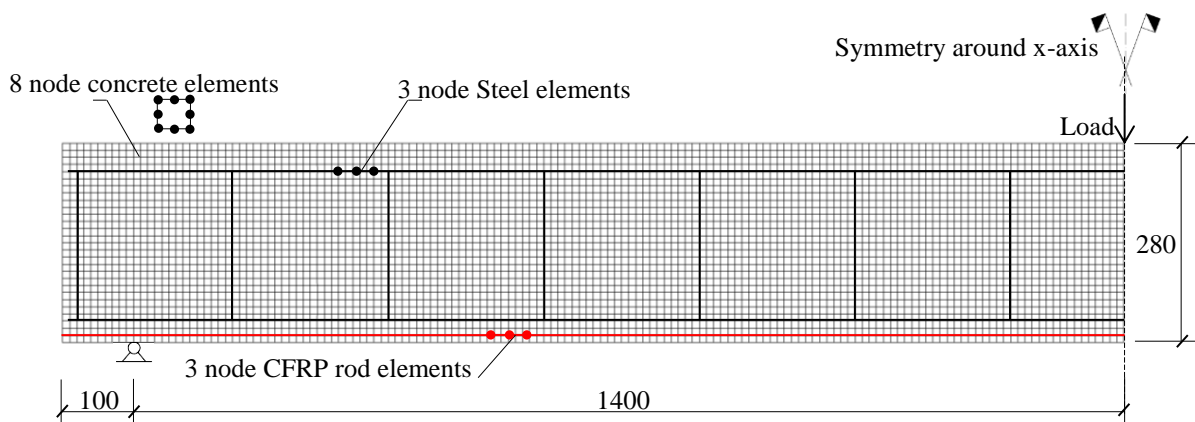
Figure I- 10 Modèle éléments finis pour la simulation des poutres renforcées par la technique NSM

Pour la modélisation 2D utilisant FEMIX, le béton a été modélisé en utilisant des éléments à 8 nœuds en formulation contrainte plane. Les armatures et les joncs de carbone ont été simulés en utilisant des éléments linéaires à 3 nœuds de type « cable ». Pour ce modèle, les armatures et les joncs sont supposés parfaitement adhérent au béton (figure I-10). Il s'agit bien sûr d'une hypothèse forte mais l'idée est de simuler dans un premier temps les charges ultimes et la flèche ultime et pas la rigidité en flexion. La corrosion des armatures a été simulée en réduisant la section des armatures de façon uniforme en considérant le degré de corrosion expérimental mesuré à mi-portée des poutres simulées. La corrosion des cadres d'effort tranchant n'a pas été considérée car elle n'intervient pas sur la résistance en flexion.

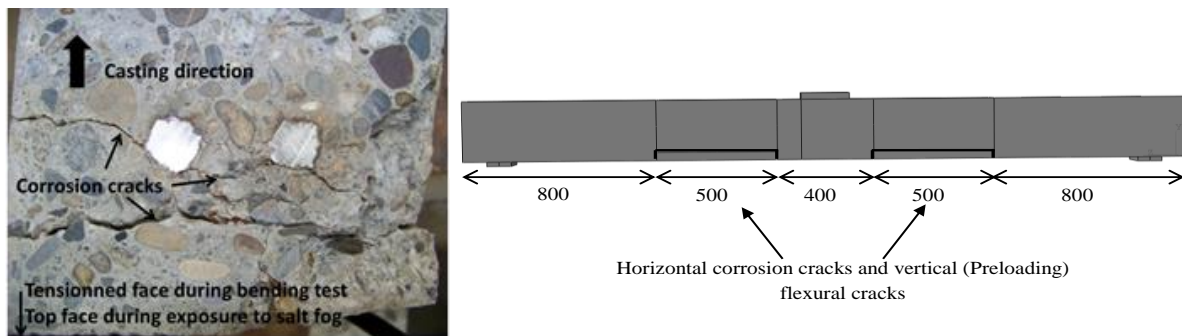
Figure I- 11 Fissures de corrosion obtenues expérimentalement et modélisation correspondante avec ABAQUS

Le comportement plastique du béton en compression a été modélisé via un critère de Drucker-Prager avec un comportement d'érouissage différent en traction qu'en compression. Les fissures de corrosion dans la poutre A1CL3-R sont supposées être la cause de la rupture non conventionnelle de la poutre en flexion. Pour cette raison, la surface plane correspondant aux fissures de corrosion a été modélisée en utilisant un outil spécifique d'ABAQUS : « crack tool in interaction section ». Pour ce faire, nous avons séparé le modèle EF en plusieurs parties pour ne définir un plan de fissuration que sur la longueur correspondant aux résultats expérimentaux (figure I-11). La fissure horizontale ainsi définie avec ABAQUS est initialement fermée mais peut s'ouvrir pendant le chargement. Comme pour la modélisation avec FEMIX, la corrosion a été prise en compte uniquement sur les armatures longitudinales en réduisant la section de 20% qui correspond au degré de corrosion maximal atteint à mi-portée de la poutre.

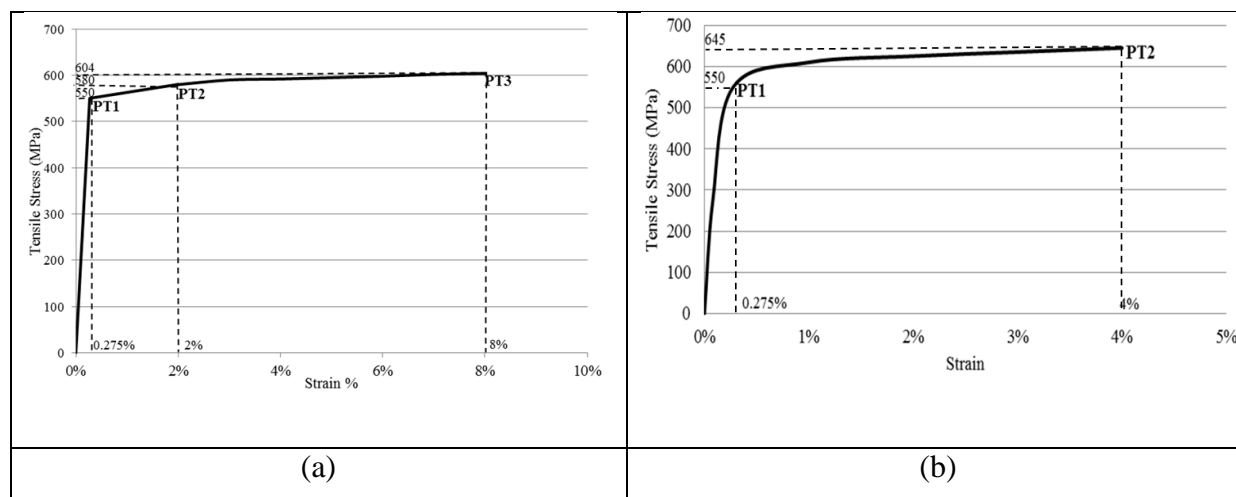
Figure I- 12 loi de comportement de l'acier en traction : non corrodé (a) ; corrodé (b)

L'analyse menée avec FEMIX permet également de visualiser la diminution de la flèche maximale à rupture des poutres corrodées non réparées due à la prise en compte d'une loi de comportement de l'acier modifiée par la corrosion avec une rupture fragile pour une déformation maximale à rupture réduite de 50% (figure I-12).

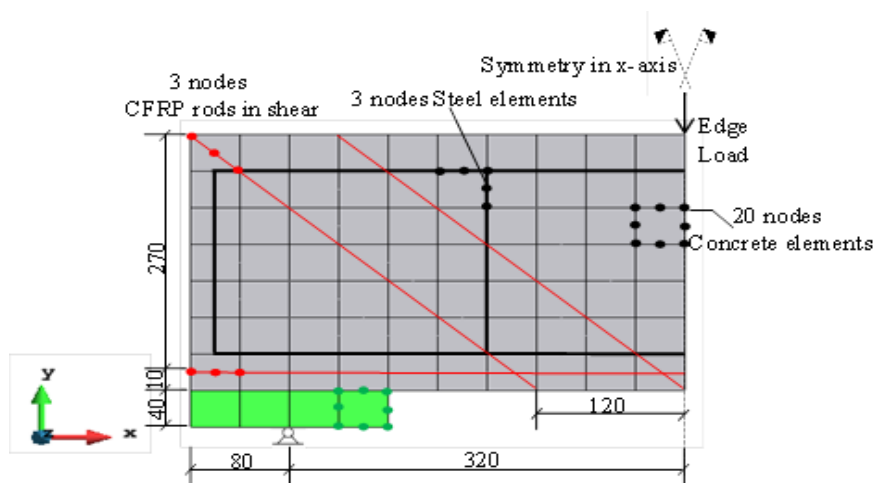
Figure I- 15 modélisation EF de la poutre courte renforcée au cisaillement par les joncs de carbone engravés à 45°

La modélisation est basée sur une approche multidirectionnelle de la fissuration diffuse afin de reproduire le comportement vis-à-vis de l'effort tranchant. L'aspect le plus important de ce modèle constitutif est l'utilisation d'un effet adoucissant du béton dans le cas de la formation de fissures en mode II capable donc de prendre en compte le développement des fissures de cisaillement d'effort tranchant. Le modèle est réalisé en contraintes planes (figure I-15).

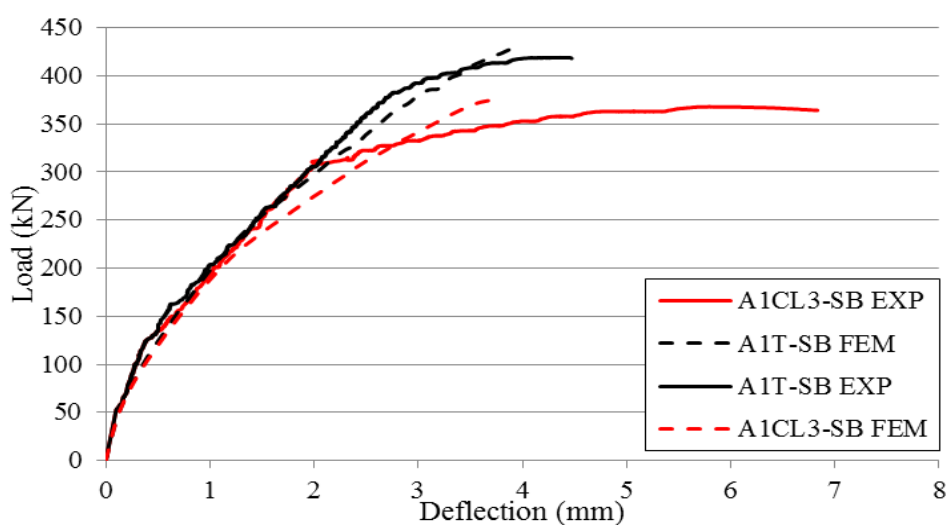
Figure I- 16 Comparaison entre les résultats expérimentaux et les simulations EF pour les poutres réparées vis à vis de l'effort tranchant A1CL3-SB et A1T-SB

Pour les poutres réparées vis-à-vis de l'effort tranchant A1CL3-SB et A1T-SB, les résultats expérimentaux et numériques font apparaître une baisse de charge de plastification de 12% qui est cohérent avec l'intensité de la corrosion également de 12% au milieu de la poutre corrodée (figure I-16).

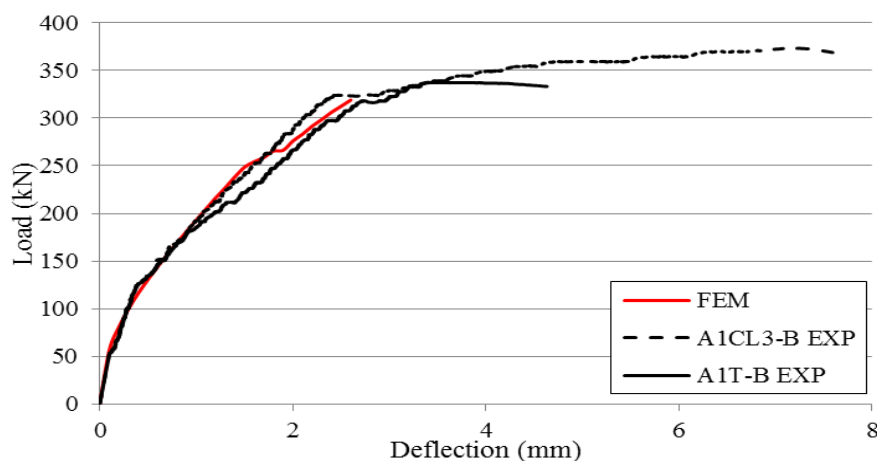
Figure I- 17 Comparaison entre les résultats expérimentaux et les simulations EF pour les poutres non réparées vis à vis du cisaillement A1CL3-B et A1T-B

Pour les poutres non renforcées vis-à-vis de l'effort tranchant A1CL3-B et A1T-B, on ne constate pas de changement de charge de plastification puisqu'il n'y a pas de corrosion significative à l'endroit où se produisent les fissures les plus ouvertes (figure I-17).

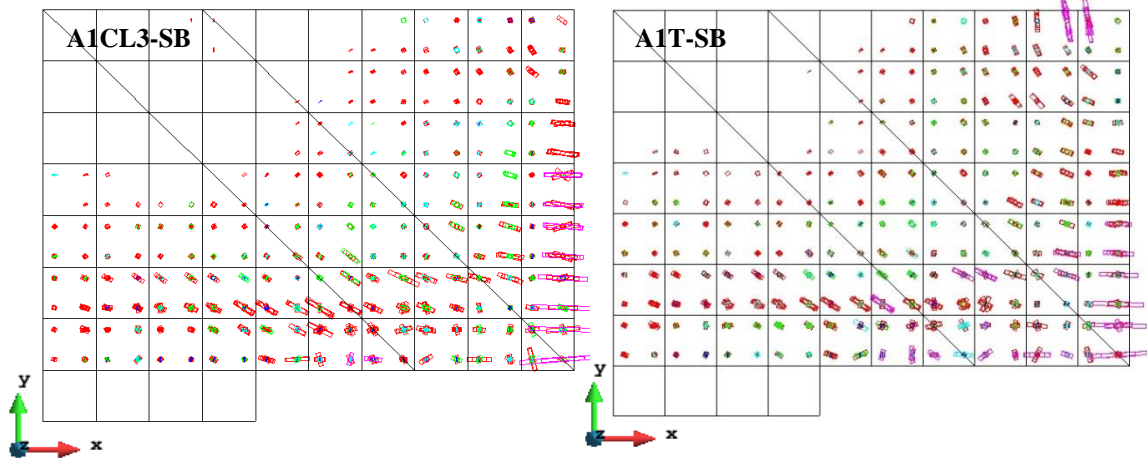
Figure I- 19 (a) faciès de fissuration obtenus par EF pour les poutres renforcées vis à vis de l'effort tranchant (en rose les fissures complètement ouvertes, en rouge celles qui s'ouvrent, en bleu les fissures qui se ré-ouvrent, en vert celles qui se ferment et en bleu foncé celles qui sont fermées).

fissuration obtenus sur les poutres réparées vis-à-vis de l'effort tranchant avec des fissures s'ouvrant également le long de la surface inférieure de la poutre et jusqu'aux appuis (figure I-19b).

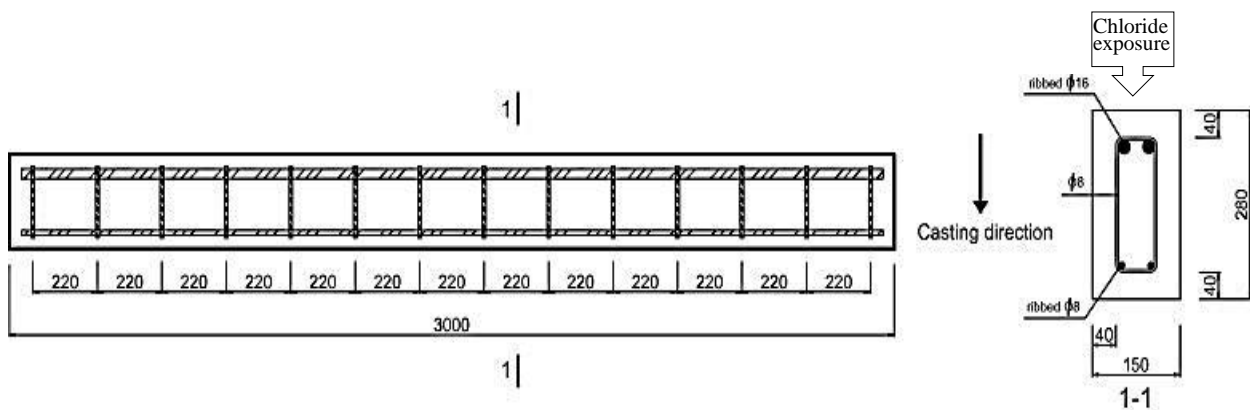
Figure 1 - 2 Reinforcement layout for Type A beams. Dimensions are in mm

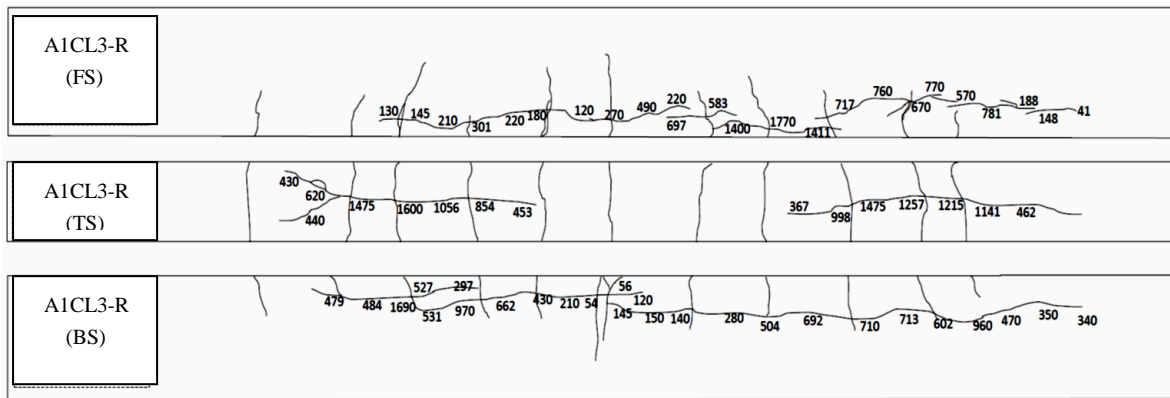
Figure 1 - 5 A1CL3-R cracking map after 20 kN loading

Figures 1-5 and 1-6 show the cracking maps of the beams A1CL3-R and A1T-R after 26 years. All the corrosion cracks were concentrated in the tension area of the concrete and their maximum width was found to be 1.8 mm. Only the width of longitudinal cracks was measured using a binocular lens. The transversal cracks were due to the initial and sustained loading during beam storage. Despite the cover being the same for tension and compression bars, long-term storage in the chloride environment induced mainly corrosion and corrosion cracks along the tension reinforcement.

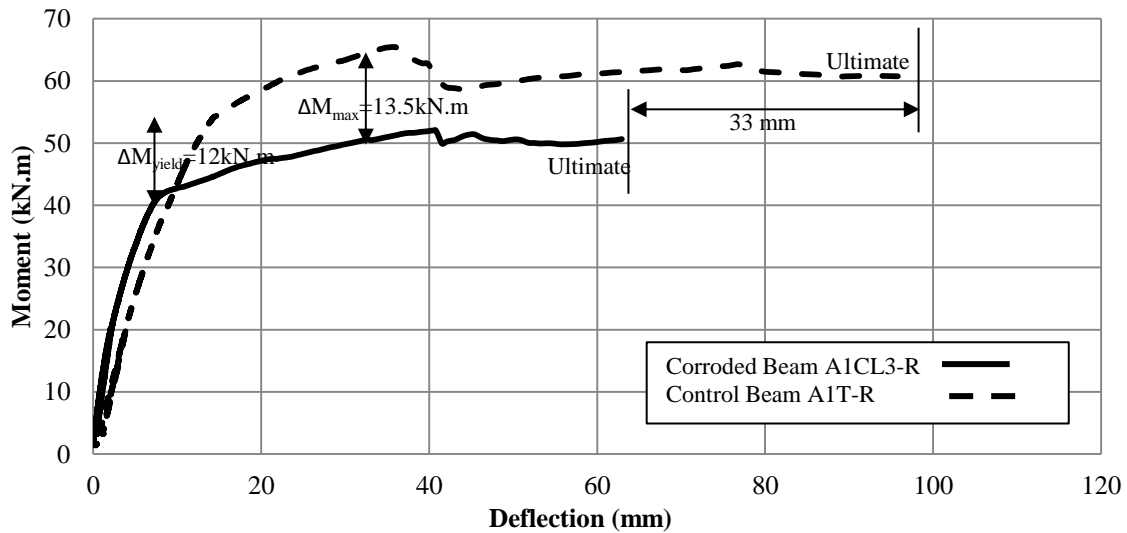
Figure 1 - 8 Bending moment versus deflection

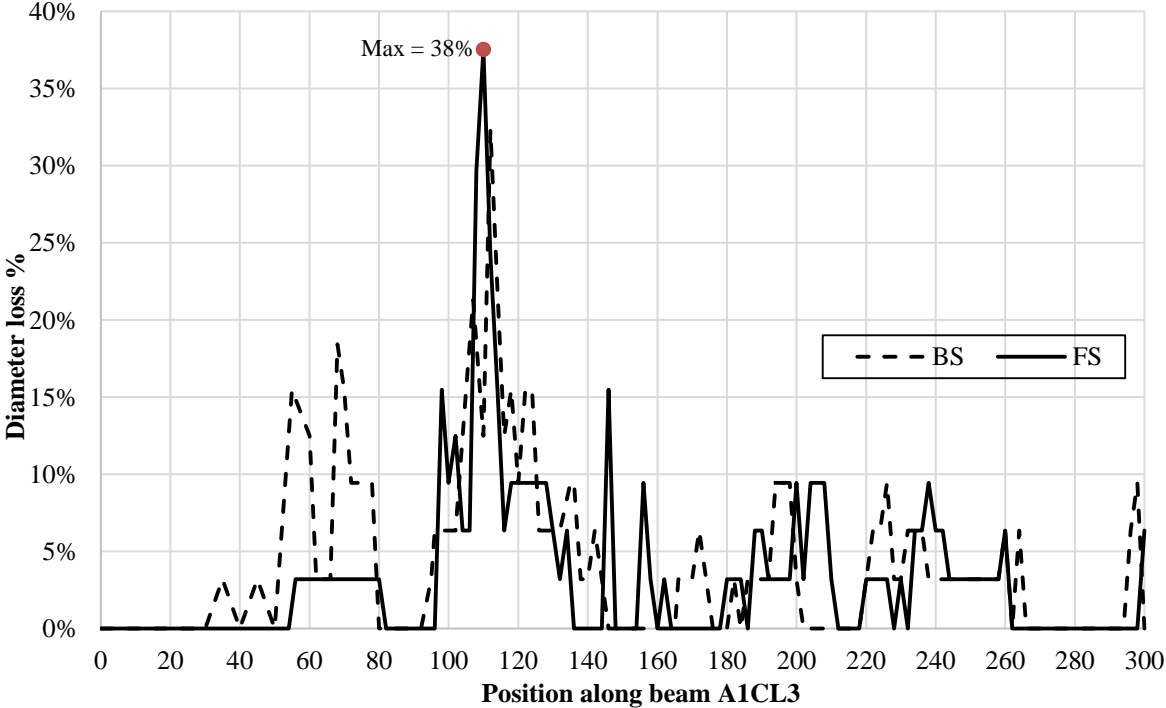
Figure 1 - 12 Diameter loss percentages vs. position along the corroded beam A1CL3-R

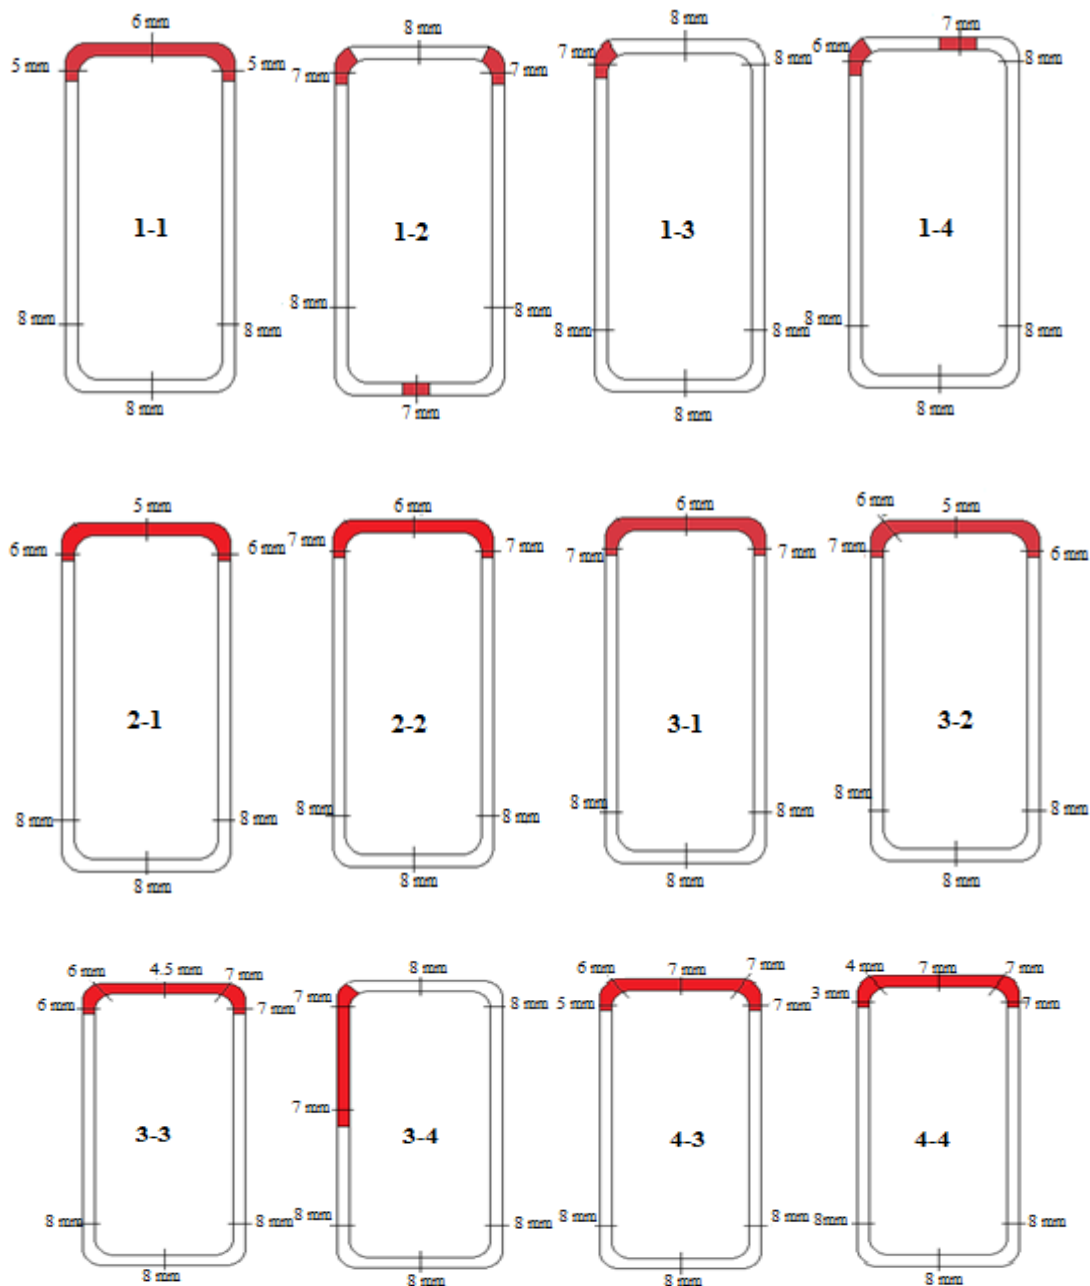
Figure 1 - 14 Corrosion in steel stirrups of A1CL3-R

Figure 1-14 shows the locations of corrosion in the steel stirrups and the diameter values:

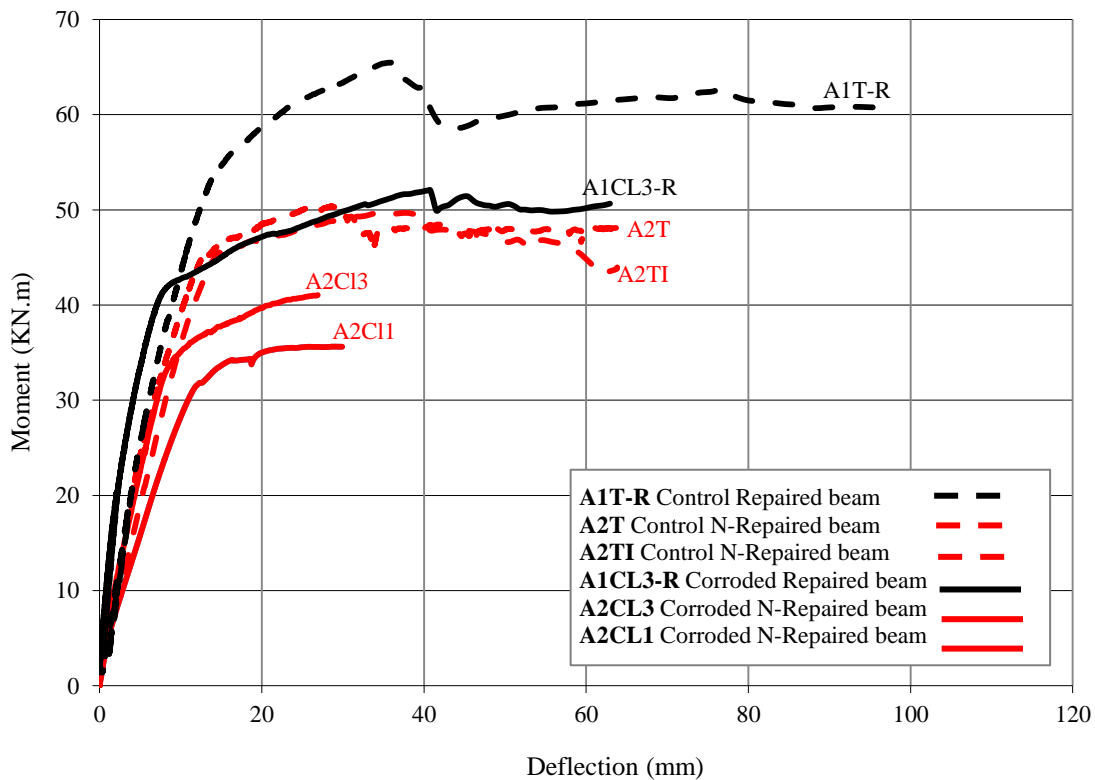
Figure 1 - 15 Comparisons of moment capacity (A2T, A2TI, A1T-R, A2CL3, A1CL3-R and A2CL1 (8,9))

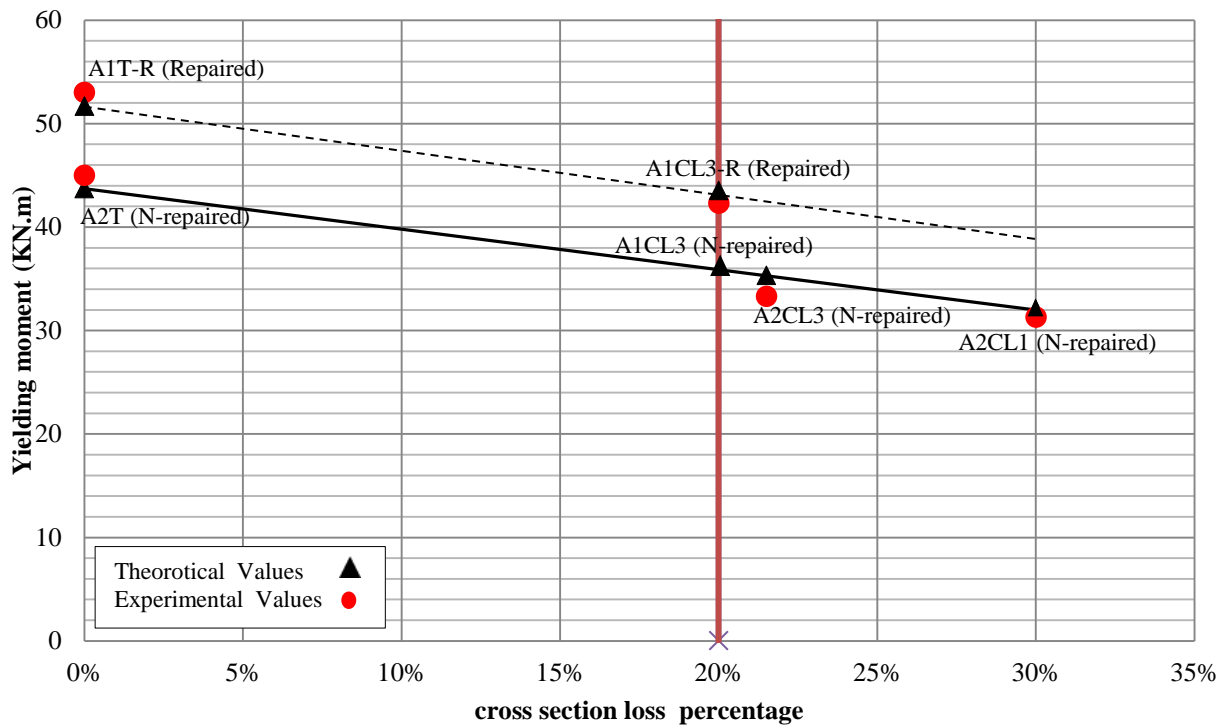
Figure 1 - 17 Yielding capacity increase

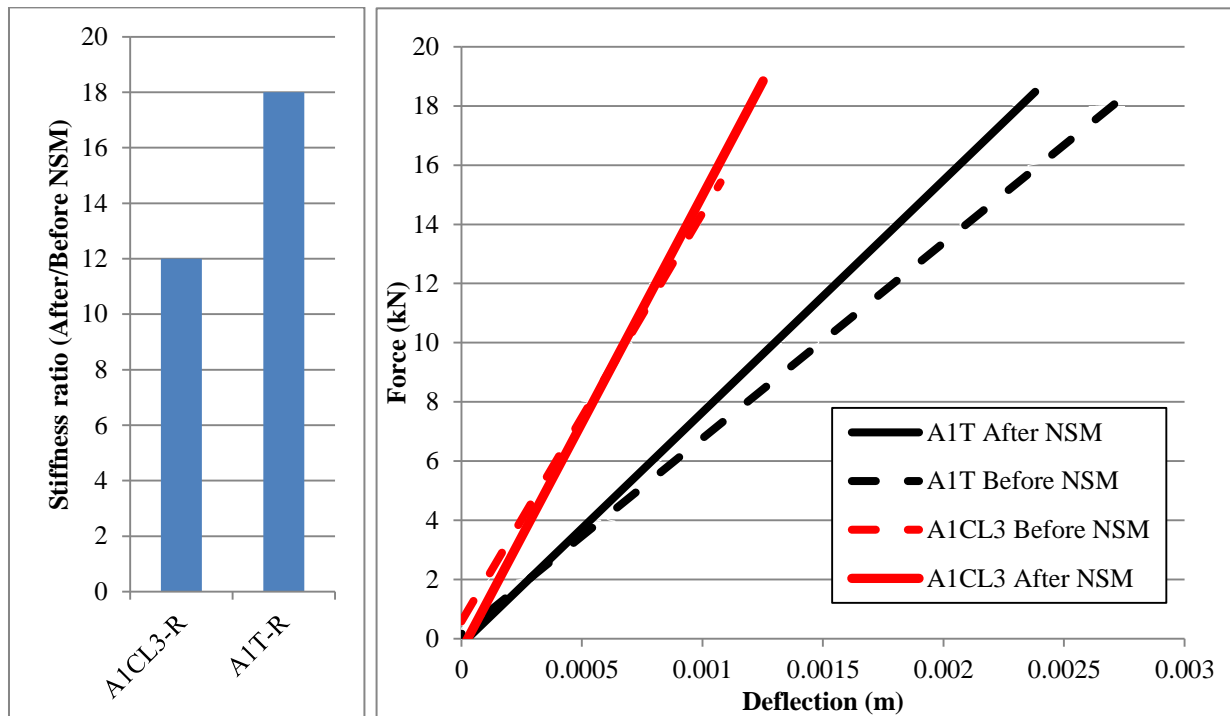
Figure 1 - 18 Stiffness ratio for repaired beams

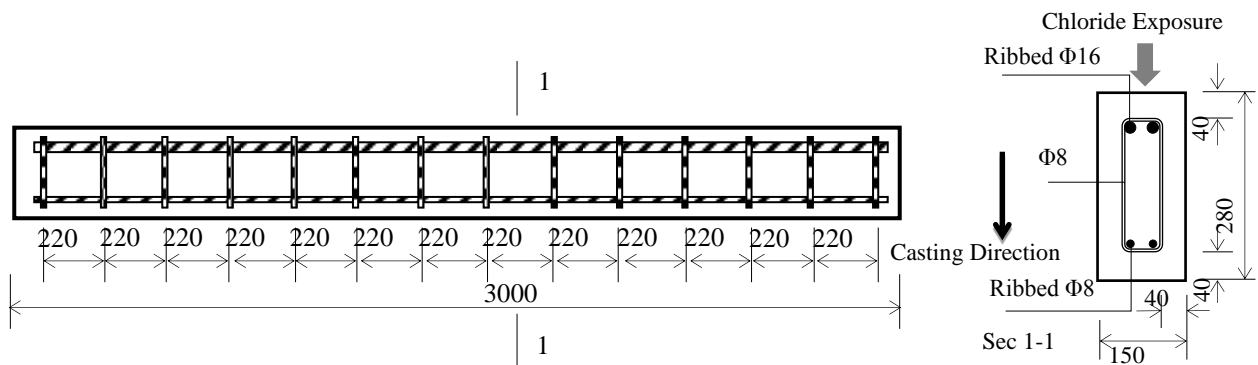
Figure 2 - 2 Reinforcement layout of type A beams. Dimensions are in mm

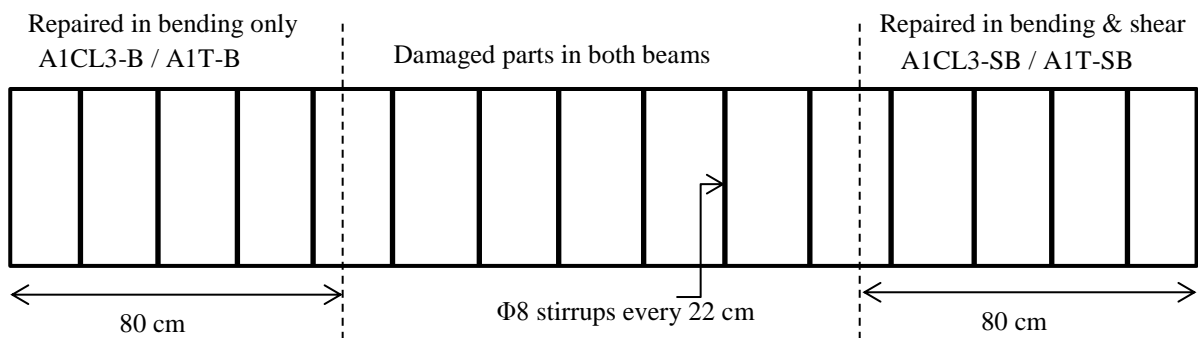
Figure 2 - 5 Parts of corroded and control beam

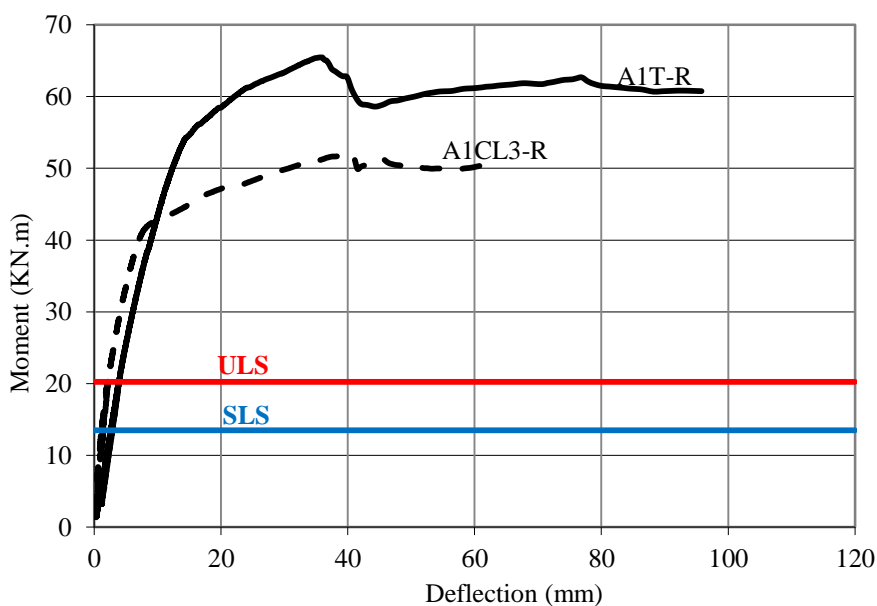
Figure 2 - 6 Moment-deflection curves for A1CL3-R and A1T-R

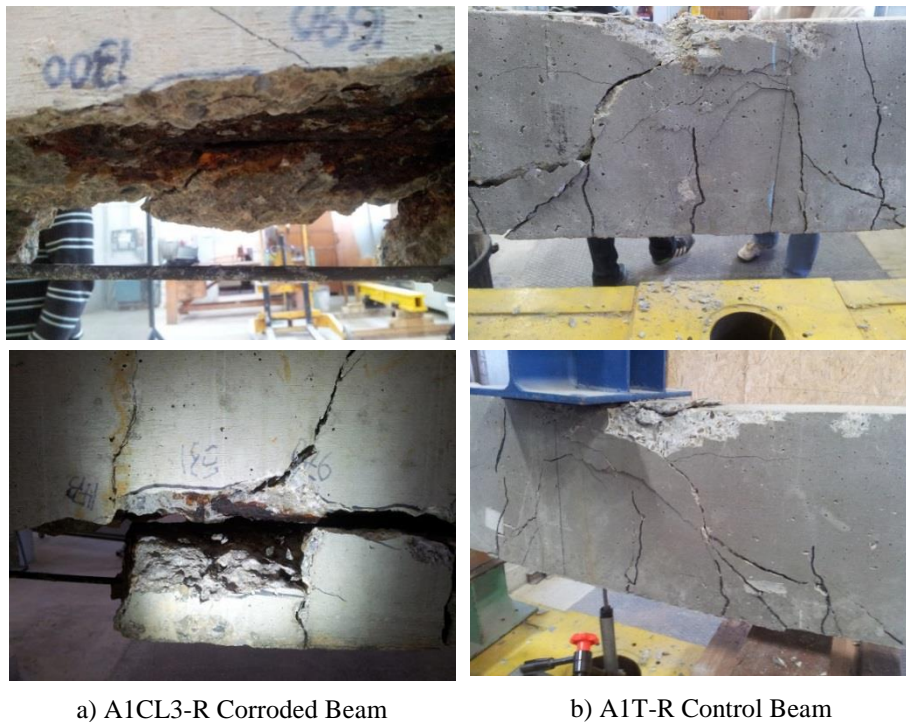
Figure 2 - 7 Modes of failure and damages of two full span beams A1CL3-R and A1T-R

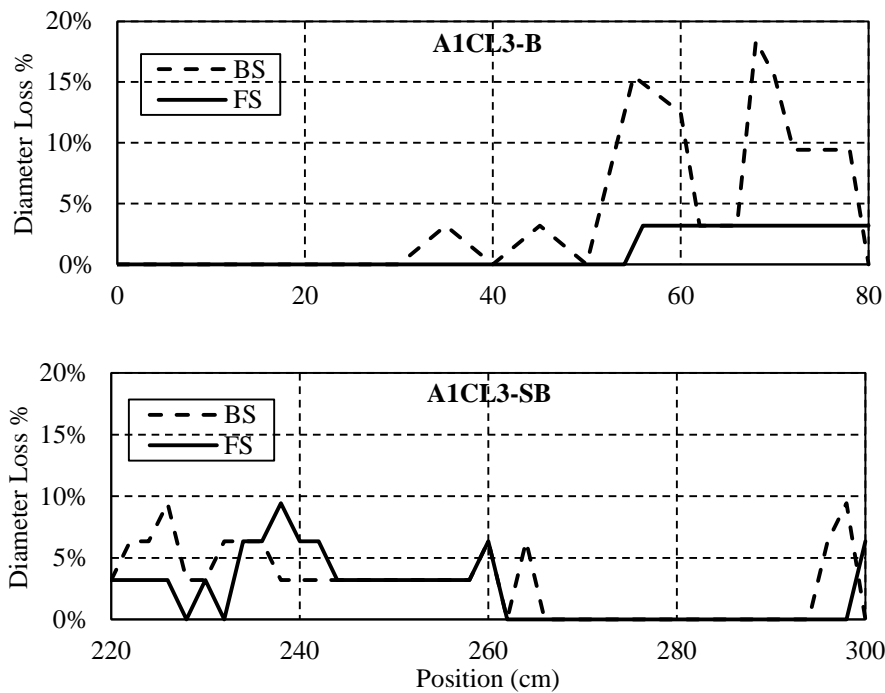
Figure 2 - 11 Diameter loss percentages of longitudinal tensile steel bars

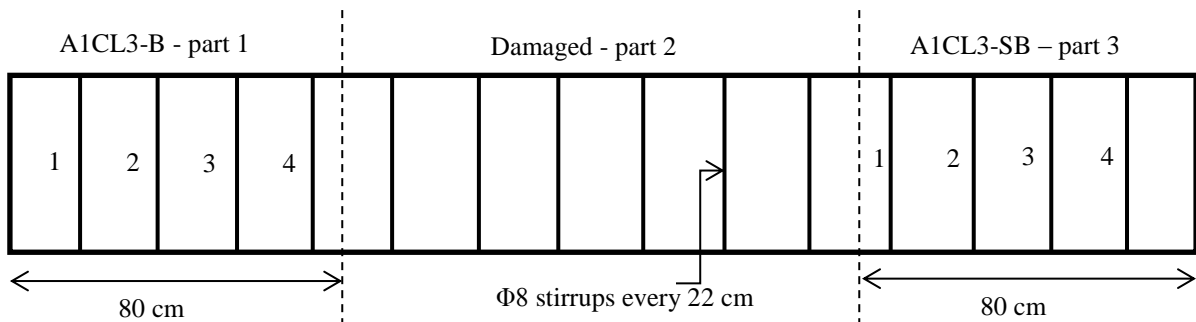
Figure 2 - 12 Parts of corroded beam A1CL3-R

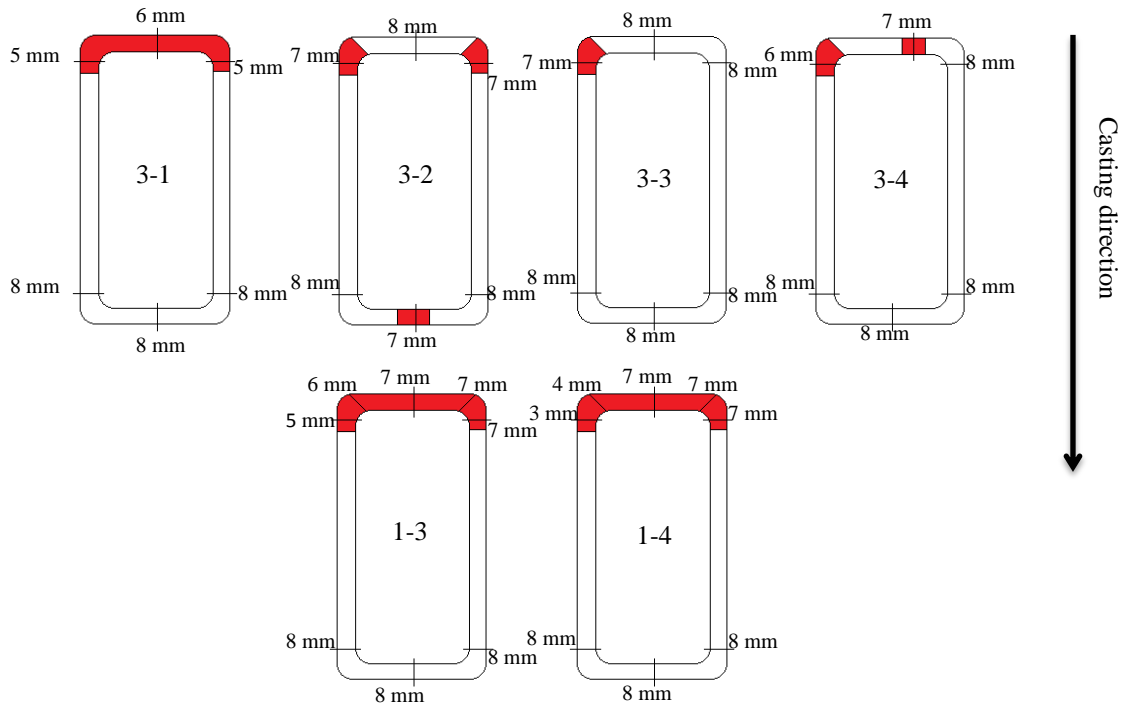
Figure 2 - 13 Corrosion in steel stirrups of corroded beam A1CL3-R

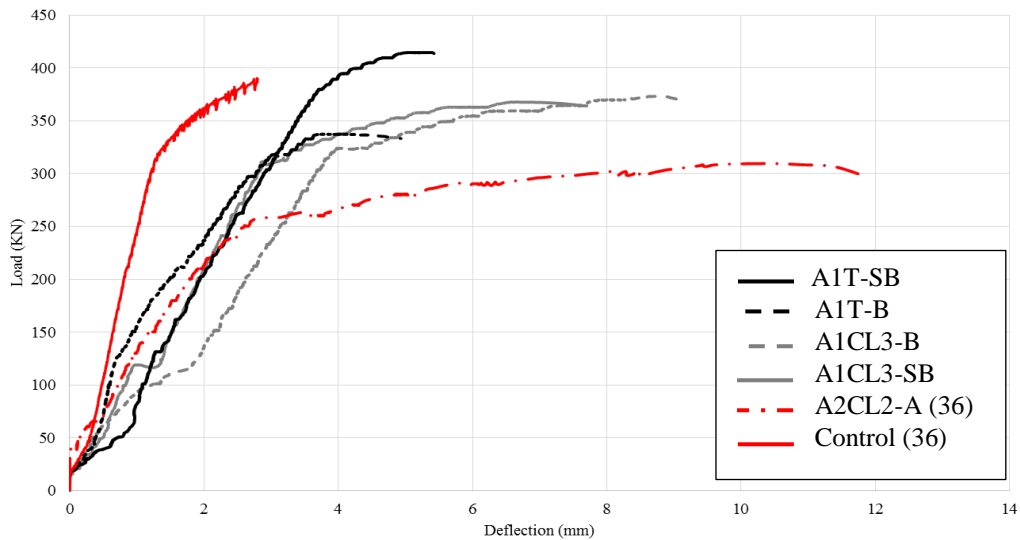
Figure 2 - 14 Load-deflection curves for all beams

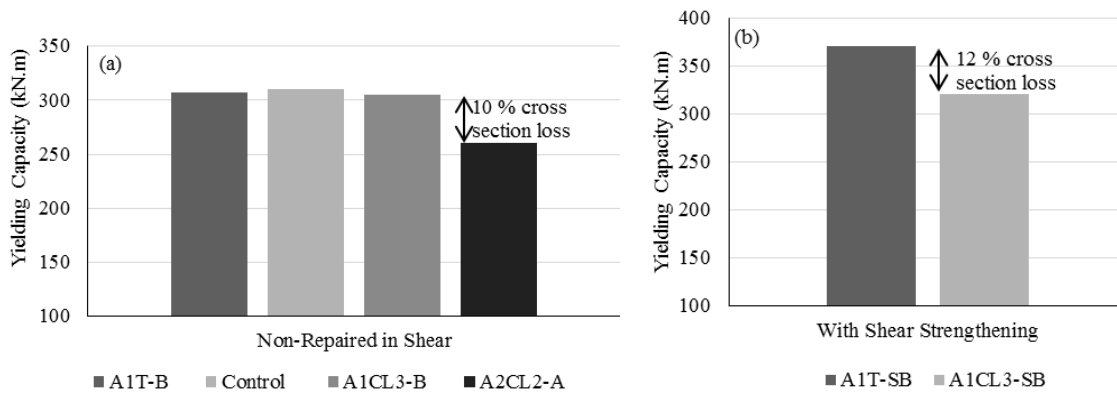
Figure 2 - 16 Yielding capacity values for all beams

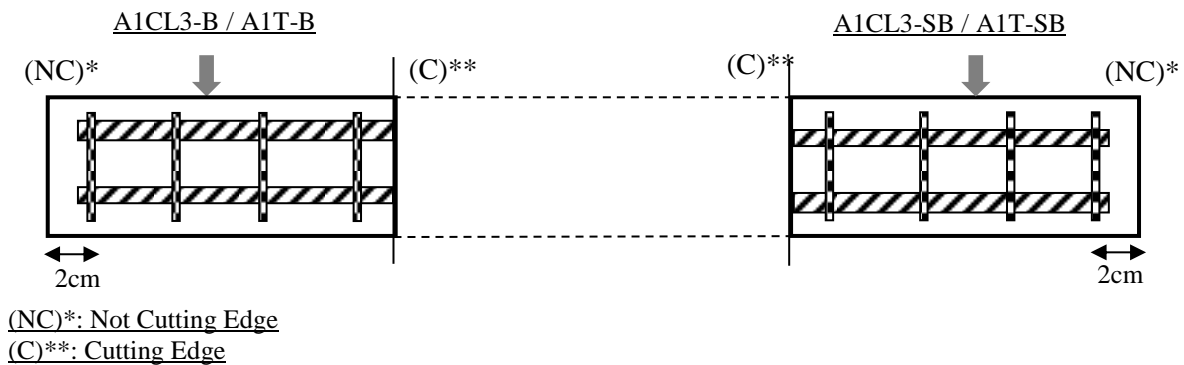
Figure 2 - 17 Steel layouts inside the four beams
