Strengthening of corroded reinforced concrete (RC) beams with near surface mounted (NSM) technique using carbon fiber polymer (CFRP) rods: an experimental and finite element (FE) modelling study

THÈSE

DOCTORAT DE L'UNIVERSITÉ DE TOULOUSE

Belal ALMASSRI

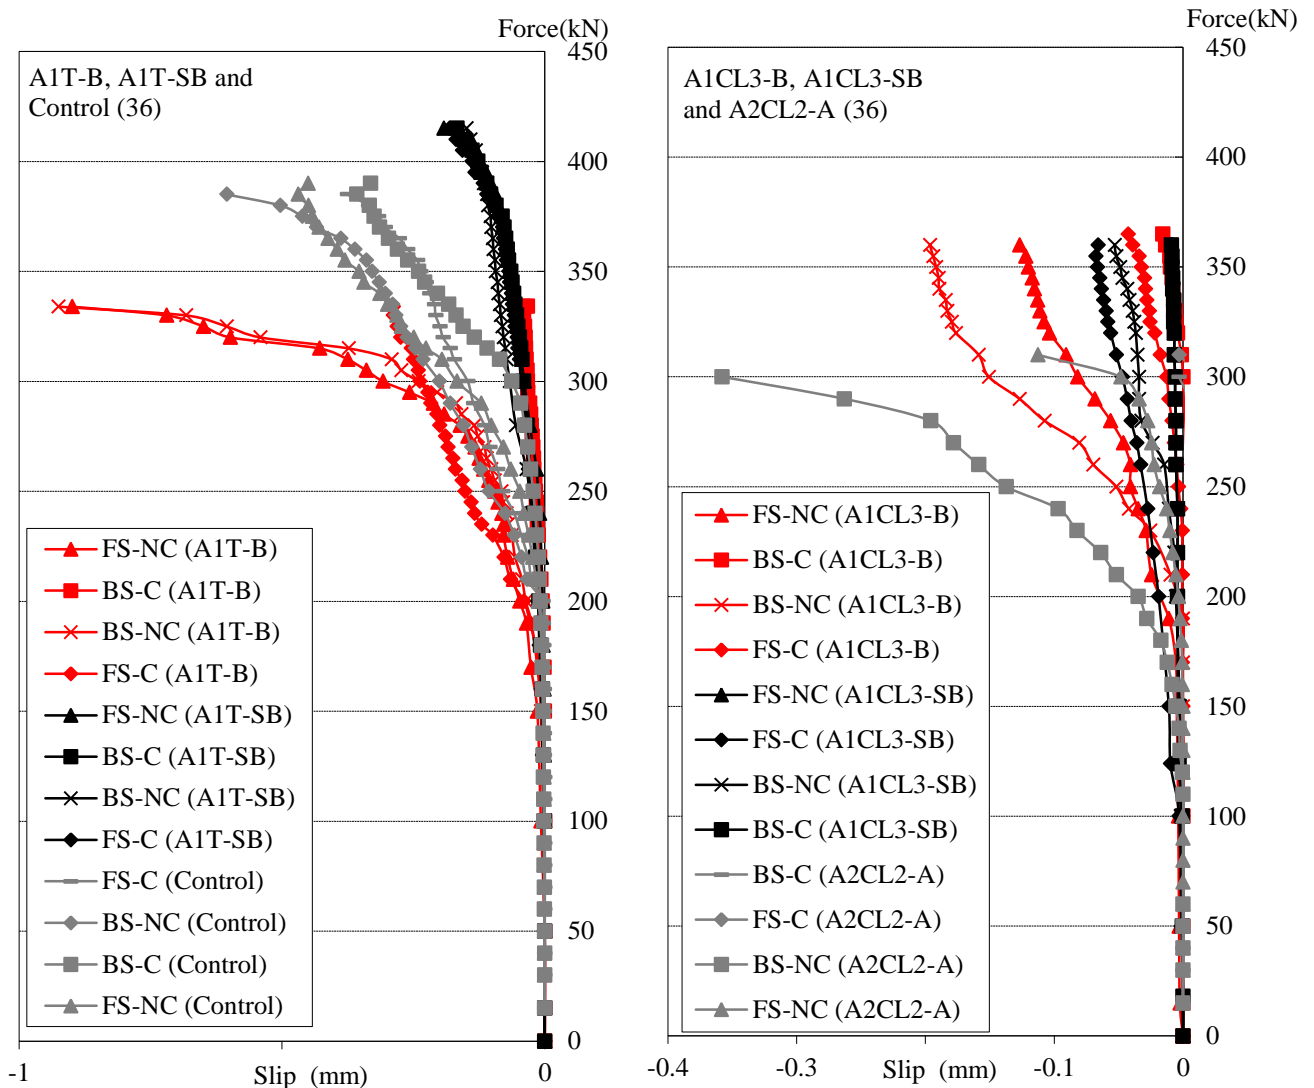
Figure 2 - 18 Slip measurements for all beams

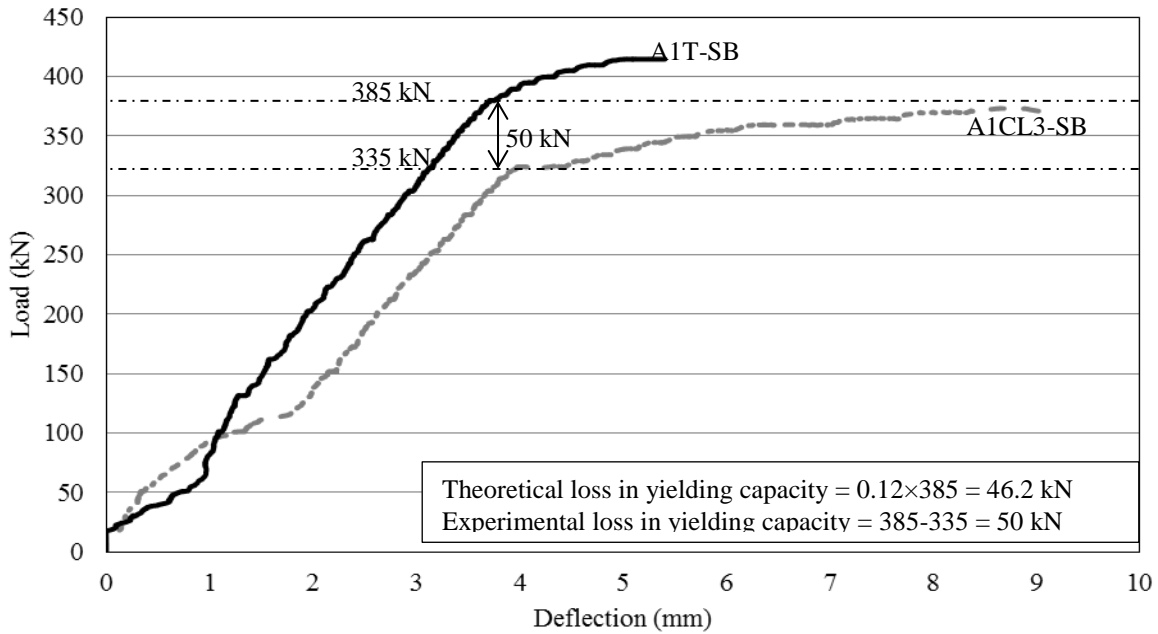
Figure 2 - 19 Effect of corrosion on yielding load capacity of beams repaired in shear

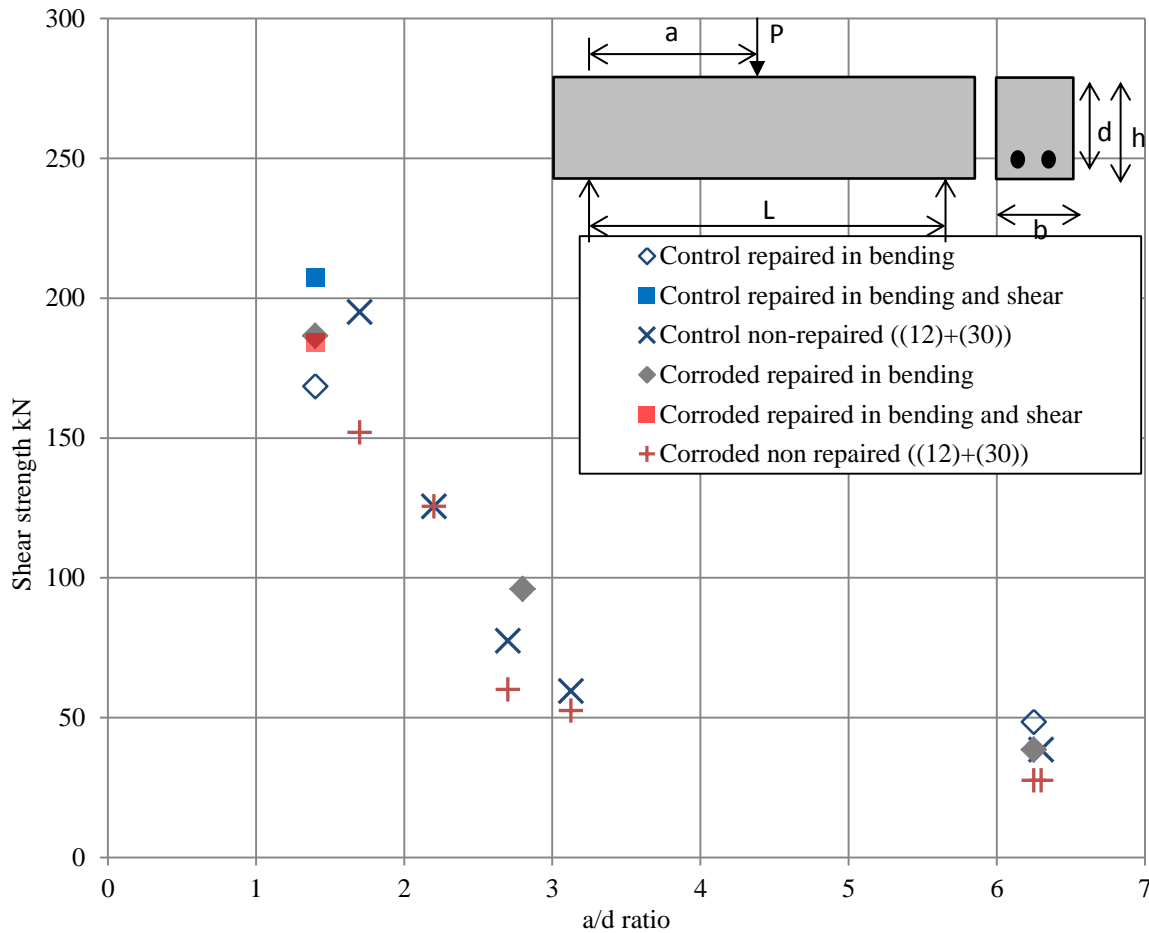
Figure 2 - 20 a/d ratio effect on the shear strength of beams

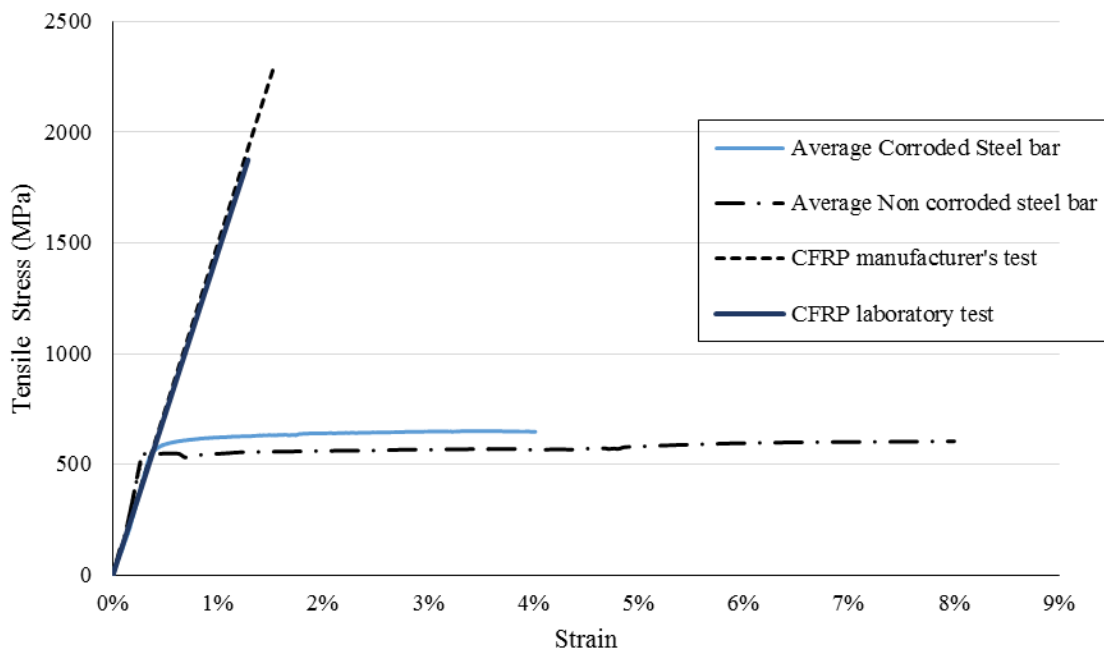
Figure 3 - 2 Tensile stress-strain curves for steel and CFRP rods (Corroded and control steel bar curves are average results of 2 tested specimens in each case)

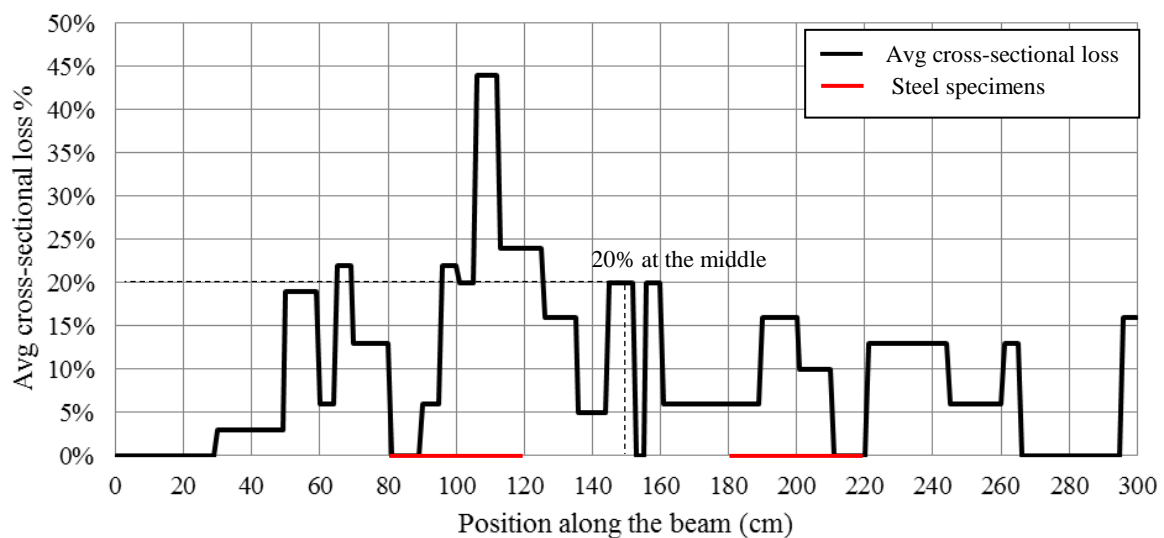
Figure 3 - 5 Average cross-section loss percentages in corroded beam A1CL3-R.

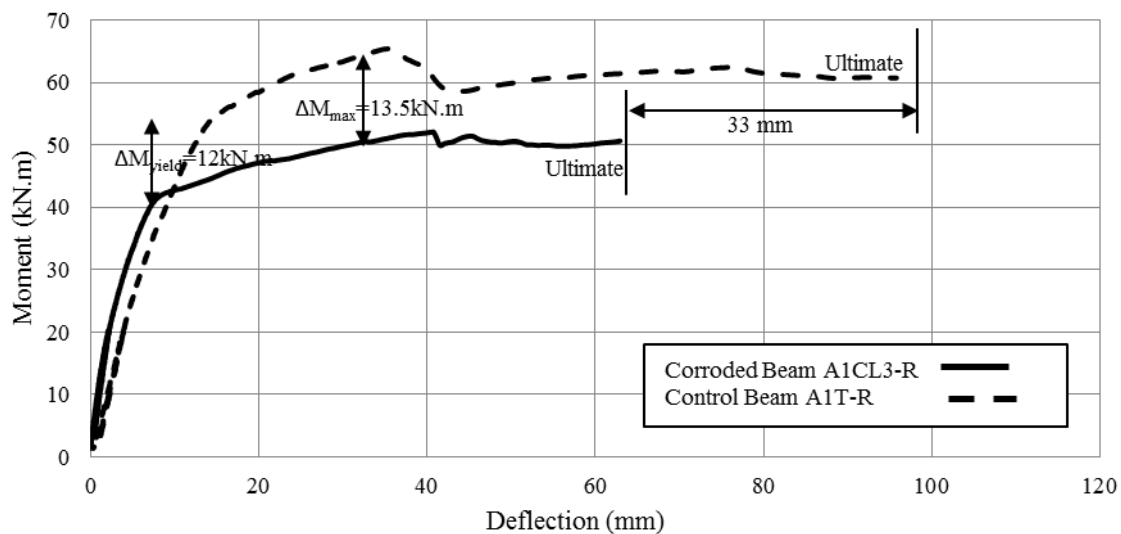
Figure 3 - 6 Moment-deflection curves for beams A1CL3-R and A1T-R tested experimentally

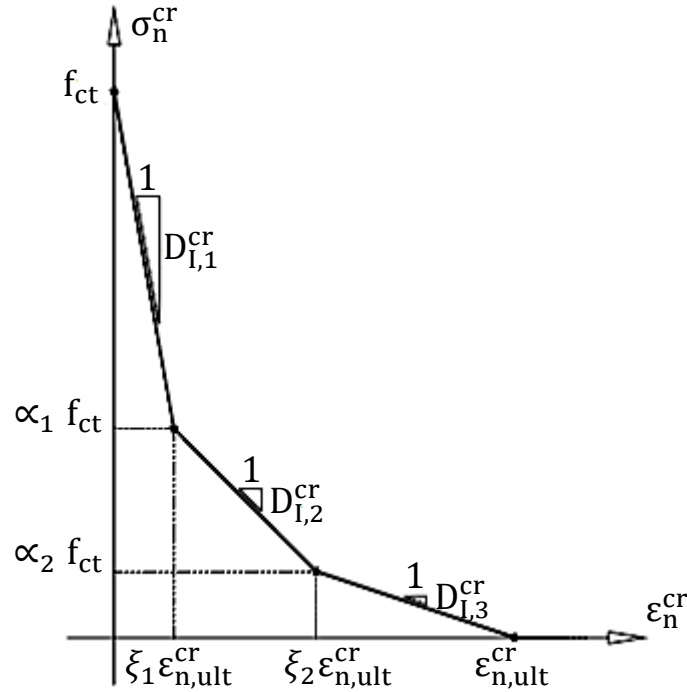
Figure 3 - 8 Tension softening diagram for concrete

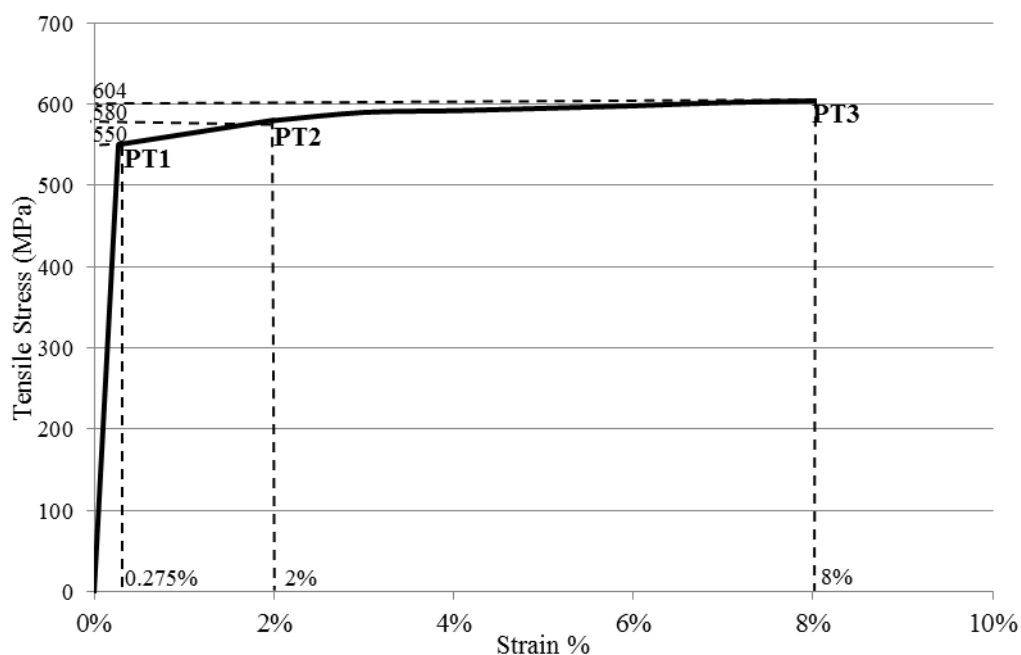
Figure 3 - 10 (a) uniaxial constitutive model for non-corroded rebar

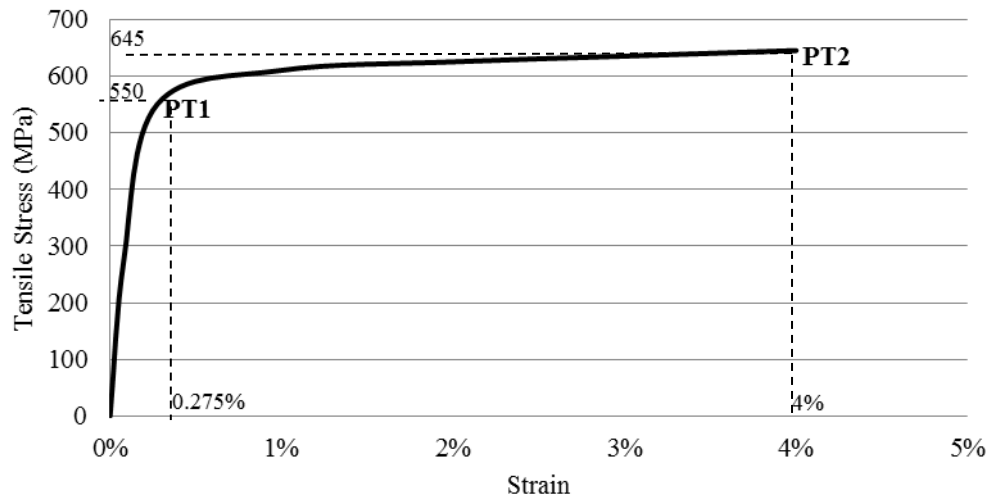
Figure 3 – 10 (b) uniaxial constitutive model for corroded rebar

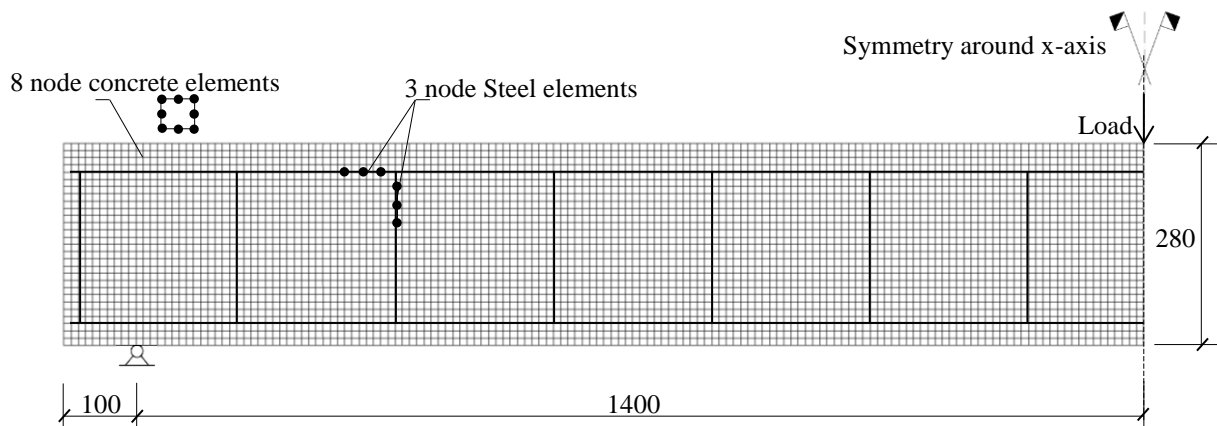
Figure 3 - 11 Geometry in (mm), mesh, loading and support conditions for non-strengthened beams with NSM CFRP

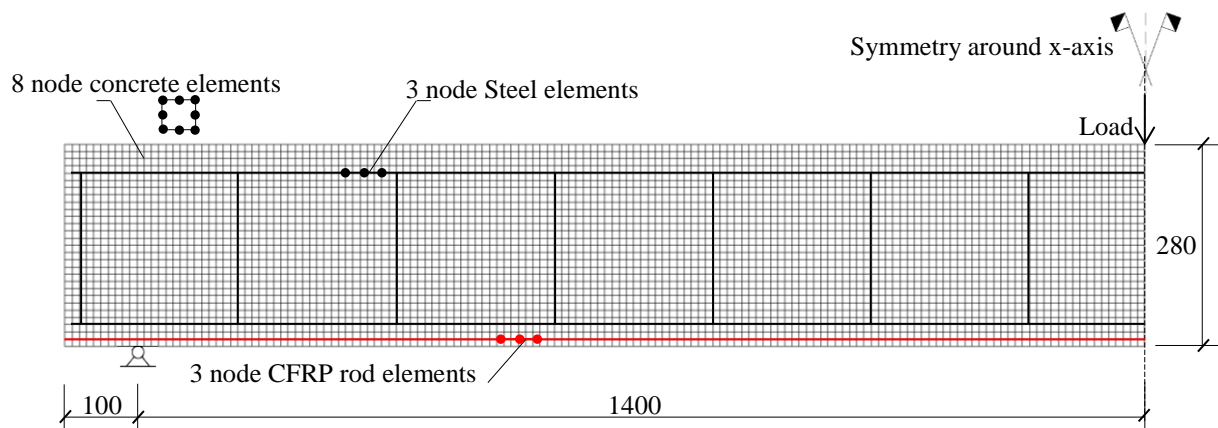
Figure 3 - 12 Geometry, mesh, loading and support conditions for strengthened beams with NSM CFRP

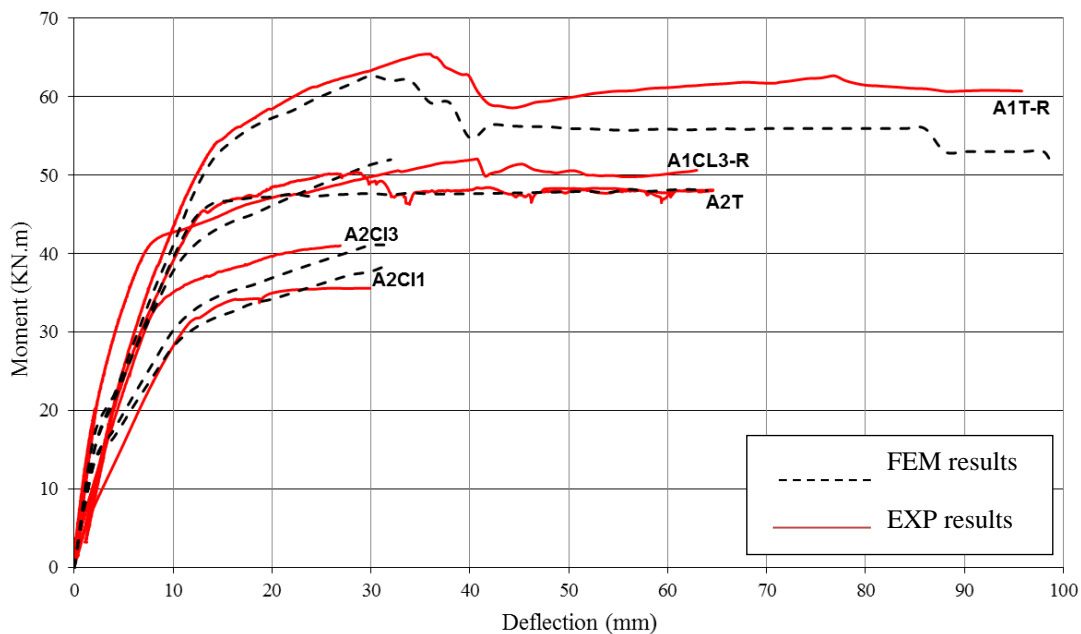
Figure 3 - 14 Load Deflection curves for all beams using FEMIX

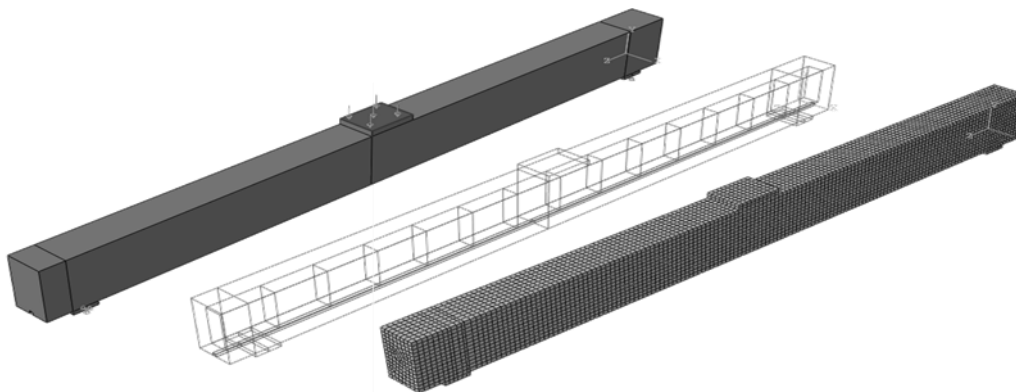
Figure 3 - 20 Boundary conditions, steel skeleton and meshing of beam model

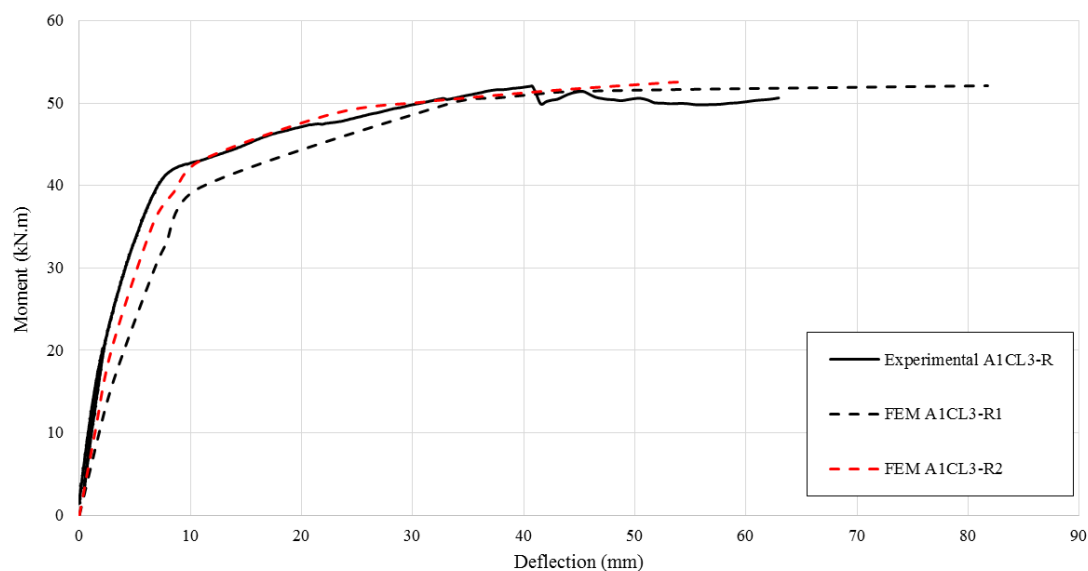
Figure 3 - 21 Experimental curves vs. 3D FE Model moment-deflection curves obtained with Abaqus for RC beam A1CL3-R

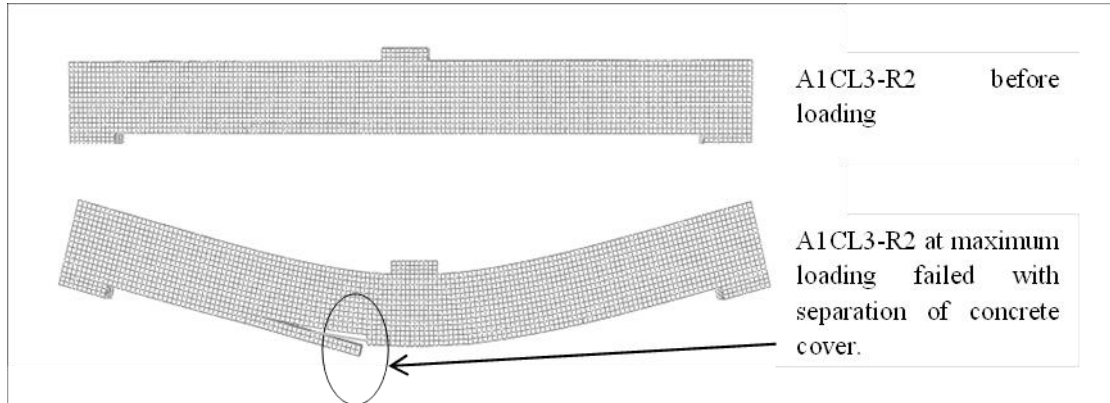
Figure 3 - 22 Mode of failure obtained for corroded RC beam A1CL3-R by 3D FE model using Abaqus

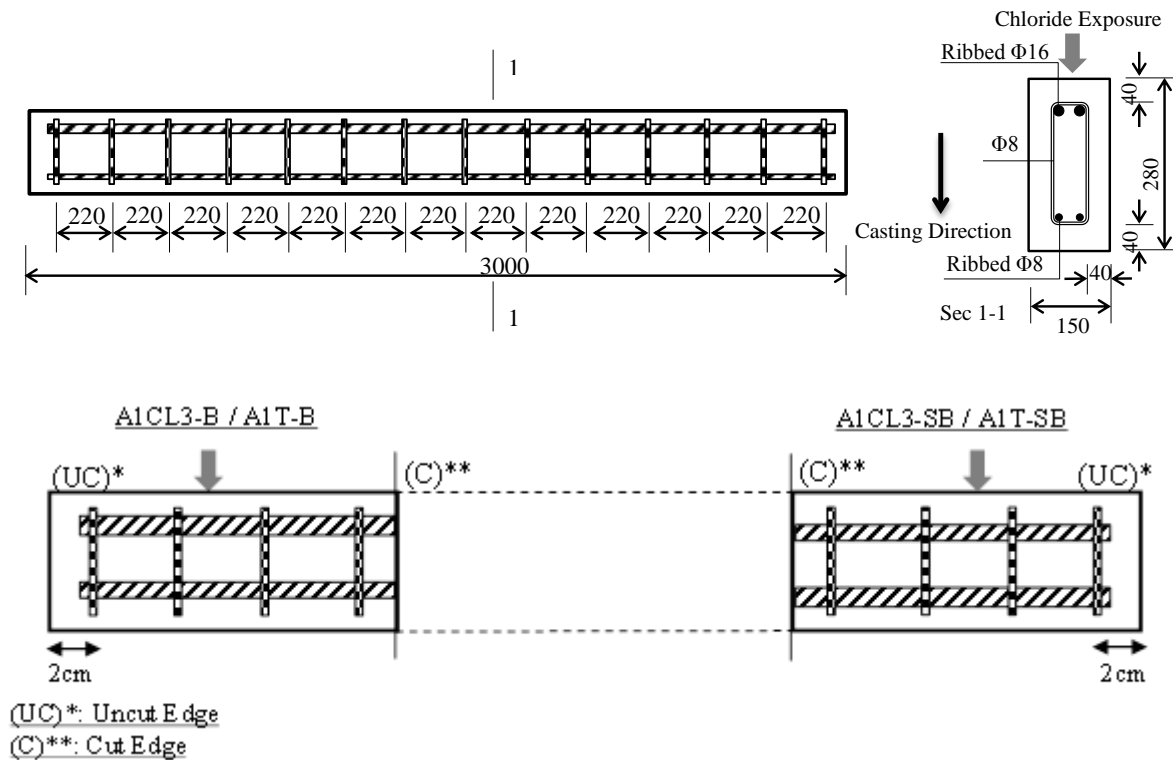
Figure 4 - 1 Reinforcement layout all beams. Dimensions are in mm

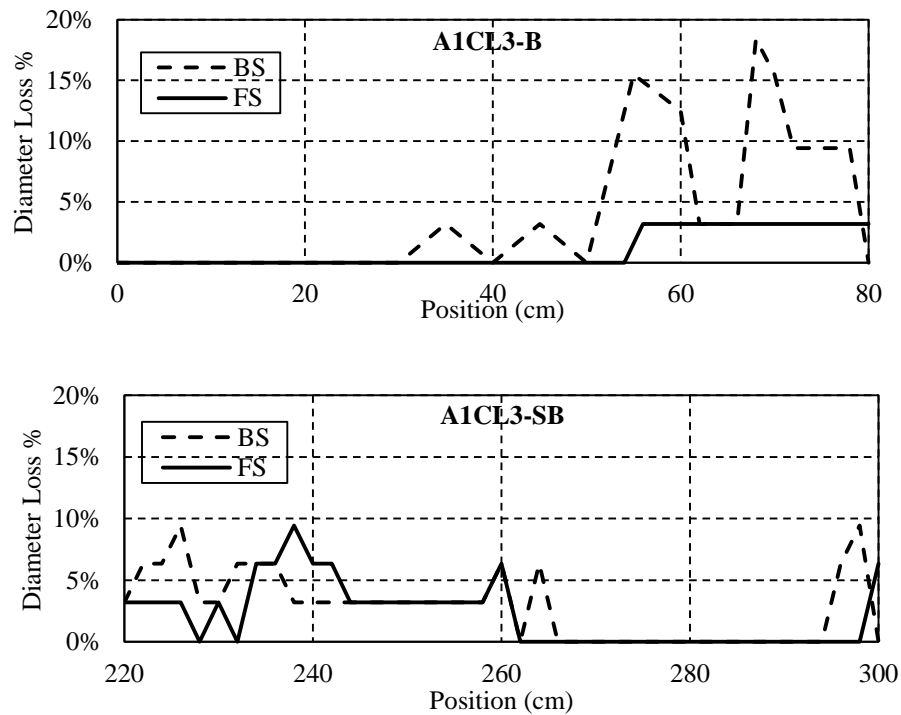
Figure 4 - 2 Diameter loss percentages of longitudinal tensile steel bars for corroded beams

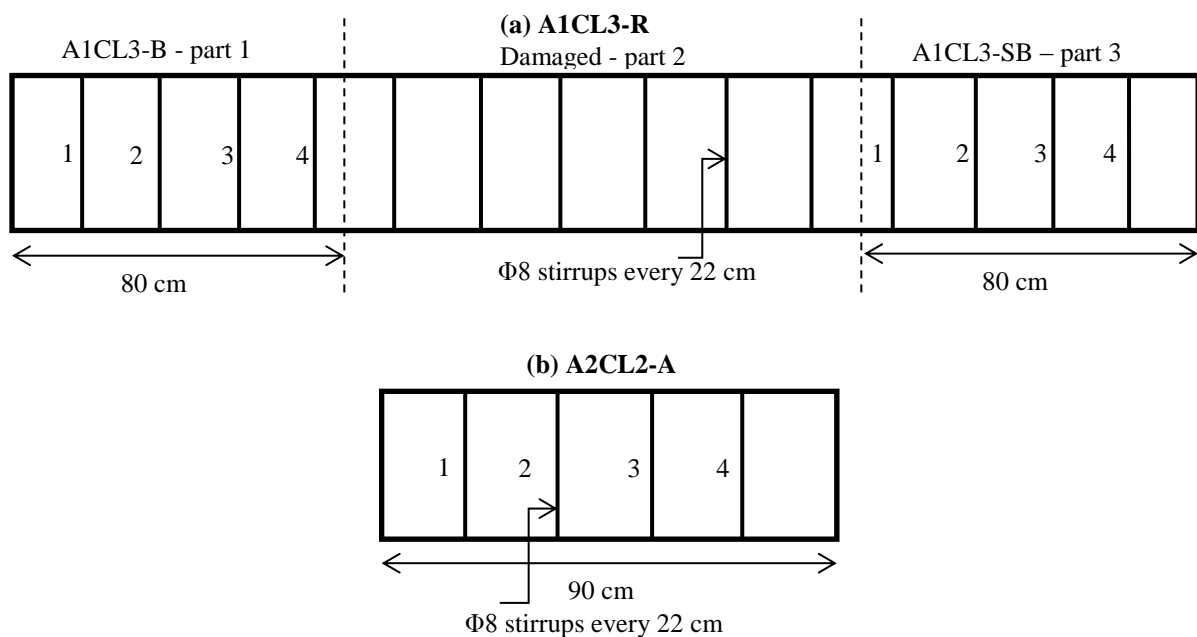
Figure 4 - 3 Stirrups numbers of corroded beams (a) A1CL3-R (b) A2CL2-A

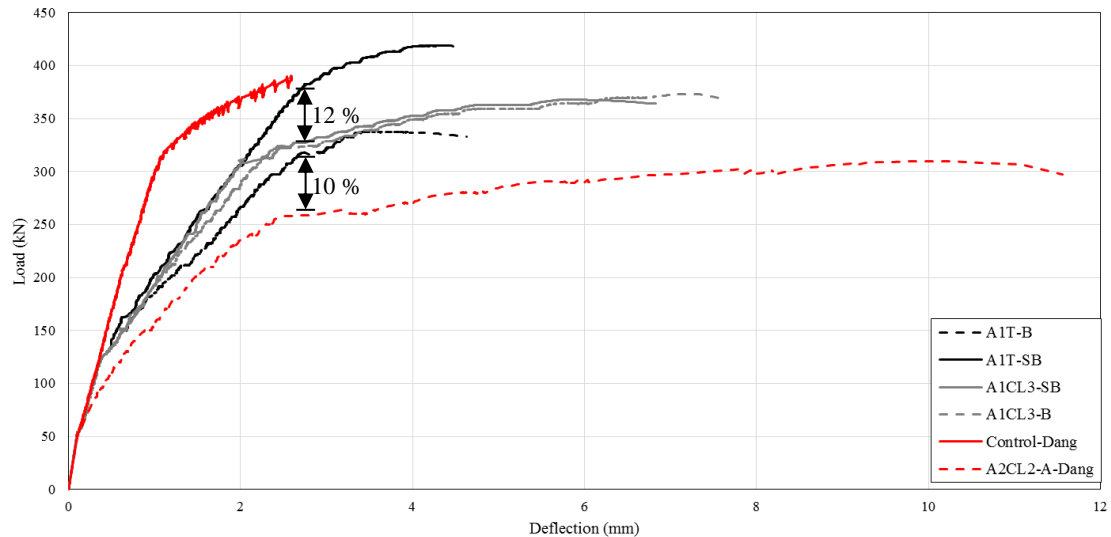
Figure 4 - 5 Load-deflection curves for all beams

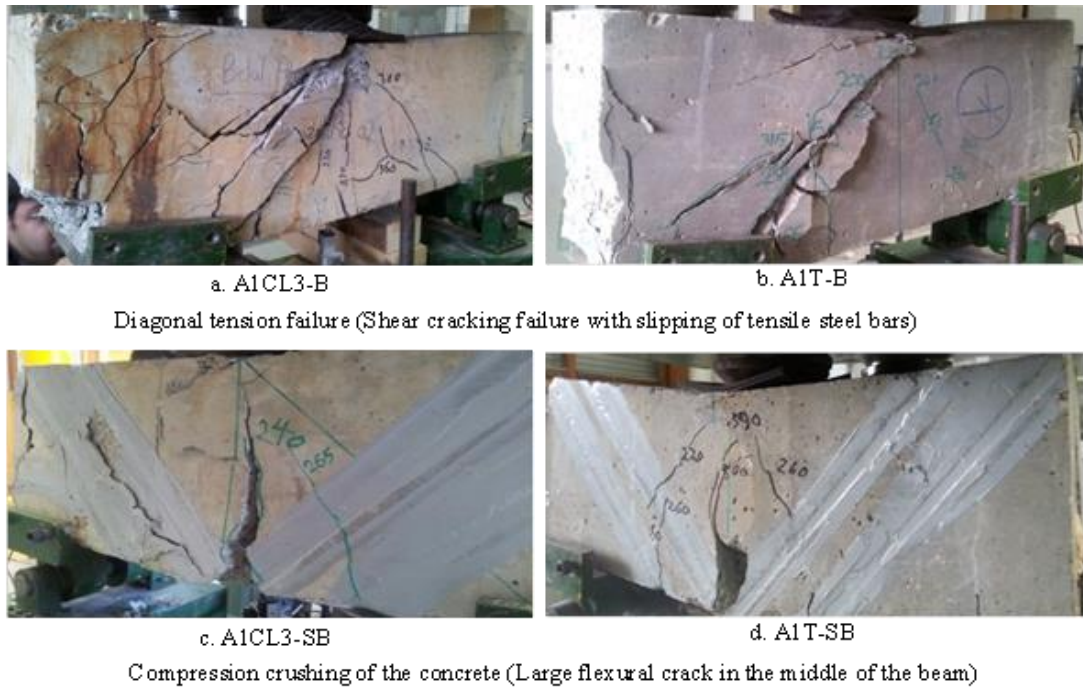
Figure 4 - 6 Experimental modes of failure for all tested beams

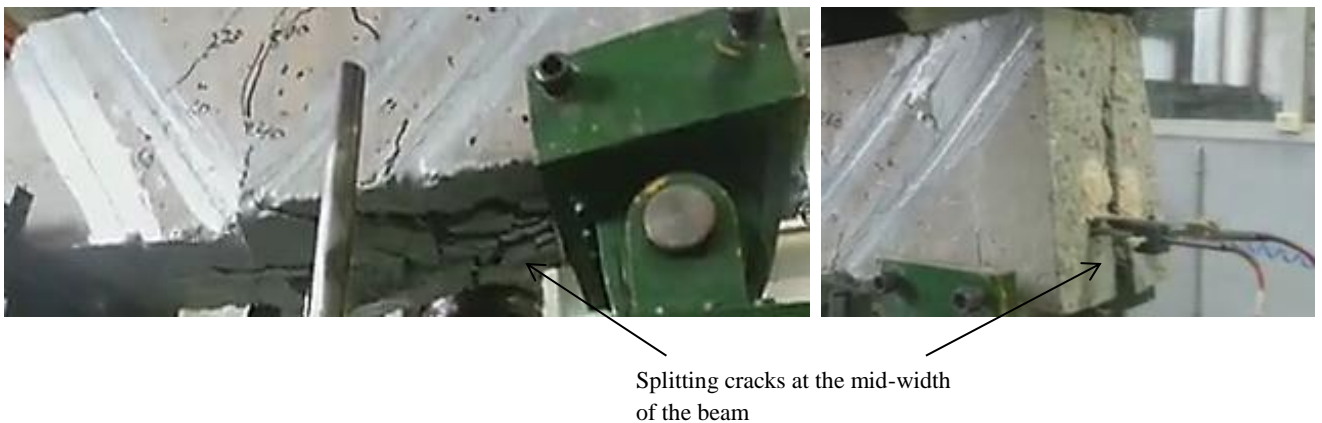
Figure 4 - 7 Tensile steel bars slip occurred in non-shear repaired beams A1T-SB and A1CL3-SB

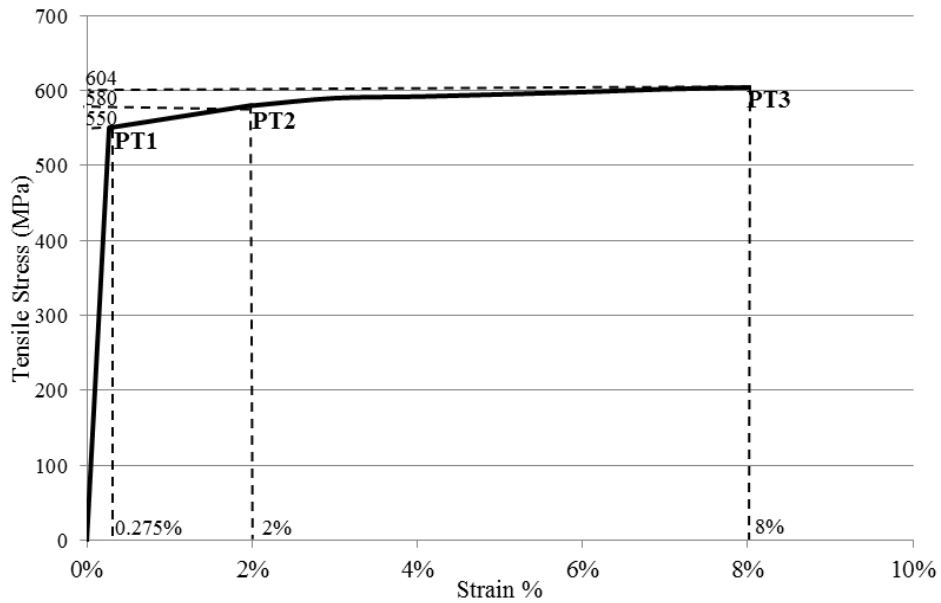
Figure 4 - 10 uniaxial constitutive model of non-corroded steel bars

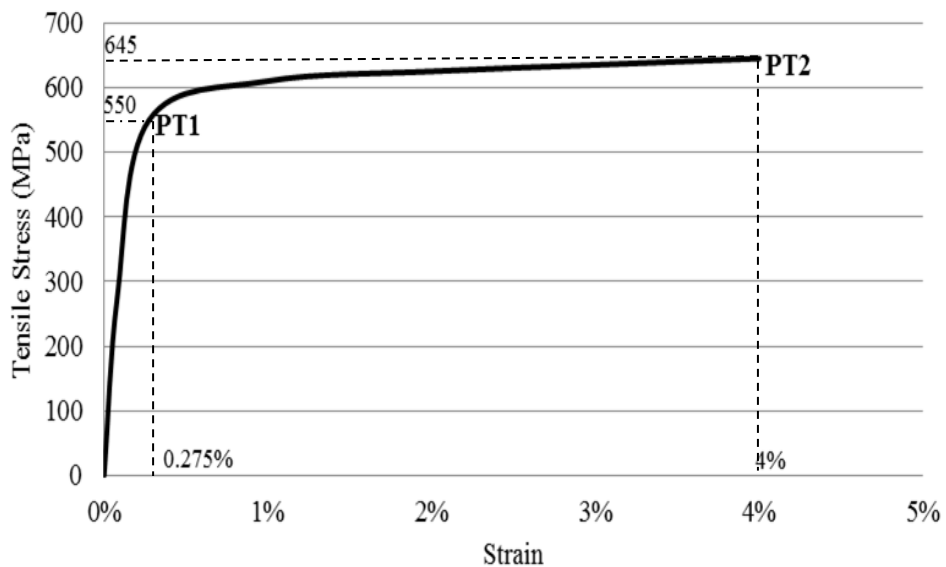
Figure 4 - 11 uniaxial constitutive model of corroded steel bars

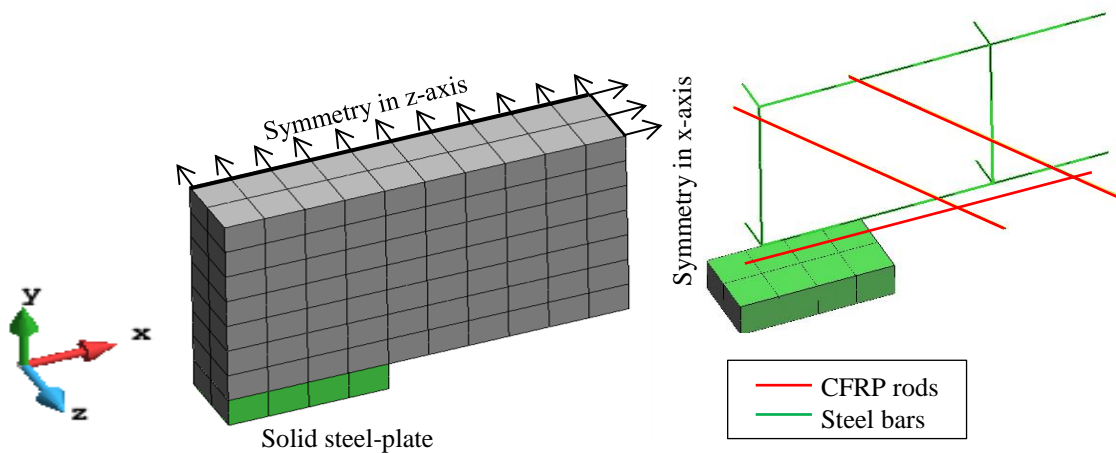
Figure 4 - 12 The boundary conditions of the 3D model in an isometric plane in GiD-FEMIX

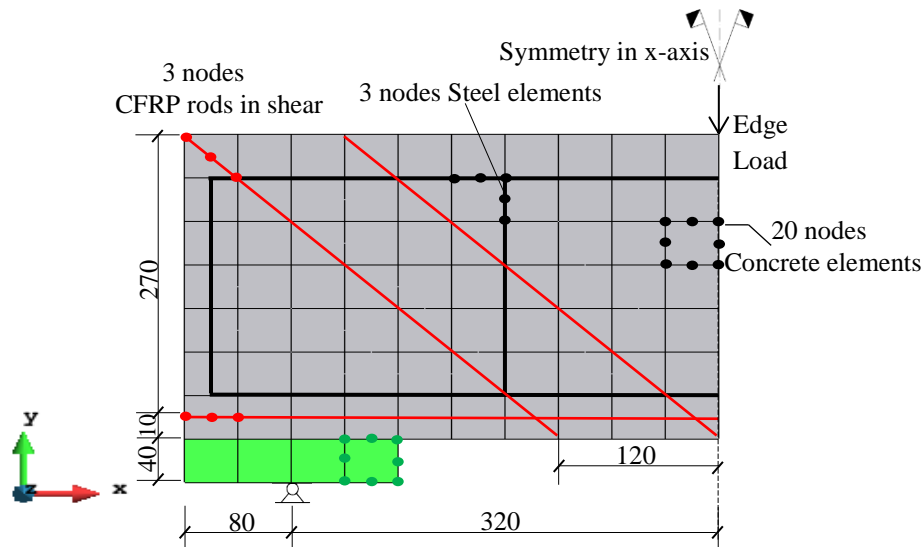
Figure 4 - 13 Geometry in (mm), mesh, loading and support conditions in x-y plane for shear repaired beams with NSM CFRP rods

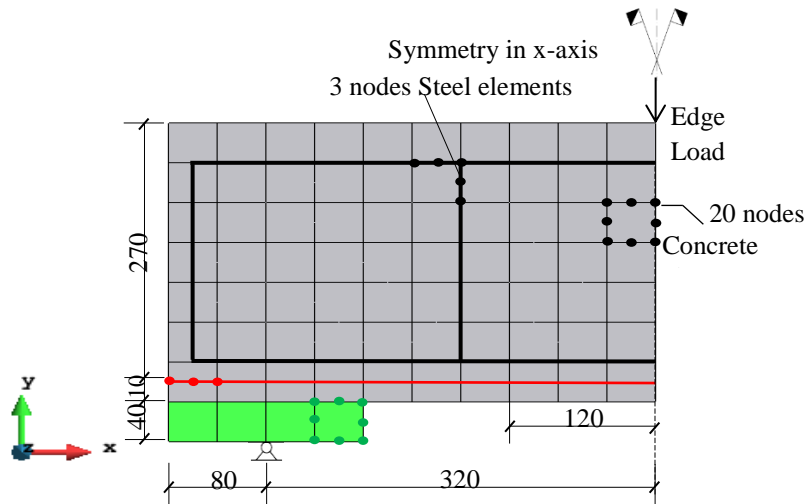
Figure 4 - 14 Geometry in (mm), mesh, loading and support conditions in x-y plane for non-shear-repaired beams with NSM CFRP rods

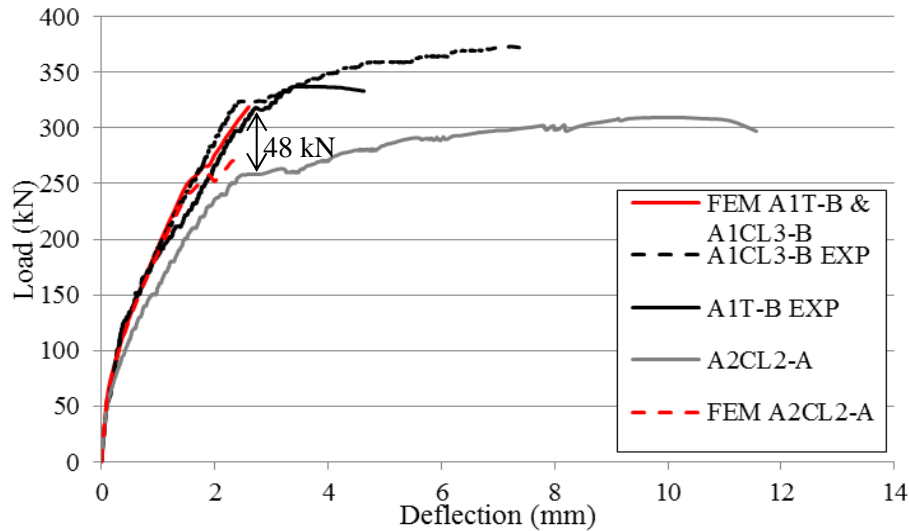
Figure 4 - 15 Experimental vs FE numerical model load-deflection curves for non-shear-repaired beams A1CL3-B , A2CL2-A and A1T-B

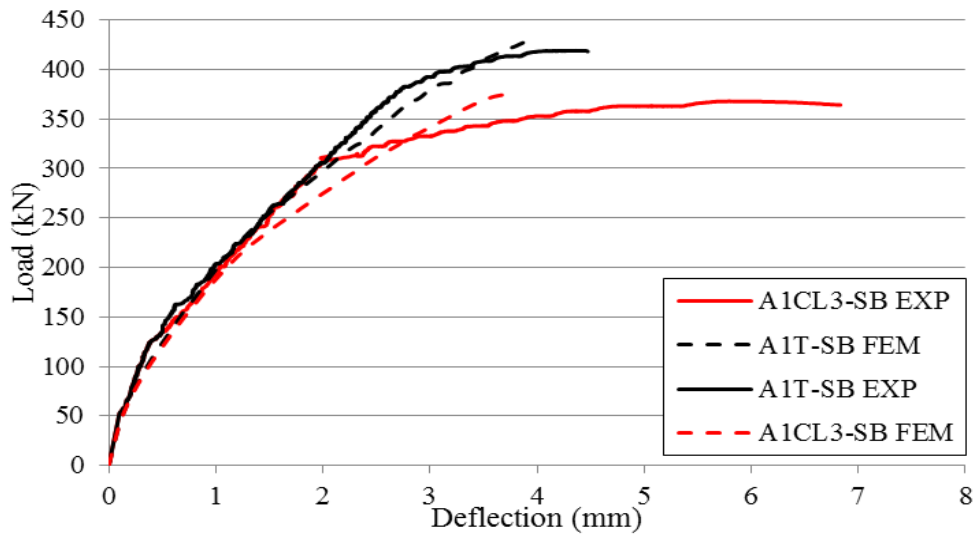
Figure 4 - 18 Experimental vs FE numerical model load-deflection curves for shear-repaired beams A1CL3-SB and A1T-SB

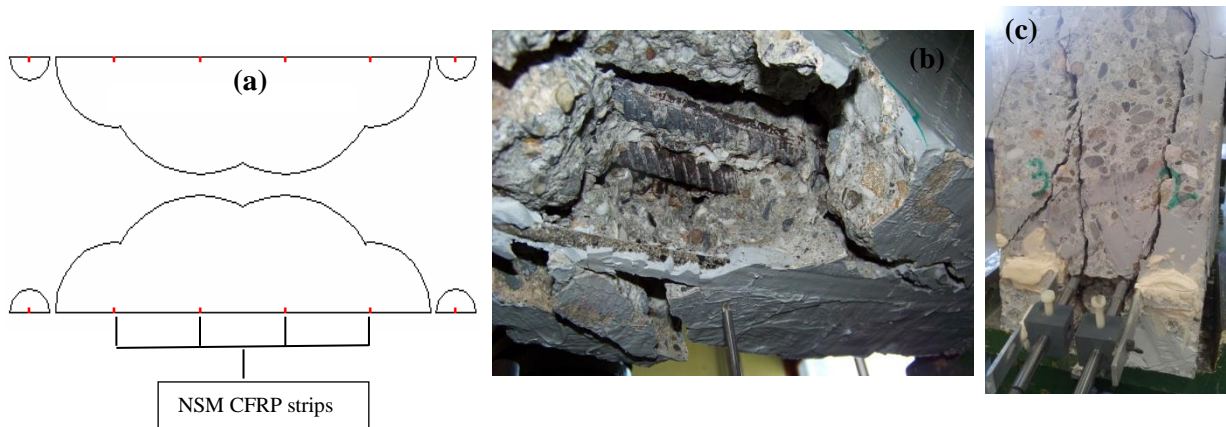
Figure 4 - 21 (a) Section parallel to the crack plane for the theory of the failure mode proposed by Bianco et al. 24. (b) Splitting cracks at the bottom of the shear repaired beams A1CL3-SB and A1T-SB. (c) Splitting cracks at the edge of the shear repaired beams A1CL3-SB and A1T-SB
