Effect of corrosion on the mechanical properties of the corroded reinforcement and the residual structural performance of the corroded beams

THÈSE

DOCTORAT DE L'UNIVERSITÉ DE TOULOUSE

Institut National des Sciences Appliquées de Toulouse (INSA de Toulouse)

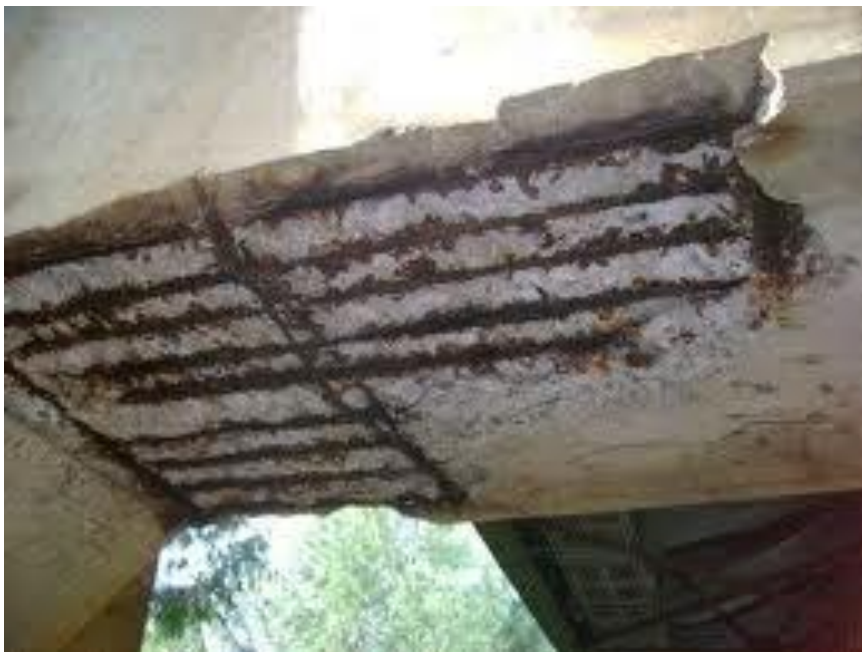
Figure 1 : corrosion de l'acier

Le béton est sans doute la meilleure protection de l'acier vis-à-vis de la corrosion en raison du pH élevé de sa solution interstitielle présente dans la porosité. Cependant, il existe deux causes principales d'amorçage de la corrosion : la diminution du pH de la solution interstitielle due à la carbonatation (réaction du gaz carbonique avec les hydrates du béton conduisant à la formation d'un acide faible) qui permet la corrosion de l'acier, ou rupture local du film passif recouvrant l'acier en raison de la présence d'un taux minimum d'ions chlore (figure 1).

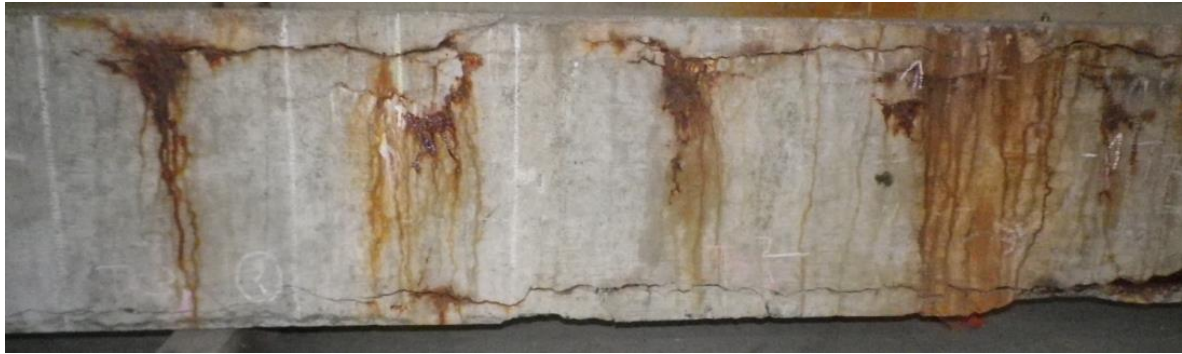
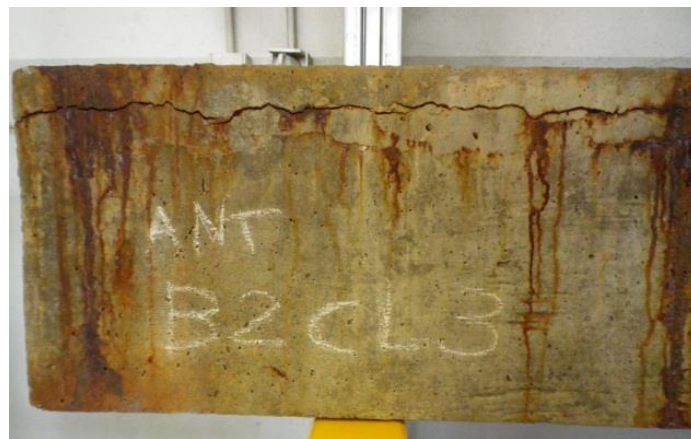
Figure 2: poutres corrodées

L'étude de la phase de propagation de la corrosion et de ses conséquences sur le fonctionnement mécanique en service ou à rupture, est basée sur l'analyse du vieillissement d'éléments en béton armé, et plus particulièrement sur l'analyse exhaustive de deux poutres corrodées notée B2CL2 et B2CL3 (figure 2). Ces poutres font parties d'un ensemble d'éléments de trois mètres longueur, conservés depuis respectivement 26 ans et 28 ans en ambiance saline et sous différentes intensités de chargement en flexion trois points. Il s'agit donc de conditions de vieillissement très proches de celles des structures réelles. Cette partie expérimentale est la suite d'un programme de vieillissement du béton armé démarré en 1984 à Toulouse, et dont le support en était la thèse de doctorat de Raoul François. Il a bénéficié d'un financement de l'AFREM (Association Française de Recherche et d'Etudes sur les Matériaux) et de l'AFB (Association Française du Béton) qui ont depuis fusionnées pour donner naissance à l'AFGC (Association Française du Génie Civil). L'objectif initial de l'étude était de comprendre les relations existantes entre la fissuration de service (structurale) du béton armé et la corrosion des armatures. En effet, les règlements de calcul (de l'époque) limitaient l'ouverture des fissures structurales afin d'obtenir une durée de vie suffisante en environnement agressif sans que ces mesures s'appuient sur des bases expérimentales suffisamment pertinentes.

(a) Poutres corrodées B2Cl2 (26 ans)

(b) Poutres corrodées B2Cl3 (28 ans)

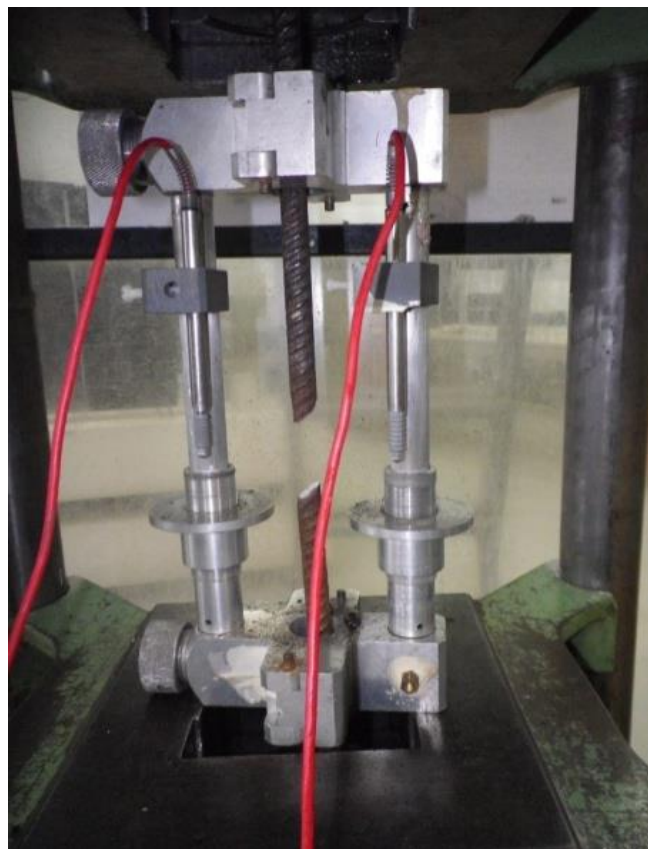
Figure 3 : les barres d'acier testées

Les barres d'acier ont été testées en traction en utilisant une machine de capacité 250 kN (figure 3). Deux LVDT ont été utilisés pour mesurer l'allongement des barres d'acier. La longueur de base pour la mesure de l'allongement était de 200 mm pour chaque barre d'acier. Les résultats obtenus sont utilisés pour tracer les diagrammes de contrainte-déformation pour chaque échantillon testé. En utilisant des diagrammes contrainte-déformation, la limite élastique, la résistance à la rupture et l'allongement des barres d'acier ont été comparées pour les barres corrodées et non corrodées.

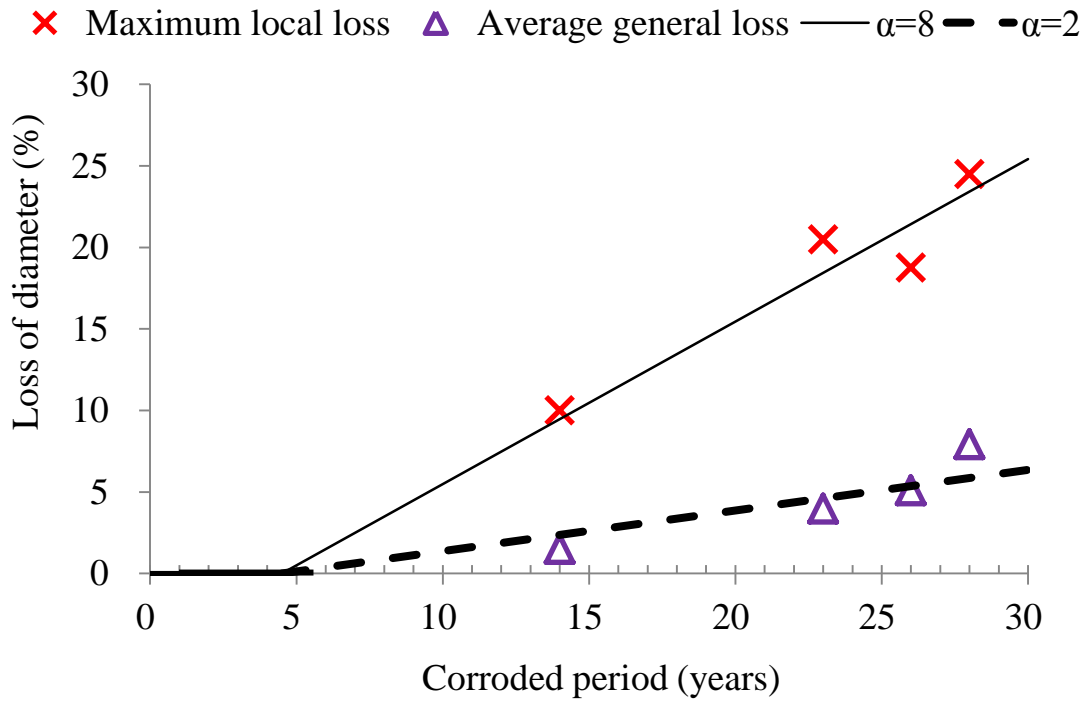
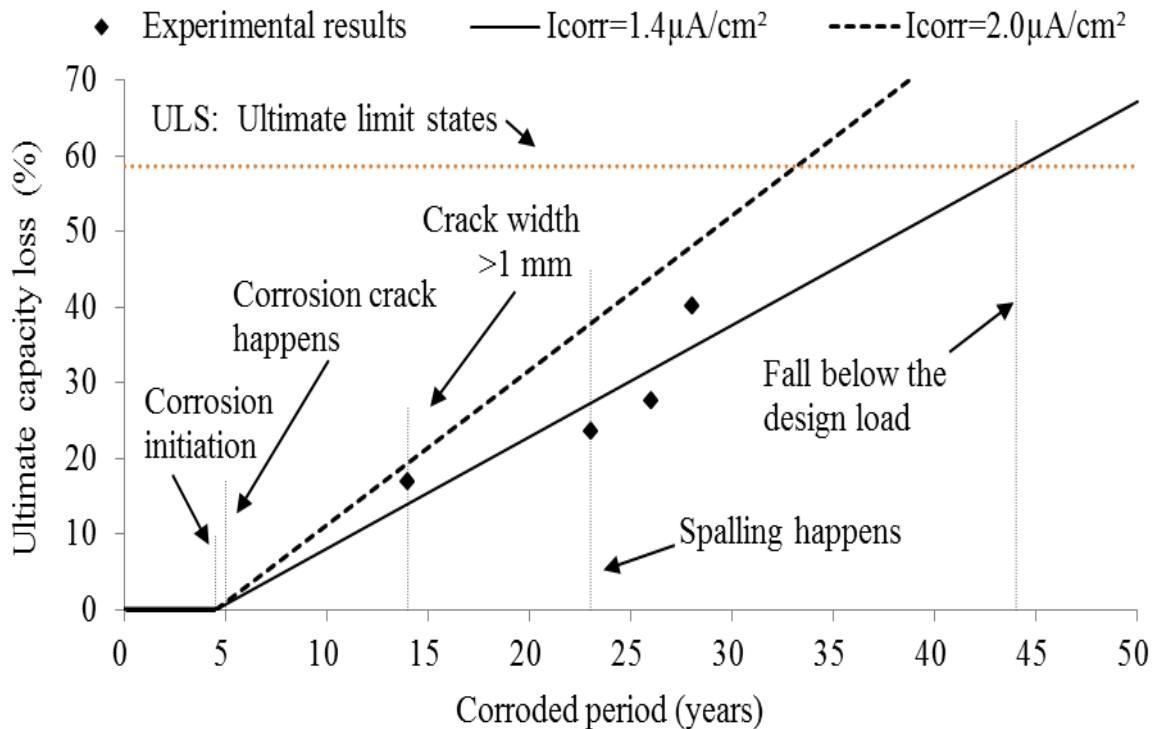
Une synthèse des intensités de corrosion calculées en fonction de la perte maximale de section d'armatures montre que la vitesse moyenne de corrosion est de l'ordre $1.4 \mu\text{A}/\text{cm}^2$ pendant tout le processus de corrosion (cf figure 9). Ce résultat confirme que la phase de propagation de la corrosion est très longue et devrait être prise en compte dans les modèles de prédiction de la durée de vie. Il reste évidemment à définir réglementairement et suivant le contexte, le critère de fin de durée de vie : cependant si l'on considère la capacité ultime résiduelle supérieure à la charge de dimensionnement à l'ELU, la durée de vie prévue est de 45 ans ce qui correspond à 5 ans d'initiation et 40 ans de propagation de la corrosion.

(a) la vitesse moyenne de corrosion pendant tout le processus de corrosion

(b) Evolution de la durée de vie

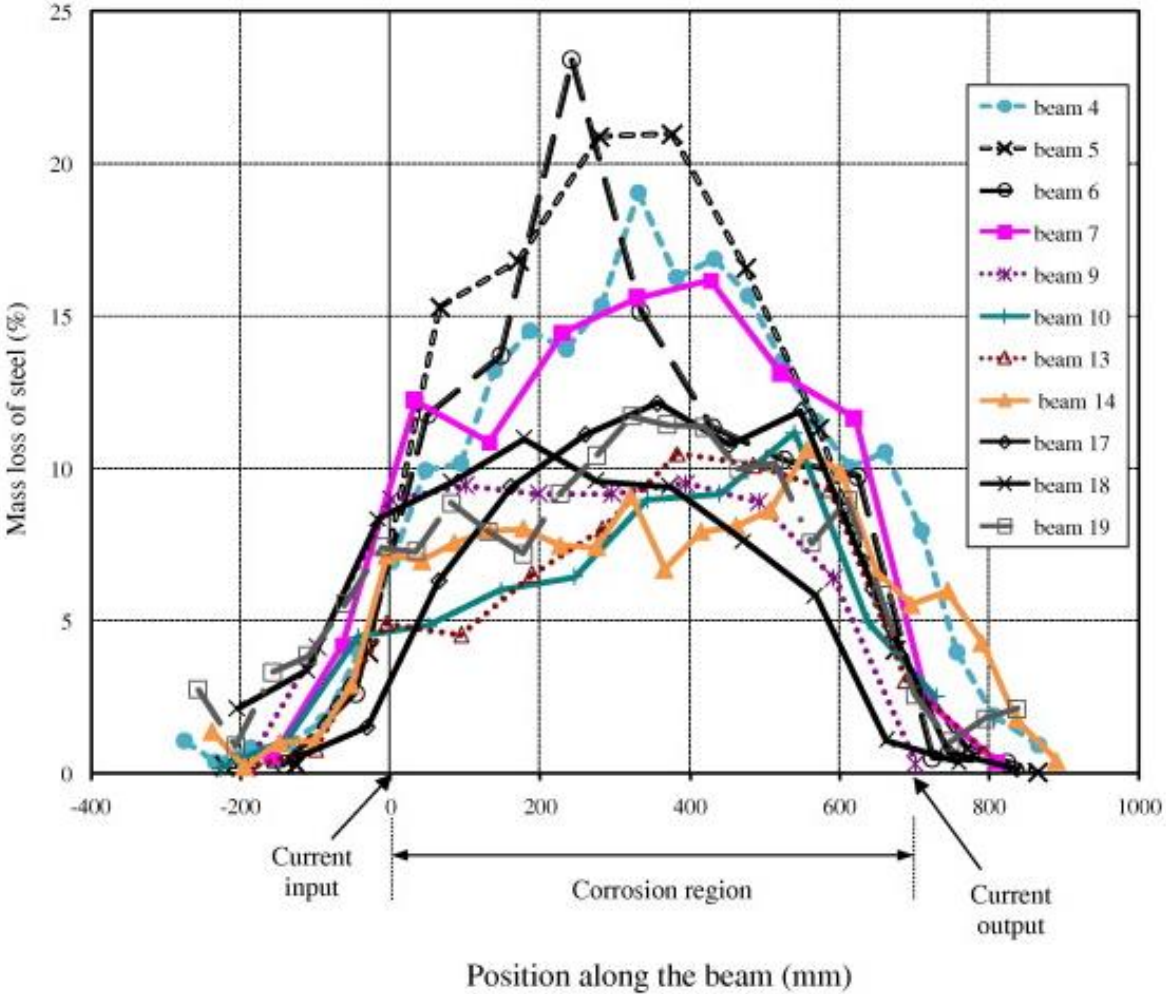
Figure 2-3 Variation of mass loss of bars along the beam[15]

The residual mass of the corroded tension bars were measured and the mass loss of the tension bars along the beam was shown in Figure 2-3. The results showed that the mass loss in the middle zone was more significant than other zones, and the distribution was not stochastic as that of nature corrosion.

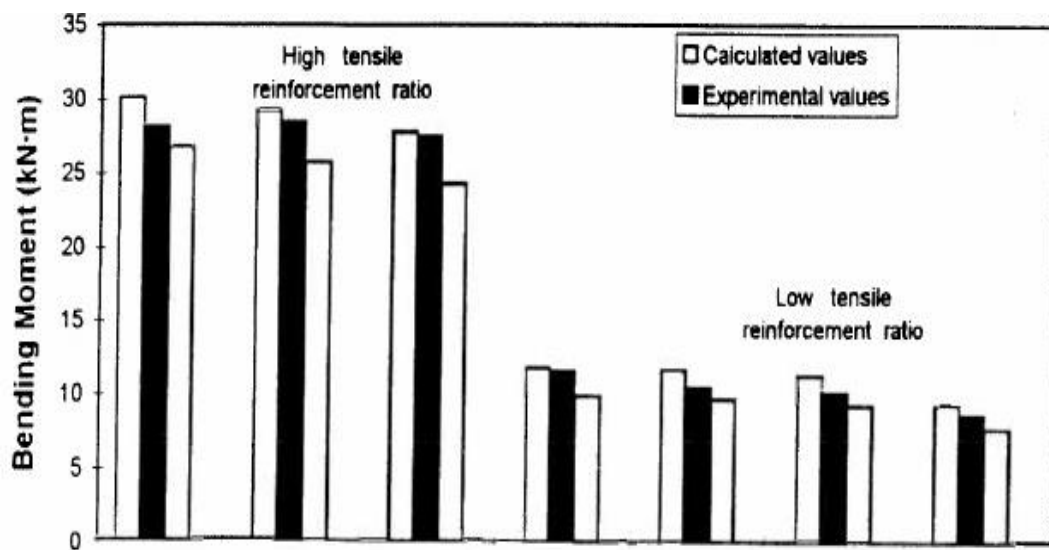
Figure 2-16 Flexural capacities of beams corroded by impressed current[25]

The mechanical results were recorded and compared with the theoretical results calculated by Eurocode 2 [26] as shown in Figure 2-16. In order to find the influence of corrosion to the RC beams, two predicted results were made subsequently: one results took account of the residual cross-section of the corroded tension reinforcements and the nominal cross-section of the concrete beams; the other results were based on the residual cross-section of the corroded tension bars and the damaged cross-section without the contribution of the concrete cover. The experimental results were close to the values deduced by the first method. The results calculated from the second method were conservative when compared to the experimental results.

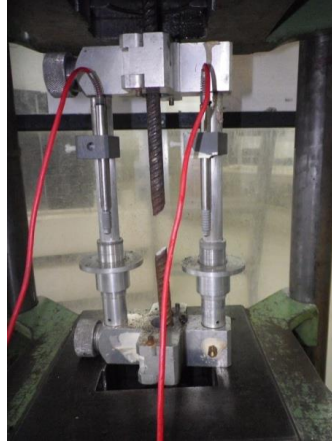
Figure 4-2 Uniaxial tension tests on the bars

After 26 years, the corroded beam B2C12 from the aggressive environment and the non-corroded beam B2T2 were broken to provide access to the tension bars of both beams. Then seven samples were taken from different parts of the two tension bars as shown in Figure 4-1. The details of the corroded and non-corroded samples are shown in Table 4-1. The length of effective range is the distance between fixed points of LVDT as shown in Figure 4-2.

A 250-kN-capacity machine was used to carry out the tension test as shown in Figure 4-2. Two LVDTs distant of about 200 mm (L_{er}) measured the elongation of the tension bar. The tensile properties of the bars were calculated from the results of the tensile test.

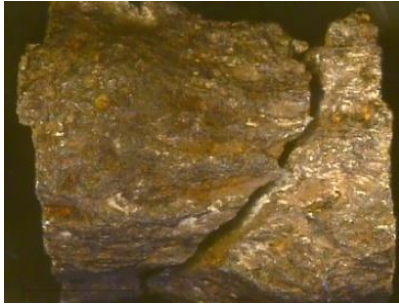
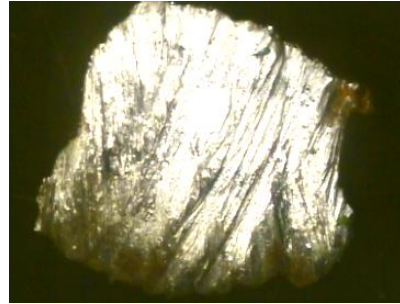
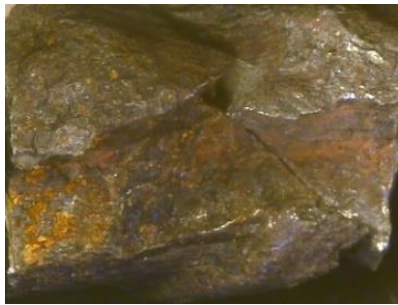
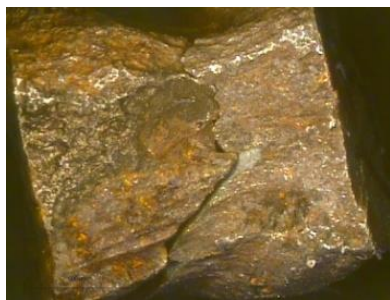
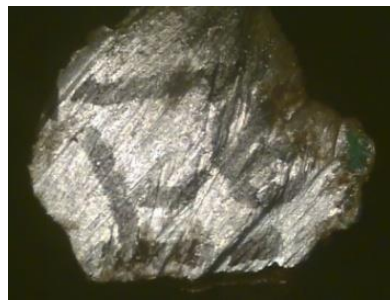
Figure 4-7 Failure points of the corroded bars

The failure points of the steel bars were sawed carefully so that their mechanical properties could be investigated effectively. Part of the failure points are shown in Figure 4-7 and Figure 4-8. The failure points of the corroded bars occurred at locations with serious pitting corrosion.

(a) 4-T-1-1

(b) 1-T-2-2-2

(c) 1-T-2-2-1

Figure 4-12 Corrosion distribution in the cross-section at failure point
 (The true residual cross-section was shown in Figure 4-7 and Figure 4-8)

The loss of diameter in the corroded bars of B2C12 was measured by vernier caliper, including the tensile bars, the compressive bars and the stirrups. The losses are shown in Figure 5-9, Figure 5-10 and Figure 5-11, respectively. As discussed in Chapter Four, the loss of the steel cross-section could be overestimated by the measurement of residual diameter since the shape of residual cross-section was irregular. The mass loss of some small pieces of the steel bar (called coupons) was also measured and is shown in Figure 5-9(b). The length of the steel coupons was depended on the corrosion distribution, with the minimum length being about 5 mm (Figure 4-7).

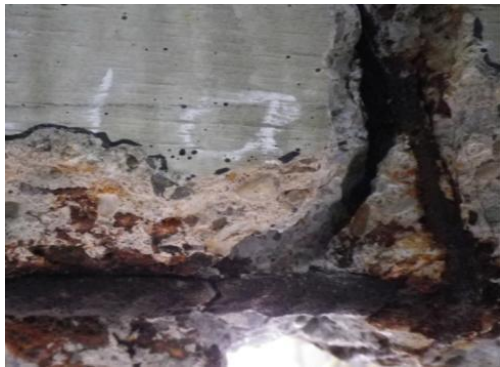
Figure 5-2 Failure of the tensile bars during the bending tests: cause of the corroded beam failure, consequence of concrete crushing for non-corroded beam

With the increase of the load, the cracking of the corroded beams B2C12 developed gradually. During the failure process, some new cracks appeared, slowly widening and extending from the bottom to the top of the beam. Two main transversal cracks in the middle of the span, coinciding with the two stirrups nearest the loading node, had obviously formed and widened before the beam yielded (Figure 5-5). Finally, the tensile bar in the front side failed, leading to beam failure as shown in Figure 5-2(a). Similar response happened to corroded beam B2C13 as shown in Figure 5-3.

(a) Corroded beam

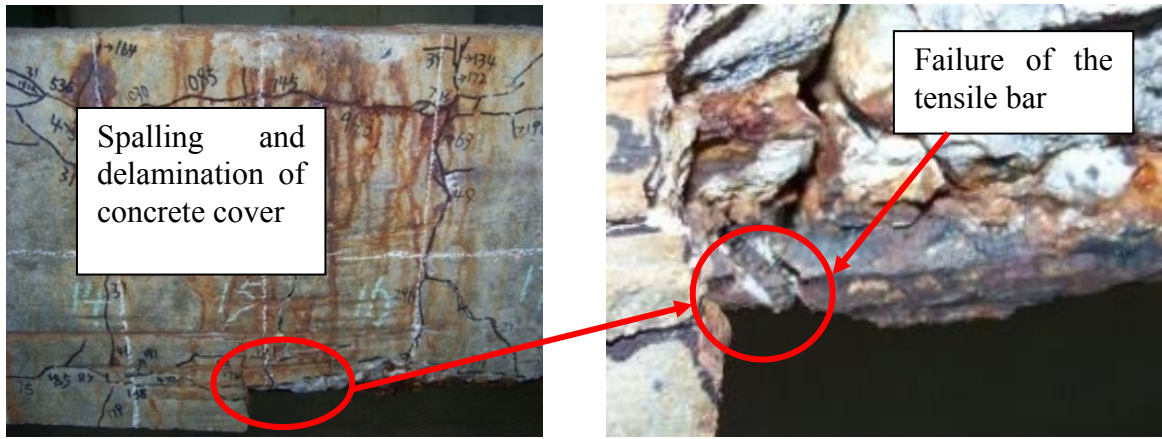
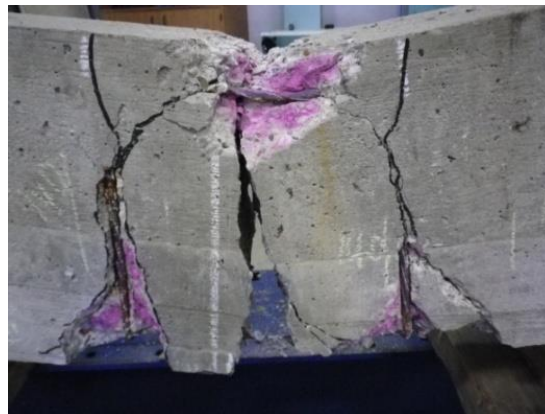
Figure 6-2 Failure modes of the beams

Figure 6-2 shows the failure of corroded beam B2C13 and non-corroded beam B2T2. Bending failure mode was modified by the corrosion of the reinforcements. Figure 6-2(a) shows that B2C13 failed with considerable spalling and even delamination of the concrete cover at the tensile section in the middle of the beam. Moreover, one of the corroded tensile reinforcements failed in the delamination zone. However, in the compressive section, only some small spalling zones were observed the compressive concrete cover. Figure 6-2(b) shows that the non-corroded beam B2T2 failed by crushing of the concrete and failure of a tensile bar.

(a) Failure of the corroded beam B2C13 due to tensile bar rupture

(b) Failure of the non-corroded beam B2T2 due to concrete crushing

All the beams failed in a bending mode. Nevertheless, there were some differences between the failure of corroded beams and non-corroded beams. As described by Castel et al. [16], corroded beam B1C11 failed due to the yielding and failure of the tensile bars, while both yielding of the tensile bars and the crushing of the compressive concrete led to the failure of non-corroded beam B1T1. The same failure mode was found in the other corroded and non-corroded beams that were loaded in the present work.

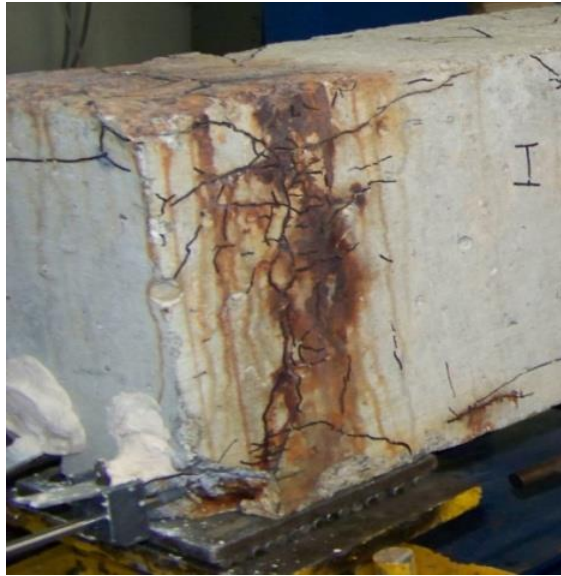
Figure 7-3 Support A/D

During the load test, four other LVDT's were fixed at the ends of the concrete beam so that the sensor touched the ends of the bottom bars in Figure 7-2, where support A and support D correspond to the two ends showed in Figure 7-3, in order to obtain detailed information of the slip behaviour of the bars. For these sensors, the accuracy was 1×10^{-4} mm. At the end which was not sawn a small hole was drilled in the concrete so that the LVDT's could be located on the end of the reinforcing bar.

The load tests on the short-span beams were performed by increasing the mid-span load monotonically up to failure (Figure 7-2 and Figure 7-3). The load and deflection at the mid-span of the beams were recorded throughout the loading process, the latter by a linear variable differential transformer (LVDT) with an accuracy of 0.01mm.

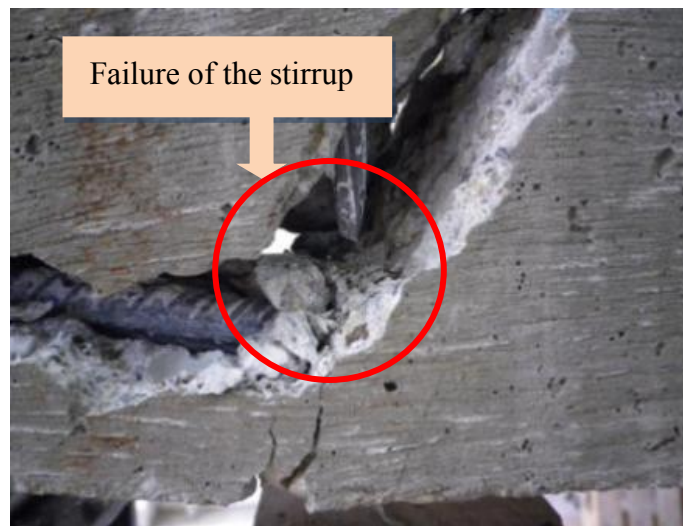
Figure 7-5 Failure point of the stirrup of the non-corroded beam (B2T2-2)

The behaviour under load and the failure modes of the corroded beams were different from those of the non-corroded beams. For the non-corroded beams without any previous damage, the first cracks appeared on the side faces of the beam. These were either vertical or inclined at a slight angle and started at the bottom close to mid-span and progressed upwards toward the location of the applied load. The failure of non-corroded beams B2T2-1 and B2T2-2 were shown in Figure 7-4. All the cracks propagated in both width and length, and then one main crack was formed, extending from the bottom of the beam to the loading point. With the crack widening progressively, failure occurred quite suddenly with the inclined crack opening wide. Surprisingly all of the main cracks appeared in the half of the beam with more stirrups. In Beam B2T2-2, simultaneously there was rupture in one of the main tension bars and two vertical legs of the stirrup, the latter close to the tension bar (Figure 7-5).

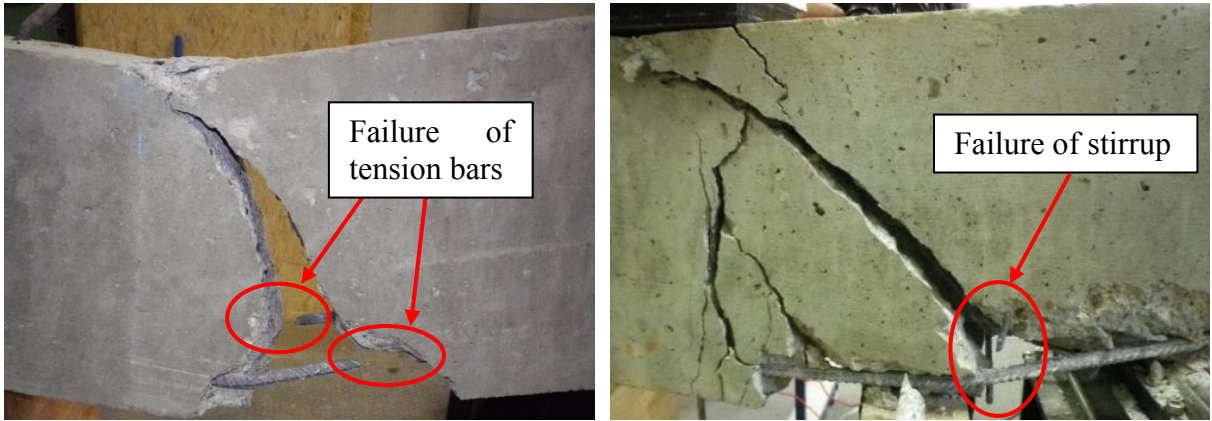
Figure 7-6 Typical rupture of short-span non-corroded beams

Similarly, the non-corroded beams B2T3-1 and B2T3-2 behaved also brittle in the loading process. As shown in Figure 7-6, several inclined cracks appeared in the tension zones when the load was applied to the beam. With the load increased, the cracks climbed to the loading location at the compressive zone gradually, and the cracks got wider significantly. Finally, the

tension bars failed, leading to the rupture of beam B2T3-1. The failure points of the tension bars were not at the middle of the beam. It was at the root of the inclined cracks as Figure 7-6(a). As for B2T2-2, one stirrup failed as shown in Figure 7-6(b), which was also at the root of the inclined crack. No matter the beam failed due to the rupture of neither the tension bars nor the stirrup, all non-corroded beams were broken in shear failure mode.

(a) Failure of non-corroded beam B2T3-1 (b) Failure of non-corroded beam B2T3-2

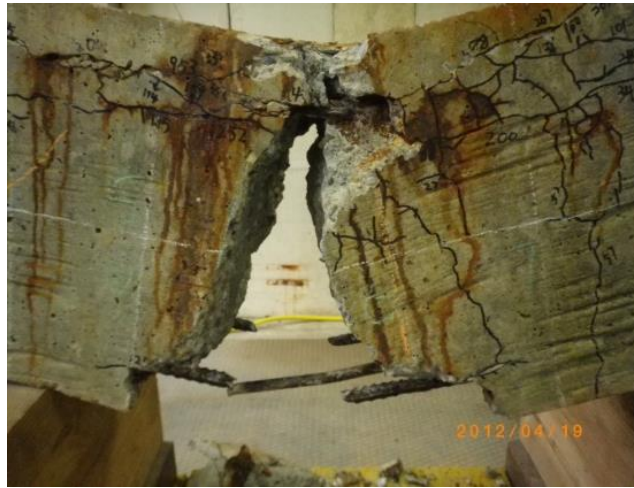
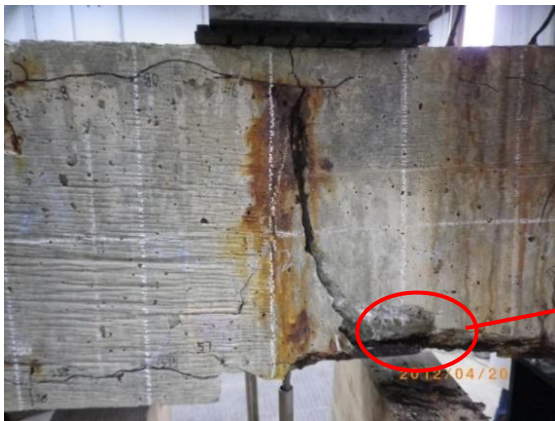
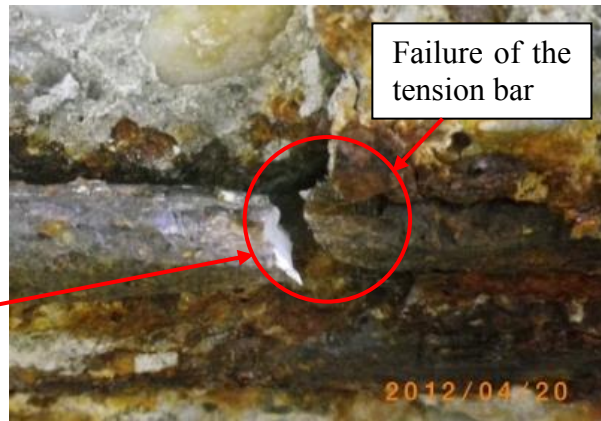
Figure 7-7 Failure of corroded beams due to bending (rupture of tension bar at mid-span)

For the corroded beam B2C12-1, B2C13-1 and B2C13-2, the main crack was almost vertical along a stirrup nearest to the loading point, i.e. at mid-span of the short beam. The crack developed gradually from the bottom towards the top of the beam. As failure approached, the rate of deflection with load increased due to yielding of the tensile bars. Beam B2C12-1 failed due to the rupture of the two tension bars: one at the mid-span of the beam then followed by the failure of the other bar near the support (Figure 7-4 and Figure 7-7).

For the corroded beam B2C12-2, the main cracks divided into two branches on the sides of the beam. One crack inclined gradually in the diagonal direction at first, while with the load increasing, another transverse crack appeared gradually, parallel to the stirrup in the middle of the span. As the load increased, the concrete cover to the bottom reinforcement became delaminated from the parent concrete as illustrated in Figure 7-4. At last, the beam failed when the front side tension bar ruptured at the mid-span (Figure 7-4). It was worth noting that for the corroded beams B2C13-1 and B2C13-2, the tension bars failed at the mid-span, which was the characteristic of the bending failure mode.

(a) Failure of corroded beam B2C13-1
(The middle bar is designed to be the handle)

(b) Failure of corroded beam B2C13-2

(c) Failure of tension bar of B2C13-2

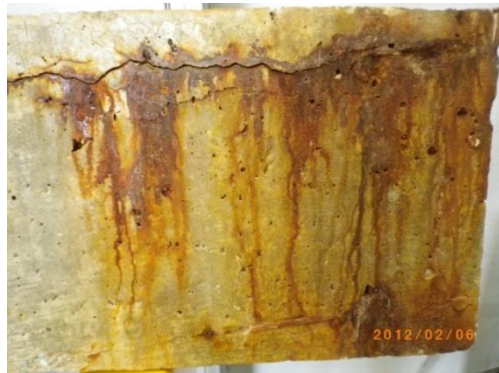
Figure 8-1 Corrosion products in the outside surface of B2Cl3

Having been corroded for 28 years, beam B2Cl3 was highly corroded. The cracking of the concrete cover was well developed so that the corrosion products could move away from the interface of the reinforcement to the outside successfully as shown in Figure 8-1. In the bottom of the beam, spalling also happened in some zone along the longitudinal reinforcement.
