Approche multi-échelle des mécanismes de vieillissement des coeurs de pile à combustible

THÈSE

DOCTEUR DE L'UNIVERSITÉ GRENOBLE ALPES

préparée au sein du **Laboratoire d' Electrochimie et de
Physico-chimie des Matériaux et Interfaces**
dans l'**École Doctorale I-MEP2**

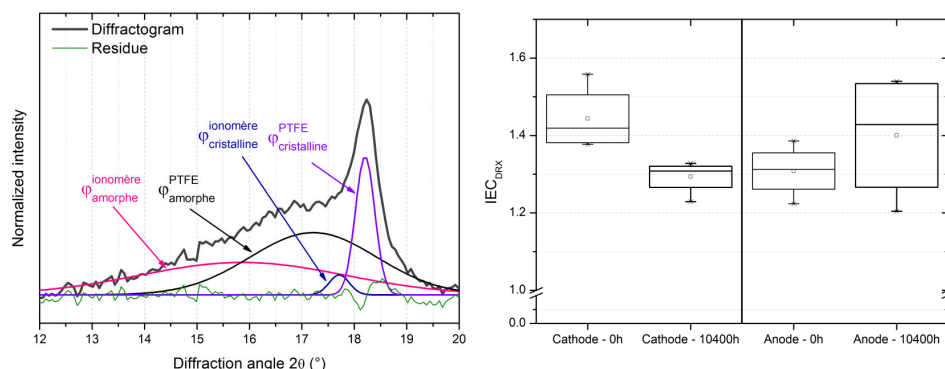
Figure I.20: Estimation de l'IEC de l'agent ionomère d'une couche active anodique et cathodique après 10400 heures de fonctionnement en pile^[1]

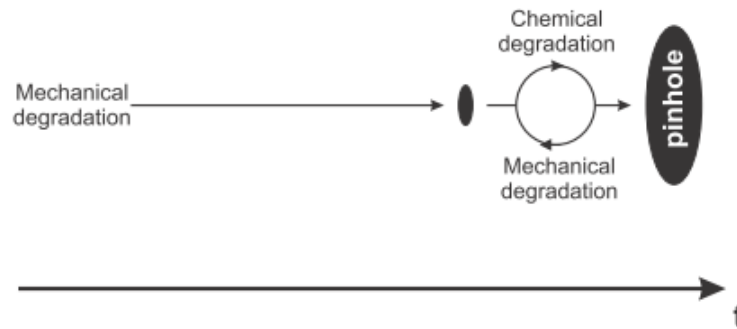
Figure I.21: Couplage mécanique et chimique autour de la formation d'un trou^[107]

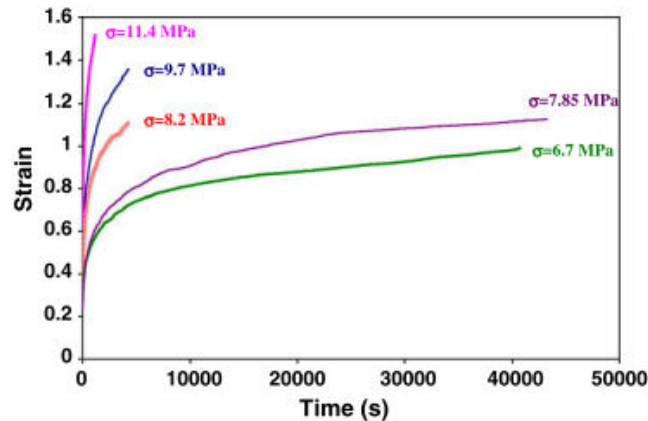
Figure I.25: Mesures de fluage pour une membrane Nafion® 111 sous différentes charges^[120]

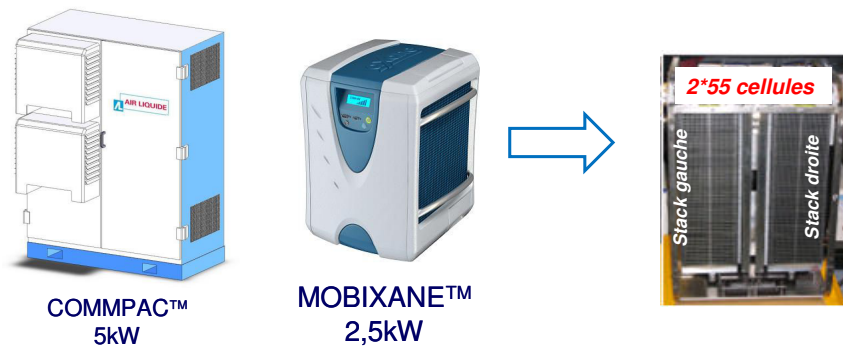
Figure II.1: Description d'un module EVOPAC™

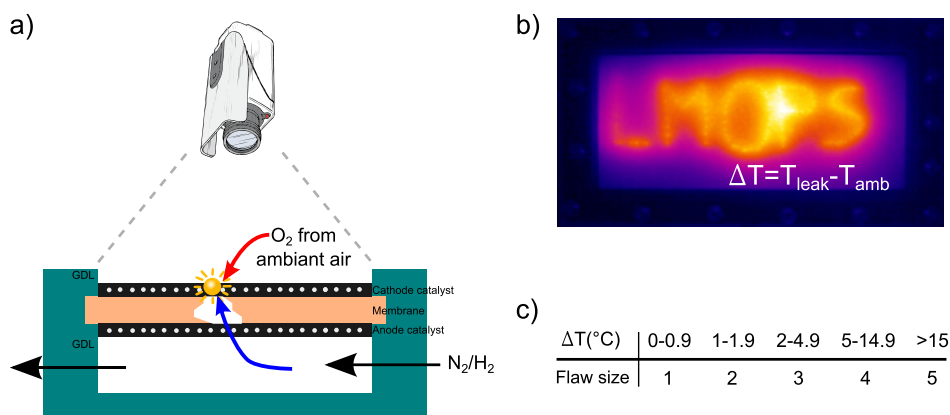
Figure II.6: Descriptif du dispositif expérimental pour les mesures de fuite par caméra infrarouge

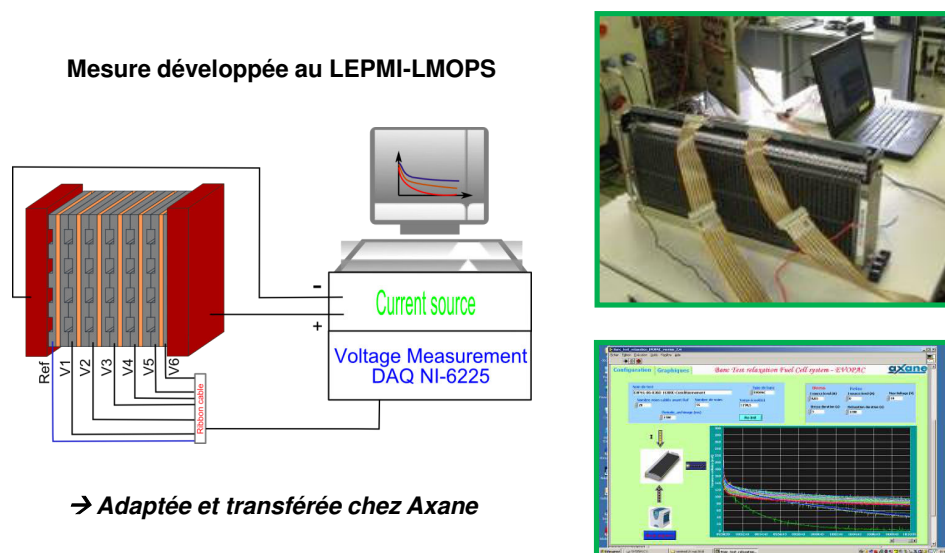
Figure II.9: Dispositif expérimental des mesures de relaxométrie *in situ*

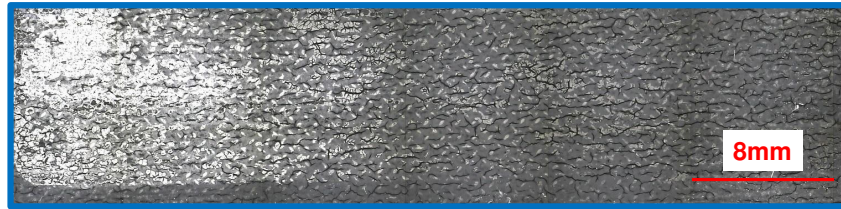
a) Machine tridimensionnelle sans contact

de mesure d'épaisseur de la membrane a été mise au point dans le but de tracer des profils d'épaisseur sur des longueurs allant jusqu'à 1.5 cm. Selon la résolution et la taille d'analyse désirée, trois types d'appareils ont été utilisés pour l'imagerie (cf. figure II.10) :

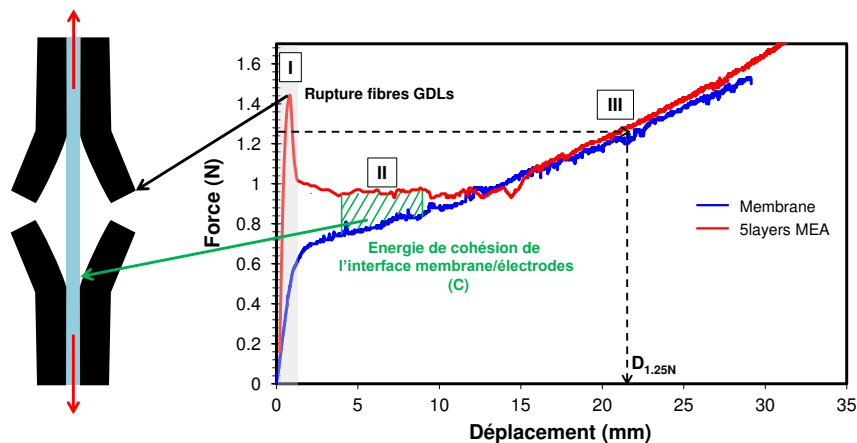
Figure II.13: Réponse typique d'une courbe de traction force *vs.* déplacement d'une AME de type CCB

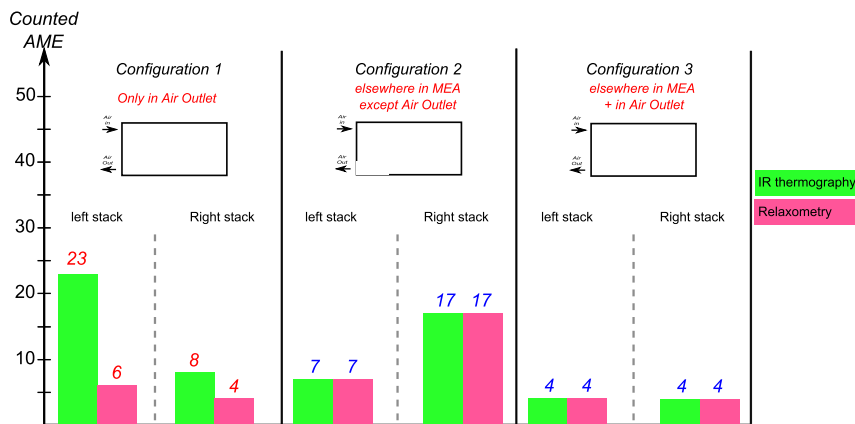
Figure IV.9: Comparison of the sensitivity of IR Thermography versus relaxometry for the two (55 cells) stacks studied (Configuration 1: defects in air outlet region solely; Configuration 2: defects in the whole MEA except in air outlet; Configuration 3: defects both in air outlet and in the rest of the MEA)

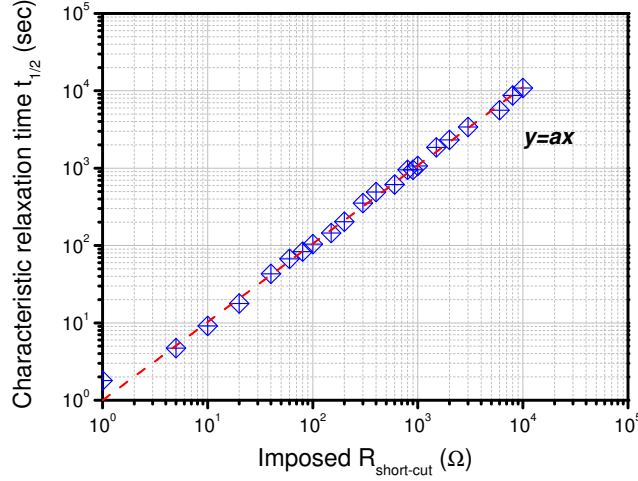
Figure V.8: Calibration curve showing the linear dependence of the relaxation time in V.6 with the applied external resistance. These data can be used the other way around to quantify the unknown electronic resistance $R_{elec-sc}$ the membrane in any MEA, even placed in a stack

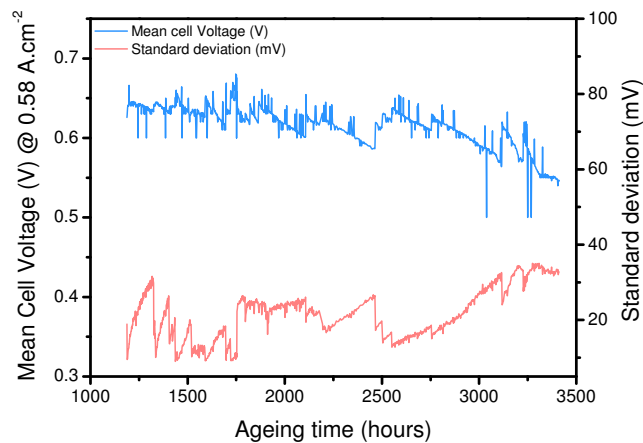
Figure V.9: Mean cell voltage and the voltage dispersion during ageing of a stack

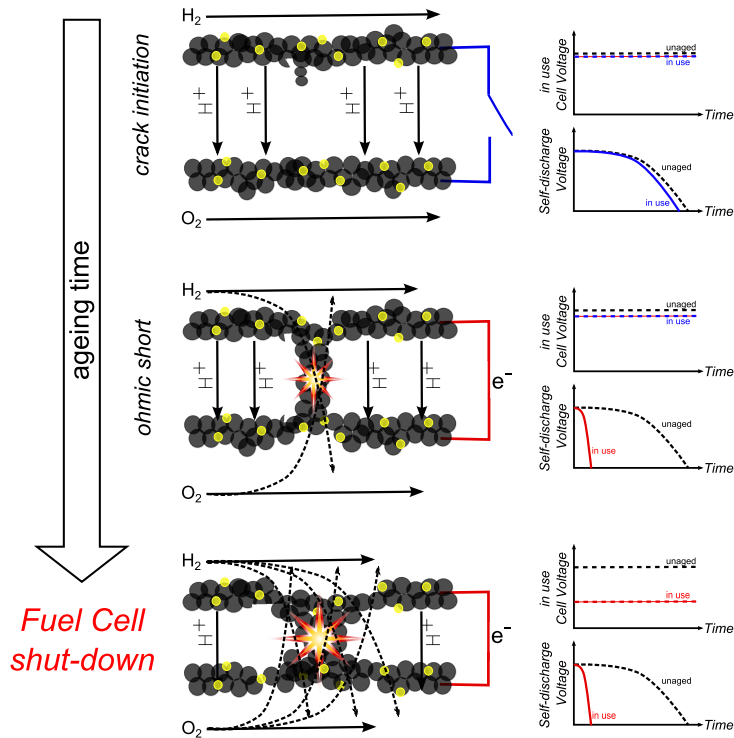
Figure V.13: Time scale and sensitivity to electronic short-circuit detection

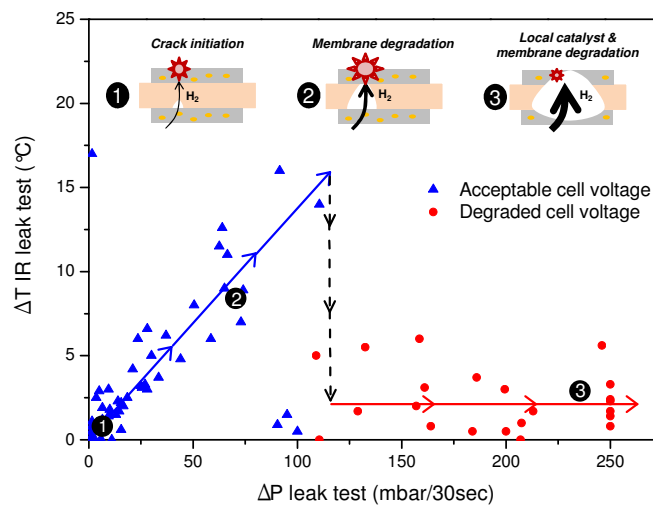
Figure VI.4: Comparison between in situ and ex situ leak tests may be used to estimate the degradation state of PFSA membrane in a cell

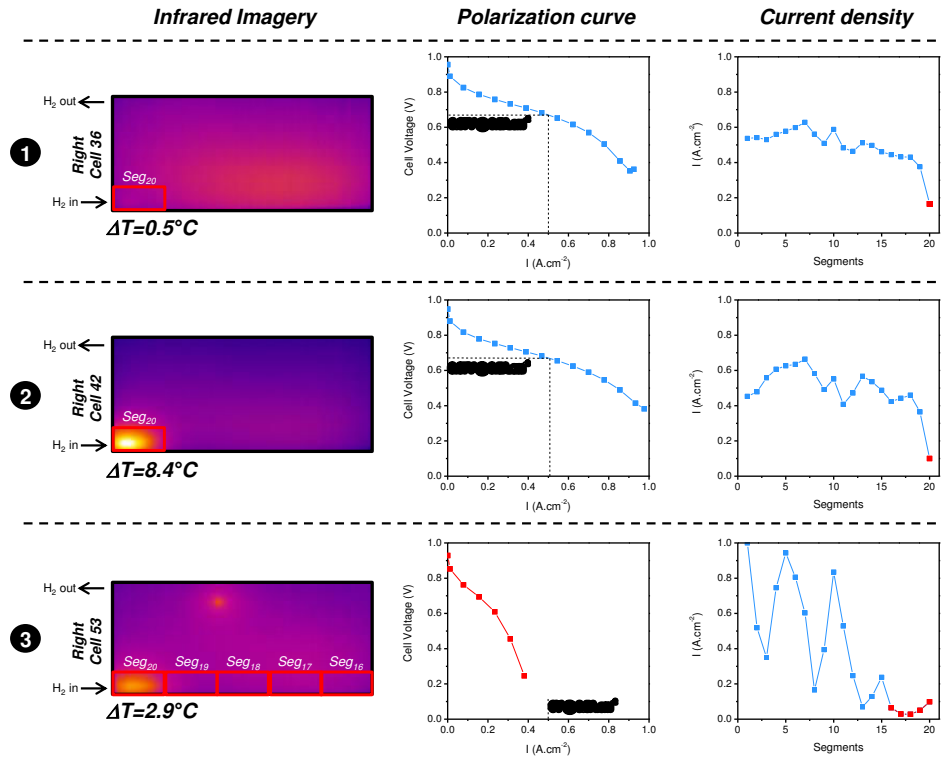
Figure VI.5: Local cell performance vs. infrared imagery for 3 different cells: 1) not degraded; 2) degradation initiated and 3) advanced degradation state

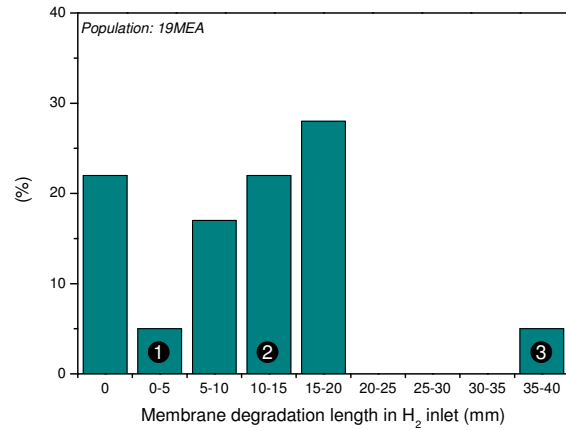
Figure VI.7: Estimation of the membrane degradation length in dry H₂ inlet

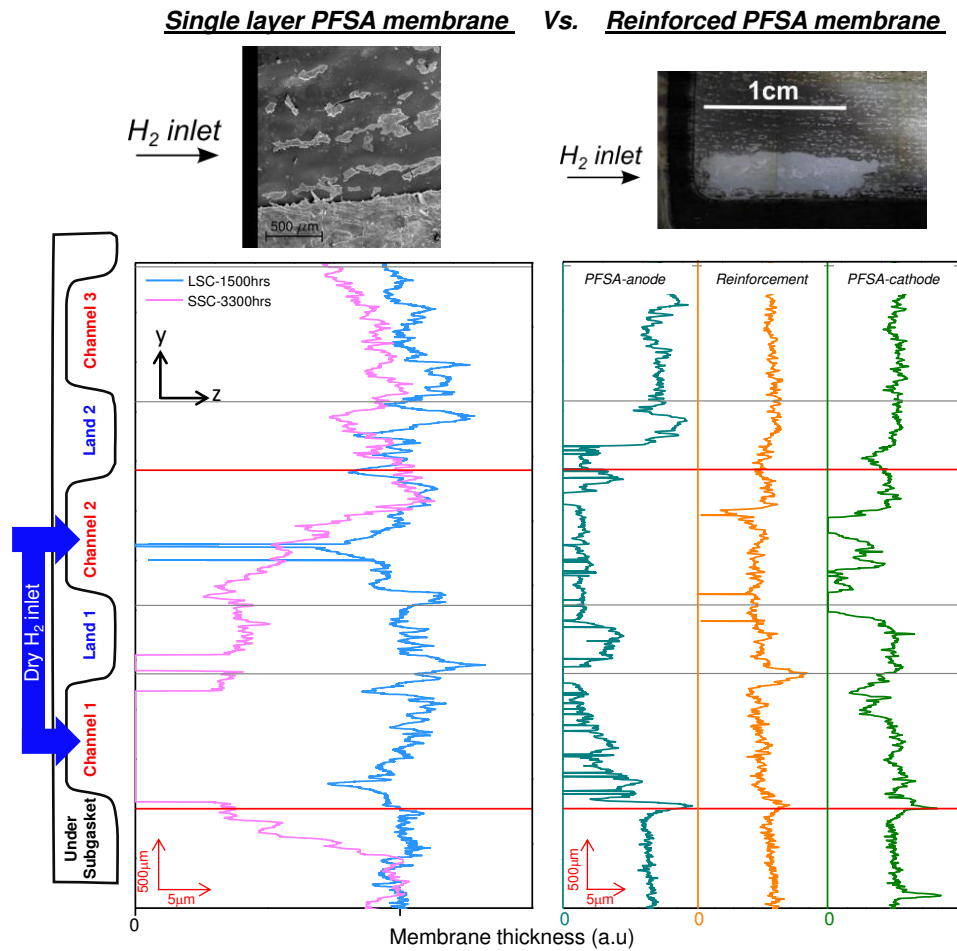
Figure VI.10: Comparison between membrane thickness profile in the H_2 inlet and air outlet region for different type of membrane

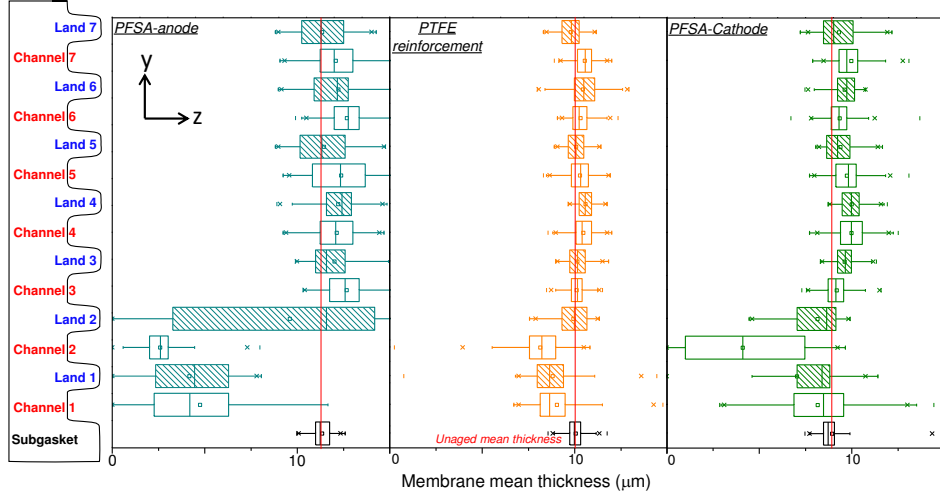
Figure VI.12: Average membrane's layers thickness (PFSA-anode, reinforcement, PFSA-cathode) as a function of the position in the bipolar plates

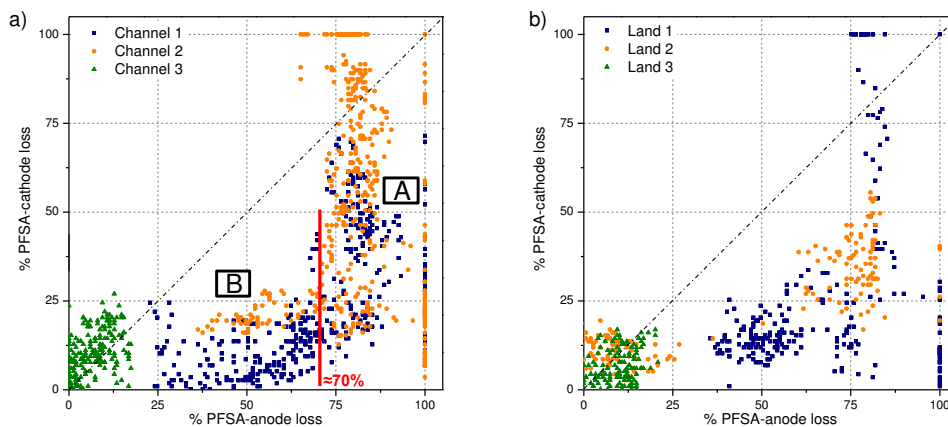
Figure VI.14: Comparison between PFSA-anode degradation vs. PFSA-cathode degradation

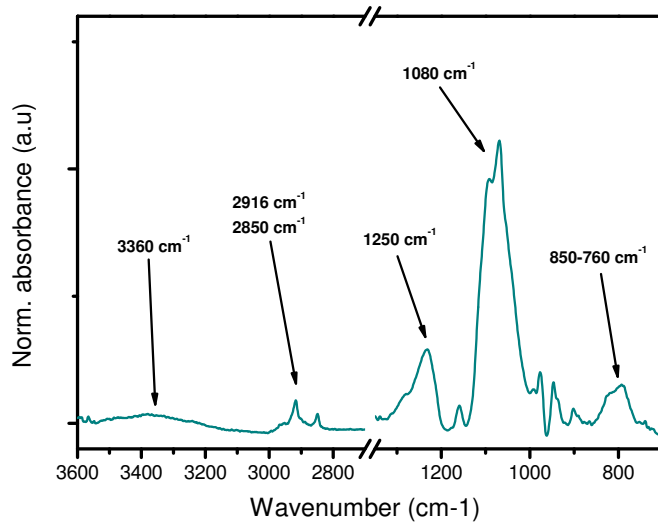
Figure VI.18: FTIR-ATR subtracted spectra between fresh and aged membrane

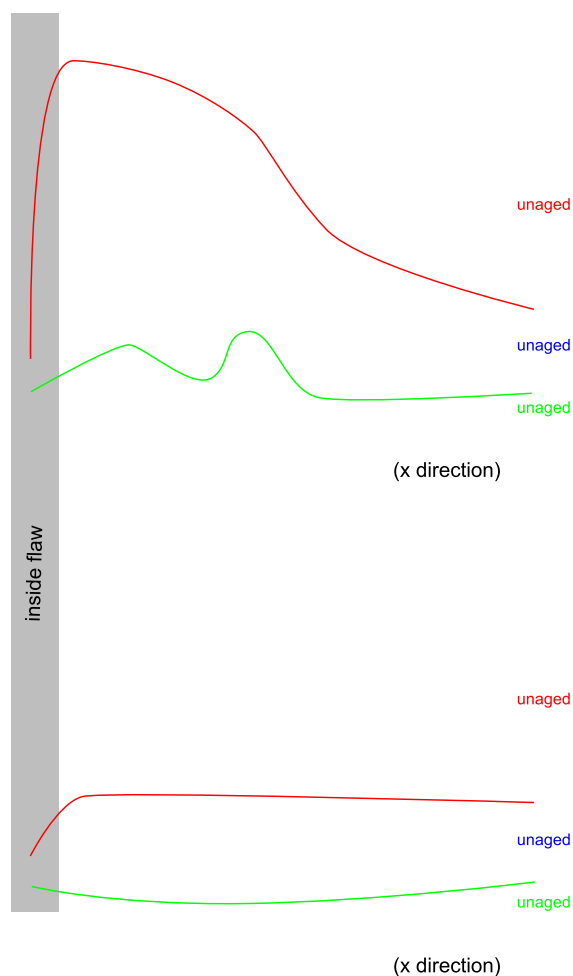
Figure VI.19: Evolution of the maximum absorbance for three new pics appeared in the membrane as a function of the H₂ travel distance

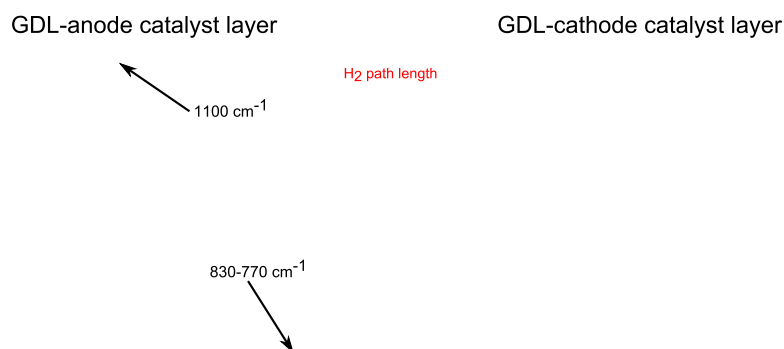
Figure VI.22: FTIR-ATR spectra normalized on 1144 cm⁻¹ for anode and cathode catalyst layers as a function of the H₂ travel distance for channels 1 and 2

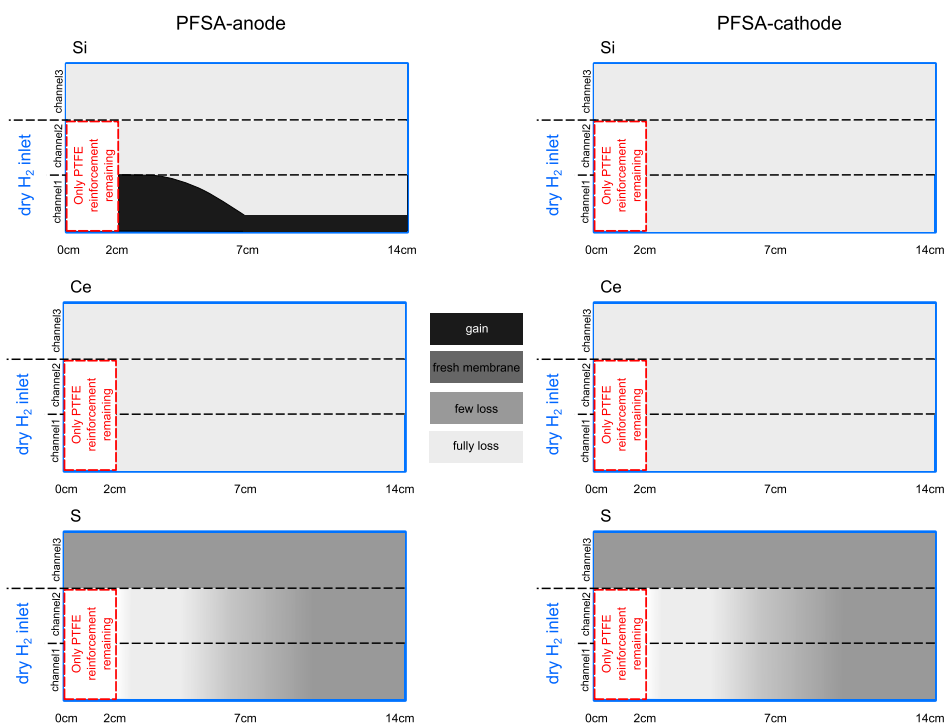
Figure VI.31: Schematic representation of the presence of Si, Ce and S elements detected by EDX as a function of the position in the channels

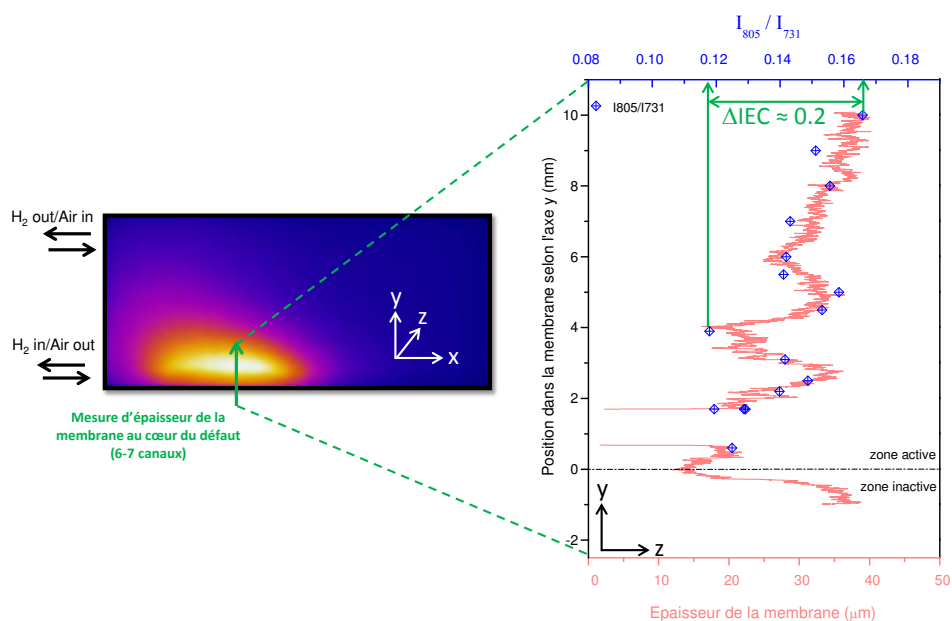
FIGURE VI.35 – Corrélation entre mesure d'épaisseur et signal Raman dans une zone de défaut de type 1
