Fatigue mechanisms in Al-based metallizations in power MOSFETs

THÈSE

**Modes de fatigue des métallisations à base d'aluminium dans les
composants MOSFET de puissance**

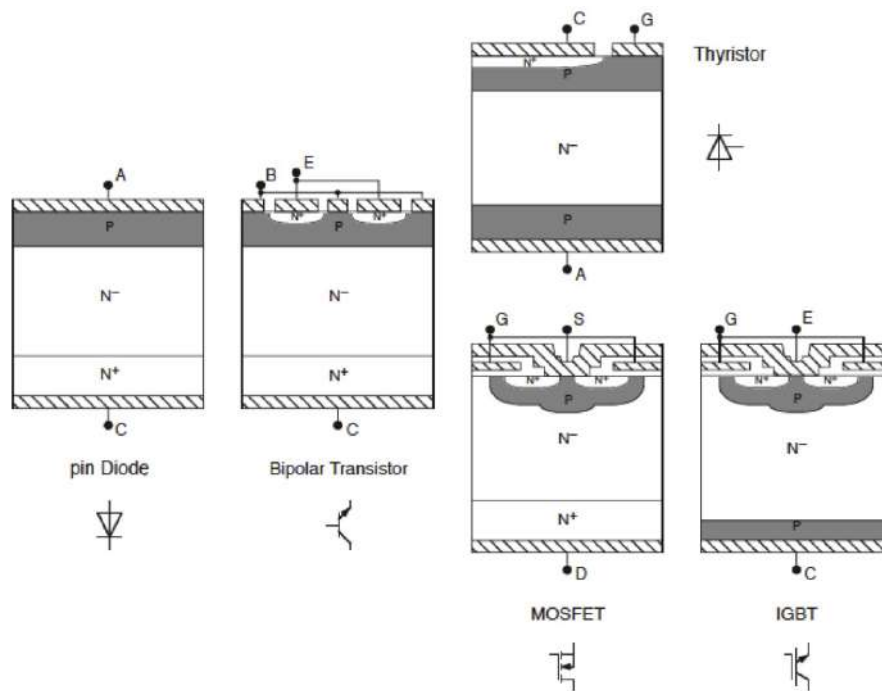
Figure 1: Basic structures of common power semiconductor devices [Lut11].

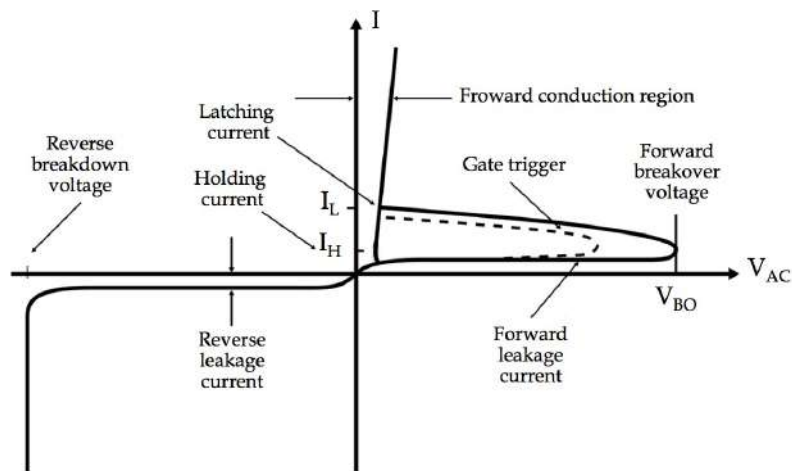
Figure 6: Thyristor static characteristic curve. The thyristor works under three modes: forward conducting mode, forward blocking mode and reverse blocking mode. The minimum anode current that causes the device to stay at forward conduction mode as it switch from forward blocking mode is called the latching current. If the SCR is already conducting and the anode current is reduced from forward conducting mode to forward blocking mode, the minimum value of anode current to remain at the forward conducting mode is known as the holding current.

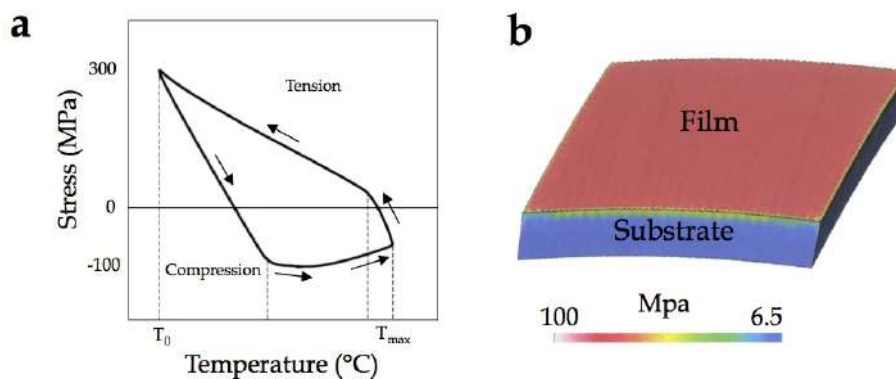
Figure 19: (a) Typical stress-temperature cycle for a 1- μm -thick poly-crystalline Al film on oxidized Si substrate ($T_{\text{max}} \sim 450^\circ\text{C}$). (b) Finite element simulation showing the Von Mises stresses generated by a temperature change of 50 °C in a 1 cm x 2 cm x 0.5 mm specimen (typical size used in wafer curvature) [Leg09].

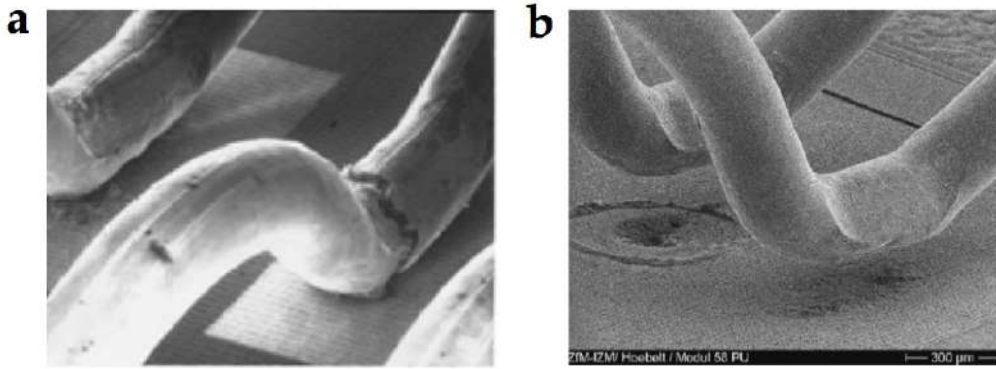
Figure 21: Examples of bond failures in power components: (a) heel crack failure [Ciao2] and (b) wire lift-off [Den17].

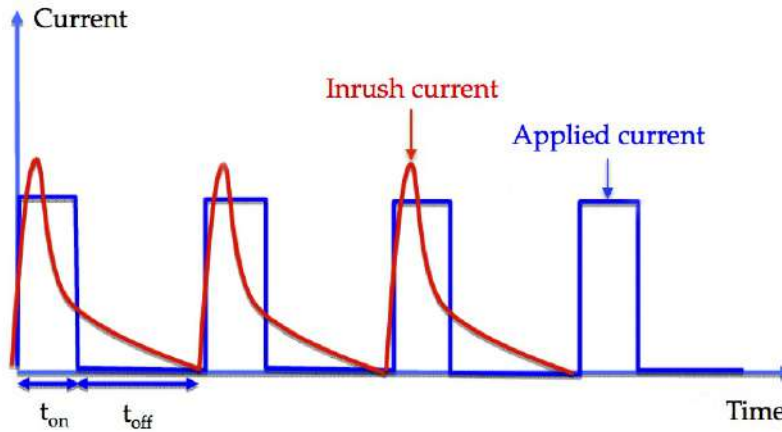
Figure 26: IOL (Intermittent Operating Life) test: the device undergoes electrical pulses during the time interval t_{on} . The test current and t_{on} values are generally limited by the control die, that protects the control die from "bulb inrush" phenomena.

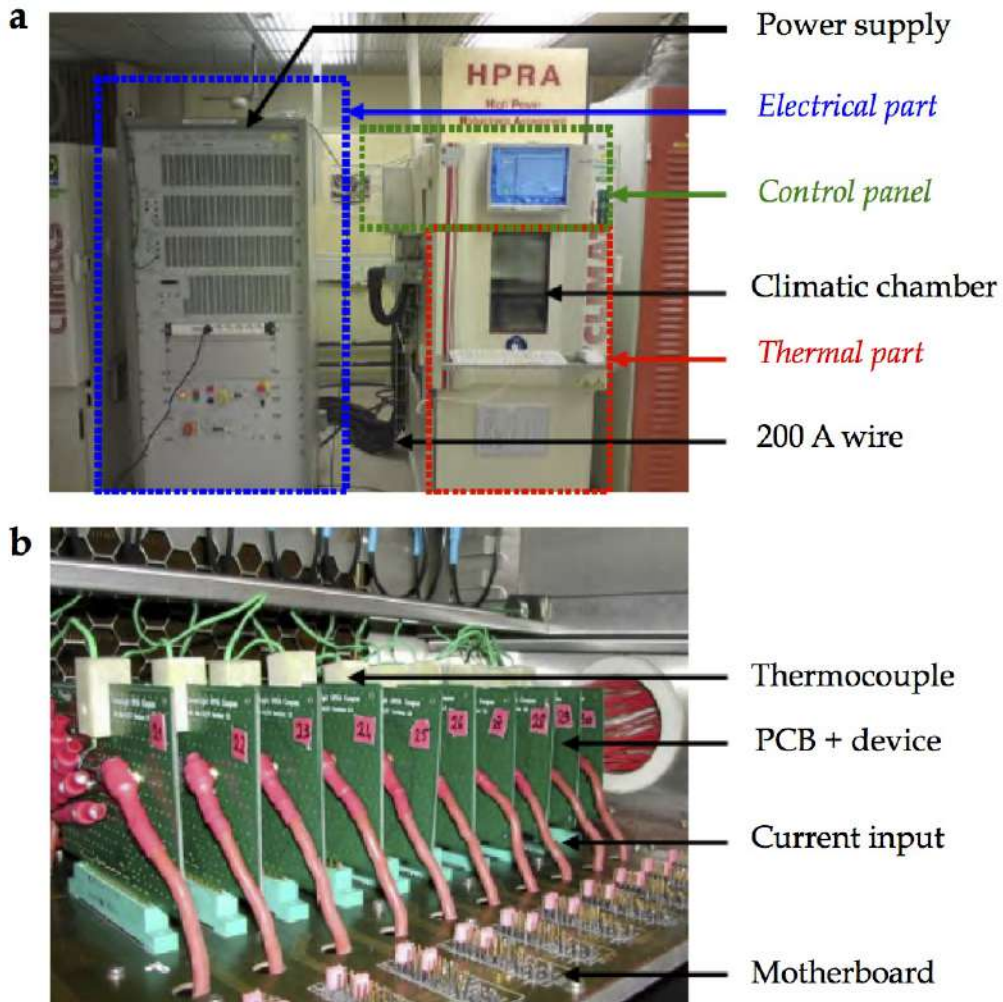
Figure 28: (a) Climats Sapratin Excal 2223-TE test bench at NXP Semiconductors. it consists in an electrical part (in blue), equipped with a 80 V, 200 A power supply and an active charge (5 - 200 A), a climatic chamber (-80°C - 180°C) containing the devices under test (in red), and a control panel (in green) with an electronic board that control the devices switching.

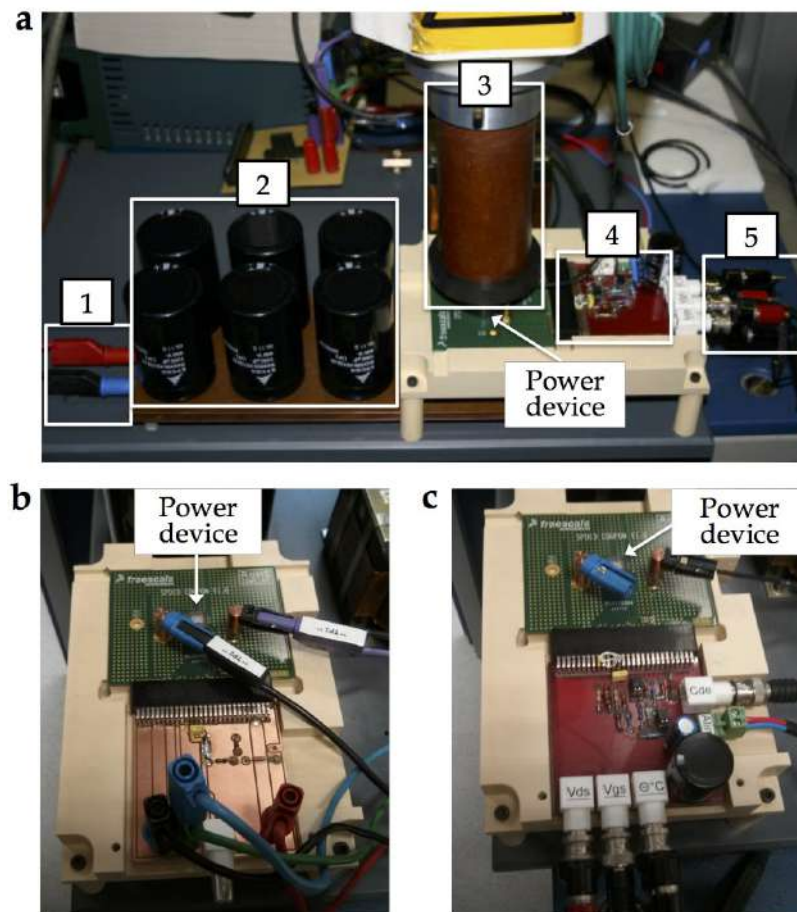
Figure 31: (a) Accelerated aging test bench set up at the Satie laboratory. The device under test can be connected to (b) a measuring board or to (c) the driving board.

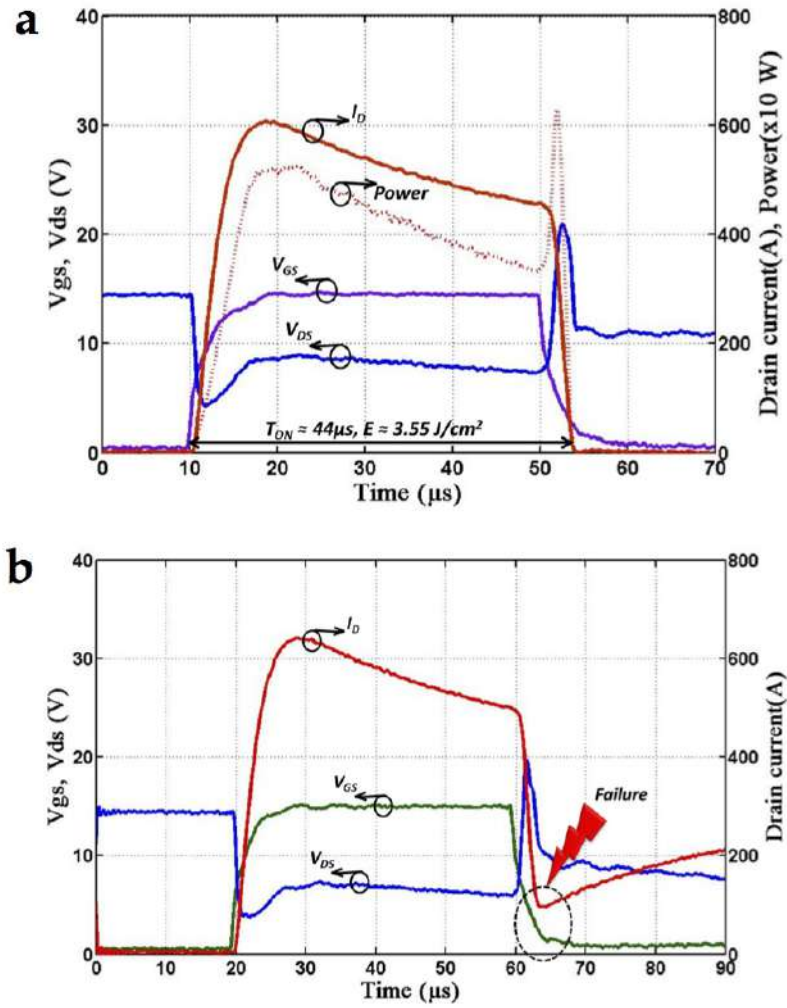
Figure 36: SC characteristics (a) just before failure (after 300 kcycles) and (b) at failure (330 kcycles). $V_{DS} = 15V$, $f = 5Hz$, $T_{ON} = 40\mu s$.

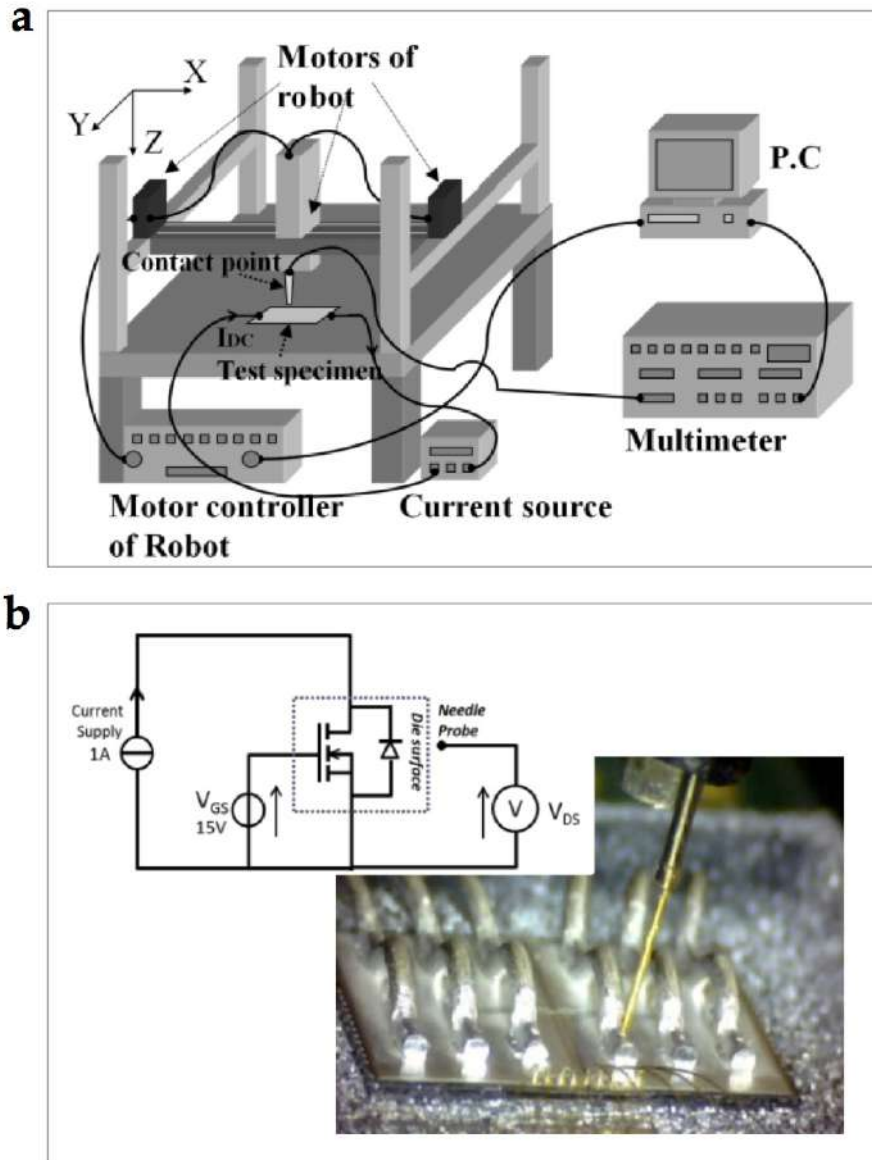
Figure 37: (a) Experimental set-up for source potential mapping of the power die. (b) Spring probe for source potential mapping, $V_{GS} = 15V$, $I_{DS} = 1A$.

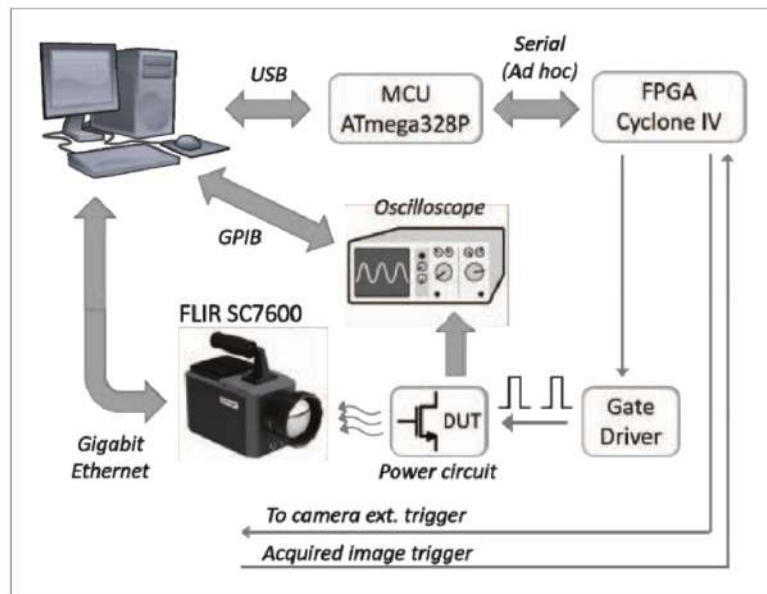
Figure 38: Schema of the IR setup showing the connections between the different parts of the system.

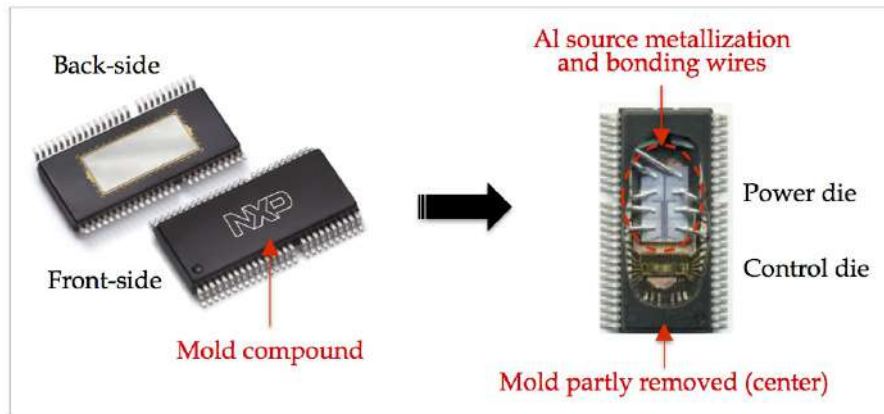
Figure 39: Decapsulation of epoxy-packaged semiconductor devices. Al source metallization and bonding wires are beneath the front epoxy side.

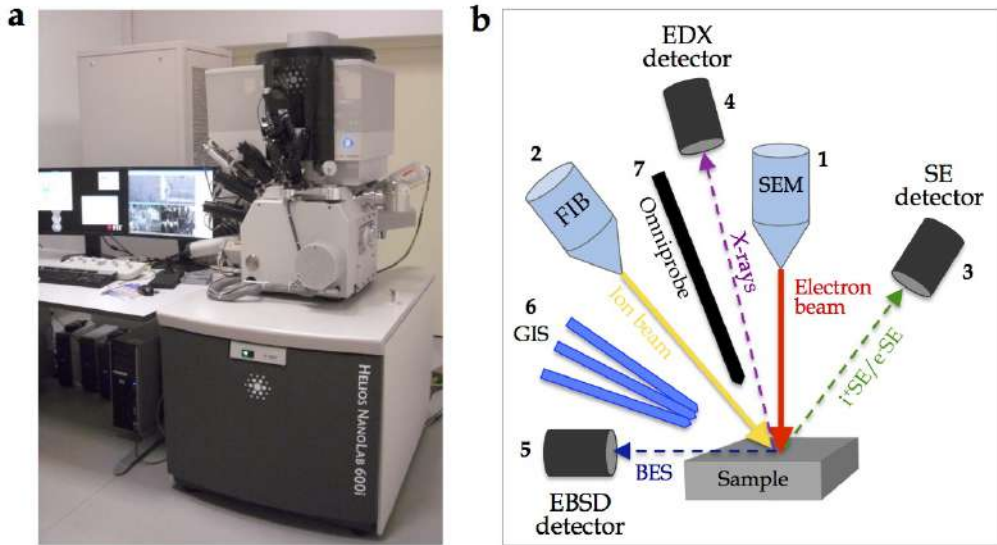
Figure 41: (a) FEI Helios dual beam microscope. (b) Schema of the main components of the microscope.

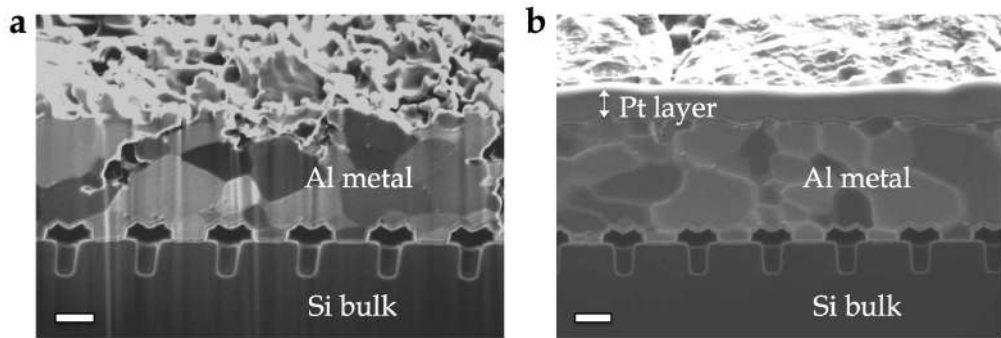
Figure 48: Cross-sectional SEM images of the Al metallization in an aged modules (a) without and (b) with Pt protective layer. Scale bar 1 μm .

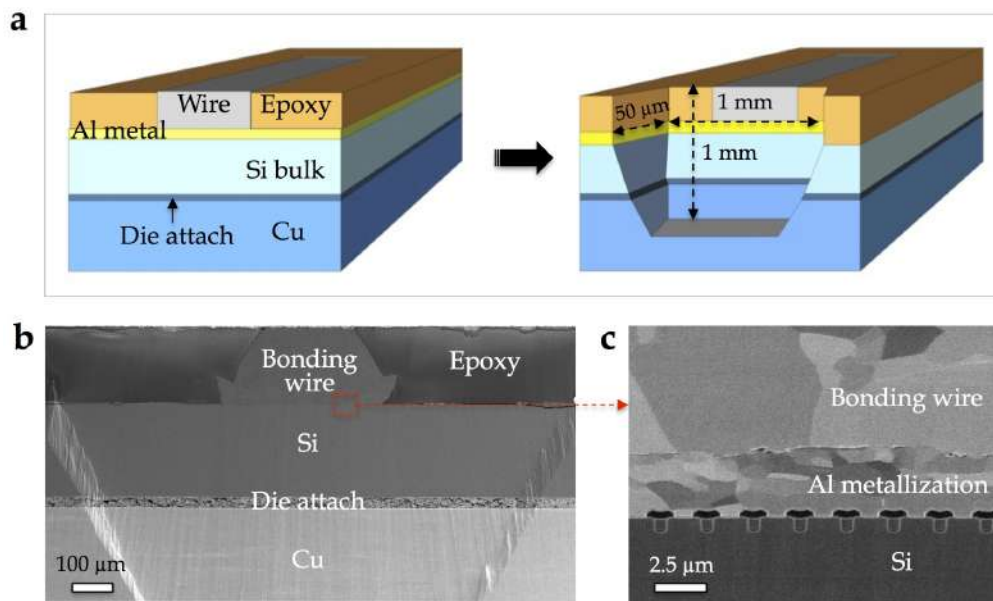
Figure 55: (a) Representation of the solid epoxy-device block (only one wire is represented for sake of simplicity) before and after CP sectioning. (b) SEM low-magnification image of the polished face, showing the layered structure: Al bonding wire, Al top metal, Si substrate, die attach and Cu radiator. (c) In the SIM higher magnification image also the MOSFET area is visible.

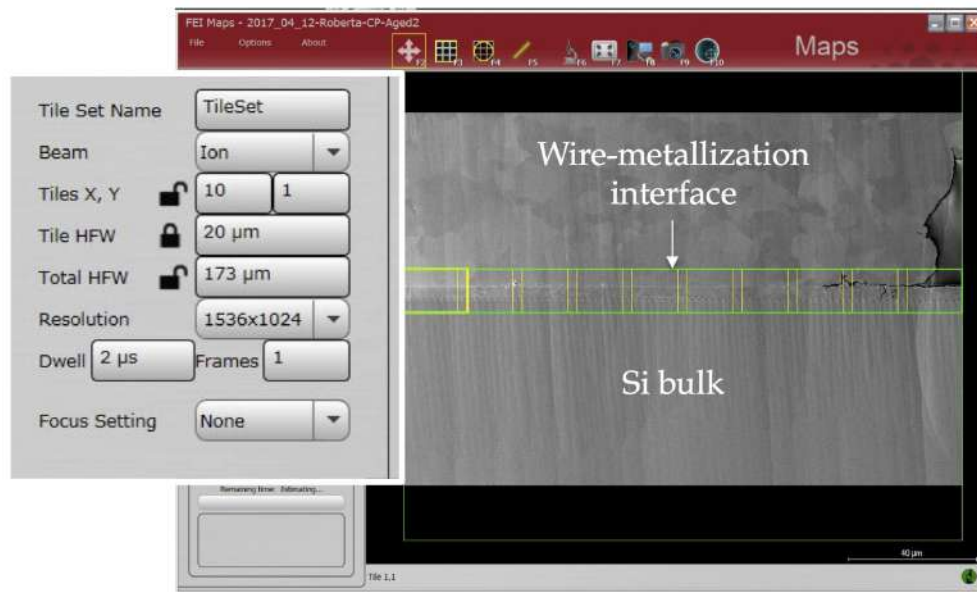
Figure 56: MAPS program interface. The wire-metal interface is split in consecutive tiles (green rectangles) of user-defined size, superposed of few microns. Each tile corresponds to a high resolution SIM image.

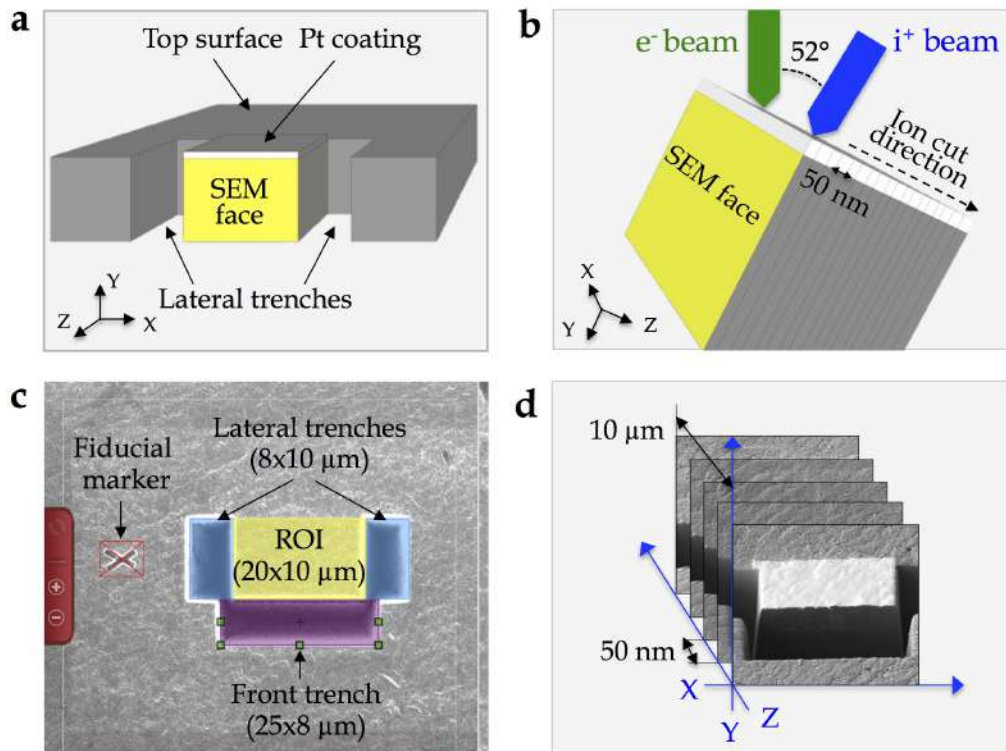
Figure 57: Schematic illustration of the serial sectioning procedure by dual-beam FIB: (a) front view and (b) lateral view of the 52° tilted sample inside the FIB chamber. (c) Slice and View FEI software interface for the preliminary trenching preparation. (d) Stack of SEM images with a z-spacing of 50 nm, through 10 μm (200 images in total).

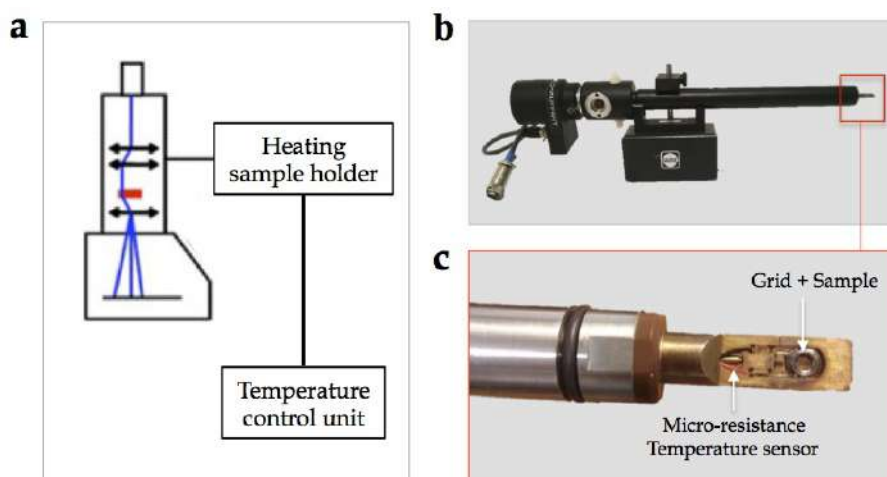
Figure 73: In situ heating TEM settings. (a) The JEOL 2010 is equipped with a (b) double tilt heating holder (Gatan) connected to a temperature control unit. (c) The TEM grid containing the sample is placed at the extremity of the sample holder and it is connected to a heating micro-resistance and a temperature sensor.

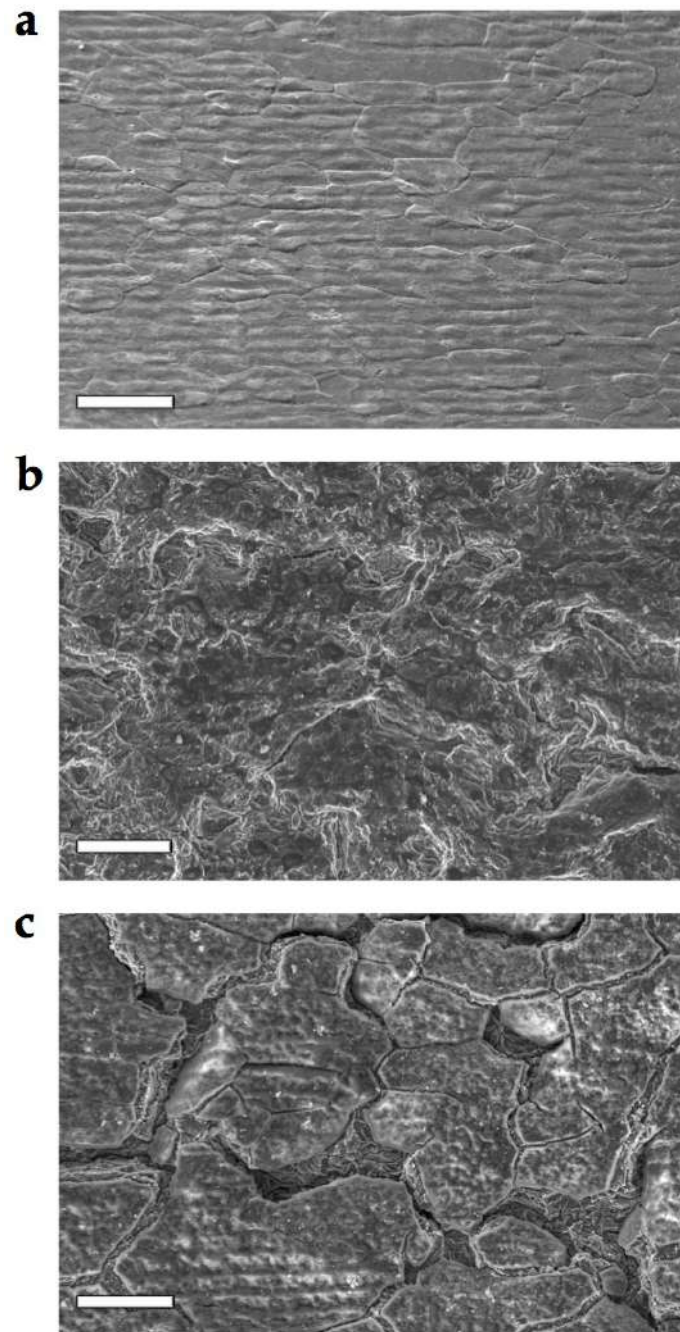
Figure 75: Top view SEM images showing the Al metallization of (a) an as-is module and (b), (c) a failed one at two different locations. The grain structure is visible in all of them as GBs are slightly grooved in (a) and more heavily cracked in (b) and (c). Scale bar 10 μm .

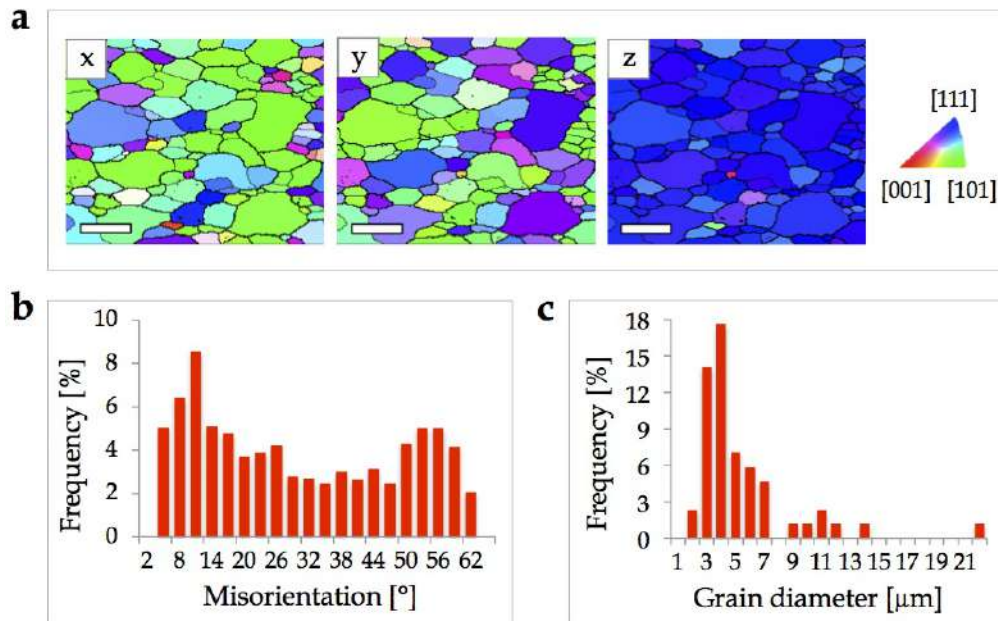
Figure 76: (a) EBSD orientation mapping along x, y and z axis of the Al metallization of a reference module and relative histograms of the (b) grain misorientation and (c) grain size (equivalent diameter).

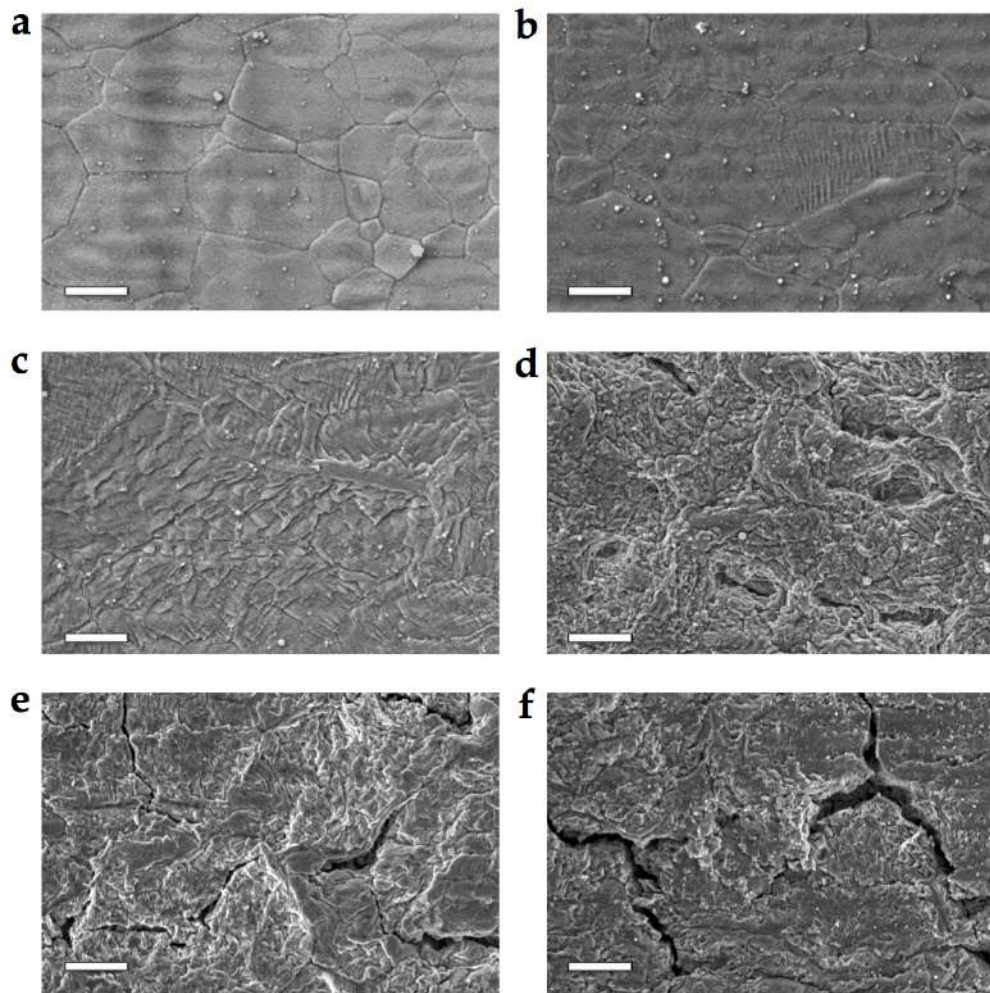
Figure 77: Top view SEM images showing the evolution of the Al source metallization surface. Grain structure (a) before starting the accelerated aging and after (b) 1 kcycles, (c) 10 kcycles, (d) 100 kcycles, (e) 200 kcycles and (f) 300 kcycles. Scale bar 5 μm .

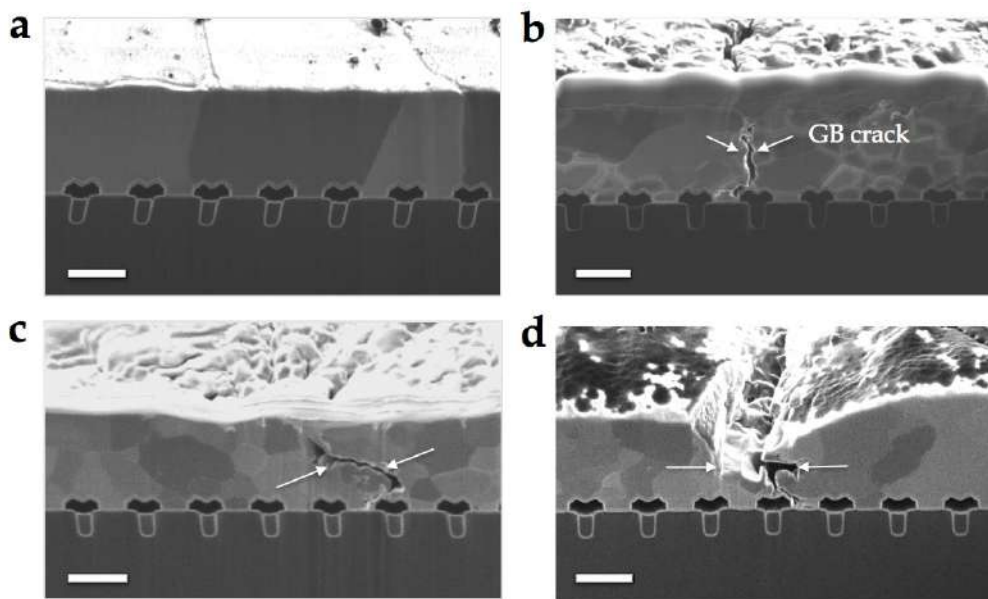
Figure 79: SIM imaging of the Al source metallization of an (a) as-is and (b) 100, (c) 200 and (d) 300 kcycles aged power modules. Scale bar 2 μm.

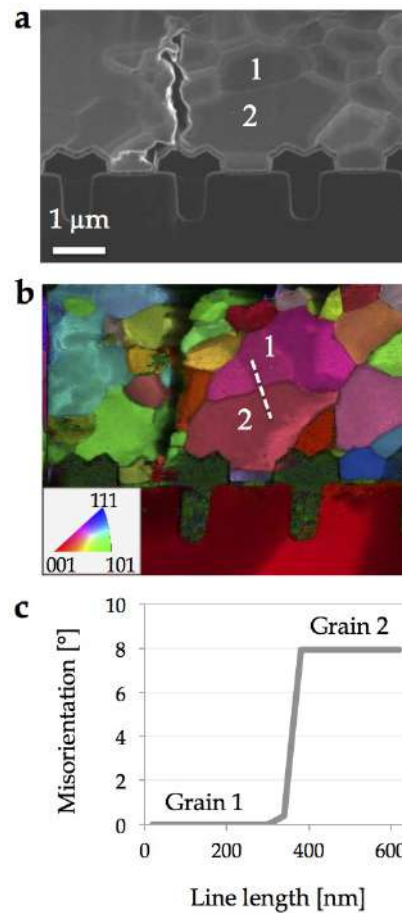
Figure 82: (a) FIB imaging and (b) ACOM orientation mapping of the source metal of an aged module (short circuit, 130k cycles) at the interface with the Si substrate. The standard stereographic triangle gives the color codes of the grain orientations, taken here along the horizontal direction. (c) The plot represents the misorientation between the grains 1 and 2 along the white line in b).

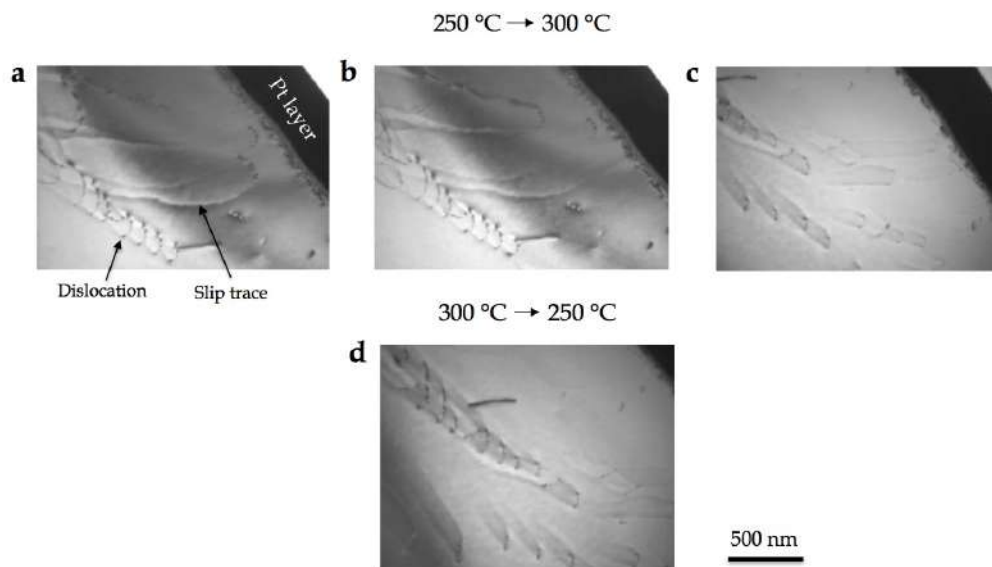
Figure 86: In situ TEM thermal cycling of a device FIB-prepared cross-section from 25°C to 450°C. (a)-(c) are snapshots captured during the heating up phase from 250°C to 300 °C, showing curved slip traces associated to a combination of dislocation climbing and gliding. Once the dislocations are dispersed, during the correspondent cooling down phase (d), no reverse motion is observed because the Si substrate is too thin to induce significant stress in the Al film.

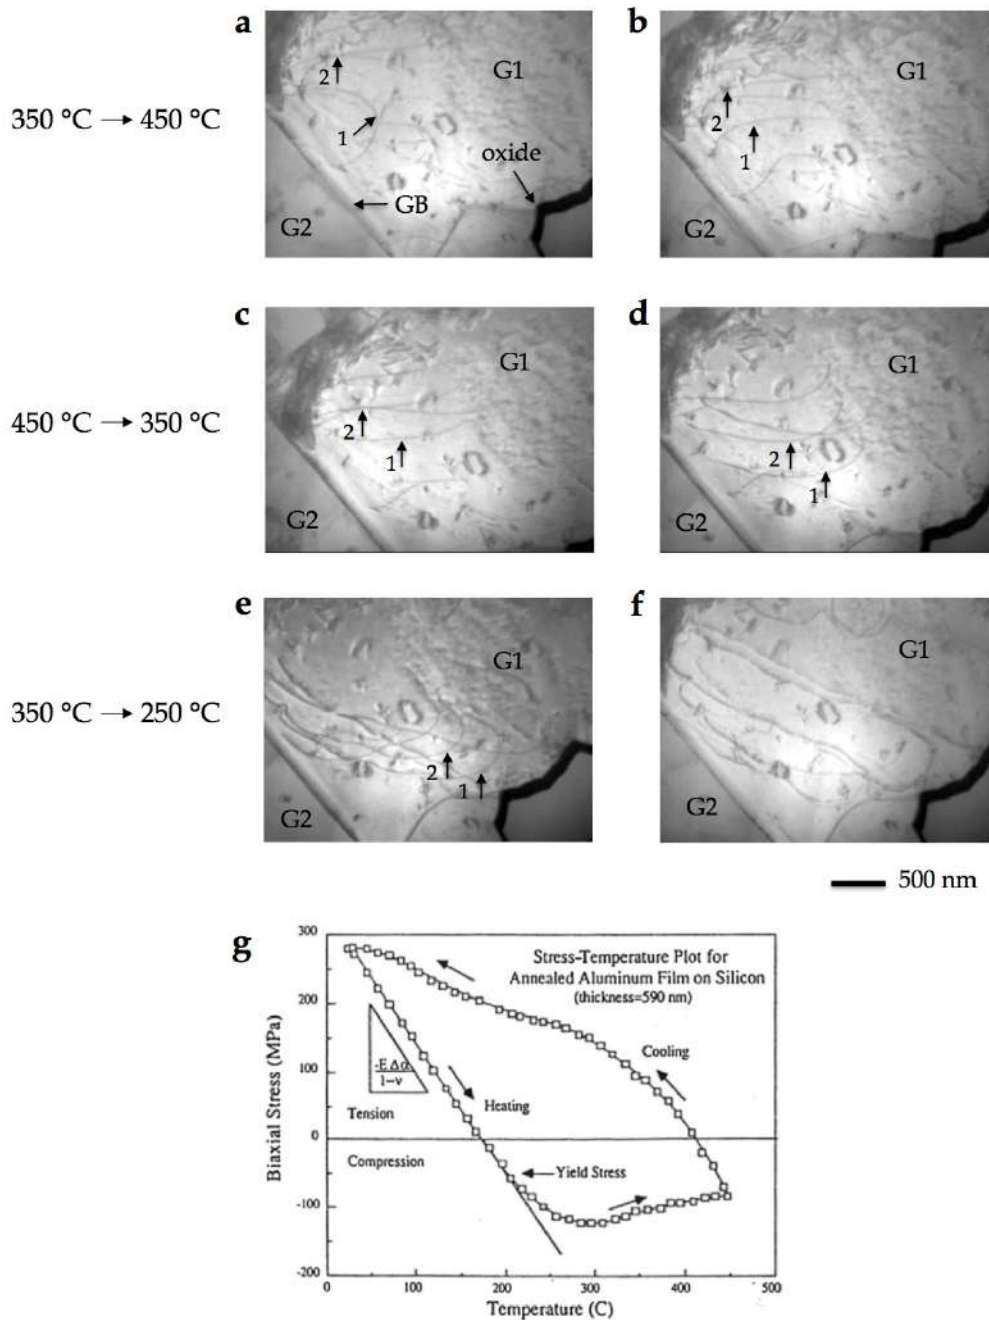
Figure 87: In situ TEM thermal cycling from 25 °C to 450 °C of a device cross-section prepared by tripod. The Si substrate is preserved, inducing a reversible motion, according to the stress inversion for a Al/Si substrate thin film in the stress-temperature curve [Fli87]. (a)-(b) are snapshots captured during the heating up phase from 350 °C to 450 °C, showing the dislocation activation. During the cooling down phase, the reversible motion is characterized by an initial dislocation straightening (c) followed by a bowing in the opposite direction (d), towards the oxide (d)-(e).

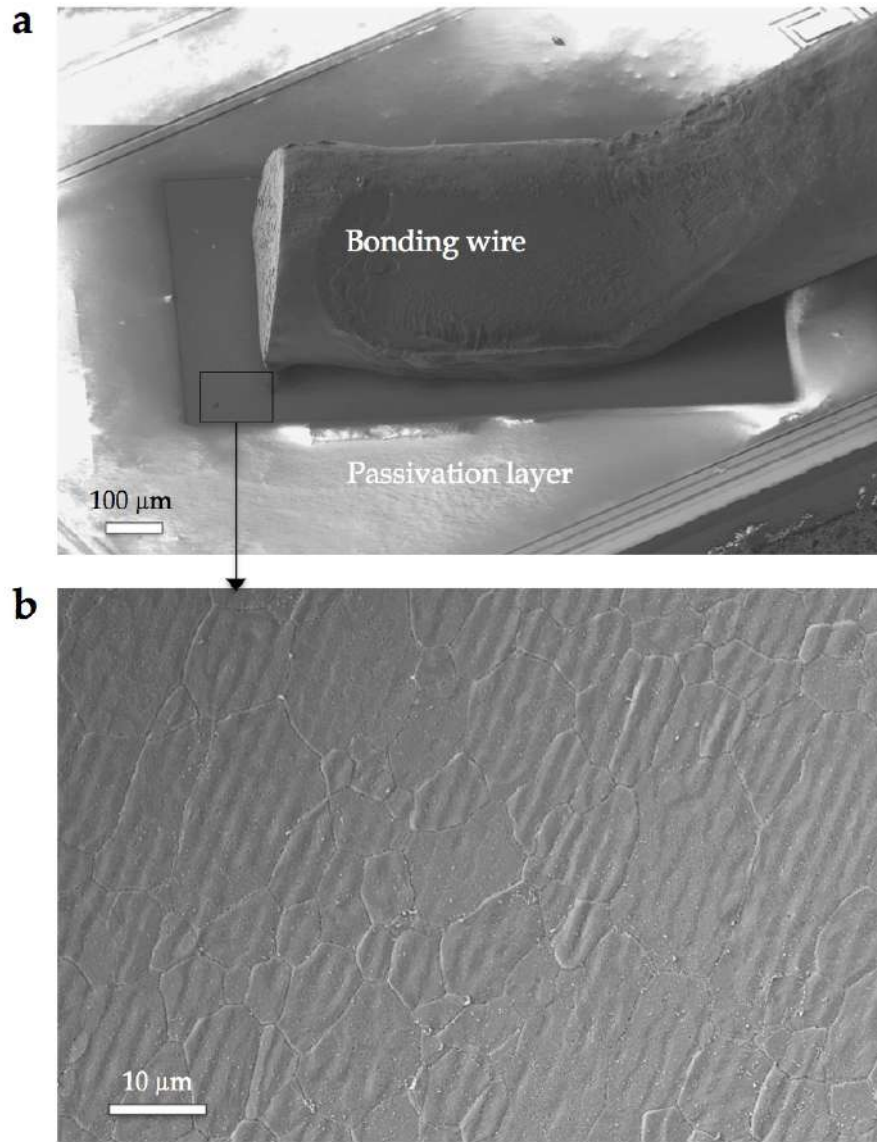
Figure 88: (a) SEM image of an Al bond wire welded on the Al source metallization on an as-is module. Away from the bonding area the metallization is coated by a SiO_2 passivation layer. (b) Higher magnification of the bare metallization close to the bonding wire.

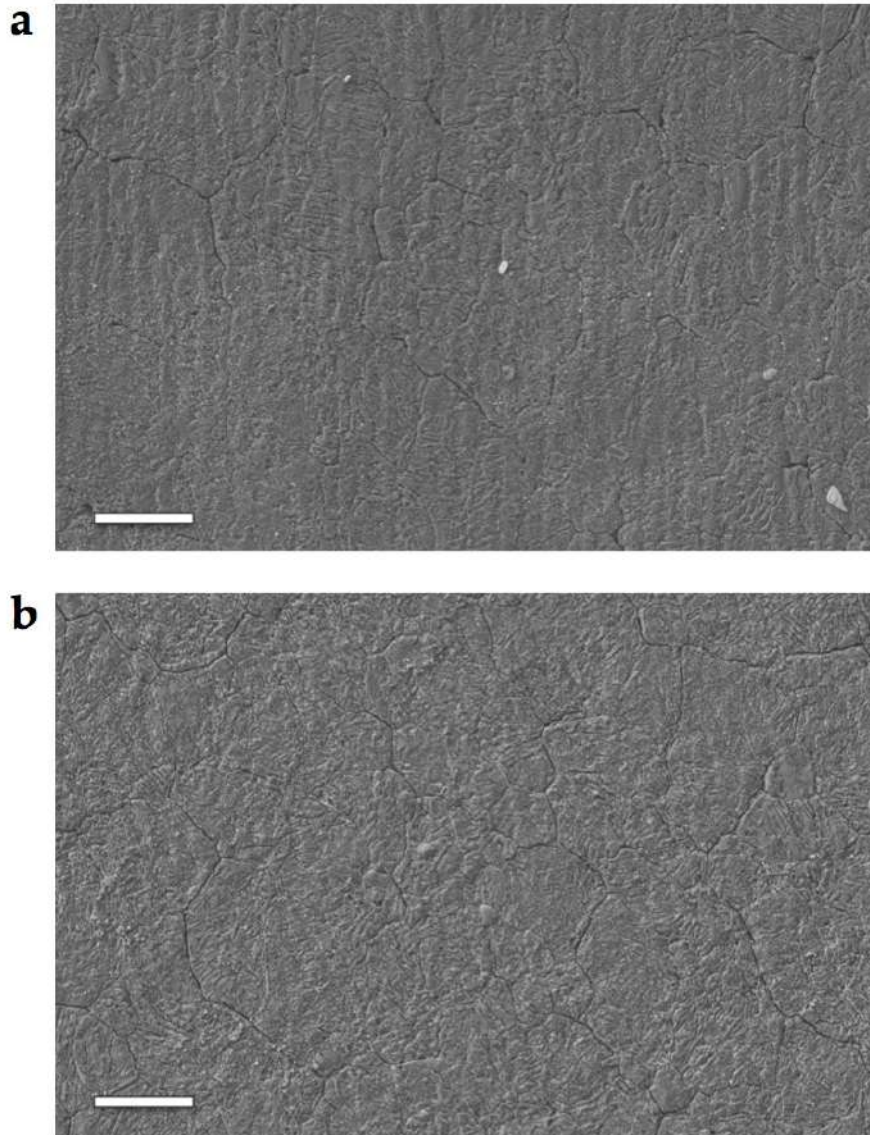
Figure 89: SEM images of the Al metallization close to the bonding wire in a (a) 25°C aged module (failed after 5.3 million cycles) and in a (b) 70°C aged one (failed after 300 kcycles). Scale bar 10 μm

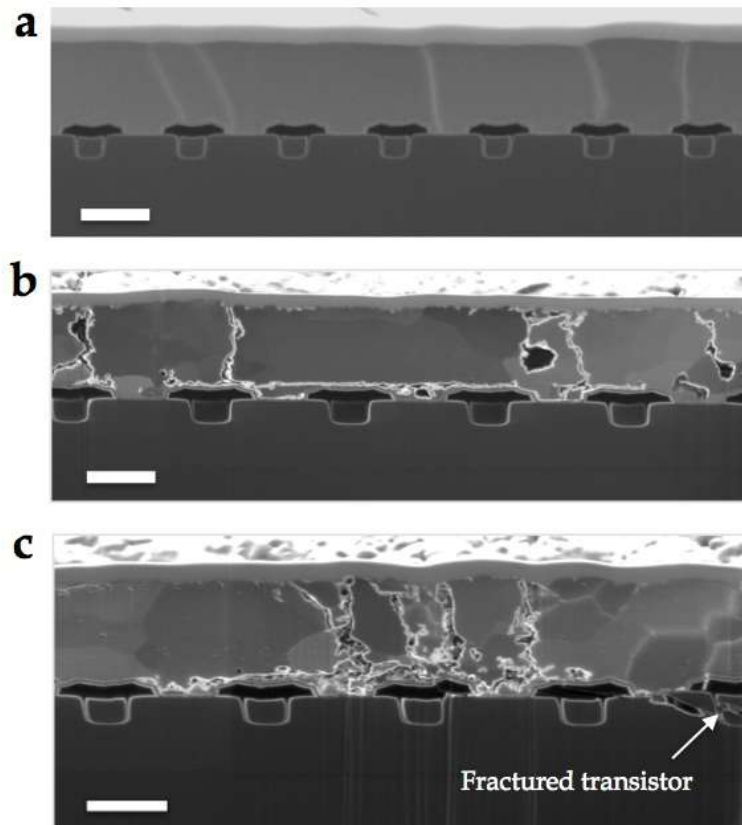
Figure 90: SIM images of the naked metallization cross-sections of (a) as-is, (b) 70°C aged and (c) 25°C aged power modules. The top layer ($\sim 1\mu\text{m}$ thick) is the Pt protective coating to prevent curtaining artefacts on the imaging faces. Scale bar $2.5\mu\text{m}$.

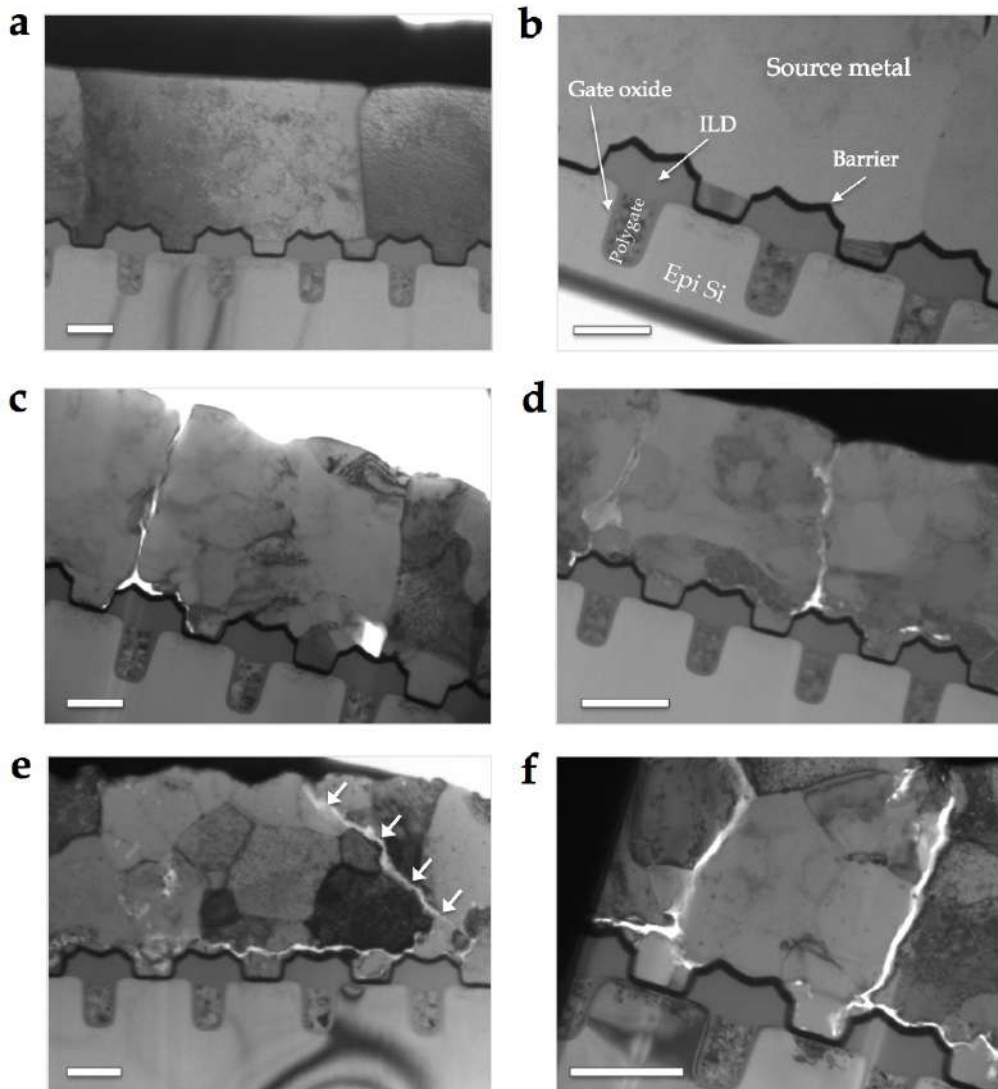
Figure 91: TEM images of some details of the transistor/metallization area from the naked metallization of an (a, b) as-is, (c, d) 25°C aged and (e, f) 70/degree C aged power modules. The trench MOSFET layered structure is described in (b) and consists in: source metal, inter-layer dielectric (ILD), gate oxide and polySi (Polygate), epitaxial Si. Scale bar: 1 μm .

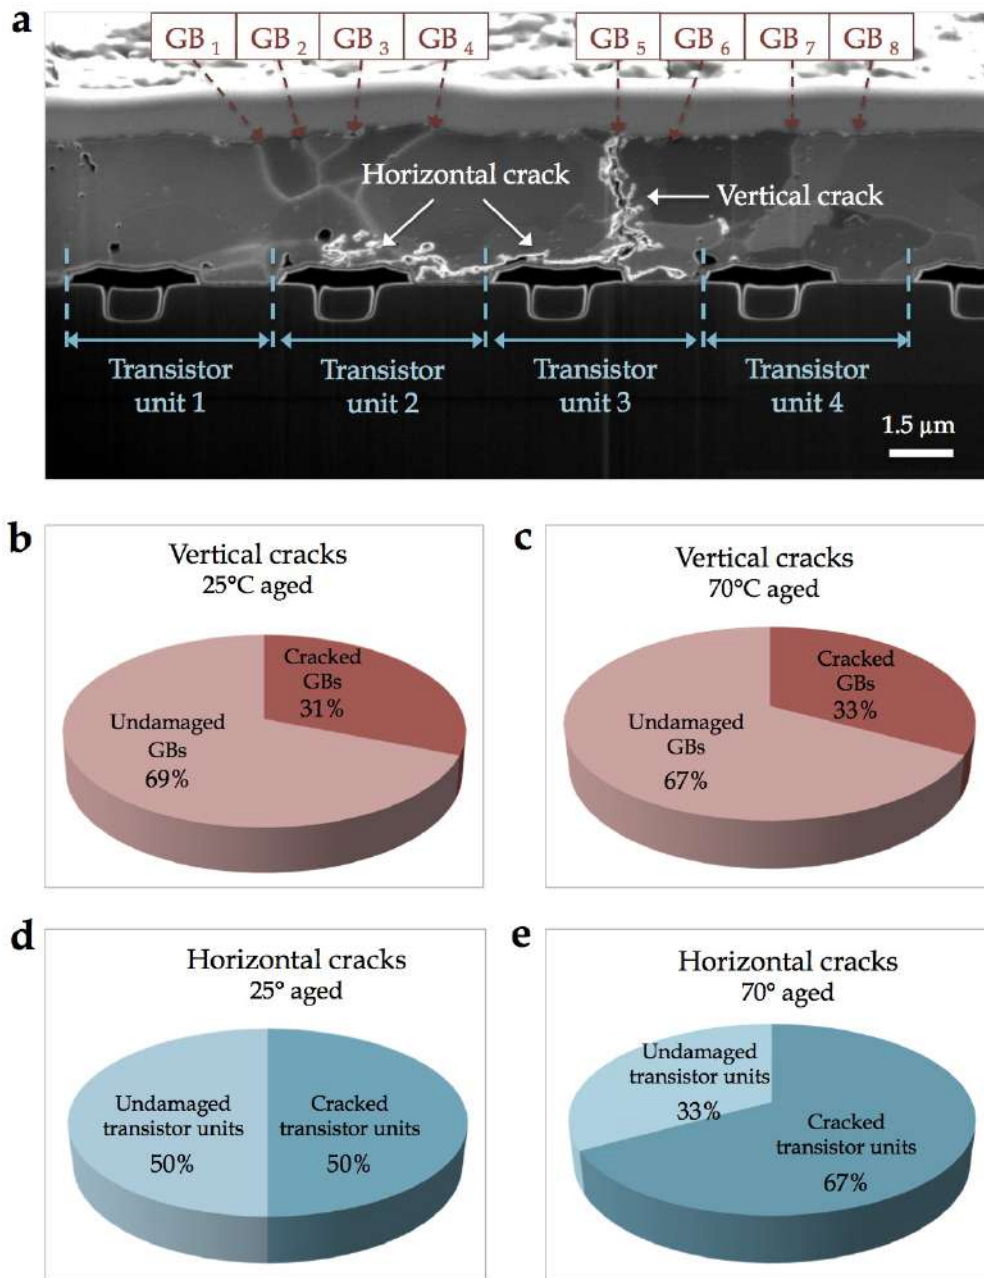
Figure 93: Horizontal and vertical cracks statistics in a 25°C and 70°C aged module. (a) Vertical cracks are evaluated by counting at the metal surface the number of cracked (GB₅) and undamaged (GB₁ – GB₄ and GB₆ – GB₈) grain boundaries. Horizontal cracks are evaluated by counting the number of transistor units with cracks on top (Transistor unit 2 and Transistor unit 3) with respect to the undamaged ones (Transistor unit 1 and Transistor unit 4). The ratio of cracked vs undamaged GBs is showed in (b) for a 25°C aged module and in (c) for a 70 °C aged one. The ratio of cracked vs undamaged transistor units is showed in (d) for a 25°C aged module and in (e) for a 70 °C aged one.

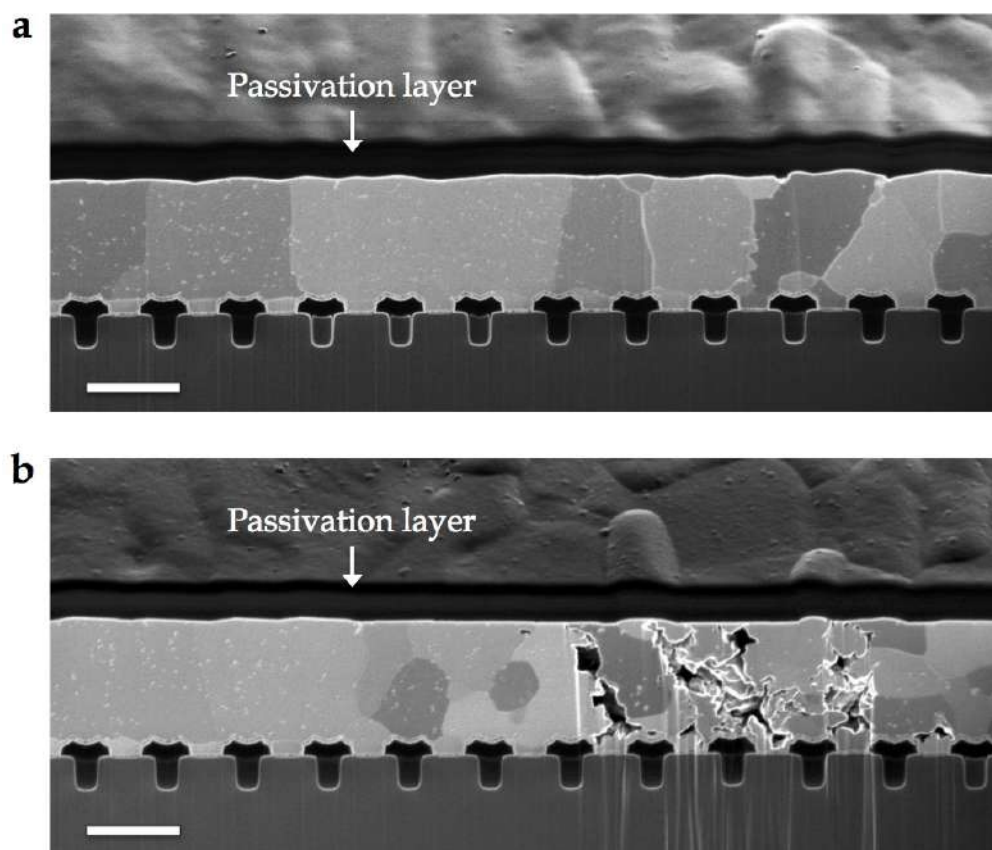
Figure 94: SIM image of the Al top metallization coated by SiO_2 passivation from two close cross-sections in a 70°C aged module.
