Fatigue mechanisms in Al-based metallizations in power MOSFETs

THÈSE

**Modes de fatigue des métallisations à base d'aluminium dans les
composants MOSFET de puissance**

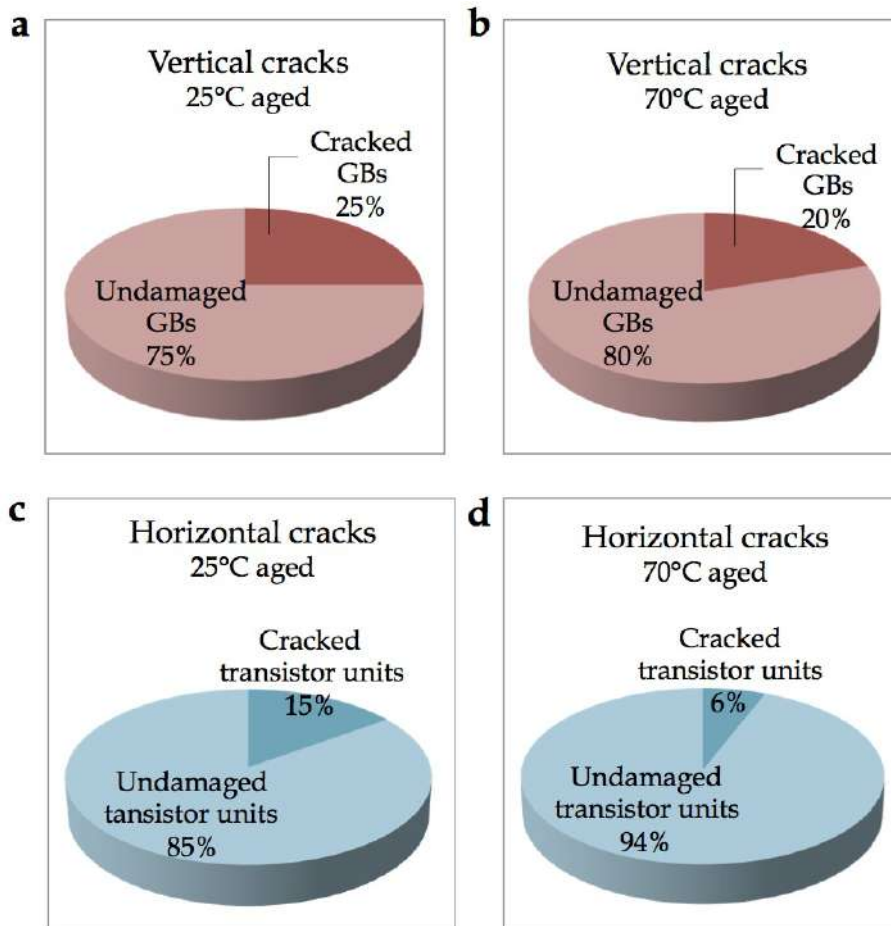
Figure 95: Ratio of cracked vs undamaged GBs in (a) a 25°C aged module and in a (b) 70 °C aged one.
 Ratio of cracked versus undamaged transistor units in (c) a 25°C aged module and in a (d) 70 °C aged one.

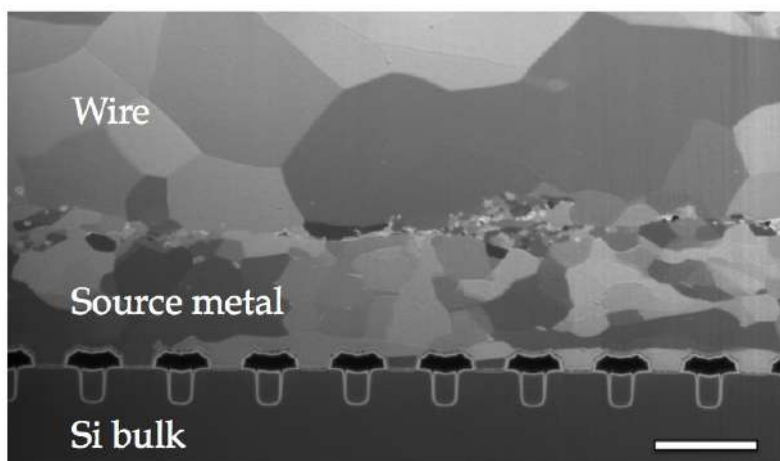
Figure 96: SIM images of the wire-source metallization interface, at the center of the bonding wire, in an as-processed module. Scale bar $2.5\ \mu\text{m}$.

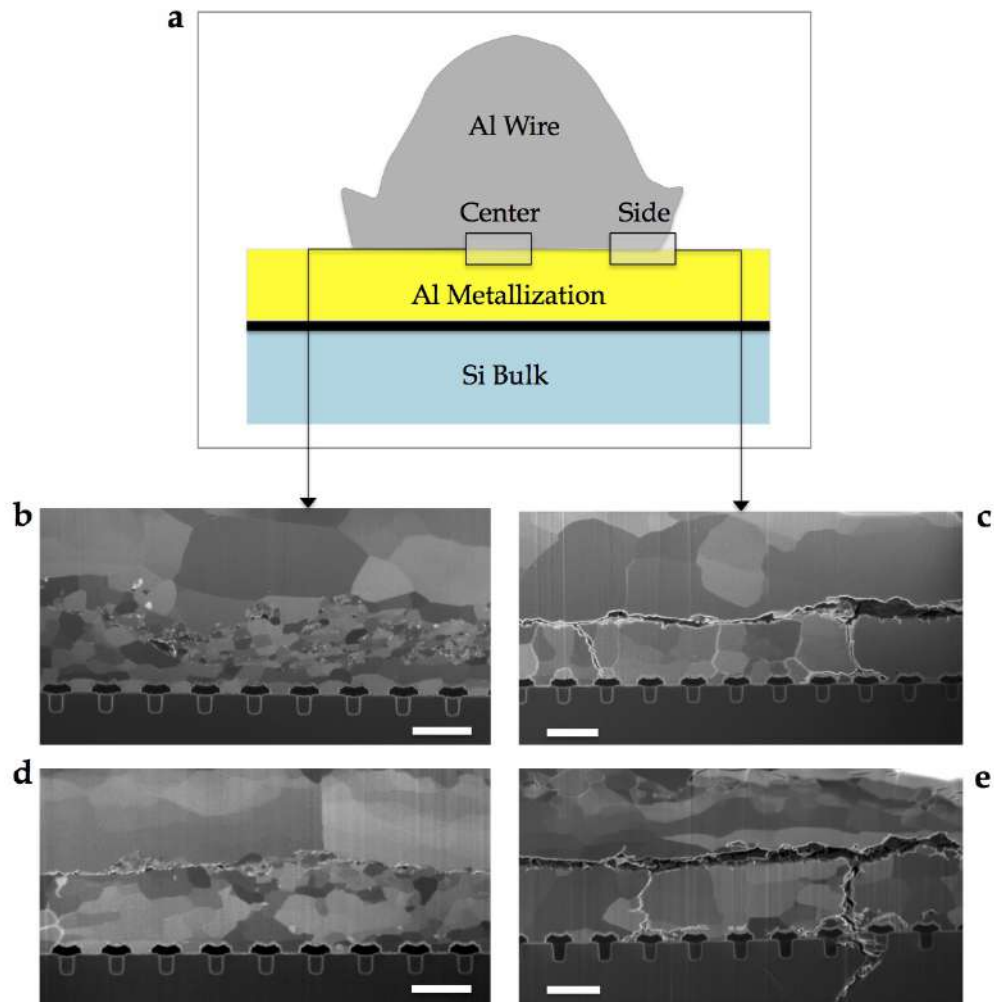
Figure 98: (b) Central and (c) side SIM images of the wire-metallization interface in a 25°C aged module. (d) Central and (e) side SIM images of the wire-metallization interface in a 70°C aged module. The images correspond to the FIB cross-section locations ("center" and "side") in the schema in (a). Scale bar 2.5 μm.

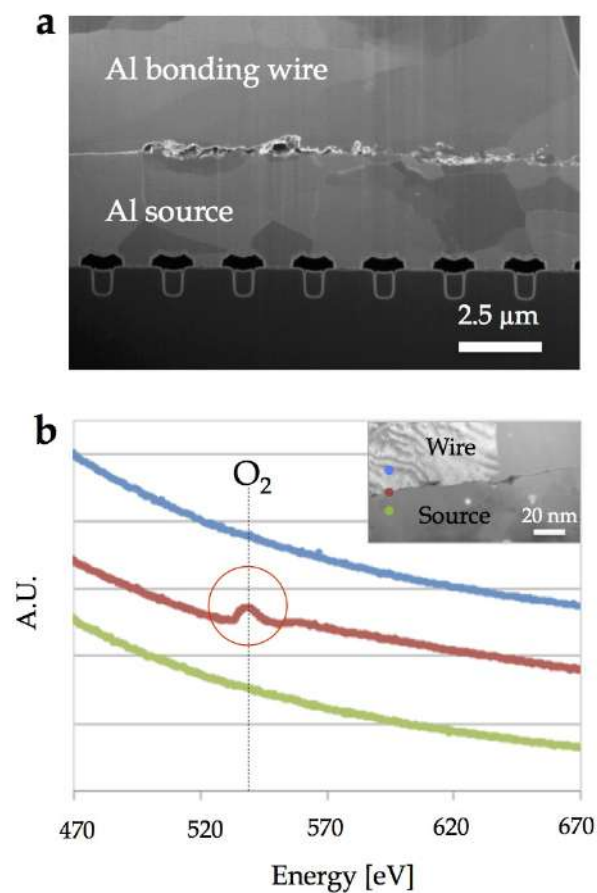
Figure 99: (a) SIM image of the initial artifacts which characterize the wire-metallization bonding of an as-is module. (b) EELS spectra from the wire (in blue), the metallization (in green) and the wire-metallization interface (in red). The red spectrum at the wire-metallization interface reveals the presence of oxygen.

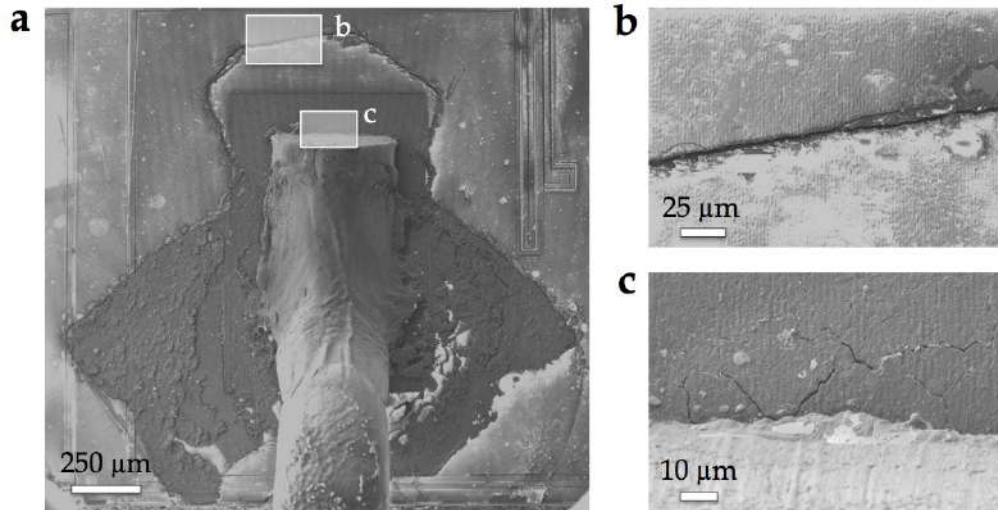
Figure 105: (a) Top view SEM image of an Al bond wire welded on the Al source metallization in a 25°C aged device, after a short-circuit event. At higher magnification, big cracks propagating in (b) the passivated metallization and (c) next to the bonding wire (located in the boxes (b) and (c) in (a)).

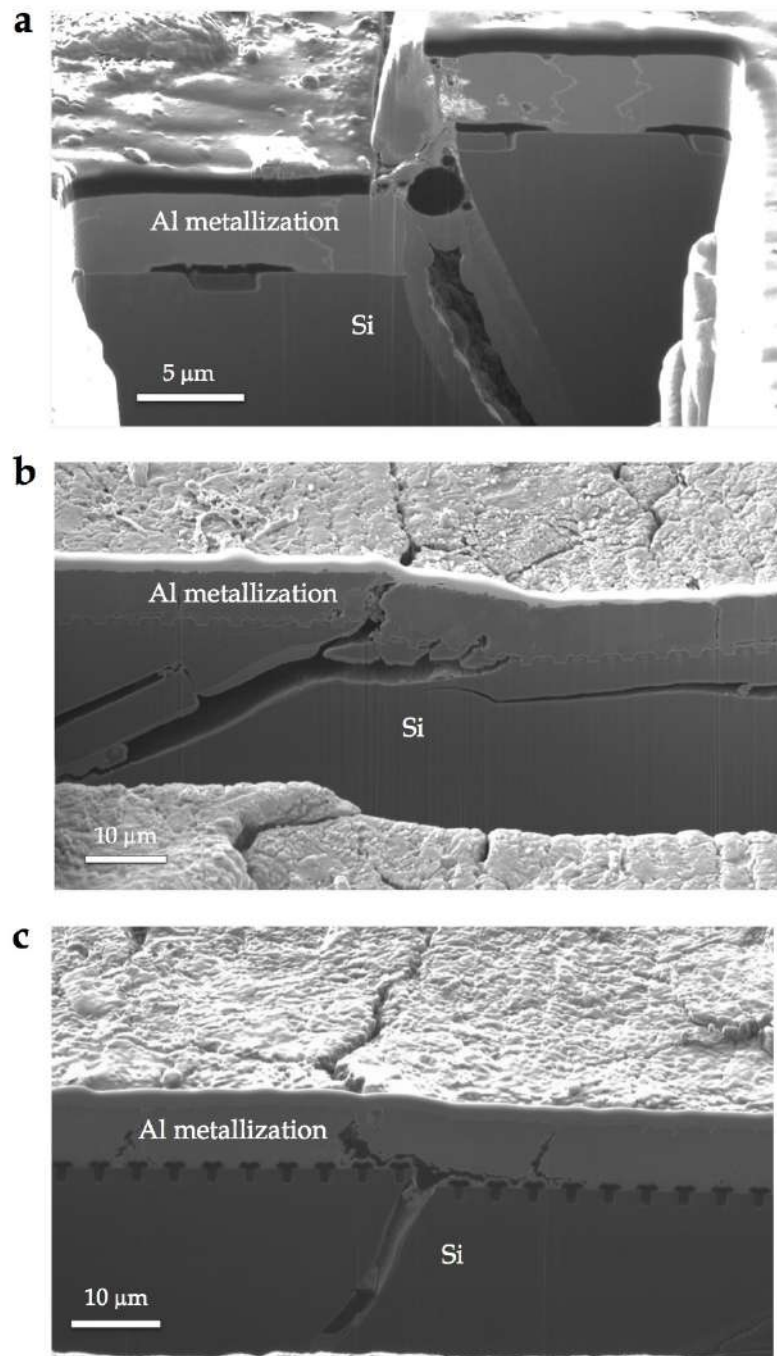
Figure 106: Cross-sectional SEM images of the heavily cracked metallization (a) in the passivated area and (b) close to the melted bonding wire of the module depicted in (Fig. 105a).

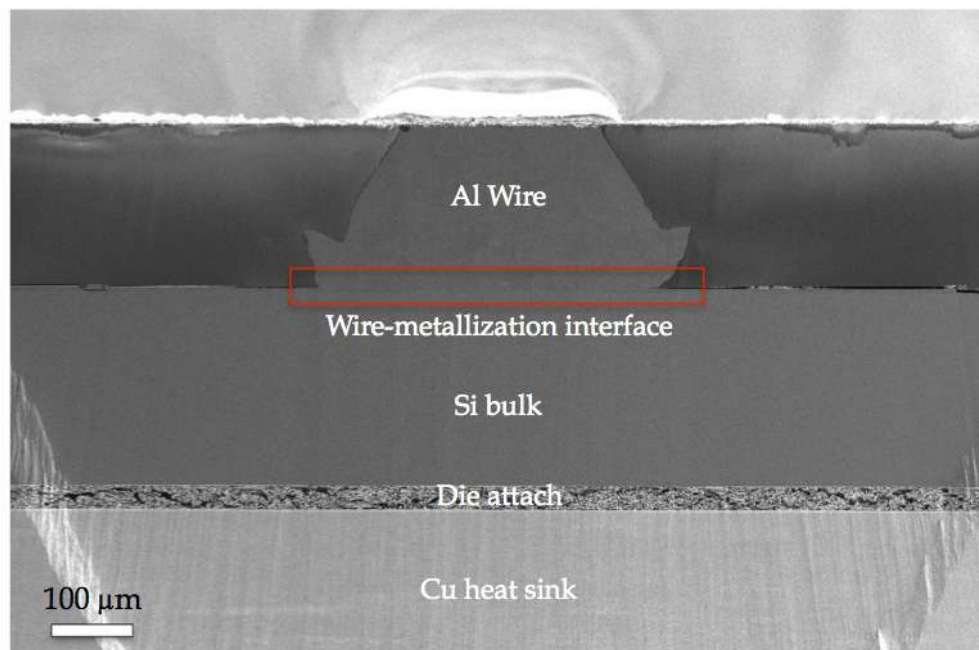
Figure 107: SEM image of a cross-section prepared by Cross Polisher system in an as-is module. The large cut area shows the power die layered structure: Al wire, Si bulk and Cu heat sink. The Al source metallization on the transistor area, at interface with the semiconductor, is not visible at this scale. The red area indicates the location of the Al wire-metallization interface that is shown in detail in Fig. 108a - n.

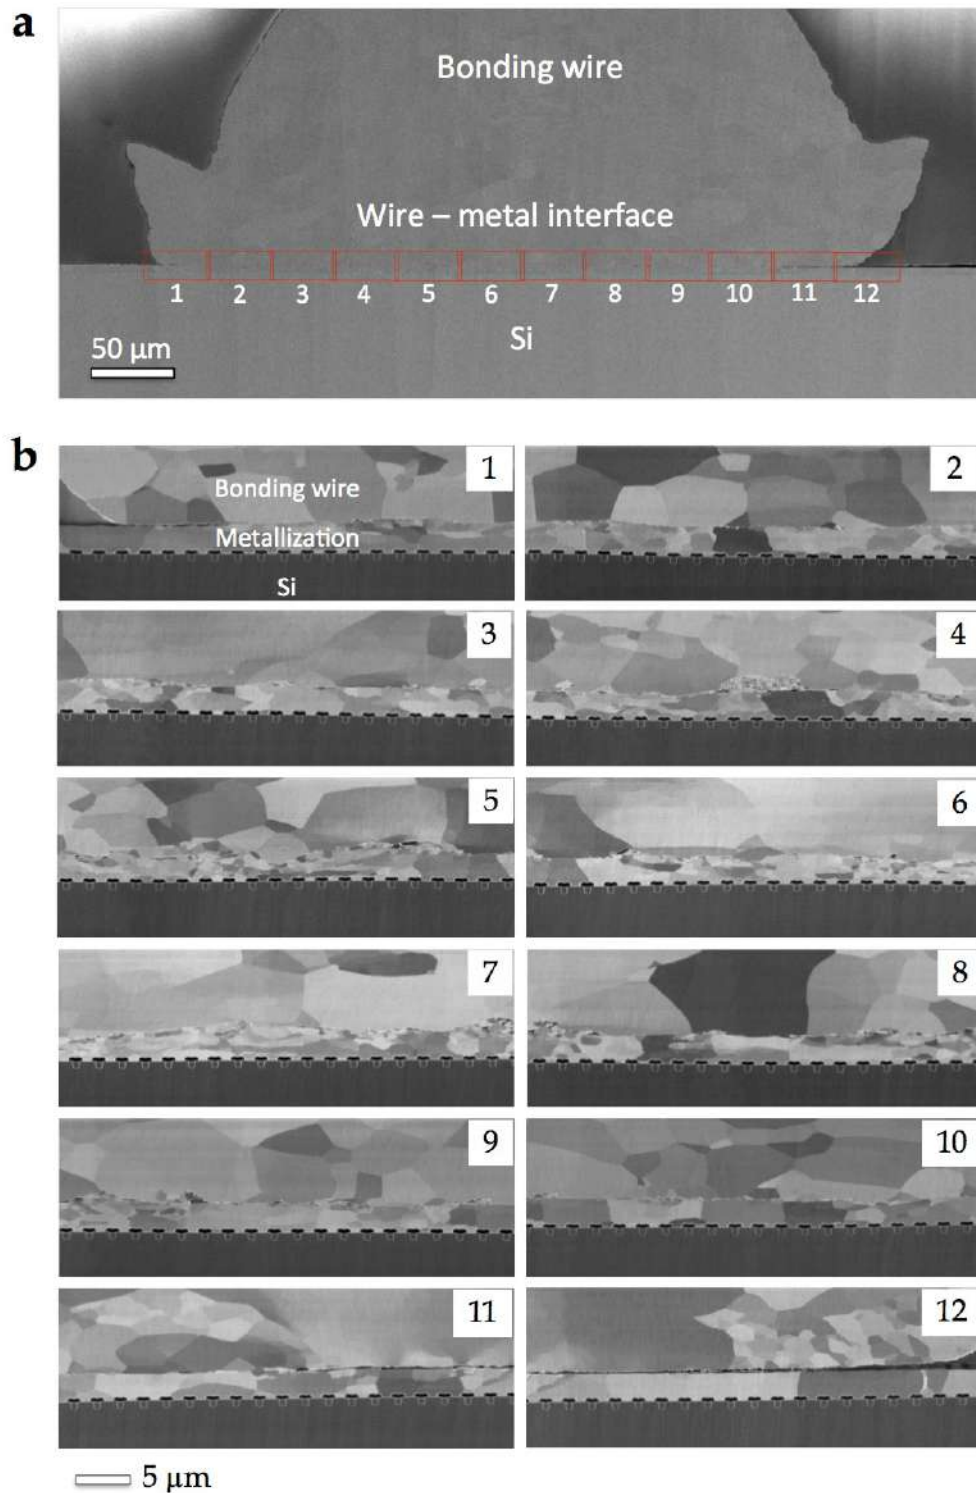
Figure 108: (b) SIM images mosaicing of the whole wire-metallization cross-section prepared by cross-polisher, according to the schema in (a). The images sequence offers a global vision of the metallization grain structure under the bonding wire and of the wire metallization interface. It can be used to calculate the total amount of deformed area due to the bonding process.

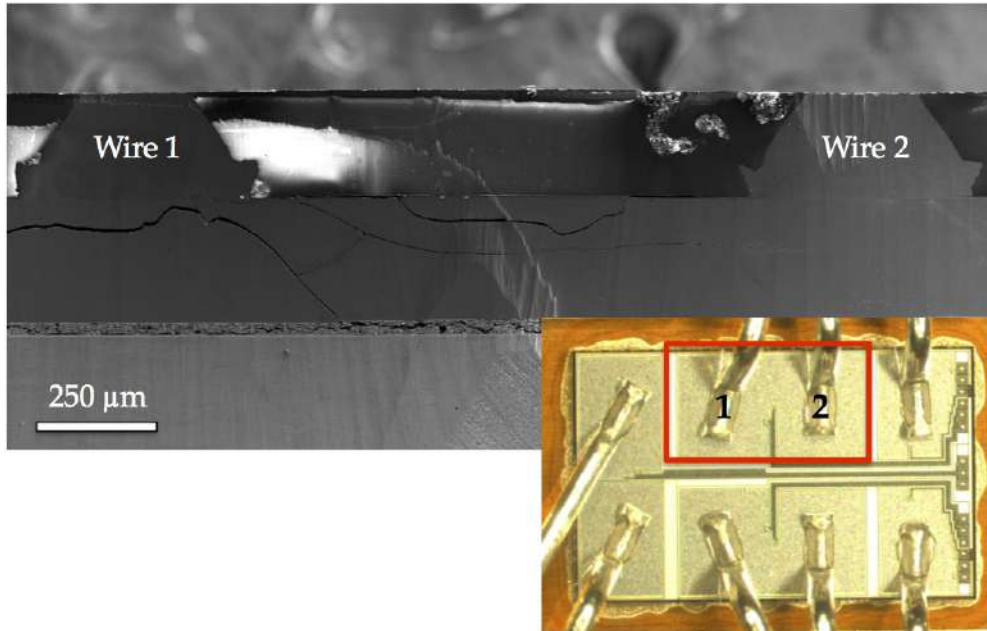
Figure 109: SEM overview of a 70°C aged module prepared by CP for the SEM/SIM inspection. In the insert, optical image image of the T07D17 device, showing the position in the aged module (in red) of wire 1 and 2 under investigation.

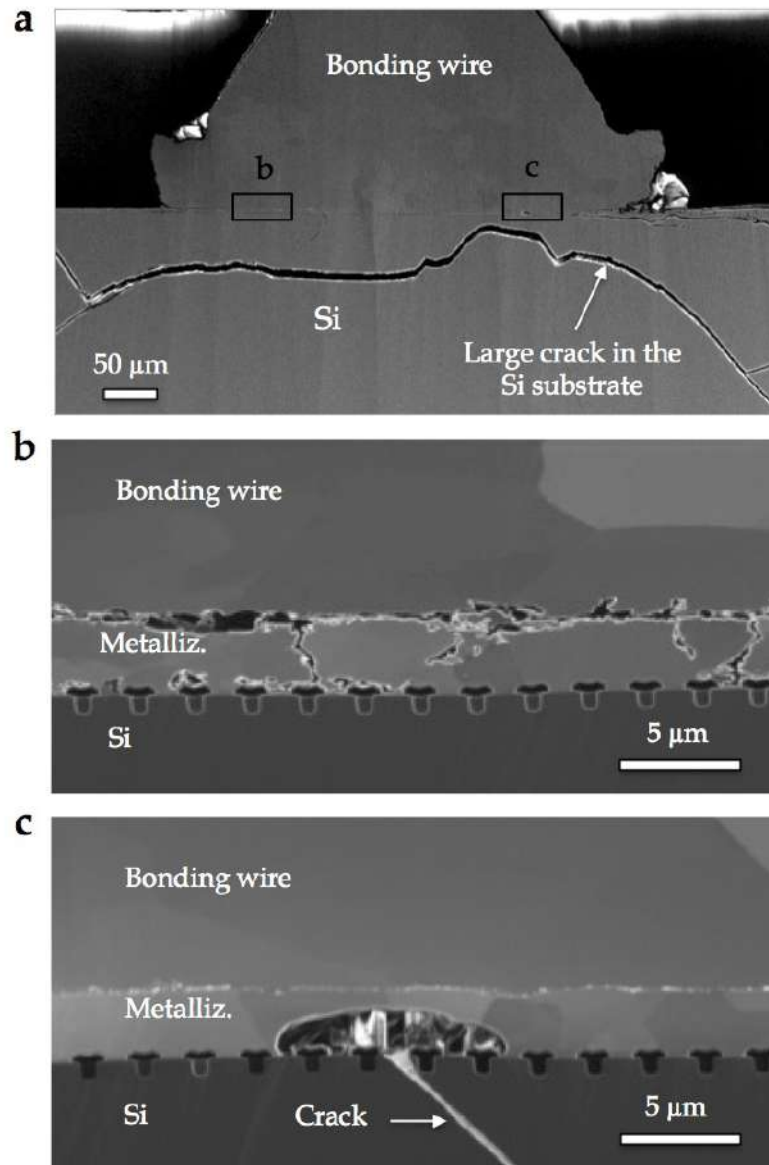
Figure 110: (a) SEM cross-sectional imaging of the bonding wire from an aged power module (70 °C aged) showing different types of cracks; (b), (c) ionic higher magnification images of the wire- metallization interface located in the boxes (b) and (c) in (a). The die crack resulted from an electro-thermal event occurring at failure time.

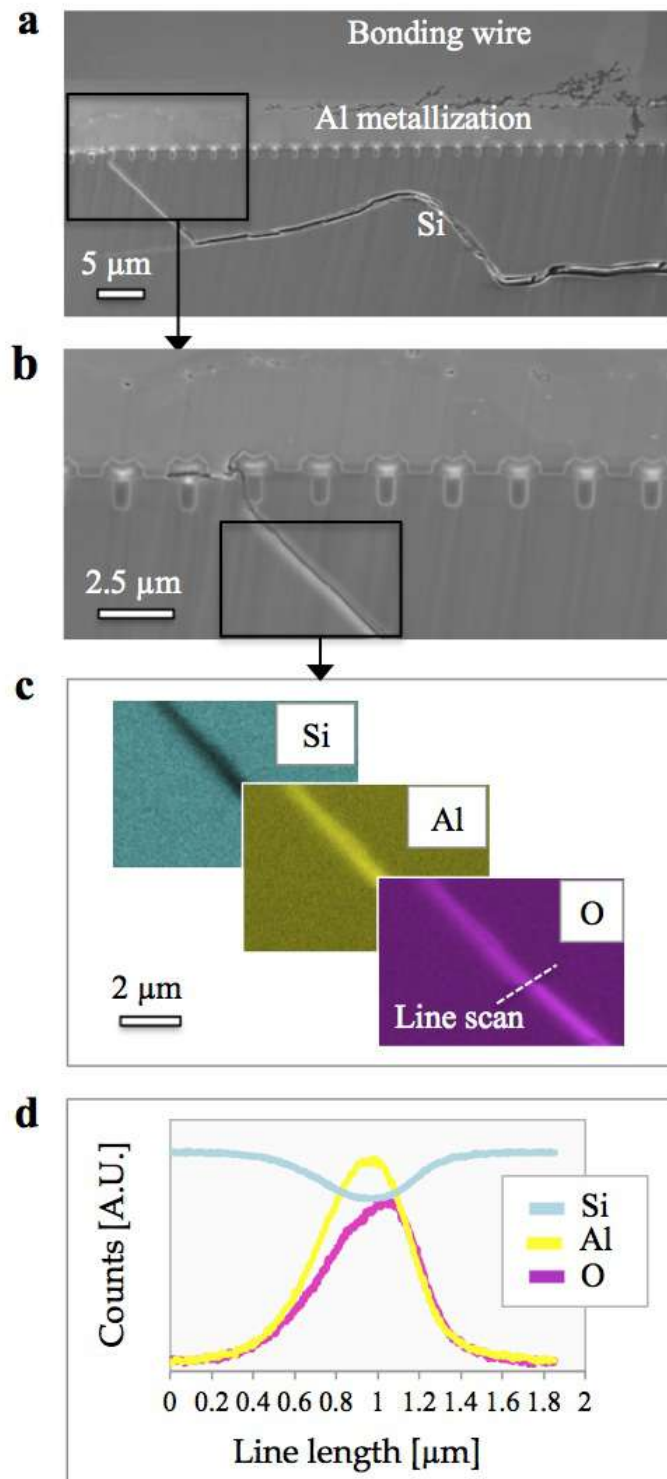
Figure 111: (a) Low and (b) high magnification SEM image of the cracked Si bulk under the bonding contact. (c) EDX mapping of the crack in the Si bulk and (d) relative line scan plot showing the element distribution along the dashed line in (c).

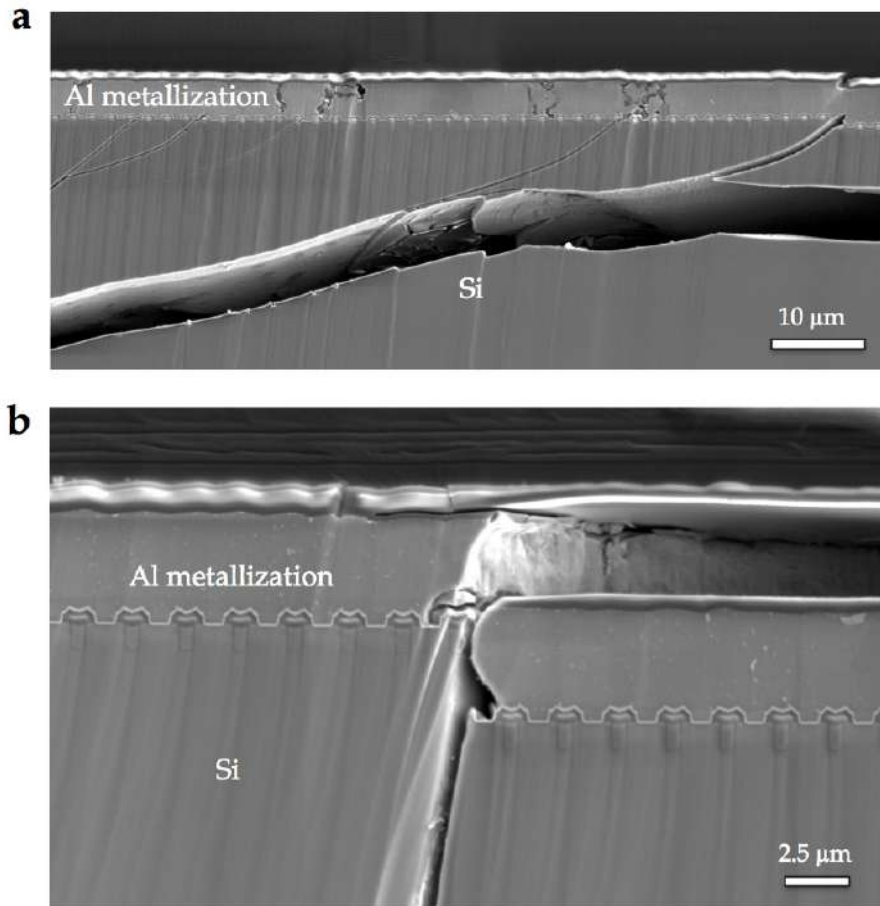
Figure 112: (a) SEM cross-sectional imaging of the naked metallization between the two bonding wire of the 70 °C aged module, showing different types of cracks: fatigue cracks in the metallization layer and fragile cracks in the Si substrate; (b) at higher magnification, the Al top metallization continuity results abruptly compromised as result of the crack propagation in the Si substrate until the surface.

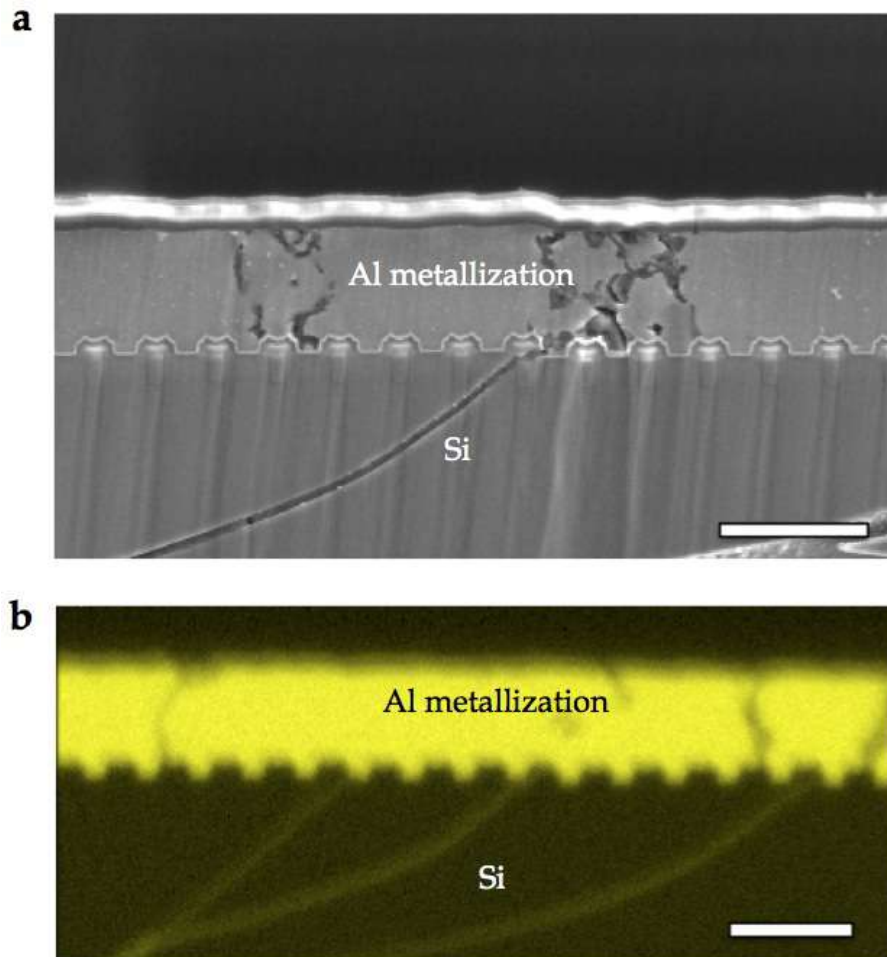
Figure 113: (a) SEM cross-sectional image of a fine crack in the Si layer contacted to the Al metallization in a 70°C aged module. (b) Al mapping by EDX showing some of these Si fine cracks filled with Al. Scale bar 5µm

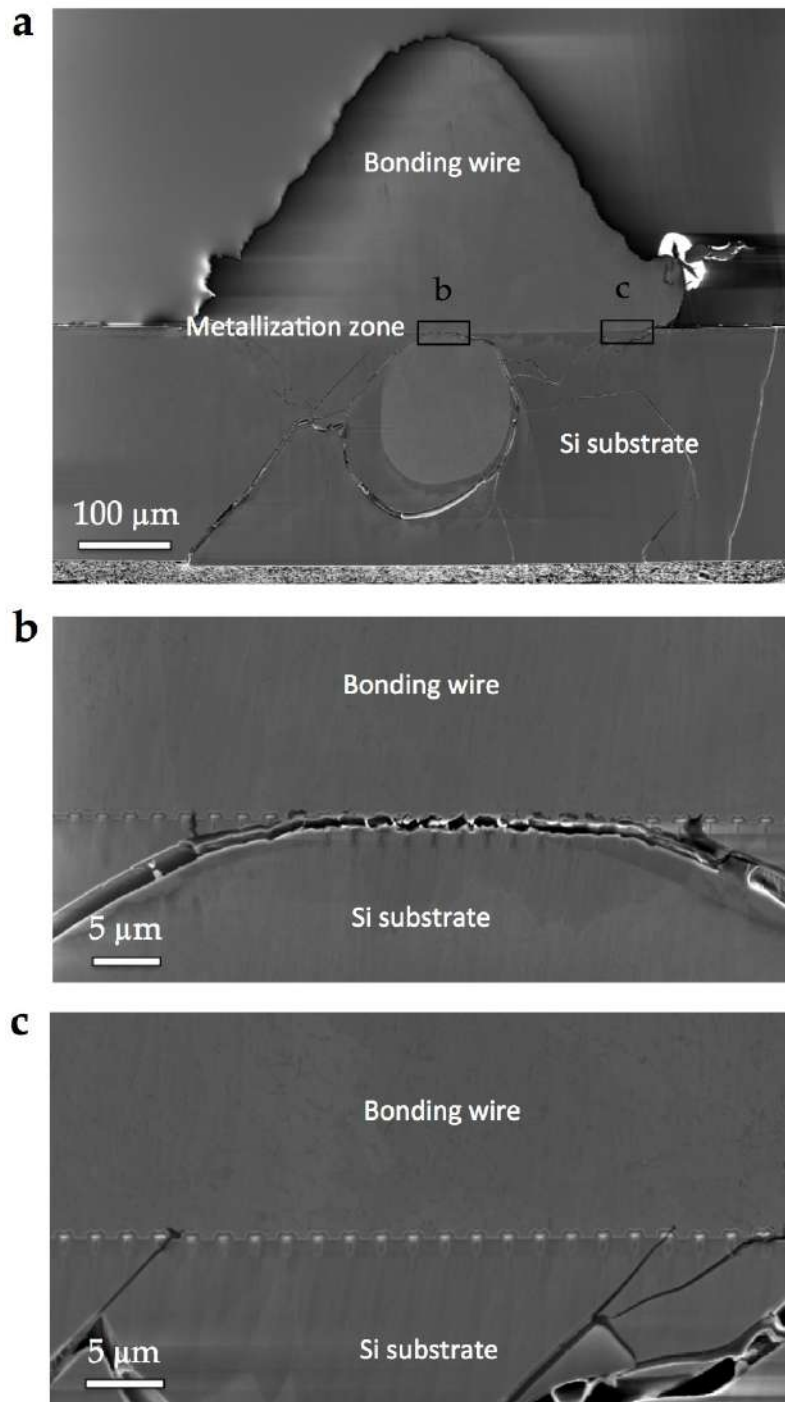
Figure 114: (a) SEM cross-sectional imaging of the bonding wire from an aged power module (25 °C aged) showing different types of cracks; (b), (c) higher magnification images of the wire- metallization interface located in the boxes (b) and (c) in (a). The die crack resulted from an electro-thermal event occurring at failure time.

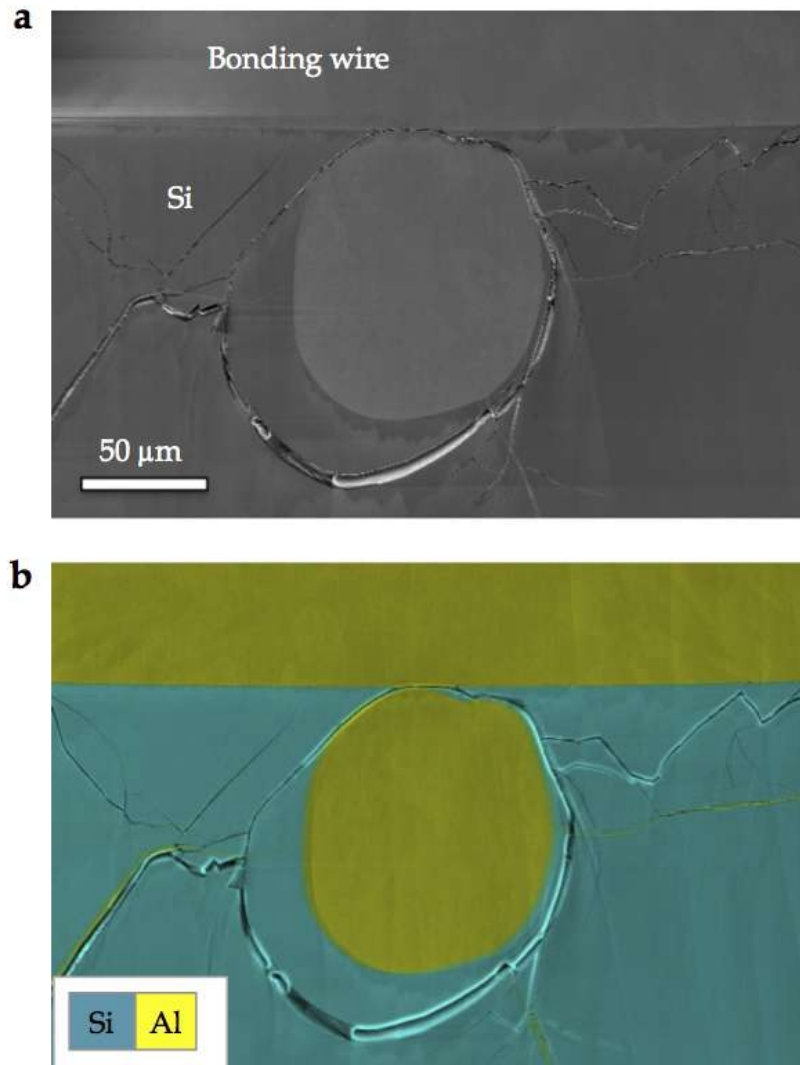
Figure 115: (a) SEM cross-sectional imaging of the round shape feature in the Si substrate (Al contrasted like) from an aged power module (25 °C aged); in (b) the corresponding EDX maps of the Si (in light blue) and Al (in yellow) are overlapped, showing that the round shape feature in the Si substrate is made out of Al. This has probably diffused from the top wire during the short-circuit event, because of the local melting of the metallic parts at high temperature.

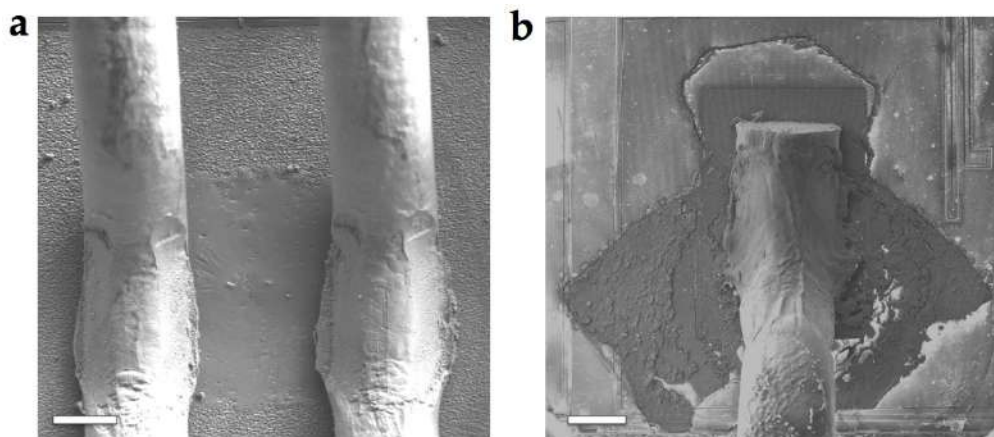
Figure 118: Burnout spots detected after failure (a) between two bond wires in a SPD06 module and (b) at the bonding connection in a T07D17 module. Scale bar: 250 μ m.

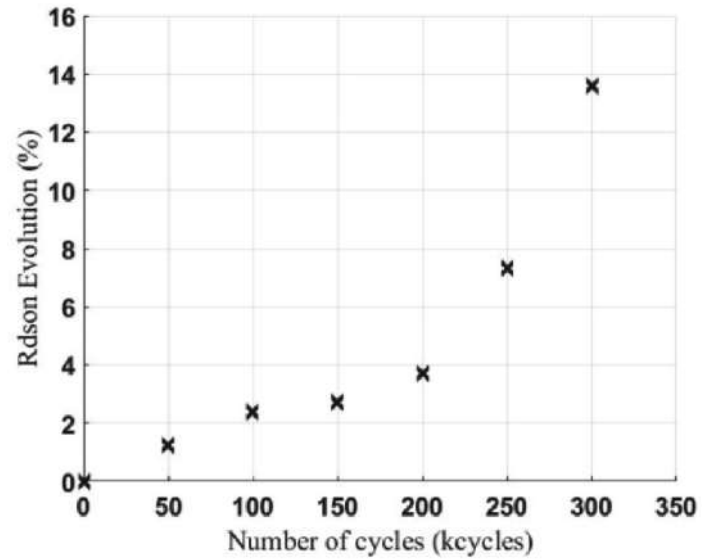
Figure 119: Increase of about 14% in the on-state resistance after repetitive SC events (3.55 J/cm^2) at ambient temperature. At 300kcycles the device failed.

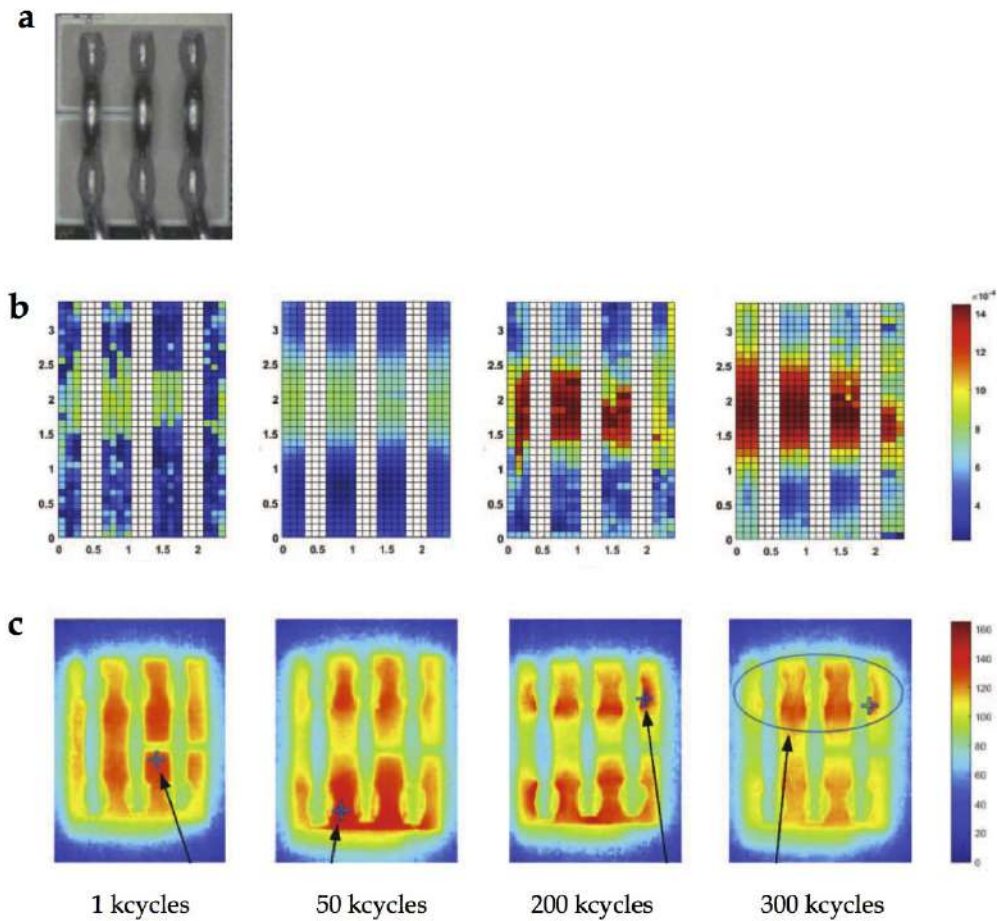
Figure 121: (a) Active module of an SPD06 device under aging test. Potential and temperature mapping of its surface have been performed during aging.
 (b) Source voltage mapping [V] at $I_D = 1A$ under SC conditions, after 1kcycles, 50 kcycles, 200 kcycles and 300 kcycles.
 (c) Temperature distribution [K] under SC conditions, after 1kcycles, 50 kcycles, 200 kcycles and 300 kcycles. Areas where the temperature is lowest correspond the bonding connections, according to the picture of the active module in (a).

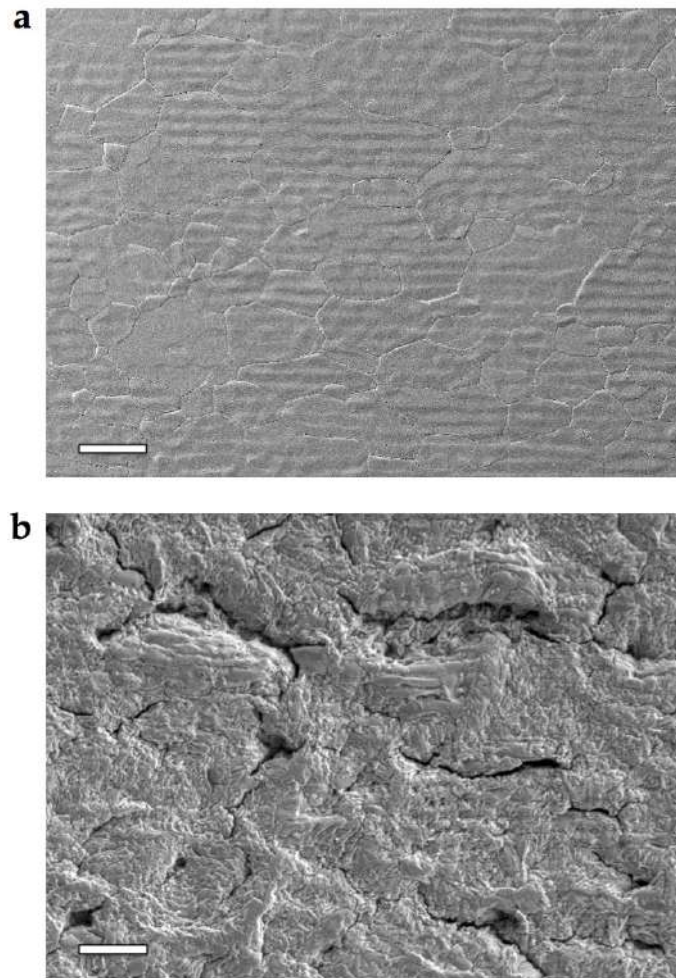
Figure 122: Al source metallization top view. (a) The initial Al structure is smooth and fits the underlying MOSFETs structure. (b) After electro-thermal aging the metallization roughness increases and many cracks propagate along the grain boundaries. The grain structure and the transistor pattern are almost no longer visible. Scale bar: $10\mu\text{m}$.

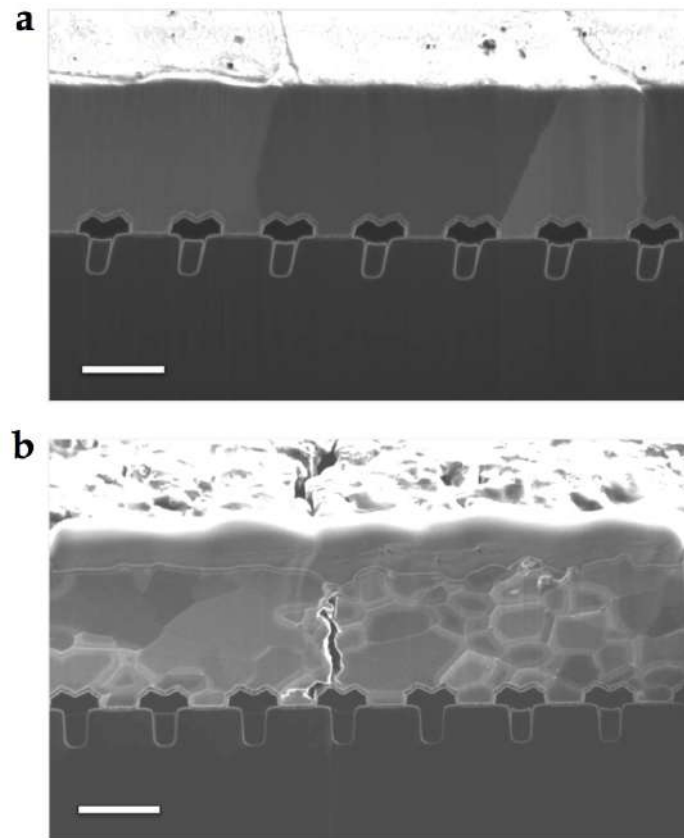
Figure 123: Cross-sectional cuts through the Al source metallization. (a) Before aging, bamboo Al grains fill all the metallization volume. After electro-thermal aging, an apparent grain shrinkage and crack propagation along the grain boundaries are observed. Scale bar: 2.5 μm.

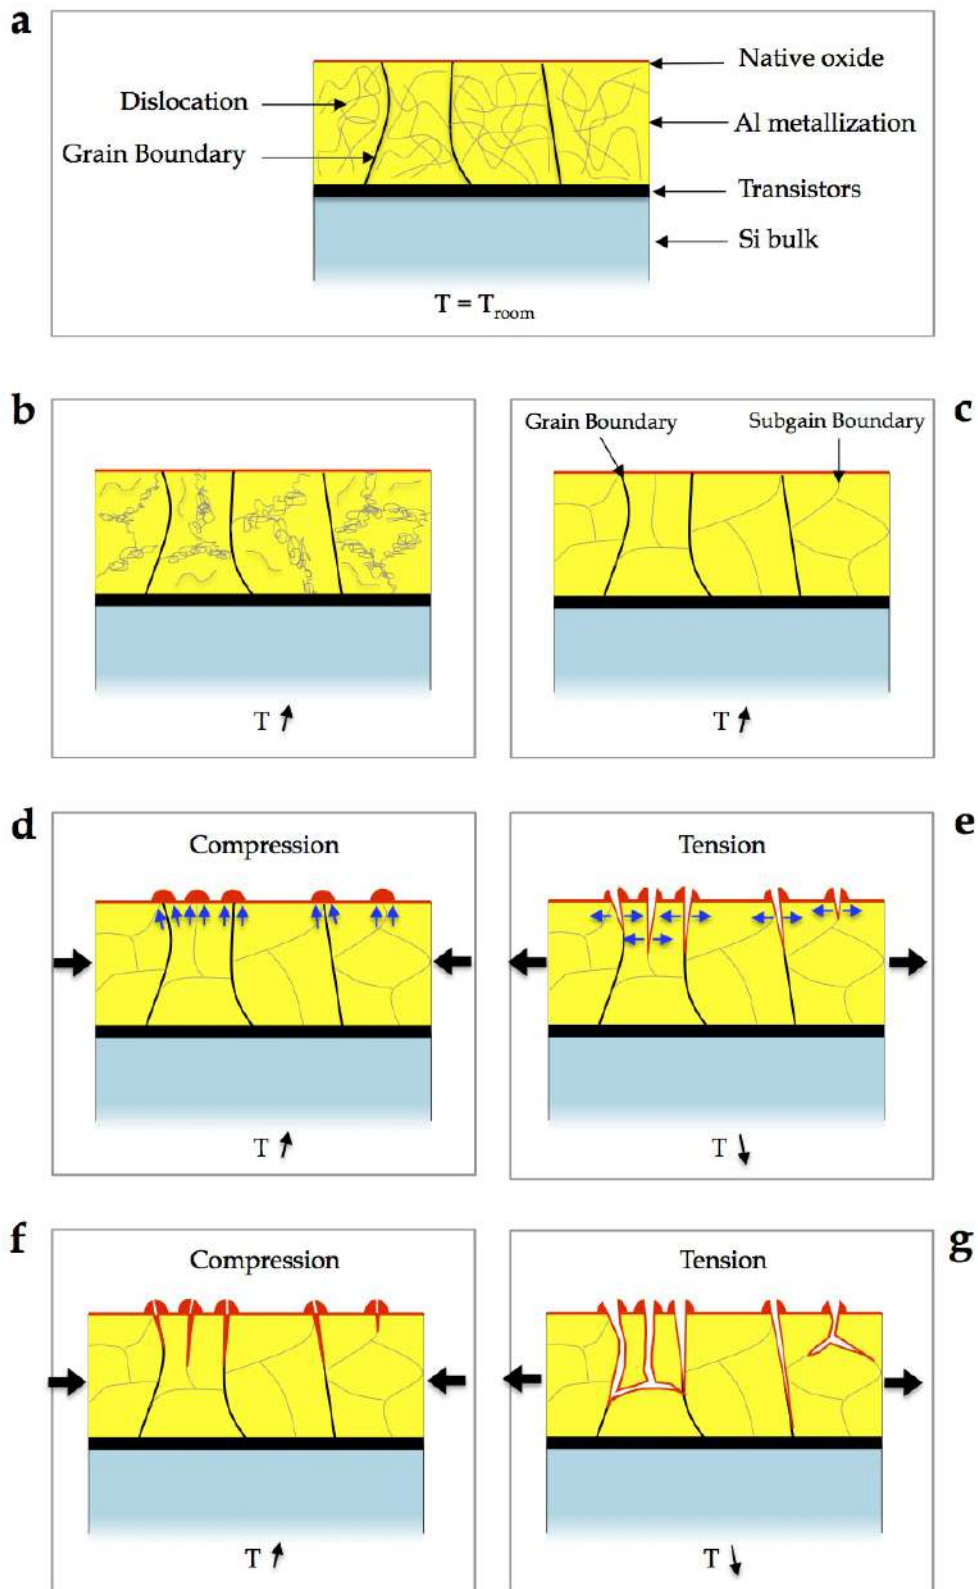
Figure 125: Gao's model extended to Al layers undergoing tension and compression stresses during thermal cycles [Mar14]. (a-c) The dislocation density decreases by recombination in sub grain boundaries and absorption at GB interfaces. (d-g) Al diffusion along grain boundaries, and subsequent oxidation causing crack propagation through the Al layer.

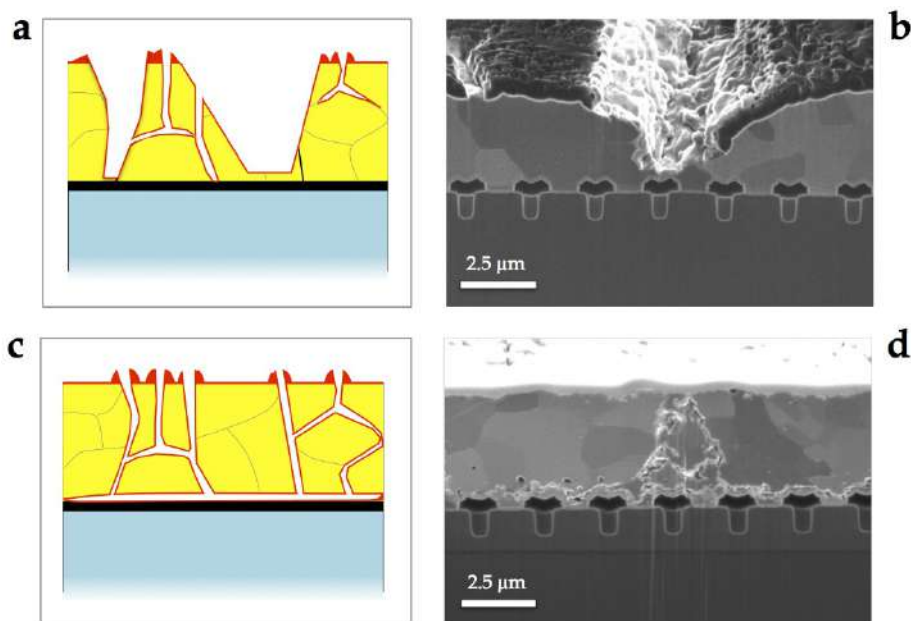
Figure 126: Crack propagation models through the Al layer at failure. (a) For SPD06 power modules at the final aging stage until failure, fatigue cracks running from the surface along the grain boundaries become broader and broader. (b) SIM cross-sectional image of the cracked metal in a failed SPD06, showing a crack width on the same order of the metallization thickness. (c) In To7D17 failed power modules, finer vertical cracks branch out and propagate horizontally all along the MOSFETs region. (d) Relative SIM cross-sectional imaging from a 70°C aged module.

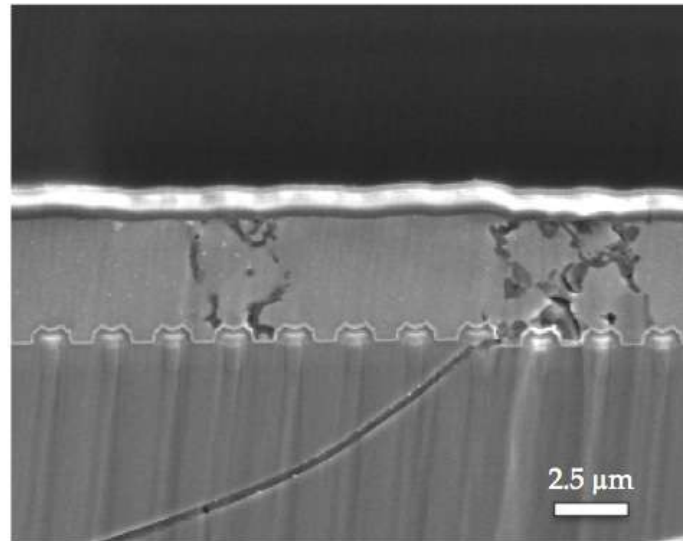
Figure 127: SEM cross-sectional image showing the whole metal-oxide-semiconductor crossed by cracks in a 70°C aged To7D17 module.

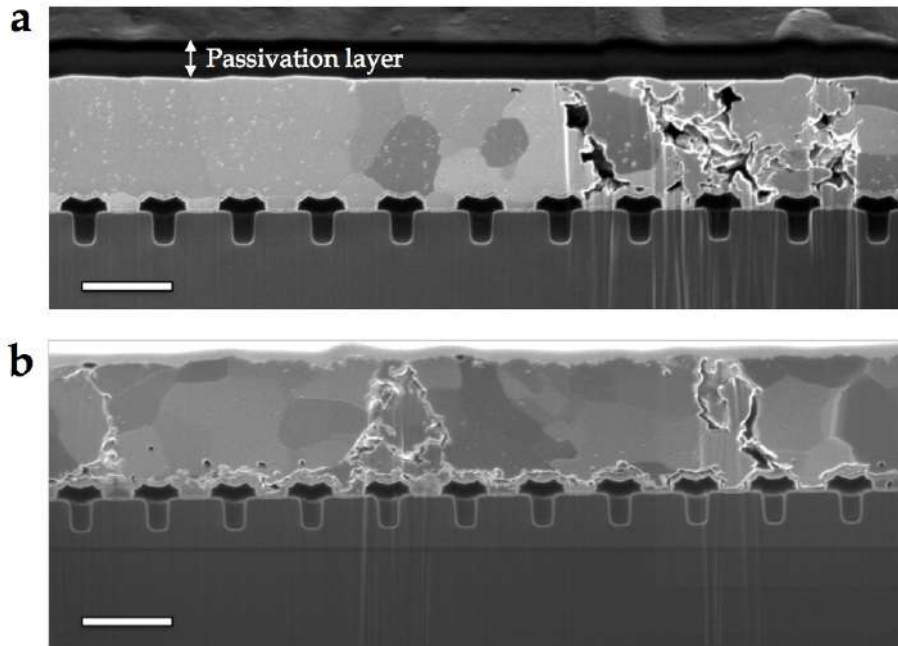
Figure 128: Cross-sectional SIM images of the (a) passivated and (b) bare Al source metallization, showing a localized propagation of vertical cracks in the first one and a generalized degradation in the second one, with horizontal cracks branching out all along the metal-transistor interface. Scale bar: $2.5\mu\text{m}$

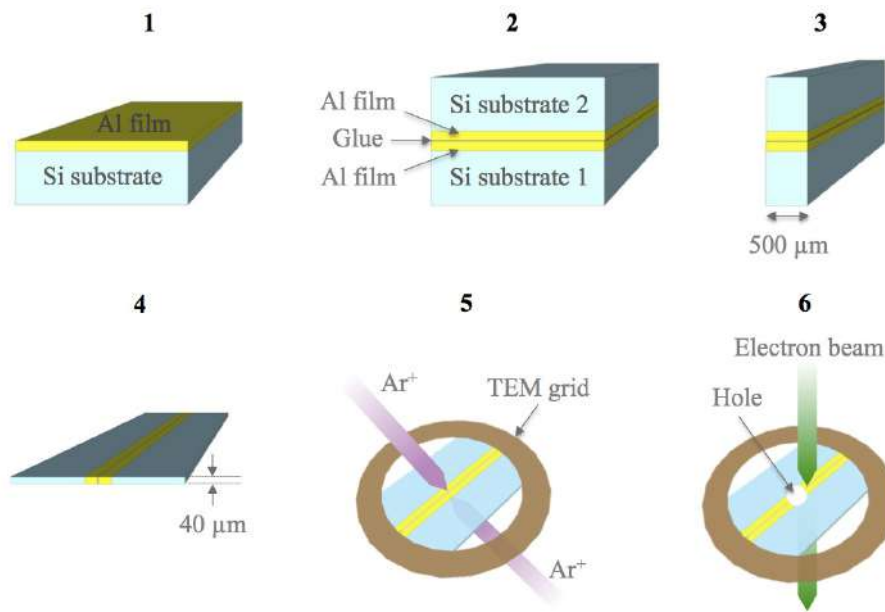
Figure 135: Sketch of the conventional TEM sample preparation procedure.
