Fatigue mechanisms in Al-based metallizations in power MOSFETs

THÈSE

DOCTORAT DE L'UNIVERSITÉ DE TOULOUSE

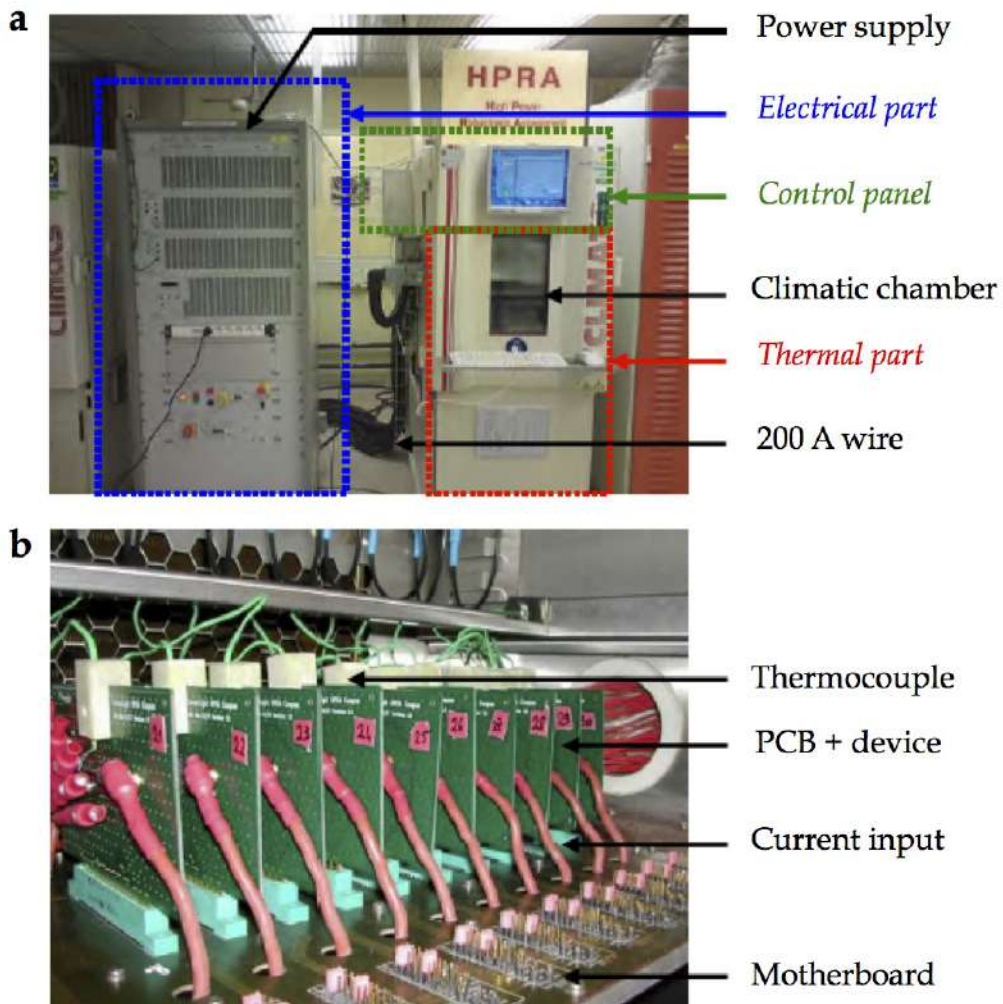
Figure 28: (a) Climats Sapratin Excal 2223-TE test bench at NXP Semiconductors. it consists in an electrical part (in blue), equipped with a 80 V, 200 A power supply and an active charge (5 - 200 A), a climatic chamber (-80°C - 180°C) containing the devices under test (in red), and a control panel (in green) with an electronic board that control the devices switching.

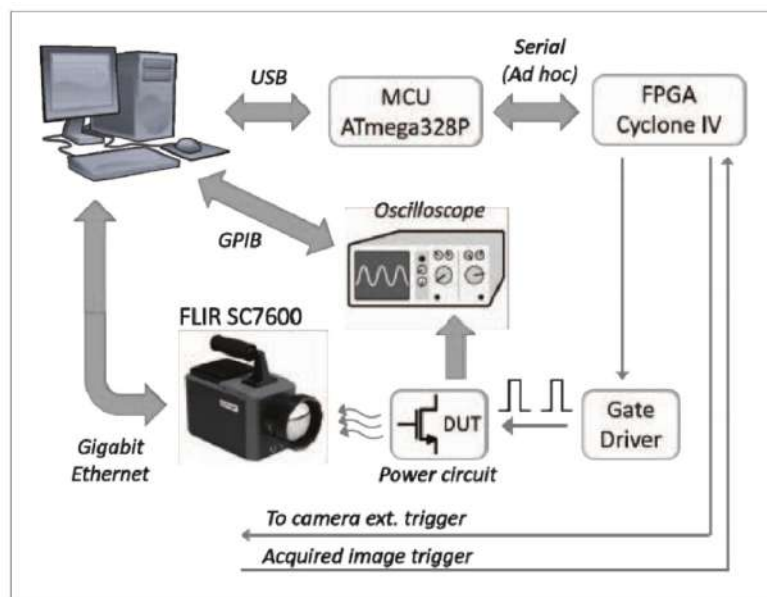
Figure 38: Schema of the IR setup showing the connections between the different parts of the system.

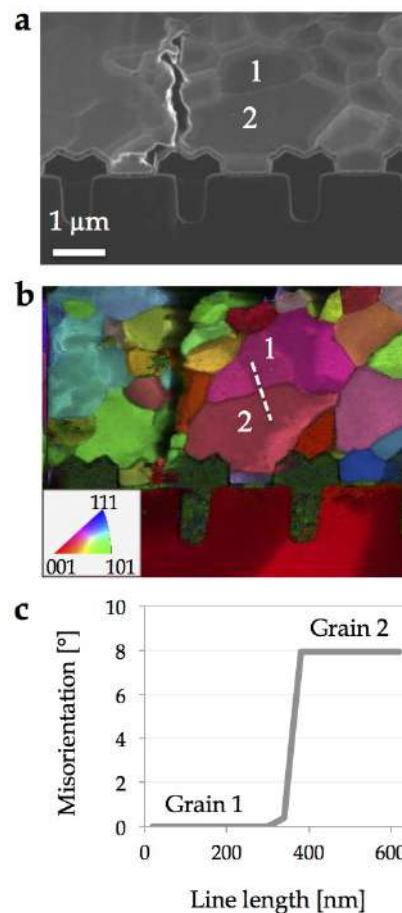
Figure 82: (a) FIB imaging and (b) ACOM orientation mapping of the source metal of an aged module (short circuit, 130k cycles) at the interface with the Si substrate. The standard stereographic triangle gives the color codes of the grain orientations, taken here along the horizontal direction. (c) The plot represents the misorientation between the grains 1 and 2 along the white line in b).

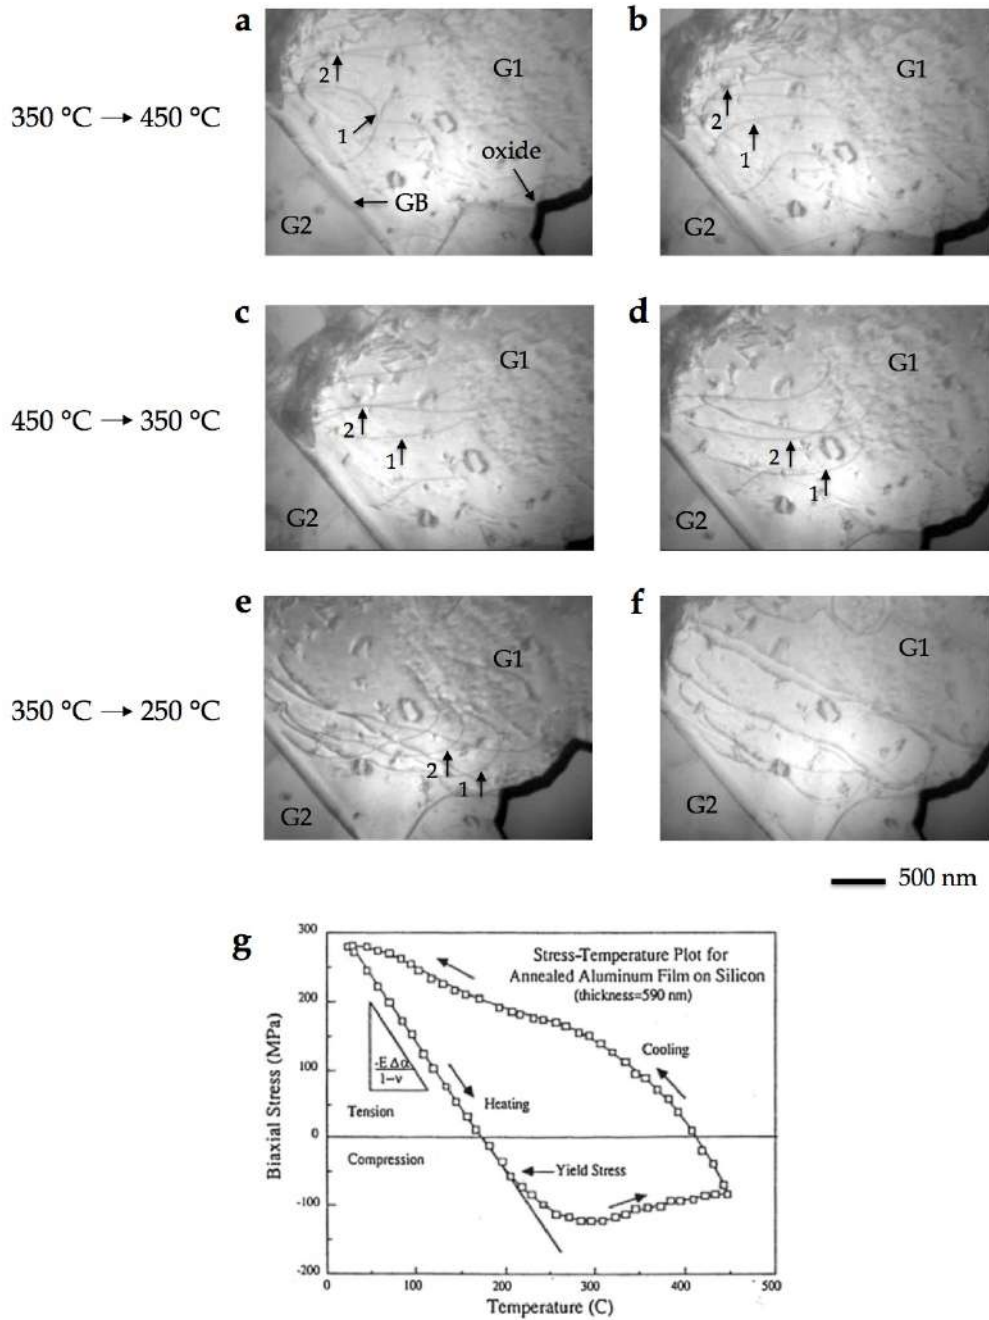
Figure 87: In situ TEM thermal cycling from 25 °C to 450 °C of a device cross-section prepared by tripod. The Si substrate is preserved, inducing a reversible motion, according to the stress inversion for a Al/Si substrate thin film in the stress-temperature curve [Fli87]. (a)-(b) are snapshots captured during the heating up phase from 350 °C to 450 °C, showing the dislocation activation. During the cooling down phase, the reversible motion is characterized by an initial dislocation straightening (c) followed by a bowing in the opposite direction (d), towards the oxide (d)-(e).

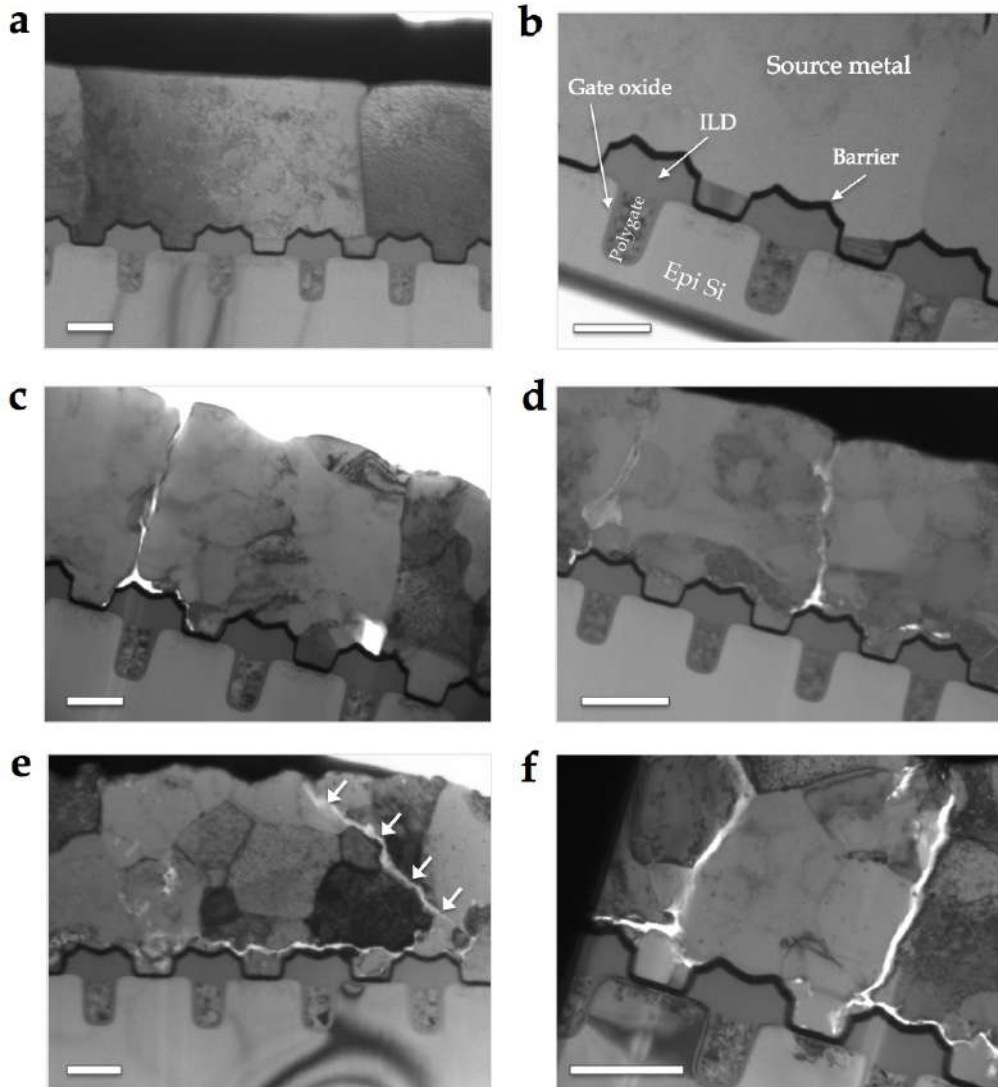
Figure 91: TEM images of some details of the transistor/metallization area from the naked metallization of an (a, b) as-is, (c, d) 25°C aged and (e, f) 70/degree C aged power modules. The trench MOSFET layered structure is described in (b) and consists in: source metal, inter-layer dielectric (ILD), gate oxide and polySi (Polygate), epitaxial Si. Scale bar: 1 μm .

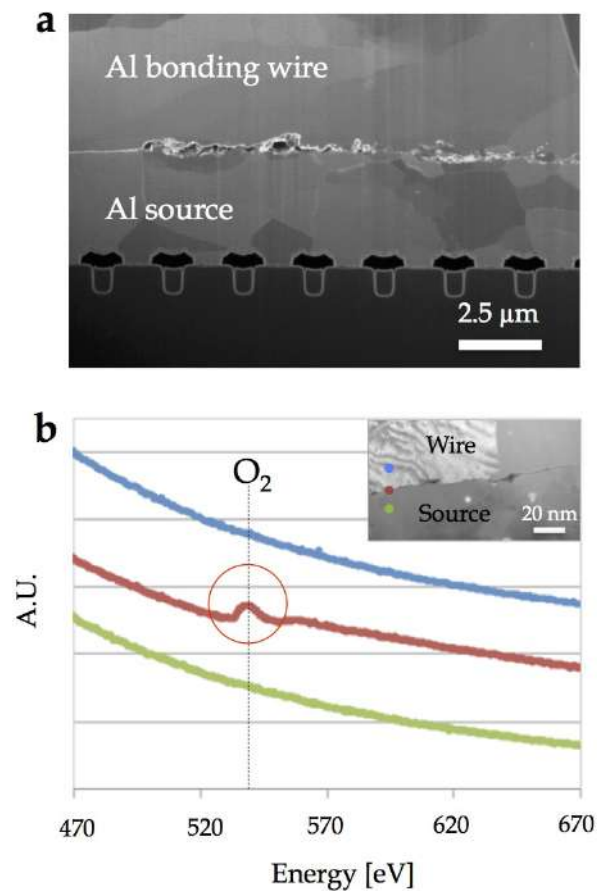
Figure 99: (a) SIM image of the initial artifacts which characterize the wire-metallization bonding of an as-is module. (b) EELS spectra from the wire (in blue), the metallization (in green) and the wire-metallization interface (in red). The red spectrum at the wire-metallization interface reveals the presence of oxygen.

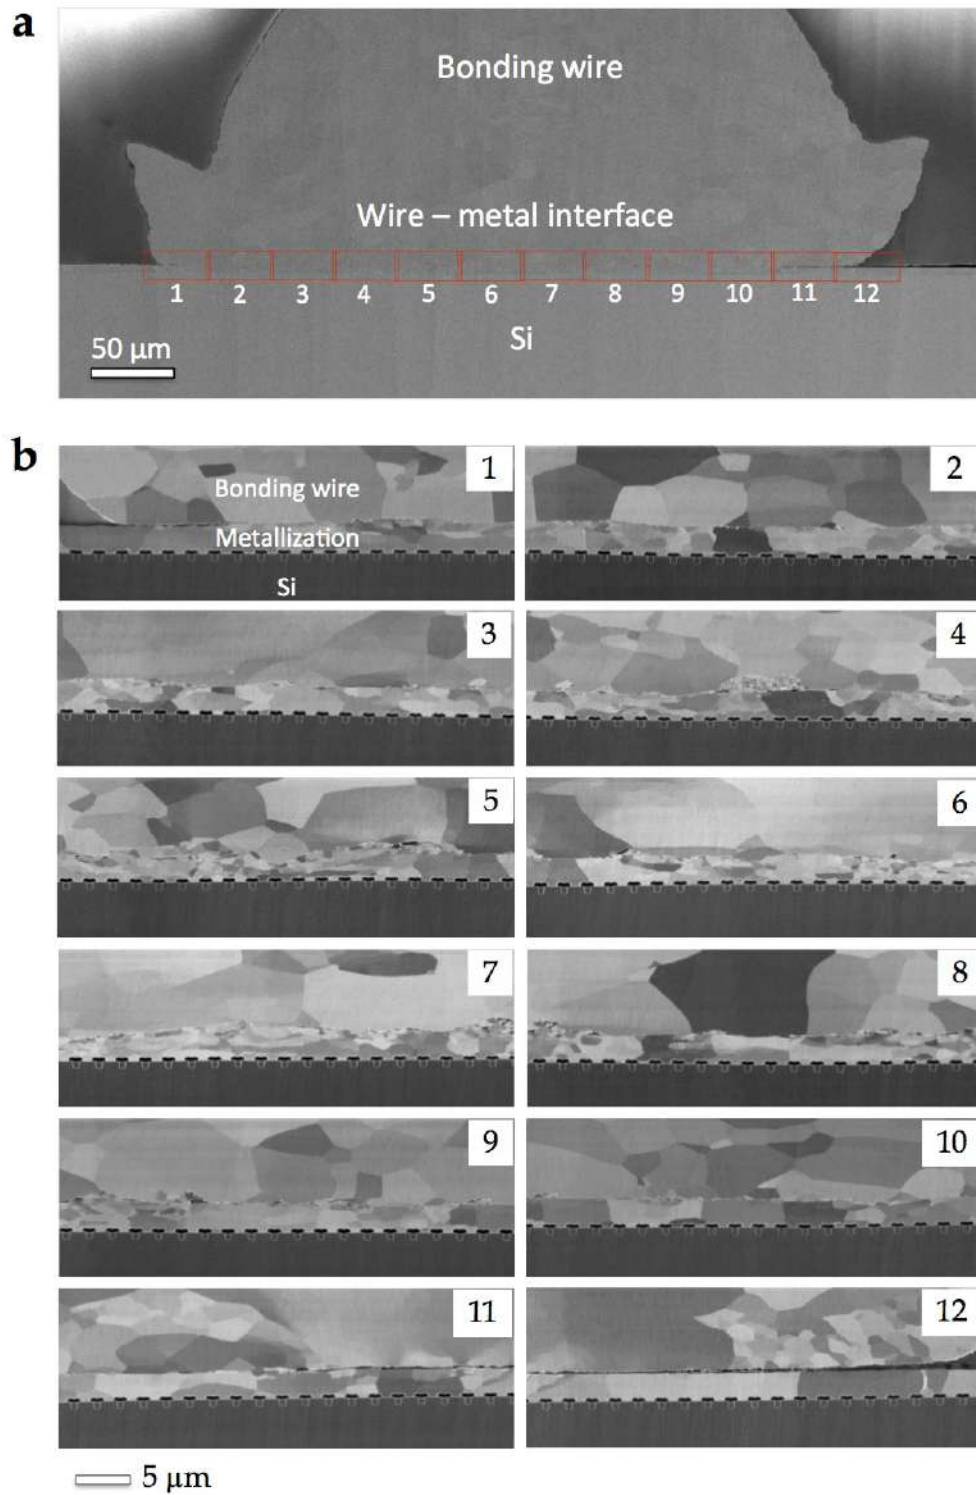
Figure 108: (b) SIM images mosaicing of the whole wire-metallization cross-section prepared by cross-polisher, according to the schema in (a). The images sequence offers a global vision of the metallization grain structure under the bonding wire and of the wire metallization interface. It can be used to calculate the total amount of deformed area due to the bonding process.

Figure 107: SEM image of a cross-section prepared by Cross Polisher system in an as-is module. The large cut area shows the power die layered structure: Al wire, Si bulk and Cu heat sink. The Al source metallization on the transistor area, at interface with the semiconductor, is not visible at this scale. The red area indicates the location of the Al wire-metallization interface that is shown in detail in Fig. 108a - n.

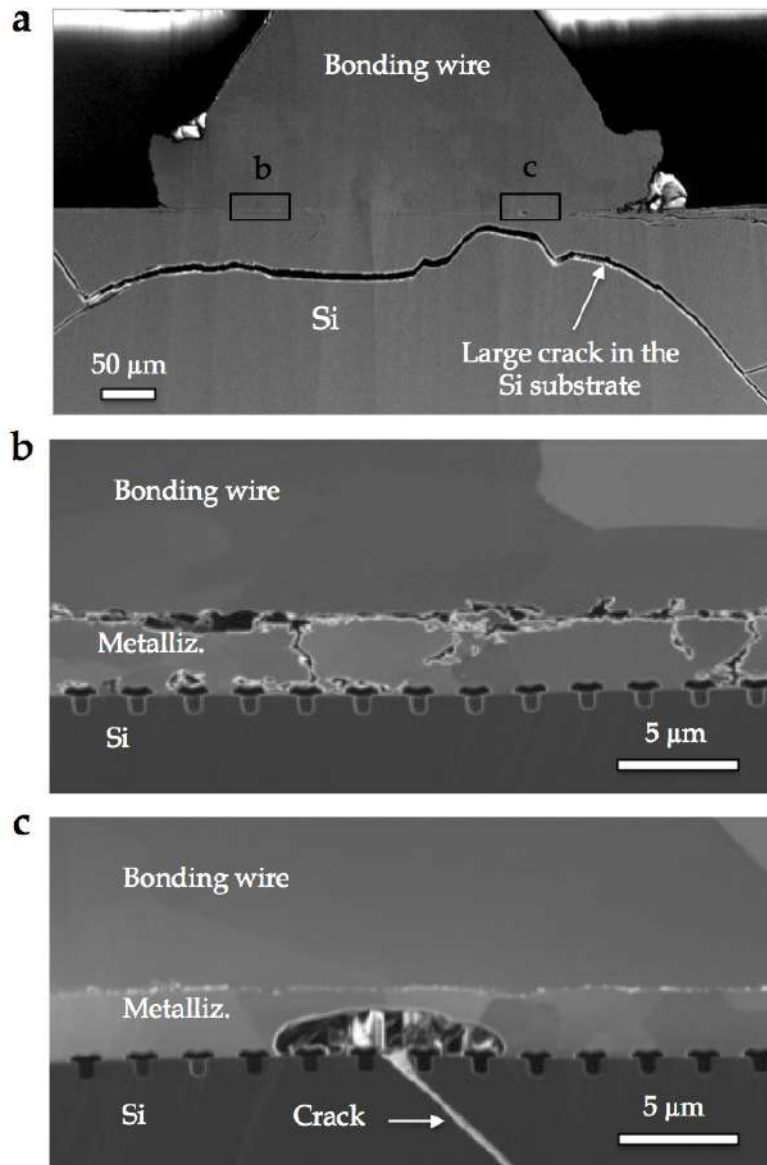
Figure 110: (a) SEM cross-sectional imaging of the bonding wire from an aged power module (70 °C aged) showing different types of cracks; (b), (c) ionic higher magnification images of the wire- metallization interface located in the boxes (b) and (c) in (a). The die crack resulted from an electro-thermal event occurring at failure time.

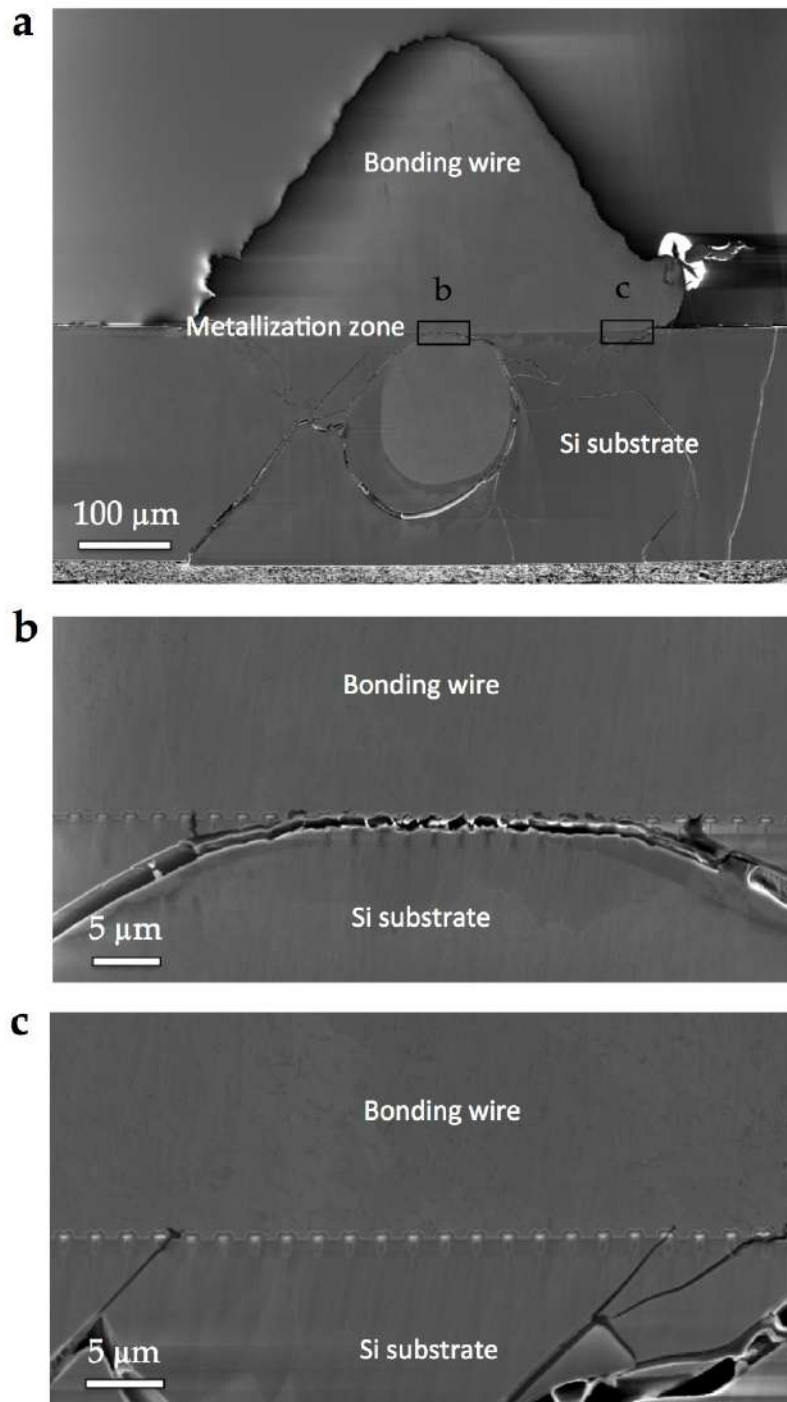
Figure 114: (a) SEM cross-sectional imaging of the bonding wire from an aged power module (25 °C aged) showing different types of cracks; (b), (c) higher magnification images of the wire- metallization interface located in the boxes (b) and (c) in (a). The die crack resulted from an electro-thermal event occurring at failure time.

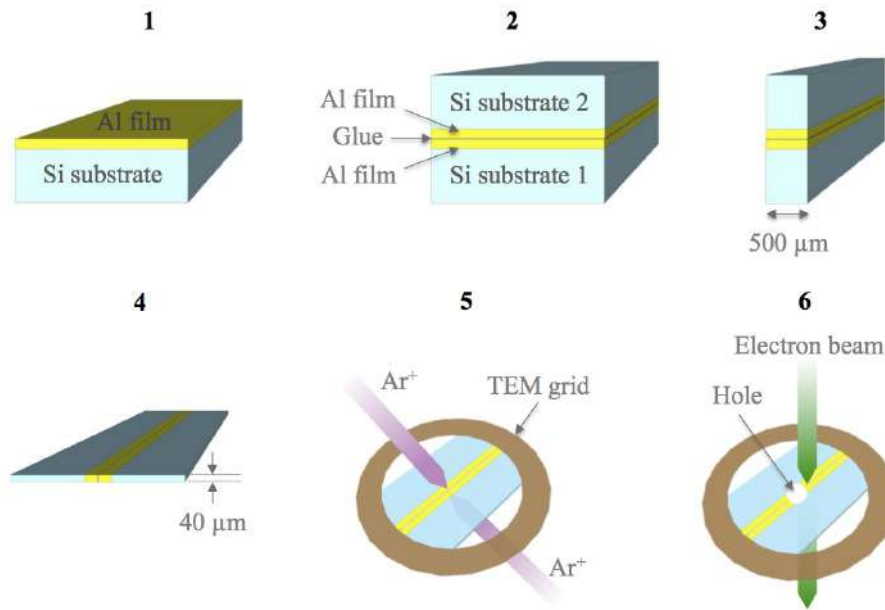
Figure 135: Sketch of the conventional TEM sample preparation procedure.
