Fatigue mechanisms in Al-based metallizations in power MOSFETs

Roberta Ruffilli. Fatigue mechanisms in Al-based metallizations in power MOSFETs. Material chemistry. Université Paul Sabatier - Toulouse III, 2017. English. NNT : 2017TOU30256 . tel-01666437v3

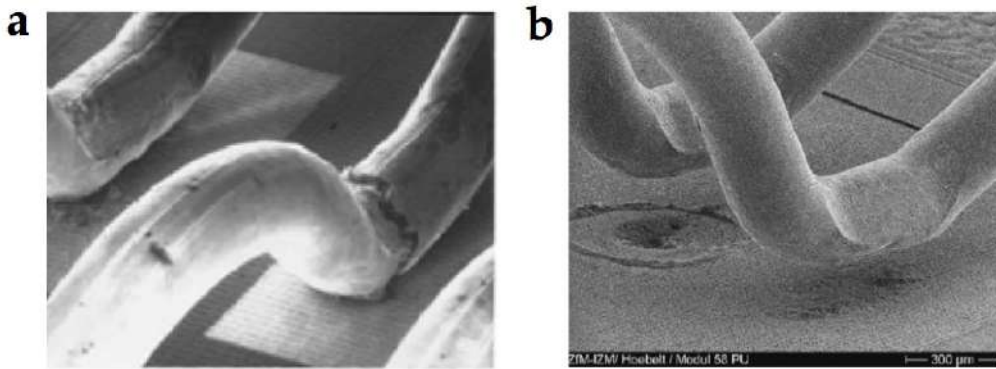
Figure 21: Examples of bond failures in power components: (a) heel crack failure [Ciao2] and (b) wire lift-off [Den17].

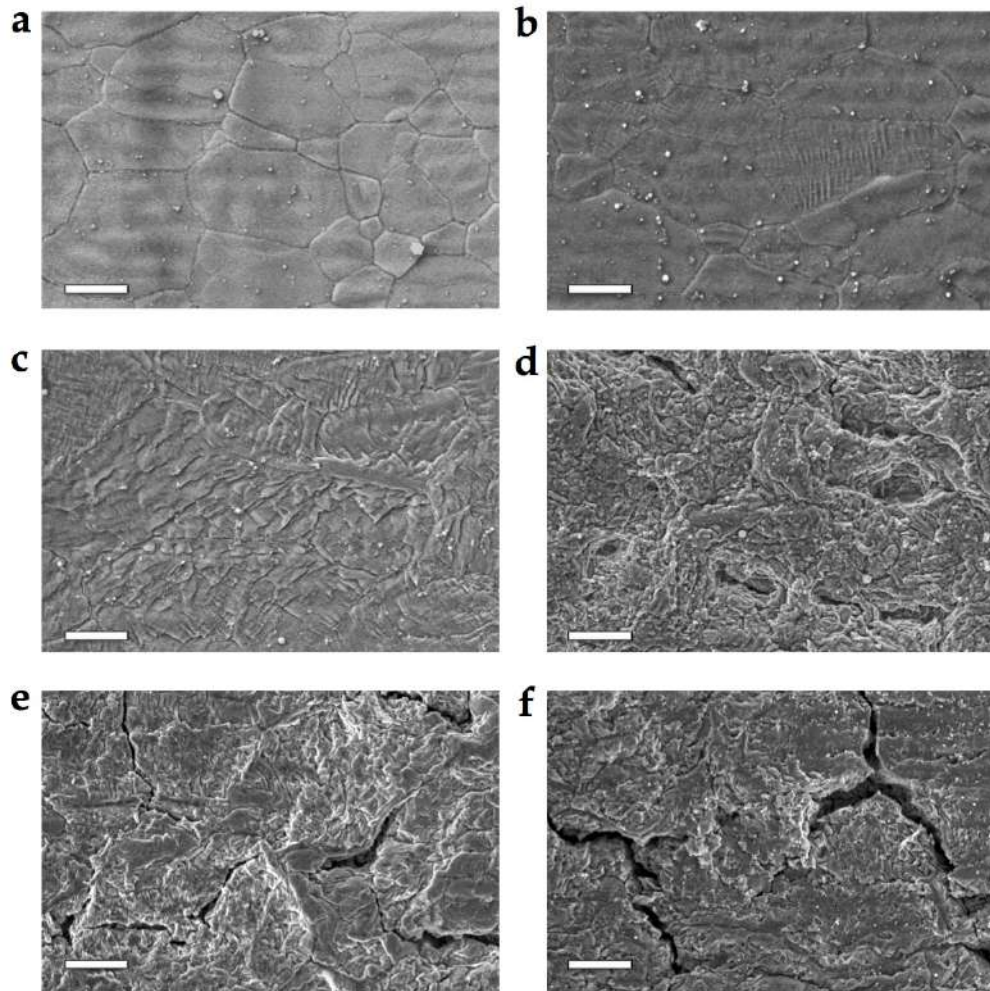
Figure 77: Top view SEM images showing the evolution of the Al source metallization surface. Grain structure (a) before starting the accelerated aging and after (b) 1 kcycles, (c) 10 kcycles, (d) 100 kcycles, (e) 200 kcycles and (f) 300 kcycles. Scale bar 5 μm .

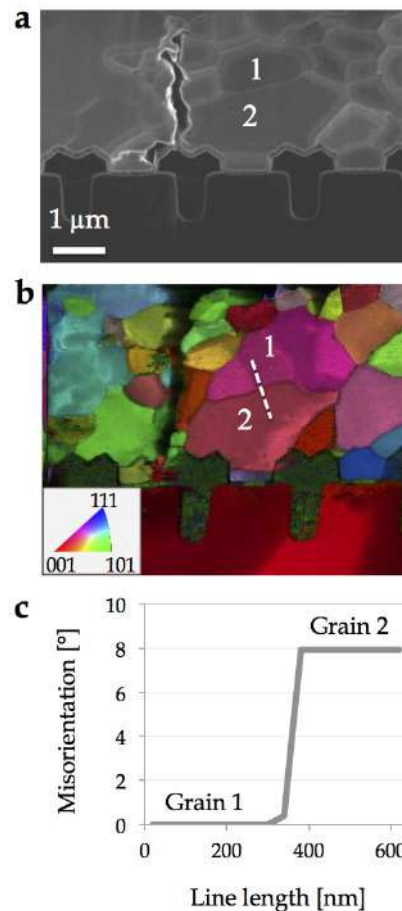
Figure 82: (a) FIB imaging and (b) ACOM orientation mapping of the source metal of an aged module (short circuit, 130k cycles) at the interface with the Si substrate. The standard stereographic triangle gives the color codes of the grain orientations, taken here along the horizontal direction. (c) The plot represents the misorientation between the grains 1 and 2 along the white line in b).
