Mécanismes de fragilisation de l'acier inoxydable super-martensitique X4CrNi16-4 Virgo™38 : Effets couplés des traitements thermiques et des milieux corrosifs contenant Na₂S ou H₂S

THESE de DOCTORAT DE L'UNIVERSITE DE LYON
opérée au sein de
l'Ecole des Mines de Saint-Etienne

**Mécanismes de fragilisation de l'acier
inoxydable super-martensitique
X4CrNi16-4 Virgo™38 :
Effets couplés des traitements
thermiques et des milieux corrosifs
contenant Na₂S ou H₂S**

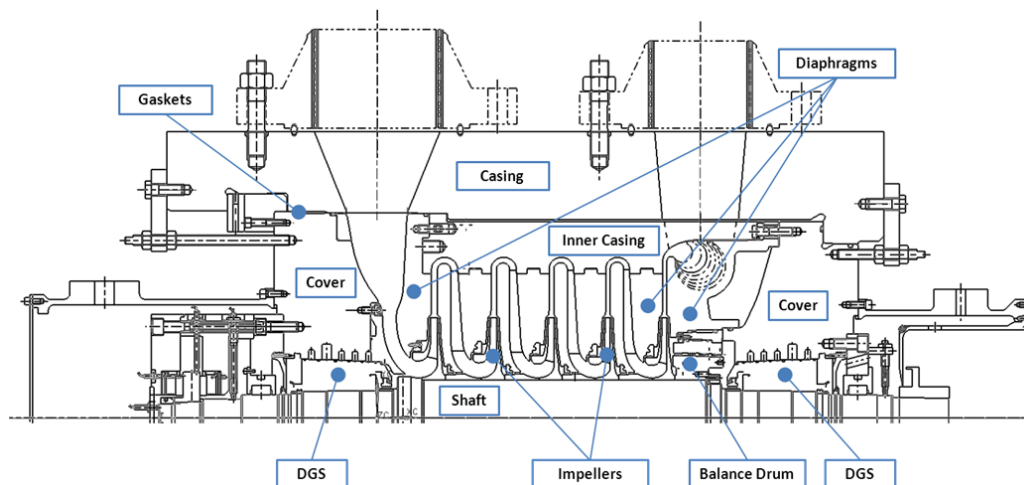
Figure 1 - Cross section of a centrifugal compressor used for oil and gas applications

This work was initially motivated by a case of environmentally assisted damage of centrifugal compressor impellers working in sour environments containing CO_2 and H_2S . Centrifugal compressors are turbomachineries with one or several compression stages in one machine. The number of stages is adapted to the targeted compression ratio. The domain of application of these compressors is very large: they are used to compress any gas with a flux between 200 and 200 000 m^3/h and the exit pressure can reach 700 bars (100 000 m^3/h and 250 bars maximum for compressor produced in Le Creusot). Centrifugal compressors impellers' are in series in a rotating shaft, and an impeller is feed by the exit of the previous impeller as shown on the cross section presented in Figure 1.

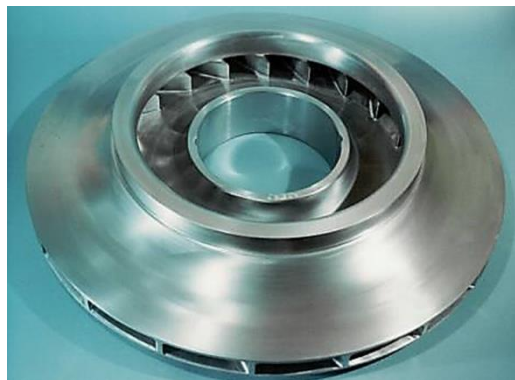
The gas to be compressed enters in the centrifugal compressor impeller (Figure 2) by the "eye" of the impeller to flow within the passages created by the blades. As the impeller rotates at high velocity, the gas gains momentum during its flow across the blades, and at the exit of the impeller, the gas passes into a stationary diffuser, where it decelerates, its dynamic pressure being converted into static pressure.

Figure 2 - Centrifugal compressor impeller

Le gaz devant être compressé entre dans la roue par un orifice appelé « œil » de la roue et s'écoule au travers des pales (Figure 2). La rotation rapide de la roue entraîne un gain de moment du gaz lors de son passage et, à la sortie de la roue, le gaz est envoyé dans un diffuseur stationnaire ayant pour but de décroître sa vitesse pour augmenter sa pression dynamique en pression statique.

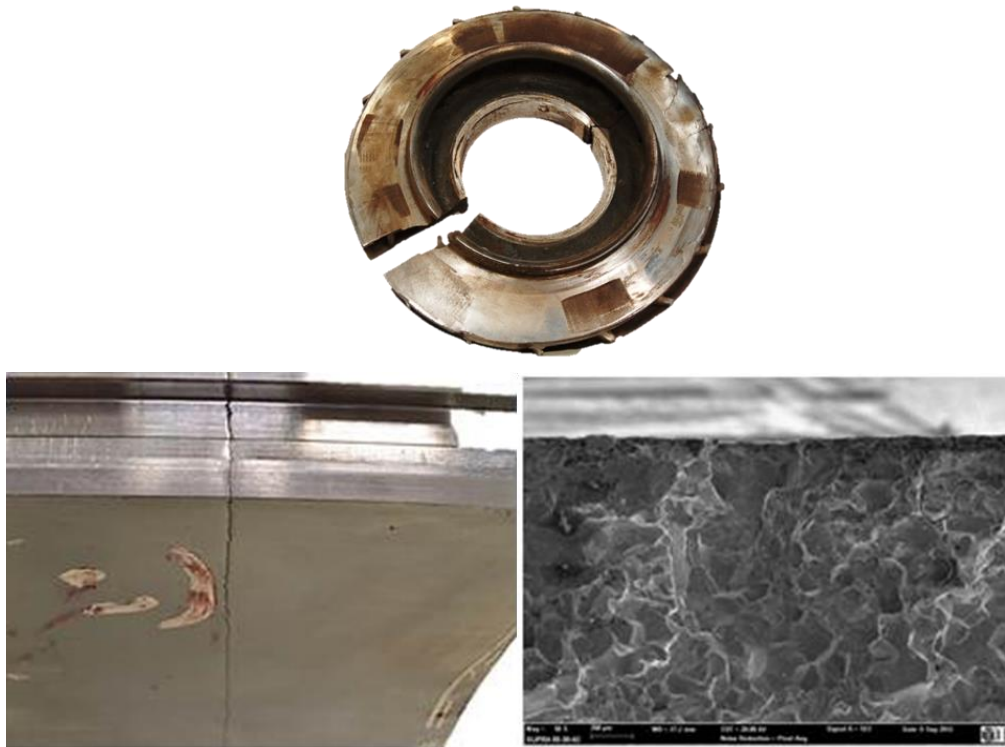
Figure 3 - Radial intergranular failure observed on Virgo™38 impeller and intergranular crack on a static component made of Virgo™38 used for oil and gas applications

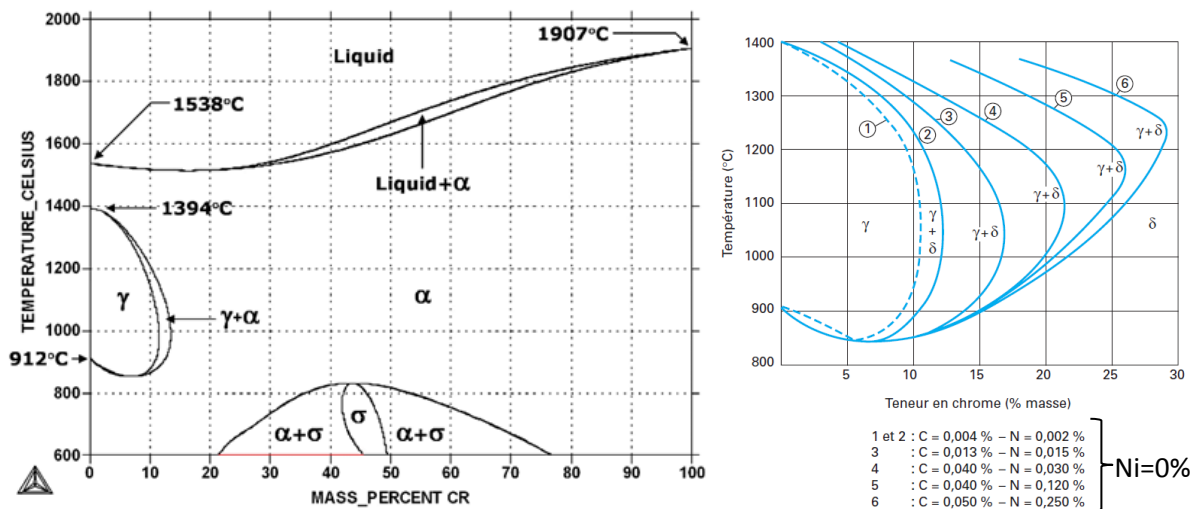
Figure 5 (a) and (b) - Fe-Cr diagram: influence of C and N on the γ -loop [13]

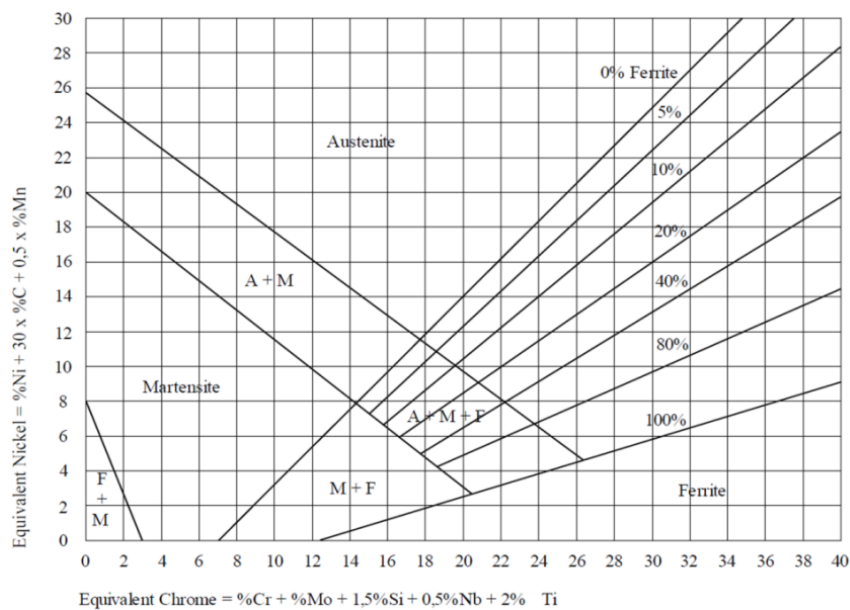
Figure 11 - Schaeffler diagram [18]

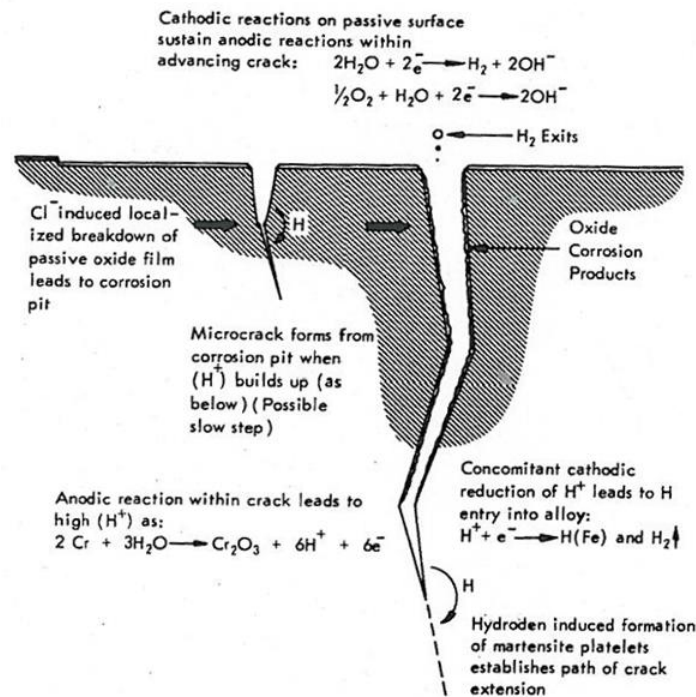
Figure 20 - Mechanism proposed by Rhodes showing crack initiation by pitting and modification of the pH deep down into pits and cracks [51]

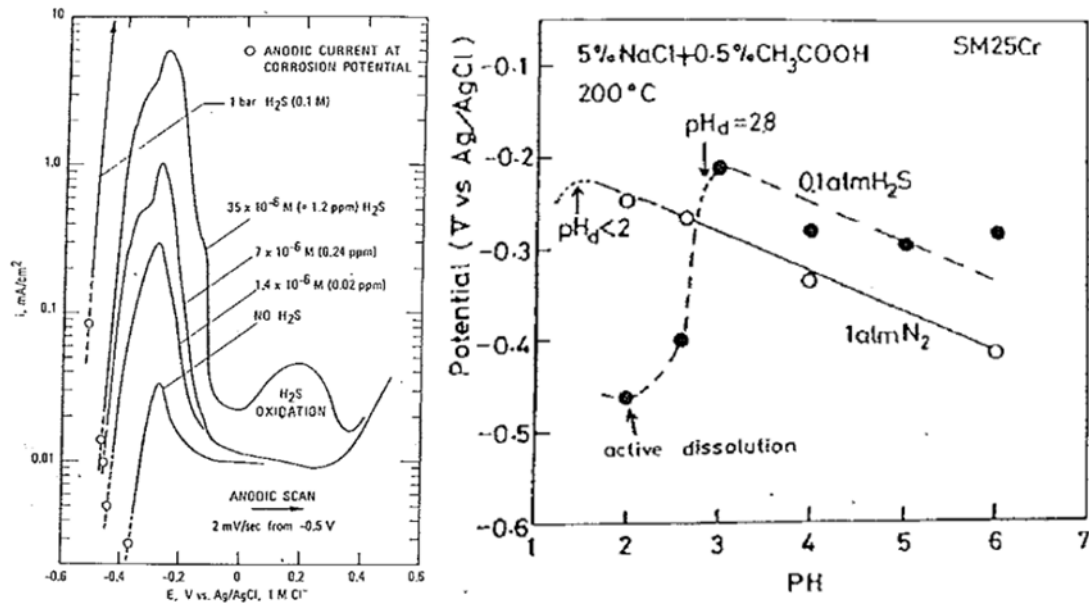
Figure 24 - Influence of H₂S content on the anodic dissolution (left [57]) and influence of its presence on the depassivation pH (pH_d) (right [58])

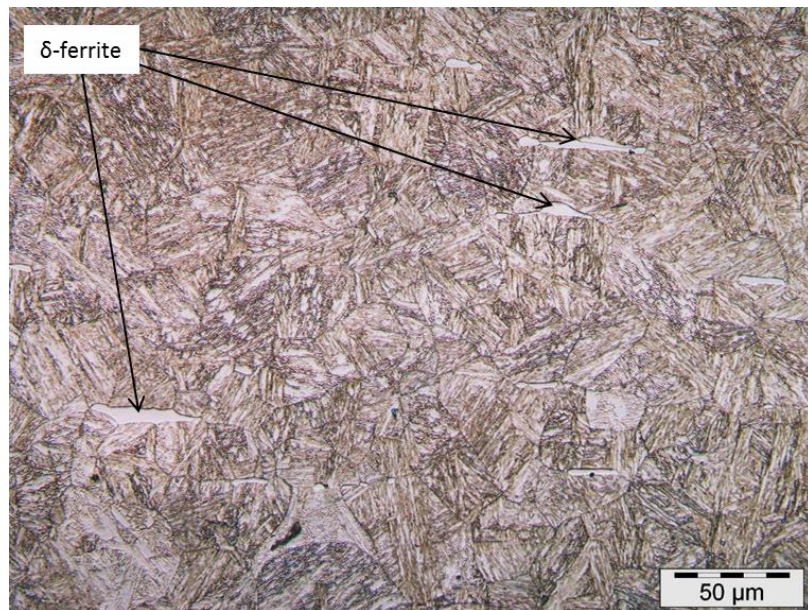
Figure 41 - Optical micrograph of Virgo™38 (sub-zero quenched and double tempered state) after electro-polishing and Vilella's etching: lath structure inside prior austenitic grains and δ -ferrite (<5%)

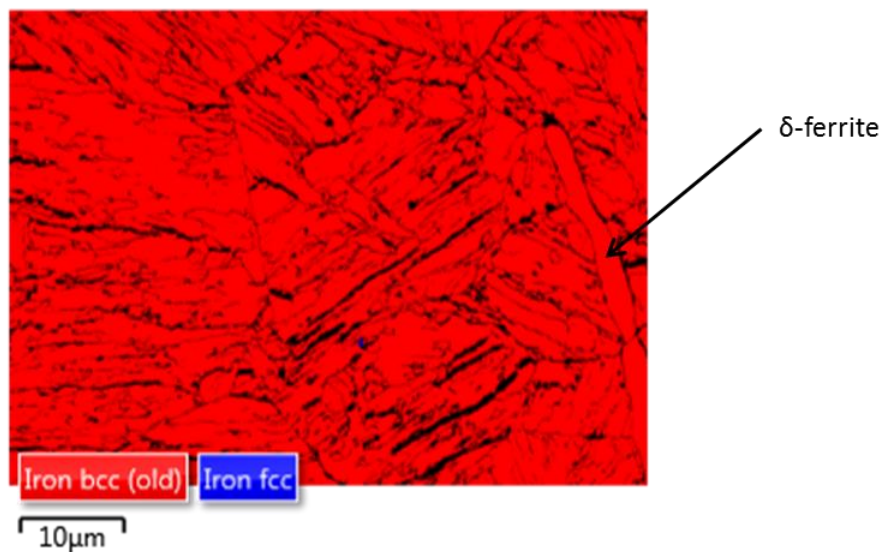
Figure 48 - EBSD phases map of re-austenitized and oil quenched sample showing martensite lathes, δ -ferrite and potentially residual austenite. Non-indexed areas (large dark areas) can potentially be attributed to the presence of another phase (FCC?)

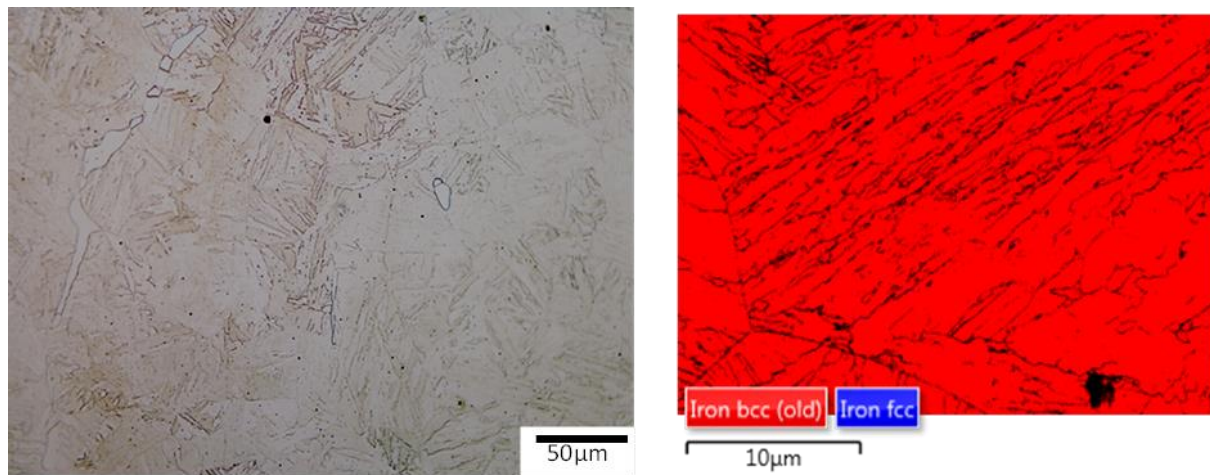
Figure 50 - Optical microscopy (Villela's etching) and EBSD phase map of re-austenitized, oil quenched and sub-zero treated microstructure

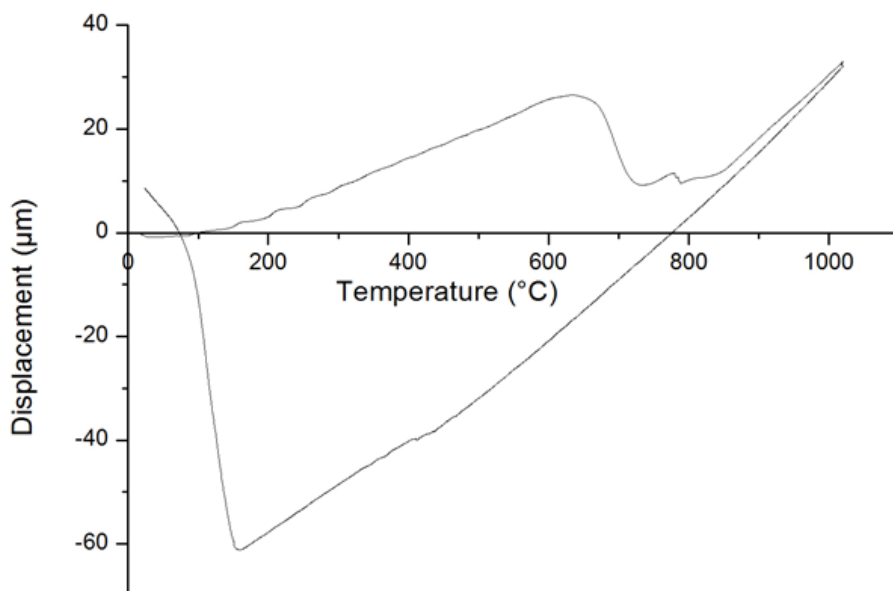
Figure 53 - Dilatometric measurements on Virgo™38 after re-austenitization at high temperature, oil-quenching and sub-zero treatment

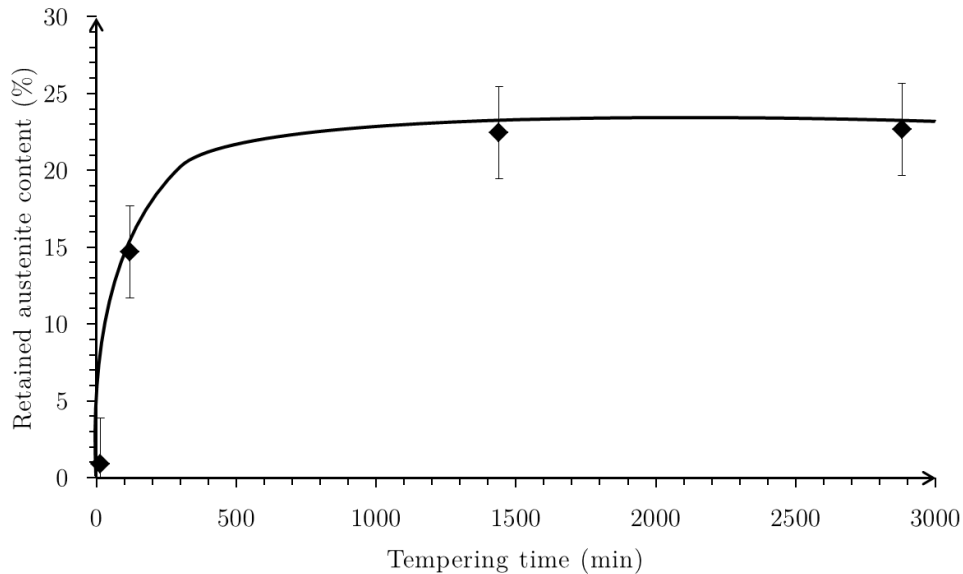
Figure 58 - Evolution of the retained austenite fraction measured by XRD after air cooling as a function of tempering holding time for a tempering temperature of 620°C

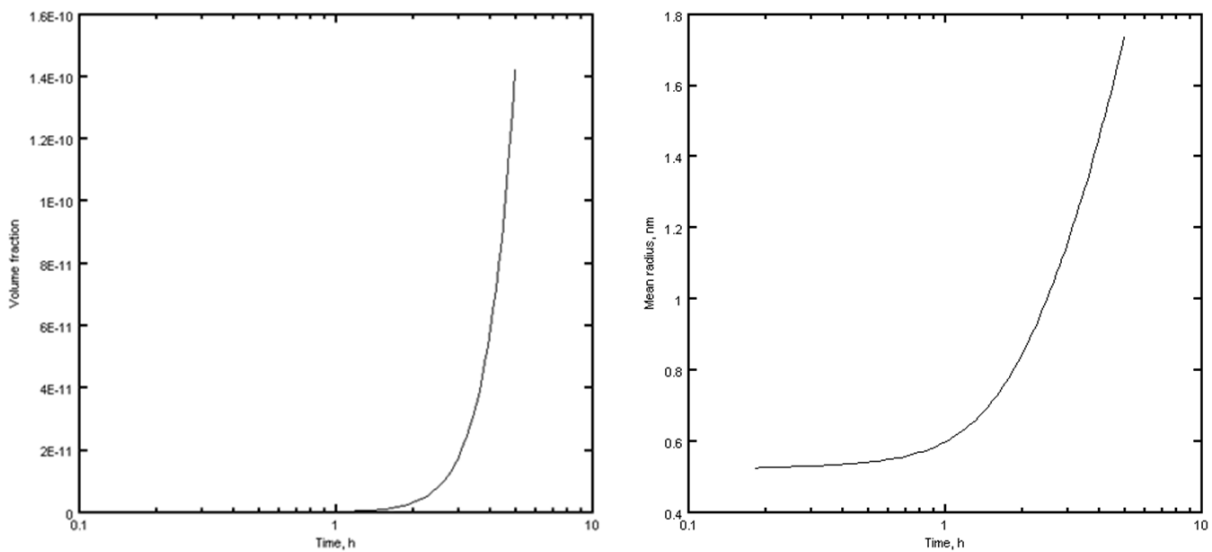
Figure 61 - Results of the Prisma simulations in retained austenite at 620°C showing: a) volume fraction vs time and b) mean radius vs time

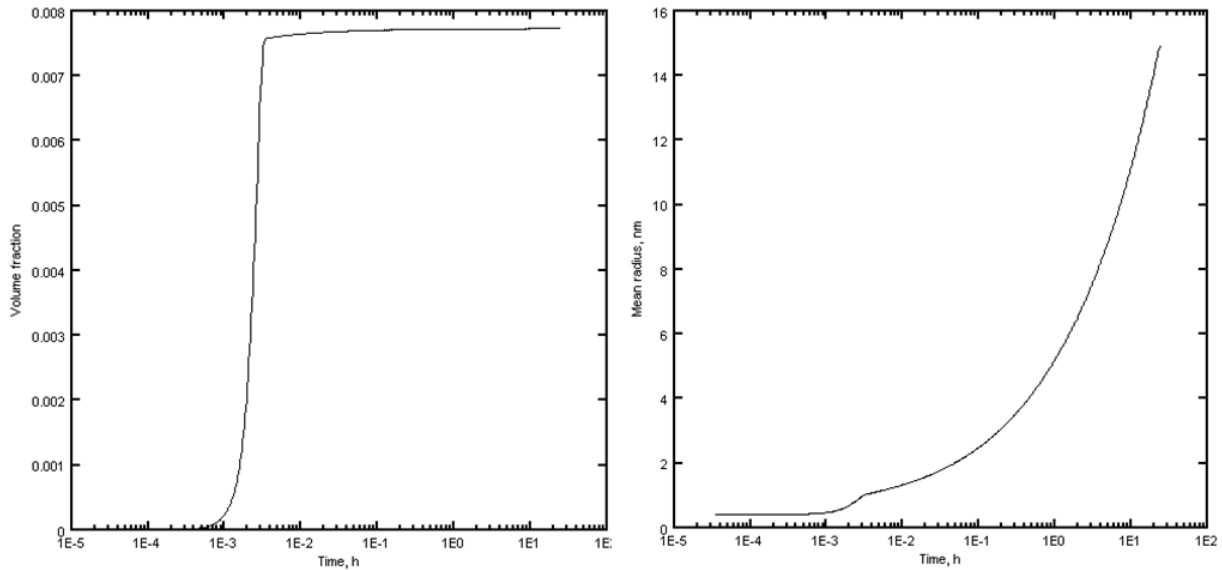
Figure 62 - Results of the Prisma simulations in the BCC phase at 620°C showing: a) volume fraction vs time and b) mean radius vs time

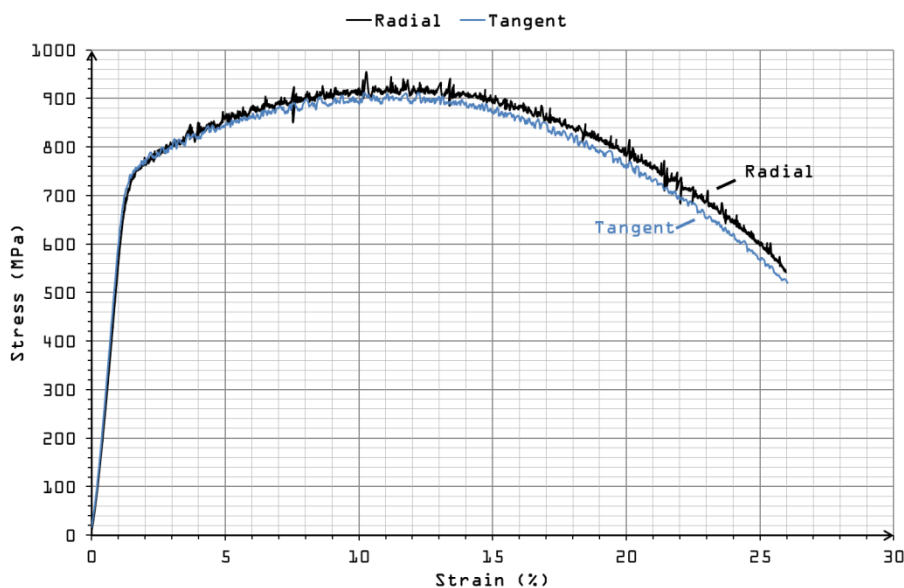
Figure 67 - Tensile curves of Virgo™38 for radial and tangential sample orientation (air, 10^{-5} s^{-1})

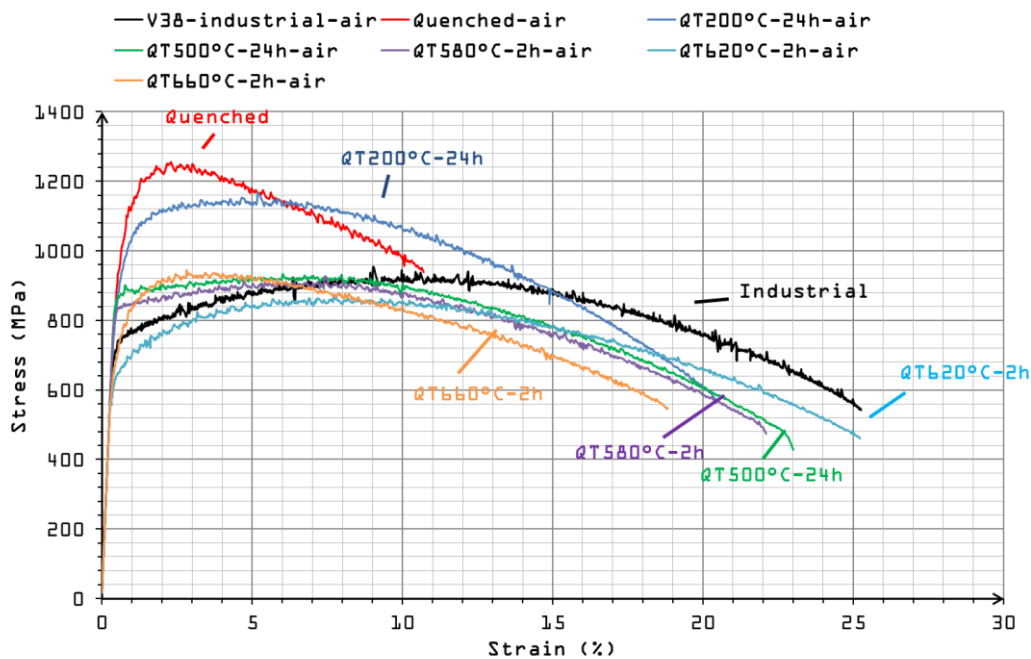
Figure 68 - Tensile curves of Virgo™38 after different heat treatments (air, strain rate of $10^{-5} s^{-1}$)

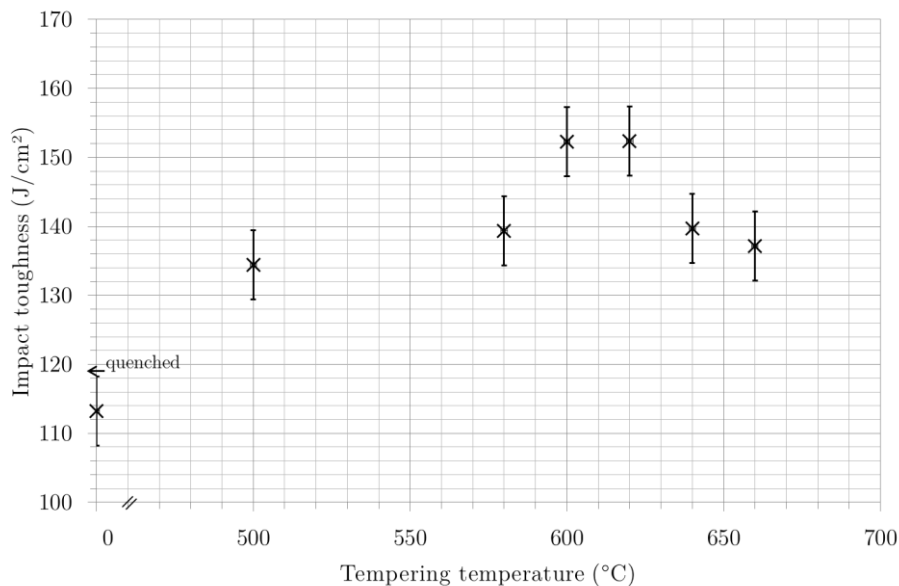
Figure 70 - Charpy impact toughness measured at room temperature for different heat treatment showing the highest impact toughness for high retained austenite content

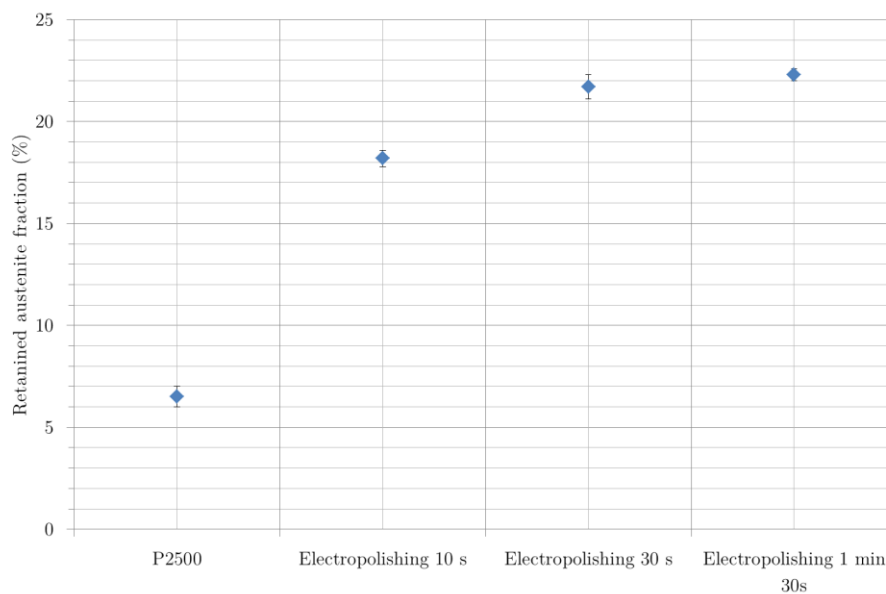
Figure 75 - Influence of the metallographic preparation on the retained austenite content measured by X-Ray Diffraction

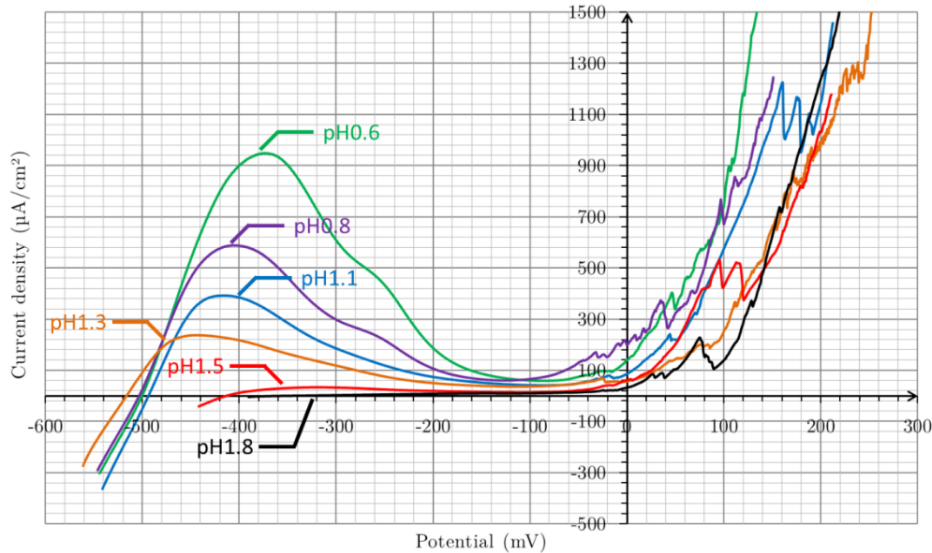
Figure 78 - Potentiodynamic measurements performed at different pH without mechanical loading on Virgo™38 at industrial state ($\alpha'' + \gamma_R$ phases) in 30g/l NaCl + 0.4g/L NaCH₃COO solution acidified with HCl

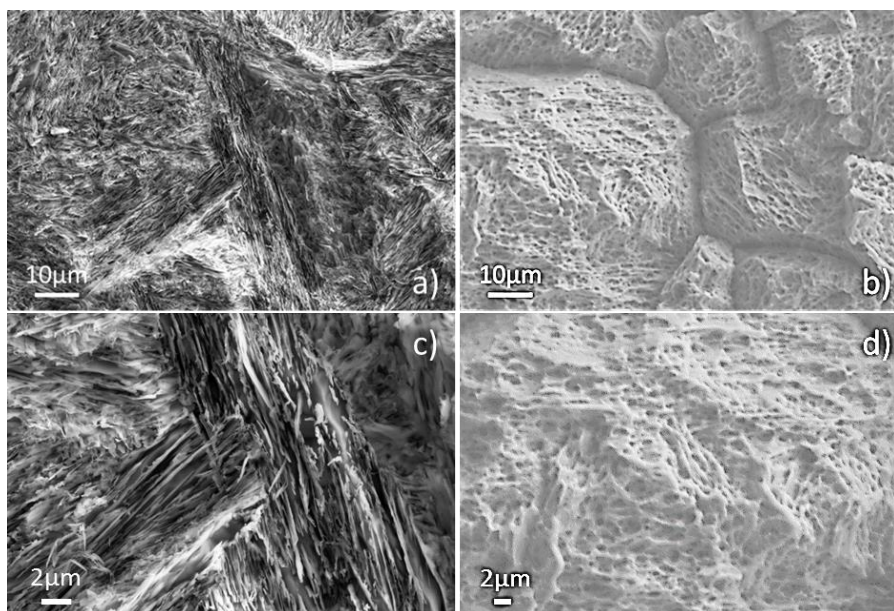
Figure 79 - SEM micrographs after preferential dissolution test in the solution at pH=0.6: a) and c) 24h at -400mV/SCE showing the dissolution of α'' and b) and d) 24h at -280mV/SCE showing the dissolution of γ

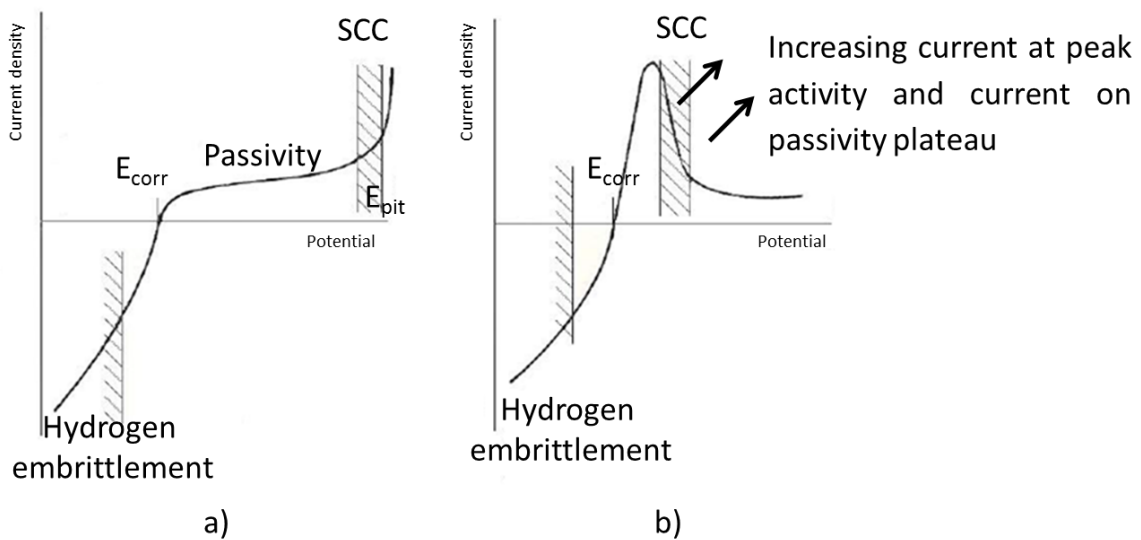
Figure 94 - Domains where SCC and HE are predominant in stainless steels (adapted from [139])
 a) Passive alloy in an environment where $\text{pH} > \text{pH}_0$
 b) System with loss of passivity (for $\text{pH} < \text{pH}_0$)

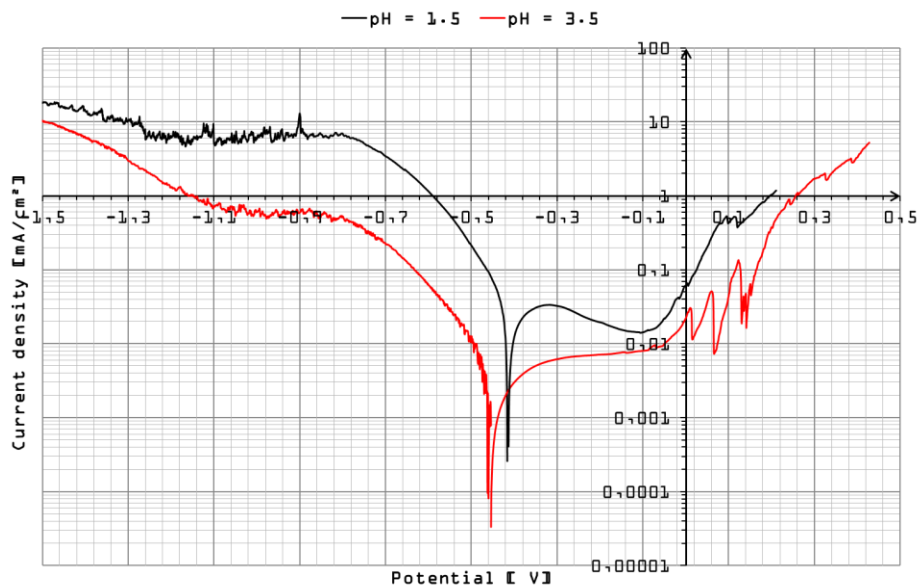
Figure 100 - Polarization curves at 1mV/s in both solutions (pH=1.5 and 3.5) showing a large cathodic domain

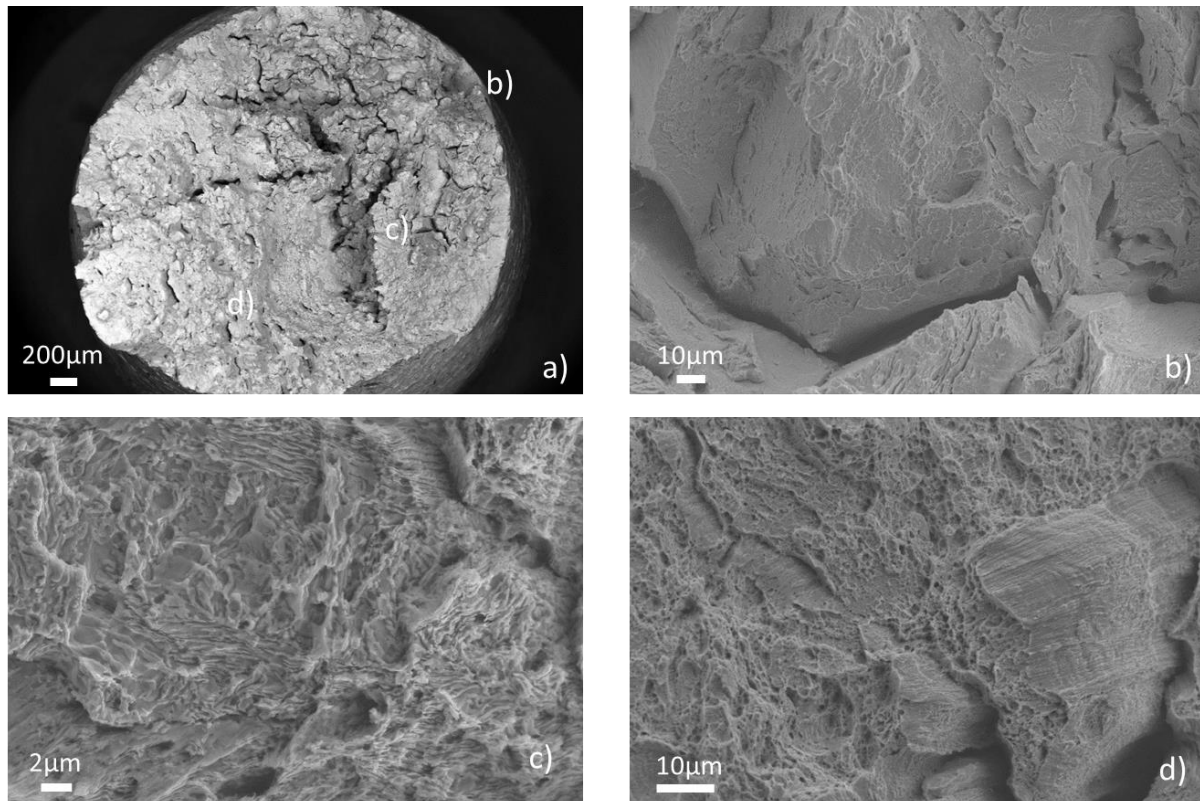
Figure 103 - Fracture surface of Virgo™38 after SSRT test at a strain rate of 10^{-6}s^{-1} and under cathodic charging at -1200mV/SCE in a solution containing 30g/L NaCl at $\text{pH}=3.5$ (adjusted with acetic acid) purged with N_2

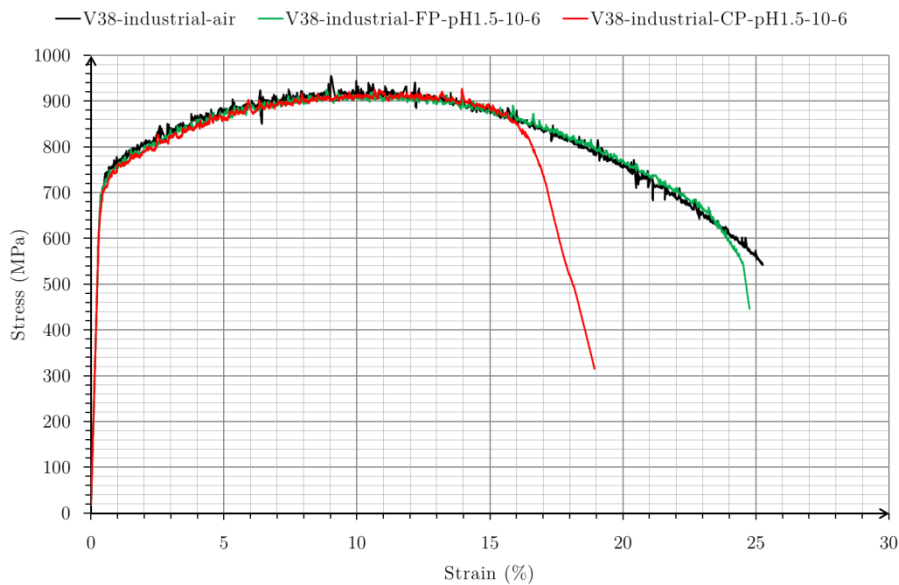
Figure 105 - Tensile curves of Virgo™38 tested at a strain rate of 10^{-6}s^{-1} under open circuit potential (FP, green curve) and cathodic charging at -1200mV/SCE (CP, red curve) in a solution containing $30\text{g/L NaCl} + 0.4\text{g/L}$ sodium acetate at $\text{pH}=1.5$ (adjusted with HCl) purged with CO_2

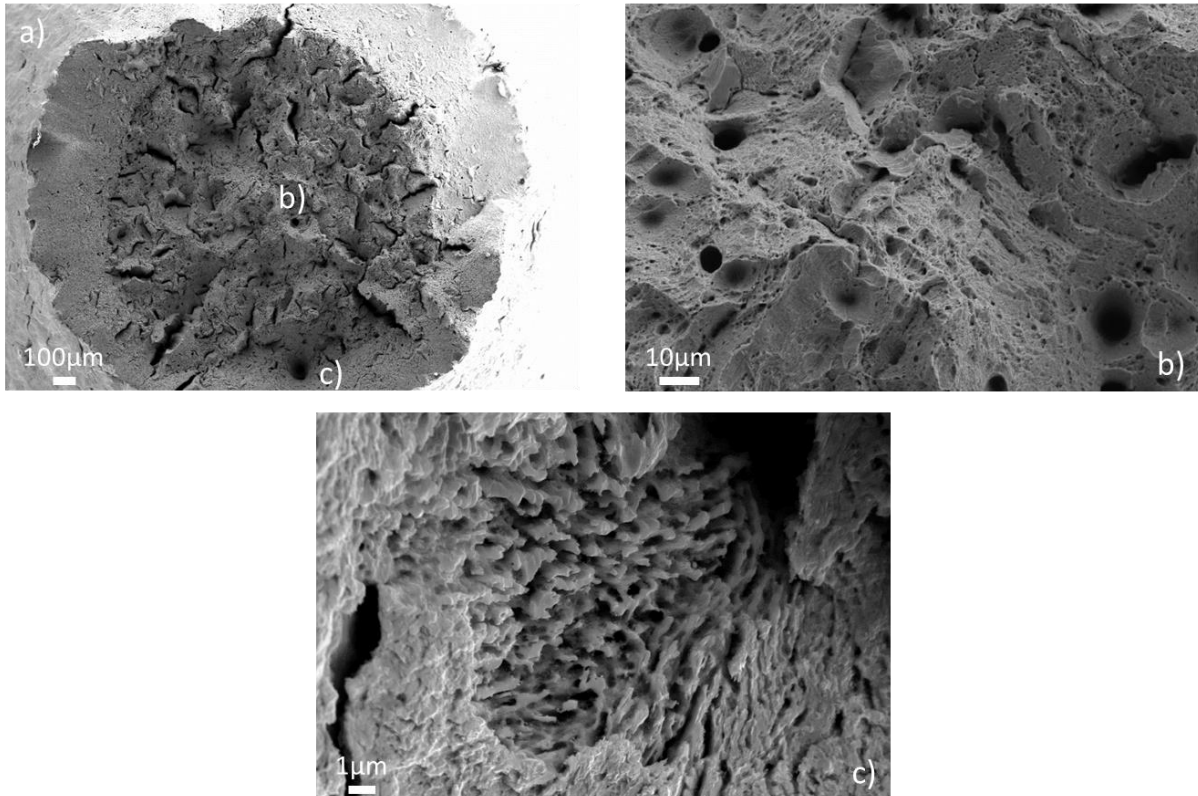
Figure 106 - Fracture surface of Virgo™38 after SSRT test at a strain rate of 10^{-6} s^{-1} and at Open Circuit Potential in a solution containing 30g/L NaCl + 0.4g/L sodium acetate at pH=1.5 (adjusted with HCl) purged with CO_2
a) Overview of the fracture surface showing ductile behavior with dimples
b) Detailed image showing dimples
c) Detailed image showing preferential dissolution on the fracture surface

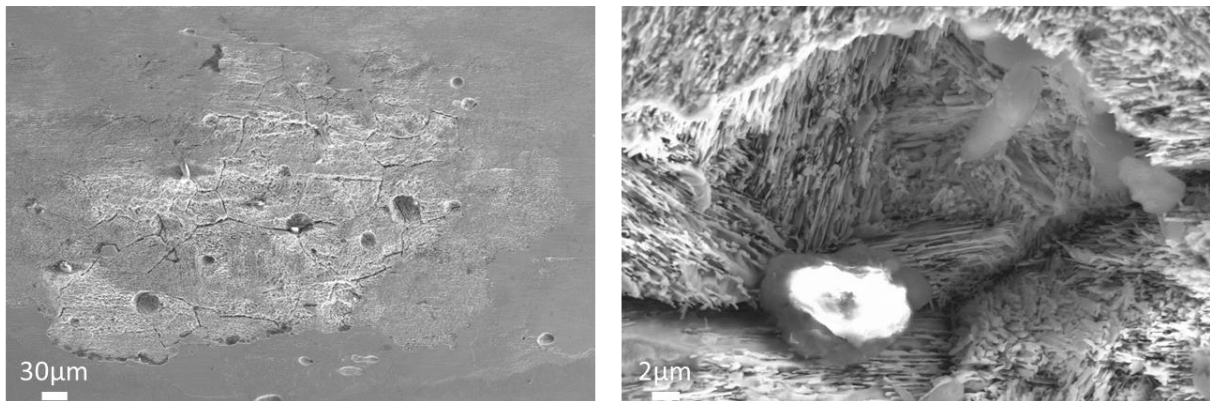
Figure 107 - Barrel surface of Virgo™38 after SSRT test at a strain rate of 10^{-6} s^{-1} and at Open Circuit Potential in a solution containing 30g/L NaCl + 0.4g/L sodium acetate at pH=1.5 (adjusted with HCl) purged with CO_2 showing marks of preferential dissolution and oxide formation at the surface

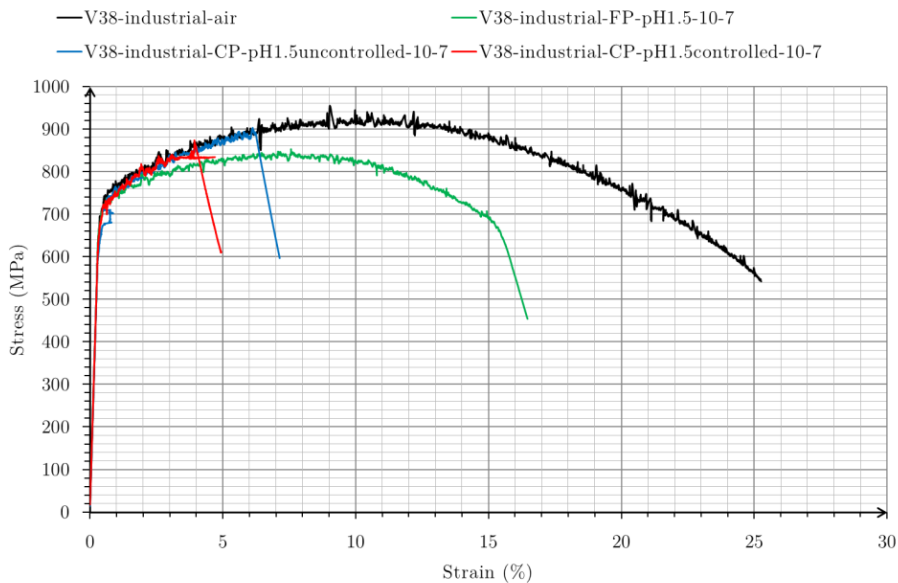
Figure 110 - Tensile curves of Virgo™38 under open circuit potential (FP, green curve) and cathodic charging at -1200mV/SCE (CP) in a solution containing 30g/L NaCl + 0.4g/L sodium acetate at pH=1.5 (adjusted with HCl) purged with CO₂ and at a strain rate of 10^{-7}s^{-1} with and without controlling the pH drift (red and blue curve respectively)

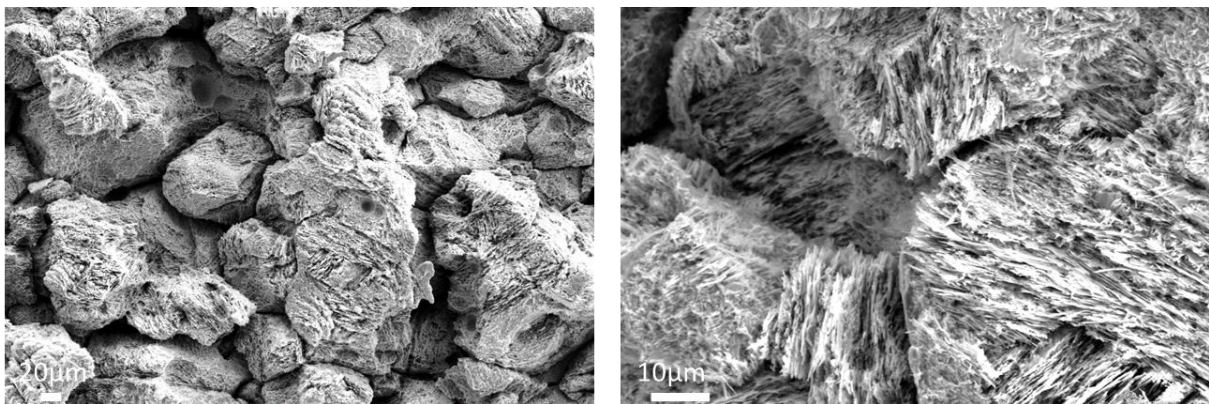
Figure 112 - Barrel surface of Virgo™38 after SSRT test at a strain rate of 10^{-7} s^{-1} and at Open Circuit Potential in a solution containing 30g/L NaCl + 0.4g/L sodium acetate at pH=1.5 (adjusted with HCl) purged with CO_2 showing generalized intergranular corrosion and preferential dissolution

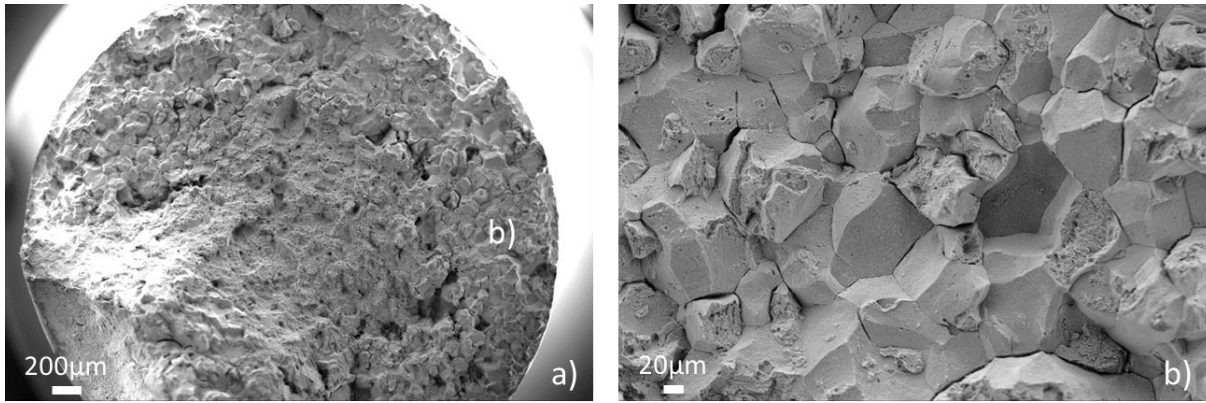
Figure 113 - Fracture surface of Virgo™38 after SSRT test at a strain rate of $10^{-7} s^{-1}$ and under cathodic charging at -1200mV/SCE in a solution containing 30g/L NaCl + 0.4g/L sodium acetate at pH=1.5 (adjusted with HCl) purged with CO₂ without controlling the pH drift
a) Overview of the fracture surface
b) Detailed image showing mixed intergranular and transgranular modes of cracking

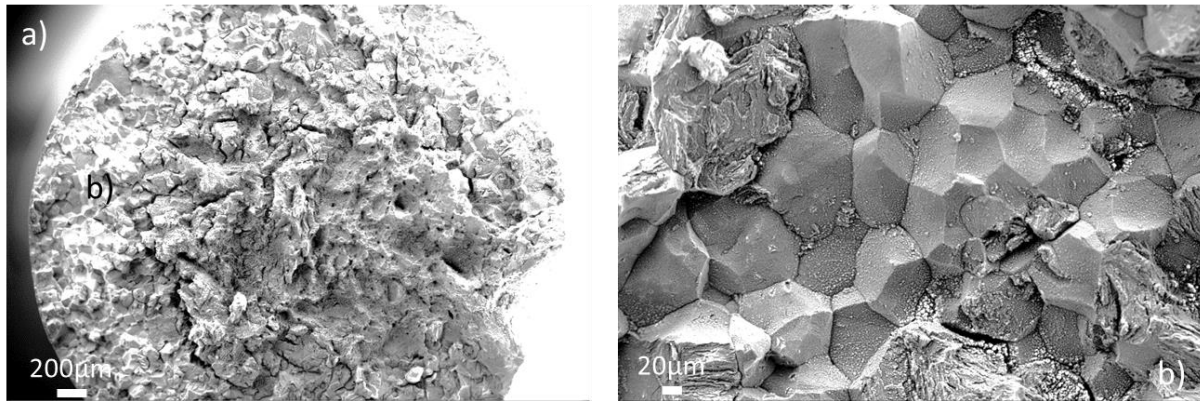
Figure 114 - Fracture surface of Virgo™38 after SSRT test at a strain rate of $10^{-7} s^{-1}$ and under cathodic charging at -1200mV/SCE in a solution containing 30g/L NaCl + 0.4g/L sodium acetate at pH=1.5 (adjusted with HCl) purged with CO₂ with the control of the pH drift
a) Overview of the fracture surface
b) Detailed image showing mixed intergranular and transgranular modes of cracking

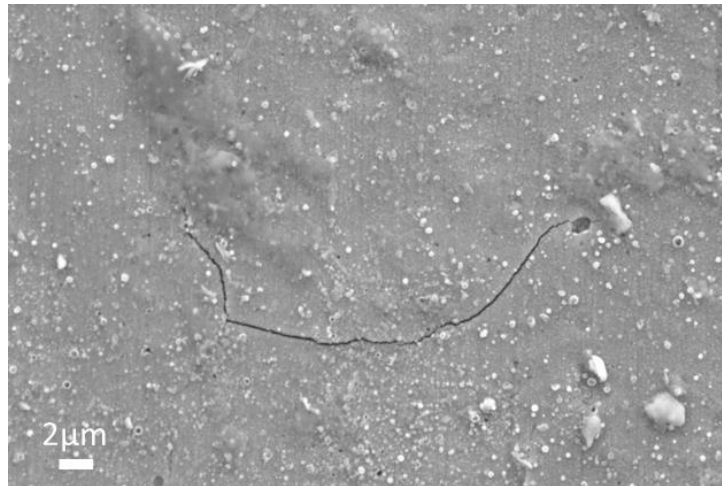
A third test under cathodic charging has been interrupted at a stress level corresponding to 0.2% proof stress, i.e. 750MPa. The observation of barrel surface shows that cracks initiate within the nominally macroscopic elastic domain (Figure 116). However, it must be emphasized that 0.01% yield stress for this microstructural state of Virgo™38 is of 570MPa, so that the applied stress corresponds to a plastic deformation which cannot be neglected. According to estimations performed in Chapter II, the elastic limit is significantly lower in tempered martensite (≈450MPa) than in retained austenite (≈710MPa). For this reason, tempered martensite is certainly exposed to heavier plastic strains, in particular when the macroscopic plasticity is low, what may have consequences on crack initiation conditions.

Figure 116 - Barrel surface of Virgo™38 after SSRT interrupted at 0.2% proof stress test at a strain rate of $10^{-7}s^{-1}$ and under cathodic charging at -1200mV/SCE in a solution containing 30g/L NaCl + 0.4g/L sodium acetate at pH=1.5 (adjusted with HCl) purged with CO₂ with controlling the pH drift showing several secondary cracks

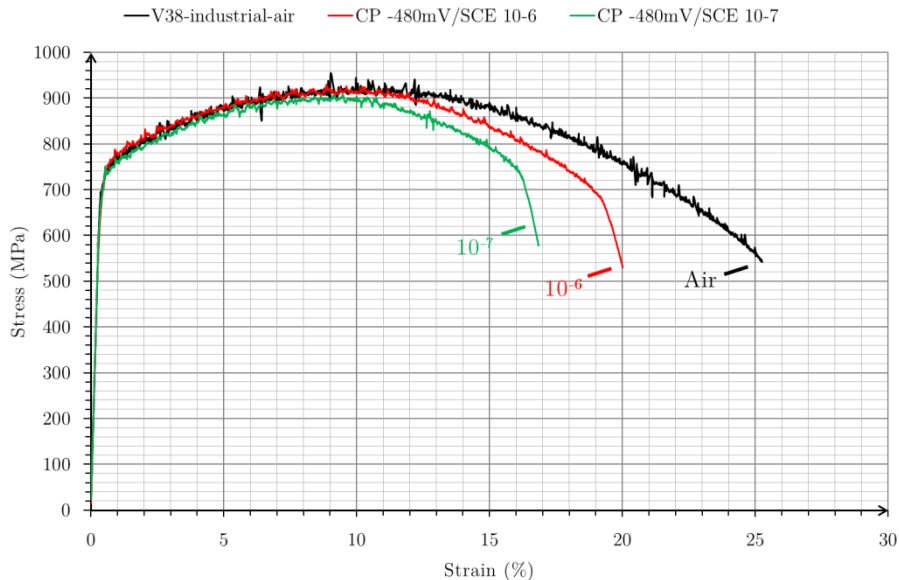
Figure 118 - Tensile curves of Virgo™38 under anodic potential of -480mV/SCE (corresponding to the martensite potential of activity) in a solution containing 30g/L NaCl + 0.4g/L sodium acetate at pH=1.5 (adjusted with HCl) purged with CO₂ and at a strain rate of 10⁻⁶s⁻¹ and 10⁻⁷s⁻¹ (red and green curves respectively)

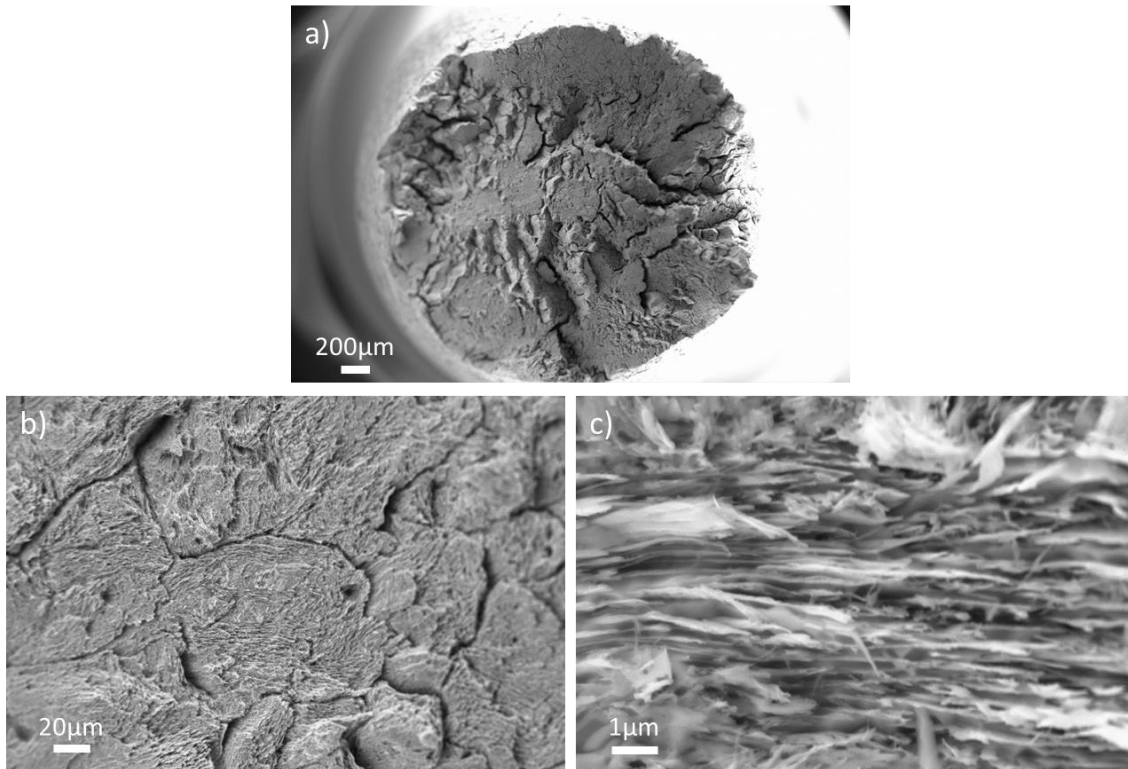
Figure 119 - Fracture surface of Virgo™38 after SSRT test at a strain rate of 10^{-6} s^{-1} and under cathodic charging at -480 mV/SCE in a solution containing $30 \text{ g/L NaCl} + 0.4 \text{ g/L sodium acetate}$ at $\text{pH}=1.5$ (adjusted with HCl) purged with CO_2
 a) Overview of the fracture surface

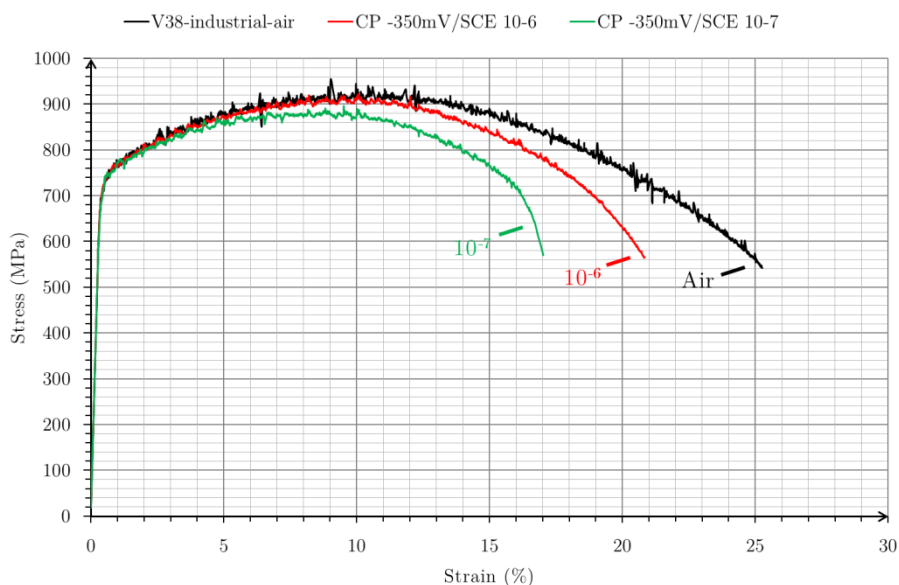
Figure 122 - Tensile curves of Virgo™38 under anodic charging at -350mV/SCE (corresponding to the activity potential of retained austenite) in a solution containing 30g/L NaCl + 0.4g/L sodium acetate at pH=1.5 (adjusted with HCl) purged with CO₂ and at a strain rate of 10⁻⁶s⁻¹ and 10⁻⁷s⁻¹ (red and green curves respectively)

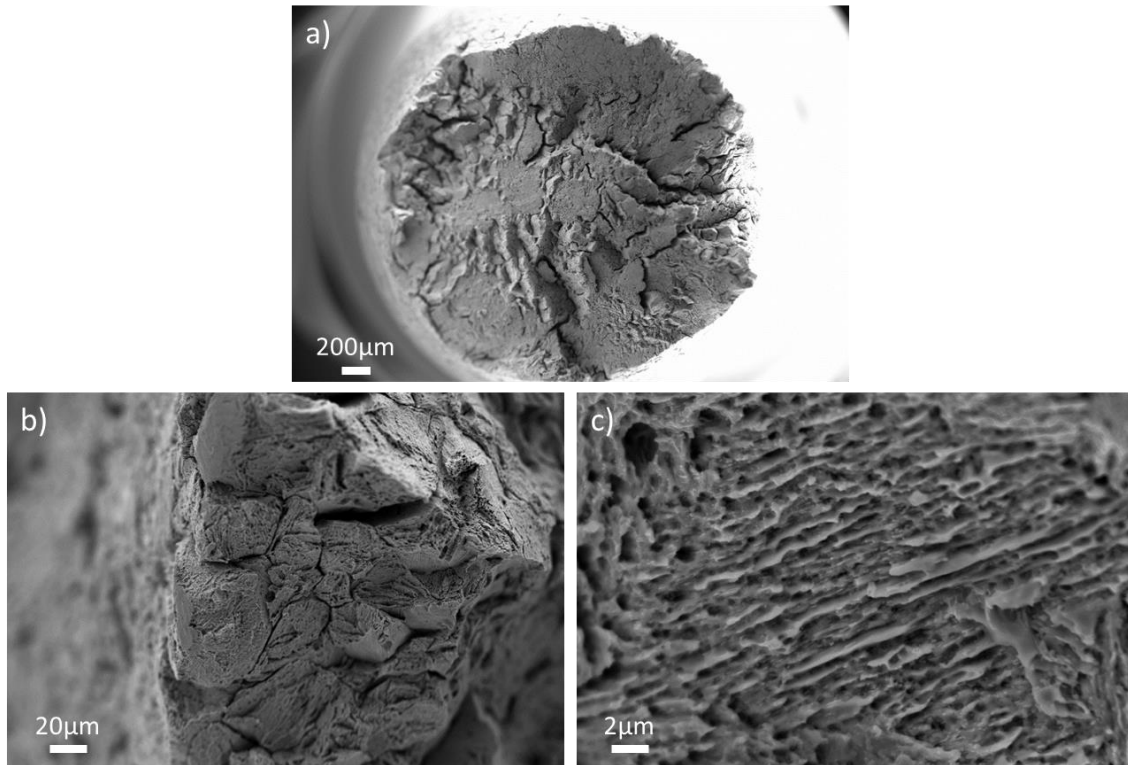
Figure 123 - Fracture surface of Virgo™38 after SSRT test at a strain rate of 10^{-6}s^{-1} and under cathodic charging at -350mV/SCE in a solution containing $30\text{g/L NaCl} + 0.4\text{g/L}$ sodium acetate at $\text{pH}=1.5$ (adjusted with HCl) purged with CO_2
 a) Overview of the fracture surface
 b) and c) Detailed images showing preferential dissolution on the fracture surface
