Mécanismes de fragilisation de l'acier inoxydable super-martensitique X4CrNi16-4 Virgo™38 : Effets couplés des traitements thermiques et des milieux corrosifs contenant Na₂S ou H₂S

THESE de DOCTORAT DE L'UNIVERSITE DE LYON
opérée au sein de
l'Ecole des Mines de Saint-Etienne

**Mécanismes de fragilisation de l'acier
inoxydable super-martensitique
X4CrNi16-4 Virgo™38 :
Effets couplés des traitements
thermiques et des milieux corrosifs
contenant Na₂S ou H₂S**

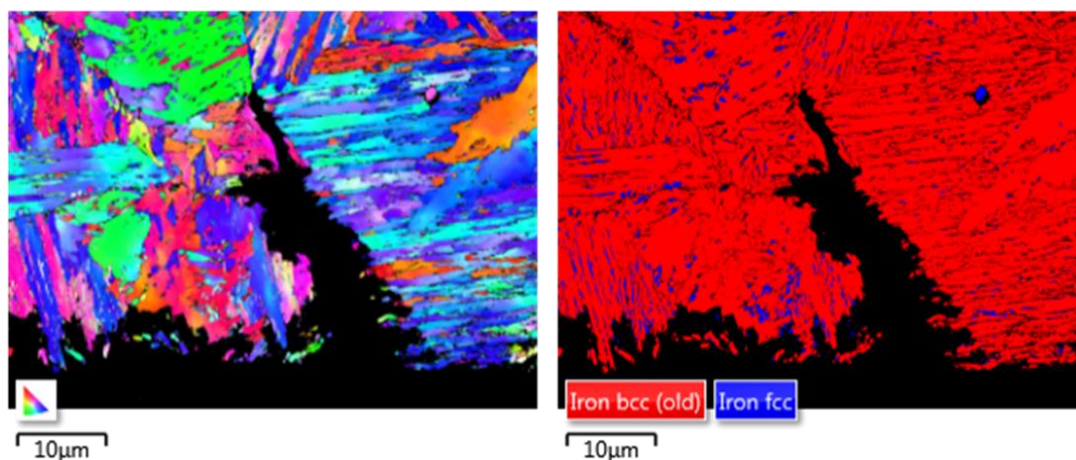
Figure 125 - EBSD mapping of a secondary crack after SCC test at -350mV/SCE (corresponding to the activity potential of retained austenite) in a solution containing 30g/L NaCl + 0.4g/L sodium acetate at pH=1.5 (adjusted with HCl) purged with CO₂ showing preferential dissolution of retained austenite

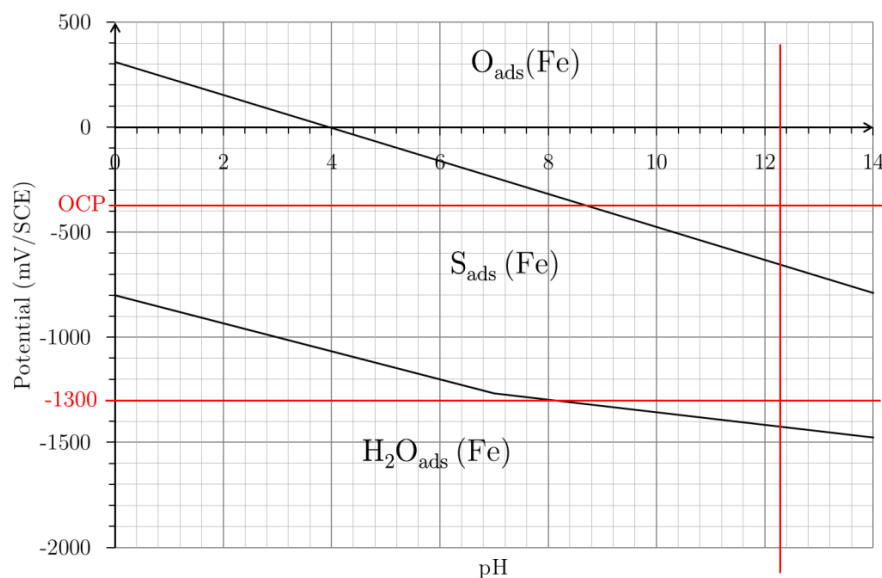
Figure 135 - Simplified re-plot of the stability diagram based on Marcus et al. data [156] for the adsorbed species on pure Fe showing that sulfur is the main element adsorbed at the surface in the cathodic charging conditions presented above while oxygen is the main element adsorbed at the OCP in the poisoned solution

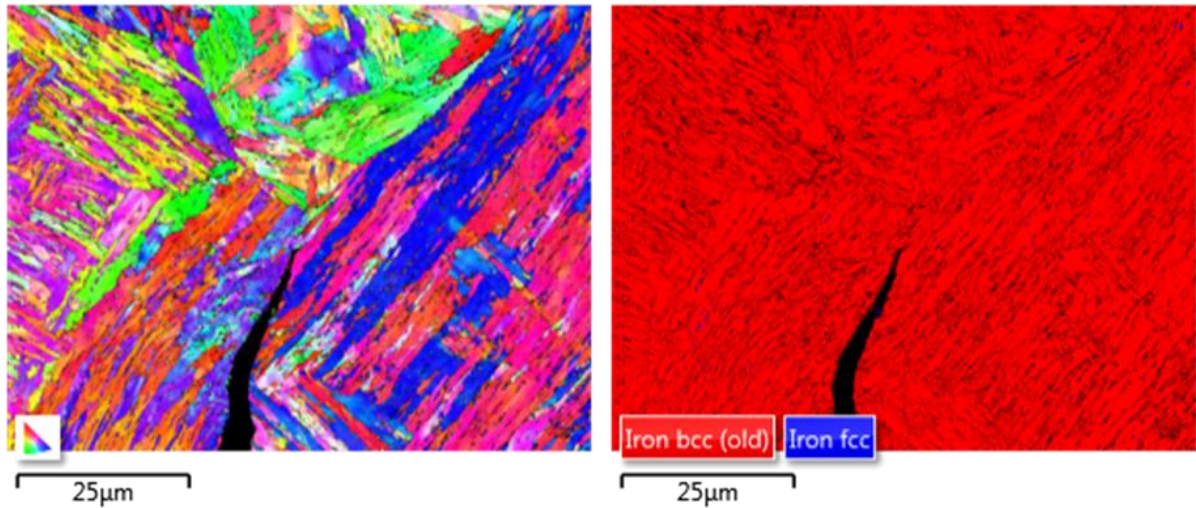
Figure 141 - Investigation of the crack propagation path by EBSD mapping at a crack tip of a secondary crack

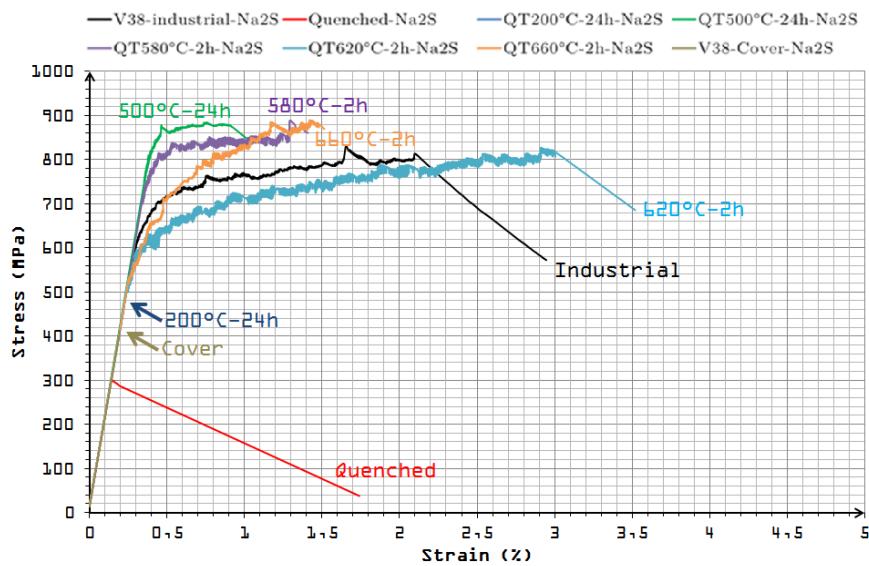
Figure 142 - Tensile curves of Virgo™38 obtained by SSRT tests under cathodic charging at -1300mV/SCE in a solution containing 0.1M NaOH + 0.02M Na₂S purged with N₂ and at a strain rate of 10⁻⁷s⁻¹. This set of curves shows the effect of different one step heat treatments after quenching.

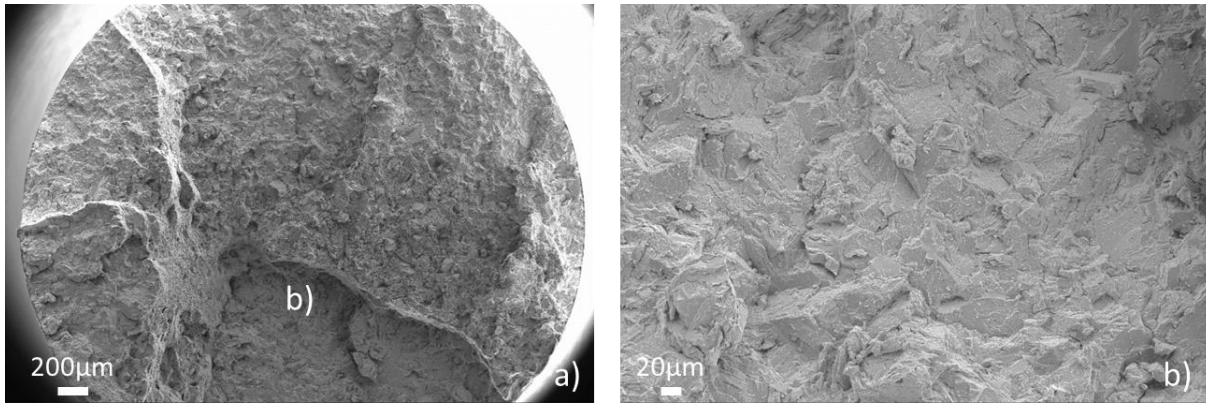
Figure 143 - Fracture surface of Virgo™38 in quenched state after SSRT test at a strain rate of 10^{-7} s^{-1} and under cathodic charging at -1300 mV/SCE in a solution containing $0.1 \text{ M NaOH} + 0.02 \text{ M Na}_2\text{S}$ purged with N_2
 a) Overview of the fracture surface, several initiation areas
 b) Detailed image showing fully transgranular mode of cracking

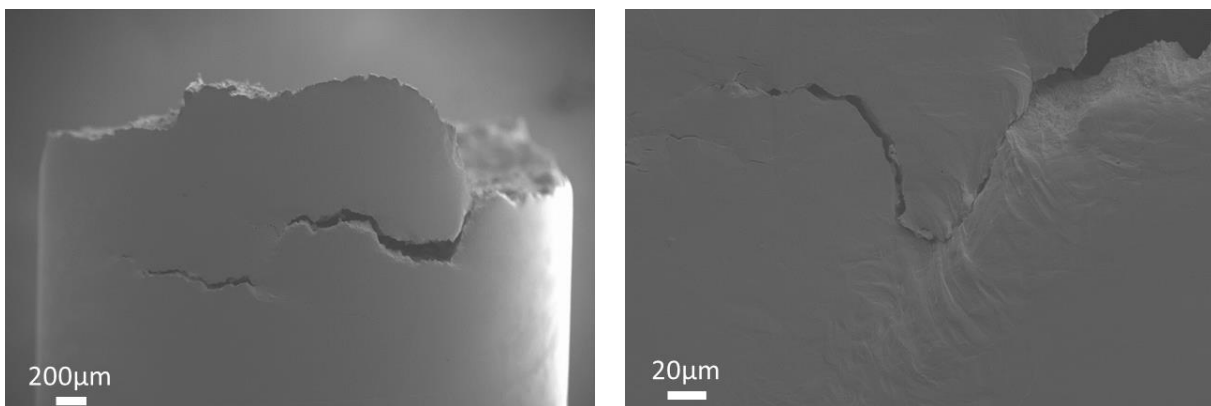
Figure 144 - Barrel surface of Virgo™38 in quenched state after SSRT test at a strain rate of 10^{-7} s^{-1} and under cathodic charging at -1300 mV/SCE in a solution containing $0.1 \text{ M NaOH} + 0.02 \text{ M Na}_2\text{S}$ purged with N_2 showing important secondary cracks

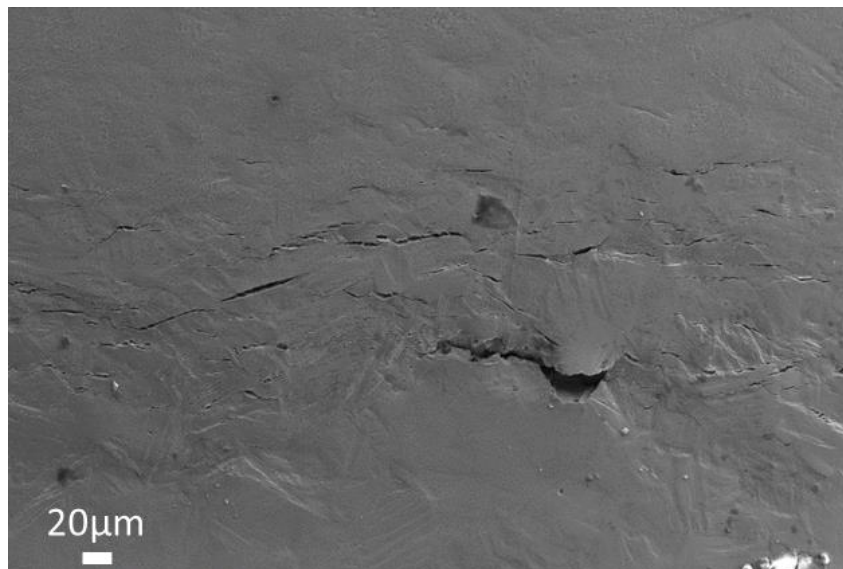
Figure 149 - Barrel surface of Virgo™38 in quenched and tempered state (24h at 500°C) after SSRT test at a strain rate of 10^{-7} s^{-1} and under cathodic charging at -1300mV/SCE in a solution containing 0.1M NaOH + 0.02M Na₂S purged with N₂ showing some small secondary cracks

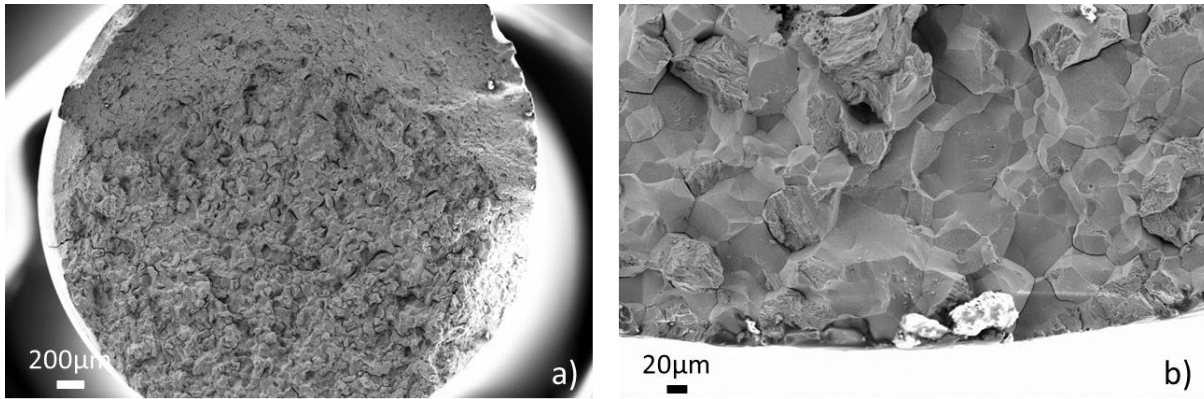
Figure 150 - Fracture surface of Virgo™38 in quenched and tempered state (2h at 580°C) after SSRT test at a strain rate of 10^{-7} s^{-1} and under cathodic charging at -1300mV/SCE in a solution containing 0.1M NaOH + 0.02M Na₂S purged with N₂
 a) Overview of the fracture surface, initiation from the bottom side
 b) Detailed image showing mixed intergranular and transgranular mode of cracking

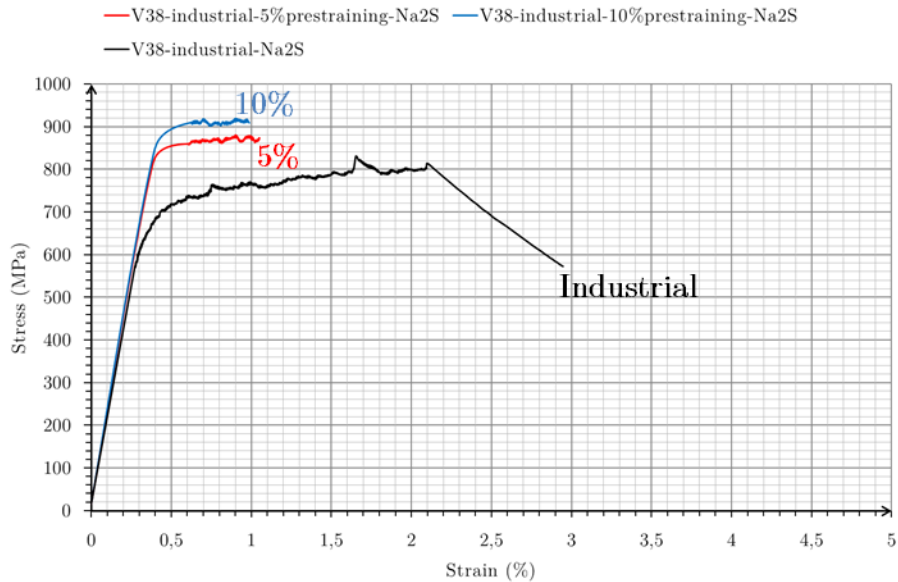
Figure 156 - Tensile curves of Virgo™38 in industrial state (black curve) and after different pre-straining ratios in air previous to the SSRT tests under cathodic charging at -1300mV/SCE in a solution containing 0.1M NaOH + 0.02M Na₂S purged with N₂ and at a strain rate of 10⁻⁷s⁻¹ (5% red curve and 10% blue curve of pre-straining in air)

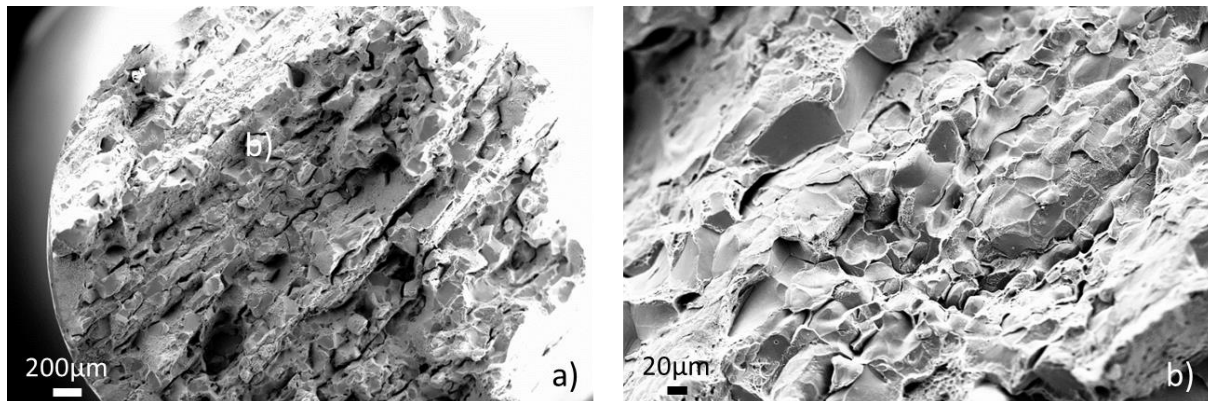
Figure 162 - Fracture surface of the Cover after tensile test in air at $10^{-5} s^{-1}$ showing brittle intergranular behavior with some ductile areas

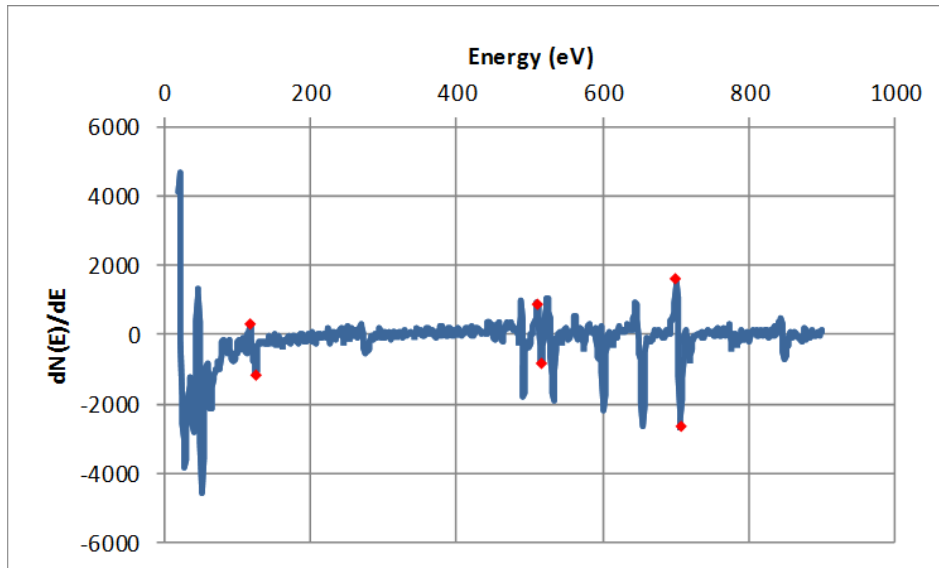
Figure 170 - Example of an Auger spectrum recorded from one intergranular facet after in situ failure under UHV showing P120, Cr529 and Fe703 peaks

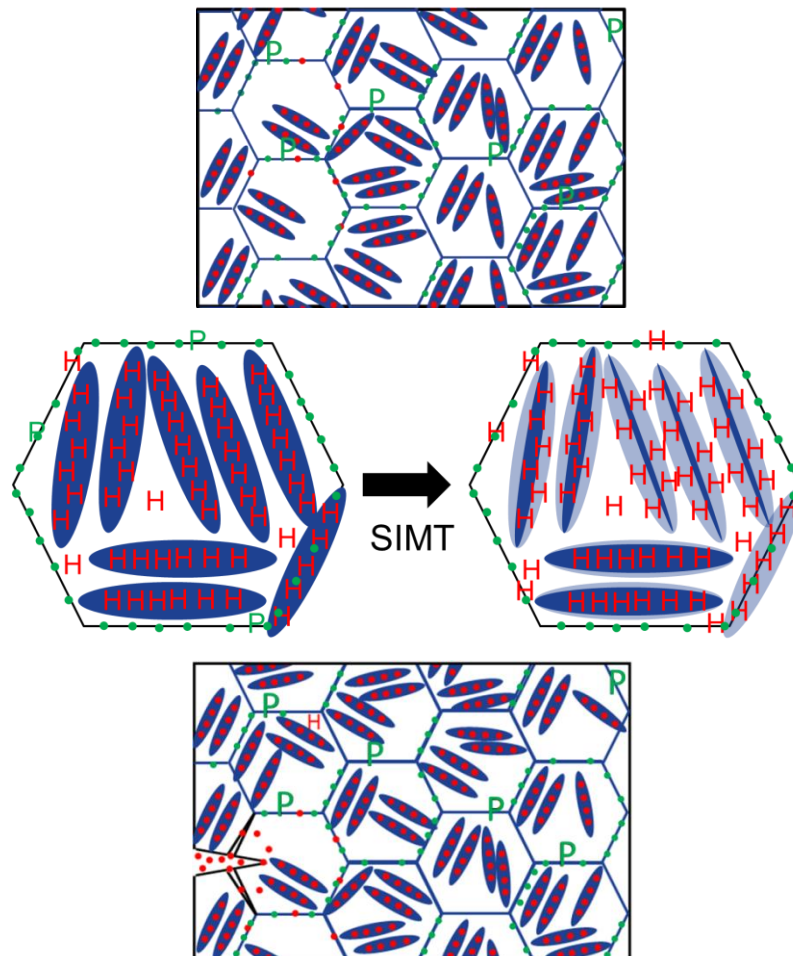
Figure 172 - Schematic representation of the Hydrogen Embrittlement mechanism based on HEDE proposed

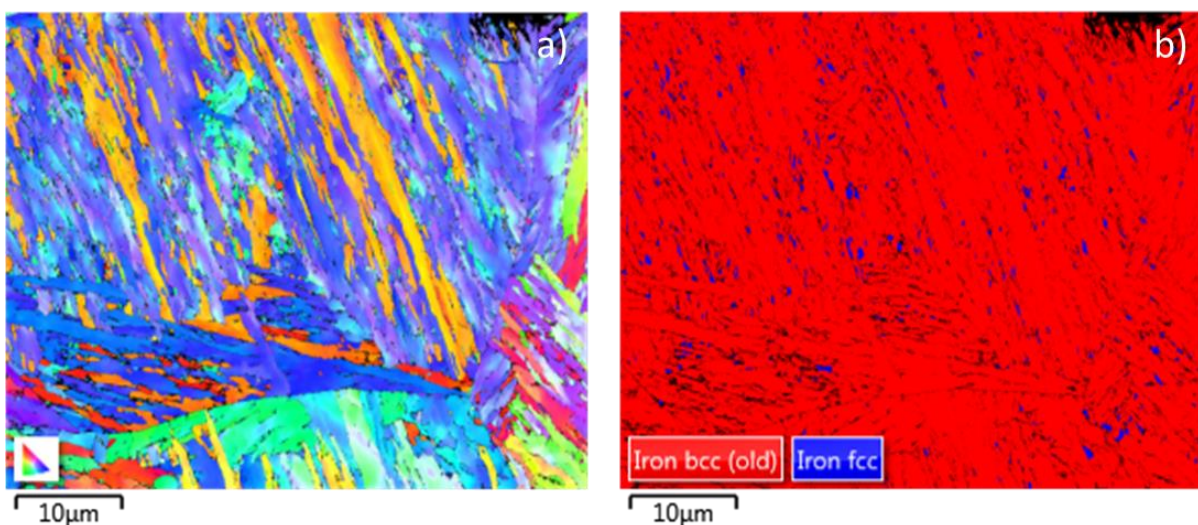
Figure 173 - EBSD maps (a) IPF and (b) phase map) of a specimen taken within the Cover

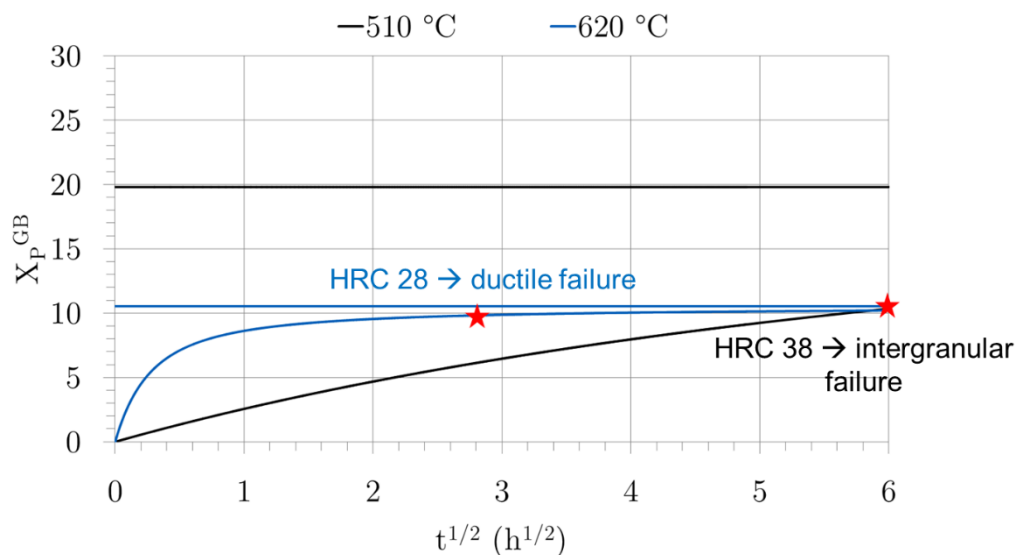
Figure 177 - Kinetics of phosphorous grain boundary segregation in Virgo™38 at different temperatures (impeller treated at around 620°C and Cover treated at 510°C) showing almost the same Phosphorous grain boundary content after two different heat treatment

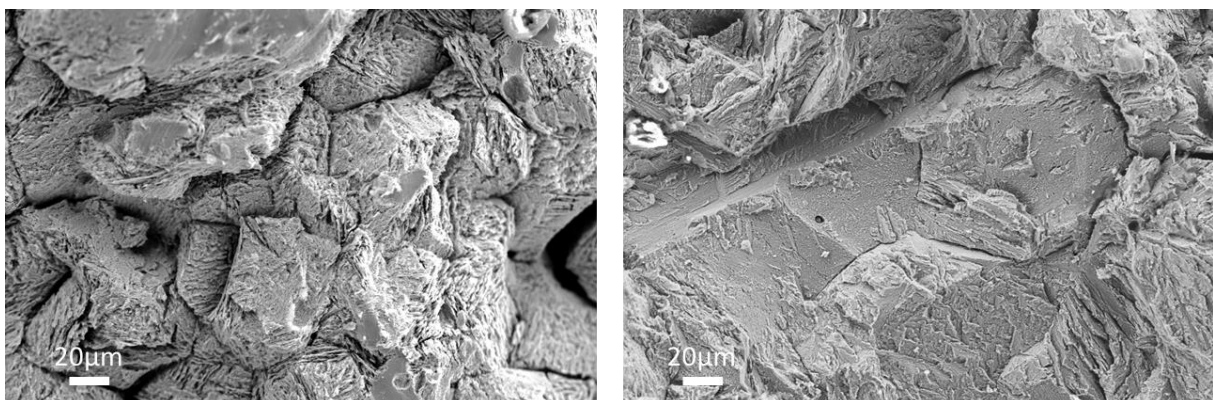
Figure 181 - Typical fracture surfaces obtained after tests at pH lower and higher than 3.0 showing fully intergranular fracture with dissolution marks at pH lower than 3.0 (left, test at pH=2.5) and mixed intergranular / transgranular failure at pH higher than 3.0 (right, test at pH=3.5).

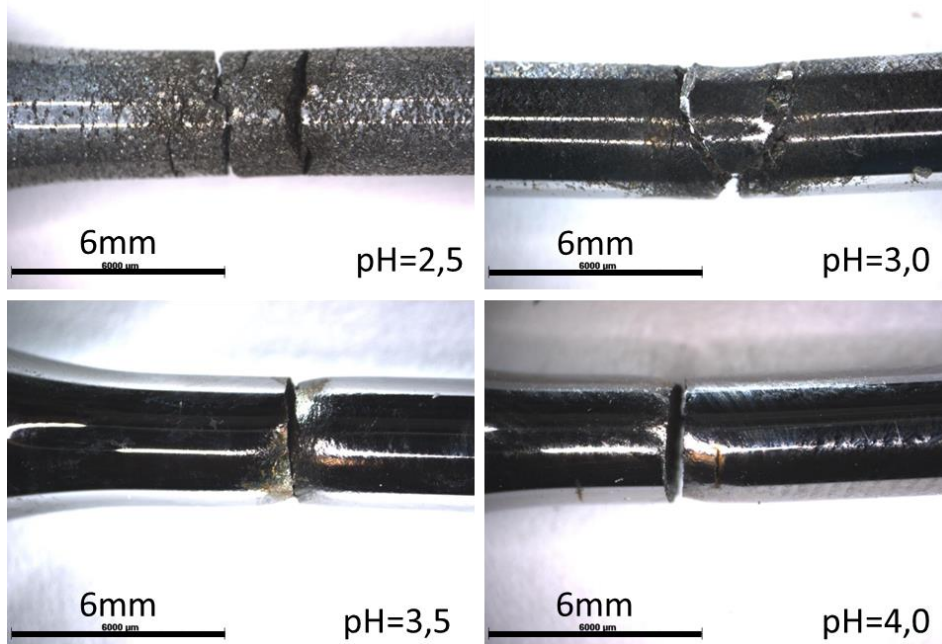
Figure 182 - Optical micrographs of barrel surfaces after SSRT tests in H_2S containing environments showing the influence of the pH and the gap between generalized and localized pitting corrosion

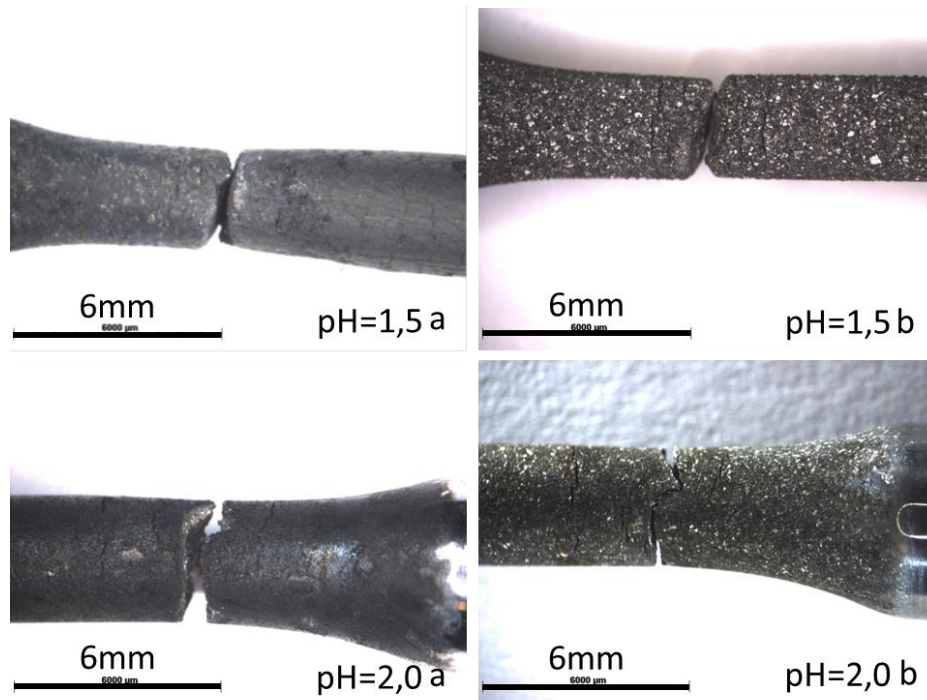
Figure 183 - Optical micrographs of barrel surfaces after SSRT tests in H₂S containing environments: influence of the pH without chlorides showing generalized corrosion with non-adherent corrosion products (before and after cleaning)

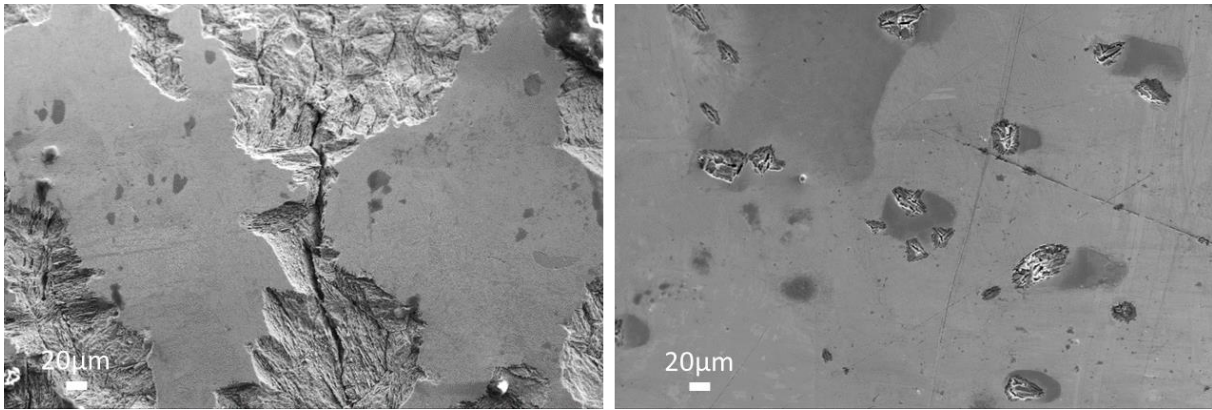
Figure 187 - SEM micrographs of barrel surfaces of tests 1 and 2 (pH 2.5 and 3.0 respectively) showing stable and generalized pitting corrosion and large areas of depassivation in probable areas of stress concentration

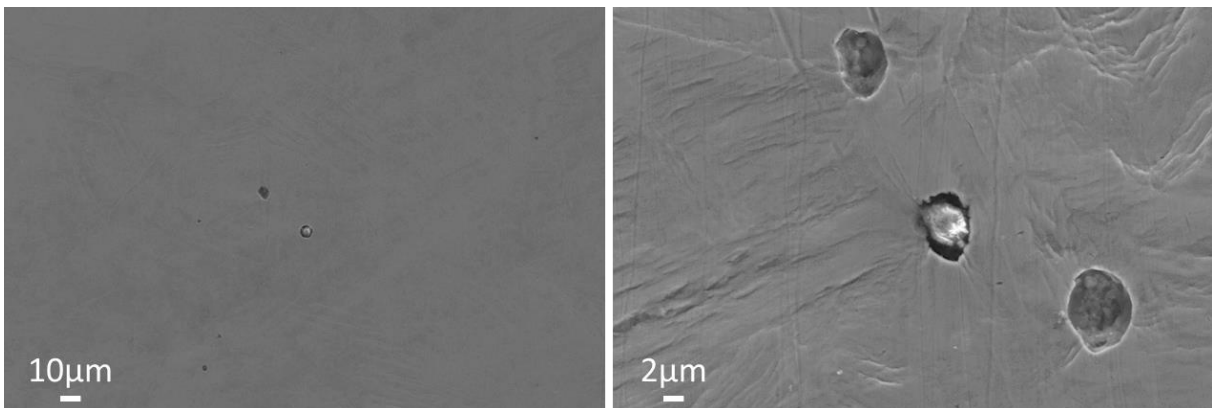
Figure 188 - SEM micrographs of barrel surfaces of tests 3 and 4 (pH 3.5 and 4.0 respectively) showing pitting corrosion that could be at the origin of the main crack

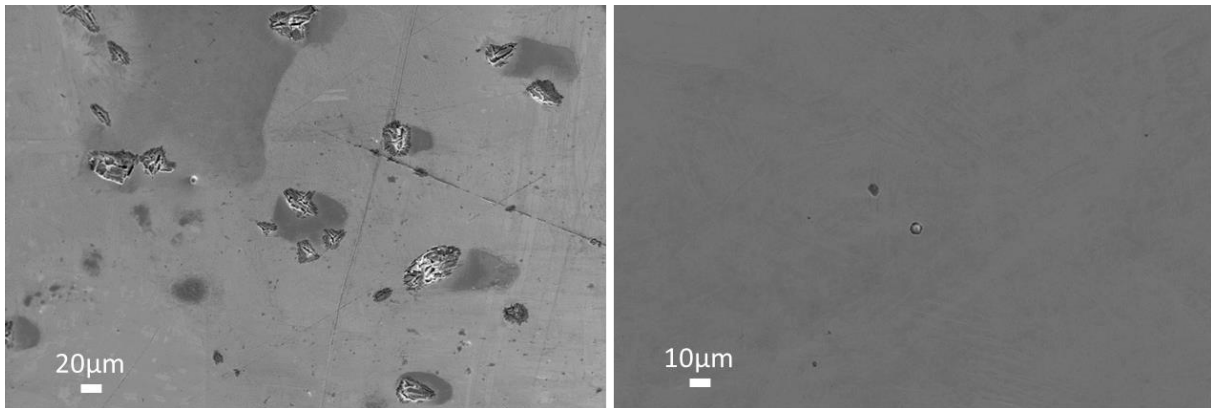
Figure 190 - Observation of the barrel surfaces after SSRT tests showing either stable (left, pH=3.0) or metastable (right, pH=3.5) pitting corrosion according to the pH of the solution at the same stress level of 680MPa

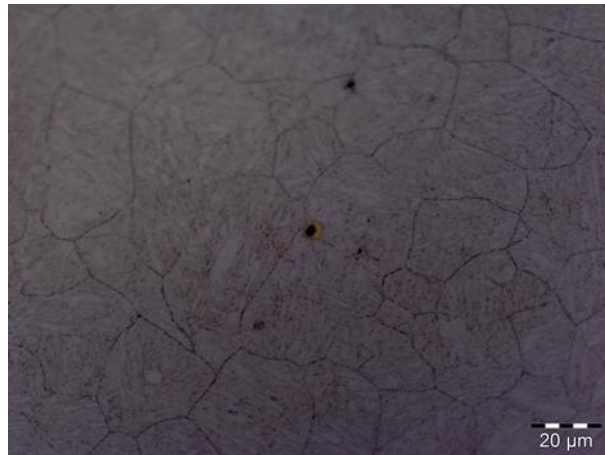
Moreover, industrial alloys contain inclusions that are much more damageable than retained austenite. Virgo™38 contains TiC for example, and it can be seen that pits mainly initiate on these inclusions (Figure 191).

Figure 191 - Optical micrograph of a sample mirror polished after 30min immersion at the Open Circuit Potential in a solution containing 30g/L NaCl + 0.4g/L sodium acetate at pH=1.5 showing pitting corrosion of TiC

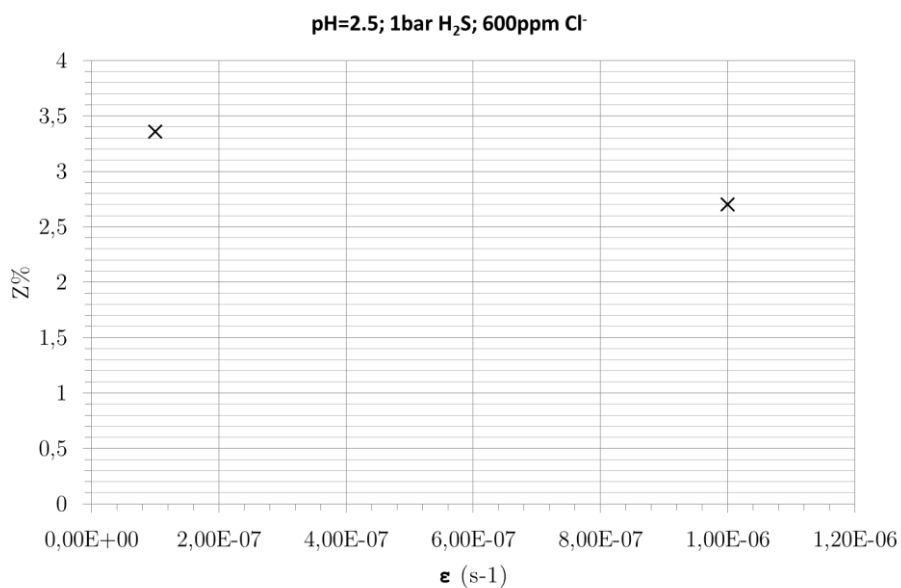
Figure 192 - Influence of the strain rate applied on the reduction in area (Z%) for slow strain rate tensile tests under pH=2.5, 1bar H₂S and 1g/L NaCl

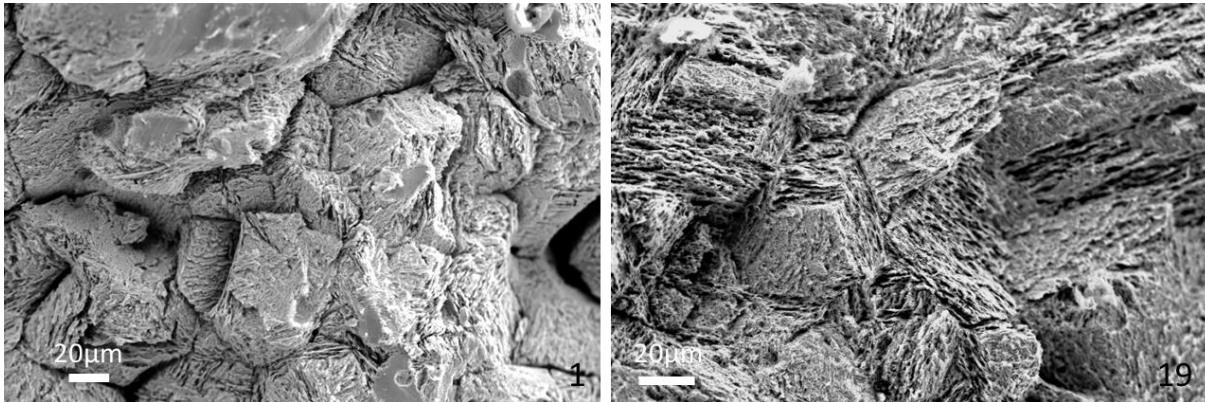
Figure 193 - Evolution of the fracture surface with the strain rate in the “low pH” domain showing mainly intergranular fracture with preferential dissolution in both cases (10^{-7} left and 10^{-6} right, respectively)

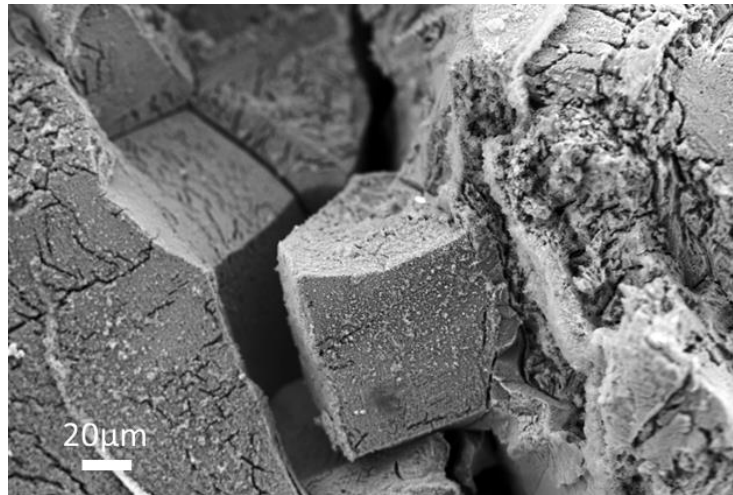
Figure 209 - Fracture surface obtained after SSRT test on the Cover sample tested under 1 bar of H₂S, in presence of 600ppm of chlorides at pH=3.5 and at a strain rate of 10⁻⁷s⁻¹ showing a fully intergranular fracture

Contrary to the test in the same conditions performed on the properly heat treated specimens of Virgo™38 (impeller test 3), Figure 209 reveals a fully intergranular fracture on the Cover (93.4±0.9% vs 34.9±0.6% for the impeller in the same conditions). Furthermore, several secondary cracks are visible on the intergranular facets. As concluded in Chapter IV, the extreme brittleness of the Cover component is due to a synergy between Phosphorous Grain Boundary Segregation (PGBS) and the high hydrogen activity encountered in H₂S containing environments.

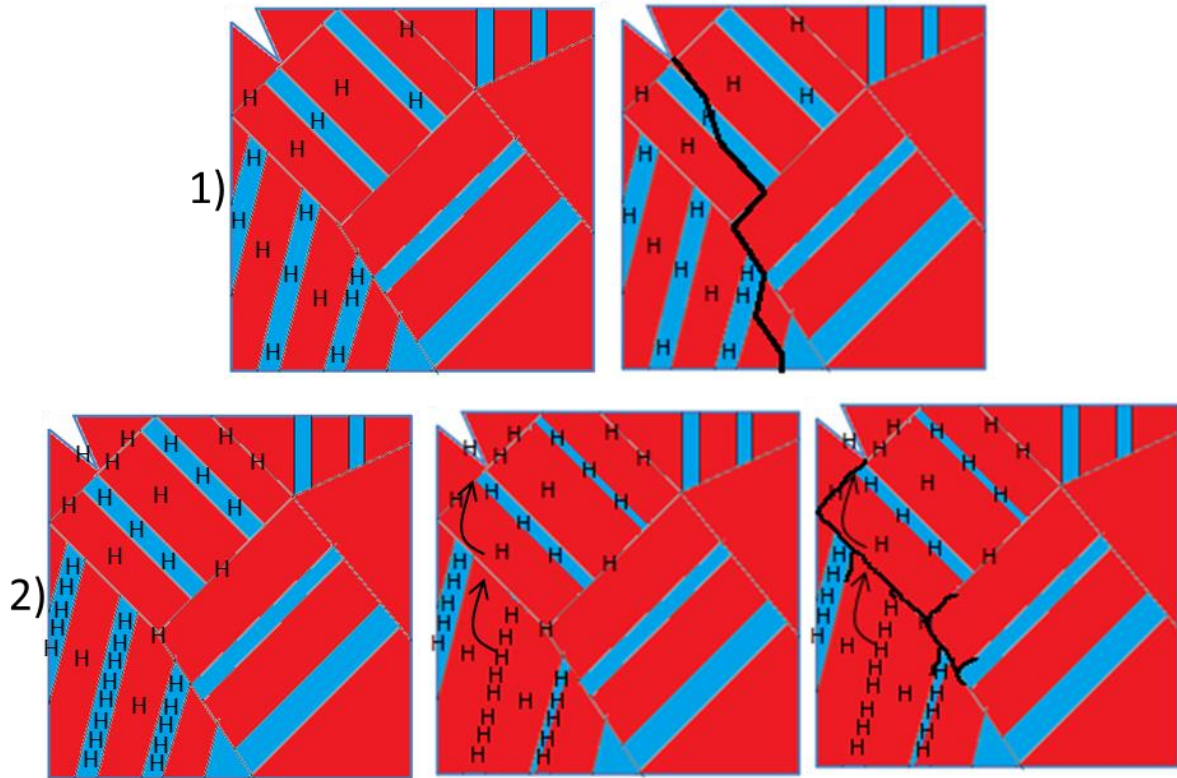
Figure 211 - Schematic representation of the proposed mechanisms of crack propagation assisted by H:
