Analysis of damage mechanisms in composite structures reinforced by tufting

Thèse présentée
pour l'obtention du grade
de Docteur de l'UTC

Spécialité : Mécanique et Matériaux : Unité de recherche en
Mécanique - Laboratoire Roberval (UMR-7337)

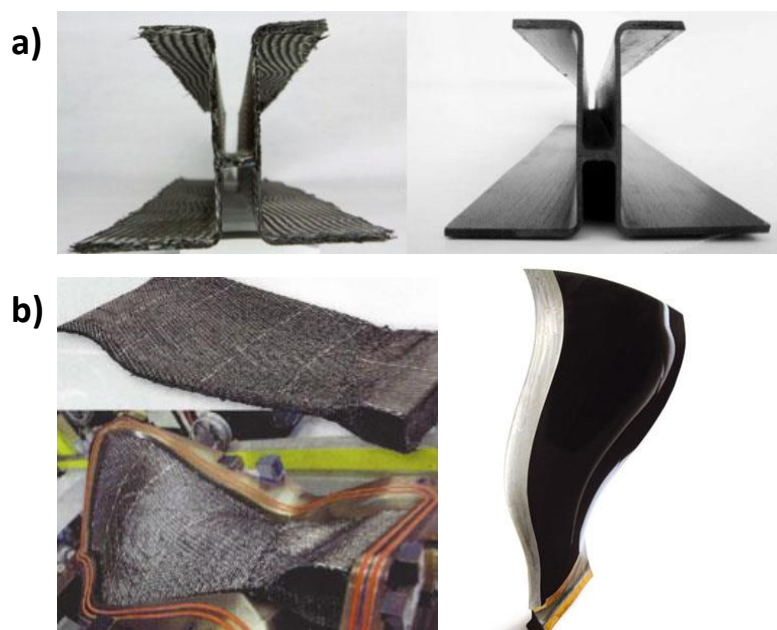
Figure 1.3- a) complex 3D woven preform geometry and composite stiffener [59] and, b) 3D woven preform applied to manufacture LEAP fan blade (Safran Aircraft Engines - Safran Group) [60].

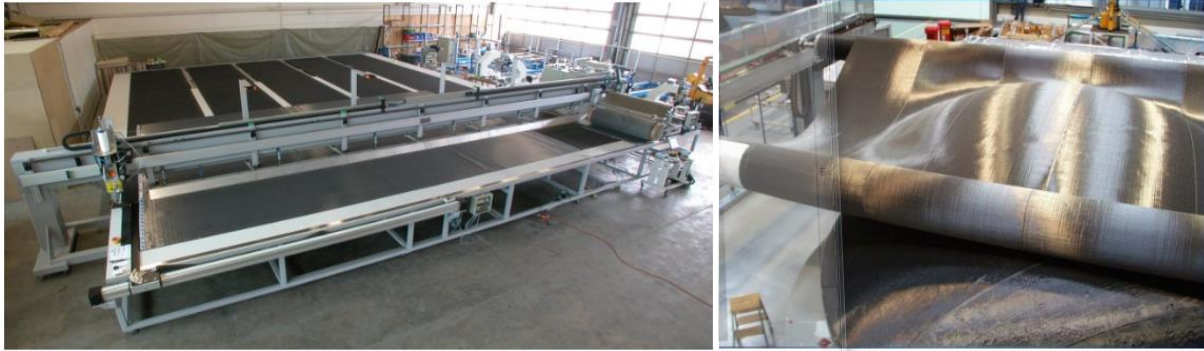
Figure 1.18- Dry-preforms joined together by blind stitching technique and laid on mold [159].

Blind stitching technology has been already applied on an industrial scale to manufacture the rear pressure bulkhead of the Airbus A380 jet airliner. Six widths of carbon dry-preforms were stitched together to obtain the appropriate dimensions of the rear pressure bulkhead measuring 5.5 m x 6.2 m (Figure 1.18) [158].

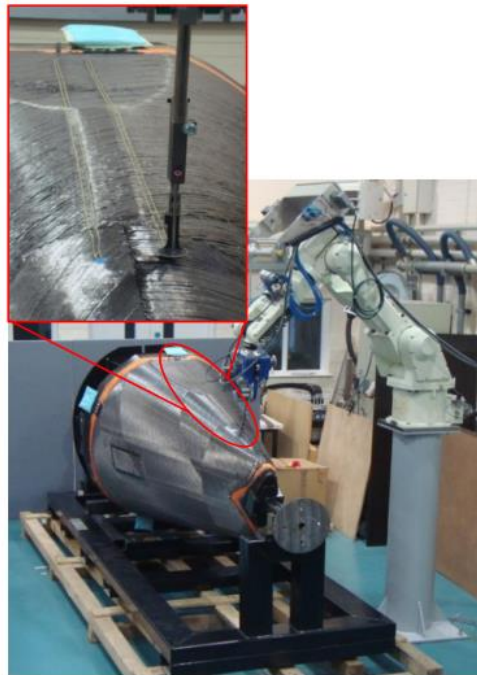
Figure 1.20 - Tail cone made of carbon composite reinforced by tufting technique [116].

Tufting process allows a maximum variability of its parameters as stitch spacing, seam radius, insertion angle (45° - 135°) and preform thickness thanks to its simple mechanism and compact tufting head design in comparison with the others single-sided stitching technologies [79]. Figure 1.20 presents manufacturing of a tail cone using the tufting process to reinforce the dry-preforms [116].

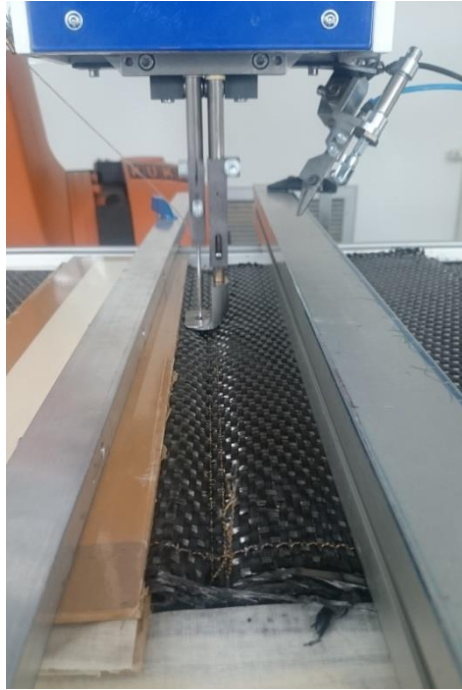
Figure 2.17 - The reinforcement between the stiffener and skin preforms for the manufacturing of the omega stringer.

Figure 2.17 shows the through-thickness reinforcement of the carbon fabrics, detailing the frame supports used to maintain the fabrics in place during tufting as well as to the trimming procedure. The stitched fabrics were carefully released from the foam after the through-thickness reinforcement, followed by the releasing of the PTFE film from the tuft loops (Figure 2.18).

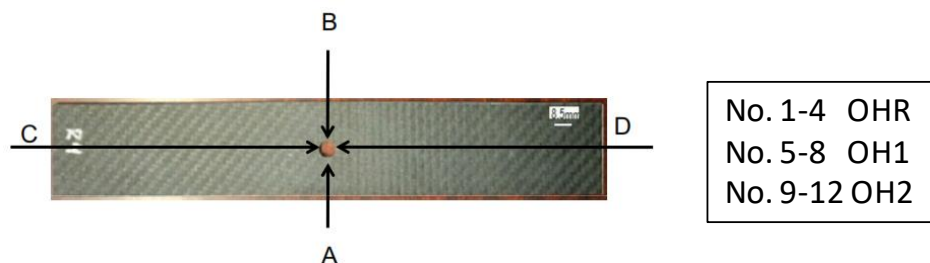
Figure 3.34 - Roughness measurements in the principal directions (described on the top) for the specimens drilled by the twist and core tools.

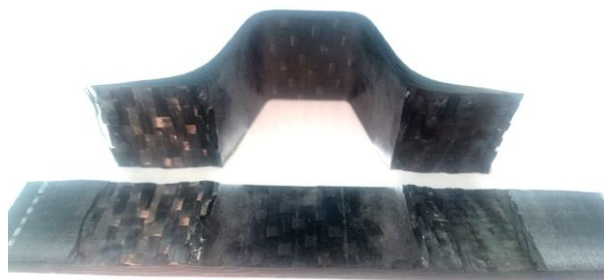
Figure 4.5 - Post-mortem image of the non-tufted omega stringer.

Figure 4.5 and Figure 4.6 show the post-mortem images for the untufted and tufted omega stringers respectively. The fracture for the control specimens is catastrophic and separates the structure into the two parts (stiffener and skin) as already reported by several authors. It is mainly owed to the concentration of strain between the contact of the stiffener and skin, as shown in Figure 4.2. On the other hand, the tufted specimens maintain the structure joined by the crack bridging effect of the tufts. The fractography presents the significant extent of interlaminar cracks in the specimen radius, delamination in the interface between stiffener and skin as well as crack deflection throughout tuft length.

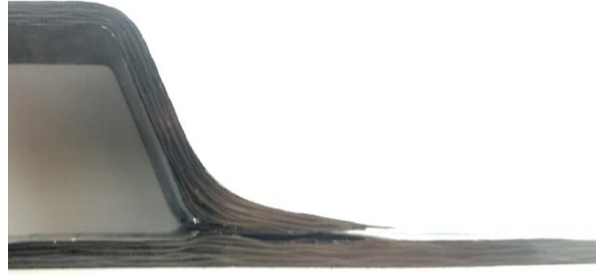
Figure 4.16 - The typical failure of control specimens.

As reported to the specimens subjected to pull-off tests, the failure mechanisms also presented unlike both specimen configurations as seen in Figure 4.16 and Figure 4.17 for the untufted and tufted structures respectively. The catastrophic failure presented in Figure 4.16 that separates the stiffener and skin parts integrally, validates the sudden load drop presented in the curve for the control specimens. On the other hand, tufts restrain the interlaminar cracks and therefore, avoid the sudden failure and separation of the main parts.

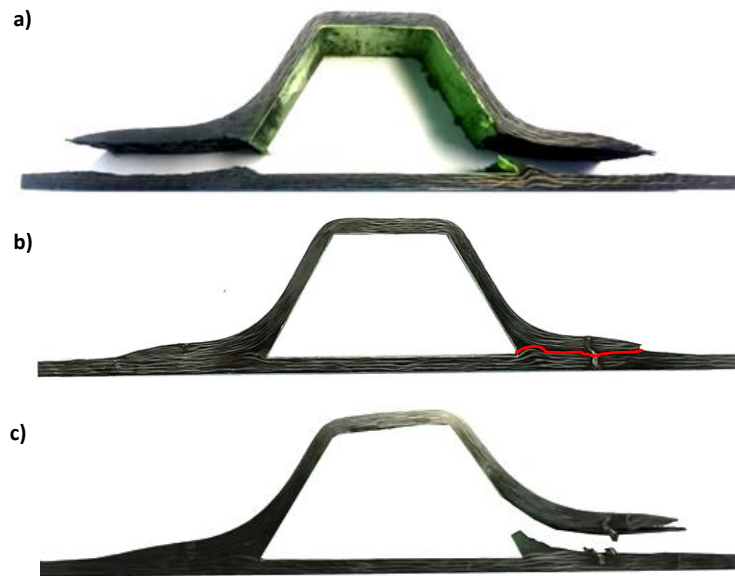
Figure 4.39 - Post-mortem images of a) REF, b) TUF1 and c) TUF2 specimens submitted to pull-off tests.
