# Microarchaeological observation on the neolithic architectural structures and cultural landscape of Sumaki Höyük

# **Microarchaeological Observation on the Neolithic Architectural Structures and Cultural Landscape of Sumaki Höyük**

PhD Thesis

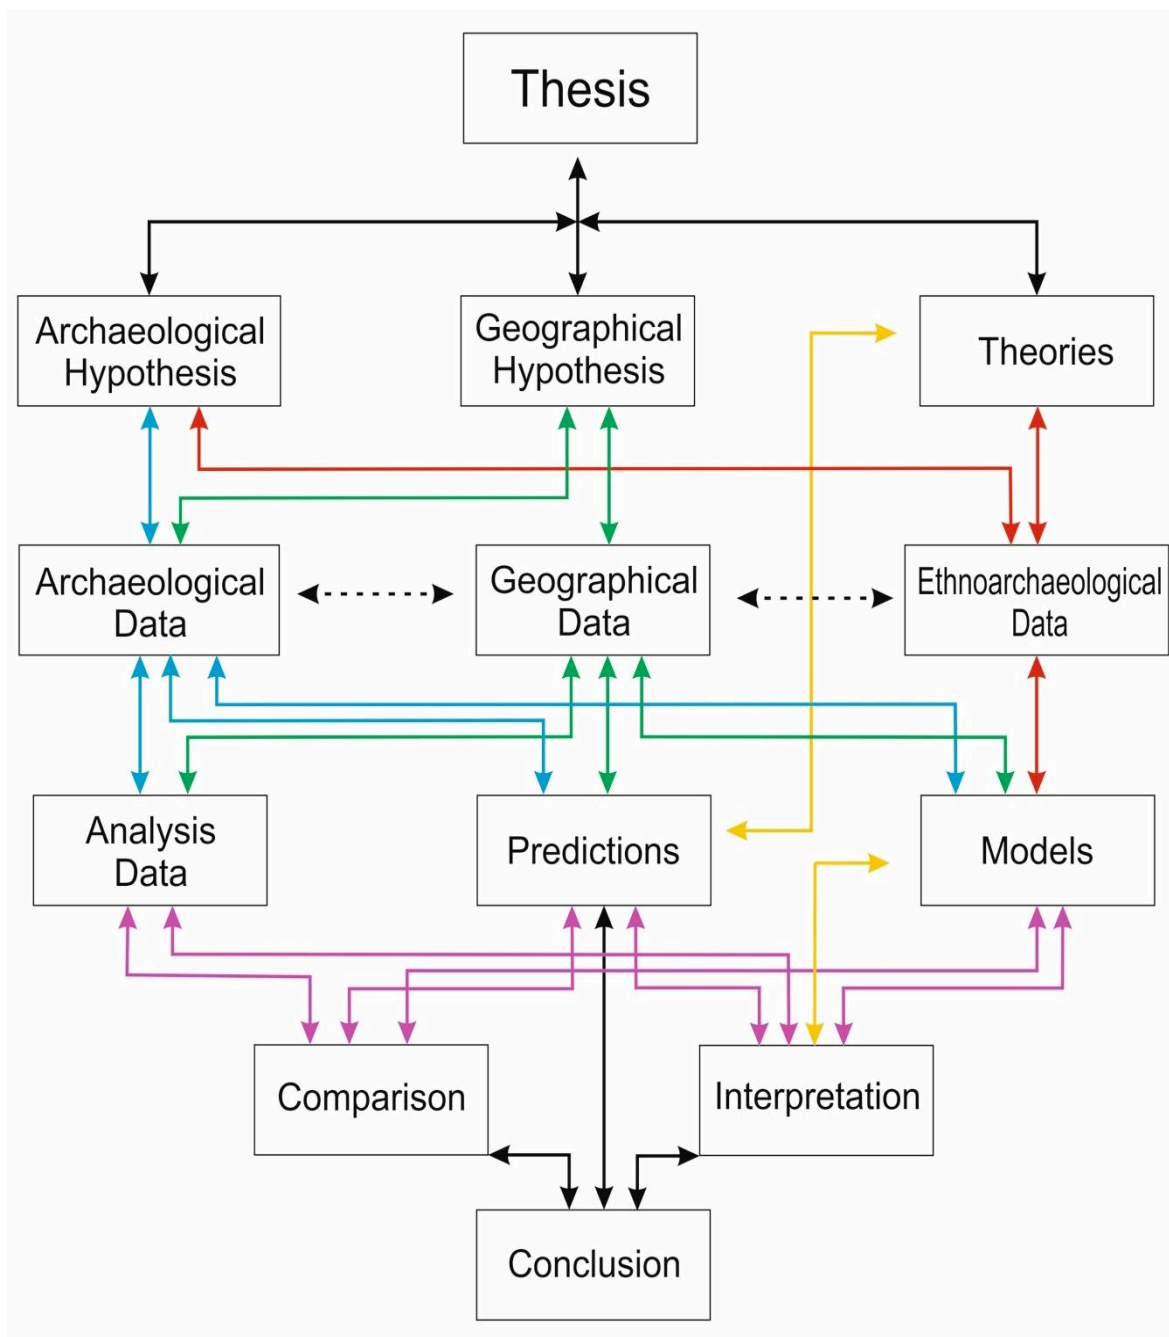
**Diagram 1.1:** Methodological chart of this thesis study

In this study, the main topics are dealt with in detail. (Diagram 1.1) However, the independent results that emerged were evaluated together with other studies, and the results were thoroughly checked. Thus, we have tried to establish in detail the construction type, construction materials and their transformations at the Neolithic settlement of Sumaki Höyük.

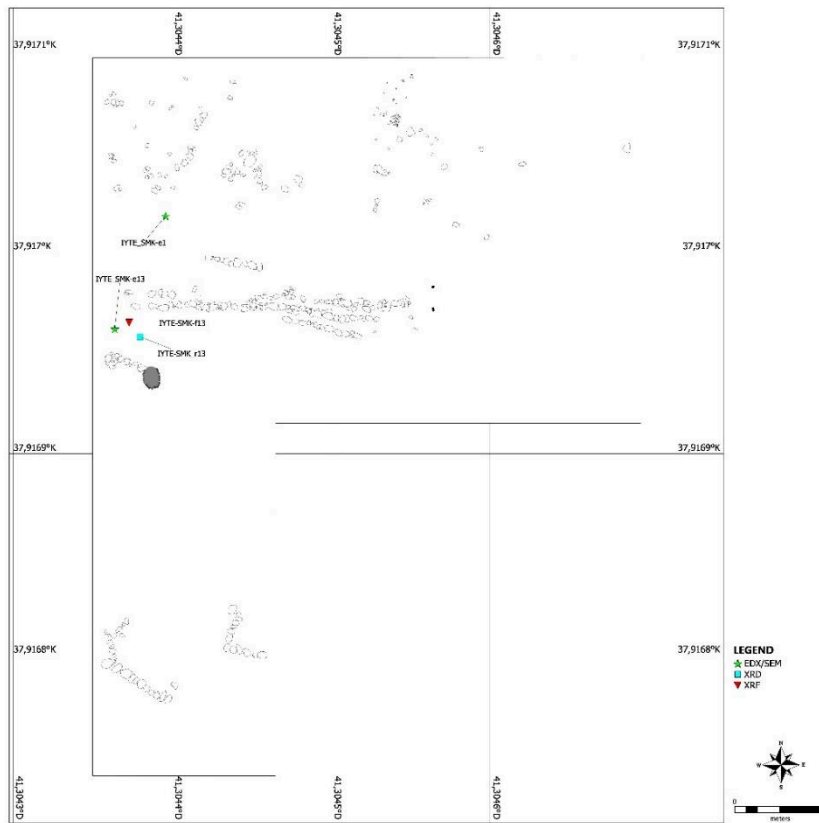
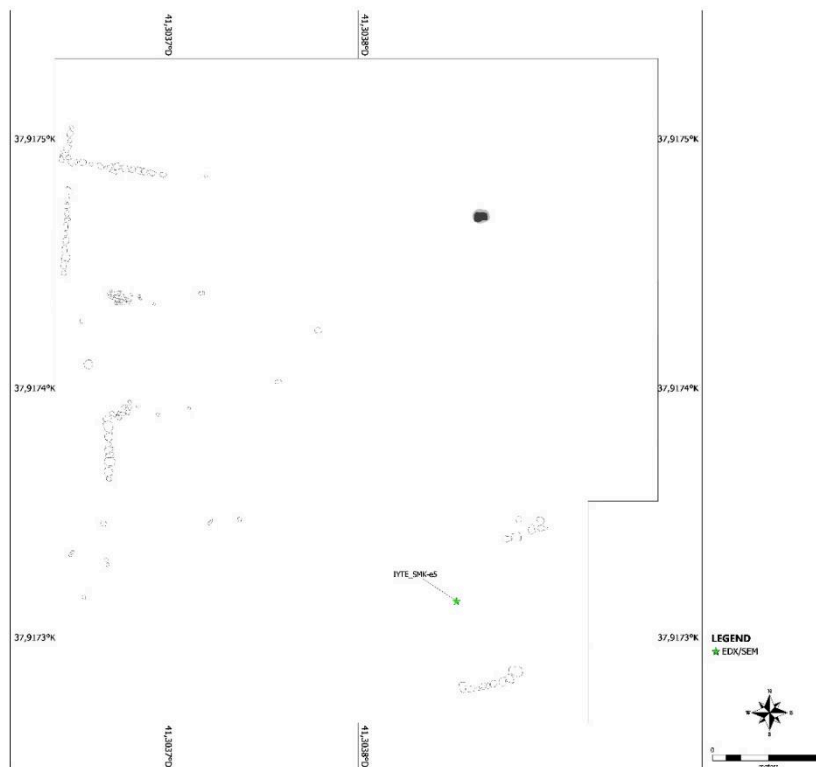
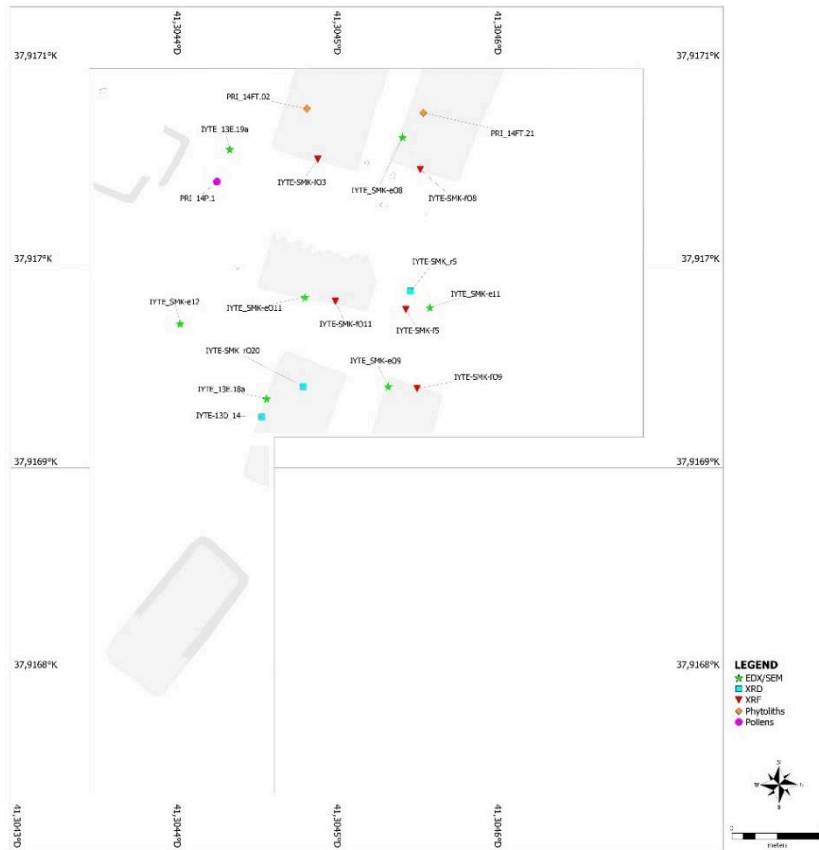
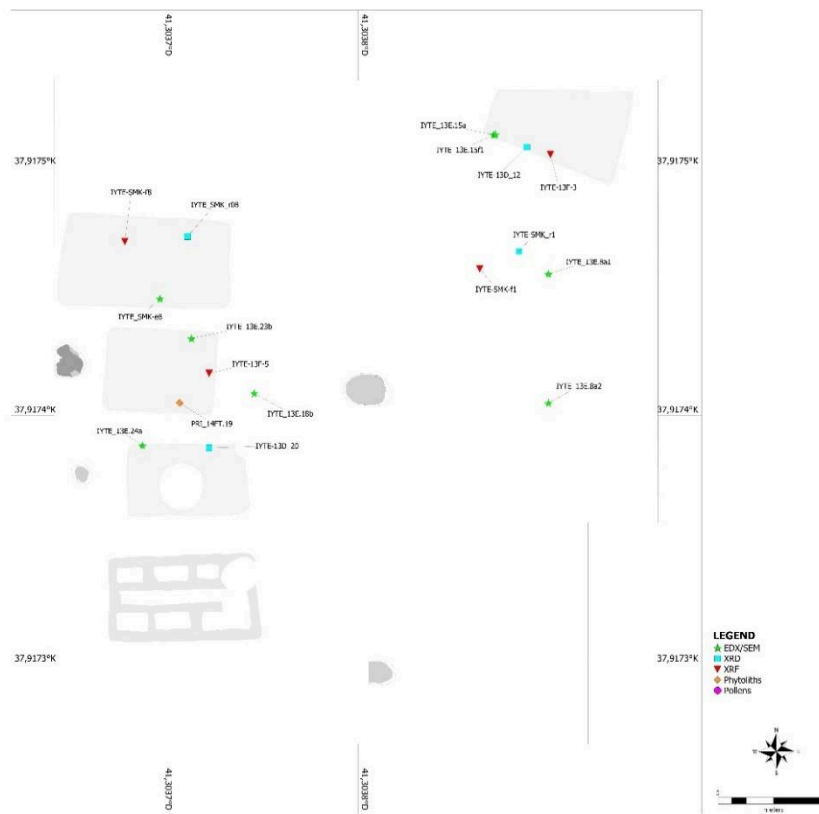
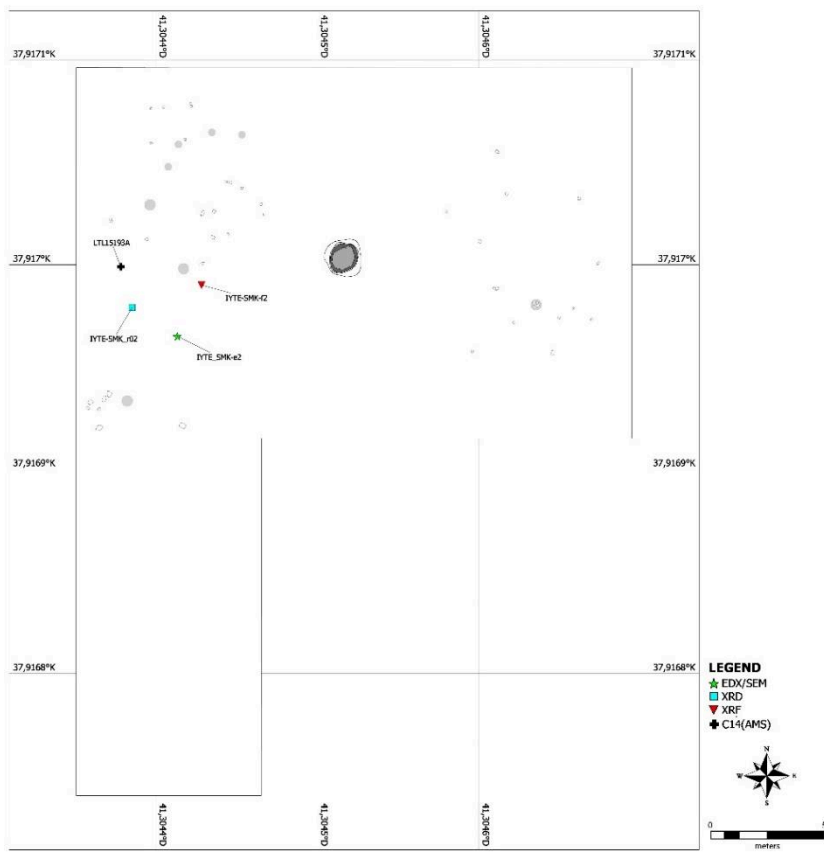
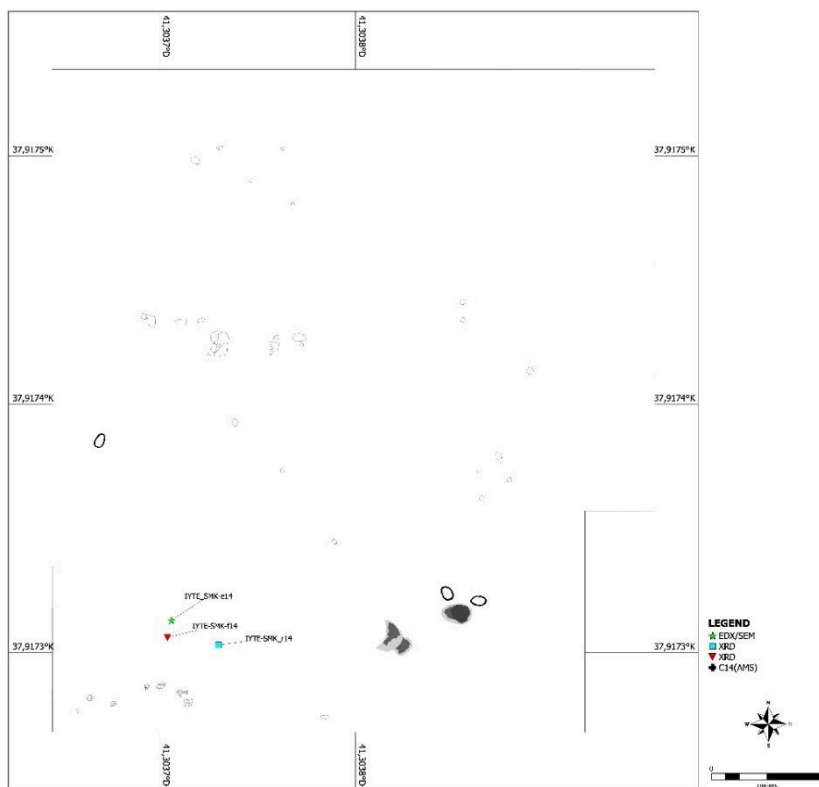
Figure 1.5: Locations of all analysis sample from Phase N1 at the Area A

Figure 1.6: Locations of all analysis sample from Phase N1 at the Area B

Figure 1.7: Locations of all analysis sample from Phase N2 at the Area A

Figure 1.8: Locations of all analysis sample from Phase N2 at the Area B

Figure 1.9: Locations of all analysis sample from Phase N3 at the Area A

Figure 1.10: Locations of all analysis sample from Phase N3 at the Area B

SEM/EDX analyses are a comprehensive method especially in re-construction of archaeological materials and micro-analyses of remains. Scanning electron microscopy is the imaging technique used to determine the surface structure of samples. In our study, high-quality images could be obtained by SEM analysis, together with defining the characteristics of samples in archaeological and geomorphological areas. SEM images utilised Philips XL-30S FEG and FEI Quanta 250 FEG instruments at İzmir Institute of Technology, Centre for Materials Research.<sup>3</sup> EDX element analyses are for identifying the chemical properties of samples. In this study, EDX analyses were applied to all SEM samples. The analyses were carried out with a Bruker AXS XFlash EDX detector connected to a scanning electron microscope. SEM imaging and EDX analyses were performed on 69 samples from the Sumaki Höyük Neolithic phases. (See Table 1.1 – 1.3, 4.8 – 4.10 and Figure 1.5 – 1.17 for detailed samples information)

An essential method complementing the SEM / EDX analyses is XRD analysis; an analytical method of identifying and describing the minerals contained in solid samples according to crystal structures. (Shrivastava, 2009: 41-47) By this method, all minerals in the sample can be identified by patent assignment. Information on the number of minerals is also available. In short, the environmental conditions during the deposition process of an example can be understood by means of XRD analysis. (Schreiner, et al., 2004: 1; Creanga, 2009: 60) Specified minerals and related elements are interpreted in our study. In the XRD analyses, a Philips X'Pert Pro device was used at İzmir Institute of Technology, Centre for Materials Research. In this study, XRD analysis was carried out on 10 samples obtained from the geological formation and 32 samples taken from the Sumaki Höyük Neolithic phases. (See Table 1.6 – 1.9, 4.13 – 4.16 and Figure 1.5 – 1.17 for detailed samples information)

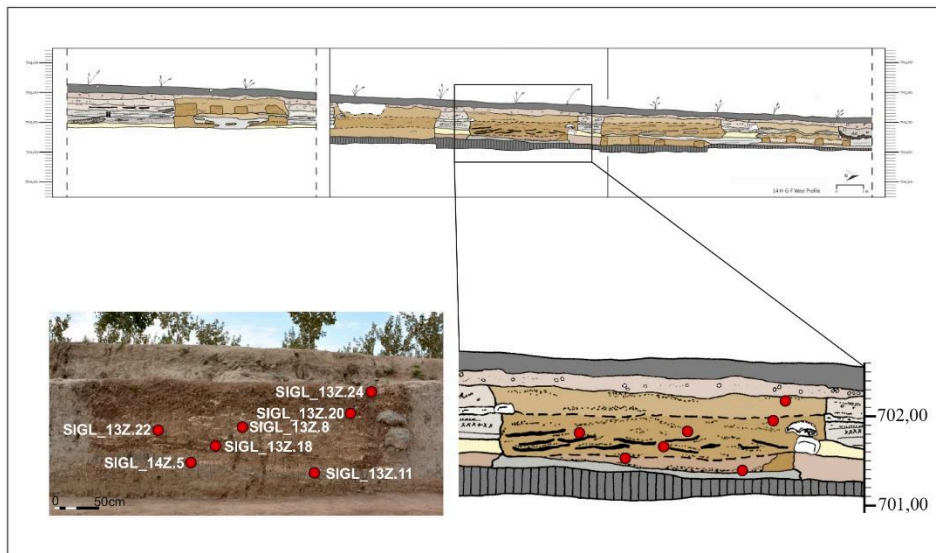
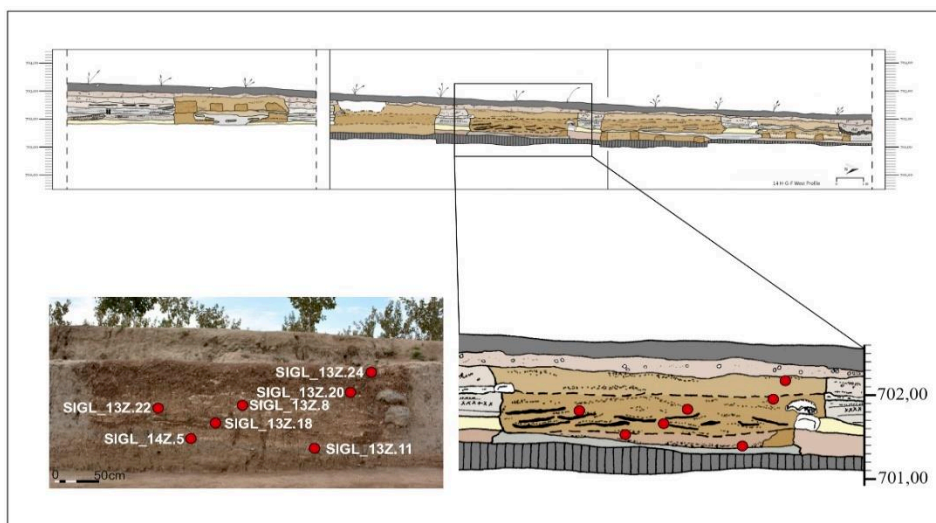
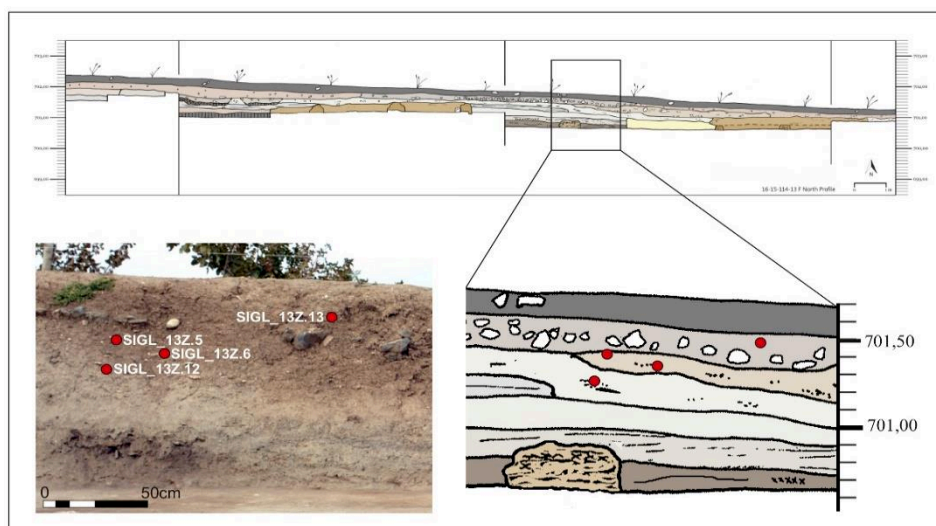
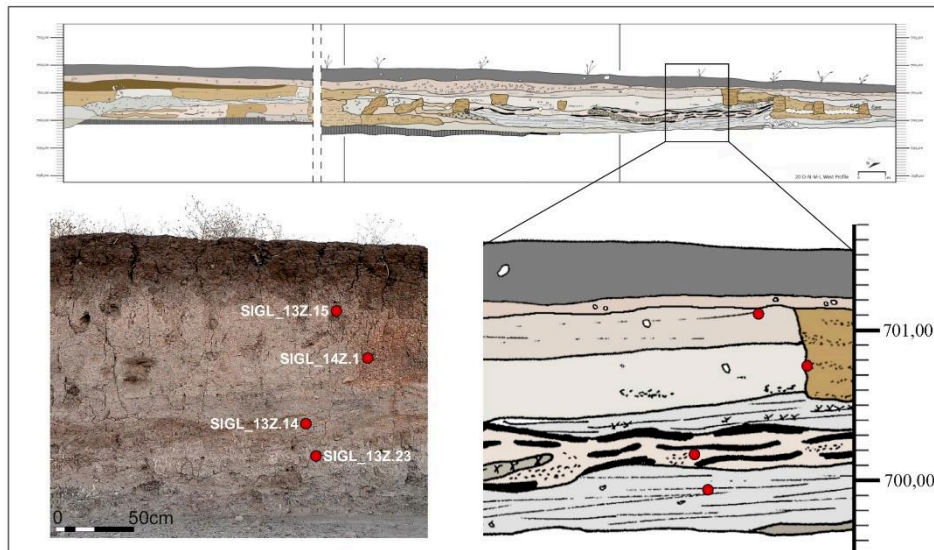
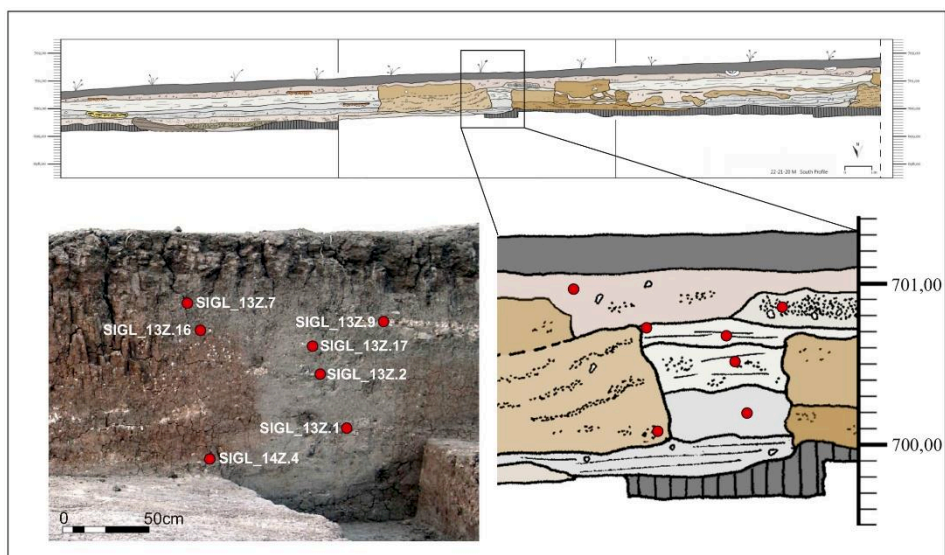
Figure 1.18: Locations of Isotope analysis sample from trench 14G at the Area B

Figure 1.19: Locations of Isotope analysis sample from trench 15G at the Area B

Figure 1.20: Locations of Isotope analysis sample from trench 15F at the Area B

Figure 1.21: Locations of Isotope analysis sample from trench 20M at the Area A

Figure 1.22: Locations of Isotope analysis sample from trench 21M at the Area A

Isotope analyses are quite prevalent for defining climatic and environmental conditions in the past and for establishing the paleo-environment of the study area. 30 lime samples taken from Neolithic structures were sent to the Environmental Isotope Laboratories at Arizona University<sup>6</sup> for isotope analysis.  $\delta^{18}\text{O}$  and  $\delta^{13}\text{C}$  of carbonates were measured using an automated carbonate preparation device (KIEL-III) coupled to a gas-ratio mass spectrometer (Finnigan MAT 252). Powdered samples were reacted with dehydrated phosphoric acid in a vacuum at 70°C. The isotope ratio measurement is calibrated based on repeated measurements of NBS-19 and NBS-18 and precision is  $\pm 0.10$  ‰ for  $\delta^{18}\text{O}$  and  $\pm 0.08$  ‰ for  $\delta^{13}\text{C}$ . (See Table 1.10, 4.17 and Figure 1.18 – 1.22 for detailed samples information)

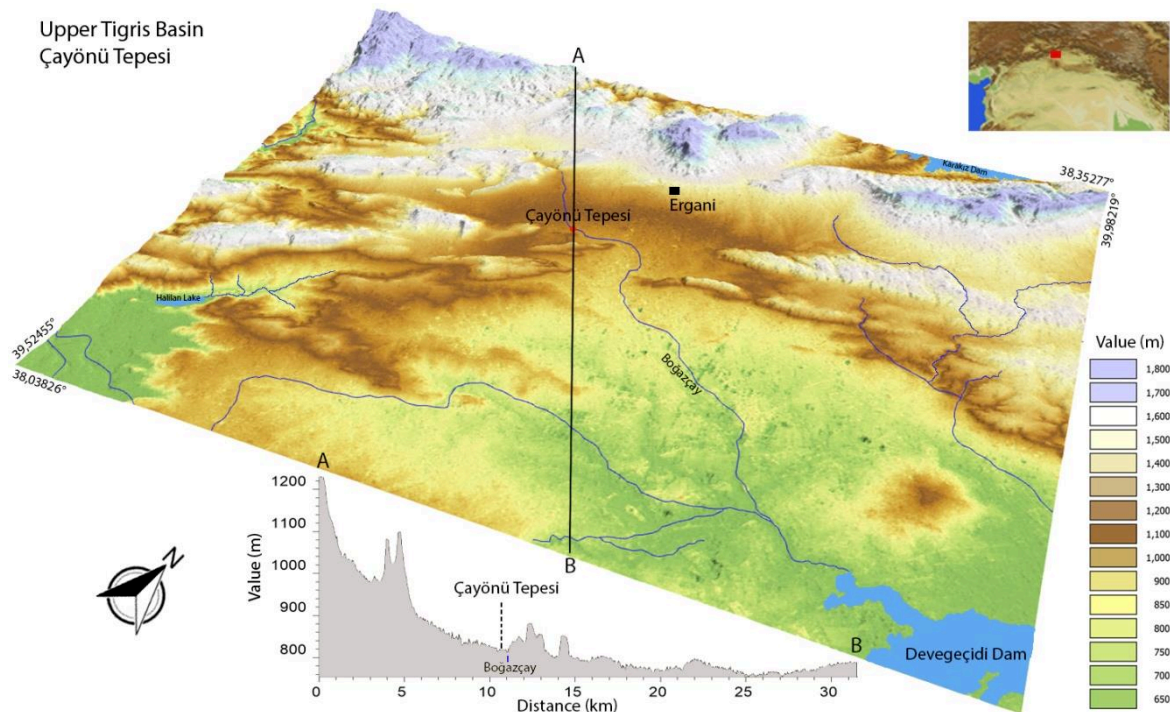
**Figure 2.1:** 3D DEM and cross-section of the environment of Çayönü Tepesi

The altitude of the settlement is 832 meters. (Figure 2.1) The settlement covers an area of approximately 5.6 hectares and has a culture fill of 4.5 m in the southern part and 6.5

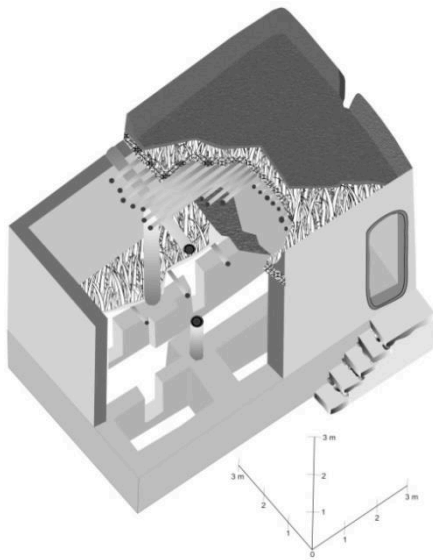
**Figure 2.2:** Reconstruction model a Cell Building from Çayönü Tepesi

The Cell Buildings were built with mudbrick walls on stone footings encircling basement floors. (Figure 2.2) It is thought that the main function of the basements constructed by partitioning in different sizes was to protect the living space from floods. None of the cells in the basements have door openings to external area. Therefore, it is foreseen that the basements were entered from multiple openings above. The basement floor, which is opened/closed by a lid on the floor of the main living area, was used for storage and/or graves. (Erim-Özdoğan, 2007: 72-73)

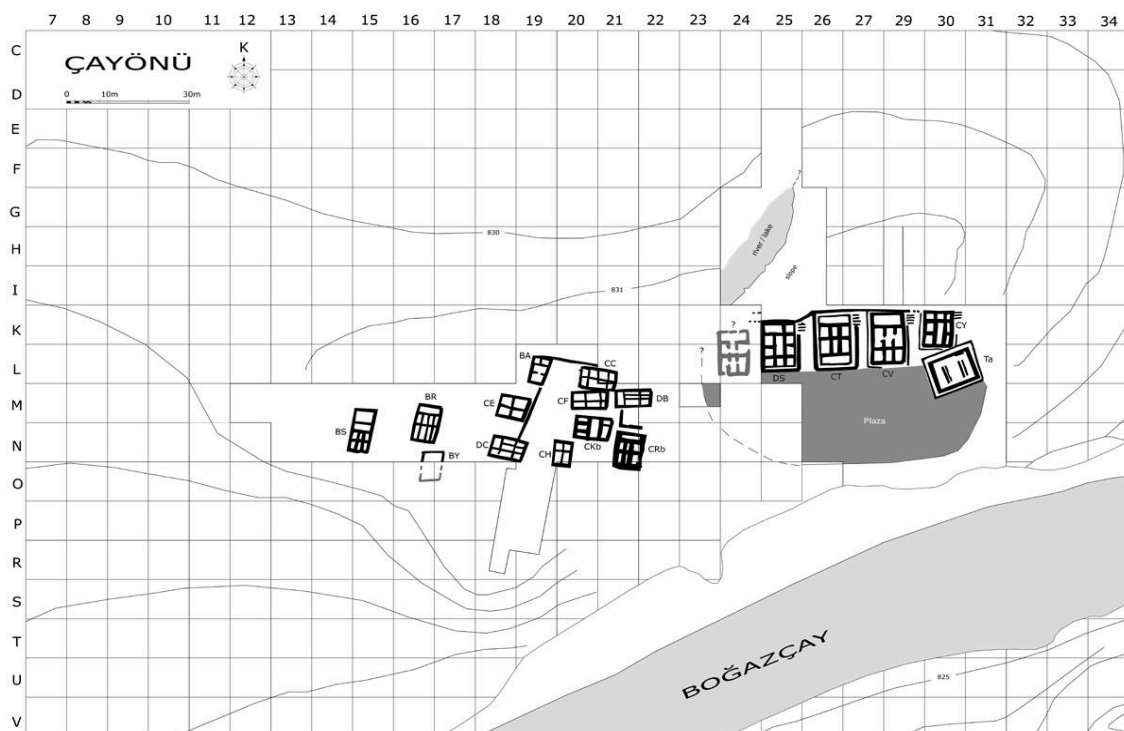
**Figure 2.3:** Settlement pattern and architecture from Subphase c3

The floors above the basements consist of a single rectangular space and the walls are built with mudbrick blocks. No trace of interior partitioning was detected on the upper floor. According to data from the Çayönü house models and burnt mudbrick fragments with traces of beams in the accumulation of buildings, the cell buildings had flat roofs. The main living quarter raised on stone footings is entered via stone stairs. (Figure Figure 2.3)

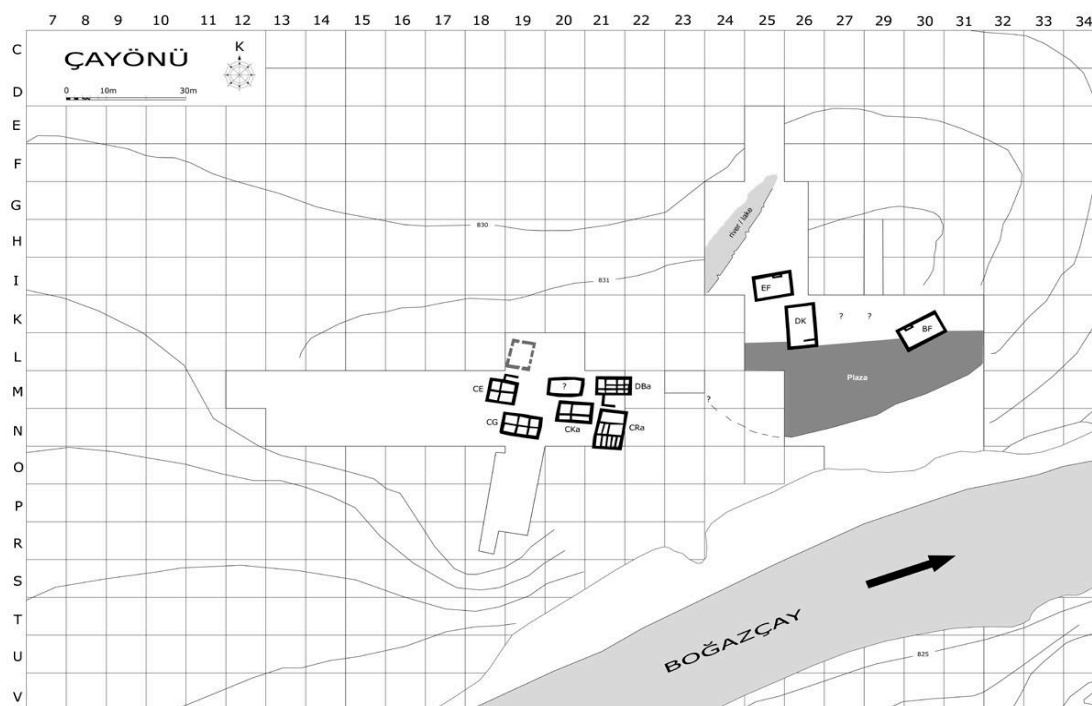
**Figure 2.4:** Settlement pattern and architecture from Subphases c3b and Ir1

From the initial phase of the Cell Building Subphase, due to changes in the water level of the Bestakot Stream, floods occurred which affected the settlement. These floods led to the accumulation of different thicknesses and qualities of filling in almost all parts of the settlement. (Erim-Özdoğan, 2007: 76) These flood events also continued in the Large-Room Building Subphase. Up to the fourth phase (Ir4) of this subphase, it is at the forefront of factors that determined the northern boundary of the settlement. It is understood that flood events also continued in the Pottery Neolithic Period, in particular, the presence of multiple terrace walls. The heterogeneous fillings determined locally are more evidence of the continuity of this phenomenon. (Erim-Özdoğan & Yalman, 2004: 69)

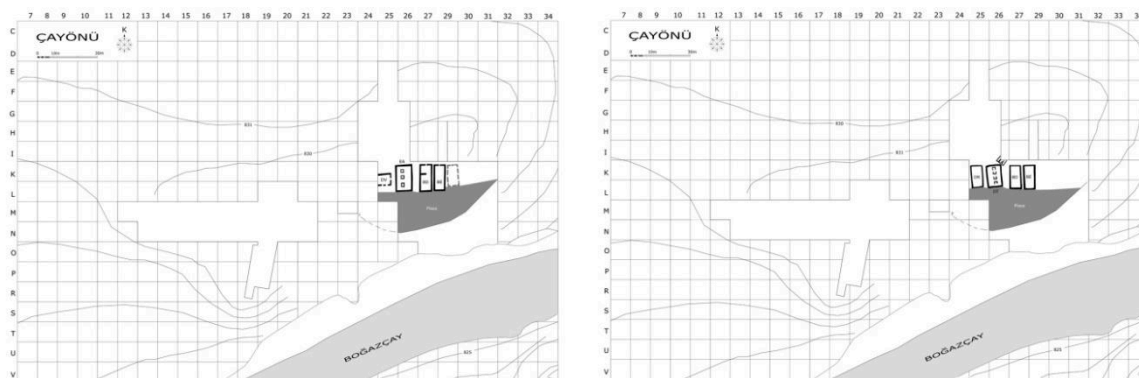
**Figure 2.5:** Settlement pattern and architecture from Subphases Ir3 and Ir2

In domestic architecture, the building of two-storey constructions was totally abandoned. (Figure 2.5) The new structures (large room buildings) are rectangular in plan, single-roomed, with rounded corners, and built using a simple stone wall technique. There are no door openings to the structures. It is thought that the entrance to the stone structures was in the interior, similar to stairs of the same height as the walls. In the early examples, mudbrick remnants were found on the stone walls, whereas these were not detected in the following phases. (Erim-Özdoğan, 2007: 79-80)

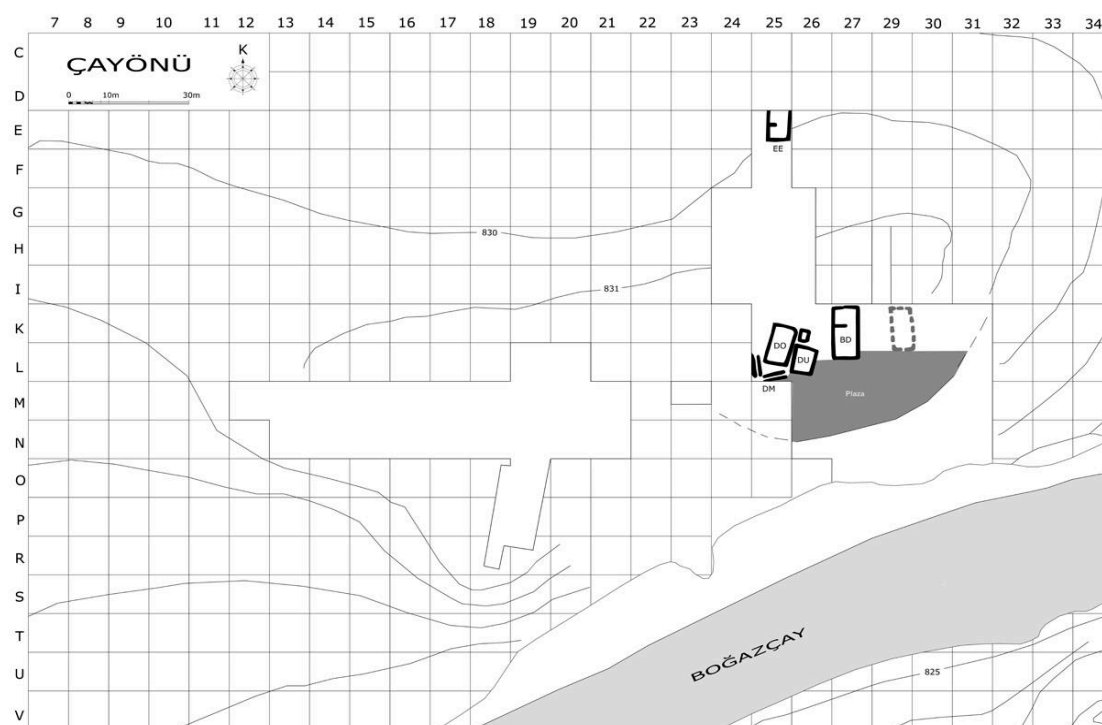
**Figure 2.6:** Settlement pattern and architecture from Subphases Ir4-Ir6

The main occupation area of the Large Room Building Subphase is in the eastern part of the site. The random placement of large room buildings disrupted the order of the outer areas. (Figure 2.6) The “Plaza” of the Cell Building Subphase was transformed into a daily use area and later on to a refuse dump. (Erim-Özdoğan, 2007: 79) According to Caneva, a different socio-economic structure similar to “pastoral life” developed. (Caneva, et al., 1998: 203) All these changes in Çayönü settlement have been defined as the “collapse” of the PPNB period, based on environmental impacts. (Erim-Özdoğan, 2007: 80-81)

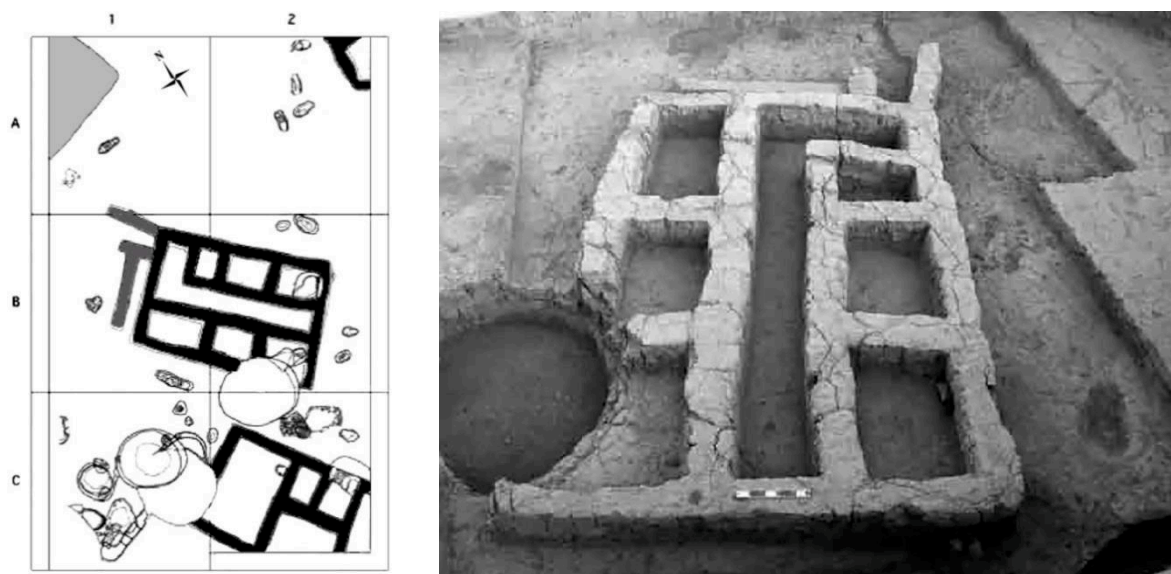
**Figure 2.8:** Settlement pattern and architecture from Phase 2 (Miyake, 2010a: 444 Çizim 2, 446 Resim 1)

Phase 2 (Layers 7–3) yielded well-preserved architectural structures. Rectangular buildings with pisé walls, oval-shaped hearths, and a subterranean fire pit at a depth of 15 to 20 cm were exposed. (Miyake, 2010a: 437; Miyake, 2010b: 421-422) Buildings with pisé walls on the uppermost layer (Layer 3) of this phase were divided into smaller rooms (cells) with partition walls. The cell buildings without stone footings were built directly on natural

ground. The inner division of the structures consists of a narrow “L” shaped corridor in the middle and three smaller spaces with different sizes on either side of Structure 166. (Figure 2.8) Structure 166 is approximately 5 m long and 3.5 m wide. Two walls were found immediately adjacent to the western edge of this structure, but their relationship with it has not been clearly established. (Miyake, 2007b: 38-40) The structures were deliberately buried with the debris of the walls, and similar constructions were built on top. (Miyake, 2009: 105) Very few materials were found in the rooms. Hearths were also rebuilt on top of each other, like the buildings. (Miyake, 2007b: 38-40) The hearths in the open areas are similar to each other with an average length of 2 m and a width of 1 to 1.5 m. Their edges are low. The parts where edges are not present are thought to be their mouth. The floors of the hearths were laid on stone pavements. (Miyake, 2010a: 439) In Layers 2 and 1 of Phase 3, there are no architectural features since their deposits had already been removed at that time. (Miyake, 2011: 132)

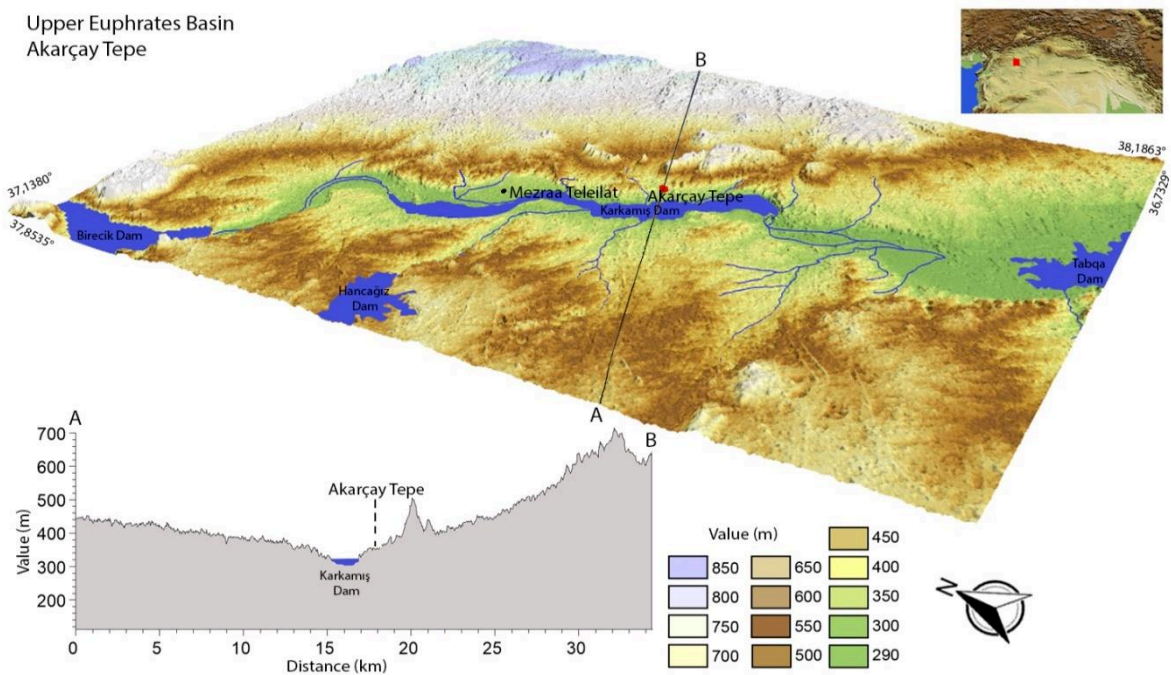
**Figure 2.10:** 3D DEM and cross-section of the environment of Akarçay Tepe

Akarçay Tepe is located just to the west of Akarçay village in the Birecik district of Şanlıurfa. The settlement lies on an alluvial flat terrace on the eastern bank of the Euphrates River, next to Su Stream. The Neolithic settlement, which is 357 meters above sea level, covers an area of approximately 5 hectares. (Figure 2.10)

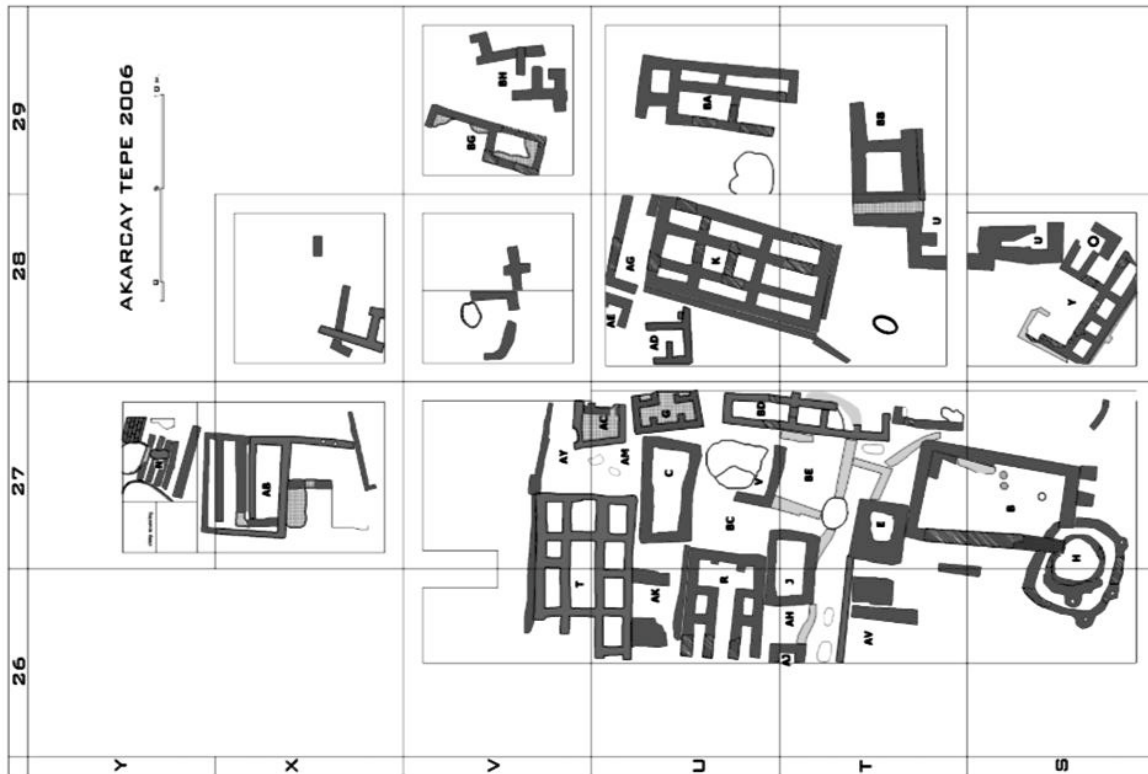
**Figure 2.11:** Settlement pattern and architecture of Akarçay Tepe (Duru, 2013:339 Şekil 20)

According to architectural construction and type of building, and also characteristics of the finds, the settlement stratification is as follows: Layer 11-9 Middle PPNB; Layer 8-7 Late PPNB; and Layer 6 defines the Final PPNB period. The layer 5-1 has been dated to the Pottery Neolithic Period. (Özbaşaran & Molist, 2007: 180-183) From the Layer 6 to Layer 1 of this settlement is dated to between 8750±40 and 7280±59 BP which has a calibrated range from 9752±93 to 8097±61 CalBP or 7802±93 to 6147±61 CalBC. (Arimura, et al., 2001: 181; Duru, 2013:340 Tablo 10)

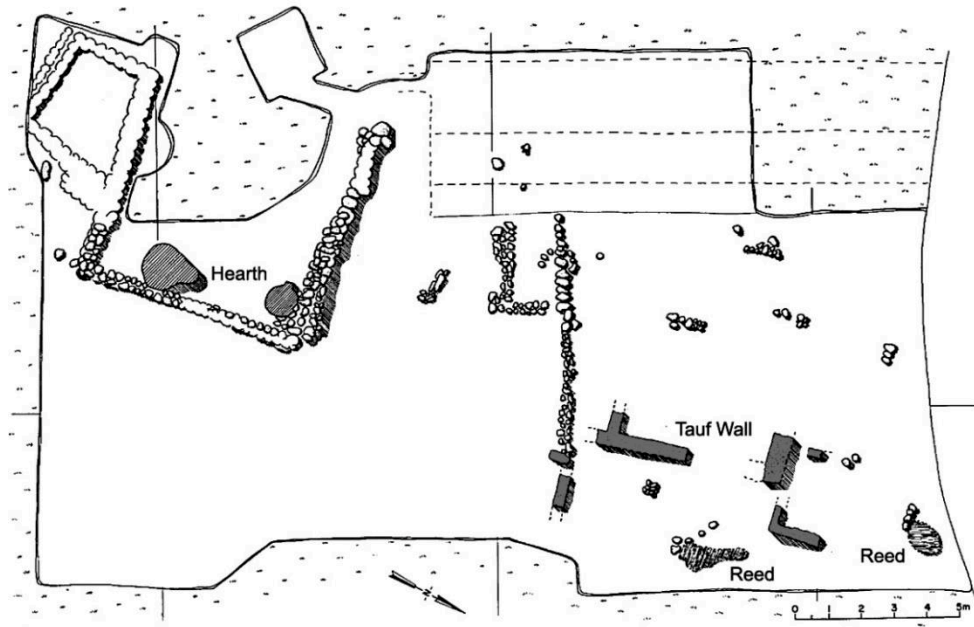
**Figure 2.14:** Settlement pattern and architecture from J-II, 3 (Braidwood, 1983a: 181 Fig.84)

Almost all structures are rectilinear and multi-roomed. Small rooms such as cells are thought to have been used for storage purposes. Similarities to the Grill Buildings of Çayönü Tepesi were revealed in Operations J-I and J-II. Stone rows were used in the later levels, (Figure 2.14) whereas in early levels there were only tauf walls, with a thickness of 40 cm. Most of the compacted earthen floors were flattened and artefacts such as large ground stone pestles, mortars and querns were found on them. The floors were covered with lime, or between their renewal stages, due to lime traces, it is thought that reeds were laid. There are also well-preserved floors with matt remains that exhibit different weaving techniques. (Adovasio, 1975: 224-230) There are many fireplaces in different areas. The architectural structures of Jarmo are thought to have been used for housing in general, although this aspect is not yet fully understood. In Jarmo, orange-coloured buff, fine sandy clayey fillings were also detected. These deposits have been interpreted as the remains of ruined or abandoned structures. (Braidwood, 1983a: 155-163)

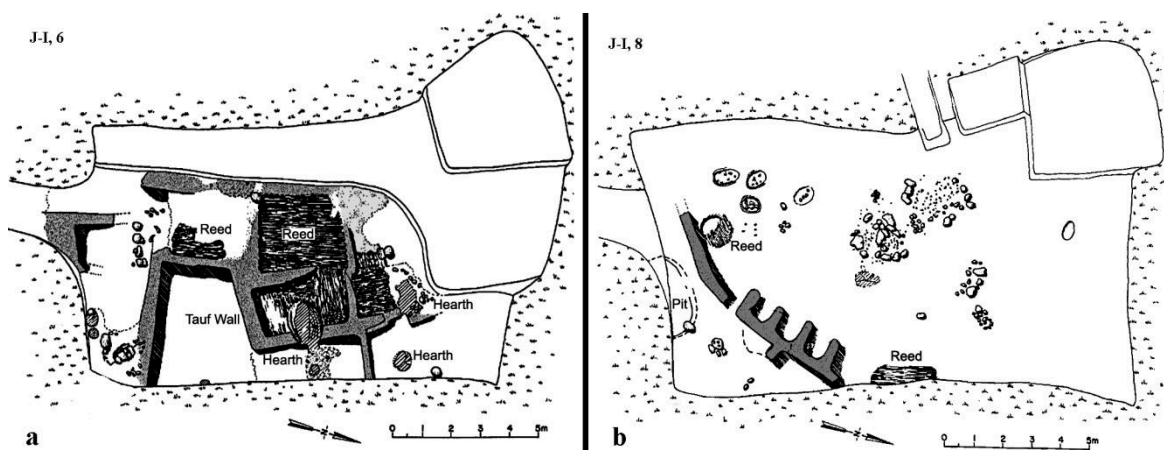
**Figure 2.15:** Settlement pattern and architecture from J-I, 6a-d, and J-I, 8 (Braidwood, 1983a: 174 Fig.41, 173 Fig.39)

The Operation J-I area has 9 phases according to architectural data. In this area, consecutive layers of reed surfaces were detected. Some of them have even been defined as short-term interior floorings, since these surfaces were almost the same size as the dimensions of the rooms. The widths of the tauf walls of the buildings are different from each other. It has been suggested that the walls and floors of buildings in this area were often renovated or short-term. The best examples of architectural remains that have been clearly identified are in Phases J-I,6a (Figure 2.15a) and J-I,7. The tauf walls generally were buff colour at Jarmo, but the tauf wall in the area J-I has an orange colour. The reason for this is thought to be the effect of fire since the floor of the stall-like alcoves yielded much ash and charcoal. (Braidwood, 1983a: 159)

The walls of buildings in Operation J-I were built with the tauf technique. In this area in Phases J-I,8 (Figure 2.15b) and J-I,9 were exposed tauf walls, a multi-room building, and a tauf wall about 5 meters long. The rooms of the multi-roomed building, which were only partly preserved, were approximately 1x1.1 m. In the open areas, archaeologists identified scattered stone rows, stone concentrations, pebbly surfaces, fireplace-like areas and fire areas (fire-pits). The edges of the fire pits were burnt. In these phases, traces of reeds were also detected in the open spaces. (Braidwood, 1983a: 173 Fig.39)

In Phase J-I,6, some of the tauf walls which were built in Phase J-I,7 were repaired and reused. The most significant feature of this phase is the abundance of reed traces either inside or outside. The number of ovens increased compared to Phase J-I,7. In Phase J-I,5, the walls of the structures were also built of tauf. The settlement pattern of this phase is very similar to Phases J-I,6 and J-I,7. (Braidwood, 1983a: 174 Fig.41-42)

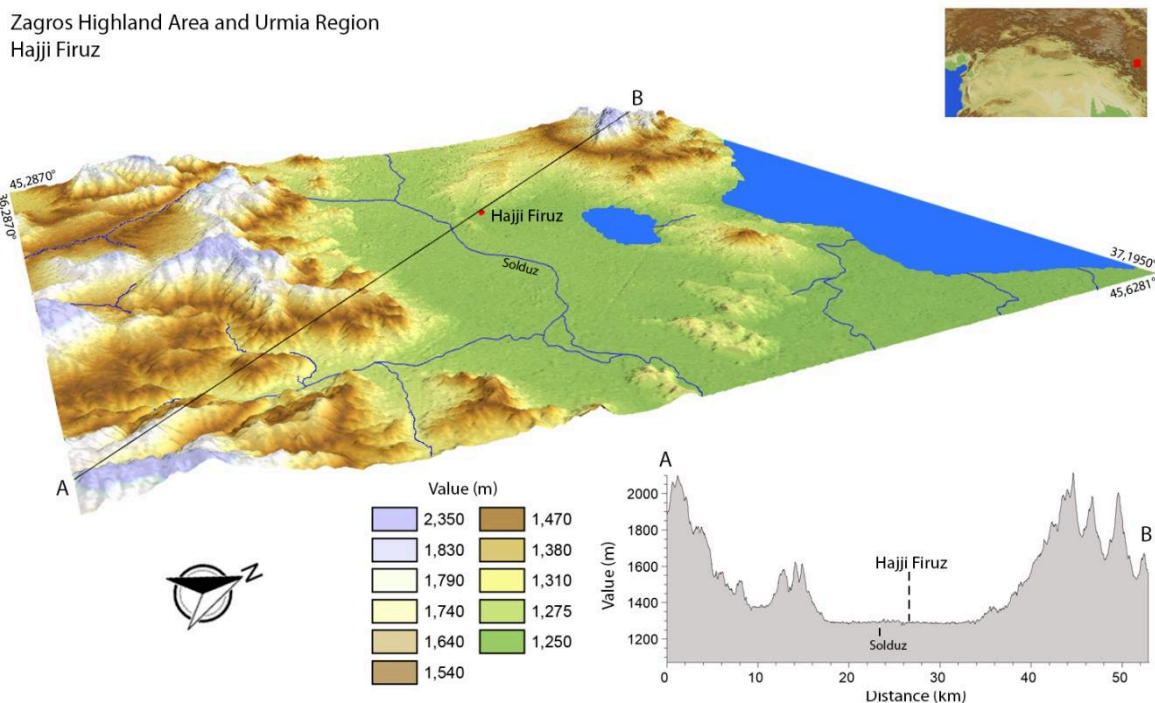
**Figure 2.16:** 3D DEM and cross-section of the environment of Hajji Firuz

Hajji Firuz is located in the north-west of Iran, about 13 km southwest of Urmia Lake and in the northeastern part of Solduz Valley. (Figure 2.16) The mound, which is about 10 m higher than the current level of the plain, continues beneath the plain. (Voigt, 1983: 7)

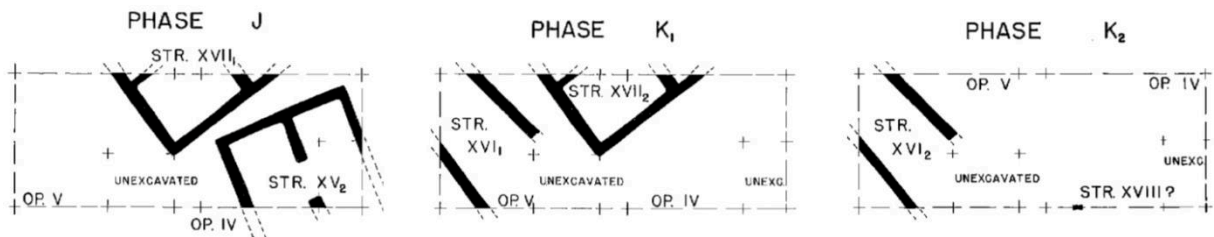
**Figure 2.17:** Settlement pattern and architecture from Phase J and Phase K (Voigt, 1983: 31 Fig.22-24)

The cultural deposit of the earliest phase (Phase L) is limited. The only building remaining is Structure XVII. There are open areas and ashy deposits that are thought to be the remains of structures exposed in Operation V. Rectilinear Structure XVII, which had been reused in Phase K, (Figure 2.17) had more than two rooms. (Voigt, 1983: 30-31) During Phase K, Structure XVI, which as flimsy walls, was added to it.

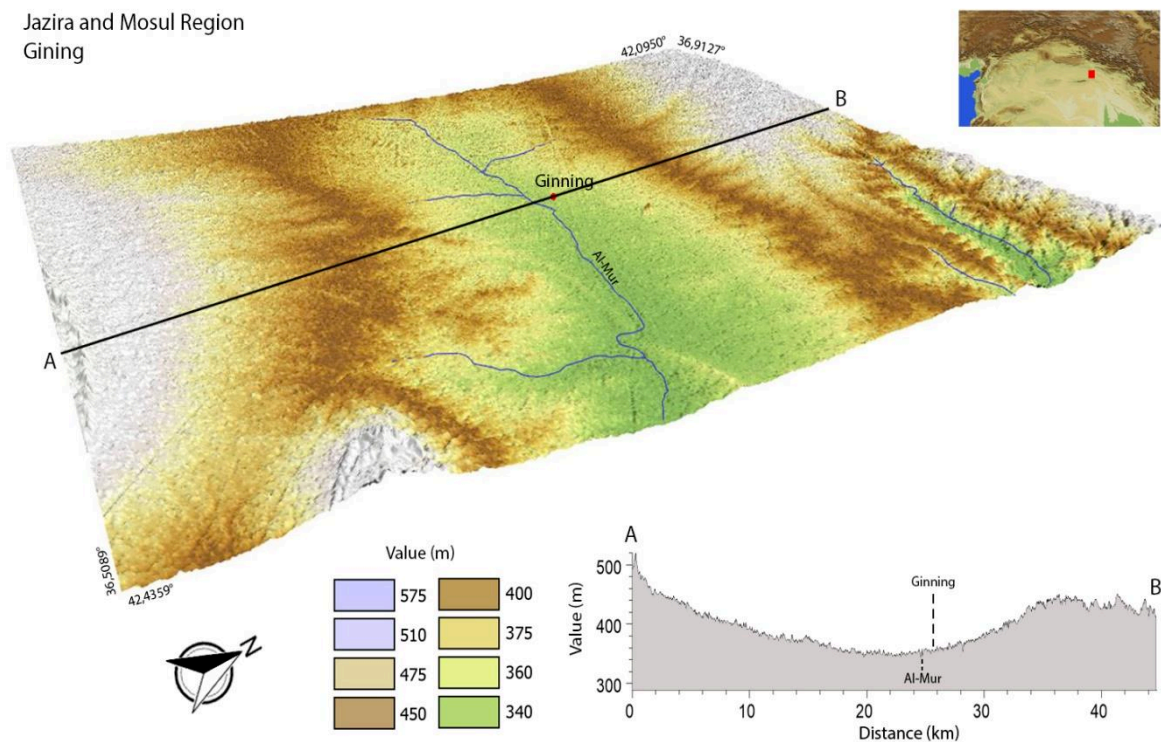
**Figure 2.19:** 3D DEM and cross-section of the environment of Gining

Ginning is located in Jazira, just north of the Wadi Al-Mur. With an altitude of 330 meters, the settlement covers an area of 0.8 hectares. (Figure 2.19) The settlement could only be excavated for four weeks as a rescue operation. An area of approximately 80.75 m<sup>2</sup> was opened and by taking a small sounding, 2x1 m virgin soil was reached 2.2 m from the surface. Only the Pottery Neolithic Period layers were able to be unearthed. (Baird & Campbell, 1990: 65) In the sounding, a natural deposit beneath the upper layer with a structure and adjacent open area points to a break in the continuity of the settlement. Below the natural deposit are consecutive layers with well-preserved tauf remains; however, no architecture was identified. Due to lack of pottery sherds in these layers, the excavators have
