# Microarchaeological observation on the neolithic architectural structures and cultural landscape of Sumaki Höyük

# **Microarchaeological Observation on the Neolithic Architectural Structures and Cultural Landscape of Sumaki Höyük**

PhD Thesis

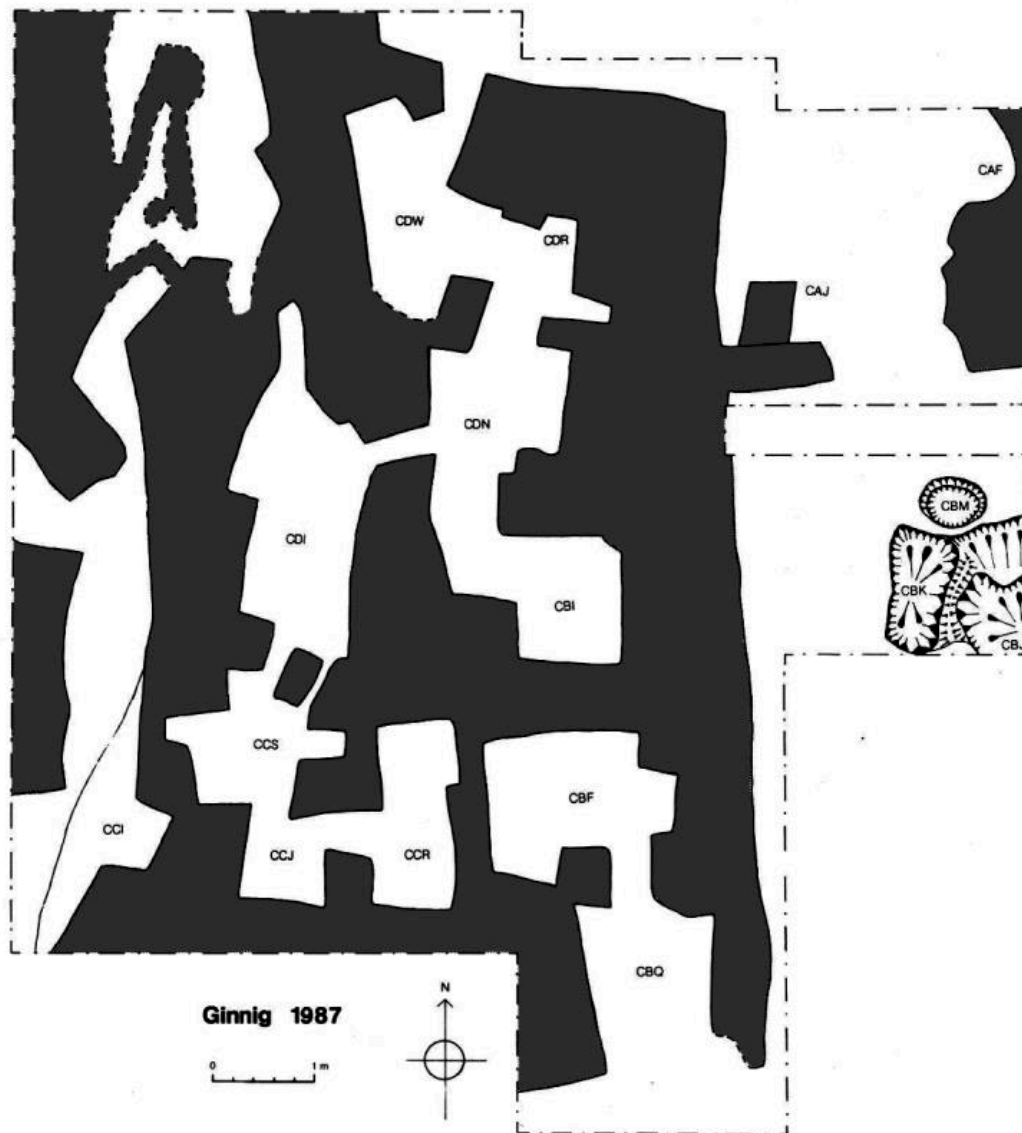
Figure 2.20: Rectangular building in Ginning (Baird & Campbell, 1990: 67 Fig.2)

The building remains beneath the surface soil were completely exposed. A rectilinear structure composed of small rooms divided by partition walls was found. All the walls were tuff and they were only preserved to 20-30 cm in height; therefore, it was very difficult to distinguish their faces. The structure, which resembles a cell-planned building (Figure 2.20) but whose plan could not be clearly determined, had compacted mud-plastered floors. The rooms generally have two floor levels but it is not well understood whether they are renovations or not. In the open areas, more than one “Fire Pit” was detected. (Baird & Campbell, 1990: 66)

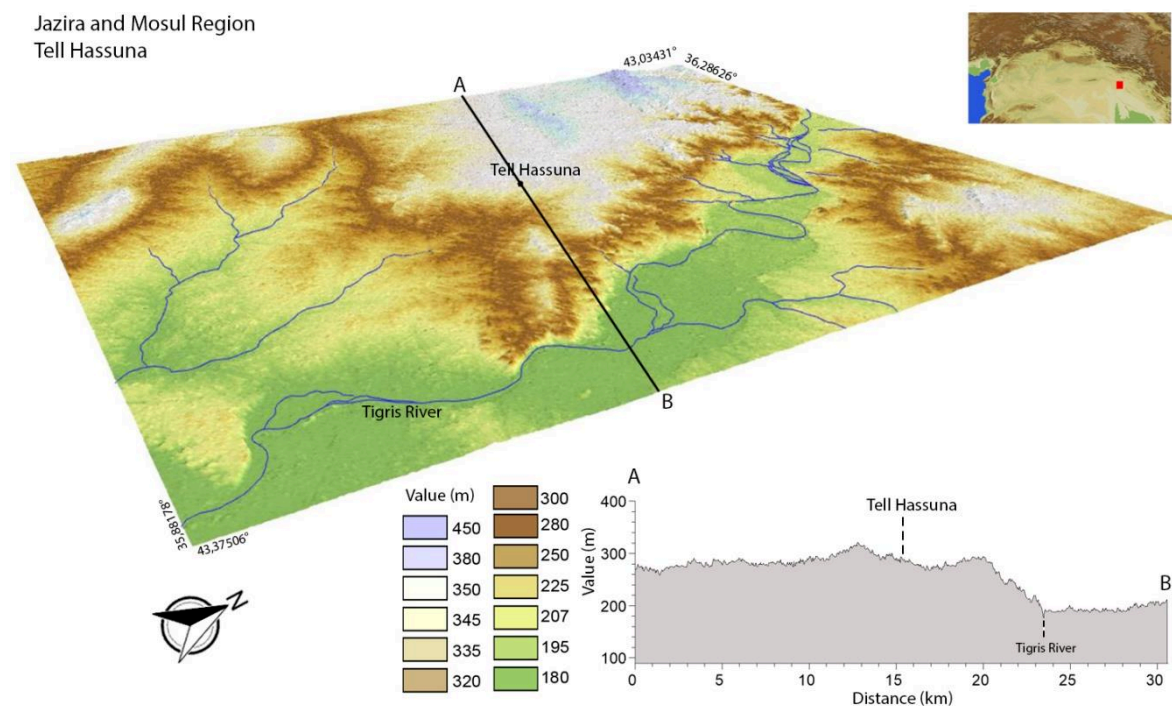
**Figure 2.21:** 3D DEM and cross-section of the environment of Tell Hassuna

Tell Hassuna is located in the Wadi Qasab, which is 5 km northeast of Shura and 25 km southeast of Mosul. Surrounding limestone extends to the immediate east of the mound (Lloyd, et al., 1945: 259) and the site is 7 m above the current level of the plain. The settlement, with an altitude of approximately 300 meters, covered an area of 3 hectares. (Figure 2.21) Fifteen layers were defined in the excavations. The levels are numbered by Roman numerals. Mixed materials belonging to the Assyrian period were found in levels XV-XIII, Ubeid and Halaf in levels XII-XI, Ubeid in levels X-VII, Halaf in levels X-VII, Hassuna Period in levels VI-Ib, and Pre-Hassuna in level Ia. (Lloyd, et al., 1945: 257 Chart 1) In our study, the architecture and elements of levels Ia, Ib and Ic were examined.

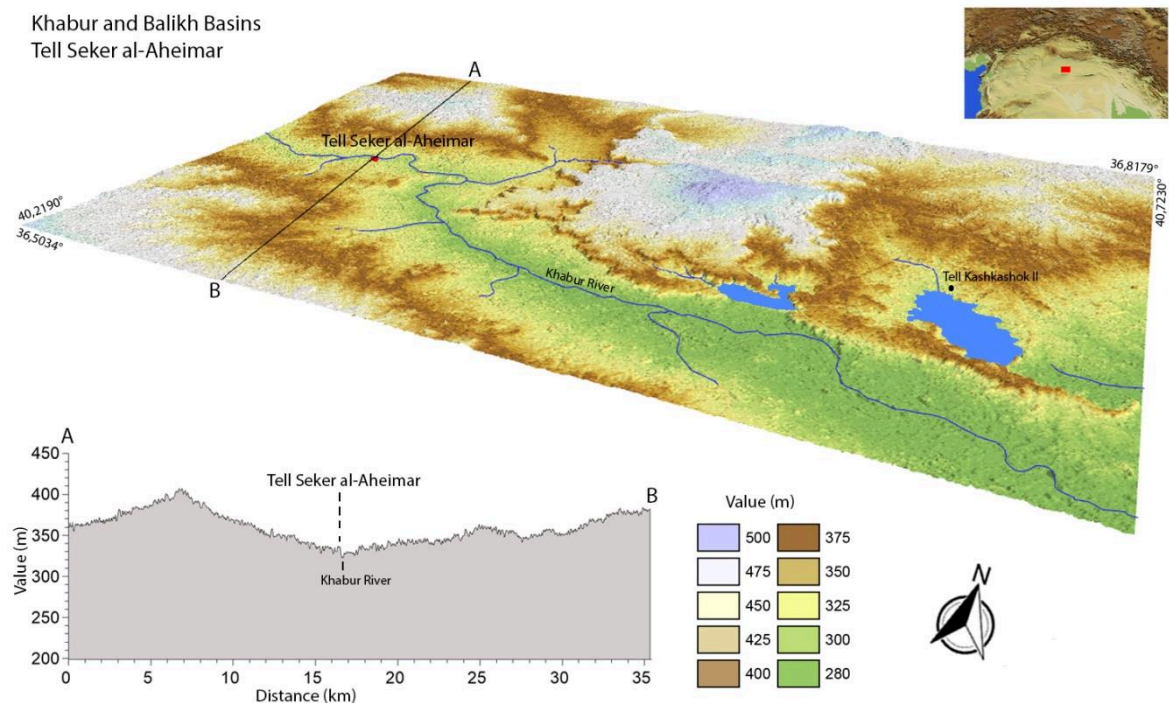
**Figure 2.23:** 3D DEM and cross-section of the environment of Tell Seker al-Aheimar

This site is located on the right terrace of Khabur River in the Upper Khabur Basin. (Nishiaki, 2016: 69) (Figure 2.23) An area of 750 m<sup>2</sup> has been excavated in the settlement which has a size of 300x180 m and a thickness of 11 m filling from the Neolithic Period. According to surface survey data, the site is estimated to have covered 4 hectares. The site has been divided into five different sectors each named using capital letters. Sector C, where Late PPNB architecture and settlement are examined among these five different excavations, the areas (Sector A-E) are the largest exposed area. (Nishiaki & Le Mière, 2005: 55-57; Portillo, et al., 2014: 108) According to the stratigraphy of Sector C; Level 1 is Chalcolithic Period, Level 2 is Proto-Hassuna, Levels 3 to 8 are Pre-Proto-Hassuna, and Levels 9 to 20 represent the late PPNB period. (Nishiaki, 2011: 63; Nishiaki, 2012: 32) The Pre-Proto-Hassuna phase in Sectors C and E has been dated to between 7900±120 and 7540±45 BP while the late PPNB Period has been dated to 8065±145 BP with a single item recovered in Sector E. (Nishiaki & Le Mière, 2005: 65) The architectural phases of Tell Seker al-Aheimar, and particularly the Pre-Proto-Hassuna and Proto-Hassuna phases, present evidence on the Neolithic Period of Khabur Basin. (Nishiaki, 2012: 2012; Portillo, et al., 2014: 107) If we use CalPal calibration on published dates from this site. The dates of Sector A range from

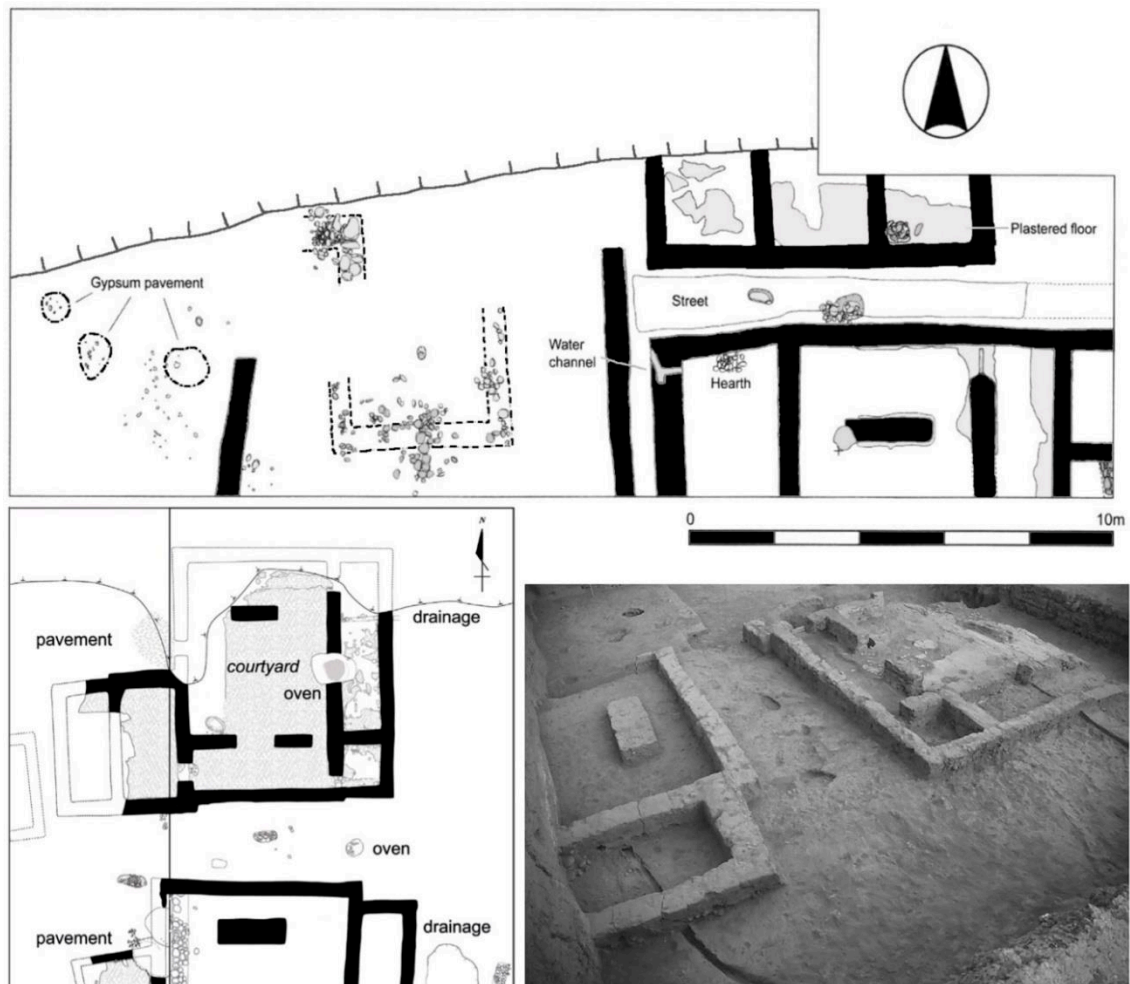
**Figure 2.24:** Settlement pattern and architecture of Tell Seker al-Aheimar (Nishiaki, 2016: 70 Fig.2; Nishiaki and Le Mière, 2005: 58 Fig.3; Portillo, et al., 2014: 108 Fig.2)

dimensions of 4x5 m were the new building type. These constructions are defined as “large room buildings”, which are very similar to the ones at Çayönü Tepesi. In this phase, there were also a few structures with approximately 1 m<sup>2</sup> small rooms (cells) with gypsum-plastered floors. (Nishiaki & Le Mière, 2005: 57)

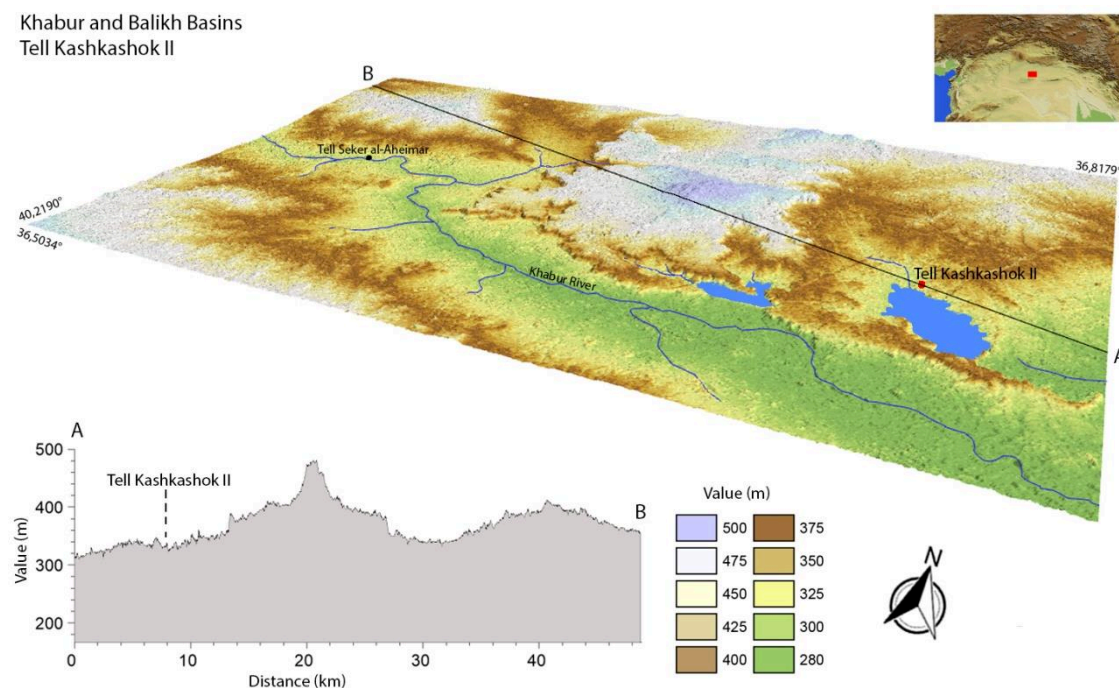
**Figure 2.25:** 3D DEM and cross-section of the environment of Tell Kashkashok II

Tell Kashkashok II is located in Wadi Al Aweiji in Upper Khabur Basin. Its archaeological deposit is 5 meters high on the current alluvial plain and four layers were identified. (Figure 2.25) Layer 1 having a mixed surface soil probably belongs to the Islamic Period, but the exact date cannot be determined. In Layer 2, approximately one hundred graves belonging to the Ubeid and Uruk periods were exposed. Layers 3 and 4 have been dated to  $7880 \pm 110$ - $6290 \pm 220$  BP and belong to the Hassuna Ia Period. (Matsutani, 1991: 5-8, 99) However, these dates presented in the publication are uncalibrated. If we use CalPal calibration method. The dates of Tell Kashkashok II in Layer 3 range from  $7880 \pm 110$  to

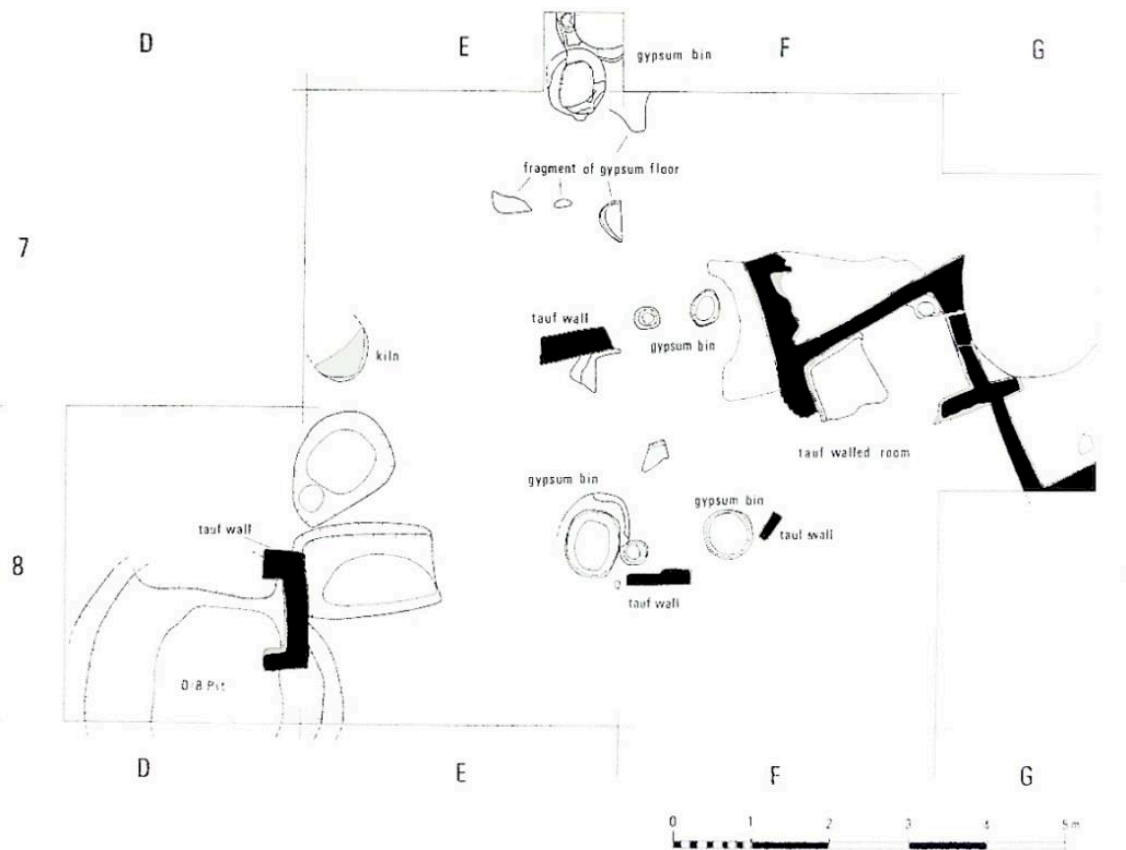
**Figure 2.26:** Settlement pattern and architecture of Tell Kashkashok II (Matsutani, 1991: Plate 57)

Layer 3 fillings were detected between the virgin soil and "Pit House" and left-over deposits among the Ubeid - Uruk burial pits. Layer 3 has four sublayers. (Matsutani, 1991: 11) In the lowermost one, there is a room that was partially disturbed by pits of the upper layer and surrounded by tauf walls 20 cm in width and 9 cm in height. The inner space of the room was 1.9x1.2 m. The room contained a rectilinear area with gypsum-plastered edges

and flooring, and two gypsum-lined jar-type bins dug into its floor as well as many gypsum fragments hinting that the walls were also plastered as was the rest of the floor of the room. Actually, the room was part of a structure consisting of a few small rooms in two or three rows. To the west of this room, tauf wall remains of another structure in a different direction have been identified. The walls were 1.5 m long, 20-40 cm wide and 20 cm high; however, the layout of the structures could not be identified. (Matsutani, 1991: 13-15, Pl 2-3)

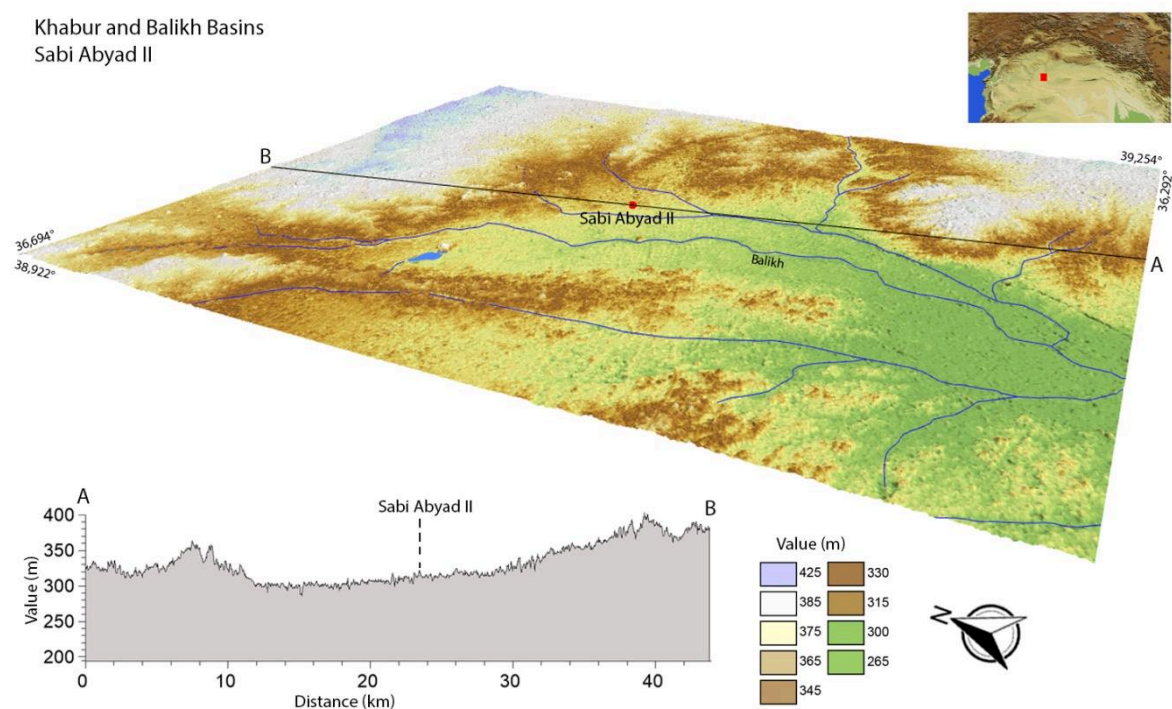
**Figure 2.27:** 3D DEM and cross-section of the environment of Sabi Abyad II

Tell Sabi Abyad is actually the name of four mounds termed Sabi Abyad I - Sabi Abyad IV (Akkermans, et al., 2006: 132; Nieuwenhuys, et al., 2010: 74-76; Verhoeven, 2000: 8) located within a short distance of each other and running north-south in the northern part of the Balikh Basin. The altitude of the settlement is 321 meters (Figure 2.27) and it covers an area of approximately 1 hectare. (Verhoeven, 2000: 8 Fig.2) The late PPNB (LPPNB) - Early Pottery Neolithic (PN) stage is divided into 4 phases at Sabi Abyad II. Phases 3 and 4 represent LPPNB, whereas phases 1 and 2 represent the first PN period. (Nieuwenhuys, et al., 2010: 78 Fig.5) These phases have been dated to 8530-7950 BP (7550-6850 CalBC). (Akkermans, et al., 2006: 143; Nieuwenhuys, et al., 2010: 79; Verhoeven, 1997: 1)

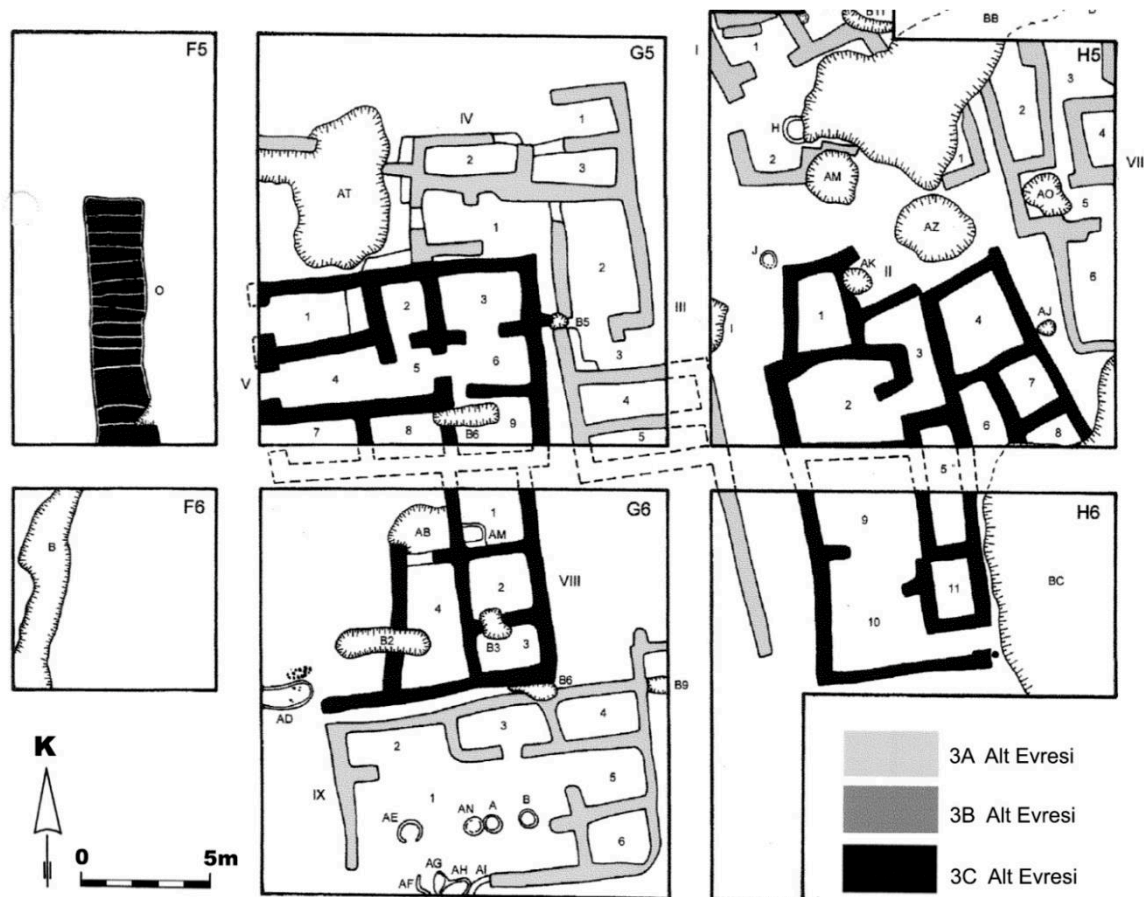
**Figure 2.28:** Settlement pattern and architecture from Phase 3 (Verhoeven, 2000: 9 Fig.3)

Buildings were constructed close to each other leaving small open spaces between them but their directions are different. These buildings were usually constructed in Subphases 3C and 3A running N-NW>S-SE while in Subphase 3D the direction is N>S. The buildings were not large; for example, Structure V in Subphase 3C was 7x5 m in dimension. (Verhoeven, 2000: 8-10)

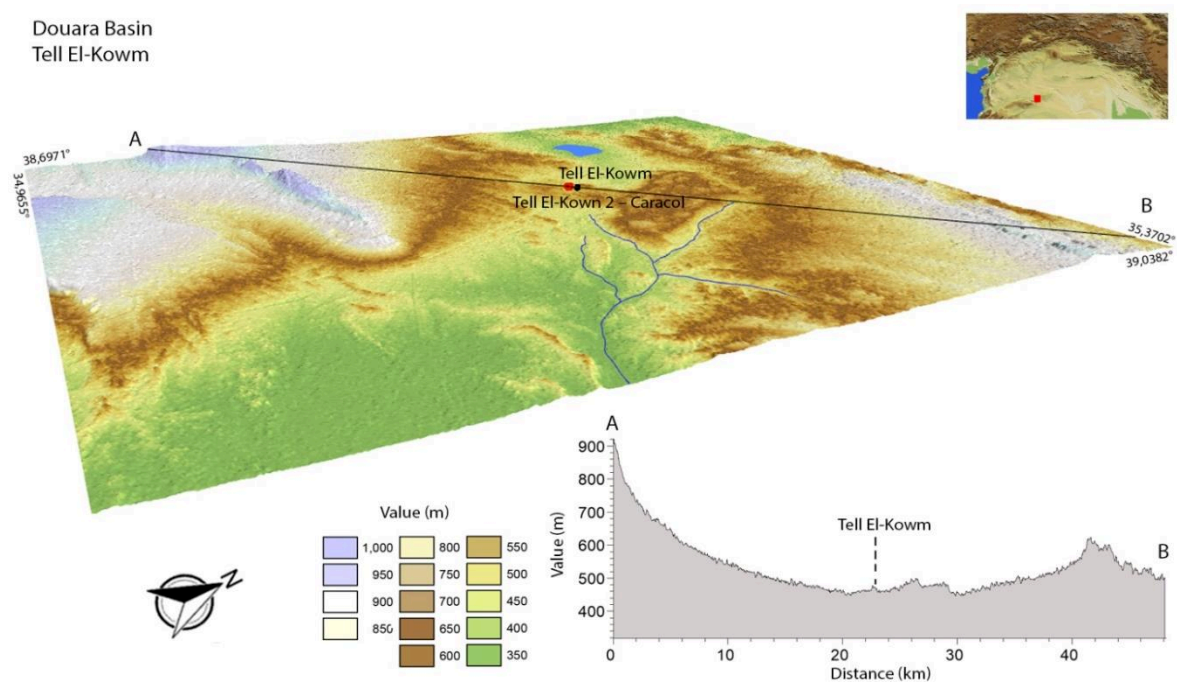
**Figure 2.29:** 3D DEM and cross-section of the environment of Tell El-Kowm

Tell El-Kowm is located between the cities Rakka and Palmyra. (Dornemann, 1986: 1 Plate1; Stordeur, 1989: 102) Its altitude is 490 m (Figure 2.29) and it covers an area of approximately 2.8 hectares. (Dornemann, 1986: Plate 3) The site's stratigraphy has been determined by a step-trench on the slope with a width of 3 meters and a length of approximately 50 meters. The step-trench is divided into nine levels (Dornemann, 1986: 1) and Roman numerals are used for their designation. The oldest layer was exposed at Step IX but virgin soil was not reached. (Dornemann, 1986: 5)

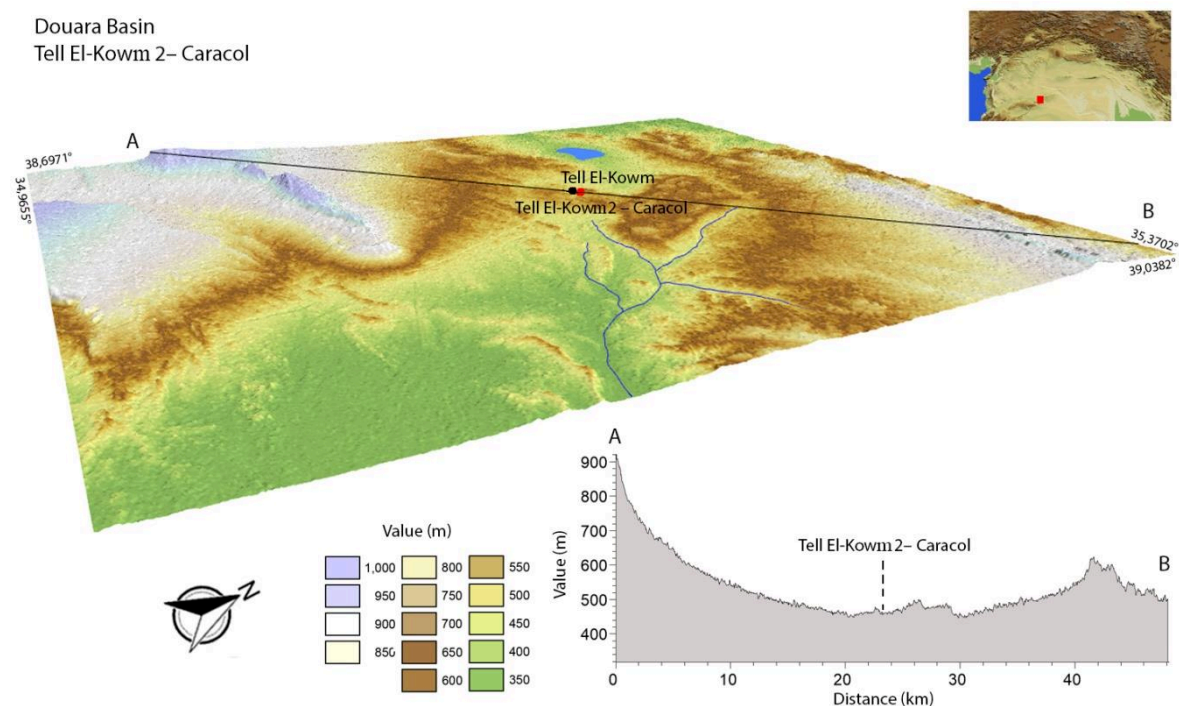
**Figure 2.30:** 3D DEM and cross-section of the environment of Tell El-Kowm 2 – Caracol

The Tell El Kowm 2 - Caracol settlement is located right next to Tell El-Kowm, (Figure 2.30) which has very thick fillings. However, the settlement of Tell El-Kowm 2 is not completely independent from the settlement of Tell El-Kowm. It is likely that Subphase AI, which was the lowest stage of the PPNB Period at Tell El-Kowm-2, was the earliest settlement in this area. (Stordeur, 2000a: 87)

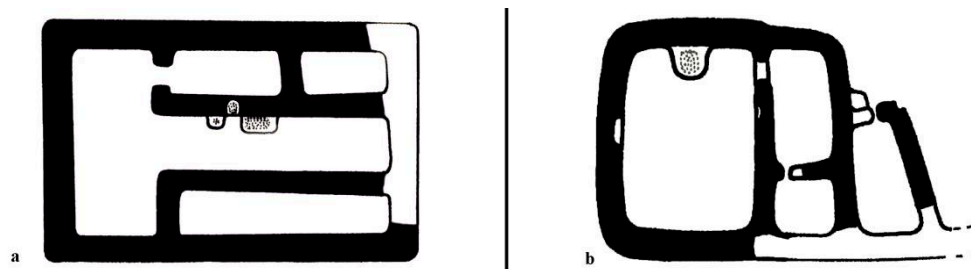
**Figure 2.31:** Type 1 and Type 2 structure plans from Tell El-Kowm 2 – Caracol (Stordeur et al., 2000b: 39 Fig.2)

The buildings in Tell El-Kowm 2 excavations are divided into two types. Structures Type 1 generally have "T" shaped corridors. (Figure 2.31a) In these structures, small rooms (cells) were arranged on both sides of the corridor which was in the middle. Small rooms are thought to have been used for storage purposes. The structures defined as Type 2 are rectangular buildings consisting of small rooms. (Figure 2.32b) Such structures do not have a standardized plan; they are of different dimensions and have different room plans. (Stordeur, et al., 2000b: 39-40) The remains of Subphase AI, which describes the first Neolithic period of the Tell El-Kowm-2 settlement, are not well preserved. In this subphase, a structure called Building XV with a plastered floor has been identified. Subphases AI and the AII were separated from each other by a sterile deposit. Building XIV, which is in Subphase AII, was found to have been built after the abandonment of Building XV.

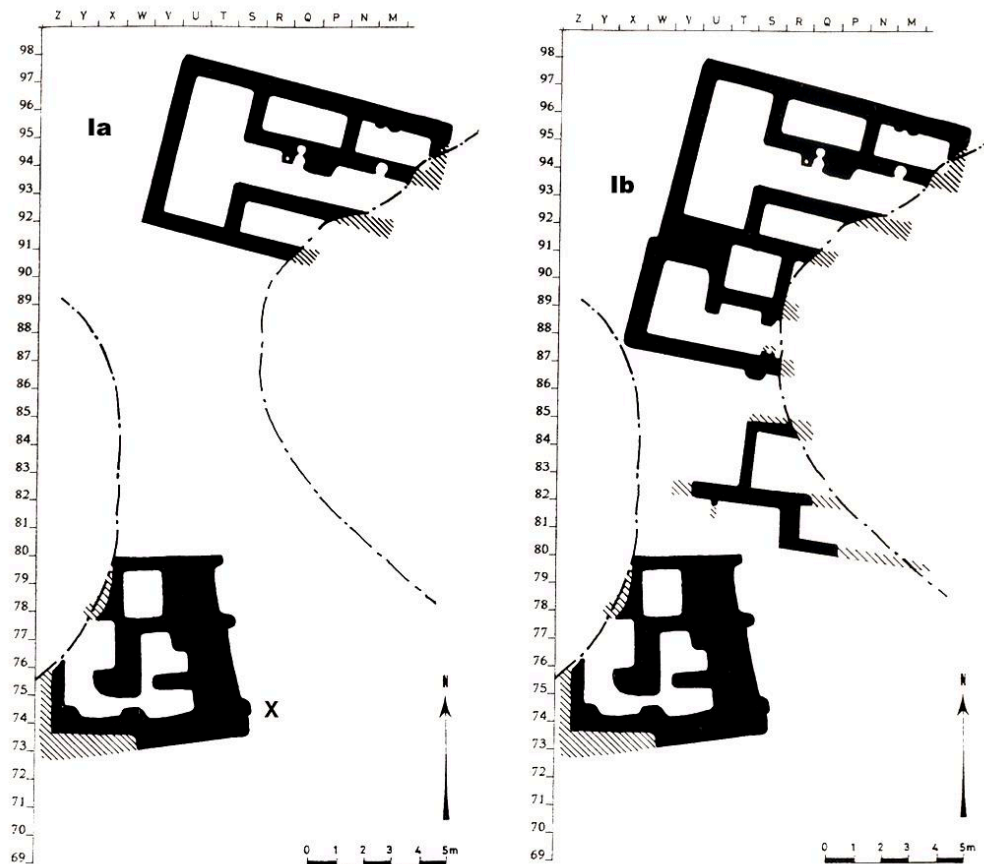
**Figure 2.32:** Settlement pattern and architecture from Subphase IX and X (Stordeur, 2000a:89 Fig1)

Subphase AIV, which was exposed in an area of about 350 m<sup>2</sup>, was quite rich in findings. Buildings I, IV, IX, X, and XII were structures separated from each other by paths or open spaces. (Stordeur, et al., 2000a: 25-27) The most important structure was Building I, with two building stages. Building Ia has a "T" shaped corridor with small rooms (cells) on both sides. (Stordeur, et al., 2000c: 61) This building is allocated as Type 1 according to the excavation classifications. (Stordeur, et al., 2000b: 39) A further structure, as much as half in size of the Building 1 structure plan, was added to Building Ia (Stordeur, et al., 2000c: 69; Stordeur, 1989: 104), namely, Building 1b. It is understood that Building 1a was abandoned or destroyed when Building 1b was in use. (Figure 2.32) In the area where this building is located, another building was built in Subphase AV. There is also a similar situation for Building IX, which was built in two stages, called Building IXa and Building IXb. After Building IV was demolished, these two structures (IXa- IXb) were replaced by Building IV. Although there are traces of abandonment in the southern part of Subphase

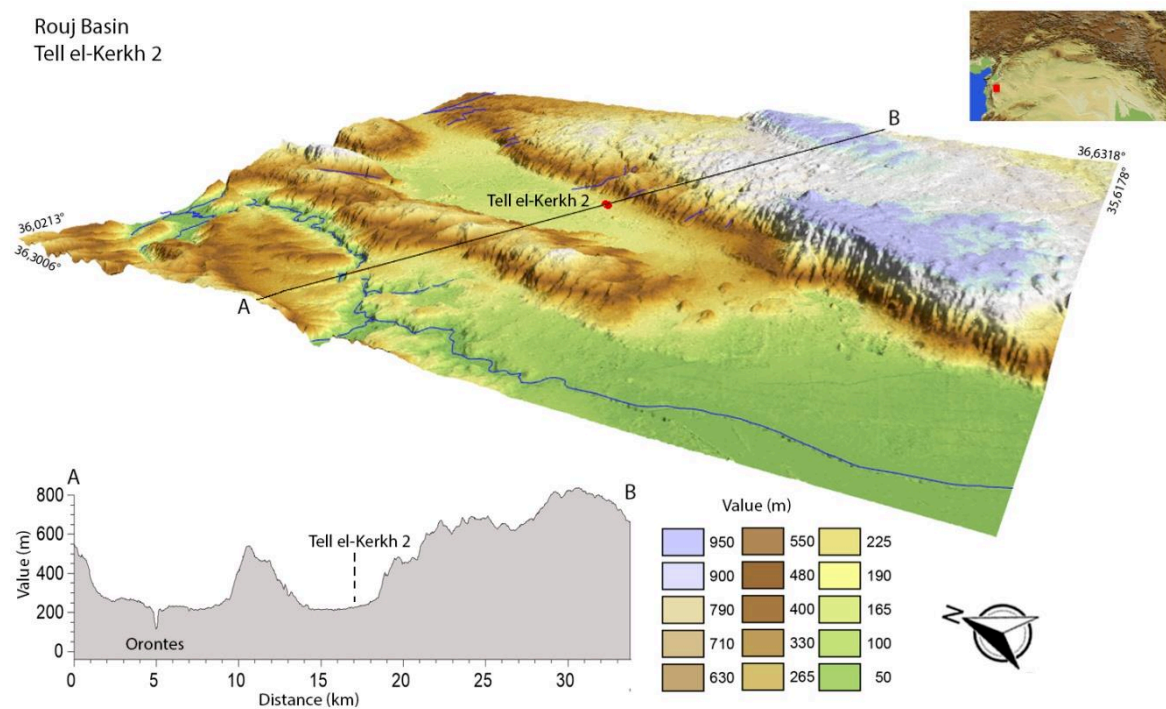
**Figure 2.33:** 3D DEM and cross-section of the environment of Tell el-Kerkh 2

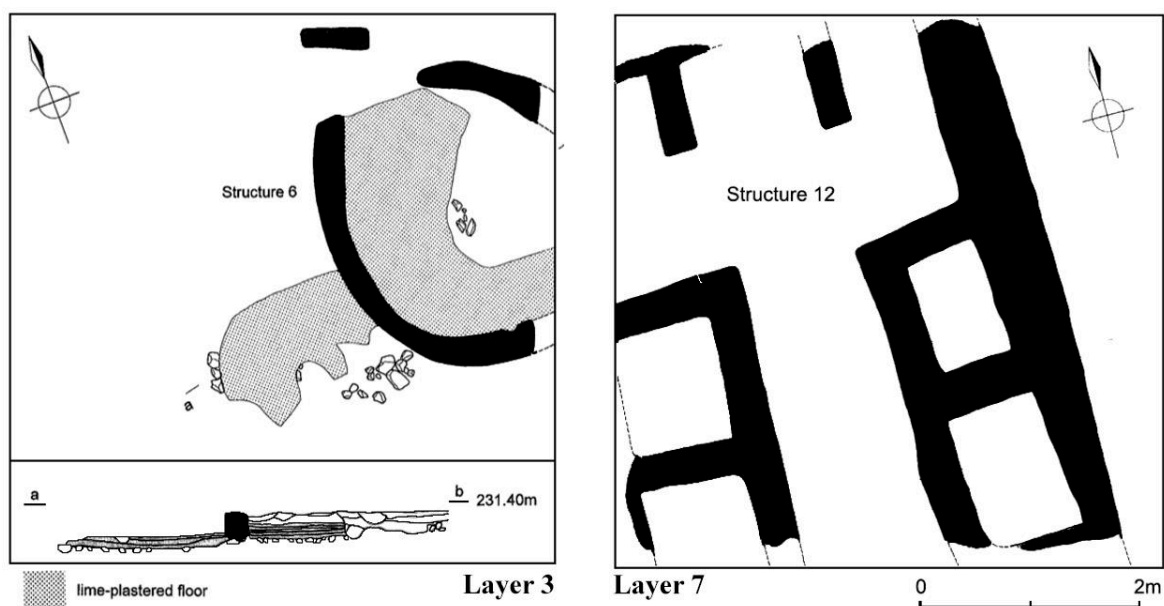
**Figure 2.34:** Architecture structures from Layer 3 and Layer 7 (Miyake & Tsuneki, 1996: 112 fig.4-5)

The best architectural remains of this settlement are in Layer 7 where a rectilinear structure with a corridor, called “Structure 12”, was unearthed. In this structure, there were rectangular small rooms (cells) lined up on either side of the corridor. The walls of the structure have been built directly on natural ground without a stone foundation. The walls were built of reddish-brown soil by the pise technique. These walls of about 60 cm thickness could be separated into reddish-brown soil layers about 5-6 cm thick. Ten dark grey fillings were detected at the junctions of these layers with a thickness of 1-2 cm. A noticeable floor was not found either in the rectangular small rooms about 1 m<sup>2</sup> or in the corridor of Structure 12. (Figure 2.34) Therefore, it has been suggested that the rectangular small rooms may have been used for storage purposes or had a foundation function for the upper structure. (Miyake & Tsuneki, 1996: 112; Tsuneki, 2003b: 45) No pottery fragments were found in the structure. Two sherd fragments in Layer 7 were found on the top of Structure 12. This structure has been dated to the Final PPNB period based on its chipped stone assemblage. (Tsuneki, 2003b: 45, 50 Fig.19)

The architectural remains of Layers 6 and 5 are poorer than those of layer 7. Remains in these layers consist of plastered floors with traces of pise walls and scattered stone concentrations. They have been suggested to be floor or platform remains. In Layers 4, 3 and 2, round structural remains of 2 – 2.5 m in diameter were found superimposed on each other. The best-preserved building is Structure 6 located in Layer 3. (Figure 2.35) This structure had 20 cm high walls with a floor that was renewed four times by plastering. The inner surfaces of the walls and floor were completely burnt. The common feature of round constructions was thick walls and well-plastered floors. However, the wall and plaster techniques, material used in walls, or the stone pavement under plastered floors have different characteristics. Even the function of these round structures is not known. It was suggested that they might be ovens or storage areas. In Layers 2 and 1 there were shallow pits with dark grey fillings and stone concentrations believed to be the remains of hearths. None of them have standard shapes. (Miyake & Tsuneki, 1996: 111; Tsuneki, 2003b: 45,46, 51-53 Fig. 20-25)

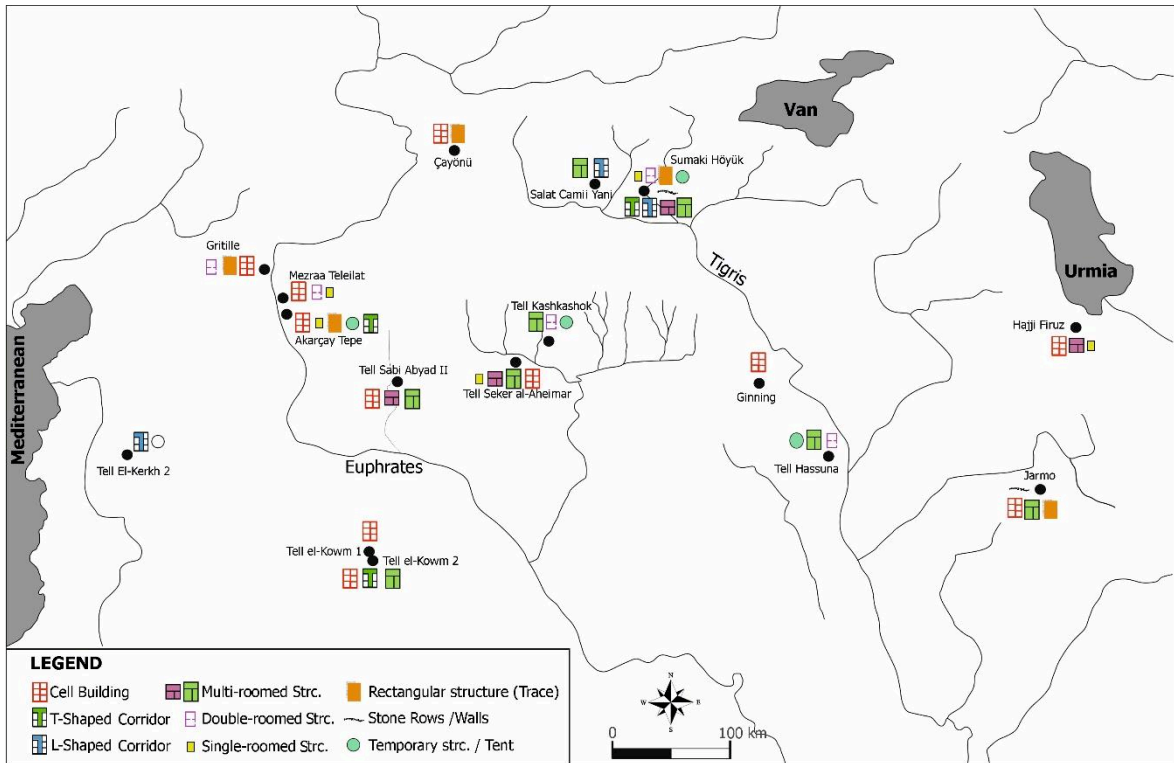
Figure 2.37: Distribution of architectural structure plans of some contemporary settlements at Sumaki Höyük

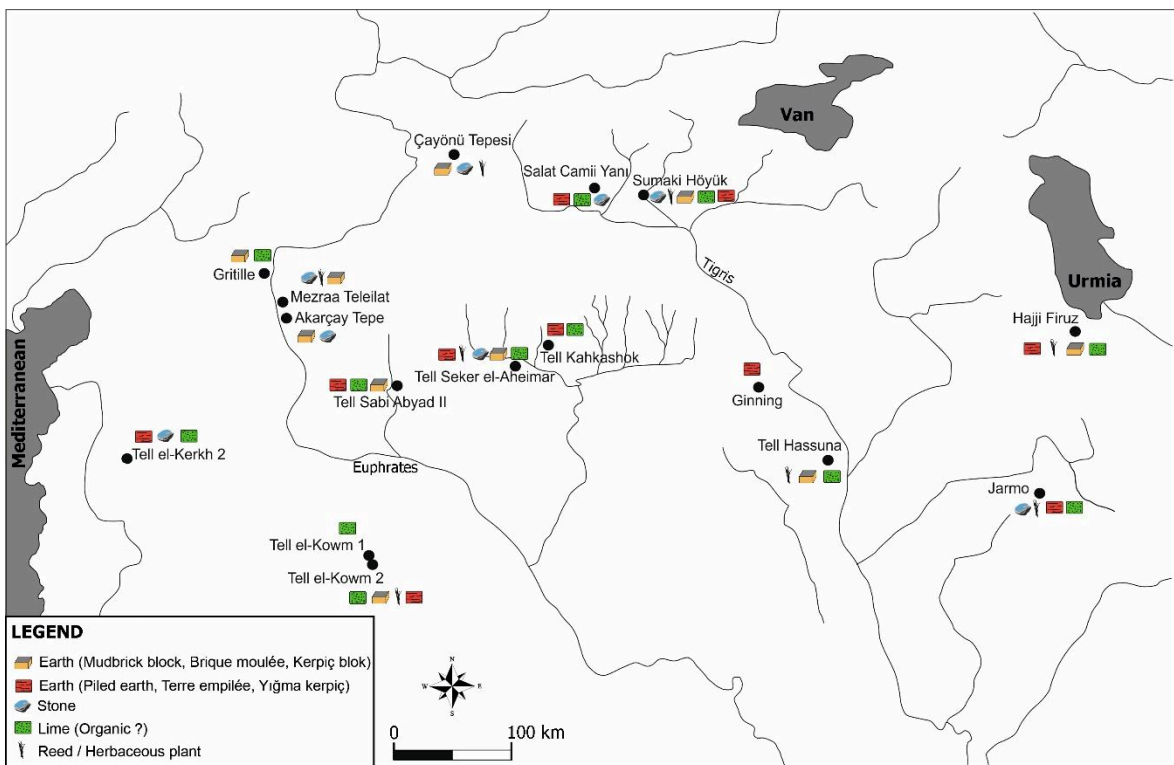
Figure 2.38: Distribution of architectural structure materials of some contemporary settlements at Sumaki Höyük

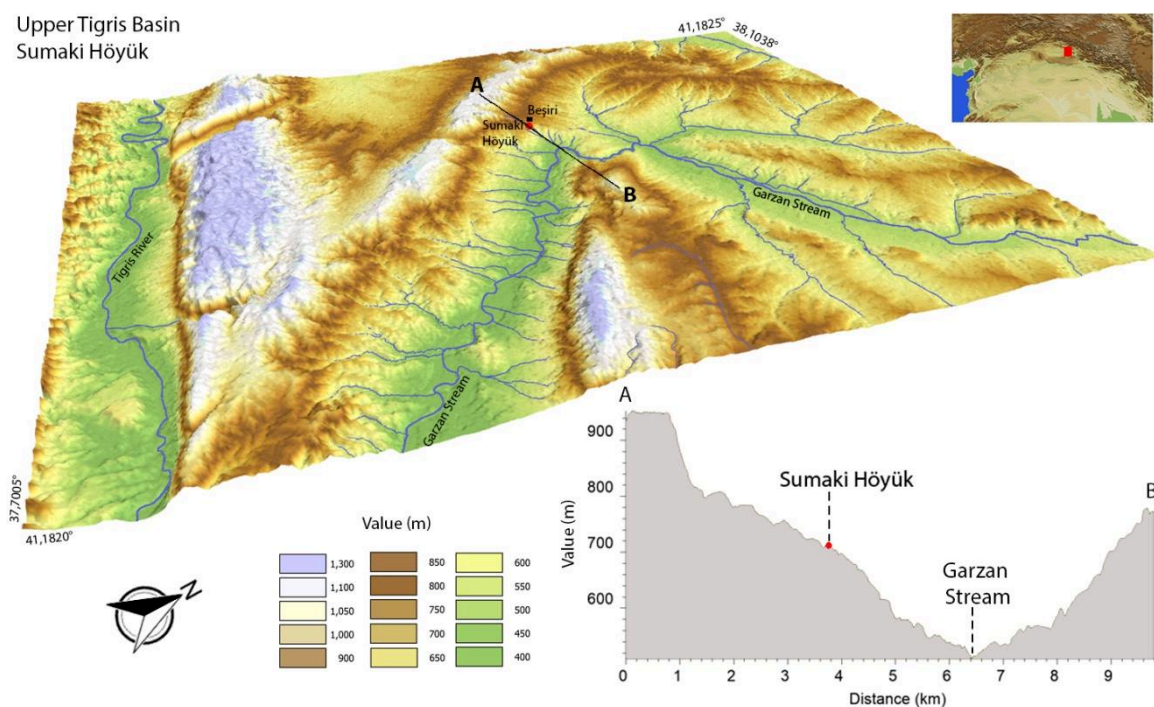
**Figure 3.1:** 3D DEM and cross-section of the environment of the Sumaki Höyük

Sumaki Höyük is located 1 km east of Beşiri district in Batman province. (Figure 3.1) The settlement is positioned in the northern portion of the Lower Garzan Valley, nearly 2.5 km east of Garzan Stream. (Figure 3.52) The settlement was founded on ground slightly sloping in a southwest-northeast direction on an erosion surface with an elevation of 700.00 - 710.00 meters. (Figure 3.2) Just north of the settlement is Kani Huşur Stream, which flows through a very deep valley.

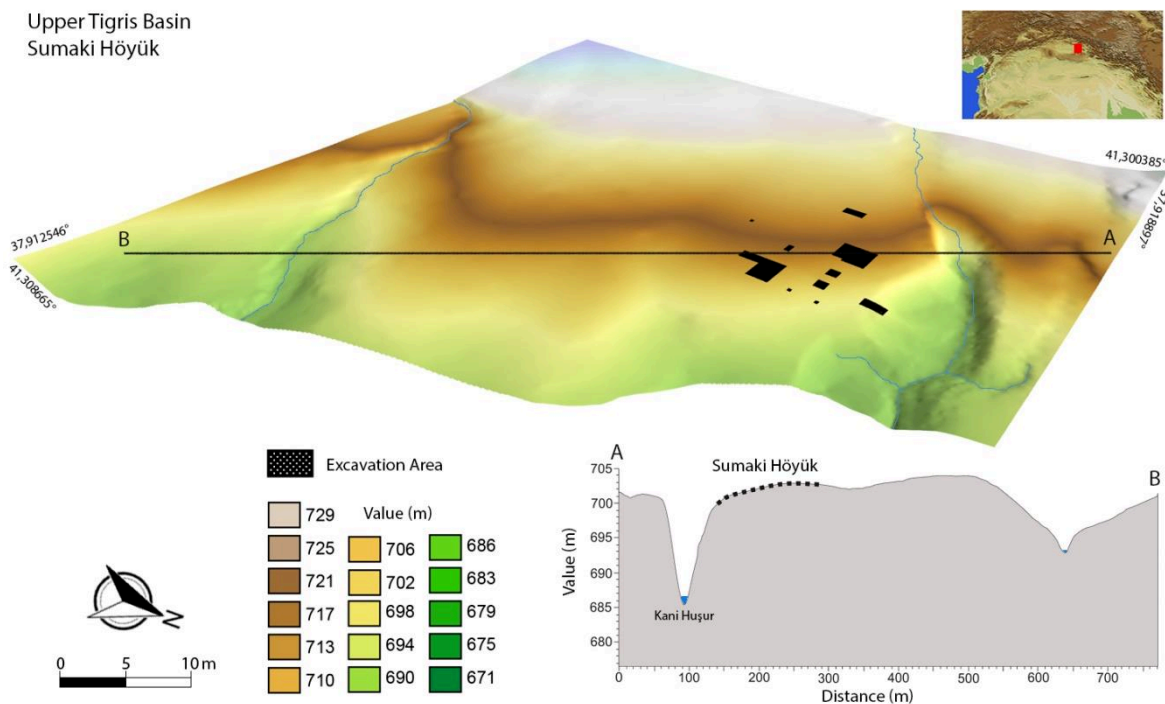
**Figure 3.2:** DEM and excavation area at Sumaki Höyük

according to archaeological and historical records. An example may be given of the partly-dry spring ca. 200 m northeast of the site (Figure 3.23) and in Kani Şırık Mevkii<sup>11</sup>. Also, the best example of a spring or tectonically-linked water drainage variation was identified in flood fill in the 20N-20/O trenches south of Sumaki Höyük (Figure 3.56-A) and a depression area to the south, according to topographic data. (Figure 3.2)

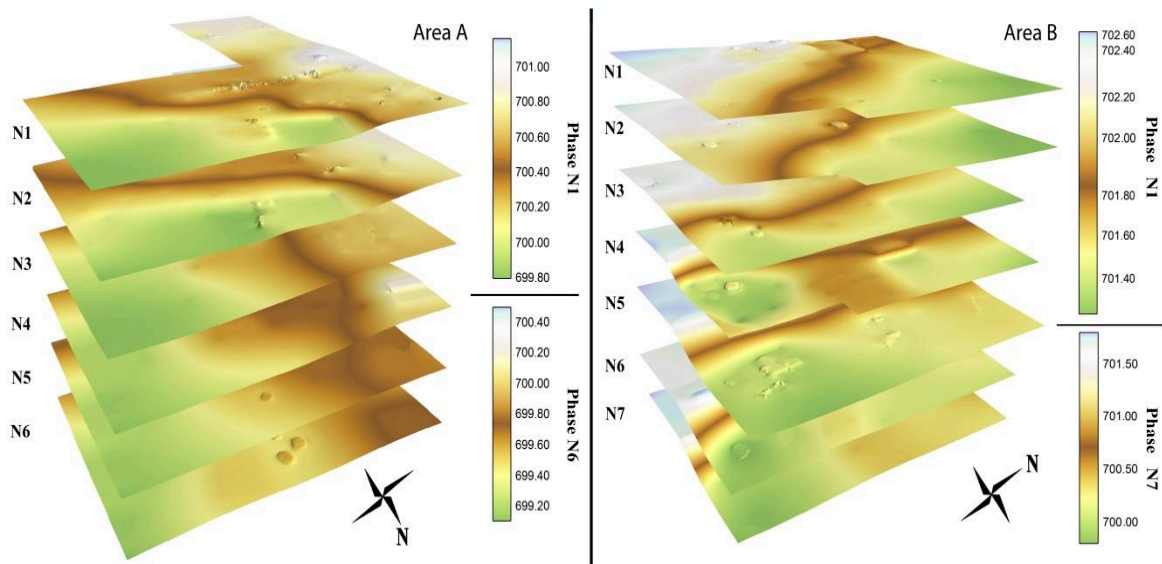
**Figure 3.3:** Changes in topography by phases at Sumaki Höyük

south and had the character of a settlement placed on southeast-northwest oriented natural terraces. However, both geographical factors and human activities have changed the topography of the settlement significantly over time. (Figure 3.3)

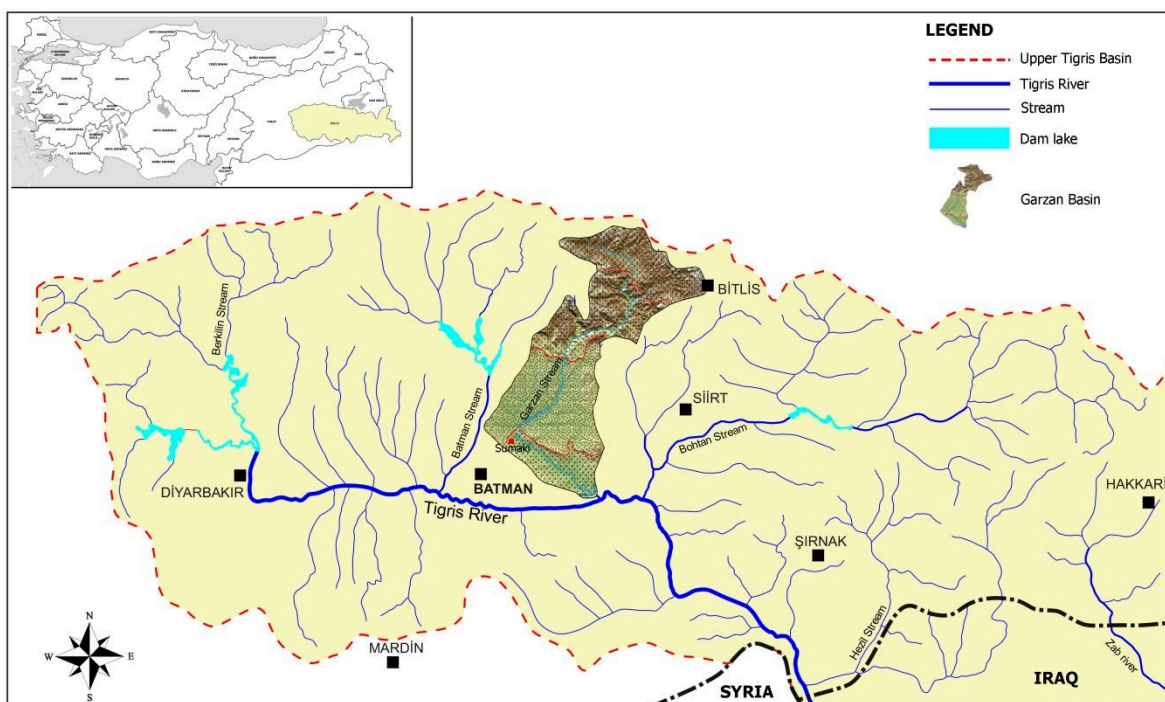
**Figure 3.4:** Location of the Garzan Basin in the Upper Tigris Basin

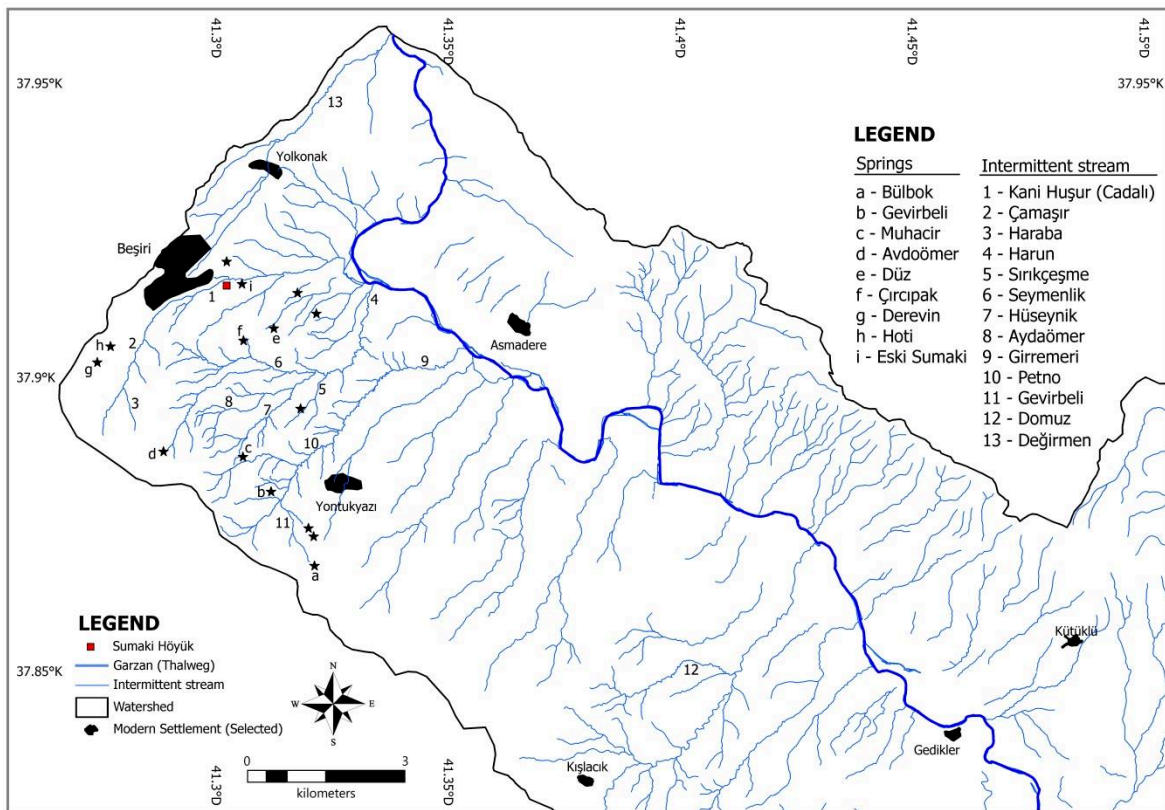
**Figure 3.5:** Hydrography of the Lower Garzan Basin

There are groundwater springs in the Kıradağı basalt and underlying Şelmo Formation immediately south-west of the study area. (Figure 3.5) These include the Kani Huşur Brook flowing in a deep valley immediately north of Sumaki Höyük, and the Çamaşır and Haraba brooks linked to it, along with Harun Brook directly south of Gre Mare, and the Sırıkçeşme, Seymenlik, Hüseyinik and Aydaömer brooks connected to it. The Girremeri Brook flowing south of Merrit Hill and the related Petno and Gevirbeli brooks are also fed by groundwater from the Kıradağı basalt and Şelmo Formation. The Bülbok, Gevirbeli, Muhacir, Avdoömer, Düz, Çırcıpak, Derevin, and Hoti springs also have their sources in these geological units.
