# Microarchaeological observation on the neolithic architectural structures and cultural landscape of Sumaki Höyük

# **Microarchaeological Observation on the Neolithic Architectural Structures and Cultural Landscape of Sumaki Höyük**

PhD Thesis

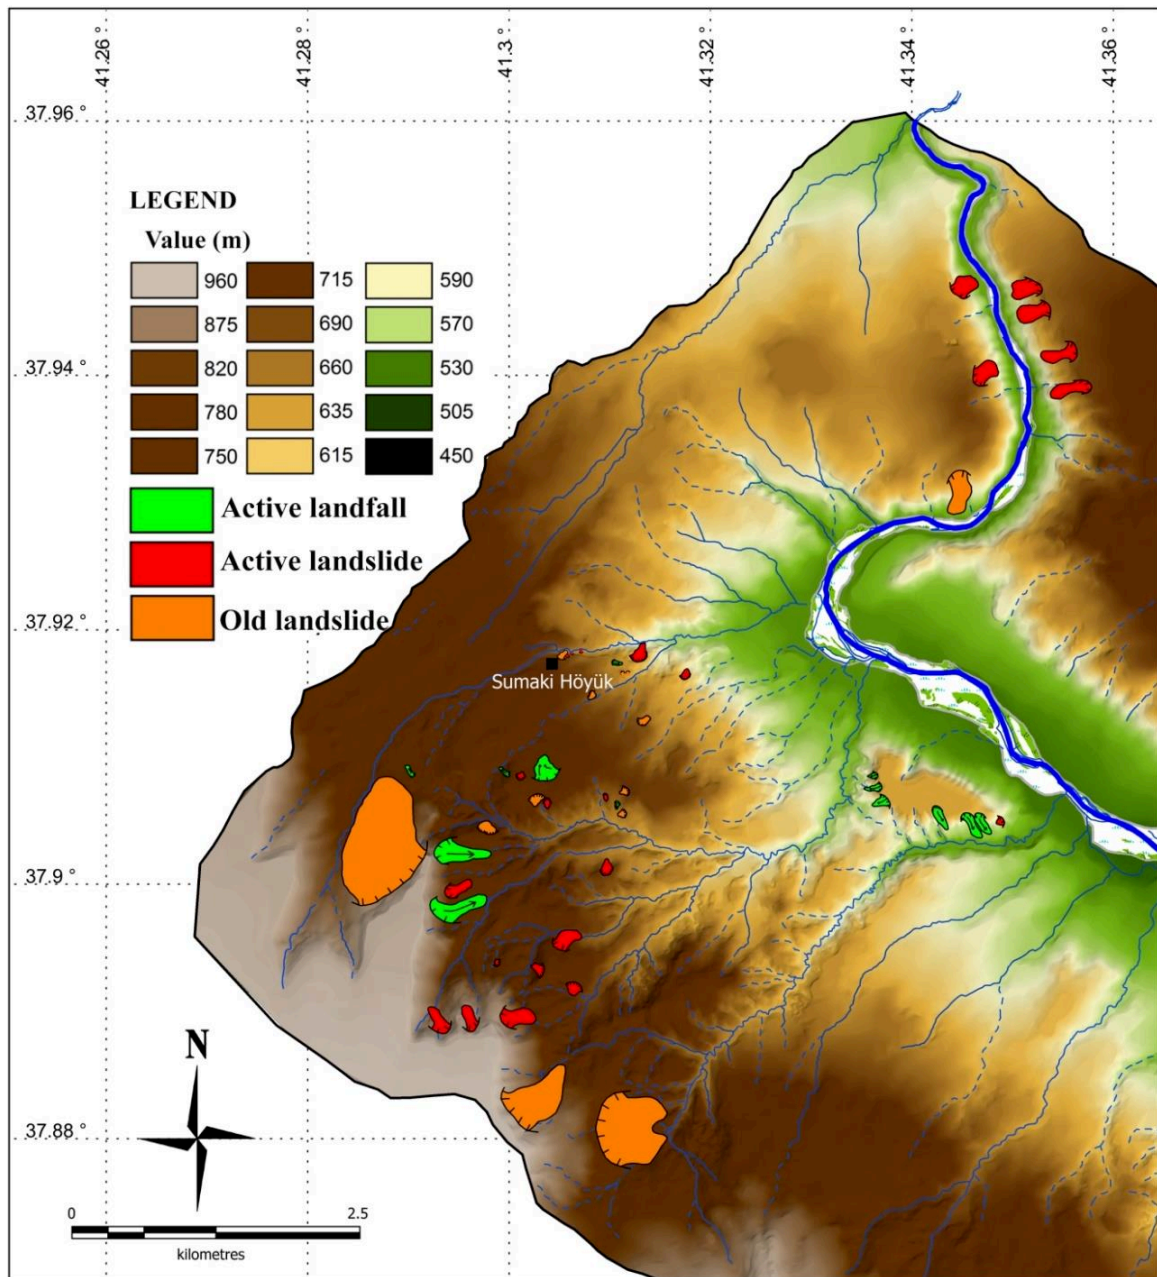
**Figure 3.6:** Landslides and landfall modeling in the vicinity of Sumaki Höyük

Kıradağ. (Figure 3.35, 3.36) The slide surface is generally flat and curved. The flow form of mass movements is observed more often in areas with a clayey, sandy or clastic structure. It is particularly effective on the west side of the Garzan Stream where the Şelmo Formation is predominant. Fall mechanisms occur in movements where hard rocks like limestone or basalt break away. Fall movement (Figure 3.37) is evident in the Kıradağı Basalt and Mare Conglomerate in the form of fragmented blocks that have been dragged.

frequently around the Sumaki Höyük. Current and paleo-landslide traces may be observed in the form of rupture surfaces, landslide rubble, and toes on the west slope of the Lower Garzan Basin. There are various traces in the excavation data as well as the environs of the site indicating that Sumaki Höyük settlement was directly affected by these landslides and/or soil flow processes.

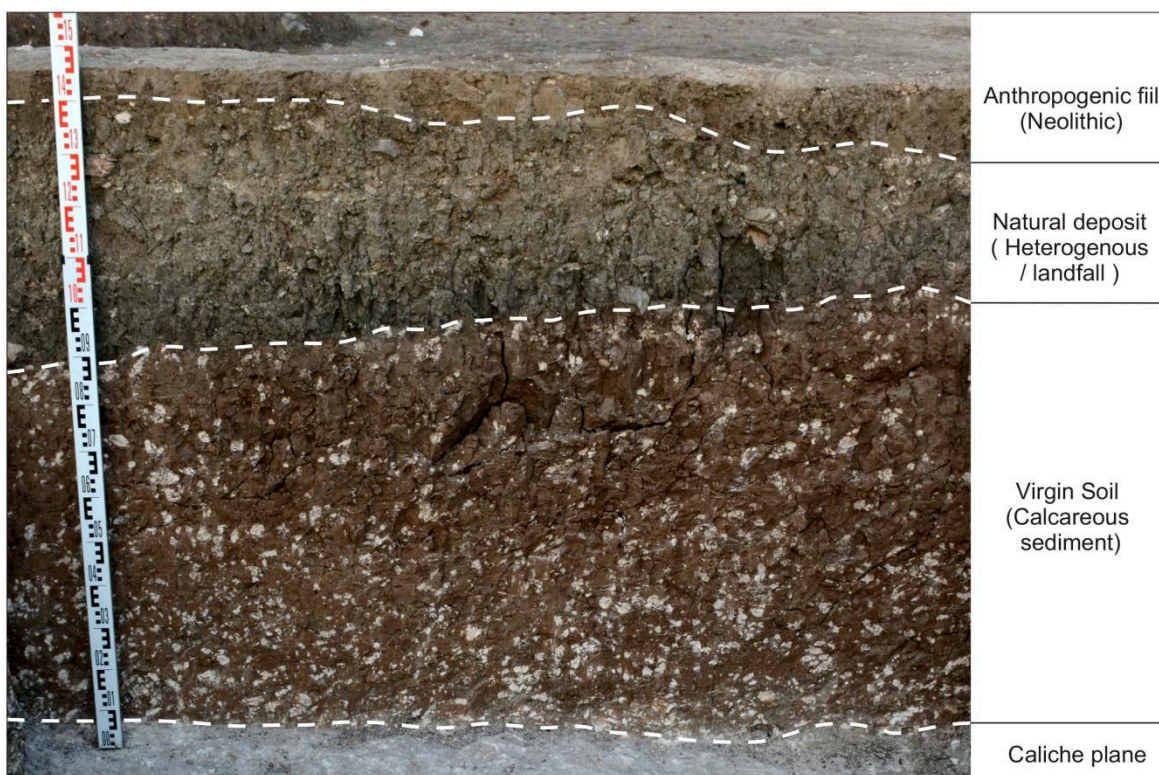
**Figure 3.7:** Cross-section of trench 22L at Sumaki Höyük

The soil types distributed through the Lower Garzan Basin generally developed in anthropogenic steppe fields formed by destruction of partial oak areas under semiarid climate conditions. The soils with broad distribution as per the climate and vegetation are zonal soils. In areas where mass movements were active, and on alluvial floodplains, the dominant type is azonal soil. The basin contains broad areas with brown steppe soils. Sumaki Höyük and its surroundings have blackish-dark brown and clayey yellow-brown soils.

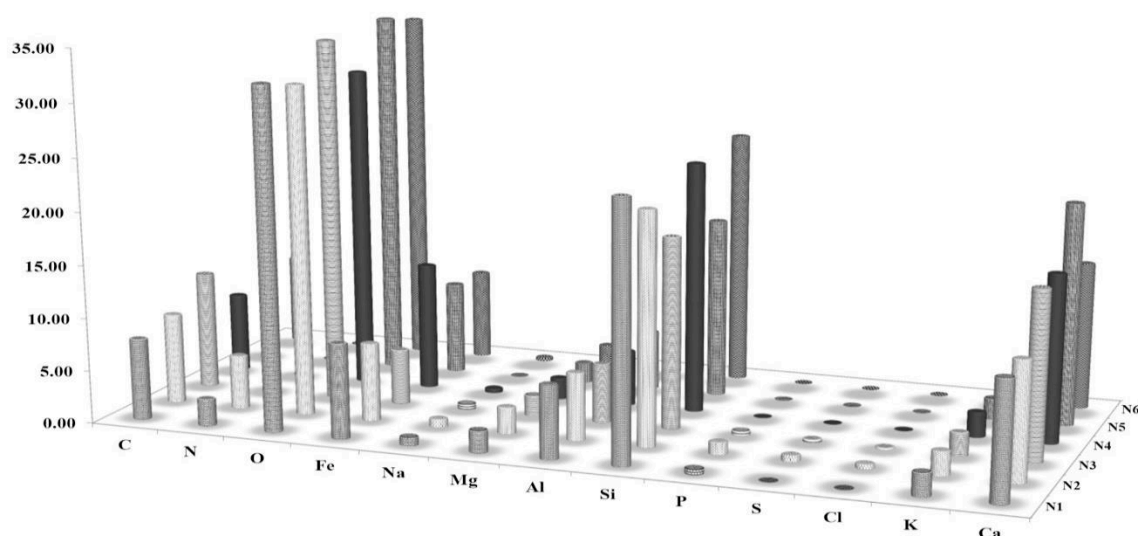
**Diagram 3.1:** Average of EDX results from Sumaki Neolithic phases

Soil formation or accumulation in settlements is the result of the mutual interaction of climate-organism-human-topography under certain conditions and within a particular process. The physical and chemical characteristics of soil from the deposits of Neolithic phases were determined. According to EDX analysis, the most common elements are O 32.83%, Si 21.58%, Ca 14.93%, Fe 8.53% and C 8.73%. (Diagram 3.1) In Phase N3 fill, the carbon element proportion (C 11.14%) is higher compared to the fill of other phases, while the silicon proportion (Si 18.16%) is lower. In Phase N4, iron (Fe 12.11%) is higher compared to the others. In Phase N5 fill, the calcium proportion is noticeably higher. These differences are mainly related to climate, the amount of lime in fills, and also to the construction tradition of the site. External factors, for instance floods, are also very

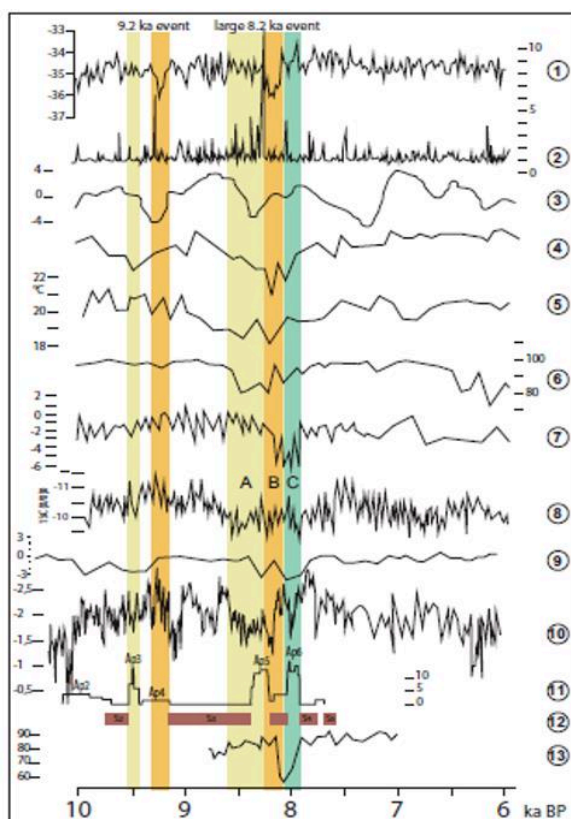
**Figure 1.** Northern Hemisphere palaeoclimate/pedosedimentary records illustrating Holocene rapid climate changes (RCCs): 1, Greenland GRIP ice-core  $\delta^{18}\text{O}$  (Grootes et al., 1993); 2, high-resolution GISP2 non-sea-salt (nss) [K+] as a proxy for the Siberian High (Mayewski et al., 1997); 3, ice-rafted debris in North Atlantic (Bond et al., 2001); 4, eastern Aegean SL21 (sea surface temperature, SST) fauna (Marino et al., 2009); 5, MD952043 SST; 6, (C) eastern Mediterranean core LC21 (SST) fauna (Rohling et al., 2002); 7, Steregiu (Romania) pollen-based temperature of peat pollen (Feurdean et al., 2008); 8, Sofular Cave  $\delta^{13}\text{C}$  (northern Turkey; Fleitmann et al., 2009); 9, Lake Maliq pollen-based temperature of the coldest month (Bordon et al., 2009); 10, Qunf Cave (Q5),  $^{18}\text{O}$  (‰ VPDB) (Fleitmann et al., 2003); 11, Sidari valleys 1 and 2 (Corfu), gully erosion/fluviocolluvial aggradation (CPDF, this study); 12, Sidari valleys 1 and 2, soil formation phases (Corfu) (Pross et al., 2009). Yellow vertical bars underline the 9.2 and 8.2 ka event phases. The yellow, orange and green bars (letters A, B, and C, respectively) represent a possible tripartite temporal structure of the 8.2 ka event (discussed in the text).

**Diagram 3.2:** Northern Hemisphere paleoclimate and pedosedimentary records, in particular showing the 9.2 and 8.2 ka events (from Berger et al., 2016: 1849 fig.1)

Since the Last Glacial Maximum, the climate is known to have changed by a significant degree (Weninger, et al., 2009: 8; Bar-Matthews, et al., 1999: 89) and our knowledge has been enriched by numerous climate change studies. Sudden climate changes occurring at approximately 2000-year periods are defined as “Rapid Climate Change (RCC)”. (Hughen, et al., 1996: 96; Migowski, et al., 2006: 427; Staubwasser & Weiss, 2006: 378-379; Weninger, et al., 2009: 48; Weninger, et al., 2014: 8) These cycles have been calibrated to 9000-8000, 6000-5000, 4200-3800, 3500-2500, 1200-1000 and 600-150 cal years BP, with a current total of six. (Mayewski, et al., 2004: 244-246; Migowski, et al., 2006: 427) Since the beginning of the early Holocene period at least eleven similar events with a much more effective and rapid climatic change which are 10.2, 9.2 and 8.2 ka events are defined. (Berger et al., 2016:1848; Park et al., 2019:9 fig.7) However, the greatest climate change most discussed in archaeological literature that occurred in the Holocene Period is the 8.2 ka event of 8200 years ago. (Morrill & Jacobsen, 2005: 1) Many studies on the 8.2 ka event show differences in terms of dating. (Diagram 3.2) (Ahn et al., 2014:605; Barber

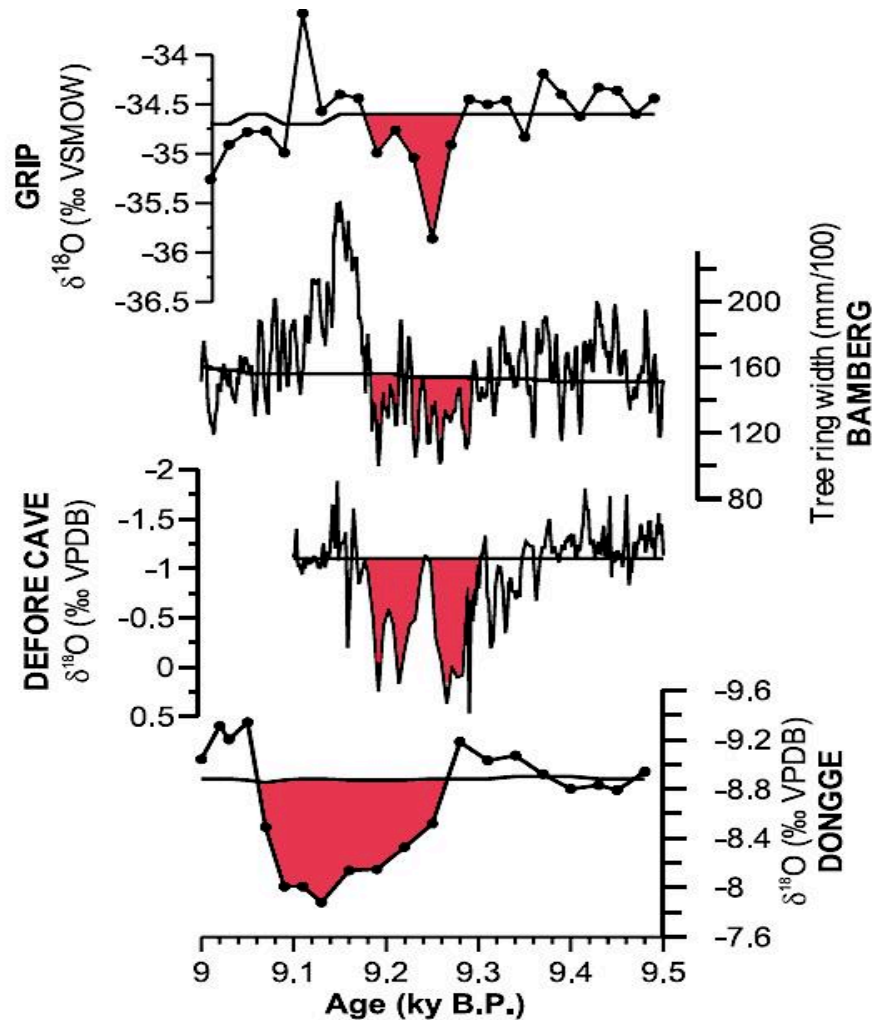
**Diagram 3.3:** Comparison of anomalies experienced during 9.2 ka event (from (Fleitmann, 2008: 4 fig. 3))

A series of paleoclimate record data show that; 9.2 ka in the northern hemisphere is a common and important climate anomaly. This phenomenon is very similar to the climatic anomalies experienced in 8.2 ka. It is characterized by a cold climate in high and medium latitudes, lower latitudes and in the tropic zone is arid climate condition during the 9.2 ka event. (Fleitmann, 2008: 1) There is strong evidence for climate anomaly at about 9.2 ka in the northern hemisphere. (Diagram 3.3) Furthermore, based on the synthesis of other Holocene climate records from the Asian summer monsoon region, it was discovered that

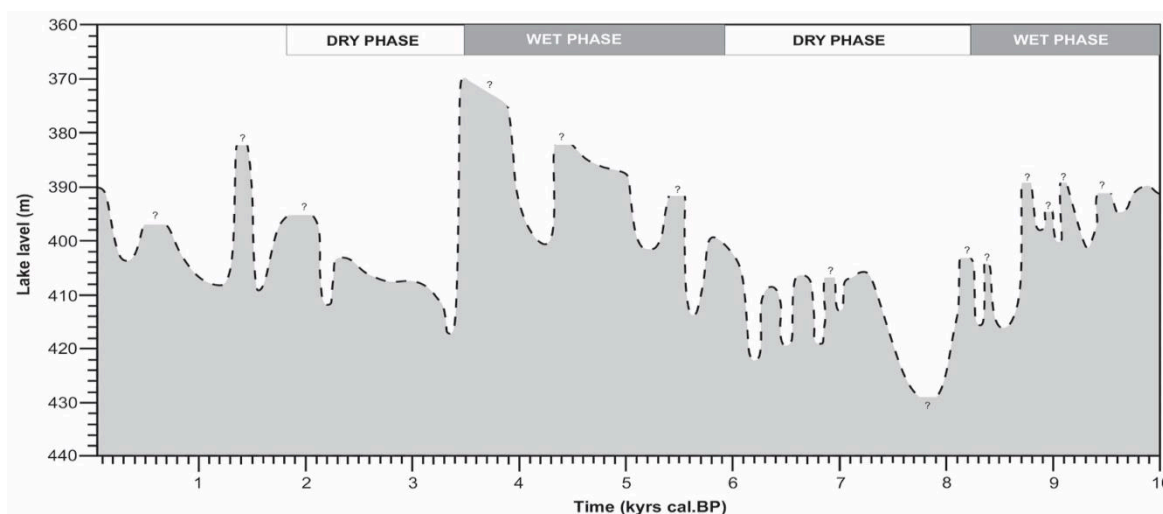
**Diagram 3.4:** Dead Sea Lake level lchanges (Adapted from Migowski, et al., 2006:427 Fig 4; Litt, et al., 2012: 101 Fig.5d; Stein et al., 2001:279 Fig.7)

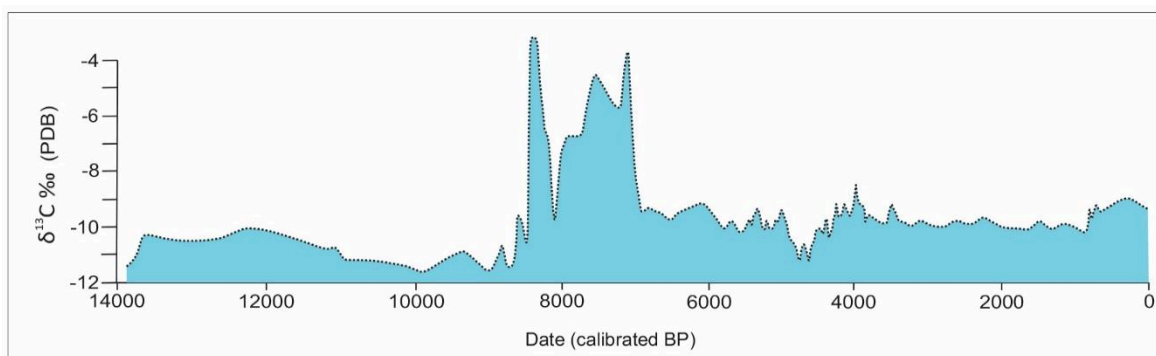
**Diagram 3.5:** Temporal variation of the  $\delta^{13}\text{C}$  isotope values of the Soreq Cave (Adapted from Weninger at al., 2009: 16 fig.5 and Bar-Matthews et al., 2003: 3190 adapted from Fig.8D)

The isotope analysis from Soreq Cave in Israel shows extraordinarily high  $\delta^{13}\text{C}$  curves from 8.5 to 7.0 ky. (Diagram 3.5) These maximum values are more distinct at 8.2, 7.5 and 7.0 ky. In other words, according to Soreq Cave isotope data, the time interval from 8.5 to 7 ky is characterized by a combination of low oxygen isotope values (-6.5 ‰) and very high carbon isotope values (-5.0 to -4.0 ‰). (Bar-Matthews, et al., 1999: 89-92)

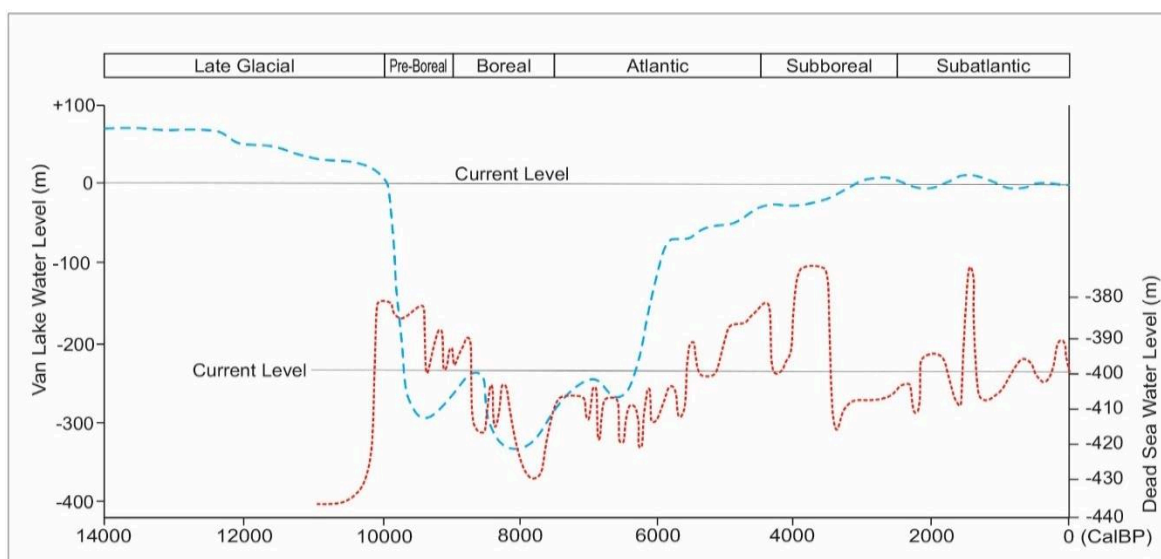
**Diagram 3.6:** Dead Sea and Lake Van levels changes (Adapted from Migowski et al., 2006:427/Fig 4; Litt et al., 2012: 101 Fig.5d; Stein et al., 2001:279/Fig.7)

8.6 - 8.0 ka CalBP) show that at intervals the Eastern Mediterranean region was under the effect of cold polar air though within a regular winter/spring cycle. In parallel with this cold period, there are falls in the water level of the Dead Sea and Lake Van around 8600 - 8000 CalBP. (Diagram 3.6) When we gather all this data, it is evident that within a certain period the Near East experienced rapid aridity. (Landmann, et al., 1996: 801; Migowski, et al., 2006: 247; Özdemir, et al., 2013: 967-968; Weiss, 2000: 76) (Diagram 3.4) However, according to Soreq Cave data, there were occasional severe rains within this arid period. (Bar-Matthews, et al., 2003: 3182-3185)

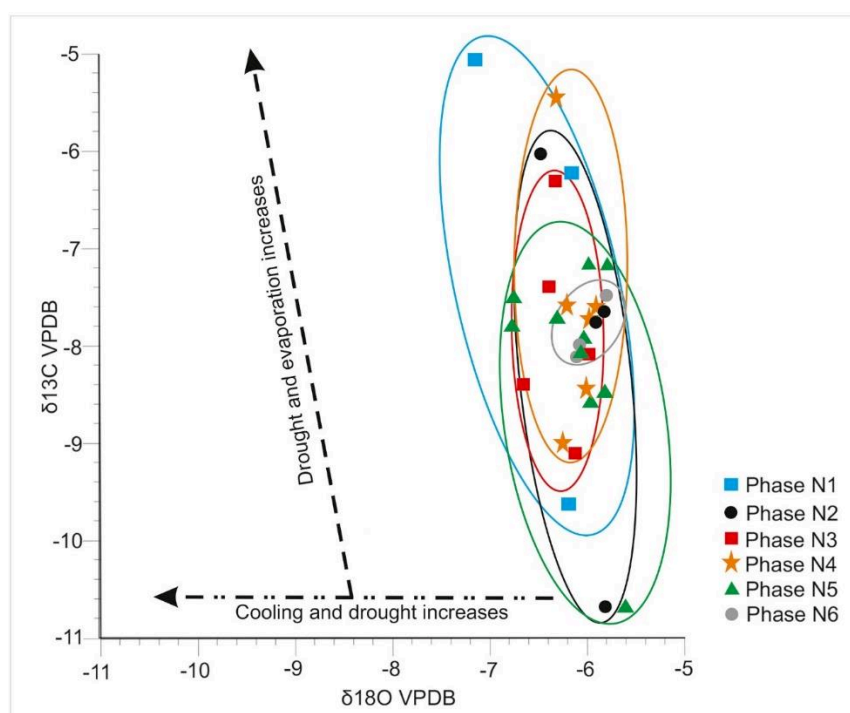
**Diagram 3.10:** Distribution of  $\delta^{18}\text{O}$  and  $\delta^{13}\text{C}$  stable isotope at Sumaki Höyük

In previous sections of this thesis, the relationship and process affecting the oxygen isotope composition and meteoric oxygen isotope in soil carbonates were explained in detail. Carbonate sediments ( $\text{CaCO}_3$ ) samples from the Neolithic deposits of Sumaki Höyük were subjected to  $\delta^{18}\text{O}$  and  $\delta^{13}\text{C}$  isotope analyses.

The stable carbone isotope data of the samples taken from the architectural walls are collected in a certain area, in addition to this, it also presents very different data especially in Phase 1, Phase 2 and Phase 4. The fact that we have also detected traces of floods and/or torrents in the archaeological fillings corresponding to the beginning or end of these phases makes this situation meaningful. (Diagram 3.10)

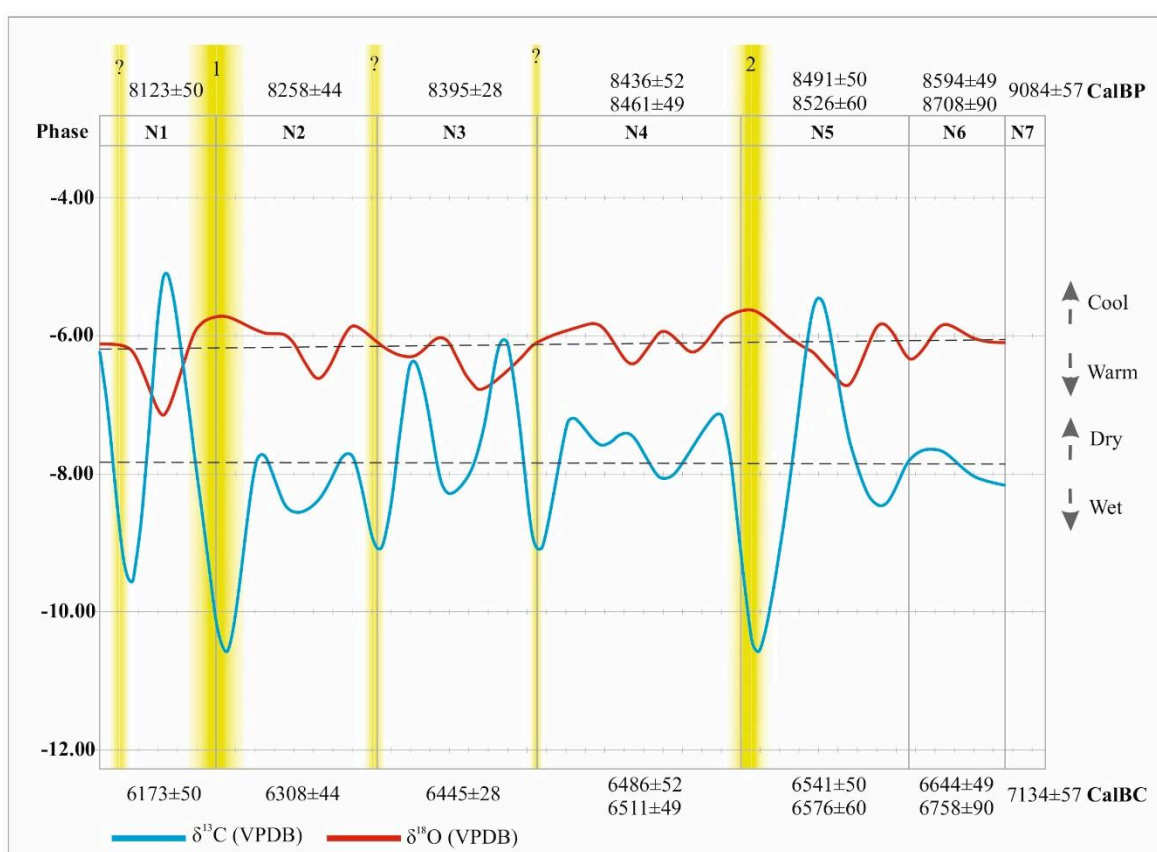
**Diagram 3.11:** Distribution of  $\delta^{18}\text{O}$  and  $\delta^{13}\text{C}$  stable isotope

Carbone isotope analyses determine extraordinarily high  $\delta^{13}\text{C}$  curves for the years between 9084±57 to 8123±50 CalBP and especially from 8501±56 - 8491±50 CalBP and from nearly 8200-8150 CalBP. According to the  $\delta^{13}\text{C}$  isotope values, a clearly arid period was identified between those eras. If these maximum  $\delta^{13}\text{C}$  values are compared with  $\delta^{18}\text{O}$  isotope values for the same period, it must be stated that a definite warm period existed, especially around 8501±56 - 8491±50 CalBP (end of Phase N5). According to isotope values and archaeological data, immediately before and after this warm - dry period, cold and wetter

Comparative examination of the isotope values of different samples from Phase N5 indicates the presence of warm-wet and warm-dry climates; however, shortly before the end of Phase N5 a cold-wet climate was extant. (Diagram 3.11) The warm-dry climate was replaced by a colder and rainier period which caused flash floods and torrents. These severely damaged the settlement and the buildings of Phase N5. A rather heterogeneous accumulation covered almost all the settlement, but particularly Area B. Irregular sequences, disorderly-deposited pottery sherds, obsidian/flint tools and flakes, animal bones, and fragments of ground stone objects in the archaeological layers also show that these floods/torrents occurred suddenly. XRD analysis of samples taken from flood/torrent fills

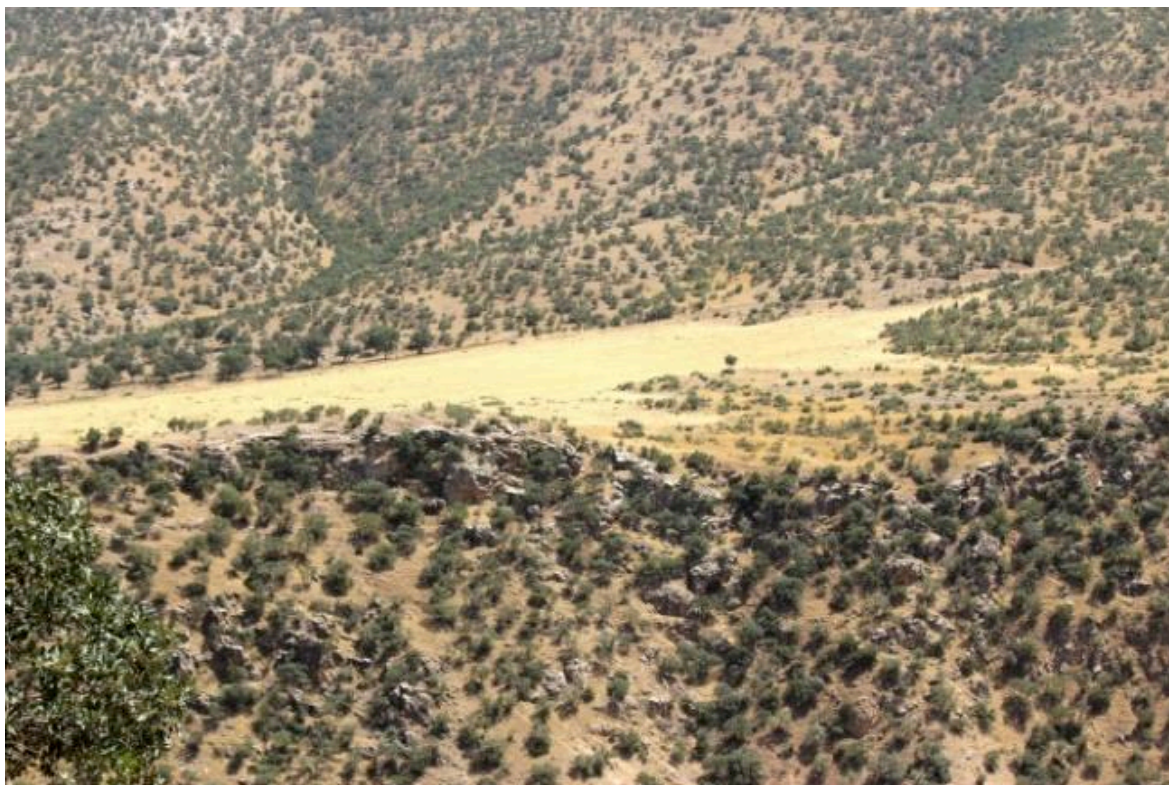
**Figure 3.8:** Oak communities in the Lower Garzan Basin

The surface forms and climate in this region affect the lower limit of the natural oak (*Quercus*) forest zone. (Figure 3.8) Oak barrens, which are mainly observed at the edge of steppe areas and high elevations, display an arid forest character. Among oak species, the Aleppo oak (*Quercus infectoria*) is common with other species being *Quercus brantii*, *Quercus libani* and *Quercus cedrorum*. These oak assemblages reach low elevations such as 700 m, mainly around Siirt, Garzan and Silvan. (Sözer, 1984: 24)

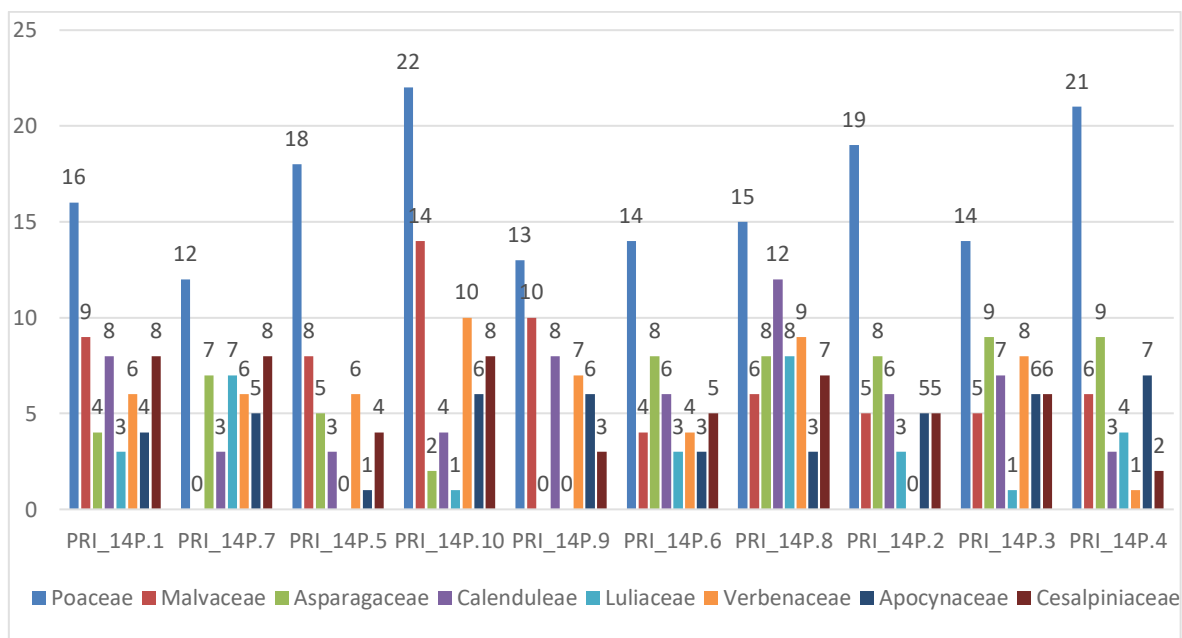
**Diagram 3.13:** Distribution of pollen data according to Neolithic phases at Sumaki Höyük

According to the phytolith taphonomy created by the Phytolith Research Institute (PRI) in India, the surfaces of fossilized plant remains are rounded, and the corners are disrupted. The potential reason for surface disruption of plant fossils in appropriate climate conditions for growing the flora is large-scale destruction of vegetation, such as animal grazing or floods/torrents. Considering that the living area at Sumaki was also used by animals and the clear evidence of floods/torrents, deformation on the phytoliths becomes meaningful. The phytolith samples from open areas were predominantly affected by this type of destruction. In phytolith analysis, the basic method for identifying plant types is based on defining their shape, with distinctions according to their structure and combination. For example, as found in *Graminea* and other families, rough-pointed *Trichomes* are grouped separately under *Trichome* due to their shape classification. Plant fossil samples were also identified using the "Phytolitharium Phytolith" database. In pollen analysis, *Poaceae* are dominant but *Apocynaceae*, *Verbenaceae*, *Cesalpiniaceae*, *Liliaceae*, *Calenduleae*, *Sparagaceae*, and *Malvaceae* pollens are also present. (Diagram 3.13)

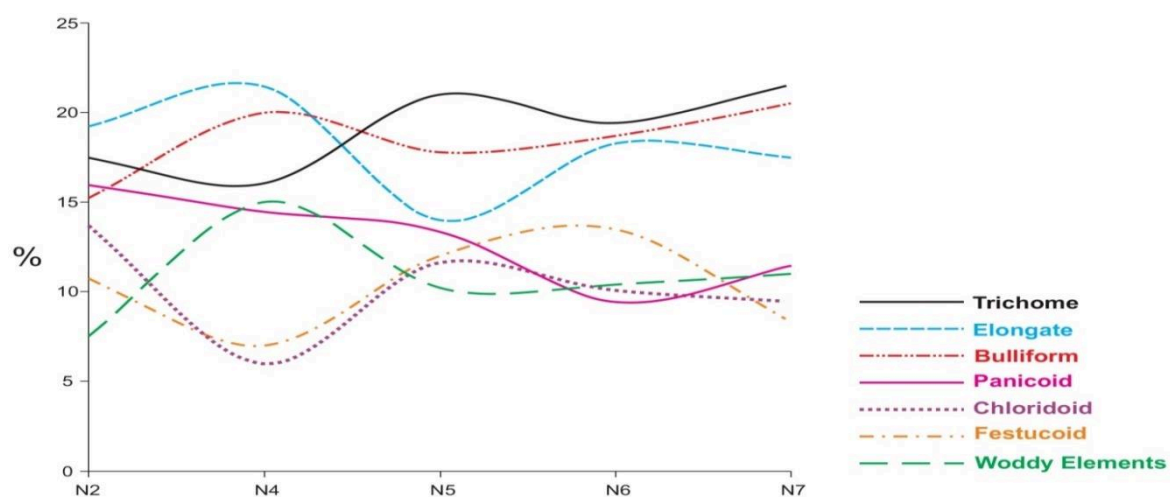
**Diagram 3.14:** Distribution of phytoliths by Neolithic phases at Sumaki

Based on anatomic origin and structural characteristics, the dominant plant cover of Phases N6 - N4 at Sumaki Höyük is, in general, the *andropogonea*/reed species. In later phases such as N3 - N1, plant cover is represented by *Chloridoid* and *Festucoid* pasture. (Diagram 3.14) Consequently, it is clear that wet-dry-wet alternations were experienced in the habitation area and its environs.

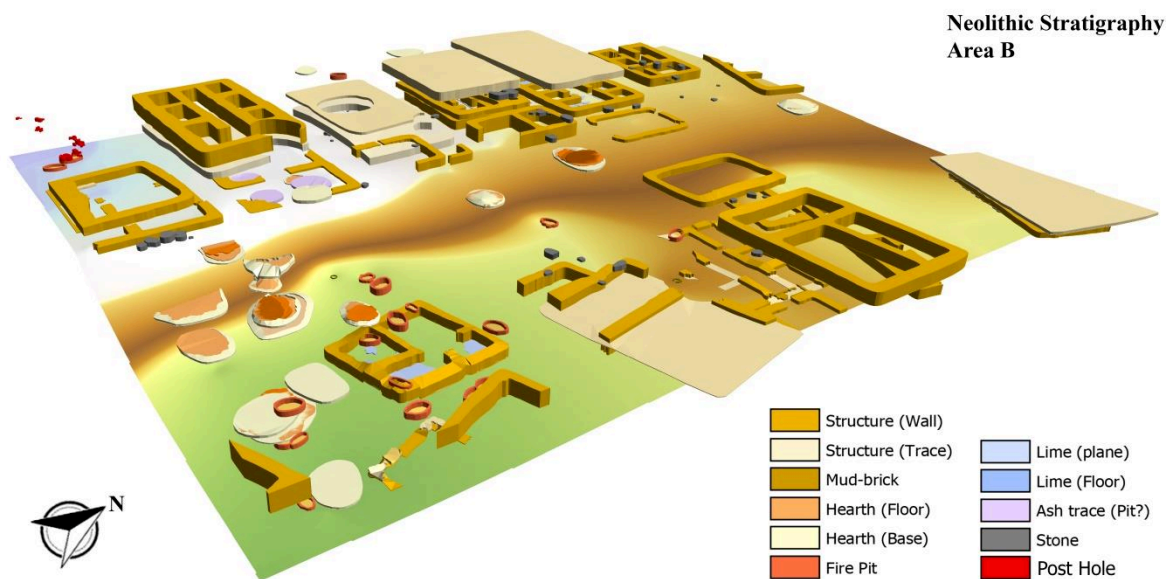
**Figure 3.9:** Neolithic stratigraphy modeling of Area B at Sumaki Höyük

To identify the Neolithic phases of Sumaki Höyük, mainly architectural remains, (Figure 3.9; Diagram 3.16) accumulations of open areas, pottery distribution and natural effects of the deposition process were taken in consideration. However, in detailed examination of the layers the presence of other materials such as clay objects, stone tools, etc. was also noted. Lastly, all data were compared with the deposits of the cultural fills.

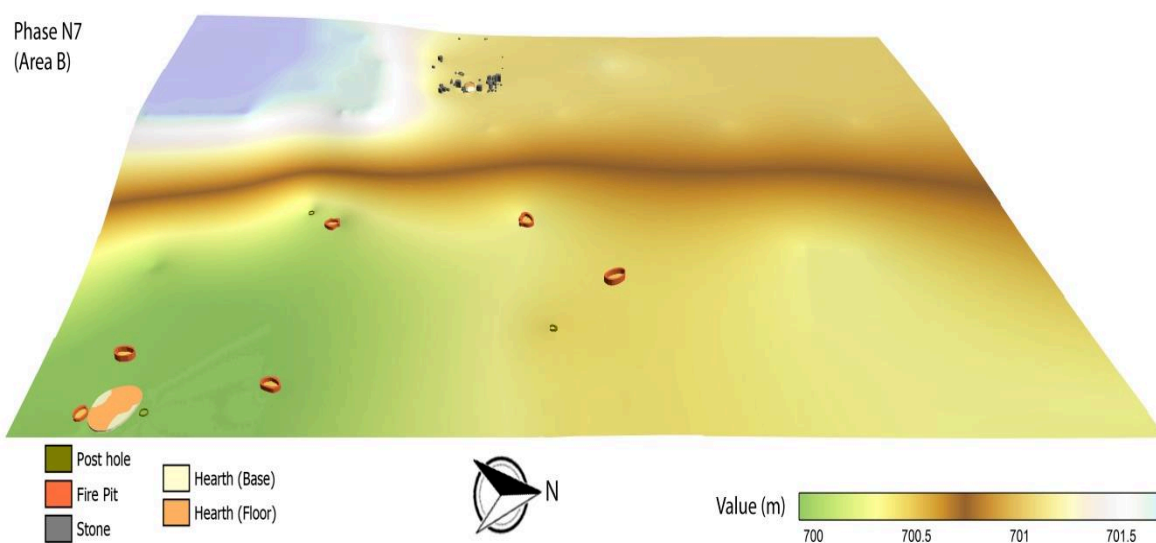
**Figure 3.10:** Settlement pattern and architecture from Phase N7 at Area B

The earliest occupation of Sumaki Höyük Phase N7 is dated to 9084±57 CalBP (7134 ±57 CalBC) according to a single C<sub>14</sub> date. (Table 3.3) The deposit of Phase N7 was randomly distinguished in an approximately 250 m<sup>2</sup> in Area B on the natural soil (Figure 3.10, 3.58) Even though the virgin soil was reached in many parts of areas A and C, not a single remainder of Phase N7 was found. The significant characteristic of this phase is the presence of well-burnished, mineral-tempered (mainly basalt) hole-mouth pottery. Large fragments of pots were recovered under Structure N5B14 of Phase N5 near hearth N7O1 and under Structure N6B10 of Phase N6. A series of post-bases or holes in different locations are thought to be stretcher/carrier systems for temporary dwellings, but their plan cannot be identified. Besides, two hearths (N7O1 -N7O2) and six fire pits (N7A1-A6) were revealed. The dimensions of the round- or oval-shaped fire pits change between 36x53 cm and 43x66 cm, and their depths are between 6-11 cm. Voluminous amounts of calcified organic material were found around fire pit N7A1 and around hearths N7O1 and N7O2.

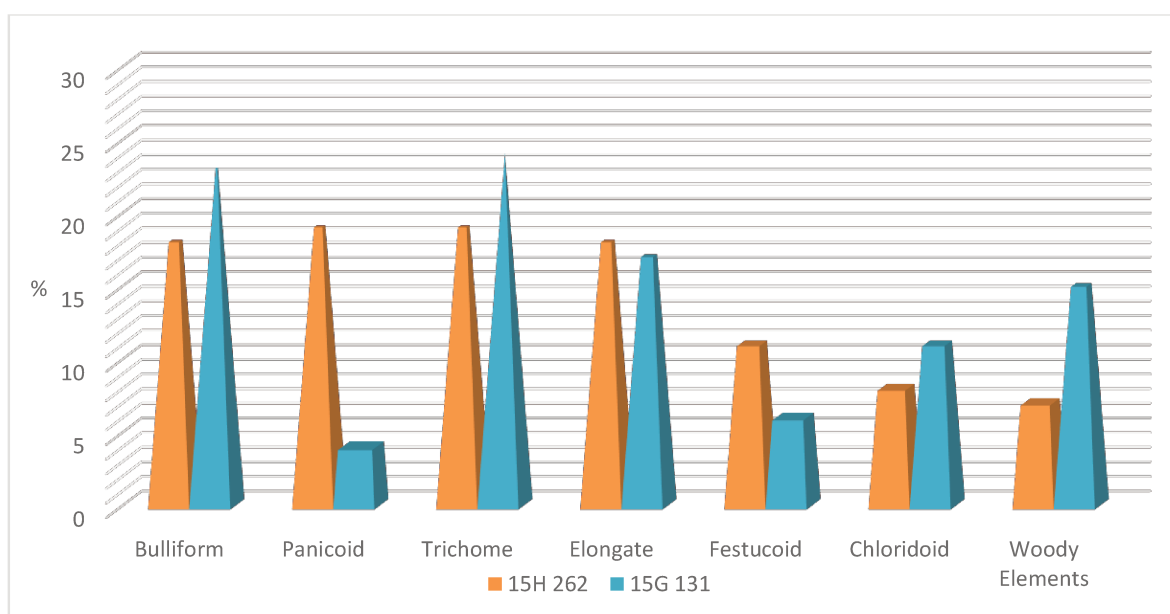
**Diagram 3.17:** Phytolith analysis of lime samples from Phase N7

According to the phytolith and pollen analysis of calcified organic material samples from Phase N7, nearly 50% of them reed or herbaceous plant remains were identified. Among the phytoliths, high frequencies of *Trichome*, *Bulliform*, and silicified woody elements were observed. Following *Panicoid*, *Trichome*, and *Bulliform* phytoliths, subtypes of other phytoliths were also identified. (Diagram 3.17; Figure 4.325 - 4.330) The natural structure of well-preserved phytoliths is clear. Pollen analysis identified *Poaceae* pollens dominantly, together with *Apocynaceae*, *Verbenaceae*, *Cesalpiniaceae*, *Liliaceae*, *Calenduleae*, *Asparagaceae*, and *Malvaceae* pollens. (Figure 4.331, 4.332)

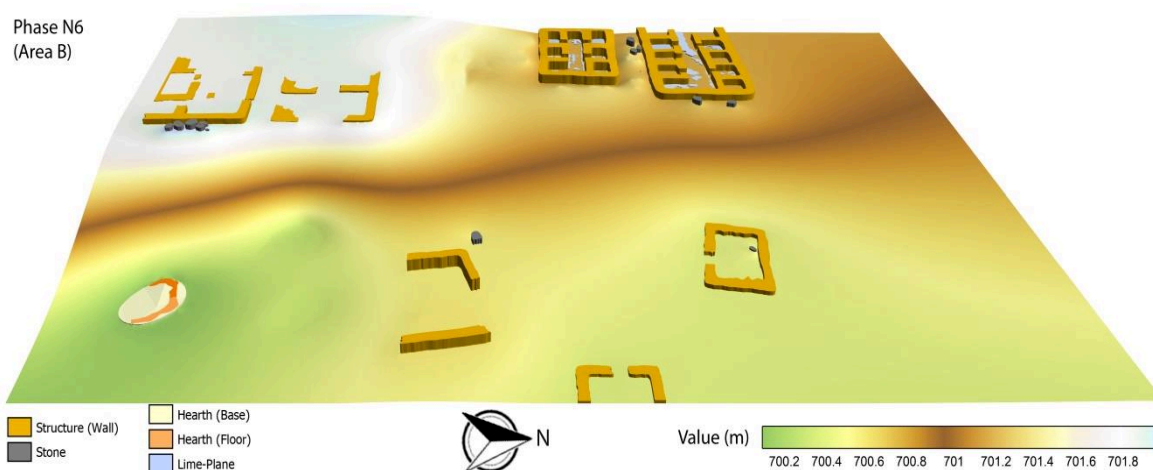
**Figure 3.11:** Settlement pattern and architecture from Phase N6 at Area B

The following phase, Phase N6, which is dated to 8708±90 – 8594±49 CalBP (6758±90 - 6644±49 CalBC), has been exposed over an area of 956 m<sup>2</sup> in areas A and B. The site was densely inhabited and there was a radical change in the settlement pattern. Buildings were erected directly on the ground without stone footings and were located by leaving spaces in between low terraces of the natural topography in areas A and B. The primary plan type is Cell Buildings with an ‘L’ or a ‘T’-shaped long rooms (corridor) in the middle and almost-square cells on either wing. (Figure 3.11, 3.12, 3.59, 3.60) There are also smaller single-roomed dwellings. All buildings were constructed using the piled earth technique. Besides the difference in the settlement strategies of Phase N7 and Phase N6, another distinctive feature of Phase N6 is an entire absence of pottery.

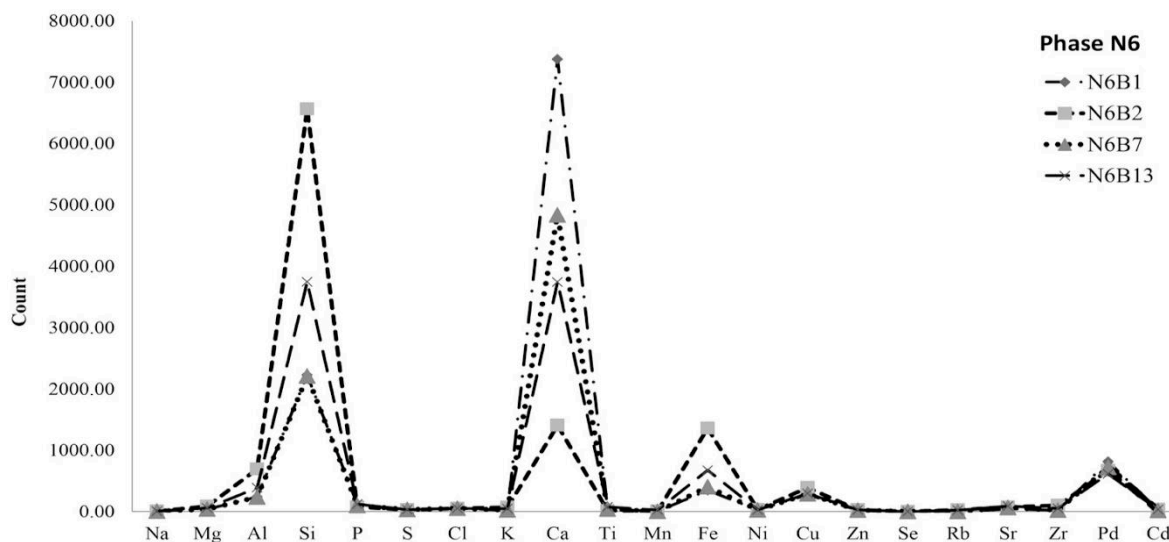
**Diagram 3.18:** Comparison of XRF analysis results taken from Phase N6 structures

Lime samples from structures were investigated with XRF and it was observed that the elements Ca (29%), Si (45%), Fe (7%), Al (5%) and Pd (5%) were dominant. Ni, Zn, Sr, Rb, Na, K, S, P, Cl, Cu, Ze, etc. were also identified in minimum amounts. (Diagram 3.18) Lime samples taken from this phase have a mean stable isotope composition of  $\delta^{18}\text{O} = -6.08$  ‰ and  $\delta^{13}\text{C} = -7.90$  ‰ V-PDB. (Diagram 3.11) The close isotopic values indicate the presence of a stable climate; even tiny fluctuations are observed. Possibly much drier or rainy periods were experienced during these fluctuations compared to previous or later periods.

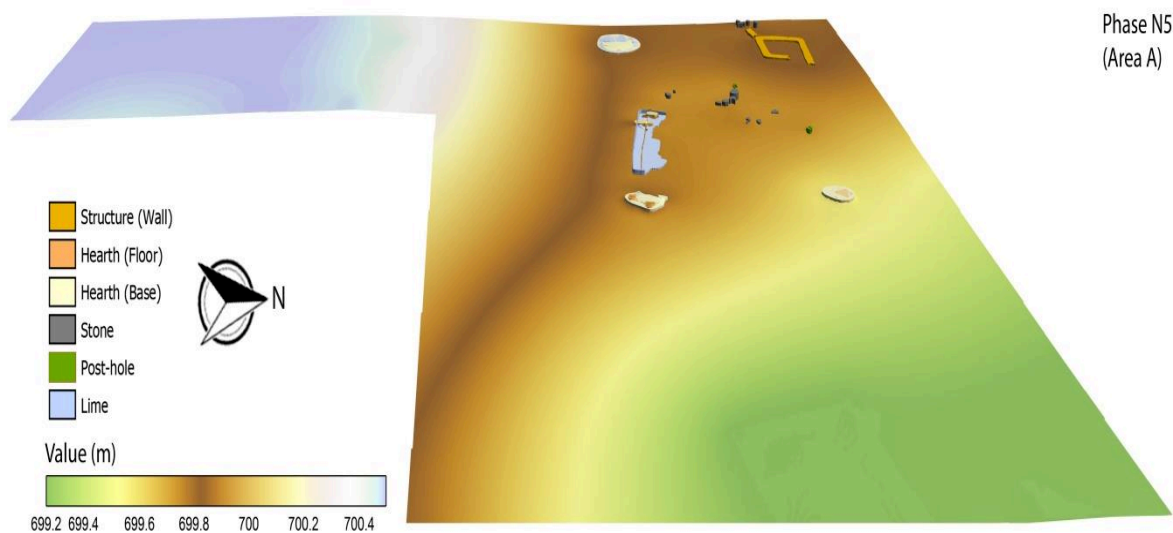
**Figure 3.13:** Settlement pattern and architecture from Phase N5 at Area A

The succeeding Phase N5 is dated to  $8526\pm 60$  -  $8491\pm 50$  CalBP ( $6576\pm 60$  -  $6541\pm 50$  CalBC) according to four  $C_{14}$  date, (Table 3.3) has a similar character to previous phase, Phase N6, and was recovered in an area of  $865\text{ m}^2$ , with  $625\text{ m}^2$  in Area B,  $200\text{ m}^2$  in Area A, and  $40\text{ m}^2$  in Area C. (Figure 3.13, 3.14, 3.61, 3.62, 3.71) Area B seems to be more intensively occupied than before, keeping the same pattern on low terraces of the natural topography as it was in Phase N6 while Area A was less settled. In Area C very limited structural remains were recorded.

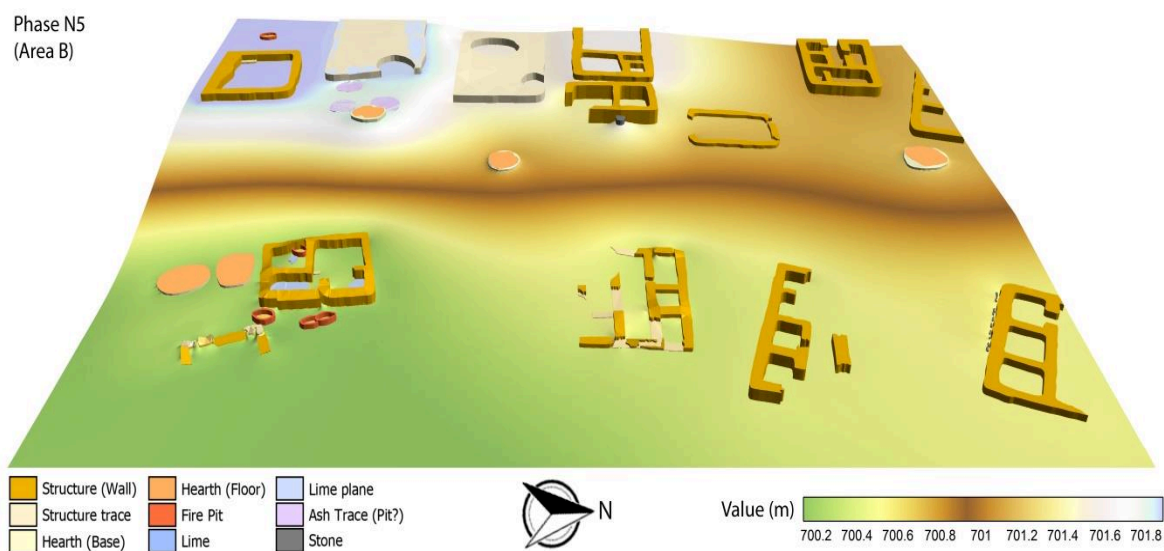
**Figure 3.14:** Settlement pattern and architecture from Phase N5 at Area B

Either in building layout or construction technique, notable changes are recognised in Phase N5. While the practice of Cell Building continued, multi-roomed and double-roomed buildings appeared. Single-roomed structures were also in use. Additionally, the lime floor in multi-roomed structure N5B12 is the only interior floor in Sumaki Höyük Neolithic settlement. Single-roomed buildings display two different traditions. They were either built by the piled earth technique as they were in Phase N6 or were ‘temporary’ structures that had only reed surroundings (probably with a flimsy upper cover), as is documented in structures N5B14 and N5B15. Close to these ‘temporary’ structures, are fire pits similar to the ones in Phase N7. It should particularly be emphasised here that these structures are located in the same area as the Cell Buildings. In this phase, ten hearths were exposed with five in Area A and five in Area B. (Table 4.5) There are generally stone pavements beneath their plastered floors although some examples were identified directly on the ground. All have a single floor except for one.

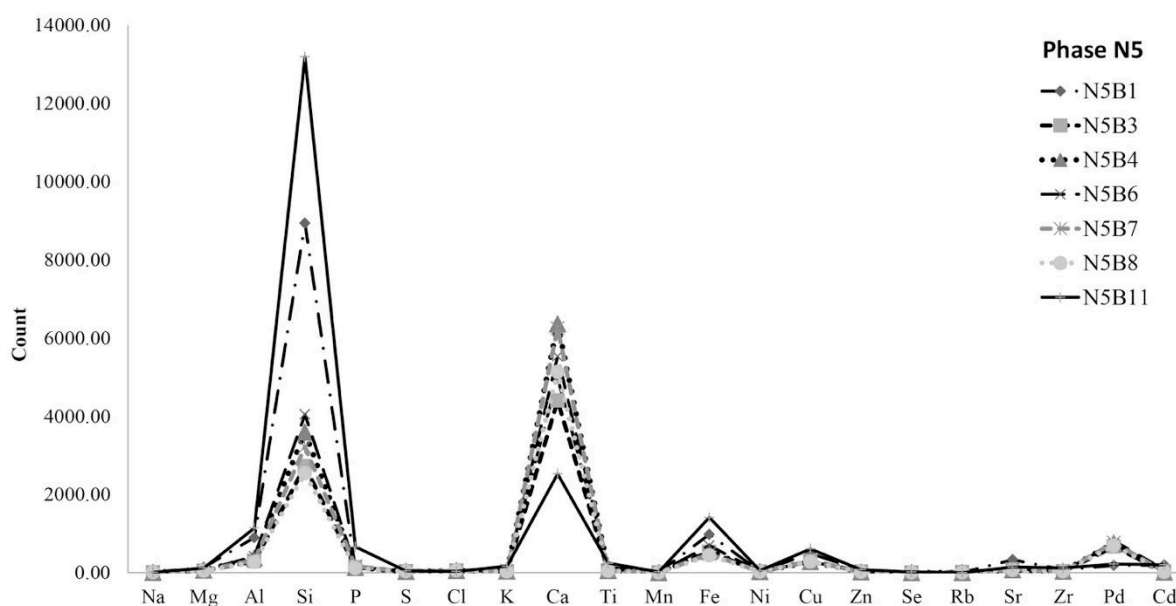
**Diagram 3.19:** Comparison of XRF analysis results taken from Phase N5 structures

envelopes were observed on the sand and stone grains from samples. SEM images found scalenohedral, prismatic, granular, and stalactitic crystal structures along with acicular crystals in some samples. Very clear calcium carbonate minerals were observed surrounding tubes formed by organic remains. The minerals surrounding the tubes are generally hexagonal and pointed-tipped mixed crystal structures. It was determined that SiO<sub>2</sub> gels filled natural cavities. The clearest one is silicon dioxide gels filling *Panicum* plant remains. Investigation of Phase N5 earth and lime samples with the EDX method found mean element ratios of O (46.95%), Ca (19.72%), C (14.93%), Si (8.85%), and Fe (2.44%). N, Na, Mg, Al, P, S and Cl elements were also identified at mean ratios of 4% to 0.24%. (Diagram 3.1) Investigation of the same samples with the XRF method observed the following elements dominating; Ca (37%), Si (40%), Fe (5%), Al (4%), and Pd (2%), together with very small amounts of Ni, Zn, Sr, Rb, Na, K, S, P, Cl, Cu, and Ze. (Diagram 3.19)

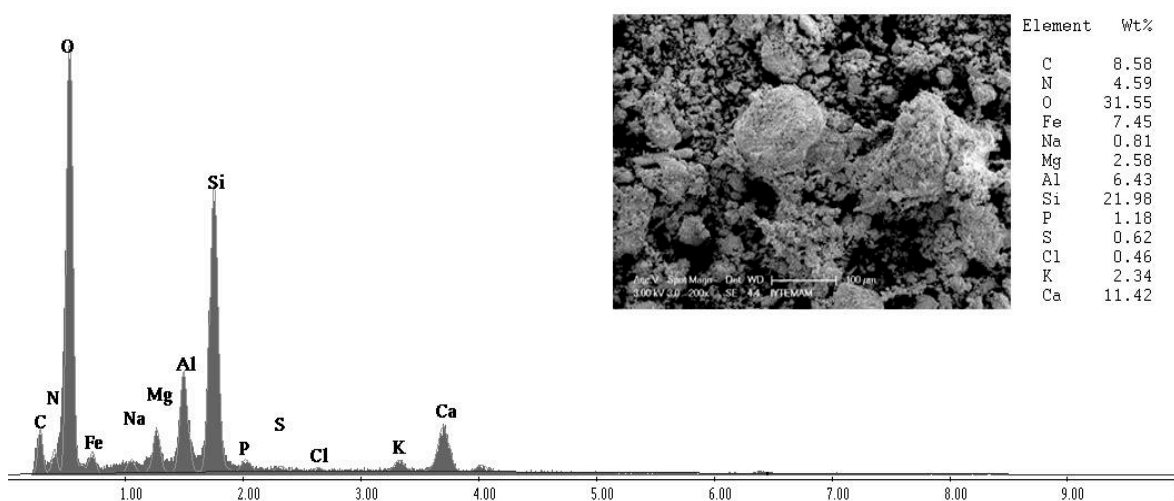
**Diagram 3.21:** EDX analysis results of soil samples taken from Phase N3 at Area A

(31.55%), Ca (11.42%), C (8.58%), Si (21.98%), Fe (7.45%), and Al (6.43%). (Diagram 3.21) Mean element proportions in Area B are O (33.83%), Ca (14.06%), C (8.59%), Si (24.13%), Fe (8.57%), and Al (6.16%). (Diagram 3.22)

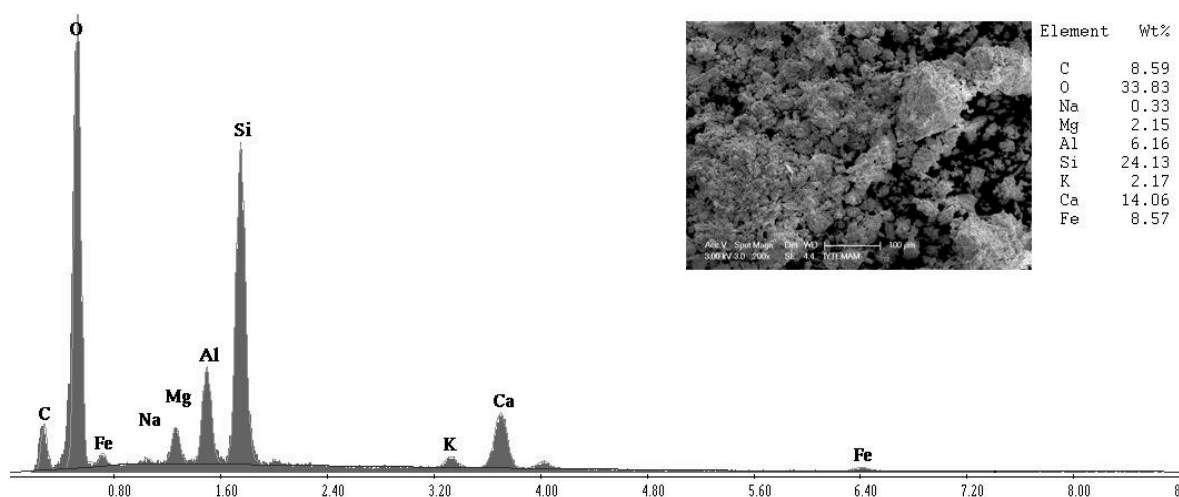
**Diagram 3.22:** EDX analysis results of soil samples taken from Phase N3 at Area B

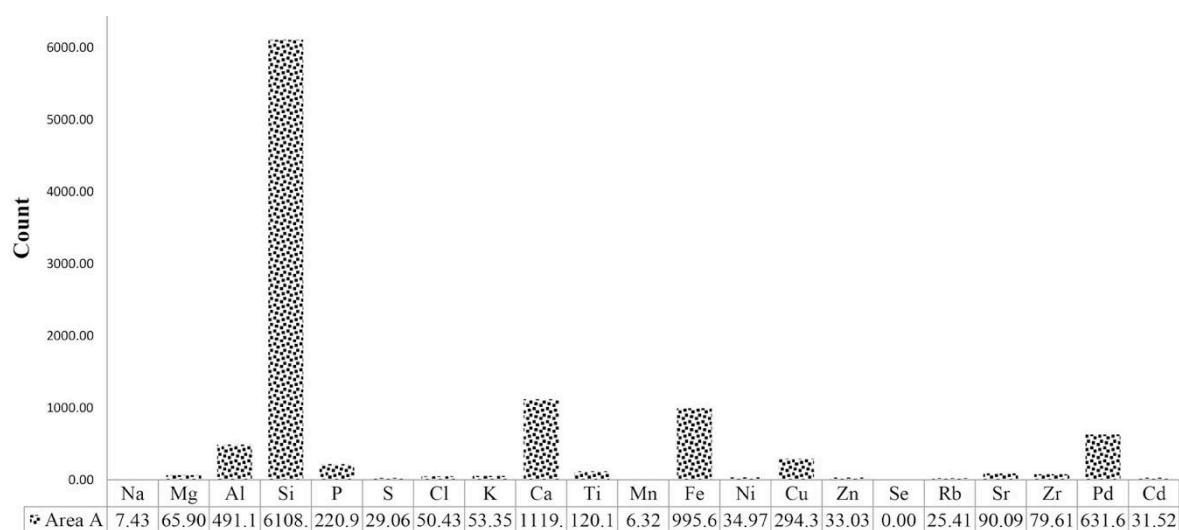
**Diagram 3.23:** XRF analysis results of soil samples taken from Phase N3 at Area A

Lime and earth samples were also investigated using the XRF method. In both areas, the elements and their ratios are not very different. In the samples from Area A, Ca (11%), Si (58%), Fe (9%), Al (5%), and Pd (6%) were dominant (Diagram 3.23) while in Area B, Ca (11%), Si (61%), Fe (8%), Al (8%), and Pd (3%) were dominant. Minimal amounts of Ni, Zn, Sr, Rb, Na, K, S, P, Cl, Cu and Ze were also identified. (Diagram 3.24)
