# Microarchaeological observation on the neolithic architectural structures and cultural landscape of Sumaki Höyük

# **Microarchaeological Observation on the Neolithic Architectural Structures and Cultural Landscape of Sumaki Höyük**

PhD Thesis

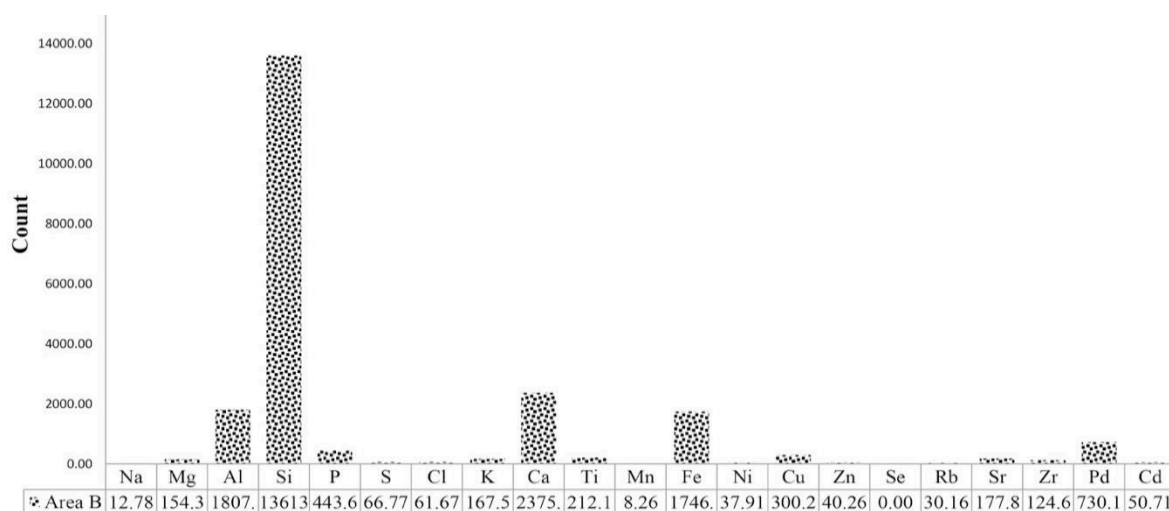
**Diagram 3.24:** XRF analysis results of soil samples taken from Phase N3 at Area B

Lime and earth samples were also investigated using the XRF method. In both areas, the elements and their ratios are not very different. In the samples from Area A, Ca (11%), Si (58%), Fe (9%), Al (5%), and Pd (6%) were dominant (Diagram 3.23) while in Area B, Ca (11%), Si (61%), Fe (8%), Al (8%), and Pd (3%) were dominant. Minimal amounts of Ni, Zn, Sr, Rb, Na, K, S, P, Cl, Cu and Ze were also identified. (Diagram 3.24)

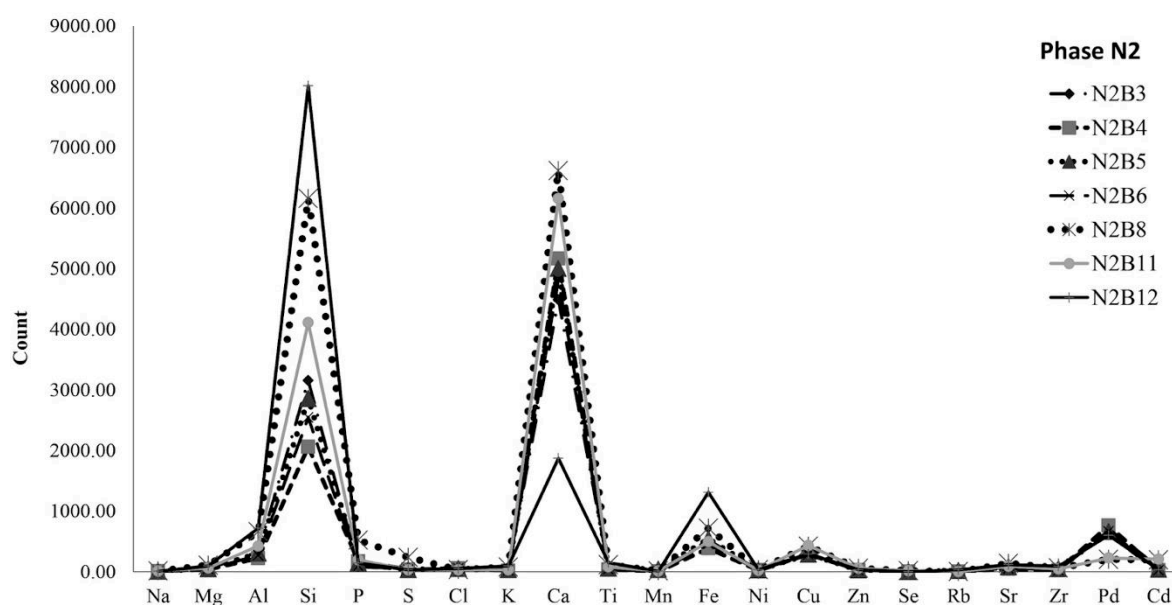
**Diagram 3.25:** Comparison of XRF analysis results taken from Phase N2 structures

Earth and lime samples taken from seven structures were also investigated with the XRF method. According to the analysis, Ca (14%), Si (59%), Fe (9%), Al (5%) and Pd (4%) were dominant in earth samples. In lime samples, the element ratios were mean Ca (47%), Si (31%), Fe (5%), Al (3%), and Pd (5%). In both earth and lime samples, low amounts of Ni, Zn, Sr, Rb, Na, K, S, P, Cl, Cu, and Ze were also identified. (Diagram 3.25) The XRF and EDX analysis results support each other.

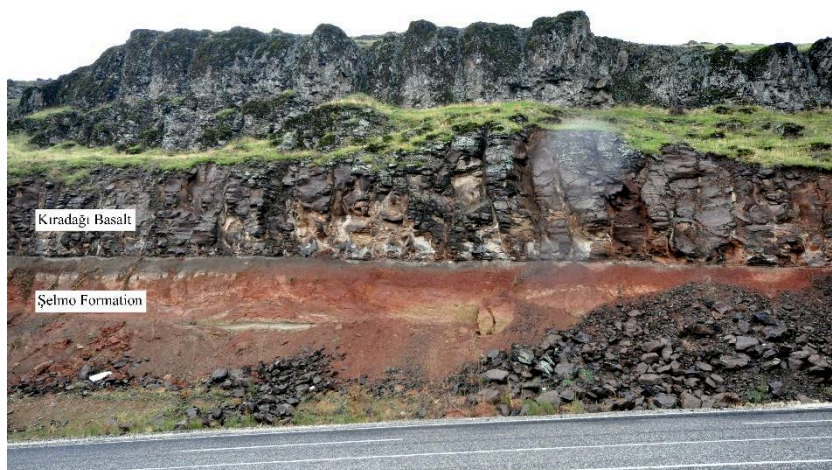
**Figure 3.28:** Cross-section of the Kıradağı basalt

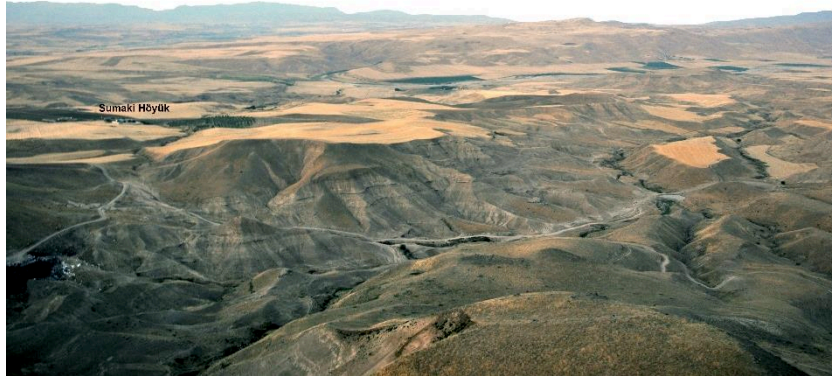
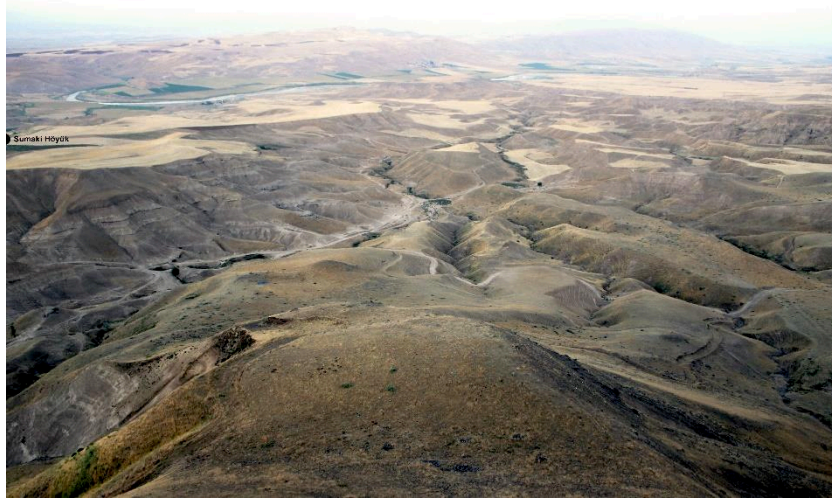
**Figure 3.35:** Mass movements and landslides area on the eastern outskirts of Kıradağı

**Figure 3.36:** Mass movements and landslides area on the eastern outskirts of Kıradağı

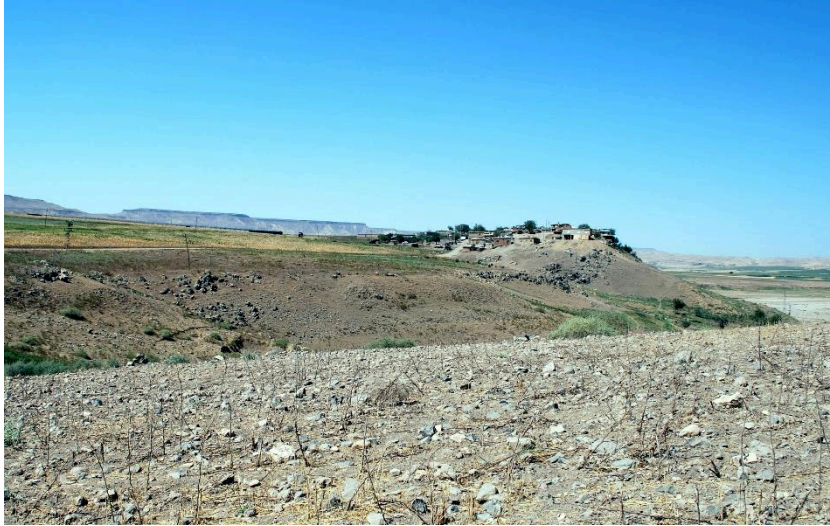
**Figure 3.38:** Drifting of blocks detached from the Kıradağı Basalt, near Tepecik village

Due to the dense, heavy basalt mass above loose units and to the instability of the slope, mass movements occur very frequently and the material is carried over large distances. The best example of this is observed near Tepecik village where basalt blocks from Kıradağ have accumulated on the slope of Garzan Stream. (Figure 3.38) In front of both of these accumulations, in the form of a line, two settlements were detected, Gre Şavo and Gre Keleke, with habitation beginning in 3000-2000 BC. (Erim-Özdoğan & Sarialtun, 2011:1088-1090) Conclusively, this indicates a large-scale landslide with fragmentation and movement occurring sometime before 3000 BC. Another area where landslide events in clay units are commonly observed is Sumaki Höyük and its surroundings.

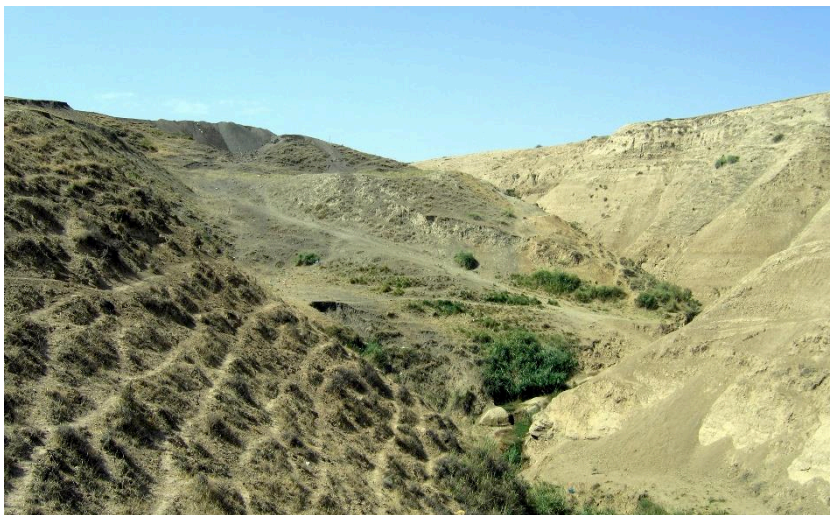
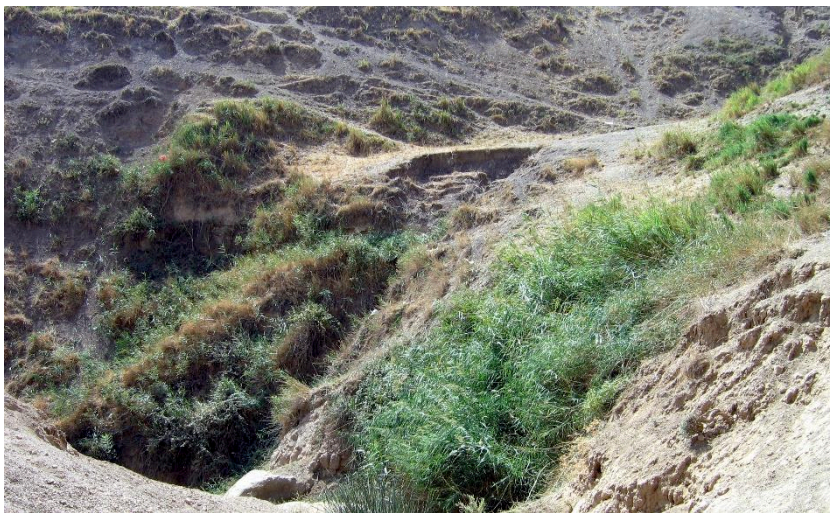
**Figure 3.39:** Mass movements and current landslide traces, on the northeastern slope of Sumaki Höyük

**Figure 3.40:** Current landslide traces, on the northeastern slope of Sumaki Höyük

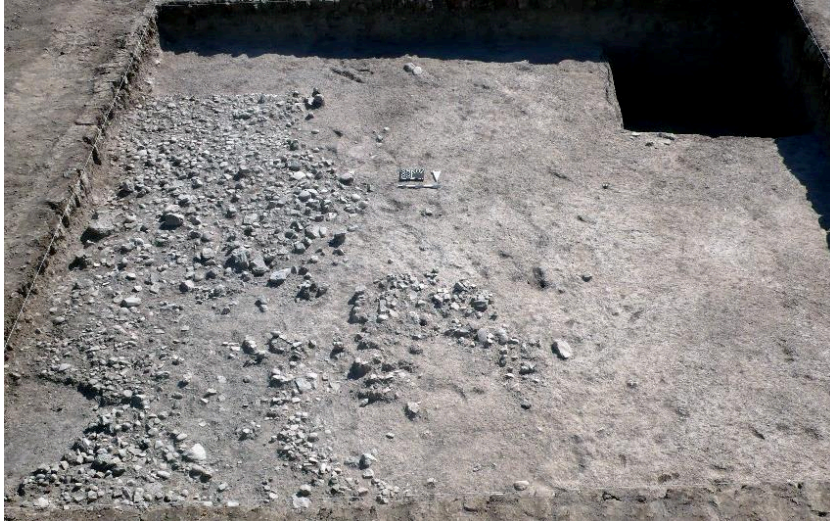
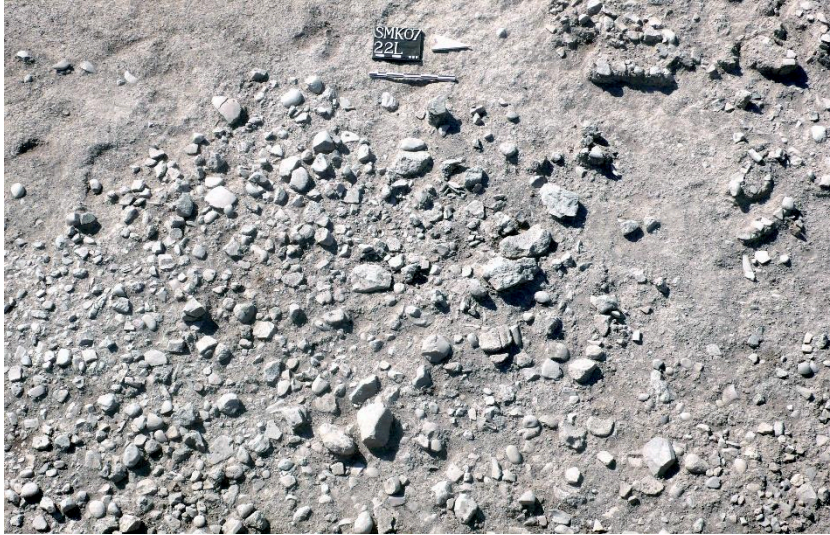
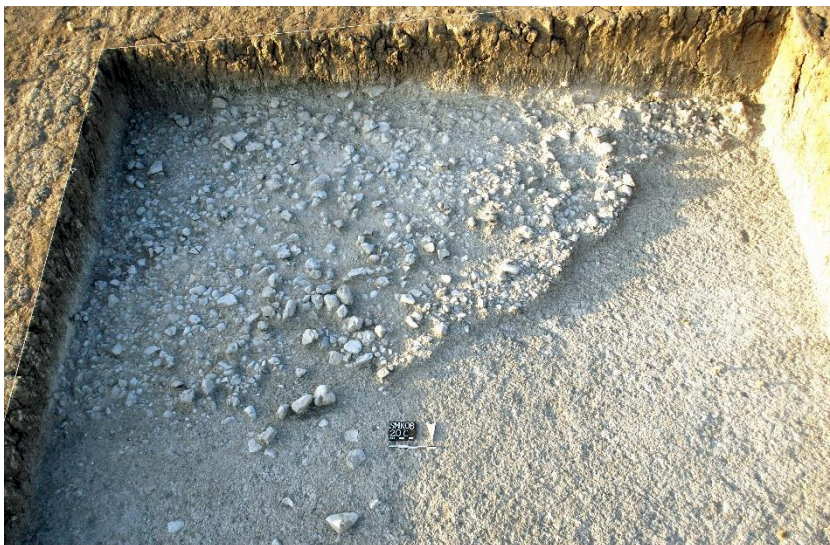
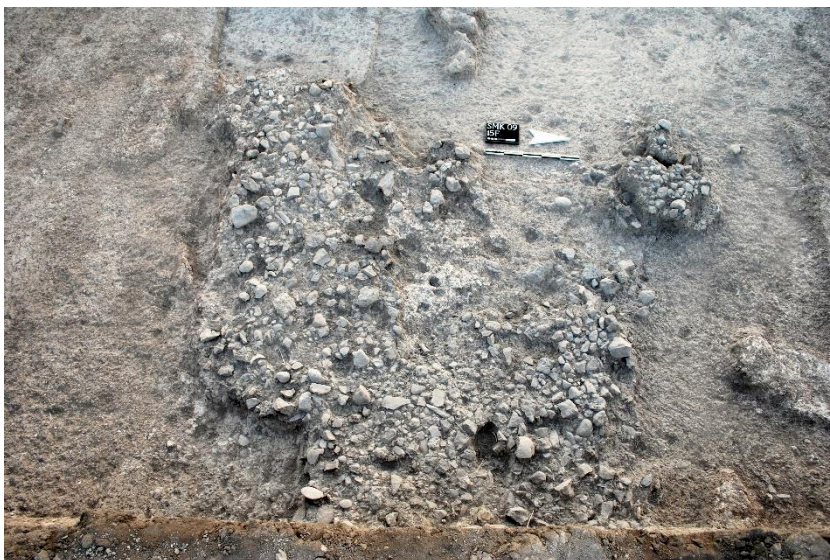
**Figure 3.41:** Torrent / flood sediment in trench 22L form Area A (Torrent 1)

**Figure 3.44:** Torrent / flood sediment in trench 15F form Area B (Torrent 1)

**Figure 3.45:** Torrent / flood sediment in trench 20C form Area C (Torrent 1)

**Figure 3.46:** Torrent / flood sediment in trench 15F form Area B (Torrent 2)

In the Neolithic layers of Sumaki Höyük, many flood/inundation/soil flow traces have been identified, with two particularly well-defined. (Figure 3.41 – 3.46) Due to these external factors, the settlement was abandoned at intervals. In periods when it was not suitable even for a temporary settlement due to the likelihood of floods, soil flows and suchlike, it is understood that tents were set up in some areas by small groups. Abandonment

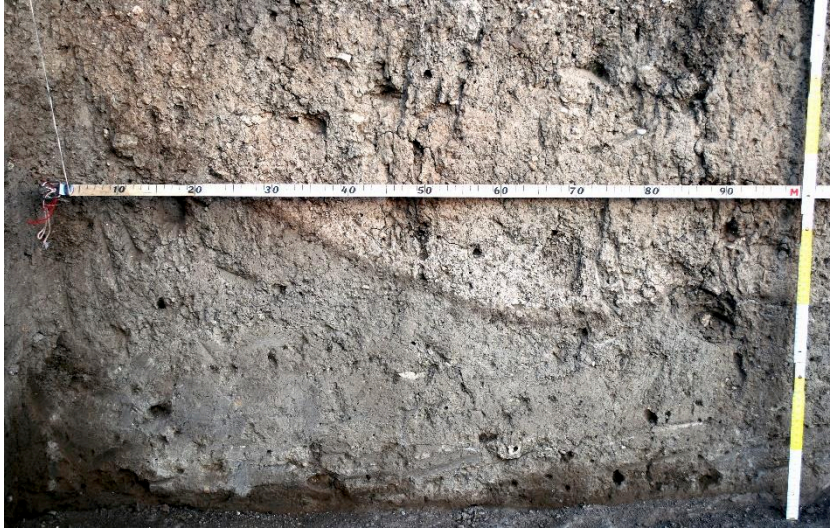
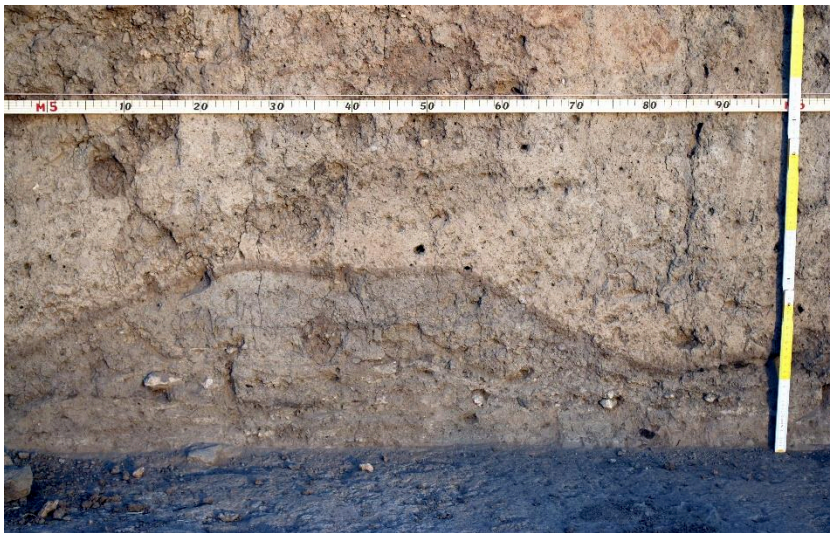
**Figure 3.47:** Thin earth line between Phase 4 and Phase 3 from Sumaki Höyük

**Figure 3.48:** Thin earth line between Phase 4 and Phase 3 from Sumaki Höyük

of the settlement was not only determined by archaeological data. In the upper levels of Phase N4 fill, a 2-3 cm-thick soil formation was identified which occurred after a probable flood, creating an aqueous environment. (Figure 3.47, 3.48) XRD and XRF analysis show that during the uninhabited periods of the settlement, deposits of different mineralogical composition were transported there by external factors. (Table 3.1) For example, Brucite and Sphalerite are related to an aqueous environment. The presence of Kyanite and Chalcopyrite, sourced in volcanic formations, indicates these minerals were probably transported by slope flows from the Kıradağı basalts.

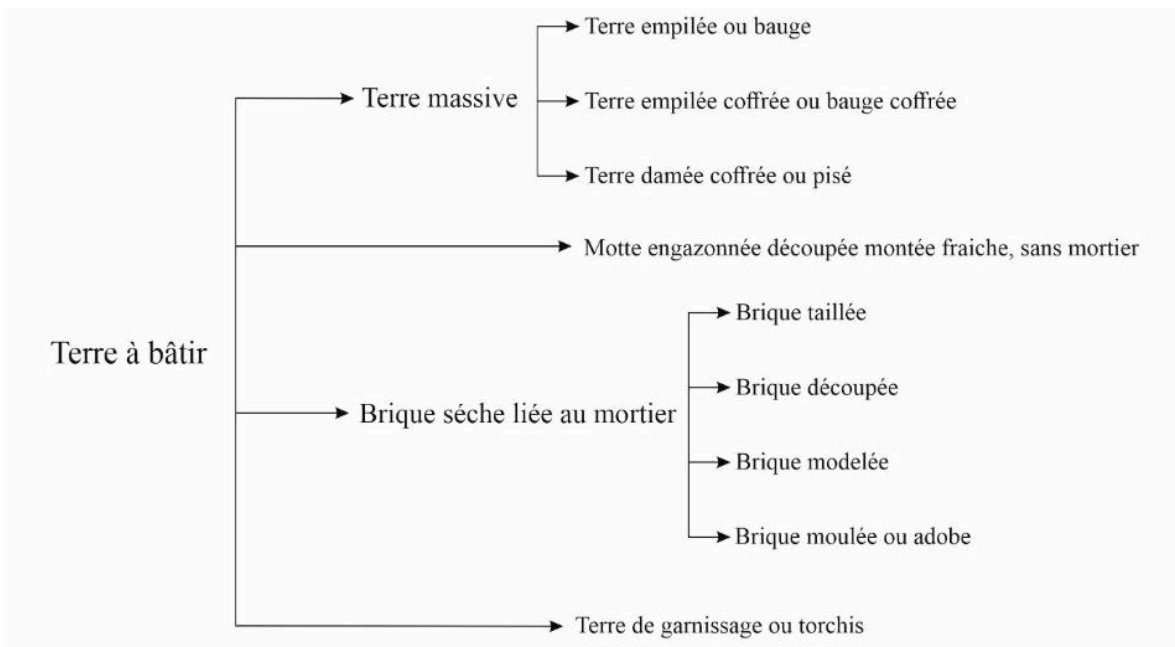
**Figure 4.1:** Classification of earth implementation (Aurenche et al., 2011:16 fig.2)

According to the Aurenche et al., 2011 (Figure 4.1) earth implementations are classified as follows;

- a) Massive earth (*terre massive*) that groups together the piled earth (without formwork)
- b) Cutting sod earth (la motte engazonnée découpée),
- c) Bricks (brique, molded brick, mud-brick, adobe or kerpiç)
- d) Wattle and daub or plastered (garnissage or torchis) (Aurenche et al., 2011:17)

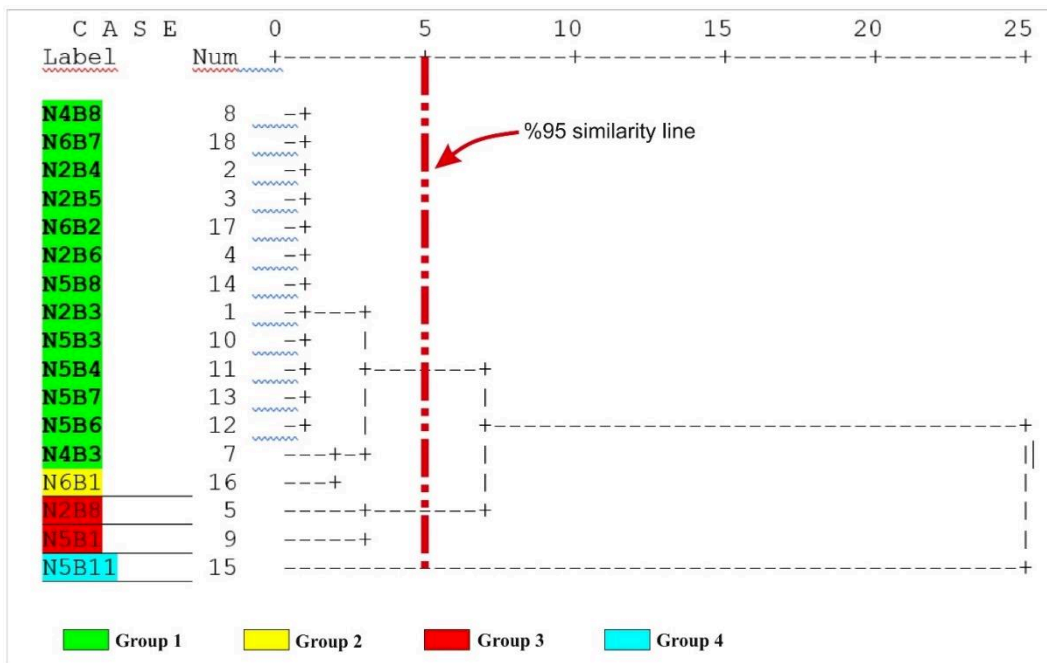
Diagram 4.1: Clustering of lime samples from all data according to XRF analysis

Sumaki Höyük Lime and soil samples taken from Neolithic architectural walls were examined by cluster analysis. As a result of this analysis, it was determined that lime samples were divided into 4 groups and soil samples were divided into three groups. According to the dendrogram and 95% similarity criteria, all the data obtained in XRF analyzes were taken into consideration and Group 1 was the largest group with 13 samples. Group 2 is represented by one example, Group 3 by two examples Group 4 is represented by one example. (Diagram 4.1)

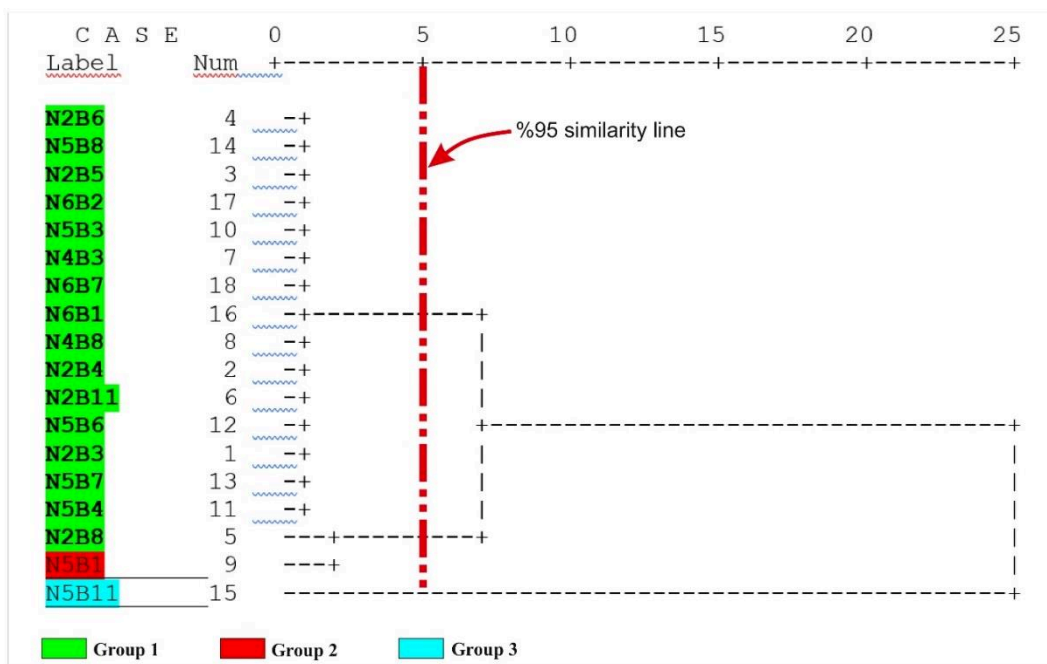
**Diagram 4.2:** Clustering of lime samples from Al and Si data according to XRF analysis

Lime samples were divided into 3 groups according to 95% similarity criteria in the classification made using only aluminum and silicon values used in the origin analysis of silicon based materials instead of all data. 1 group is the largest group as in the first table and is represented by 15 examples. (Diagram 4.2) Group 2 is represented by an example (N5B1). Group 3 is represented by an example (N5B11).

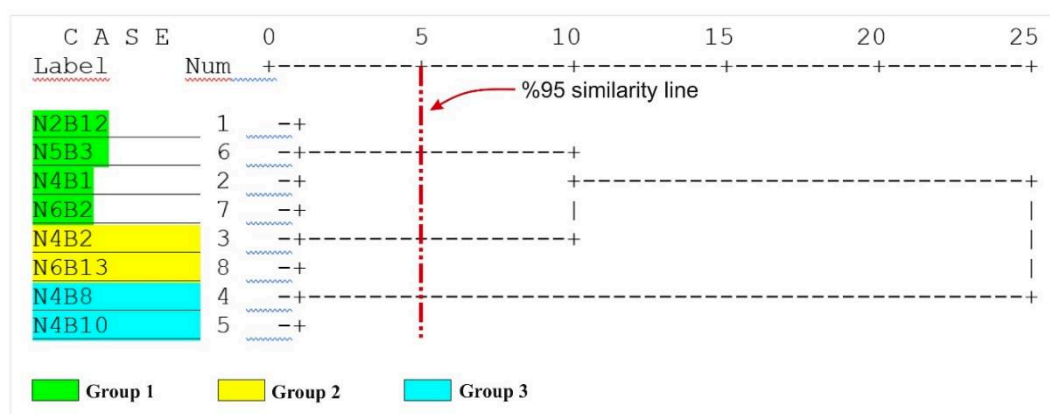
**Diagram 4.3:** Clustering of earth samples from all data according to XRF analysis

The clustering of soil samples taken from the Neolithic architectural walls of Sumaki Höyük is somewhat more complex. Again, it was determined that soil samples were divided into 3 groups according to dendrogram and 95% similarity criteria. The first group was the largest group with four samples, while the second group was represented by two third groups and two groups. A total of eight soil samples were again divided into three groups according to the dendrogram analysis, taking into account Al and Si. In both examination parameters, the results almost overlap. (Diagram 4.3)

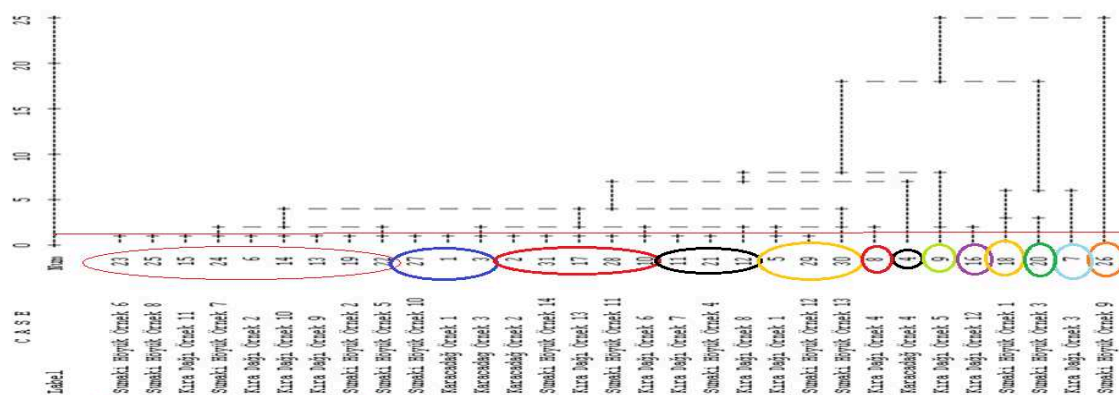
**Diagram 4.4:** Comparison and clustering of basalt samples according to XRF analysis

According to these groupings, 14 samples of Sumaki Höyük formed a cluster with five samples in Group 1; two with Group 3 and Group 5; and one with Group 2 and Group 4 with Kıradağı basalts. Therefore, 10 of 14 basalt samples that were collected from Sumaki Höyük were matched with Kıradağı samples. In other words, these 10 samples have similar chemical composition with Kıradağı basalts. Only one sample (Group 2) of Sumaki Höyük have a similar chemical composition with Karacadağ basalts. (Diagram 4.4)

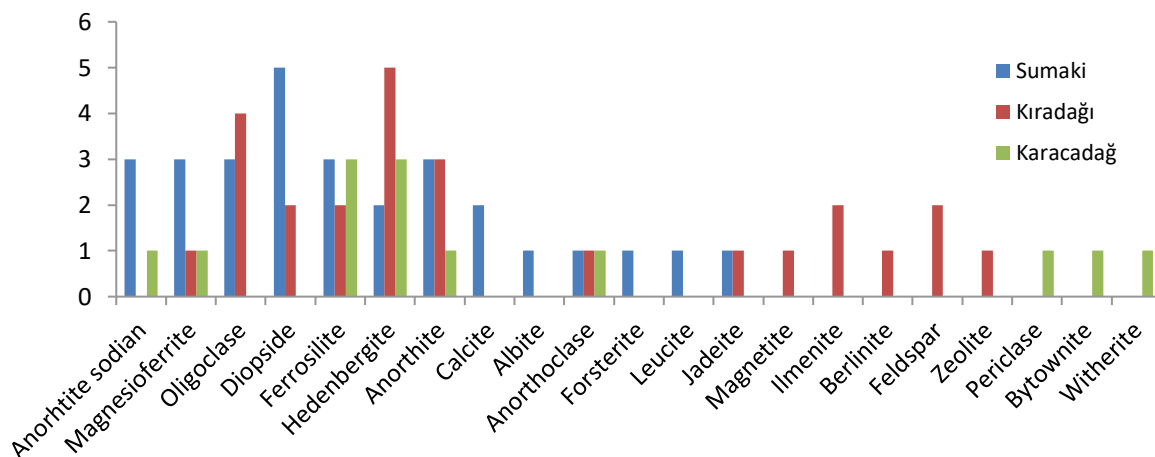
**Diagram 4.5:** Comparison of basalt samples according to XRD analysis

According to the XRD analysis results of the samples taken from Sumaki Höyük basalts, Kıradağı and Karacadağ basalt flows identified different minerals. (Diagram 4.91 – 4.100) Witherite, Bytownite and Periclase minerals were not detected in Sumaki Höyük and Kıradağı basalt samples, while they were determined in Karacadağ samples. Diopside, Jadeite, and Oligoclase minerals are examined in the basalt samples of Sumaki Höyük and Kıradağı, however, these minerals were not found in the Karacadağ samples. Although Zeolite, Feldspar, Berlinite, Ilmenite, and Magnetite minerals were identified in the Kıradağı formation, they were not found in the Sumaki Höyük and Karacadağ samples. These results may be that due to the limited number of samples and/or the periodic formation variation in the Kıradağı basalt. Since Calcium and Albite minerals were clearly identified in soil samples taken from Sumaki Höyük Neolithic deposits, their presence in the Sumaki Höyük basalt samples indicates these minerals were probably contaminate the grinding tools is noteworthy. (Diagram 4.5)

According to XRD analysis, in the Sumaki Höyük, ground stone tools made of basalt with a similar petrographic structure to the Kıradağı basalt have been obtained. Accordingly, previous interpretations that local volcanic material was intensively used in the Sumaki Höyük have been proved correct.

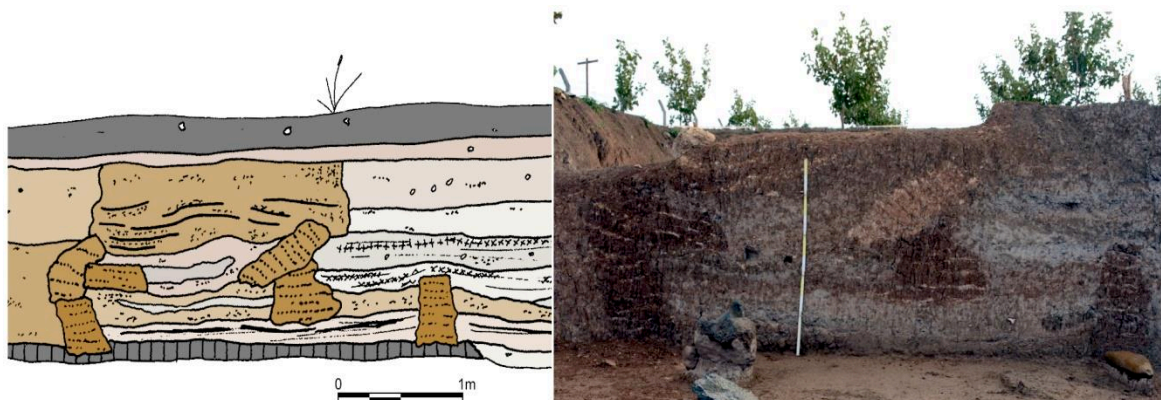
**Figure 4.2:** Traces of piled earth walls in the south trench section of 15G

Enclosures made of reeds/woody plants were identified as rectangular temporary structures. These enclosures were determined by 2-3 cm-thick lime fragments. These lime fragments do not have the characteristics of plaster but are generally the size of hazelnuts. (Figure 4.2) Micro-morphological and phytolith analysis of these lime fragments show that they contain reed and/or herbaceous plant remains. Additionally, in the ethno-archaeological field study of the Lower Garzan Basin, rectangular temporary structures surrounded by reeds or branches were identified. These structure types used by semi-nomadic groups have reed enclosures 10-12 cm in thickness. Examples with tent cover have a reed enclosure height of nearly 1 m; while in structures made only of reeds, the enclosures reach the upper cover. Enclosures made of branches, on the other hand, have a height of nearly 40 cm; with a thickness varying between 8 and 15 cm depending on their size and/or weaving techniques. The reed and/or branch enclosures do not have load-carrying capabilities, rather they have occlusive functions. This type of structural element identified in Sumaki Höyük was interpreted as having a mean height of 1 meter, from ethno-archaeological observations, but usually they do not exceed 50 cm, some were even represented by very low fill of below 10 cm.

appearance in the form of layers with different thicknesses. With a mean thickness of 7 cm, the generally reddish-brown raw earth was laid. (Figure 4.2) These homogeneous earth layers with a very soft structure are quite recognizable in the wall cross-sections. Analysis of lime fragments between the layers identified dense amounts of plant remains. Regarding all these data, it is thought that plants were placed on top of partly-wetted earth in the bounded area and then compressed. However, in structures N6B4 and N4B8, light brown homogeneous levels were identified between the reddish-brown earth layers. This data indicate that sometimes woody plants and sometimes different soils were spread between these layers. Boundary traces of reeds or herbaceous plants were mostly identified at the edge of many buildings; in particular, the continuous traces around the face of walls in Structures N4B1, N4B2, N4B3 and N5B5 are very clear. The walls, which were constructed by limiting the edges with reed or herbaceous plants, were of different thicknesses. The main walls generally had a mean thickness of 28 to 41 cm, but there are walls with a thickness between 18 cm and 46 cm. No connection was identified between wall thickness and the function of buildings.

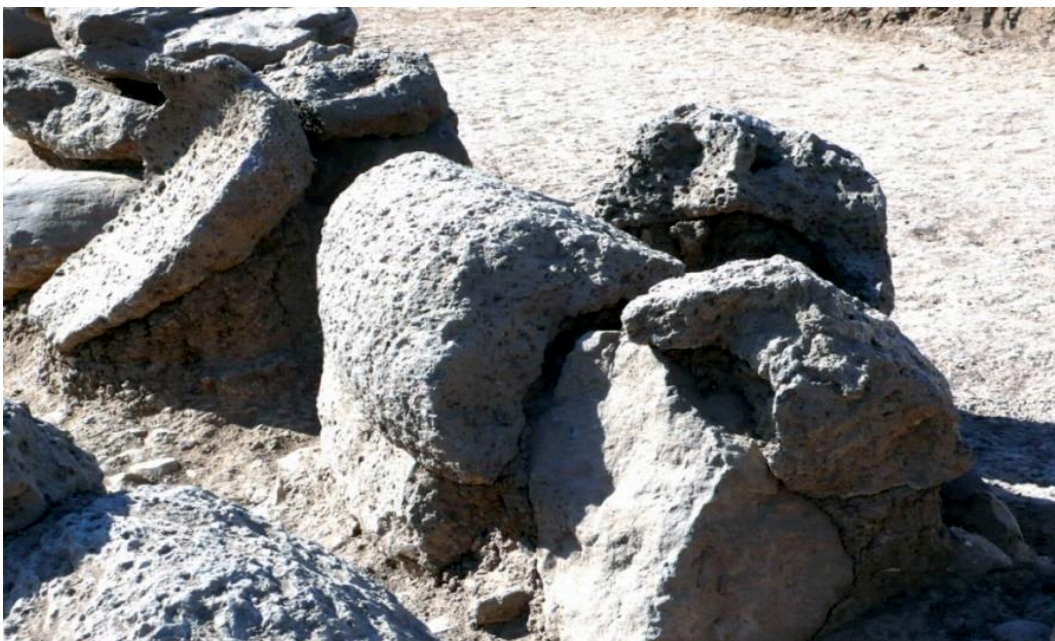
**Figure 4.4:** Stone row from Phase N1

In the upper phase of the settlement (Phase N1), stone rows and/or stone wall remains are clearly encountered. These rows of stones were used as enclosures surrounding the structure and/or as support material. Stone rows surrounding the structures were in a single row with thickness varying from 25 to 55 cm. The main reason for this diversity is that the stones were placed irregularly. In the central exposed area of Area A, parallel stone walls and/or rows were recovered in an east-west direction. They were in a single series and occasionally increased to 3-4 rows in height. There was no mortar between the stones, but occasionally earth filling was observed. Nearly all the stones were large grinding stones and their fragments. (Figure 4.4)

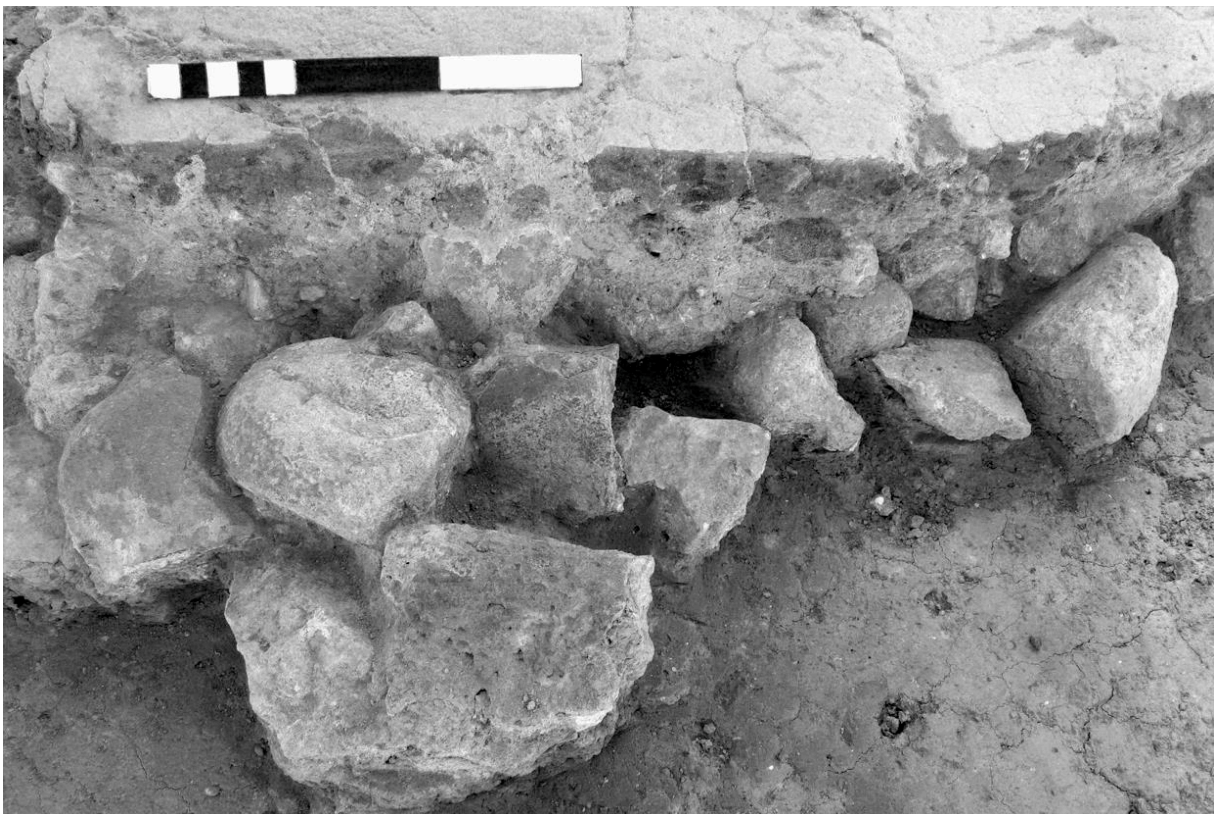
**Figure 4.5:** Construction stages and cross section of a hearth (N101)

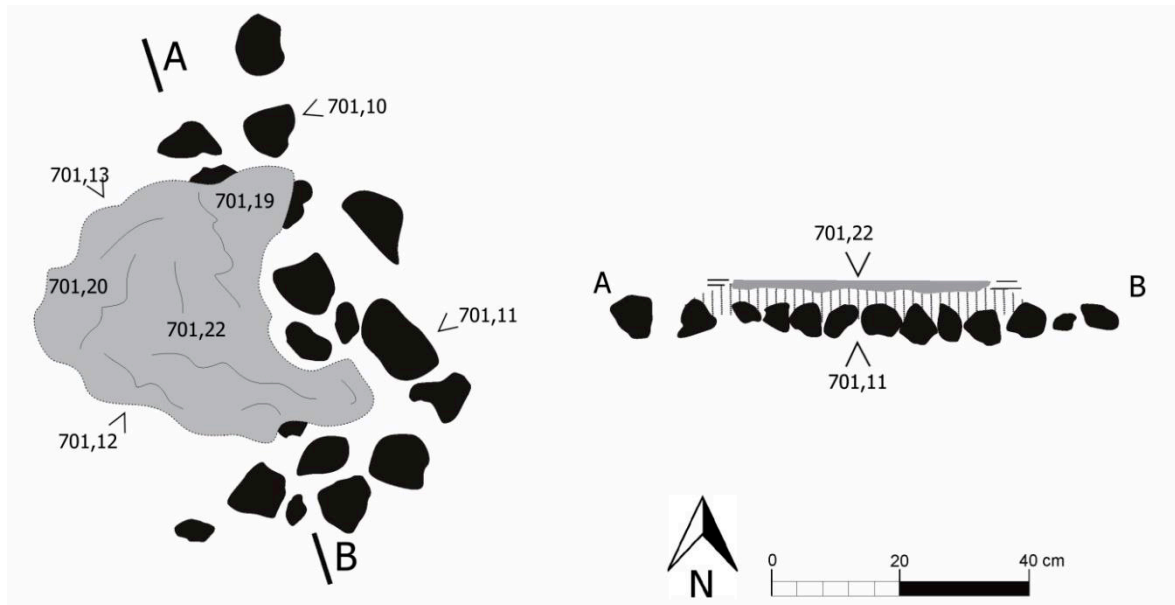
**Figure 4.6:** Hearth N7O1 and its cross-section

This was found in the southeastern part of trench 14G in Area B on the reddish-brown natural earth. It covers an area of approximately 2 m<sup>2</sup> at elevations of 701.10 – 701.22. It had a single plastered floor with a stone pavement. The partly-preserved plastered floor was approximately 47x80 cm in size. (Figure 4.6, 4.207, 4.208) The stone pavement was made of basalt and pebbles of different sizes between 3x3x5 - 15x20x25 cm. Between the stone pavement and the plastered floor was a layer of pebble and sand-tempered greyish buff-coloured filling. The plastered floor was an orange buff colour about 2 cm in thickness with traces of burning. The surface of the medium hard floor was rippled and densely cracked.

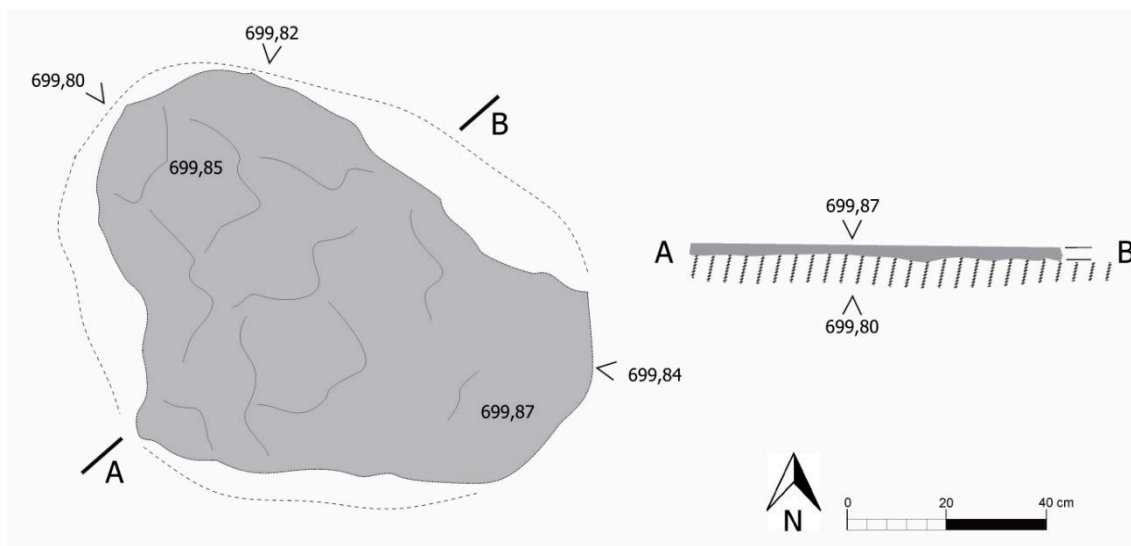
**Figure 4.7:** Hearth N7O2 and its cross-section

This was found in the southeastern part of trench 15H in the open area in Area B on the greyish buff homogeneous soil. The hearth covers an area of approximately 1.12 m<sup>2</sup> between the elevations of 699.80 to 699.87. The oval-shaped hearth had a single plastered floor without a stone pavement. The plastered floor was 121x156 cm in size. (Figure 4.7, 4.209) Based on the floor remains, the hearth slightly inclined to the east. Its partly destroyed plastered floor was dark grey-coloured about 2 cm in thickness with traces of black burning. The surface of the medium hard plastered floor was slightly rippled and cracked.

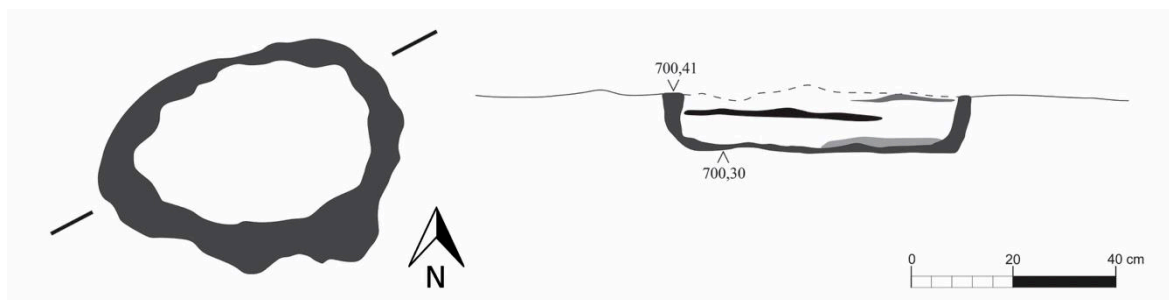
**Figure 4.8:** Fire Pit N7A1 and its cross-section

This was located in an open area in the western part of trench 15G in Area B. The oval-shaped fire pit was between the elevations of 700.30 – 700.41. Dug in a light grey ashy soil, the fire pit was 43x66 cm in size and 11 cm deep. (Figure 4.8) On its edge, there is a dark-brown line due to burning with 2-5 cm thickness. There were no signs of plastering on its sides or its bottom. Its inner deposits were yellowish buff, grey and orange in places. Near the fire pit, yellowish buff-coloured soil traces were also found. (Figure 4.273) This yellowish-coloured soil with similar features to the inner deposit was probably waste ash deposited near the pit after the fire was extinguished.

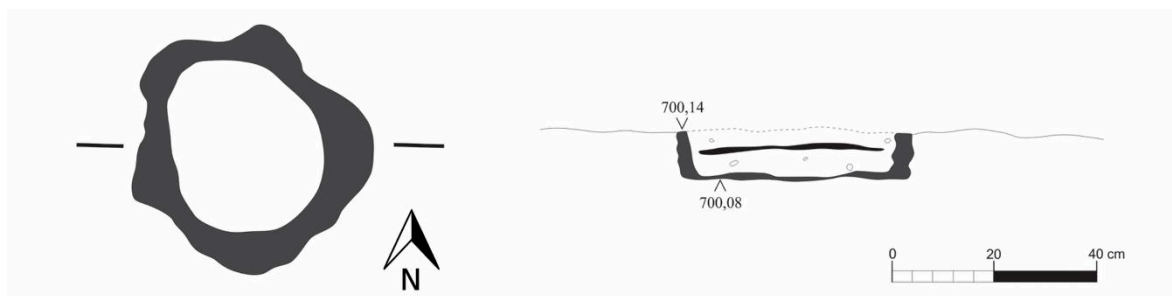
**Figure 4.9:** Fire Pit N7A2 and its cross-section

This was located in an open space in the northwestern side of trench 15H in Area B. The round-shaped fire pit was between the elevations of 700.08 to 700.17. Dug in a light grey ashy soil, the fire pit was 47x49 cm in size and 9 cm deep. (Figure 4.9) On its edge, there is a brown line due to burning with 2-4 cm thickness. There were no signs of plastering on its sides or its bottom. It was filled with yellowish buff- and grey-coloured ash. On its southwest side there was a post-hole 14 cm in diameter. If the temporary character and function of the fire pits are taken into account, this post-hole should have been associated with another architectural structure or element.

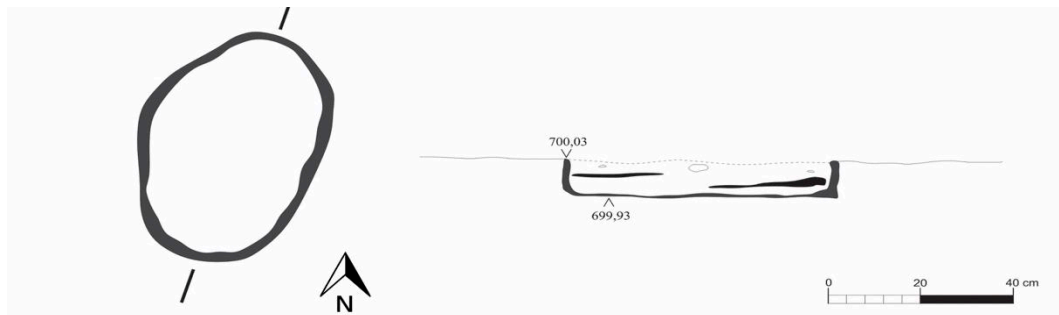
**Figure 4.10:** Fire Pit N7A3 and its cross-section

This was located in an open space in the western part of trench 15H in Area B. The oval-shaped fire pit was between the elevations of 699.93 to 700.03. Dug in a light grey dense ashy and limey soil, the fire pit was 40x61 cm in size and 10 cm deep. (Figure 4.10) On its edge, there is a dull greyish-yellowish buff line due to burning with 1-2 cm thickness. (Figure 4.276, 4.277) There were no signs of plastering on its sides or its bottom. It was filled with dull grey-coloured dense ash. Plant remains were not detected in soil samples taken from its close surrounding, instead, many animal bone fragments were found.

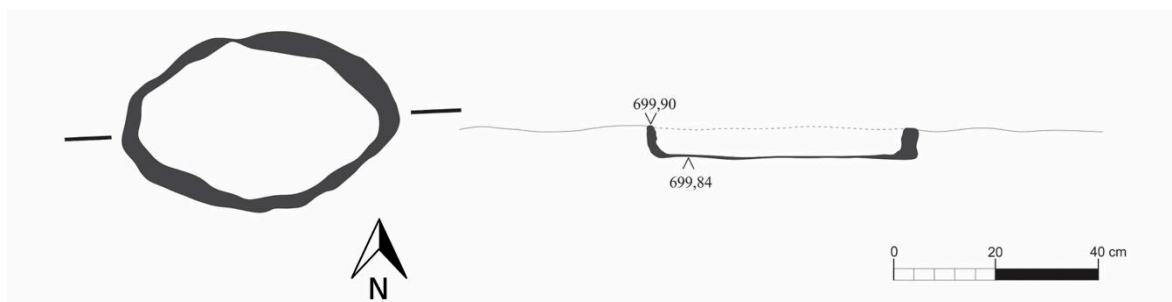
**Figure 4.11:** Fire Pit N7A4 and its cross-section

This was located in an open space in the southeastern part of trench 15H in Area B. The oval-shaped fire pit was between the elevations of 699.84 to 699.90. Dug in a grey ashy and sandy deposit, the fire pit was 36x53 cm in size and 6 cm deep. (Figure 4.11) On its edge, there is a dark brown line due to burning with 2-4 cm thickness. There were no signs of plastering on its sides or its bottom. Plant remains that were detected in earth samples taken from its inner deposit by flotation are mainly *Triticum/Hordeum* and *Fabaceae* family (*Lens culinaris*, *Medicago radiata*, and *Vicia ervilia*). *Ficus carica* seeds were also identified. (Table 3.2)

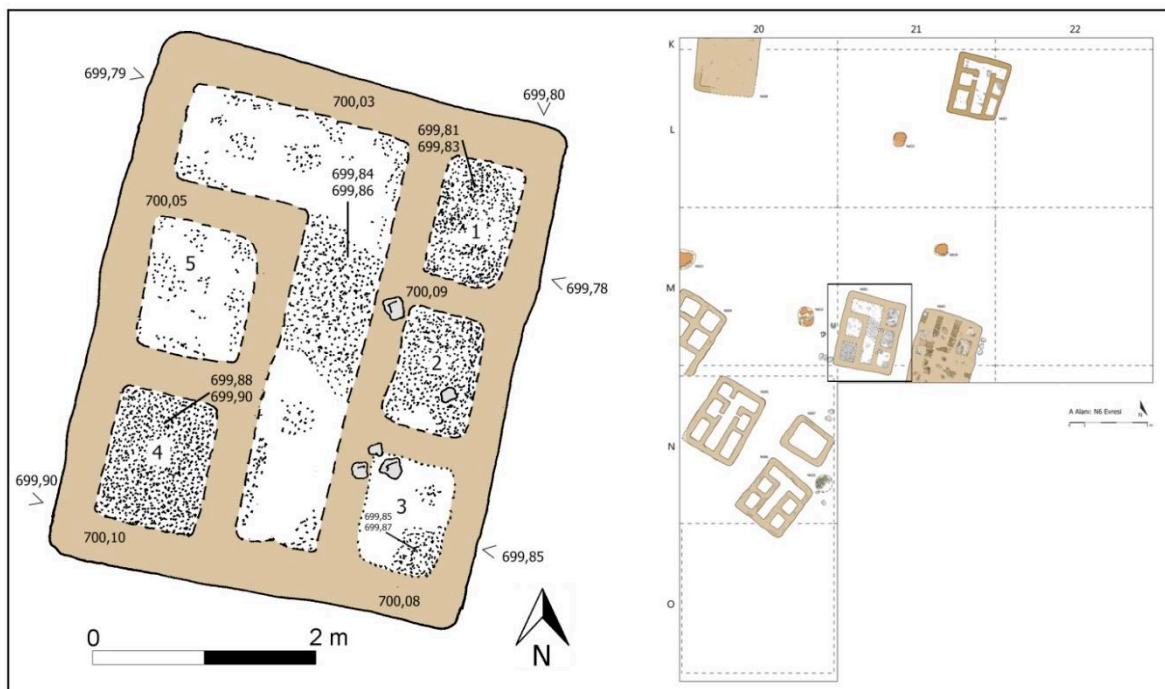
**Figure 4.12:** Location and plan of Structure N6B1

This structure is located in Area A, southwest of trench 21M between the elevations of 699.90 to 700.04 meter. The structure was constructed following the slope of the natural topography without a stone foundation. The Cell Building has an “L-shaped” corridor in the centre. (Figure 4.12, 4.93 – 4.95, 4.333) The walls have been preserved to a height of 14 cm. The partition walls, which appear to be partially destroyed, are lower than the main walls.

The structure was built on the north slope of a natural terrace with southwest-northeast orientation. It has a width of 384 cm in the east-west direction and is 472 cm long in the north-south direction. Covering an area of nearly 18 m<sup>2</sup>, the cells of the structure are almost 1 m<sup>2</sup> in size. Though there is no very significant difference in the thickness of the

The Cell Building has three cells along the east wing and two cells on the west side with an “L-shaped” corridor in between having the dimensions of 370 cm long and 77 cm wide. The cells are 75x94 cm to 98x116 cm in size. Cells numbered 4 and 5 on the west wing are larger than the ones on the east side. None of the cells have doorways. Lime surfaces in the cells numbered 1, 2 and 4 and in some parts of the corridor simultaneously form the floor level of the structure. There are no traces of plaster on these lime surfaces. As mentioned above, the lime surfaces are directly related to the evaporation and calcification process of organic structural material. The internal fill of the cells is very similar to the outer areas with a grey colour and low ash content but a lot of lime fragments. There were no graves found within the cells or under the lime surfaces.

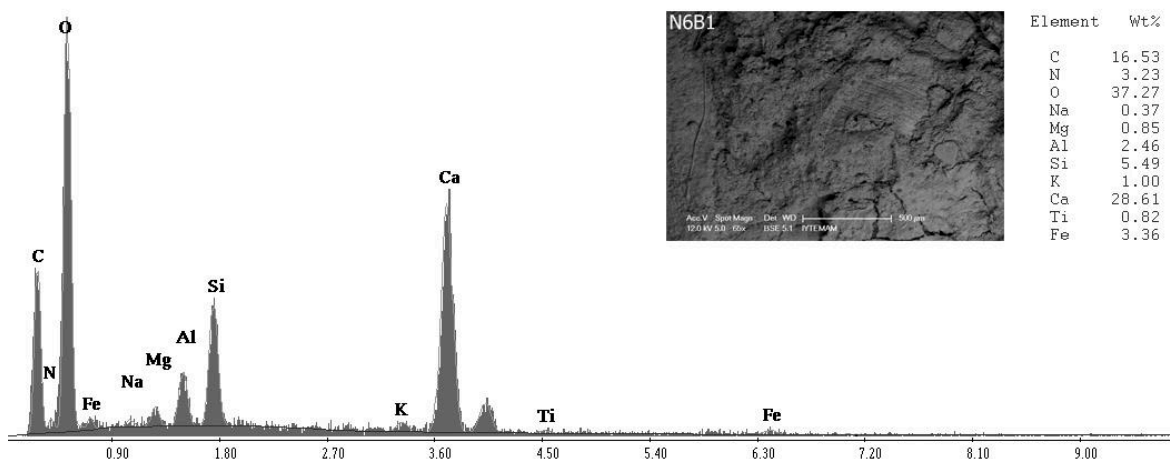
**Diagram 4.6:** EDX analysis of lime samples taken from Structure N6B1

Occasional lime fragments appear to have bound the walls. Continuing as weak and uncertain lines, their thickness varies from 1 to 3 cm. The internal fill of walls is homogeneous reddish-brown loose earth. Within the walls, calcified surfaces are observed at nearly 4-5 cm intervals. These surfaces, which continue irregularly between the layers, did not have mortar characteristics. Organic remains are observed on SEM images of lime samples taken from within the walls. (Figure 4.291) Earth samples taken from wall fills were identified to contain calcite, quartz, iron, and nitrate after XRD analysis. Their chemical compositions comprise calcium carbonate, silicon dioxide, iron oxide and sodium nitrate compounds. The sodium nitrate compound indicates the presence of aridity. (Diagram 4.101)

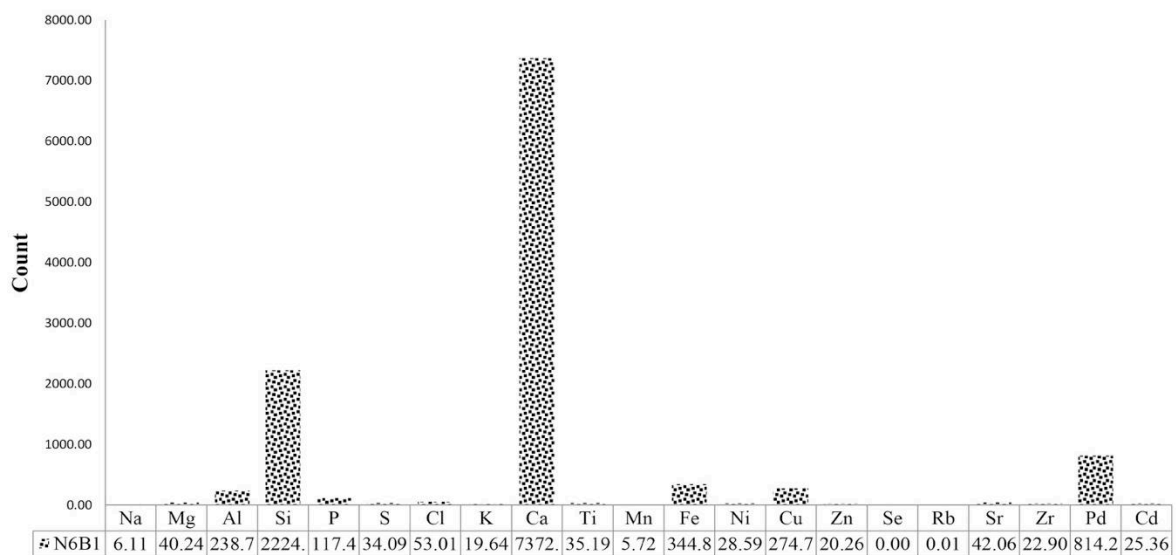
**Diagram 4.7:** XRF analysis of the lime samples taken from Structure N6B1

Occasional aragonite crystals and SiO<sub>2</sub> gels covering organic material have been observed on SEM images of lime samples. Their EDX analysis identified O (37.27%), Ca (28.61%), C (16.53%), Si (5.49%), and Fe (3.36%) elements. N, Na, Mg, Al, K, and Ti were also detected with proportions from 3% to 0.37%. (Diagram 4.6) According to XRF analysis of the lime samples, it was observed that Ca (63%), Si (19%), Fe (3%), Al (2%), and Pd (7%) are dominant with very small amounts of Ni, Zn, Sr, Rb, Na, K, S, P, Cl, Cu, and Ze elements. (Diagram 4.7)
