# Microarchaeological observation on the neolithic architectural structures and cultural landscape of Sumaki Höyük

# **Microarchaeological Observation on the Neolithic Architectural Structures and Cultural Landscape of Sumaki Höyük**

PhD Thesis

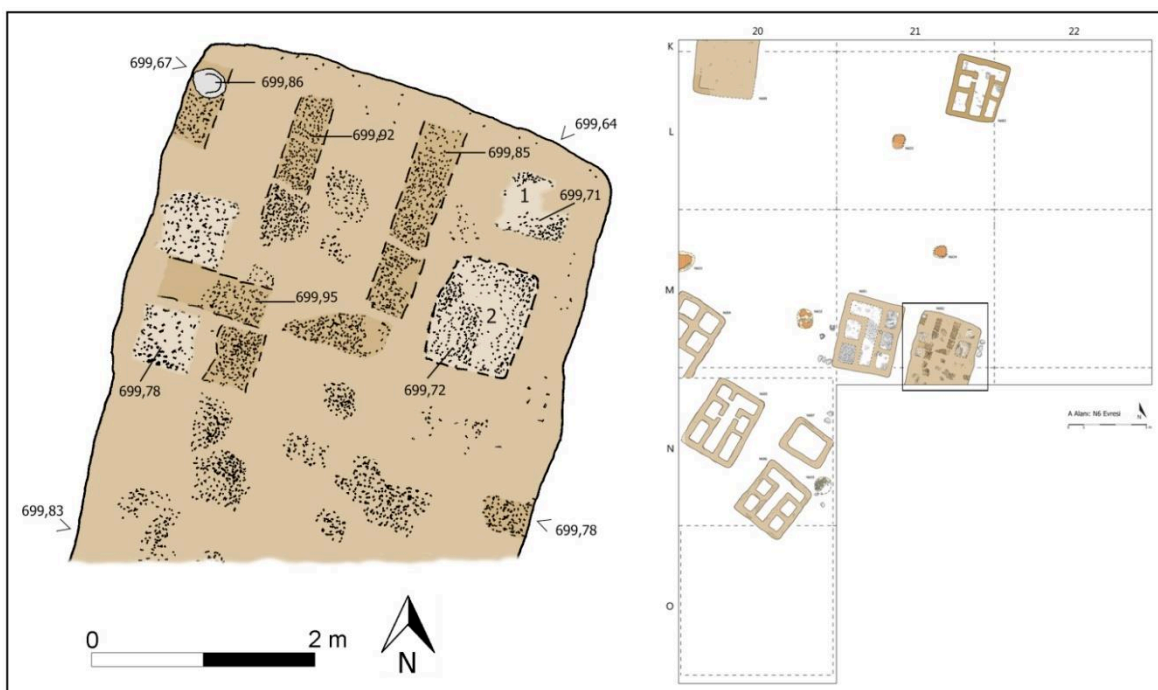
**Figure 4.13:** Location and plan of Structure N6B2

This structure is located in Area A, in the southeast section of trench 21M and 1 m to the east of structure N6B1 between the elevations of 699.86 to 700.00 meter. The Cell Building was not well-preserved. Partially preserved walls and cells were determined in an area of nearly 1 m<sup>2</sup>. (Figure 4.13) The walls have been preserved to a height of 6-8 cm. The structure was constructed on the north slope of a natural terrace parallel to the structure N6B1 with southwest-northeast orientation following the slope of the natural topography without a stone foundation.

The structure is 403 cm wide in the east-west direction. Since its southern portion is outside the exposed area, its north-south dimensions could not be determined. Its exposed part is 433 cm long. Based on the dimensions of the other cell buildings, it is stated that this structure covered an area of nearly 20 to 22 m<sup>2</sup>. The well-preserved cell is 82x99 cm in size. Three cell traces are also identified, but their dimensions could not be detected. The walls are 33-38 cm thick.

The Cell Building has a corridor in the centre with traces of cells on either wing; however, the corridor plan has not entirely been identified. Occasional thin lime fragments appear to have bound the walls and the cells. The internal fill of walls is homogeneous reddish-brown loose earth. (Figure 4.96 – 4.98) There are no traces of plaster or mortar found

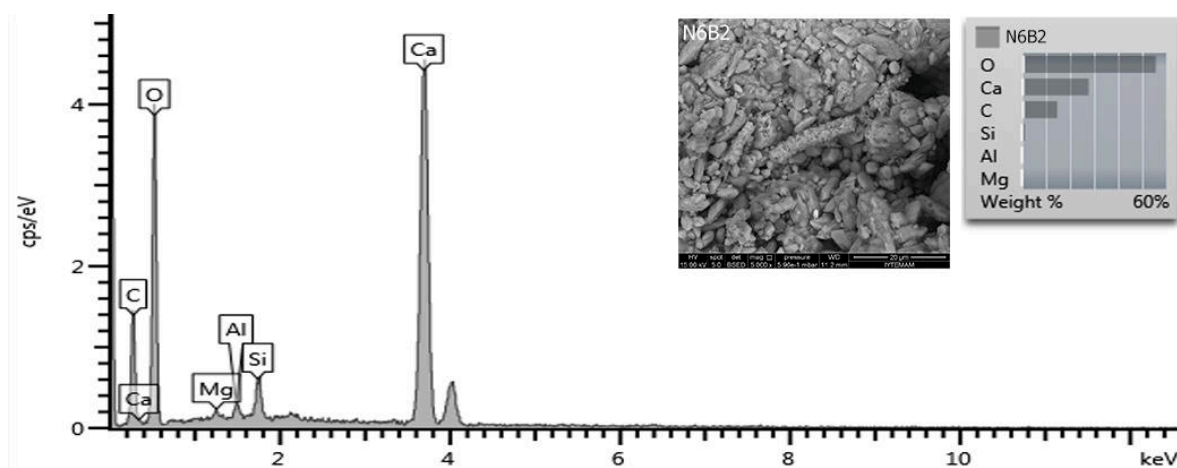
**Diagram 4.8:** EDX analysis of lime samples taken from Structure N6B2

Scalenohedral crystal structures are observed on SEM images of samples taken from the structure. Calcium carbonate minerals were clearly identified surrounding tubes formed by organic remains. Lime samples taken from wall fills were identified to contain elements O (55.63%), Ca (27.70%), C (14.74%), Si (1.23%), Al (0.48%), and Mg (0.23%) after EDX analysis. (Diagram 4.8)

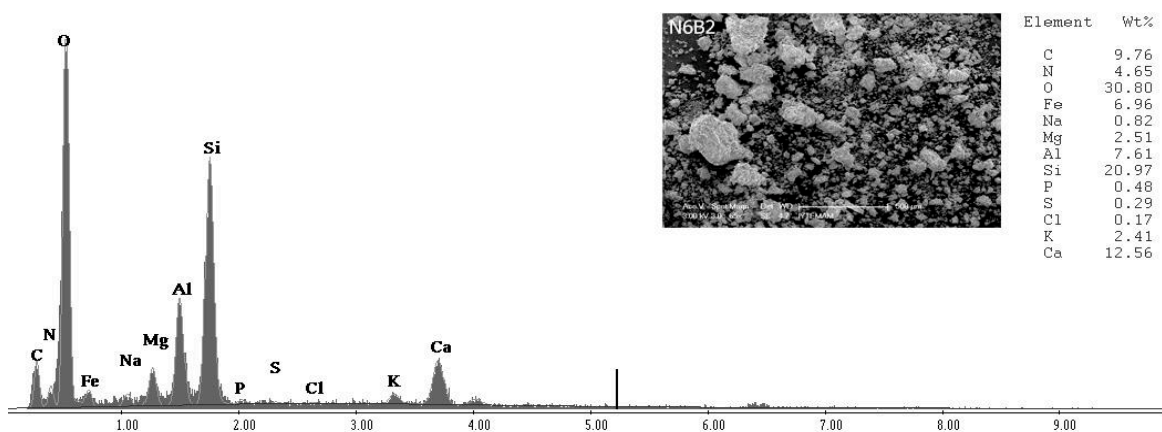
**Diagram 4.9:** EDX analysis results of soil samples taken from Structure N6B2

Their EDX analysis identified the following elements with their mean values; O (30.80%), Ca (12.56%), C (9.76%), Si (20.97%), Fe (6.96%), and Al (7.61%). The elements N, Na, Mg, P, S, Cl and K were identified with proportions from 3% to 0.17%. (Diagram 4.9)

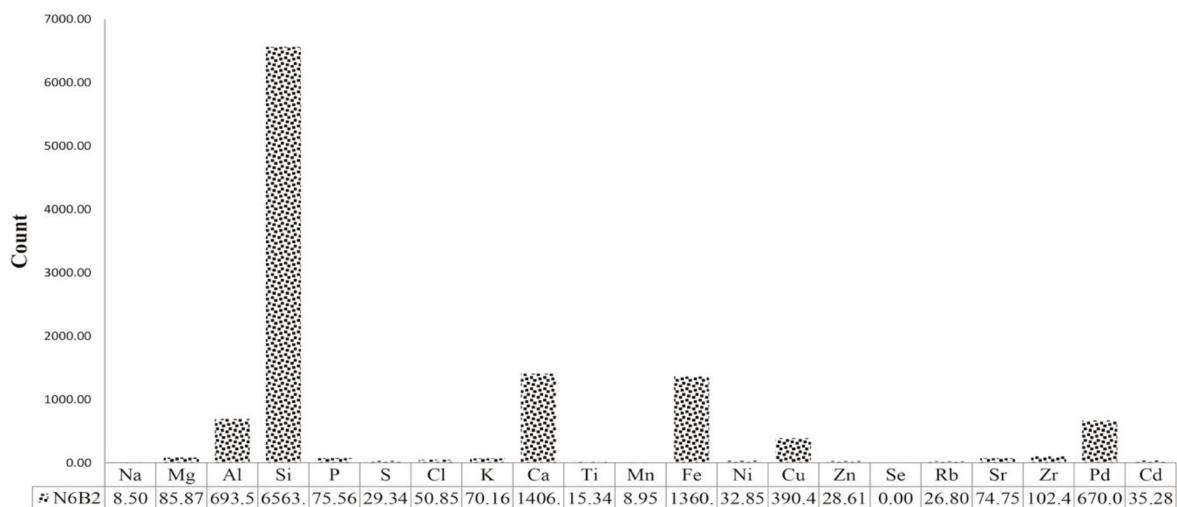
**Diagram 4.10:** XRF analysis of the soil samples taken from Structure N6B2

XRD analysis of soil samples observed various minerals such as calcite, quartz, albite, berzelianite, monticellite, and brucite. Their chemical compositions comprise calcium carbonate, silicon dioxide, sodium calcium aluminum silicate, copper selenide, calcium magnesium silicate, and magnesium hydroxide compounds. According to their XRF analysis, it was observed that the following elements dominating; Si (56%), Ca (12%), Fe (12%), Al (6%), and Pd (6%), together with very small amounts of Ni, Zn, Sr, Rb, Na, K, S, P, Cl, Cu, and Ze. (Diagram 4.10)

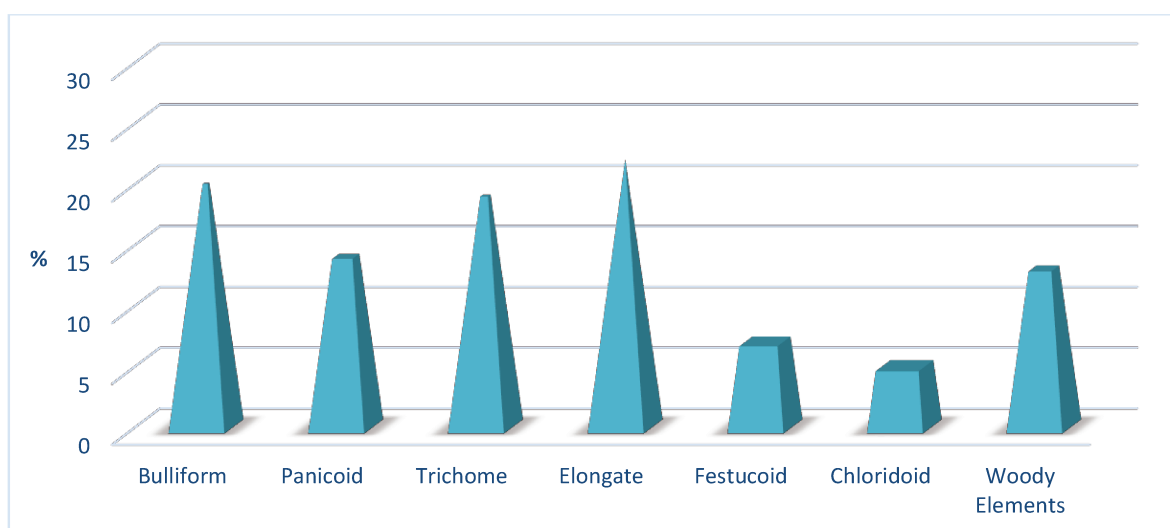
**Diagram 4.11:** Distribution of phytoliths in the lime samples taken from Structure N6B2

Phytolith analysis of lime samples observed reed or herbaceous plant remains. The phytoliths contained high frequencies of *Trichome*, *Bulliform*, *Panicoid*, *Elongated*, and *Silicified Woody Forms*. Different shapes of *Chloridoid* and *Fusturoid* forms were also defined. (Diagram 4.11; Figure 4.325 - 4.330)

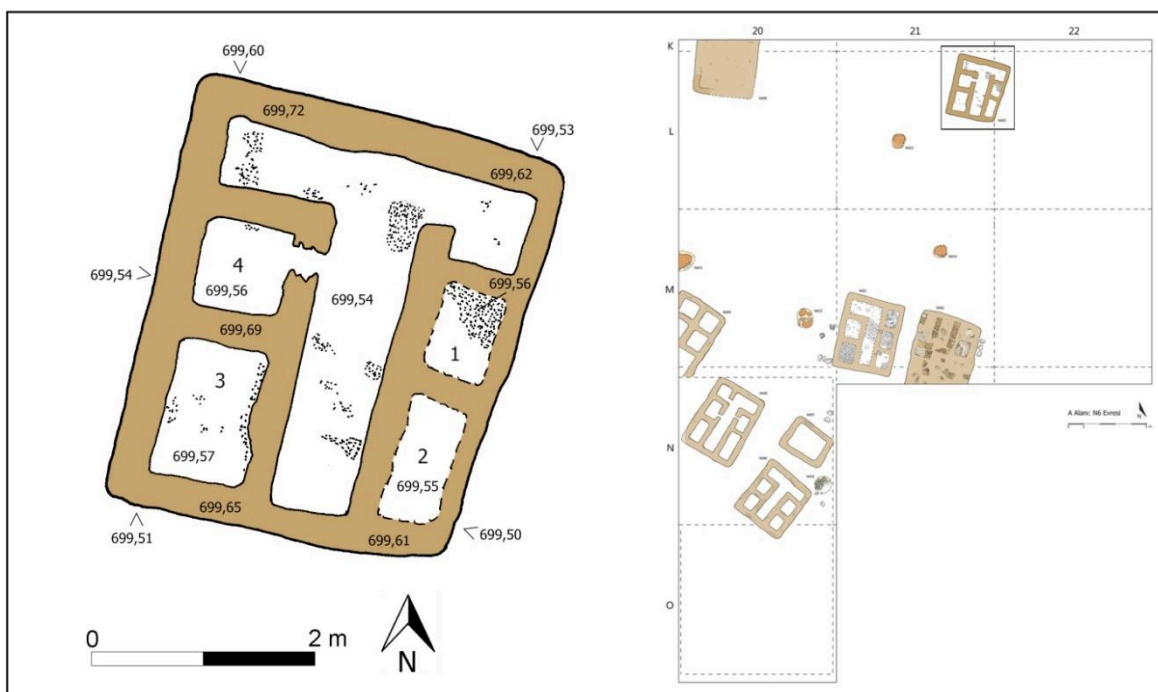
**Figure 4.14:** Location and plan of Structure N6B3

This structure is located in Area A in northeast of trench 21L and northwest of trench 22L between the elevations of 699.53 to 699.64 meter. The walls have been preserved to a height of 10 cm, but the walls in the southeast part are lower, only 4-5 cm high. The structure was constructed following the slope of the natural topography without a stone foundation. The structure was constructed immediately south of a natural rise with southwest-northeast orientation. Regarding a natural slope with a north orientation in trenches 20M and 21M, in this area the inclination is towards south and east.

The structure is 314 cm wide in the east-west direction and 381 cm long in the north-south direction. Covering an area of nearly 13 m<sup>2</sup>, the cells of this structure are smaller compared to those of the other Cell Buildings. (Figure 4.14) The cells are 119x77 cm to 76x54 cm in size. The thickness of the bearing and partition walls are different; the bearing walls are 30-37 cm thick, and the partition walls are 21-30 cm thick. Both the bearing and

the partition walls in the east section of the structure are narrower than those in the west section. The internal fill of walls is homogeneous black-dark brown loose earth.

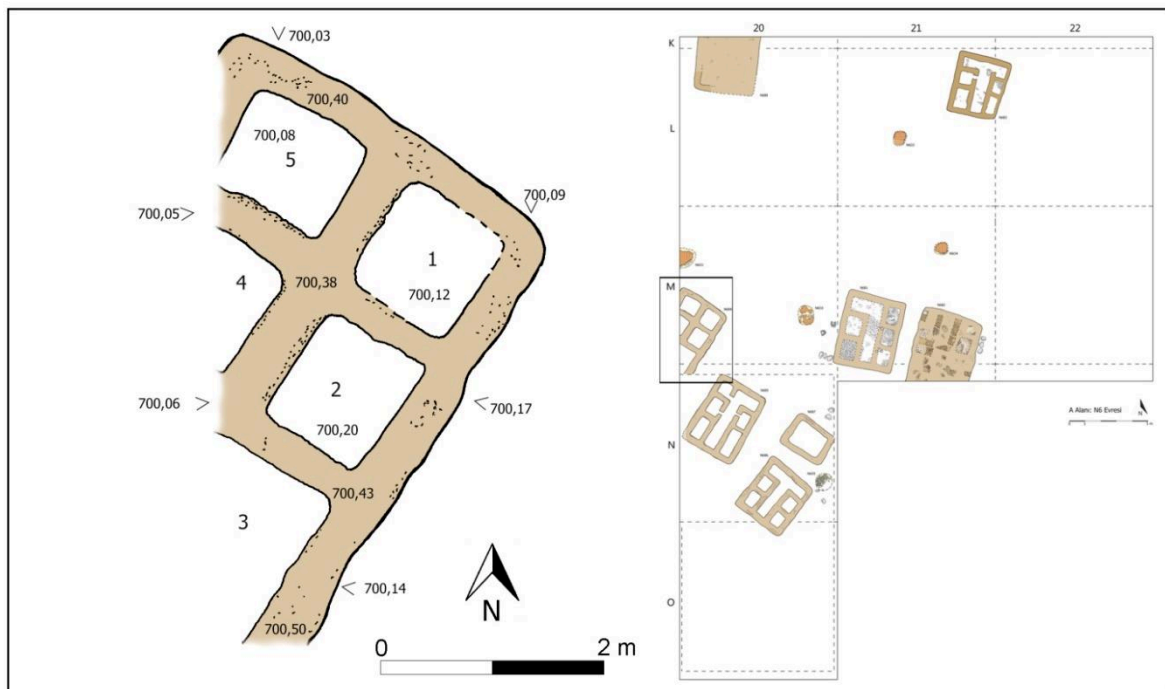
**Figure 4.15:** Location and plan of Structure N6B4

This structure is located in Area A in southwest of trench 20M with its southern section outside the trench between the elevations of 700.03 to 700.50 meter. The Cell Building has no corridor in the centre; all cells are side by side. (Figure 4.15, 4.102, 4.103) The walls and the fill have been preserved to a height of 47 cm. Based on the clear traces observed in the trench section, both the limits of the walls and their construction technique was clearly identified. The partition walls are lower and partially destroyed. The bottom surfaces of the main walls slightly incline to the north, as in the structures N6B1 and N6B2.

The Cell Building has four side-by-side cells, and in the southern section possibly has a larger cell (room?). There is no corridor identified. The cell dimensions are nearly the same, varies from 103x105 cm to 111x96 cm. None of the cells have door openings. This structure has small amounts of lime traces. Based on the wall section observed in the southern cross-section of trench 20M, the wall construction technique of this structure was somewhat different from the others. Although the structure N6B4 was constructed by the piled earth technique with a homogeneous dark-brown loose internal fill, light brown homogeneous levels were identified between the dark-brown earth layers instead of lime-rich lines. (4.104) Accordingly, soil used between the bedding of the walls of this structure was different in terms of colour and texture. This data indicate that woody plants were less used during ramming compared to those in the other structures.

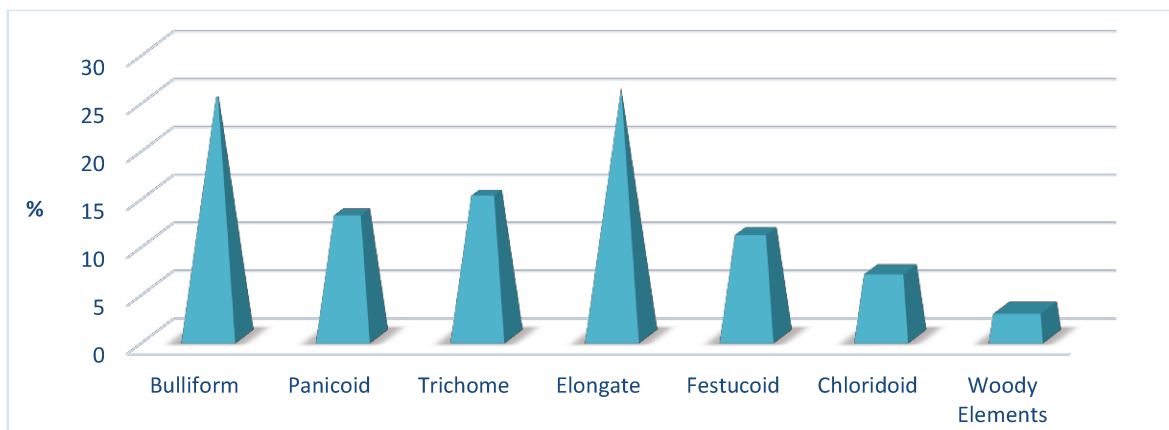
**Diagram 4.12:** Distribution of phytoliths in the lime samples taken from Structure N6B4

According to the phytolith analysis of the lime fragments, reed or herbaceous plant remains were identified. Multifform *Elongate* phytoliths were dominant. The phytoliths contained high frequencies of *Trichome*, *Bulliform*, *Panicoid*, and *Silicified Woody Forms*. The frequency of *Chloridoid* and *Festucoid* forms are higher compare to those found in the other structures. (Diagram 4.12; Figure 4.325 - 4.330)

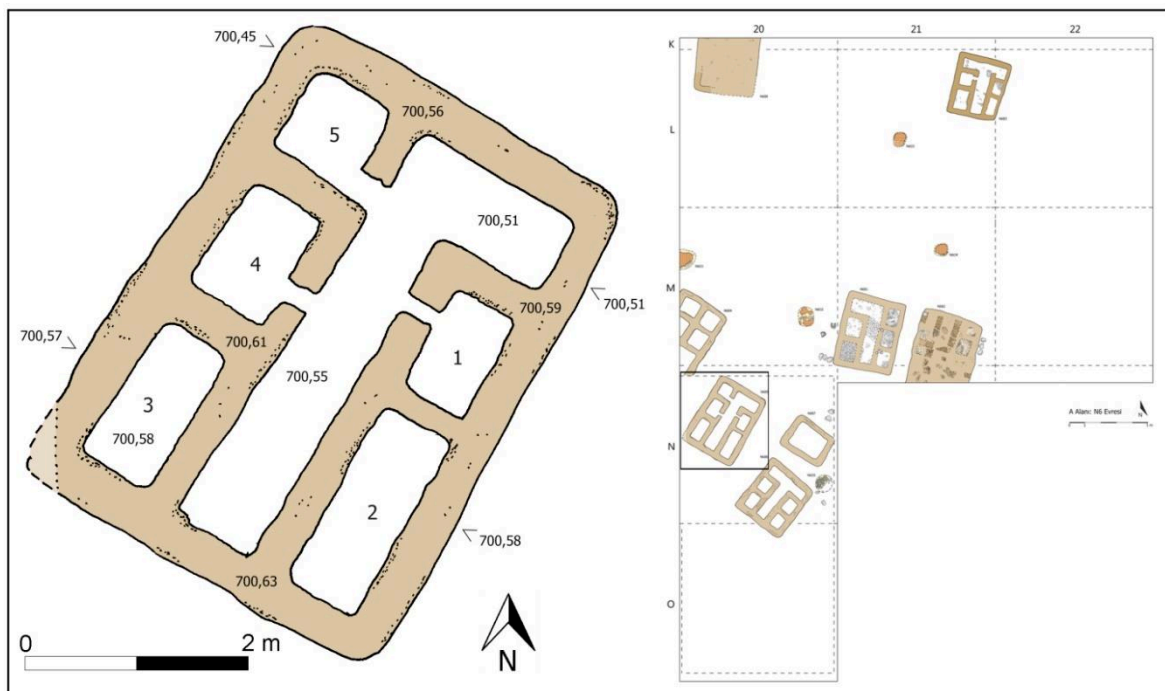
**Figure 4.16:** Location and plan of Structure N6B5

The Cell Building is 352 cm wide in the east-west direction and 480 cm long in the north-south direction. Covering an area of nearly 17 m<sup>2</sup>, except for one, the cells are smaller than 1 m<sup>2</sup>. Though there was no significant difference in the thickness of the bearing and partition walls, the bearing walls are 32-43 cm thick and the partition walls are 21-34 cm thick. (Figure 4.16, 4.335) The Cell Building has three cells along the west wing and two cells on the east side with an east-oriented L-shaped corridor in between having the dimensions of 398 cm long and 72 cm wide.

The cells have different dimensions varying from 68x175 cm to 62x98 cm. Cells number 2 and 3 in the southern section of the structure are longer and larger in size compared to cells in the north. Though, there are no door openings in the relatively large cells, smaller cells have door openings. These doorways with a width of 20 cm are very narrow for a passage. There were no plaster floor remains within the cells or the corridor. The internal fill of the cells is grey-buff colour occasionally limey, and ashy with small amounts of lime fragments. (Figure 4.105 – 4.107) There were no graves found within the cells or under the lime surfaces.

Occasional lime fragments appear to have bound the walls. Continuing as weak and uncertain lines, their thickness varies from 1 to 3 cm. The internal fill of bounded walls is homogeneous dark reddish-brown loose earth. Plaster traces were not encountered on the lime lines. Considering the architectural tradition of Sumaki Höyük and the construction technology, the walls of the structure N6B5 were constructed by the piled earth technique. The lime lines identified on the faces of the walls are the remains of woven reeds or herbaceous plant material used during ramming.

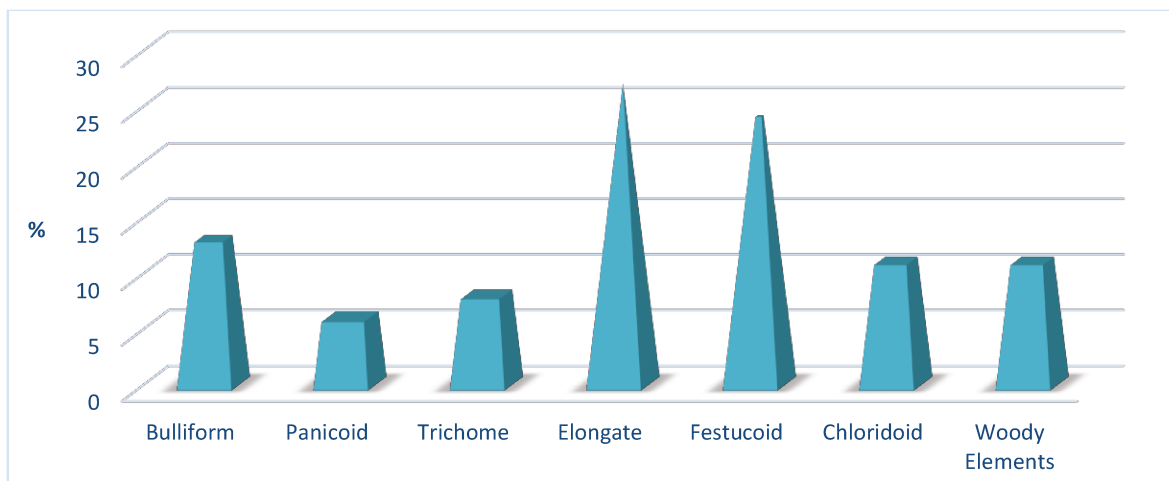
**Diagram 4.13:** Distribution of phytoliths in the lime samples taken from Structure N6B5

Phytolith analysis of lime samples identified reed and/or herbaceous plant remains. The natural structure of well-preserved phytoliths is clear. The elongate and *Festucoid* forms of phytolith were dominant. *Trichome*, *Bulliform*, *Panicoid*, *Chloridoid* and *Silicified Wood Forms* were also defined. (Diagram 4.13)

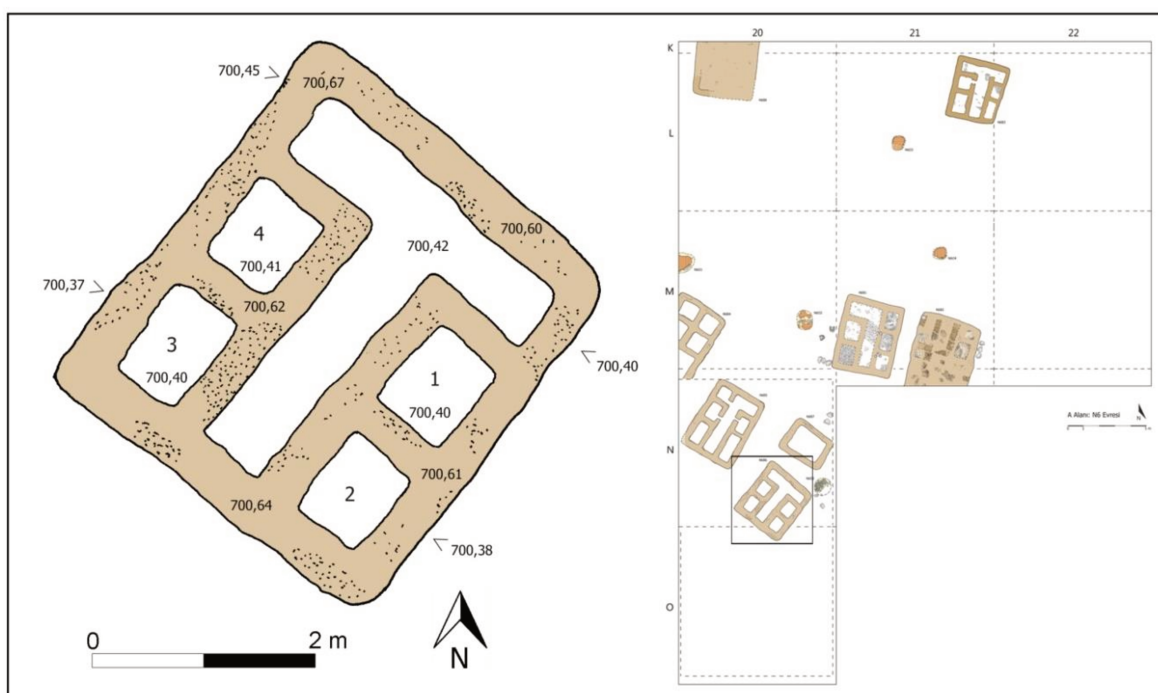
**Figure 4.17:** Location and plan of Structure N6B6

This structure is located in Area A, in southeast of trench 20N and north of trench 20/O between the elevations of 700.38 to 700.67 meter. The structure was constructed following the slope of the natural topography without a stone foundation. The bottom levels of the walls slope slightly to the south indicating a natural terrace surface incline somewhat to the south in this phase. The fill of Phase N6 and the traces in the trench sections also support this fact.

Similar to the other Cell Buildings exposed in Area A, this structure was constructed with southwest-northeast orientation. It has a width of 347 cm in the east-west direction and is 390 cm long in the north-south direction. Covering an area of nearly 14 m<sup>2</sup>, the dimensions of cells are very close to each other, varies from 68x93 cm to 70x84 cm. None of the cells have doorways. (Figure 4.17) The walls have been preserved to a height of 29 cm. There is no very significant difference in the thickness of the bearing walls and partition walls, the bearing walls are 34-42 cm wide and the partition walls are 33-40 cm wide.

The Cell Building has pairs of cells on the east and the west wing with a T-shaped corridor in between having the dimensions of 307 cm long and 62 cm wide. (Figure 4.108, 4.109, 4.334) Although there is no any archaeological material found in the cells, in the northern section of the T-shaped corridor, a group of finds comprises of stone tools (predominantly hammer stones), an animal jaw and an obsidian flake (Figure 4.110) covering an area of nearly 1 m<sup>2</sup> was exposed between the elevations of 700.40 to 700.53. There were no pottery sherds among the finds. This level was defined the living surfaces of the corridor and the cells. The bottom level of the wall is at an elevation of 700.38 in this area. In this context, the walls of the structure were in the same level as its living surfaces, therefore it is understood that the walls have been constructed directly on the existing ground. There are no graves found within the cells or under the floor levels.

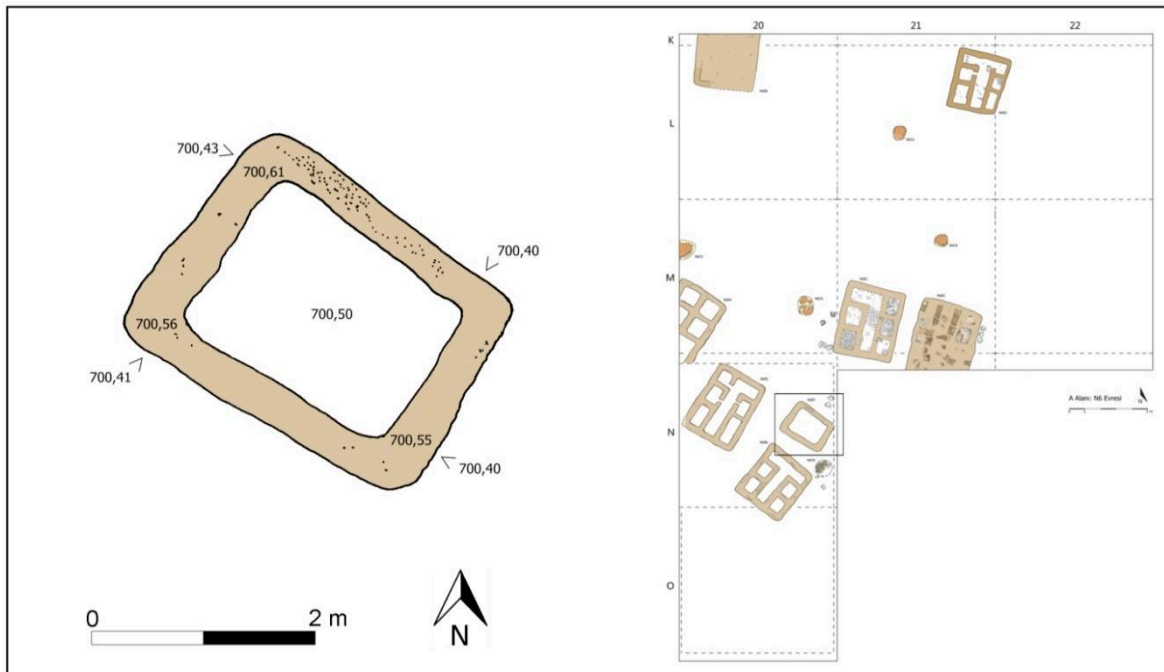
**Figure 4.18:** Location and plan of Structure N6B7

This structure is located in Area A, in east of trench 20N between the elevations of 700.40 to 700.66 meter. This rectangular structure was classified as a single-roomed structure. The structure was directly constructed on the natural surface following the slope of the natural topography without a stone foundation.

Per other structures in this area, this structure has a length of 290 cm in the northwest-southeast direction and is 223 cm wide in the southwest-northeast direction. (Figure 4.18, 4.343) Covering an area of nearly 6 m<sup>2</sup>, the internal dimensions of the structure are minimum 208x153 cm. The walls are 31-40 cm thick and 26 cm high. As there is no any plaster floor remains or hardened floor surfaces or archaeological material detected within the room, the living surface of the structure could not be determined. There were no graves found within the room or under floor levels.

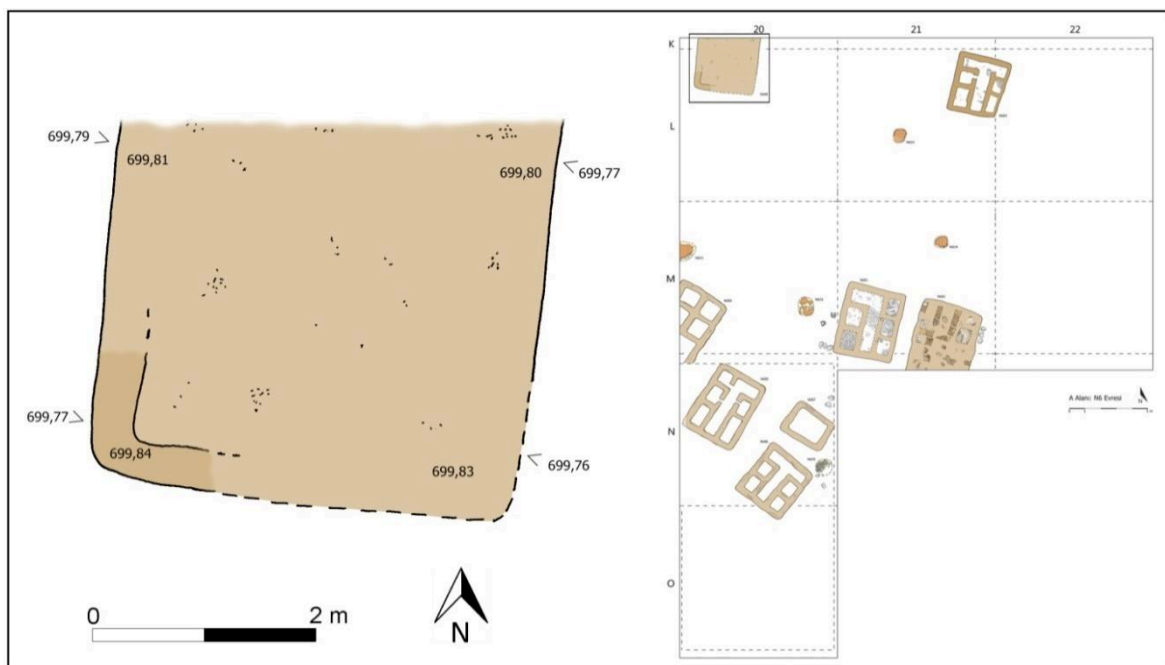
**Figure 4.19:** Location and plan of Structure N6B8

This structure is located in Area A, in northwest of trench 20L and southwest of trench 20K between the elevations of 700.76 to 700.84 meter. The limits of the structure were only determined by reddish-brown soil traces and unprecise wall remains in the southwest corner. (Figure 4.19, 4.113)

This structure with rectangular/square plan appears to have a single room but the partitioning in this badly-preserved structure could not precisely be determined. Therefore, it is classified as an 'indeterminate planned building'. Its fill has been preserved to a height of 7-8 cm. In its southwest corner section, the only preserved wall has a height of 7 cm and is 32-35 cm wide. The structure was constructed following the slope of the natural topography with the north-south orientation without a stone foundation. The east-west dimension of the structure was 395 cm. Since its northern section remains outside the exposed area, the dimensions in the north-south direction could not be determined, the remaining portion has a length of 346 cm. The structure did not have any plaster floor remains or hardened floor surface or partition walls.

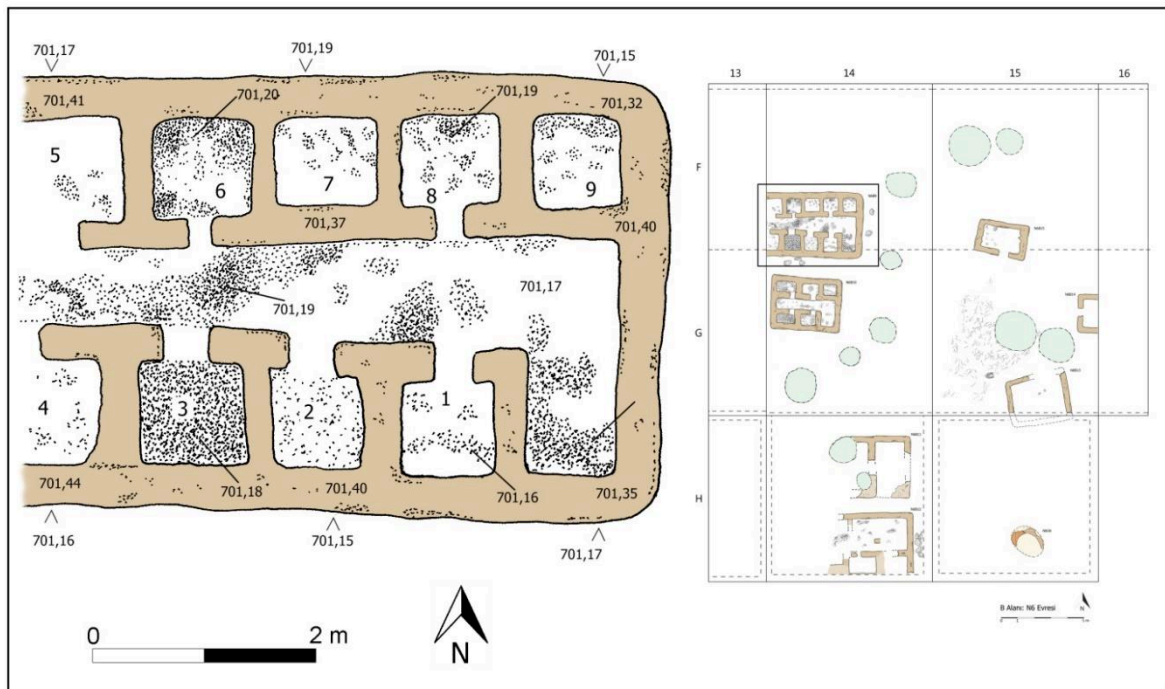
**Figure 4.20:** Location and plan of Structure N6B9

This structure is located in Area B, in southwest of trench 14F and northwest of trench 14G between the elevations of 701.15 to 701.44 meter. The structure was constructed on the undulating surface of a terrace with a very steep incline towards the east, following the slope of the natural topography without a stone foundation.

The structure has a width of 388 cm in the north-south direction. Since its west section remains outside the exposed area, the dimensions in the east-west direction could not be determined. (Figure 4.20, 4.114 – 4.116) Its exposed portion is 593 cm long. In the western part, the half-revealed cell is considered to be the last cell. The walls have been preserved to a height of 21 cm in the east, and 24 cm in the west. The thickness of the bearing and the partition walls are different; the bearing walls are 36-45 cm wide, and the partition walls are 26-35 cm wide.

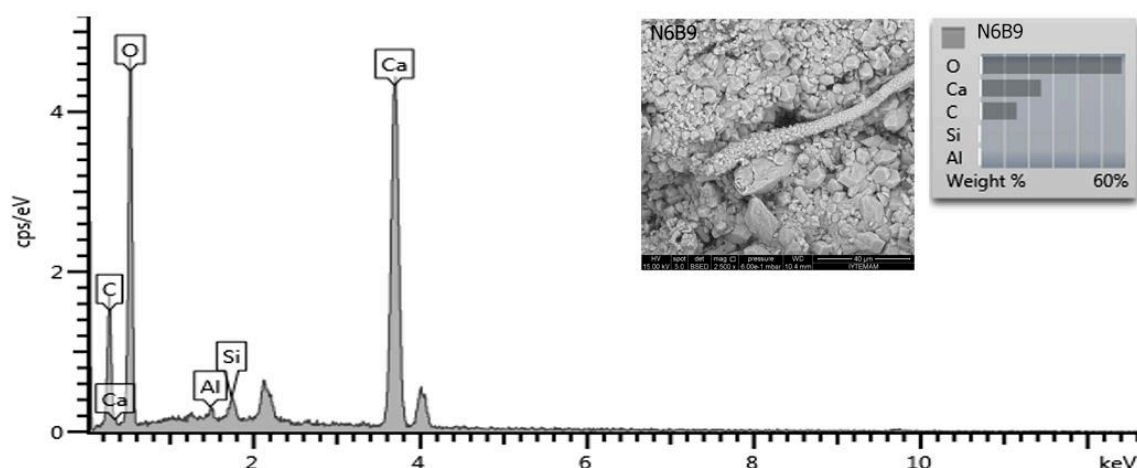
**Diagram 4.14:** EDX analysis of lime samples taken from Structure N6B9

SEM images of lime samples clearly show rhombohedral-shaped calcium carbonate minerals surrounding tubes formed by organic remains. (Figure 4.294d) Analysis of minerals surrounding the tubes by the EDX method identified the elements O (58.44%), Ca (25.30%), C (15.28%), Si (0.64%), and Al (0.33%). (Diagram 4.14)

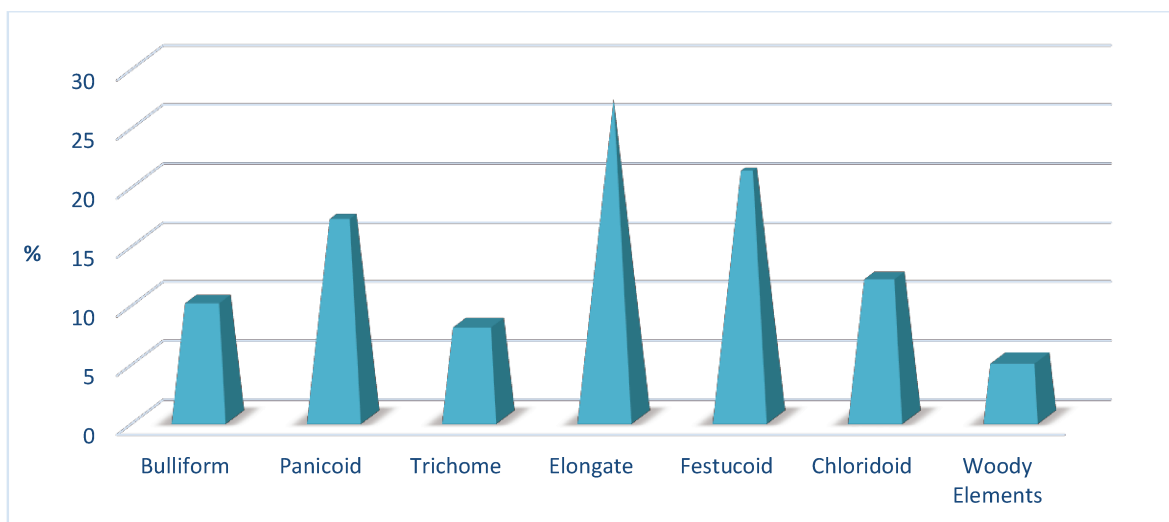
**Diagram 4.15:** Distribution of phytoliths in the lime samples taken from Structure N6B9

Phytolith analysis of lime samples identified reeds or herbaceous plant remains. The phytoliths contained high frequencies of elongate, *Fusoid*, and *Panicoid* phytoliths. *Trichome*, *Bulliform*, *Chloridoid*, and *Silicified Woody Forms* were also identified. The *Bulliform* and *Trichome* phytoliths have subtypes such as long, pointed and bulky *Trichomes*. (Diagram 4.15; Figure 4.325 - 4.330) Pollen analysis of the same samples

Accordingly, based on this data, the walls of the structure N6B9 were constructed by the piled earth technique. The lime lines partially identified on the faces of the walls are the remains of woven reeds or woody material used during ramming. Due to this wall technology, it is unlikely that the roof was earthen. Considering the intensity of lime fragments indicating organic material used in the wall construction, it may be stated that the structure was covered with a light material such as reeds or branches.

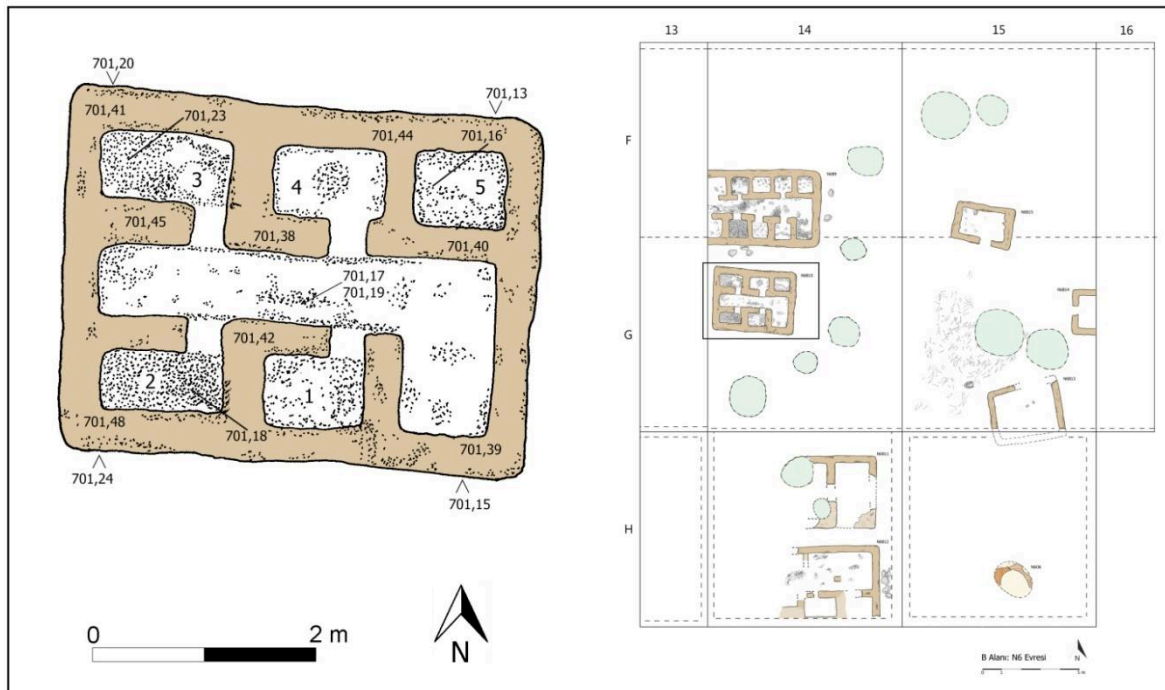
**Figure 4.21:** Location and plan of Structure N6B10

This structure is located in Area B, northwest of trench 14G between the elevations of 701.13 to 701.48 meter. The structure is on a steep terrace sloping towards east. The structure was constructed following the natural topography of the slope with a slight incline toward the northeast without a stone foundation. There is a nearly 20 cm difference between the southwest and northeast edge of the natural surface. Accordingly, in Phase N6, the terrace surface, at least in the section where the structure N6B10 was built, had an incline towards northeast. This inclination is also observed in the trench sections. The occurrence of this slope is directly related to the 10-15 cm-thick fill comprises pottery and ground stone tools of Phase N7 under the Structure N6B10. Accordingly, it appears that the structure N6B10 has been constructed at the northern limits of the Phase N7 settlement.

Covering an area of nearly 13 m<sup>2</sup> the structure is 431 cm long in the east-west direction and is 312 cm wide in the north-south direction. The walls have been preserved to a height of 31 cm in the east and 35 cm in the west. The bearing walls and partition walls have nearly the same thickness, namely, bearing walls are 30-39 cm thick, and partition walls are 27-36 cm thick. (Figure 4.21)

The Cell building has two cells along the south wing and three cells on the north side with an L-shaped corridor in between having the dimensions of 363 cm long and 59 cm wide. (Figure 4.120 – 4.122) The rectangular cells have the dimensions of 54x110 cm and 64x85 cm with mean sizes of 0.60 m<sup>2</sup>. Except one, doorways were identified in the other cells with a width of 27-32 cm. There were no graves found within the cells or under the floor levels.

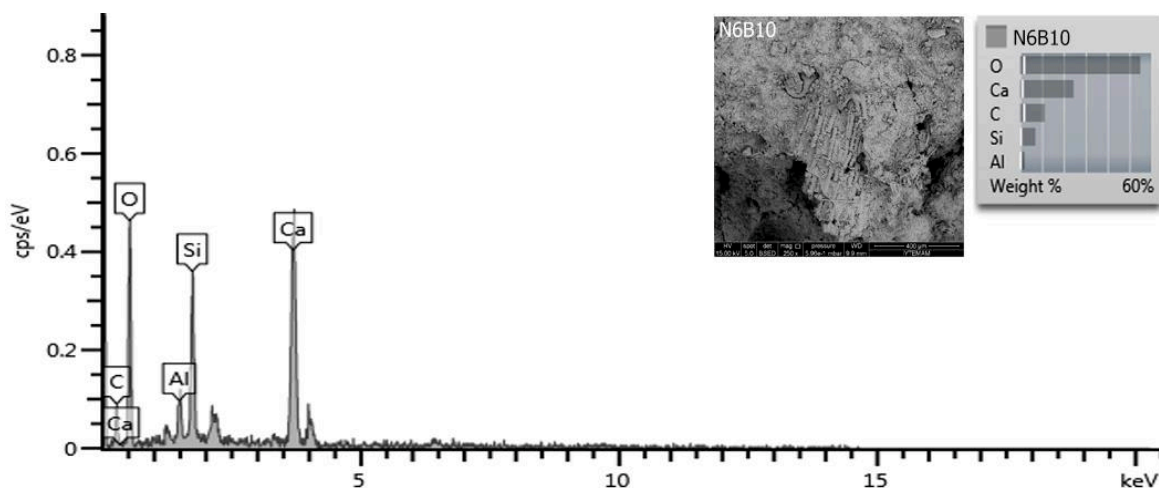
**Diagram 4.16:** EDX analysis of lime samples taken from Structure N6B10

EDX analysis of the lime samples taken from within the walls observed the following the elements O (55.05%), Ca (24.50%), C (11.29%), Si (7.03%), and Al (2.13%). (Diagram 4.16) Analysis of minerals surrounding the tubes by the EDX method the crystals found mean element ratios of O (47.06%), Ca (25.46%), C (12.87%), Si (6.57%), Al (1.15%), and Fe (6.90%). (Diagram 4.17)

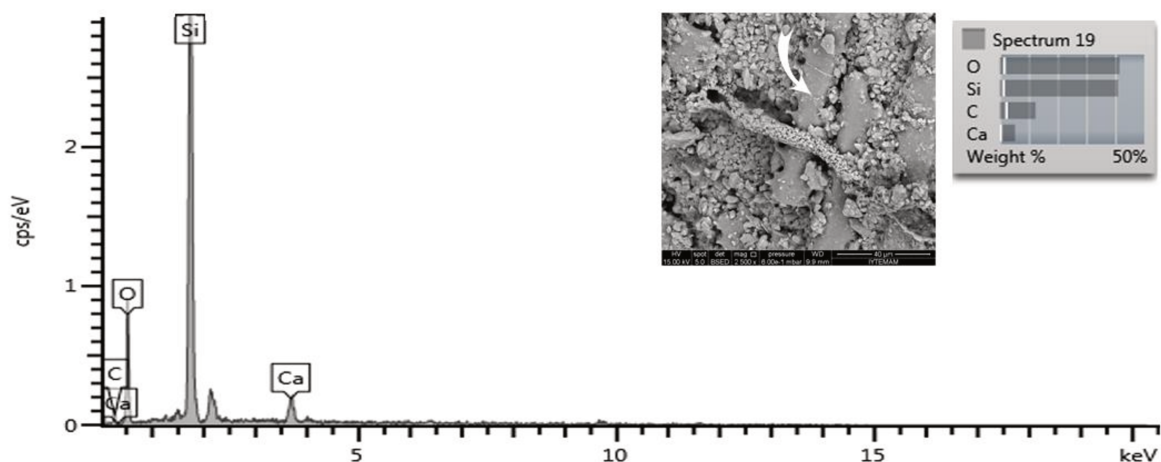
**Diagram 4.18:** EDX analysis of plant remains found in the lime samples taken from Structure N6B10

SiO<sub>2</sub> gels filling the organic cavities are observed on SEM images of the same lime samples. The clearest is silicon dioxide gel (SiO<sub>2</sub>) filling a *Panicum* plant remnant. Detailed

analysis of these areas with EDX method identified the elements O (41.42%), Ca (5.29%), C (12.38%), and Si (40.91%). (Diagram 4.18)

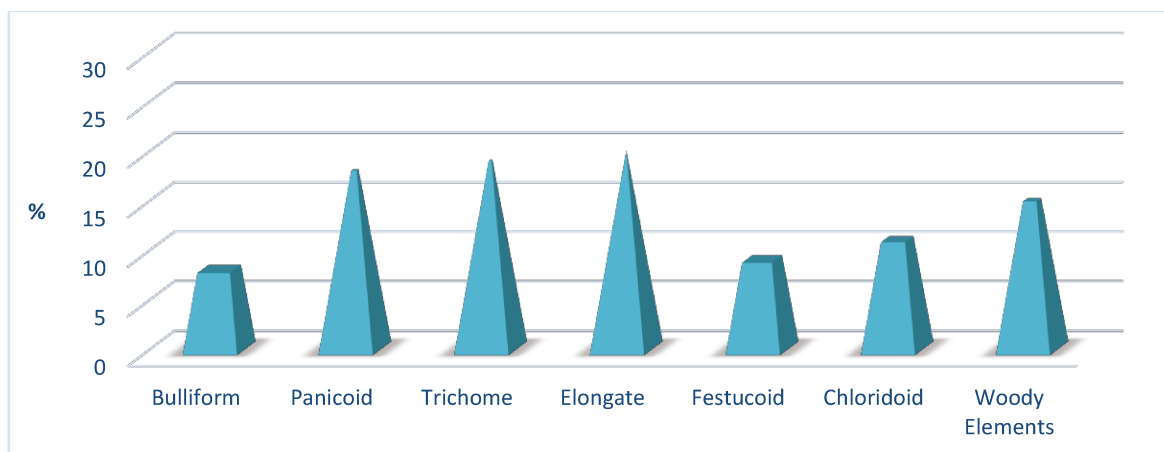
**Diagram 4.19:** Distribution of phytoliths in the lime samples taken from Structure N6B10

According to phytolith analysis the lime samples contains reeds or herbaceous plant remains. The phytoliths contained high frequencies of *Trichome*, *Panicoid*, *Elongate* and *Silicified Woody Forms*. *Bulliform*, *chloridoid*, and *festucoid* forms were also present. (Diagram 4.19; Figure 4.325 - 4.330) Pollen analysis of the same samples identified *Poaceae* and *Calenduleae* pollens dominantly, together with *Apocynaceae*, *Verbenaceae*, *Cesalpiniaceae*, *Liliaceae*, *Asparagaceae*, and *Malvaceae* pollens. (Figure 4.331, 4.332)

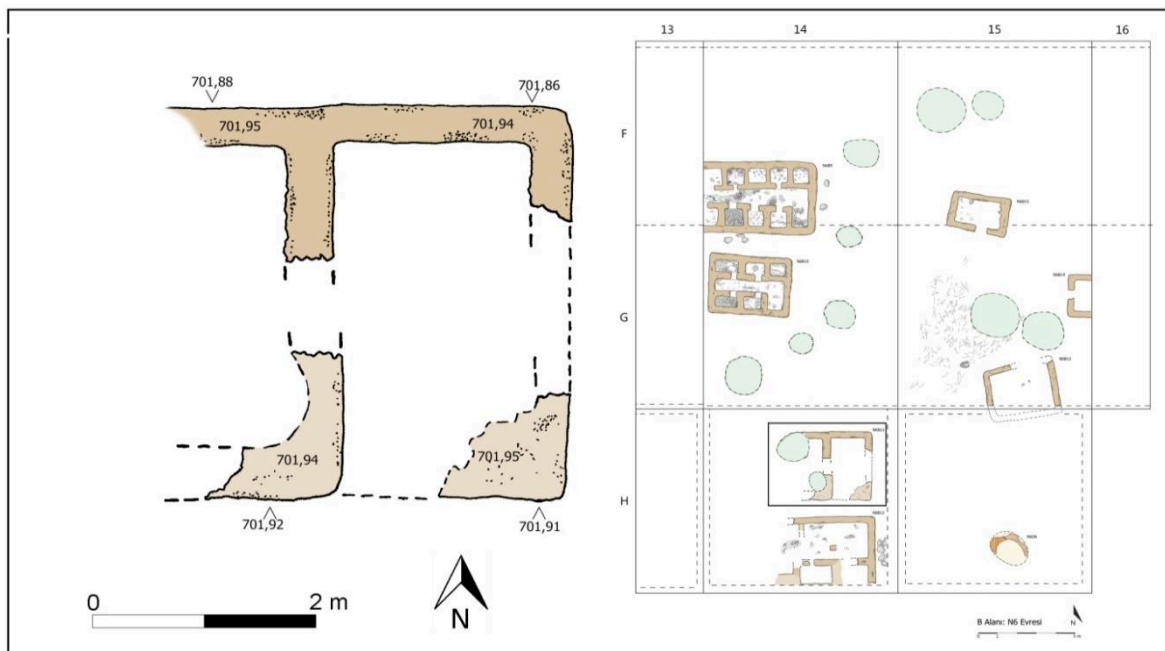
**Figure 4.22:** Location and plan of Structure N6B11

This structure is located in Area B, northeast of trench 14H between the elevations of 701.86 to 701.95 meter. Its western half, which remains under the Structure N5B15 of Phase N5, has been disturbed. (Figure 4.22, 4.126) The eastern portion of the structure has also been disturbed by the ash pits and the hearth N5O8 of Phase N5. Accordingly, the plan of the structure was partially determined by the remains of some walls and wall corners. The preserved walls have a height of 7-9 cm. The structure was constructed following the slope of the natural topography without a stone foundation. There was no Phase N7 fill defined under the structure or in its close surroundings.

The structure has an east-west orientation following the other cell buildings in Area B. The structure is 368 cm wide in the north-south direction. As its western part has been destroyed, the length in the east-west direction could not precisely be measured; the preserved section is 375 cm long. The walls with clear edges are 33-42 cm wide.

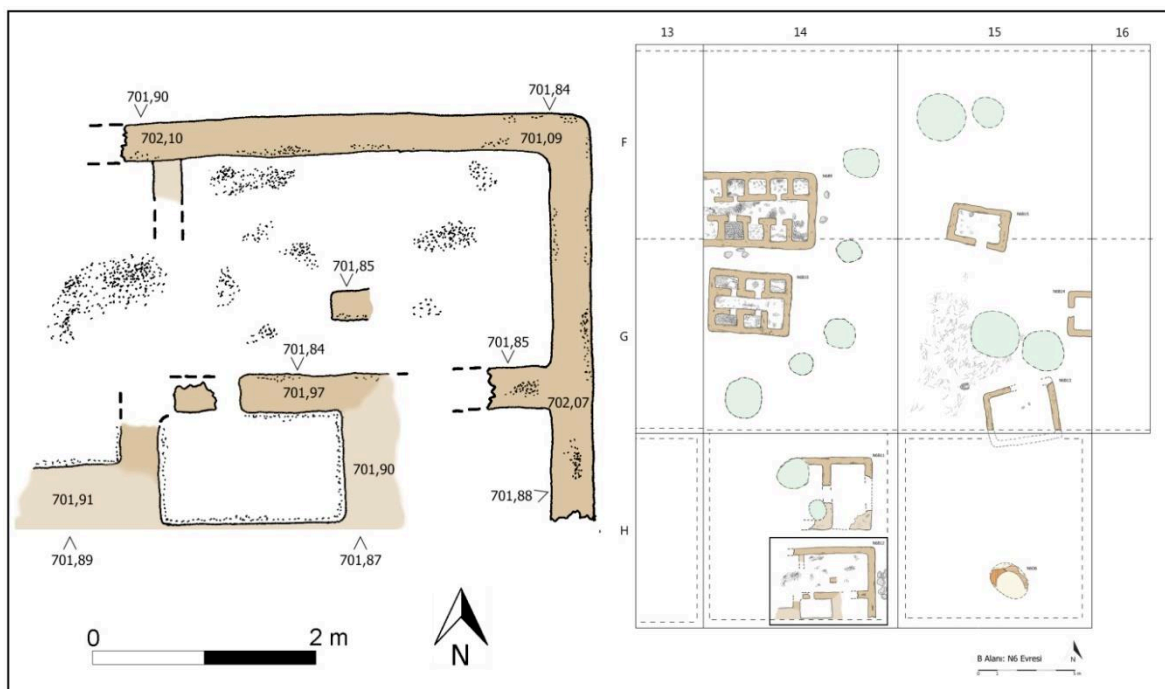
**Figure 4.23:** Location and plan of Structure N6B12

This structure is located in Area B, in the northeast section of trench 14H between the elevations of 701.84 to 702.10 meter. Since its west and northwest sections remain under the Structure N5B8, the structure was not well-preserved. (Figure 4.23, 4.127, 4.128)

Based on the partially preserved walls, wall corners and general layout the structure is classified as a Cell Building. The thickness of its remaining portion under the structure N5B8 is 4-5 cm. The walls and cell traces in this area are the only remains of the structure. In the east section, the identified walls forming its eastern boundary have a height of 16 cm. The walls sit on a natural terrace with an undulating surface, similar to the Structure N6B11.

Except for one, the limits of the cells could not be determined. However, based on the clearly identified Cell number 2 with the dimensions of 169 cm long and 94 cm wide, the cells appear to be larger than 1 m<sup>2</sup>. There are no traces of plaster floor. Although the corridor plan has not entirely been identified, it has at least two wings. Cell traces are more apparent in the south section of the structure. Lime lines are occasionally observed both on the wall faces of the bearing and the partition walls of the cells. Occasional lime fragments appear to have bound the walls of cell number 2. Continuing as weak and uncertain lines, their thickness varies from 1 to 2 cm. The internal fill of walls is homogeneous dark reddish-brown loose earth. Considering the wall construction technology of Sumaki Höyük, this structure was constructed by the piled earth technique.

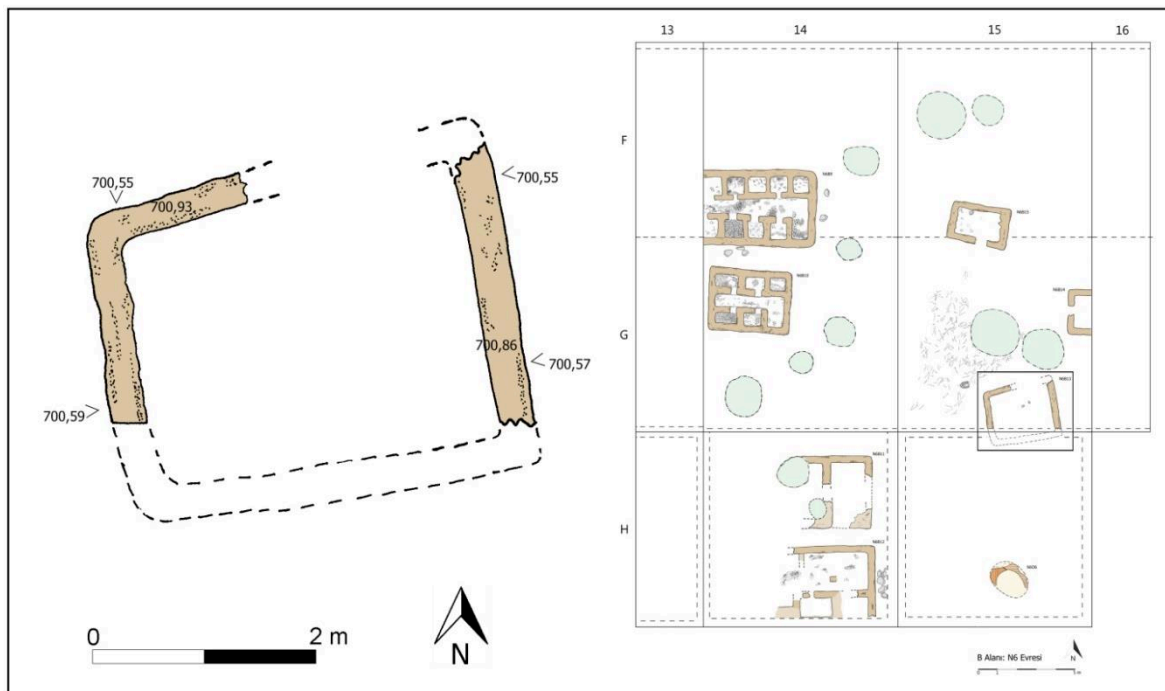
**Figure 4.24:** Location and plan of Structure N6B13

This structure is located in Area B, in the south profile edge of trench 15G and partly under the trench cross-section between the elevations of 700.55 to 700.93 meter. The northeast portion of the structure has been badly disturbed by a deep Middle Age pit while its eastern part remains under the Structure N4B8. Additionally, the east wall of the structure N5B13 and the partition wall in the central section of the structure N4B8 are overlapping. This fact is clearly observed in the south part of trench 15G. Based on the walls and general layout, the structure classified as a single-roomed structure. (Figure 4.24, 4.129)

The walls sit on a surface sloping slightly to the east. The traces in the cross-section of trench 15G clearly shows the occurrence of this slope. The rectangular structure was 374 cm long in the east-west direction and was 286 cm wide in the north-south direction. Covering an area of nearly 11 m<sup>2</sup>. The walls with clear edges are 28-34 cm in width. There are no plaster floor remains identified within the structure.
