# Microarchaeological observation on the neolithic architectural structures and cultural landscape of Sumaki Höyük

# **Microarchaeological Observation on the Neolithic Architectural Structures and Cultural Landscape of Sumaki Höyük**

PhD Thesis

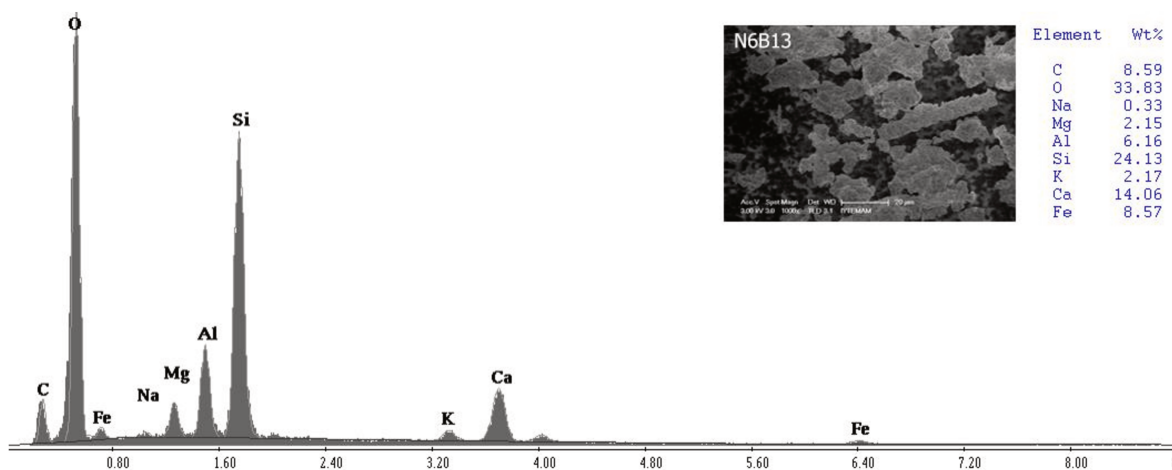
**Diagram 4.20:** EDX analysis of soil samples taken from Structure N6B13

SEM investigation of lime samples observed occasional scalenohedral-shaped calcium carbonate minerals. Acicular crystal formations were also identified. Analysis of these lime samples by EDX identified the following elements with their mean values; O (33.83%), Ca (14.06%), C (8.59%), Si (24.13%), Fe (8.57%), and Al (6.16%). Na, Mg, and K were identified with proportions from 2% to 0.13%. (Diagram 4.20)

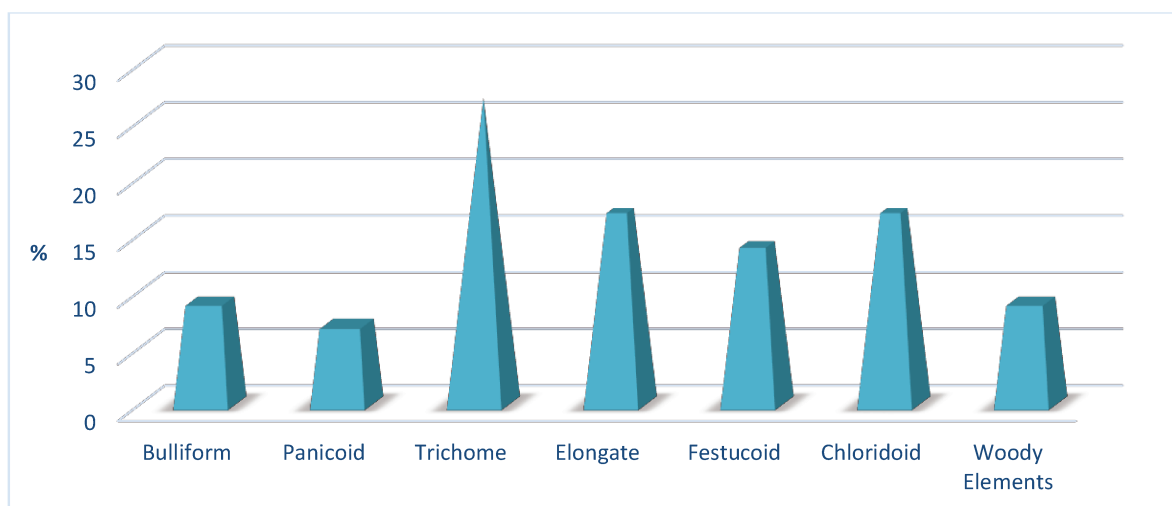
**Diagram 4.21:** Distribution of phytoliths in the lime samples taken from Structure N6B13

According to phytolith analysis, the lime samples contain reeds or woody plant remains. Multiform *Panicoid* phytoliths were dominant with high frequencies of elongate, *Fuscoïd* and *Panicoid* elements. *Trichome*, *Bulliform*, *Chloridoid* and *Silicified Woody Forms* were also found. The *Bulliform* and *Trichome* phytoliths have subtypes such as long, pointed and bulky *Trichomes*. (Diagram 4.21; Figure 4.325 - 4.330) Soil samples that were taken from immediately east outside of the structure encountered small amounts of plant remains. Examination by flotation identified *Triticum* or *Hordeum*, *Lens culinaris*, and *Triticum turgidum* spp. (Table 3.2)

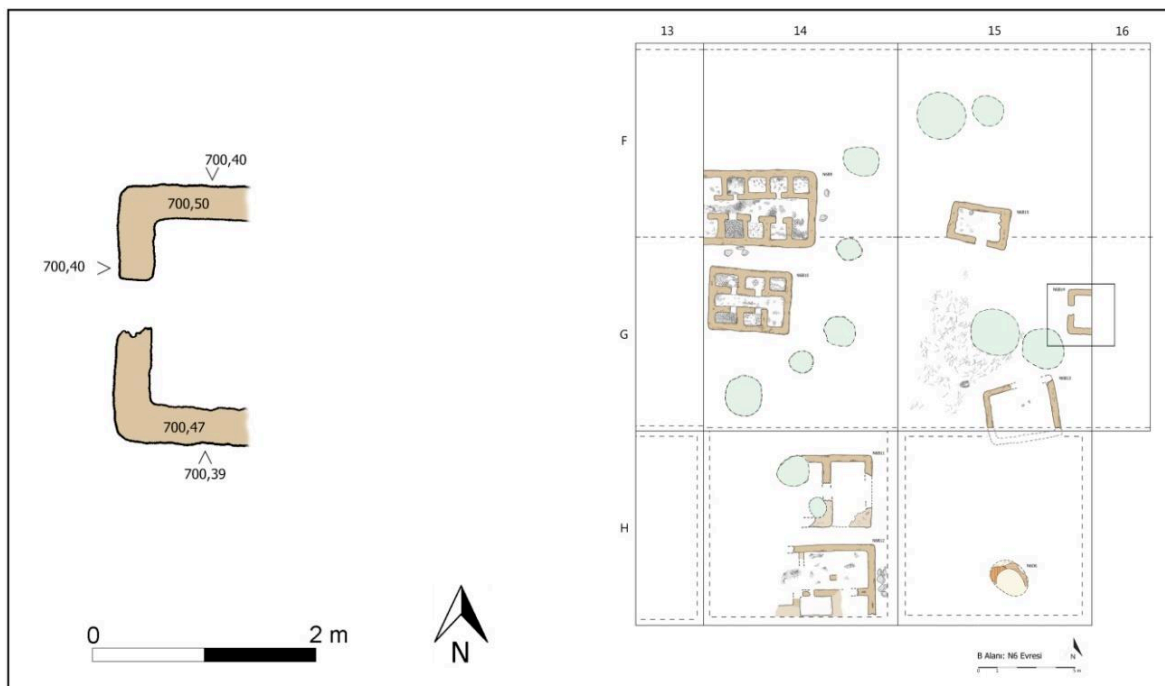
**Figure 4.25:** Location and plan of Structure N6B14

This structure is located in Area B, in the east profile edge of trench 15G and partly under the baulk between the elevations of 700.39 to 700.50 meter. Based on the wall remains and general layout, this structure is similar to a single-roomed structure. (Figure 4.25) However, the exposed portion may be the west section of a double-roomed structure similar to the structure N5B4. Therefore, this structure is classified as an ‘indeterminate planned structure’.

The rectangle structure is 229 cm wide in the north-south direction, and a section measuring 124 cm was revealed in the east-west direction. The walls are 25-31 cm wide. Its narrow west wall with a nearly 45 cm-wide doorways is at the same level with the living surface of the structure. There are no traces of plaster floor. Its earth walls are very similar to other structures with a homogeneous reddish-brown very loose filling. Considering the wall construction technology of Sumaki Höyük, the walls were constructed by the piled earth technique.

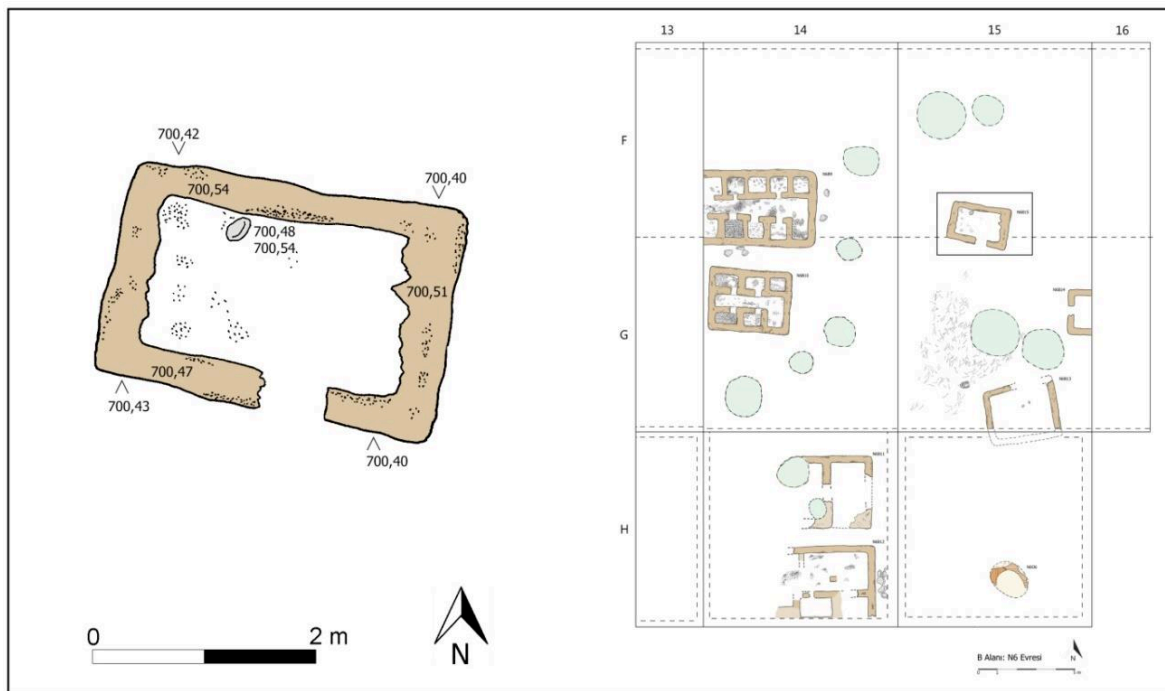
**Figure 4.26:** Location and plan of Structure N6B15

The structure is classified as a Single-roomed structure. (Figure 4.26, 4.131) The northwest-southeast-oriented structure has a length of 312 cm in the east-west direction and is 198 cm wide in the north-south direction. (Figure 4.344) Covering an area of nearly 6 m<sup>2</sup>, the interior size of room is 234x131 cm (3 m<sup>2</sup>). The walls are 24-31 cm wide and the south wall and external area linked with a nearly 56 cm-wide doorway is at the same level.

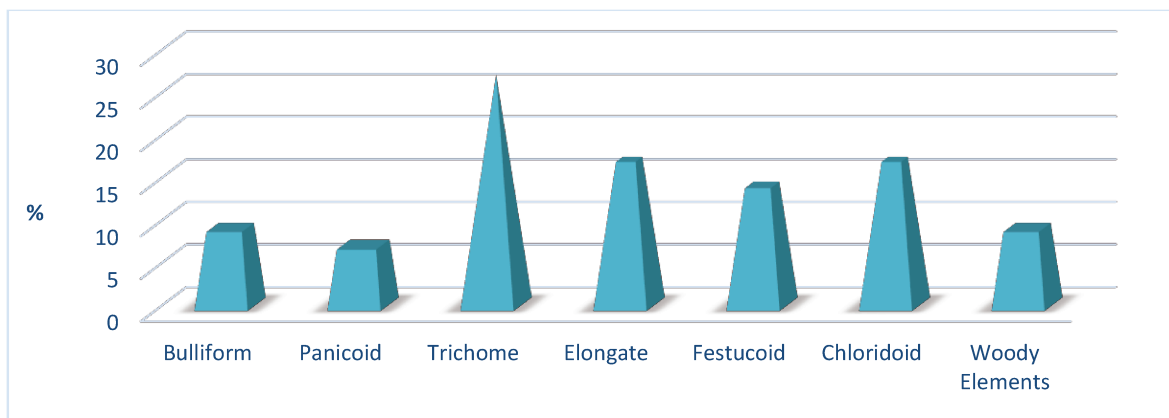
**Diagram 4.22:** Distribution of phytoliths in the lime samples taken from Structure N6B15

In the examination of earth samples taken from the south part of the structure and from the doorway by flotation minimal amounts of plant remains, only *Triticum* or *Hordeum*, and *Fabaceae*, were identified. Phytolith analysis of lime samples identified reeds and/or herbaceous plant remains. *Trichome* and elongate forms are dominant. *Festucoid*, *Bulliform*, *Panicoid*, *Chloridoid* and *Silicified Woody Forms* were also identified. The frequency of *Trichome* phytoliths are higher compared to other morphotypes. (Diagram 4.22)

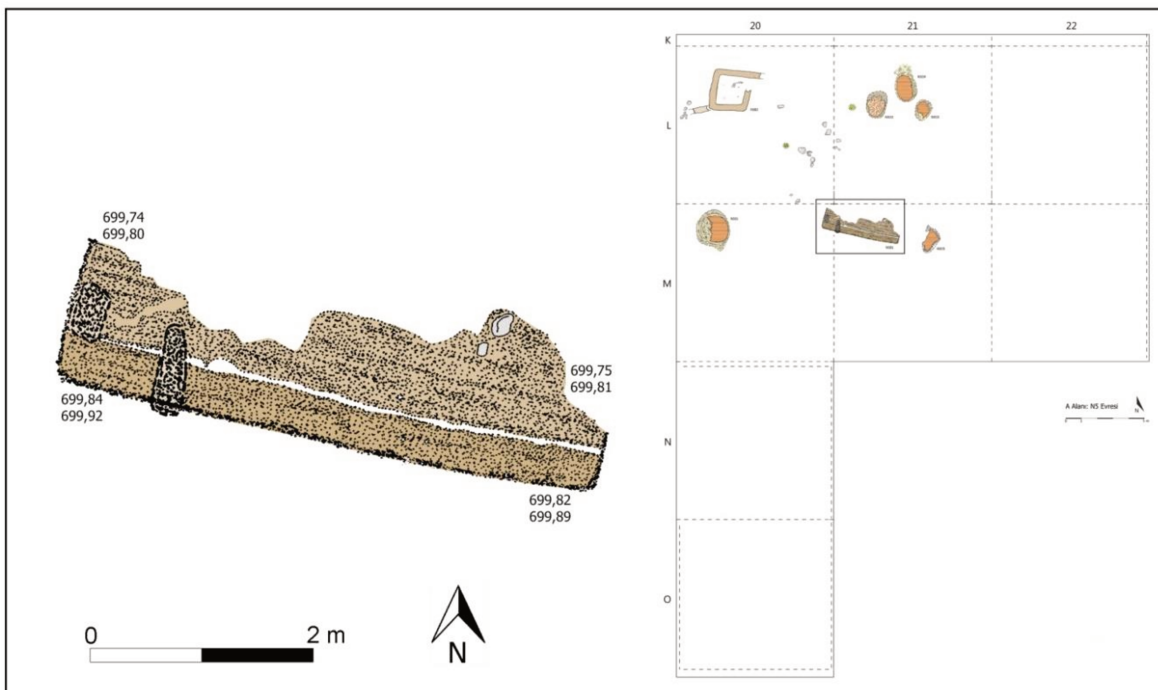
**Figure 4.27:** Location and plan of Structure N5B1

The wall corners of its southern section were identified. Measurements based on these boundaries found that this disturbed structure was 502 cm long in an east-west direction. In the north-south direction, a portion 145 cm long was partly preserved. (Figure 4.27) Lime lines with 4-7 cm thickness and 7-10 cm height were identified in its southern section. (Figure 4.132 – 4.134) According to mineralogical examination, and there were dense plant remains within this lime. Compact lime surfaces were also defined within the structure. In 2-3 cm-thick lime covering nearly the whole interior of the structure, there is no trace of plaster. Within, below and above this lime surface, there are fist-sized stones without plaster traces. SEM images of lime samples clearly show calcified plant remains. According to phytolith analysis of the same lime samples, only abundant reed/woody plant remains were identified. As a result, it is understood that this surface represents the calcified remains of a surrounding architectural element made of woody plants which fell into the structure. Ethno-archaeological studies in the Lower Garzan Basin also identified samples of reed surroundings which had fallen into structures.

These types of construction usually have tents as the upper covering. The general appearance of Structure N5B1 is very similar to these modern examples. In the eastern part of the structure there are two lime blocks 26-28 cm in width, possibly used as a partition wall. Reddish-brown earth was identified under one of the blocks while the other one sat on grey, ash-rich fill similar to the fill under the structure. The edges of the two duripans cut into the lime surface mentioned above. (Figure 4.134) Phytolith analysis of lime samples observed *Bulliform*, *Trichome* and *Festucoid* forms with high frequency. Different forms of *Bulliform* and *Trichome* phytoliths were identified. *Panicoid*, *Chloridoid* and silicified woody forms were also defined. (Diagram 4.23)

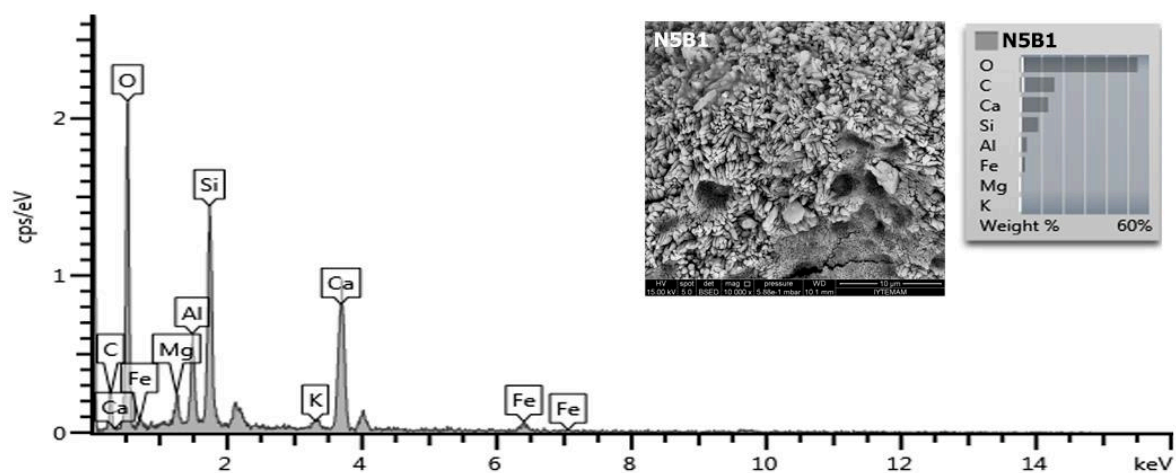
**Diagram 4.24:** EDX analysis of lime samples taken from Structure N5B1

SEM images of lime samples observed scalenohedral-shaped calcium carbonate minerals. (Figure 4.296c) Investigation of the same samples with EDX analysis identified the elements O (54.55%), Ca (13.17%), C (16.06%), Si (8.60%), and Fe (2.53%). Mg, Al, and K were also identified at rates from 3% to 0.37%. (Diagram 4.24)

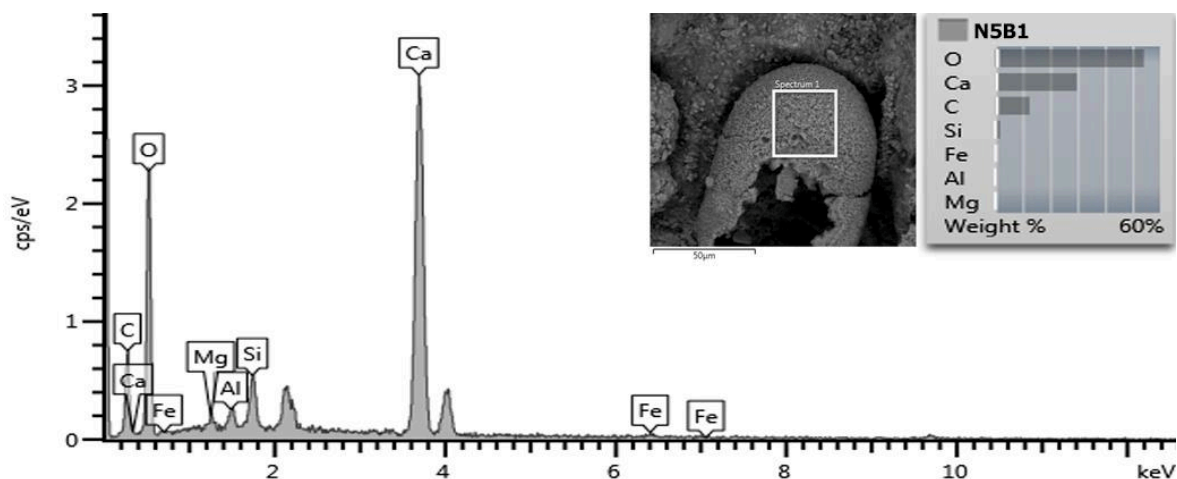
**Diagram 4.25:** EDX analysis results of insect chitin found in lime samples taken from Structure N5B1

Investigation of insect chitin determined on SEM images identified the elements O (54.01%), Ca (29.68%), C (12.49%), Si (1.79%), Fe (0.89%), Mg (0.44%), and Al (0.70%). (Diagram 4.25; Figure 4.296d)

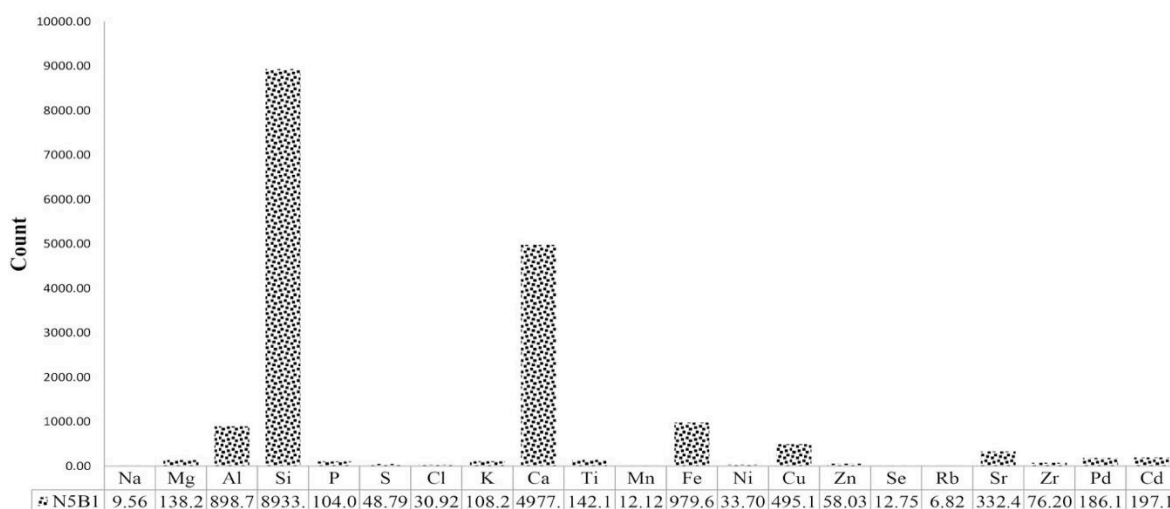
**Diagram 4.26:** XRF analysis of the lime samples taken from Structure N5B1

Analysis of lime samples using the XRF method observed that Ca (28%), Si (50%), Fe (6%), and Al (5%) elements were dominant with very small amounts of Ni, Zn, Sr, Rb, Na, K, S, P, Pd, Cl, Cu, and Ze. (Diagram 4.26) Additionally, in  $7741 \pm 50$  years BP when the structure N5B1 was being used, its stable isotope composition was  $\delta^{18}\text{O} = -6.72\%$  and  $\delta^{13}\text{C} = -7.54\%$  V-PDB. (Diagram 3.11) When assessed together with the other Sumaki Höyük isotopes, it can be concluded that this period had a warmer and drier climate compared to previous and later periods.

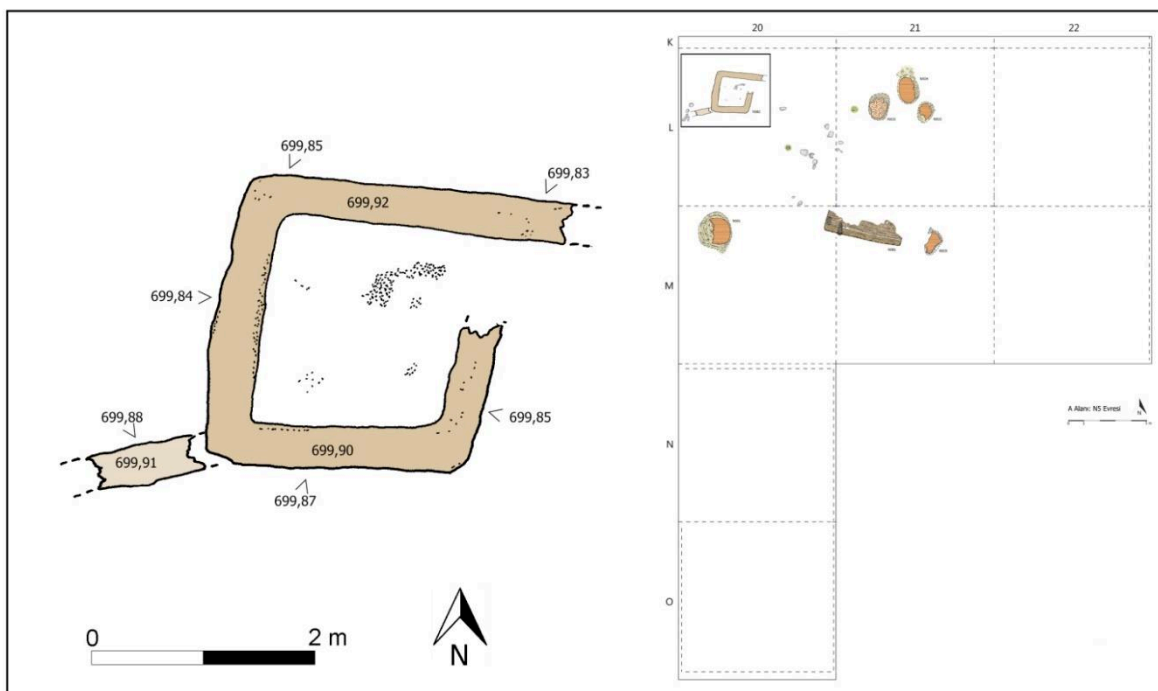
**Figure 4.28:** Location and plan of Structure N5B2

This rectilinear structure is 304 cm long in the east-west direction and 243 cm wide in the north-south direction. Covering an area of nearly  $7 \text{ m}^2$ , the internal dimensions of the room are 177x175 cm; in other words, it is a small structure. (Figure 4.28, 4.135 – 4.137) Its north wall extends almost 50 cm to the east. In the northeast section, an opening which is thought to be the entrance of the structure was determined. Outside the southeast corner of

The walls without a stone foundation are 32-43 cm wide. The homogeneous reddish-brown very loose earth walls were constructed following the slope of the natural surface. Considering the architectural tradition and construction technology of Sumaki Höyük, the walls were built by the piled earth technique.

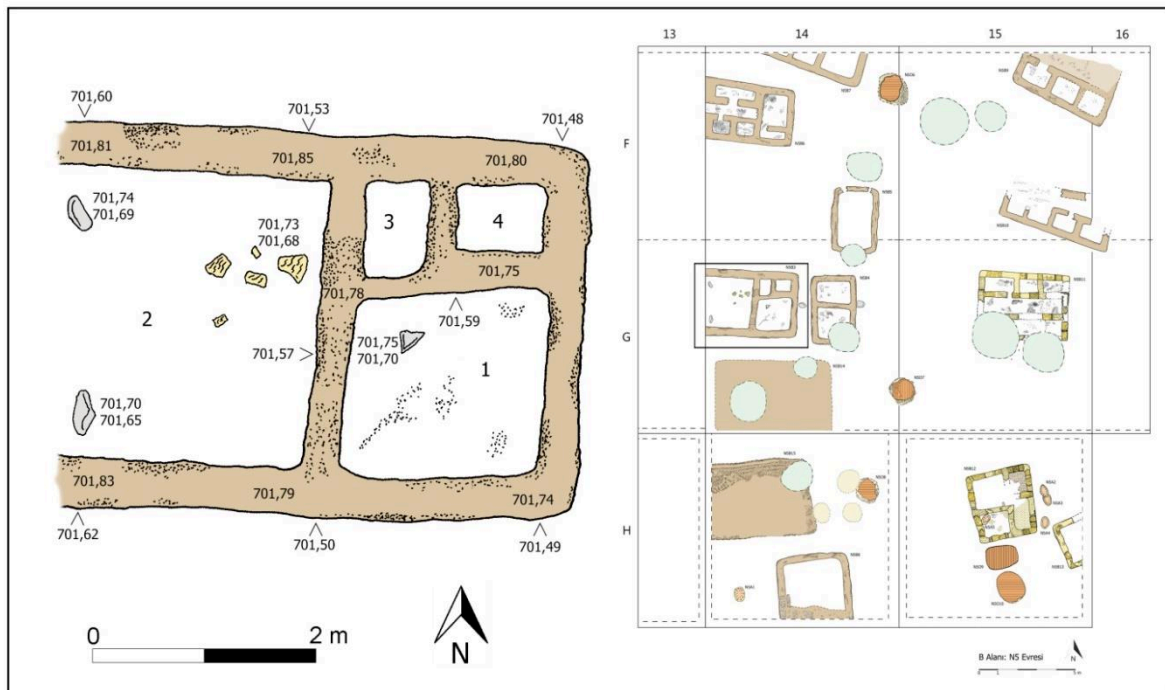
**Figure 4.29:** Location and plan of Structure N5B3

This is located in Area B, in the northwest section of trench 14G between the elevations of 701.48 to 701.85 meter. Based on the wall remains and general appearance, this structure is classified as a multi-roomed structure. The structure has two cells and two large rooms. This structure appears to be ‘transitional building’ regarding to its plan between the Cell Buildings and the multi-roomed structures. (Figure 4.29) The walls have been preserved to a height of 37 cm. The structure was constructed on a yellowish grey-coloured ash-poor and occasionally hard fill following the slope of the natural topography without a stone foundation.

The structure is located on the east-west oriented natural terrace slightly sloping toward the east. In the north-south direction, it has a width of 338 cm, (Figure 4.337) very similar to the dimensions of the other cell buildings. However, as its western limits remains outside the exposed area the dimensions could not be determined. Its exposed section is 490 cm long. Based on the trench cross-section and the length-width ratio of structures with similar plans, the large room with more than half excavated is assumed to be the last space in west. The thickness of the bearing walls and partition walls are different. The bearing walls are 31-42 cm wide, and the partition walls are 18-34 cm wide. However, the thickness of the partition walls is entirely different from each other; such as the partition walls between the cells are thinner.

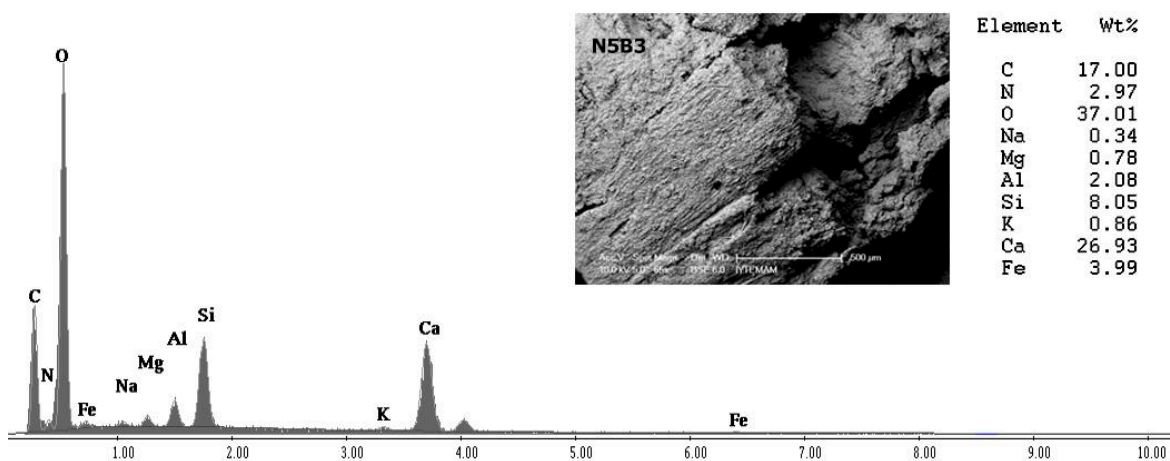
**Diagram 4.27:** EDX analysis of lime samples taken from Structure N5B3

Calcium carbonate minerals with scalenohedral shapes are observed on SEM images of lime samples taken from within the walls and internal fill of the structure. Additionally, samples were identified with SiO<sub>2</sub> gels filling the organic cavities. The clearest is silicon dioxide gel filling a *Panicum* plant remnant. (Figure 4.297) Calcium carbonate minerals have accumulated within the silicon dioxide gels. Acicular-shaped crystals were also observed in the soil samples. (Figure 4.298) EDX analysis of the lime samples identified the following elements with their mean values; O (37.01%), Ca (26.93%), C (17.00%), Si (8.05%), and Fe (3.99%), together with the elements N, Na, Mg, Al, and K with proportions from 3% to 0.34%. (Diagram 4.27)

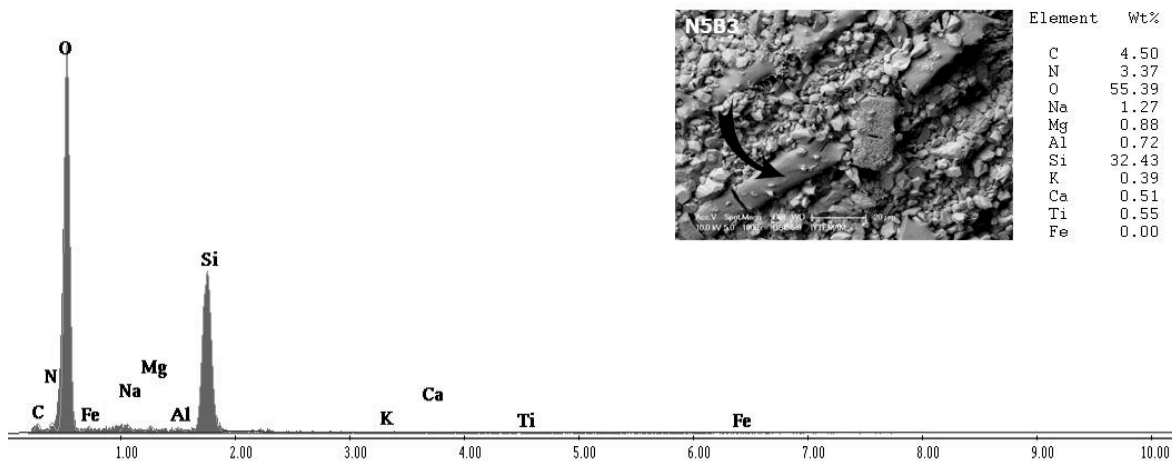
**Diagram 4.28:** EDX analysis results of SiO<sub>2</sub> gels found in lime samples taken from Structure N5B3

Analysis of areas filled with SiO<sub>2</sub> gels by the EDX method observed an increase in the proportions of silicon. The ratios of the element in the gels were O (55.39%), Ca (0.51%), C (4.50%), and Si (32.43%). N, Na, Mg, Al, K, and Ti were identified with proportions from 4% to 0.39%. (Diagram 4.28)

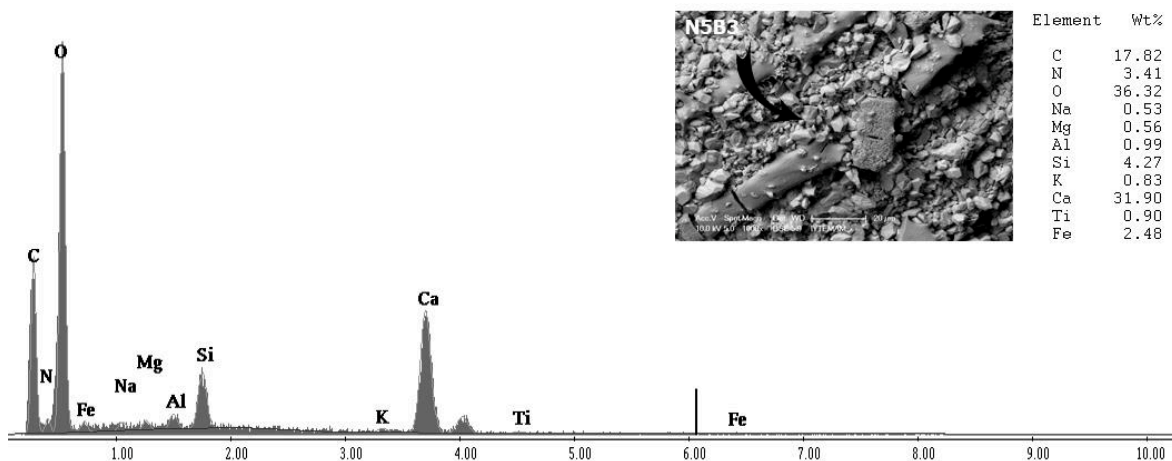
**Diagram 4.29:** EDX analysis results of lime fragment around the SiO<sub>2</sub> gels found in lime samples taken from Structure N5B3

Analysis of the same samples with carbonates surrounding these areas filled with SiO<sub>2</sub> gels found calcium peaks. It was also observed that O (36.32%), Ca (31.90%), C (17.82%), and Si (4.27%) elements were dominant, together with the elements N, Na, Mg, Al, K, Fe, and Ti at rates from 4% to 0.39%. (Diagram 4.29)

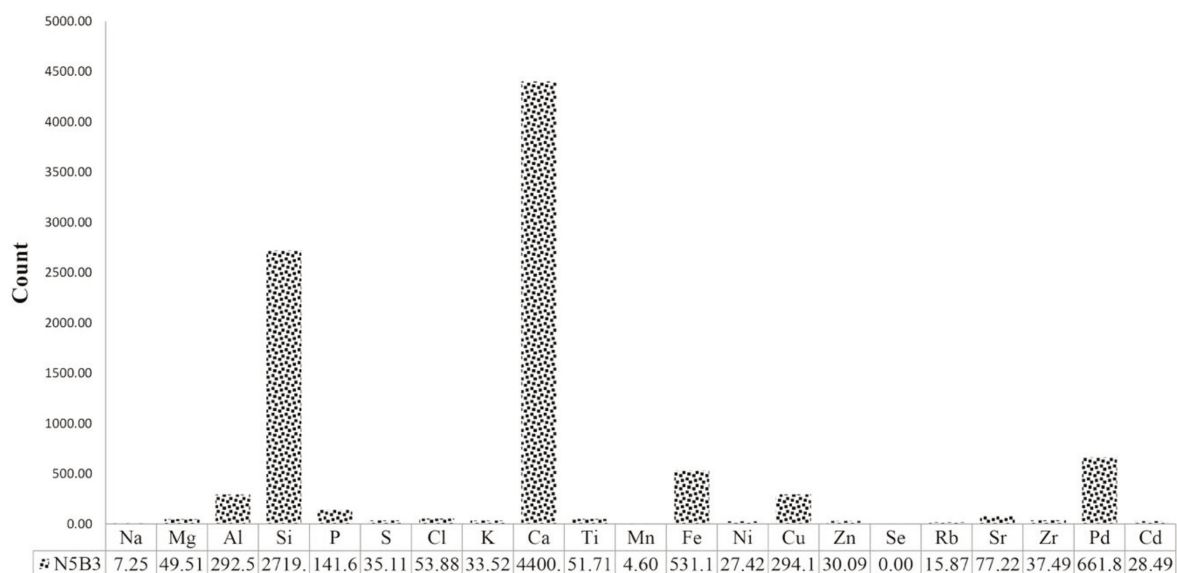
**Diagram 4.30:** XRF analysis of the lime samples taken from Structure N5B3

Investigating the same lime samples with XRF method observed the following elements dominating; Ca (28%), Si (50%), Fe (6%), and Al (5%), together with trace amounts of Ni, Zn, Sr, Rb, Na, K, S, P, Pd, Cl, Cu, and Ze. (Diagram 4.30)

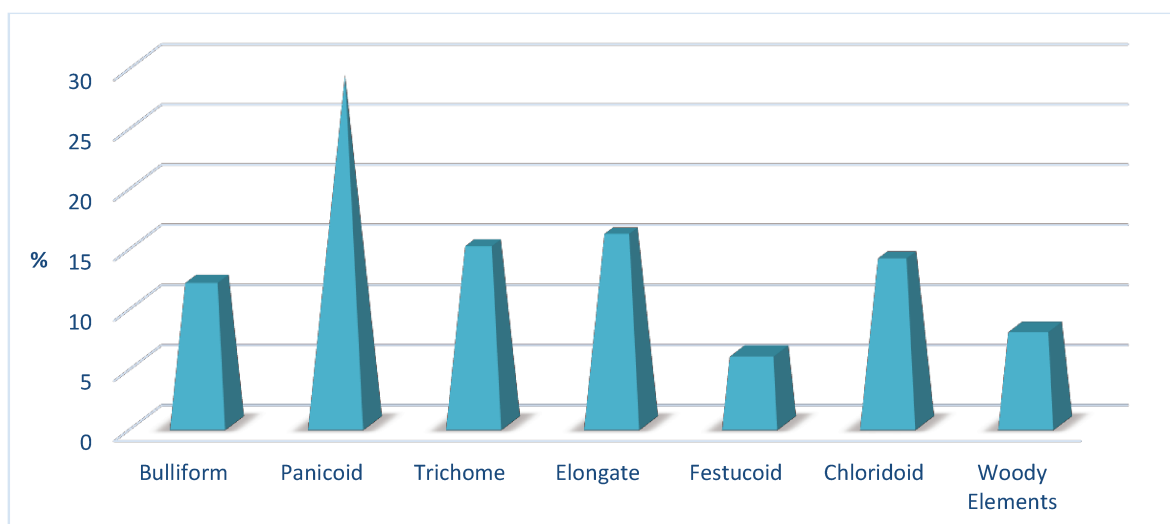
**Diagram 4.31:** Distribution of phytoliths in the lime samples taken from Structure N5B3

Phytolith analysis of the lime samples identified reed or herbaceous plant remains. The phytoliths contained high frequency of *Panicoid* forms. *Trichome*, elongate *Chloridoid*, *Bulliform*, *Festucoid*, and *Silicified Woody Forms* were also identified. (Diagram 4.31) *Panicoid* phytoliths have multiple forms, such as dominantly short and long-shafted rounded forms. Saddle-shaped *Chloridoid*, rectangular/square formed *Festucoid* phytoliths and other *Silicified Woody Forms* were also observed. (Figure 4.325 - 4.330) Considering the architectural tradition and construction technology of Sumaki Höyük, both the bearing and

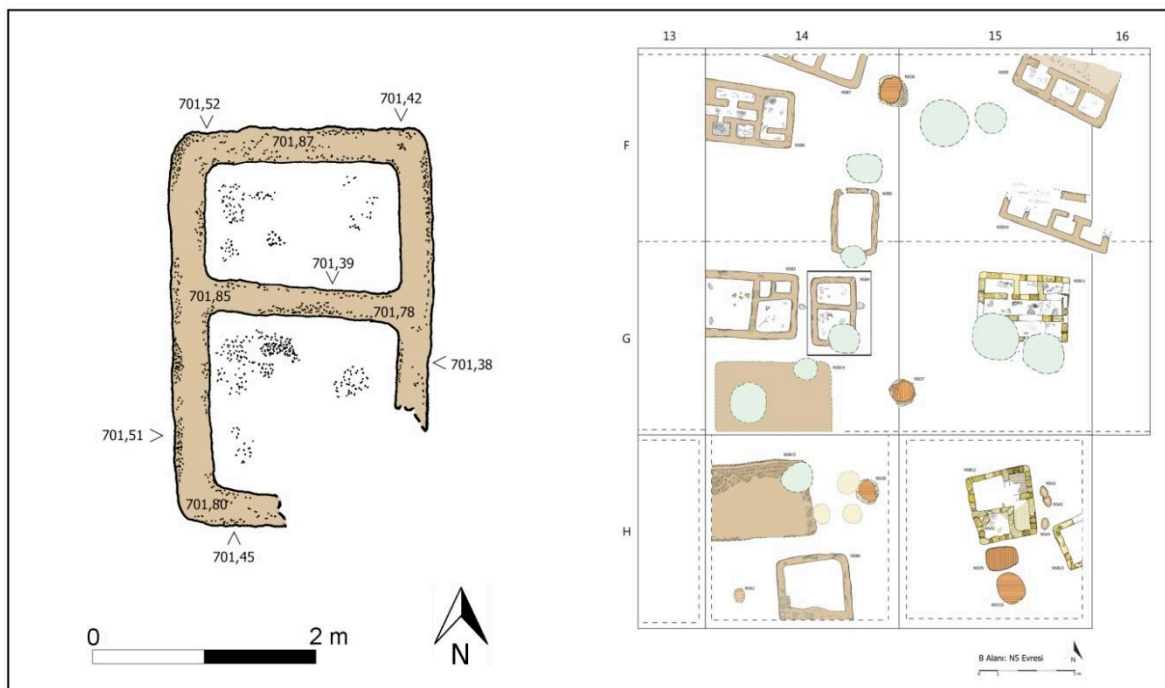
**Figure 4.30:** Location and plan of Structure N5B4

This is located in Area B, in the northeast of trench 14G between the elevations of 701.38 to 701.87 meter. The walls have been preserved to a height of 50 cm. Based on the wall remains and general appearance, this structure classified as a double-roomed structure. (Figure 4.30, 4.141) The structure was constructed at the edge of an east-west oriented natural terrace, on a slope inclined toward the east.

The structure was constructed with a north-south orientation, contrary to other structures in the same area, had a width of 238 cm in the east-west direction and a length of 353 cm in the north-south direction. (Figure 4.340) The bearing walls are 30-32 cm thick while the partition walls are 22-27 cm thick. The walls in the eastern part are at least 25 cm higher than the walls in the western section. Lime line traces are clearly identified on both faces of the walls and in their internal fill. Lime lines at 4-5 cm intervals between reddish-brown bedding on either faces of the walls in the south and east section of the structure are notably well-defined. (Figure 4.142, 4.143)

The structure has two rooms. The north room is 108x77 cm in size (nearly 2 m<sup>2</sup>). The south room with a size of 156x170 cm (2.6 m<sup>2</sup>) is larger than the north one. The structure has no door openings either between the rooms or to outer space. A large stone between the elevations of 701.43 to 701.54 observed outside the structure appears to be the living surface of the structure.

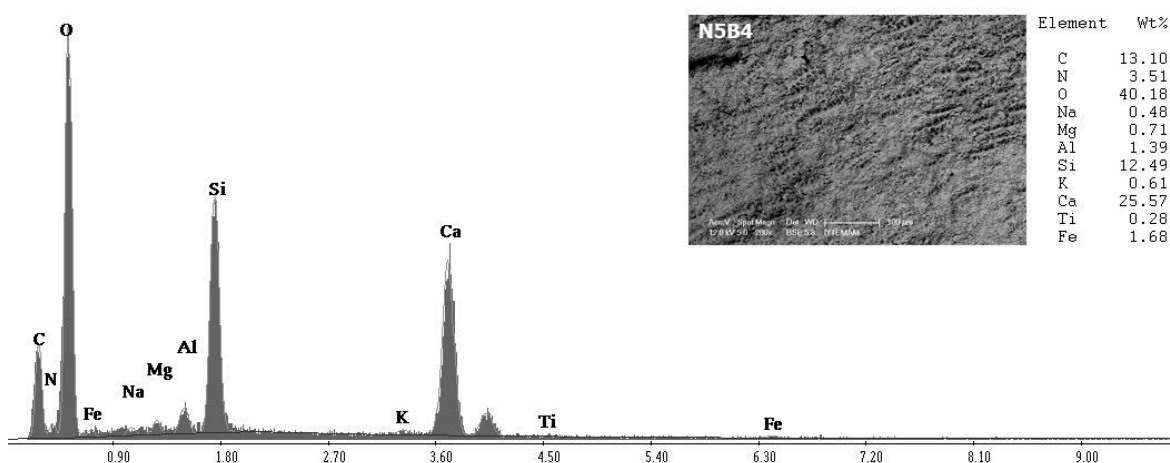
**Diagram 4.32:** EDX analysis of lime samples taken from Structure N5B4

SiO<sub>2</sub> gels filling the organic cavities are observed on SEM images of the lime samples. The clearest is silicon dioxide gel filling a *Panicum* plant remnant. (Figure 4.299) Examination of lime samples with the EDX method identified the elements O (40.18%), Ca (25.57%), C (13.10%), Si (12.49%), Al (1.39%), and Fe (1.68%), together with very small amounts of Na, Mg, K, and Ti. (Diagram 4.32)

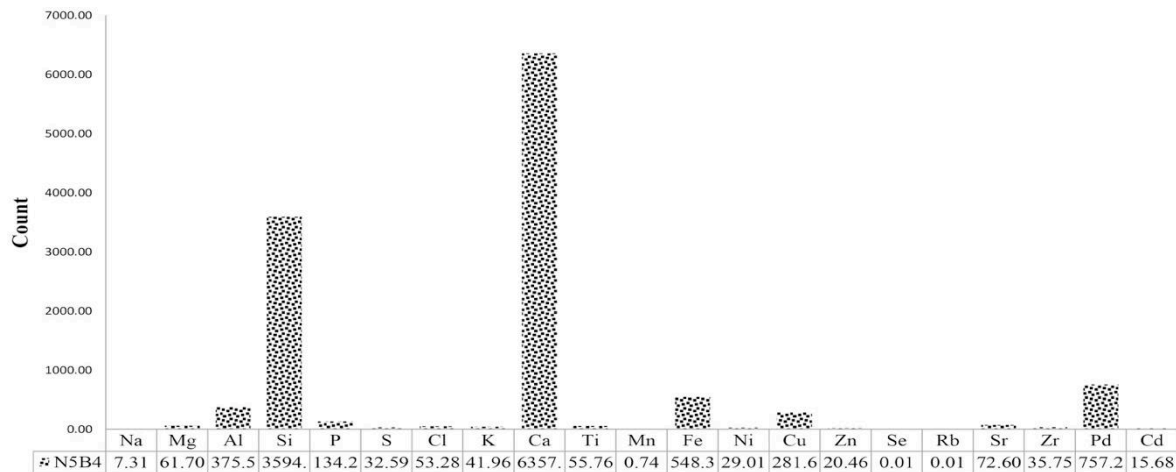
**Diagram 4.33:** XRF analysis of the lime samples taken from Structure N5B4

Investigation of the same samples with the XRD method identified as containing calcite, silica, quartz, villiaumite, and nitratine minerals. Their chemical composition is calcium carbonate, silicon dioxide, sodium fluoride, and sodium nitrate compound. The sodium nitrate compound indicates the presence of aridity. (Diagram 4.105) XRF analysis of the lime samples observed the following elements dominating; Si (29%), Ca (51%), Fe (4%), Al (3%), and Pd (6%), together with traces amounts of Ni, Zn, Sr, Rb, Na, K, S, P, Cl, Cu, and Ze. (Diagram 4.33)

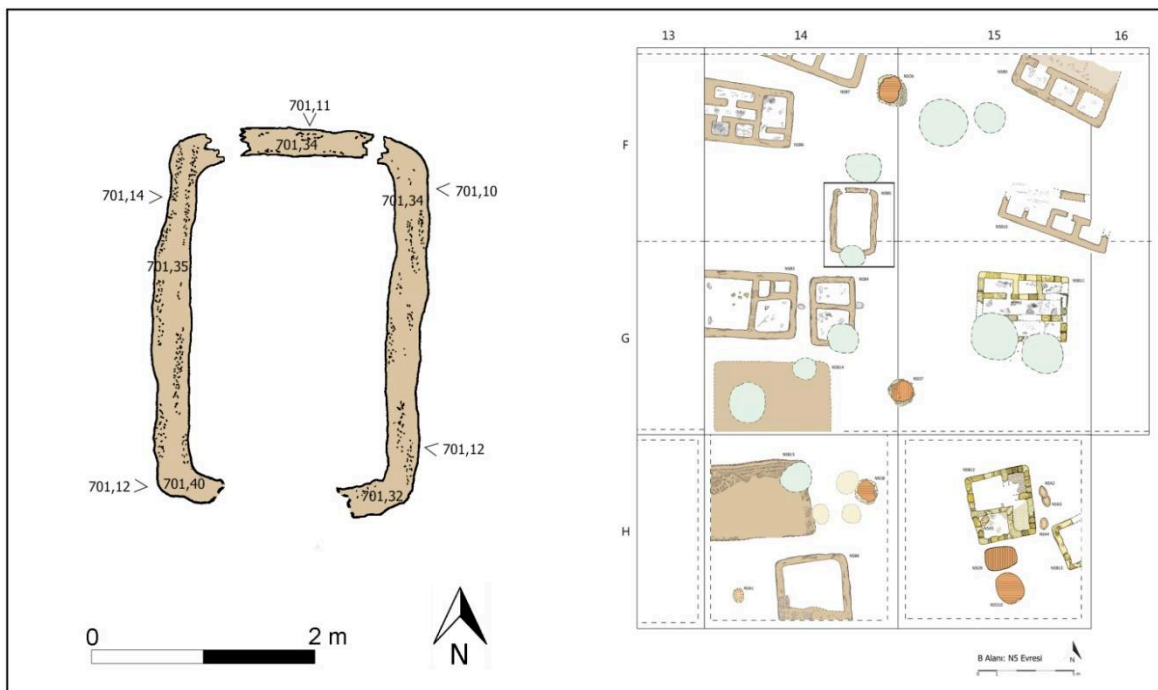
**Figure 4.31:** Location and plan of Structure N5B5

This is located in Area B, in the southeast of trench 14F and northeast of trench 14G between the elevations of 701.15 to 701.43 meter. Based on the wall remains and general appearance, the structure classified as a single-roomed structure. (Figure 4.31, 4.144 – 4.146) The structure was constructed with an east-west orientation at the edge of an undulating natural terrace sloping toward the east, similar to the Structure N5B4. The walls, which have been preserved to a height of 18 cm, were constructed directly on the natural ground.

The rectangular single-roomed structure was 248 cm long in the east-west direction and 336 cm wide in the north-south direction. (Figure 4.341) The internal dimensions of the structure are 176x283 cm with an area of nearly 8 m<sup>2</sup>. The structure has no doorway. Though the southern part of the structure was partially disturbed by a pit the entrance was either in this disturbed area or at a higher level. The badly-preserved walls are 22-34 cm thick.

Although there are no traces of plaster floor remains or hardened floor surfaces detected in the structure, scattered small stones were found at nearly the same level as the walls. The walls occasionally appear to be bounded by lime fragments. On both faces of the wall, but on the western wall, compact lime lines with 2-5 cm thickness are clearly observed. The internal fill of the bounded walls is homogeneous reddish-brown loose earth. There were no mortar or plaster surfaces identified on either faces of the walls. Considering the architectural tradition of structures with similar plan and the wall construction technology of Sumaki Höyük, this structure was constructed by the piled earth technique.

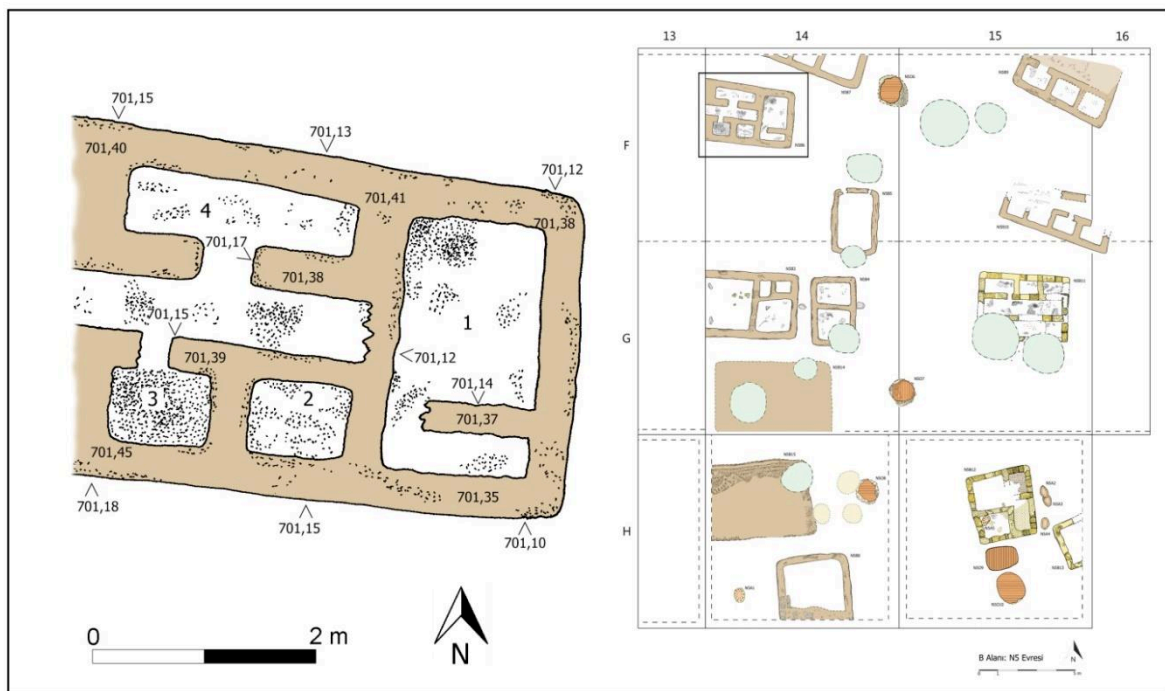
**Figure 4.32:** Location and plan of Structure N5B6

This is located in Area B in the northwest of trench 14F between the elevations of 701.12 to 701.47 meter on a grey intensely ashy fill following the slope of the natural surface without a stone foundation. Based on the wall remains and general layout, the structure is classified as a Cell Building. However, some differences in its plan are noteworthy compared to the Cell Buildings of Phase N6. Firstly, the presence of a room on the east side of the structure; secondly an L-shaped or a T-shaped corridor plan appears not be used; third the dimensions of the cells can easily be regarded as rooms. Therefore, considering its plan, the

structure appears to be a ‘transitional structure’ between Cell Buildings and Multi-roomed Structures. The walls have been preserved to a height of 35 cm. (Figure 4.32, 4.147 – 4.149)

Per structures in the same area, N5B6 is constructed on an undulating flat surface on the east-west oriented natural terrace. Its exposed part is 471 cm long in the east-west direction. Since its western section is outside the exposed area the dimensions in the east-west direction could not clearly be measured. This rectangular structure has a width of 308 cm in the north-south direction. Its area within the trench is nearly 14 m<sup>2</sup>. Based on this data, the area of the structure is not more than 16 m<sup>2</sup>. The main walls are 33-36 cm wide, and the partition walls are 21-36 cm wide.

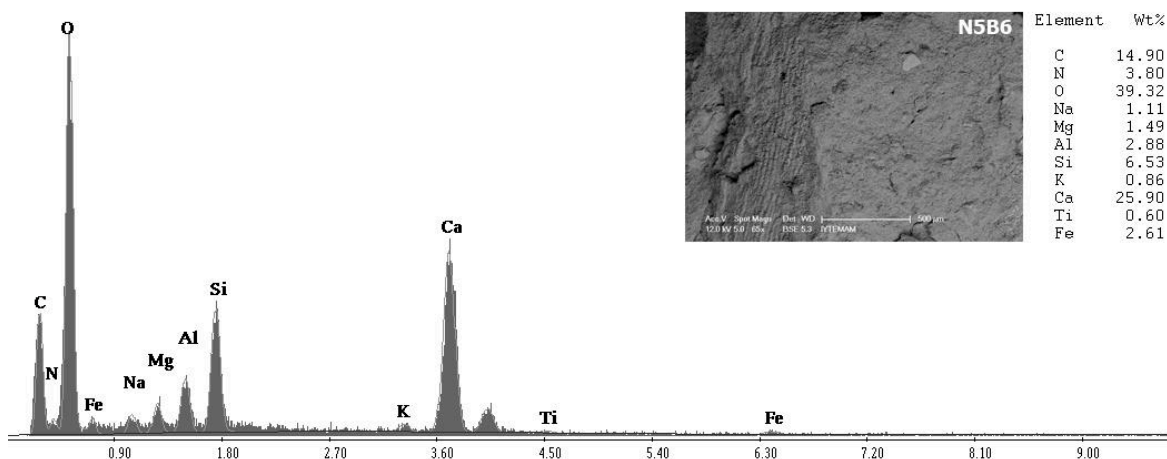
**Diagram 4.34:** EDX analysis of lime samples taken from Structure N5B6

SiO<sub>2</sub> gels filling the organic cavities are observed on SEM images of the lime samples. (Figure 4.300) Their EDX analysis identified the elements O (39.32%), Ca (25.90%), C (14.90%), Si (6.53%), Al (2.88%), and Fe (2.61%) with traces amounts of Na, Mg, K, and Ti. (Diagram 4.34) XRD analyses of the same samples were identified as containing calcite, silica, quartz, altaite, and iron minerals. Their chemical compositions

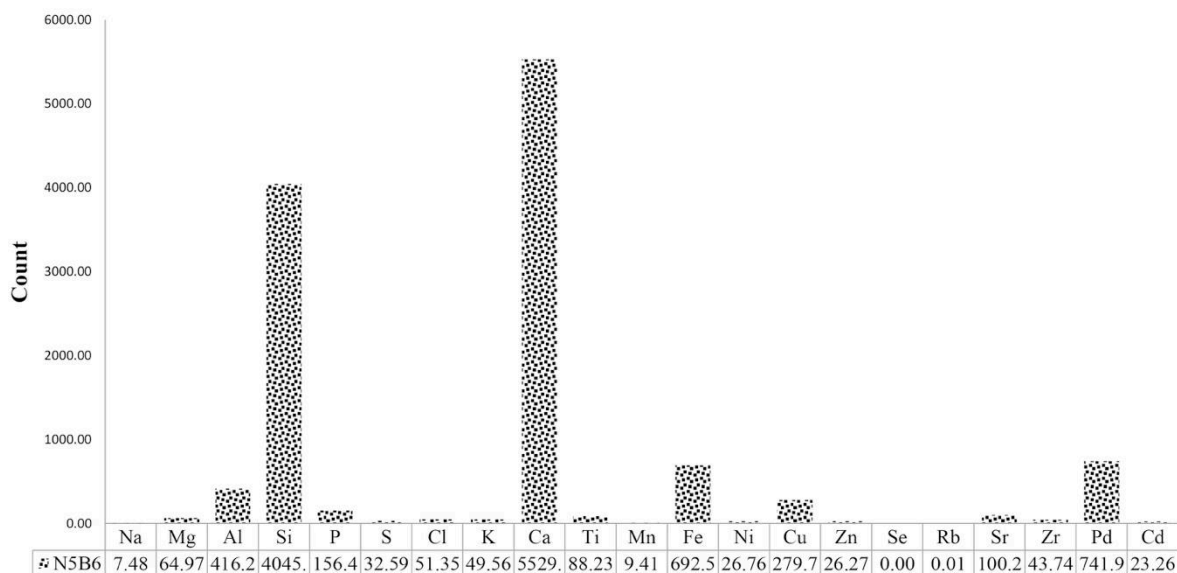
**Diagram 4.35:** XRF analysis of the lime samples taken from Structure N5B6

comprise calcium carbonate, silicon dioxide, iron oxide, and lead telluride compounds. (Diagram 4.106) According to their XRF analysis, it was observed that the following elements dominating; Si (33%), Ca (45%), Fe (6%), Al (3%), and Pd (6%), together with traces amounts of Ni, Zn, Sr, Rb, Na, K, S, P, Cl, Cu, and Ze. (Diagram 4.35)

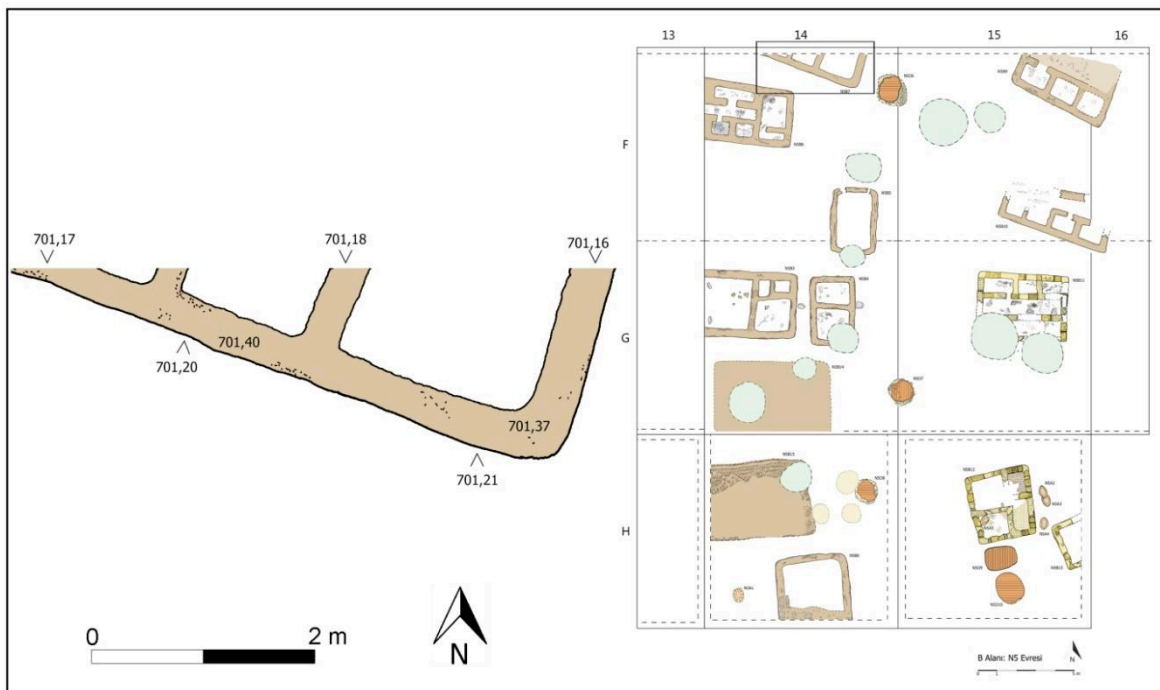
**Figure 4.33:** Location and plan of Structure N5B7

This is located in Area B, in the north of trench 14F between the elevations of 701.16 to 701.40 meter on a grey ashy fill. The structure having at least three rooms is classified as a multi-roomed structure. It appears to be constructed following the slope of the natural surface without a stone foundation. The structure was built on a natural terrace with southeast-northwest orientation on a surface slightly inclined to the east. (Figure 4.33, 4.149) Since its northern section is outside the exposed area, the structure could not clearly be measured. Its exposed section is 494 cm long in the southeast-northwest direction and 136 cm wide in the northwest-southeast direction. The walls have been preserved to a height of 24 cm. The bearing walls are 33-38 cm wide, and the partition walls are 25-34 cm wide.

The internal fill of the walls is homogeneous reddish-brown loose earth. Considering the architectural tradition of structures with a similar plan and the wall construction technology of Sumaki Höyük, the structure was constructed by the piled earth technique.

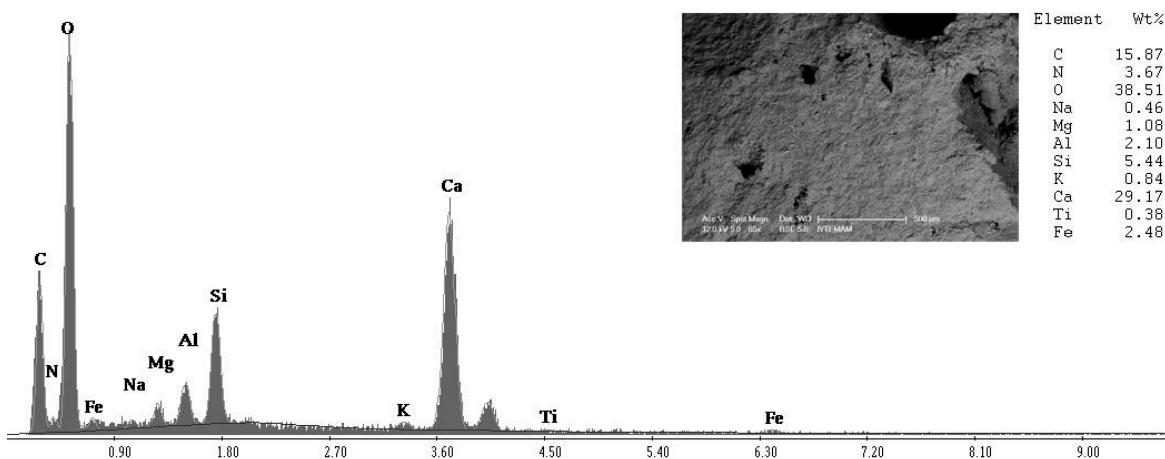
**Diagram 4.36:** EDX analysis of lime samples taken from Structure N5B7

On SEM images of the lime samples, scalenohedral and acicular crystal structure surrounding the cavities formed by organic material are observed. (Figure 4.301) The sharp-tipped crystals are aragonite minerals. Zinc with 24.11 ppm value identified by the XRF method also shows that this crystal is aragonite. Investigation of the same lime samples with EDX analysis identified the elements O (38.51%), Ca (29.17%), C (15.87%), Si (5.44%), Al (2.10%), and Fe (2.48%), together with traces amounts of Na, Mg, K, and Ti. (Diagram 4.36)

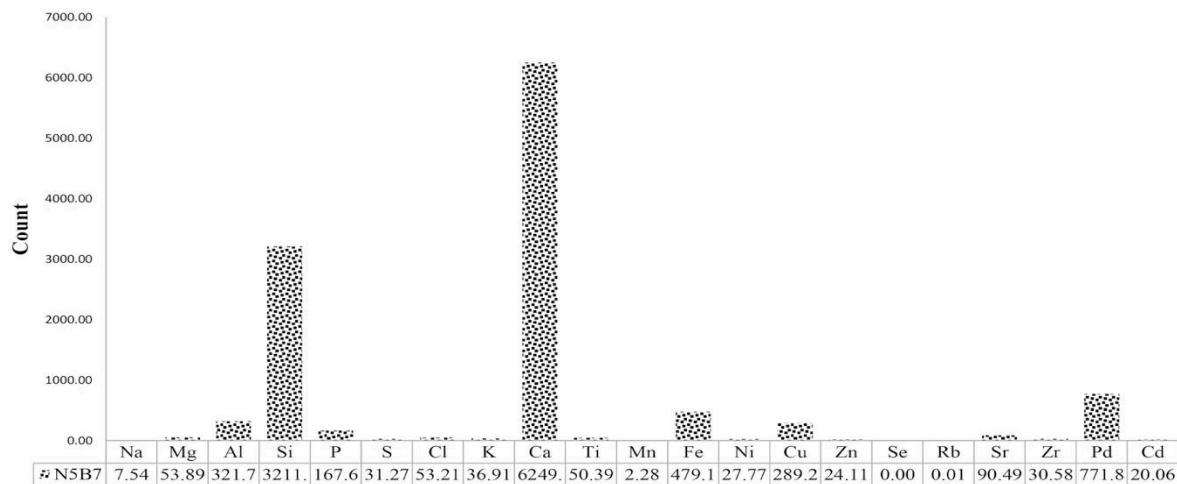
**Diagram 4.37:** XRF analysis of the lime samples taken from Structure N5B7

XRF analysis of the same samples observed the following elements dominating; Si (27%), Ca (52%), Fe (4%), Al (3%), and Pd (6%), together with very small amounts of Ni, Zn, Sr, Rb, Na, K, S, P, Cl, Cu, and Ze. (Diagram 4.37)
