# Microarchaeological observation on the neolithic architectural structures and cultural landscape of Sumaki Höyük

# **Microarchaeological Observation on the Neolithic Architectural Structures and Cultural Landscape of Sumaki Höyük**

PhD Thesis

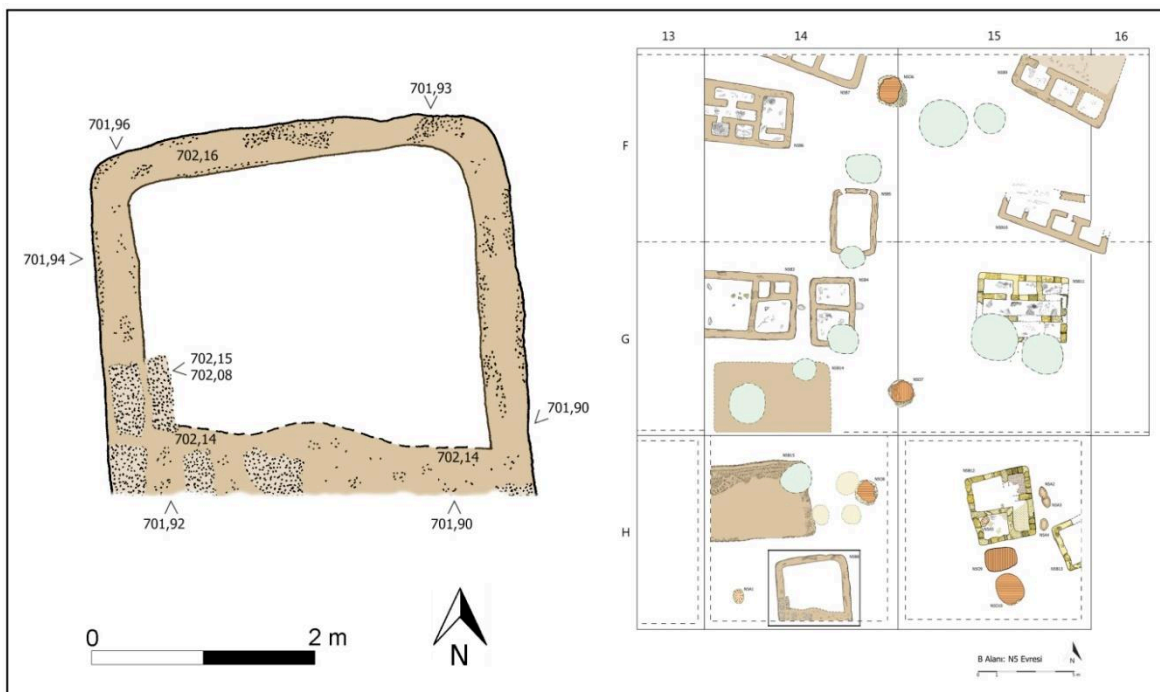
**Figure 4.34:** Location and plan of Structure N5B8

This is located in Area B in the south of trench 14H between the elevations of 701.90 to 702.16 meter on a grey ashy fill without a stone foundation. Based on the wall remains and general layout, the structure is classified as a single-roomed structure; however, considering the size and plan of the structure, there may be another room existed outside the exposed area. Its layout is very similar to the layout of the structure N5B3. Therefore, it may be the remains of a multi-roomed structure. The walls have been preserved to a height of 22 cm. (Figure 4.34, 4.150 – 4.152)

The structure sits on a slightly higher terrace than the terrace where the structures N5B3 and N5B6 built on. Contrary to the structure N5B3, the north-south oriented structure N5B8 sits on a natural terrace with an undulating flat appearance. Its exposed section is 384 cm wide in the east-west direction. Since its southern part is outside the exposed area, the dimensions in the north-south direction could not be detected. The remaining section has a

length of 339 cm. The walls are 34-37 cm thick. The only room with a rectangular plan is 306x243 cm in size. This room covering an area of 8 m<sup>2</sup> has a grey ash-poor fill. No door opening was detected. There were no plaster floor remains or hardened floor surfaces identified.

Occasional lime fragments appear to have bound the walls with homogeneous reddish-brown loose earth. In the south cross-section of the structure, six block-like lime traces were identified between the bedding of piled earth walls. The lengths of these block-like lime traces are different, though the widths are the same. Considering this data, the structure was constructed by using the piled earth and the kerpiç blocks technique. (Figure 4.152)

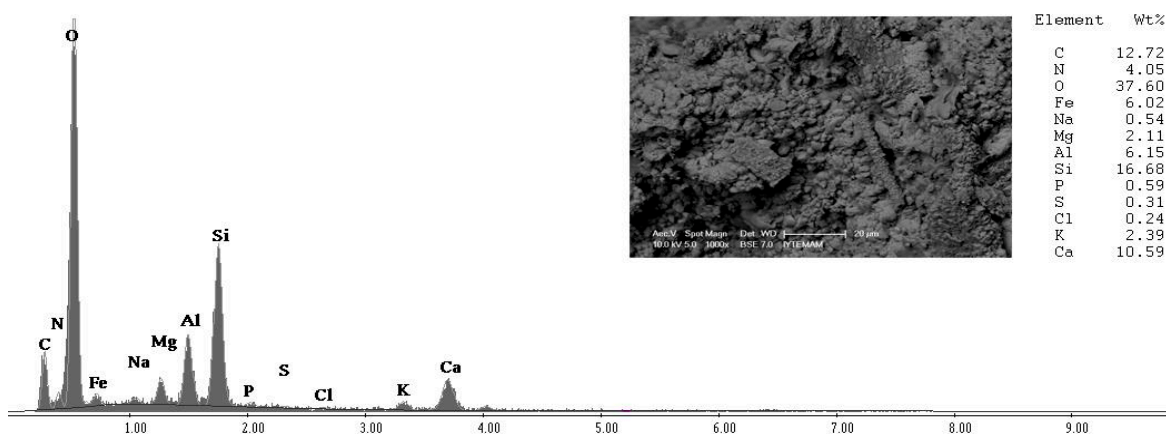
**Diagram 4.38:** EDX analysis of lime samples taken from Structure N5B8

SiO<sub>2</sub> gels filling the organic cavities are partially observed on SEM images of the lime samples. (Figure 4.32a-c) Calcium carbonate minerals with scalenohedral crystal structure were found surrounding tubes formed by organic remains. (Figure 4.302d) Investigation of lime samples with EDX analysis identified the elements O (37.60%), Ca (10.59%), C (12.72%), Si (16.68%), Al (6.15%), and Fe (6.02%) with very small amounts of Na, Mg, P, S, Cl and K. (Diagram 4.38)

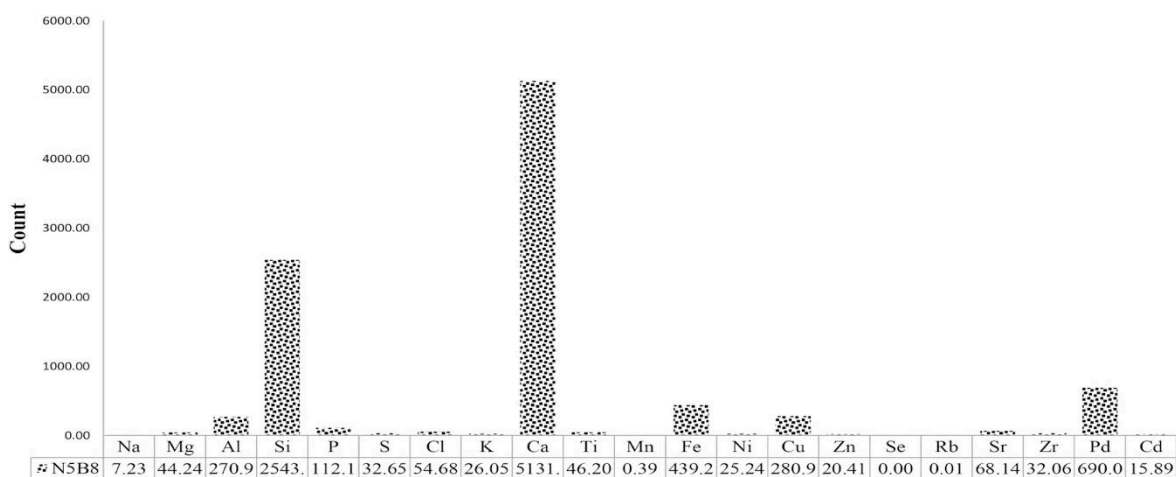
**Diagram 4.39:** XRF analysis of the lime samples taken from Structure N5B8

Investigation of the same samples with XRD analysis only identified calcite and graphite minerals. (Diagram 4.108) Their chemical composition is calcium carbonate and carbon compounds. According to the XRF analysis of the same samples, it was observed that Si (26%), Ca (52%), Fe (4%), Al (3%), and Pd (7%) elements are dominant with very small amounts of Ni, Zn, Sr, Rb, Na, K, S, P, Cl, Cu, and Ze. (Diagram 4.39)

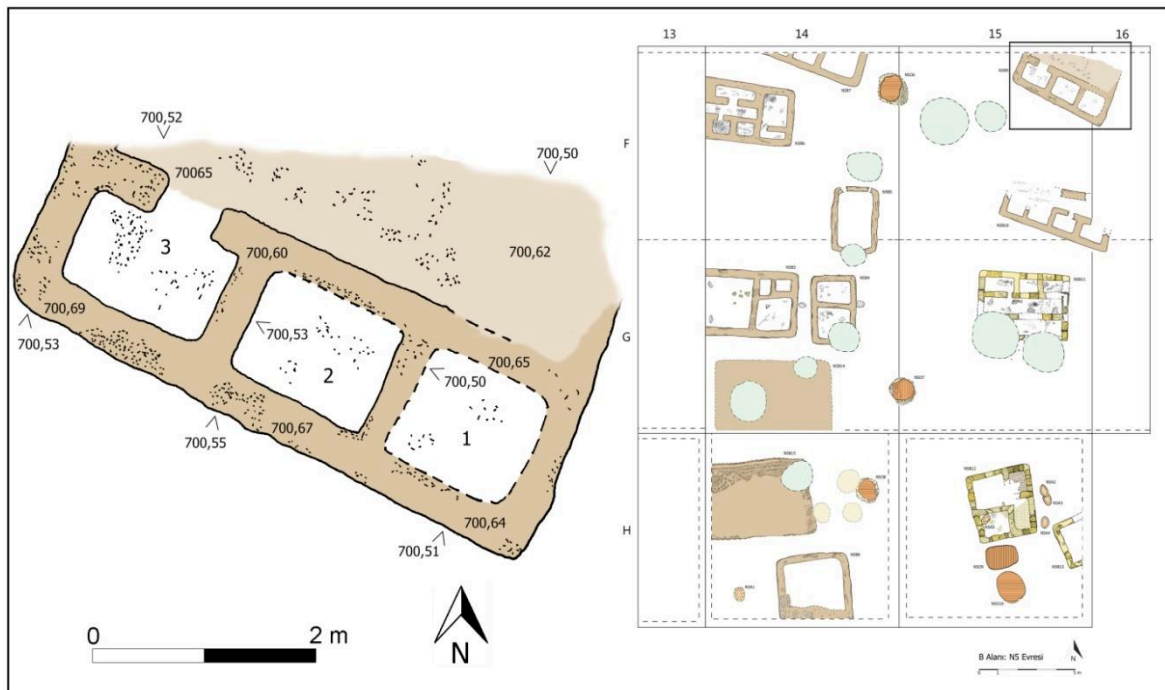
**Figure 4.35:** Location and plan of Structure N5B9

The structure is 526 cm long in the southeast-northwest direction. Its northern part is outside the exposed area. The remaining section is 236 cm in the southwest-northeast direction. Regarding the exposed section, there is a corridor between the cells, but its plan has not entirely been identified. (Figure 4.35, 4.153, 4.154) The widths of the bearing and the partition walls are different. The bearing walls are 36-40 cm wide, and the partition walls are 22-31 cm wide.

The exposed south section has three cells with a corridor in the north. The corridor has a length of nearly 440 cm. The dimensions of cells are different sizes varies from 87x143 cm to 110x123 cm. Cell number 3 located in the south is longer than the others. This cell and the corridor are linked by a 56 cm-wide doorway. Other cells have no door openings.

Plaster floor remains or hardened living surface have not entirely been identified within the cells or the corridor, instead found limey areas and fist-sized stones at an elevation of 700.56. There is no grave found within the cells or under the floor levels.

Occasional lime fragments appear to have bound the walls with thickness from 1 to 3 cm. Plaster traces were not encountered on the scattered lime lines with very rough surfaces. The internal fill of walls is homogeneous dark reddish-brown loose earth. Considering the architectural tradition and wall construction technology of Sumaki Höyük, the structure was built using the piled earth technique.

This is located in Area B, in the northeast of trench 15F and northwest of trench 16F between the elevations of 700.50 to 700.69 meter. Based on the wall remains and general appearance, this structure is classified as a Cell Building. Contrary to structures located on the upper terrace, the structure N5B9 was constructed with a southeast-northwest orientation on an undulating flat surface, on the eastern part of the lower terrace along with the structures N5B3 and N5B6. The walls have been preserved to a height of 19 cm.

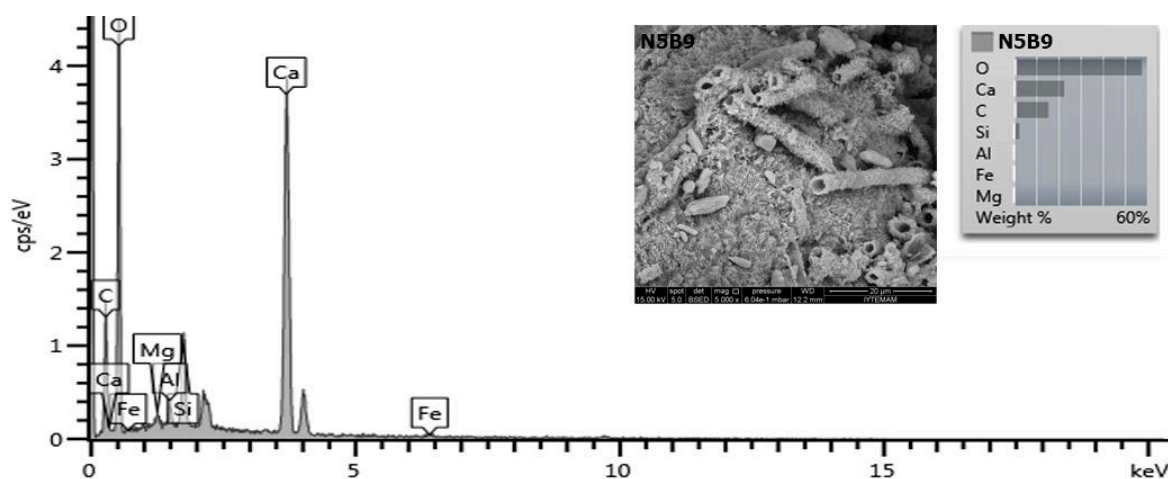
**Diagram 4.40:** EDX analysis of lime samples taken from Structure N5B9

On SEM images of lime samples, very clear scalenohedral, and stalactite-shaped calcium carbonate minerals around tubes formed by organic remain are observed. (Figure 4.303) The sharp-tipped and stalactite-shaped crystals are very clear. The minerals surrounding these tubes are generally sharp-tipped mixed crystal structures of aragonite. EDX analysis of the lime samples identified the elements O (57.70%), Ca (22.68%), C (15.58%), Si (2.51%), Al (0.63%), Mg (0.32%), and Fe (0.57%). (Diagram 4.40) Investigation of lime samples with the XRD method were identified as containing calcite, silica and quartz minerals. Their chemical composition is calcium carbonate and silicon dioxide compounds. (Diagram 4.109)

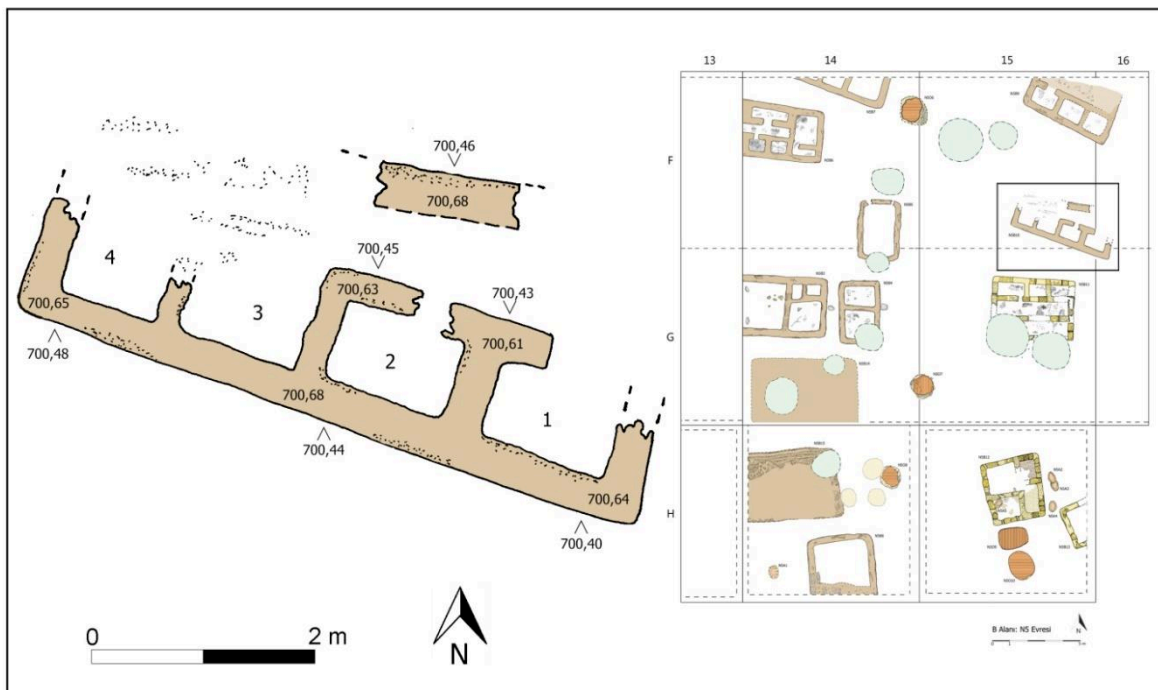
**Figure 4.36:** Location and plan of Structure N5B10

The structure is 594 cm long in the southeast-northwest direction. Its northern part was destroyed. This destruction may directly have related to torrents occurring towards the end of Phase 5. Its preserved southern section appears to have a corridor; however, its plan has not entirely been identified. The bearing walls and the partition walls have different widths. The bearing walls are 26-34 cm wide, and the partition walls are 20-35 cm wide.

The preserved southern portion of the building has four cells along with a corridor in north. The dimensions of the cells are almost the same. Cell number 2 with clear limits is 75x113 cm in size. This cell was linked by a 33 cm-wide doorway to the corridor. Even the northern limits of the other cells have been destroyed, their lengths were measured between 92 cm and 118 cm. Due to the destruction, the presence of doorways in these cells was not clear. The cells and corridor did not have any plaster floor remains or hardened floor surfaces, or any artefactual material. There were no graves found within the cells or under the floor levels.

Occasional lime fragments appear to have bound the walls. Continuing as weak and uncertain lines, their thickness varies from 1 to 2 cm. The internal fill of bounded walls is homogeneous reddish-brown loose earth. At 6-8 cm intervals in the wall section, calcified surfaces were also identified between bedding. These surfaces, which continue irregularly between the layers, did not have mortar characteristics. There was no regular surface at the bottom or top of the reddish-brown bedding. Organic remains are observed on SEM images of lime samples taken from within the walls.

This is located in Area B, in the southeast of trench 15F and northeast of trench 15G between the elevations of 700.40 to 700.68 meter. Based on the wall remains and general appearance, the structure is classified as a Cell Building. (Figure 4.36, 4.155) The structure was constructed with the southeast-northwest orientation on a slightly undulating surface similar to the structure N5B9. It is located on the eastern part of the lower terrace along with the structures N5B3 and N5B6. The walls have been preserved to a height of 28 cm.

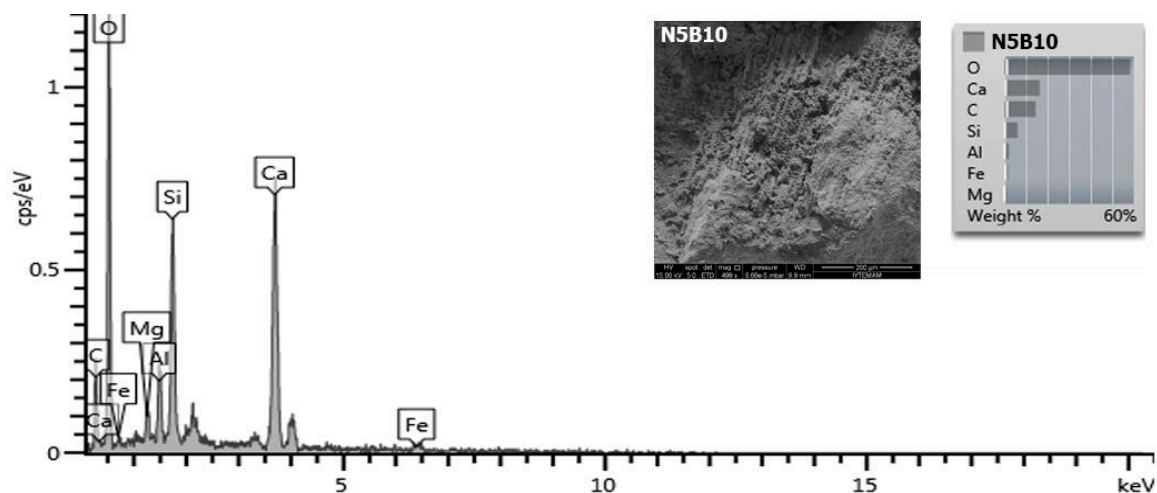
**Diagram 4.41:** EDX analysis of lime samples taken from Structure N5B10

SiO<sub>2</sub> gels filling the organic cavities are observed on SEM images of the lime samples taken from the internal fill of the cells. (Figure 4.304) The clearest is silicon dioxide gel filling a *Cyperaceae* plant remnant. EDX analysis of the lime samples identified the elements O (58.28%), Ca (16.41%), C (14.47%), Si (6.14%), Al (2.12%), Fe (1.64%), and Mg (0.93%). (Diagram 4.41) Investigation of plant remains by EDX analysis identified crystals contained the elements O (67.01%), Ca (14.15%), and Si (14.46%) with traces amounts of Al, P, Mn, and Fe. (Diagram 4.42) Silicon peak in this area clearly show silicon dioxide gel filling plant remnants. There are very a few granular crystal structures covering plant remains filled with silicon dioxide.

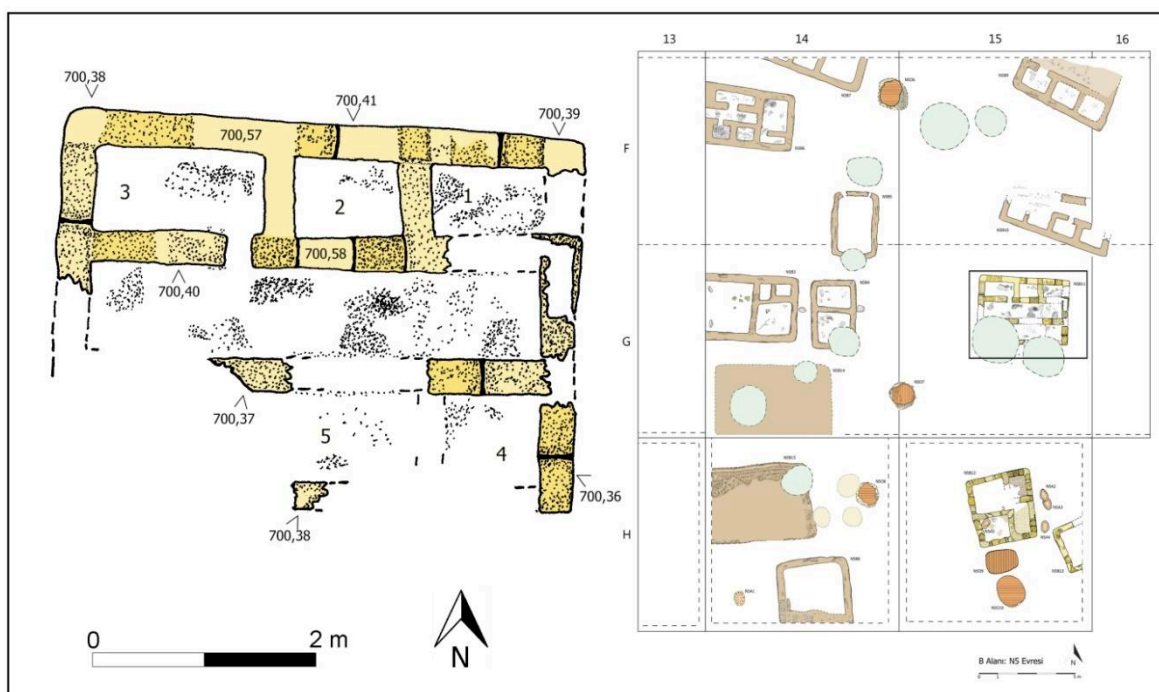
**Figure 4.37:** Location and plan of Structure N5B11

The structure is 476 cm long in the east-west direction and is 343 cm wide in the north-south direction. The Cell Building has five cells; three cells along the north wing and two cells in the south side. (Figure 4.37, 4.156 – 4.158) However, there may have been three cells in the south wing as the southwest corner of the structure was disturbed by a deep Middle Age pit. Since the corridor having the dimensions of 410 cm long and 76 cm wide was partially destroyed, its plan has not entirely been identified.

The cells and the corridor did not have any plaster floor remains or hardened living floors; however, occasionally dense 2-3 cm-thick lime surfaces were identified. These lime surfaces were defined the floor level of the structure. Due to the entire absence of archaeological material in fills of the cells and the corridor, it appears that the structure was thoroughly cleaned before it was left. There are no graves found within the cells or under the floor levels.

The noteworthy characteristic of this structure is the clear difference in the wall construction technique; in the walls both piled earth technique and the duripans were used together. Duripans having substandard sizes, indicate the absence of standard-sized molds. The 4-7 cm-thick duripans were irregularly placed in upper or lower rows inserted in layers made with the piled earth technique. (Figure 4.158) In contrast to the structural walls made with piled earth, there were more varieties of earth used in the duripans. Occasionally, it was milk-white lime-rich earth, occasionally dirty white earth, and on occasion grey buff coloured soil was used. The limey earth was probably taken raw from the caliche level above the Miocene sandstones that the settlement sits on. The caliche layer is observed nearly 1 m below the natural soil in two soundings in trenches 20/O and 22M. Analysis of the whitish lime-rich soils from the caliche level identified having similar mineralogical property to the white-coloured duripans. However, contrary to the samples taken from the caliche layers, organic remains are observed on SEM images of the duripans. (Figure 4.305)

This is located in Area B, in the northeast section of trench 15G between the elevations of 700.38 to 700.58 meter. According to its wall remains and general appearance, the structure is classified as a Cell Building. The structure is located on the lower terrace with a slightly undulating appearance, similar to the structures N5B9 and N5B10. However, contrary to other structures on the lower terrace, it was built with east-west orientation along with the structures on the upper terrace. The walls have been preserved to a height of 20 cm.

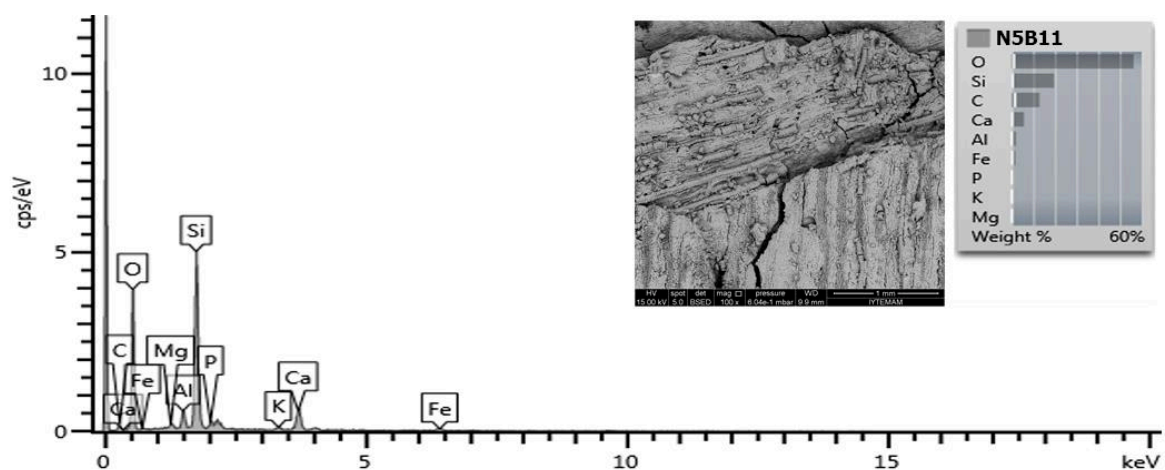
**Diagram 4.43:** EDX analysis of lime samples taken from Structure N5B11

Calcified  $\text{SiO}_2$  gels filling the organic cavities are observed on SEM images of the lime samples taken from the cells. The clearest ones are silicon dioxide gel filling *Gramineae*, *Cyperaceae*, *Ericaceae*, and *Panicoideae* plant remnants. (Figure 4.305b-d) Investigation of lime samples with EDX analysis identified the elements O (56.27%), Ca

(5.64%), C (12.85%), Si (19.58%), Al (1.99%), and Fe (1.59%) with traces amounts of Na, Mg, P, and K. (Diagram 4.43)

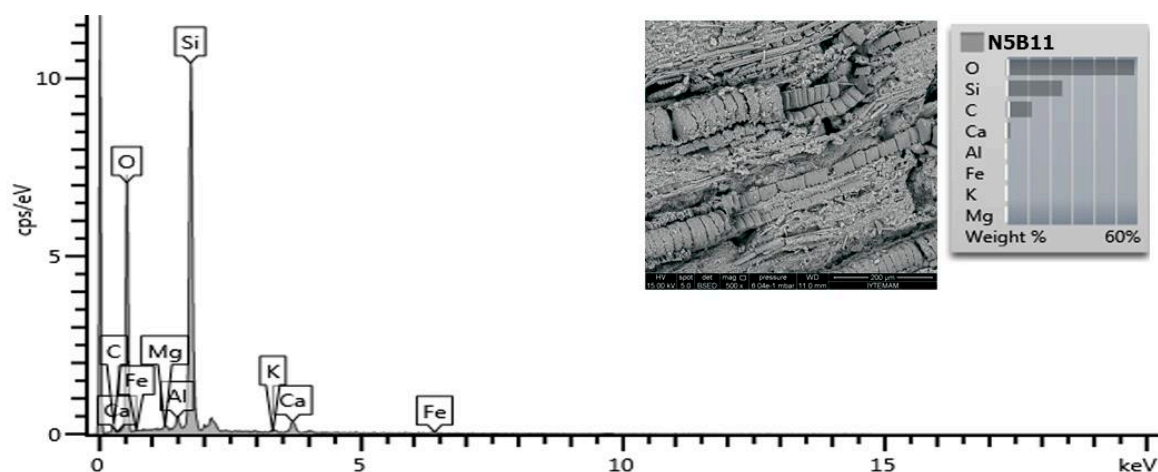
**Diagram 4.44:** EDX analysis of plant remains found in the lime samples taken from Structure N5B11

Analysis of plant remains by EDX method identified the crystals in these areas contained O (58.57%), Ca (1.96%), C (11.79%), and Si (25.63%) elements. (Diagram 4.44) The high rate of silicon in this area clearly shows that these plant remains were filled with  $\text{SiO}_2$  gel. Small proportions of scalenohedral and granular crystal structures accumulate around the plant remains filled with silicon dioxide. (Figure 4.305c)

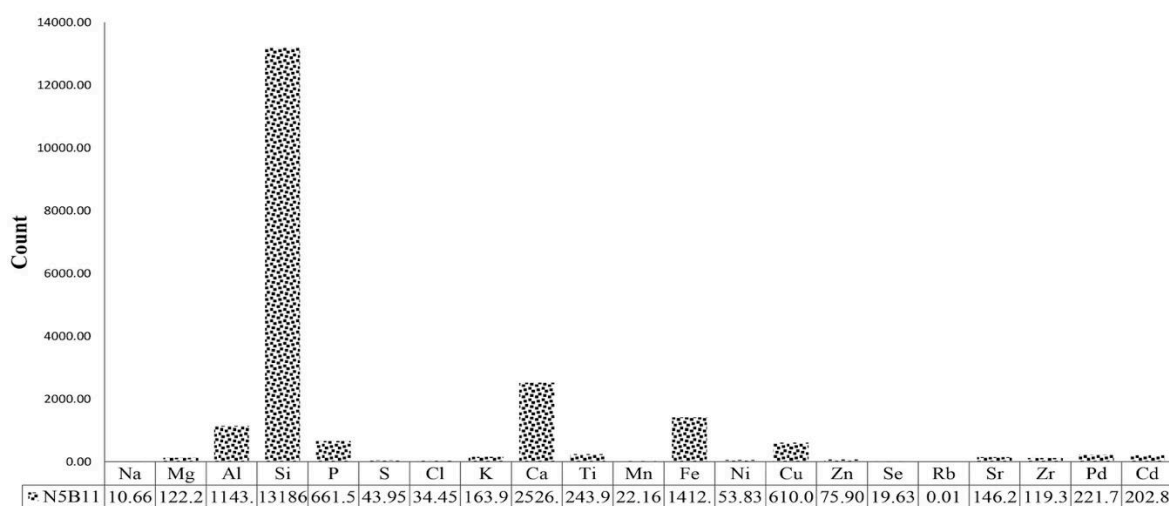
**Diagram 4.45:** XRF analysis of the lime samples taken from Structure N5B11

Investigation of lime samples with the XRD method were identified as containing calcite, quartz and graphite minerals. Their chemical composition is calcium carbonate, silicon dioxide, and carbon compounds. (Diagram 4.110) Investigation of the same samples with the XRF analysis observed that the following elements dominating; Si (63%), Ca

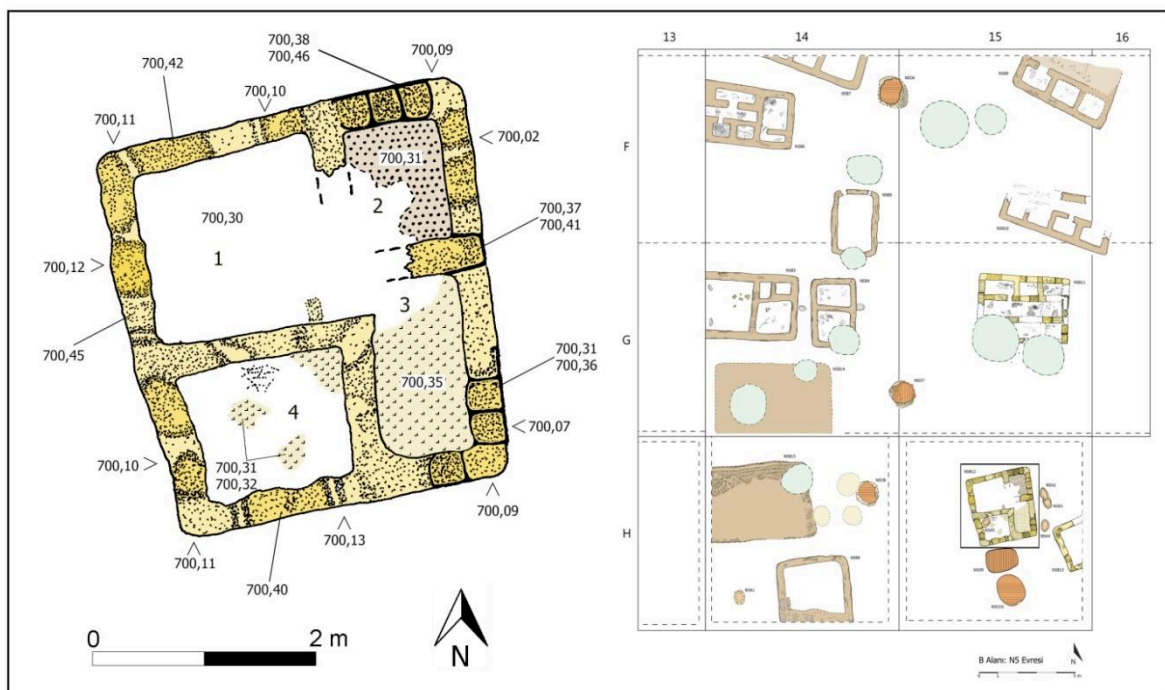
**Figure 4.38:** Location and plan of Structure N5B12

The rectangular structure is 351 cm long in the east-west direction and 337 cm wide in the north-south direction. The bearing walls are 28-34 cm wide, and the partition walls are 22-30 cm wide. The structure has four rooms. The dimensions of the rectangular rooms are different from each other with the sizes of 87x109 cm and 160x167 cm. (Figure 4.338) The intersection of the room's number 1, 2 and 3 has partially been destroyed, therefore,

This is located in Area B, almost in the centre of trench 15H between the elevations of 700.10 to 700.40 meter. Based on the walls and general appearance of the structure, it is classified as a multi-roomed structure. (Figure 4.38, 4.159) Contrary to the other structures of Phase N5 in Area B, the structure N5B12 was constructed with southeast-northwest orientation. Sitting on a slightly undulating surface, the structure is located on the lower terrace along with the structures N5B9, N5B10, and N5B11. Structure N5B12 mainly sits on a greyish buff fill, however, in the structure cross-sections identified occasional yellow-coloured ashy and lead-grey dense ashy fill within this greyish buff fill. The preserved walls without a stone foundation are 30 cm high.

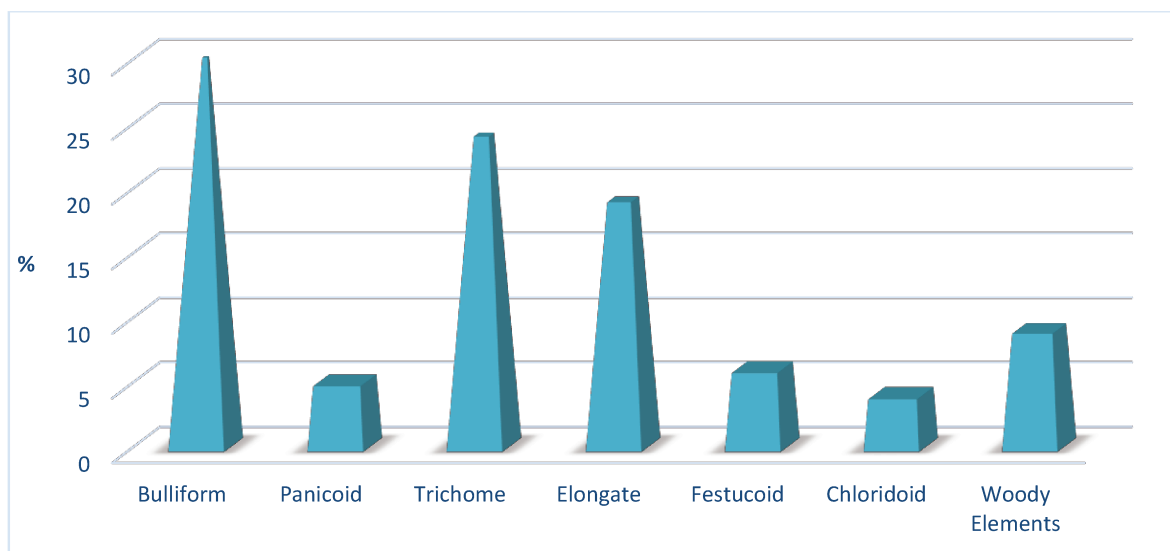
**Diagram 4.46:** Distribution of phytoliths in the lime samples taken from Structure N5B12

Phytolith analysis of lime samples identified reeds, or herbaceous plant remains. The phytoliths contained high frequencies of *Bulliform*, *Trichome* and *Elongate* form. *Festucoid*, *Panicoid* and *Chloridoid* and *Silicified Woody Forms* were also identified. The proportions of *Festucoid*, *Panicoid* and *Chloridoid* phytoliths were relatively low. (Diagram 4.46) Pollen analysis of the same samples identified *Poaceae* pollens dominantly, together with

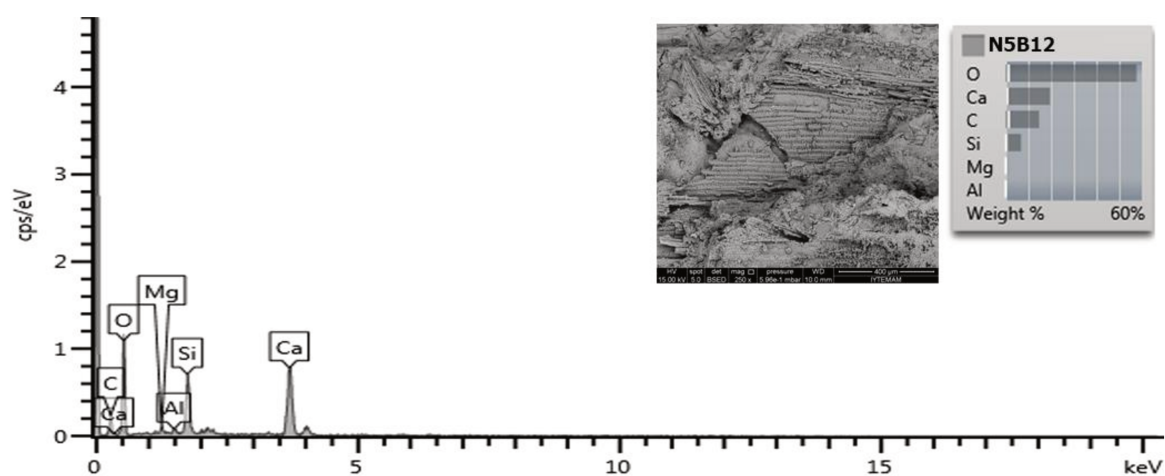
**Diagram 4.47:** EDX analysis of lime samples taken from Structure N5B12

$\text{SiO}_2$  gels filling the organic cavities are observed on SEM images of the lime samples. (Figure 4.306) The clearest ones are silicon dioxide gel filling the *Gramineae*, *Cyperaceae* and *Ericaceae* plant remnants. Investigation of lime samples with the EDX

analysis identified the elements with mean ratios O (57.65%), Ca (19.56%), C (14.71%), Si (6.77%), Al (0.59%), and Mg (0.72%). (Diagram 4.47)

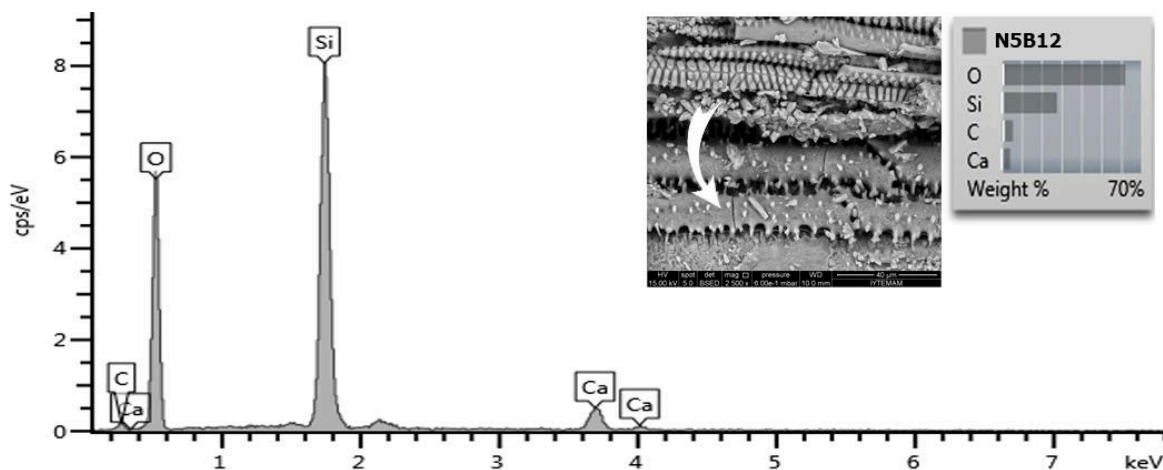
**Diagram 4.48:** EDX analysis of plant remains found in the lime samples taken from Structure N5B12

Investigation of calcified plant remains identified on SEM images with EDX analyses identified crystals in this area comprise O (62.06%), Ca (4.37%), C (5.70%), and Si (27.87%) elements. The proportion of silicon confirmed the presence of  $\text{SiO}_2$  gels within these crystals. (Diagram 4.48)

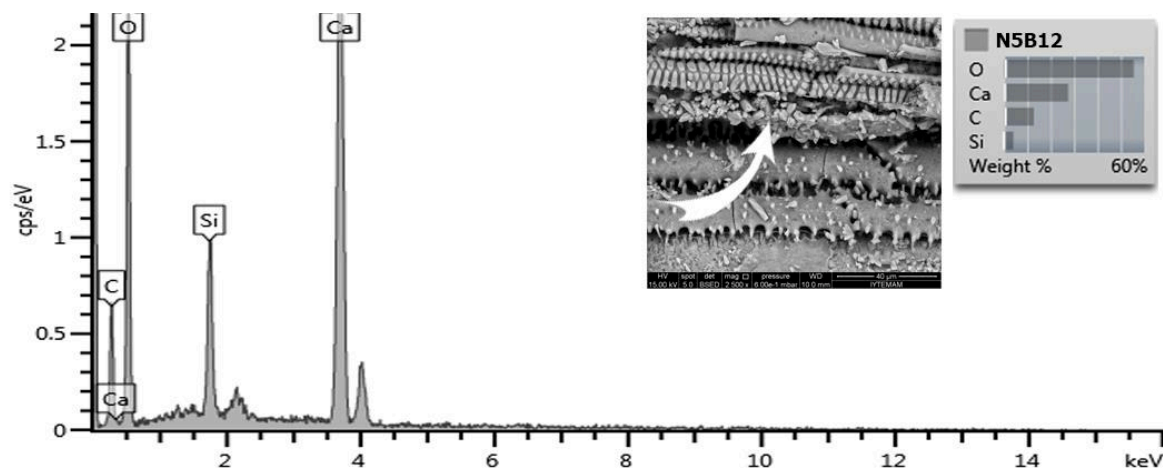
**Diagram 4.49:** EDX analysis results of lime fragments around the plant residues found in lime samples taken from Structure N5B12

Scalenohedral crystal structures accumulated around the silicon dioxide filling plant remains. Analysis of these accumulations by EDX method identified O (55.52%), Ca (27.54%), C (12.83%), and Si (4.10%) elements. (Diagram 4.49) Contrary to plant surfaces, calcite and carbon elements increased in these accumulation areas, while the Si proportion reduced. According to XRD analysis of the calcified lime samples identified as containing calcite, quartz, magnesium, and enstatite minerals. Their chemical composition comprises

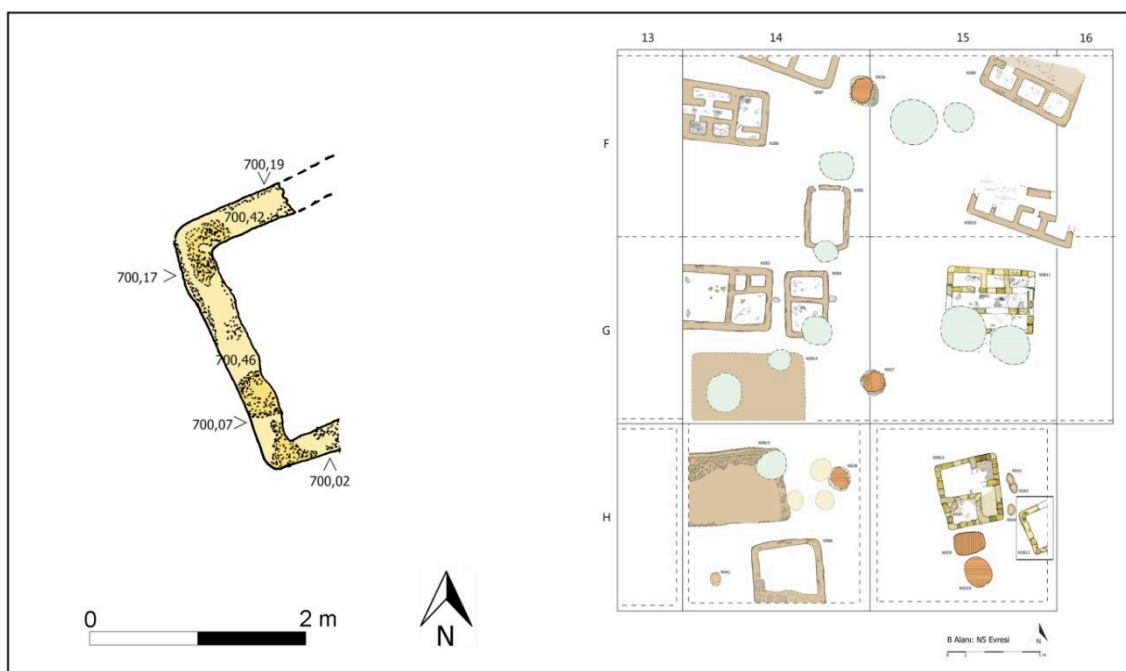
**Figure 4.39:** Location and plan of Structure N5B13

The structure is 248 cm wide in the north-south direction, and the exposed section is 121 cm wide in the east-west direction. The walls identified with clear edges have a width of 30-35 cm. There was no plaster floor remains identified. The 5-10 cm-thick kerpiç blocks were irregularly placed in upper or lower rows inserted in layers made with the duripan technique. Since the duripan sizes were not the same, it is understood molds have substandard. The earth fills above and/or below the duripans were flattened either during construction or due to compression by the upper rows of kerpiç and were in direct contact

with both duripans. No trace of mortar was identified between these earth bedding and the duripan fragments. As in structure N5B12, there were more varieties of earth used in the construction of the walls the structure N5B13.

This is located in Area B in the east profile edge of trench 15H between the elevations of 700.19 to 700.42 meter. Only the eastern section of the structure was uncovered, the rest was outside the exposed area. Based on the wall remains and general layout of the structure, it may be a single-roomed structure. (Figure 4.39, 4.165) However, there may be another room existed in the east section outside the exposed area. Similar to the structure N5B4, this exposed section may be the west room of a double-roomed structure. Therefore, the structure is classified as an 'indeterminate planned structure'.

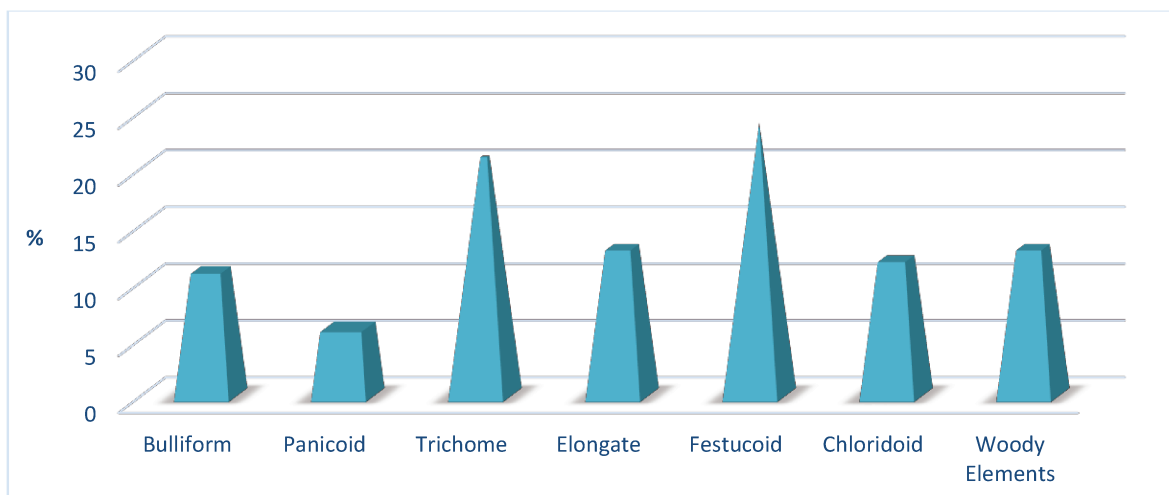
**Diagram 4.50:** Distribution of phytoliths in the lime samples taken from Structure N5B13

Phytolith analysis of lime samples identified reeds or woody plants. The phytoliths contained high frequencies of *Trichome* and *Festuroid* forms. *Elongate*, *Bulliform*, *Panicoid*, *Chloridoid*, and *Silicified Woody Forms* were also identified. (Diagram 4.50; Figure 4.325 - 4.330) The phytoliths found within the lime samples are diagnostic and well-preserved. Pollen analysis of the same samples identified *Poaceae* pollens dominantly, together with *Malvaceae*, *Apocynaceae*, *Verbenaceae*, *Cesalpiniaceae*, *Liliaceae*, *Asparagaceae*, and *Calenduleae* pollens. (Figure 4.331, 4.332)

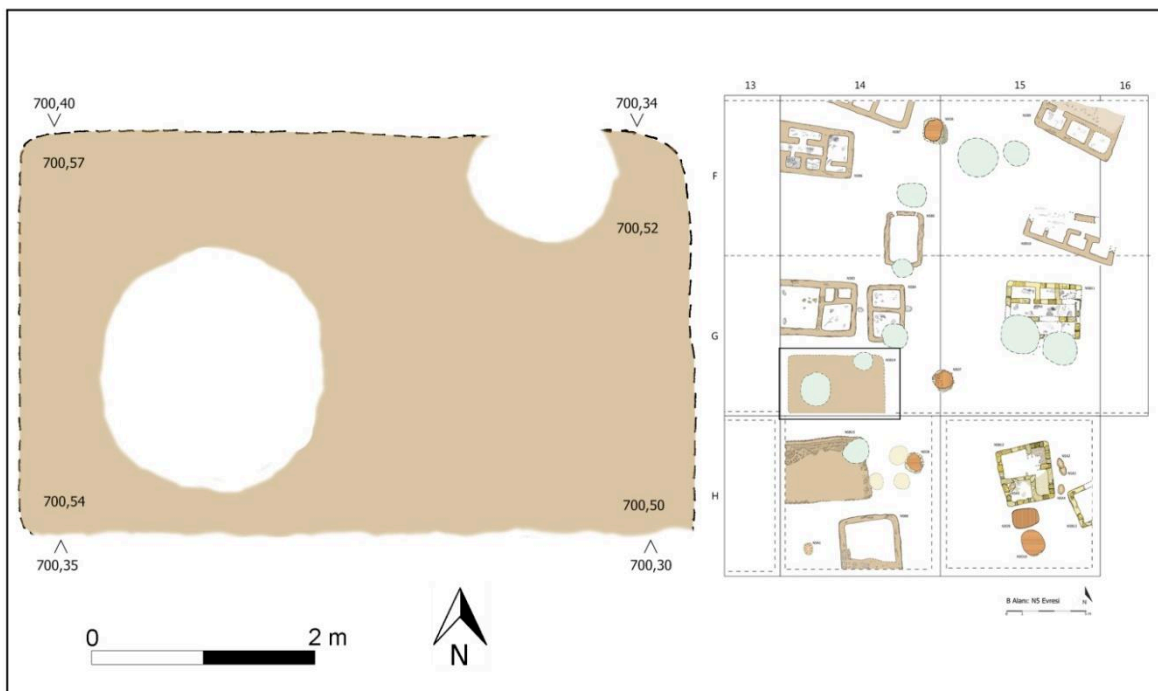
**Figure 4.40:** Location and plan of Structure N5B14

The structure has 611 cm in length in the east-west direction and is 367 cm wide in the north-south direction. Forming a large rectangular single room, plaster floor and inner partitions were not identified. Its living surface was not defined.

The layout of the structure is only distinguished from the external area by its colour and the weak lime lines. The structural filling is light reddish-brown. On this context, these traces are probably remains of a temporary structure with a reed surrounding. Similar traces were commonly observed in our ethno-archaeological field studies in the Lower Garzan Basin. The best examples are in the winter quarter of Bazivan Kom.

This is located in Area B, in the southwest of trench 14G between the elevations of 701.30 to 700.57 meter. Based on the traces and general appearance, the structure is classified as a single-roomed structure. As per this type, it was a temporary structure without walls probably surrounded by reeds with flimsy upper cover. The fill has been preserved to a height of 27 cm. The structure was seriously disturbed by two Middle Age pits. (Figure 4.40, 4.166)

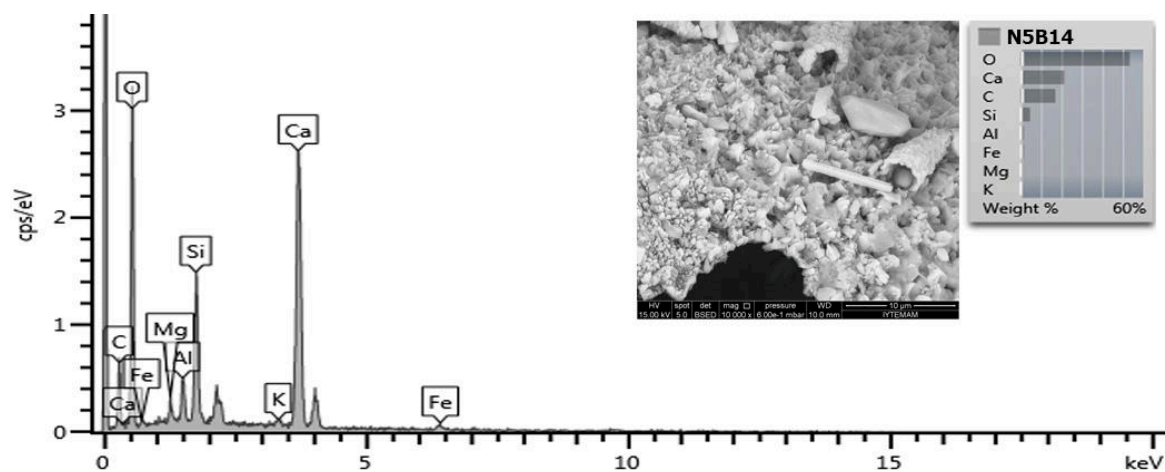
**Diagram 4.51:** EDX analysis of lime samples taken from Structure N5B14

SEM images of lime samples observed scalenohedral, stalactite and acicular crystal structures. (Figure 4.307) Sharp-tipped and stalactite-shaped crystals were very clearly observed around tubes left by organic remains and insect chitin. EDX analysis of lime samples identified the elements O (53.33%), Ca (21.33%), C (16.98%), and Si (4.58%) with trace amounts of Al, Mg, K, and Fe. (Diagram 4.51)

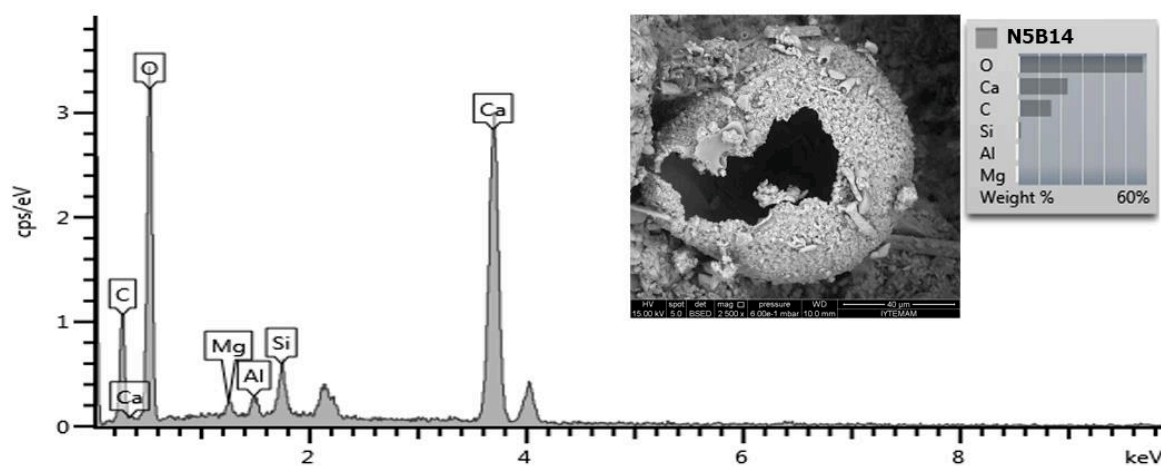
**Diagram 4.52:** EDX analysis results of insect chitin found in lime samples taken from Structure N5B14

Investigation of lime samples containing the insect chitin with the EDX analysis identified the elements O (58.14%), Ca (23.33%), C (15.71%), Si (1.60%), Al (0.68%), and Mg (0.55%). (Diagram 4.52; Figure 4.307b-c) XRD analysis of the same lime samples were identified as containing calcite, quartz, and nitratine minerals. Their chemical composition, which comprises calcium carbonate, silicon dioxide, and sodium nitrate compounds, indicates the presence of aridity. (Diagram 4.112)

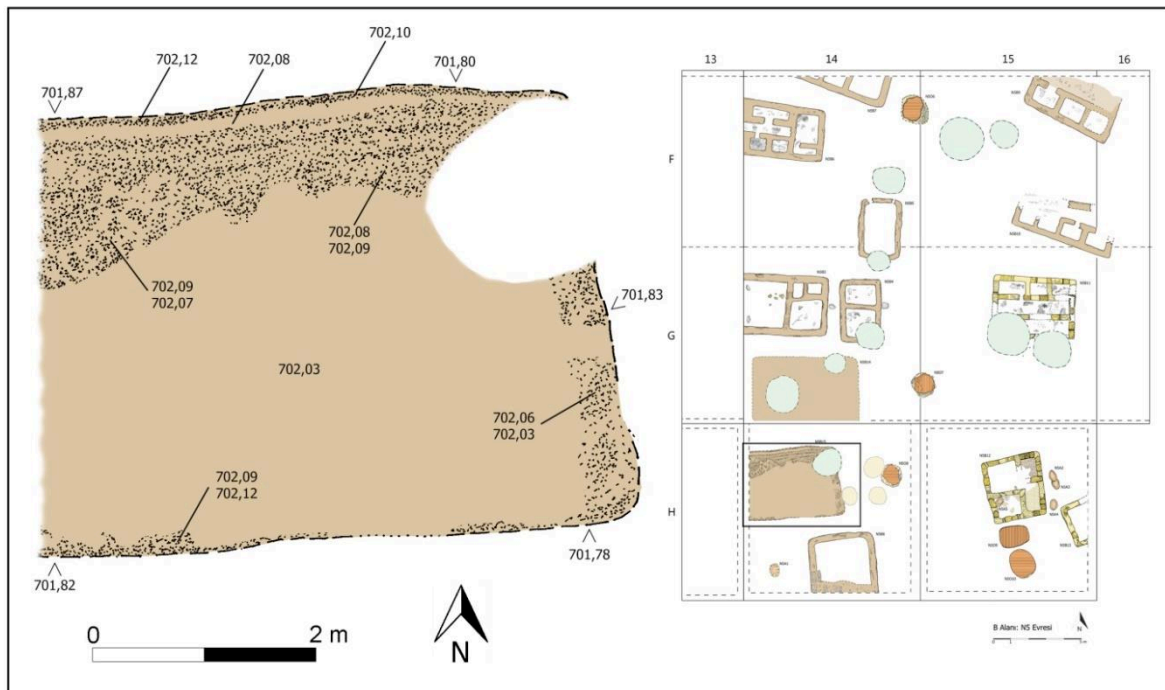
**Figure 4.41:** Location and plan of Structure N5B15

This is located in Area B, in the northwest of trench 14H and trench 13H between the elevations of 701.87 to 701.12 meter. Based on the traces and general appearance, the structure is classified as a single-roomed structure. (Figure 4.41, 4.167) As per this type, it was a temporary structure without walls, probably surrounded by reeds with flimsy upper cover. Similar to the other contemporary structures in the area, it sits on a grey, ashy occasionally stone-rich fill. The structure was constructed on a natural terrace with an undulating flat surface in east-west orientation along with the other structures. The area appears to be a higher terrace than the terrace where the structures N5B3 and N5B6 built on. The structure is 554 cm long in the east-west direction and is 387 cm wide in the north-south

direction. The structure has reed surroundings with curved corners. Surrounding the structure, but dominantly in the northern side, there is 3-7 cm-wide and nearly 60-82 cm-high lime traces with organic content. On this surface did not identify any plaster remains. This surrounding with a height of at least 1 m appears to have fallen into the structure.

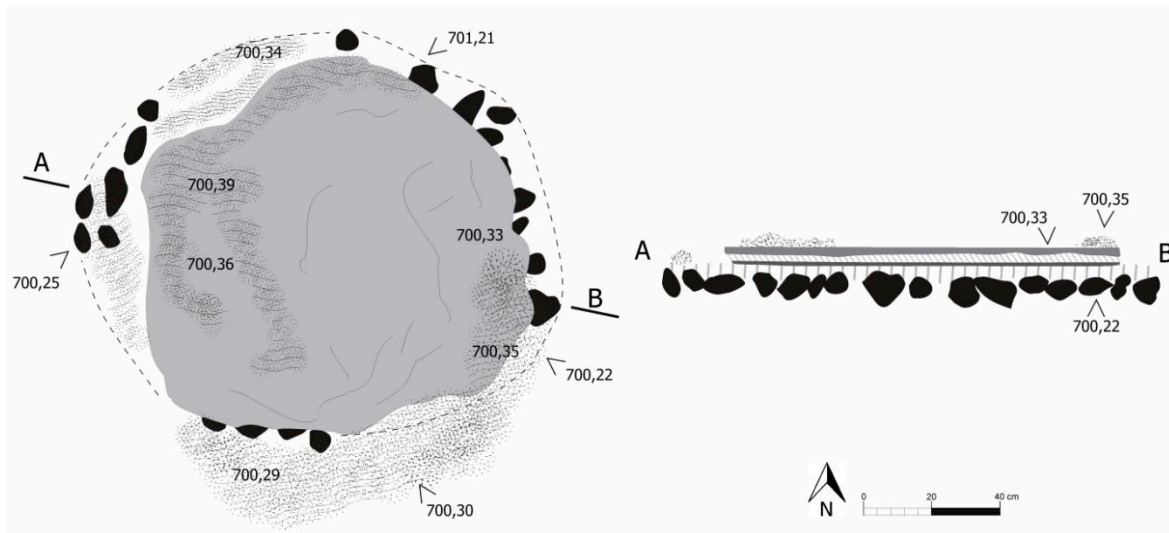
**Figure 4.42:** Hearth N507 and its cross-section

The dimensions of the round-shaped hearth were 106 cm in the north-south direction and 111 cm in the east-west direction. The pavement was made of basalt and pebbles of different sizes between 4x5x7 - 6x8x13 cm. Between the stone pavement and the first plastered floor was a layer of sandy yellowish buff-coloured 3-4-thick filling. The first plastered floor was a bluish-grey colour about 1 cm in thickness. The surface of this floor was densely cracked with traces of burning. After that, a yellowish stone-tempered 2 cm-thick filling was laid on the first plaster floor and a new floor was plastered. The second 2 cm-thick floor has a buff colour with a rippled and slightly cracked surface.

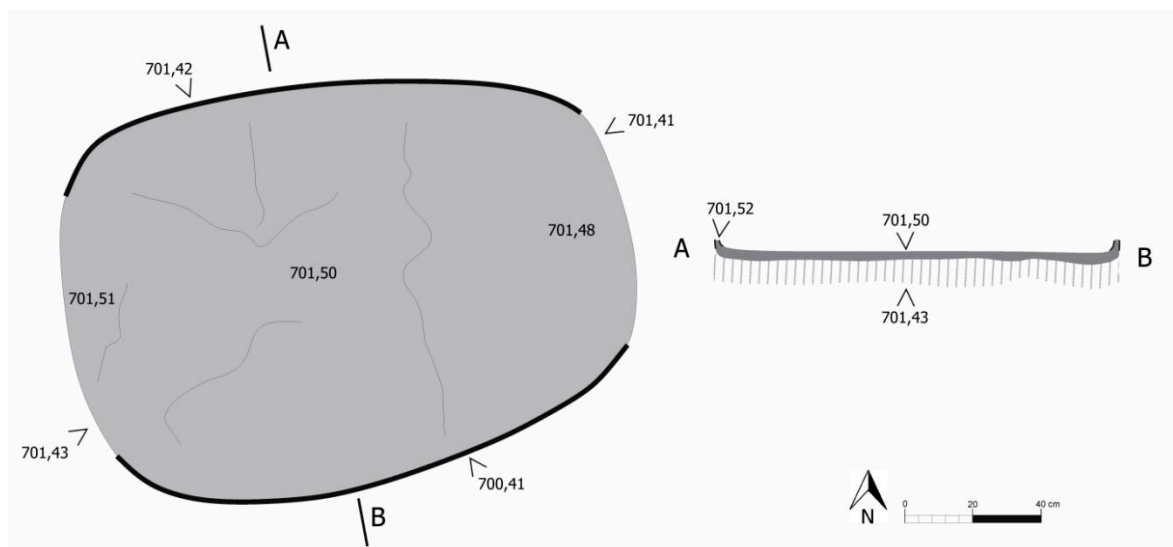
**Figure 4.43:** Hearth N5O9 and its cross-section

This was located in an open space in the northern part of trench 15H, 20 cm north of the Hearth N5010 in Area B. The hearth covers an area of approximately 1.7 m<sup>2</sup> between the elevations of 701.41 to 701.52 and it was built on a grey densely ashy and slightly limey

fill. It had a single bluish dark grey coloured plastered floor without a stone pavement. Based on the floor remains, the hearth inclined to the east.

The oval /"U"-shaped hearth was 118 cm wide in the north-south direction and 169 cm long in the east-west direction. (Figure 4.43, 4.229, 4.230) Contrary to the other hearths, the hearth N5O9 was positioned in the east-west direction. The plastered floor with a thickness of 3 cm was built on a yellowish grey-coloured sandy nearly 6-7 cm-thick filling. The surface of the hard floor was rippled and slightly cracked. There are curved edges on the northern and southern sides of the floor with a height of 1-3 cm.
