# Microarchaeological observation on the neolithic architectural structures and cultural landscape of Sumaki Höyük

# **Microarchaeological Observation on the Neolithic Architectural Structures and Cultural Landscape of Sumaki Höyük**

PhD Thesis

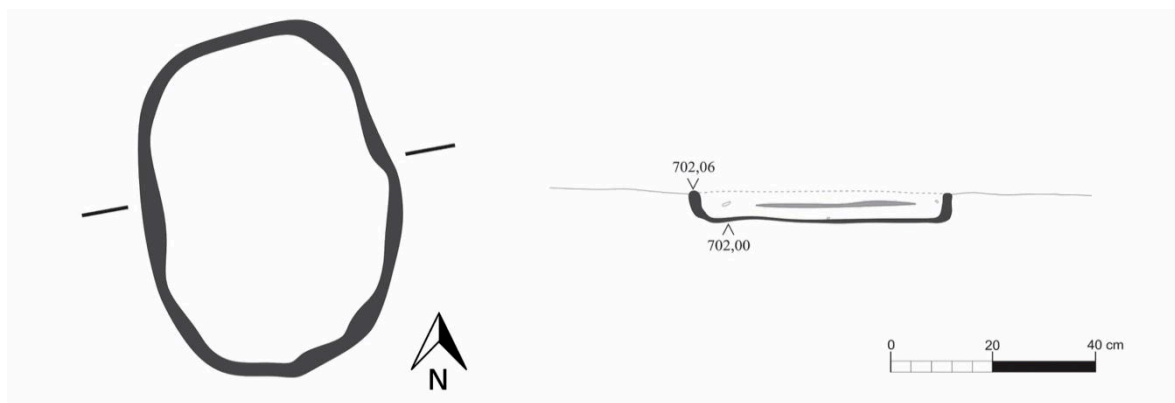
**Figure 4.44:** Fire Pit N5A1 and its cross-section

It was located in an open space in the southeastern part of trench 14H in Area B. The oval-shaped fire pit was between the elevations of 702.00 to 702.06. Dug in a grey homogeneous soil, the fire pit was 53x72 cm in size and 6 cm deep. (Figure 4.44) On its edge, there is an orangish buff line due to burning with 2-3 cm thickness. There were no signs of plastering on its sides or its bottom. Its inner deposit was grey and yellowish buff with little ash.

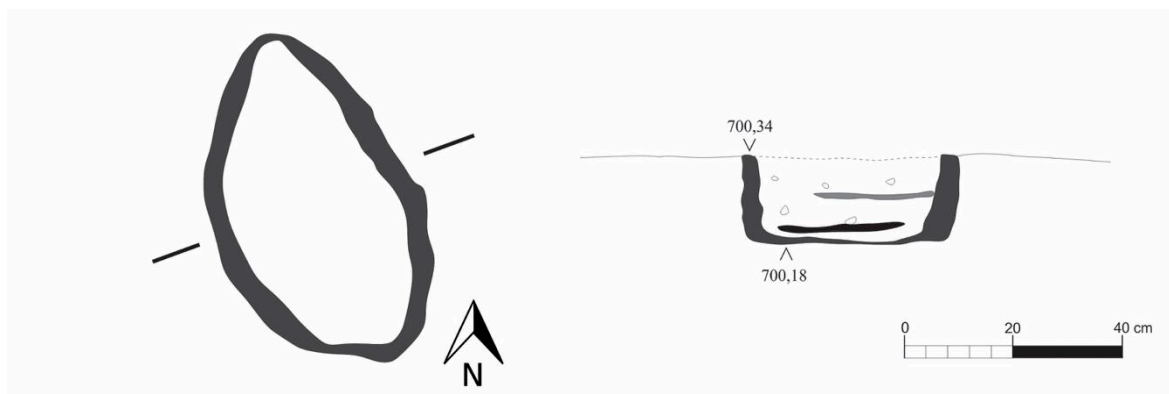
**Figure 4.45:** Fire Pit N5A2 and its cross-section

This was located in an open space in the northeastern part of trench 15H in Area, in the northern part of Fire pit N5A3. The north part of the Fire Pit N5A3 was partly destroyed when this fire pit was dug. The waterdrop-shaped fire pit was between the elevations of 700.18 to 700.34. Dug in a grey homogeneous soil, the fire pit was 39x64 cm in size and 16

cm deep. On its edge, there is a dark, dull grey line due to burning with 2-3 cm thickness and 16 cm deep. (Figure 4.45, 4.279 – 4.281) There were no signs of plastering on its sides or its bottom. Its inner deposits were grey, little stony and ashy soil. Different plant remains detected from its inner deposit by flotation were *Triticum/Hordeum*, *Triticum turgidum* ssp, *Lathyrus/Vicia*, and *Linum*.

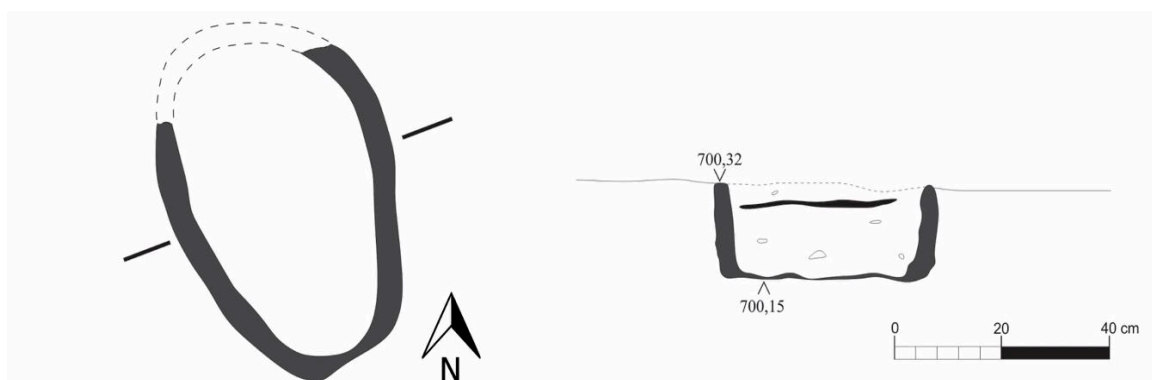
**Figure 4.46:** Fire Pit N5A3 and its cross-section

This was located in an open space in the northeastern part of trench 15H in Area B, just below the Fire Pit N5A2, due to it was partially destroyed. The waterdrop-shaped fire pit was between the elevations of 700.15 to 700.32. Dug in a grey homogeneous soil, the fire pit was 41x67 cm in size and 17 cm deep. (Figure 4.46, 4.279 – 4.281) On its edge, there is a buff line due to burning with 1-2 cm thickness. There were no signs of plastering on its sides or its bottom. Its inner deposits were dull grey little stony and densely ashy soil. Different plant remains detected from its inner deposit by flotation were *Triticum/Hordeum*, *Fabaceae* family, *Lens culinaris*, and *Chrozophora tinchoria*. (Table 3.2)

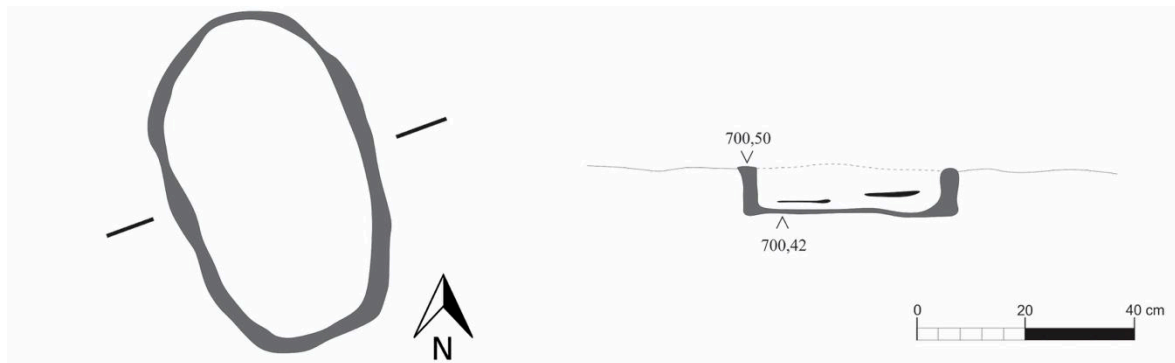
**Figure 4.47:** Fire Pit N5A4 and its cross-section

This was located in an open space in the northeastern part of trench 15H and south of the Fire Pit N5A4 in Area B. The oval-shaped fire pit was between the elevations of 700.42 to 700.50. Dug in a dark grey homogeneous soil, the fire pit was 41x63 cm in size and 8 cm deep. (Figure 4.47) On its edge, there is a dark brown line due to burning with 2-3 cm thickness. There were no signs of plastering on its sides or its bottom. Its inner deposits were dull grey densely ashy soil.

Abundant amounts of different plant remain were found in its inner deposit by flotation. *Fabaceae* family (*Lens culinaris*, *Vicia ervilia*, *Medicago*, *Medicago radiate*); *Poaceae* family (*Triticum/Hordeum*, *Hordeum vulgare*), and wild grassland species like *Linum*, *Cyperaceae* and *Centaurea* seeds were identified. (Table 3.2)

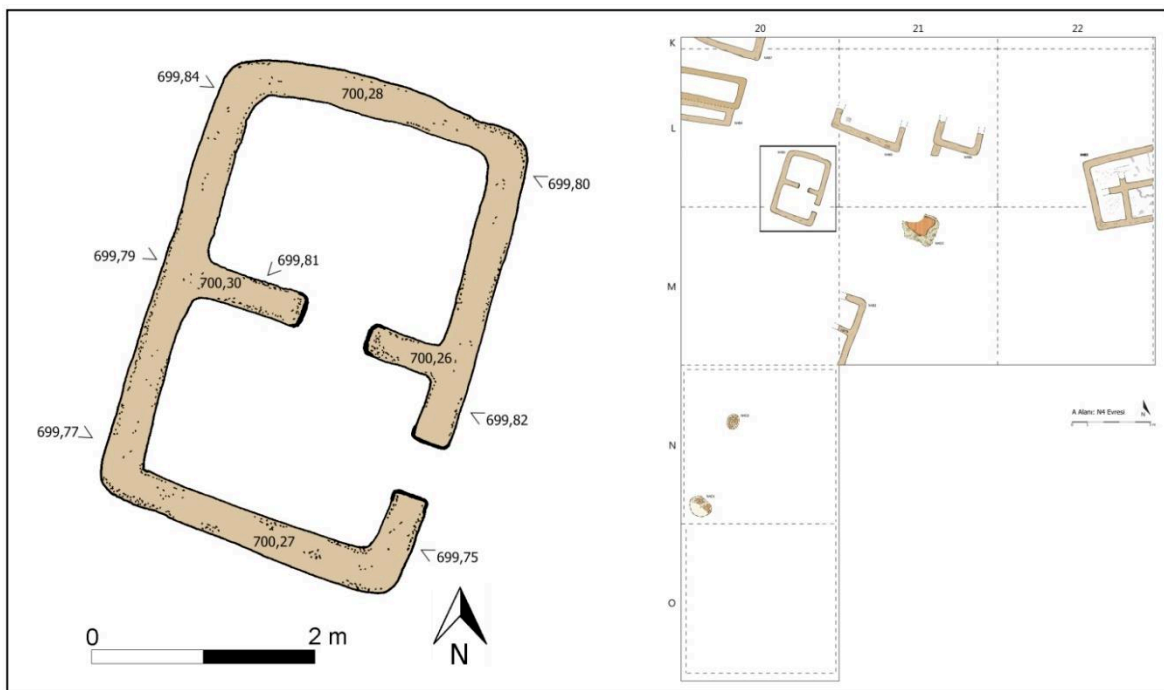
**Figure 4.48:** Location and plan of Structure N4B1

Structure N4B1 is located in Area A southeast of trench 20L and northeast of trench 20M between the elevations of 699.80 – 700.30 meter. The structure sits on a grey and ashy fill. Based on the wall remains and general appearance, this structure is classified as a two-roomed structure. (Figure 4.48, 4.168 – 4.170) It was constructed with a southwest-northeast orientation nearby other structures in the same area, and following the slope of the natural surface without a stone foundation. Its wall height is 42 cm.

The rectangular structure is 426 cm in a southwest-northeast direction and 291 cm wide in a southeast-northwest direction. The bearing walls are 30-34 cm wide, and the partition walls are 26-28 cm wide. There are two rooms with very similar measurements, namely, 165x224 cm for the north room and 164x230 cm for the south one. Nearly 3.8 m<sup>2</sup> in size, these two rooms are linked by a 67 cm-wide doorway. (Figure 4.339) Its main entrance was narrower than the passage door between the rooms and measured nearly 50 cm. The internal fill of the rooms is grey and ashy with few stones and areas where plentiful lime fragments were observed. Plaster traces were not encountered on the lime surfaces. These very scattered lime fragments are probably the remains of collapsed wall or the upper cover of the structure. There are no plastered floors in either room. Animal bones and minimal amounts of pottery sherds exposed at elevations of 699.92 - 699.94 in the south

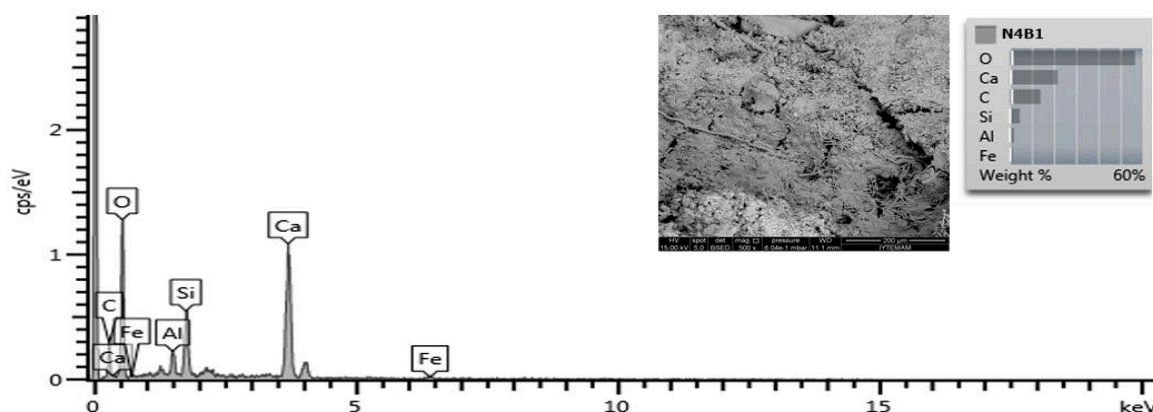
**Diagram 4.53:** EDX analysis of lime samples taken from Structure N4B1

SEM investigation of lime samples observed very clear calcium carbonate minerals surrounding tubes formed by organic remains. (Figure 4.308) EDX analysis identified O (56.66%), Ca (21.68%), C (13.94%), Si (4.55%), Al (1.83%), and Fe (1.34%). (Diagram 4.53)

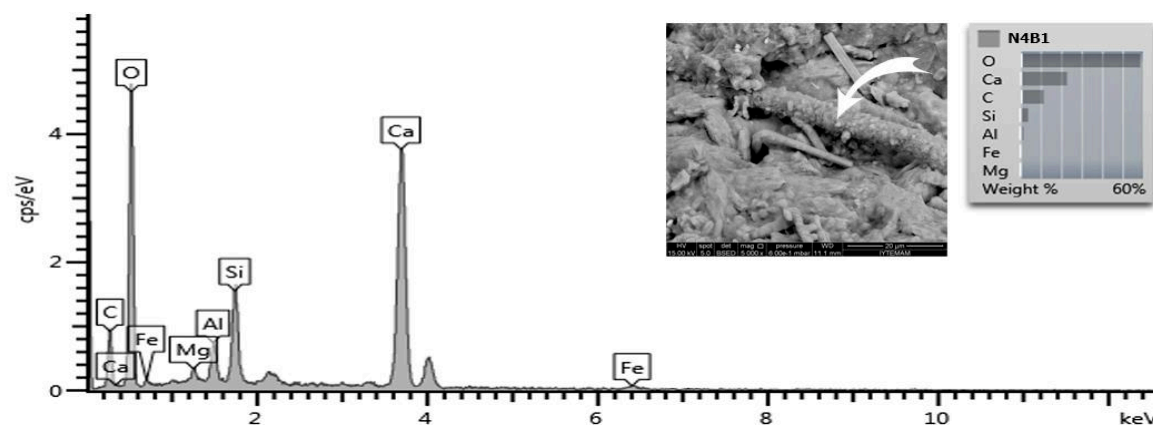
**Diagram 4.54:** EDX analysis results of tubes found in lime samples from Structure N4B1

Analysis of minerals surrounding the tubes by the EDX method identified O (58.74%), Ca (22.87%), C (11.53%), Si (3.89%), Al (1.53%), Mg (0.53%), and Fe (0.91%). (Diagram 4.54) Analysis of acicular crystals with EDX found O (56.89%), Ca (15.79%), C (19.35%), Si (4.26%), Al (1.73%), Mg (0.70%), and Fe (0.99%) elements. (Diagram 4.55)

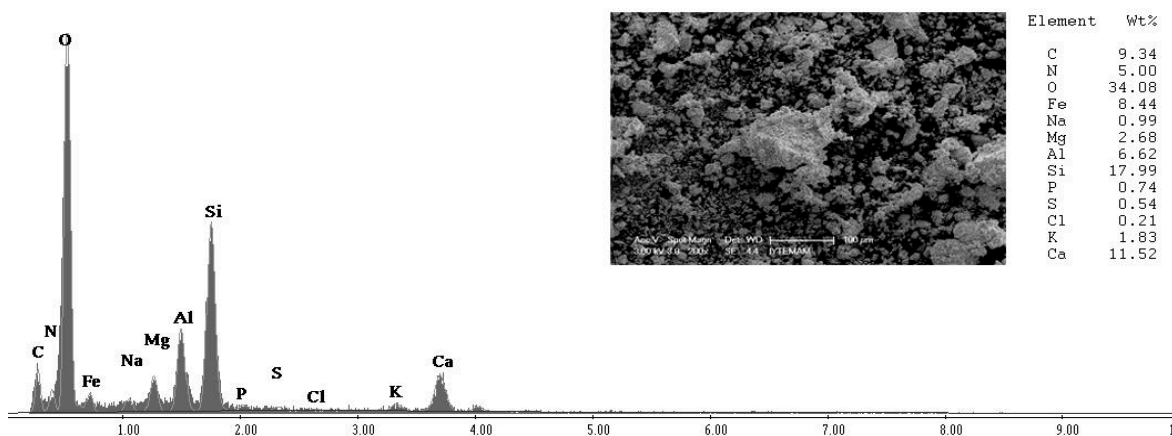
Diagram 4.56: EDX analysis results of soil samples taken from Structure N4B1

On SEM images of reddish-brown earth samples, micritic envelopes on sand and stone grains and acicular-shaped calcium carbonate crystals are observed. (Figure 4.309) According to EDX analysis, these soil samples contain O (34.08%), Ca (11.52%), C (9.34%), Si (17.99%), Fe (8.44%), and Al (6.62%). N, Na, Mg, P, S, Cl, and K elements were also identified at rates from 5% to 0.21%. (Diagram 4.56)

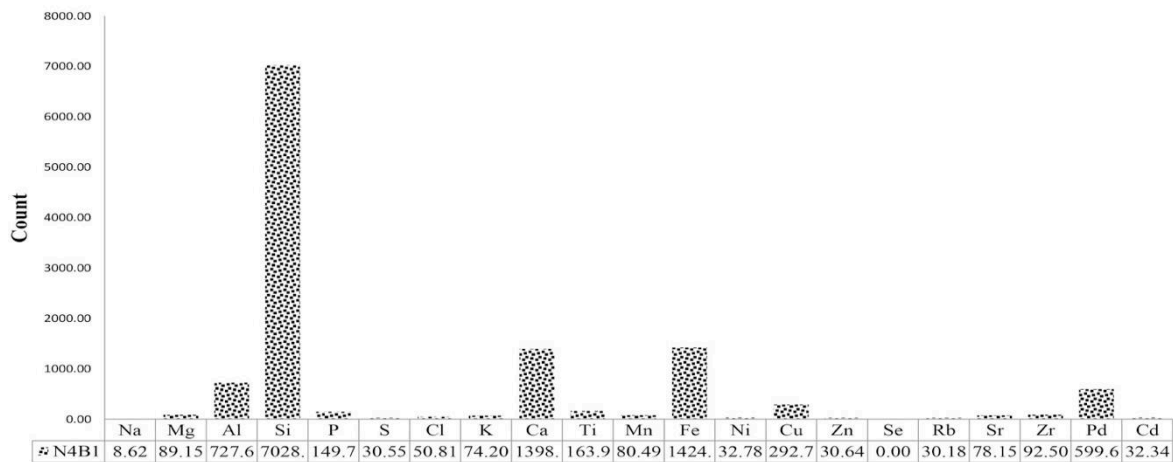
**Diagram 4.57:** XRF analysis of the lime samples taken from Structure N4B1

Investigation of XRD analysis of the lime samples only identified calcium carbonate. (Diagram 4.113) Earth samples with XRD analysis identified calcite, silica, quartz and kyanite minerals. Their chemical composition is calcium carbonate, silicon dioxide, and aluminium silicate compounds. (Diagram 4.114) The earth sample was also investigated by the XRF method found Si (57%), Ca (11%), Fe (11%), Al (6%), and Pd (5%) with trace amounts of Ni, Zn, Sr, Rb, Na, K, S, P, Cl, Cu, and Ze. (Diagram 4.57)

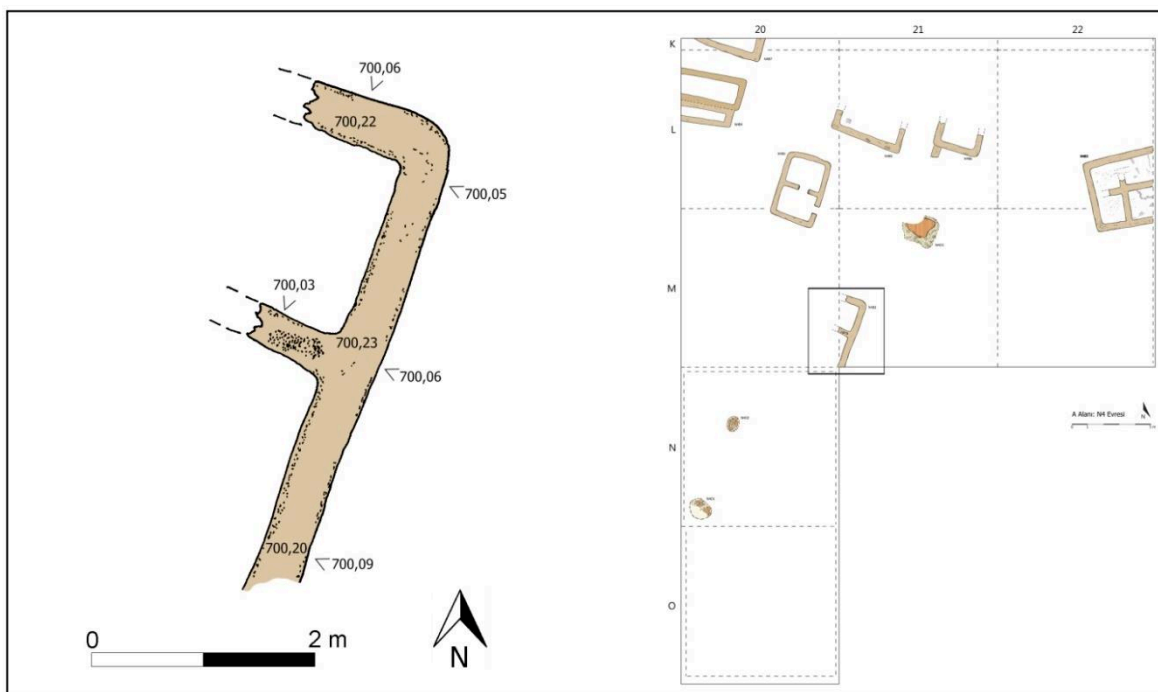
**Figure 4.49:** Location and plan of Structure N4B2

This was built between the elevations of 700.05 to 700.18 meter following the slope of the natural surface at the southwest part of trench 21M in Area A. Its western half has been destroyed similar to the Cell Building N5B10, and its southern section remains outside the exposed area. (Figure 4.49, 4.171, 4.172) Accordingly, the limits of the structure could

not be detected. Based on the wall remains and general appearance, the structure is classified as a double-roomed structure. The building was constructed on a grey ash-poor fill following the slope of the natural topography without a stone foundation. The width of the bearing walls is 41-43 cm, and the partition walls are 30-31 cm wide. The walls have been preserved to a height of 13 cm.

The structure has two rooms. The southern room is larger than the northern one. The north room is 160 cm long, and the south room is longer than 212 cm. Their internal fill is grey ash-poor with occasional lime fragments. As the structure was badly preserved, door openings cannot be detected.

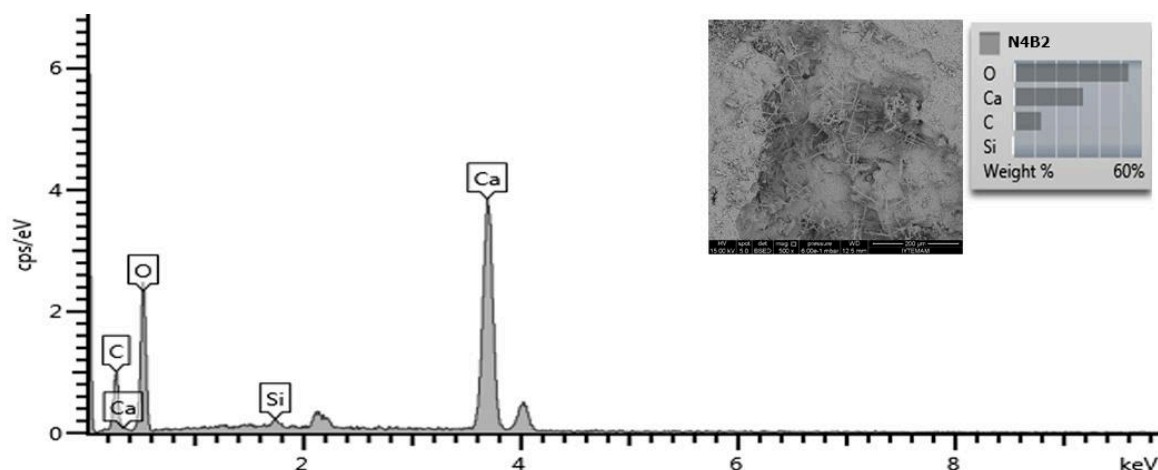
**Diagram 4.58:** EDX analysis of lime samples taken from Structure N4B2

Investigation of lime fragments from the faces of the walls and within the structure determined very dense organic material. (Figure 4.310) Investigation of lime samples with EDX method identified the elements O (53.75%), Ca (32.64%), C (13.17%), and Si (0.44%). (Diagram 4.58) EDX analysis of acicular crystals observed the elements O (55.19%), Ca (29.53%), C (14.95%), and Si (0.34%). (Diagram 4.59) Investigation of the same lime samples with XRD method identified as containing calcite, nitratine, berlinite, and moissanite minerals. (Diagram 4.115) Their chemical composition is calcium carbonate, aluminum phosphorus oxide, silicon carbide with silicon-carbon content, and sodium nitrate compound. Sodium nitrate compound indicates the presence of aridity.

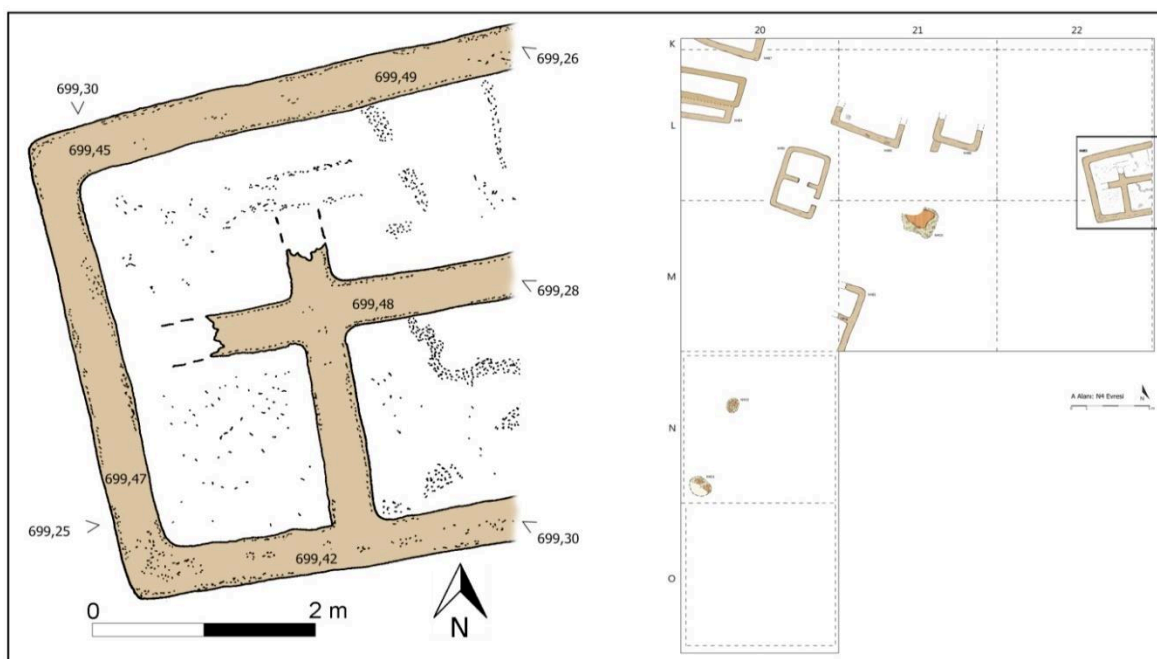
**Figure 4.50:** Location and plan of Structure N4B3

This is located in Area A, in the southeast of trench 22L and northeast of trench 22M between the elevations of 699.26 to 699.49 meter. Based on the wall remains and general appearance, this structure is classified as a multi-roomed structure. Its eastern section is outside the exposed area. (Figure 4.50, 4.173) Contrary to other structures in the area, Structure N4B3 was constructed on a grey ash-rich fill with east-west orientation following to the slope of the natural surface without a stone foundation. The walls have been preserved to a height of 23 cm.

The exposed portion of the structure is more than 440 cm long in the east-west direction and is 462 cm wide in the north-south direction. The bearing and the partition walls have nearly the same widths, 37-43 cm.

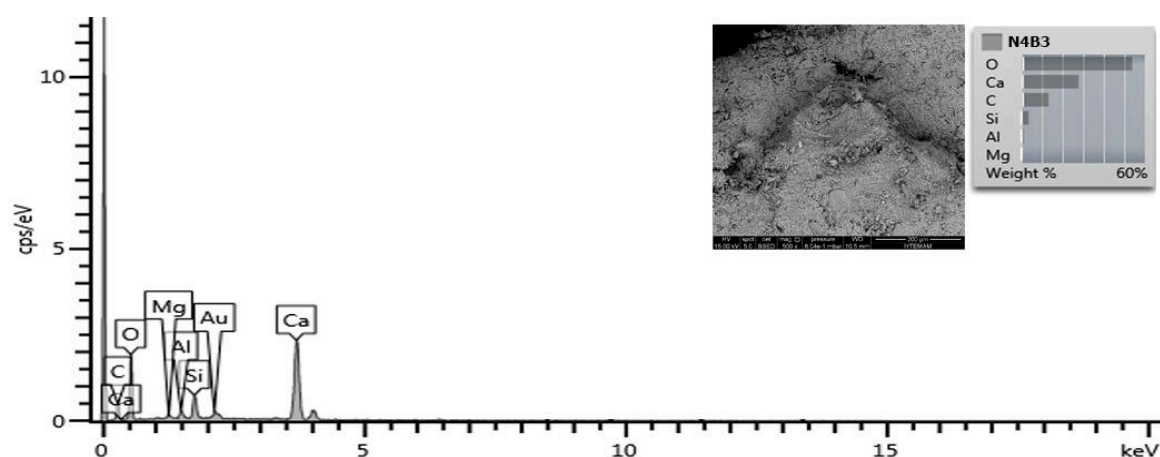
**Diagram 4.60:** EDX analysis of the lime samples taken from Structure N4B3

Investigation of lime samples with the EDX method identified the elements O (53.85%), Ca (27.80%), C (13.23%), Si (3.60%), Al (1.04%), and Mg (0.49%). (Diagram 4.60) Analysis of scalenohedral-shaped minerals surrounding the tubes with the EDX method identified the crystals containing O (53.36%), Ca (26.72%), C (12.25%), Si (3.50%), Al (1.20%), and Fe (2.98%) elements. (Diagram 4.61)

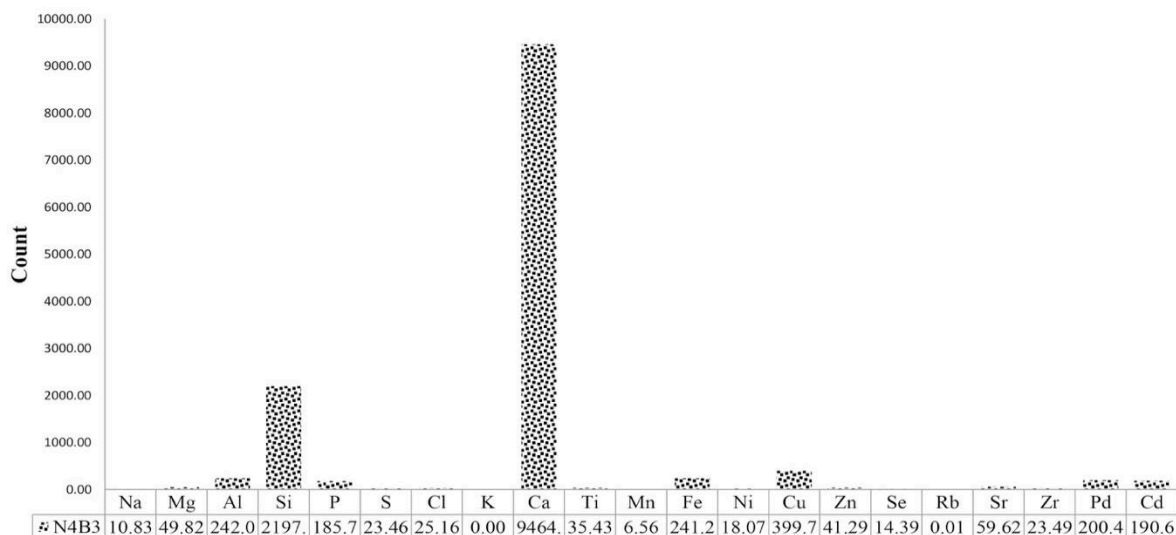
**Diagram 4.62:** XRF analysis of the lime samples taken from Structure N4B3

Investigation of lime samples by XRD method only found calcium carbonate mineral. (Diagram 4.116) Examination of the same samples with the XRF method observed the following elements dominating; Ca (70%), Si (16%), Cu (3%), Fe (2%), Al (2%), and Pd (1%), together with trace amounts of Ni, Zn, Sr, Rb, Na, S, P, Cl, Cu, and Ze. (Diagram 4.62)

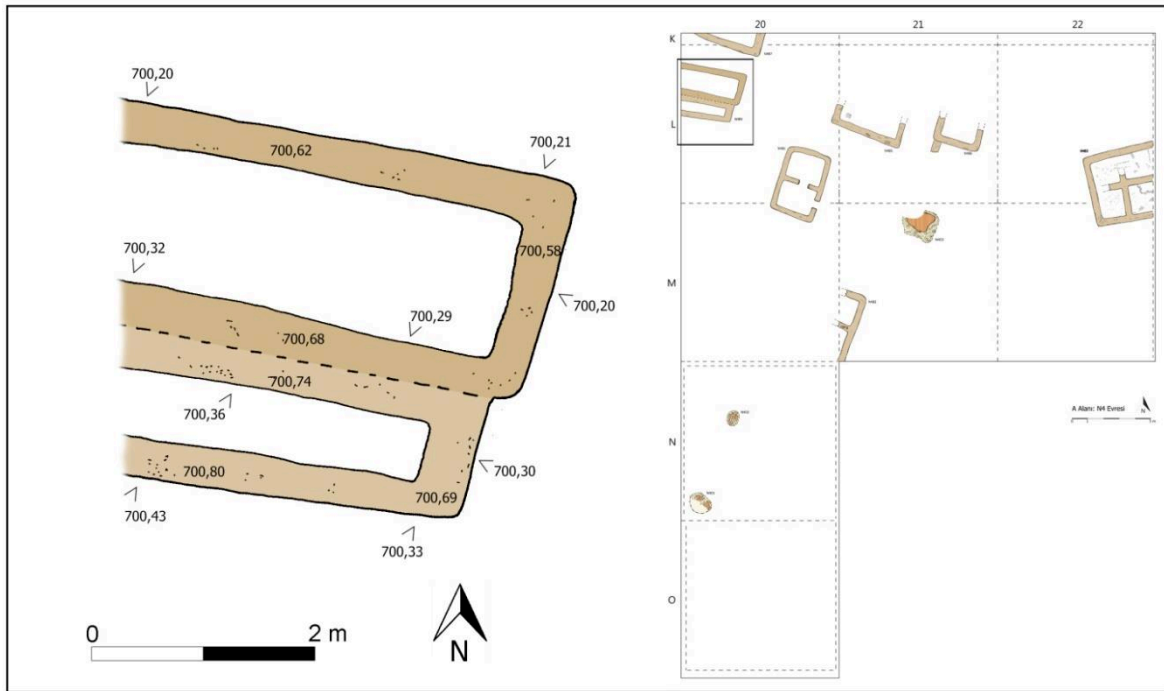
**Figure 4.51:** Location and plan of Structure N4B4

This is located in Area A, in the southeast of trench 20L between the elevations of 700.20 to 700.80 meter. According to the wall remains and general appearance, the structure is classified as a double-roomed structure. (Figure 4.51, 4.174, 4.175) Its west section remains outside the exposed area. The structure was constructed with southwest-northeast orientation following the slope of the natural topography on a grey stone-poor fill with occasional ashy area without a stone foundation. The walls have been preserved to a height of 37-48 cm.

Its exposed section is 385 cm long in the southeast-northwest direction, and is 318 cm wide in the southwest-northeast direction. Consisting of two rooms added to each other, the walls are nearly in the same width: 35-38 cm. However, due to the addition of the wall, the wall between the rooms becomes wider. Based on the wall traces in the trench section, the limit of the auxiliary walls was clearly defined.

The structure appears to have two rooms. The south room was built after the first one. There is a 12-13 cm elevation difference between the bottom levels of the walls of the two rooms. The widths of both rooms were determined; however, their lengths were not. The width of the north room is 124 cm. The south room is 60 cm wide. There was no doorway identified between the rooms. There were no traces of plaster floor in either room. Some material such as an obsidian core and a few blade fragments found at an elevation of 700.30 within the rooms is defined the living surfaces of the structure.

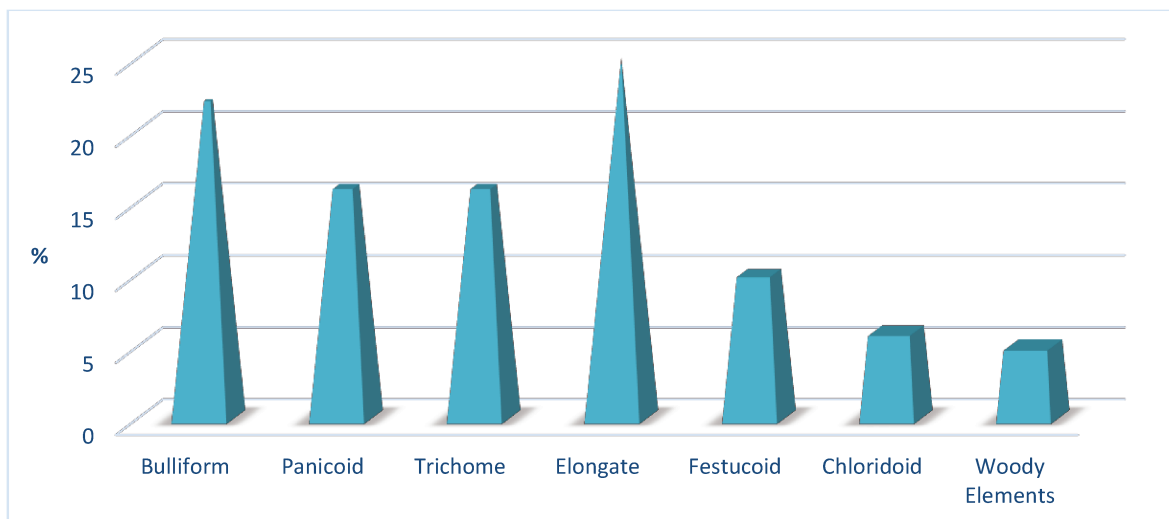
**Diagram 4.63:** Distribution of phytoliths in the lime samples taken from Structure N4B4

Phytolith analysis of lime samples identified reeds or herbaceous plant remains with high frequencies of *Bulliform* and *Elongate* forms. *Trichome*, *Festucoid*, *Panicoid*, *Chloridoid* and *Silicified Woody Forms* were also identified. (Diagram 4.63; Figure 4.325 - 4.330) Though there are very small amounts of silicified woody structures, the size of the phytoliths is noteworthy. The phytoliths are generally larger than 150 microns.

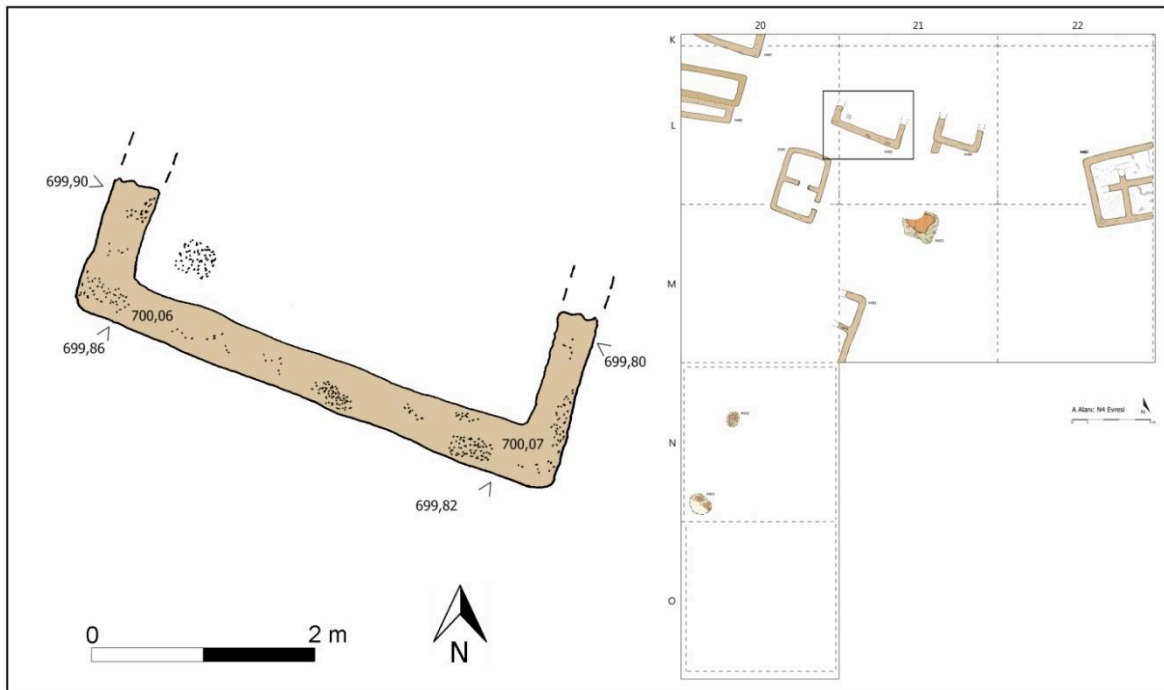
**Figure 4.52:** Location and plan of Structure N4B5

This is located in Area A in the central section of trench 21L. Structure N4B5 is partially underneath the structure N2B5 of Phase N2 between the elevations of 699.80 to 700.07 meter. Although the southern part of the structure was revealed, data allowing determination of its plan were insufficient in the exposed area. (Figure 4.52) The structure was constructed following the slope of the natural topography on a grey ash-poor fill without a stone foundation. Structure N4B5 appears to have southwest-northeast orientation. Based on the wall remains, the structure was 455 cm wide in the east-west direction. The uncovered section is 134 cm in the north-south direction. The walls have been preserved to a height of 27 cm and are 34-43 cm thick. The homogeneous reddish-brown loose fill of walls is only distinguished from the external area by its colour. Considering the architectural tradition and construction technology of Sumaki Höyük, the walls of the structure were built by the piled earth technique.

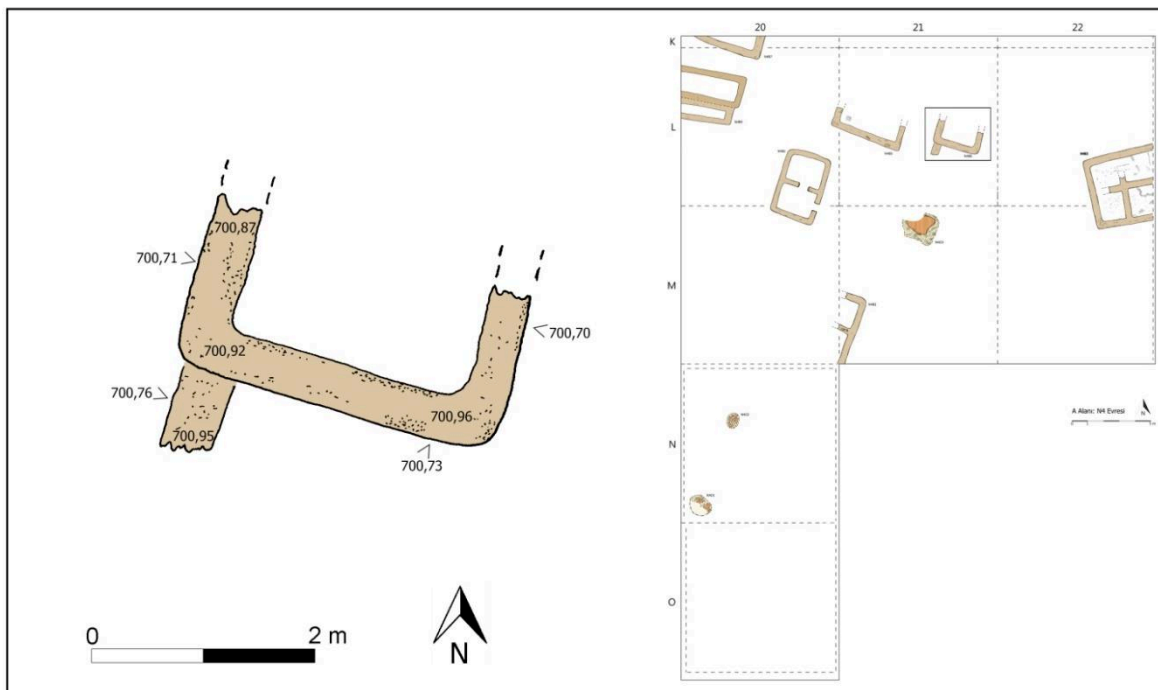
**Figure 4.53:** Location and plan of Structure N4B6

This is located in Area A, in the centre of trench 21L; this structure is partly underneath the Structure N2B6 between the elevations of 699.70 to 699.96 meter. Although the southern part of the structure was revealed, data allowing determination of its plan were insufficient in the exposed area. (Figure 4.53) Therefore, N4B6 is classified as an indeterminate-planned structure. The structure was constructed on a grey ash-poor fill following the slope of the natural topography without a stone foundation. The walls have been preserved to a height of 26 cm and are 36-44 cm thick. Structure N4B6 appears to have a southwest-northeast orientation. According to the wall remains, it was 302 cm wide in the east-west direction and the exposed section was 158 cm wide in the north-south direction. A partially preserved wall with the dimensions of 43x72 cm appeared to be an extension in the southwest corner of the structure. The homogeneous reddish-brown loose earth fill within the walls is only distinguished from the external area by its colour. Considering the architectural tradition and construction technology of Sumaki Höyük, the remaining walls of the Structure N4B6 were constructed by the piled earth technique.

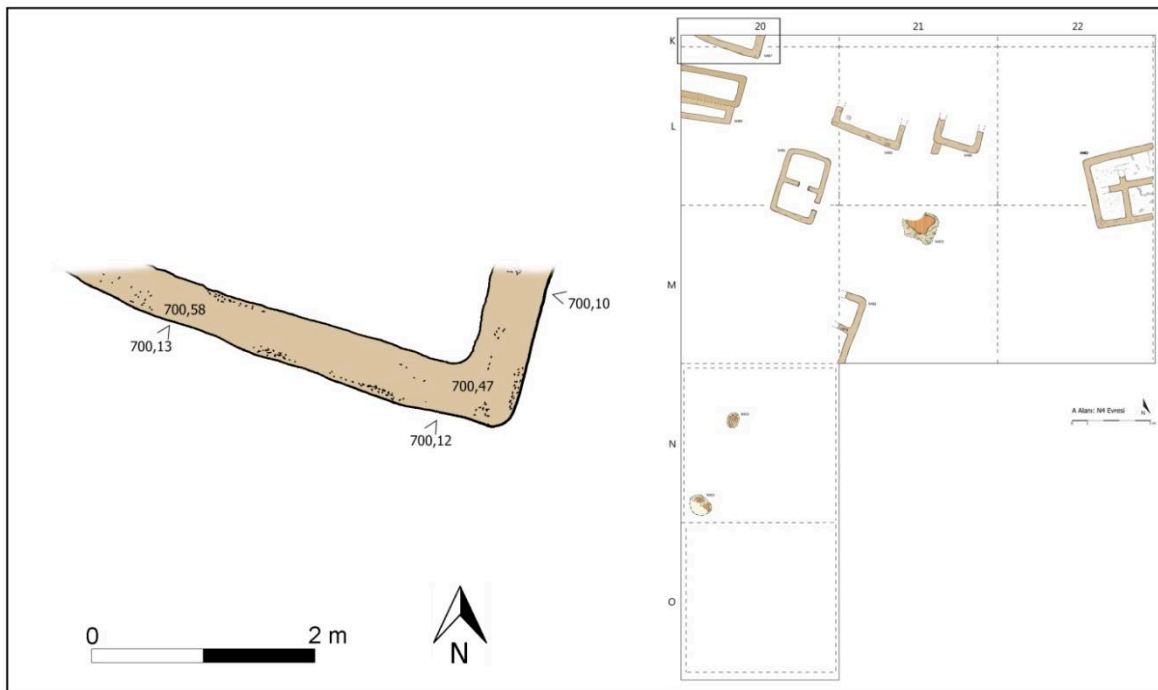
**Figure 4.54:** Location and plan of Structure N4B7

This is located in Area A in the northwest of trench 20L between the elevations of 700.10 to 700.48 meter on a grey ash-poor occasionally stony fill. Although the southern part of the structure was revealed, data allowing determination of its plan were insufficient in the exposed area. Accordingly, N4B7 is defined as an indeterminate-planned structure. (Figure 4.54, 4.176) The structure was constructed following the slope of the natural topography without a stone foundation. The walls have been preserved to a height of 38 cm, and are 38-46 cm thick. Its exposed section is 437 cm in the southeast-northwest direction and 1.4 m in the southwest-northeast direction. The internal fill of walls is homogeneous reddish-brown loose earth. There was no plaster floor remains in the single room. Considering the architectural tradition and construction technology of Sumaki Höyük, the walls were constructed by the piled earth technique.

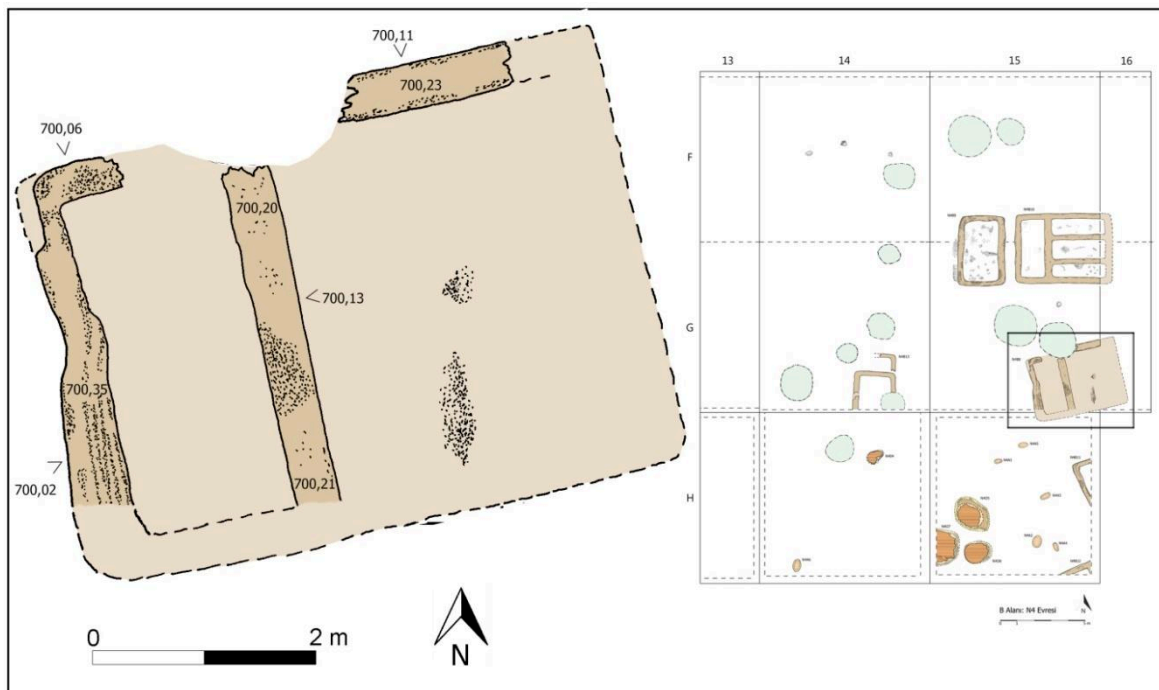
**Figure 4.55:** Location and plan of Structure N4B8

This is located in Area B in the southeast of trench 15G between the elevations of 701.02 to 701.35 meter. Its southwest corner turn and south limit are observed in the cross-section of the baulk between the trenches 15G and 15H. The north wall was partially disturbed by a deep Middle Age pit. (Figure 4.55, 4.177)

Based on the wall remains and general appearance, the structure is classified as a double-roomed structure. The walls on the west side and the partition wall have been preserved to a height of 30 cm. The north bearing walls have only been preserved to a height of 12-17 cm. (Figure 4.178, 4.179) The wall on the east side was not detected. The eastern limits of the structure are only distinguished from the external area by its colour and the clear reddish-brown traces in the trench section. The rectangular structure was built with southwest-northeast orientation on a light-grey fill occasionally dense carbon fragments and ashy areas following the slope of the natural topography without a stone foundation. The bottom surfaces of the walls slope slightly toward the east. There are no traces of plastered flooring identified. Some artefacts such as grinding stone fragments define the living surface of the structure.

The structure was 543 cm long in the southwest-northeast direction and was 394 cm wide in the southeast-northwest direction. The walls are 31-45 cm thick. The western wall leans toward the west. Occasional thin lime fragments are clearly observed on the faces of the walls made of homogeneous light brown loose earth. A different ramming technique was used in this wall; here the 1-2 cm-thick lime fragment traces between reddish-brown bedding, as it was documented in the other structures constructed by piled earth wall technique, are not identified. Instead, based on the wall sections, this wall has a 12-13 cm-thick lime line on its external surface, and in the interior 1-2 cm-thick reddish-brown lines between the light brown bedding. Neither the lime lines nor thin reddish-brown lines, which continue irregularly between the bedding, had mortar characteristics. Plaster traces were not encountered at the bottom or the top of the reddish-brown and light brown bedding. Considering the architectural tradition and construction technology of Sumaki Höyük, the walls of the structure N4B8 were constructed by the piled earth technique.

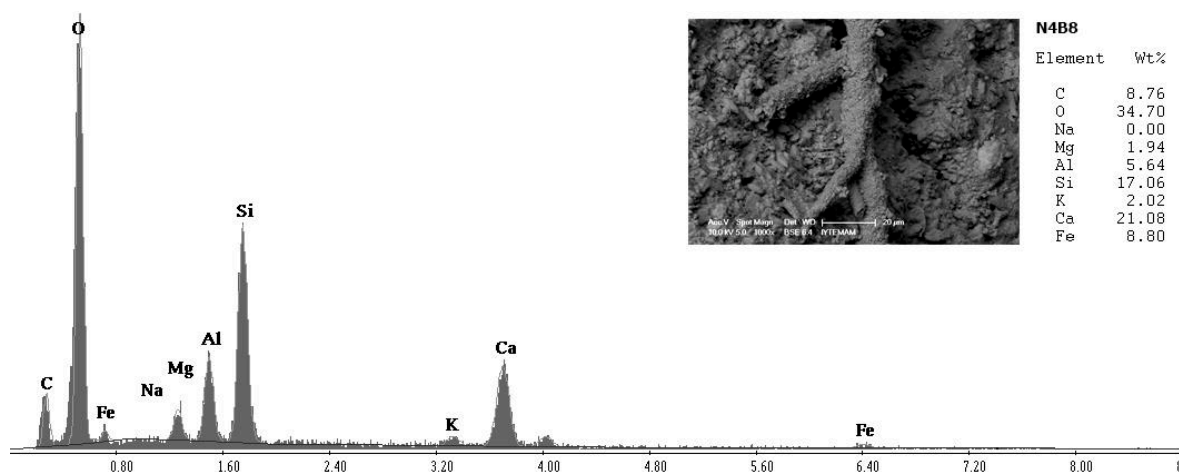
**Diagram 4.64:** EDX analysis of lime samples taken from Structure N4B8

SEM images of lime samples very clearly showed organic remains with calcium carbonate minerals surrounding tubes. (Figure 4.312c-d) Investigation of lime samples with EDX analysis found O (34.70%), Ca (21.08%), C (8.76%), Si (17.06%), Fe (8.80%), Al (5.64%), Mg (1.94%), and K (2.02%) elements. (Diagram 4.64)

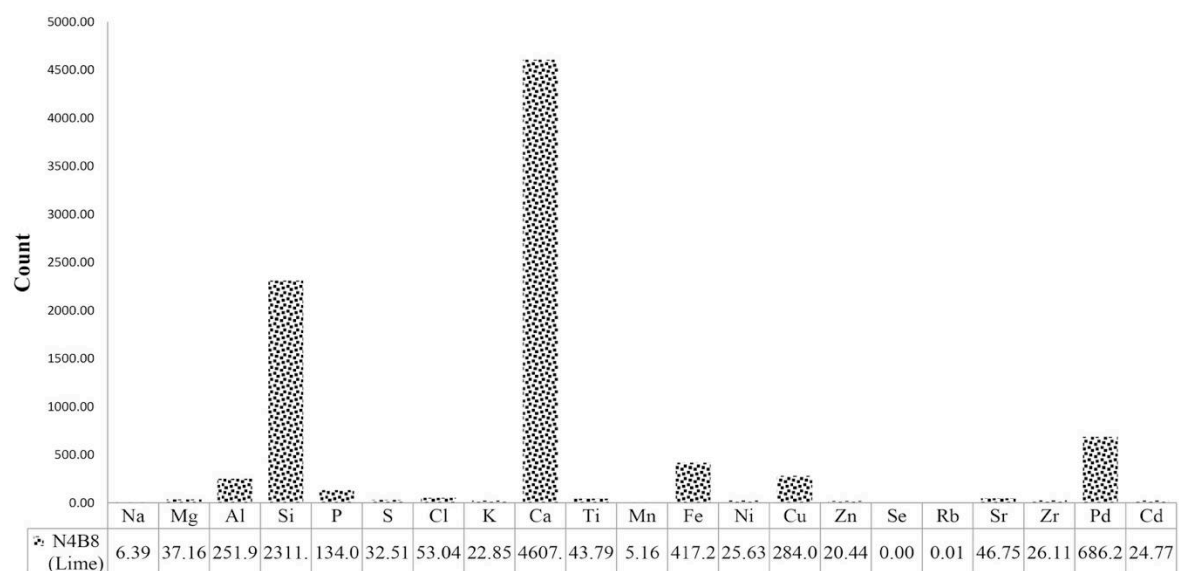
**Diagram 4.65:** XRF analysis of the lime samples taken from Structure N4B8

samples with the XRF analysis observed the following elements dominating; Si (26%), Ca (51%), Fe (5%), Al (3%), and Pd (8%).( Diagram 4.65)

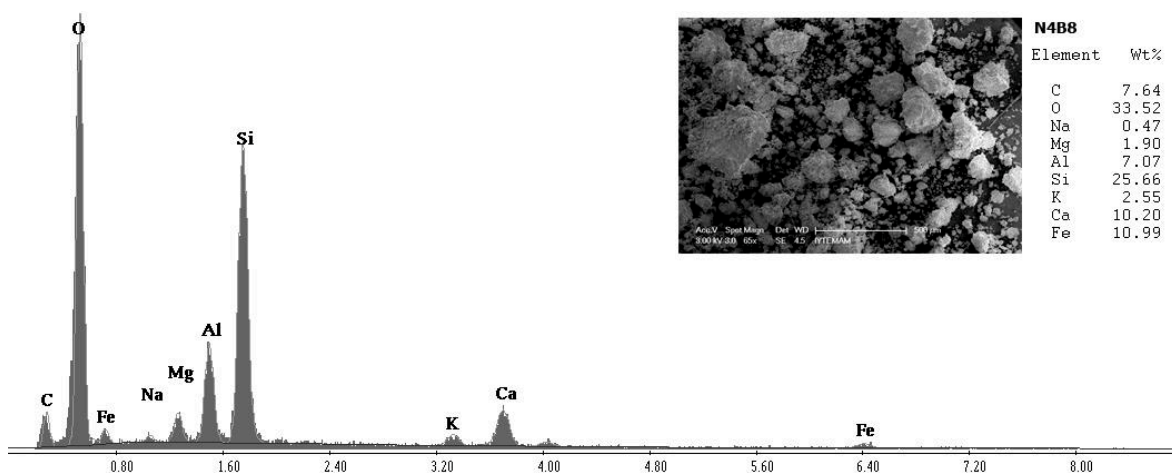
Diagram 4.66: EDX analysis results of soil samples taken from Structure N4B8

On SEM images of reddish-brown earth samples, micritic envelopes on sand and stone grains and acicular-shaped calcium carbonate crystals are observed. (Figure 4.313) According to EDX analysis, they comprise the elements O (33.52%), Ca (10.20%), C (7.64%), Si (25.66%), Fe (10.99%), Al (7.07%), Mg (1.90%), K (2.55%), and Na (0.47%). (Diagram 4.66)

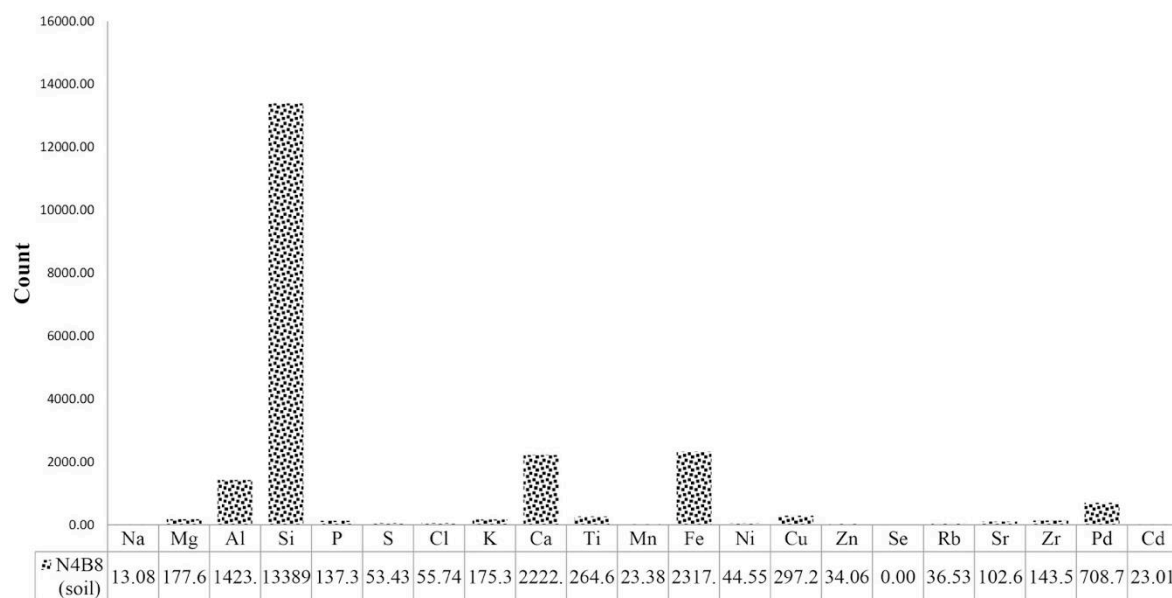
Diagram 4.67: XRF analysis results of soil samples taken from Structure N4B8

Investigation of the same samples with the XRF analysis observed the following elements dominating; Si (62%), Ca (10%), Fe (11%), Al (7%), and Pd (3%), together with very small amounts of Ni, Zn, Sr, Rb, Na, K, S, P, Cl, Cu, and Ze. (Diagram 4.67) A high silicon proportion in samples taken from the reddish-brown soil is associated with the sand content in these fills. The reason for higher calcium and lower silicon in the lime samples is related to the presence of organic material within these lime fragments.

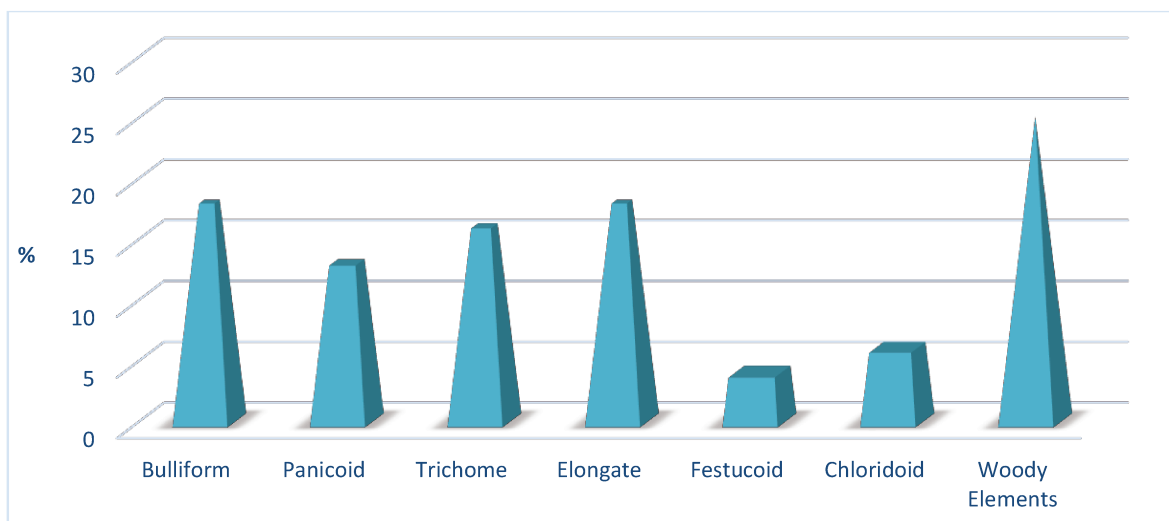
**Diagram 4.68:** Distribution of phytoliths in the lime samples taken from Structure N4B8

Phytolith analysis of lime samples identified reeds and/or woody plant remains were dominant. The natural structure of well-preserved phytoliths is clear. Among the phytoliths, high frequencies of *Trichome*, *Panicoid*, *Bulliform*, *Elongate*, and *Silicified Woody Forms* were observed. *Chloridoid* and *Fusturoid* forms were also identified. (Diagram 4.68; Figure 4.325 - 4.330) Pollen analysis of the same samples identified *Poaceae* pollen dominantly, together with *Calenduleae*, *Apocynaceae*, *Verbenaceae*, *Cesalpiniaceae*, *Liliaceae*, *Asparagaceae*, and *Malvaceae* pollens. (Figure 4.331, 4.332)

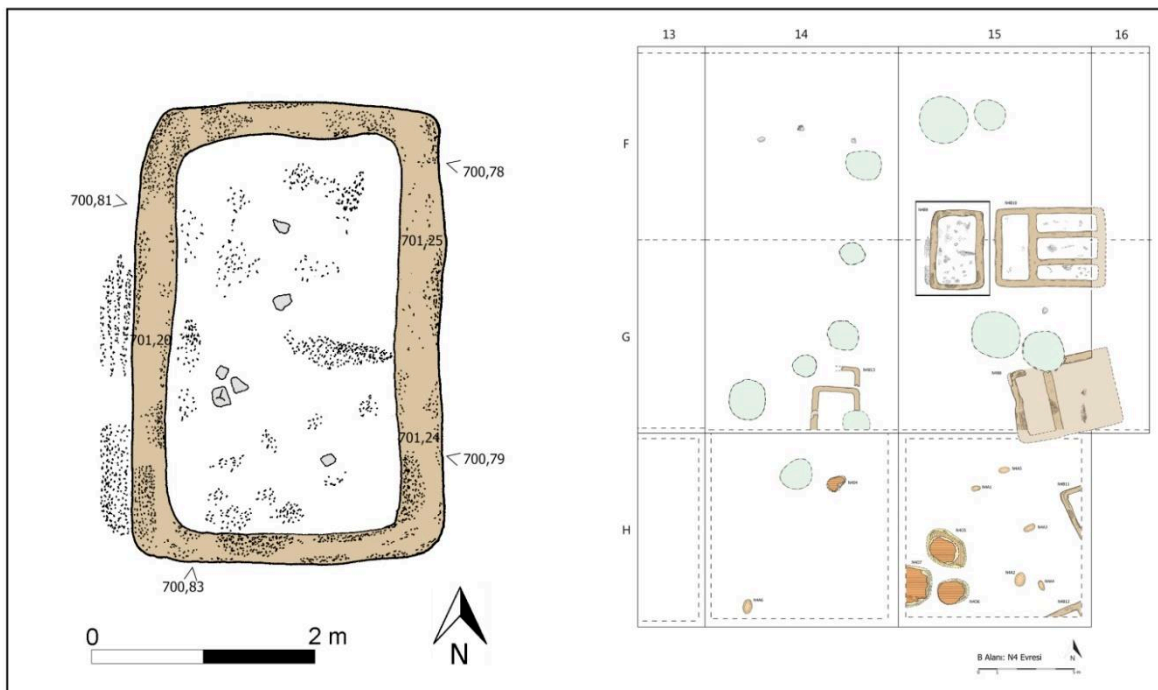
**Figure 4.56:** Location and plan of Structure N4B9

This is located in Area B in the northwest of trench 15G and southwest of trench 15F between the elevations of 701.18 to 701.59 meter. According to the wall remains and its layout this structure is classified as a single-roomed structure. N4B9 was constructed with north-south orientation on a grey occasionally stony and ashy fill following the slope of the natural topography without a stone foundation. (Figure 4.56, 4.180 – 4.182) The walls have been preserved to a height of 40 cm.

The rectangular structure is 283 cm wide in the east-west direction and 409 cm long in the north-south direction. (Figure 4.342) The internal area of the single-roomed structure was 8 m<sup>2</sup>. Plaster floor remains were not identified. The walls are 28-43 cm in width. The faces of the walls are irregular and have undulating appearance. Occasional lime fragments appear to be bound the walls with a thickness of 6-9 cm. The internal fill of the walls is homogeneous reddish-brown loose earth. At 4-6 cm intervals in the wall section, calcified surfaces were also observed between bedding. These calcified surfaces, which continue irregularly between the layers, did not have mortar characteristics. On the outer faces of the walls, but notably those in the south section of the structure, there is parallel 9-12 cm-thick lime lines. These parallel lines might be the remains of woven reeds or woody material used during ramming, which fell outside. Plaster traces were not encountered on the rough lime surfaces.

Accordingly, the walls of structure N4B9 were constructed by the piled earth technique. The lime lines partially identified on the faces of the walls are the remains of woven reeds or woody material used during ramming. Due to this wall technology, it is unlikely that the roof was earthen. However, considering the density of lime fragments indicating organic material, it may be stated that the structure was covered with a light material such as reeds or branches.
