# Microarchaeological observation on the neolithic architectural structures and cultural landscape of Sumaki Höyük

# **Microarchaeological Observation on the Neolithic Architectural Structures and Cultural Landscape of Sumaki Höyük**

PhD Thesis

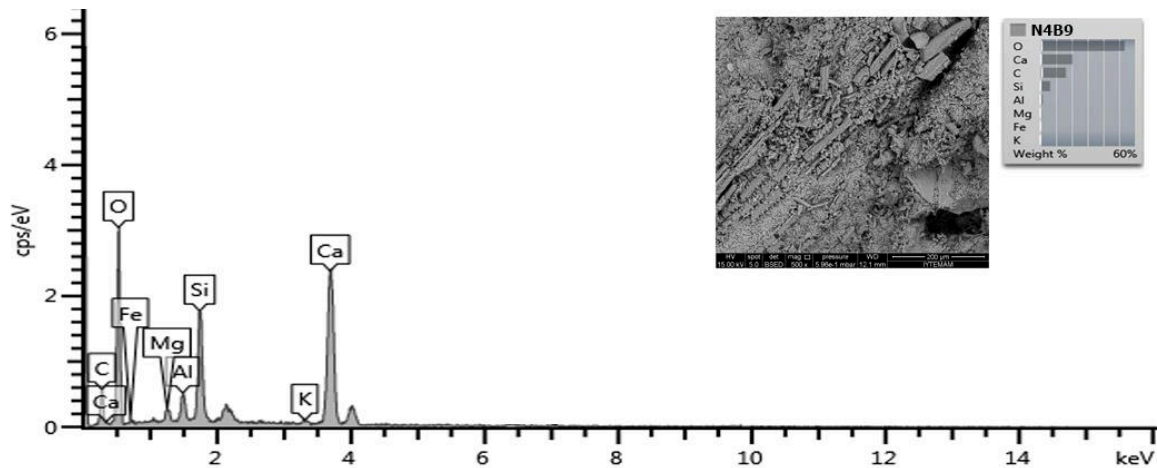
**Diagram 4.69:** EDX analysis of lime samples taken from Structure N4B9

SEM images of lime samples very clearly showed organic remains with calcium carbonate minerals surrounding tubes. SiO<sub>2</sub> gels filling the organic cavities are observed on SEM images of the same samples. The clearest is silicon dioxide gel filling a *Panicum* plant remnant. (Figure 4.314) EDX analysis of the lime samples observed the elements O (53.50%), Ca (20.50%), C (16.22%), Si (6.20%), Al (1.51%), Mg (0.82%), K (0.45%), and Fe (0.79%). (Diagram 4.69) XRD analysis of the lime samples only identified calcium carbonate minerals. (Diagram 4.119)

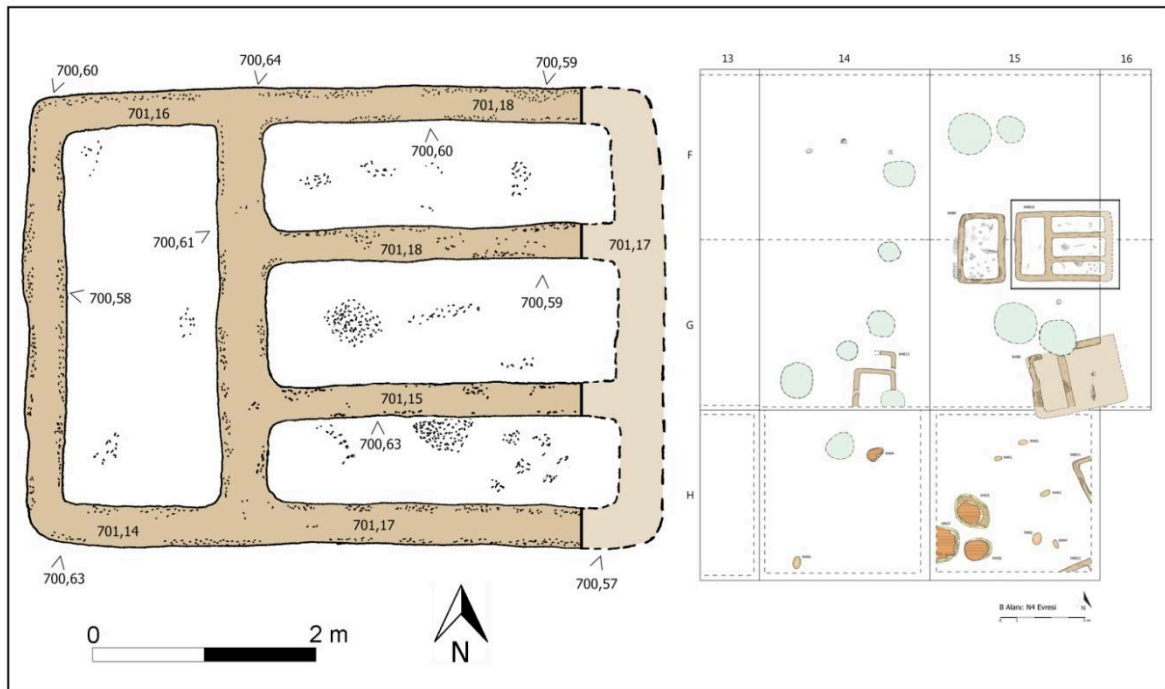
**Figure 4.57:** Location and plan of Structure N4B10

This is located in Area B in the northeast of trench 15G and southeast of trench 15F between the elevations of 700.78 to 701.25 meter. Based on the wall remains and general layout, the structure is classified as a multi-roomed structure. (Figure 4.57, 4.183) The structure was constructed with east-west orientation on a light grey occasionally stony and ashy fill on the slope of the natural topography without a stone foundation. The structure was constructed on the lower terrace on the surface sloping slightly toward the west. The elevation difference between the east and west of the structure is 8-10 cm. The walls have been preserved to a height of 40 cm.

The rectangular structure is 575 cm long in the east-west direction and 413 cm wide in the north-south direction. Covering an area of nearly 24 m<sup>2</sup>. (Figure 4.336) Thickness of the bearing walls and the partition walls are not significantly different, with bearing walls are 33-44 cm wide and partition walls are 28-42 cm wide. The earthen walls, partially bounded by lines of lime fragments have homogeneous reddish-brown very loose fill.

The structure has 4 rooms. On its western wing, the rectangular room number 4 is 140x358 cm in size with north-south orientation. Covering an area of nearly 5 m<sup>2</sup>, this room is larger than those on the east side. Contrary to the room on the west side, the ones on the east side have east-west orientation. These rectangular rooms have very similar measurements. Covering an internal area of nearly 3 m<sup>2</sup> area, they are 84x330 cm and 99x322 cm in size. The rooms are not linked by doorways. The internal fill of the rooms is greyish-brown with low ash content. There was no plaster floor remains identified. It is stated that the dense lime fragments within the structure are the calcified remains of structural material made of woody plants which fell into the structure.

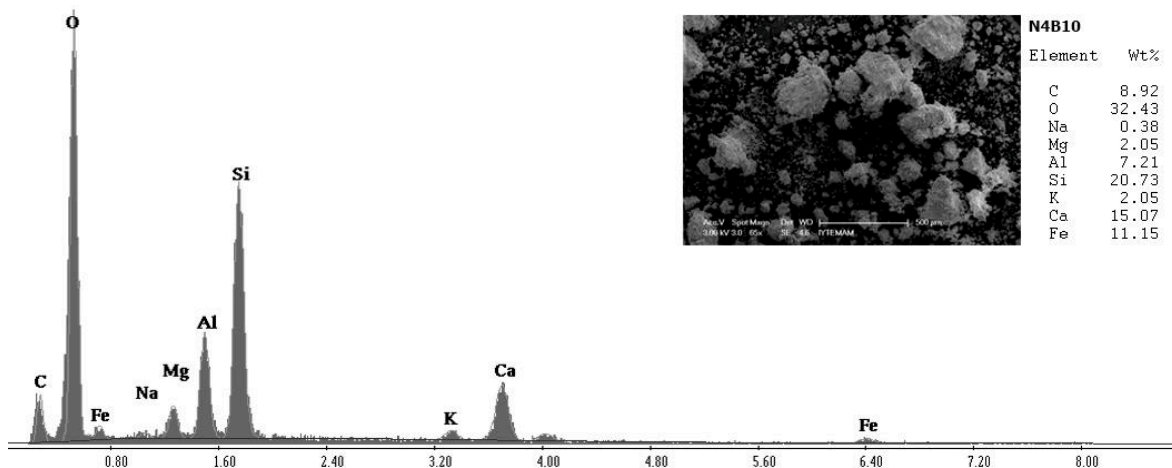
Diagram 4.70: EDX analysis results of soil samples taken from Structure N4B10

On SEM images of reddish-brown soil samples, micritic envelopes on sand and stone grains and acicular-shaped calcium carbonate crystals are observed. (Figure 4.315c-d) According to EDX analyses of the soil samples identified the elements O (32.43%), Ca (15.07%), C (8.92%), Si (20.73%), Fe (11.15%), Al (7.61%), Mg (2.05%), K (2.05%), and Na (0.38%). (Diagram 4.70)

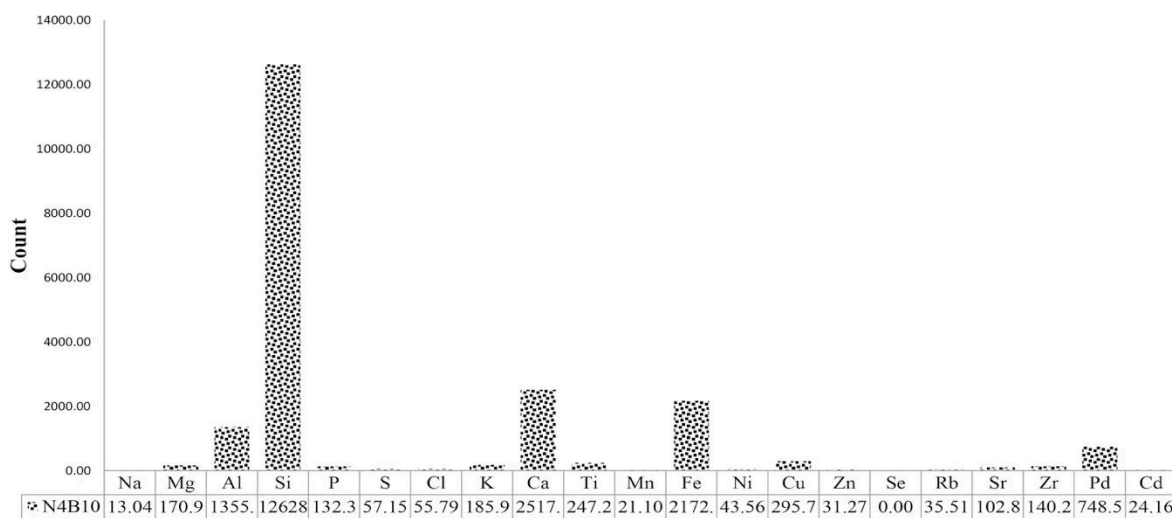
Diagram 4.71: XRF analysis of the soil samples taken from Structure N4B10

XRD analysis of the same samples were identified as containing calcite, cliftonite, graphite, silica, quartz, sakhaite, iron, and brucite minerals. (Diagram 4.120) Their chemical compositions comprise calcium carbonate, silicon dioxide, carbon, iron oxide, magnesium hydroxide, and calcium magnesium carbonate borate hydrate compounds. Investigation of the soil samples taken from the structure with the XRF method observed the following elements dominating; Si (60%), Ca (12%), Fe (10%), Al (6%), and Pd (4%). (Diagram 4.71)

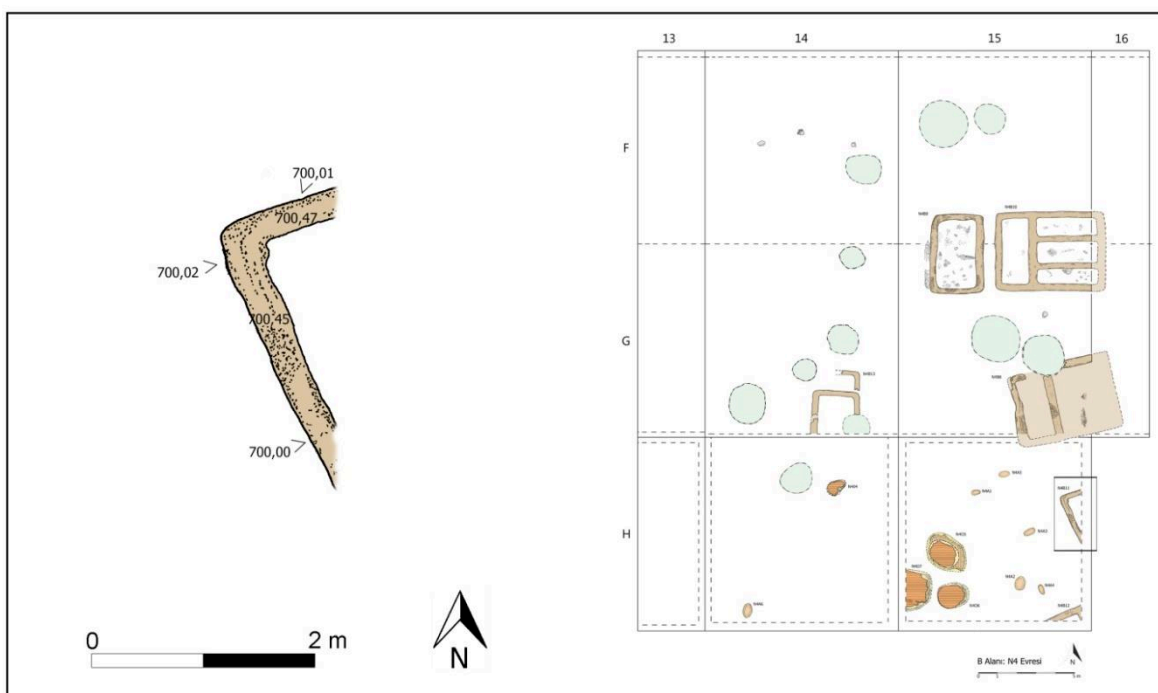
**Figure 4.58:** Location and plan of Structure N4B11

This is located in Area B in the east profile edge of trench 15H between the elevations of 700.01 to 700.47 meter. Since the eastern portion of the structure remains outside the exposed area neither its dimensions nor its plan could clearly be identified. (Figure 4.58, 4.184) The structure sits on a light grey fill with random carbon fragments and stones without

a stone foundation. The walls have been preserved to a height of 46 cm, and their width is 29-32 cm. The internal fill of walls is homogeneous reddish-brown loose earth. At 8-12 cm intervals in the wall section, lime lines were identified between bedding. These lime lines, which continue irregularly between the layers, did not have mortar characteristics. Besides, plaster traces were not encountered on the surfaces of reddish-brown earth bedding. There are no plaster floor remains identified. Considering the architectural tradition and construction technology of Sumaki Höyük, the walls were constructed by the piled earth technique.

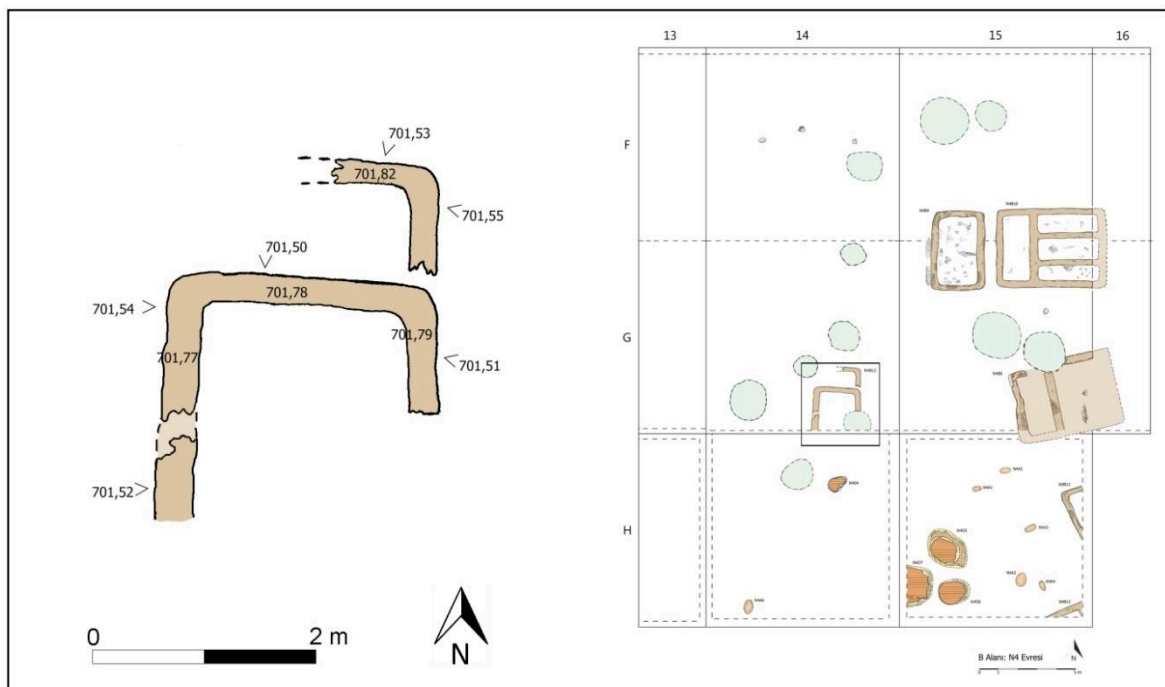
**Figure 4.59:** Location and plan of Structure N4B13

This is located in Area B in the southeast of trench 14G between the elevations of 701.53 to 701.82 meter. The southern section and the northwest corner of the structure were disturbed by Middle Age pits. (Figure 4.59, 4.185) Based on the wall remains and general appearance, this structure is classified as a double-roomed structure. The rectangular structure has north-south orientation sits on a light grey stony fill occasionally with dense carbon fragments without a stone foundation. The walls have been preserved to a height of 29 cm.

The structure is 227 cm wide in the east-west direction, and at least 332 cm in the north-south direction. The walls are 20-29 cm thick. The earth fill within the walls is only distinguished from the external area by its colour. At 3-6 cm intervals in the wall section, thin lime lines were identified. These lime lines, which continue irregularly between the layers, did not have mortar characteristics. Besides, there is no plaster surface at the top or

the bottom of the homogeneous reddish-brown loose bedding. Considering the architectural tradition and construction technology of Sumaki Höyük, the walls of the structure were constructed by the piled earth technique.

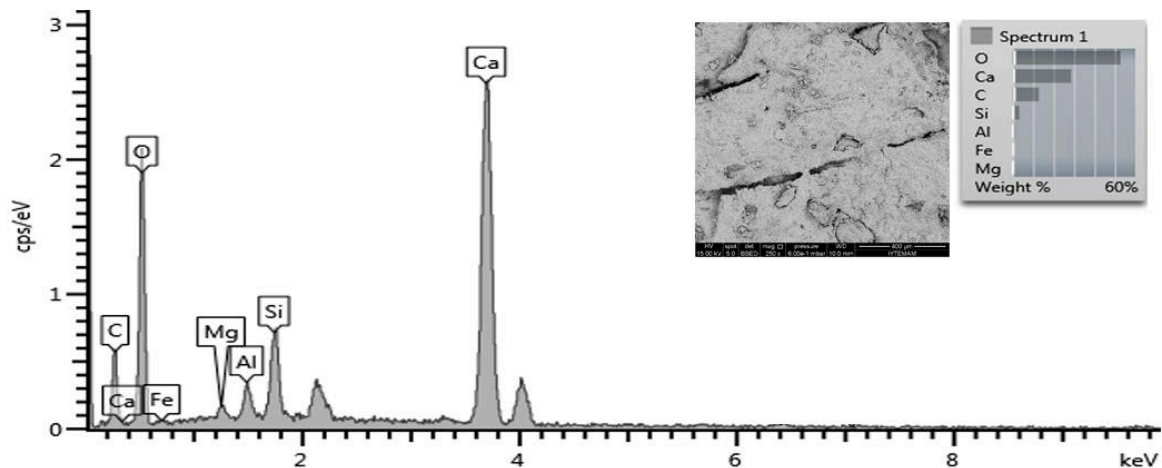
**Diagram 4.72:** EDX analysis of lime samples taken from Structure N4B13

SEM images of lime samples clearly show cavities formed by organic remains. Calcium carbonate minerals filled the edges of these cavities. (Figure 4.316) These calcium carbonate minerals with scalenohedral and granular crystal structure are probably aragonite crystals. Investigation of the lime samples with the EDX method identified the elements O (52.77%), Ca (28.59%), C (12.73%), Si (3.18%), Al (1.15%), Mg (0.49%), and Fe (1.09%). (Diagram 4.72)

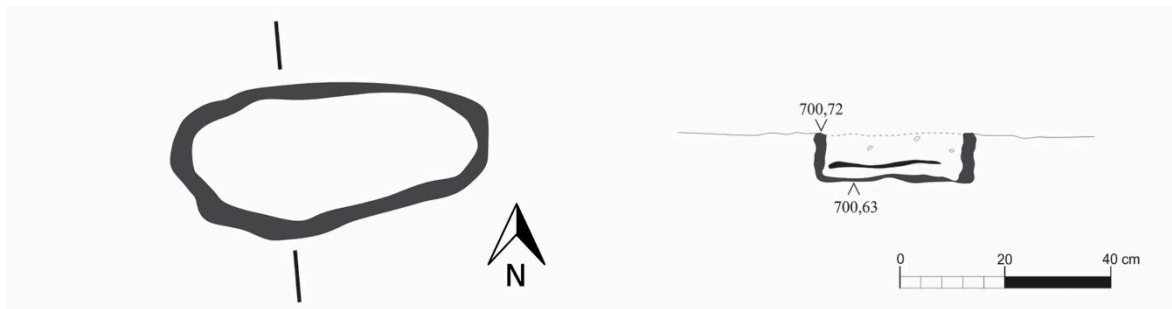
**Figure 4.60:** Fire Pit N4A1 and its cross-section

It was located in an open space in the northwestern part of trench 15H in Area B. The oval-shaped fire pit was between the elevations of 700.63 to 700.72. Dug in a grey ashy and limey soil, the fire pit was 30x62 cm in size and 9 cm deep. (Figure 4.60, 4.282, 4.283) On its edge, there is a dark grey line due to burning with 2-3 cm thickness. There were no signs of plastering on its sides or its bottom. It was filled with yellowish grey-coloured ash comprising a few stones.

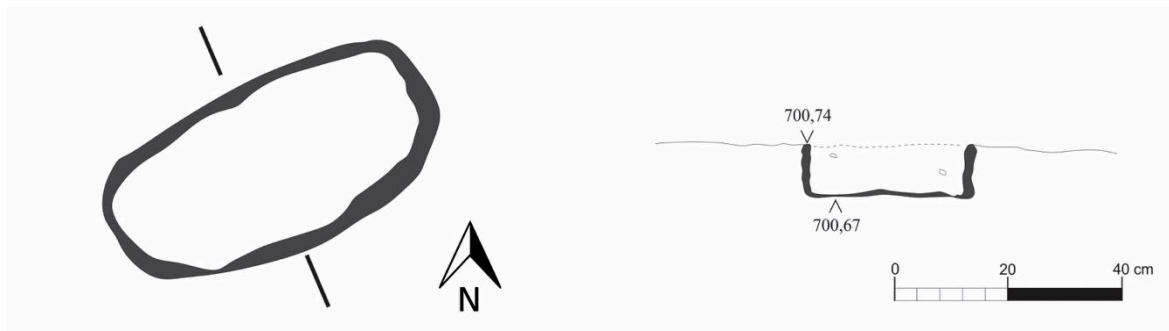
**Figure 4.61:** Fire Pit N4A2 and its cross-section

This was located in an open space in the south part of trench 15H in Area B. The oval-shaped fire pit was between the elevations of 700.67 to 700.74. Dug in a grey-coloured little ashy and limey soil, the fire pit was 48x72 cm in size and 7 cm deep. (Figure 4.61) On its edge, there is a dark grey line due to burning with 1-2 cm thickness. There were no signs of plastering on its sides or its bottom.

It was filled with grey-coloured ash. Plant remains were detected in earth samples taken from its fill and its close surroundings by floatation. The plants from its inner deposit detected *Triticum/Hordeum*, *Fabaceae* family (*Lens culinaris*), and *Linum* seeds. The ones from its surroundings were *Poaceae* family (*Triticum turgidum* ssp. and *Triticum/Hordeum*), and *Fabaceae* family. (Table 3.2)

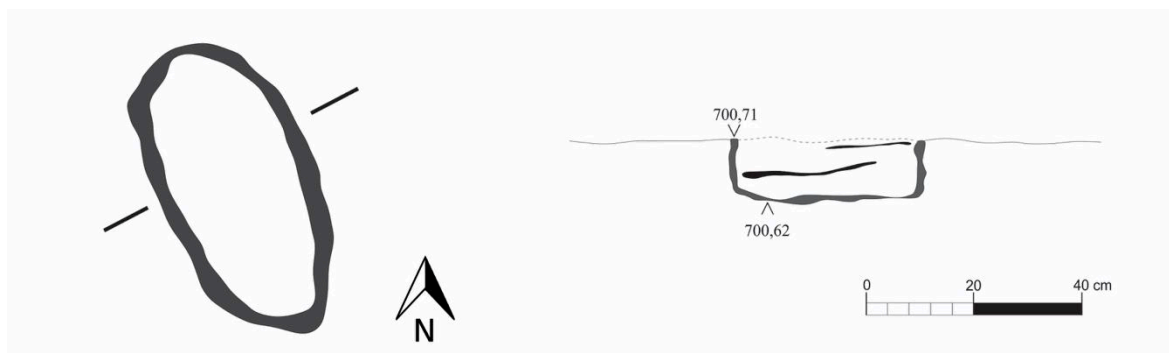
**Figure 4.62:** Fire Pit N4A3 and its cross-section

It was located in an open space in the western-central part of trench 15H in Area B. The oval-shaped fire pit was between the elevations of 700.63 to 700.72. Dug in a yellowish grey densely limey soil, the fire pit was 31x60 cm in size and 9 cm deep. (Figure 4.62, 4.284) On its edge, there is a dark, dull grey line due to burning with 2-3 cm thickness. There were no signs of plastering on its sides or its bottom. It was filled with dull grey- and yellowish buff-coloured ash comprising a few stones.

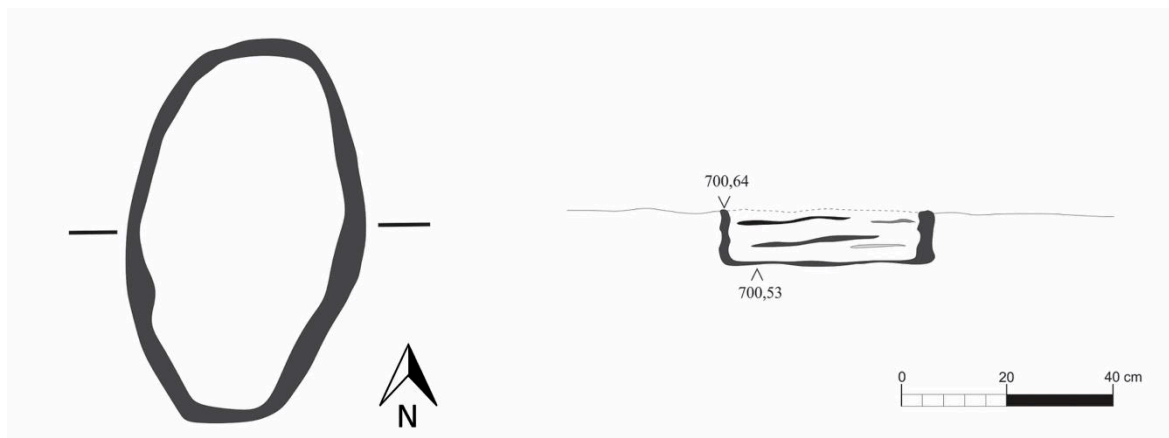
**Figure 4.63:** Fire Pit N4A4 and its cross-section

densely limey soil, the fire pit was 36x57 cm in size and 11 cm deep. (Figure 4.63) On its edge, there is a light brown line formed due to burning with 1-2 cm thickness. There were no signs of plastering on its sides or its bottom. It was filled with dull grey- and yellowish buff-coloured ash comprising a few stones.

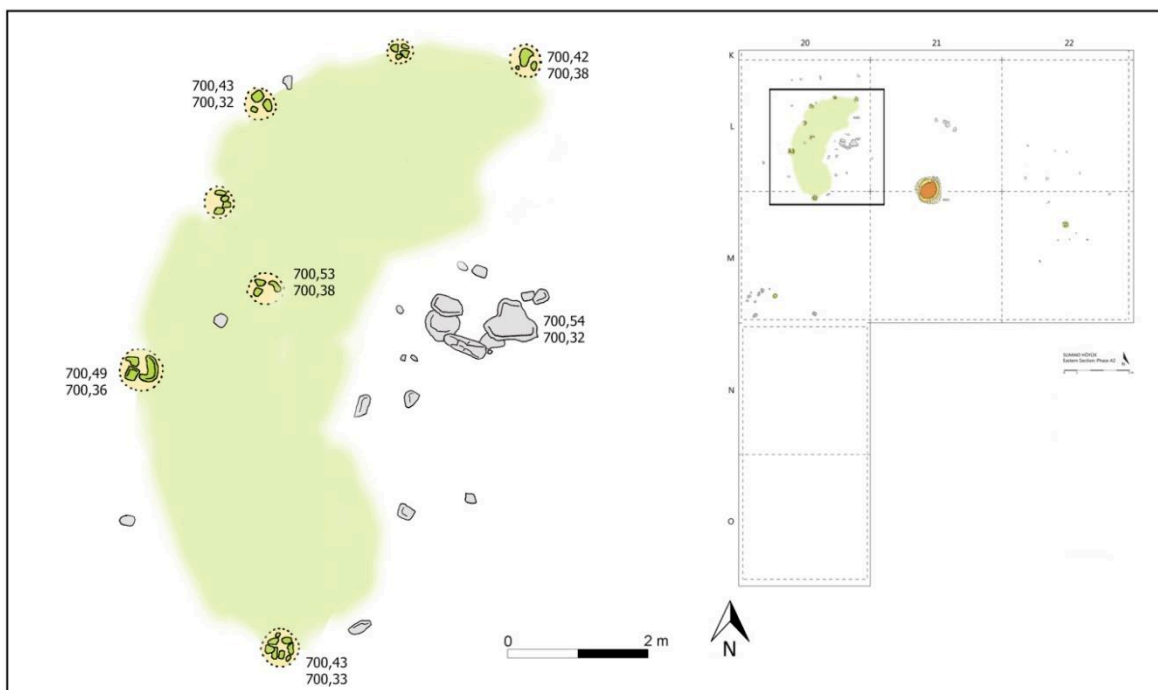
**Figure 4.64:** Location and plan of Structure N3B1

Structure N3B1 is located in Area A in the eastern section of trench 20L and northeast of trench 20M between the elevations of 700.33 – 700.54. Covering an area of nearly 30 m<sup>2</sup>, there are seven post-hole traces identified around the area, with five clear and two partly disrupted. (Figure 4.64, 4.186)

The post-holes were surrounded by basalt and ground stone fragments measuring from 7x10x11 to 10x14x23 cm in size. There are some scattered stones to the east of these post-holes. Since no clear post-hole trace was identified in this area, these stones may be

There is no trace of wall or surroundings between the post-holes as well as no evidence of a plastered floor surrounding these posts. The level determined as the existing surface was the surface where finds such as bone tools like awls and borers were found. There are occasional lime traces observed within the area surrounded by posts and at the edges of the posts.

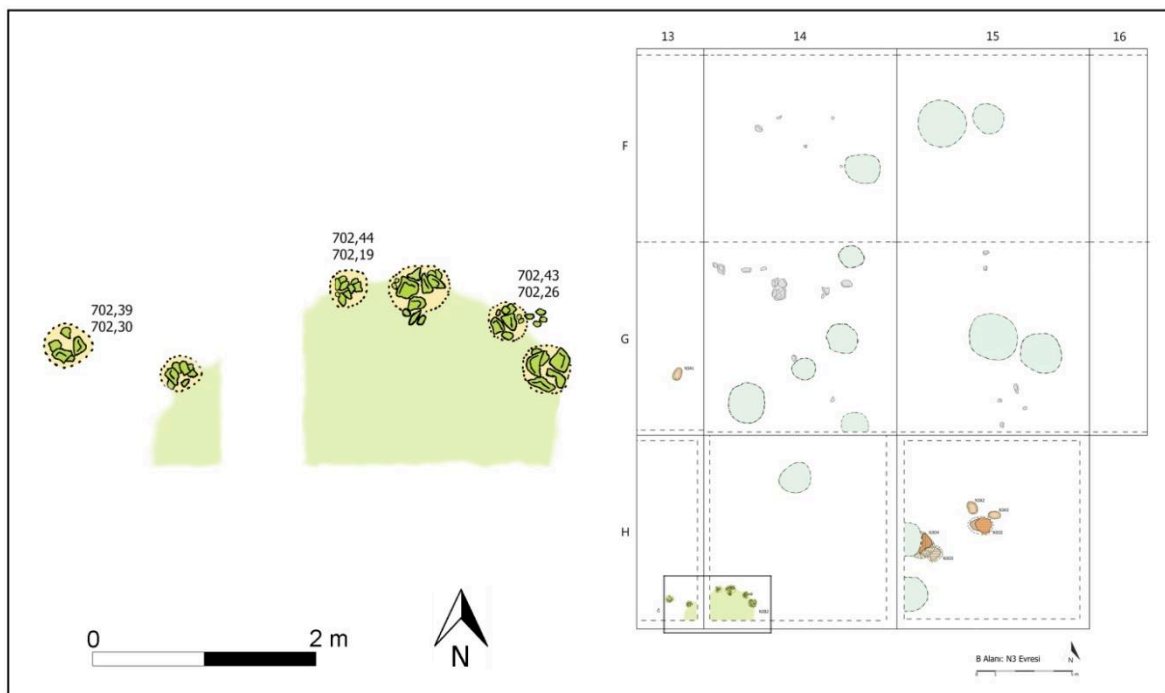
**Figure 4.65:** Location and plan of Structure N3B2

The area surrounded by posts in the exposed area is nearly 8 m<sup>2</sup>. (Figure 4.65, 4.188) Five post-holes were surrounded by stones with sizes of 6x7x11 - 10x17x22 cm. Their general appearance shows the presence of at least one circular temporary structure with tent covering on top.

There are no traces showing walls or surroundings between the post-holes as well as no marks of plastered floors in the area surrounded by the holes within the excavation or sections. However, there are thick ash-rich lines and fill within the area enclosed by the posts and around it.

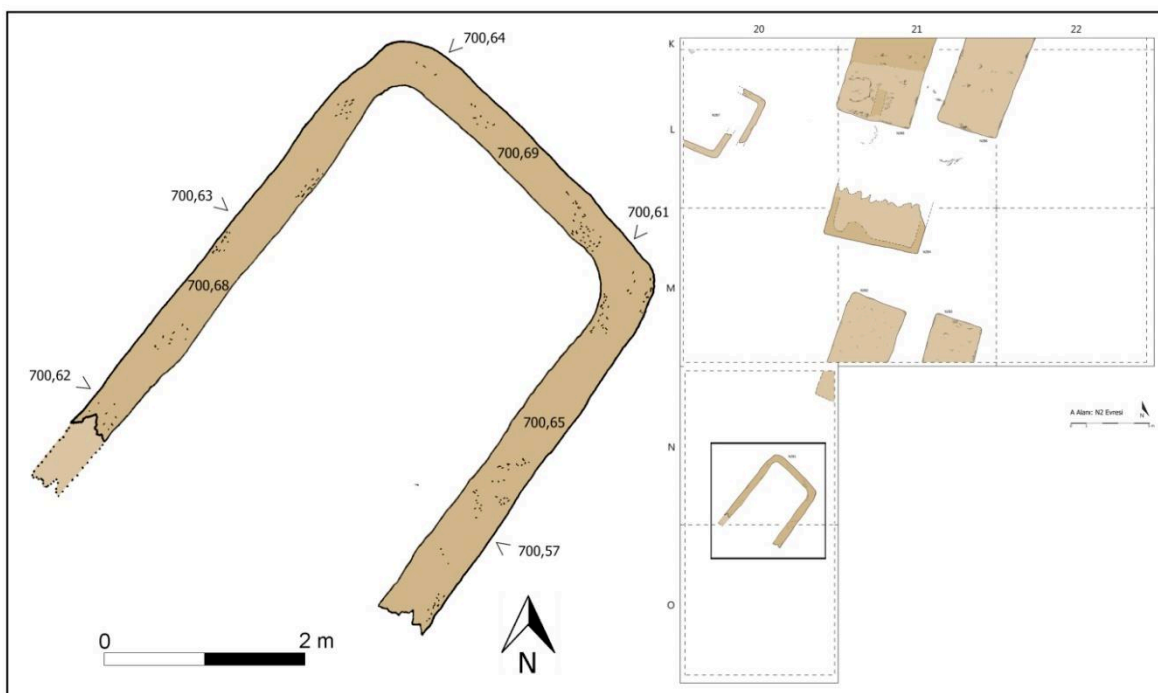
**Figure 4.66:** Location and plan of Structure N2B1

Structure N2B1 is located in Area A south of trench 20N and the northern section of trench 20/O between the elevations of 700.77 – 700.89 meter. According to its wall remains and general appearance, the structure is classified as a Single-roomed Structure. (Figure 4.66, 4.189) It was constructed with a southwest-northeast orientation following other structures in the same area on the slope of the natural surface without a stone foundation. The height of the walls is 7 cm.

This rectangular structure is 398 cm wide in a southeast-northwest direction, and the preserved section is 592 cm long in a northeast-southwest direction. The walls are 32 -43 cm in width with irregular and undulating surfaces. There is no plaster floor in the structure.

The wall faces are identified from differences in soil colour. The walls in its southern half could not be determined since this area appears to have been disturbed by structure N1B4 of Phase N1. The wall fill, which is of a homogeneous brown and loose character, is only distinguished from the external area soil by its colour. Considering the architectural tradition and construction technology of Sumaki Höyük, the structure was built using the piled earth technique.

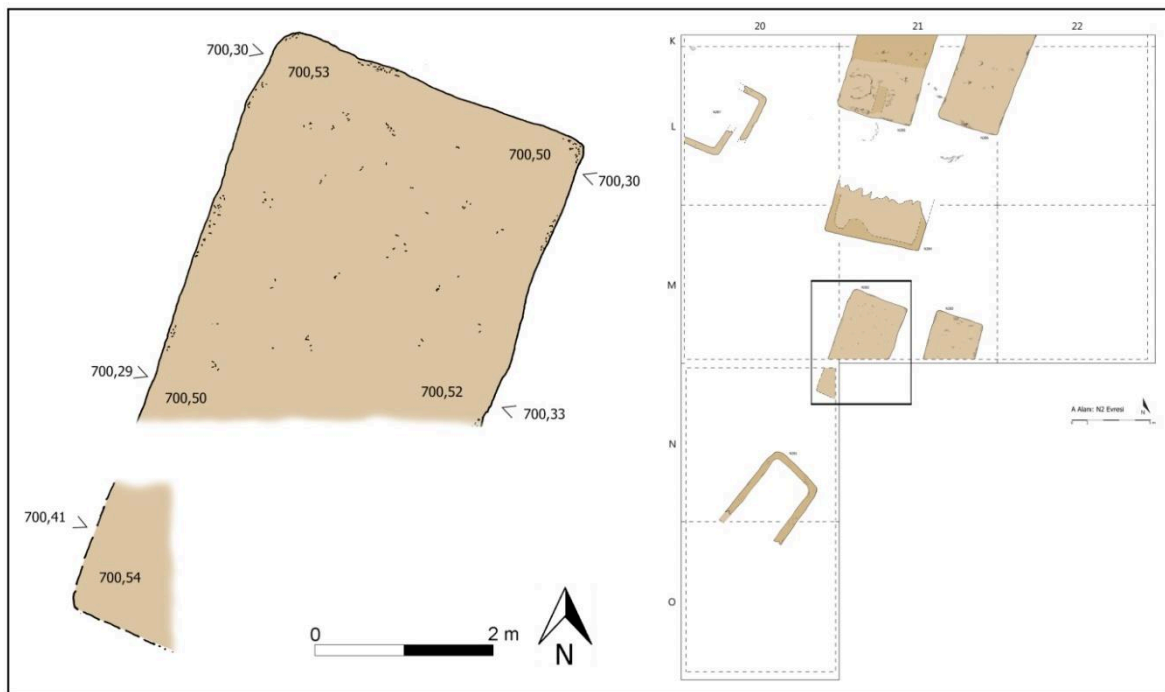
**Figure 4.67:** Location and plan of Structure N2B2

Constructed on the northern slope of a slight rise with southwest-northeast orientation, N2B2 is 372 cm wide in an east-west direction, and along with the area within trench 20N, it is 671 cm long in a north-south direction. Covering an area of nearly 25 m<sup>2</sup>. This structure with a rectangular plan and single large room did not have any plaster floor remains or hardened floor surface or partition walls.

The limits of the structure were determined by lime fragment lines 2-3 cm thick and reddish-brown soil traces. The observed reddish-brown colour and lime traces in trench sections were used to define the structure. These traces most likely belong to a temporary structure with probably reed surroundings and flimsy upper cover. Similar examples were commonly observed in our ethno-archaeological field studies in the Lower Garzan Basin. Similar structures with an upper tent cover used for brief durations by semi-nomadic societies leave identical traces on the ground after removing the posts and tent after a certain period of use. However, there were no post traces encountered inside or outside this structure.

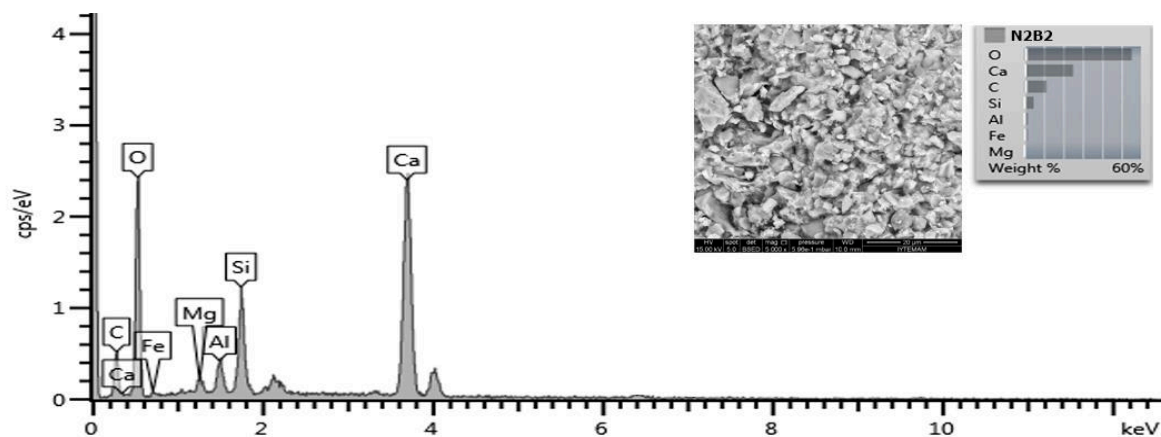
Diagram 4.73: EDX analysis of lime samples taken from Structure N2B2

SEM images of lime samples taken from N2B2 fill observed scalenohedral and granular crystal structures. (Figure 4.318) Their EDX analysis identified O (54.60%), Ca (25.98%), C (11.30%), Si (4.73%), Al (1.49%), Fe (1.03%), and Mg (0.86%). EDX analysis in areas with clear scalenohedral and granular crystal structures determined element ratios very consistent with the general surface. (Diagram 4.73) Investigation of lime sample with

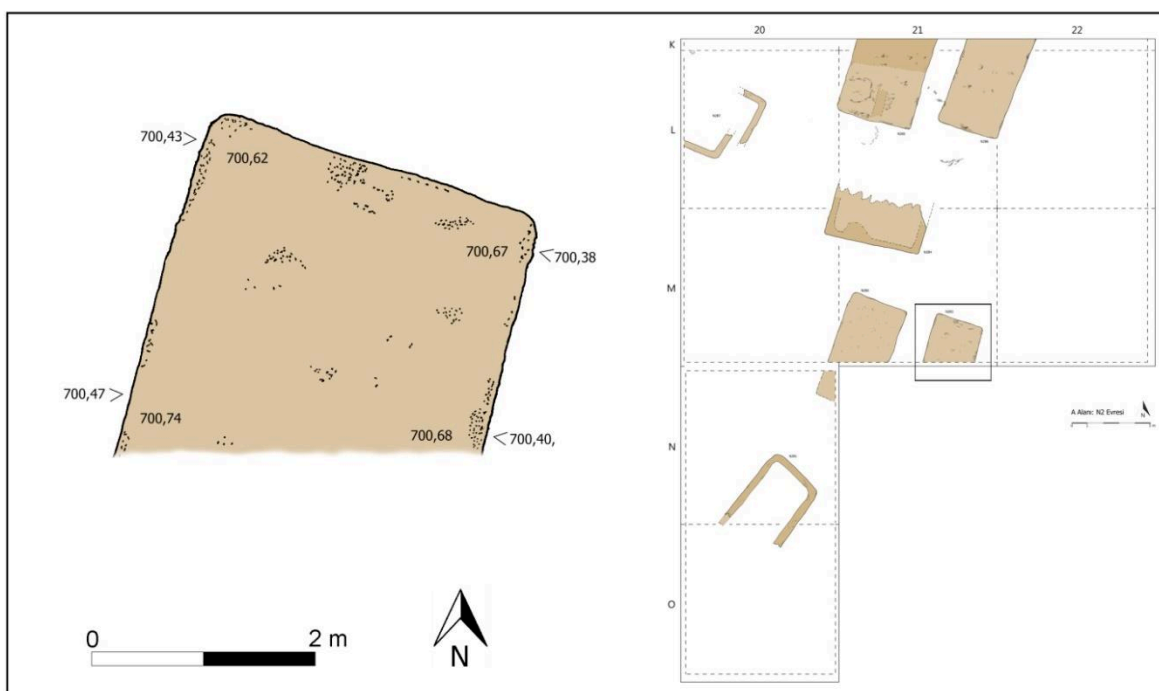
Figure 4.68: Location and plan of Structure N2B3

This is located in Area A in the southeast of trench 21M; its southern part is outside the exposed area between the elevations of 700.38 to 700.74 meter. Based on the traces and general appearance, the structure is classified as a single-roomed structure. (Figure 4.68, 4.191, 4.192) As per this type it was a temporary structure without walls, probably surrounded by reeds with flimsy upper cover.

Constructed on a slight rise with southwest-northeast orientation, the structure is 315 cm wide in the east-west direction and is 315 cm long in the north-south direction. The limits of the structure were determined by 1-2 cm-thick lime fragment lines and reddish-brown soil traces. This structure with rectangular-plan and a single large room did not have any plaster floor remains or hardened floor surface or partition walls.

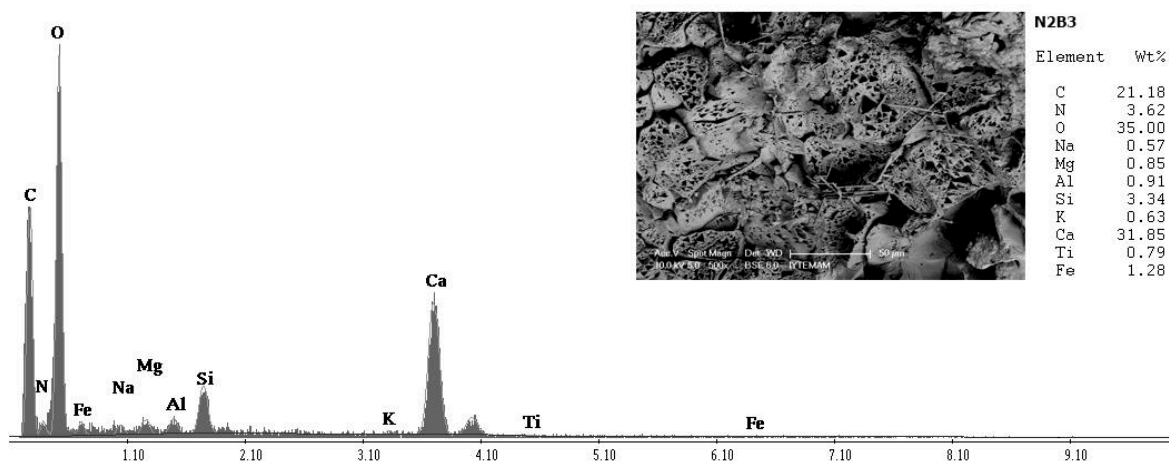
Diagram 4.74: EDX analysis of lime samples taken from Structure N2B3

SEM images of lime samples taken from its fill observed scalenohedral, prism-shaped crystal structures along with acicular crystals. (Figure 4.319) EDX analysis of the lime samples found the elements O (35.00%), Ca (31.85%), C (21.18%), Si (3.34%), and Fe (1.28%) with trace amounts of Na, Mg, Al, K, and Ti. (Diagram 4.74)

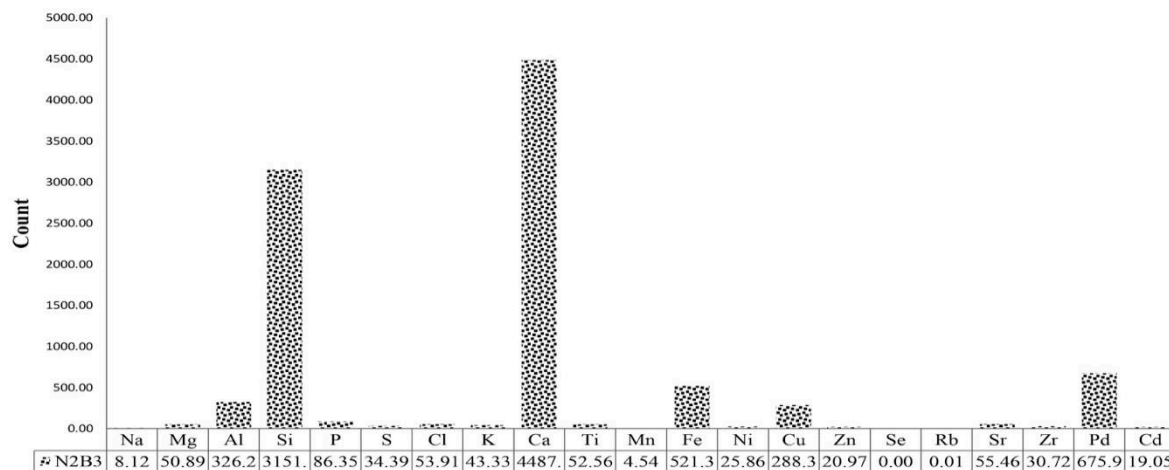
Diagram 4.75: XRF analysis of the lime samples taken from Structure N2B3

XRF analysis of the lime samples complied with the EDX analysis, accordingly, it was observed that the following elements dominating; Si (32%), Ca (45%), Fe (5%), Al (3%), and Pd (7%), together with very small amounts of Ni, Zn, Sr, Rb, Na, K, S, P, Cl, Cu, and Ze. (Diagram 4.75)

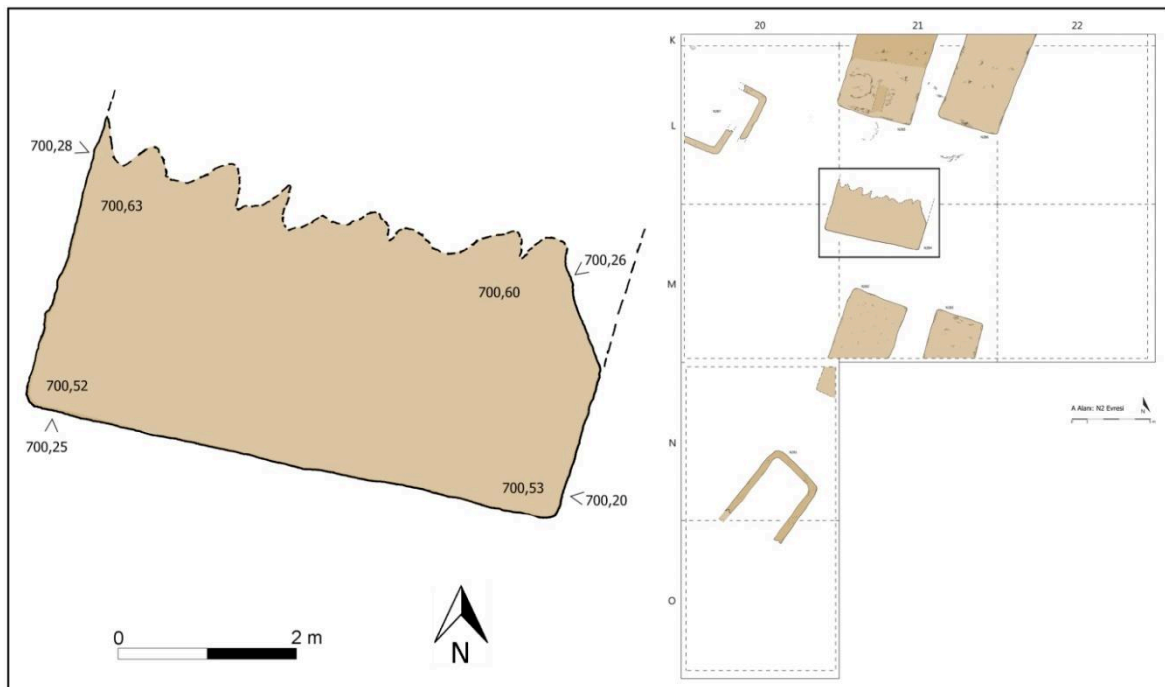
**Figure 4.69:** Location and plan of Structure N2B4

It is located in Area A in the north of trench 21M between the elevations of 700.30 to 700.53 meter; its northern limits could not be detected. Based on the traces and general appearance, the structure is classified as a single-roomed structure. (Figure 4.69, 4.192 – 4.194) As per this type, it was a temporary structure without walls, probably surrounded by reeds with flimsy upper cover.

Constructed on the northern slope of a slight rise with southwest-northeast orientation, the exposed section of the structure is 610 cm long in the east-west direction and is 317 cm wide in the north-south direction. The limits of the structure were determined by very thin occasionally traceable lime lines and light reddish-brown soil. This structure with a rectangular plan and single large room did not have any plaster floor remains or hardened floor surface or partition walls.

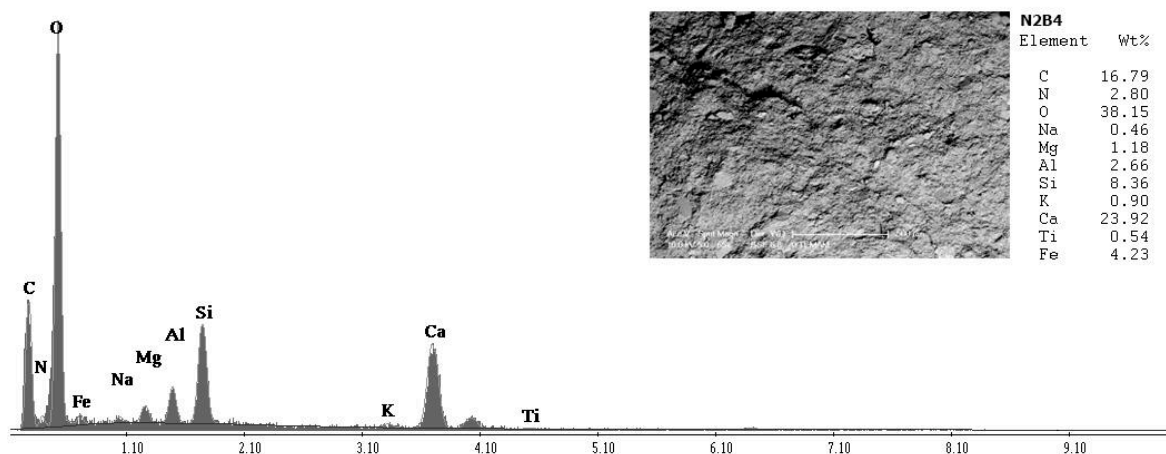
**Diagram 4.76:** EDX analysis of lime samples taken from Structure N2B4

SEM images of lime samples show granular crystal structures. (Figure 4.320) Investigation of the same samples with EDX observed the following elements dominating; O (38.15%), Ca (23.92%), C (16.79%), Si (8.36%), and Fe (4.23%), together with trace amount of Na, Mg, Al, K, and Ti. (Diagram 4.76)

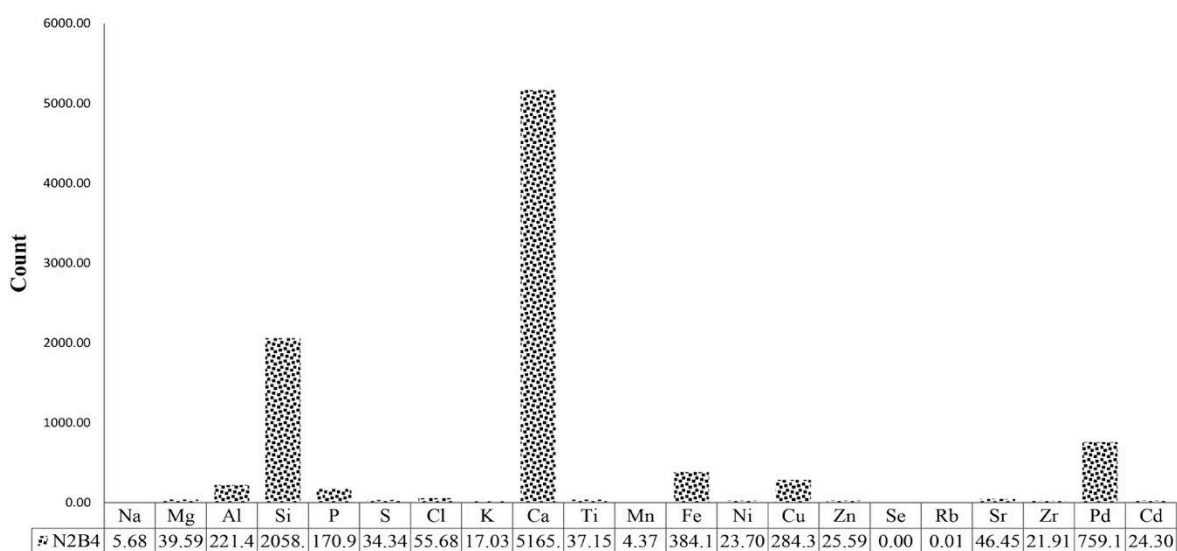
**Diagram 4.77:** XRF analysis of the lime samples taken from Structure N2B4

Investigation of the same samples with XRF analysis observed the elements Si (22%), Ca (55%), Fe (4%), Al (2%), and Pd (8%), complying with the EDX data. Trace amounts of Ni, Zn, Sr, Rb, Na, K, S, P, Cl, Cu, and Ze elements were also identified. (Diagram 4.77)

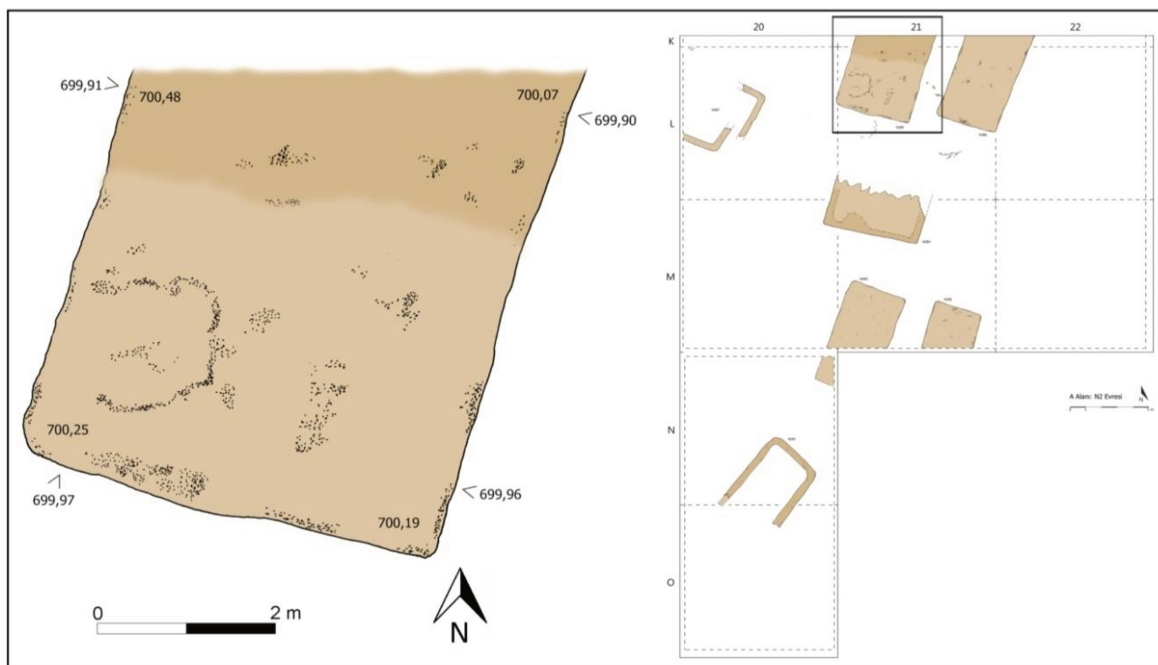
**Figure 4.70:** Location and plan of Structure N2B5

This is located in Area A in the north of trench 21L, with its northern section outside the exposed area between the elevations of 700.80 to 700.02 meter. Based on the traces and general appearance, this structure is classified as a single-roomed structure. (Figure 4.70, 4.195 – 4.197) As per this type, it was a temporary structure without walls, probably surrounded by reeds with flimsy upper cover.

Constructed on the northern slope of a slight rise with southwest-northeast orientation, the structure is 470 cm wide in the east-west direction, and its exposed section is 523 cm long in the north-south direction. The limits of the structure were determined by 1-3 cm-thick lime lines and reddish-brown soil traces. This structure with a rectangular plan and single large room did not have any plaster floor remains or hardened floor surface or partition walls.

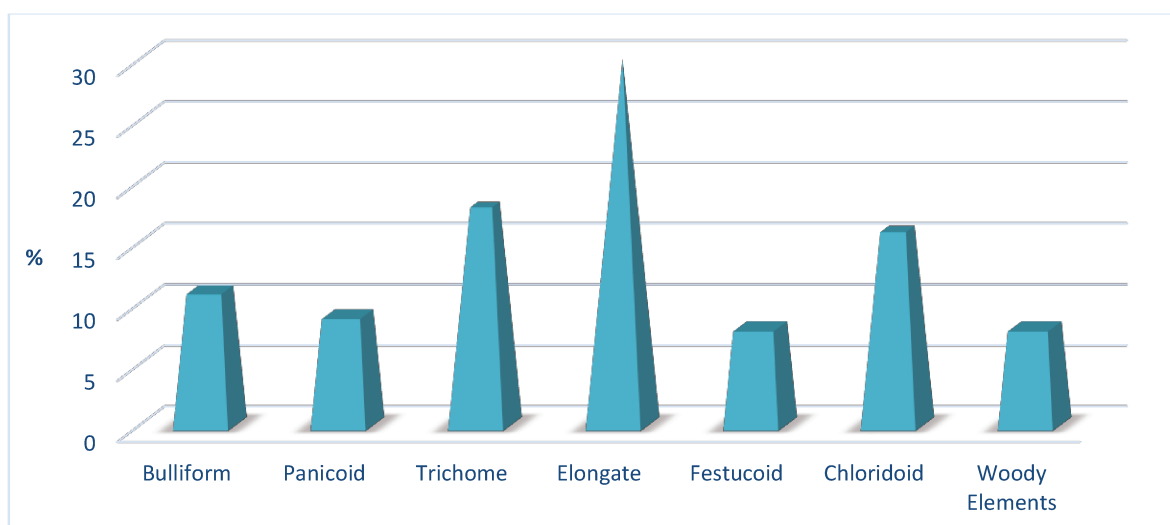
**Diagram 4.78:** Distribution of phytoliths in the lime samples taken from Structure N2B5

Phytolith analysis of lime samples identified reed or woody plant remains particularly with high frequencies of *Trichome* and *Elongate* forms. *Bulliform*, *Panicoid*,

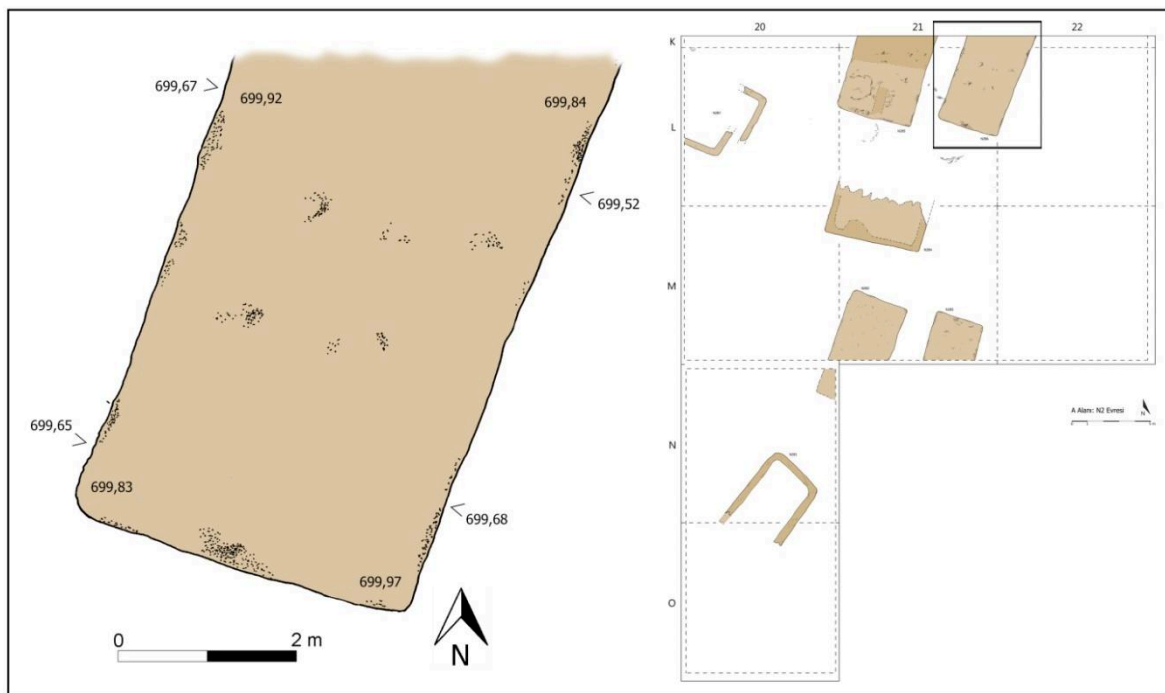
**Figure 4.71:** Location and plan of Structure N2B6

This is located in Area A in the northeast of trench 21L. The northern section of the structure is outside the exposed area between the elevations of 700.63 to 700.87 meter. According to the traces and general appearance, the structure is classified as a single-roomed structure. (Figure 4.71, 4.195 – 4.197) As per this type, it was a temporary structure without walls, probably surrounded by reeds with flimsy upper cover.

Constructed on the northerneastern slope of a slight rise with southwest-northeast orientation, the structure is 402 cm wide in the east-west direction, and the exposed part is 611 cm long in the north-south direction. The limits of the structure were determined by very thin, occasionally traceable lime lines and light reddish-brown earth fill. Similar examples have been commonly observed in our ethno-archaeological field studies in the Lower Garzan Basin. This structure with a rectangular plan and single large room did not have any plaster floor remains or hardened floor surface or partition walls.

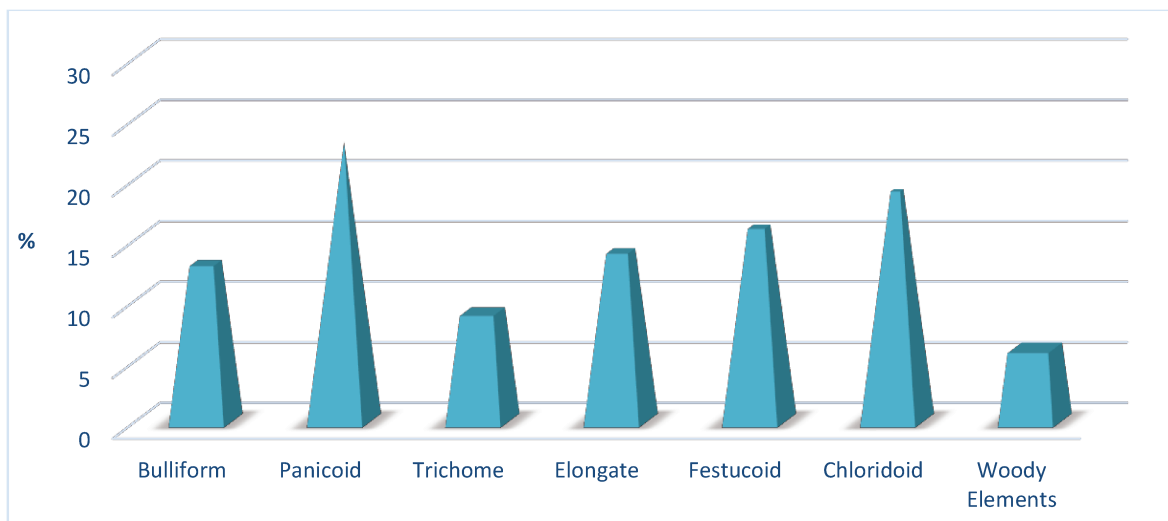
**Diagram 4.79:** Distribution of phytoliths in the lime samples taken from Structure N2B6

Phytolith analysis of lime samples identified reed, and herbaceous plant remains. The phytoliths contained high frequencies of *Panicoid*, *Chloridoid*, *Elongate* and *Festucoid* forms along with *Trichome*, *Bulliform* and silicified forms. *Trichome* phytoliths have multiple forms. (Diagram 4.79; Figure 4.325 - 4.330)

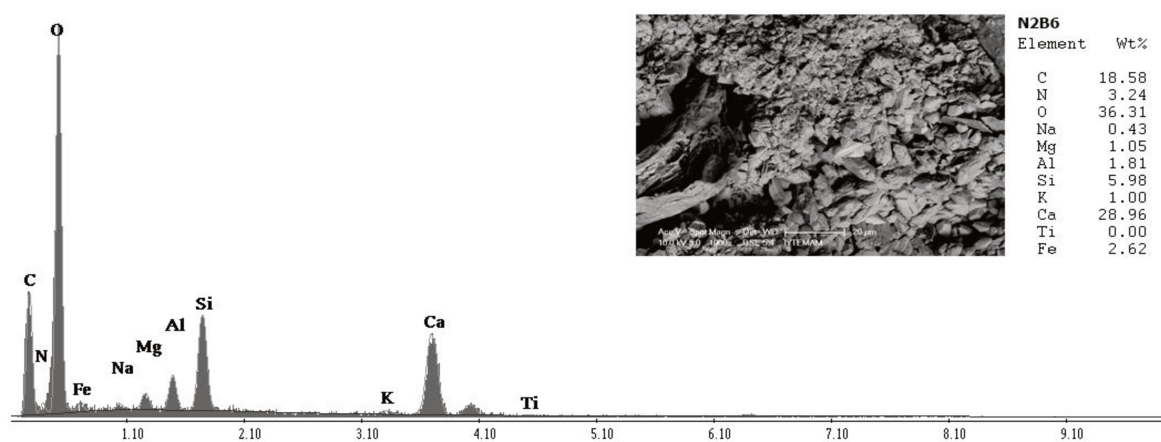
**Diagram 4.80:** EDX analysis of lime samples taken from Structure N2B6

SEM images of lime samples show scalenohedral, prismatic, and granular crystals. Rod-like shaped cavities were also identified. The crystals surrounding these cavities were generally scalenohedral. (Figure 4.321c-d) Investigation of the lime samples with EDX method identified the elements O (36.31%), Ca (28.96%), C (18.58%), Si (5.98%), and Fe (2.62%). Na, Mg, Al, and K were also identified at rates from 2% to 0.43%. (Diagram 4.80)
