# Microarchaeological observation on the neolithic architectural structures and cultural landscape of Sumaki Höyük

# **Microarchaeological Observation on the Neolithic Architectural Structures and Cultural Landscape of Sumaki Höyük**

PhD Thesis

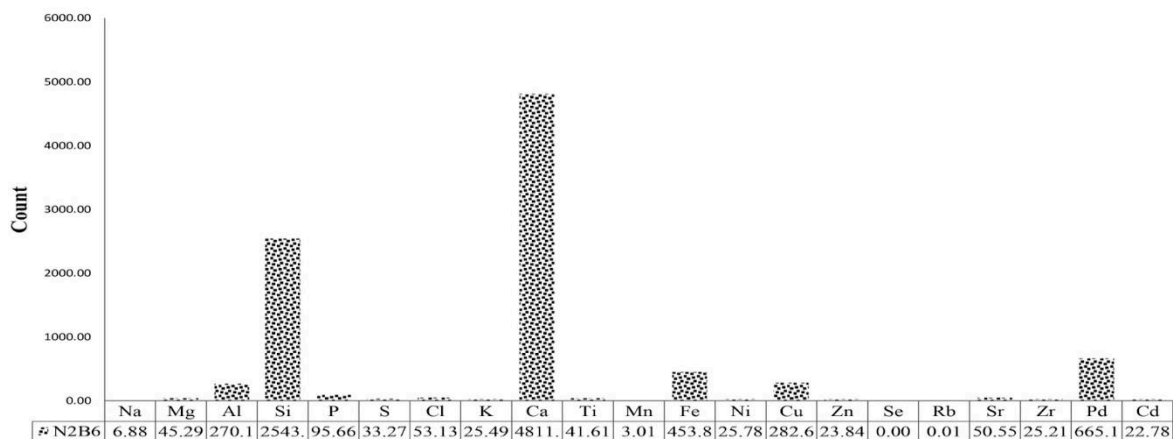
**Diagram 4.81:** XRF analysis of the lime samples taken from Structure N2B6

Investigation of the lime samples with XRF analysis observed the elements Si (27%), Ca (51%), Fe (5%), Al (3%), and Pd (7%), complying with the EDX analysis. Very small amounts of Ni, Zn, Sr, Rb, Na, K, S, P, Cl, Cu, and Ze were also detected. (Diagram 4.81)

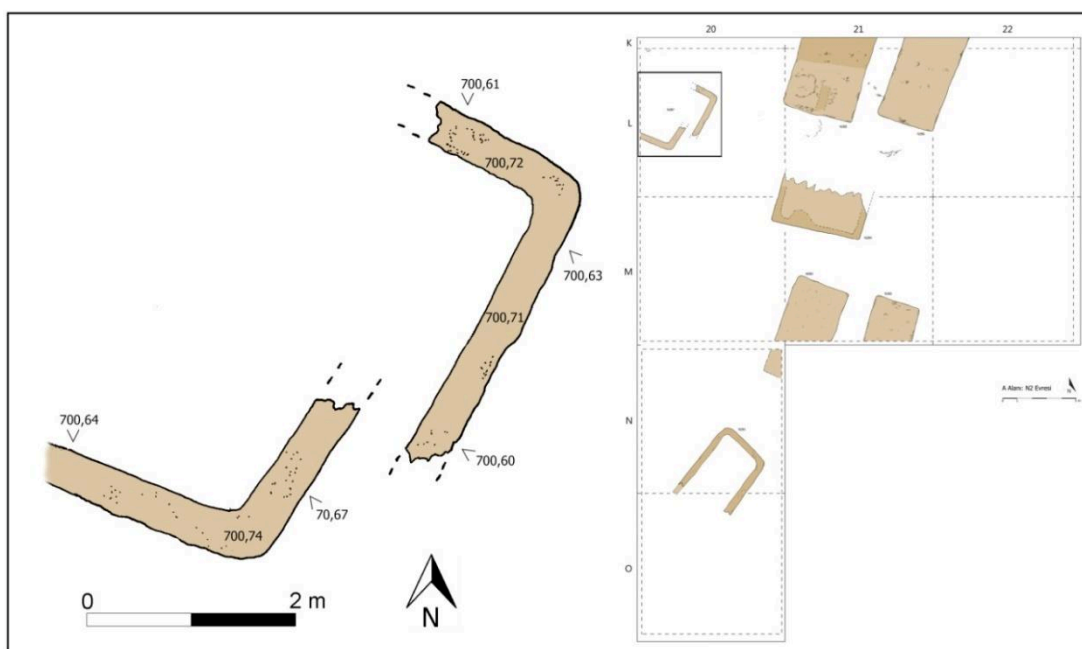
**Figure 4.72:** Location and plan of Structure N2B7

This is located in Area A in the northeast section of trench 20M between the elevations of 700.50 to 700.74 meter. Architectural elements identified in this area are poorly-preserved walls with a height of 10 to 14 cm. According to the wall remains and general appearance the structure can be classified as a single-roomed structure, however, data allowing determination of its plan were insufficient in the exposed area. Therefore, the structure is classified as an indeterminate-planned structure. (Figure 4.72, 4.198 – 4.200)

Walls were directly erected on the ground without a stone foundation. The walls with curved corners are 32-35 cm wide. The limits of the walls were determined by light reddish-

brown fillings. The internal fill of walls is homogeneous light reddish-brown very loose earth. Considering the architectural tradition and construction technology of Sumaki Höyük, Structure N2B7 was constructed by the piled earth wall technique.

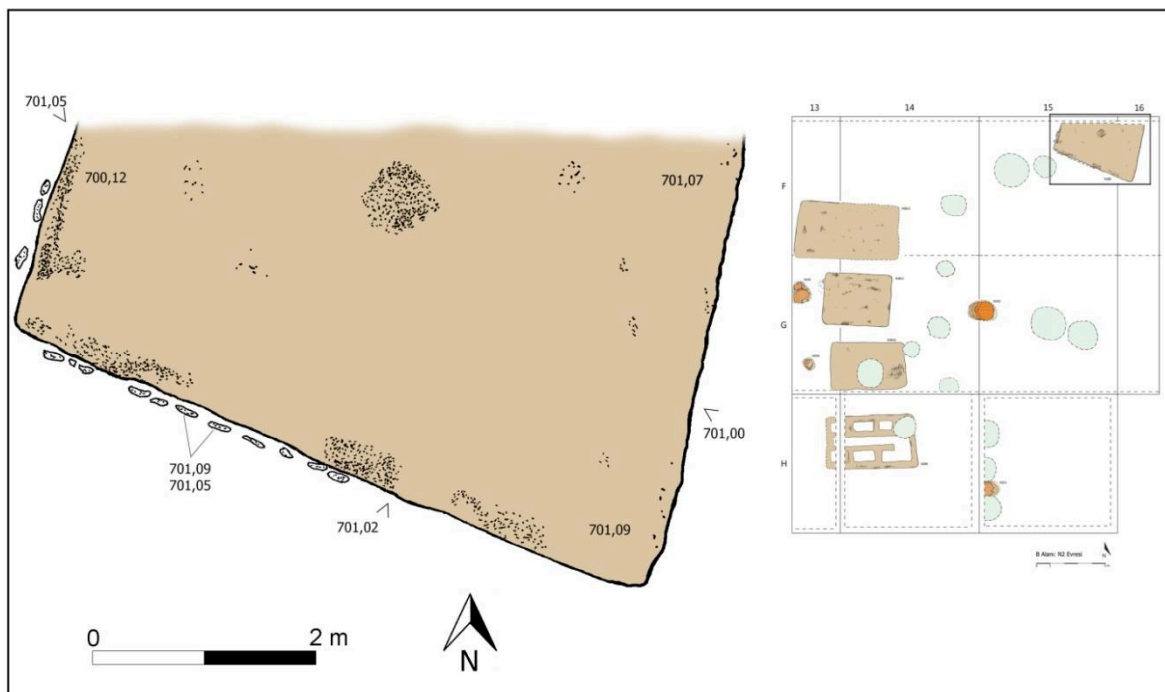
**Figure 4.73:** Location and plan of Structure N2B8

This is located in Area B in the northeast of trench 15F and northwest of trench 16F between the elevations of 701.00 to 701.10 meter. Based on the traces and general appearance, this structure is classified as a single-roomed structure. As per this type, it was a temporary structure without walls, probably surrounded by reeds with flimsy upper cover. (Figure 4.73, 4.201 – 4.203)

Constructed on the northern slope of a slight rise with southwest-northeast orientation, the structure is 614 cm long in the east-west direction, and its exposed section is 337 cm wide in the north-south direction. The limits of the structure were determined by very thin, occasionally traceable lime and light reddish-brown earth fill. This structure with a rectangular plan and single large room did not have any plaster floor remains or hardened floor surface or partition walls. Its south and west external sides were surrounded by walnut-sized stones with calcified surfaces in a line.

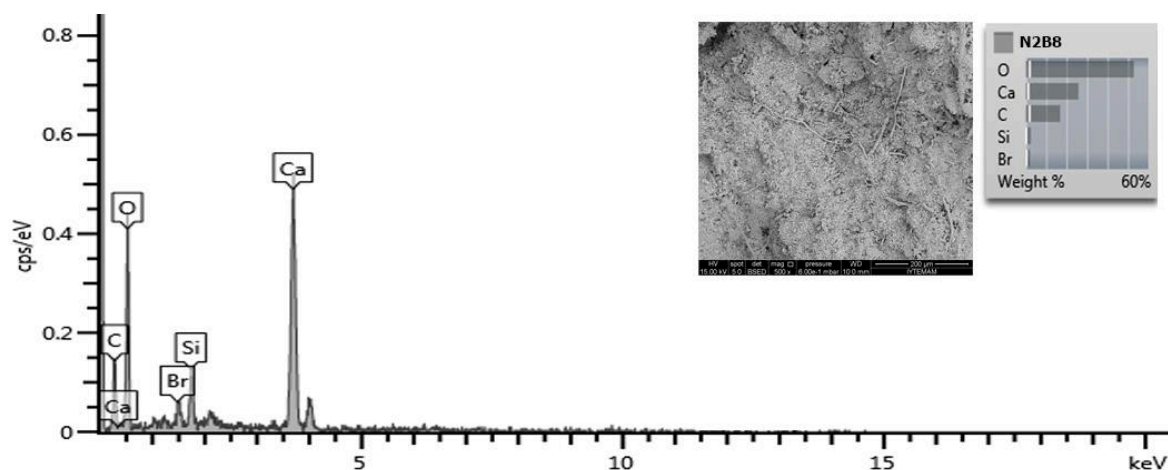
**Diagram 4.82:** EDX analysis of lime samples taken from Structure N2B8

SEM images of lime samples show scalenohedral, prismatic, granular and acicular crystals. The minerals surrounding these tubes are generally sharp-tipped and needle-shaped crystal structures of aragonite. (Figure 4.322) Scalenohedral-shaped calcium carbonate minerals clearly observed surrounding the tubes left by organic remains. Their EDX analysis identified O (52.81%), Ca (25.76%), C (16.89%), Si (2.47%), and Br (2.06%) elements. (Diagram 4.82)

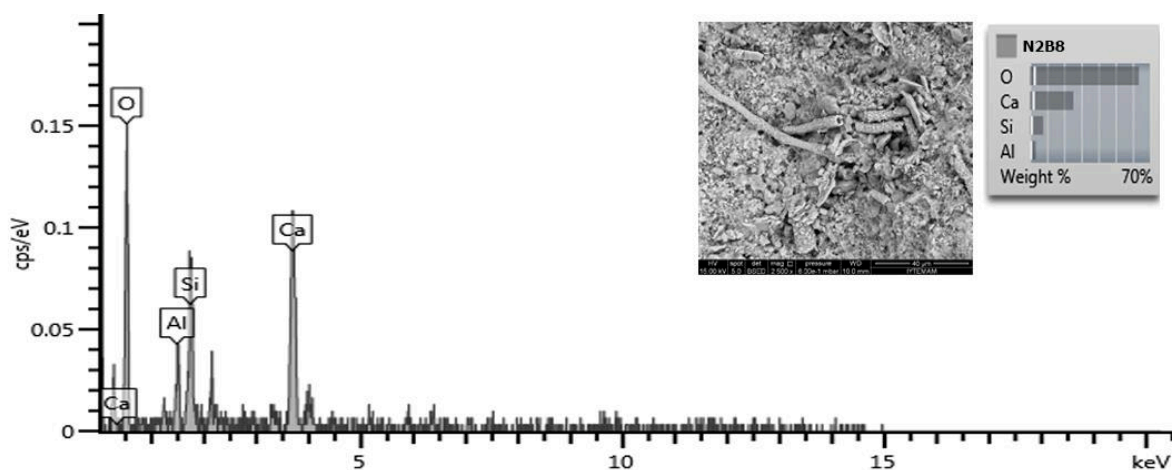
**Diagram 4.83:** EDX analysis results of tubes found in lime samples from Structure N2B8

Analysis of minerals surrounding the tubes by the EDX method comply with each other. EDX analysis identified O (%63,52), Ca (%25,31), Si (%7,74) and Al (%3,43) elements of this sample. (Diagram 4.83; Figure 4.322c-d)

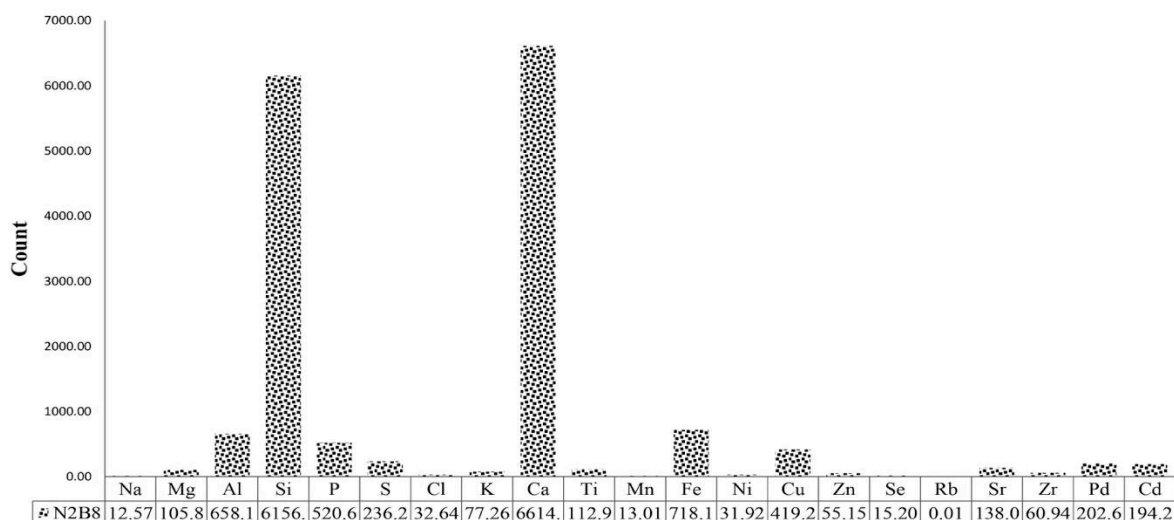
**Diagram 4.84:** XRF analysis of the lime samples taken from Structure N2B8

Investigation of the same samples with XRF analysis found the elements Si (38%), Ca (40%), Fe (4%), Al (4%), and P (3%), per the EDX analysis. Trace amounts of Ni, Zn, Sr, Rb, Na, K, S, Pd, Cl, Cu, and Ze elements were also identified. (Diagram 4.84) The lime

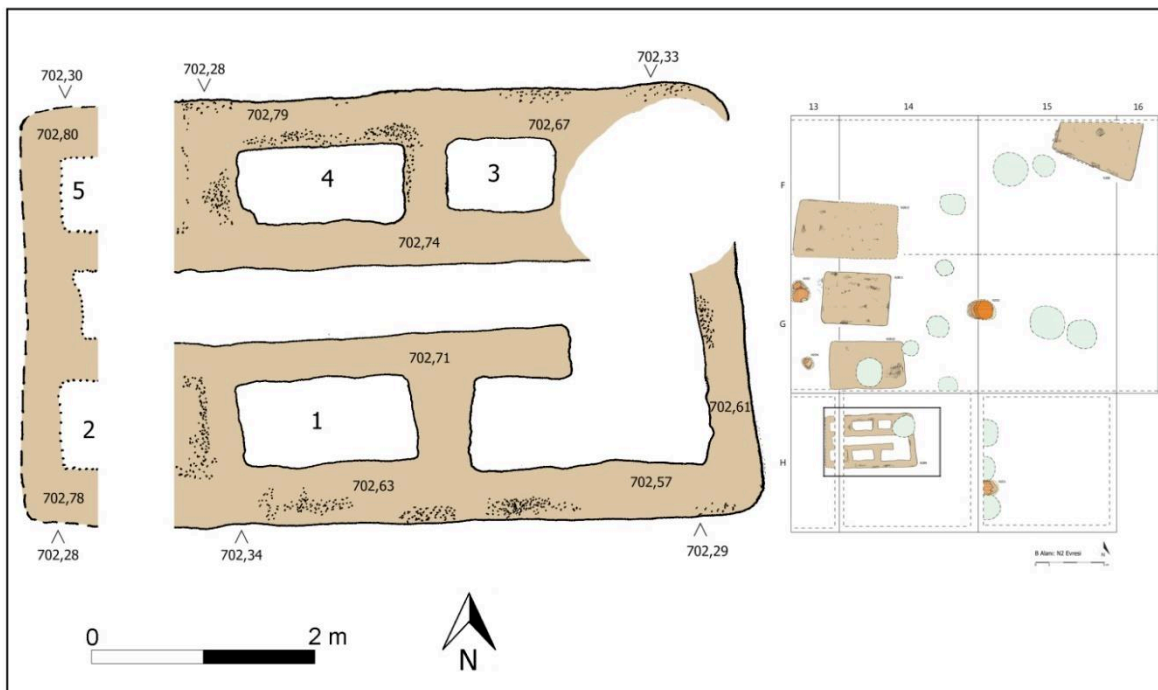
**Figure 4.74:** Location and plan of Structure N2B9

The structure is 610 cm long in the east-west direction, and is 337 cm wide in the north-south direction. Covering an area of nearly 21 m<sup>2</sup>, the cells of the structure are 65x98 cm and 76x163 cm in size and have mean area of 1 m<sup>2</sup>. However, the cells on the north side are smaller. There is no very significant difference in the thickness of the bearing and partition walls, the bearing walls are 42-45 cm and the partition walls are 29-46 cm.

The Cell Building has three cells along the north wing and two cells on the south side with an L-shaped corridor in between having the dimensions of 564 cm long and 62 cm wide. (Figure 4.74, 4.204) It appears the south end of the L-shaped corridor was partly divided. There might be a cell in this area but, the data allowing determination of a cell were insufficient.

The structure has 3 small cells in different sizes. Especially, cell number 3 is much smaller than the others. There are no doorways identified between the cells. The cells and the corridor did not have any plaster floor remains or hardened floor levels.

Occasional lime fragments appear to have bound the walls. Continuing as weak and uncertain lines, their thickness varies from 1 to 2 cm. The internal fill of the walls is homogeneous reddish-brown with a very soft structure. Considering the architectural tradition and construction technology of Sumaki Höyük, both bearing walls and partition walls were constructed by the piled earth wall technique. However, considering the distribution of lime fragments found within the structure, it may be stated that the structure was covered with a light material.

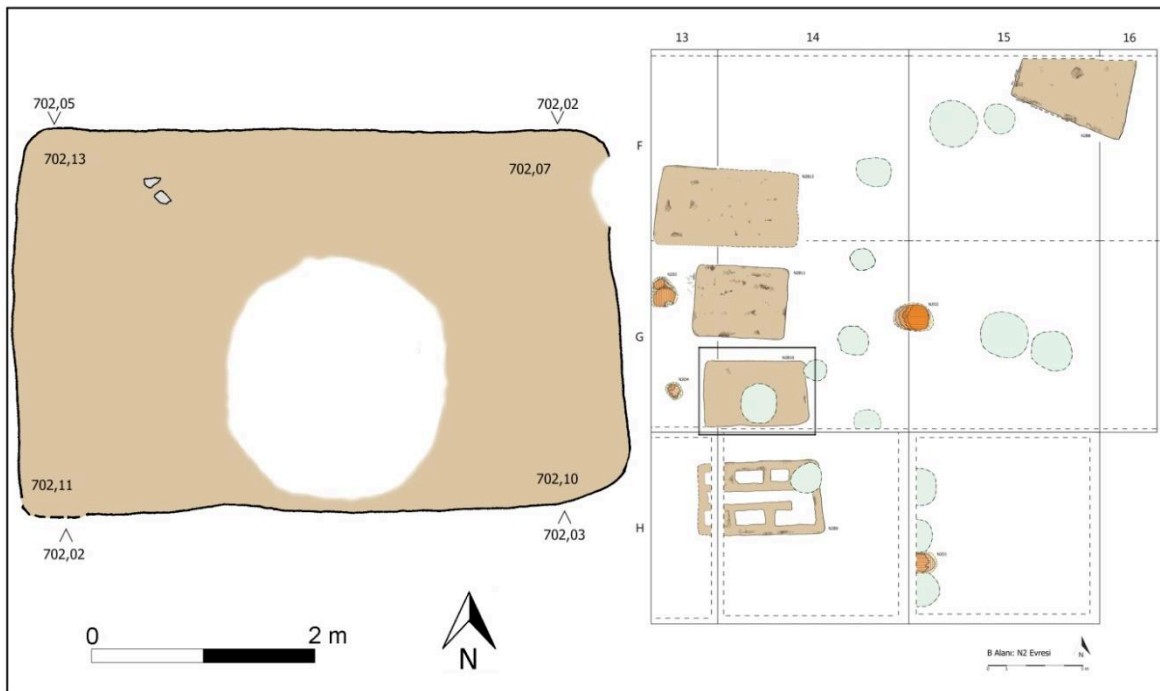
**Figure 4.75:** Location and plan of Structure N2B10

This is located in Area B in the south of trench 14G between the elevations of 702.02 to 702.13 meter. The structure was disturbed by a large and deep Middle Age pit. Based on the traces and general appearance, this building is classified as a single-roomed structure. (Figure 4.75, 4.205) As per this type, it was a temporary structure without walls, probably surrounded by reeds with flimsy upper cover.

The structure was constructed on the north slope of a natural terrace with east-west orientation. The structure is 532 cm long in the east-west direction and is 319 cm wide in the north-south direction. (Figure 4.345) Covering an area of nearly 17 m<sup>2</sup>. The limits of the structure were determined by traces of light reddish-brown soil. This structure with a rectangular plan and single large room did not have any plaster floor remains or hardened floor surface or partition walls.

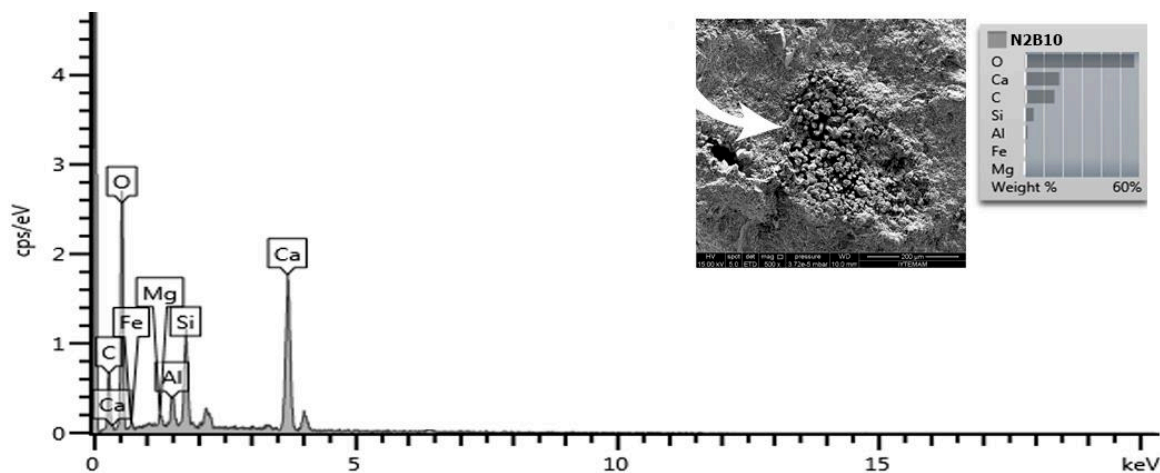
**Diagram 4.85:** EDX analysis of lime samples taken from Structure N2B10

SEM images of the lime sample taken from the fills observed scalenohedral and granular crystals. Investigation of the same lime samples with EDX analysis identified the elements O (57.47%), Ca (18.28%), C (15.71%), Si (4.93%), Al (1.61%), Mg (0.66%), and

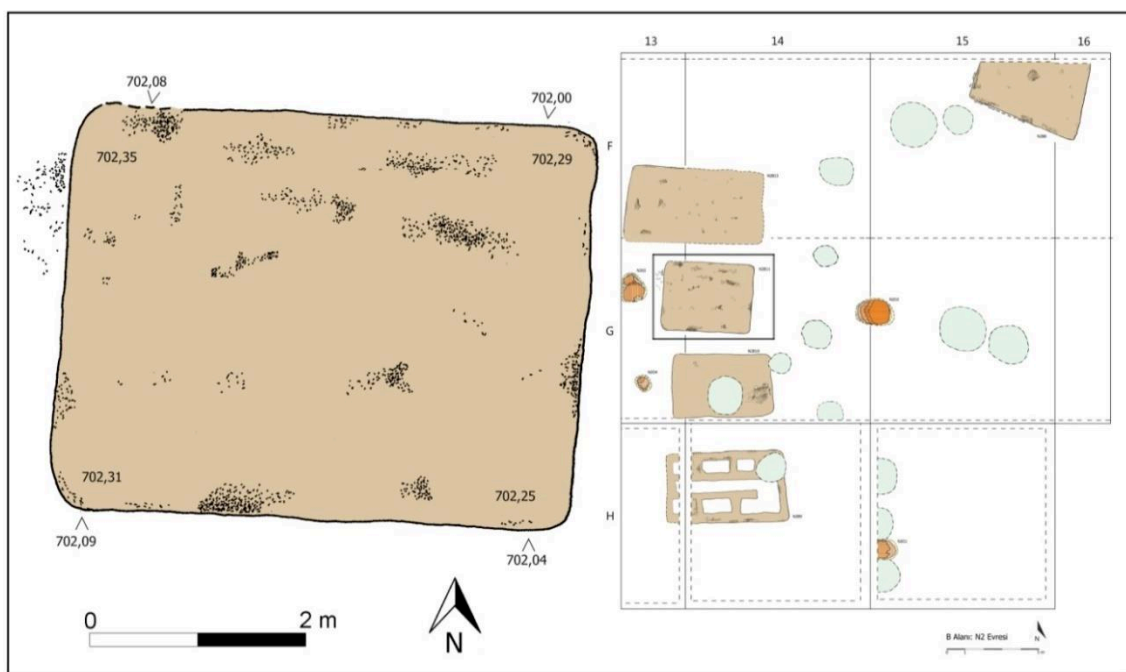
**Figure 4.76:** Location and plan of Structure N2B11

This is located in Area B in the south of trench 14G between the elevations of 702.00 to 702.35 meter. Based on the traces and general appearance, the structure is classified as a single-roomed structure. (Figure 4.76) As per this type, it was a temporary structure without walls, probably surrounded by reeds with flimsy upper cover.

The structure was constructed on a natural terrace with east-west orientation. It is 490 cm long in the east-west direction and is 374 cm wide in the north-south direction. Covering an area of nearly 18 m<sup>2</sup>. (Figure 4.346) The limits of the structure were determined by very thin, traceable lime lines and light reddish-brown fill. This structure with a rectangular plan and single large room did not have any plaster floor remains or hardened floor surface or partition walls.

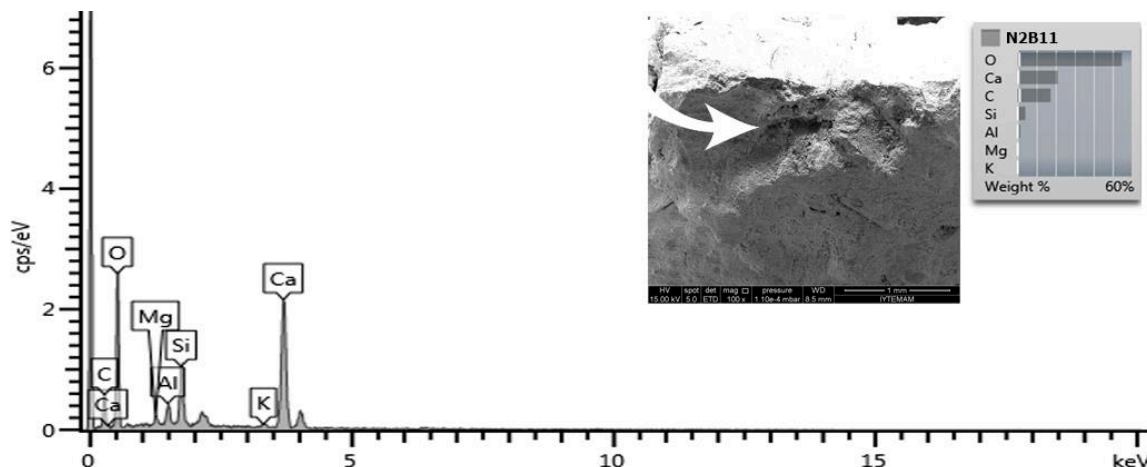
Diagram 4.86: EDX analysis of lime samples taken from Structure N2B11

SiO<sub>2</sub> gels filling the organic cavities are observed on their SEM images. (Figure 4.323d) The clearest is silicon dioxide gel filling a *Panicum* plant remnant. EDX analysis of these lime samples identified O (54.89%), Ca (21.12%), C (17.43%), Si (4.13%), Al (1.38%), Mg (0.64%), and K (0.40%) elements. (Diagram 4.86)

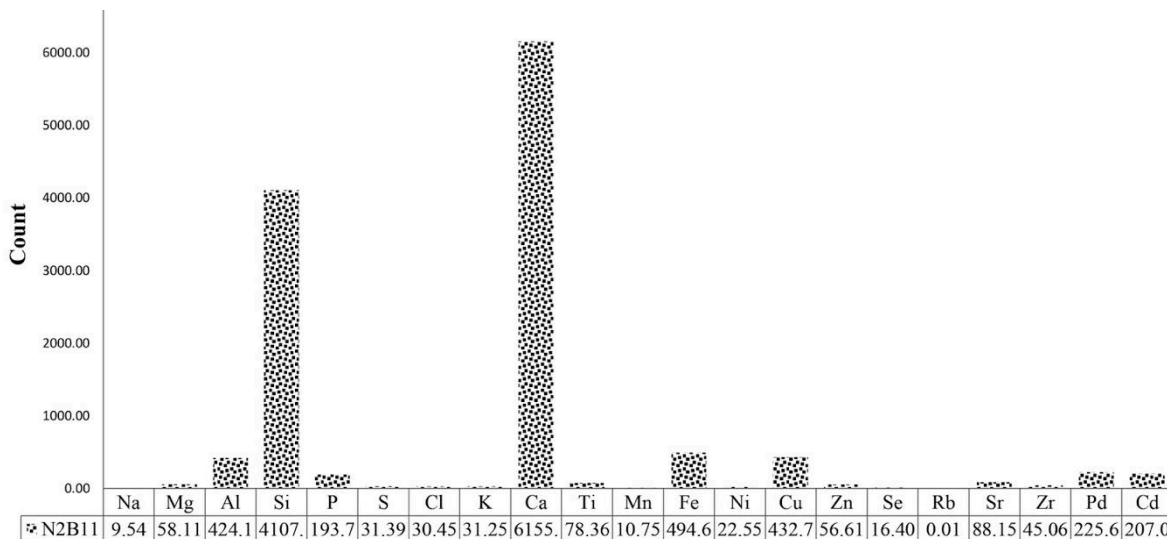
Diagram 4.87: XRF analysis of the lime samples taken from Structure N2B11

XRF analysis of lime samples observed the following elements dominating; Si (32%), Ca (48%), Fe (4%), Al (3%), Pd (2%), and Cd (2%), together with very small amounts of Ni, Zn, Sr, Rb, Na, K, S, Pd, Cl, Cu, and Ze. (Diagram 4.87)

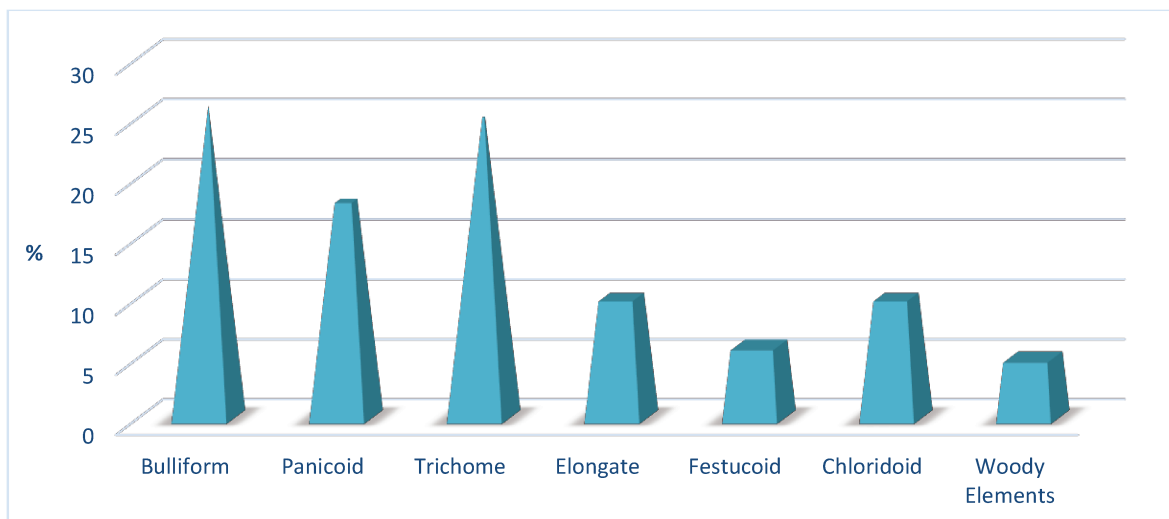
**Diagram 4.88:** Distribution of phytoliths in the lime samples taken from Structure N2B11

Phytolith analysis of lime samples identified reed or woody plant remains. The phytoliths contained high frequencies of *Trichome*, *Bulliform*, and *Panicoid* forms. *Chloridoid*, *Elongate*, *Festucoid*, and *Silicified Woody Forms* were also identified. *Chloridoid* phytoliths have a subtype form, and *Panicoid* phytoliths have short-shafted forms. *Trichome* phytoliths have long pointed tips. (Diagram 4.88; Figure 4.325 - 4.330)

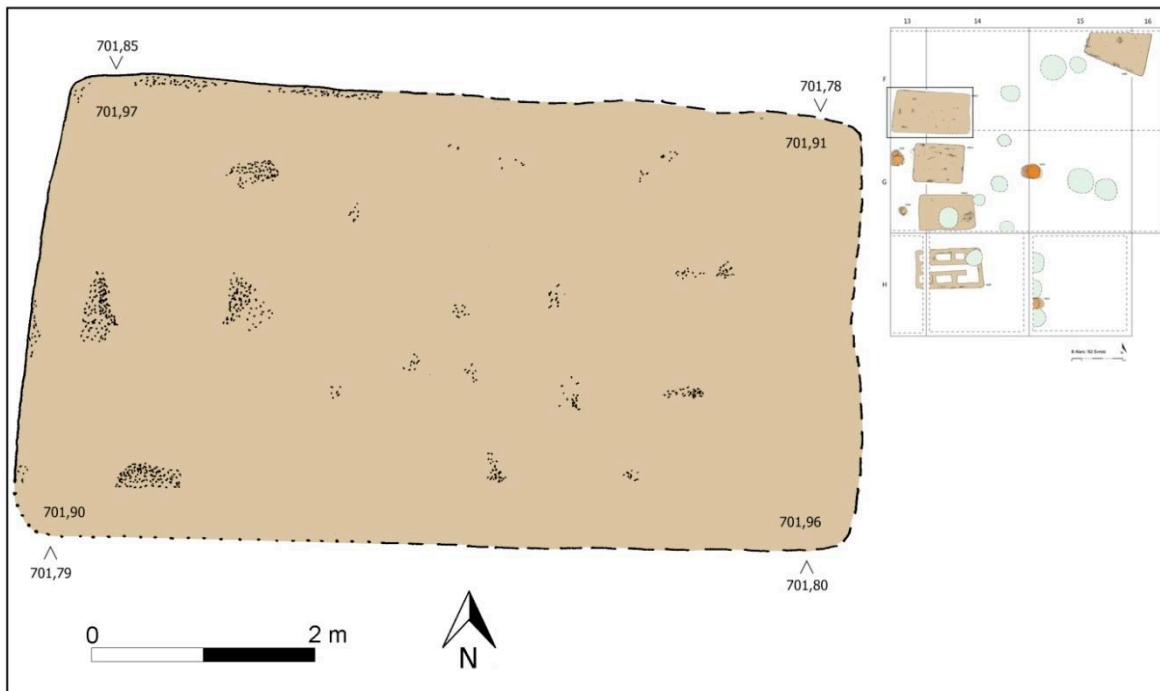
Figure 4.77: Location and plan of Structure N2B12

This is located in Area B in the south sections of trenches 14F and 13F between the elevations of 701.78 to 701.94 meter. Based on the traces and general appearance, the structure is classified as a single-roomed structure. (Figure 4.77, 4.206) As per this type, it was a temporary structure without walls, probably surrounded by reeds with flimsy upper cover.

N2B12 was constructed on a natural terrace sloping slightly to the south with east-west orientation. The structure is 745 cm long in the east-west direction and is 403 cm wide in the north-south direction. (Figure 4.347) Covering an area of nearly 30 m<sup>2</sup>. The limits of the structure were determined by very thin occasionally traceable lime lines and light reddish-brown fill. This structure with a rectangular plan and single large room did not have any plaster floor remains or hardened floor surface or partition walls.

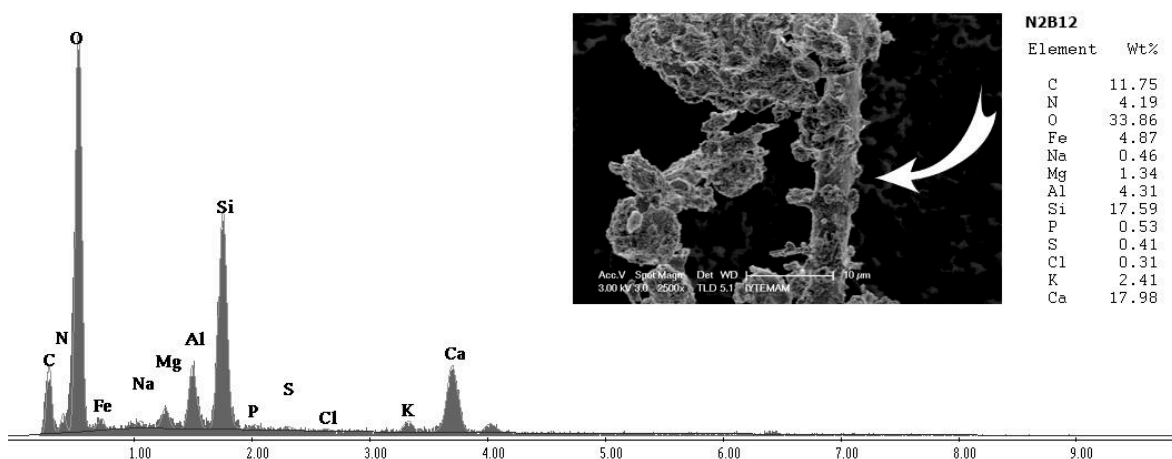
Diagram 4.89: EDX analysis results of calcareous soil samples taken from Structure N2B12

SEM images of lime samples taken from structures revealed granular and laminar crystal structures along with acicular-shaped crystals. Sharp-tipped or needle-shaped crystals are generally aragonite. (Figure 4.324) Besides SiO<sub>2</sub> gels filling the rod-like organic remains are observed on SEM images of the lime samples. The clearest is silicon dioxide gel filling a *Panicum* plant remnant. (Figure 4.324c) EDX analysis of these lime samples identified the elements O (33.86%), Ca (17.98%), C (11.75%), Si (17.59%), Al (4.31%), and Fe (4.87%). N, Na, Mg, P, S, Cl, and K were also identified at rates from 4% to 0.31%. (Diagram 4.89)

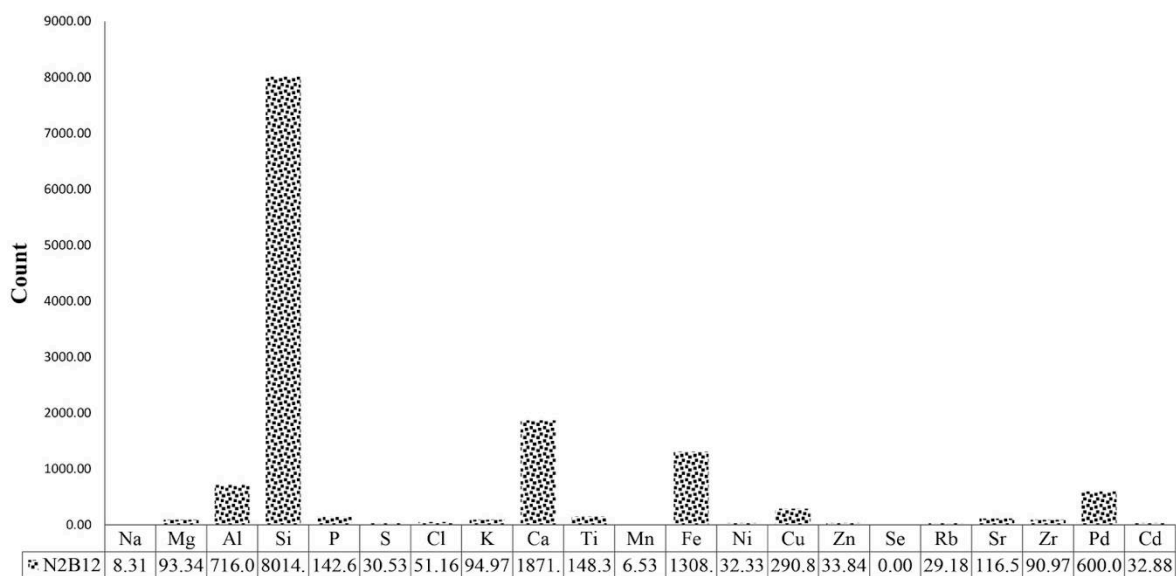
**Diagram 4.90:** XRF analysis of the soil samples taken from Structure N2B12

Investigation of lime samples with the XRF method observed the elements Si (58%), Ca (14%), Fe (10%), Al (5%), Pd (4%), and Cu (2%), together with very small amounts of Ni, Zn, Sr, Rb, Na, K, S, P, Cl, and Ze. (Diagram 4.90) Their XRD analysis identified calcite minerals and organic carbon minerals such as graphite, sphalerite, and dolomite. Their chemical composition is calcium carbonate, zinc sulphide, carbon, and calcium magnesium carbonate compounds. (Diagram 4.126)

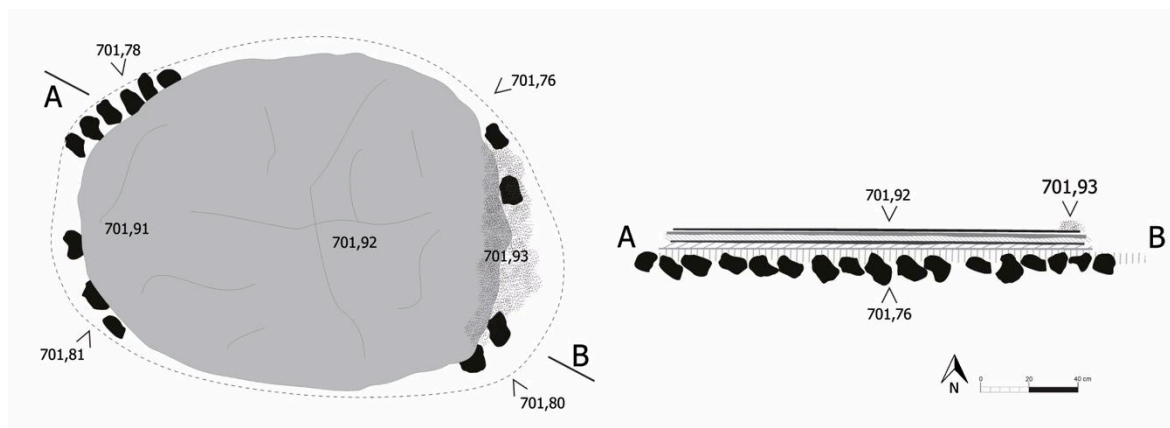
**Figure 4.78:** Hearth N2O2 and its cross-section

The hearth was located in an open space at the edge of the eastern profile of trench 14G in Area B. The hearth was constructed on the dark grey ashy soil containing scattered lime particles. It covers an area of approximately 2.2 m<sup>2</sup> between the elevations of 701.76 to 701.92. It had four superimposed plastered floors with a single stone pavement. The hearth slightly inclined to the west. (Figure 4.78, 4.252 – 4.254)

The oval-shaped hearth was 190 cm long in the east-west direction and was 134 cm wide in the south-north direction. The pavement, which was made of basalt and pebbles of different sizes between 3x5x8 - 5x7x15 cm was under the first plastered floor. Between the stone pavement and the first plastered floor was a layer of orangish buff-coloured filling with low stone content about 5-6 cm in thickness. The first plastered floor was a yellowish grey colour with locally dully grey-coloured traces due to burning in 1 cm thickness. After its usage, buff-coloured a stone-tempered 2 cm-thick filling was laid on the first floor, then the 2<sup>nd</sup> floor was plastered. This one was a grey colour 1.5 cm in thickness. On the second floor, a heterogeneous yellowish buff-coloured sandy 1-1.5 cm-thick filling was laid, and the 3<sup>rd</sup>

floor was plastered. This floor was a yellowish grey colour about 2 cm in thickness. Hereafter, the last renewal floor of the hearth was made directly on the 3<sup>rd</sup> floor without any filling. The last floor was a light grey colour. Except for the first floor with medium-hard and densely cracked appearance, all the surfaces of the plastered floors were very hard with local cracks.

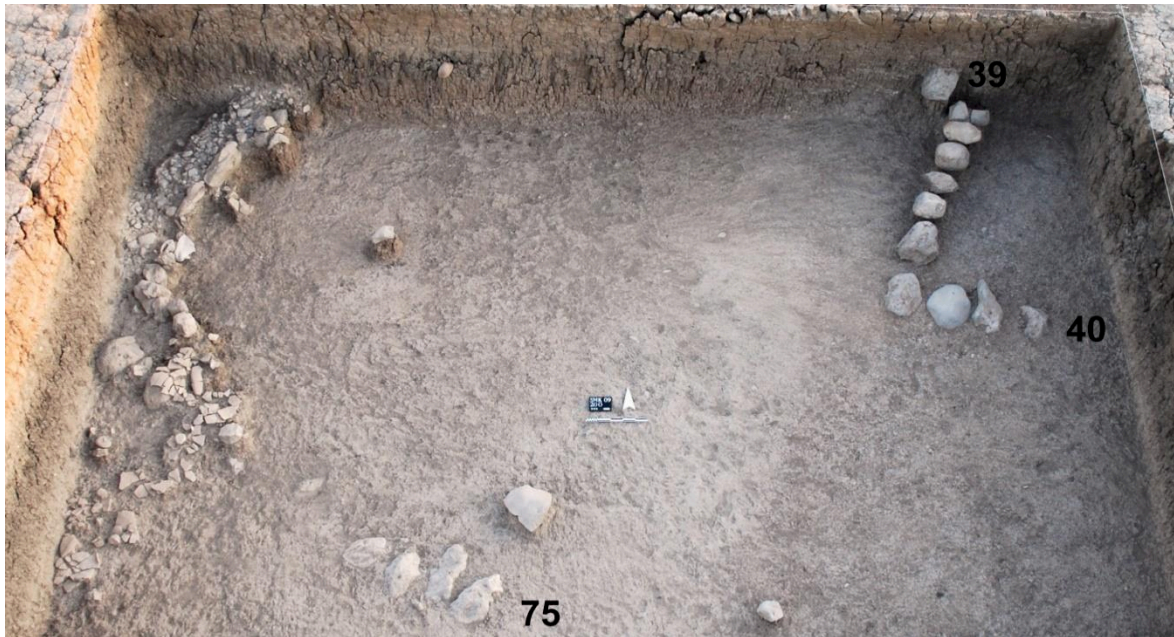
**Figure 4.79:** Stone rows from Phase N1

The architectural tradition in this phase is different to nearly all of the previous phases. In this phase, stone walls and rows are dominant in almost all exposed areas. Together with walls/rows belonging to more than one structure, the structural plans and measurements are uncertain. In some areas at least, the rows/walls with corners may be determined as belonging to rectilinear structures. (Figure 4.79) Apart from these, stone rows are observed in different areas. Broken grinding stones from previous phases were reused in stone walls or rows. (Figure 4.80) In the area inside the stone rows, uncertain reddish-brown traces and occasional lime fragments were identified. Since the edges of these traces are not precise, as in the Single-roomed Structures identified in previous phases, these stone rows were not included in the structural classification. Additionally, as some of these stone rows are at the edge of and above the fill from Phase N2 structures, it may be considered that these structures were repaired and reused in this phase. Possibly, these stone rows and walls are the remains of temporary shelters covered with a tent, or tent-like material as upper cover, having surroundings made of thin reeds/branches, and the rows of stones.

This is located in Area A in the northeast section of trench 20/O between the elevations of 700.75 to 701.03. This row with corner turns slopes slightly to the east. Probably surrounding the south and west of a structure, its west section is Stone Row Number 39, and its southern part is Stone Row Number 40. (Figure 4.79, 4.85)

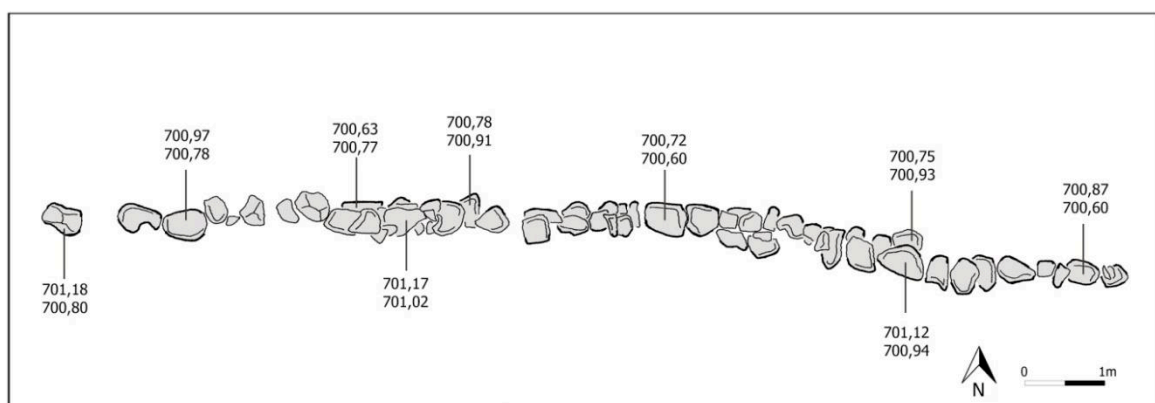
**Figure 4.81:** Number 6 Stone Row / Wall

Located in Area A in the central part of trenches 20M and 21M, this extends in an east-west direction and makes a slight curve toward the southeast in trench 20M then continues. (Figure 4.81, 4.192) Its western part is between the elevations of 700.80 – 701.18, while its eastern section is between the elevations of 700.54 – 700.87. Built according to the slope of the natural surface, and inclined slightly to the east, it has a length of nearly 14 m in an east-west direction and 28-47 cm width. Extending as a single row and at single stone height, this row/wall occasionally reached 3 or 4 stone height.

There is no corner turn identified to its west or east. No association with any structure was determined. In its construction, natural basalt along with whole and broken ground stones were used. Grinding stones belonging to previous phases found a secondary use. There are no *in situ* grinding stones in this phase. The robust and scattered stony fill under the row/wall was spread over nearly all areas of the Neolithic settlement. It was

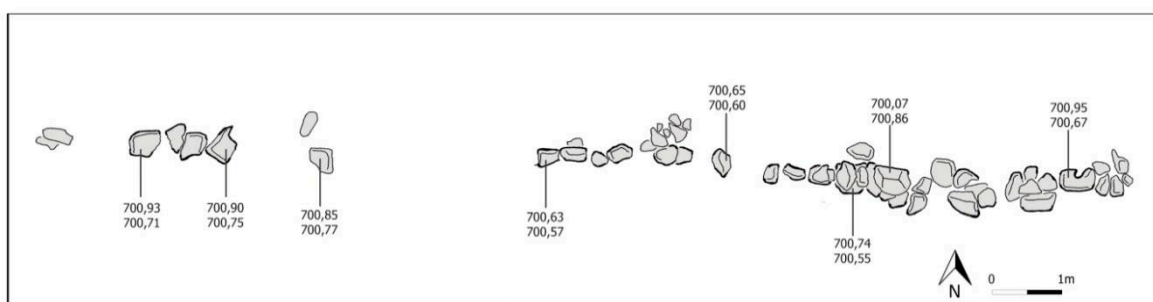
**Figure 4.82:** Number 7 Stone Row / Wall

Located in Area A in the centre of trenches 20M and 21M, and 20-35 cm north of Number 6 Stone Row/Wall, this wall extends in an east-west direction. In trench 20M, a nearly 4 m section appears to have been destroyed. (Figure 4.82, 4.192)

Its western part is 700.74 – 700.95 in elevation while its eastern part was identified to be at 700.55 to 700.97. Constructed on a stone-rich heterogeneous surface sloping slightly to the east, it is 16 m long in an east-west direction and 32-43 cm wide. Generally extending as a single row and at single stone height, it was identified to have some sections preserved to 3-4 stone heights, especially in the eastern part. No corner turn was identified at either end and it does not relate to any structure. Whole natural basalt and broken grinding stones were used in its construction.

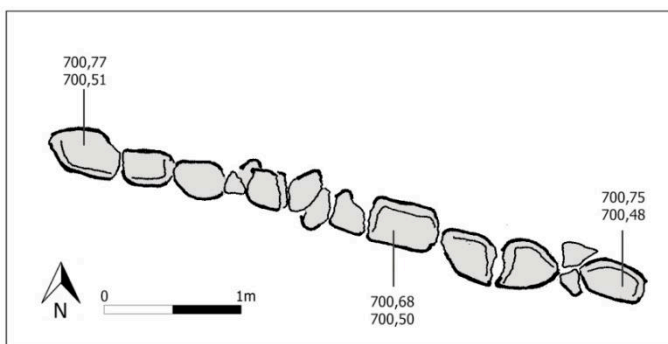
**Figure 4.83:** Number 12 Stone Row

Located in Area A in the centre of trench 21M, and 22-34 cm south of stone wall Number 6, this row extends in a southeast-northwest direction. (Figure 4.83, 4.192) Its western section is between the elevations of 700.51 to 700.77 while its eastern part is between the elevations of 700.48 to 700.75. This stone row was constructed on a compact heterogeneous fill on a depression area in the central section of Area A. It has a length of 447 cm in southeast-northwest direction and a width of 25-34 cm. Extending as a single row and at single stone height, no corner turn was identified. No association with any structure

was determined. In its construction, natural basalt along with whole and broken ground stones were used.

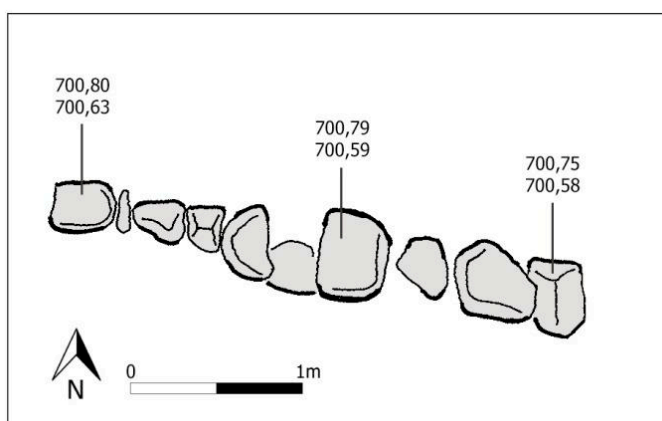
**Figure 4.84:** Number 38 Stone Row

Located in Area A in the northeast of trench 20M and southeast of trench 20L, this row extends in a southeast-northwest direction between the elevations of 700.58 to 700.80. It was constructed on a compact heterogeneous fill, similar to the other rows in the same area. In its construction, natural basalt along with whole and broken ground stones were used. The row is 319 cm long in southeast-northwest direction and is 21-48 cm in width. (Figure 4.84)

Extending as a single row and at single stone height, no corner turn was identified. No association with any structure was determined. However, there are occasional reddish-brown traces and scattered lime fragments determined in the northern section. This row might form the north boundary of a structure, but the reddish-brown soil traces do not represent a fill of a structure.

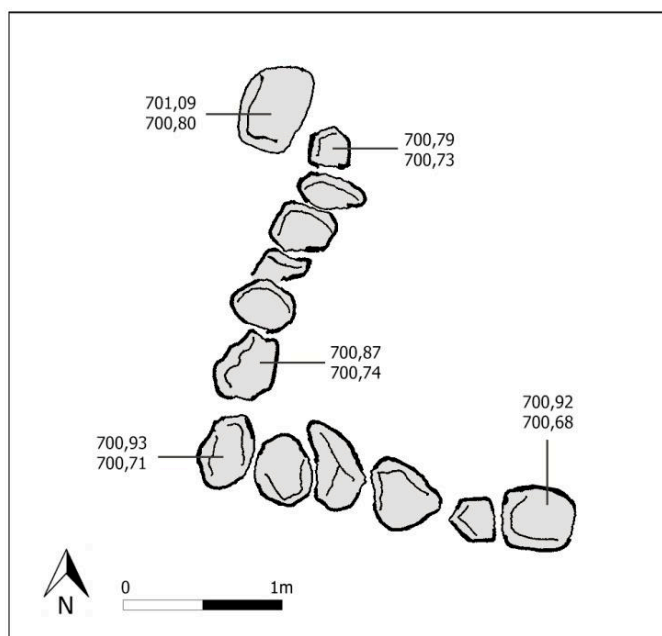
**Figure 4.85:** Number 39-40 Stone Rows

The first one is 232 cm long in the southwest-northeast direction and is 21-37 cm in width. Stone row Number 40 is 242 cm long in the exposed area in a northwest-southeast direction and is 25-44 cm in width. Constructed on a grey ash-poor and occasionally more or less stony fill both rows have wall pattern with a single row and at single stone height. Whole natural basalt and broken grinding stones were used in their construction. These stone rows surrounded the reddish-brown soil traces from south and west side. Since the limits of these traces were not precisely determined, the dimensions of the structure could not be clarified. These stone rows probably bounded only the southwest edge of a rectangular temporary structure while the rest is completed with perishable surroundings.

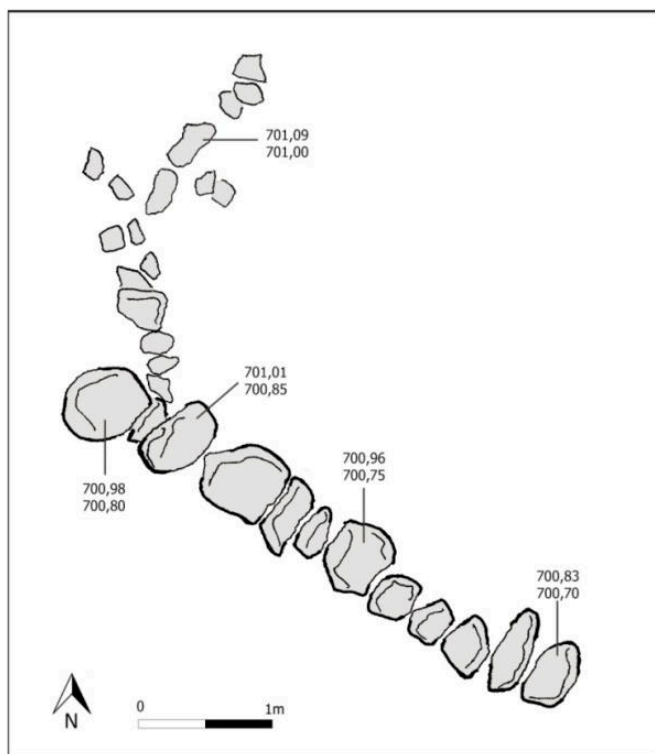
**Figure 4.86:** Number 75 Stone Row

fill the row is 434 cm long in the southeast-northwest direction and 32-35 cm wide. (Figure 4.86) There is a stone concentration in the northwest section of the row.

This stone-poor homogenous fill is directly related to the torrent that occurred after Phase N1. The stone has a single row and at single stone height. In its construction, natural basalt along with whole and broken ground stones were used. The stone row probably limits only the southern edge of a temporary structure while the rest is completed with perishable material. Our ethno-archaeological observations reveal the existence of temporary structures constructed of different material predominantly in the winter quarters such as Sulan Kom, Bazivan Kom, and Sulane Girgiz Kom.

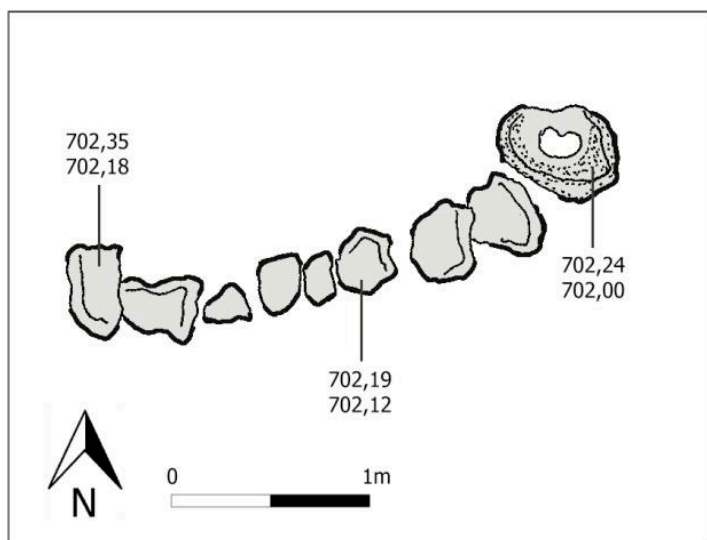
**Figure 4.87:** Number 28 Stone Row

Located in Area B in the southeast of trench 15H, this row extends in a southwest-northeast direction. Its northwest portion is between the elevations of 702.18 to 702.35 while the southeast part is between the elevations of 702.00 to 702.24. Constructed on a surface sloping slightly to the east, the row is 292 cm long and 24-53 cm wide. (Figure 4.87) Extending as a single row and at single stone height, this row was not identified to have

corner turns. In its construction, natural basalt along with whole and broken ground stones were used.

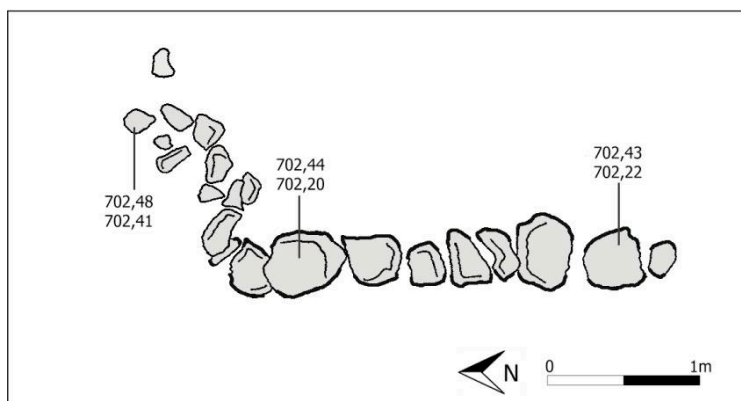
**Figure 4.88:** Number 32 Stone Row

This is located in Area B in the southern section of trench 13G between the elevations of 702.21 to 702.44. This stone row, which is extending in a north-south direction, was constructed on a surface sloping slightly to the south. Extending as a single row and at single stone height, it is 291 cm long in the north-south direction and is 25-51 cm wide. (Figure 4.88) There are very few stones identified in its northern part. In its construction, natural basalt along with broken ground stones, and large cobbles were used.

The stone row sits on a buff occasional grey ashy and stony heterogeneous fill. Immediately east of this row, light reddish-brown colour earth traces were identified,

however, their limits could not be determined. Probably, only the west edge of a rectangular temporary structure was bounded by the stone row, while the rest is completed with perishable material such as reeds or branches. Similar temporary structures were commonly observed in our ethno-archaeological field studies in the Lower Garzan Basin. The best examples were in the winter quarters Sulan Kom, Bazivan Kom, and Sulane Girgiz Kom. Stone rows identified in these winter quarters appear to be on the slope-side of the structures are similar to the stone rows of Sumaki Höyük. Probably more extensive material was preferred against slope flow.

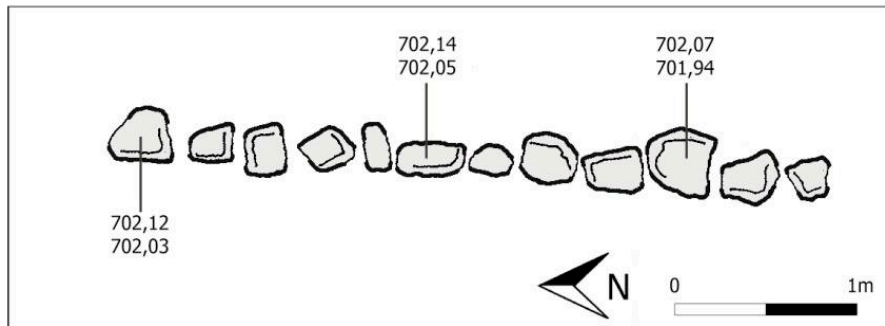
**Figure 4.89:** Number 33 Stone Row

This is located in Area B in the south section of trench 13F between the elevations of 701.94 to 702.14. The row was constructed on a surface sloping slightly to the north in a north-south direction. Extending as a single row and at single stone height it is 397 cm long in the north-south direction and is 18-37 cm wide. (Figure 4.89) In its construction, natural basalt along with broken ground stones, large cobbles, and limestone were used.

The row was laid on a buff colour occasionally grey ashy and stony heterogeneous fill in the north, and on reddish-brown occasionally limey homogeneous fill in the south. Immediately east of the row, light reddish-brown soil traces were identified. Since their definite boundaries could not be determined the dimensions of the structure could not be clarified. Probably, the west edge of a rectangular temporary structure was bounded by the stone row while the rest is completed with perishable material such as reeds or branches. Temporary structures made of different materials were commonly observed in our ethno-archaeological field studies in the Lower Garzan Basin.

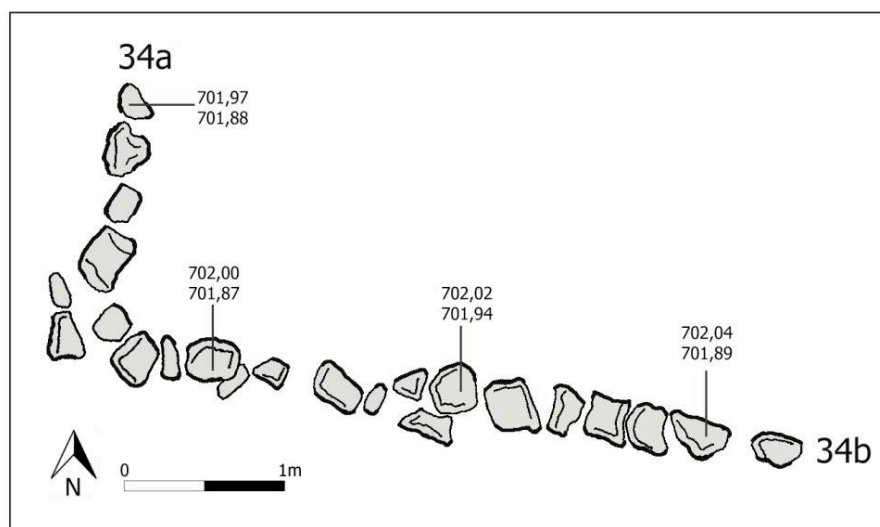
**Figure 4.90:** Number 34 Stone Row

This stone row is located in Area B in the north section of trench 13F between the elevations of 701.87 to 702.02. Its western part slightly sloping toward the east is 34a Stone Row, and the south section is Stone Row 34b. (Figure 4.90) Stone Row 34a is 171 cm long in a north-south direction and is 22-34 cm in width.

Stone Row 34b is 482 cm long in the east-west direction and is 19-35 cm in width. Both extend as a single row and at single stone height. In their construction, natural basalt was used. The rows sit on a heterogeneous buff-coloured, occasionally grey ashy and stony surface. Immediately east of it within the corner, reddish-brown colour soil traces were identified. Since their definite boundaries could not be determined the measurements of the structure could not be clarified. Probably, only southwest edge of a rectangular temporary structure was bounded by the stone row, while the rest is completed with perishable material such reeds or branches.

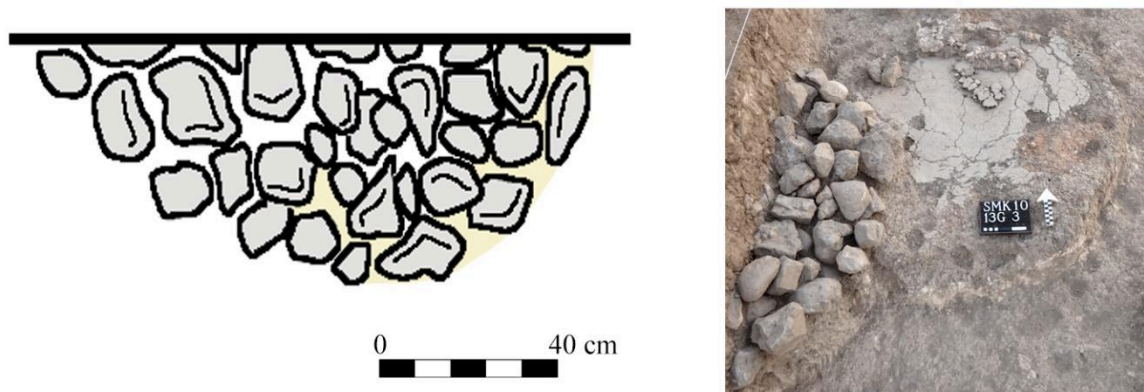
**Figure 4.91:** Number 4 Stone Pavement

This is located in Area B in the northwest of trench 13G immediately above the hearth N2O3 in an open area between the elevations of 702.52 to 702.80. It sits on a grey buff-coloured ash-poor stony fill. Its exposed eastern section is 140x55 cm in size while its western part remains outside the exposed area. (Figure 4.91, 4.258) The pavement is made of basalt and broken groundstone with a small amount of limestone with sizes from 8x10x15 to 14x20x25 cm. This stone pavement is partially different than the stone pavements of the

hearths. The rocks used in these stone pavements are more extensive than the stones used for pavements of the hearths. Besides, there were found no plaster traces. Therefore, its function was not defined.
