# Microarchaeological observation on the neolithic architectural structures and cultural landscape of Sumaki Höyük

# **Microarchaeological Observation on the Neolithic Architectural Structures and Cultural Landscape of Sumaki Höyük**

PhD Thesis

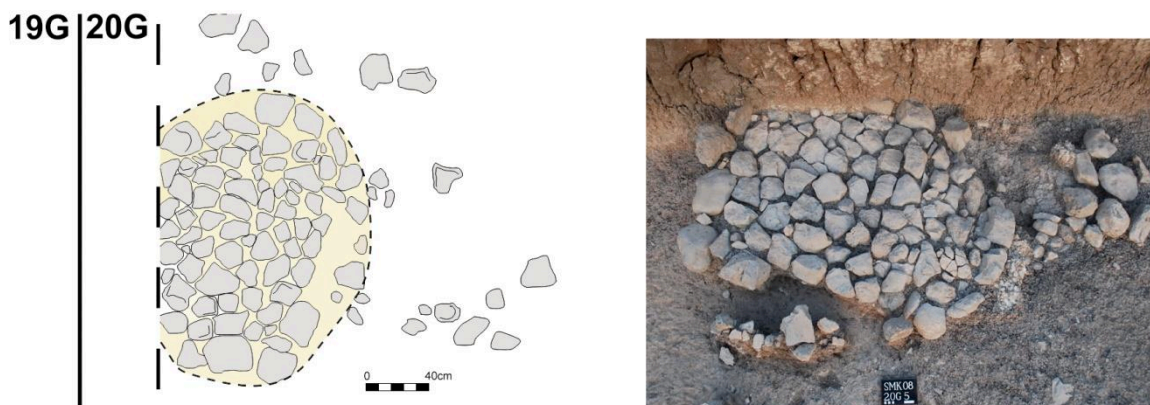
**Figure 4.92:** Number 5 Stone Pavement

This is located in Area C in the northwest of trench 20G, immediately above the hearths N2O4 and N2O5, in an open area between the elevations of 698.20 to 698.37. It was built on grey buff stone-poor fill. Its exposed eastern section is 188x134 cm in size while its western part remains outside the exposed area. The pavement was made of basalt and large pebbles with 6x7x12 - 15x21x29 cm in size. This stone pavement is partially different than the stone pavements of the hearths. (Figure 4.92, 4.258, 4.259) The stones used in these pavements are more extensive than the stones used for pavements of the hearths and have a different pattern; besides, there were found no plaster traces. Therefore, its function was not defined.

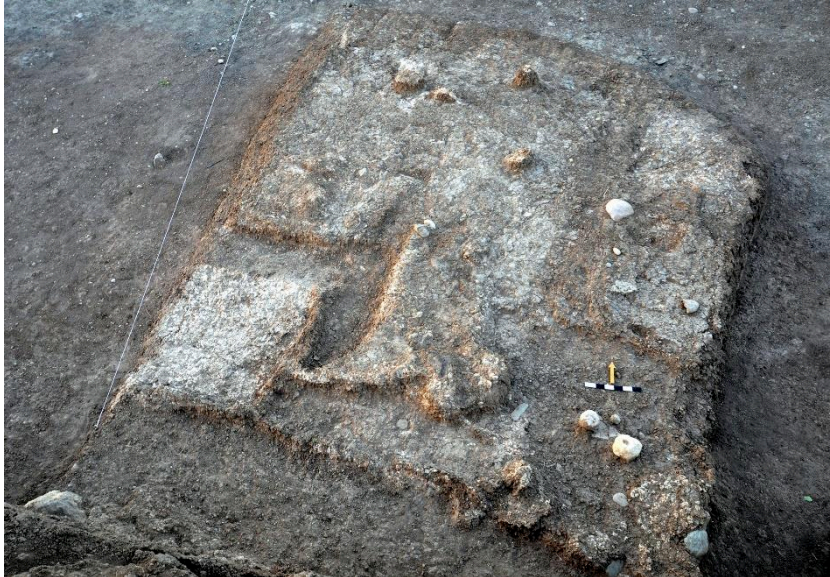
*Figure 4.93: Structure N6B1 from south*

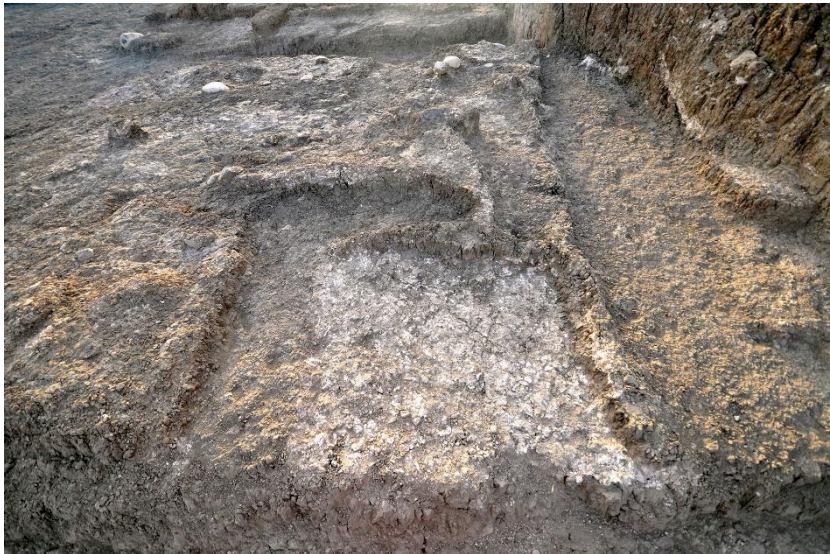
*Figure 4.94: Lime traces on the cell base of Structure N6B1*

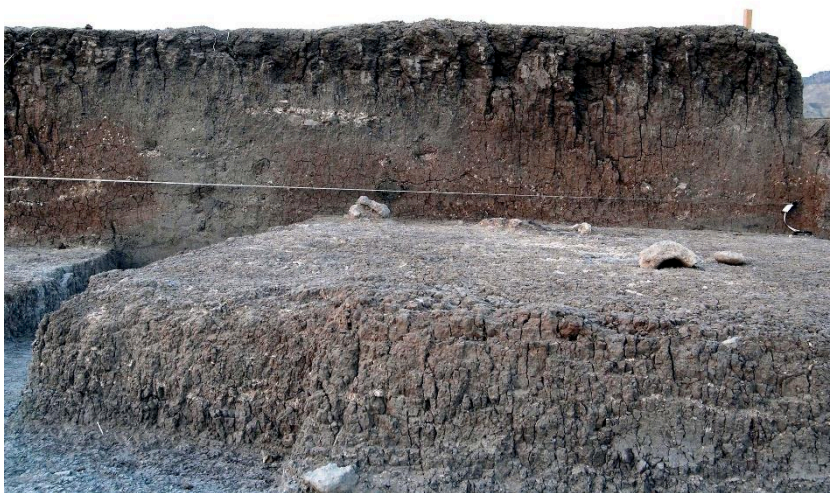
*Figure 4.95: Cross-section view of massive piled earth (Structure N6B1)*

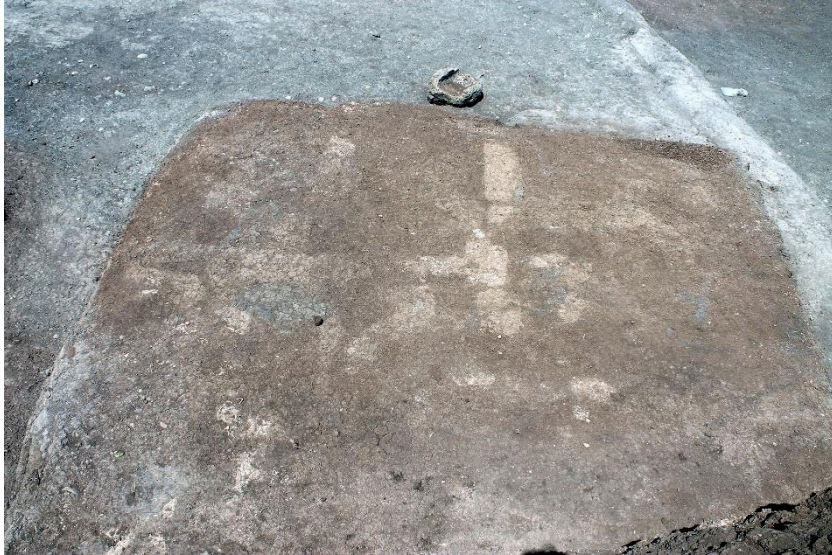
*Figure 4.96: Structure N6B2 from south*

The Cell Building has a corridor in the centre with traces of cells on either wing; however, the corridor plan has not entirely been identified. Occasional thin lime fragments appear to have bound the walls and the cells. The internal fill of walls is homogeneous reddish-brown loose earth. (Figure 4.96 – 4.98) There are no traces of plaster or mortar found

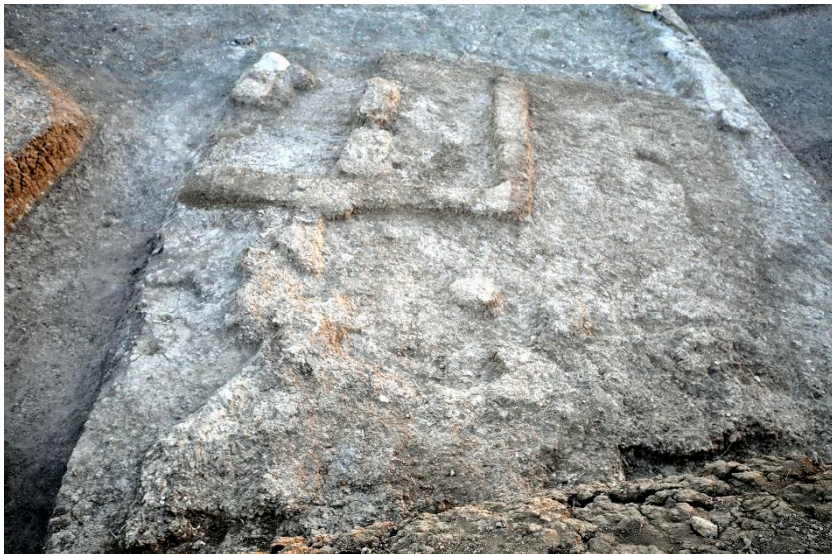
*Figure 4.97: Lime traces and piled earth / duripan (?) wall of Structure N6B2*

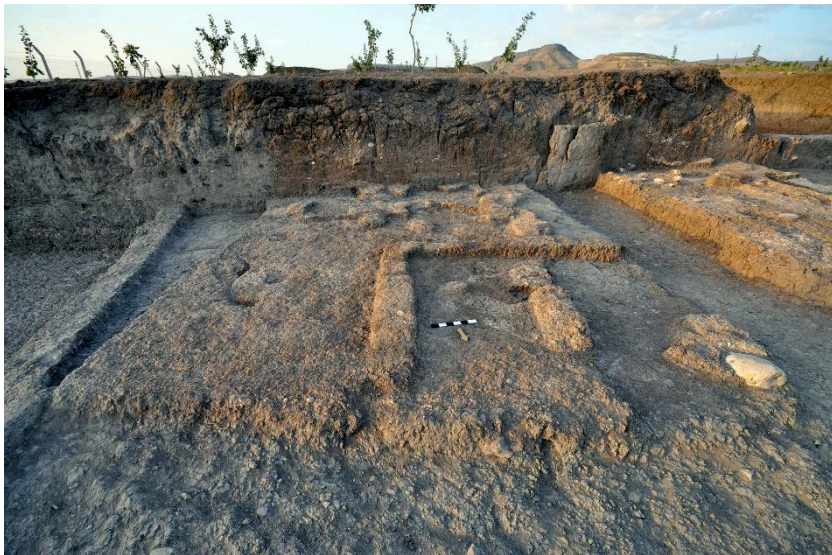
*Figure 4.98: Structure N6B1 from north*

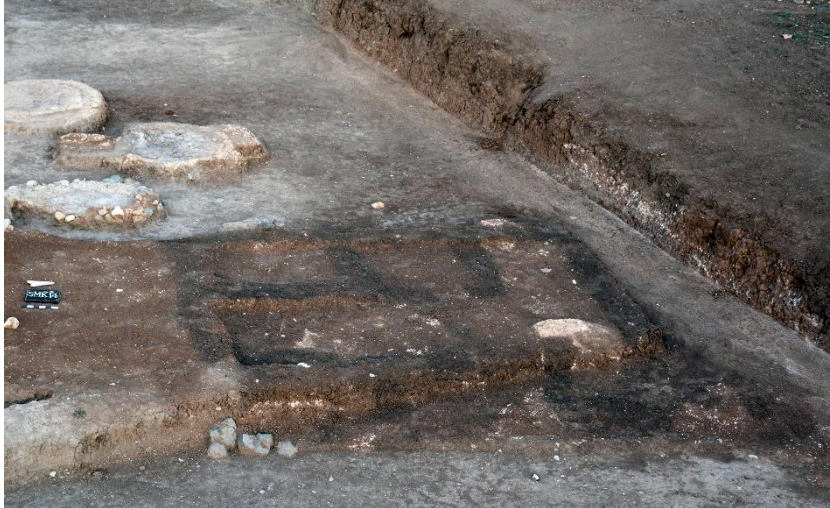
*Figure 4.99: Structure N6B3 from southeast*

The Cell Building has pairs of cells along the east and west wings with a T-shaped corridor in between having the dimensions of 320 cm long and 76 cm wide. The 'T' part of the corridor appears to be partially divided at its eastern end. Here might be a cell, as within the L-shaped corridor structures but data allowing determination of a cell plan were insufficient. (Figure 4.99 – 4.101)

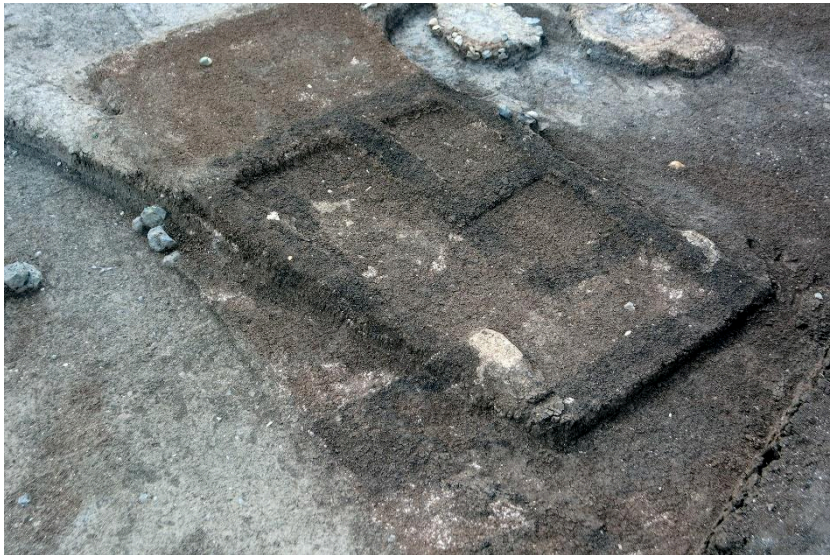
*Figure 4.100: Structure N6B3 from northeast*

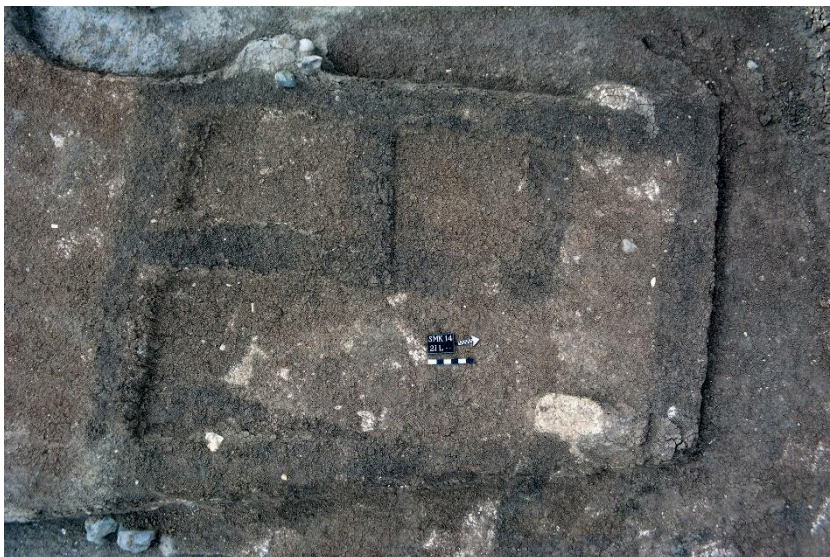
*Figure 4.101: Bird's-eye view of Structure N6B3 and its piled earth walls*

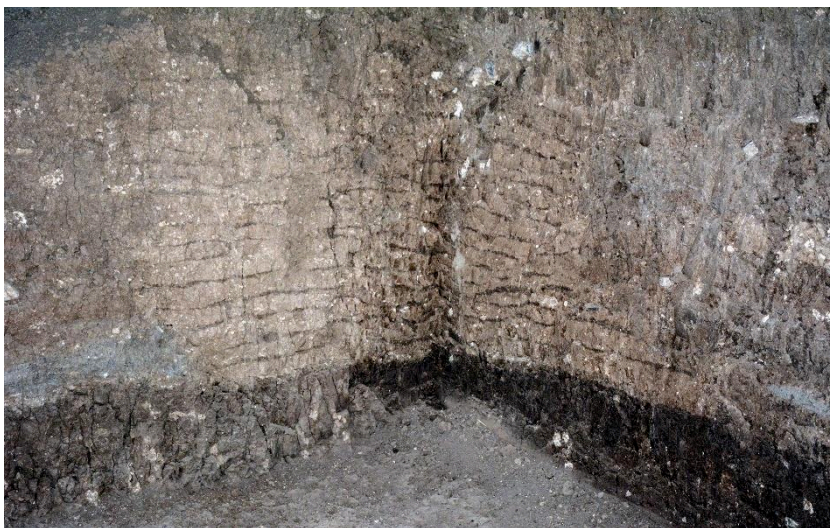
*Figure 4.104: Cross-section of massive piled earth (Structure N6B4)*

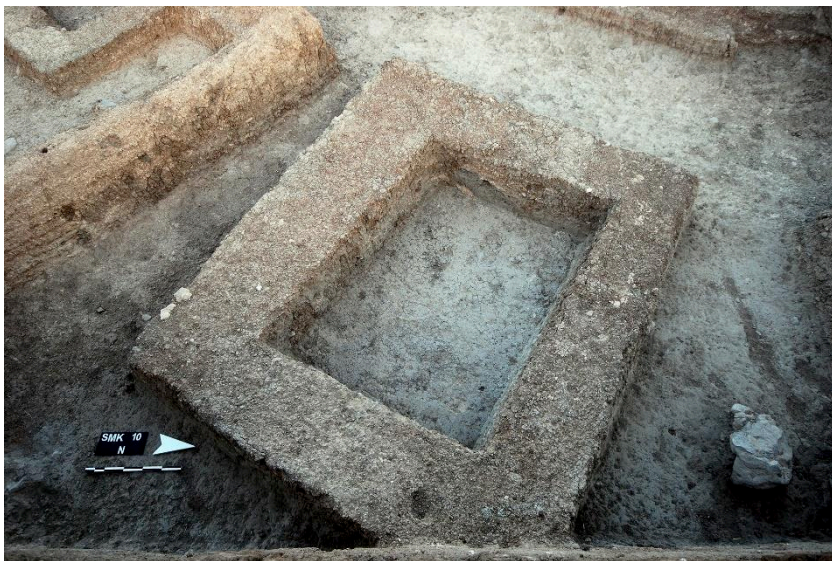
*Figure 4.111: Trace of Structure N6B7*

The internal fill of the structure is grey-buff occasionally limey. The large stone in the southeast corner of the structure is thought to have been used as a wall support or as a weight holding an upper light cover. (Figure 4.111, 4.112) A similar stabilization technique was also identified during ethno-archaeological field studies in the Lower Garzan Valley: a thread-like material tied to a stone to keep the light top cover is less affected by external factors such as wind, etc. Probably this stone had the same function. At 6-10 cm intervals in the wall section, calcified surfaces were also identified. These calcified surfaces, which continue irregularly between the layers, did not have mortar characteristics. The homogeneous reddish-brown filling of the walls is very loose. Considered with the architectural tradition and construction technology of Sumaki Höyük, the Structure N6B7 were constructed by the piled earth technique.

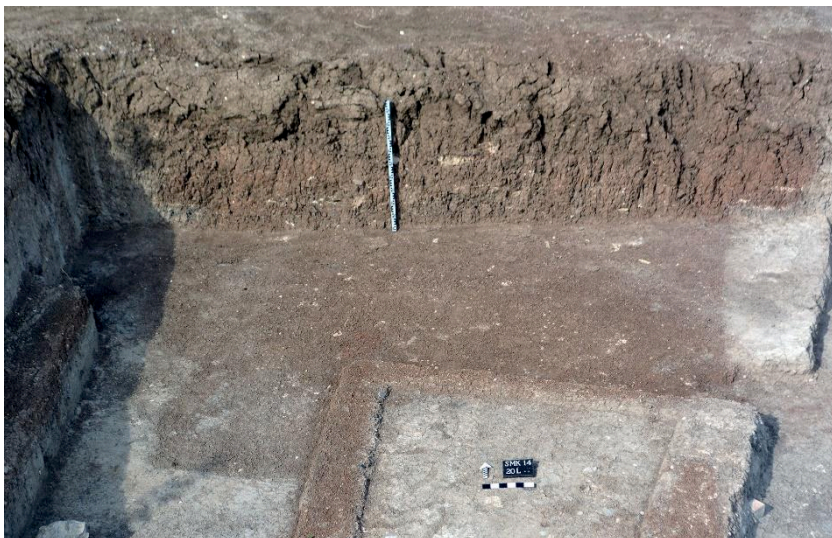
*Figure 4.112: Massive piled earth walls Structure N6B7*

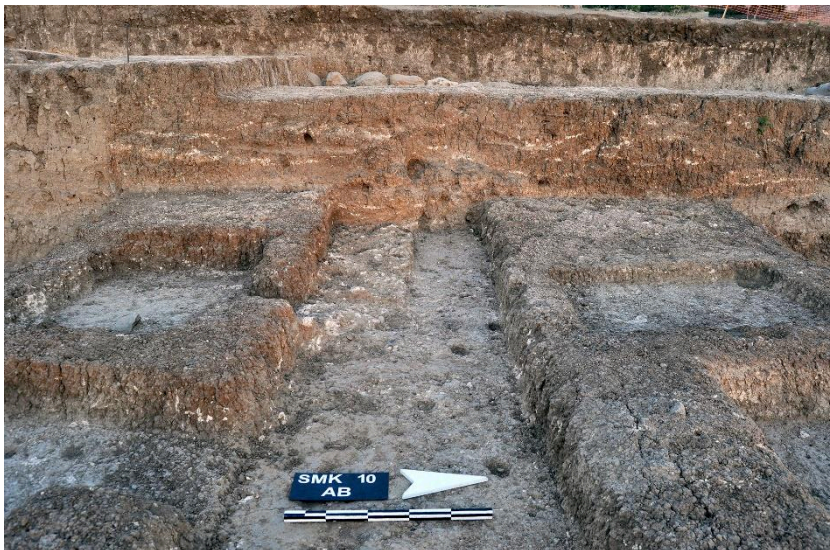
*Figure 4.117: Lime traces on the cells and corridor base of Structure N6B9*

the structure. (Figure 4.117 – 4.119) As mentioned above, these lime surfaces are directly related to the evaporation and calcification process of organic construction material. There were no any artefacts found within the fill or on the lime surfaces of the cells and the corridor. Therefore, the structure might have been cleaned before being left. The internal fill of the cells is very similar to the outer areas with a grey colour and low ash content but a lot of lime fragments. There are no graves found within the cells or under the floor levels.

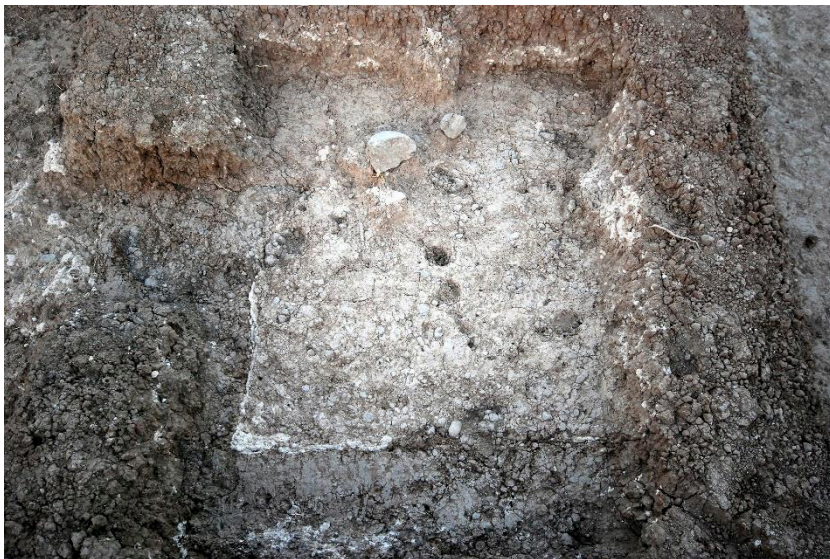
*Figure 4.118: Cross-section view of massive piled earth (Structure N6B9)*

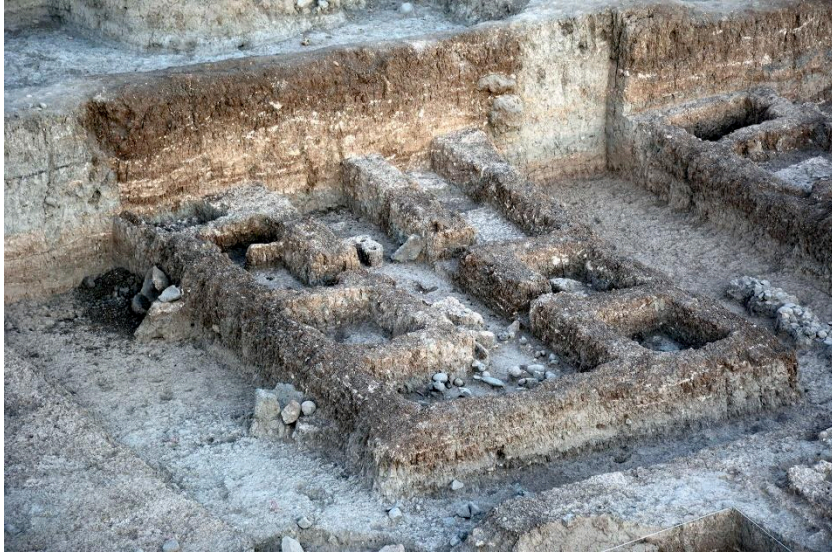
*Figure 4.119: Lime traces on the cell base and earth wall edge of Structure N6B9*

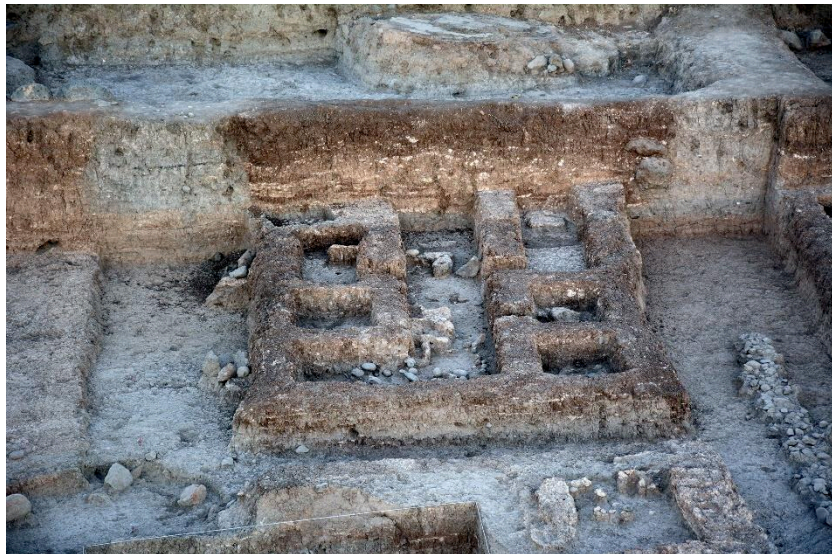
*Figure 4.120: Structure N6B10 from southwest*

The Cell building has two cells along the south wing and three cells on the north side with an L-shaped corridor in between having the dimensions of 363 cm long and 59 cm wide. (Figure 4.120 – 4.122) The rectangular cells have the dimensions of 54x110 cm and 64x85 cm with mean sizes of 0.60 m<sup>2</sup>. Except one, doorways were identified in the other cells with a width of 27-32 cm. There were no graves found within the cells or under the floor levels.

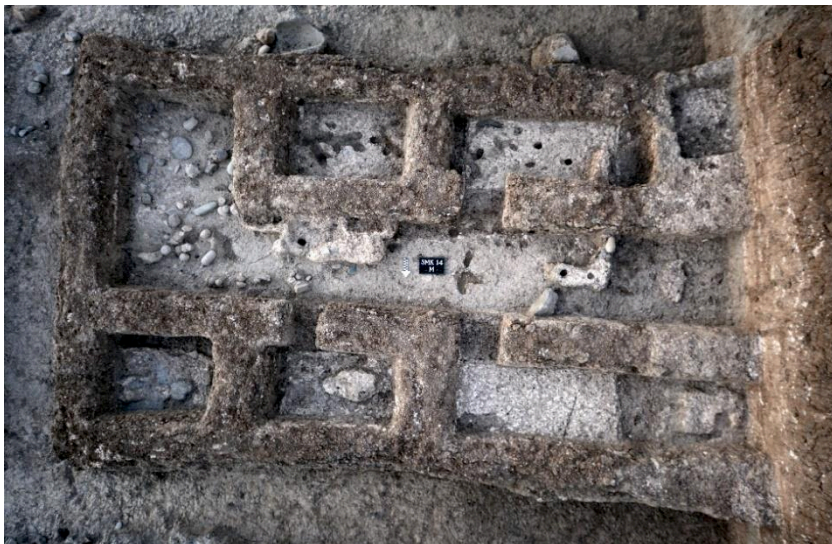
*Figure 4.121: Structure N6B10 from west*

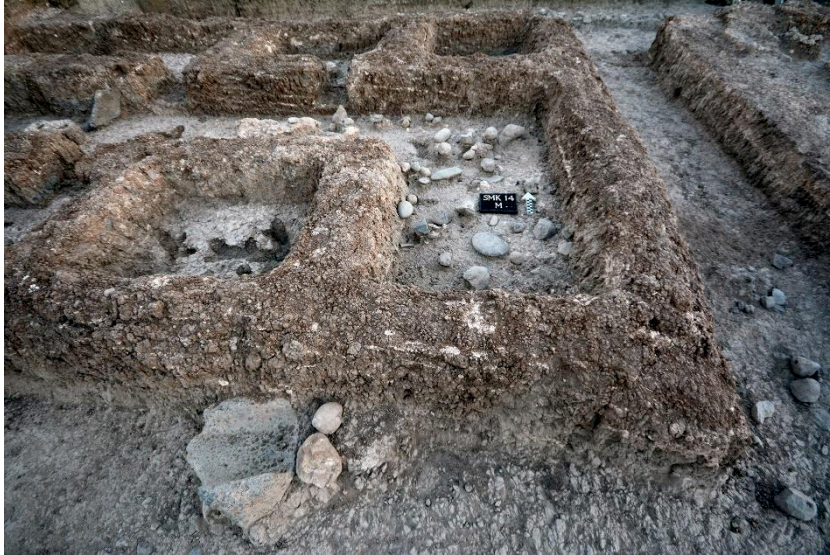
*Figure 4.122: Lime traces on the cells and corridor base and also earth walls edge of Structure N6B10*

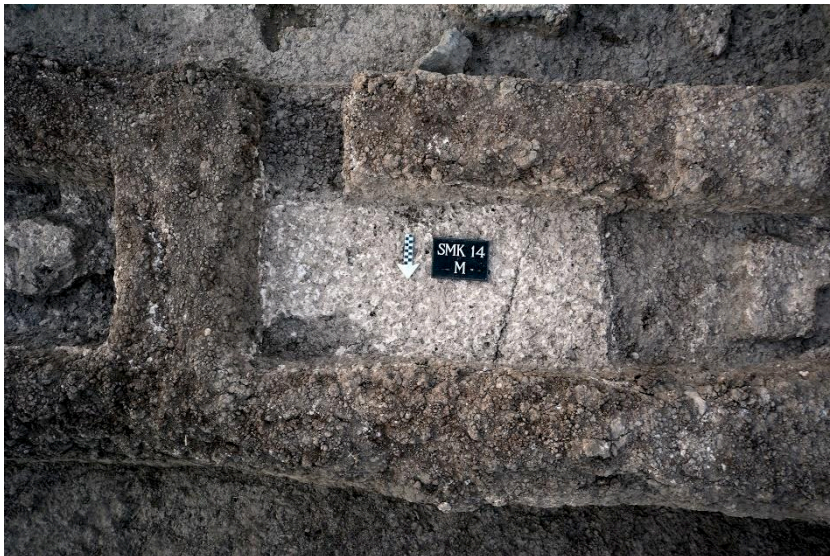
**Figure 4.123: Massive piled earth walls layers from Structure N6B10**

Occasional lime fragments appear to have bound the walls. Continuing as weak and uncertain lines, their thickness varies from 1 to 4 cm. (Figure 4.125) The internal fill of these bounded walls is homogeneous reddish-brown loose earth. In the wall sections, calcified

surfaces are clearly observed between the bedding at 4-8 cm intervals. (Figure 4.123) These surfaces, which continue irregularly between the layers, did not have mortar characteristics. Besides, there were no regular surfaces at the bottom or top of the reddish-brown bedding. SEM images of lime samples taken from within the walls clearly showed organic remains. (Figure 4.295)

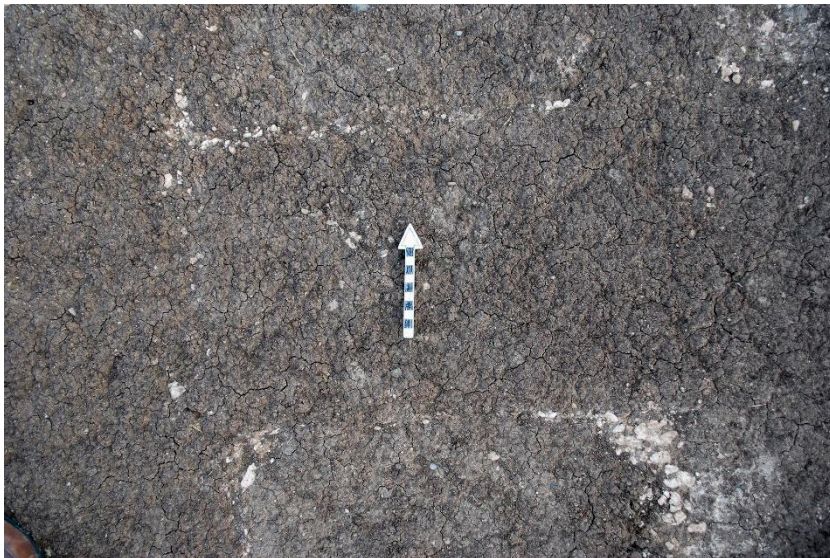
**Figure 4.124: Massive piled earth walls and lime traces on the cell base of Structure N6B10**

Lime surfaces were observed within the cells and the corridor. These lime surfaces without plaster traces were notably very intense in the corridor, in the cells number 2 and 3, and on faces of the walls. (Figure 4.124) As mentioned above, these lime surfaces are directly related to the evaporation and calcification process of organic construction material.

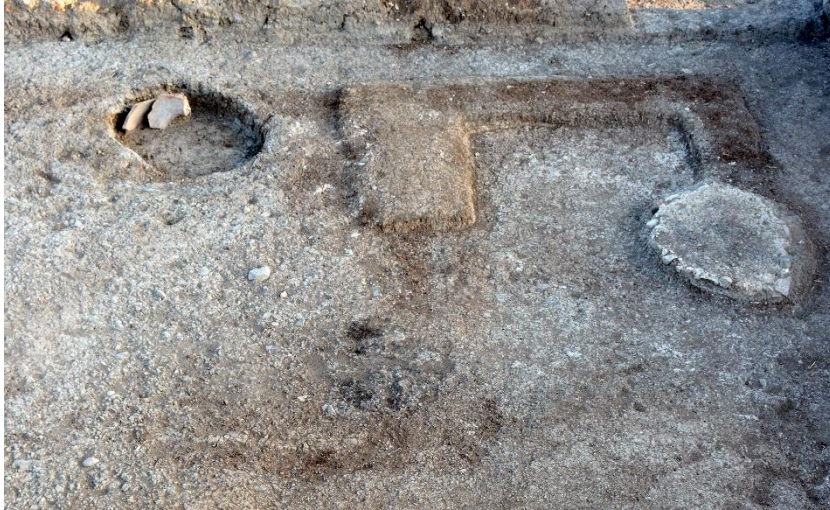
**Figure 4.125: Thin lime traces from massive piled earth walls edge of Structure N6B10**

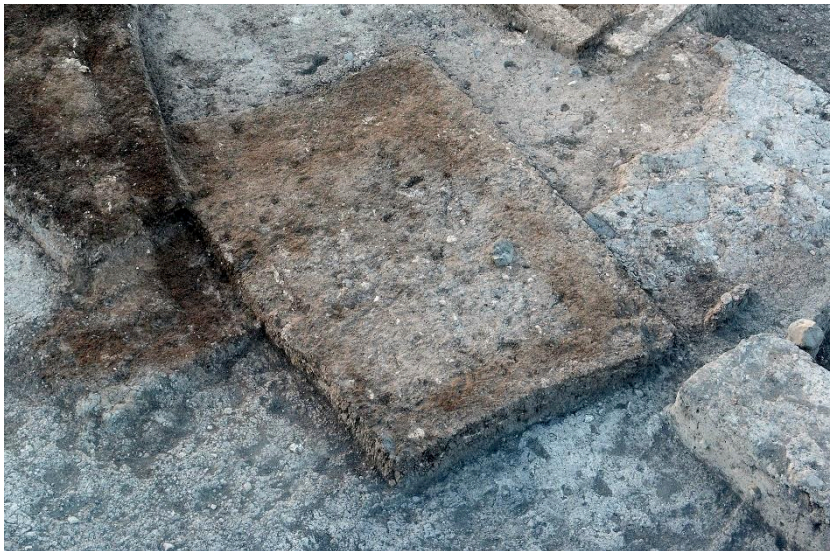
**Figure 4.130: Massive piled earth walls layers from Structure N6B13**

Occasional lime fragments appear to have bound the walls. Continuing as weak and uncertain lines, their thickness varies from 1 to 3 cm. The internal fill of the bounded walls is homogeneous reddish-brown loose earth. Within the walls, calcified surfaces are observed at nearly 6-8 cm intervals. These surfaces, which continue irregularly between the layers, did not have mortar characteristics. There were also no flat surfaces at the bottom or top of the reddish-brown bedding. (Figure 4.130) SEM images of lime samples taken from within the walls clearly showed organic remains.

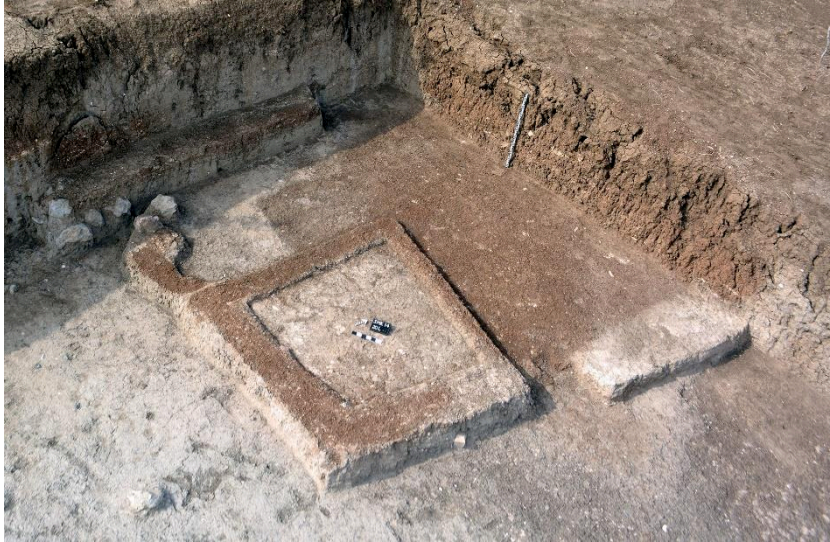
Figure 4.134: Lime traces of wickerwork and duripan wall from Structure N5B1

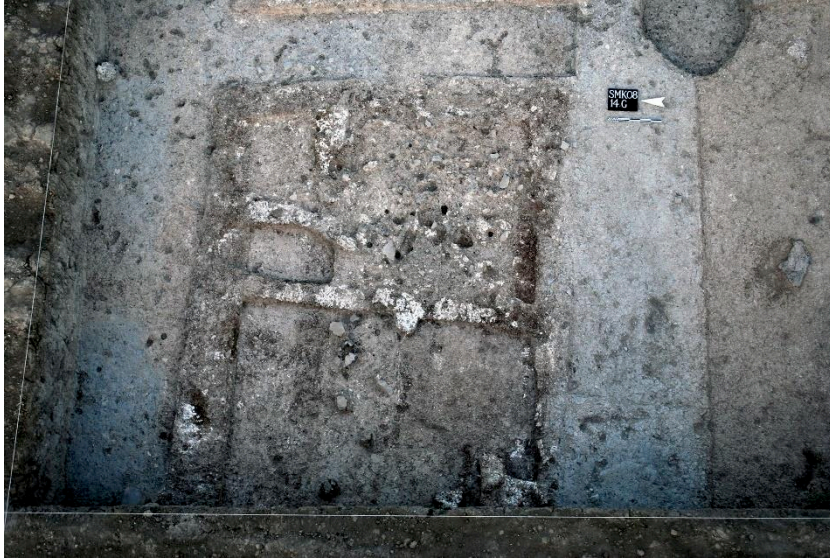
**Figure 4.137: Cross-section of piled earth walls from Structure N5B2**

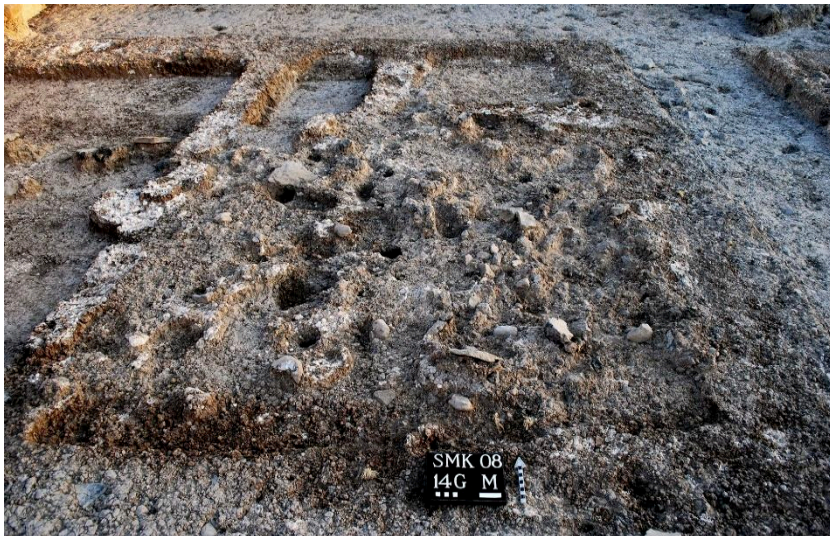
**Figure 4.138: Bird's-eye view of Structure N3B3**

Occasional lime fragments appear to have bound the walls. Continuing as weak and uncertain lines, their thickness varies from 2 to 4 cm. (Figure 4.138) The internal fill of these bounded walls is homogeneous reddish-brown loose earth. Within the walls, calcified surfaces are observed at nearly 5-8 cm intervals. These surfaces, which continue irregularly between the layers, did not have mortar characteristics. Organic remains are clearly observed on SEM images of lime samples taken from within the walls.

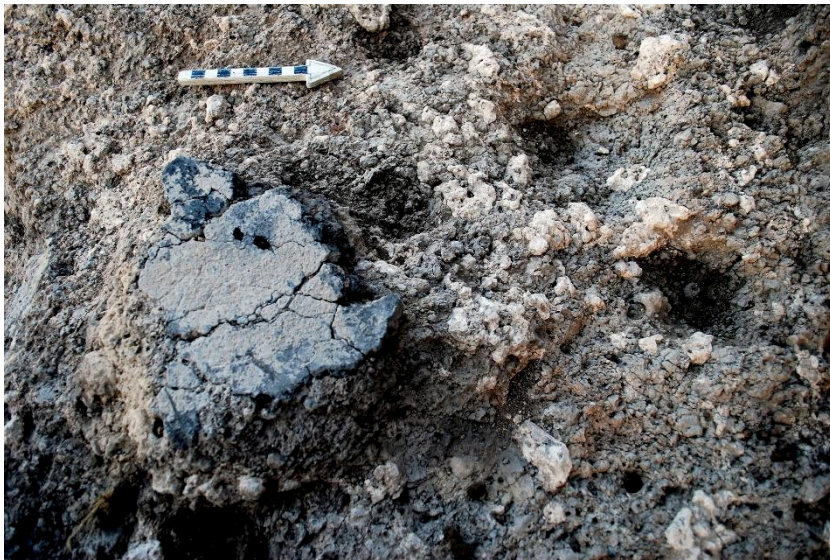
**Figure 4.139: Limy wall trace and plastered floor residues in room number 2 from Structure N5B3**

The internal fill of the rooms is grey and intensely ashy. In the large room number 2, plastered floor remains of a hearth with burning traces were identified. (Figure 4.139, 4.140)

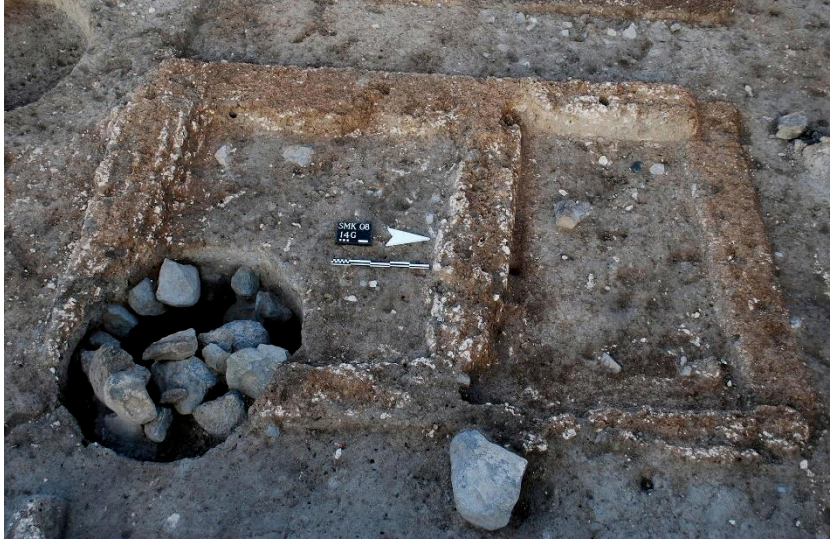
**Figure 4.140: Detail view of plastered floor residues in room number 2 and lime fragments from Structure N5B3**

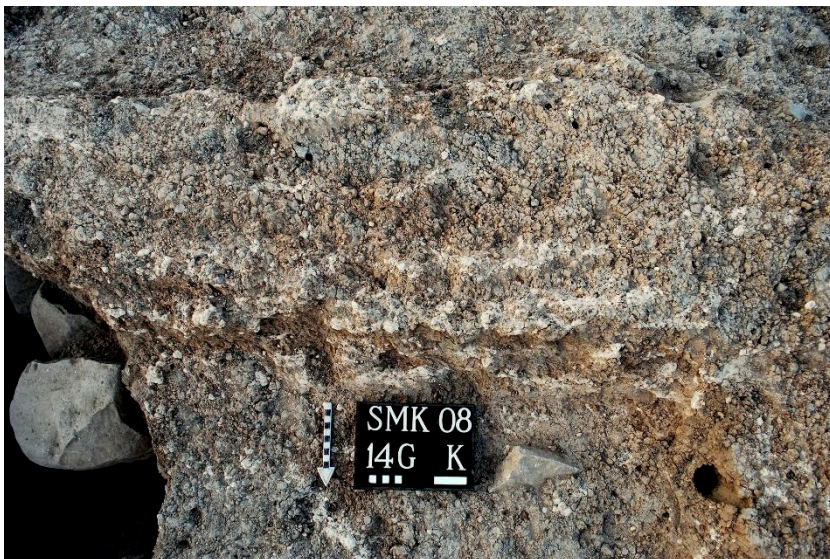
**Figure 4.142: Massive piled earth walls layers from Structure N5B4**

The structure was constructed with a north-south orientation, contrary to other structures in the same area, had a width of 238 cm in the east-west direction and a length of 353 cm in the north-south direction. (Figure 4.340) The bearing walls are 30-32 cm thick while the partition walls are 22-27 cm thick. The walls in the eastern part are at least 25 cm higher than the walls in the western section. Lime line traces are clearly identified on both faces of the walls and in their internal fill. Lime lines at 4-5 cm intervals between reddish-brown bedding on either faces of the walls in the south and east section of the structure are notably well-defined. (Figure 4.142, 4.143)

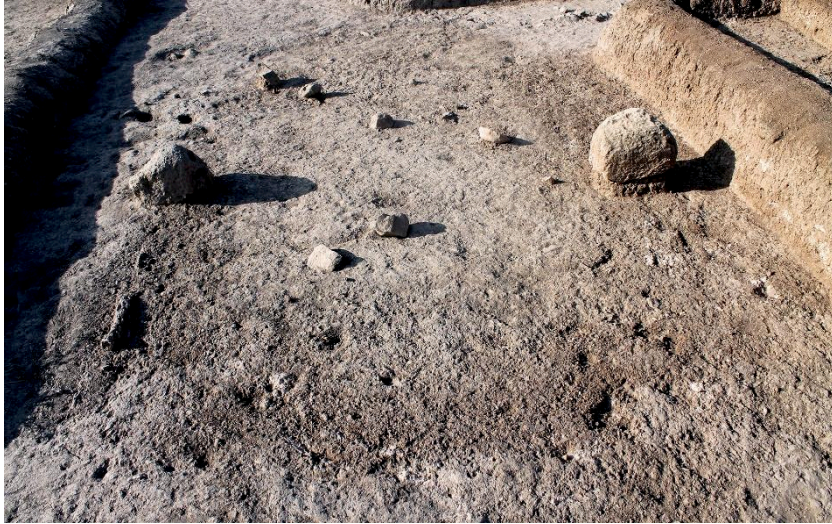
**Figure 4.143: Detail view of massive piled earth walls layers from Structure N5B4**

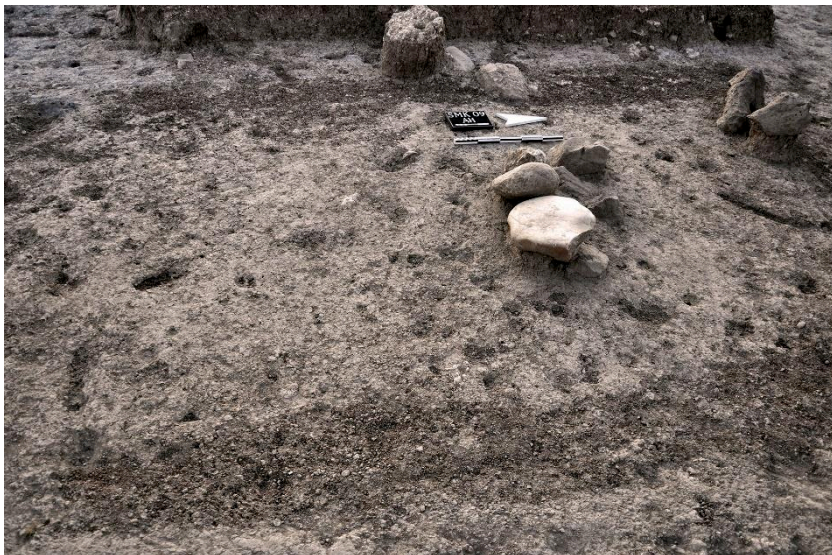
**Figure 4.145: Piled earth wall trace and lime fragment of Structure N5B5**

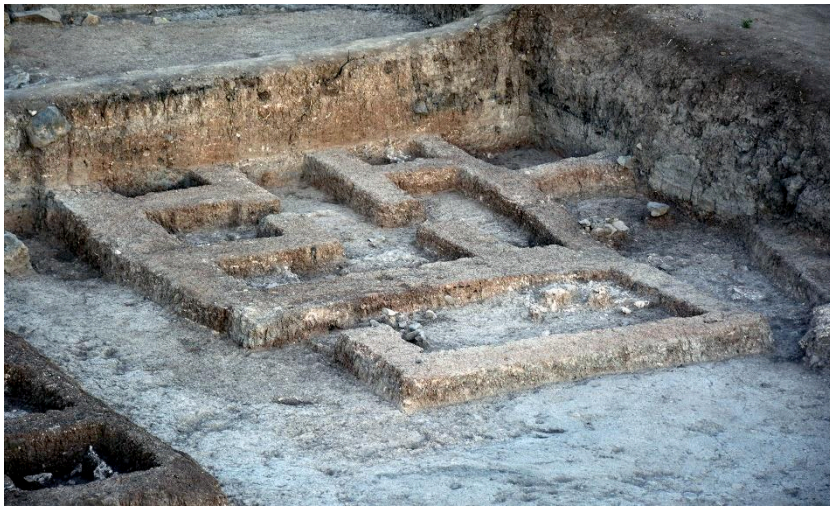
**Figure 4.147: Massive piled earth wall trace of Structure N5B6 from north**

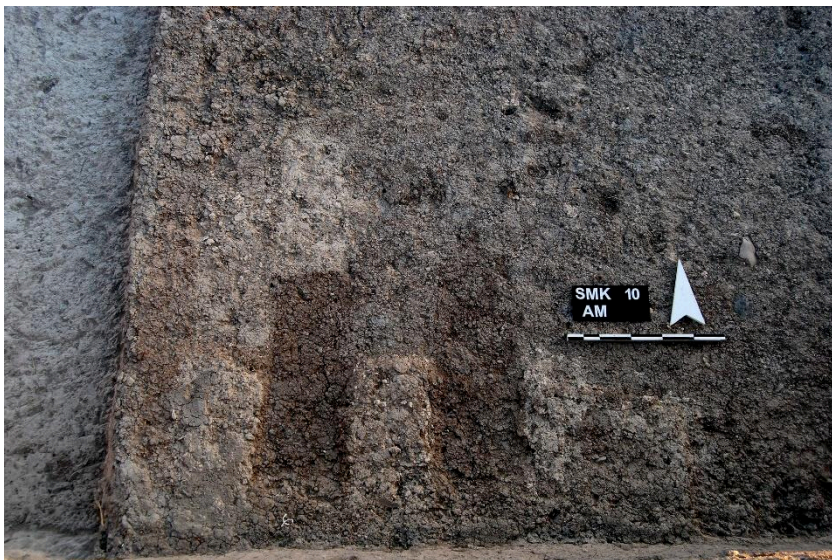
**Figure 4.151: Piled earth / duripan wall of Structure N5B8**

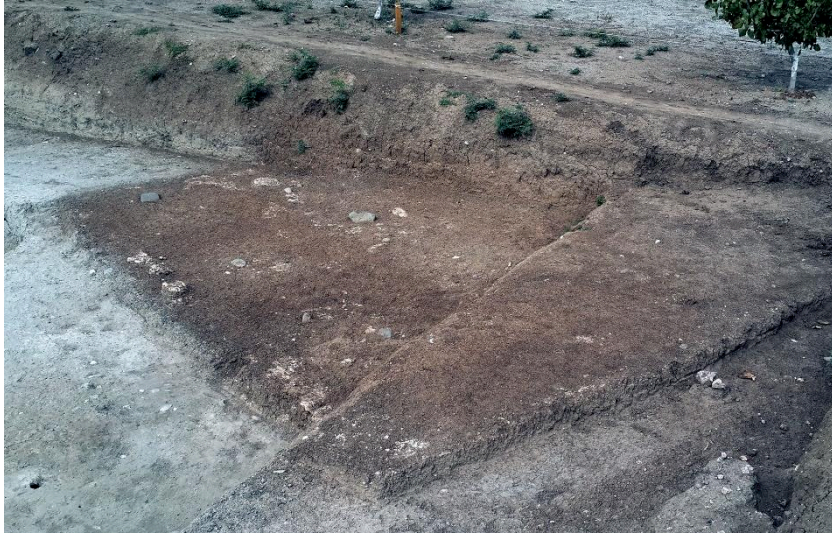
**Figure 4.152: Duripan wall of Structure N5B8**

Occasional lime fragments appear to have bound the walls with homogeneous reddish-brown loose earth. In the south cross-section of the structure, six block-like lime traces were identified between the bedding of piled earth walls. The lengths of these block-like lime traces are different, though the widths are the same. Considering this data, the structure was constructed by using the piled earth and the kerpiç blocks technique. (Figure 4.152)

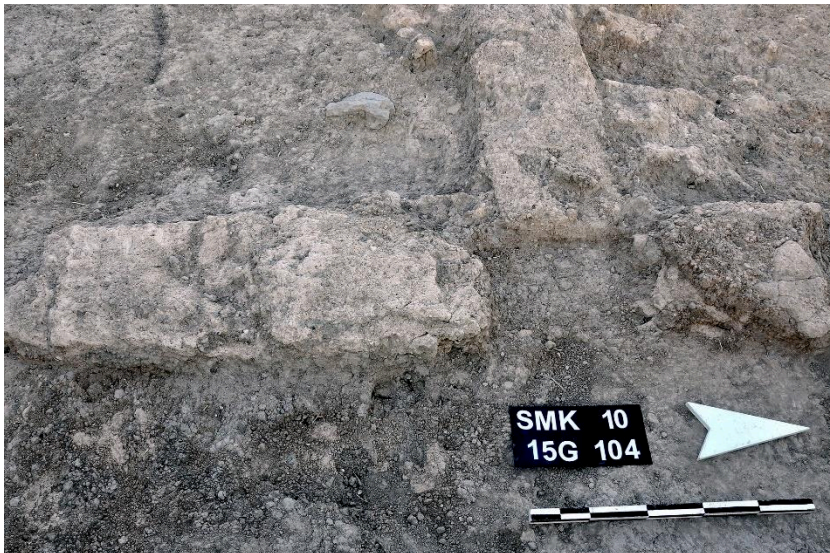
Figure 4.157: Duripan wall from Structure N5B11

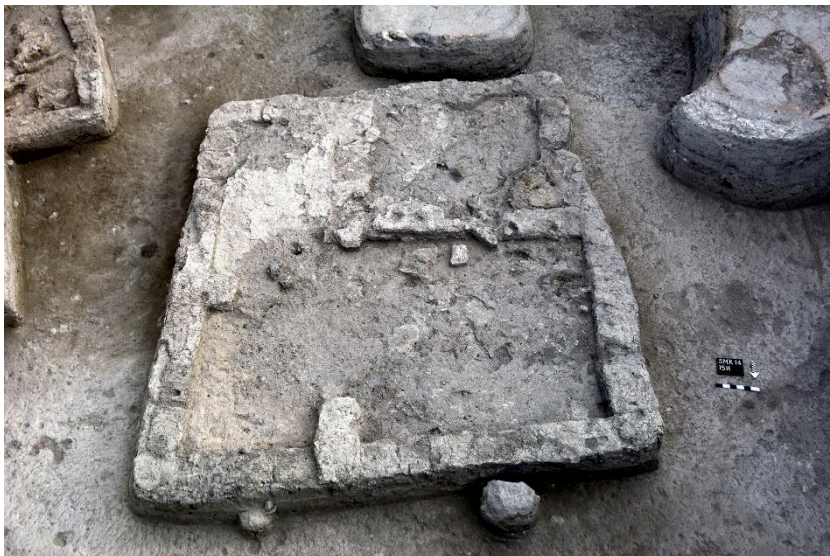
Figure 4.158: Example of duripan wall from Structure N5B11

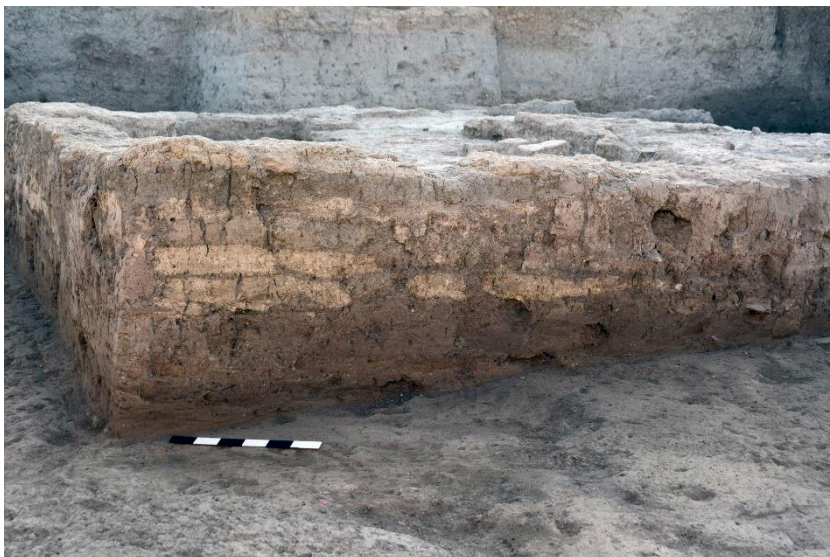
**Figure 4.160:** Plastered floor residues in room number 3 from Structure N5B12

Nearly 1 cm-thick gypsum plastered floors were identified in two rooms, namely, rooms number 3 and 4. (Figure 4.160) The plaster floor continuing to the edges of the walls in the room number 3 was randomly be distinguished in the room number 4. In room number 2, a yellowish-brown coloured surface was identified nearly at the same level as the other plaster floors. Covering almost the entire room, this yellowish-brown surface is interpreted as the disrupted floor remains. Room number 1 did not have any plaster floor remains. An entire absence of material within the rooms pointed that the structure was cleaned when it was left.

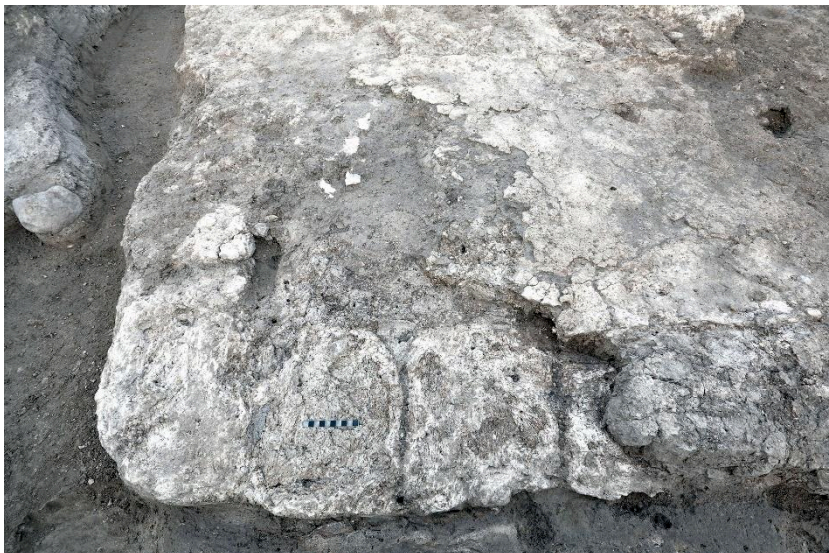
**Figure 4.161:** Cross-section of the wall from Structure N5B12

doorways between the rooms could be identified. There is no door opening detected in the preserved walls of the room number 4. There is a nearly 20 cm elevation difference between the plaster floors and the bottom level of the walls. (Figure 4.161)

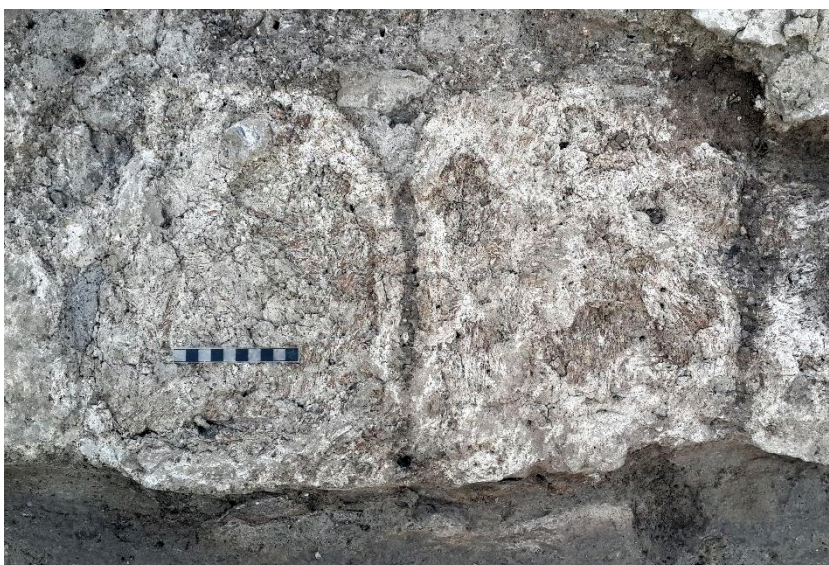
**Figure 4.162: Some mud bricks example from Structure N5B12**

Another noteworthy characteristic of the structure N5B12 is simultaneously usage of the duripantechnique and kerpiç block technique. Except for 5 kerpiç blocks in the upper rows, the sizes of the kerpiç blocks are different. Since the kerpiç block sizes were not the same, it is understood molds have substandard sizes. The 5-10 cm-thick kerpiç blocks were irregularly placed in upper or lower rows inserted in layers made with the duripantechnique. The earth filling above and/or below the kerpiç blocks was flattened either during construction or due to compression by the upper rows of kerpiç and was in direct contact with both blocks. (Figure 4.162 – 4.164) Although no trace of mortar was identified between these earth bedding and the kerpiç blocks, there were clear mortar traces between kerpiç blocks in the upper rows. The kerpiç blocks in the upper rows have oval-curved sides and mean dimensions of 30x35x6 cm. In contrast to the structural walls made with piled earth, there were more varieties of earth used in the construction of these walls. Occasionally it was brown sandy earth, occasionally yellow-clay earth, and on occasion lime-rich soil was used. The kerpiç blocks in the upper rows contain rich organic material whereas the samples that were taken from the yellowish brown- or greenish grey-coloured kerpiç blocks in the lower rows found nearly no proportion of plant material within them.

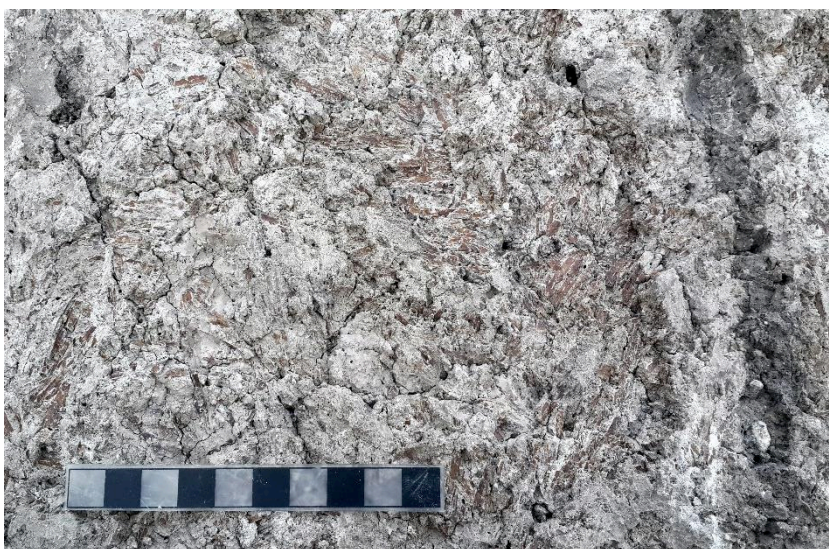
**Figure 4.163: Detail view of mud bricks and mortar from Structure N5B12**

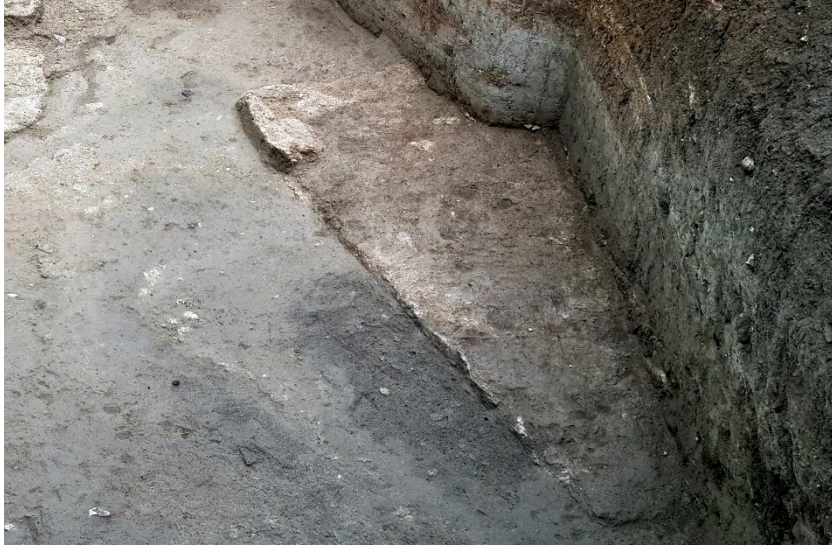
**Figure 4.164: Traces of plants in mud brick mud and also mortar**

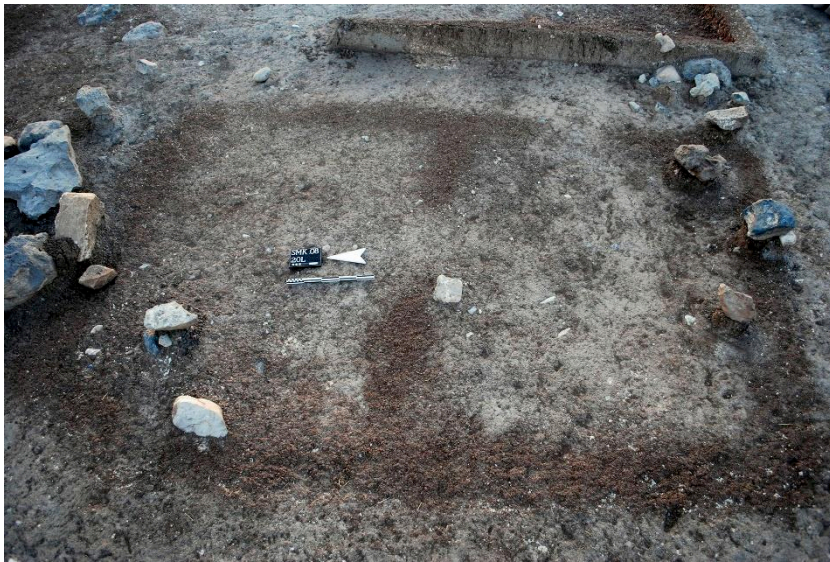
**Figure 4.168: Massive piled earth walls traces of Structure N4B1 from west**

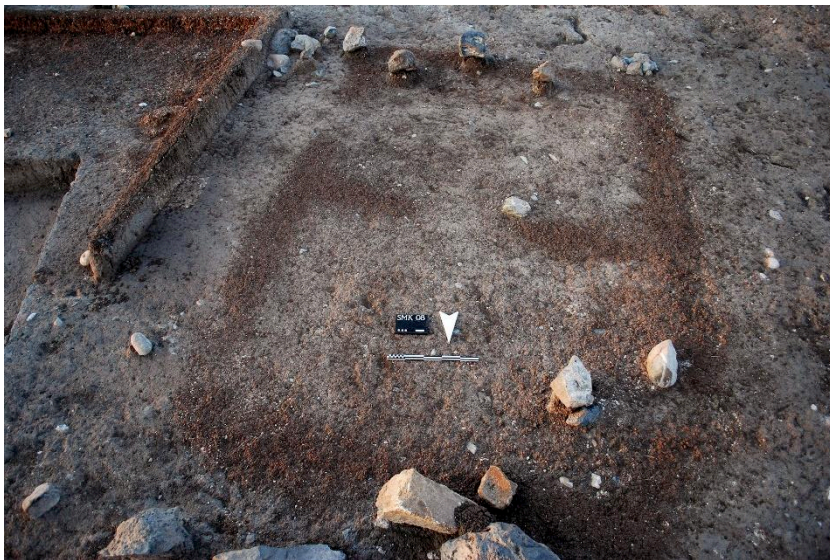
**Figure 4.169: Thin lime traces from massive piled earth walls edge of Structure N4B1**
