# Microarchaeological observation on the neolithic architectural structures and cultural landscape of Sumaki Höyük

# **Microarchaeological Observation on the Neolithic Architectural Structures and Cultural Landscape of Sumaki Höyük**

PhD Thesis

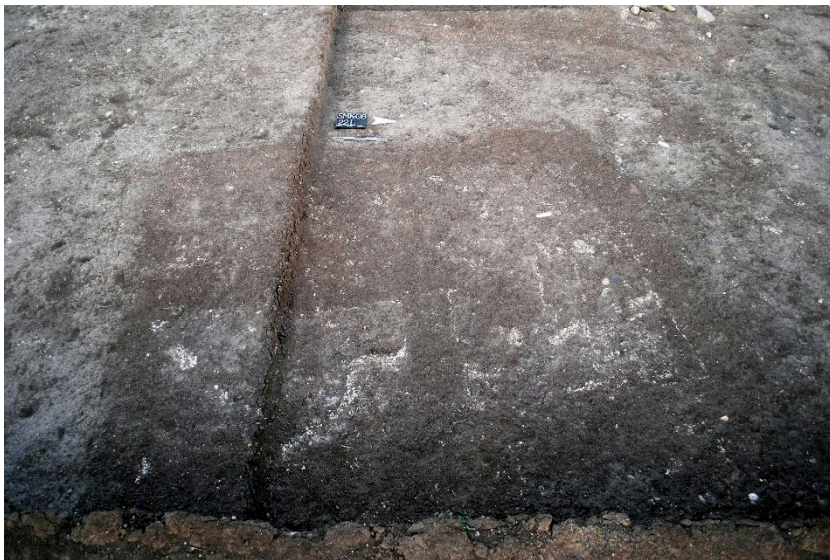
**Figure 4.172: Thin lime traces from piled earth walls edge of Structure N4B2**

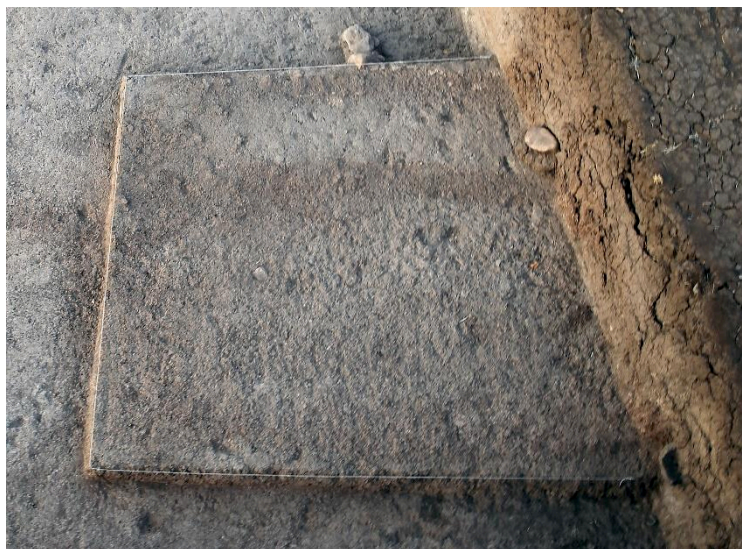
**Figure 4.173: Structure N4B3 from east and thin lime traces from its piled earth walls edge**

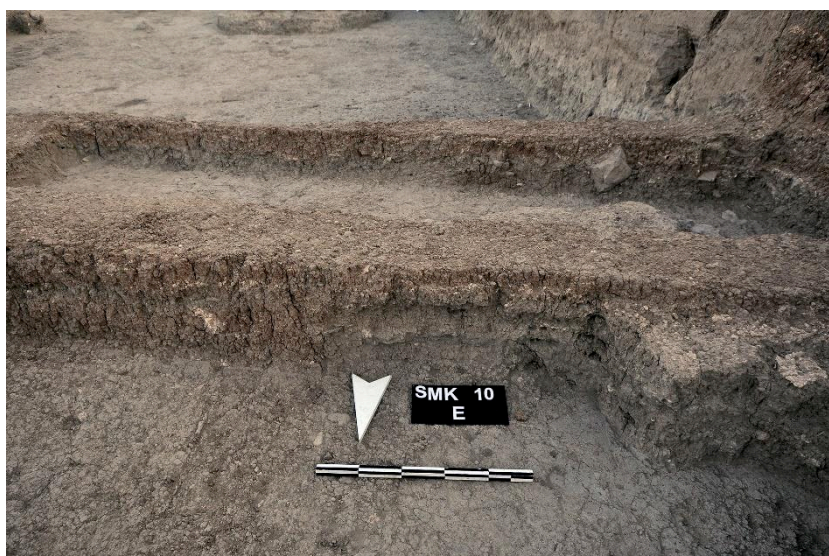
**Figure 4.174: Massive piled earth walls traces of Structure N4B4 from north**

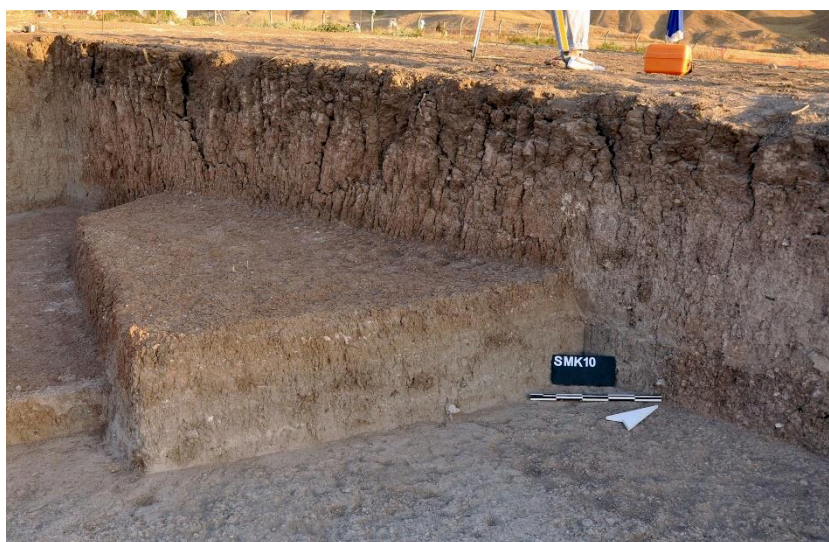
**Figure 4.175: Detail view of massive piled earth walls layers from Structure N4B4**

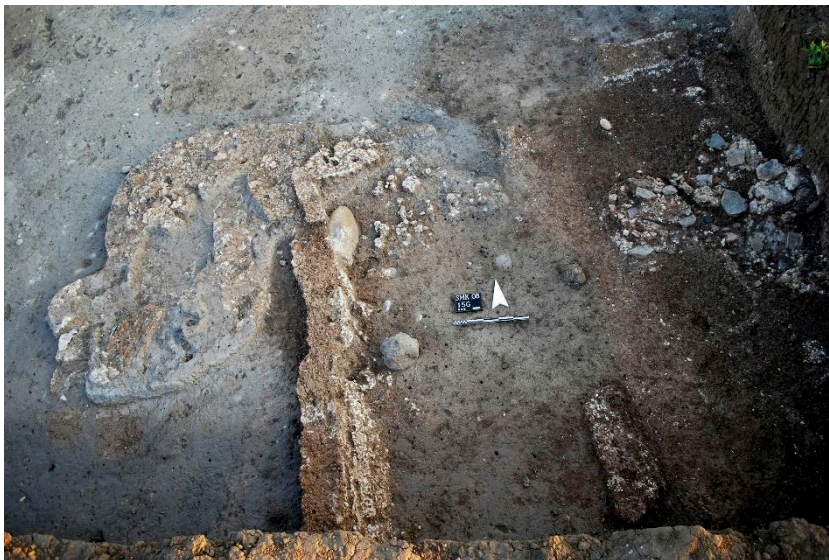
**Figure 4.176: Structure N4B7 from southeast and cross-section of earth wall**

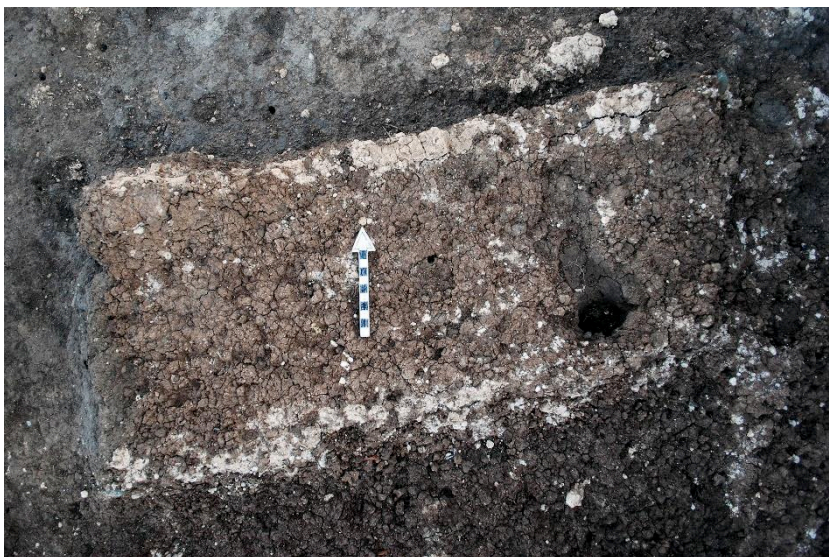
**Figure 4.178: Detail view of wattle frame of massive piled wall from Structure N4B8**

Based on the wall remains and general appearance, the structure is classified as a double-roomed structure. The walls on the west side and the partition wall have been preserved to a height of 30 cm. The north bearing walls have only been preserved to a height of 12-17 cm. (Figure 4.178, 4.179) The wall on the east side was not detected. The eastern limits of the structure are only distinguished from the external area by its colour and the clear reddish-brown traces in the trench section. The rectangular structure was built with southwest-northeast orientation on a light-grey fill occasionally dense carbon fragments and ashy areas following the slope of the natural topography without a stone foundation. The bottom surfaces of the walls slope slightly toward the east. There are no traces of plastered flooring identified. Some artefacts such as grinding stone fragments define the living surface of the structure.

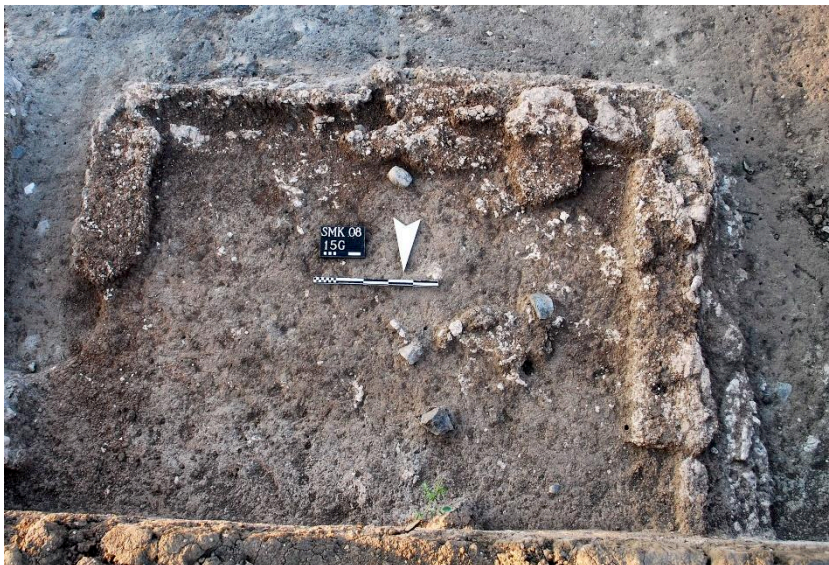
**Figure 4.179: Thin lime traces from massive piled earth walls edge of Structure N4B8**

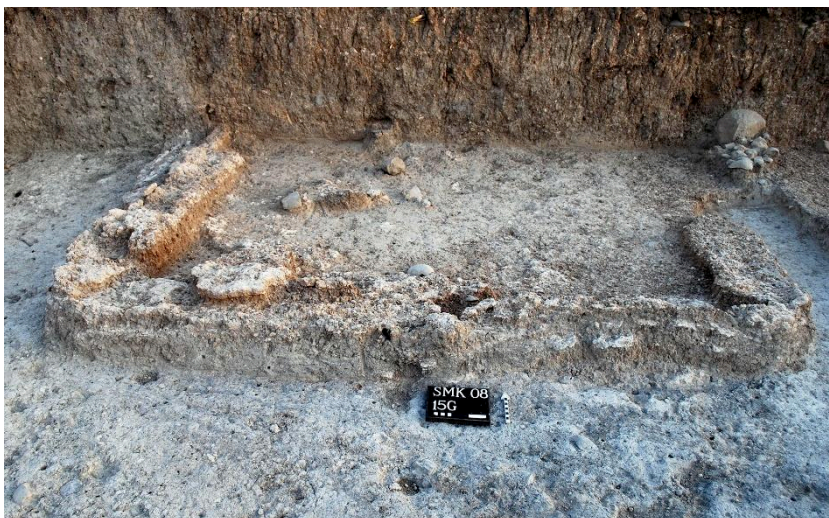
**Figure 4.180: Bird's-eye view of Structure N4B9 and lime fragment in its piled earth walls**

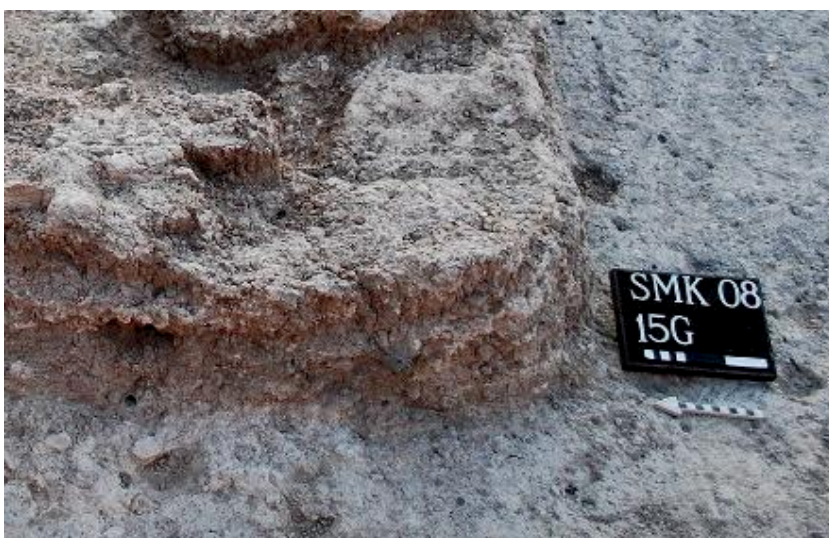
**Figure 4.181: Massive piled earth walls layers from Structure N4B9**

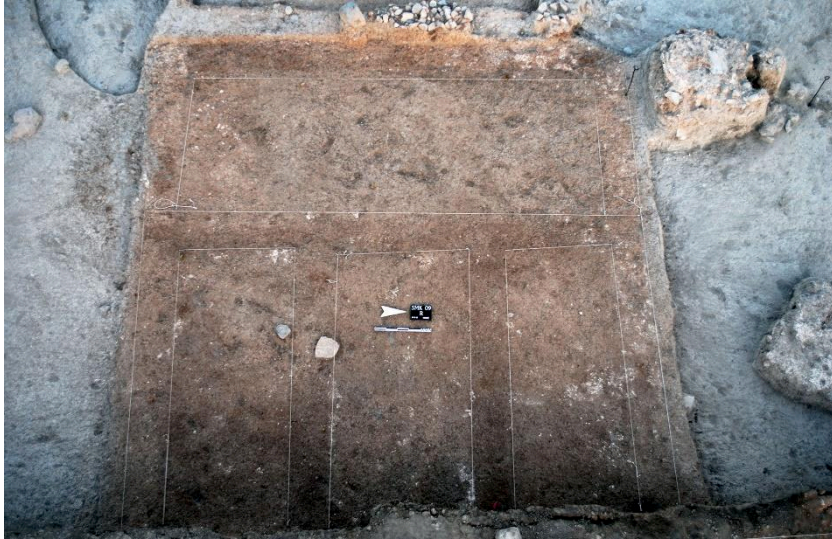
**Figure 4.182: Detail view of massive piled earth walls layers from Structure N4B9**

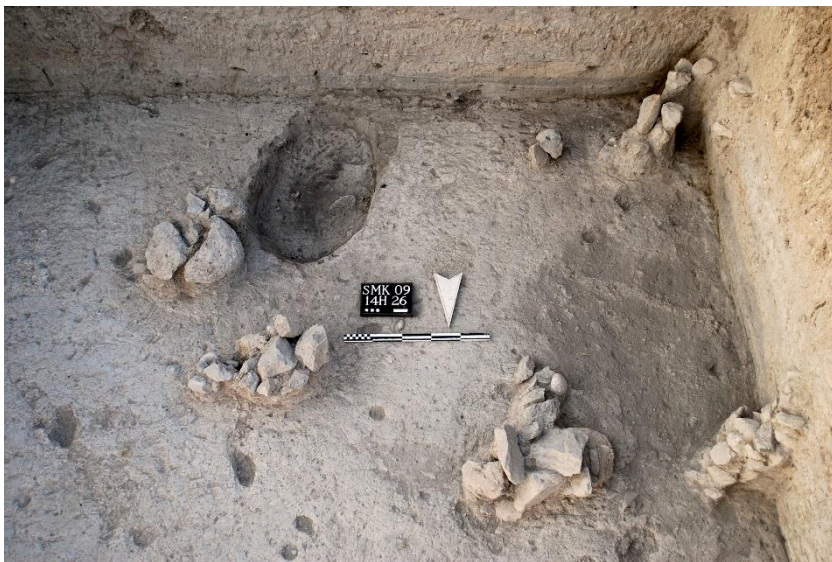
Figure 4.187: Example a post-hole from Structure N3B1

disrupted post-holes. (Figure 4.187) The general appearance of the post-holes indicates the presence of at least one circular temporary structure.

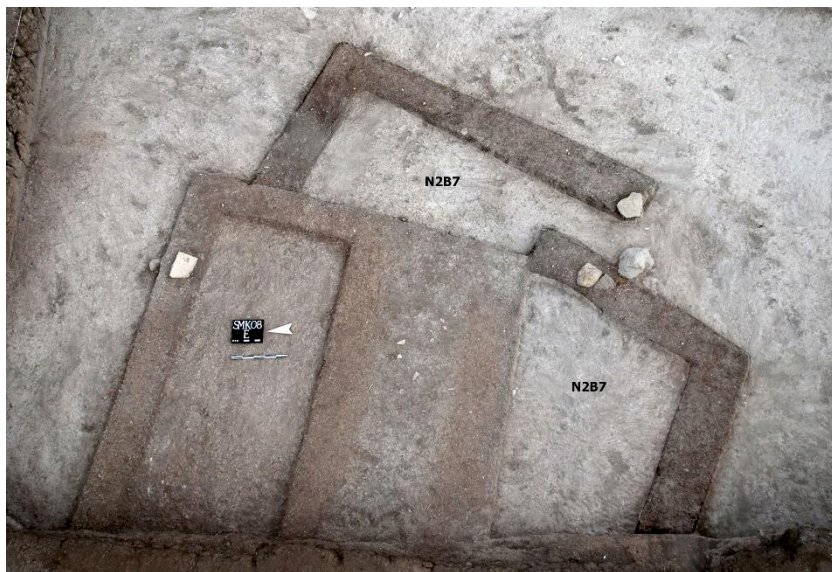
**Figure 4.198: Piled earth wall traces of Structure N2B7**

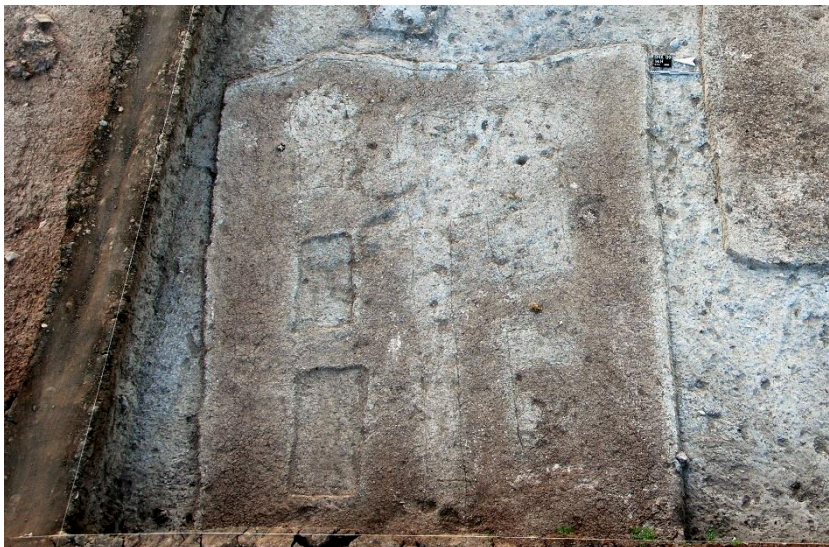
Figure 4.203: Structure N2B8 and 1st stage torrent/flood fillings accumulated on its edge

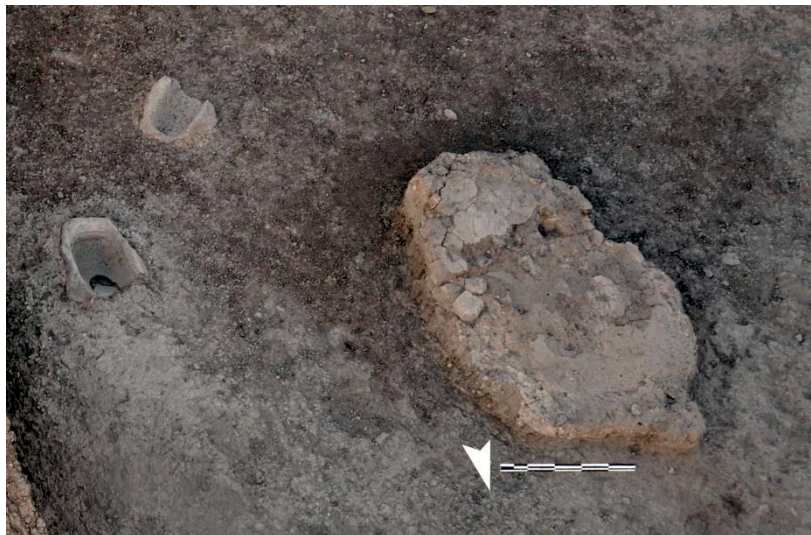
Figure 4.211: Bird's-eye view of Hearth N6O2

slightly inclined to the south. The oval-shaped hearth was 120 cm in the north-south direction and 99 cm in the east-west direction. The pavement was made of basalt and pebbles of different sizes between 2x4x7 - 5x9x15 cm. (Figure 4.211, 4.212) Between the stone pavement and the plastered floor was a layer of yellowish grey buff-coloured stone-tempered 4 cm-thick filling. The partly-preserved plastered floor was 2 cm in thickness. The surface of the very hard plastered floor was slightly cracked and smooth. To the east of the hearth, two broken ground stones were found *insitu*.

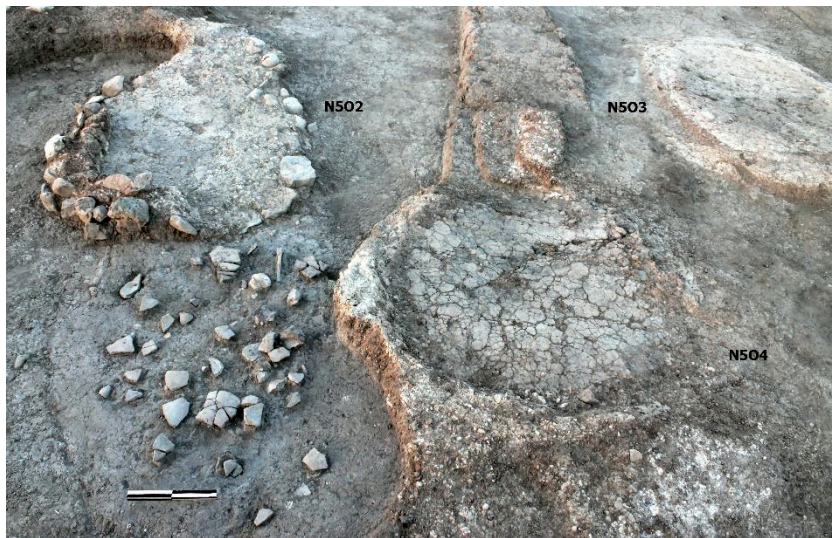
Figure 4.216: Hearth N501 from west

This was located in an open space in the northwestern part of trench 20M in Area A. It covers an area of approximately 2 m<sup>2</sup> between the elevations of 699.80 to 699.93. It had a single, light grey-coloured plastered floor with a stone pavement. Based on the floor remains, the hearth slightly inclined to the north. (Figure 4.216)

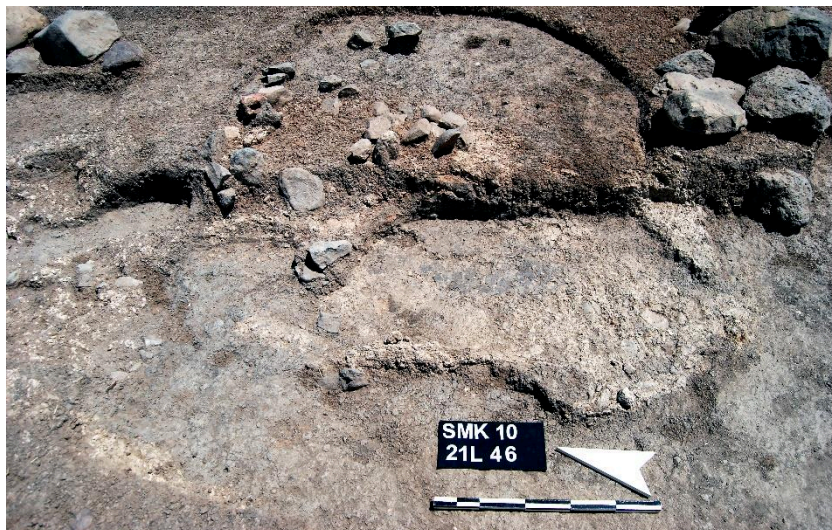
Figure 4.217: Overview of Phase N5 hearths together at the Area A

This was one from the triple hearth group located in the northern part of trench 21L in Area A, to the east of Hearth N5O3 and south of Hearth N5O4. (Figure 4.217, 4.218) It covers an area of approximately 1 m<sup>2</sup> between the elevations of 699.50 to 699.62. There was very loose lime debris around the hearth 2-4 cm in thickness without any plaster traces. The hearth had a single bluish grey-coloured plastered floor with a stone pavement. Based on the floor remains, the hearth slightly inclined to the north.

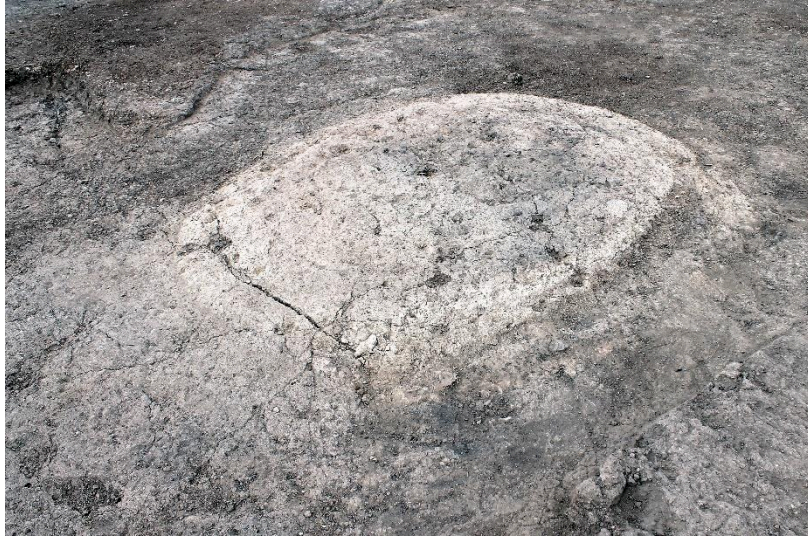
Figure 4.218: Hearth N502 from west

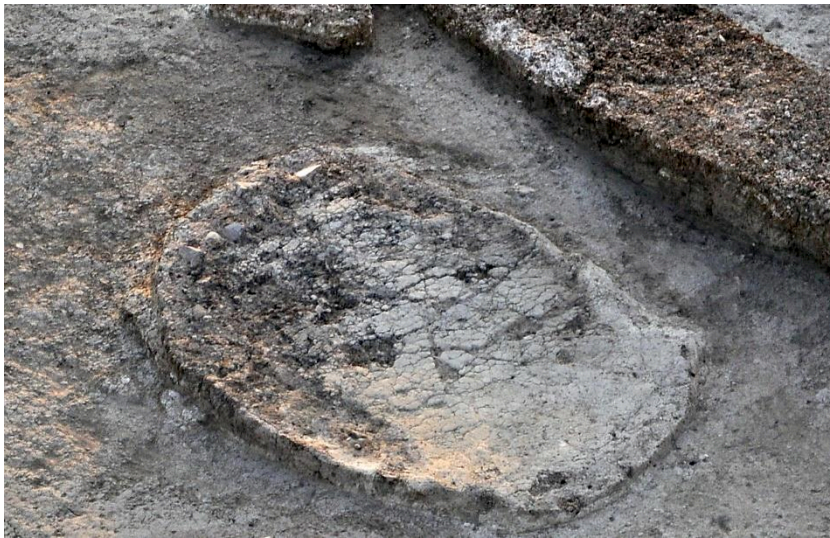
Figure 4.219: Hearth N5O3 base under the plastered floor from east

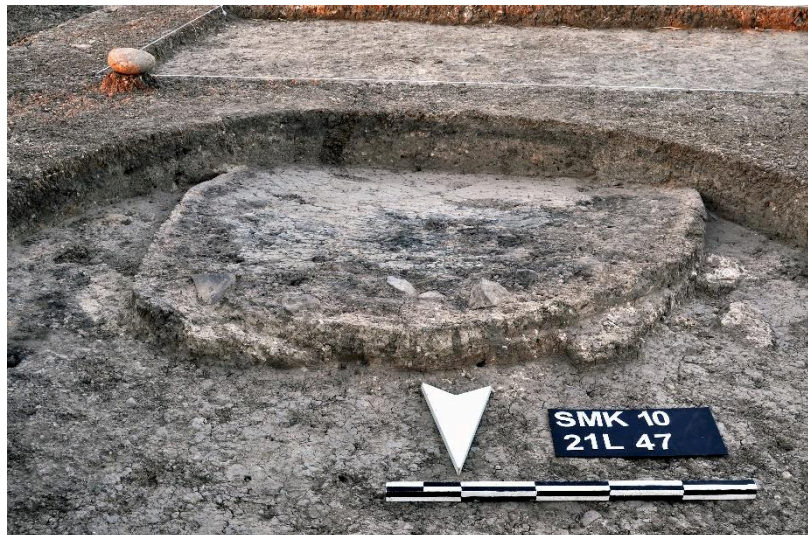
Figure 4.220: Hearth N5O3 from southwest

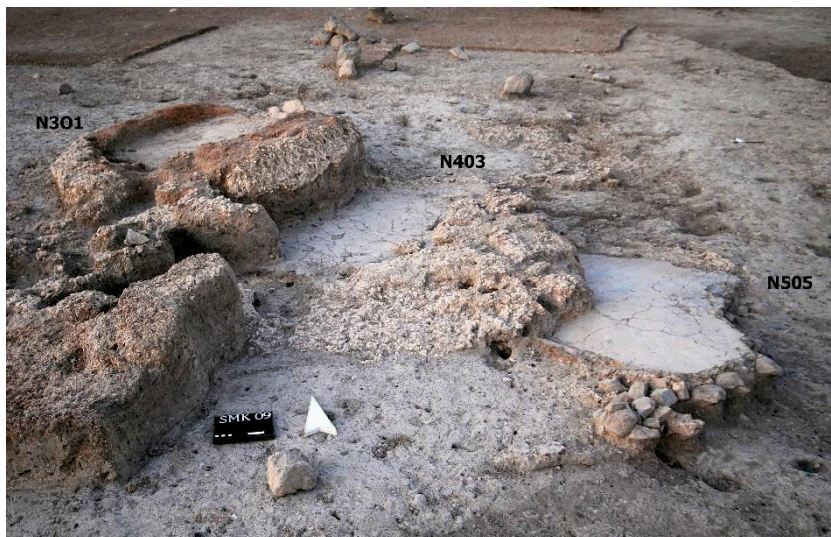
Figure 4.221: Hearth N5O3 from west

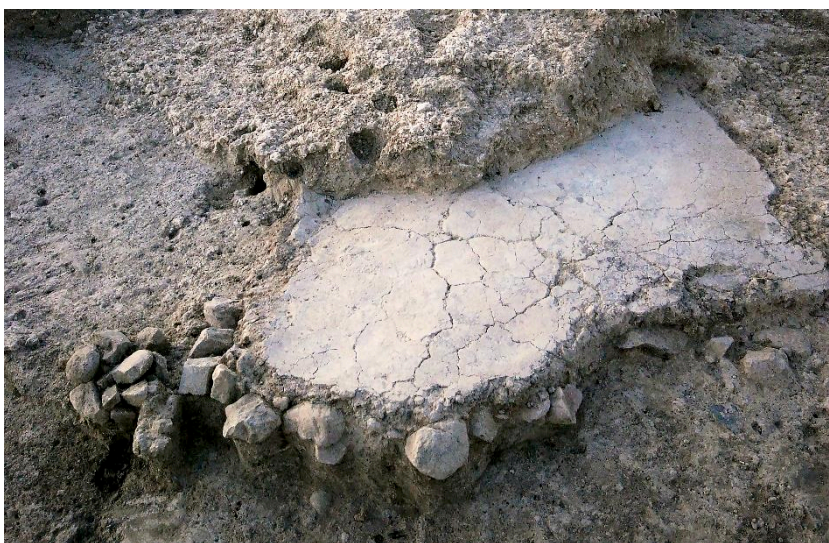
**Figure 4.222: Hearth N505 from south**

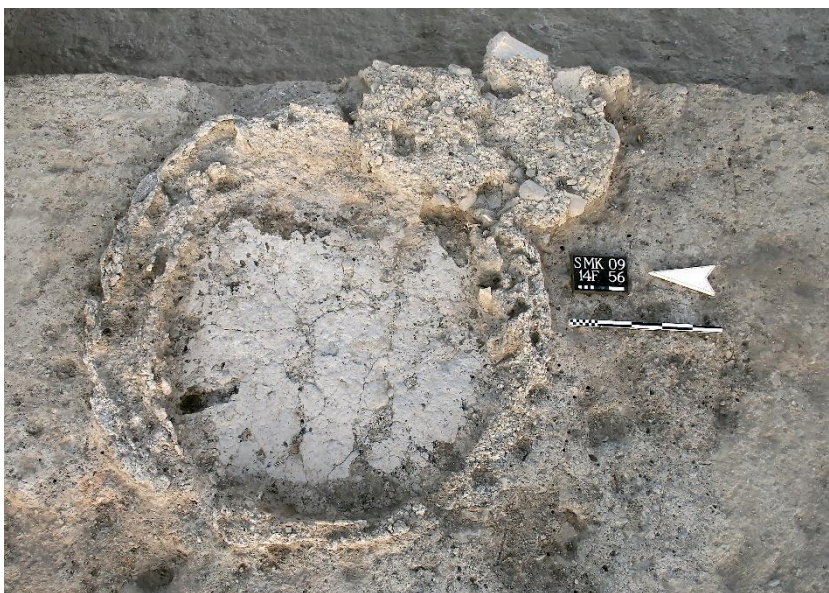
**Figure 4.223: Hearth N505 from east**

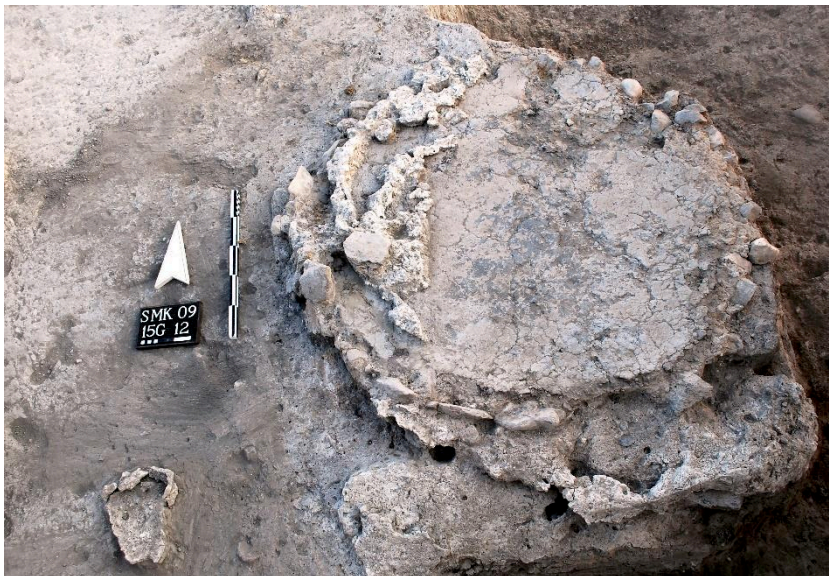
**Figure 4.224: Bird's-eye view of Hearth N506 and lime fragments around it**

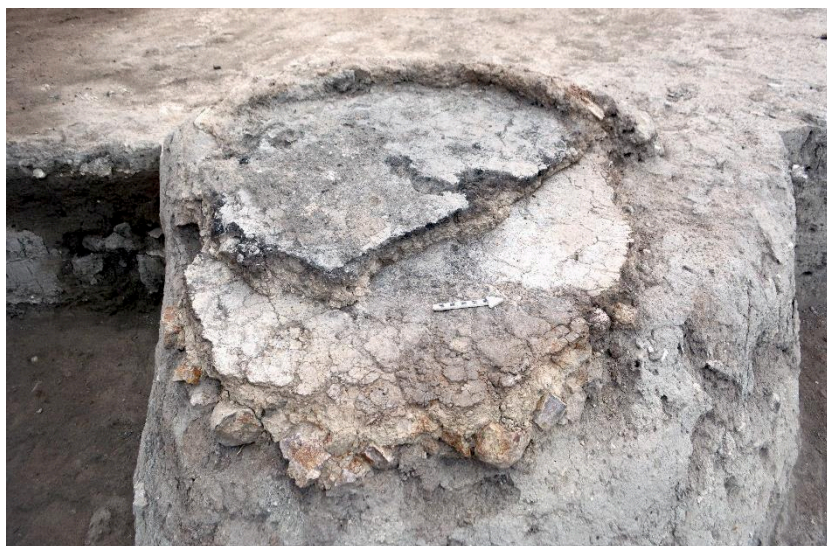
**Figure 4.225: Hearth N507 and lime fragments around it and also on its plastered floor**

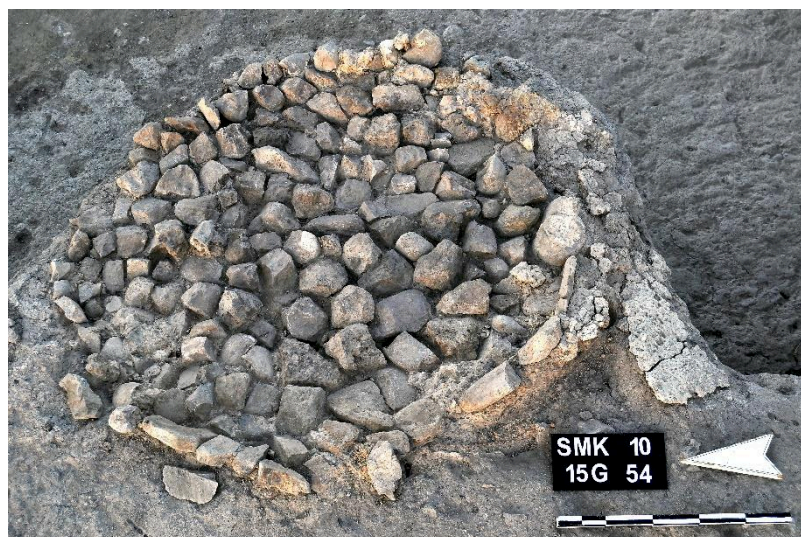
**Figure 4.226: Cross-sectional view of stone pavement and plastered floors from Hearth N507**

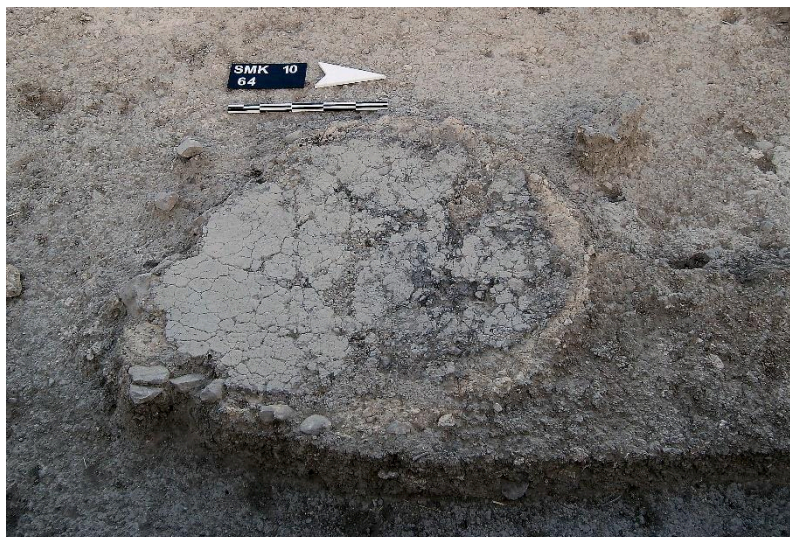
**Figure 4.227: Stone pavement from Hearth N507**

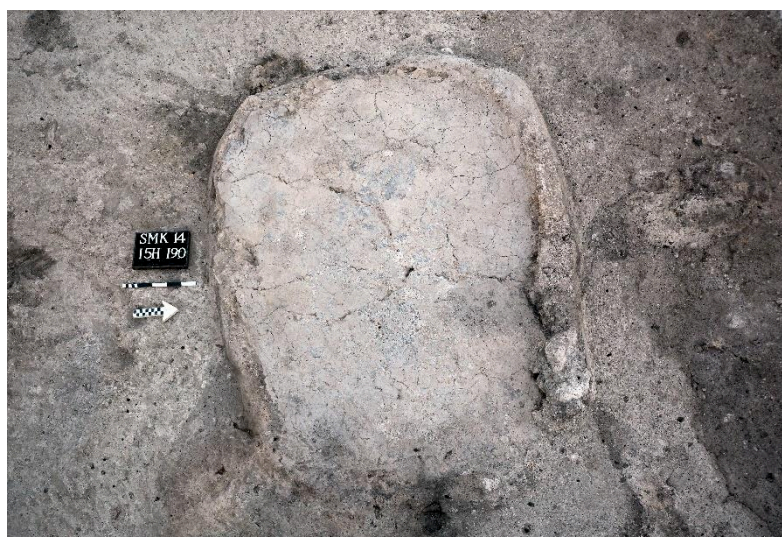
Figure 4.229: Overview of Hearth N509 and Hearth N5010 together at the Area B

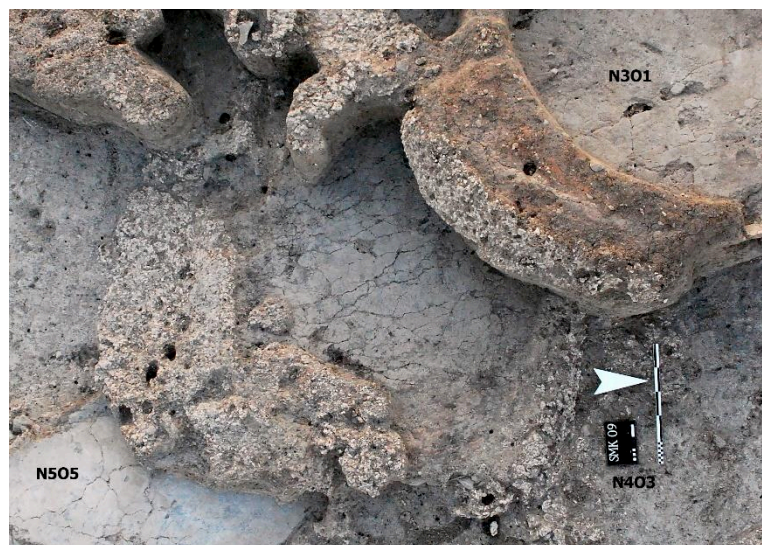
Figure 4.231: Location of Hearth N404 from south

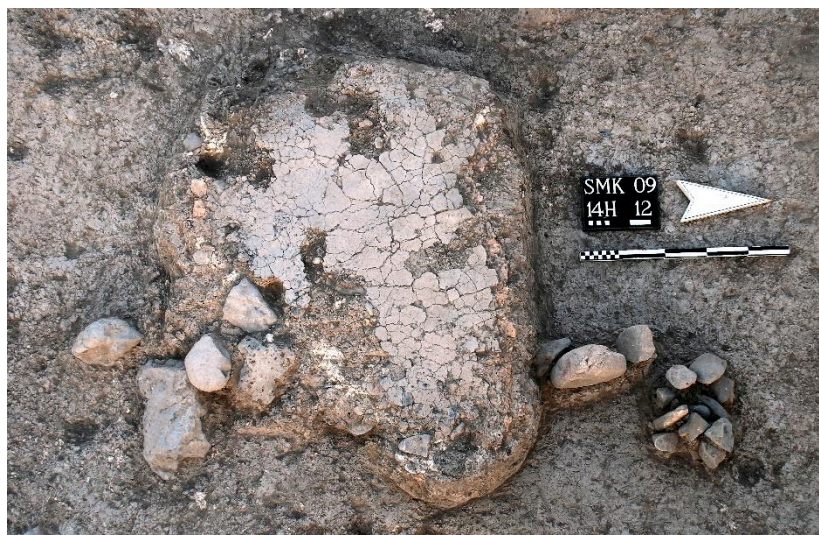
Figure 4.232: Bird's-eye view of Hearth N403 and lime fragments around it

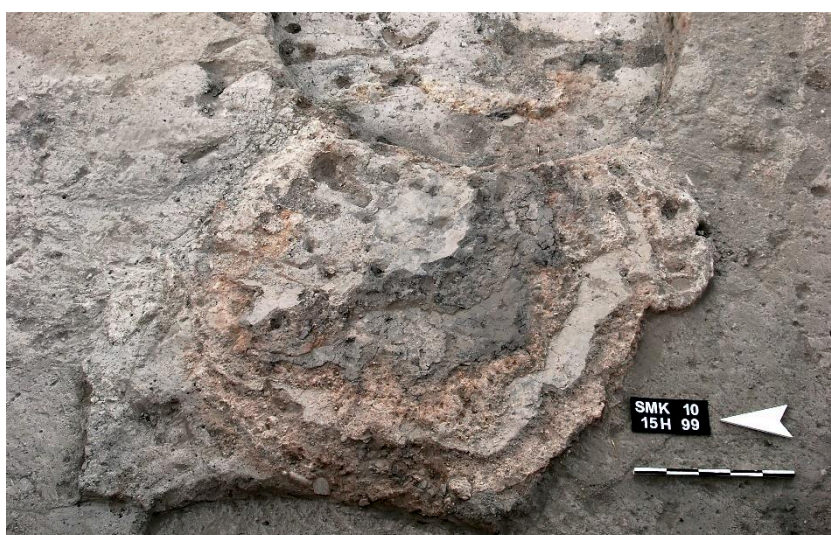
**Figure 4.234:**Hearth N405 from east (1st stage)

on a light grey homogeneous fill. (Figure 4.234 – 4.236) It had three superimposed plastered floors on a single stone pavement. Based on the floor remains, the hearth inclined to the southeast.

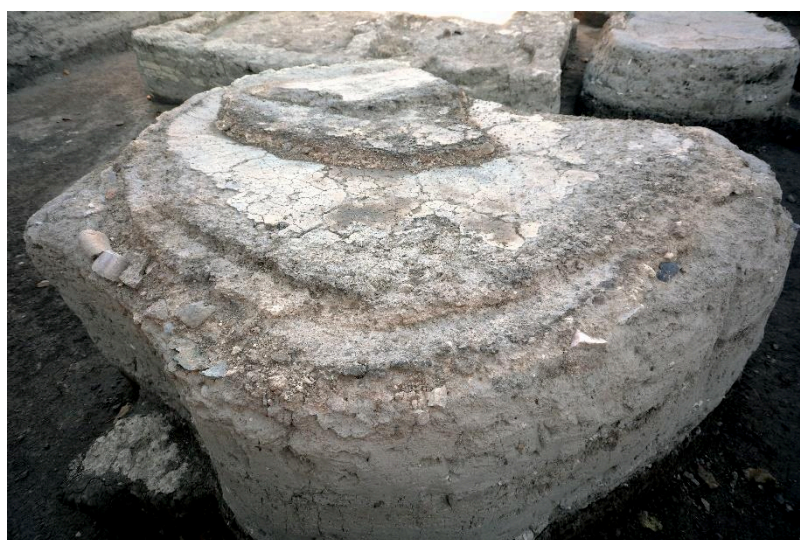
**Figure 4.235:** Hearth N405 from west (1st stage)

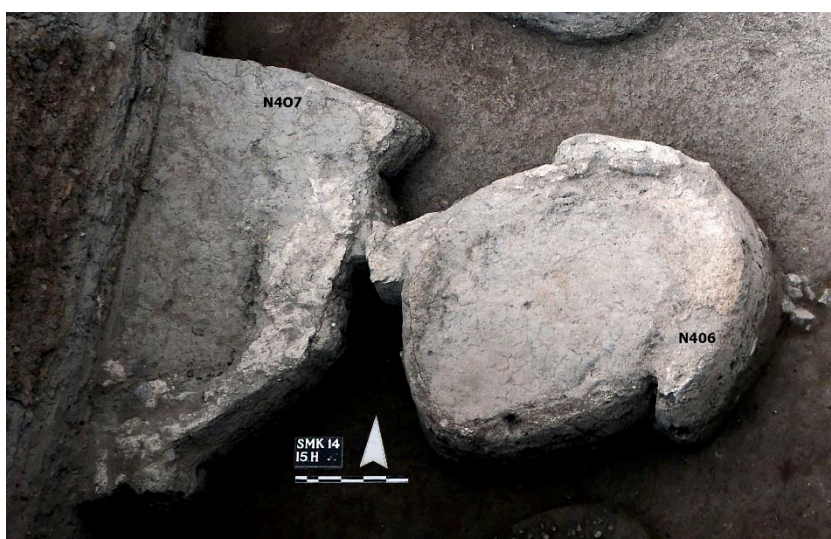
Figure 4.237: Overview of Phase N4 hearths together at the Area B

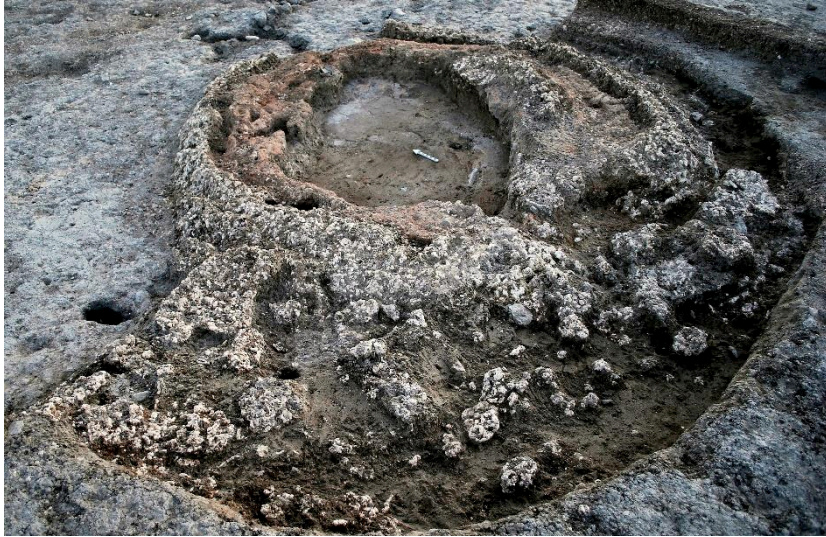
Figure 4.239: Hearth N406 from south

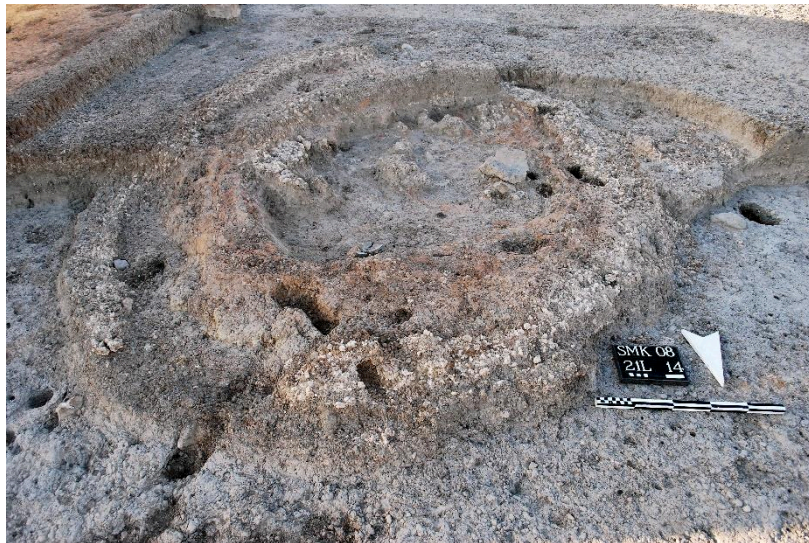
**Figure 4.240: Hearth N301 from southwest and densely lime fragments around it**

This was located in an open space in the northern part of trench 21M and the southern part of trench 21L, under the Structure N2B4 of the Phase N2, in Area A. In other words, Structure N2B4 was built slightly sloping to the south on this hearth. The hearth covers an area of approximately 2 m<sup>2</sup> between the elevations of 699.96 to 700.12 and it was constructed on the grey-coloured densely ashy earth. It had two superimposed plastered floors with a stone pavement under the earliest plastered floor. Based on the floor remains, the hearth slightly inclined to the south. (Figure 4.240 – 4.242)

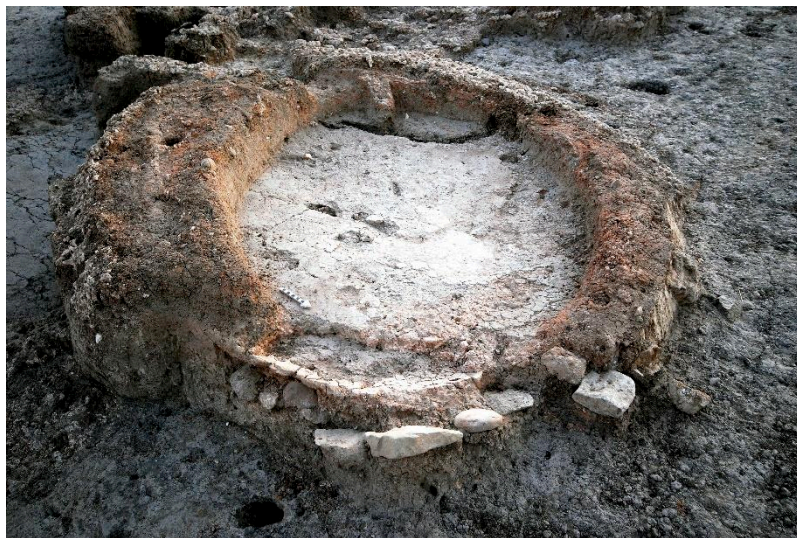
**Figure 4.241: Hearth N301 from north**

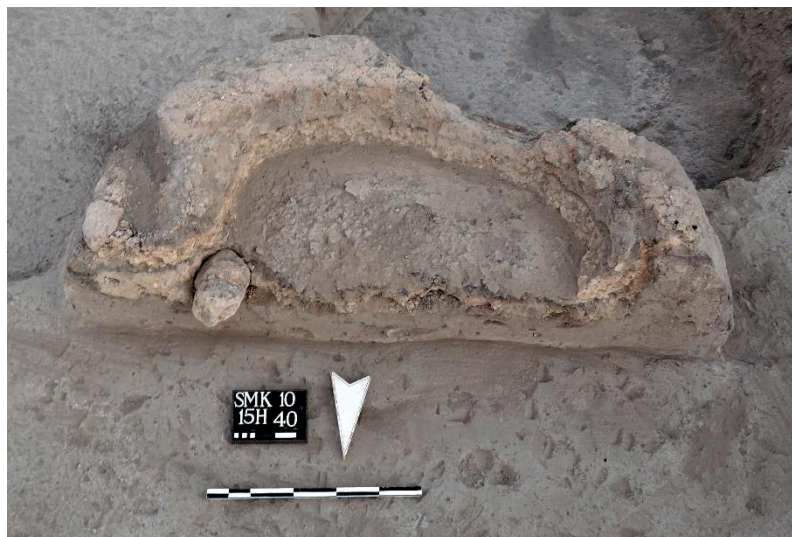
**Figure 4.242: Cross-sectional view of stone pavement and plastered floors from Hearth N301**

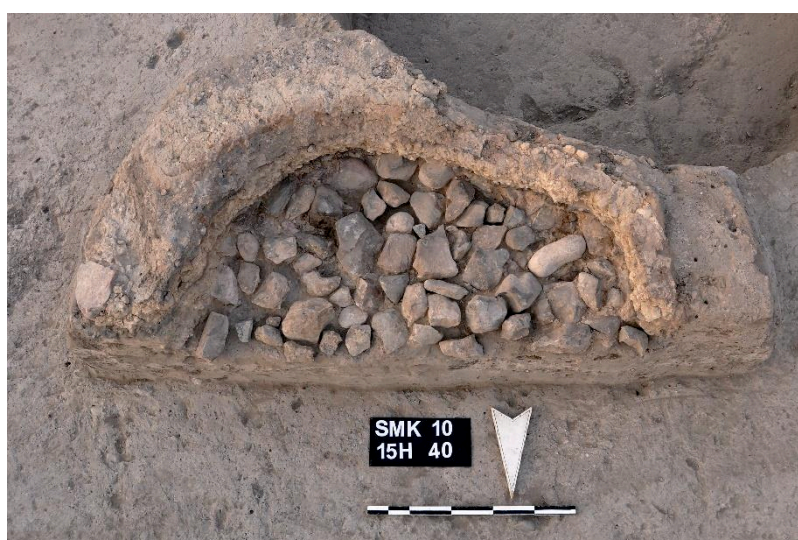
Figure 4.244: Cross-sectional view of stone pavement and plastered floors from Hearth N302

This was located in an open space in the middle of trench 15H in Area B on the greyish buff soil mixed with random calcareous pieces. The hearth covers an area of approximately 1 m<sup>2</sup> between the elevations of 701.20 to 701.37. Two plastered floors were laid on top of each other with a stone pavement under the first one. (Figure 4.243 – 4.245) The hearth slightly inclined to the west.

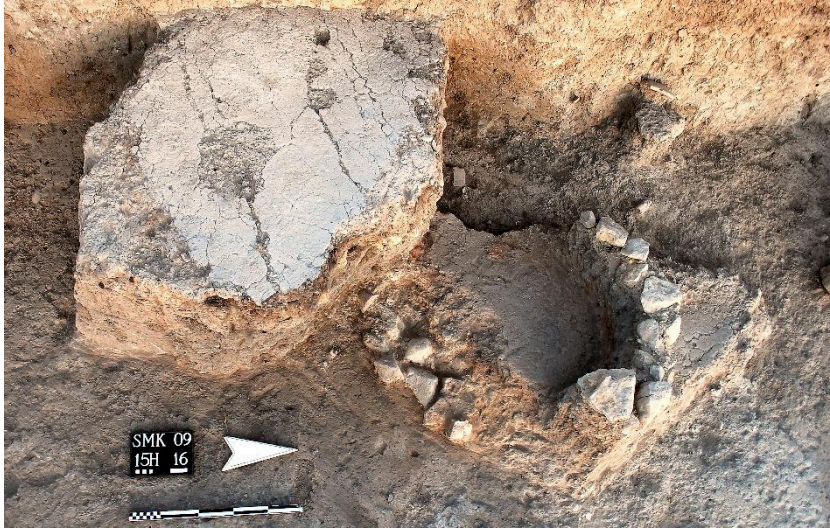
Figure 4.248: General view of the superimposed position of Hearth N303 and Hearth N304

This was located in an open space in the middle of trench 15H in Area B on the reddish-brown soil with random grey ash lines. It covers an area of approximately 1 m<sup>2</sup> between the elevations of 701.54 to 701.67. It had a single light grey-coloured plastered floor with a stone pavement. (Figure 4.246 – 4.248) Based on the floor remains, the hearth inclined to the south.

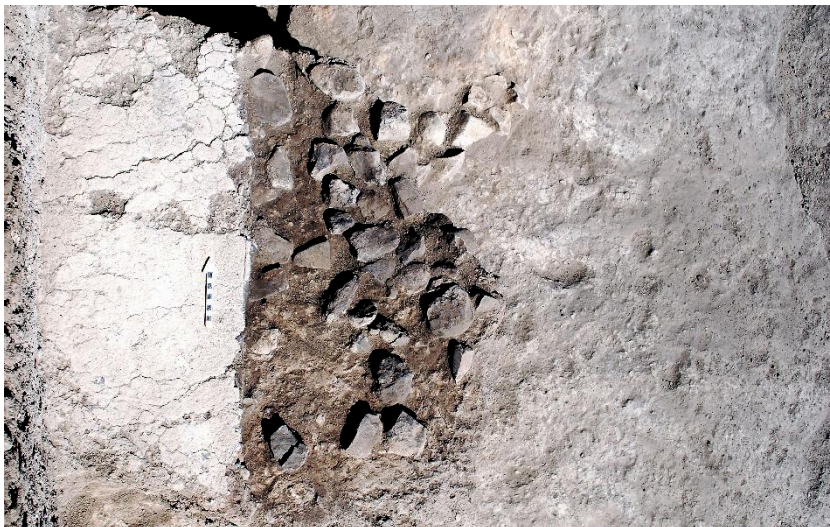
**Figure 4.250: Bird's-eye view of Hearth N201**

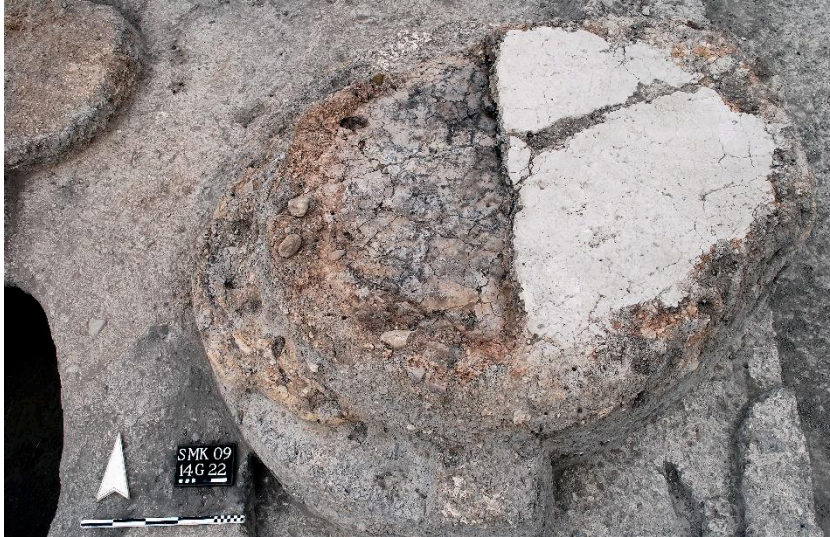
**Figure 4.251: Plastered floor and stone pavement together from Hearth N201**

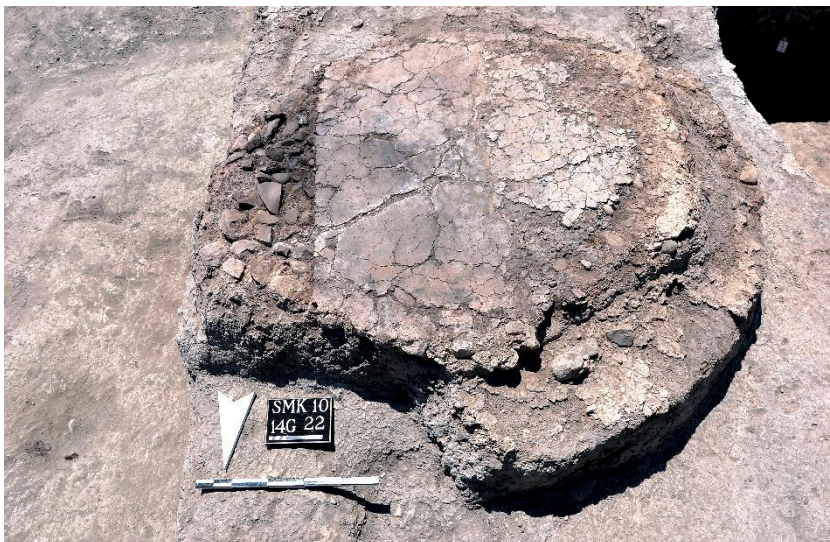
**Figure 4.252: Hearth N2O2 from south (1st floor stage)**

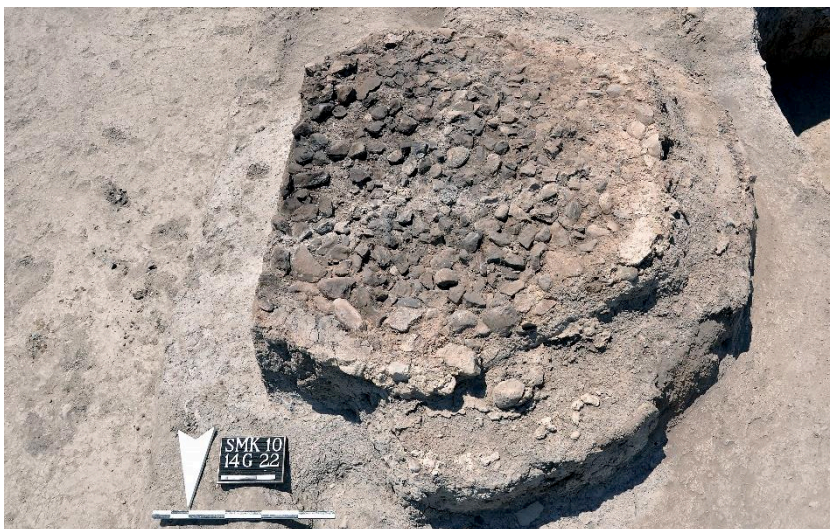
**Figure 4.253: Hearth N2O2 from south (3th floor stage)**

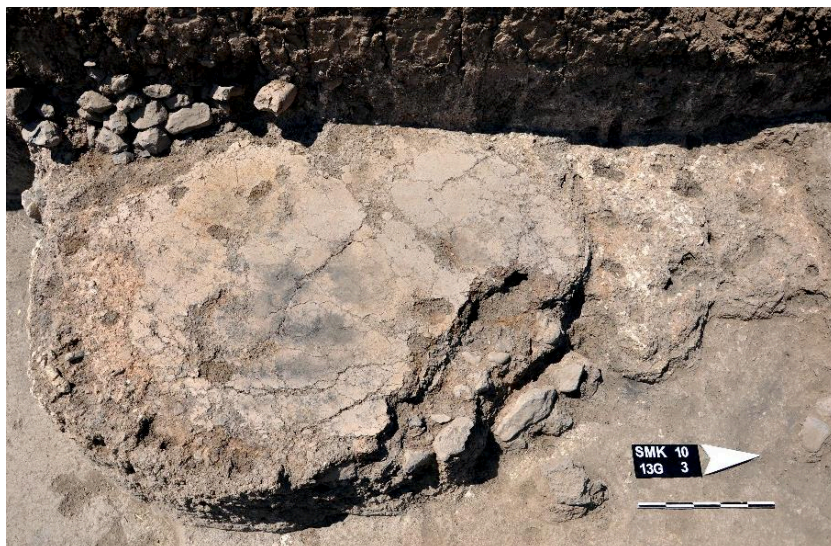
**Figure 4.254: Stone pavement from Hearth N2O2**

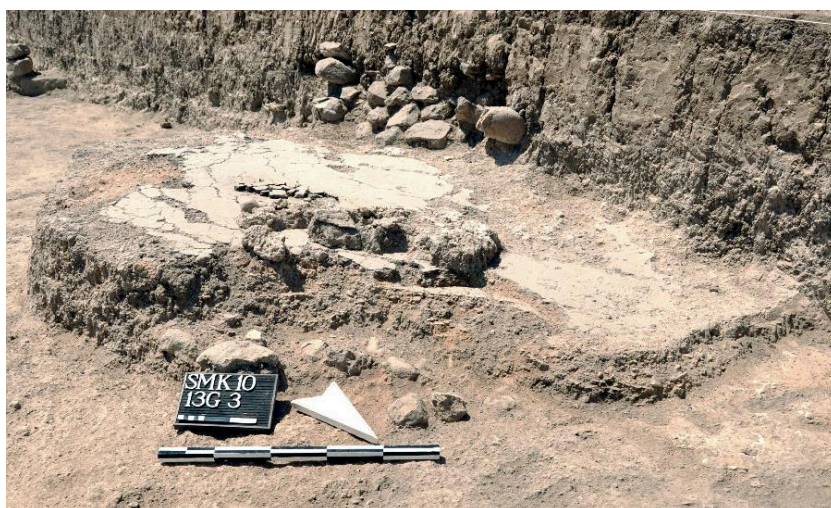
Figure 4.255: Hearth N2O3 from west

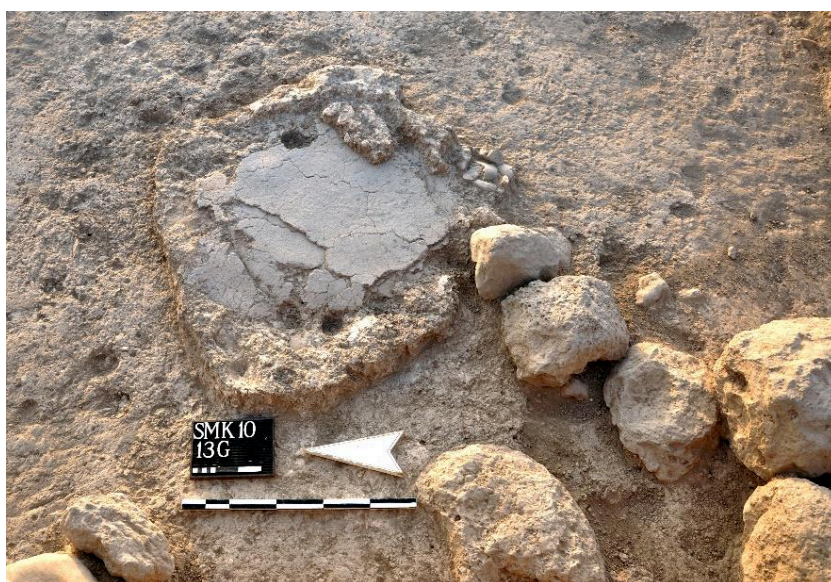
Figure 4.256: Cross-sectional view of stone pavement and plastered floors from Hearth N2O3

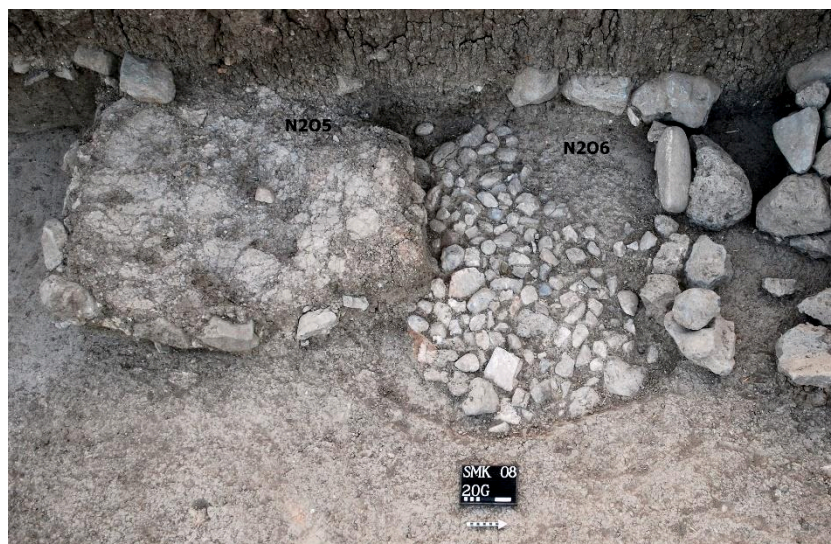
Figure 4.258: Overview of Hearth N205 and Stone Pavement / Hearth N206 together at the Area C

This was located in an open space at the edge of the eastern profile of trench 20G and also partially underneath the Hearth N2O5 in Area C. This stone pavement (hearth) covers an area of approximately 1.1 m<sup>2</sup> between the elevations of 697.95 to 698.02 and it was on the grey stone-poor soil. (Figure 4.258, 4.259) Its plastered floor was not detected and its southeast part was not well-preserved. The dimensions of the oval / rounded-shaped feature were 102 cm in the east-west direction and 73 cm in the north-south direction. Since it had a similar type of stone pavement of the hearth' bases this feature was defined as hearth. It is likely that the plastered floor was left unfinished. The stone pavement was constructed of basalt and pebbles of different sizes between 4x6x9 - 5x8x14 cm.
