# Microarchaeological observation on the neolithic architectural structures and cultural landscape of Sumaki Höyük

# **Microarchaeological Observation on the Neolithic Architectural Structures and Cultural Landscape of Sumaki Höyük**

PhD Thesis

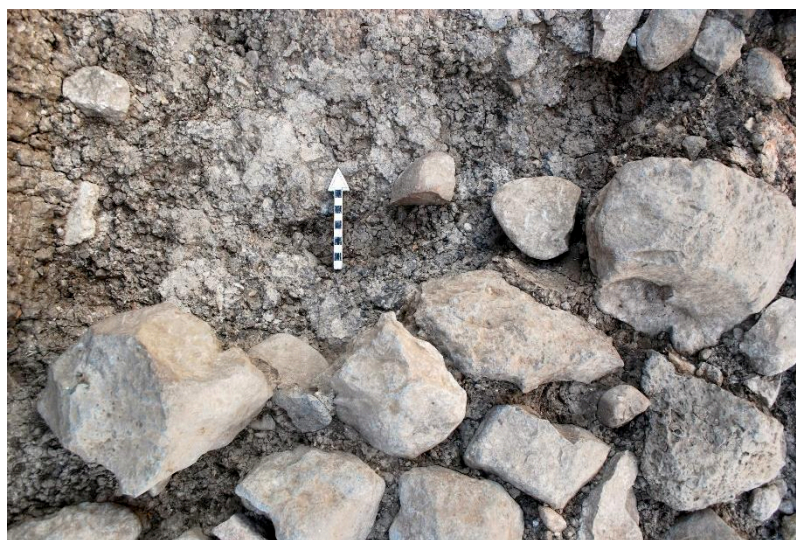
Figure 4.259: General view of the superimposed position of Hearth N205 and Stone Pavement / Hearth N206

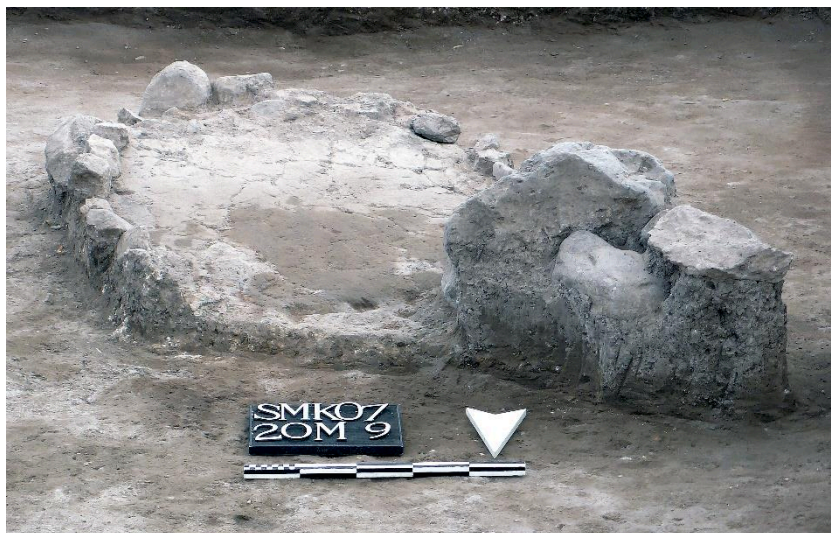
Figure 4.260: Detail view of plastered floor from Hearth N205

This was located in an open space at the edge of the eastern profile of trench 20G in Area C. The hearth was constructed on a grey stone-poor soil. It covers an area of approximately 1.2 m<sup>2</sup> between the elevations of 698.01 to 698.17. It had a single plastered floor with a stone pavement. The dimensions of the oval/ “U”-shaped hearth were 92 cm in the east-west direction and 120 cm in the north-south direction. (Figure 4.258 – 4.260) Its plastered floor was bluish-grey colour and 2 cm in thickness. The pavement was made of stones of different sizes. Between the stone pavement and the plastered floor was a layer of buff-coloured scattered stone-tempered 2-4 cm-thick filling. The surface of the plastered floor was densely cracked and rippled.

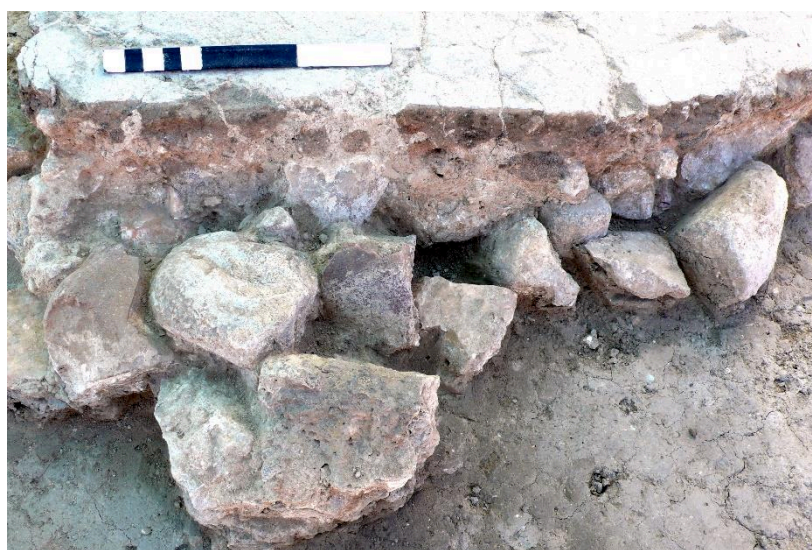
**Figure 4.261: Hearth N101 from north**

It was located in an open space in the southwestern part of trench 20M in Area A. The hearth covers an area of approximately 1 m<sup>2</sup> between the elevations of 700.95 to 701.14 and it was built on the grey ashy, stony and sandy soil. It had a single yellowish grey-coloured plastered floor with a stone pavement. (Figure 4.261 – 4.263) The hearth inclined to the north.

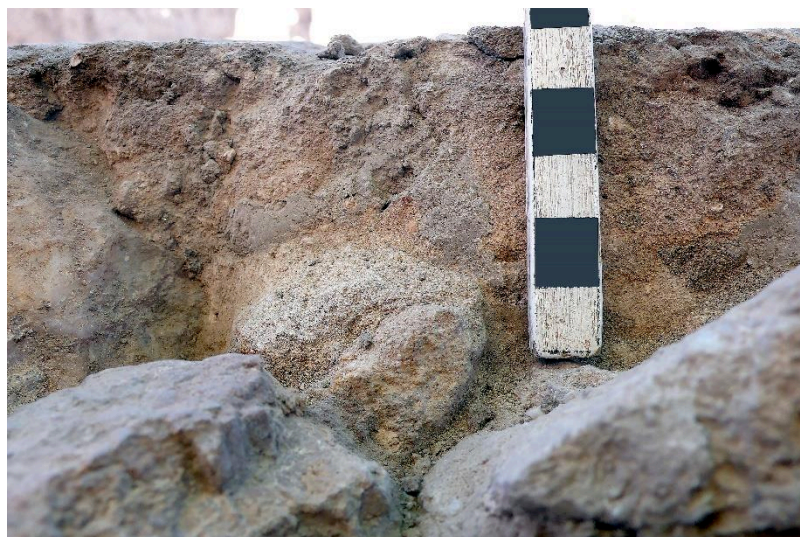
**Figure 4.262: Cross-sectional view of stone pavement and plastered floors from Hearth N101**

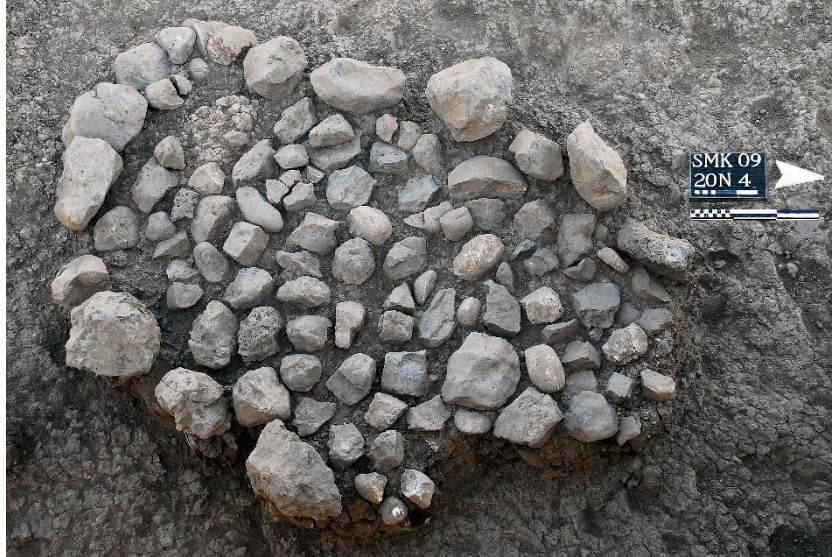
**Figure 4.263: Detail view of cross-sectional view of Hearth N101**

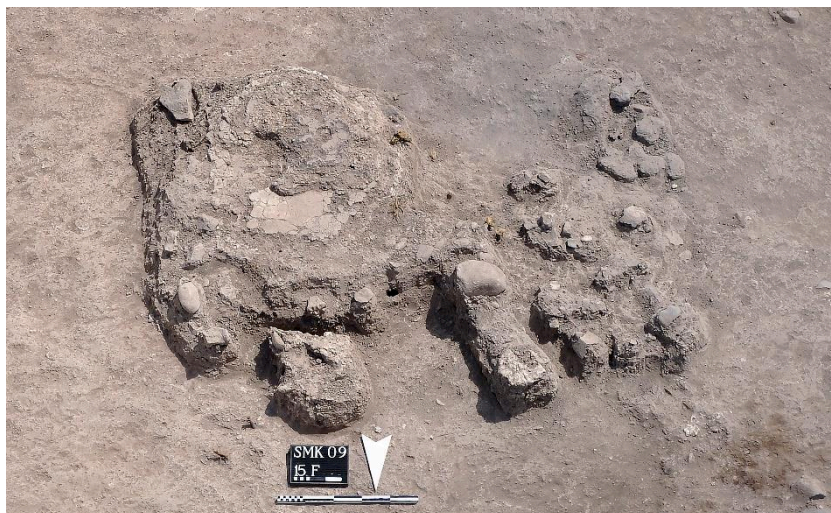
Figure 4.266: Cross-sectional view of stone pavement and plastered floors from Hearth N104

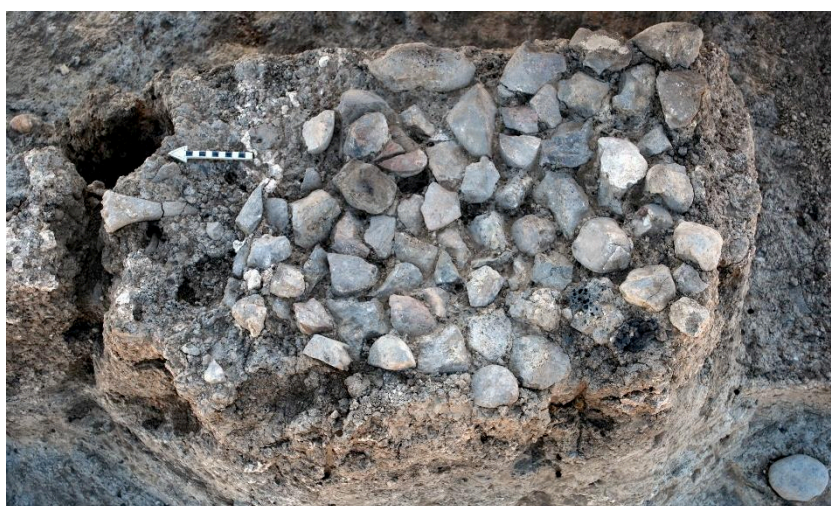
**Figure 4.268: Detail view of plastered floors from Hearth N105**

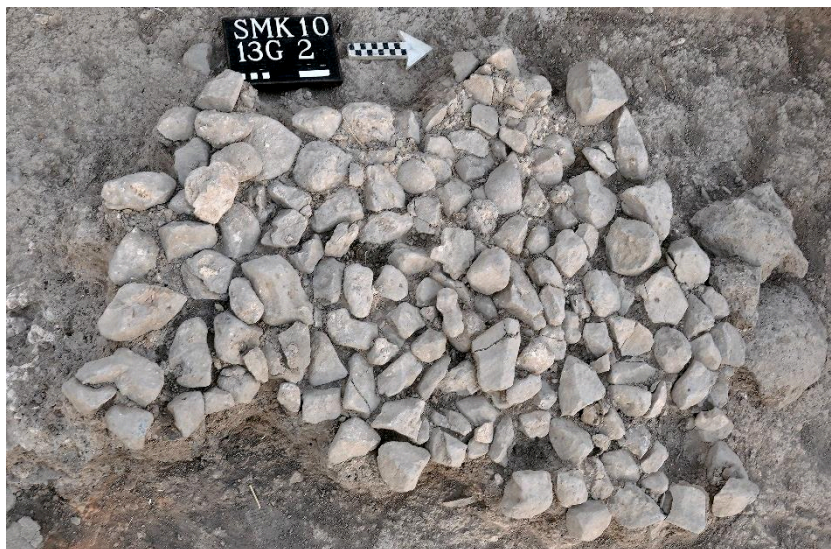
**Figure 4.269: Stone pavement from Hearth N105**

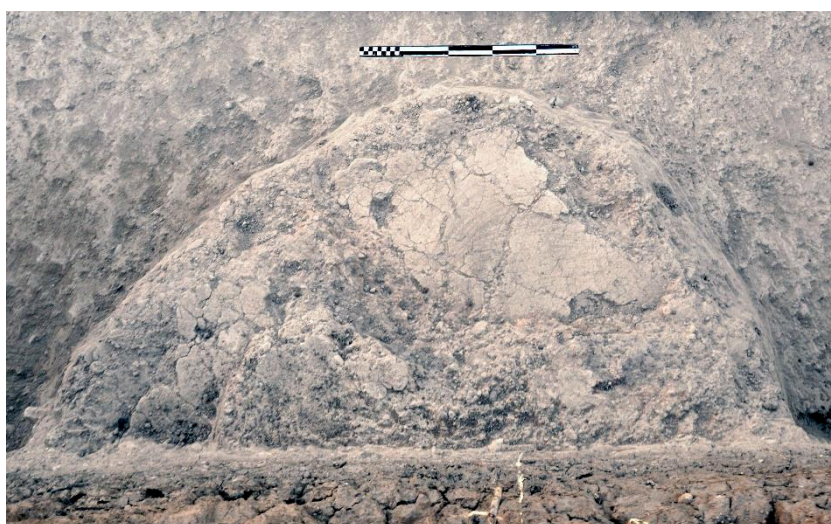
Figure 4.270: Stone Pavement / Hearth N106

This was located in an open space in the northern part of trench 13G in Area B. The stone pavement was constructed on the greyish buff soil. It covers an area of approximately 1.2 m<sup>2</sup> between the elevations of 702.54 to 702.66. Its plastered floor was not preserved. (Figure 4.270) The diameters of this oval / rounded feature were 118 cm in the north-south direction and 102 cm in the east-west direction. The main reason for defining this feature as the hearth since it had a similar type of stone pavement of the hearth bases. It is likely that the plastered floor was left unfinished. The stone pavement was made of basalt and pebbles of different sizes between 4x7x8 cm and 5x7x15 cm similar to the pavements of other hearths.

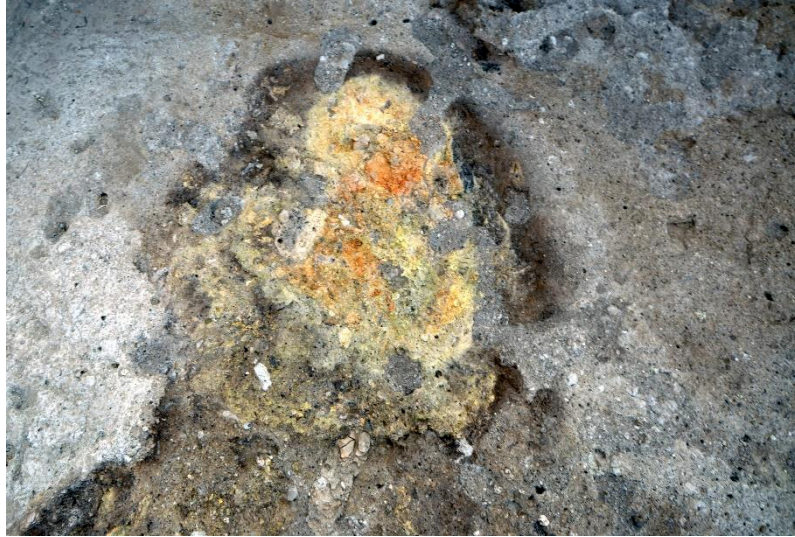
Figure 4.272: Cross-sectional view of stone pavement and plastered floors from Hearth N107

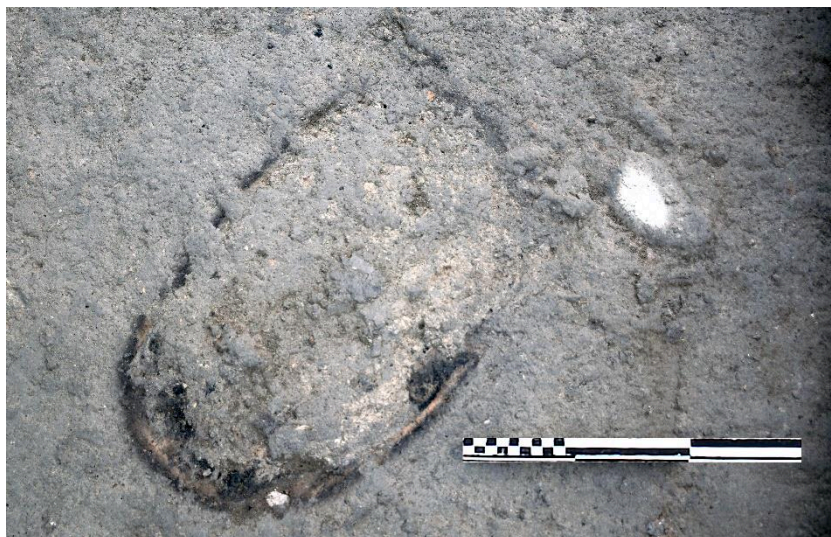
**Figure 4.275: Cross-section of its burnt filling of Fire Pit N7A2**

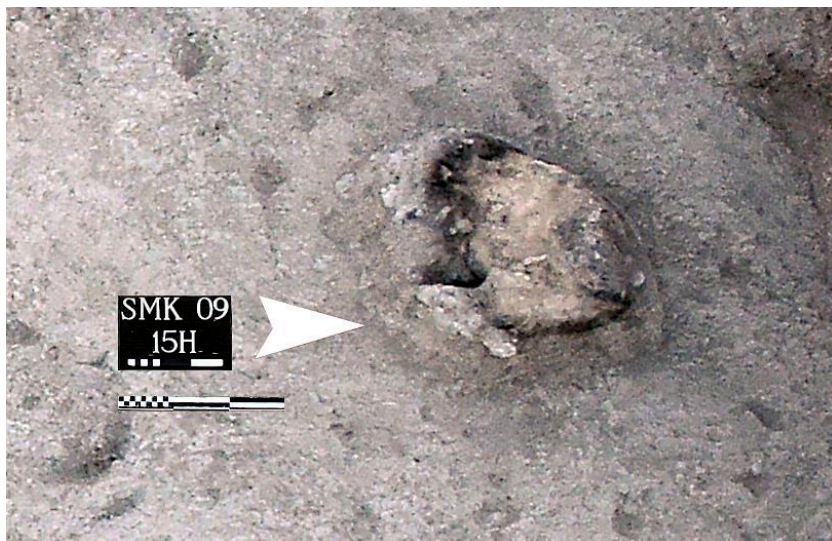
Figure 4.283: Cross-section of Fire Pit N4A1

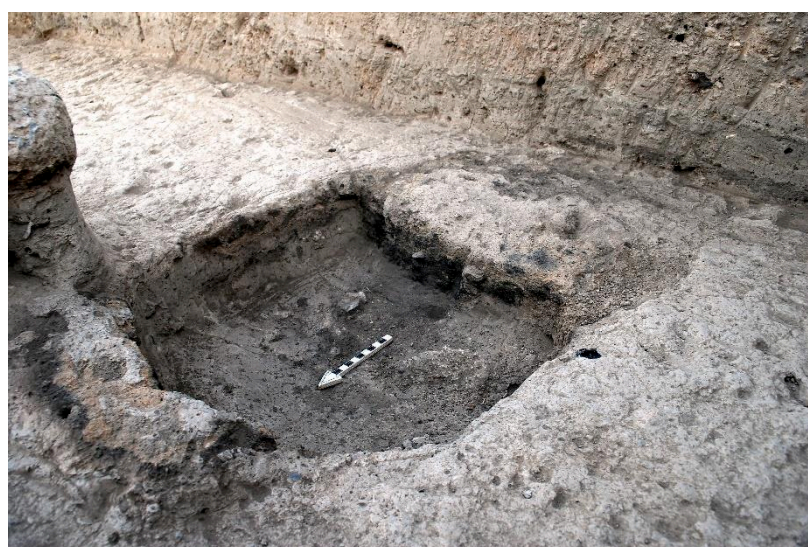
Figure 4.285: Fire Pit N4A6

plastering on its sides or its bottom. It was filled with yellowish buff-coloured ash comprising some stones and carbon particles. (Figure 4.285 – 4.287)

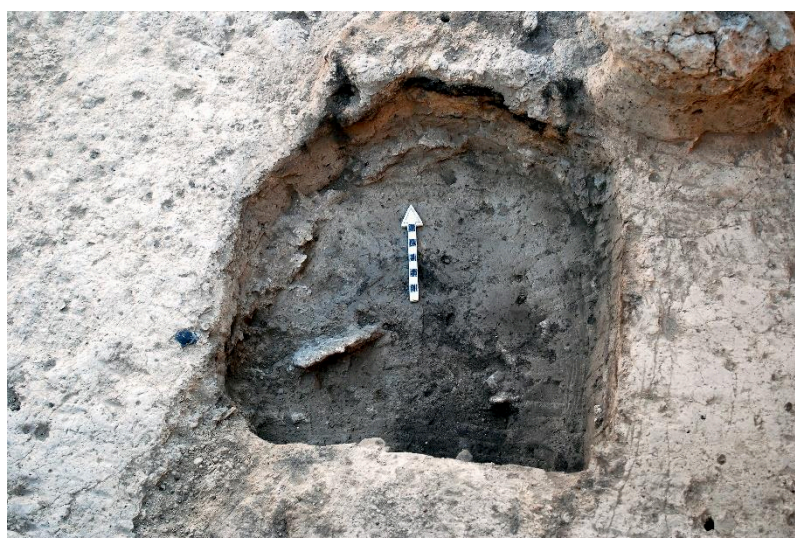
Figure 4.286: Cross-section of Fire Pit N4A6 from northwest

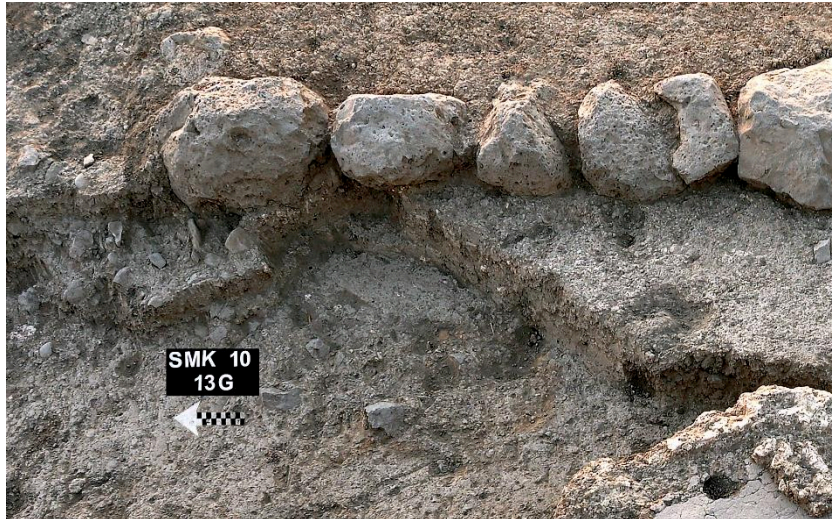
Figure 4.287: *Bird's-eye view* of Fire Pit N4A6

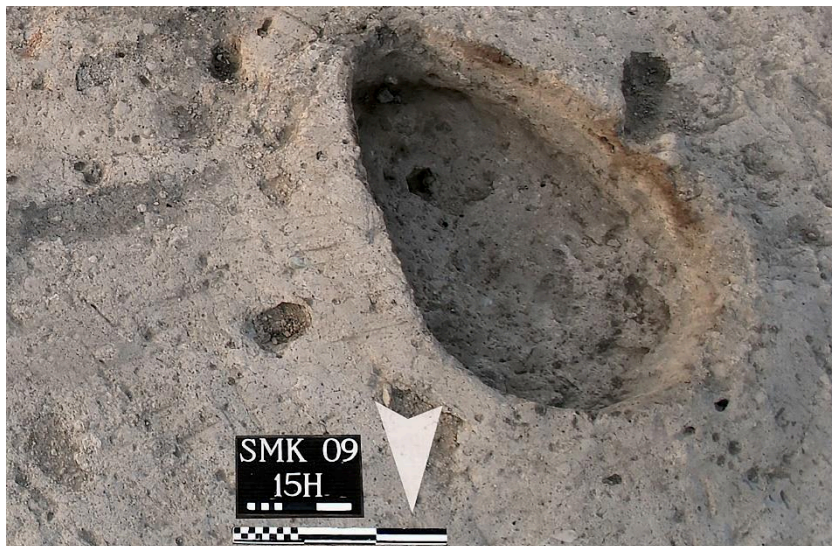
Figure 4.289: Fire Pit N2A2

This was located in an open space in the mid-side of trench 15H, and northwestern of Hearth N3O2 in Area B. The waterdrop-shaped fire pit was between the elevations of 701.47 to 701.56. Dug in a grey densely limey soil, the fire pit was 35x60 cm in size and 9 cm deep. (Figure 4.289) On its edge, there is a dark grey line due to burning with 1-2 cm thickness. There were no signs of plastering on its sides or its bottom. Its inner deposit was light grey-coloured ash.

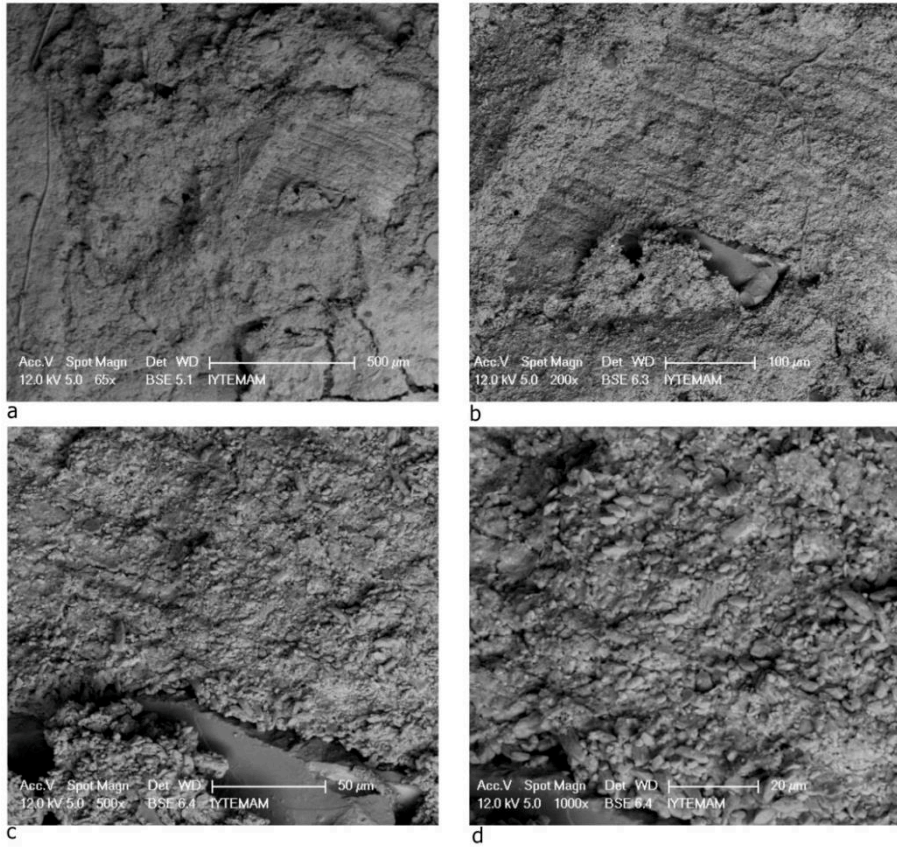
Figure 4.291: SEM images of lime samples taken from Structure N6B1

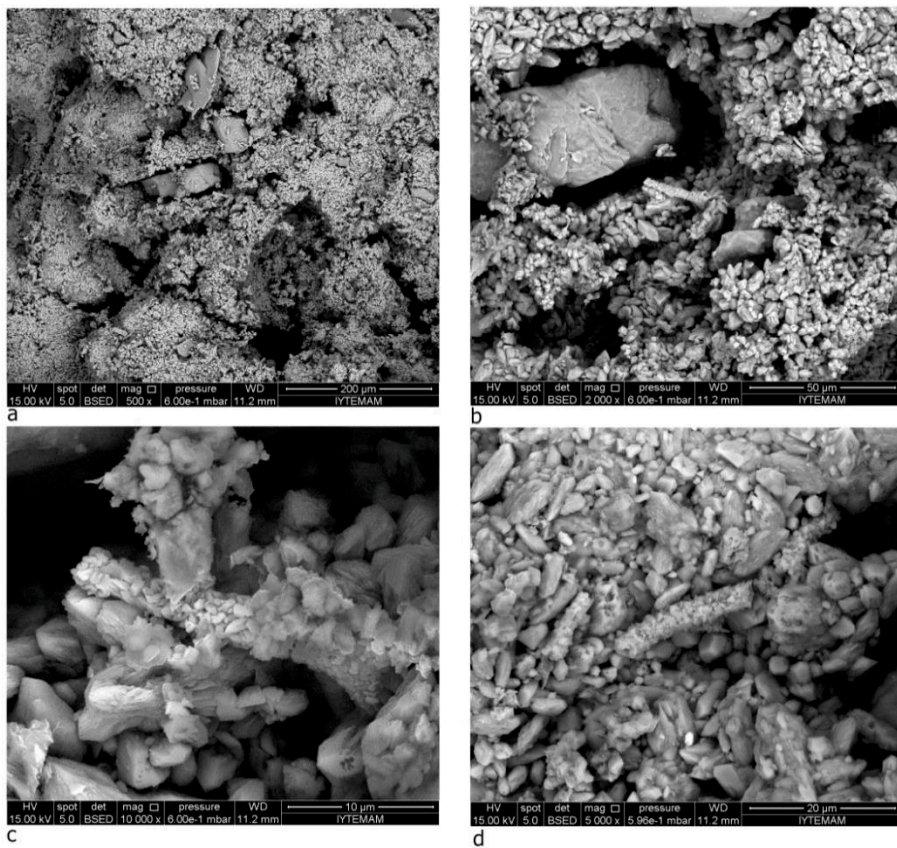
Figure 4.292: SEM images of lime samples taken from Structure N6B2

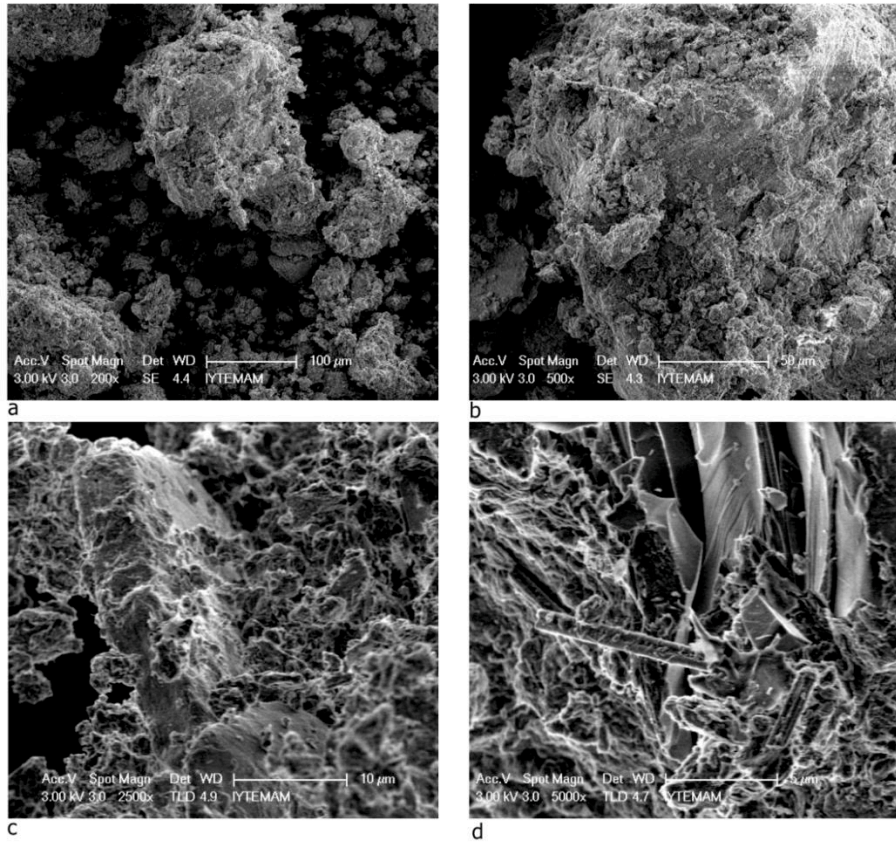
Figure 4.293: SEM images of soil samples taken from Structure N6B2

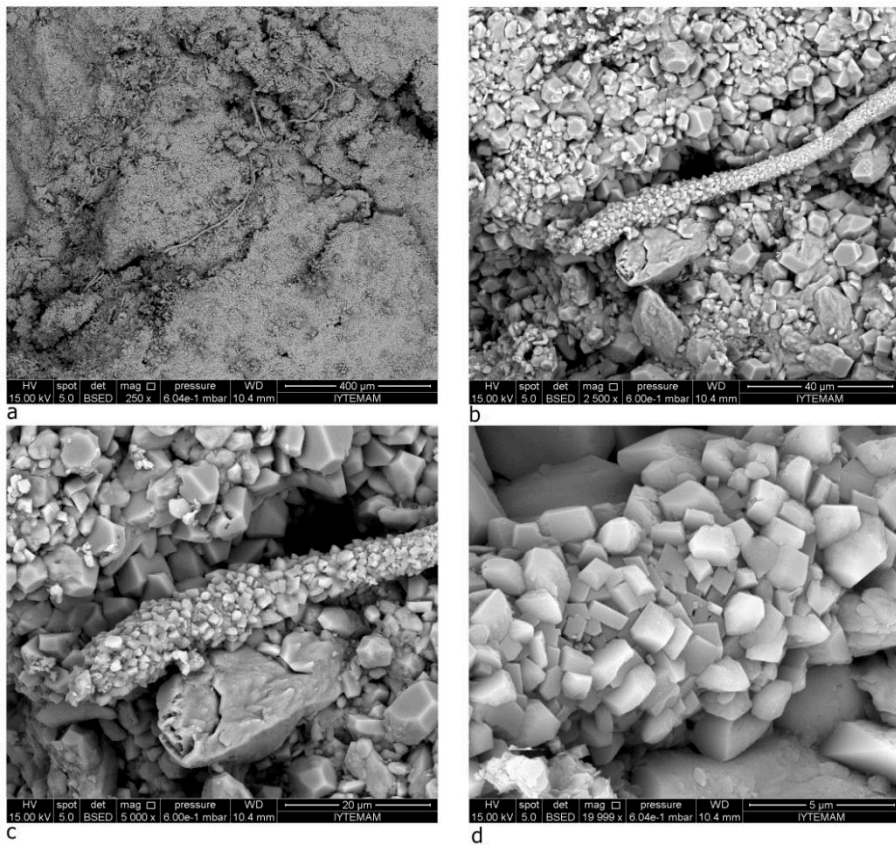
Figure 4.294: SEM images of lime samples taken from Structure N6B9

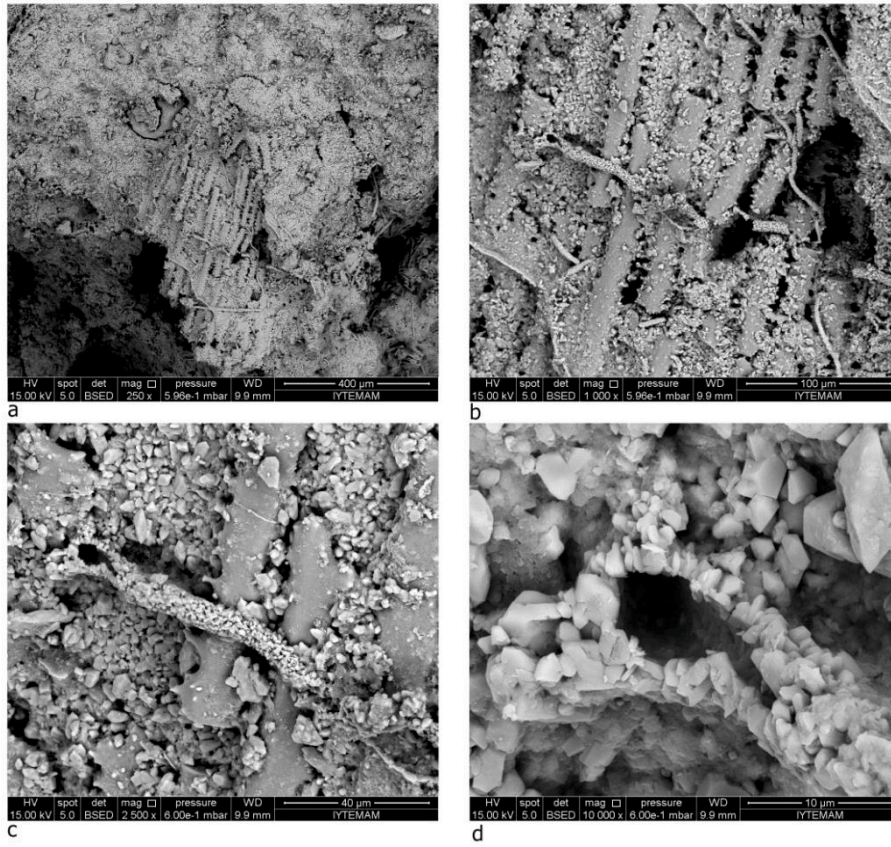
Figure 4.295: SEM images of lime samples taken from Structure N6B10

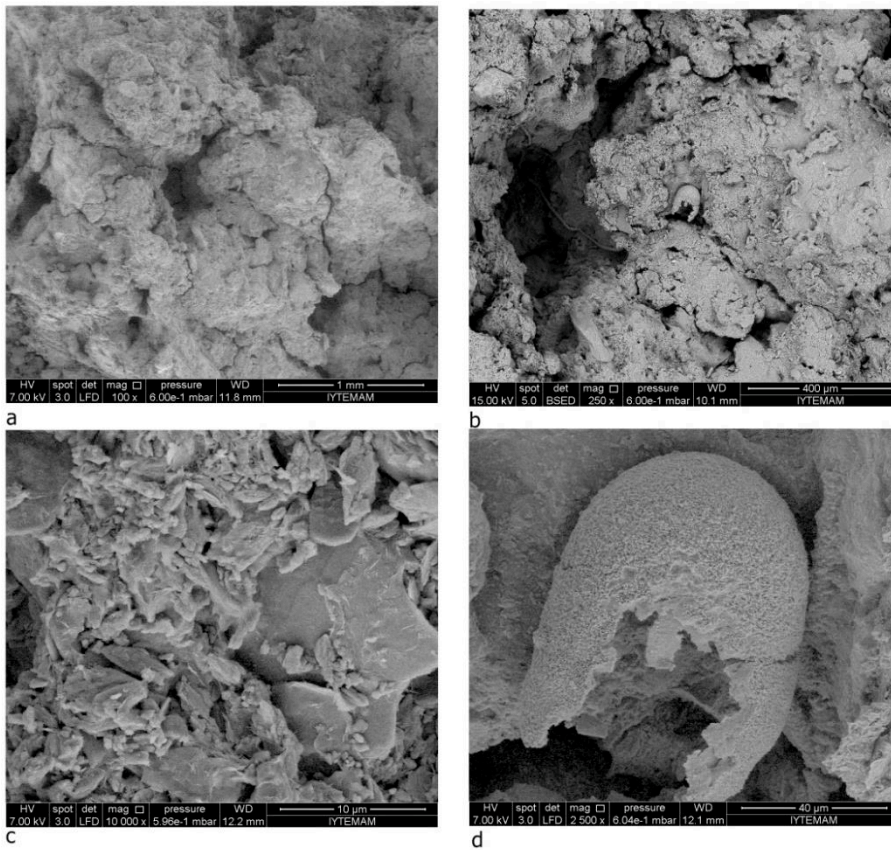
Figure 4.296: SEM images of lime samples taken from Structure N5B1

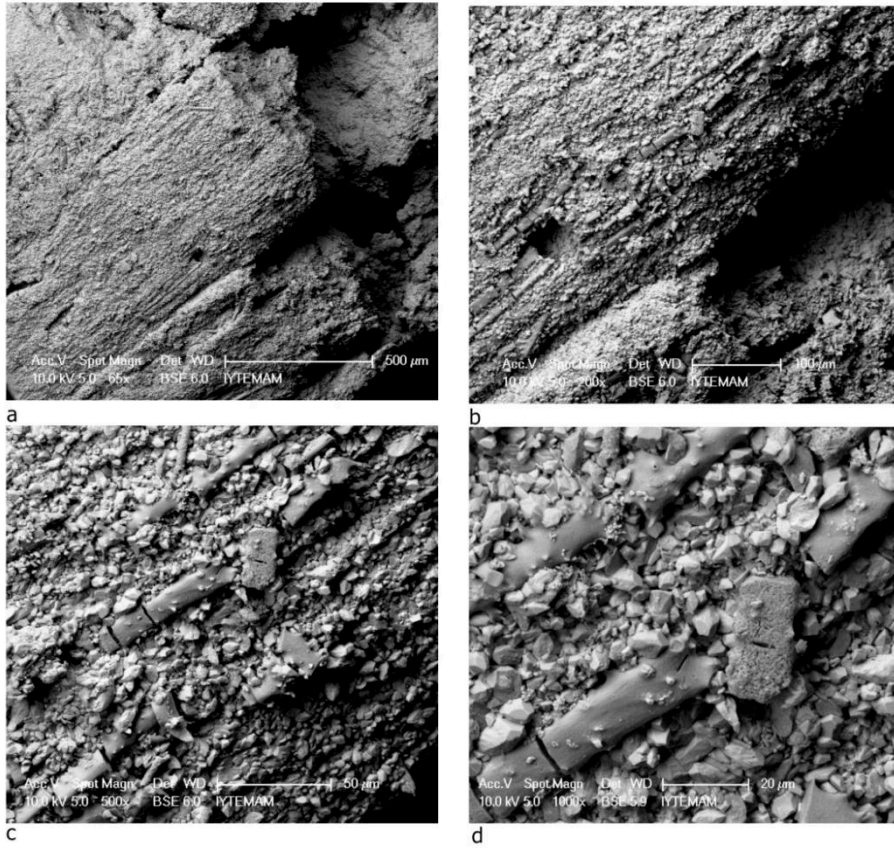
Figure 4.297: SEM images of lime samples taken from Structure N5B3

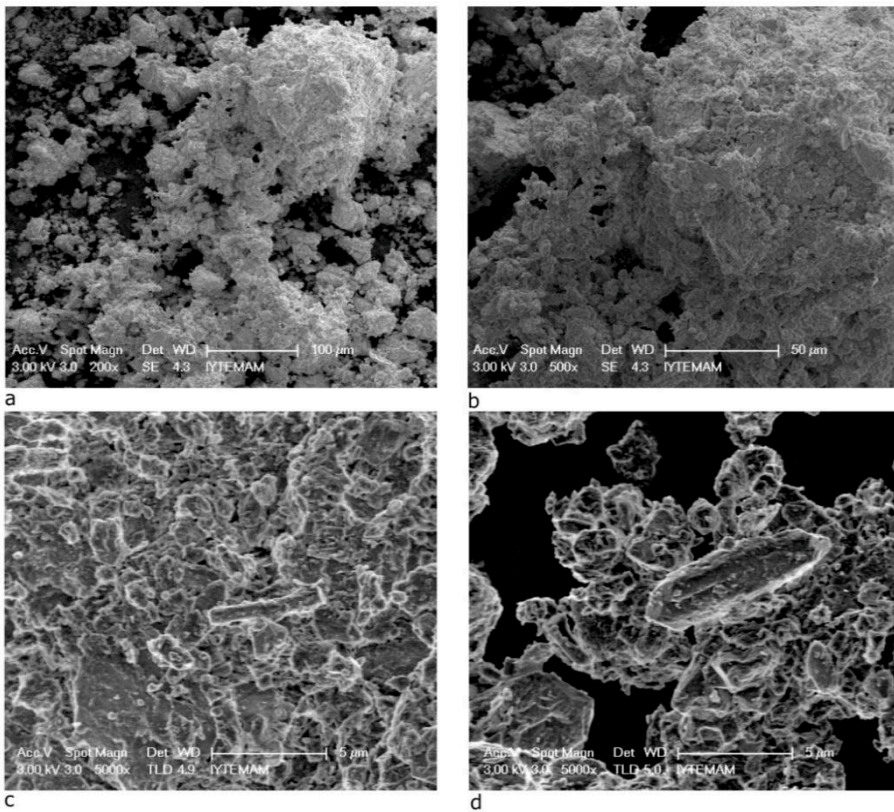
Figure 4.298: SEM images of soil samples taken from Structure N5B3

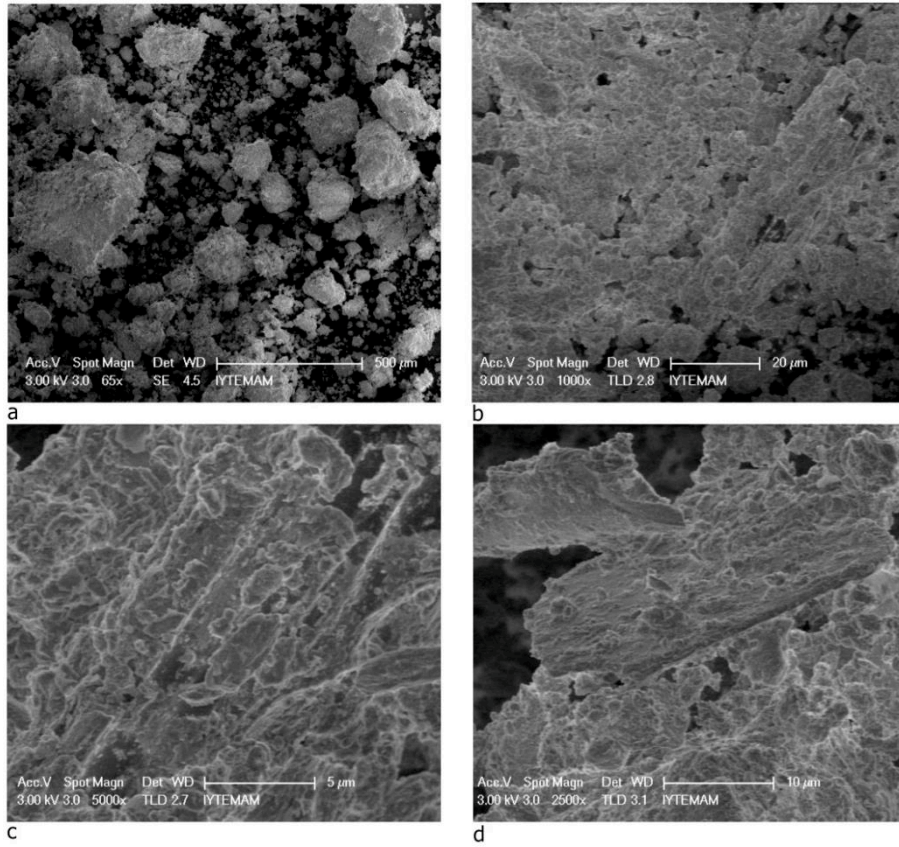
Figure 4.312: SEM images of lime samples taken from Structure N4B8

SEM images of lime samples very clearly showed organic remains with calcium carbonate minerals surrounding tubes. (Figure 4.312c-d) Investigation of lime samples with EDX analysis found O (34.70%), Ca (21.08%), C (8.76%), Si (17.06%), Fe (8.80%), Al (5.64%), Mg (1.94%), and K (2.02%) elements. (Diagram 4.64)

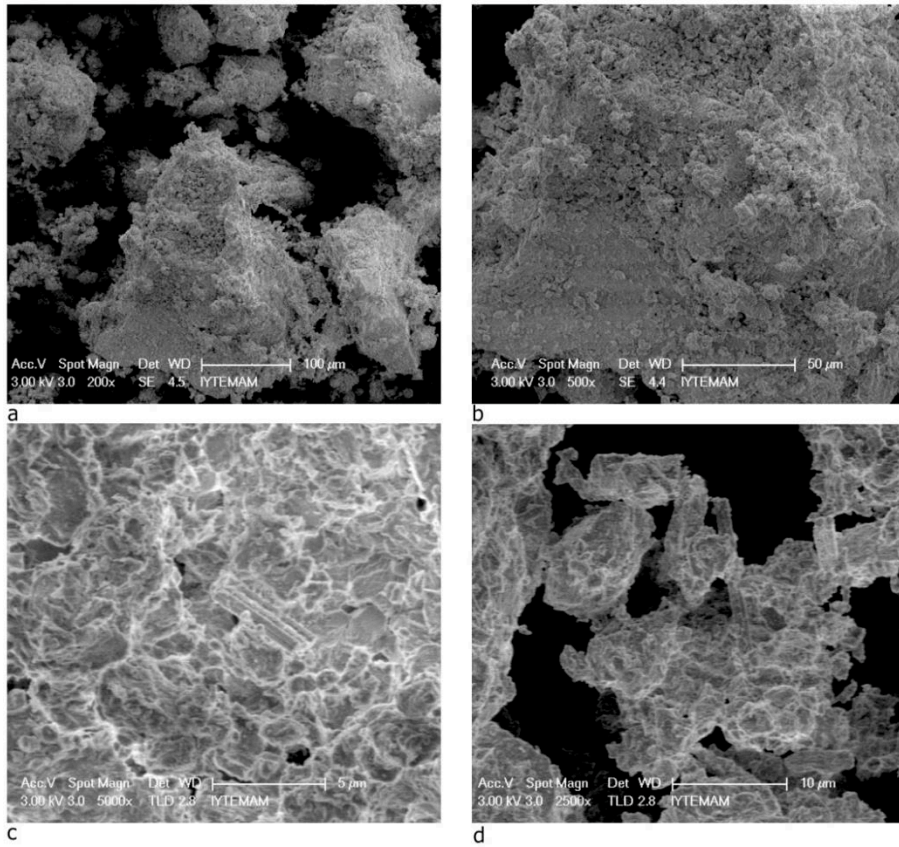
Figure 4.314: SEM images of lime samples taken from Structure N4B9

SEM images of lime samples very clearly showed organic remains with calcium carbonate minerals surrounding tubes. SiO<sub>2</sub> gels filling the organic cavities are observed on SEM images of the same samples. The clearest is silicon dioxide gel filling a *Panicum* plant remnant. (Figure 4.314) EDX analysis of the lime samples observed the elements O (53.50%), Ca (20.50%), C (16.22%), Si (6.20%), Al (1.51%), Mg (0.82%), K (0.45%), and Fe (0.79%). (Diagram 4.69) XRD analysis of the lime samples only identified calcium carbonate minerals. (Diagram 4.119)

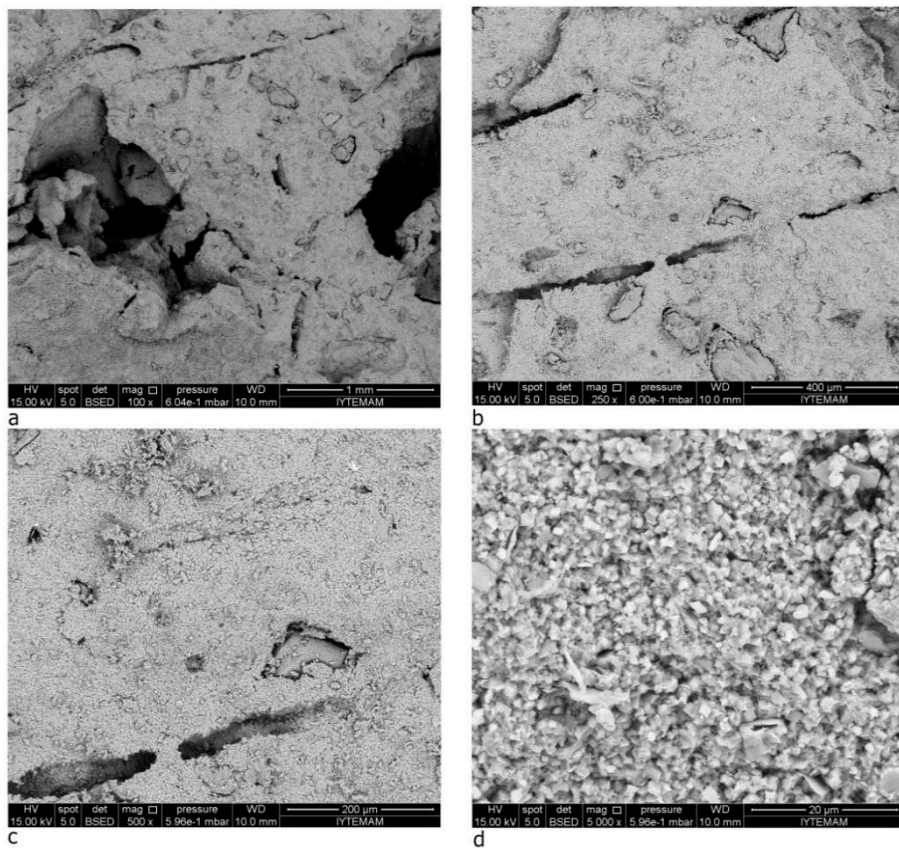
Figure 4.315: SEM images of soil samples taken from Structure N4B10

On SEM images of reddish-brown soil samples, micritic envelopes on sand and stone grains and acicular-shaped calcium carbonate crystals are observed. (Figure 4.315c-d) According to EDX analyses of the soil samples identified the elements O (32.43%), Ca (15.07%), C (8.92%), Si (20.73%), Fe (11.15%), Al (7.61%), Mg (2.05%), K (2.05%), and Na (0.38%). (Diagram 4.70)

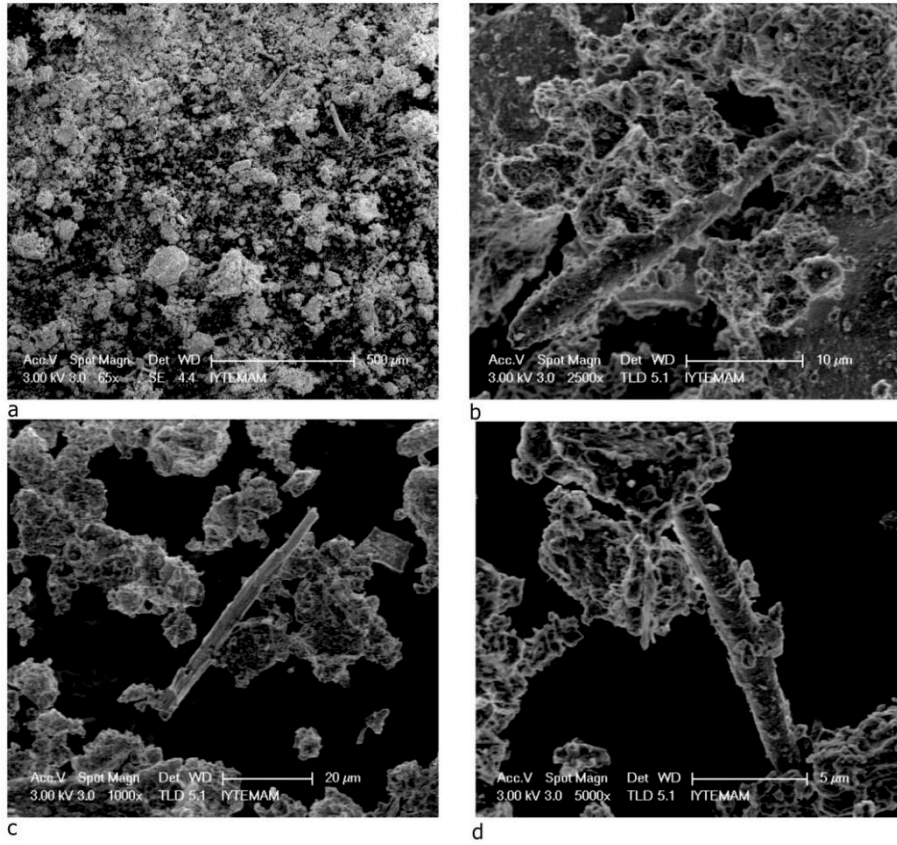
Figure 4.316: SEM images of lime samples taken from Structure N4B13

SEM images of lime samples clearly show cavities formed by organic remains. Calcium carbonate minerals filled the edges of these cavities. (Figure 4.316) These calcium carbonate minerals with scalenohedral and granular crystal structure are probably aragonite crystals. Investigation of the lime samples with the EDX method identified the elements O (52.77%), Ca (28.59%), C (12.73%), Si (3.18%), Al (1.15%), Mg (0.49%), and Fe (1.09%). (Diagram 4.72)

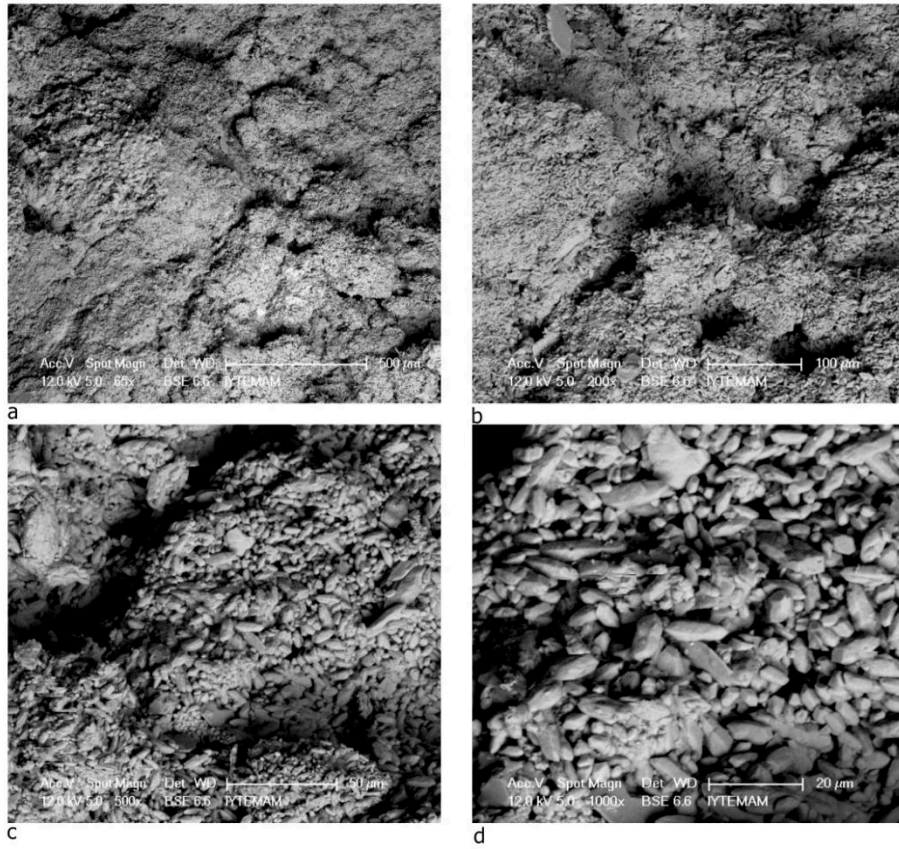
**Figure 4.318: SEM images of lime samples taken from Structure N2B2**

SEM images of lime samples taken from N2B2 fill observed scalenohedral and granular crystal structures. (Figure 4.318) Their EDX analysis identified O (54.60%), Ca (25.98%), C (11.30%), Si (4.73%), Al (1.49%), Fe (1.03%), and Mg (0.86%). EDX analysis in areas with clear scalenohedral and granular crystal structures determined element ratios very consistent with the general surface. (Diagram 4.73) Investigation of lime sample with

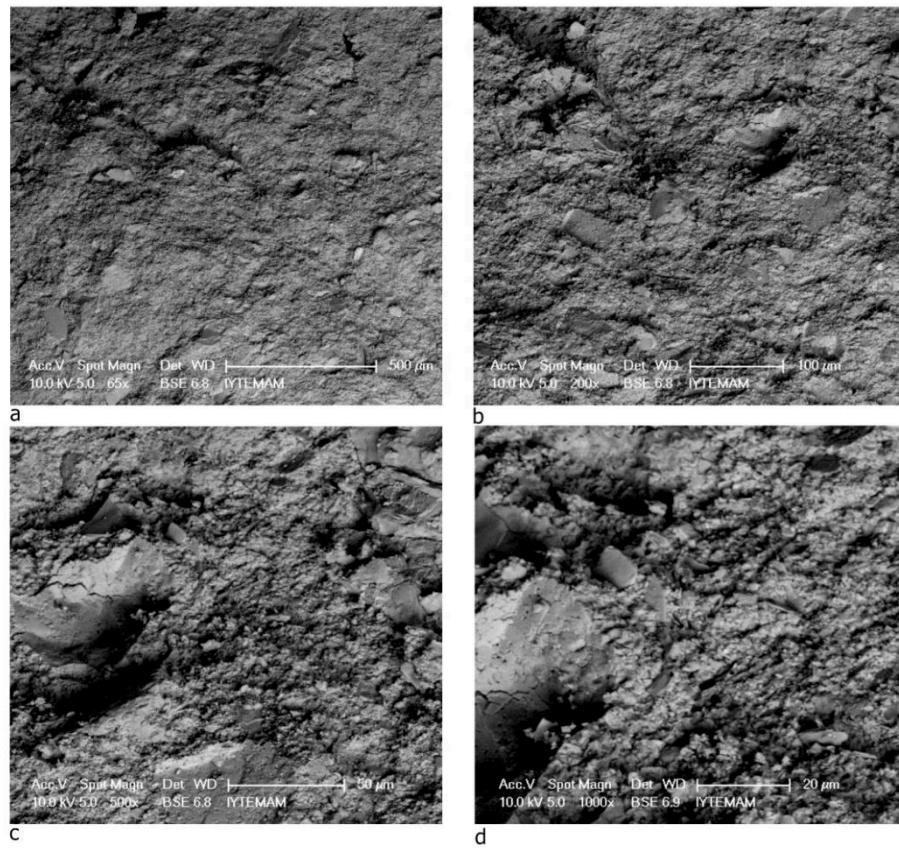
**Figure 4.319: SEM images of lime samples taken from Structure N2B3**

SEM images of lime samples taken from its fill observed scalenohedral, prism-shaped crystal structures along with acicular crystals. (Figure 4.319) EDX analysis of the lime samples found the elements O (35.00%), Ca (31.85%), C (21.18%), Si (3.34%), and Fe (1.28%) with trace amounts of Na, Mg, Al, K, and Ti. (Diagram 4.74)

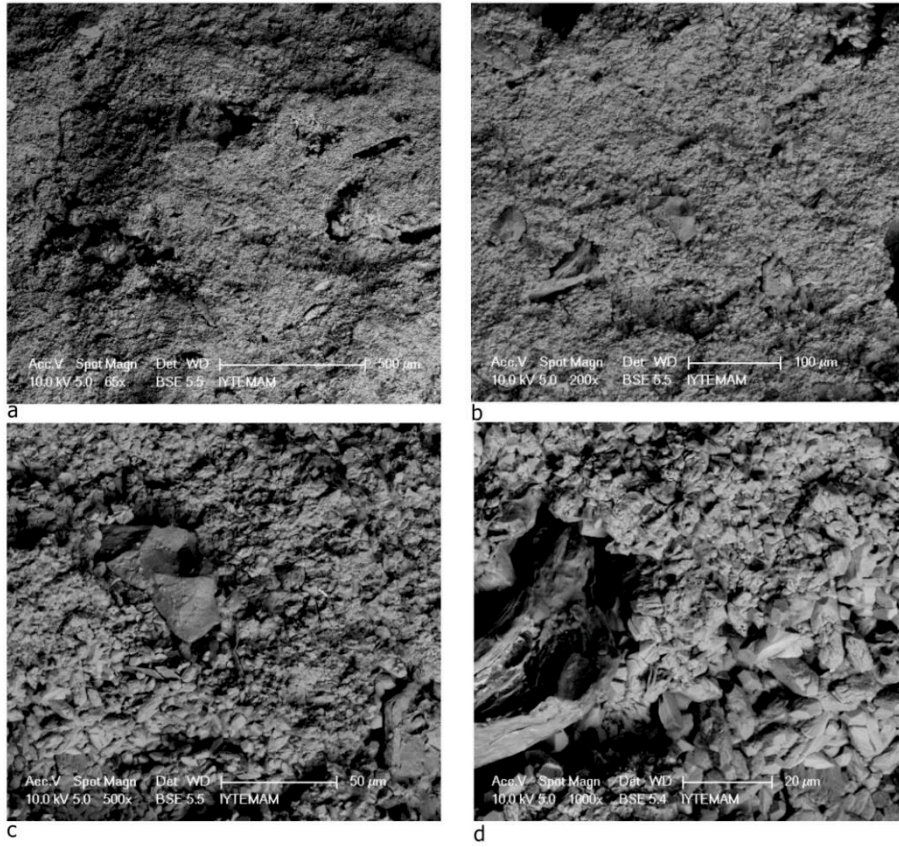
**Figure 4.320: SEM images of lime samples taken from Structure N2B4**

SEM images of lime samples show granular crystal structures. (Figure 4.320) Investigation of the same samples with EDX observed the following elements dominating; O (38.15%), Ca (23.92%), C (16.79%), Si (8.36%), and Fe (4.23%), together with trace amount of Na, Mg, Al, K, and Ti. (Diagram 4.76)

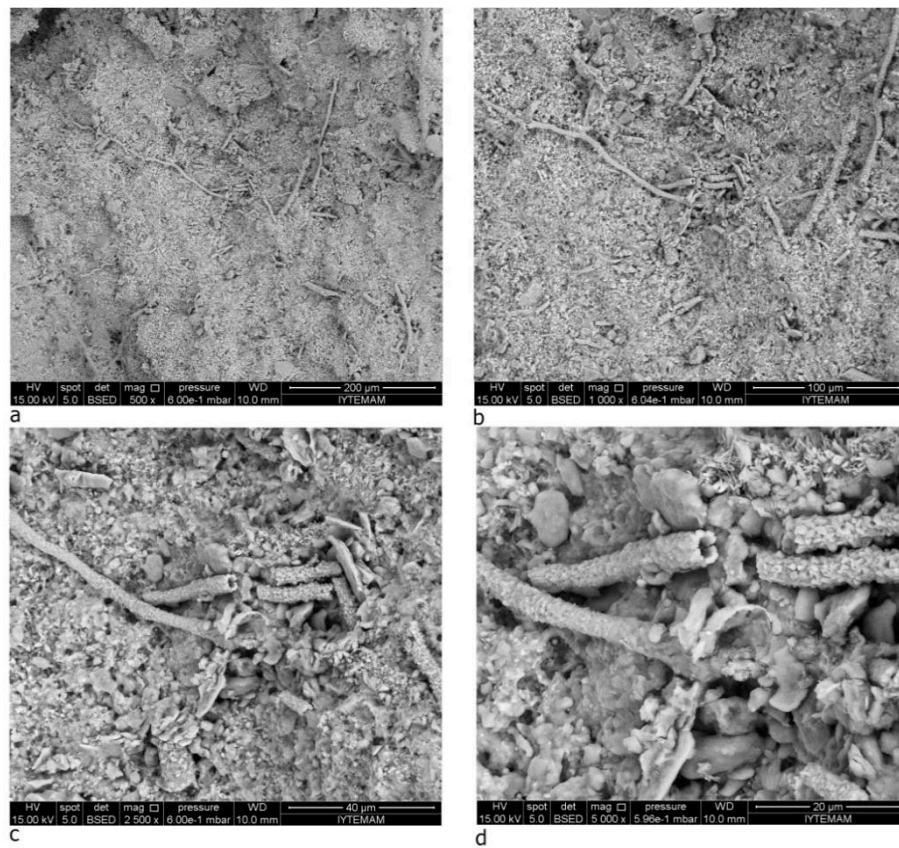
**Figure 4.321: SEM images of lime samples taken from Structure N2B6**

SEM images of lime samples show scalenohedral, prismatic, and granular crystals. Rod-like shaped cavities were also identified. The crystals surrounding these cavities were generally scalenohedral. (Figure 4.321c-d) Investigation of the lime samples with EDX method identified the elements O (36.31%), Ca (28.96%), C (18.58%), Si (5.98%), and Fe (2.62%). Na, Mg, Al, and K were also identified at rates from 2% to 0.43%. (Diagram 4.80)

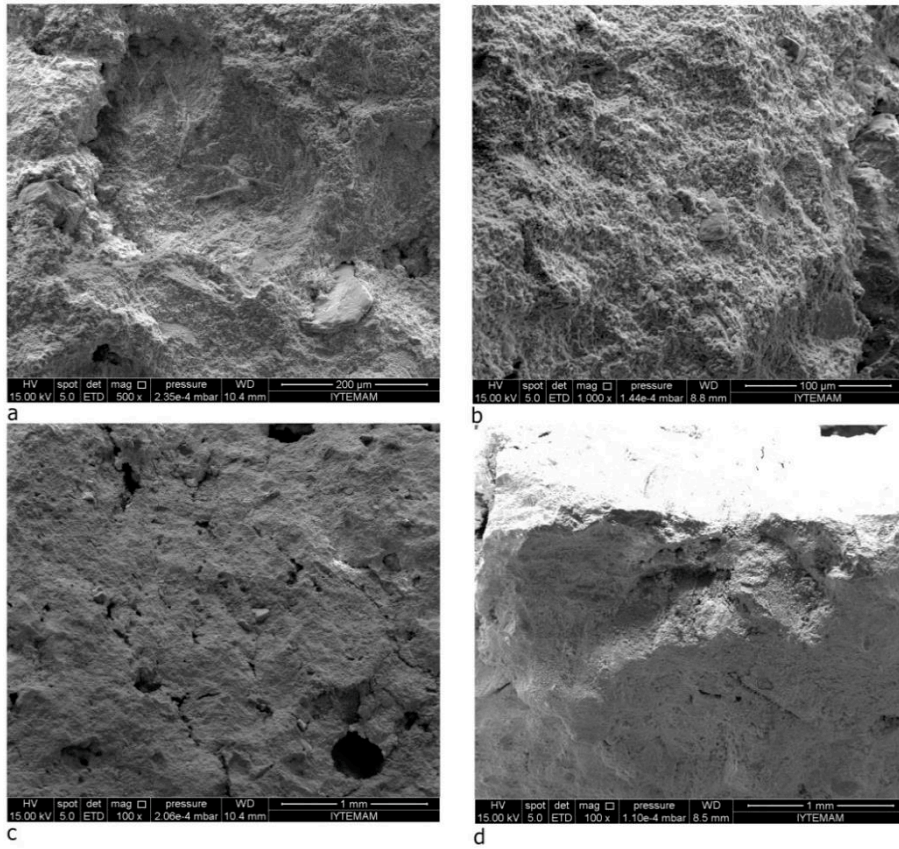
**Figure 4.322: SEM images of lime samples taken from Structure N2B8**

SEM images of lime samples show scalenohedral, prismatic, granular and acicular crystals. The minerals surrounding these tubes are generally sharp-tipped and needle-shaped crystal structures of aragonite. (Figure 4.322) Scalenohedral-shaped calcium carbonate minerals clearly observed surrounding the tubes left by organic remains. Their EDX analysis identified O (52.81%), Ca (25.76%), C (16.89%), Si (2.47%), and Br (2.06%) elements. (Diagram 4.82)

Analysis of minerals surrounding the tubes by the EDX method comply with each other. EDX analysis identified O (%63,52), Ca (%25,31), Si (%7,74) and Al (%3,43) elements of this sample. (Diagram 4.83; Figure 4.322c-d)
