# Microarchaeological observation on the neolithic architectural structures and cultural landscape of Sumaki Höyük

# **Microarchaeological Observation on the Neolithic Architectural Structures and Cultural Landscape of Sumaki Höyük**

PhD Thesis

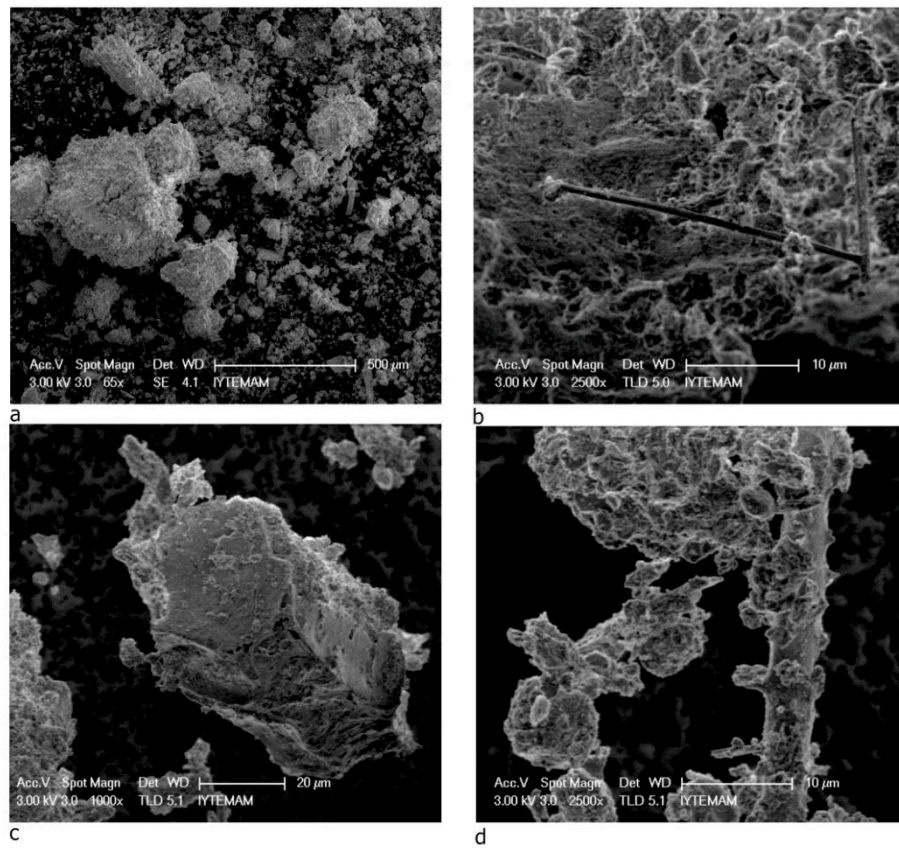
Figure 4.323: SEM images of lime samples taken from Structure N2B11

SiO<sub>2</sub> gels filling the organic cavities are observed on their SEM images. (Figure 4.323d) The clearest is silicon dioxide gel filling a *Panicum* plant remnant. EDX analysis of these lime samples identified O (54.89%), Ca (21.12%), C (17.43%), Si (4.13%), Al (1.38%), Mg (0.64%), and K (0.40%) elements. (Diagram 4.86)

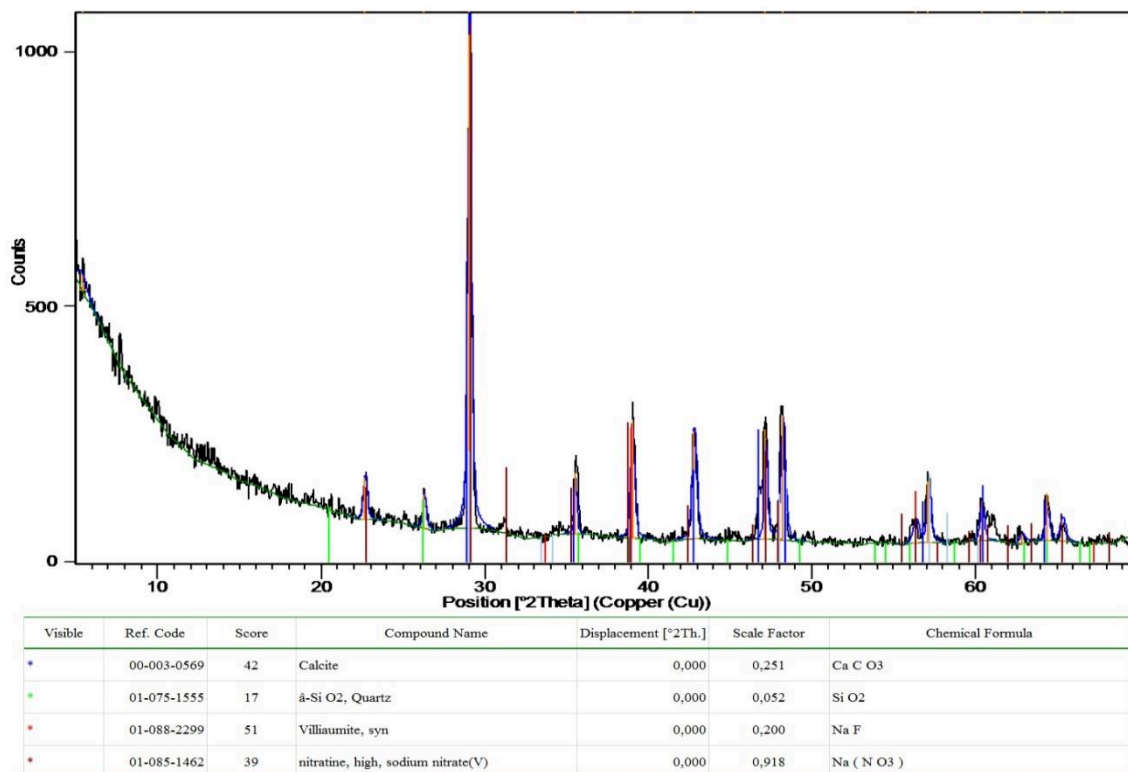
Diagram 4.104: XRD analysis pattern and detected minerals of lime samples taken from Structure N5B1

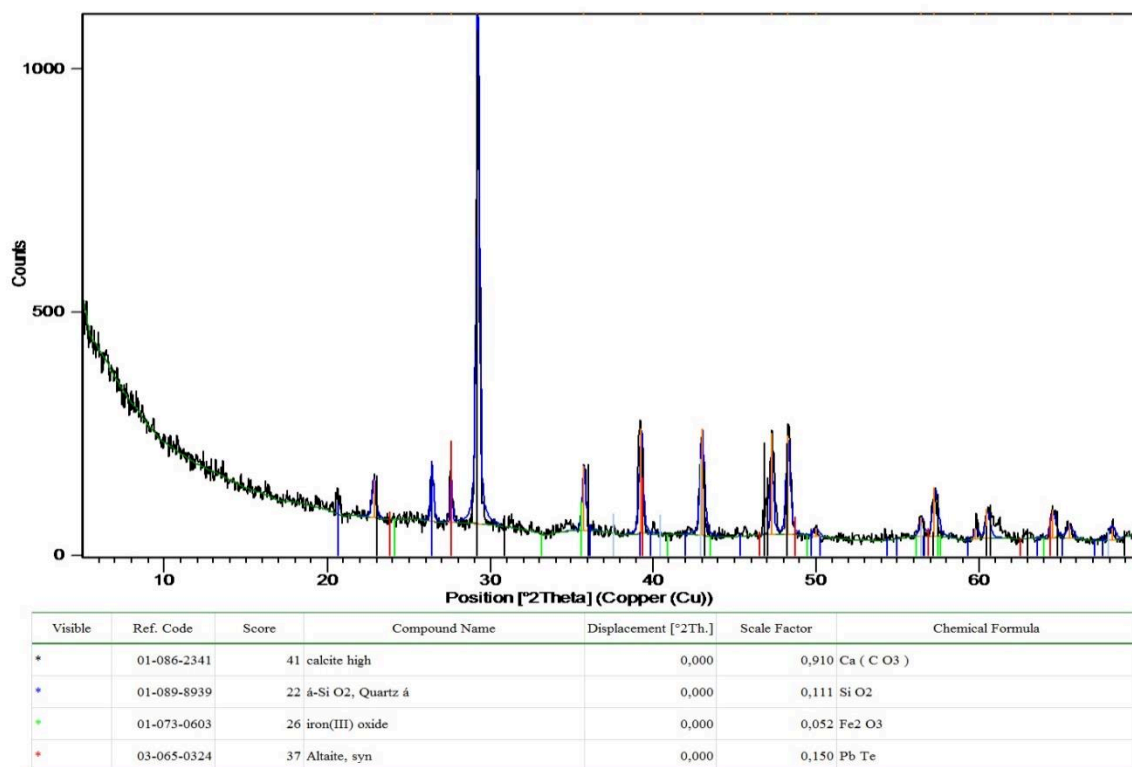
Diagram 4.105: XRD analysis pattern and detected minerals of lime samples taken from Structure N5B4

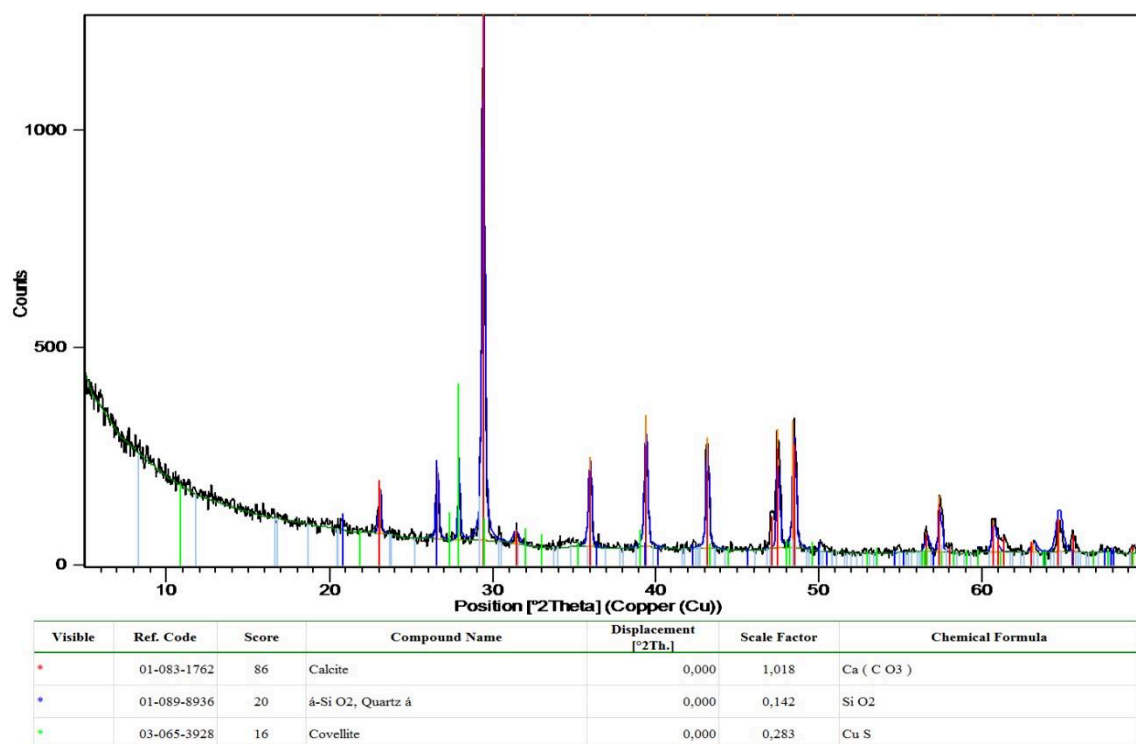
Diagram 4.106: XRD analysis pattern and detected minerals of lime samples taken from Structure N5B6

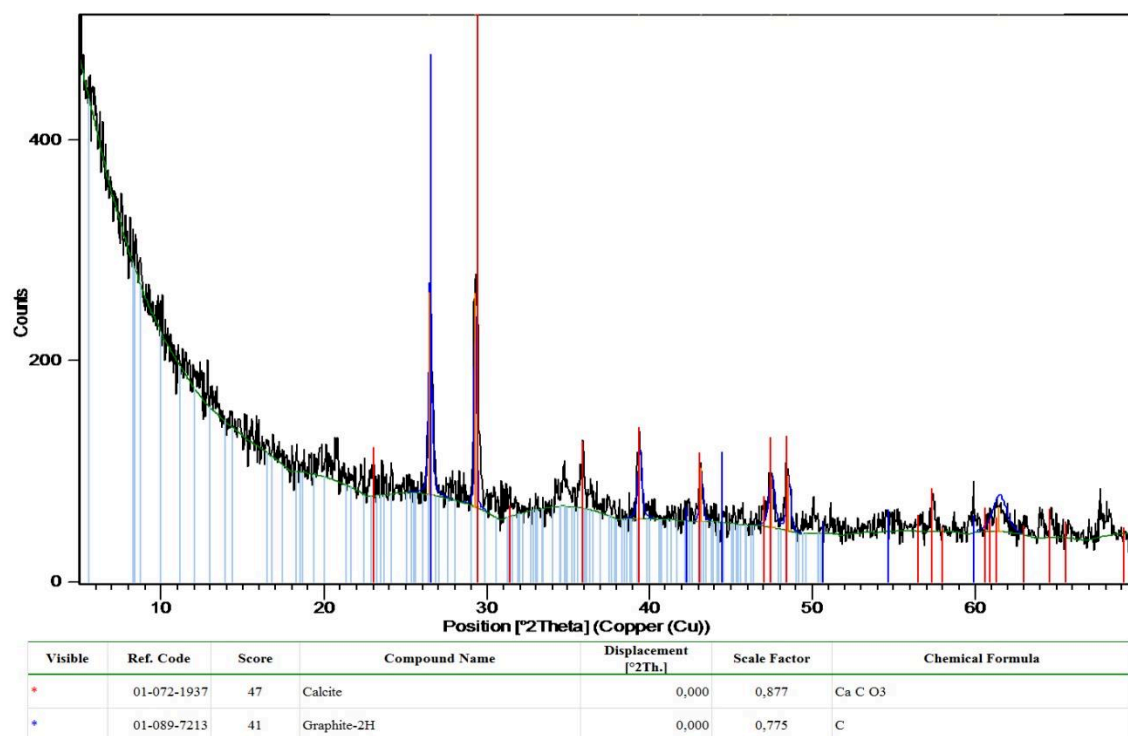
Diagram 4.107: XRD analysis pattern and detected minerals of lime samples taken from Structure N5B7

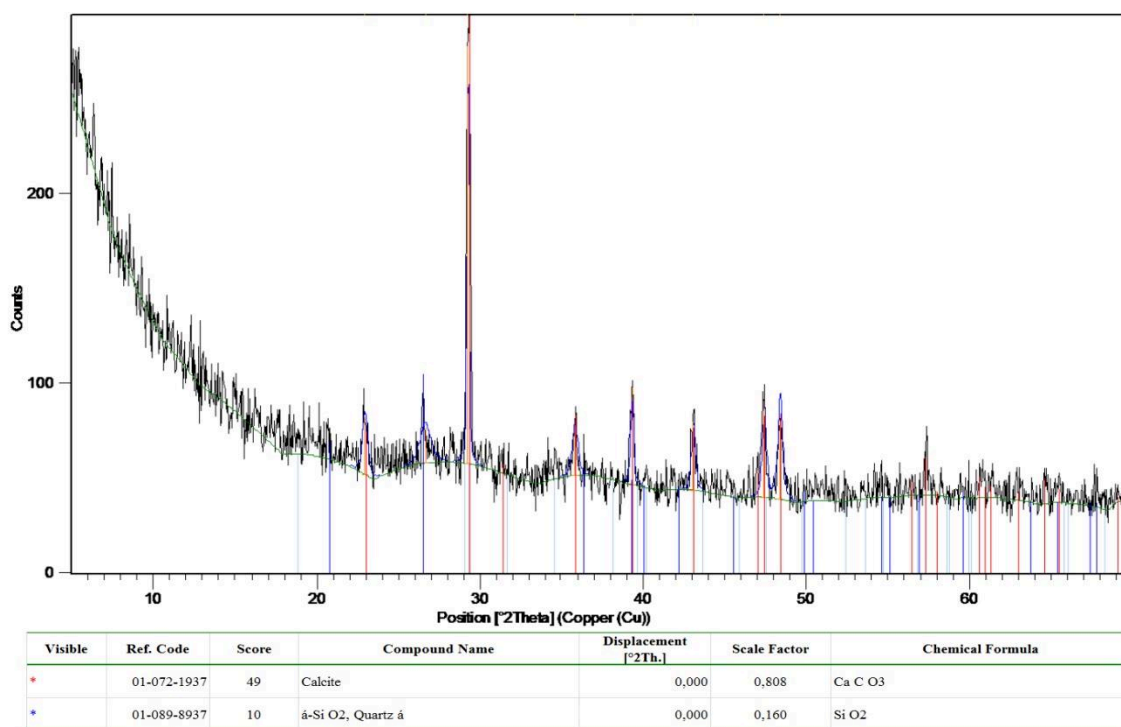
Diagram 4.108: XRD analysis pattern and detected minerals of lime samples taken from Structure N5B8

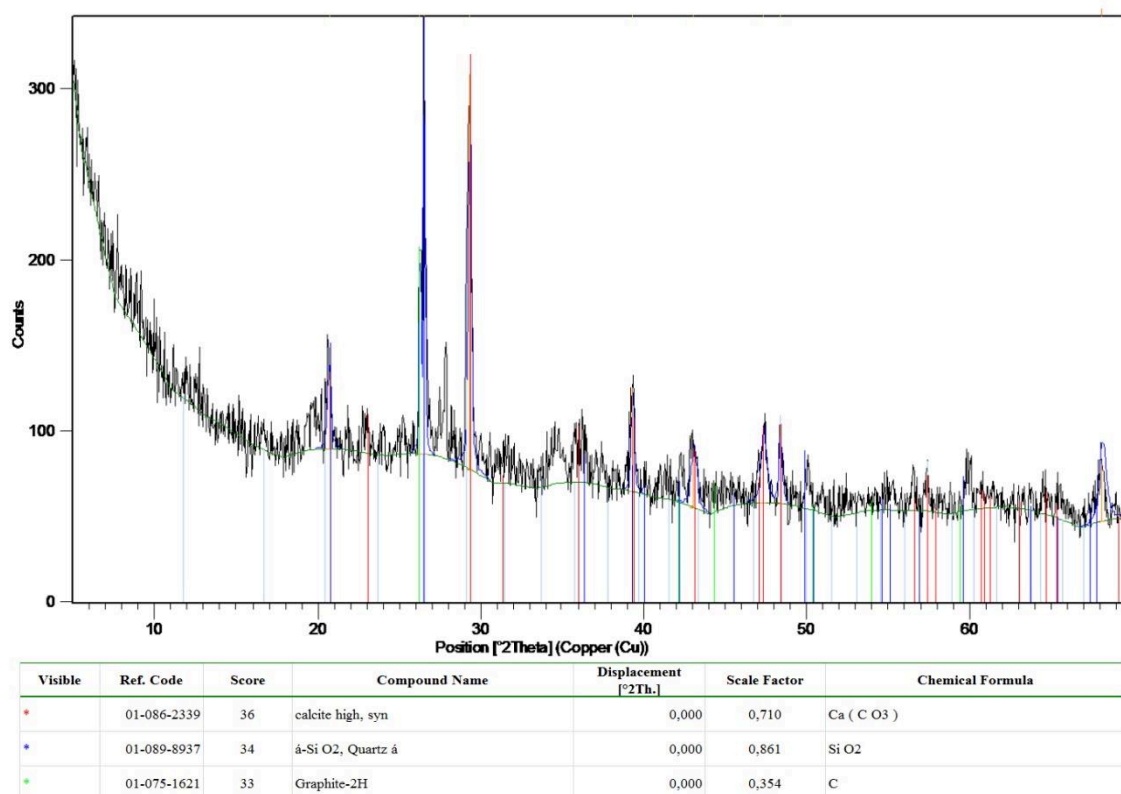
Diagram 4.109: XRD analysis pattern and detected minerals of lime samples taken from Structure N5B9

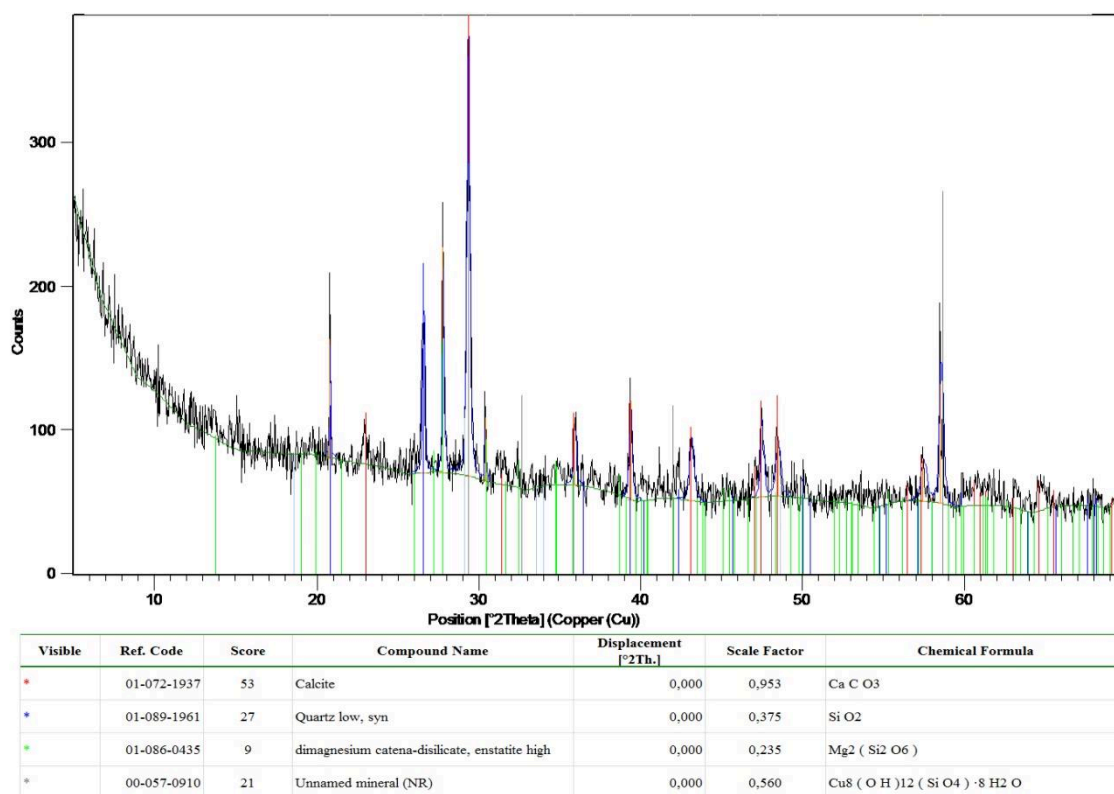
Diagram 4.110: XRD analysis pattern and detected minerals of lime samples taken from Structure N5B11

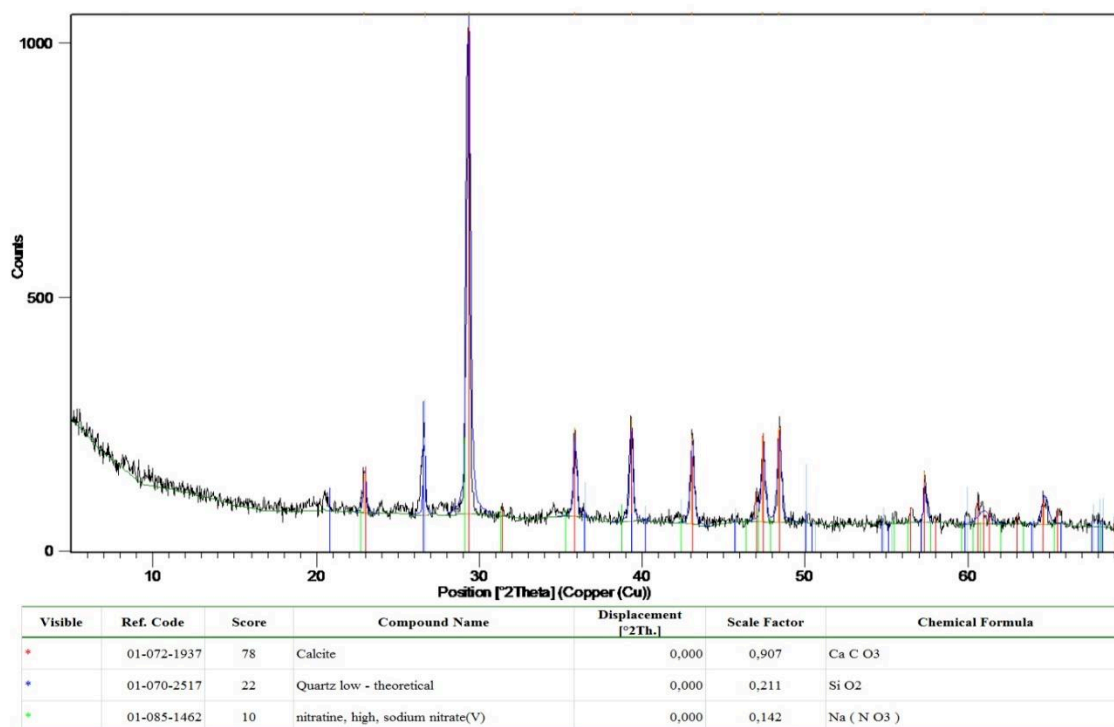
Diagram 4.111: XRD analysis pattern and detected minerals of lime samples taken from Structure N5B12

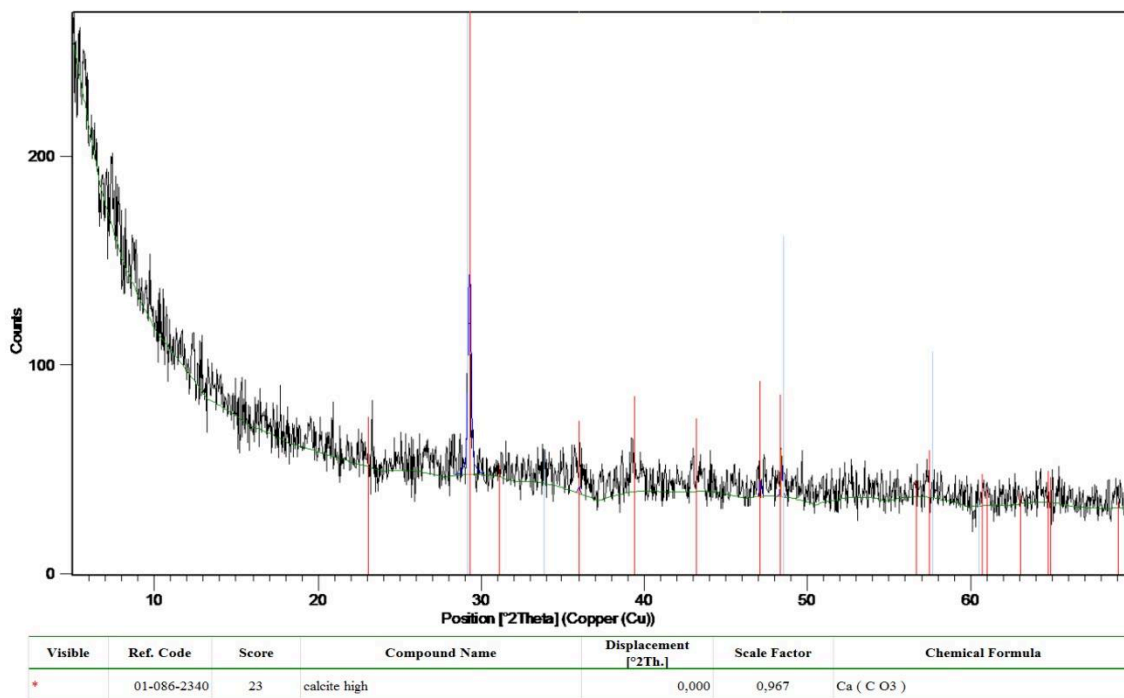
Diagram 4.112: XRD analysis pattern and detected minerals of lime samples taken from Structure N5B14

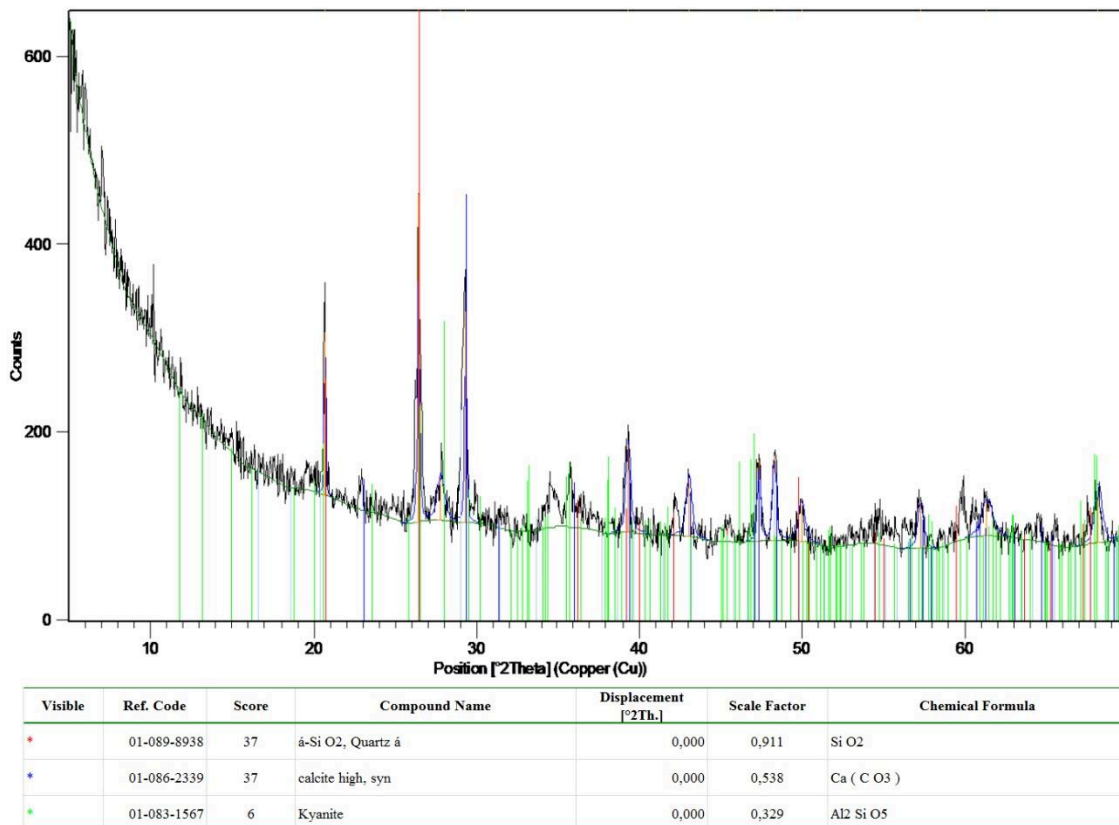
Diagram 4.113: XRD analysis pattern and detected minerals of lime samples taken from Structure N4B1

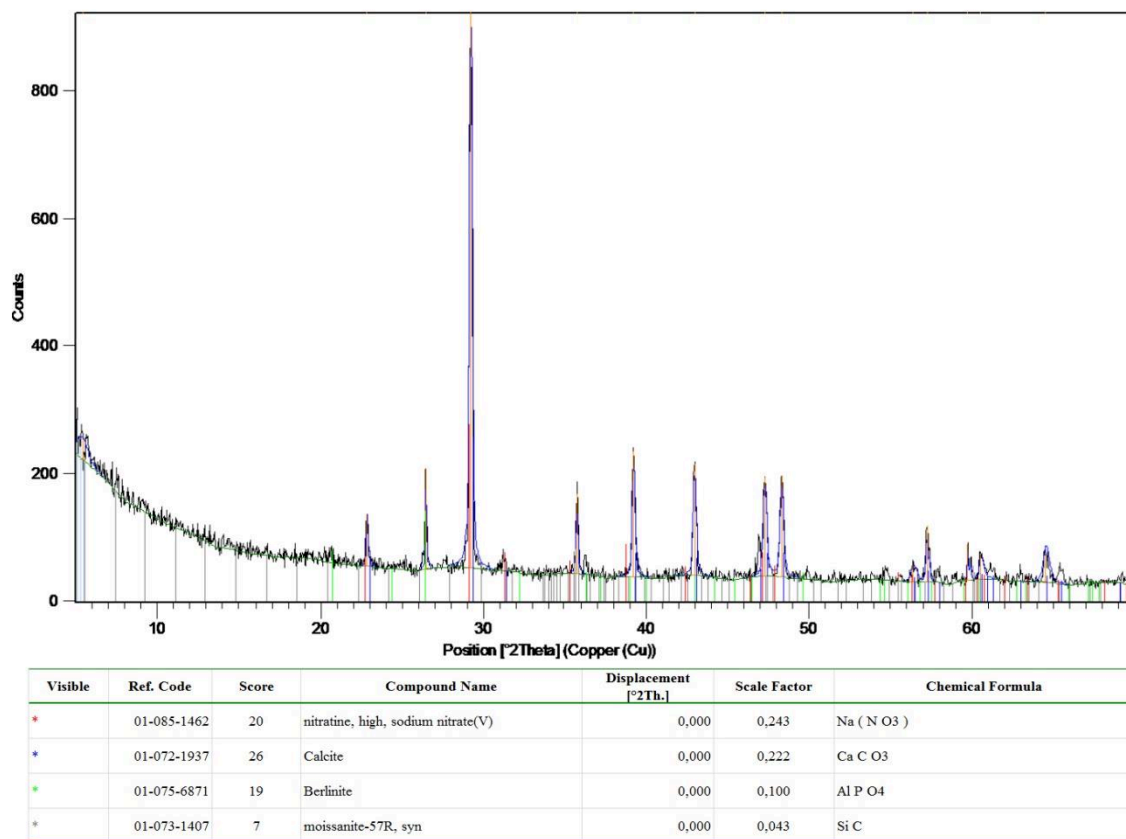
Diagram 4.114: XRD analysis pattern and detected minerals of soil samples taken from Structure N4B1

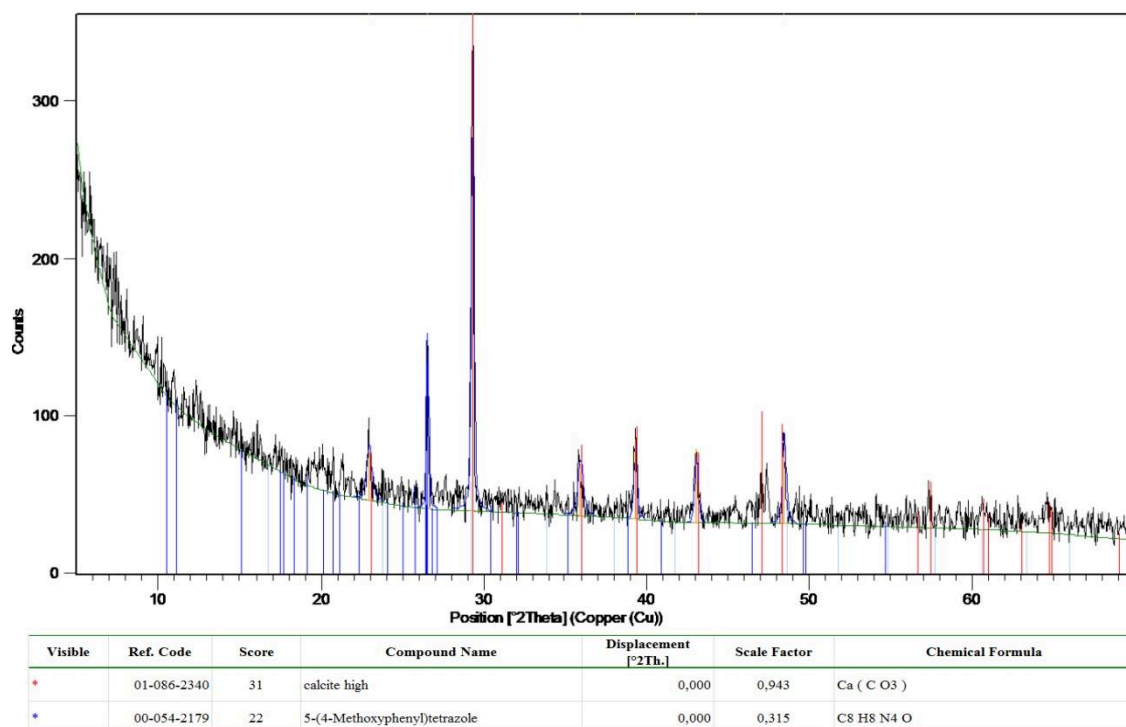
Diagram 4.115: XRD analysis pattern and detected minerals of soil samples taken from Structure N4B2

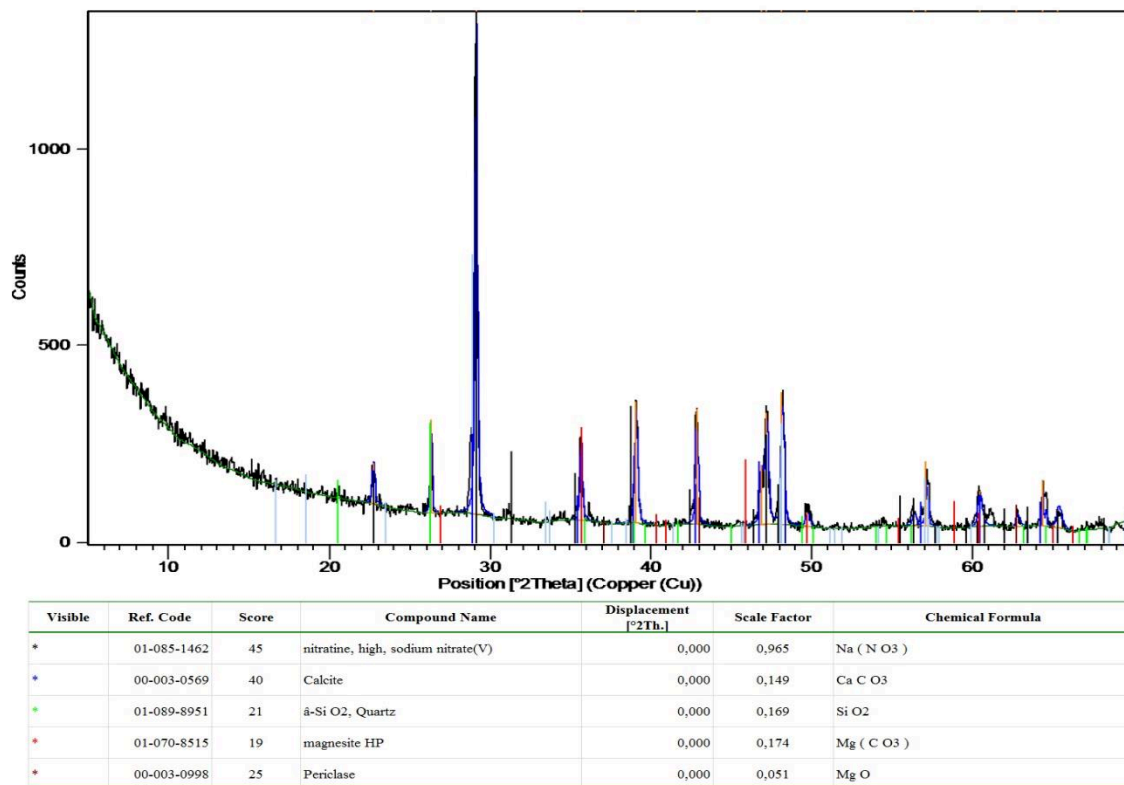
Diagram 4.116: XRD analysis pattern and detected minerals of lime samples taken from Structure N4B3

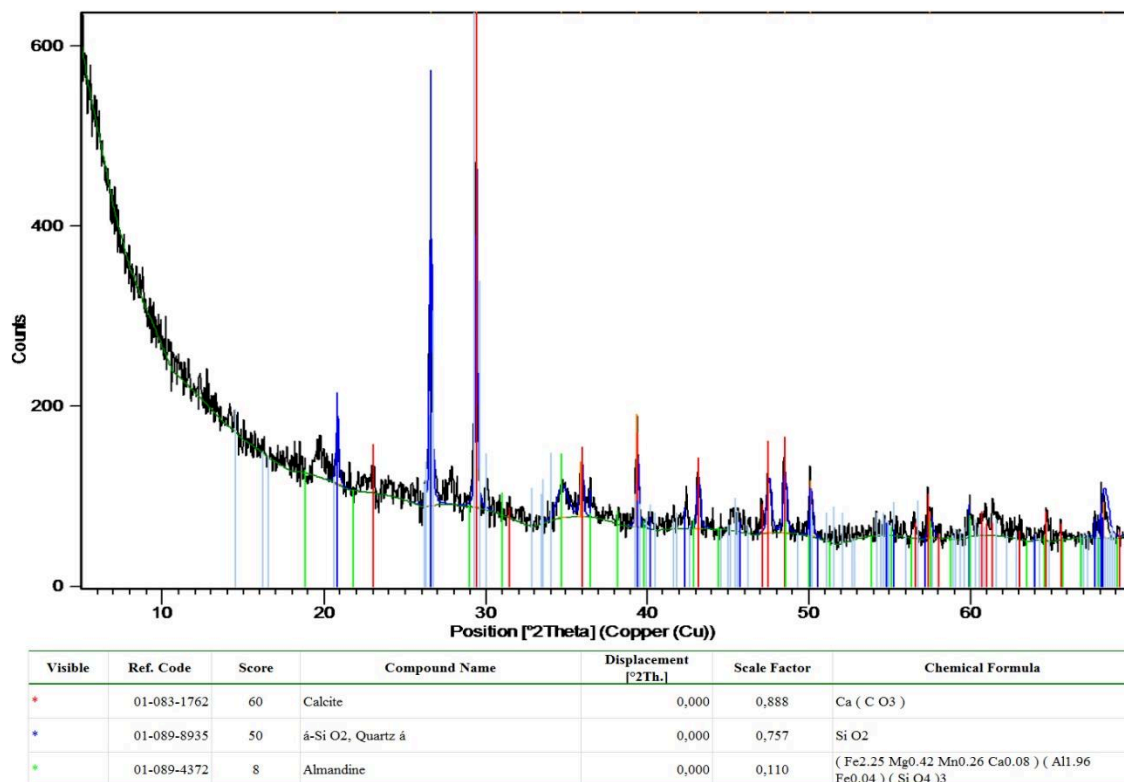
Diagram 4.117: XRD analysis pattern and detected minerals of lime samples taken from Structure N4B8

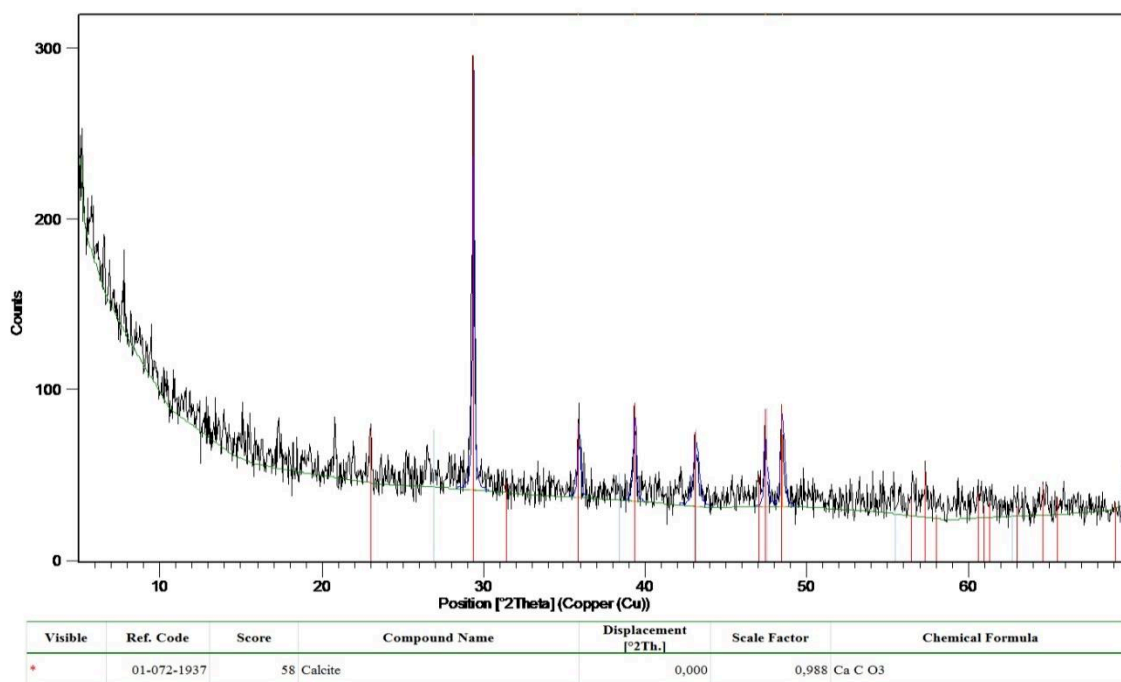
Diagram 4.118: XRD analysis pattern and detected minerals of soil samples taken from Structure N4B8

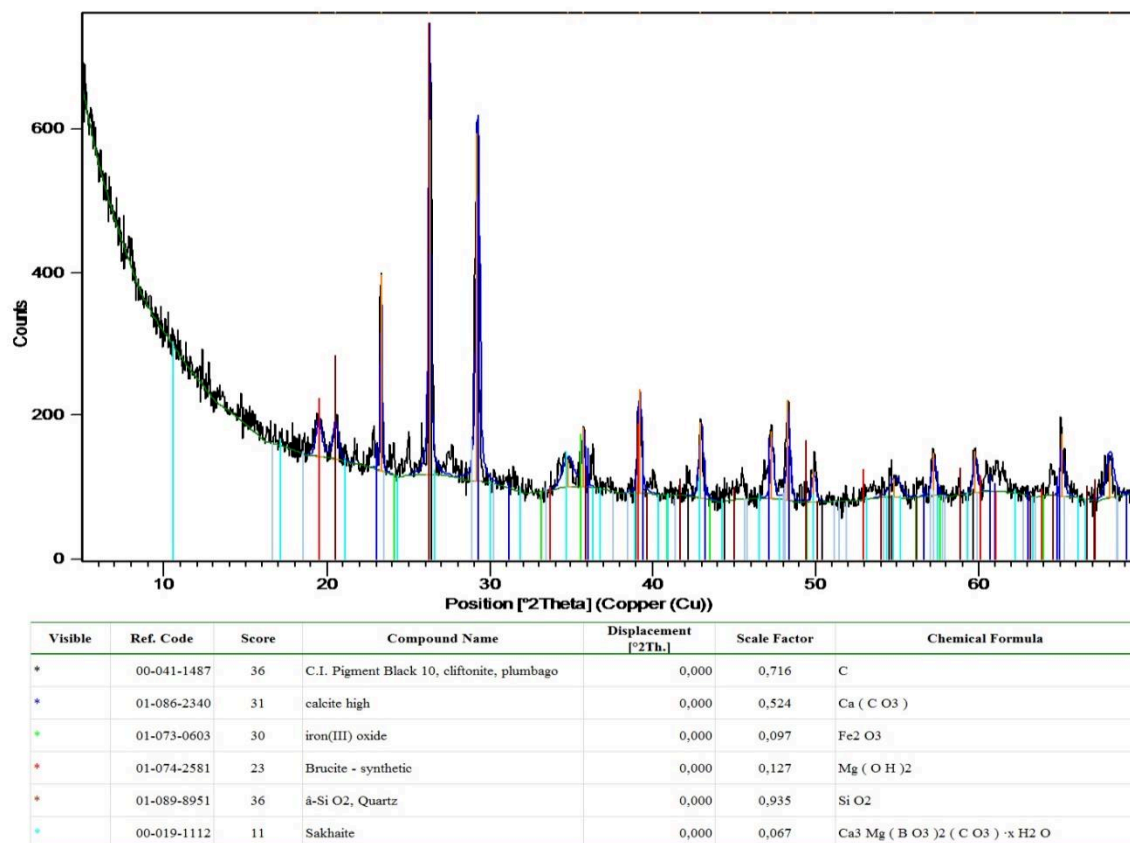
Diagram 4.119: XRD analysis pattern and detected minerals of lime samples taken from Structure N4B9

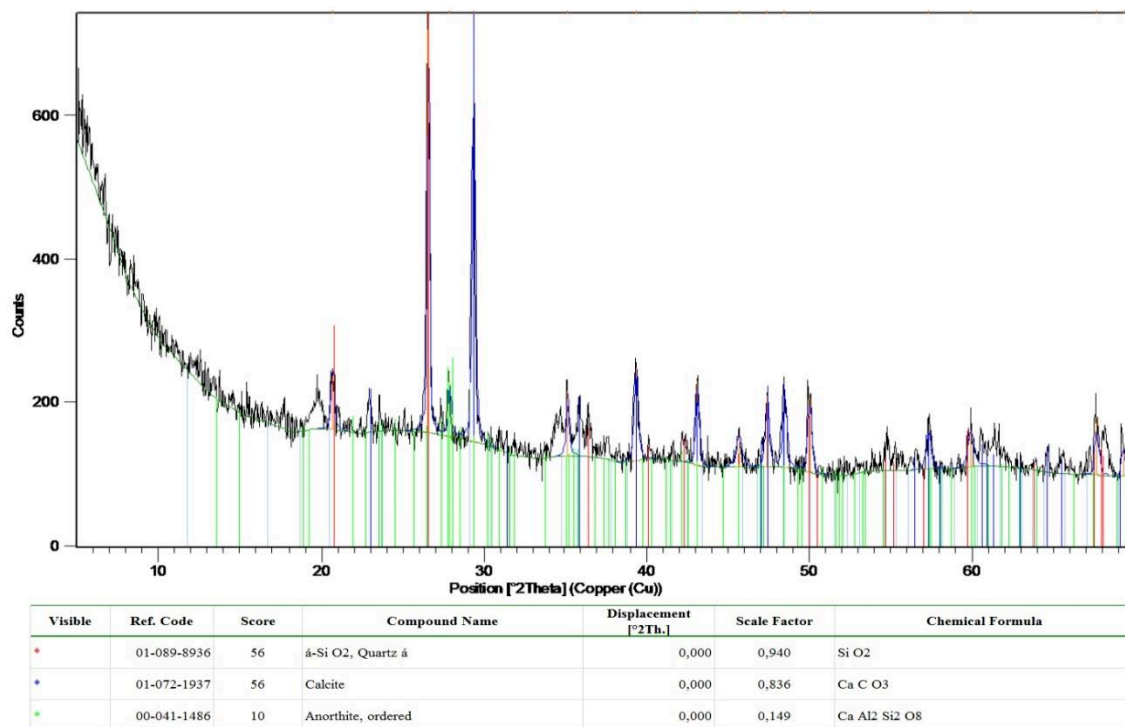
Diagram 4.120: XRD analysis pattern and detected minerals of lime samples taken from Structure N4B10

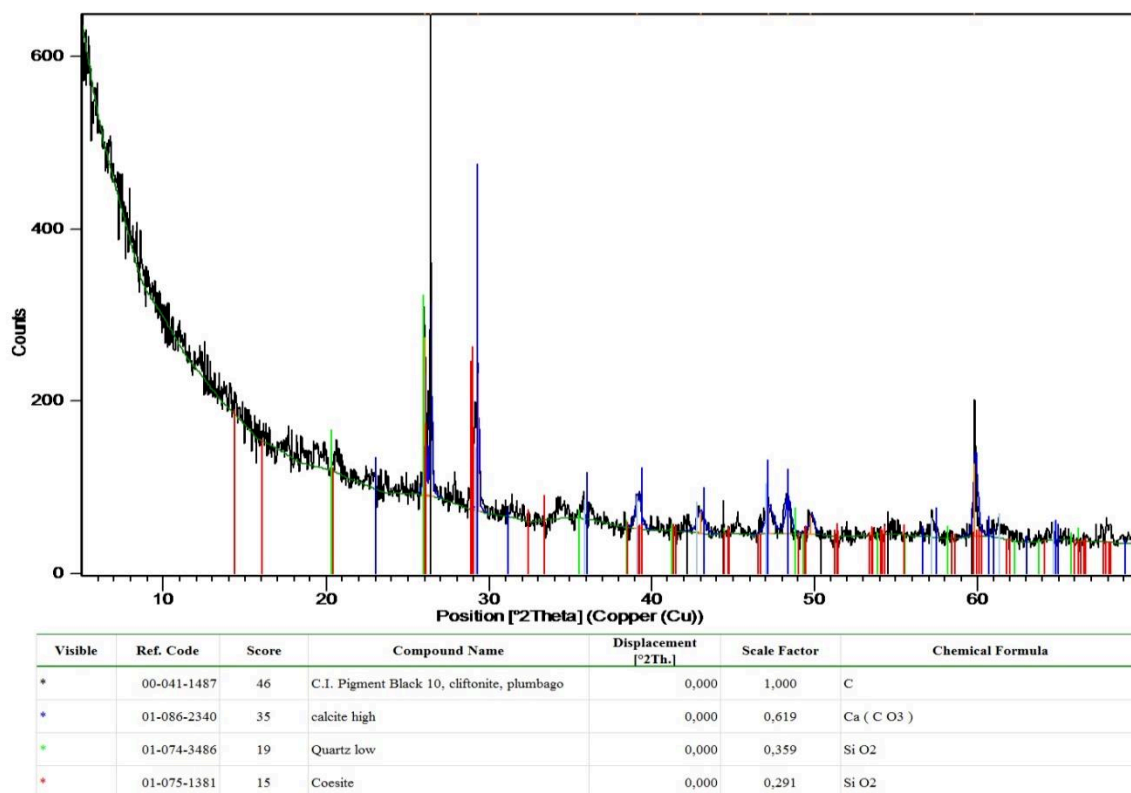
Diagram 4.121: XRD analysis pattern and detected minerals of lime samples taken from Phase N3 at Area A

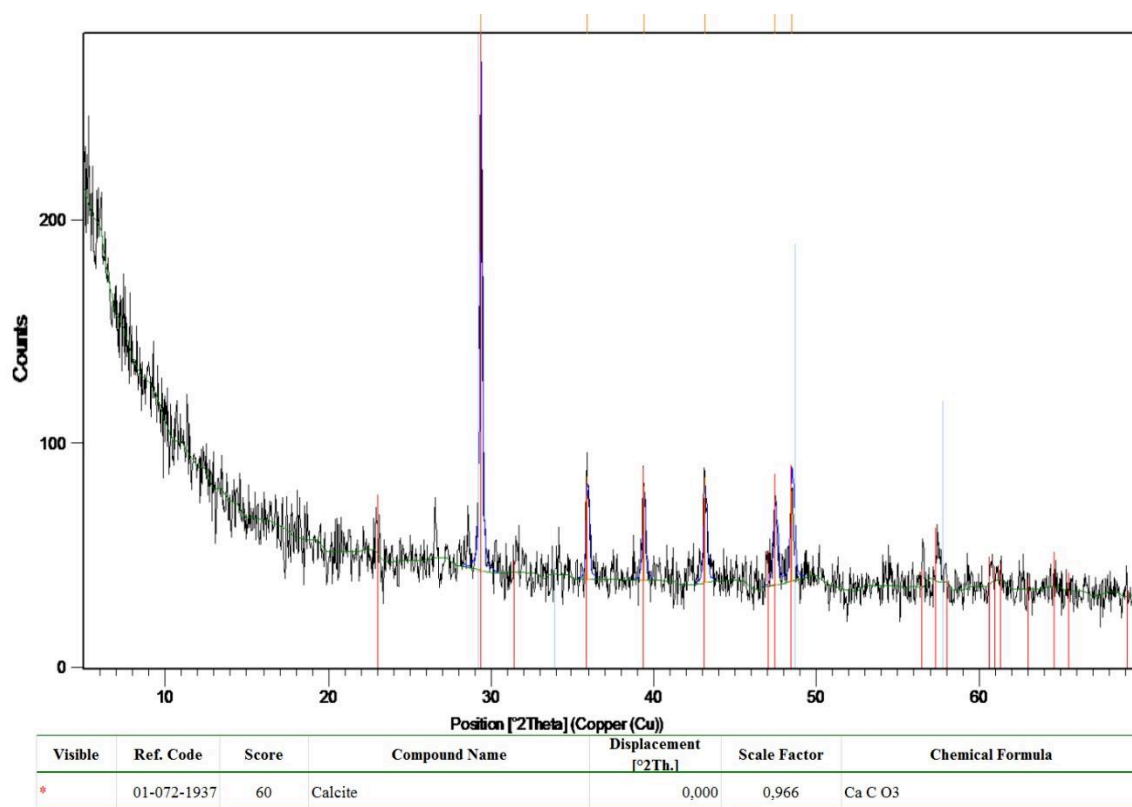
Diagram 4.122: XRD analysis pattern and detected minerals of lime samples taken from Phase N3 at Area B

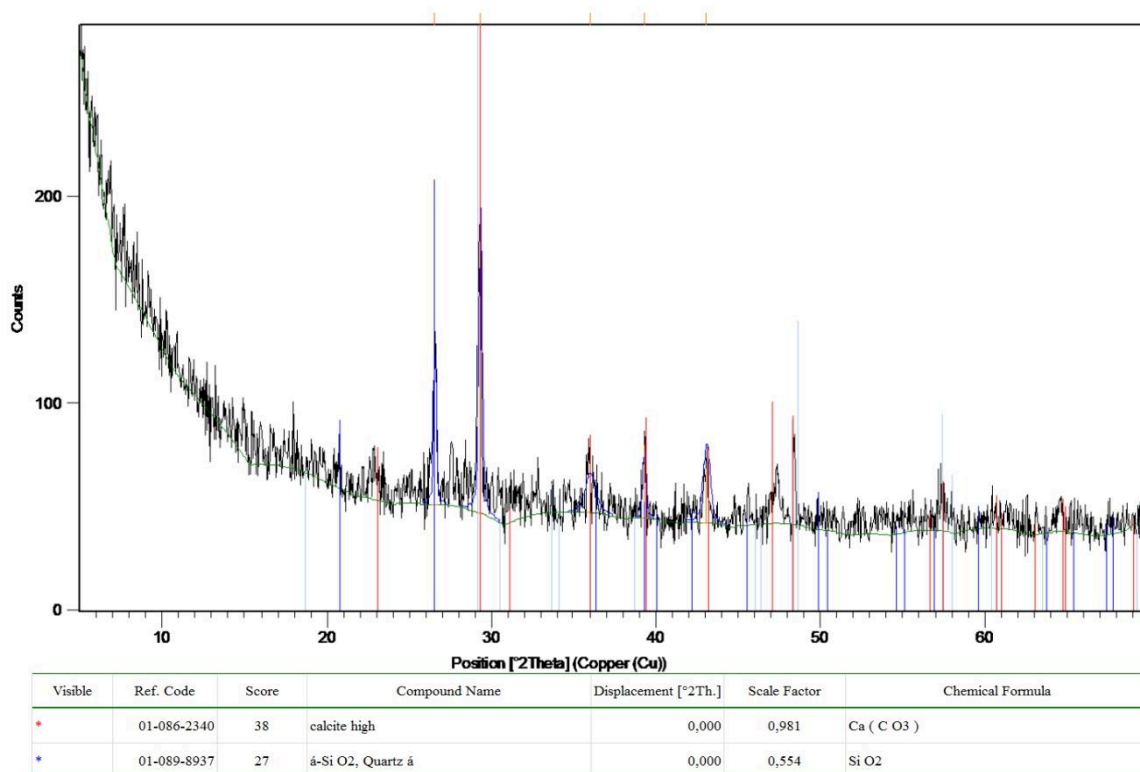
Diagram 4.123: XRD analysis pattern and detected minerals of lime samples taken from Structure N2B2

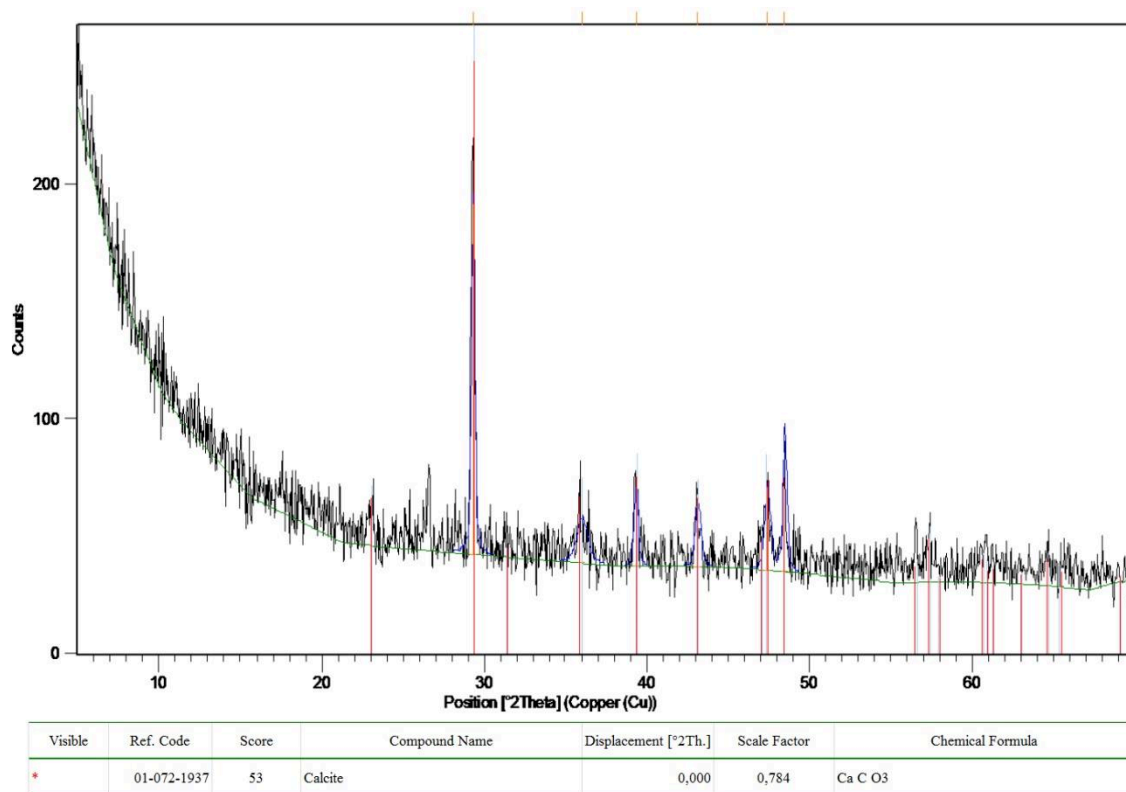
Diagram 4.124: XRD analysis pattern and detected minerals of lime samples taken from Structure N2B8

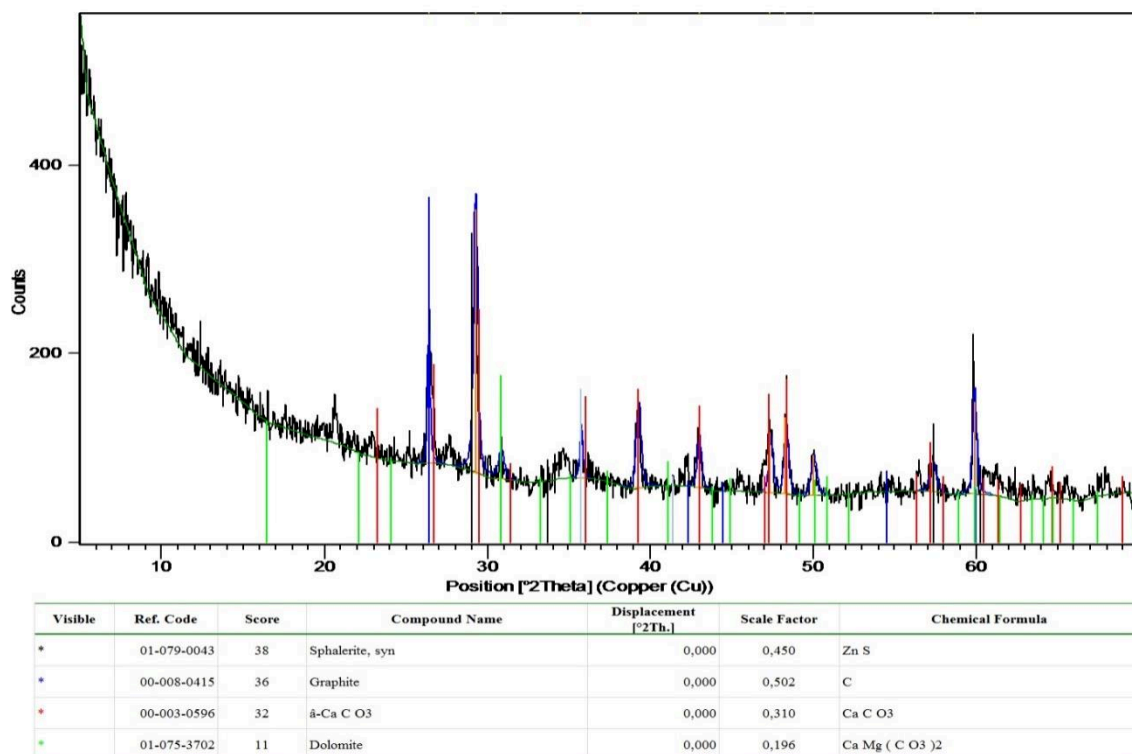
Diagram 4.125: XRD analysis pattern and detected minerals of lime samples taken from Structure N2B10
