# Microarchaeological observation on the neolithic architectural structures and cultural landscape of Sumaki Höyük

# **Microarchaeological Observation on the Neolithic Architectural Structures and Cultural Landscape of Sumaki Höyük**

PhD Thesis

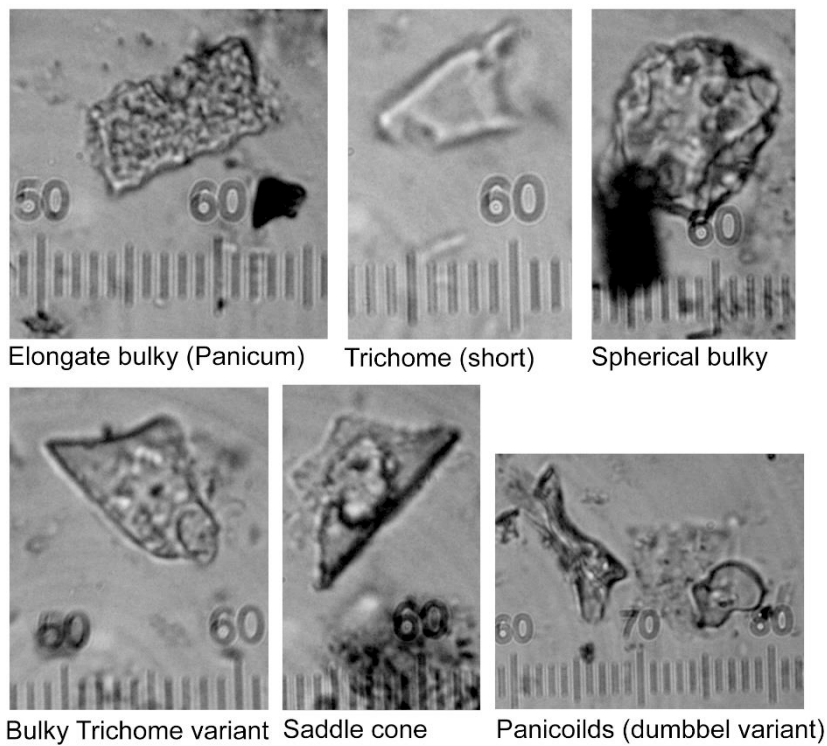
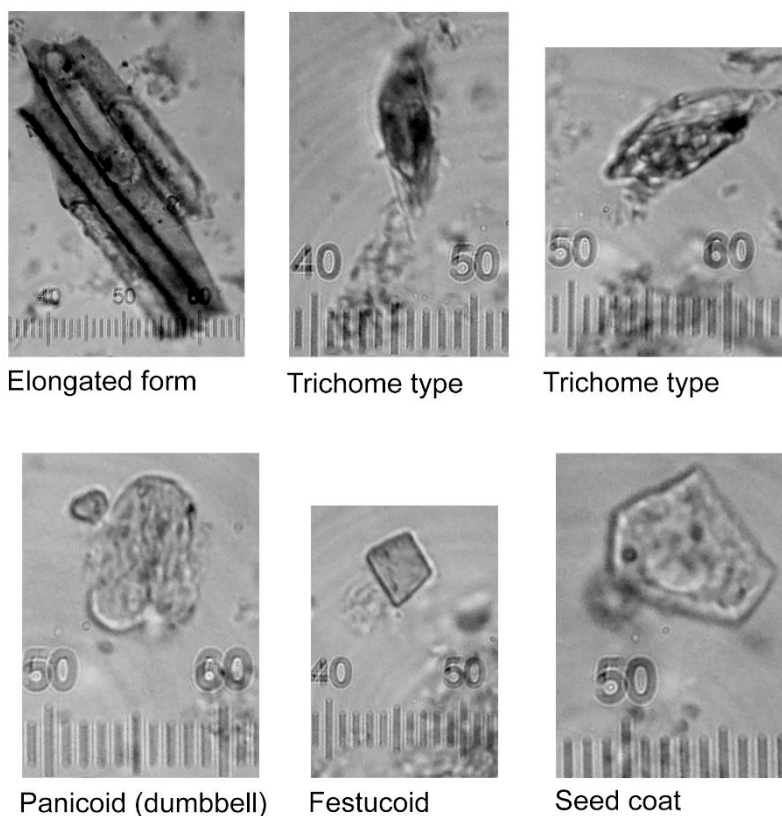
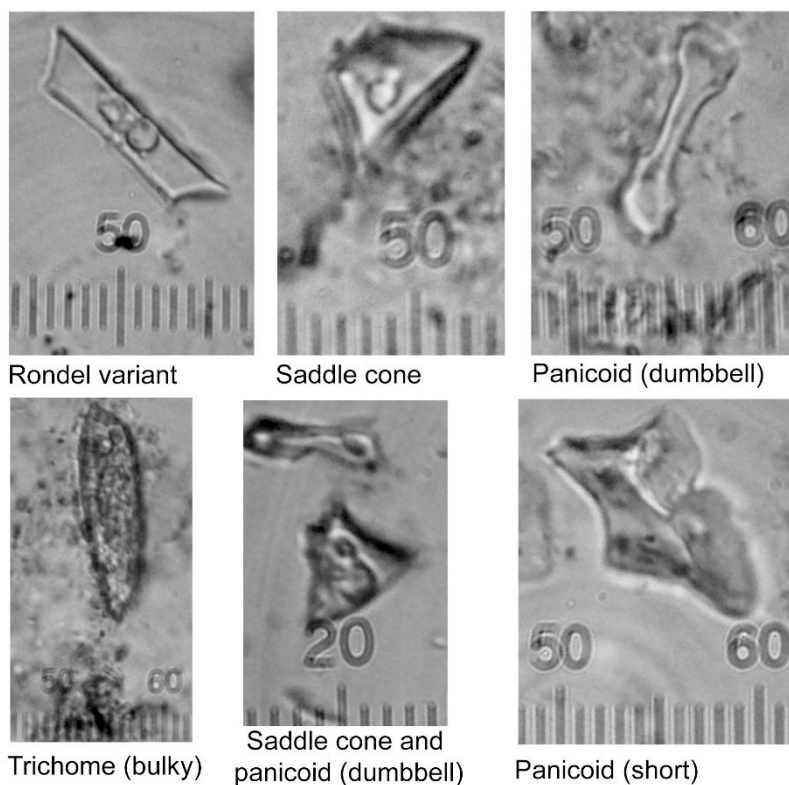
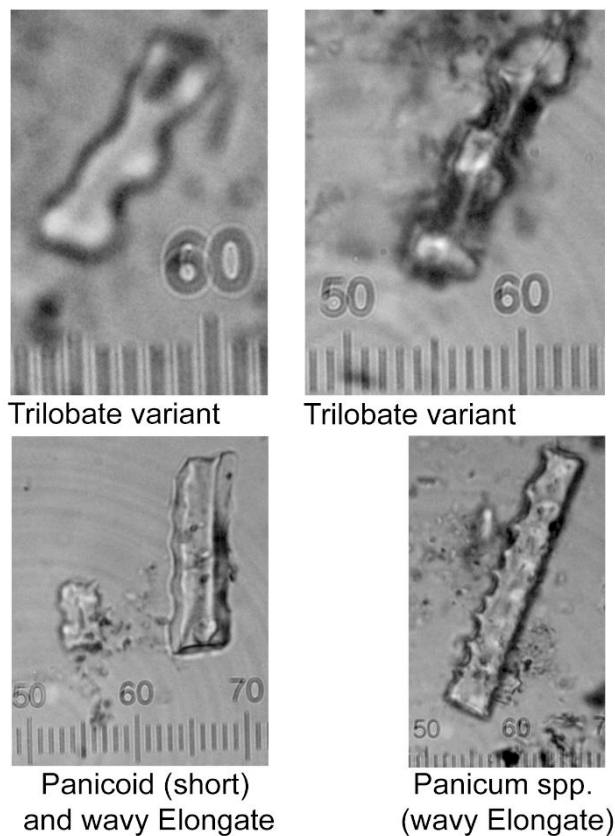
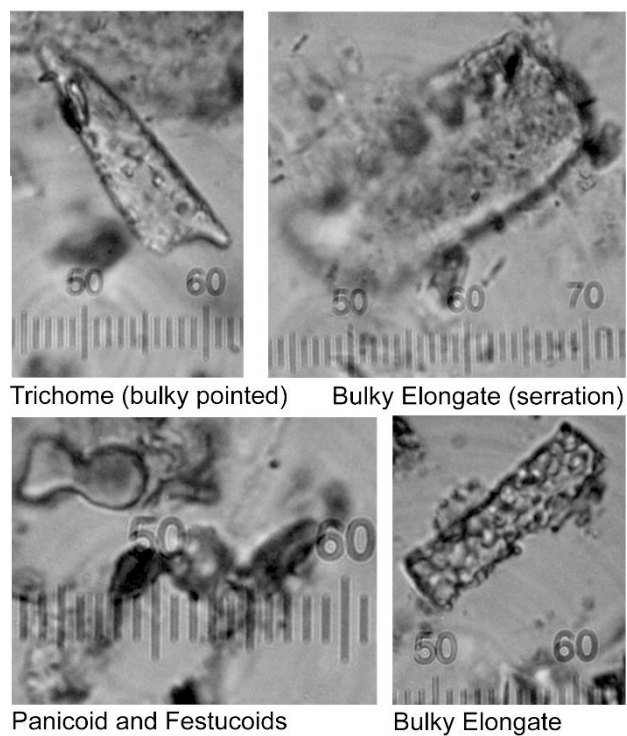
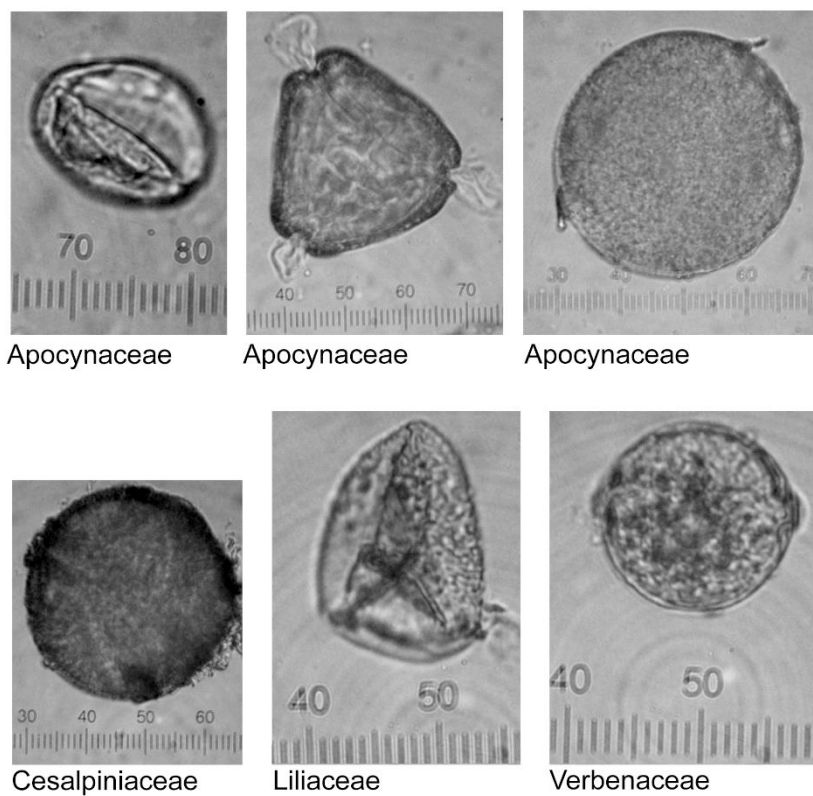
**Figure 4.325: Bulliform shape, Elongate, and Trichome phytoliths determined of lime samples taken from architectural remains**

**Figure 4.326: Elongate, Trichome and Panicoid phytoliths determined of lime samples taken from architectural remains**

**Figure 4.327: Trichome, Panicoid and Festucoid phytoliths determined of lime samples taken from architectural remains**

**Figure 4.328: Trichome and Panicoid phytoliths determined of lime samples taken from architectural remains**

**Figure 4.329: Trilobate and Panicoid phytoliths determined of lime samples taken from architectural remains**

**Figure 4.330: Trichome, Panicoid and bulky Elongate phytoliths determined of lime samples taken from architectural remains**

*elongate*, *Chloridoid*, and *Fusturoid* forms were found as well. (Figure 4.325 - 4.330) *Apocynaceae*, *Verbenaceae*, *Cesalpiniaceae*, *Liliaceae*, *Calenduleae*, *Asparagaceae*, *Malvaceae*, and *Poaceae* pollens were also identified. (Figure 4.331, 4.332)

Phytolith analysis of lime samples identified reeds or woody plants. The phytoliths contained high frequencies of *Trichome* and *Festuroid* forms. *Elongate*, *Bulliform*, *Panicoid*, *Chloridoid*, and *Silicified Woody Forms* were also identified. (Diagram 4.50; Figure 4.325 - 4.330) The phytoliths found within the lime samples are diagnostic and well-preserved. Pollen analysis of the same samples identified *Poaceae* pollens dominantly, together with *Malvaceae*, *Apocynaceae*, *Verbenaceae*, *Cesalpiniaceae*, *Liliaceae*, *Asparagaceae*, and *Calenduleae* pollens. (Figure 4.331, 4.332)

Phytolith analysis of lime samples identified reeds and/or woody plant remains were dominant. The natural structure of well-preserved phytoliths is clear. Among the phytoliths, high frequencies of *Trichome*, *Panicoid*, *Bulliform*, *Elongate*, and *Silicified Woody Forms* were observed. *Chloridoid* and *Fusturoid* forms were also identified. (Diagram 4.68; Figure 4.325 - 4.330) Pollen analysis of the same samples identified *Poaceae* pollen dominantly, together with *Calenduleae*, *Apocynaceae*, *Verbenaceae*, *Cesalpiniaceae*, *Liliaceae*, *Asparagaceae*, and *Malvaceae* pollens. (Figure 4.331, 4.332)

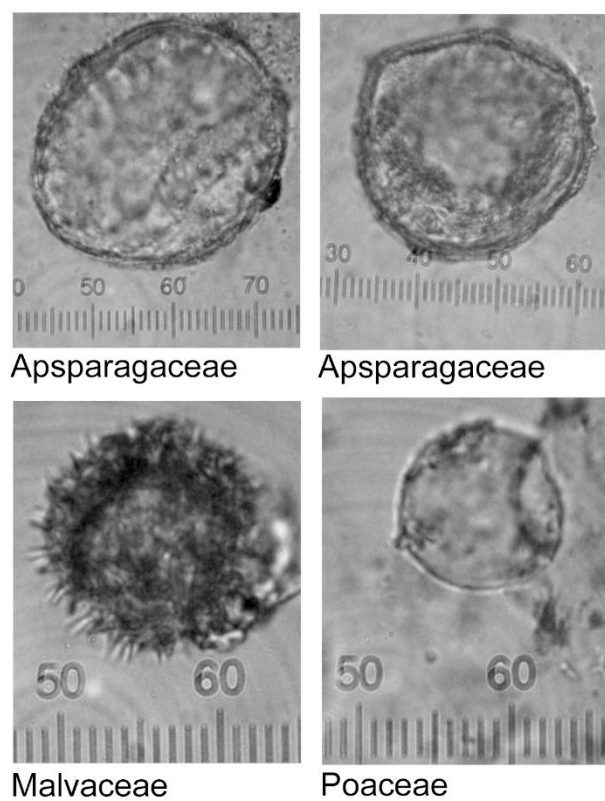
**Figure 4.331: Apocynaceae, Cesalpiniaceae, Liliaceae and Verbenaceae pollens determined of lime samples taken from architectural remains**

**Figure 4.332: Apsparagaceae, Malvaceae and Poaceae pollens determined of lime samples taken from architectural remains**

identified *Apocynaceae*, *Verbenaceae*, *Poaceae*, *Cesalpiniaceae*, *Liliaceae*, *Calenduleae*, *Asparagaceae*, and *Malvaceae* pollens. (Figure 4.331, 4.332)

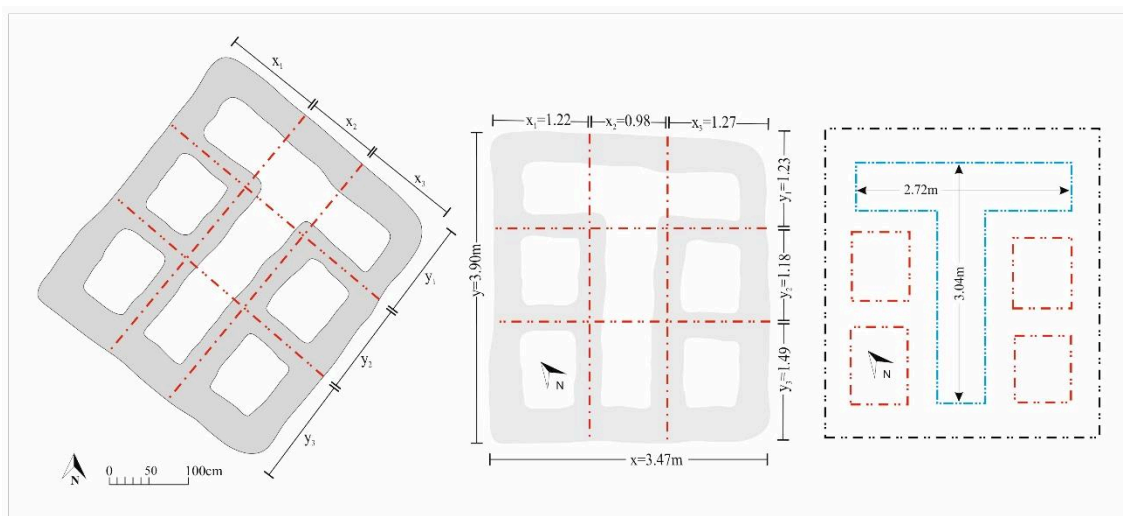
Figure 4.333: Geometric layout of Structure N6B1

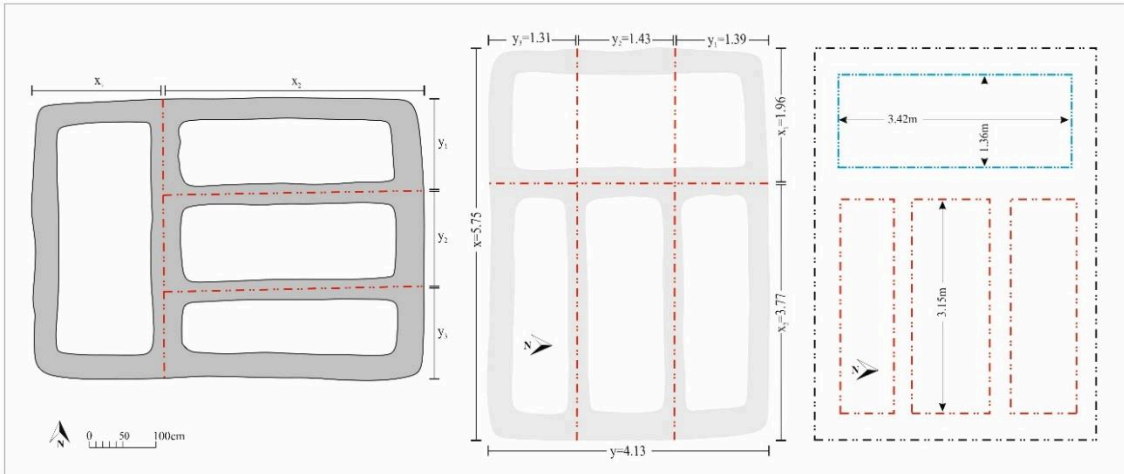
Figure 4.335: Geometric layout of Structure N6B5

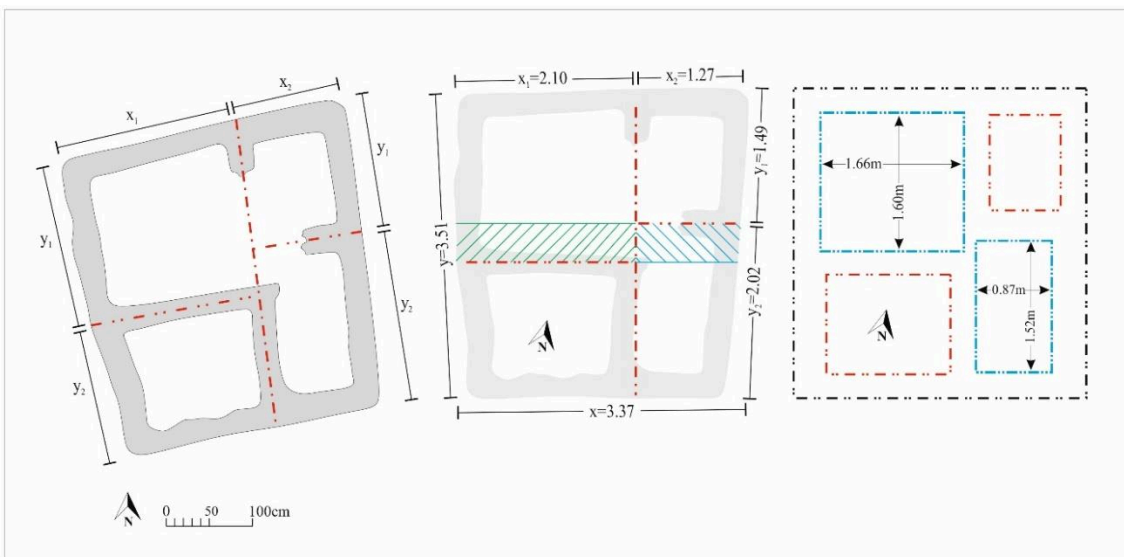
Figure 4.337: Geometric layout of Structure N5B3

The structure is located on the east-west oriented natural terrace slightly sloping toward the east. In the north-south direction, it has a width of 338 cm, (Figure 4.337) very similar to the dimensions of the other cell buildings. However, as its western limits remains outside the exposed area the dimensions could not be determined. Its exposed section is 490 cm long. Based on the trench cross-section and the length-width ratio of structures with similar plans, the large room with more than half excavated is assumed to be the last space in west. The thickness of the bearing walls and partition walls are different. The bearing walls are 31-42 cm wide, and the partition walls are 18-34 cm wide. However, the thickness of the partition walls is entirely different from each other; such as the partition walls between the cells are thinner.

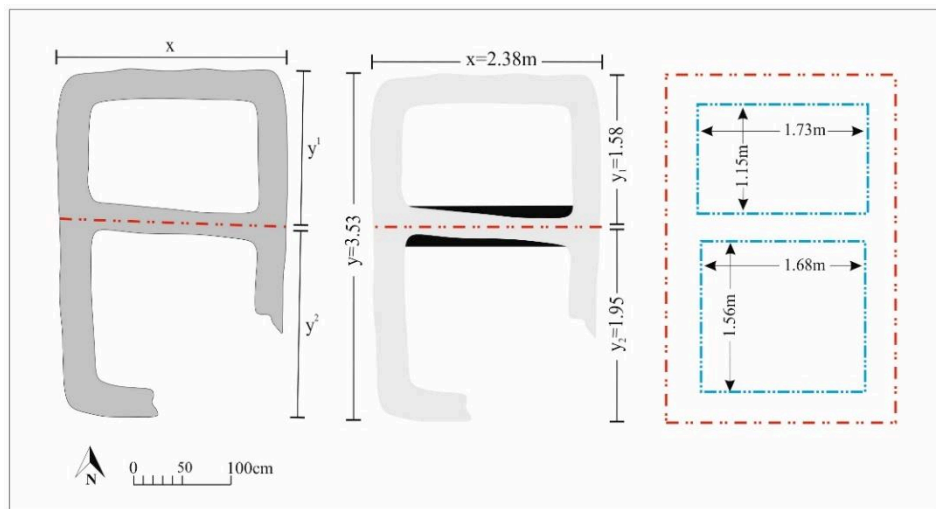
Figure 4.339: Geometric layout of Structure N4B1

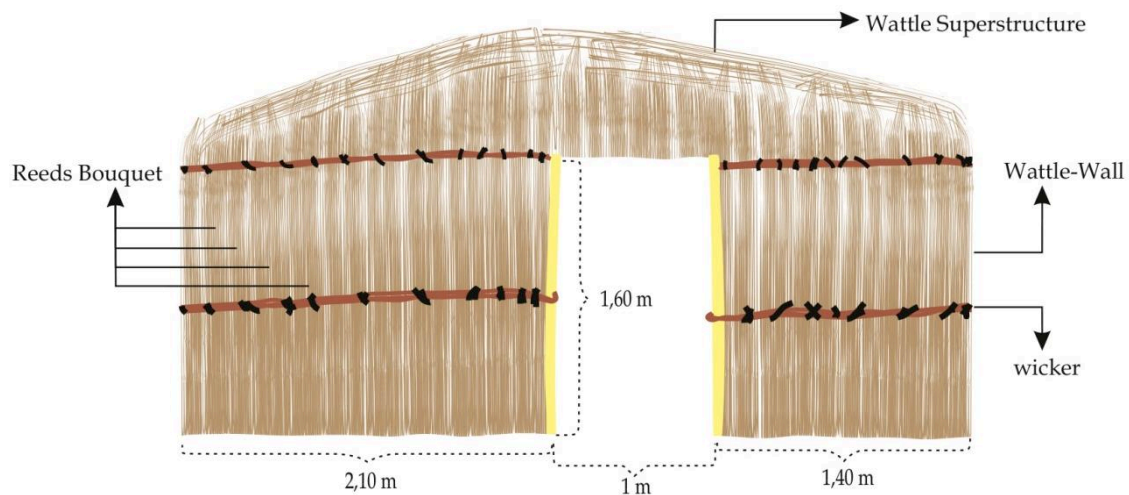
A rectilinear structure with “walls” made of a series of reed bundles carried by a wooden frame and posts is the basic description of these dwellings. In simple terms, these dwellings look like “huge upside-down baskets”. They are represented by 16 examples in the Garzan Basin, constructed at Memika Kom, Mezrik Kom, and Bazivan Kom. Ten or twelve wattle reeds with their leaves attached are made into a bundle; then these bundles are placed next to one another and woven tightly with fresh leaves. The bottom parts of the wattle bundles are buried 5-6 cm in the ground and then covered with earth and securely pressed. This wattle screen, wrapping the whole structure like a curtain, is 12-15 cm thick and 220 cm high on average. (Figure 5.6, 5.32 – 5.47) The top fringes of the wattle screen are intertwined with a platform made out of reeds, like a bouquet or garland, which form the upper top. Branches surrounding the screen bundles integrated with the structure's upper woven joints in an oval shape make the structure into a whole.

**Figure 5.6:** Architectural elements of a Wattle Structures

Nowadays, frames and posts are made of the poplar tree. In former times, the thick wattle reed called *Zirc* by the locals was used. *Zirc* ripens only at the end of March until mid-April and is collected in that period.<sup>15</sup> This type of example was not encountered in the field studies, and generally, poplar branches were used as structural bearing components. (Figure 5.30, 5.31, 5.43) The stretch and therefore the strength of the structure, which is constructed

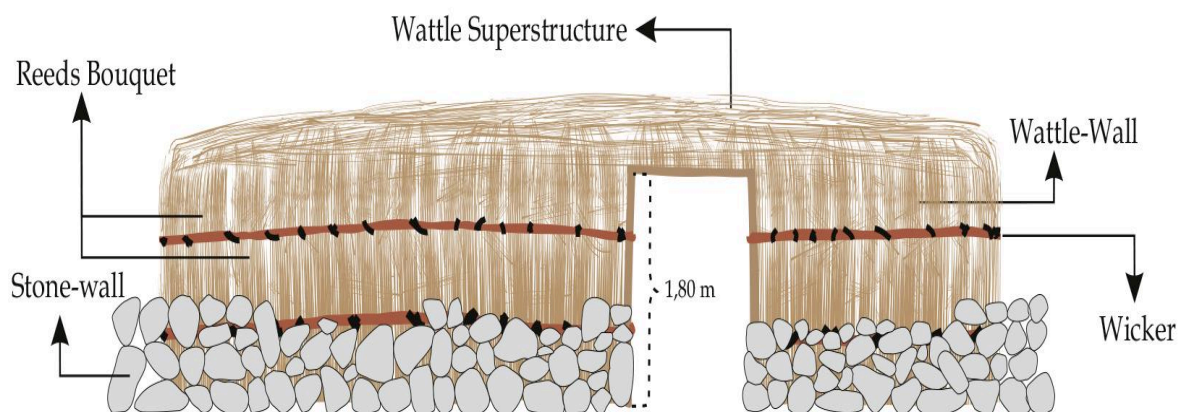
Rectangular *Wattle Structures* are encircled by stone surroundings. Construction of the Wattle Structure part of the dwellings is similar to the ones of the *Wattle Structures with stone surroundings*. Stone surroundings are constructed of middle-sized (20x30 cm) and relatively large cobbles (30x40 cm on average) without mortar. They are generally 40-50 cm thick, and 50-70 cm high (in 4-5 rows). The approximately 1 m-wide openings are sometimes on the long axis and sometimes on the short axis. (Figure 5.7, 5.48 – 5.57) Although I did not have a chance to see the process during construction, it seems that the stone walls are built just after erecting the wattle structure. There is no standard in the dimensions of the structures; they differ between 18.5x7.2 m and 14.5x6.9 meters. There is no actual flooring; the ground inside hardens with constant usage.

**Figure 5.7:** Architectural elements of a Stone-Walled Wattle Structure

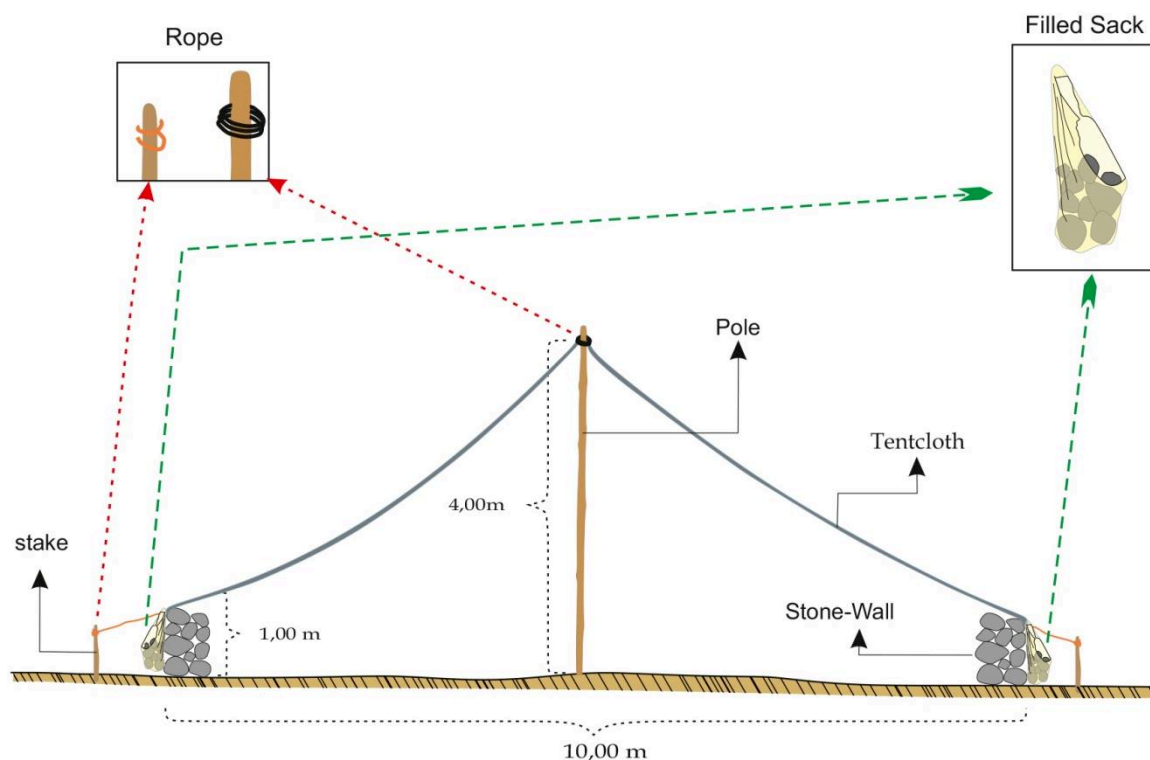
The general definition of this type is that rectilinear stone surroundings serve as “walls” for the mobile tents. Erected with non-stable poles, the tent is stretched by sacks filled with stones that are either tied or sewn around the tent. Poles are not embedded in the ground, but stand with the stretched forms within themselves. (Figure 5.8, 5.58 – 5.63)

**Figure 5.8:** Architectural elements of a Stone-Walled Tentsites

This stretching enables the tent not only to be erected tightly but also to be unaffected by precipitation. Stone surroundings are constructed of middle-sized (20x30 cm) and relatively large stones (30x40 cm on average) without mortar. They are generally 25x60 cm wide, and their height ranges from 40 to 80 cm (3 to 6 rows). Examples such as the 125 cm-

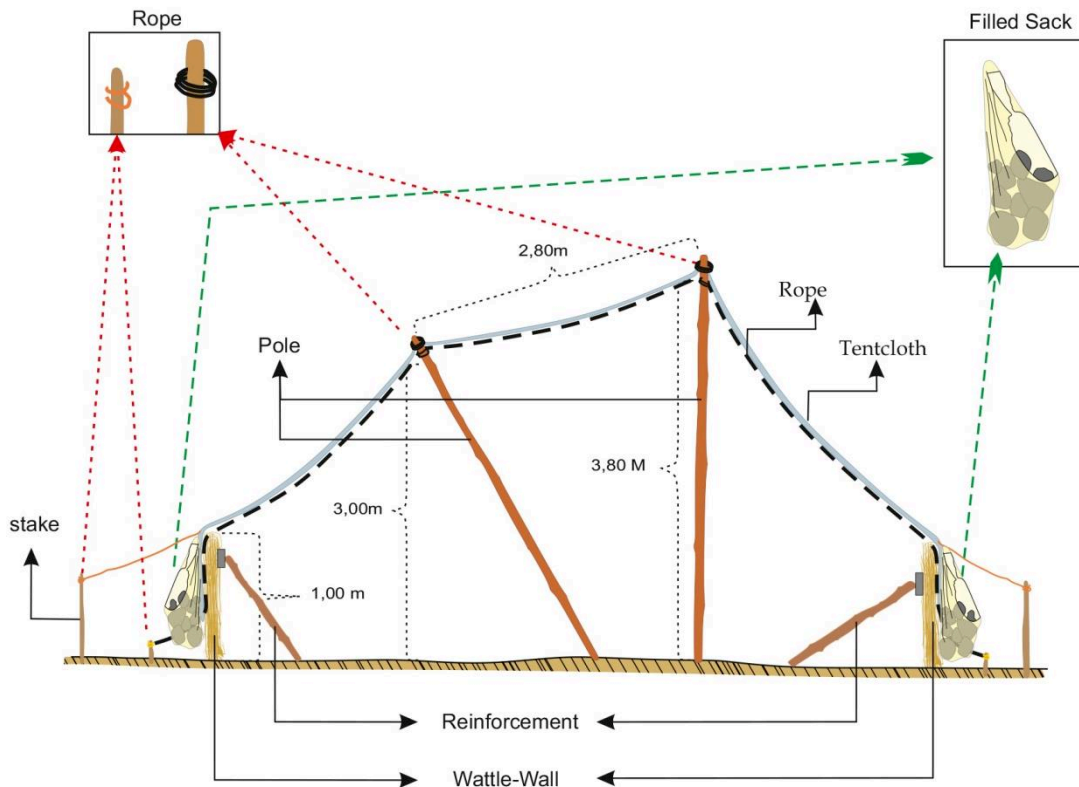
This concept is similar to the *Stone-Walled Tentsites*. Here, wattle surroundings displace the stone surroundings and serve as “walls” for mobile tents. Except for minor details, the construction technique of the wattle part is basically similar to the wattle structures, but they are lower. A rather tight and enduring surrounding is woven with bundles of wattle placed vertically next to each other; and horizontally-laid reeds are passed through the bundles. Wattle bundles woven by being intertwined with each other are bound tightly with wicker. These surroundings, which are tighter and thicker than the walls of *Wattle Structures*, are approximately 15-20 cm. This wattle sheet covering the whole structure like a curtain is generally 120 cm high. Wattle bundles are buried 5-6 cm in the ground and tightly covered with earth to fix them. By twisting the upper fringes of the wattle sheet inwards, the upper parts of the surrounding gain a round shape. Erected with non-stable poles, the tent is stretched by sacks filled with stones that are either tied or sewn around the tent. (Figure 5.9, 5.64 – 5.69) Mobile poles are not embedded in the ground, but stand with the stretched entity formed within themselves. There is no standard in the dimensions of the structures, which range between 15.6x7.5 m and 7.4x5.6 meters.

**Figure 5.9:** Architectural elements of a Wattle-Walled Tentsites

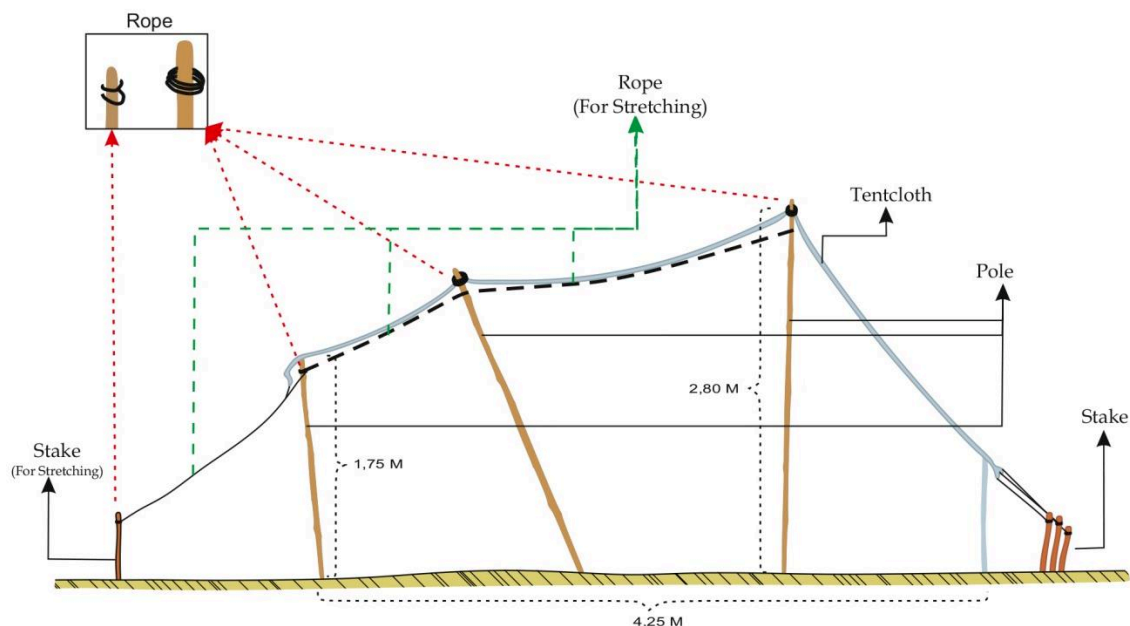
Black Tents are made of covers woven with hair from the "Black Goat", also named *Kilis goat*. It is a very large (approximately 6 by 8 meters) single-piece cover erected in 4-6 stacks, and stretched over 10-12 stakes. The cover is made of eight strips one meter wide that are joined together. According to Beşikçi's records, (Beşikçi, 1969: 73) each strip woven of goat hair is trimmed in the pastures and it is only possible to weave one 100 cm line per year. Therefore, the strips of the tents need to be renewed constantly. Renewal of the whole tent cover takes about 7 to 8 years. Nomads recycle the discarded pieces as floor mats, sacks or feeding trough covers. In the pastures, Black Tents are sometimes surrounded by other sheets or reed mats made of goat hair. This practice is not observed in the temporary camps.

**Figure 5.10:** Architectural elements of a Tent

Tents, known as Black Tent (Jafar, 1976: 109) or *Kil Çadır*, are typical structures of nomads (*Koçer*) used in pastures, winter quarters and temporary camps. (Figure 5.10, 5.73 - 5.75) Black Tents were made out of goat's hair up until 10 years ago; however, today's nomads, under the influence of modern "trends", prefer ready-made tarpaulin or canvas instead of goat hair, which is very hard to weave.

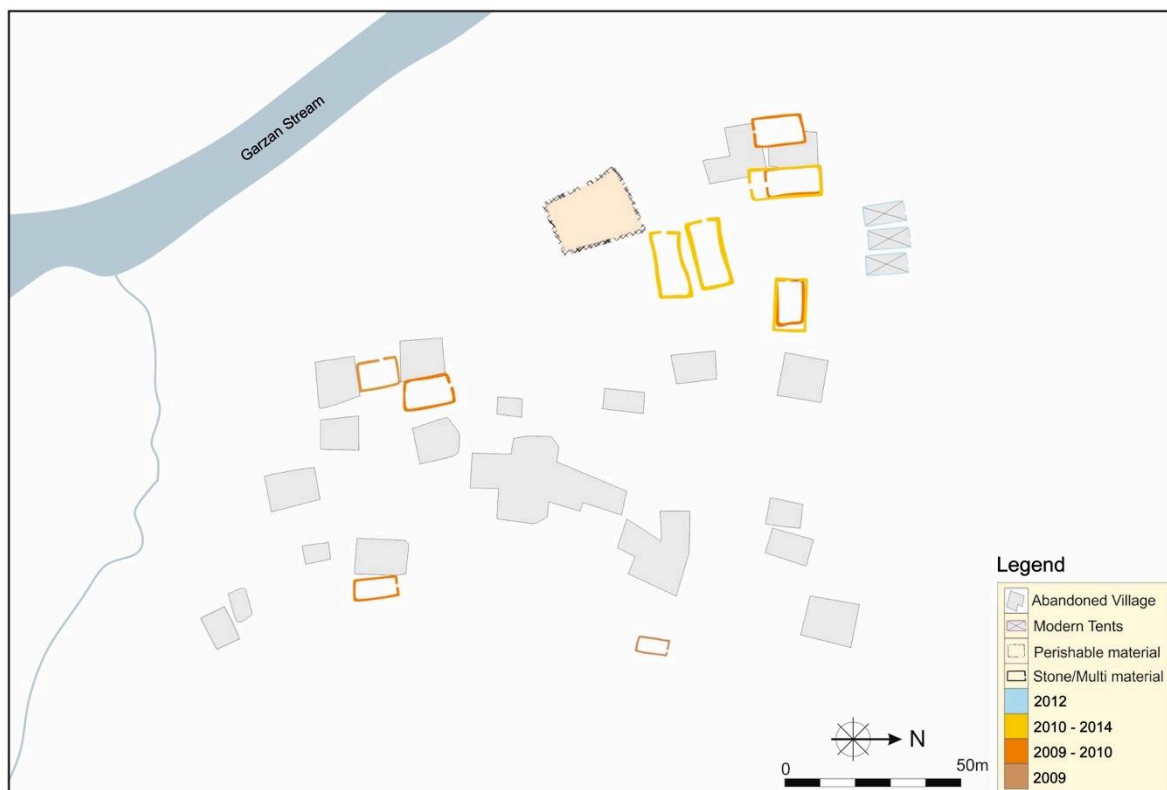
**Figure 5.12:** Settlement pattern and architecture of the Şeyhosel Kom

Ten nomadic structures have been identified between 2007 and 2013. (Figure 5.12; Table 5.2) In 2009 there were five Stone-Walled Structures. They were six in 2010. Three of the five structures were built next to or on top of the ruins of Şeyhosel village by using

the partially-preserved walls. The dimensions of the rectilinear Stone-Walled Structures, which were built in 2009 and 2010 changed between 4.1x8.7 m and 7.3x12.75 meters. The widths of the stone surroundings alter between 40 and 50 cm, and their height is between 40-65 cm (3-5 rows). Stone surroundings are constructed of middle-sized (20x30 cm) and relatively large limestone ( $\geq 40 \times 50$  cm) mostly removed from the foundations of abandoned buildings in the village. Three of the rectilinear structures have openings facing north, while two of them face west and one faces south. The direction of the openings might have been associated with family relations.

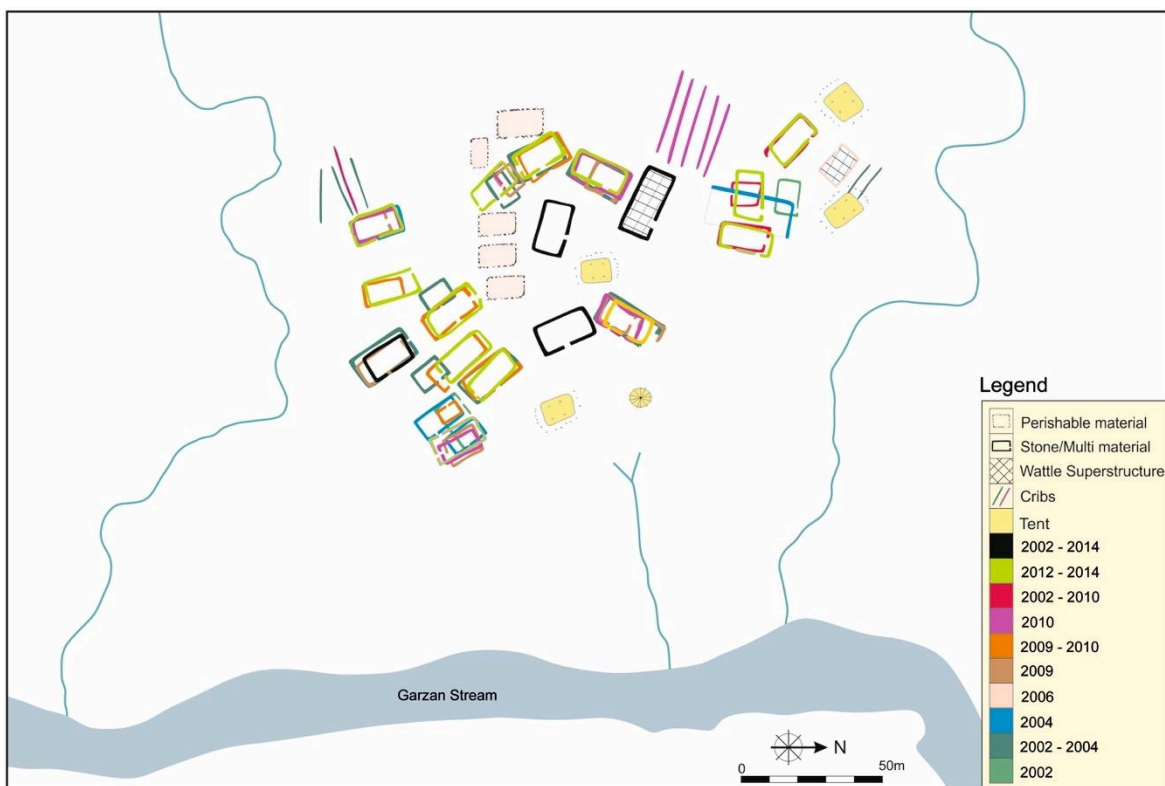
**Figure 5.13:** Settlement pattern and architecture of the Çemisitrin Kom

In the years between 2002 and 2004, there were 21 rectilinear (Table 5.2) Stone-Walled Structures with dimensions between 5.2x3.9 m and 16.4x8.35 m. (Table 5.4; Figure 5.139) The stone surroundings are approximately 60-80 cm high and their thickness varies

Çemisitrin Kom is far from any sedentary villages. The winter quarter is geographically situated on a moderately-sloping terrace on the south bank of the Garzan Stream at elevations of 470-480 m. Two intermittent streams bordered the winter quarter. Floods have partly fragmented the site. Çemisitrin is among the M1 type of winter quarters. (Table 5.1, 5.85) A direct relationship has not been established in the vital sense of villages situated around this type of winter quarters. Although it has been stated that Çemisitrin had been the winter quarters of semi-nomads for a long period of time, it was documented in 2002 for the first time. (Erim-Özdoğan & Sarıaltun, 2011: 991) (Figure 5.13, 5.84, 5.89)

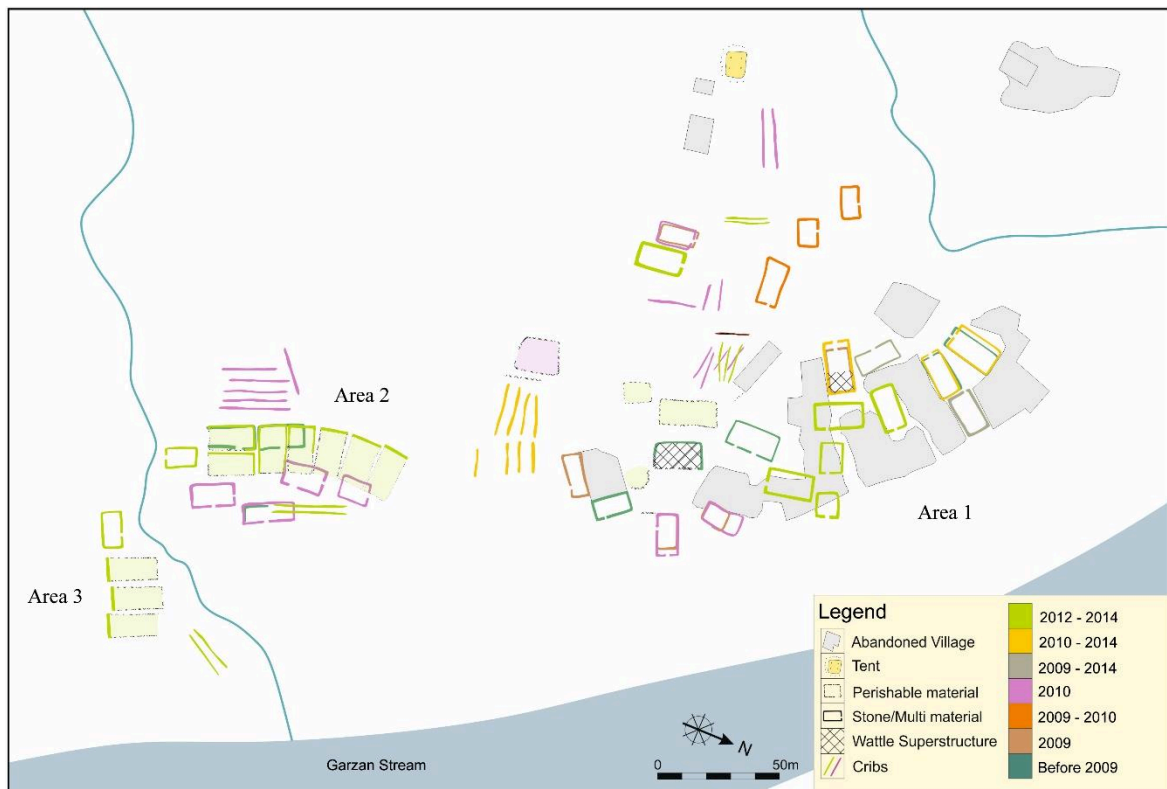
**Figure 5.14:** Settlement pattern and architecture of the Sulan Kom

This winter quarters can be divided into three areas. Area 1 is located; between the ruins of the village house and partly on it. Area 2 is located southeast of the village. (Figure 5.90 – 5.96) The campsite in this area consists of adjacent buildings with a specific plan. Area 3 is located just south of Seyh Cemaleddin River. This area can be specified as being used by a relatively small group. The construction material of the buildings in this area resembles the structures in the 2<sup>nd</sup> Area. (Figure 5.14)

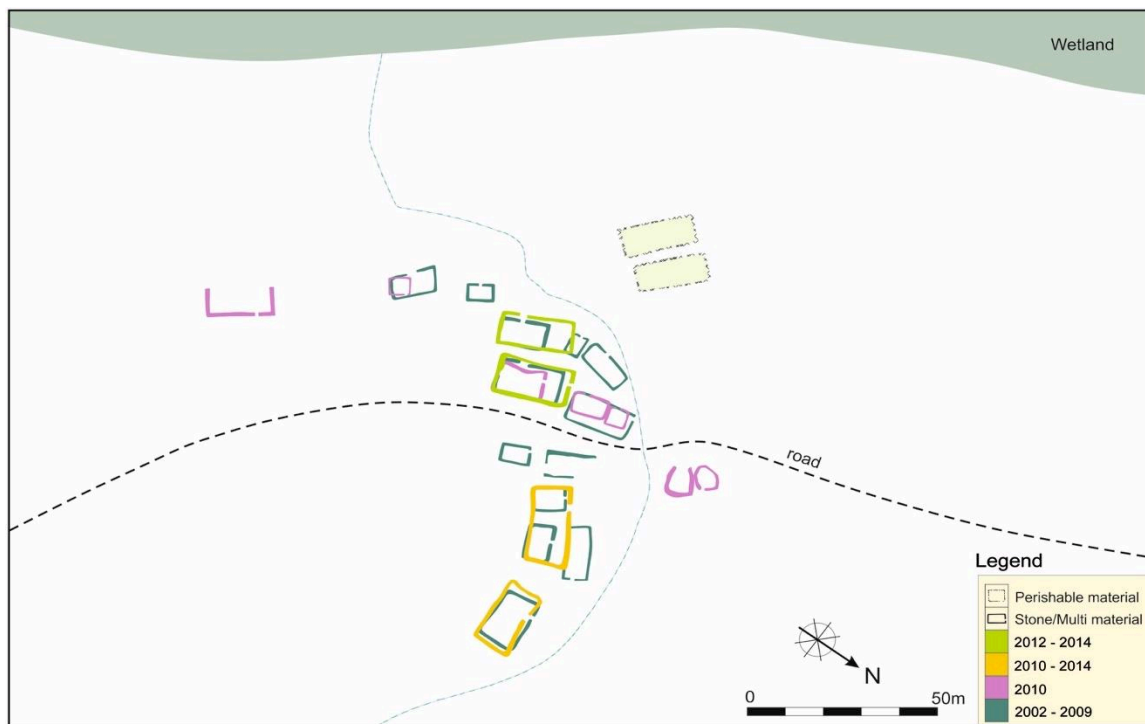
**Figure 5.15:** Settlement pattern and architecture of the Sulane Girgiz Kom

Sulane Girgiz Kom, which is situated approximately 400 meters southeast of Rıdvan village and Başarı hamlet on the east bank of the Garzan River, lies on the gentle eastern-sloping bank of Sinder intermittent stream at elevations of 485-495 m. (Figure 5.15, 5.96 - 98) A village road divides the winter quarters into two sections. Structures on the east side are on more sloping land compared to those on the west. Sulane Girgiz Kom was evaluated as being the M1 type of winter quarters. (Table 5.1) However, the village, which was abandoned in the distant past, may be partially related as it is very close to the others.

Twenty-three structures were identified. (Table 5.2) Twenty-one of them are Stone-Walled Structures, the other two Brushwood-Walled Structures. The dimensions of the structures are not standard. The largest is 9.8x21.1 m and the smallest one is 3.2x5.3 meters. (Table 5.6; Figure 5.141) The average height of the stone surroundings is 60 cm and their width ranges between 30-50 cm. Rectilinear structures do have a single opening in general - except one of them - and the openings are usually on the long axis. In 2002, there were 10 structures. In 2009, six of them with dimensions of 9.4x4.7 m and 4.5x4.1 m was reused without repair. Since there are no wattle remains inside or outside the structures, only mobile

tents are used for coverage. Lack of remnants of earth- or stone-filled sacks points to the stretching of tents by means of wooden poles. Except for secondary utilisation, all the structures built in 2009 occupy 40 m<sup>2</sup> or less space. Taking these data into consideration, Sulane Girgiz Kom has not been intensively used and it can be proposed that it was occupied by a small group for 1 or 2 months as a temporary camp in the winter of 2009.

In 2010 there is an increase in the number of structures. Not only the former Stone-Walled Structures have been reused by partial repair, but also new ones have been erected. This shows that the nomadic group in 2010 was more populous than that of the previous year and the quarters were occupied all through the winter.

After being deserted in 2011 and 2012, the winter quarters were reoccupied in 2013. Four Stone-Walled Structures on either side of the road were repaired and used as pens. In addition to these, two Brushwood-Walled structures were constructed on the western side of the road. Absence of animal waste and traces of daily tools and implements are evidence that the newly built structures are intended for humans.

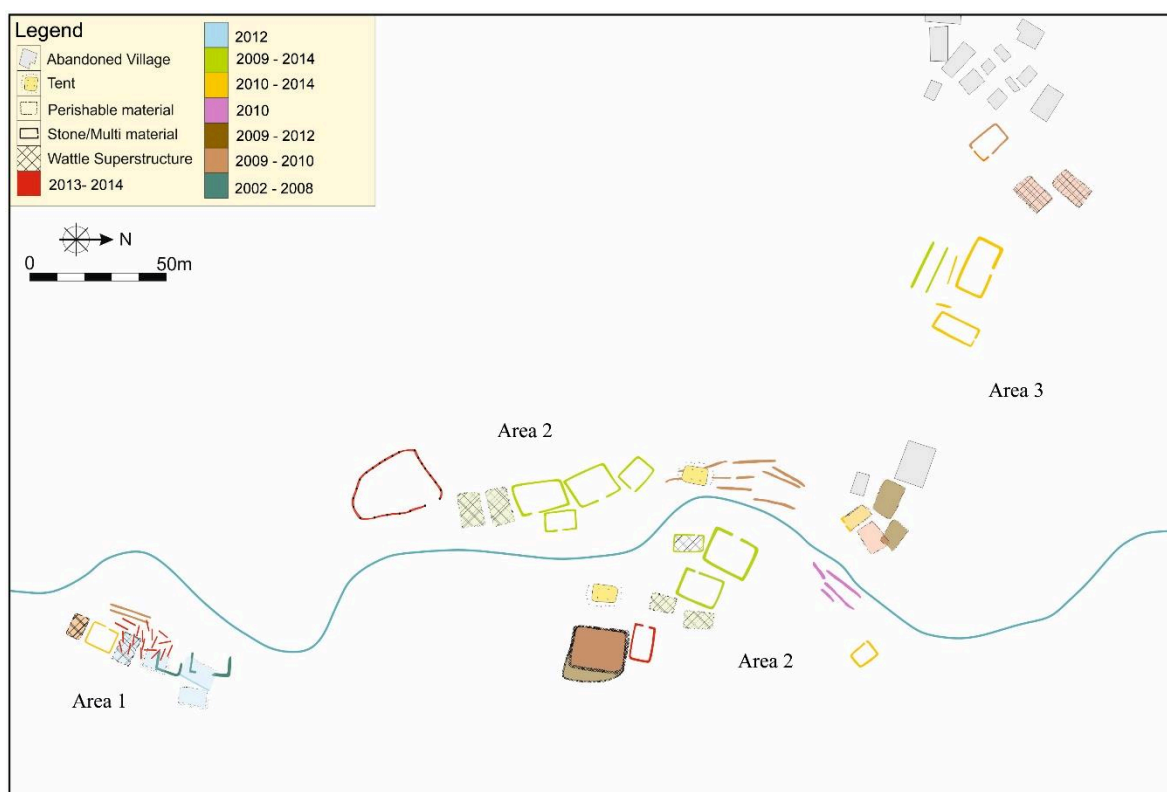
**Figure 5.16:** Settlement pattern and architecture of the Bazivan Kom

The winter quarters are located in the valley of the Variconi intermittent stream, a tributary of the Garzan River. The structures are distributed either in the streambed or on the slopes. (Figure 5.16, 5.99 – 5.113) It is only 200 m from Kumgeçit village and we were told that there is a close relationship between the two groups of ladies, who share daily activities. Bazivan Kom was evaluated as being the M2 type of winter quarters. (Table 5.1) The winter quarters are separated into three main areas according to structure distribution and utility of the open-air areas.

This winter quarters can be divided into three different areas according to the structure distribution and changing usage space. (Figure 5.99 – 5.101) Area 1: The southern area is a relatively sheltered area towards the inner valley of Variconi stream. It covers an area of 2000 m<sup>2</sup> on the gentle slope on the east bank of the stream. There are seven structures of which only one is a tent with stone surroundings; the rest are either Wattle Structures or Brushwood-Walled Structures. It occupies a space of 50m<sup>2</sup> and functions as a pen. There are two *Wattle Structures* on either side of the tent with stone surroundings, north and south. The northerly one is 9.7x5.5 m whereas the southerly one is 7.5 by 4.7 m. Both are 2.4 m high and are used by humans even though they lack regular flooring. (Table 5.7; Figure

5.142) In the fieldwork of 2012, the wattle structure in the south, which had been completely demolished, left little trace of its presence. (Figure 5.102 - 104) The off colouring on the ground is the only indicator of its existence. The one in the north had been accidentally burnt while it was in use (Oral interview with Sedat Taş, 2013, Kumgeçit Village / Batman). What is left from that structure is dark-coloured patches on the ground. To the north of the group of two Wattle Structures and tent with stone surroundings is a relatively steep slope where there are Brushwood-Walled Structures. One of them has a stone surrounding 90 cm in height and 30-40 cm in thickness on the side leaning towards the slope. The rest of the structures are made of brushwood. In 2013, Area 1 radically changed. All the structures were totally demolished except for the tent with stone surroundings. Feeding troughs were placed all around the structure and the area was reserved only for livestock.

Area 3: This place is situated north-northeast of the winter quarters in an area between the village and the mouth of the Variconi stream. Here exist nine structures from different time periods. On the west bank of the stream where the feeding troughs are located are structures made of wattle and brushwood. One of them has a stone surrounding on its front side. The structures, which are 30-70 m<sup>2</sup>, in size, are reserved for humans. Three Stone-Walled Structures used as pens as well as four feeding troughs were constructed right next to the permanent village houses. The area, which was only occupied between 2009 and 2010, remained inactive afterwards. In 2014, a group came here and built two wattle structures. (Figure 5.38 – 5.42) They told us that they had pastures on Süphan Mountain, and had not come to Bazivan before. (Oral interview with a semi-nomadic woman, 2014, Çemisitrin Kom / Batman. The new group has no kinship with the previous users of Bazivan Kom but they are also from the Alikan tribe. They also told us that it took a month to build the Wattle Structures and they occupied them for 6 or 7 months. The Wattle Structures of Bazivan Kom are similar to the ones at Memika and Mezrik winter quarters. Types T1, T3, T5 and T6 structures have all been used at Bazivan Kom.

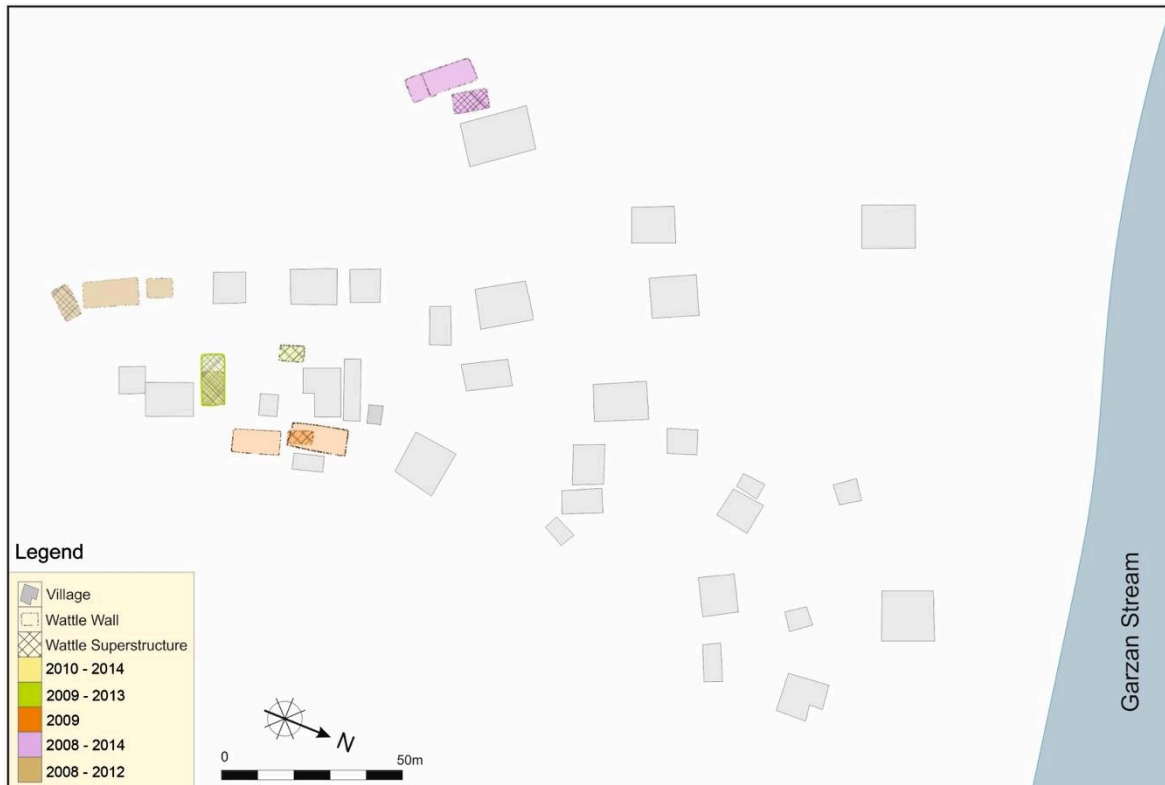
**Figure 5.17:** Settlement pattern and architecture of the Memika Kom

This is located on a gentle slope at an elevation of 440-460 meters south to southeast of a steep slope on the south bank of the Garzan River. Memika Kom is within the territory of Gedikli hamlet of Yazıhan village. It is a typical winter quarters that is integrated with the village and some members of the nomadic group remain all through the year. Memika Kom was evaluated as being the M3 type of winter quarters. (Table 5.1) The structures, to the south of the hamlet, are constructed in empty spaces free from modern dwellings. (Figure

5.17) The villagers allow this area to be occupied by the nomads. The other reason for choice of this area as winter quarters is the existence of some buildings, which were used for drying tobacco leaves about 20 years ago, and are rented to the nomads.

In this winter quarters, there are two types of buildings. One of these Wattle Structure (Figure 5.123 – 5.125) is usually used by human and Stone-Walled Tentsites is used for an animal shelter. The walls of the structures are made by placing 10-12 cm-thick wattle bundles next to each other and tying them tightly together. According to Koçer Ömer, one of the residents, the structures can last 7-8 years with partial repair. We were informed that the Wattle Structure, which we detected in 2008, was 3 years old. The wattle structure, which I have termed the "Memika Saz Ev" (Figure 5.18) within the scope of this thesis, was followed consecutively since 2008. The aging, decomposition, and destruction process of this structure are documented here with all the stages. (Figure 5.120 – 5.122) In July 2008, it was observed that the "Memika Saz Ev" was still standing, yet partially ruined and some reeds bundle had broken off. Another rectangular wattle structure in the neighbourhood was partially damaged and needed serious repair. It was clearly seen in 2009 that the damaged parts in 2008 had been repaired. However, it was detected that the parts of wattle structures, which were not damaged in 2008 and therefore not repaired in 2009, had suffered the same

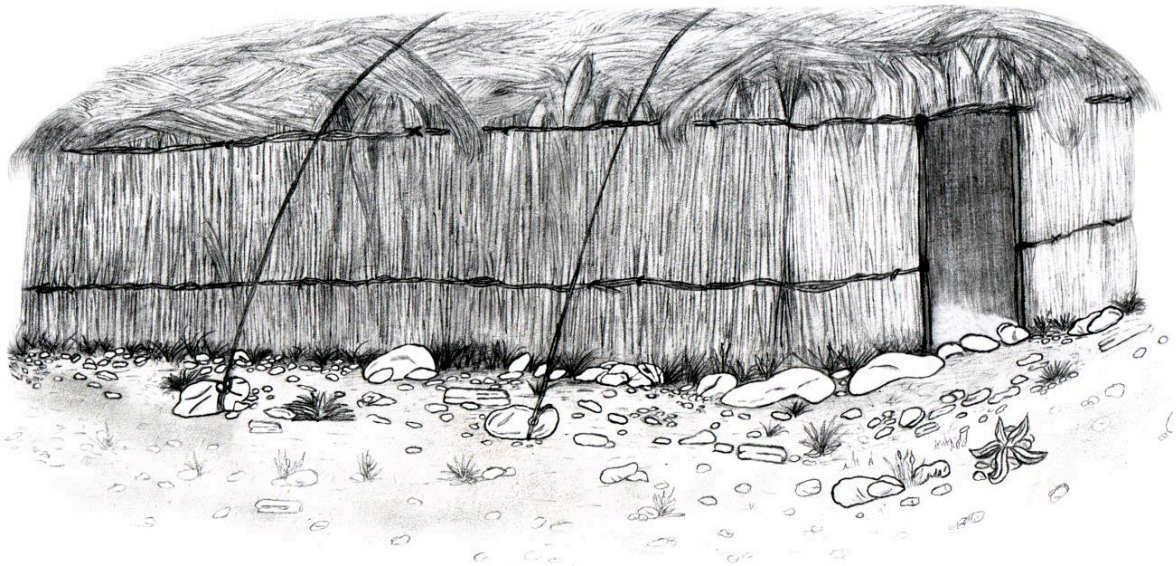
**Figure 5.18:** Pencil drawing of the Memika Saz Evi (by Nilüfer İdikut)

fate and were falling apart. The “Memika Saz Ev” leaned towards the north and if it was not seriously repaired, it was impossible for it to withstand the following winter. In November 2012, it was seen that the "Memika Saz Ev" had completely fallen apart and the remains were in a form of a low heap mixed with earth. Even the location of the poles could not be determined, neither by a colour change on the surface nor by shallow depressions in the ground. Under this circumstance, the layout of the structure can only be identified by hardly visible traces on the ground. The colour change of the soil is another indicator of decomposed structures.

In May 2013 the remains of the "Memika Saz Ev" formed a rise on the ground where structure once was and was becoming intermingled with the earth. By October of the same year, data showed a structure remaining in the field that had almost disappeared. The area where the "Memika Saz Ev" and wattle surroundings were previously erected had been transformed into a rank (hayloft) and also used for feeding troughs in November 2013. It is almost impossible to identify the location of the former structures with the naked eye. If we accept the life cycle of a wattle structure is a minimum 3 years as we were informed by Koçer Ömer in 2008, then depending on environmental effects, periodical “restorations”, and the abandonment stage, the life cycle of a wattle structure is a maximum of 8 or 9 years. Repairs affect the life cycle of a structure while environmental effects increase the decomposition process. For example, another wattle structure that we detected in 2008 next to a village house is still standing and being used. In communications with villagers during
