# Microarchaeological observation on the neolithic architectural structures and cultural landscape of Sumaki Höyük

# **Microarchaeological Observation on the Neolithic Architectural Structures and Cultural Landscape of Sumaki Höyük**

PhD Thesis

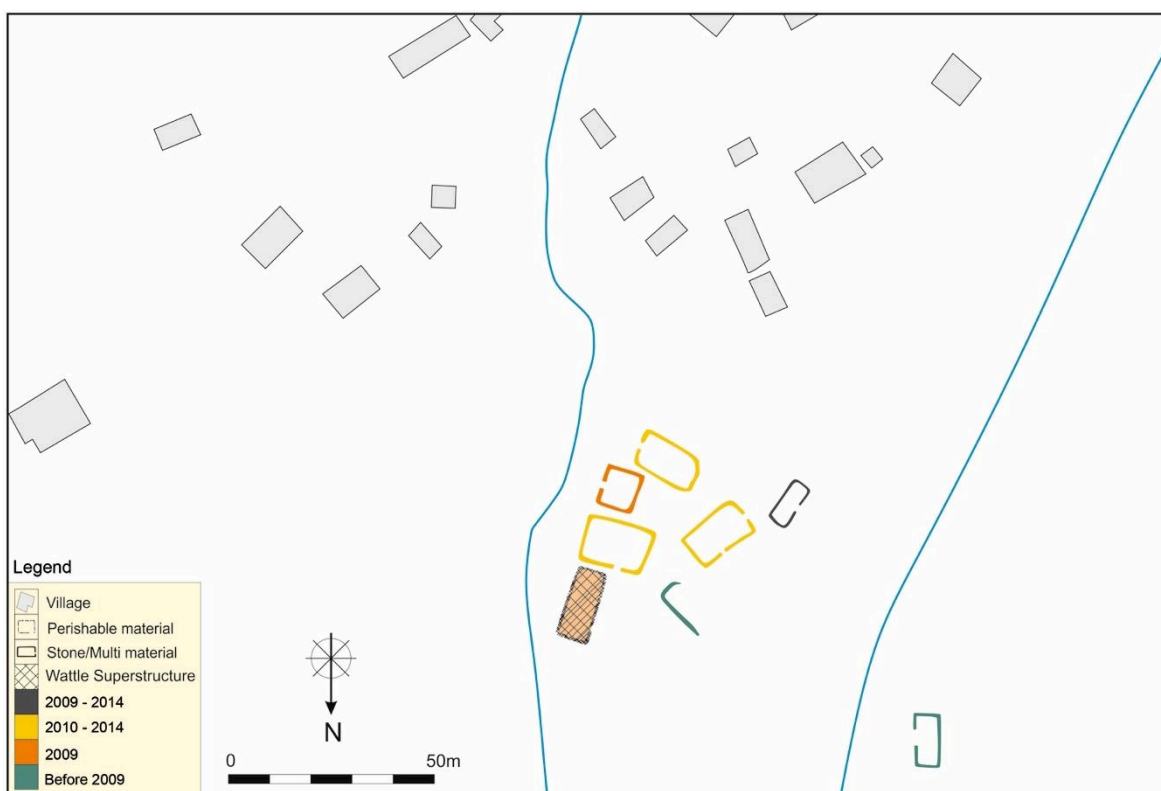
**Figure 5.19:** Settlement pattern and architecture of the Mezrik Kom

Mezrik Kom is located on the south bank of Kuşikapınar intermittent stream on a ridge to the north of Yazıhan village. (Figure 5.19, 5.126 – 5.128)

The winter quarters are used by a small group who are relatives of the ones who occupy Memika Kom<sup>18</sup>. It seems that the winter quarters are partly integrated with Yazihan village, since the relationship between the nomads and villagers is close, as with those in M2 type of quarters. (Table 5.1)

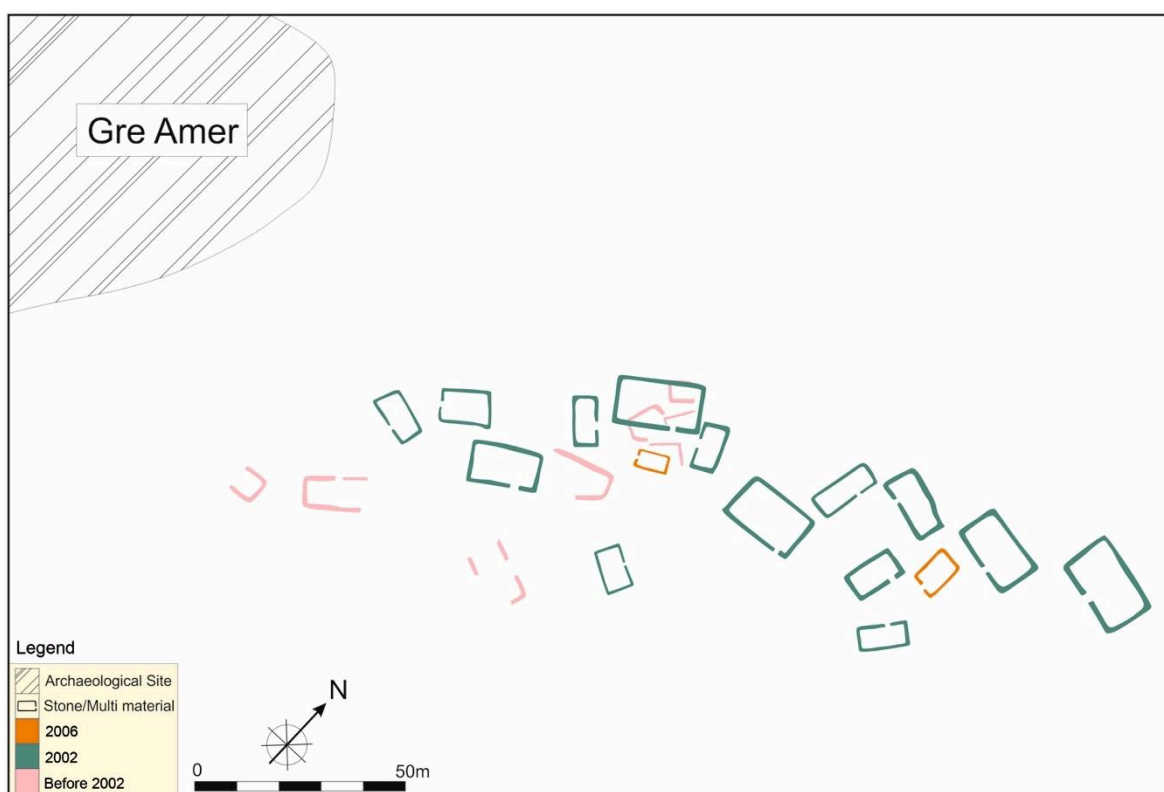
**Figure 5.20:** Settlement pattern and architecture of the Işıkveren Kom I

Işıkveren Kom I was first recorded in 2002. (Erim-Özdoğan & Sarıaltun, 2011: 973) The stone surroundings of the structures demonstrate different features in comparison with the rest of the winter quarters in the south Garzan Basin in terms of construction technique. First of all, they are rather high, sometimes the height is 1.25 m. The bottom rows of the surroundings are composed of rather large, angular, gathered stones around 50x70 cm in size.

From the masonry point of view, it is observed that all the stones forming the surroundings are made to fit to each other. This type of construction technique is basically practiced in long-lasting structures with a stable roofing system rather than temporarily-occupied ones with tent coverage. There is also another aspect that we came across only at Işıkveren Kom I. This is the existence of two short “pillar”-like standing piles made by putting a couple of flat stones on top of each other in a regular way on the top rows of the short axis of rectangular Stone-Walled Structures. Based on our observations between the years 2002-2009, four of them have these standing elements. (Figure 5.20, 5.129 – 5.131) Since we were unable to document the manner of putting up tents, the function of this architectural feature is not clarified. Another interesting practice is that some of the stone

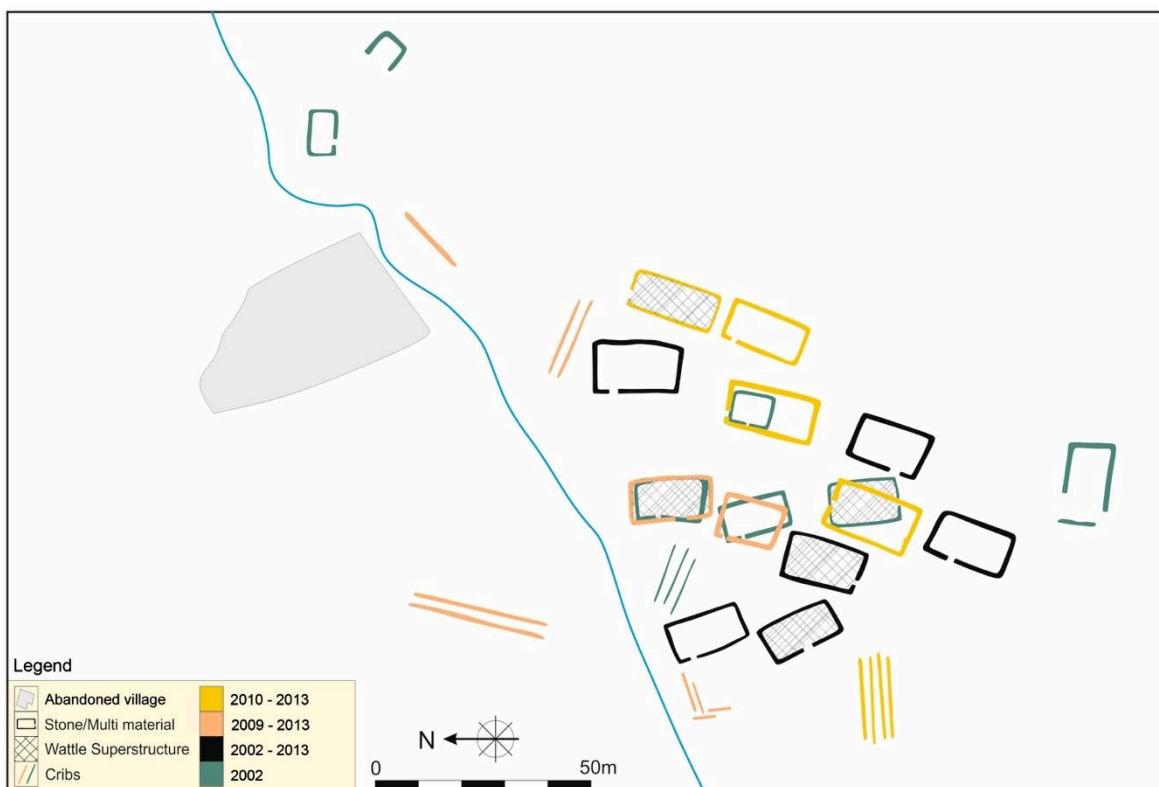
**Figure 5.21:** Settlement pattern and architecture of the Işıkveren Kom II

Işıkveren Kom II is the second winter quarters area located on the same terrace (on Amer Plain) as Işıkveren Kom I. It is situated on the south bank of Kereken intermittent stream, approximately 500 meters northeast of the Garzan River and 750 meters southeast of Işıkveren Kom I. (Figure 5.21, 5.132 – 5.134) It lies both on a gentle slope and flat terrace. Işıkveren Kom II was evaluated as being the M2 type of winter quarters. (Table 5.1)

The winter quarters extend towards the slope area with structures positioned parallel to each other in a southwest-northeast direction. All of the structures have stone surroundings. Işıkveren Kom II was first recorded in 2002. (Erim-Özdoğan & Sarıaltun, 2011: 973) During our 12 years of research at regular intervals, it was seen that five structures are Stone-Walled Wattle Structures. The dimensions of these structures are not different from others, varying between 18.5x7.2 m and 14.5x6.9 meters. (Table 5.11; Figure 5.146) At Memika Kom and Bazivan Kom, the stone surroundings of the wattle structures, which are relatively low and imprecisely constructed, are basically for reinforcement of the *Wattle Structures* and usually they are later additions. However, at Işıkveren Kom II this practice is a conscious choice; in other words, a tradition.

The structures at Işıkveren Kom II are usually repaired and used numerous times; yet serious changes in the settlement pattern took place in the central area. In 2002 the Stone-Walled Structures were in a southeast-northwest direction and they were relatively small compared to the structures of the succeeding periods, which have a more elaborate masonry technique. In 2010 and after, it was observed that the orientation of the structures changed to southwest-northeast and their size was noticeably larger. The area of the tents with stone surroundings varies from 60 to 220 m<sup>2</sup>. It was stated during interviews with settled villagers in the neighbourhood that this winter quarters was unoccupied between 2004-2007 and the current group is not the same group as in 2002. Yet the reason for the 2002 group migrating to a new campsite could not be specified by the villagers.

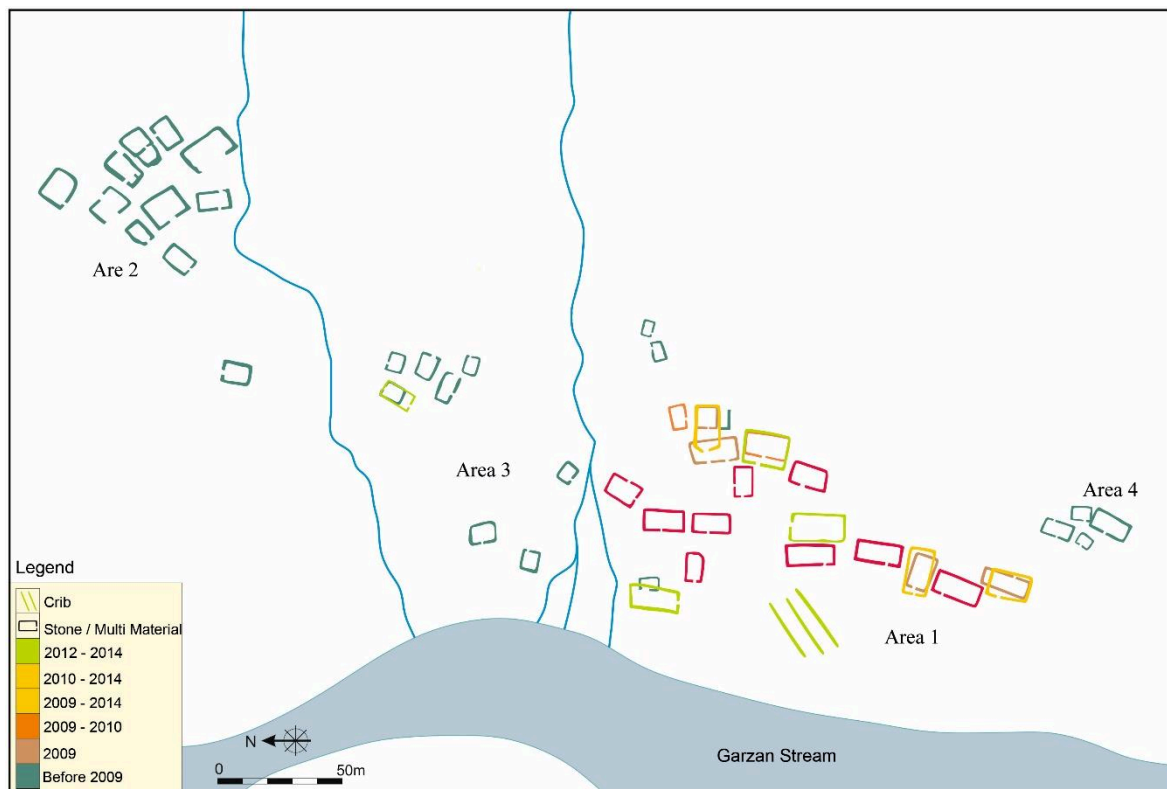
**Figure 5.22:** Settlement pattern and architecture of the Boğaz Kom

Boğaz Kom is situated in the Lower Garzan Basin, which has an embedded valley character that separates the south and the north basins of the Garzan River. The general layout of the winter quarter is in a southeast to northwest direction, covering an area of 450 by 150 meters. The area is separated into four area according to the dwelling density and periodic utilisation of structures. (Figure 5.22, 5.135 – 5.137) Boğaz Kom was evaluated as being the M1 type of winter quarters. (Table 5.1)

Area 1 is in the centre next to the Garzan River and is situated on the south bank of Ziyaret intermittent stream. It extends in a south-north direction in general terms, and rests on two terraces of the slope, where Cemal spring is located. Area 1 displays the most intensive and longest utilisation. Structures in this area are concentrated in two areas, the ones on the northwest side are more numerous compared to its southeast part. While the southeast is more organized and displays a contiguous plan, the northwest side is disorganized and has an architectural plan that has changed and been renewed constantly over time. Some severely damaged structural ruins without a regular plan, which belong to a previous utilisation, have also been detected. Taking into account all this data, the core of

Boğaz Kom can be stated as the northwest part of Area 1. Generally, the openings of the structures face south towards the Garzan River. There are three rows of feeding troughs parallel to each other in the south of Area 1. Just east of these 25-30 m feeding troughs, some run-down feeding trough ruins can also be seen. When field observations and satellite images were compared, it was detected that between 2010 and 2013, the feeding troughs were re-used after repair without changing their places. They display similar features to other winter quarters that are woven with wattle and brushwood together.

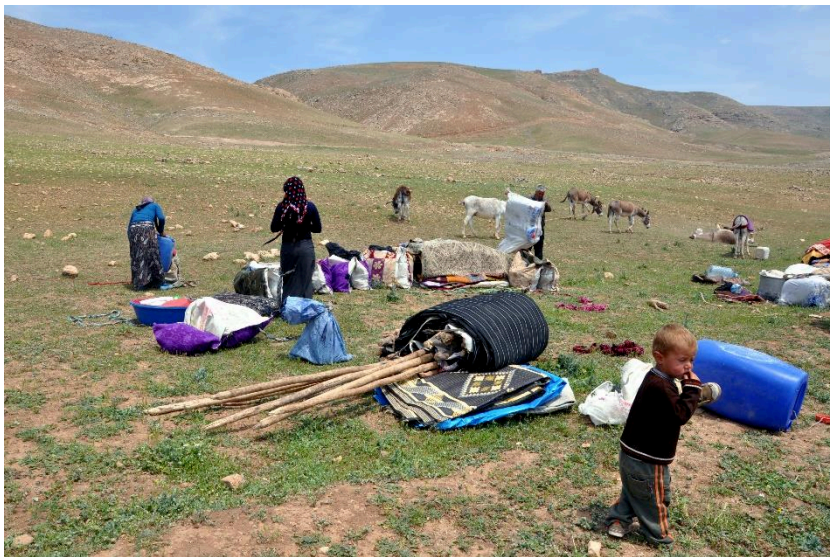
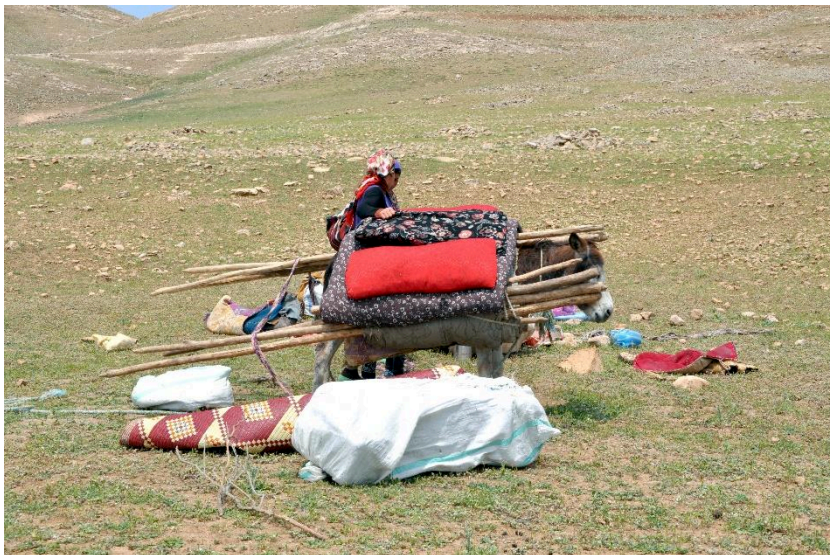
Nowadays, frames and posts are made of the poplar tree. In former times, the thick wattle reed called *Zirc* by the locals was used. *Zirc* ripens only at the end of March until mid-April and is collected in that period.<sup>15</sup> This type of example was not encountered in the field studies, and generally, poplar branches were used as structural bearing components. (Figure 5.30, 5.31, 5.43) The stretch and therefore the strength of the structure, which is constructed

*Figure 5.30: Establishment of a temporary campsite in the Lower Garzan Basin, near the town of Bəspınar*

*Figure 5.31: Establishment of a temporary campsite in the Lower Garzan Basin, near the town of Bəspınar*

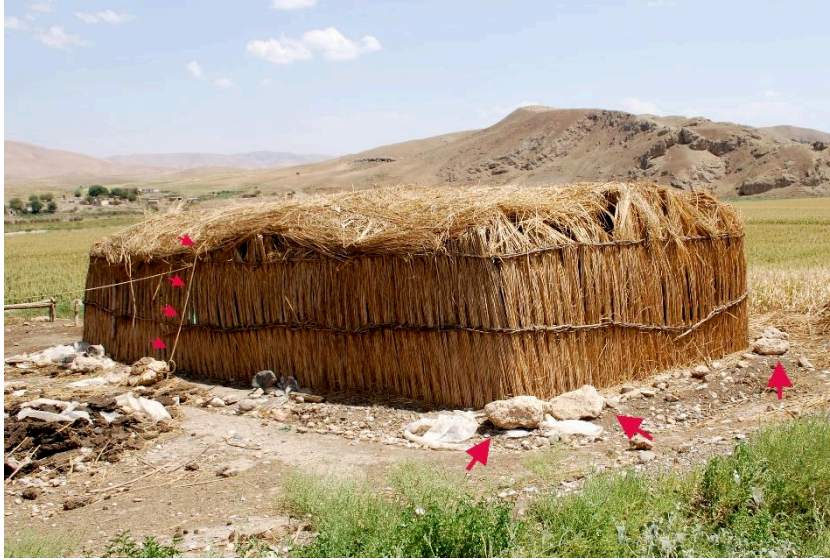
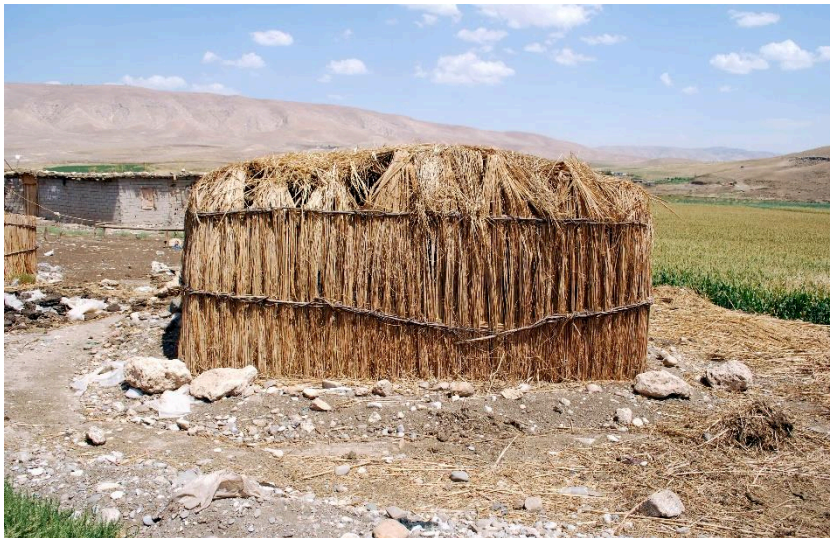
solidly both with tight weaving and ridgepole parts, is increased by ropes tied to large rocks. (Figure 5.32, 5.33) This *Wattle Structure* is covered by a tent in very cold and rainy seasons.

*Figure 5.32: External view of Memika Saz Evi and its tensioning system, near Gedikli village*

*Figure 5.33: External view of Memika Saz Evi , near Gedikli village*

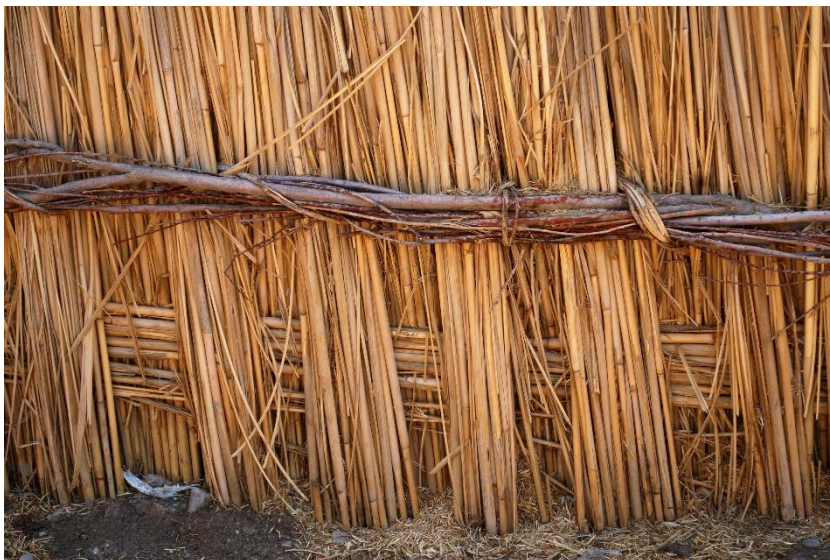
*Figure 5.34: Wickerwork detail of the Wattle Structure, near Gedikli village*

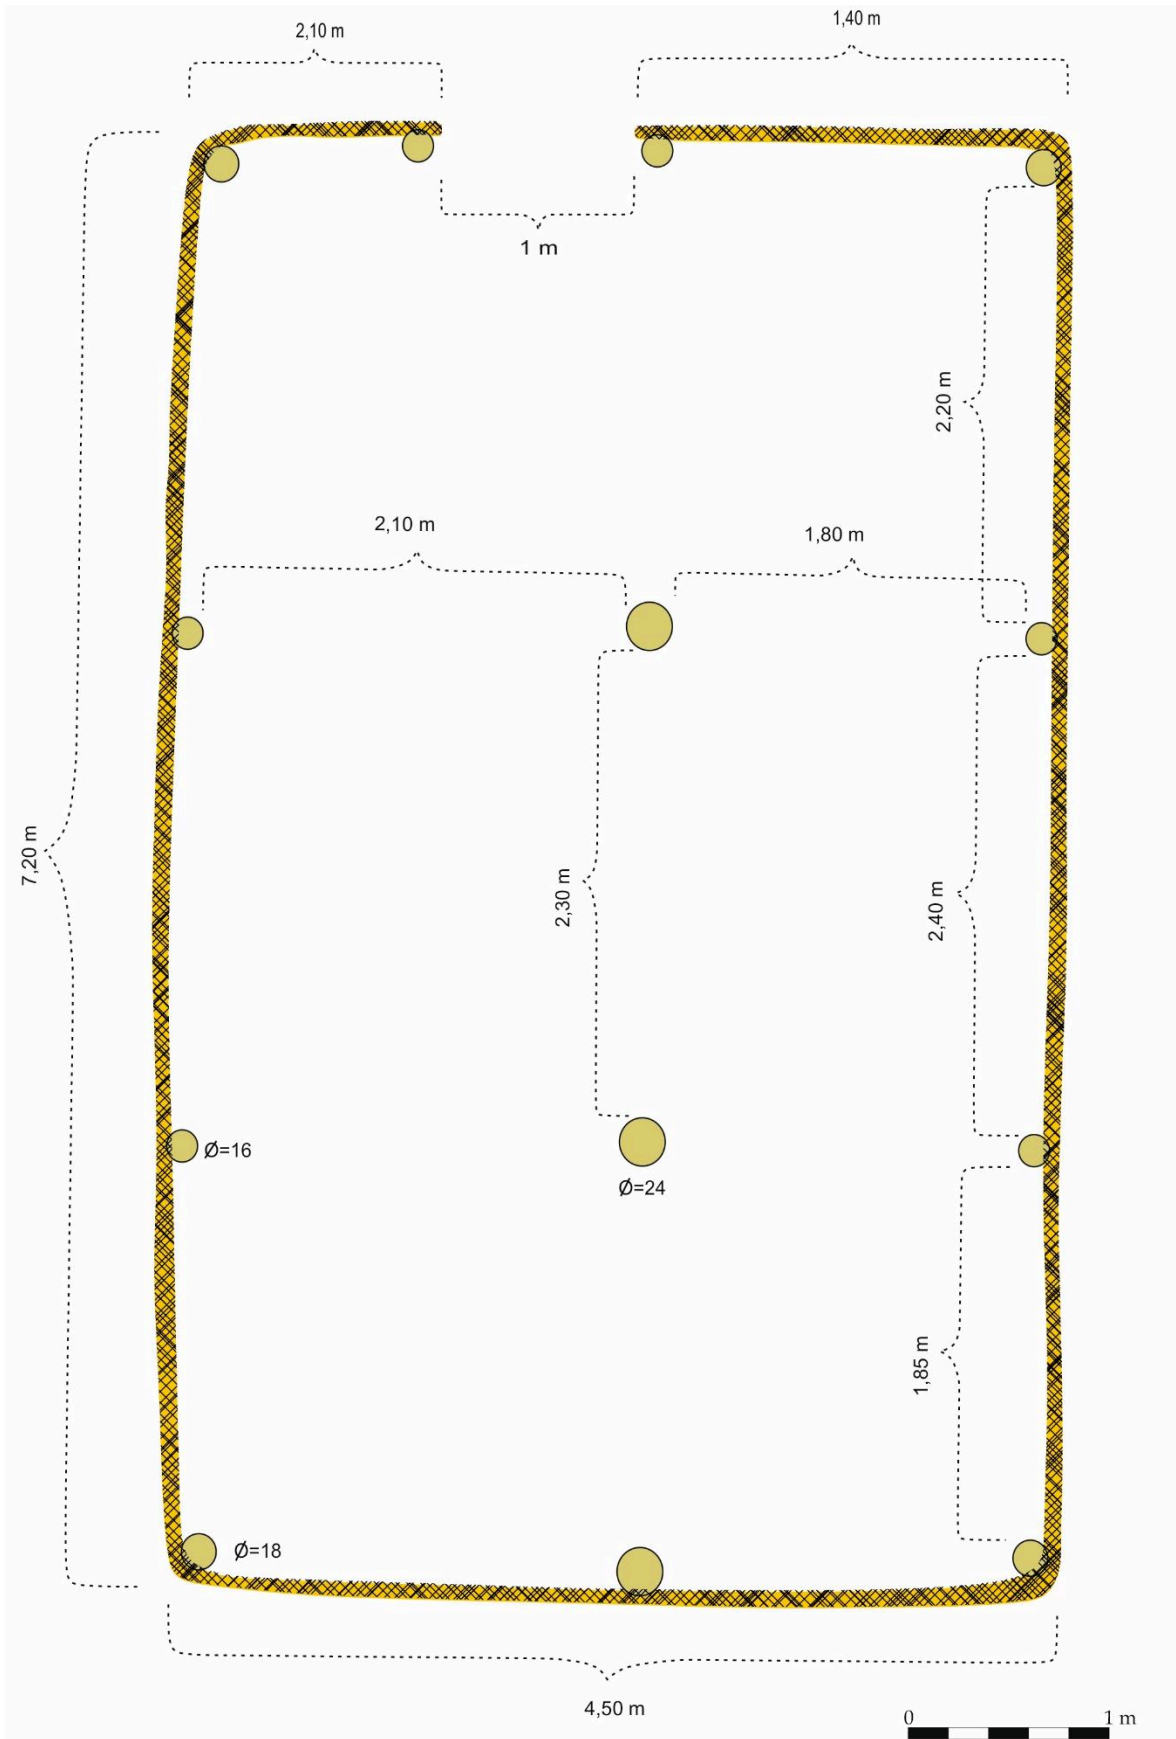
Figure 5.35: Wattle Structure: its plan with dimensions

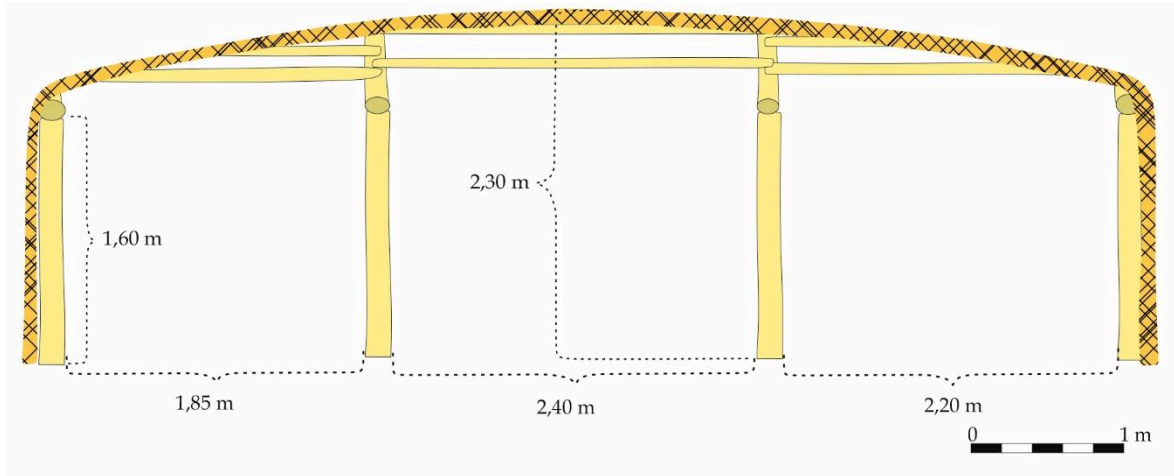
Figure 5.36: Architectural components and its dimensions of a Wattle Structure (long axle)

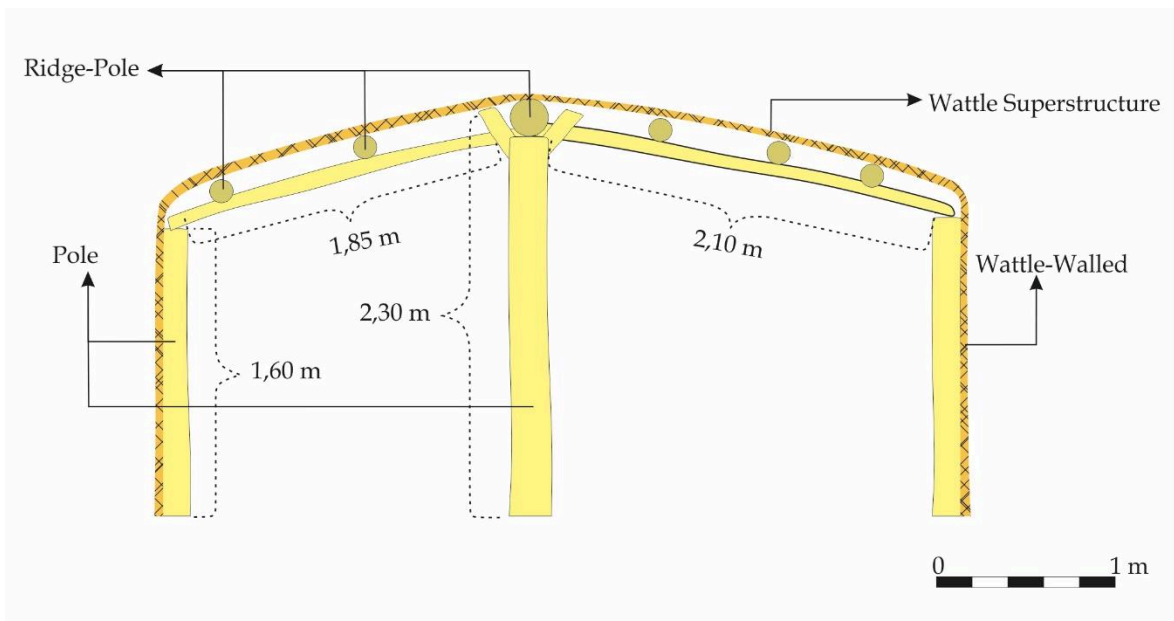
Figure 5.37: Architectural components and its dimensions of a Wattle Structure (short axle)

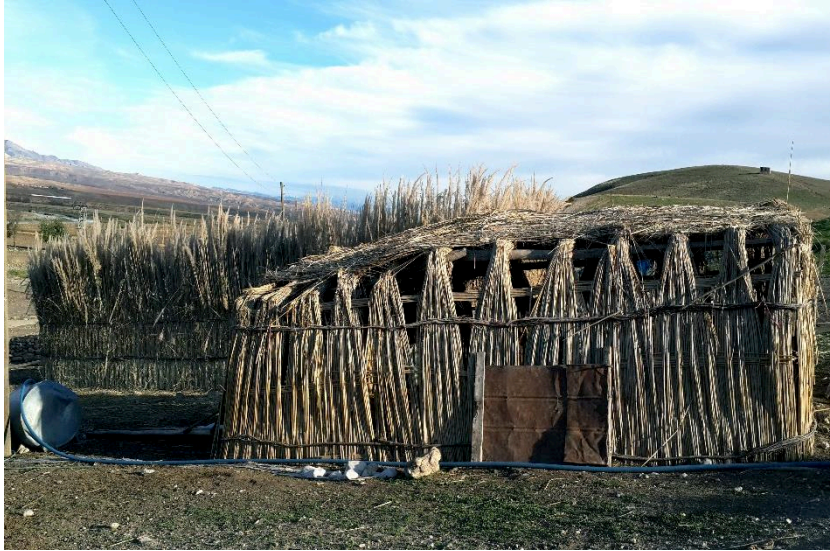
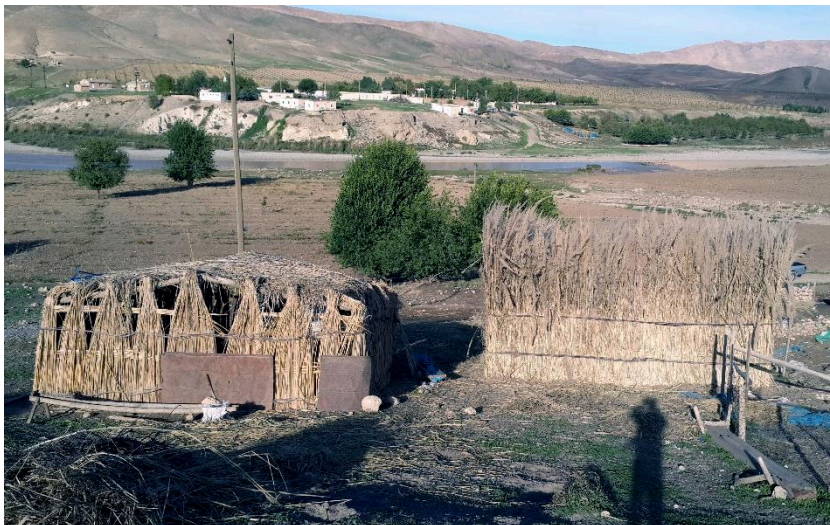
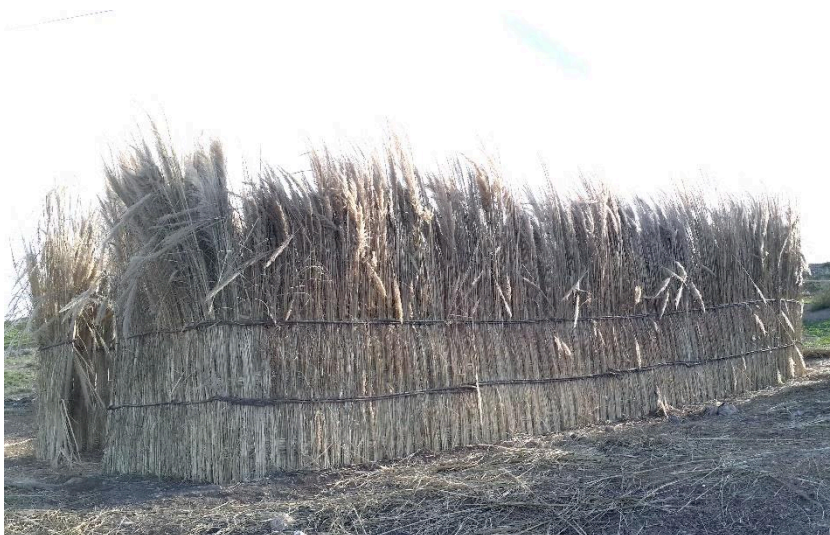
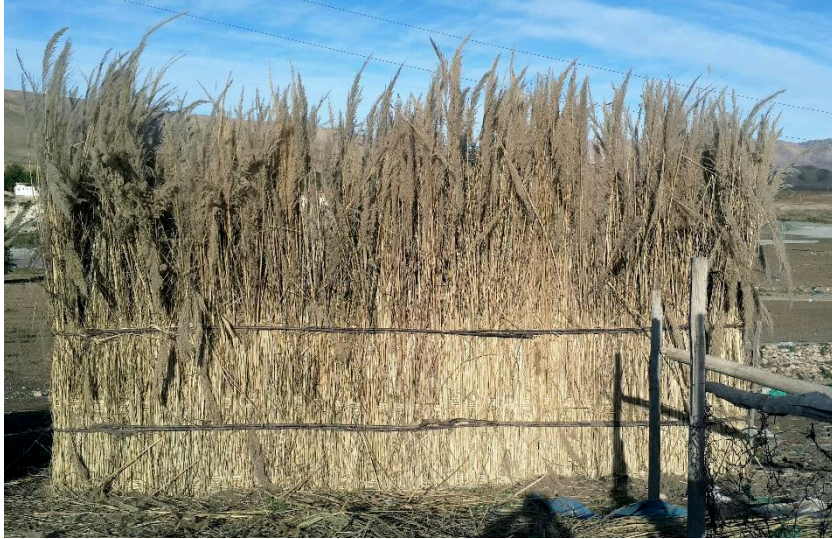
*Figure 5.38: External view of the Wattle Structures and its architectural construction process, near Kumgeçit*

*Figure 5.39: External view of the Wattle Structures and its architectural construction process, near Kumgeçit*

*Figure 5.40: Architectural construction process of a Wattle Structure, near Kumgeçit village*

*Figure 5.41: Architectural construction process of a Wattle Structure, near Kumgeçit village*

According to oral interviews with *Koçer* members, to build a wattle structure takes about a month. Usually the men are responsible for cutting and collecting the reeds while women deal with the weaving process, but most of the time they share the work. This type of structure was encountered at Memika Kom, Mezrik Kom and Bazivan Kom in the Lower Garzan Basin. According to Koçer Ömer, from the Memika Kom, the wattle structures can last 7-8 years with partial repair.

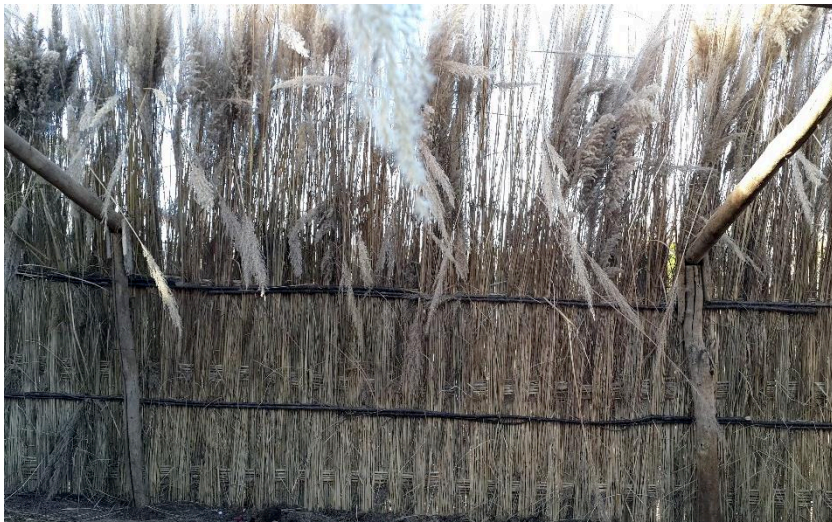
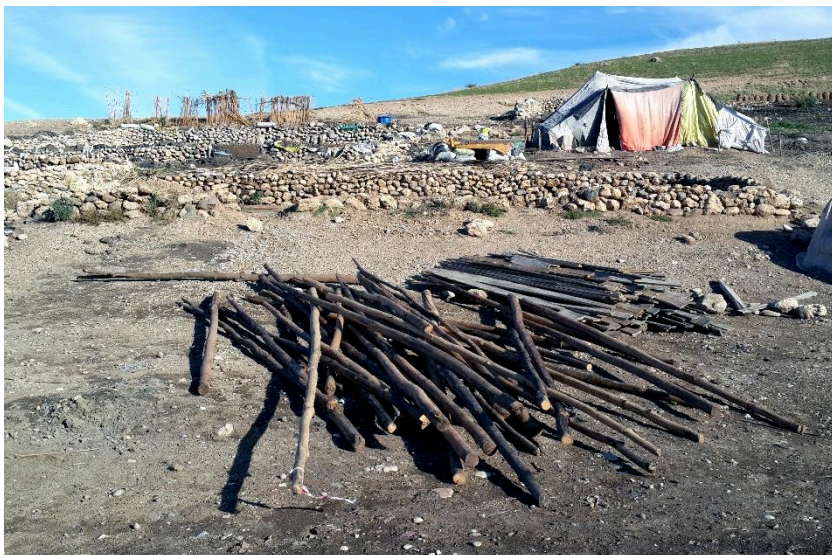
*Figure 5.42: Some wooden poles in a Wattle Structure, near Kumgeçit village*

*Figure 5.43: Some wooden poles was used for Wattle Structures, near Kumgeçit village*

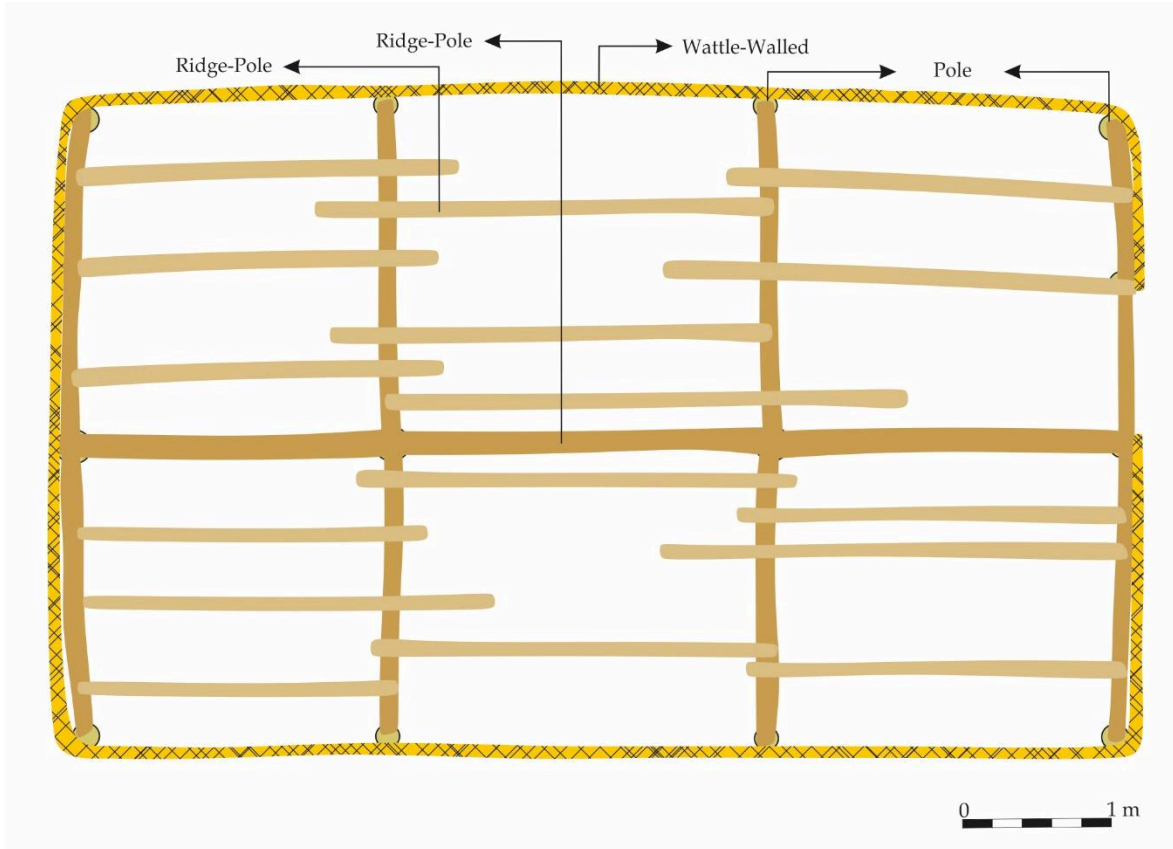
Figure 5.44: Architectural components of the superstructure of a Wattle Structure

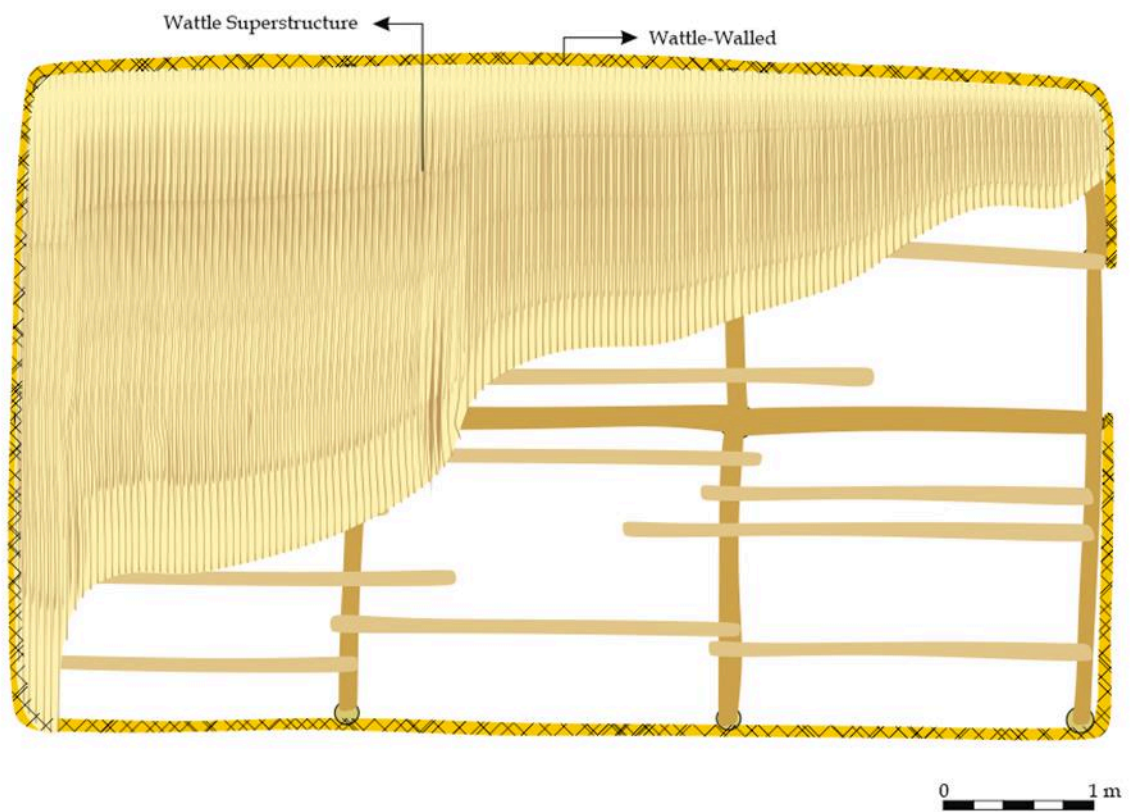
Figure 5.45: Reeds cover of the superstructure of a Wattle Structure

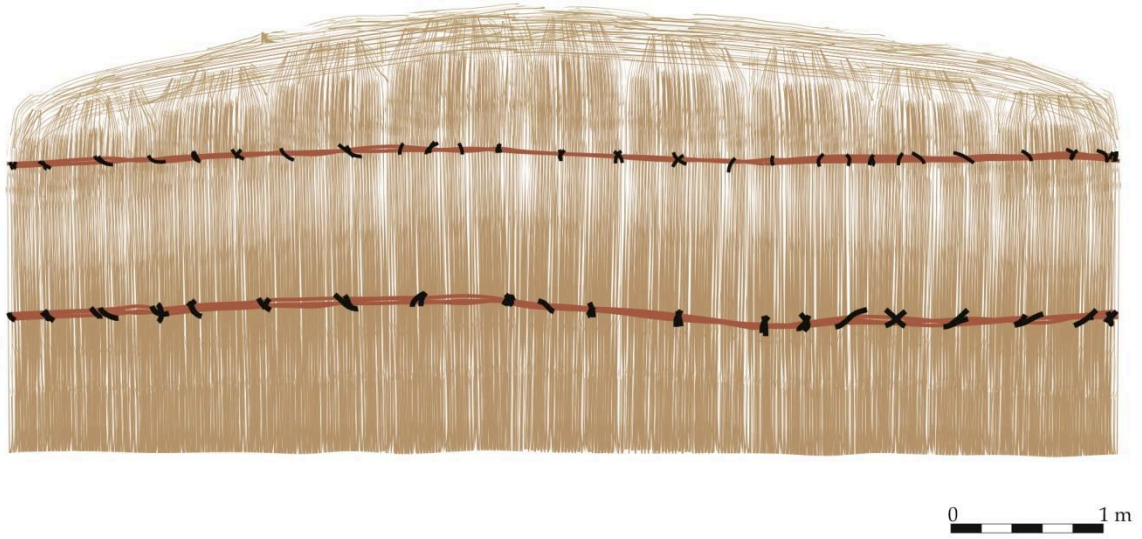
Figure 5.46: *Exterior view of a Wattle Structure (long axle)*

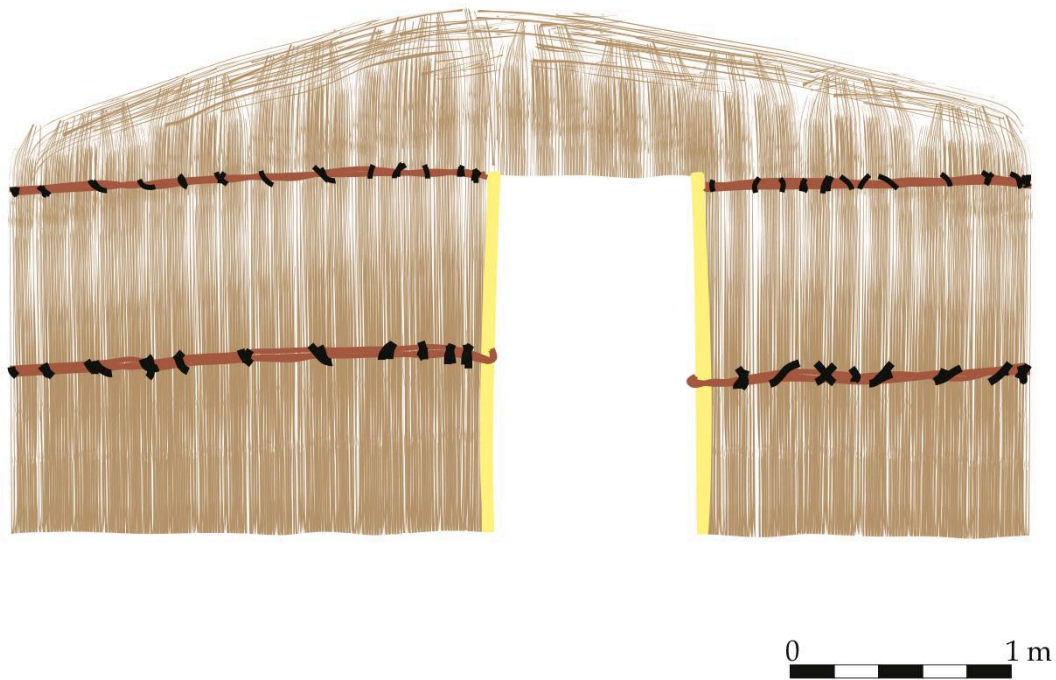
Figure 5.47: *Exterior view of a Wattle Structure (short axle)*

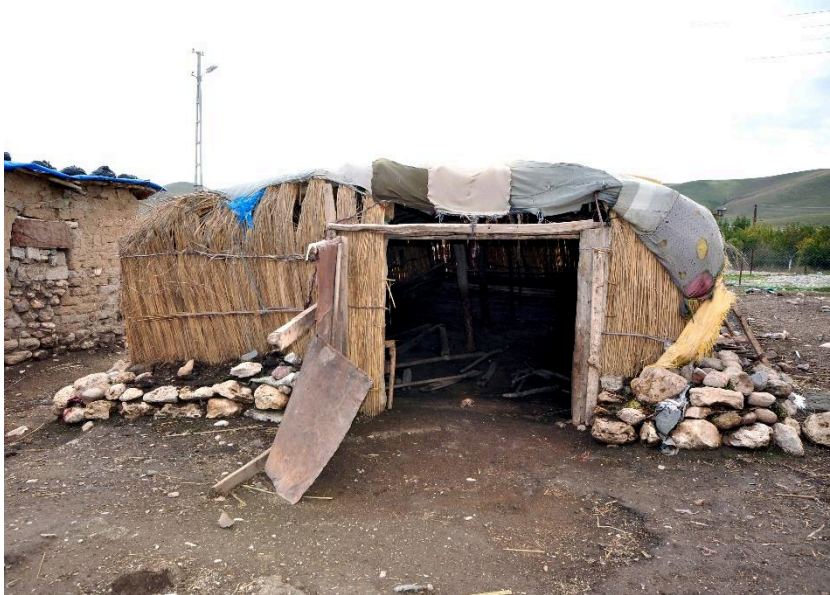
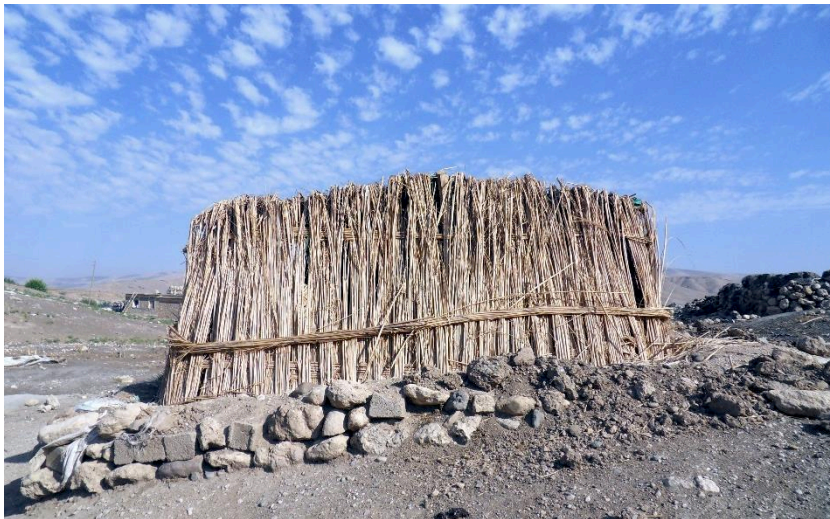
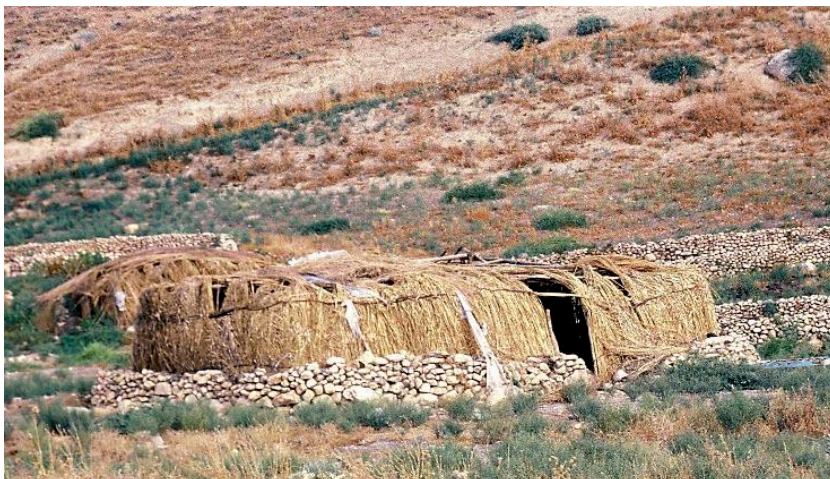
Ethno-archaeological field studies in the Lower Garzan Basin identified structural remains partly surrounded by stone rows or walls. (Figure 5.48 – 5.50) In this type of rectangular structure, three sides were surrounded by temporary material such as soil in sacks, reeds, and branches while stone rows surrounded its other side. These rows are generally located on the narrow side on the slope section. (Figure 5.76, 5.77) The best example is encountered in Sulan Kom winter quarters. These temporary structures have a single inner space. In this context, the stone rows or walls found in Sumaki Höyük are considered to be the remains of rectangular Single-roomed Structures. Additionally, in some winter quarters, it was observed that old structures had a plan or measurements that had been altered on one side, primarily by adding a stone wall to the narrow side. The best examples are in winter quarters of Memikan Kom and Çemisitrin Kom.

*Figure 5.48: Stone-Walled Wattle Structure in Memika Kom, from Gedikli village*

*Figure 5.49: Stone-Walled Wattle Structure in Bazivan Kom, south of Kumgeçit village*

*Figure 5.50: Stone-Walled Wattle Structure in Işıkveren Kom II, south of Işıkveren village*

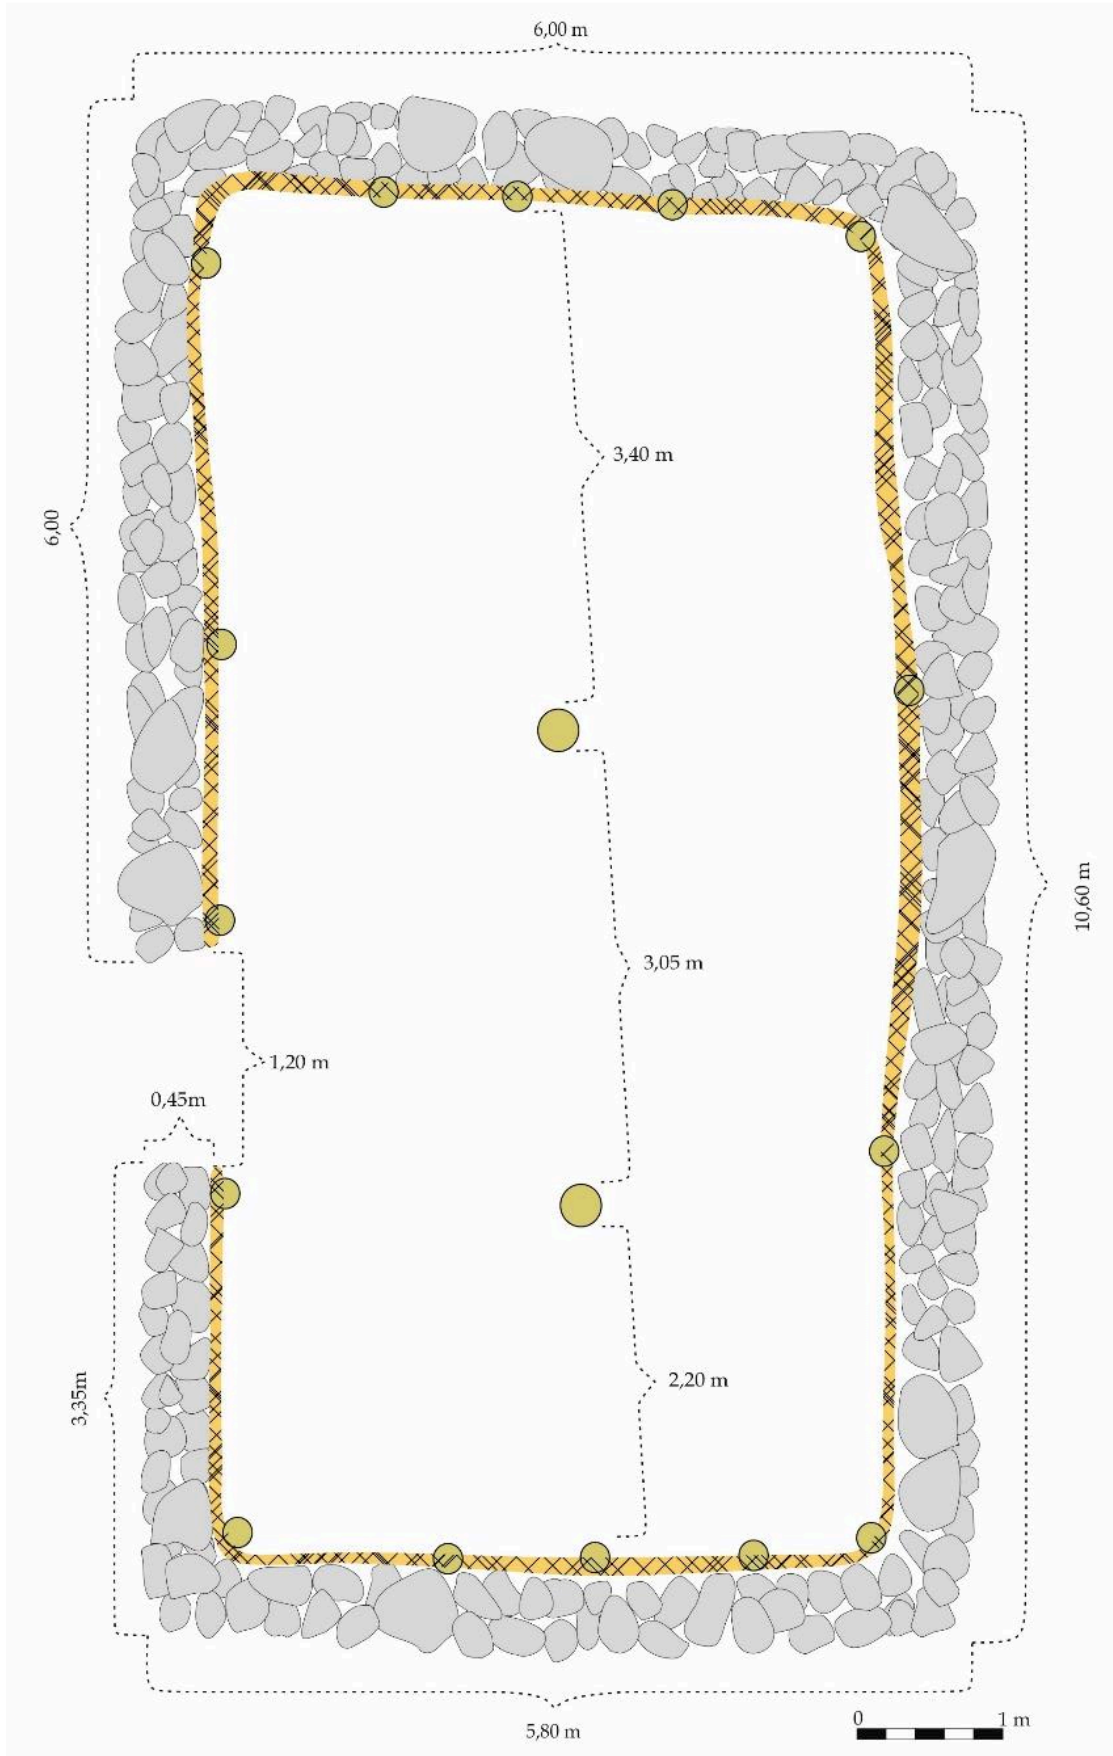
Figure 5.51: Stone-Walled Wattle Structure: plan with dimensions

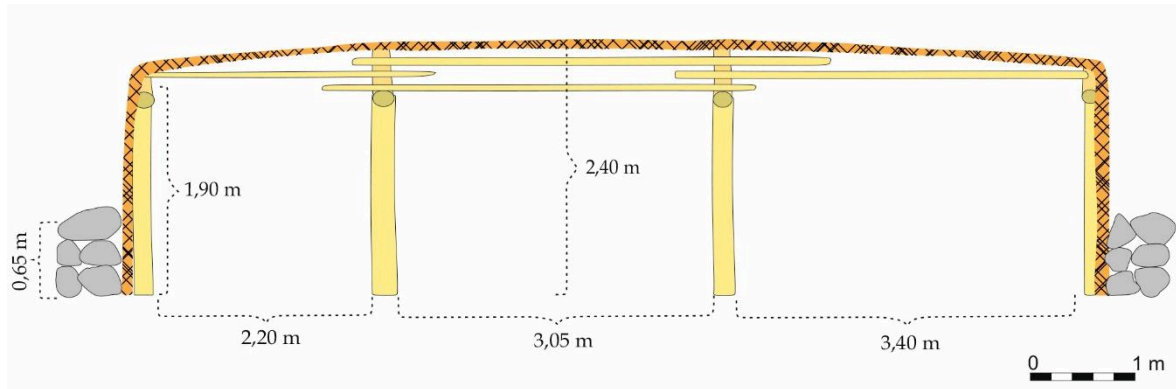
Figure 5.52: Architectural components and its dimensions of a Stone-Walled Wattle Structure (long axle)

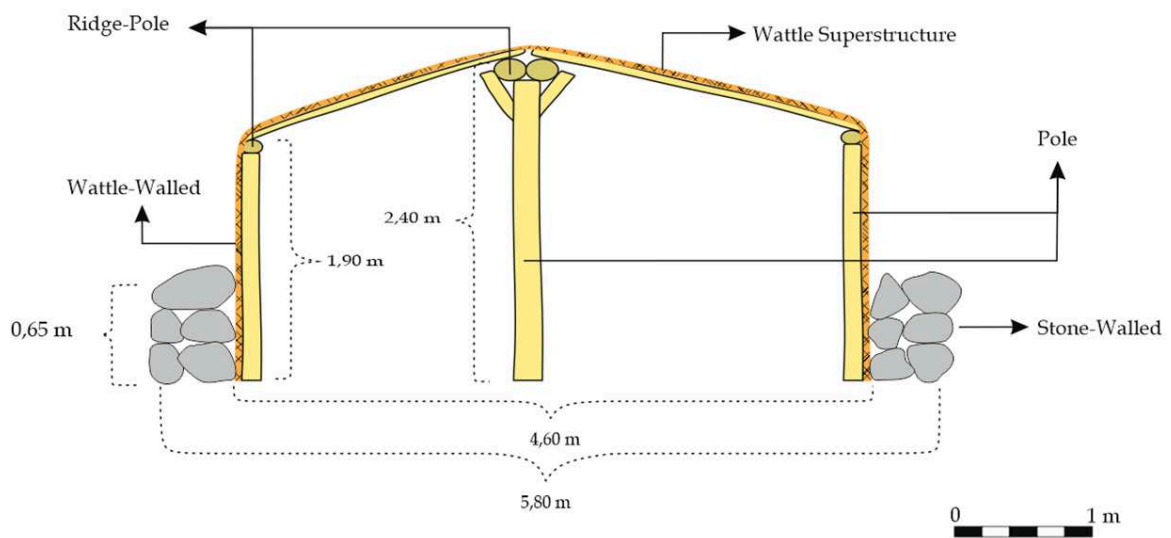
Figure 5.53: Architectural components and its dimensions of a Stone-Walled Wattle Structure (short axle)
