# Microarchaeological observation on the neolithic architectural structures and cultural landscape of Sumaki Höyük

# **Microarchaeological Observation on the Neolithic Architectural Structures and Cultural Landscape of Sumaki Höyük**

PhD Thesis

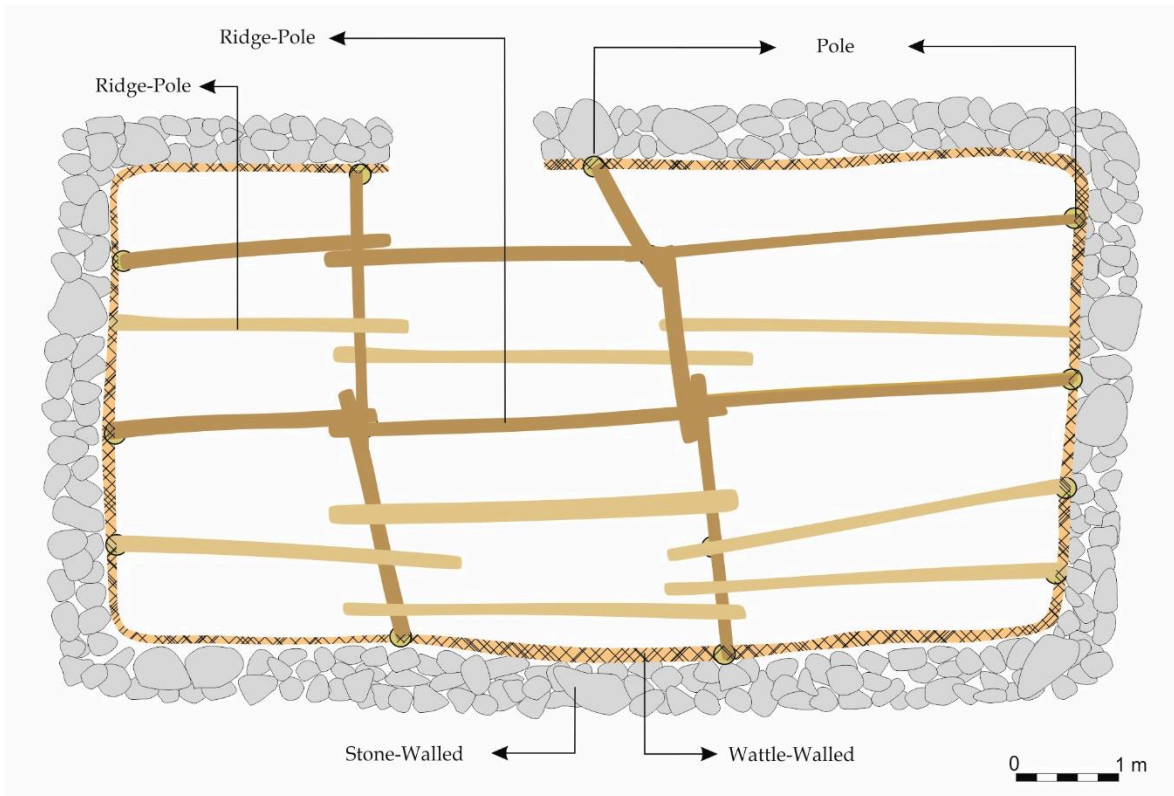
**Figure 5.54: Architectural components of the superstructure of a Stone-Walled Wattle Structure**

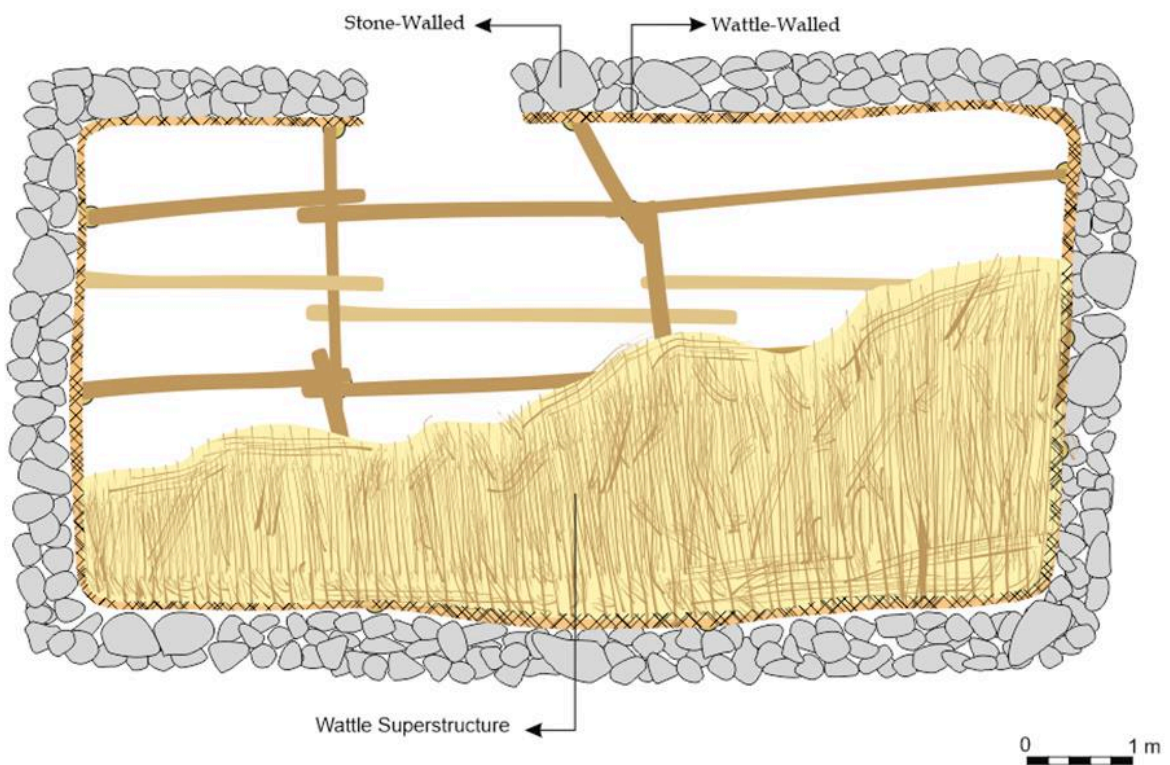
**Figure 5.55: Reeds cover of the superstructure of a Stone-Walled Wattle Structure**

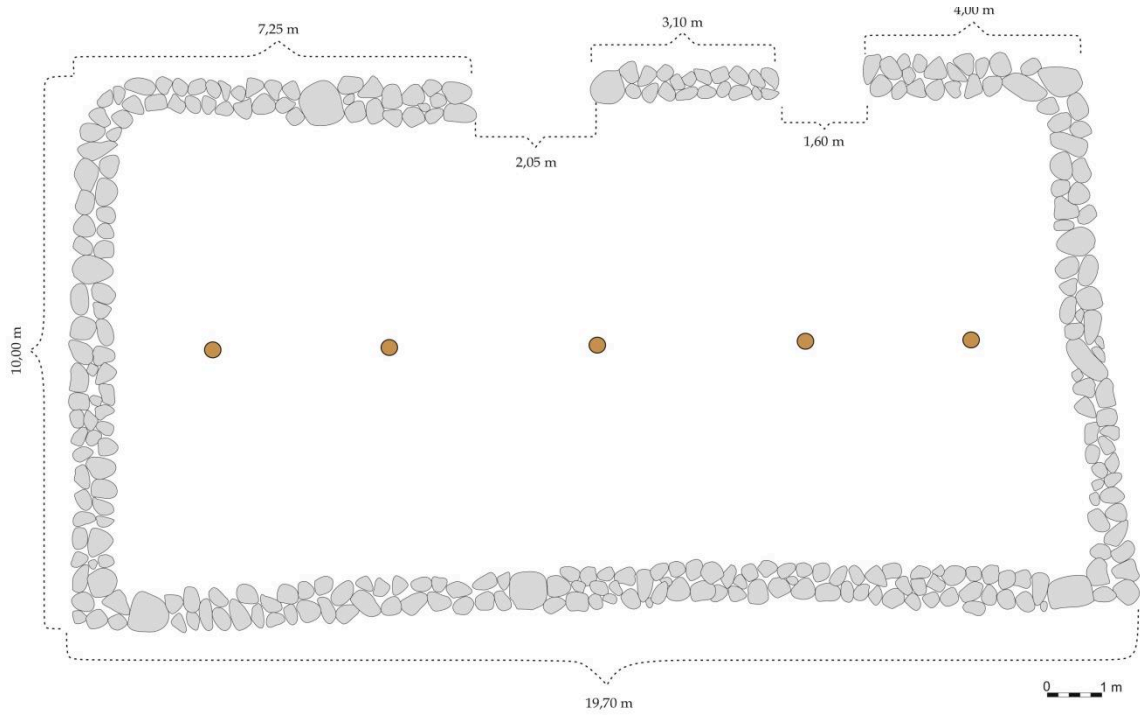
Figure 5.61: *Stone-Walled Tentsite: plan and dimensions*

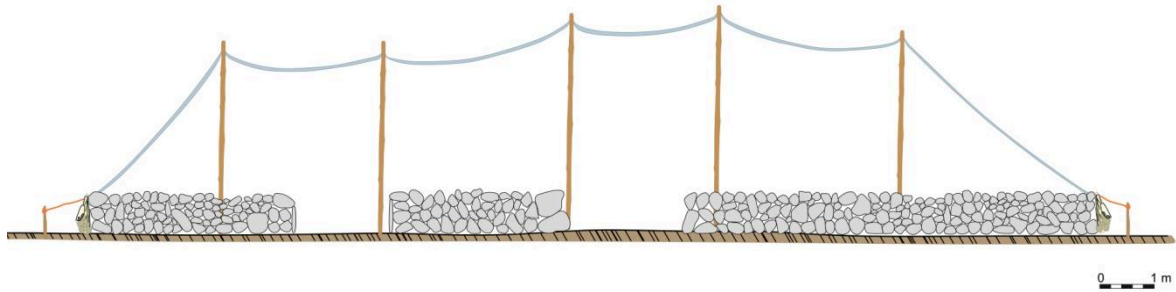
Figure 5.62: *Architectural components and its dimensions of a Stone-Walled Tentsite (long axle)*

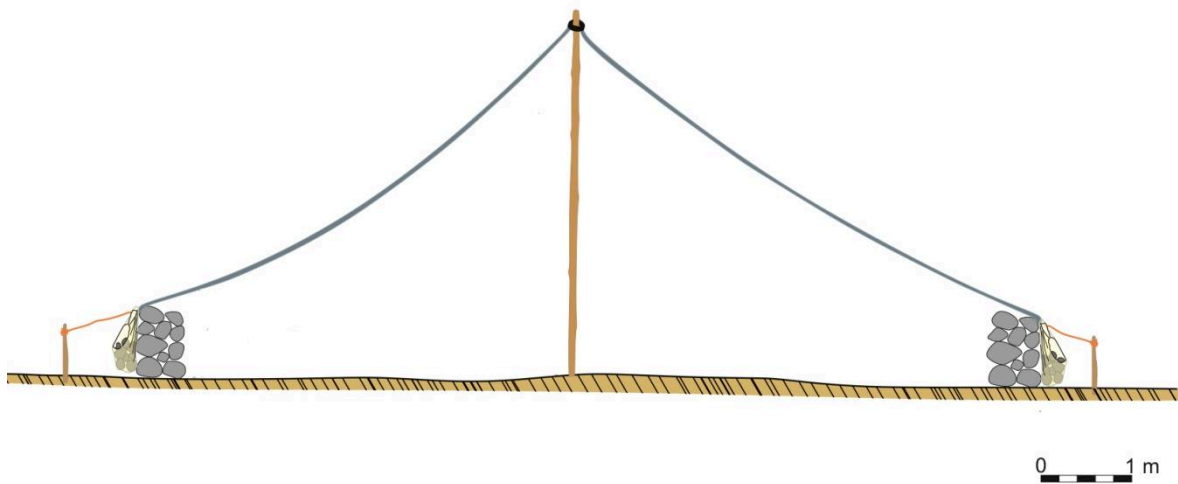
Figure 5.63. *Architectural components and its dimensions of a Stone-Walled Tentsite (short axle)*

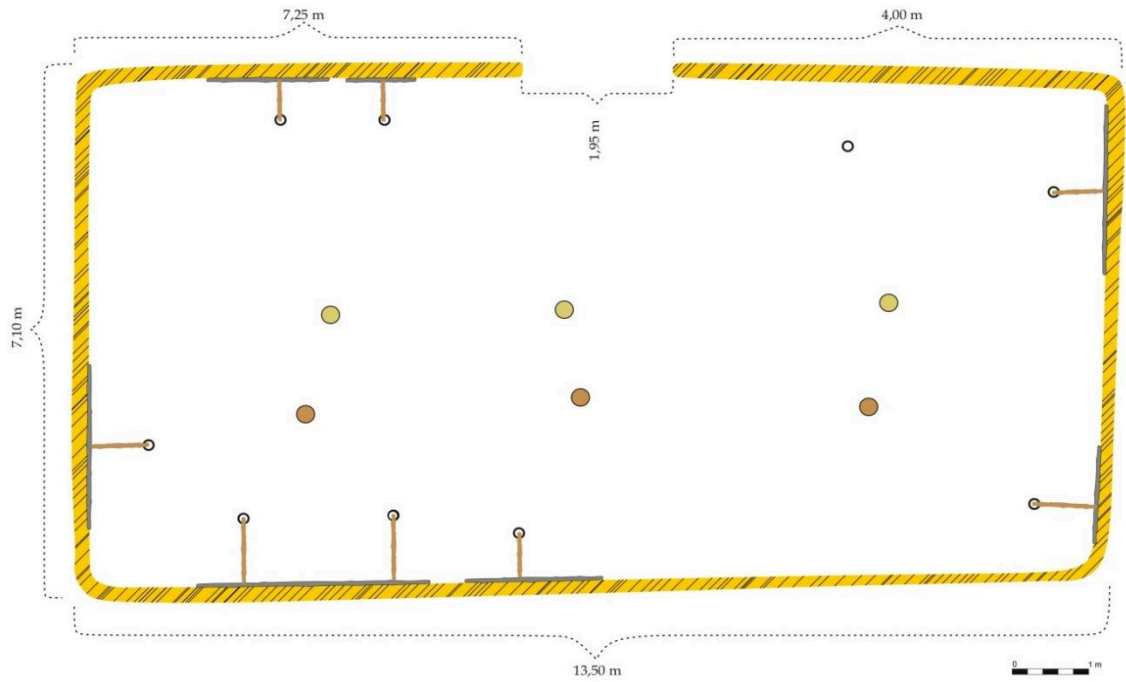
Figure 5.67: *Wattle-Walled Tentsite: plan and dimensions*

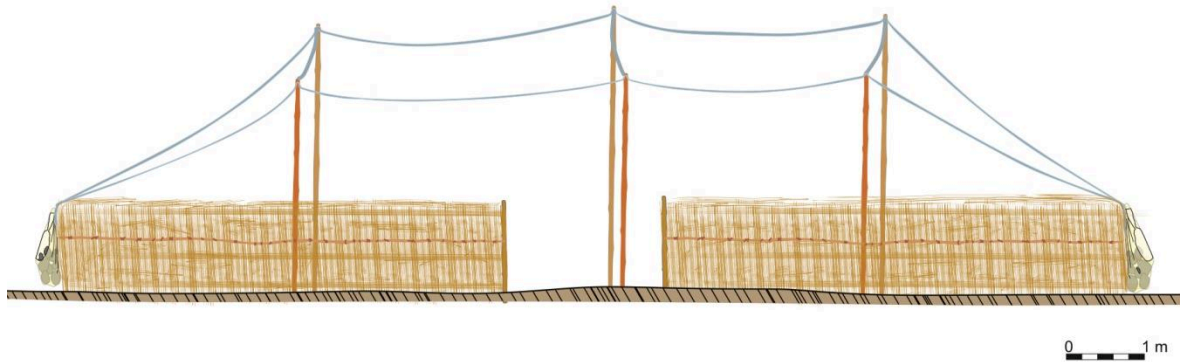
Figure 5.68: *Architectural components and appearance of a Wattle-Walled Tentsite (long axle)*

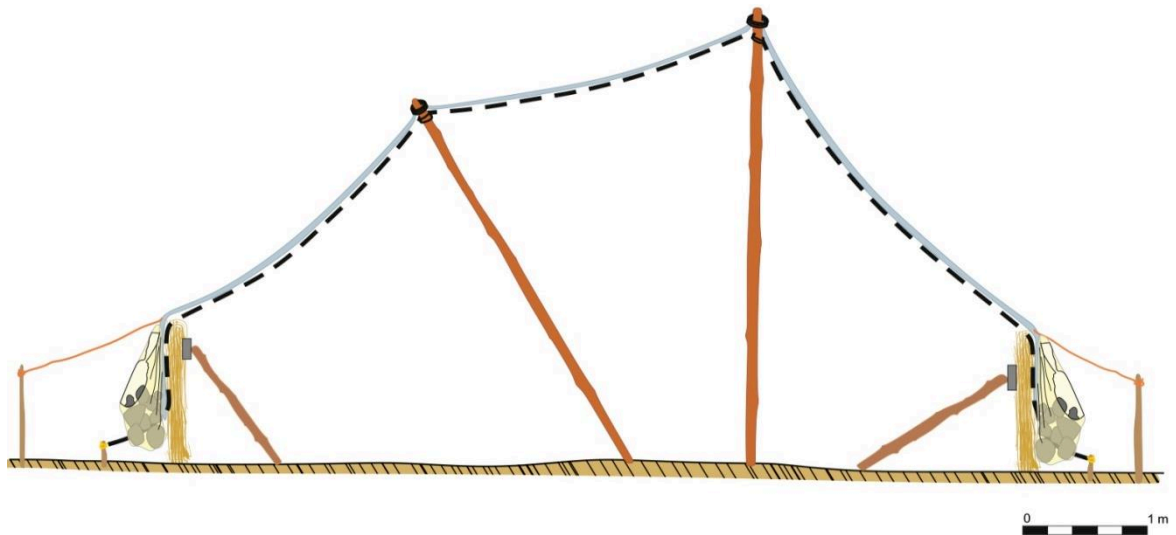
Figure 5.69: *Architectural components and appearance of a Wattle-Walled Tentsite (short axle)*

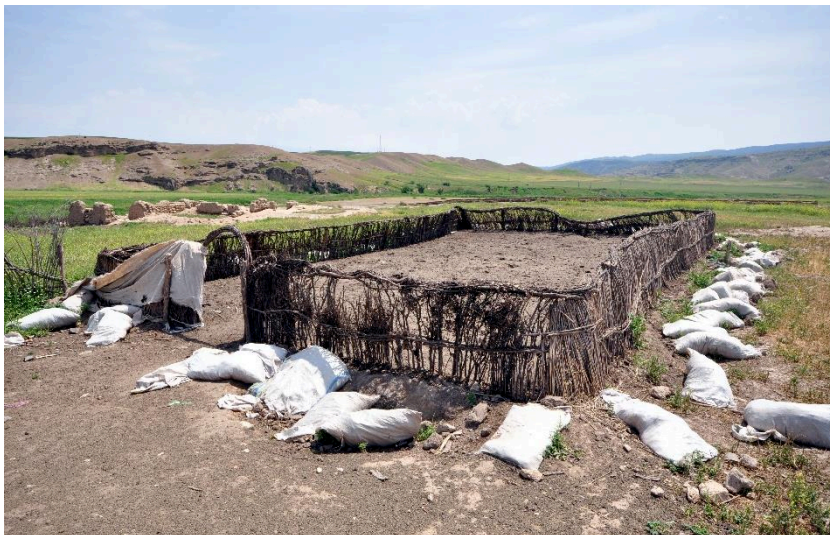
*Figure 5.70: External view of a Brushwood-Walled Tentsite in Sulane Girgiz Kom (after usage)*

This model is similar to the Wattle-Walled Structures, but instead, brushwood or branches are used in these structures to imprecisely construct the wattle surroundings. (Figure 5.70, 5.71) There is no standard in this type either in the plan or in craftsmanship. All of them have openings on the short side. The technical and structural details of the tents are similar to those of other tent types. This type of dwelling is represented by 9 samples in the Garzan Basin. The best examples are at Sulan Kom and Sulane Girgiz Kom. The brushwood surrounding at Bazivan Kom is not covered by a tent.

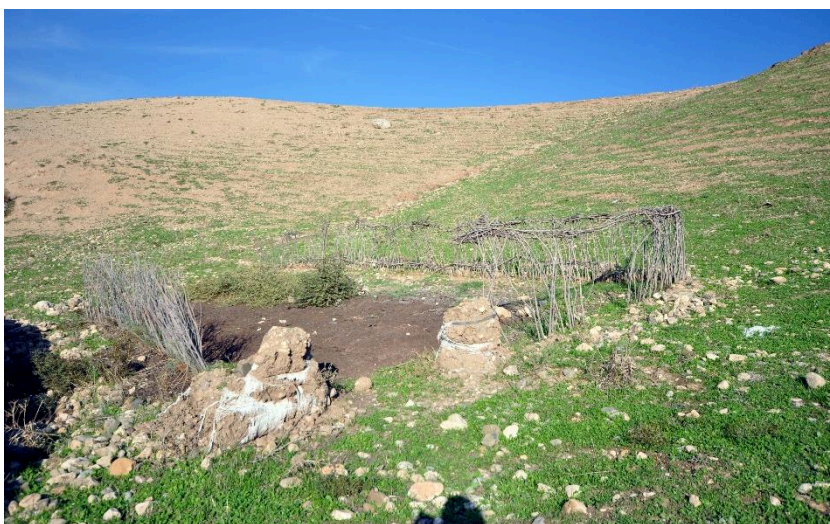
*Figure 5.71: Abandoned Brushwood-Walled Tentsite in Bazivan Kom, south of Kumgeçit village*

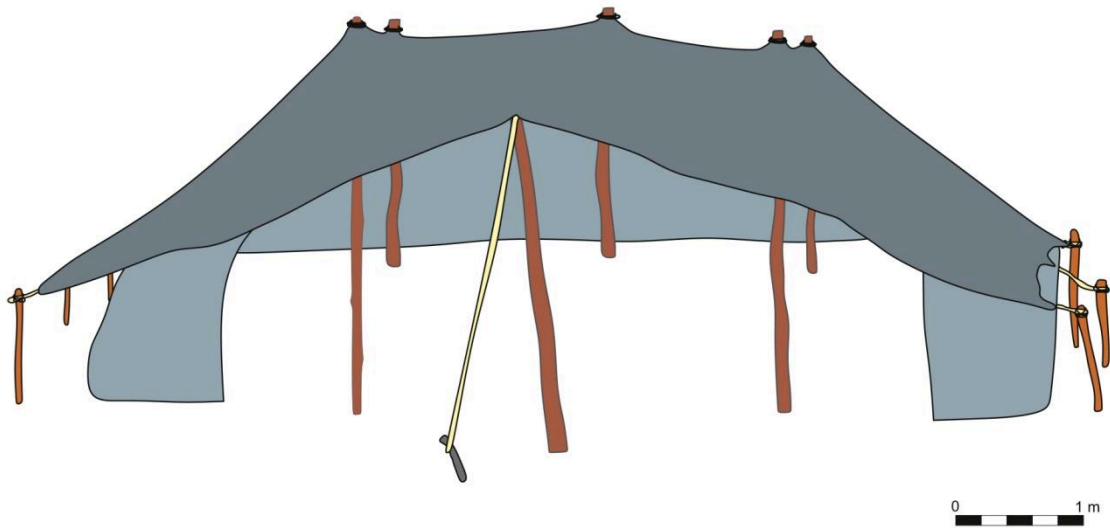
Figure 5.76: *View from the front: a tent with architectural components*

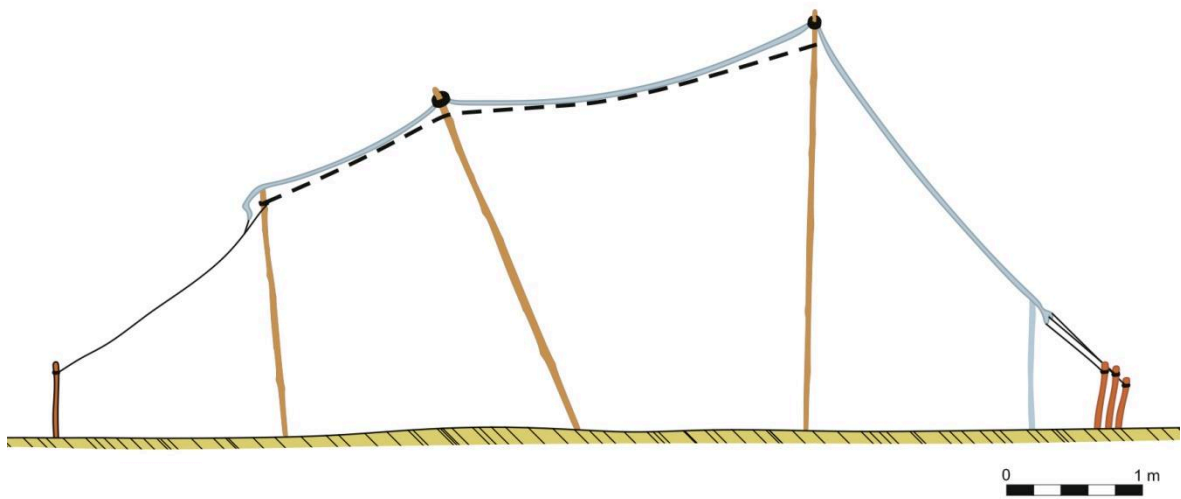
Figure 5.77: *Side view of a tent with its architectural components*

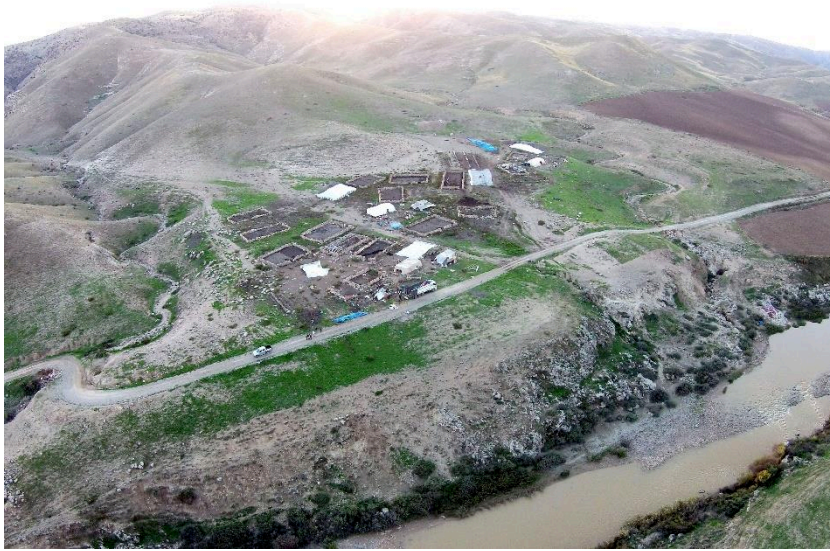
*Figure 5.78: Independent model of a winter quarters (M1), Çemistrin Kom*

Based on 10 followed-up winter quarters (Figure 5.11) in the Lower Garzan Basin between 2002 and 2014, they can be classified into three types according to their relationship with settled populations. (Table 5.1; Figure 5.78 – 5.80)

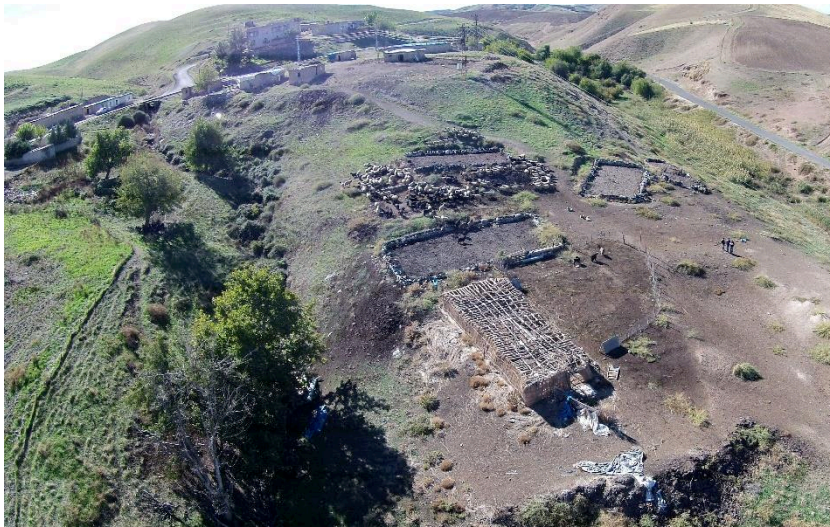
*Figure 5.79: Nearby-village model of a winter quarters (M2), Mezrik Kom*

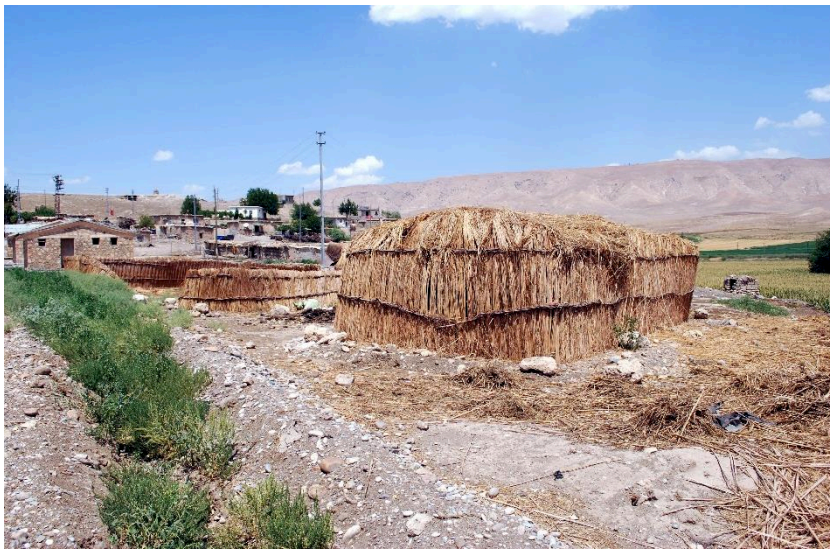
*Figure 5.80: Intra-village model of a winter quarters (M3), Memika Kom*

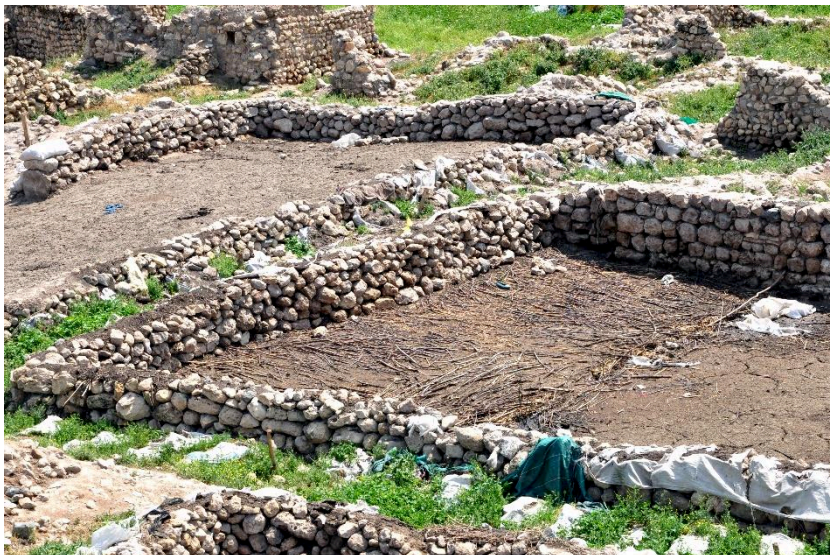
*Figure 5.92: Stone surrounding and wattle remains in the in the Area 1 (Sulan Kom)*

In 2002, there were nine structures with average dimensions of 15.5x6.2 meters. Eight structures have stone surroundings while one is a Mixed-Walled Structure. Their sides facing the slope are encircled with stone, while the rest is completed with perishable material. (Figure 5.92) Besides these structures, the nomads also occupied some of the abandoned village houses. Some of the structures are reserved for animals. In 2009, it is seen that some of the village houses were totally destroyed by nomads to open spaces for their structures. All obtainable materials supplied by demolishing the buildings were reused in the nomadic structures. The Stone-Walled Structures, which expanded to cover a vast area in 2009, have dimensions of 12.3x6.8 m and 19.2x8.5 m. (Table 5.5; Figure 5.140) The width of the stone

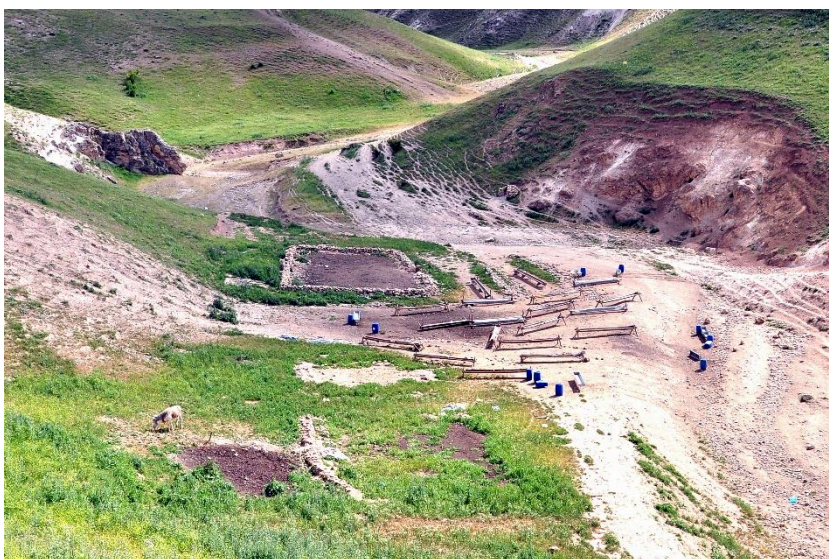
*Figure 5.99: Location of Area 1 and its architectural structure remains in Bazivan Kom (1st stage)*

This winter quarters can be divided into three different areas according to the structure distribution and changing usage space. (Figure 5.99 – 5.101) Area 1: The southern area is a relatively sheltered area towards the inner valley of Variconi stream. It covers an area of 2000 m<sup>2</sup> on the gentle slope on the east bank of the stream. There are seven structures of which only one is a tent with stone surroundings; the rest are either Wattle Structures or Brushwood-Walled Structures. It occupies a space of 50m<sup>2</sup> and functions as a pen. There are two *Wattle Structures* on either side of the tent with stone surroundings, north and south. The northerly one is 9.7x5.5 m whereas the southerly one is 7.5 by 4.7 m. Both are 2.4 m high and are used by humans even though they lack regular flooring. (Table 5.7; Figure

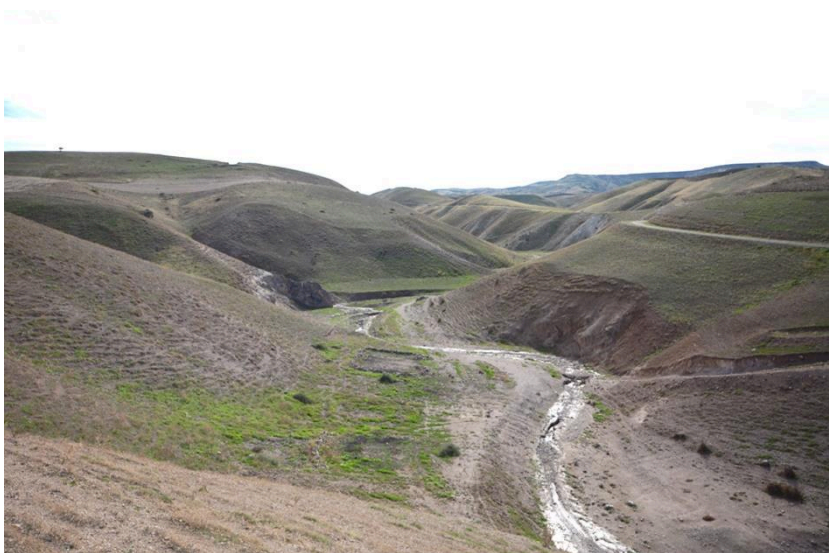
*Figure 5.100: Field usage of Area 1 and its changing settlement pattern in Bazivan Kom (2nd stage)*

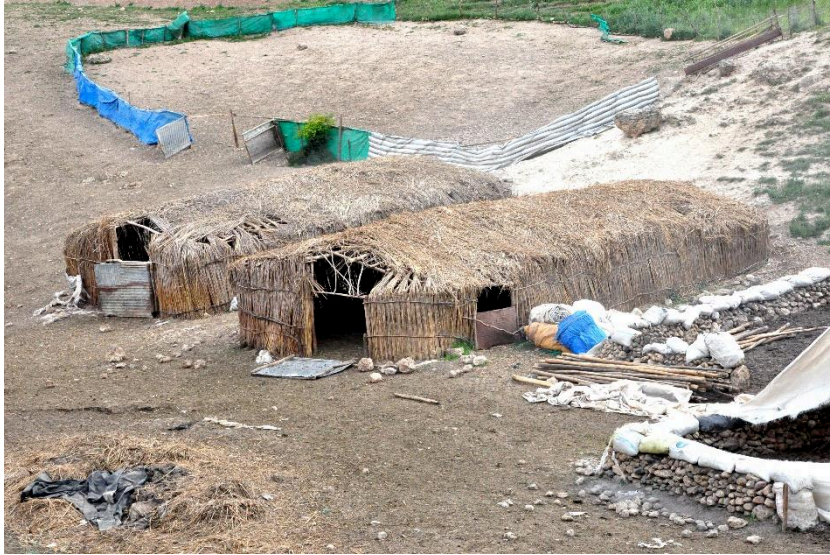
*Figure 5.101: Overview of Area 1 after abandonment in Bazivan Kom (3rd stage)*

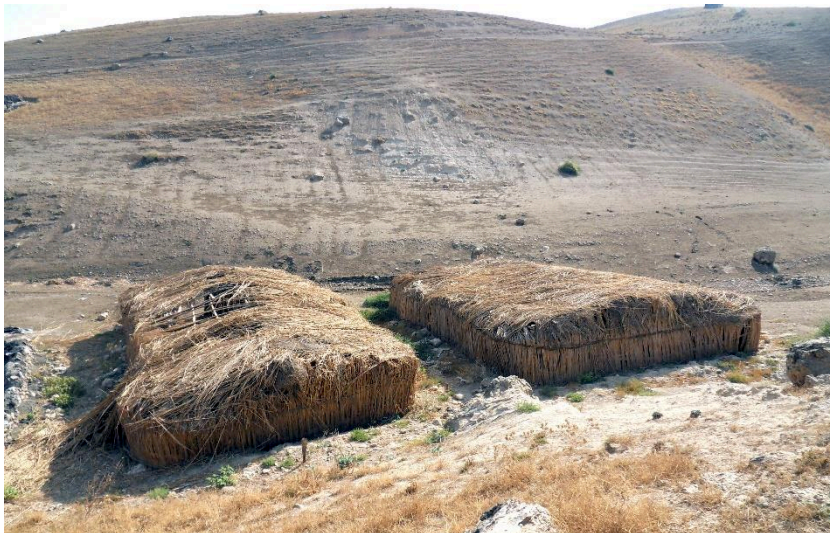
*Figure 5.102: Front view of some Wattle Structures in the Area 2 from Bazivan Kom*

5.142) In the fieldwork of 2012, the wattle structure in the south, which had been completely demolished, left little trace of its presence. (Figure 5.102 - 104) The off colouring on the ground is the only indicator of its existence. The one in the north had been accidentally burnt while it was in use (Oral interview with Sedat Taş, 2013, Kumgeçit Village / Batman). What is left from that structure is dark-coloured patches on the ground. To the north of the group of two Wattle Structures and tent with stone surroundings is a relatively steep slope where there are Brushwood-Walled Structures. One of them has a stone surrounding 90 cm in height and 30-40 cm in thickness on the side leaning towards the slope. The rest of the structures are made of brushwood. In 2013, Area 1 radically changed. All the structures were totally demolished except for the tent with stone surroundings. Feeding troughs were placed all around the structure and the area was reserved only for livestock.

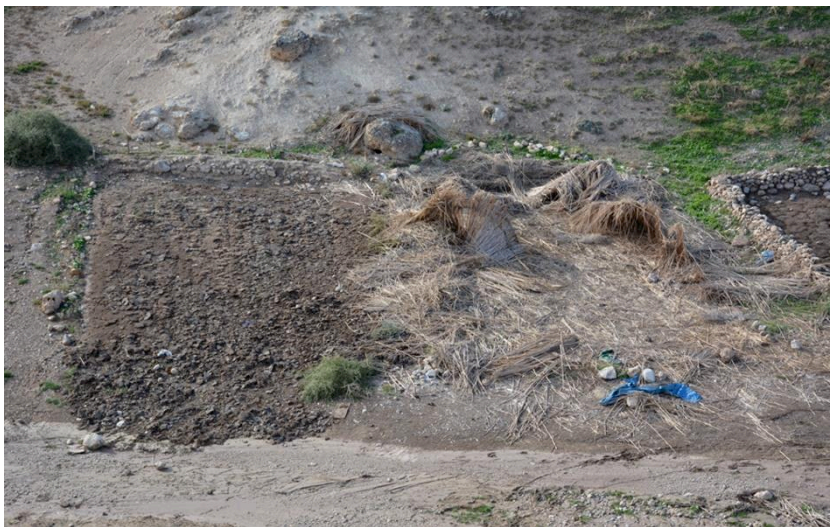
*Figure 5.103: Rear view of some Wattle Structures in the Area 2 from Bazivan Kom*

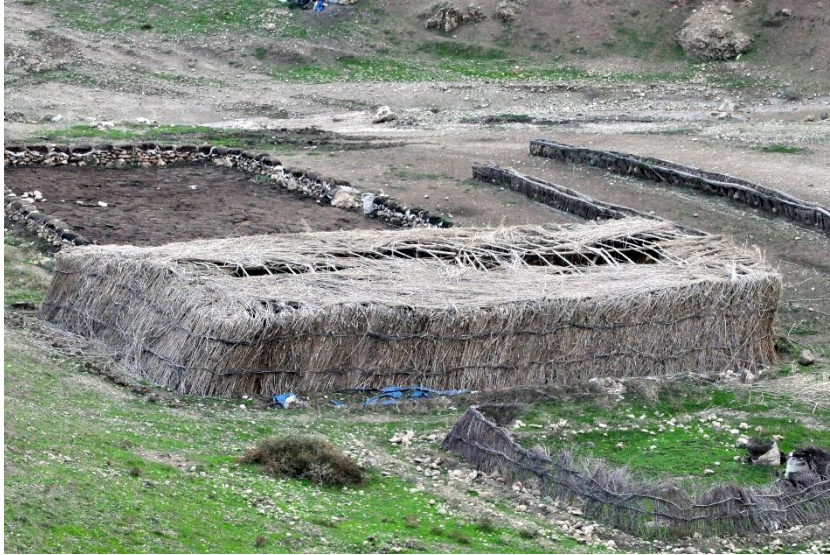
*Figure 5.104: View of some Wattle Structures in the Area 2 from Bazivan Kom (after abandonment)*

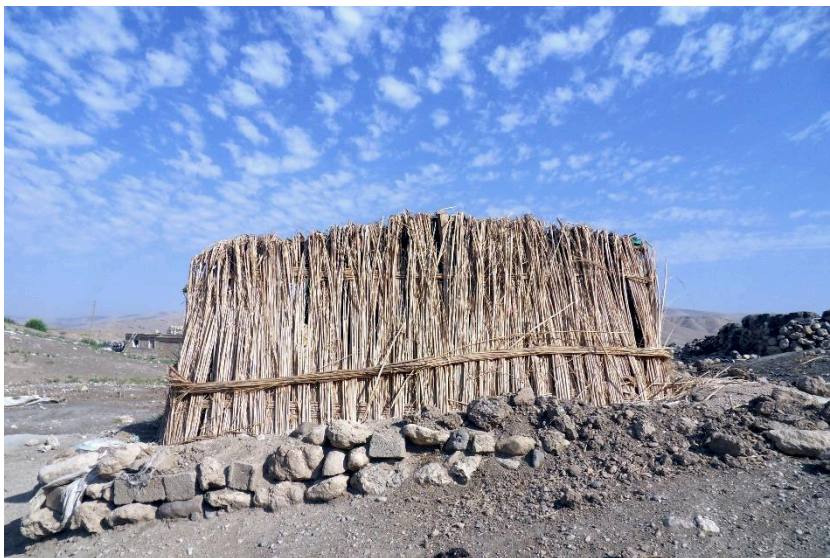
*Figure 5.109: Overview during evacuation of Area 2 in Bazivan Kom*

On the west bank there are six structures next to each other with a simple rectilinear stone surrounding. (Figure 5.109) Two of them are wattle structures, and the other four are Stone-Walled Structures. The Wattle Structures do not have stone surroundings. Their dimensions are quite similar to each other. The internal dimension of the one to the south is 11.9x7.6 m and the one to the north is 12.4x7.2 m. Their openings are on the narrow side facing east. Both of the Wattle Structures are used for sheltering animals. To the north of the wattle structures, there are four Stone-Walled Structures next to each other which have openings facing east. The tension of the tent, which is the top of these structures, is provided by pillars and filled sacks stones-filled sacks. The largest tent with stone surroundings has internal dimensions of 16.7x10.05 m and the smallest one is 10.5x6.2 m. Their floors are totally covered with a thick layer of animal waste. In November 2012, it was observed that animal waste was partly disposed of by burning. In the north and northeast of the Stone-Walled Structures, there are fifteen feeding troughs.

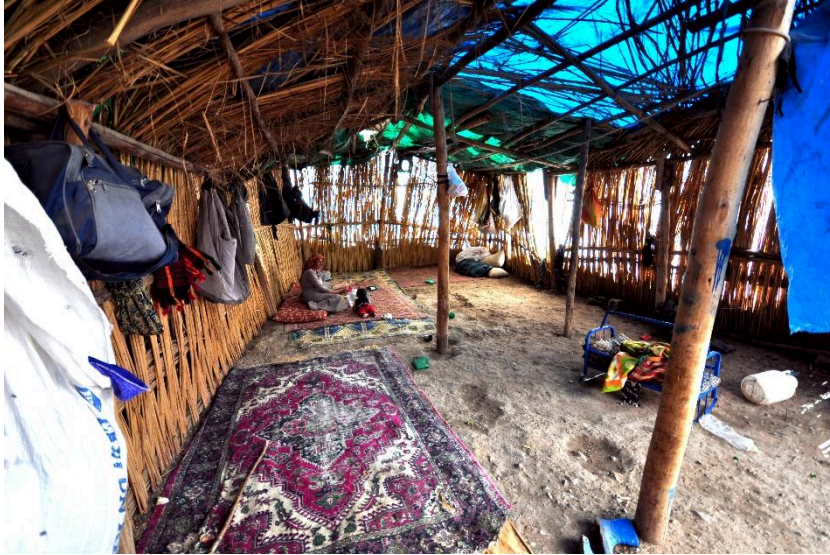
*Figure 5.110: External view of a Stone-Walled Wattle Structure in Area 2 from Bazivan Kom*

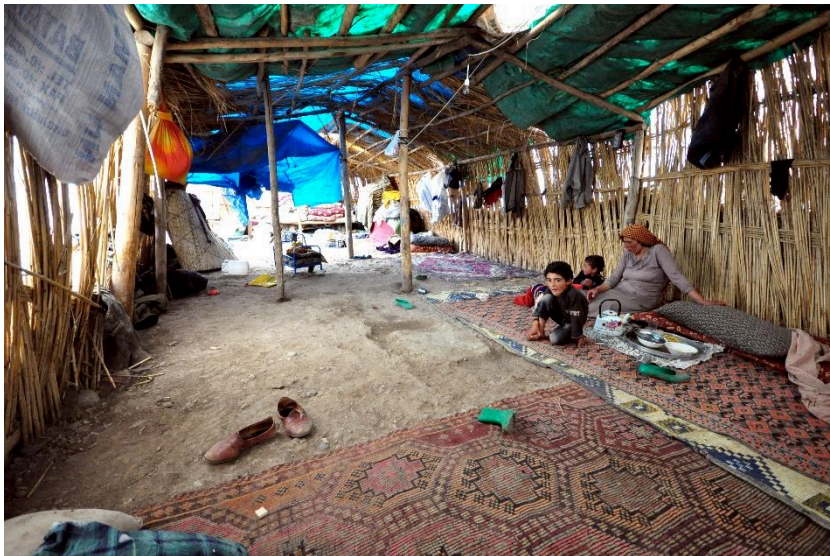
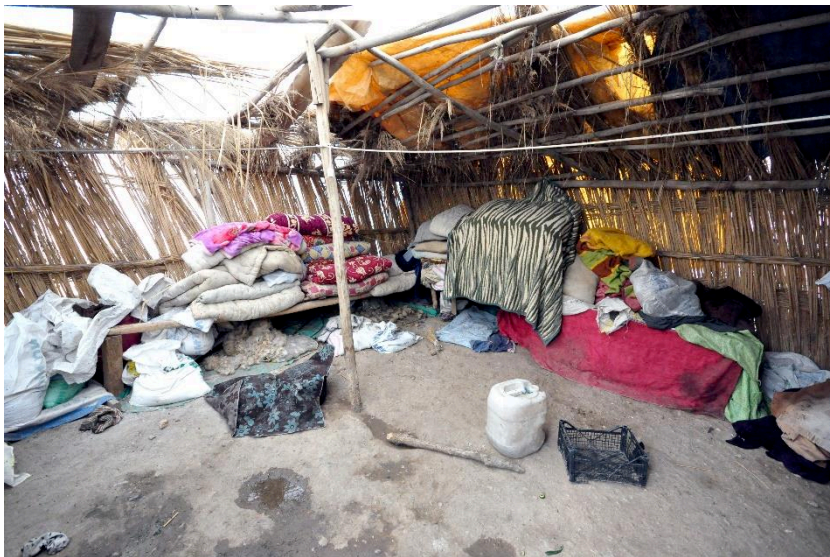
Figure 5.111: Interior view of Stone-Walled Wattle Structure and arrangement of living space in Area 2

Figure 5.112: Interior view of Stone-Walled Wattle Structure and arrangement of living space in Area 2

Figure 5.113: Interior view of Stone-Walled Wattle Structure and arrangement of living space in Area 2

The area identified as a kitchen is right next to the door in the north corner of the structure. The area on the east side (north east of the structure) of the kitchen is kept for piling beds, blankets and pillows. Carpets and rugs are laid on the west, south and partially southeast ends of the structure and this area is reserved for guests and some daily activities. (Figure 5.111-113) On the west side of the wattle structure in the area up to the door is free from any ground cloth. According to the Koçer woman, the owner of the dwelling, this part is reserved for daily activities, children being washed in the cold seasons, and the structure is heated with a small stove in cold winters. Cooking usually takes place outside. *Tandır*, used for making bread, is in common usage among the villagers.

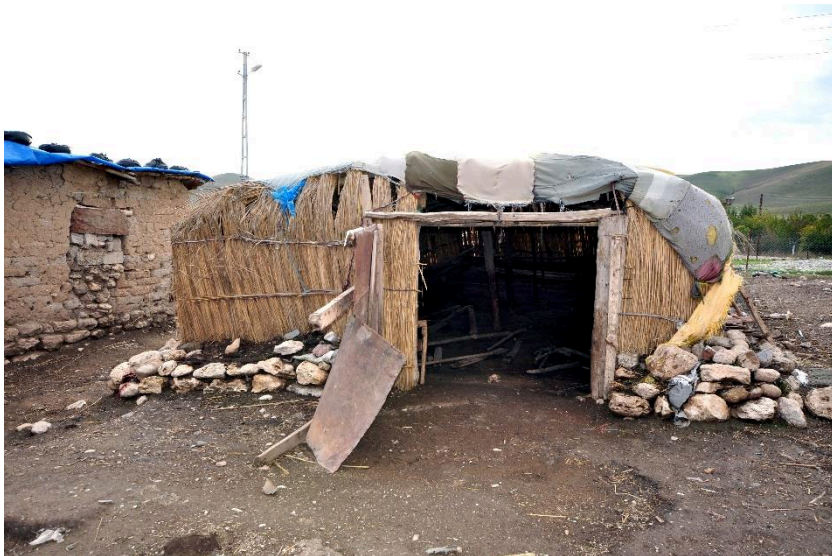
*Figure 5.123: Wattle Structures in Memika Kom*

In this winter quarters, there are two types of buildings. One of these Wattle Structure (Figure 5.123 – 5.125) is usually used by human and Stone-Walled Tentsites is used for an animal shelter. The walls of the structures are made by placing 10-12 cm-thick wattle bundles next to each other and tying them tightly together. According to Koçer Ömer, one of the residents, the structures can last 7-8 years with partial repair. We were informed that the Wattle Structure, which we detected in 2008, was 3 years old. The wattle structure, which I have termed the "Memika Saz Ev" (Figure 5.18) within the scope of this thesis, was followed consecutively since 2008. The aging, decomposition, and destruction process of this structure are documented here with all the stages. (Figure 5.120 – 5.122) In July 2008, it was observed that the "Memika Saz Ev" was still standing, yet partially ruined and some reeds bundle had broken off. Another rectangular wattle structure in the neighbourhood was partially damaged and needed serious repair. It was clearly seen in 2009 that the damaged parts in 2008 had been repaired. However, it was detected that the parts of wattle structures, which were not damaged in 2008 and therefore not repaired in 2009, had suffered the same

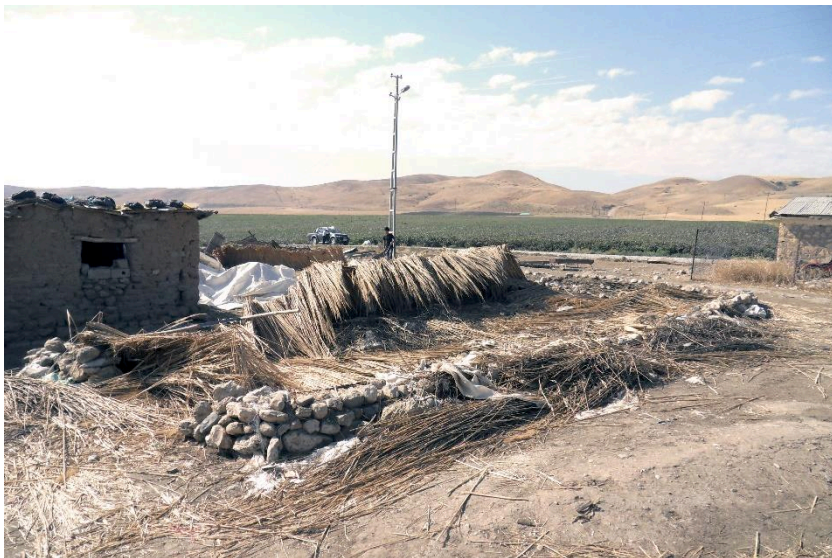
*Figure 5.124: Architectural change of Wattle Structures to Stone-Walled Wattle Structures in Memika Kom*

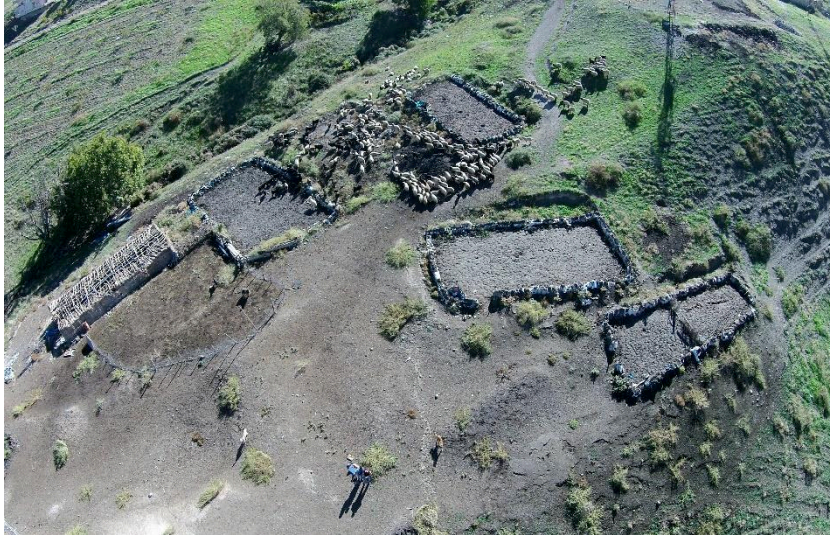
*Figure 5.125: Destroyed a Stone-Walled Wattle Structures in Memika Kom*

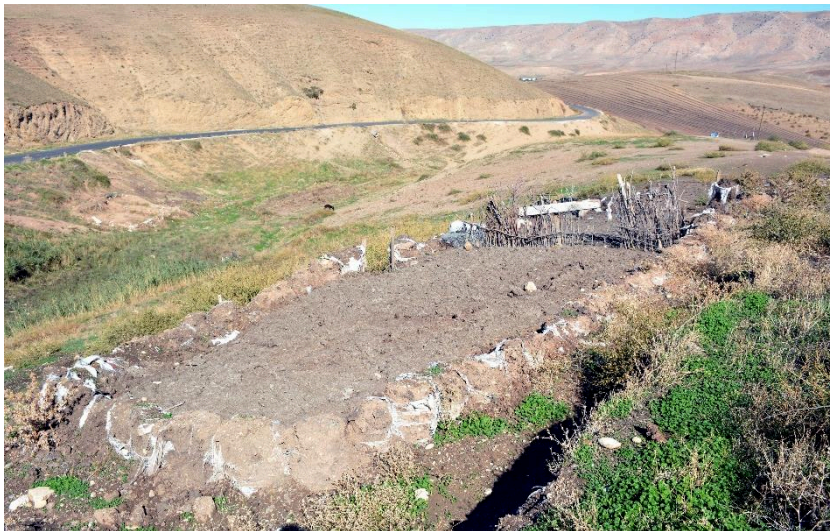
*Figure 5.127: Wattle Structure in Mezrik Kom*

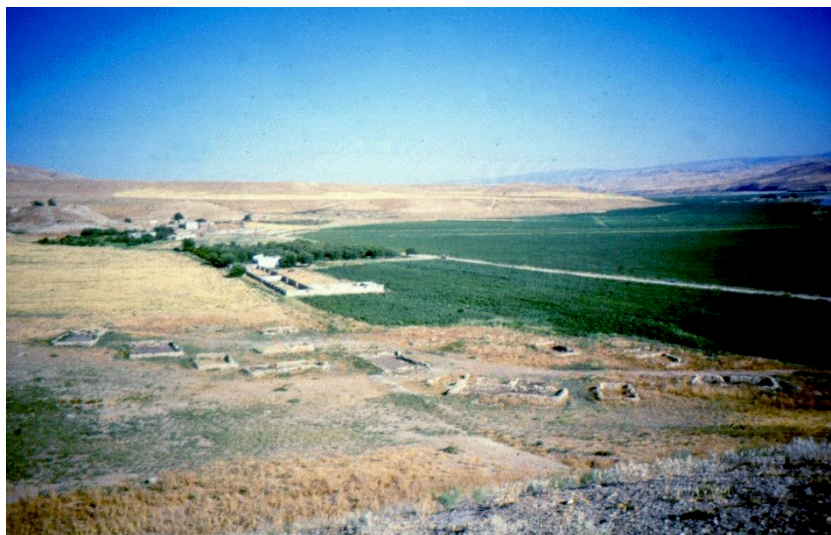
*Figure 5.128: Example of Earth Wall (Piled Earth) in Mezrik Kom*

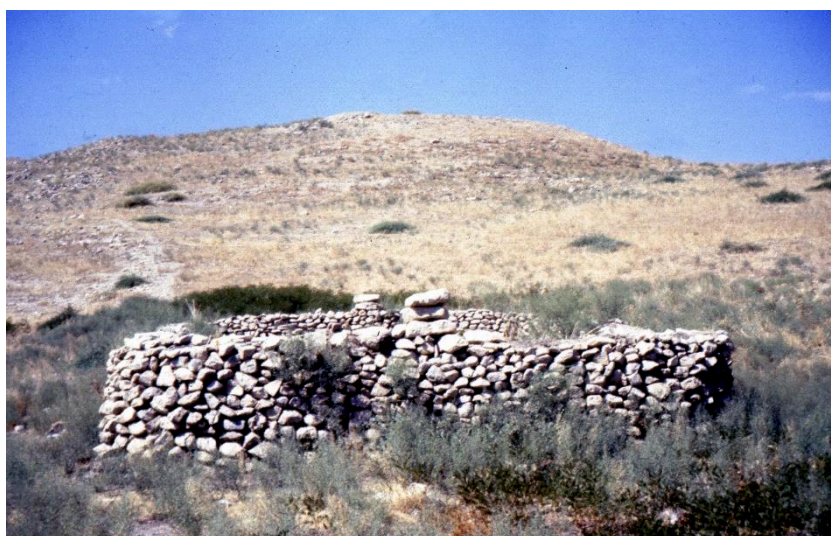
*Figure 5.130: External view of a Stone Walled Wattle Structure in Işıkveren Kom I*

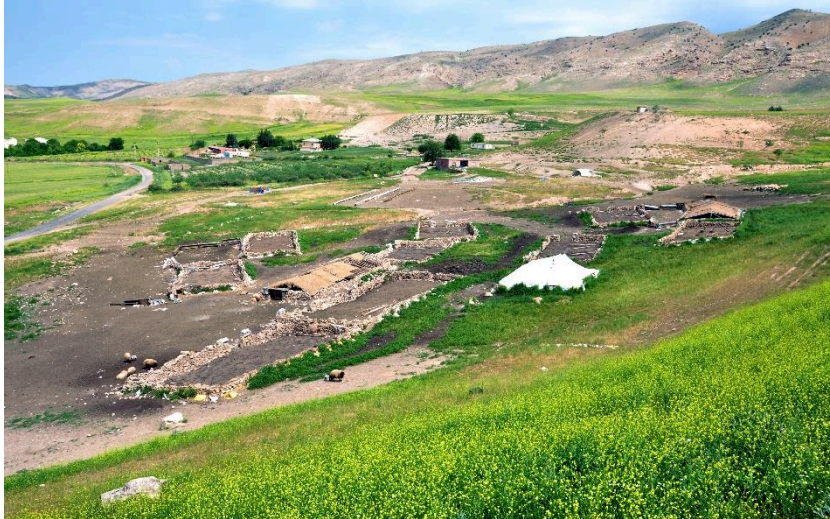
*Figure 5.131: External view of a Stone Walled Wattle Structure in Işıkveren Kom I*

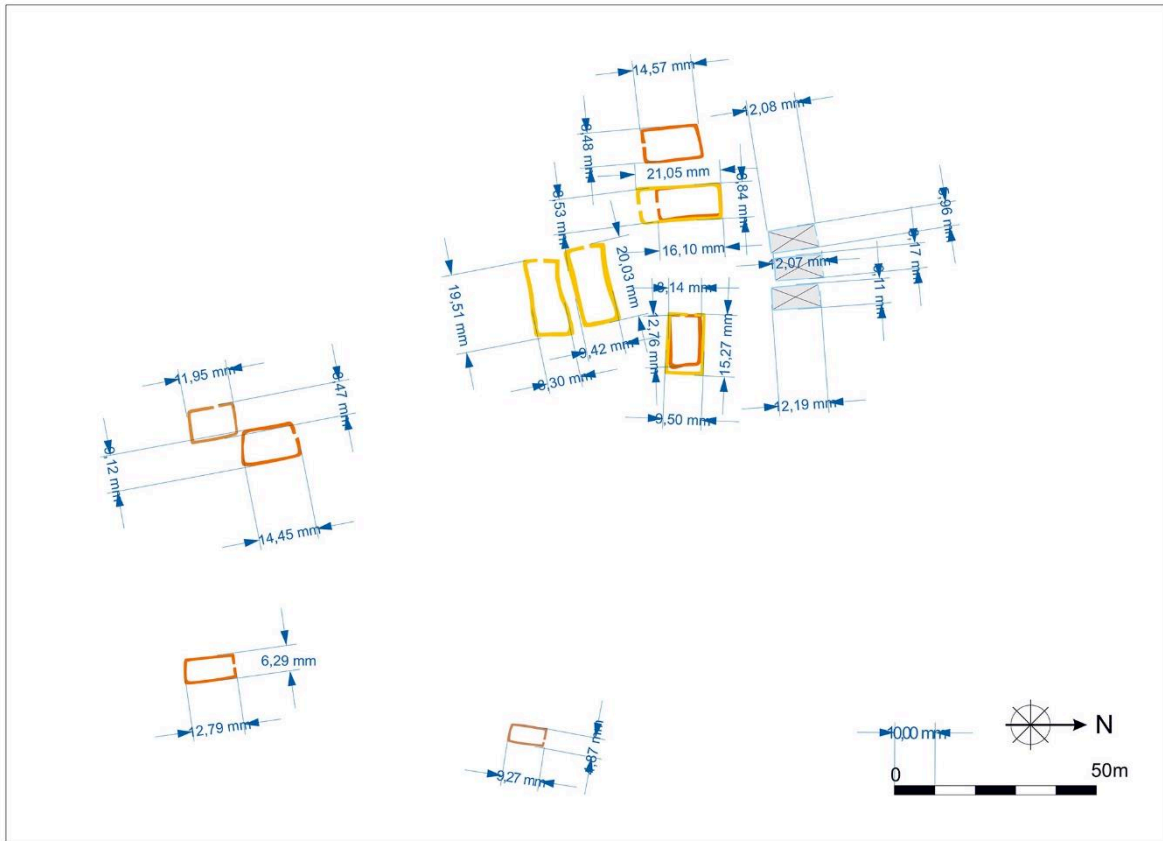
Figure 5.138: Parallel dimensions of architectural structures from Şeyhosel Kom

In 2012, the general layout of the winter quarters significantly changed. The previously-built six Stone-Walled Structures were out-of-use, and instead, four new sites were constructed to the west and north of the Şeyhosel village. The winter quarters is separated into two areas: "Modern tents", which are used by humans, are set parallel to each other at the northern limit of the village. The area on the west side of the village is reserved for livestock. The structures that function as pens are Stone-Walled Structures with openings facing north or west. The rectilinear structures are approximately 9 meters wide and 16 meters long. (Table 5.3; Figure 5.138) The stone surroundings are 50-55 cm wide and 60-70 cm high. The upper rows of some of the surroundings are made of kerpiç blocks, which were removed from the abandoned village houses. The general appearance of the surroundings points to rapid construction for short-term usage. This situation may imply that the Şeyhosel winter quarter were not planned for long-term occupation.

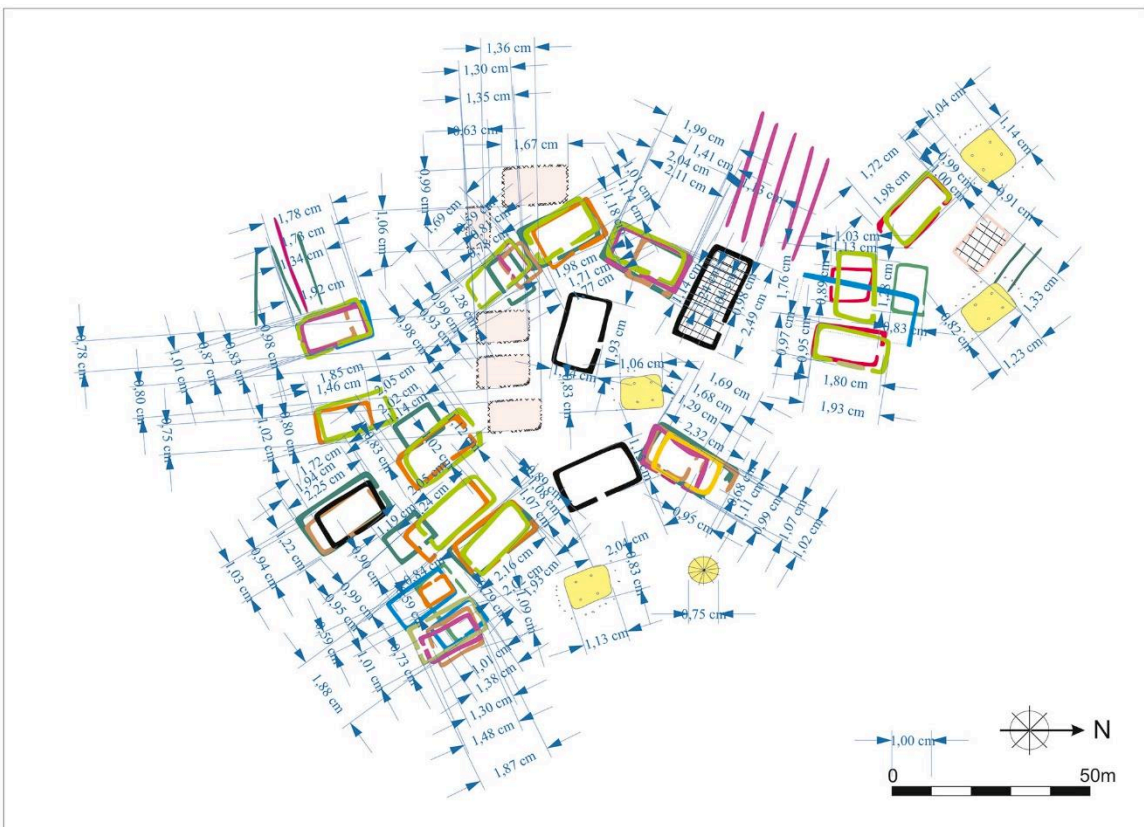
Figure 5.139: Parallel dimensions of architectural structures from Çemisitrin Kom

In the years between 2002 and 2004, there were 21 rectilinear (Table 5.2) Stone-Walled Structures with dimensions between 5.2x3.9 m and 16.4x8.35 m. (Table 5.4; Figure 5.139) The stone surroundings are approximately 60-80 cm high and their thickness varies

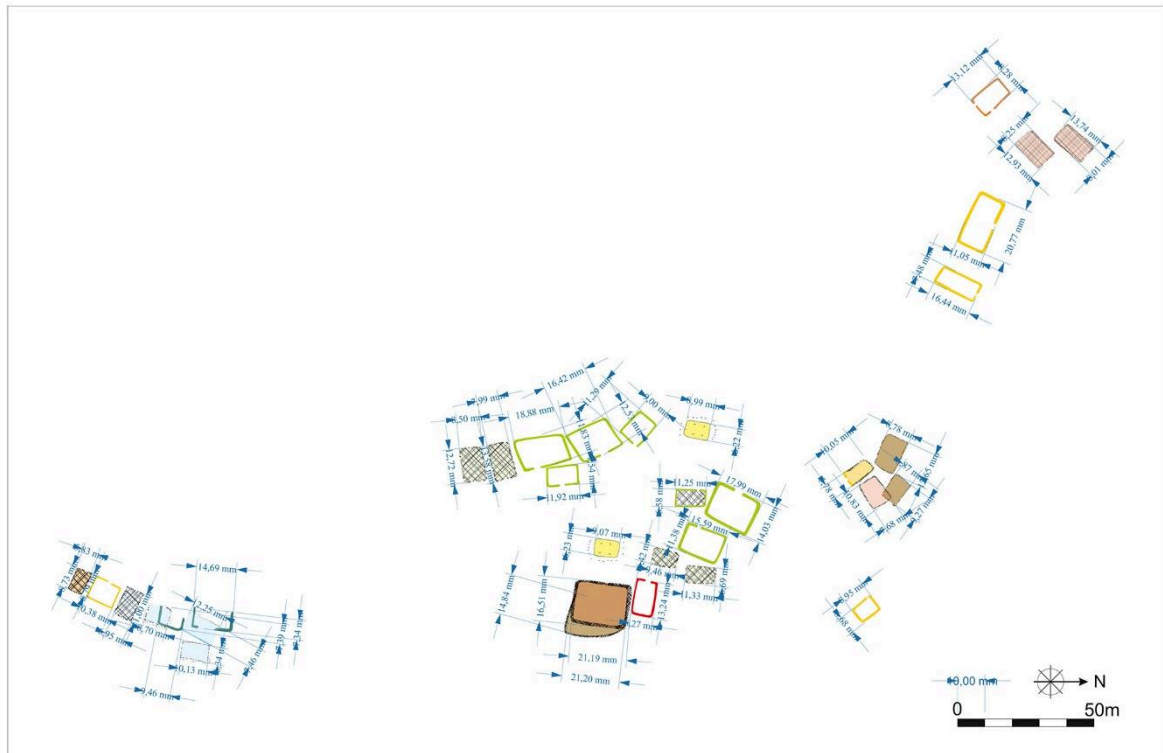
Figure 5.142: Parallel dimensions of architectural structures from Bazivan Kom
