# Microarchaeological observation on the neolithic architectural structures and cultural landscape of Sumaki Höyük

# **Microarchaeological Observation on the Neolithic Architectural Structures and Cultural Landscape of Sumaki Höyük**

PhD Thesis

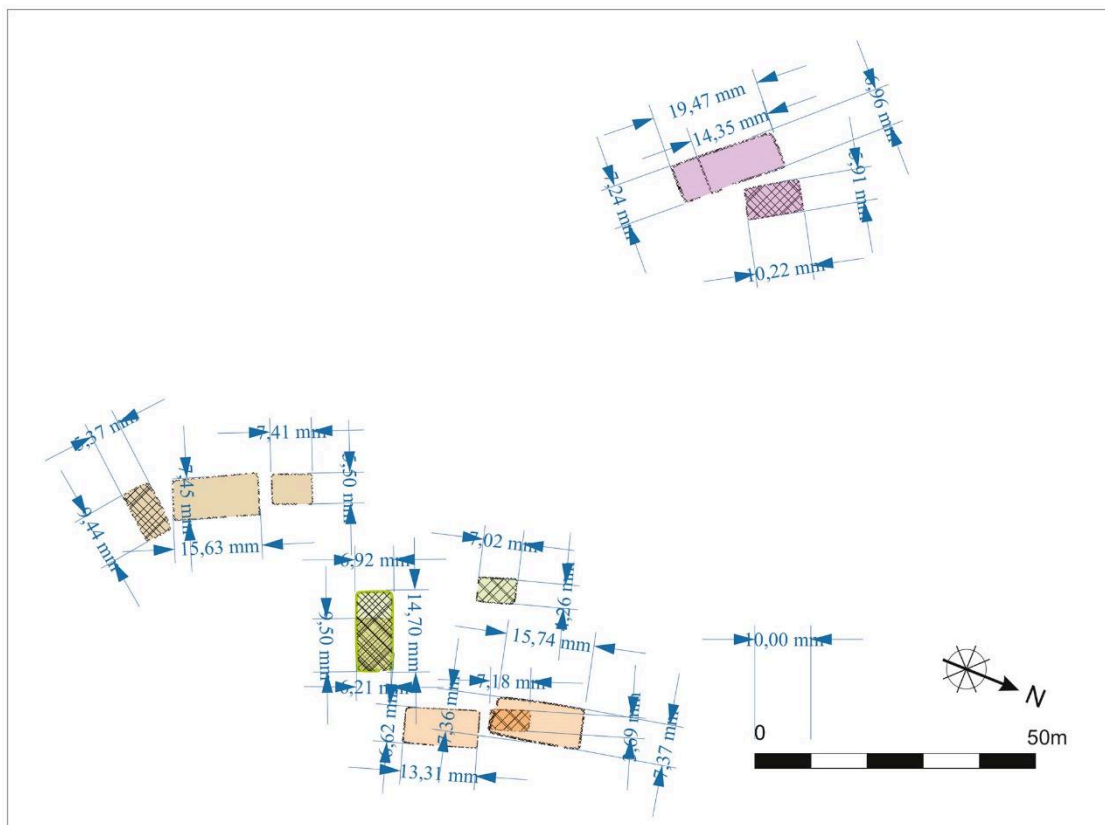
Figure 5.143: Parallel dimensions of architectural structures from Memika Kom

Besides the structures defined above, there are five more buildings at Memika Kom. Three of them are wattle structures, the rest are Wattle-Walled Structures. The structures serving as pens are 16x6.7 m and 12.9x6.55 m in size. (Table 5.8; Figure 5.143) The average height of the wattle surroundings is 120 cm and the average thickness is 15-20 cm. The tents' upper cover stands by means of movable poles. The upper woven stretch is maintained by stone-filled sacks, which are sewn by the women<sup>17</sup> in the outer section. The larger structure to the north has two openings whereas the small one has a single opening. The number of openings depends on the size of the structures, not their function.

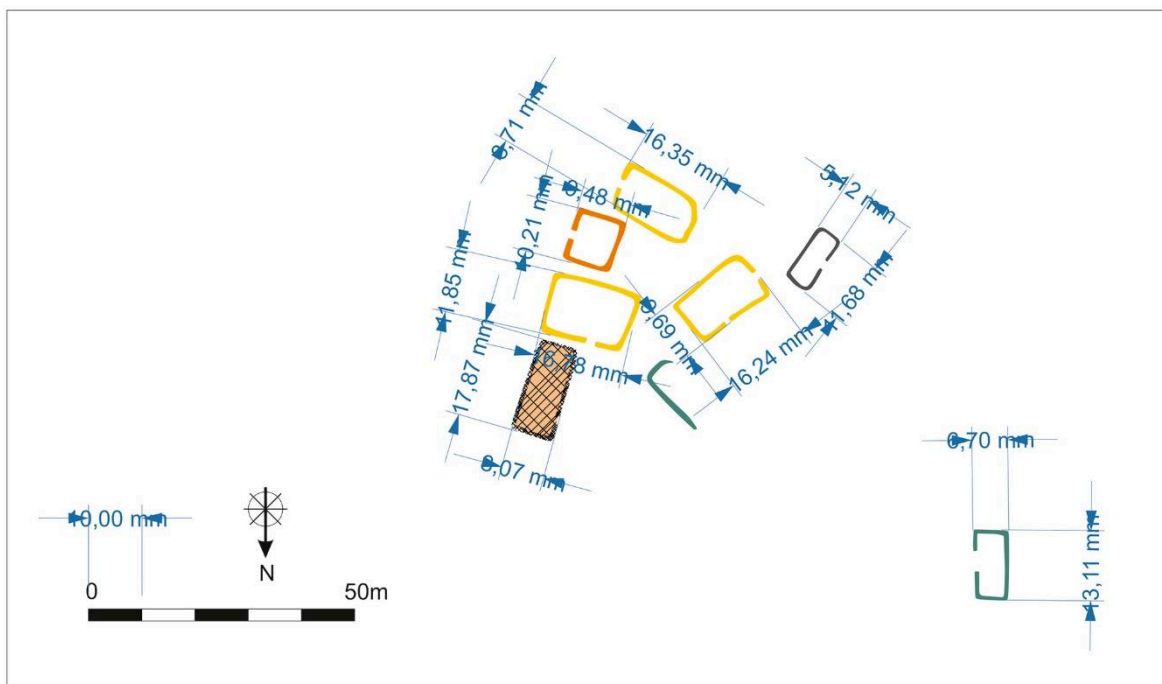
Figure 5.144: Parallel dimensions of architectural structures from Mezrik Kom

In 2009, there were six structures with dimensions varying between 8.8x3.2 m and 14.3x9.6 m. The one to the north is a narrow long Wattle Structure, 5.4x16.3 meters in size. (Table 5.9; Figure 5.144) The other structures are Stone-Walled Structures without any remains of wattle being determined inside.

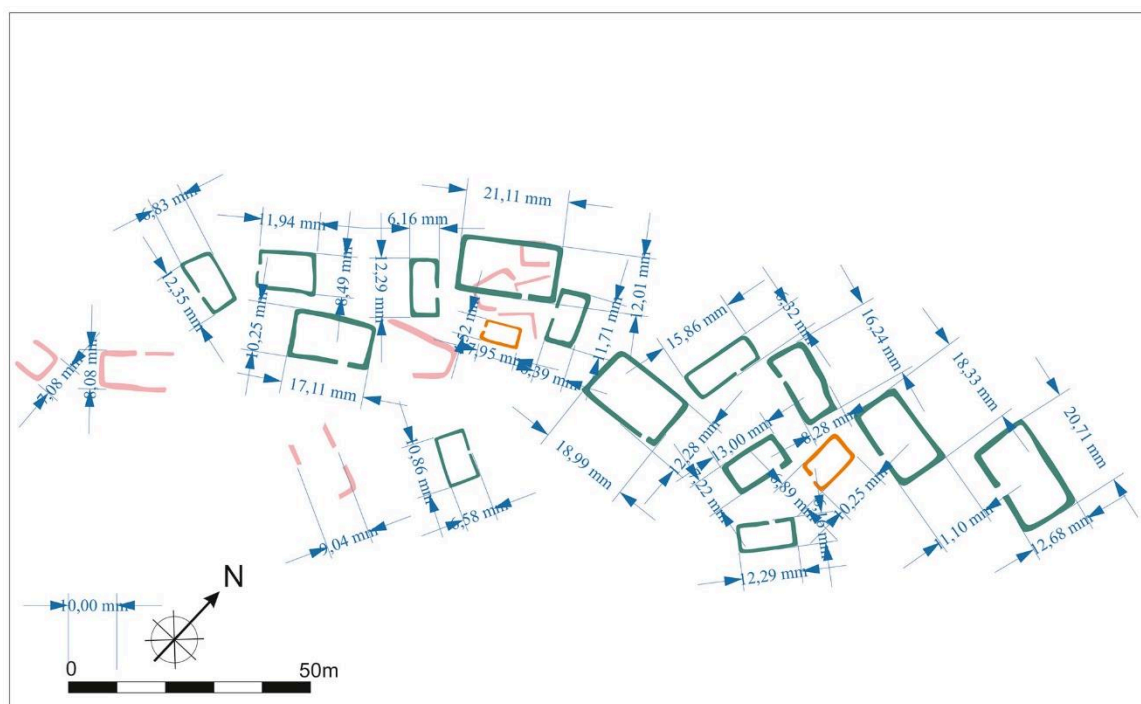
Figure 5.145: Parallel dimensions of architectural structures from Işıkveren Kom I

All the structures have single openings facing different directions. Either side of the openings is bordered by flat stones. This practice is also not known among the occupants of other winter quarters. The layout of the winter quarters is structures built relatively parallel in a northeast-southwest direction. In 2002, there were six structures 14x8 m in size, and 8 structures 9x5 m in size. (Table 5.10; Figure 5.145) In 2005 some of the Stone-Walled Structures were reused and two new ones were built. The new ones are rather small, and cover an area of not more than 24 m<sup>2</sup>. The construction technique of their surroundings is completely different from that of the previous structures. The height of these elaborately-constructed structures is 55-60 cm and the width is 50 cm.

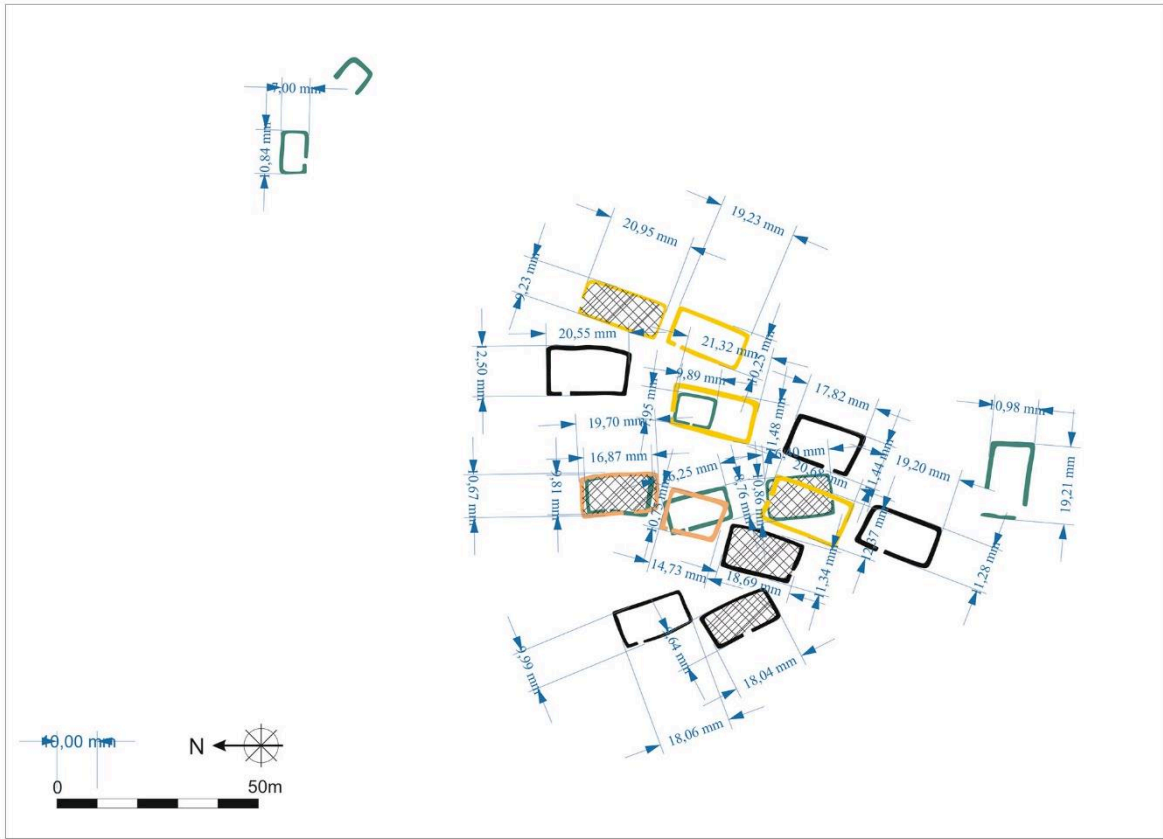
*Figure 5.146: Parallel dimensions of architectural structures from Işıkveren Kom II*

The winter quarters extend towards the slope area with structures positioned parallel to each other in a southwest-northeast direction. All of the structures have stone surroundings. Işıkveren Kom II was first recorded in 2002. (Erim-Özdoğan & Sarıaltun, 2011: 973) During our 12 years of research at regular intervals, it was seen that five structures are Stone-Walled Wattle Structures. The dimensions of these structures are not different from others, varying between 18.5x7.2 m and 14.5x6.9 meters. (Table 5.11; Figure 5.146) At Memika Kom and Bazivan Kom, the stone surroundings of the wattle structures, which are relatively low and imprecisely constructed, are basically for reinforcement of the *Wattle Structures* and usually they are later additions. However, at Işıkveren Kom II this practice is a conscious choice; in other words, a tradition.

Feeding troughs at Işıkveren Kom II are clearly outside the residential area. Especially the western outer part, which is closer to water and meadows, is reserved for herds. Nonetheless, structures for animal sheltering are dispersed in the winter quarters without a regular plan. There is no clear distinction in construction technique or relationship between structures used by humans and shelters for animals. However, humans prefer to use the smaller ones. Tandırs and small fireplaces are placed between the structures. (Figure 5.134) There are no interior hearths; all the cooking of food takes place outside. T2 and T3 Type structures have been used at Işıkveren Kom II.

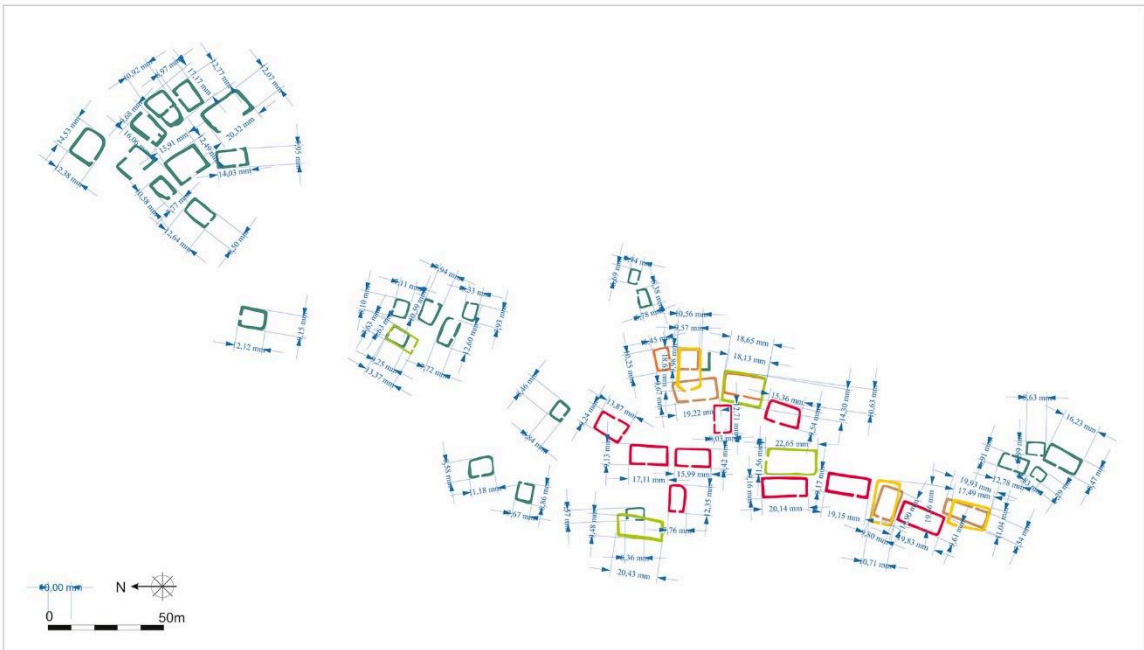
*Figure 5.147: Parallel dimensions of architectural structures from Boğaz Kom*

Area 2 is in the middle of the winter quarters and shows signs of expansion, especially on the terrace on the west slope of Ziyaret Hill, which reflects the earliest period of the seasonal campsite sequence. Stone-Walled Structures are rather small in size and their plan is rectangular or square. Their dimensions are 11x5.1 and 4x3.8 meters and their surroundings are 50 cm high and 25-40 cm thick. (Table 5.12; Figure 5.147)
