# Effect of a Prior Plastic Deformation during Heat Treatments on the Mechanical Properties of Ni-Based Superalloys for Turbine Blade Application

Satoshi Utada. Effect of a Prior Plastic Deformation during Heat Treatments on the Mechanical Properties of Ni-Based Superalloys for Turbine Blade Application. Other. ISAE-ENSMA Ecole Nationale Supérieure de Mécanique et d'Aérotechnique - Poitiers, 2020. English. NNT : 2020ESMA0019 . tel-03166502

**Effect of a prior plastic deformation during heat treatments  
on the mechanical properties of Ni-based superalloys  
for turbine blade application**

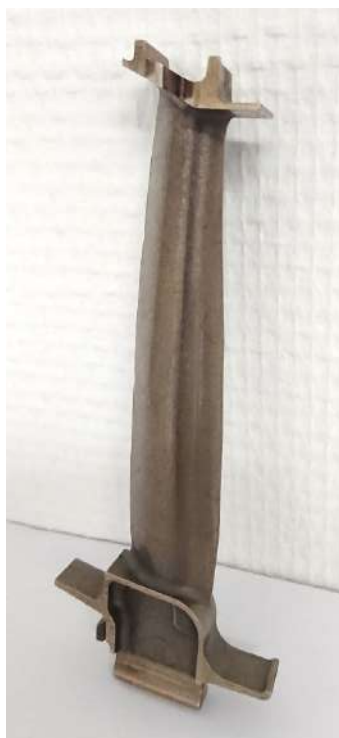
Figure iii. An example of a non-cooled first stage LPT blade

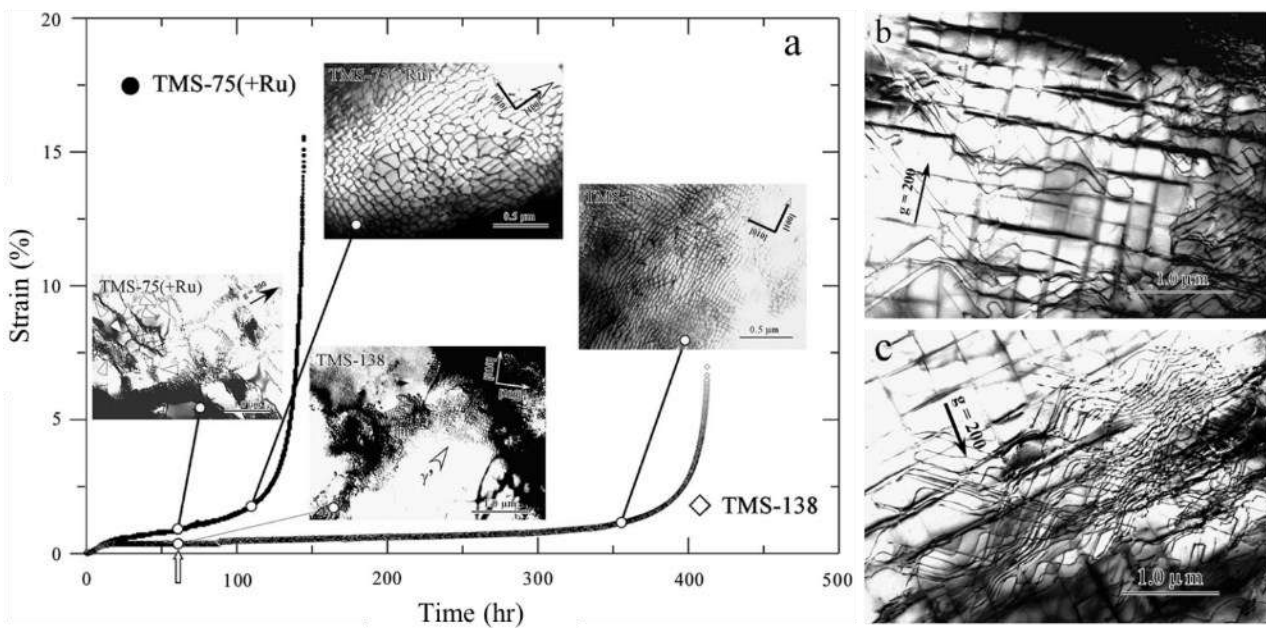
Figure 1.14. Creep curve of TMS-75(+Ru) and TMS-138 at 1100 °C / 137 MPa with TEM images at different creep stages (a). (b) and (c) are TMS-138 at 2 h and 5 h, respectively. [80]

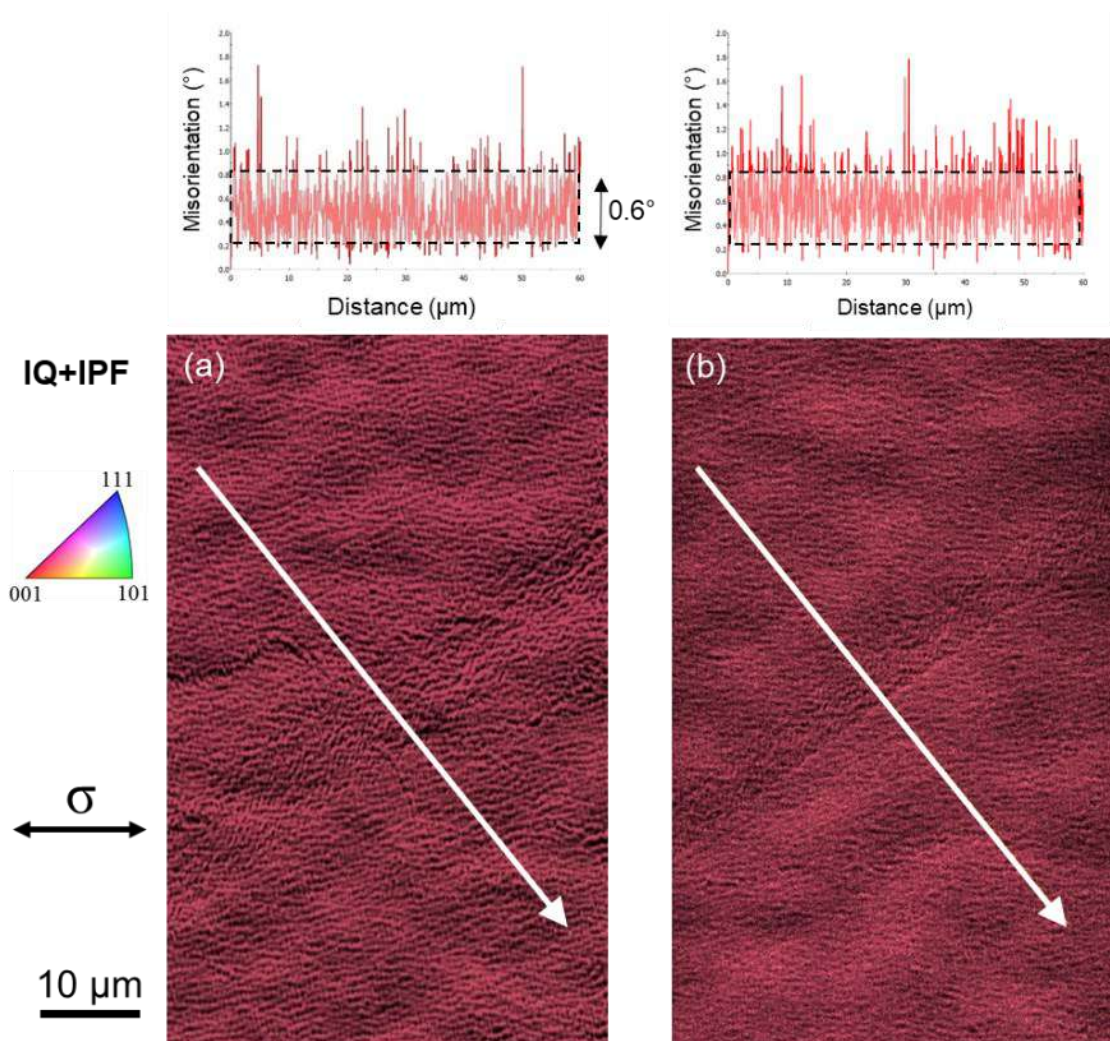
Figure 1.39. IPF (coded along tensile axis) superimposed to Image Quality maps in a primary dendrite arm (a) and in an interdendritic spacing (b) of AM1 alloy after solution treatment + 0.8% PD + 1100 °C / 5 h / quenched in air + 870 °C / 16 h / quenched in air. Misorientation profiles (white arrows) are presented above each map.

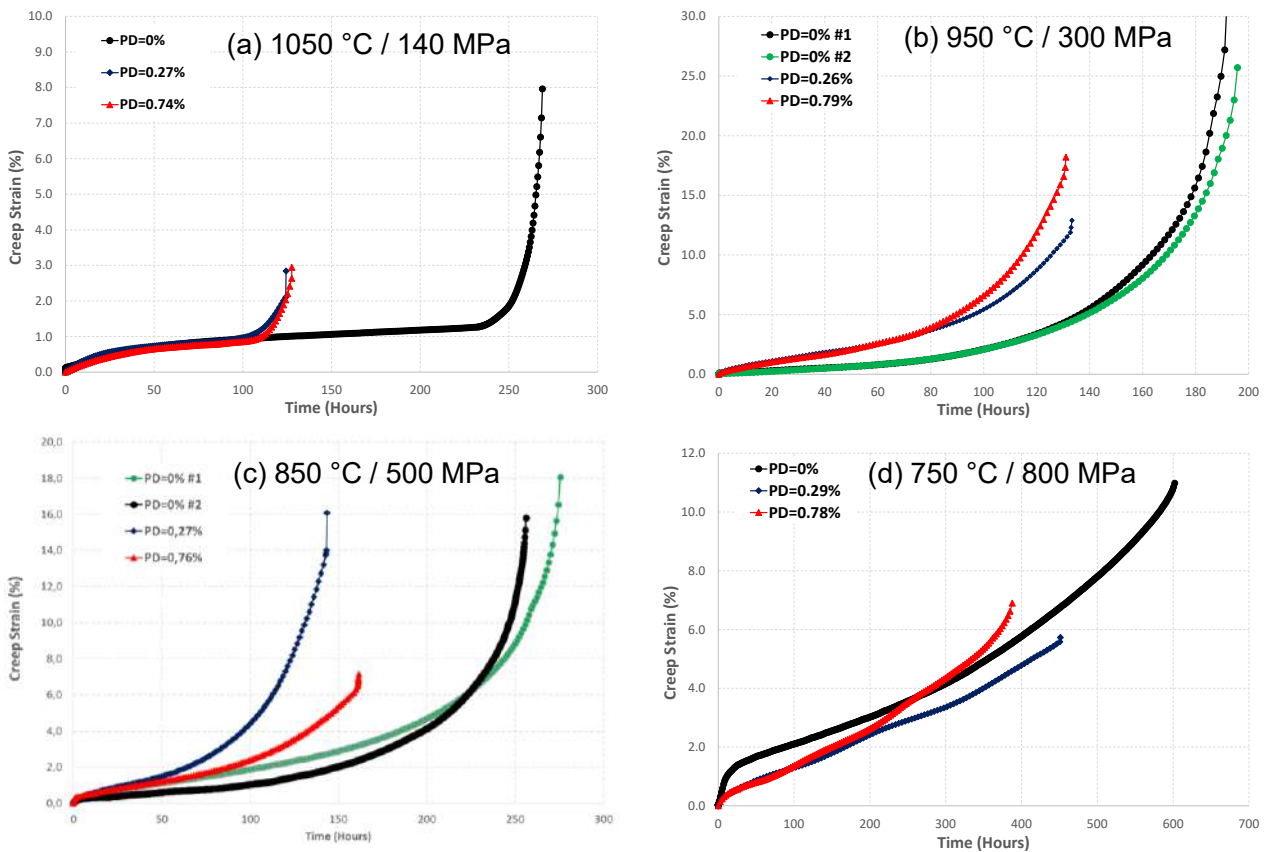
Figure 1.40. Creep curves without PD and with PD of about 0.3% and about 0.8% at (a) 1050 °C / 140 MPa, (b) 950 °C / 300 MPa, (c) 850 °C / 500 MPa, and (d) 750 °C / 800 MPa.

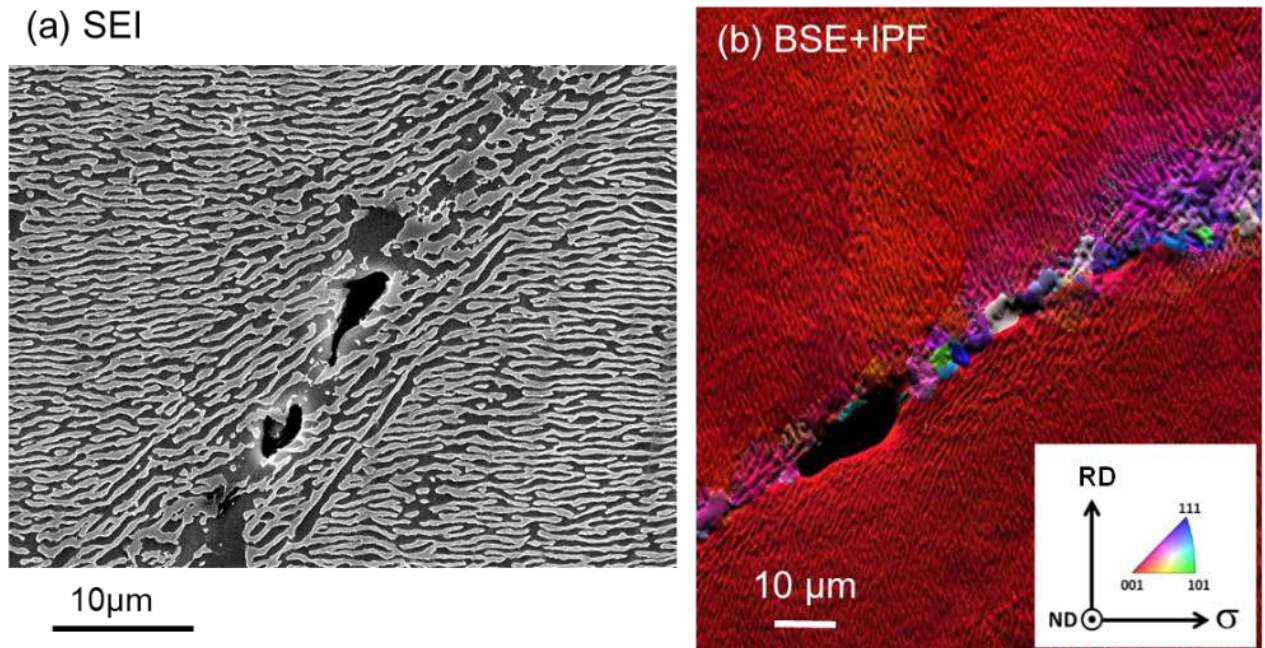
Figure 1.42. (a) Crack initiation and cavitation along coarsened microstructure in the band. (b) Inverse Pole Figure color-coded orientation maps referring to the tensile direction after creep rupture test at 1050 °C / 140 MPa / PD=0.74%.

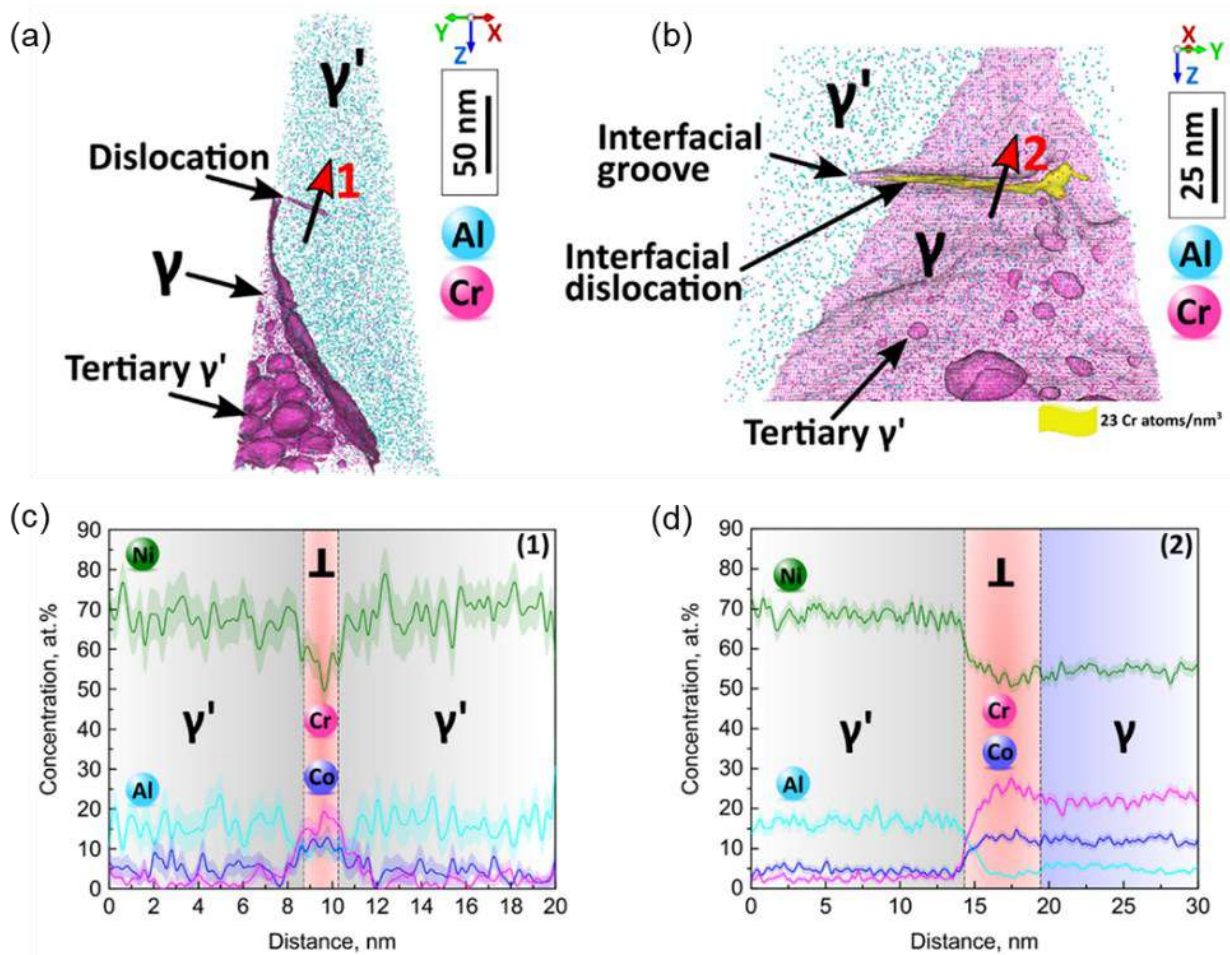
Figure 1.43. Atom probe reconstruction at the  $\gamma/\gamma'$  interface of a rafted  $\gamma'$  precipitate in the immediate vicinity of a recrystallized band after creep rupture test on pre-deformed AM1 specimen at 1050 °C / 140 MPa showing a dislocation within the  $\gamma'$  phase (a). The dislocation and the  $\gamma/\gamma'$  interface are shown with an iso-compositional surface at 8.0 at% Cr. (b) is a detail of the atom probe reconstruction from (a), showing the position of the cylindrical region of interest focusing on an interfacial dislocation groove within the  $\gamma'$  precipitate. (c) and (d) are 1D concentration profiles perpendicular to the dislocation denoted by the red arrow (1) in (a) and to the interfacial dislocation groove denoted by red arrow (2) in (b), respectively. Error bars are shown as lines filled with color and correspond to the  $2\sigma$  counting error.

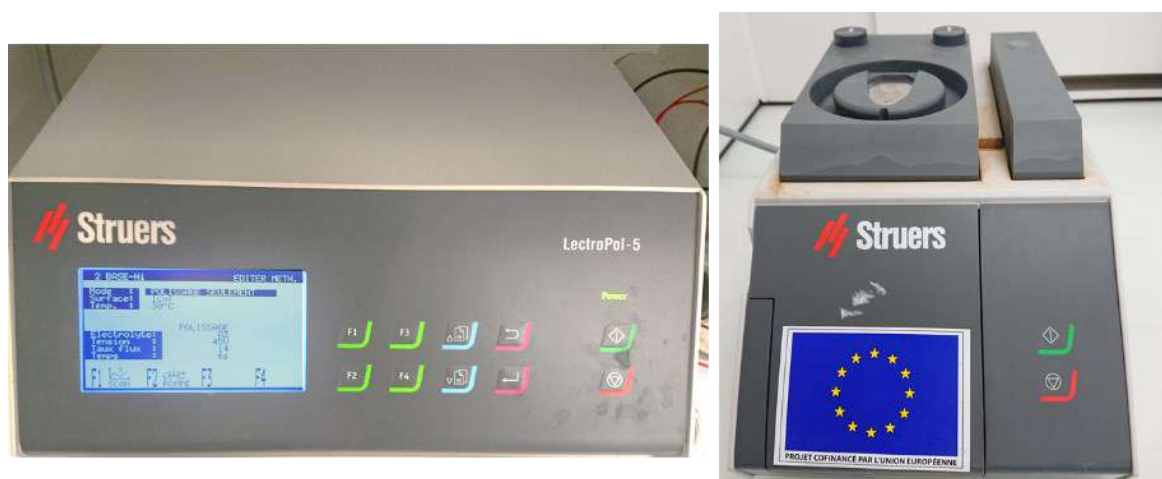
Figure 2.11. Struers LectroPol-5 system with electrochemical polishing parameters shown in on the screen.

Electron backscatter diffraction (EBSD) scans were performed on creep ruptured and interrupted specimens using JEOL JSM-6100 SEM equipped with EDAX forward scatter detector controlled by TSL OIM software. Specimens for the EBSD analysis were prepared by mechanical polishing down to 1- $\mu\text{m}$  diamond powder spray followed by electrochemical polishing using Struers LectroPol-5 system operated at 45 V for 6 s with a solution of perchloric acid, 2-butoxyethanol, and methanol (Struers electrolyte A3) kept at room temperature and flow level of 14 (Figure 2.11).

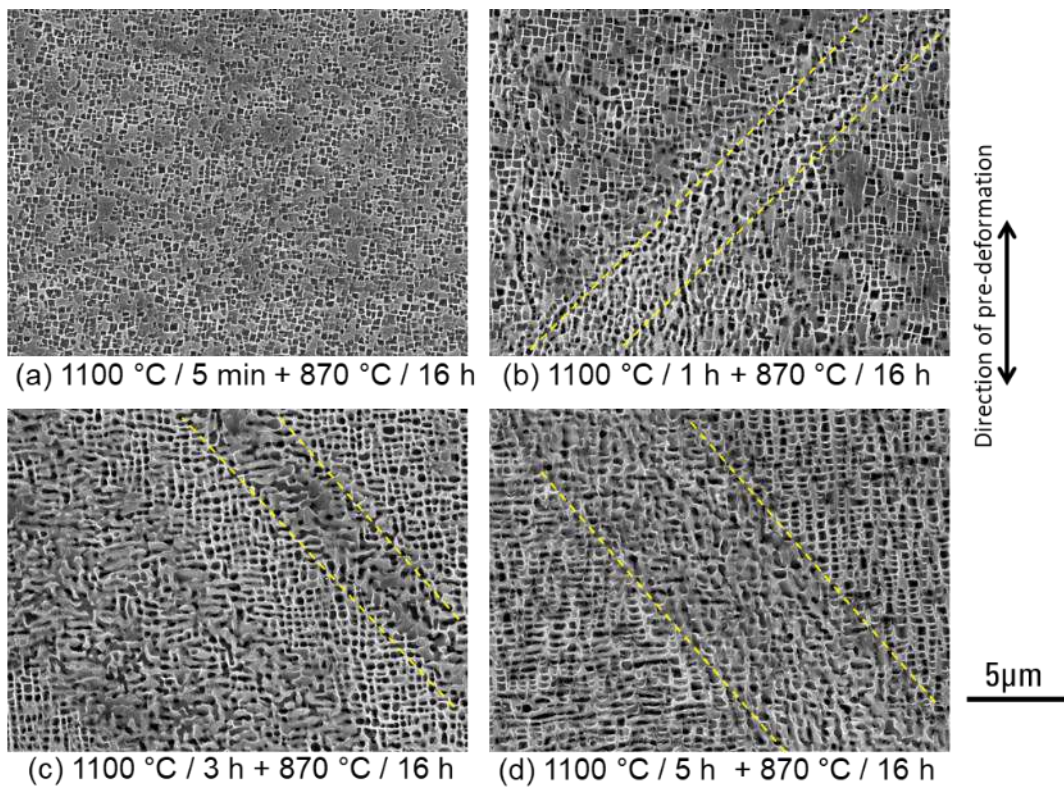
Figure 3.7. Microstructures of pre-deformed specimen after solution treatment, in (110) plane after 5 min to 5 h of the first stage aging treatment at 1100 °C followed by the second stage aging treatment at 870 °C for 16 h, in higher magnification.

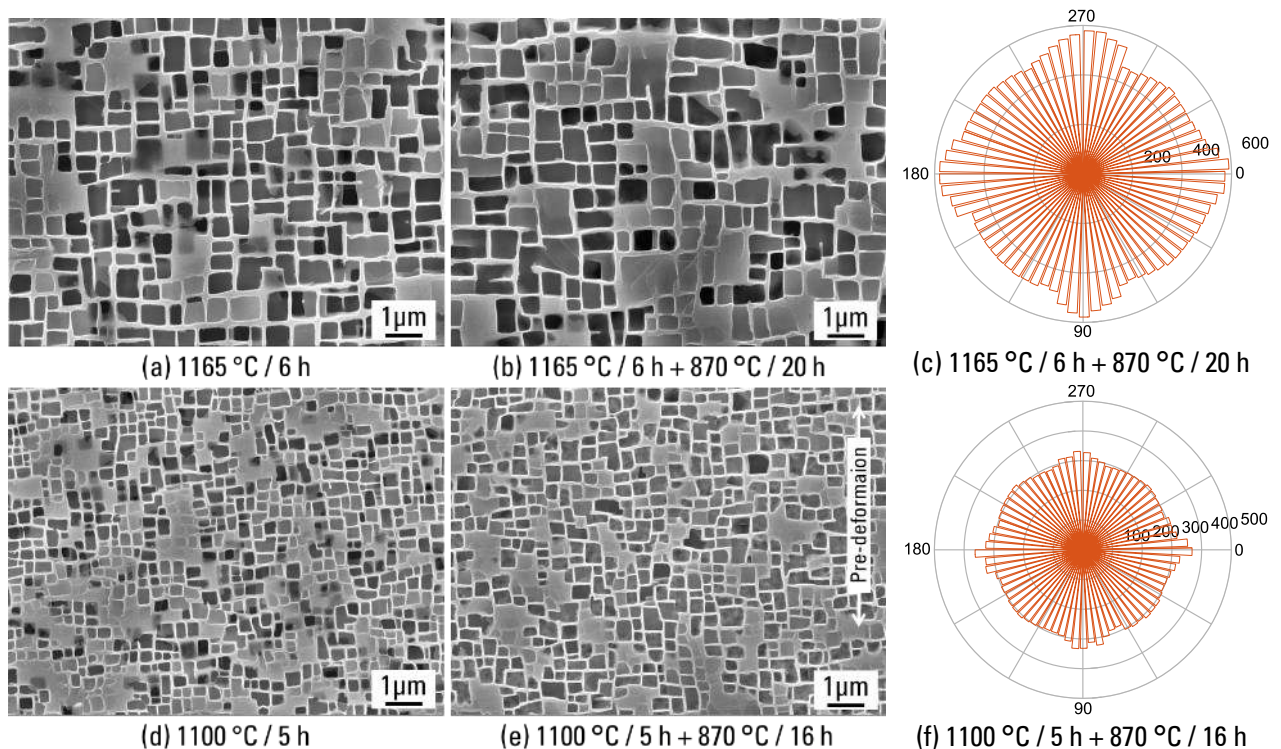
Figure 3.27. Typical microstructure of CMSX-4 Plus in the primary dendrite arms after aging treatments labeled to each image (a, b, d, e). (c) and (f) are rose diagrams of average  $\gamma'$  precipitate size obtained by RIM-X analyses on images (b) and (e). Concentric scale of the rose diagrams is in nm.

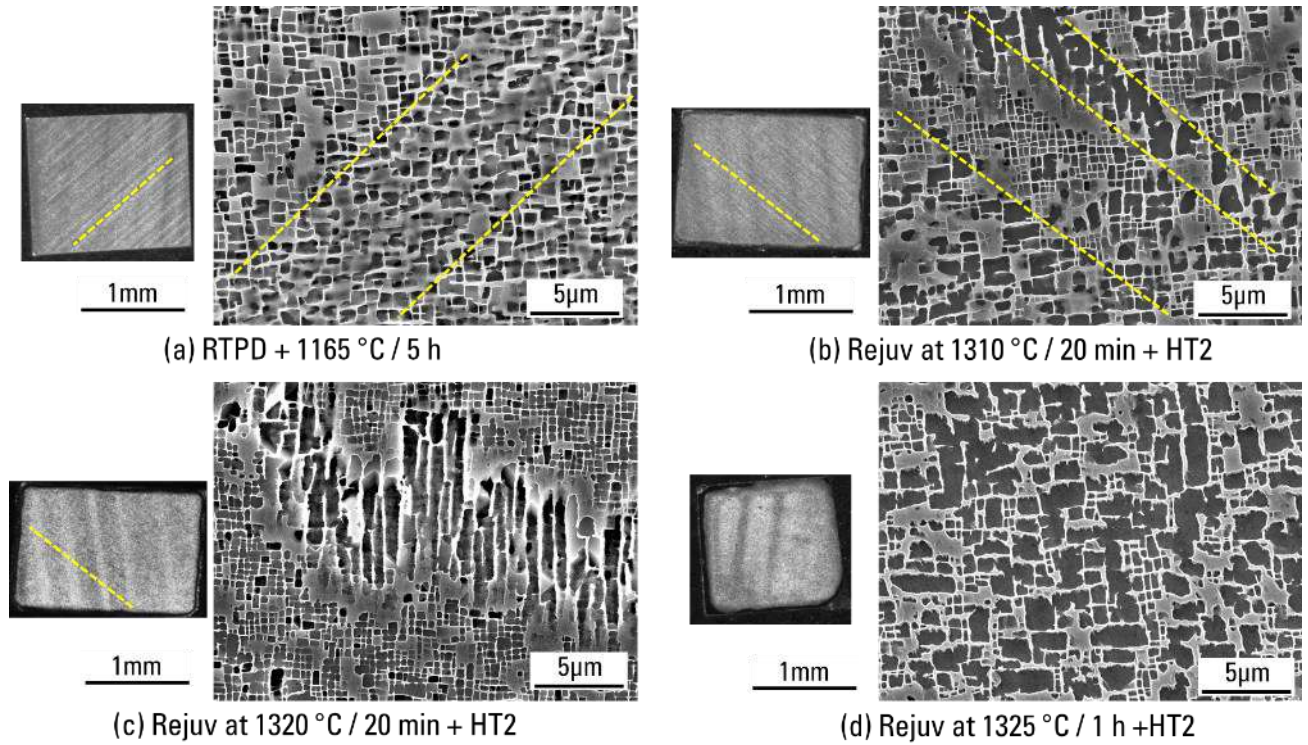
Figure 3.41. Microstructure of CMSX-4 Plus after PD at RT. (a) is for comparison with other images, only first aging treatment of HT2 applied. (b-c) are with rejuvenation treatment and subsequent HT2 aging treatments.

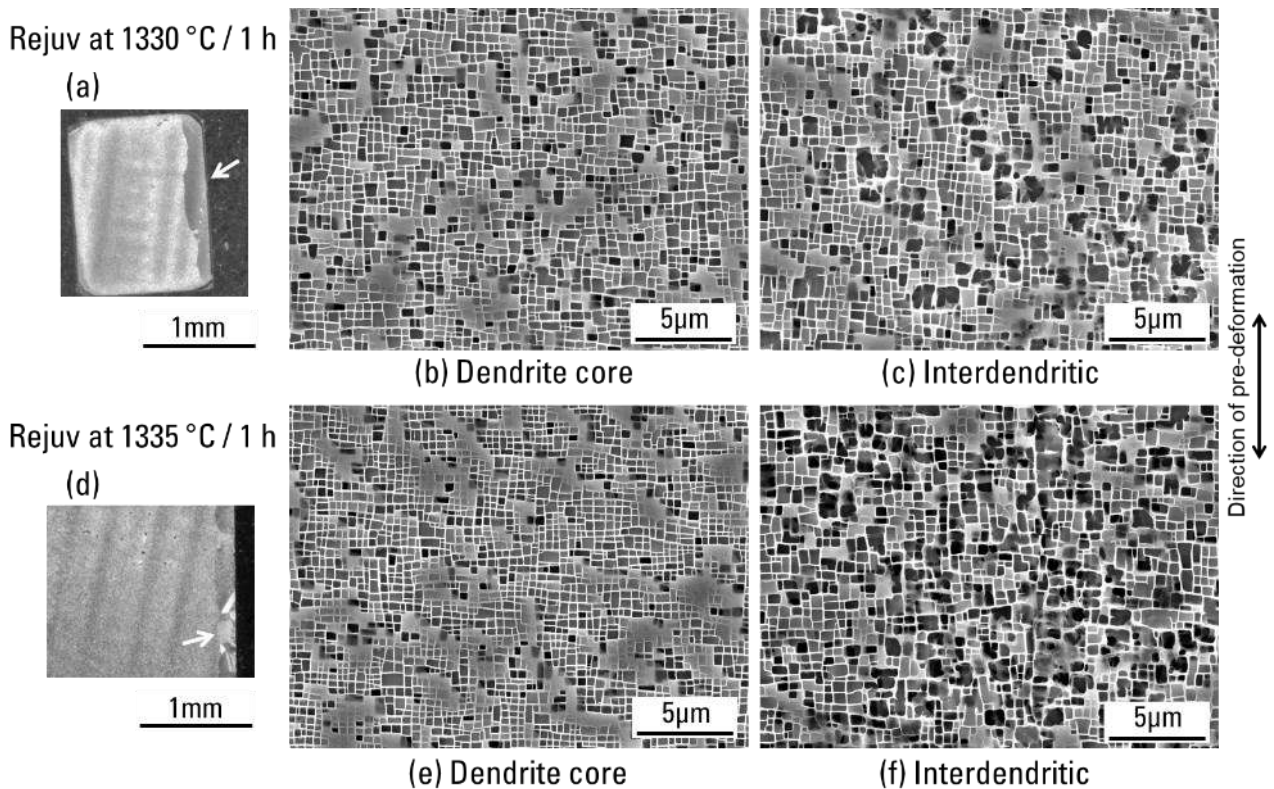
Figure 3.42. Microstructure of CMSX-4 Plus after PD at RT with rejuvenation treatment and subsequent HT2 aging treatments. Arrows are indicating surface recrystallization at the cylindrical surface.

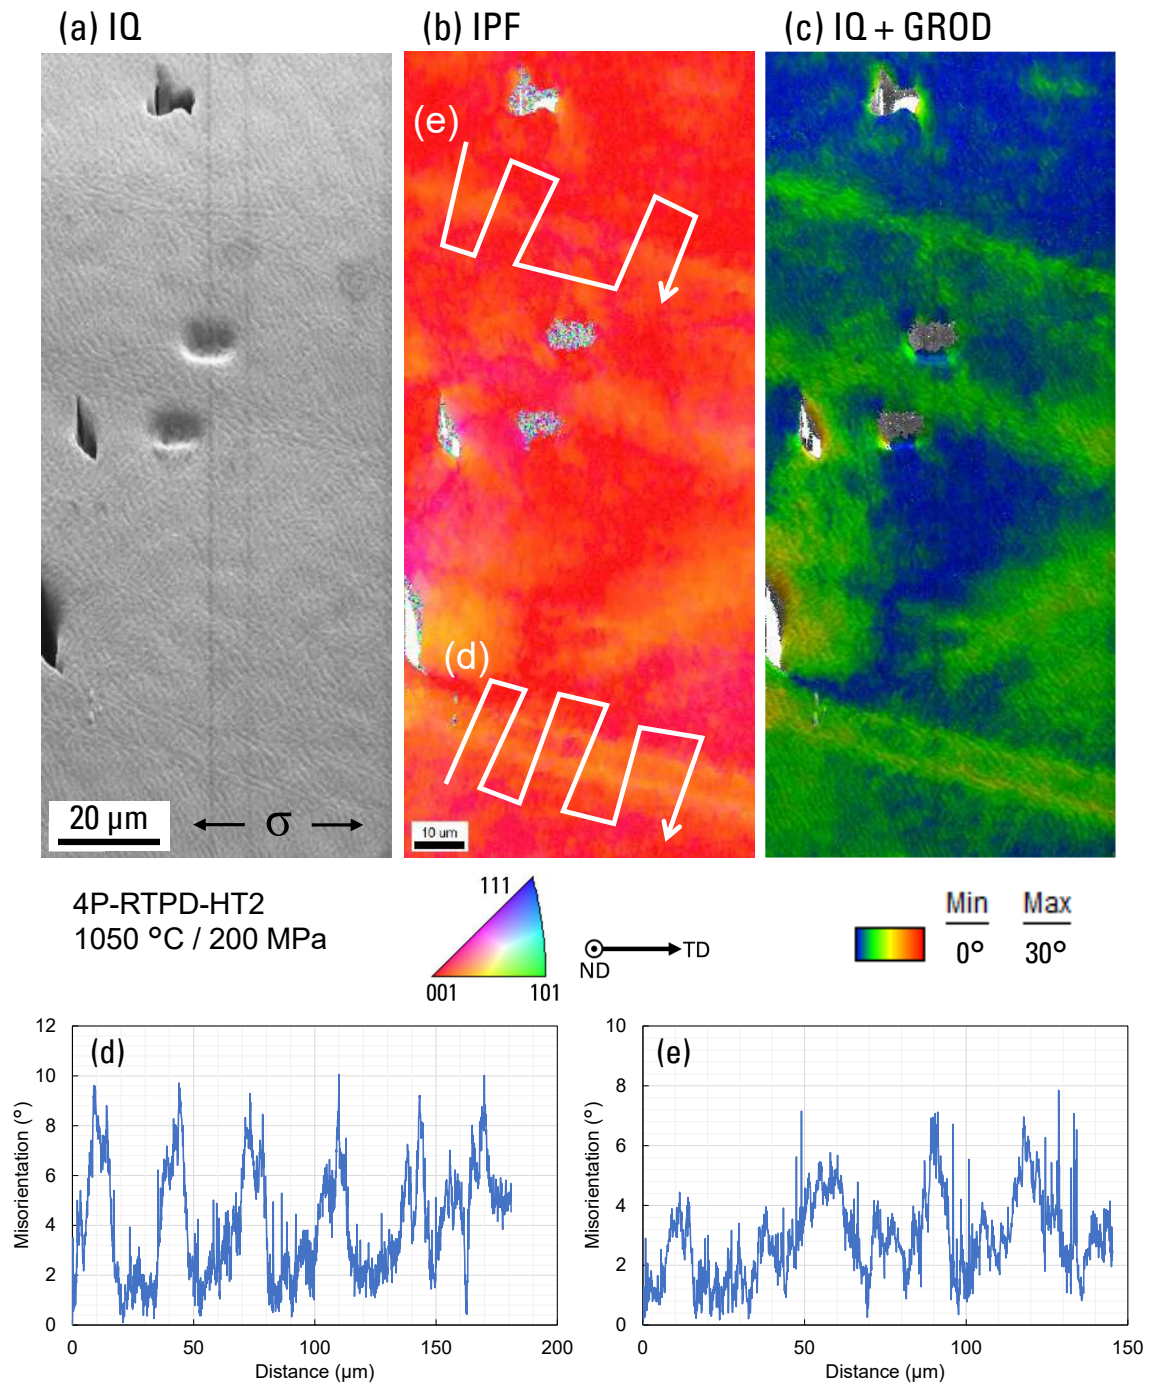
Figure 4.30. IQ map (a), IPF color-coded orientation maps referring to the tensile direction (b), and IQ + GROD map (c) on 4P-RTPD-HT2 after creep test at 1050 °C / 200 MPa obtained at 1 mm away from fracture surface. Misorientation profiles (d, e) are obtained from line analysis following arrows in (b).

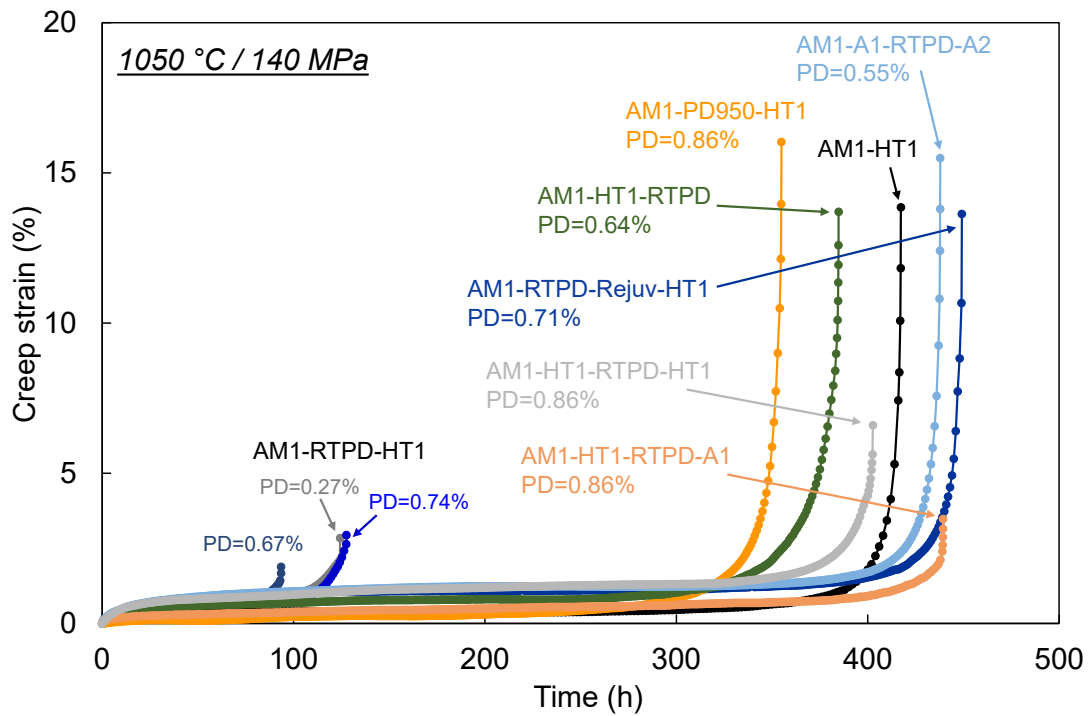
Figure 4.58. Creep curves of AM1 specimens with various preparation conditions tested at 1050 °C / 140 MPa
