Effect of top-casting defects and transverse cracks on the corrosion behavior of steel in reinforced concrete exposed to chloride environment

Wulong Zhang. Effect of top-casting defects and transverse cracks on the corrosion behavior of steel in reinforced concrete exposed to chloride environment. Civil Engineering. INSA de Toulouse, 2020. English. NNT : 2020ISAT0009 . tel-03185579

**Influence des défauts de mise en place du béton et des fissures
fonctionnelles transversales sur la corrosion des armatures des
structures en béton exposées aux chlorures**

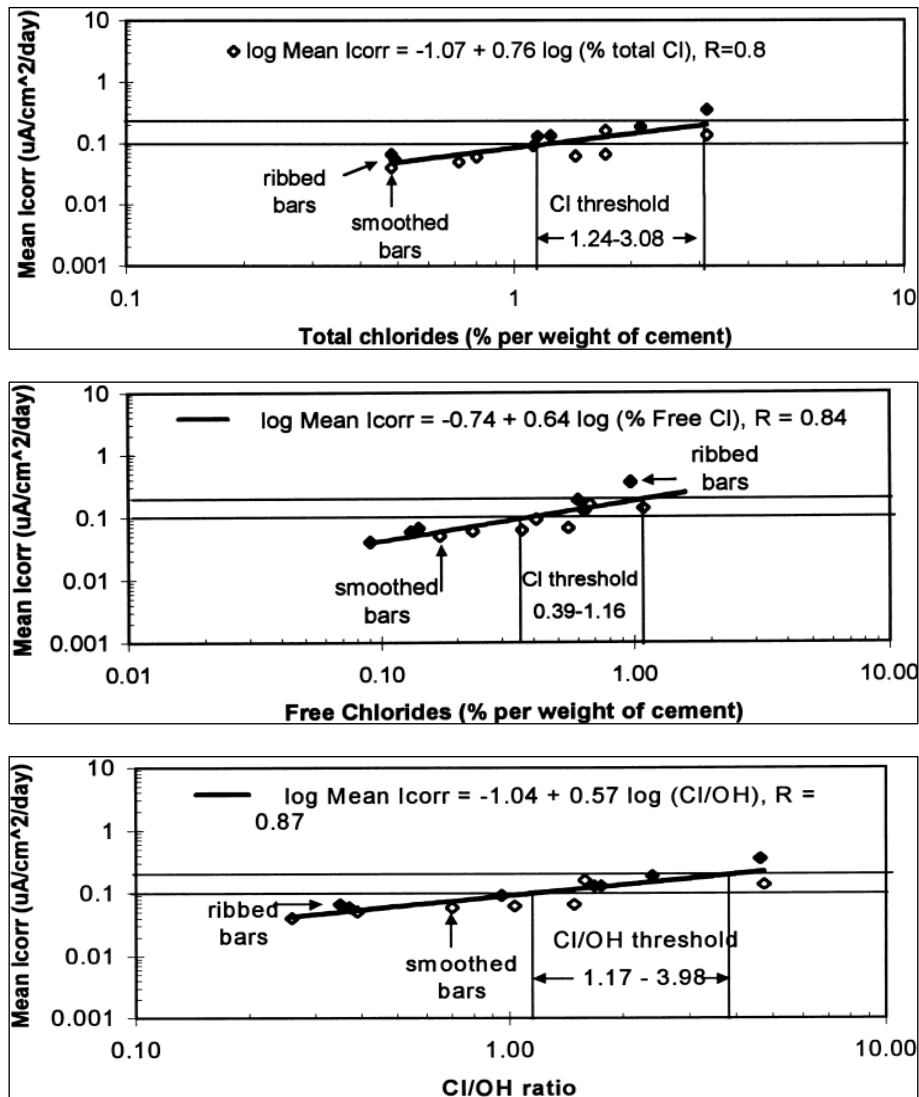
Figure II-26 Relationship between corrosion current and critical chloride threshold (free chloride, total chloride and Cl/OH ratio)[120]

The corrosion potential, the electrical resistance and the polarization resistance were recorded periodically during 90 or 200 days and the I_{corr} was calculated through the Stern and Geary equation. And the results of the correlation between I_{corr} and the critical chloride threshold characterized in different mode are shown in Figure II-26.

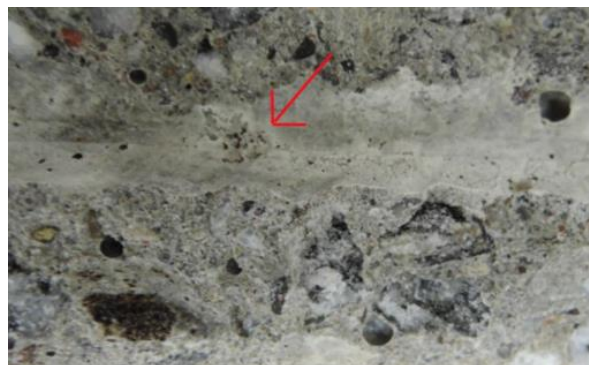
Figure II-51 Examples of irregularities at the steel-concrete interface Locally higher porosity (arrow) and small air voids (left part) as well as coarse air voids (right part). Corrosion initiated in this case at the arrow[139]

According to Figure II-51 and Figure II-52, in one third of the samples where corrosion initiation was not found to correlate with visible irregularities at the steel-concrete interface, there were actually air voids present at the steel-concrete interface (elsewhere). It means that for these samples, corrosion initiated preferentially not at air voids or other defects, but at a location without any visible irregularity. This may be explained by the moisture content of the samples, i.e.

unsaturated. Coarse air voids can only get saturated under prolonged immersion or pressure saturation. In the presence of air in the voids, initiation of corrosion is hardly possible.

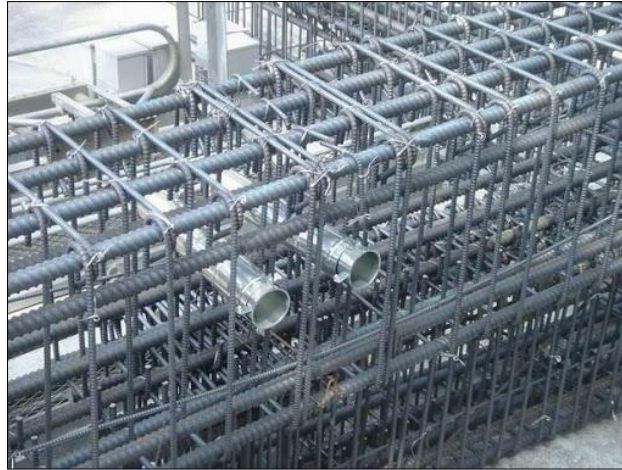
Figure II-70 Steel frame

Generally, reinforcing steels are induced in concrete by the way of steel frame (Figure II-70),

and the role of stirrups is to fix the main steel rebars during manufacturing and install steel frame and to carry the shear stress during the service life of reinforced concrete buildings. Therefore, stirrup can be regarded as an important part in reinforced concrete constructions.

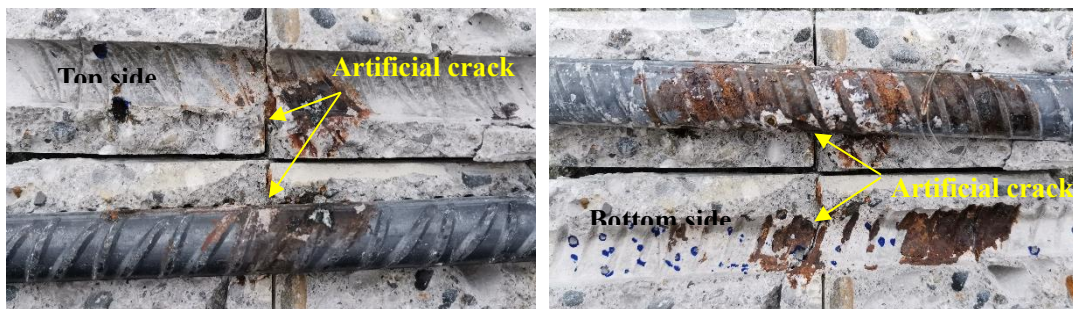
Figure IV-19. Corrosion pattern of top bar of B-1

After 28 cycles, the top steel rebars were extracted from the concrete blocks to check the real state of corrosion, and the results are shown in Figure IV-19. The rust was mainly distributed on the bottom interface and, on the top interface, small pieces of corrosion products appeared in the vicinity of the artificial crack. However, the location of rust does not represent the location of pitting corrosion.

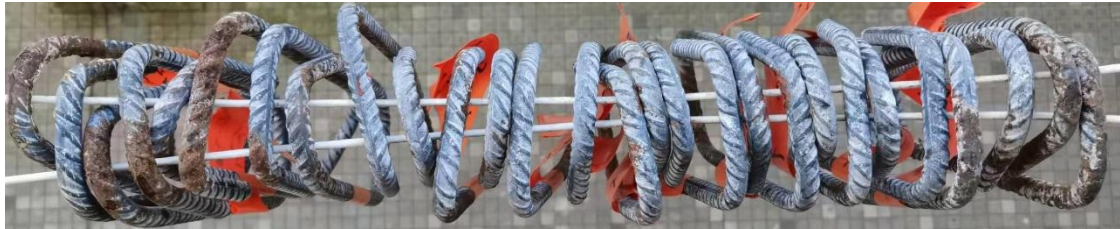
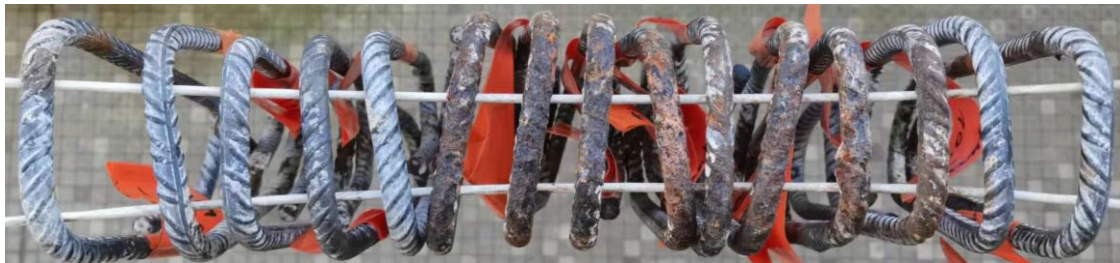
Figure IV-79 and Figure IV-80 present the corrosion patterns of horizontal legs in both beams before cleaning with Clark's solution. In the compressive zone, corrosion mainly took place at both ends while, in the tensile zone, corrosion mainly occurred at mid span of the beam.

(a) Corrosion of horizontal legs in compressive zone

(b) Corrosion of horizontal legs in tensile zone

Figure IV-79 Horizontal legs of stirrups in beam As01

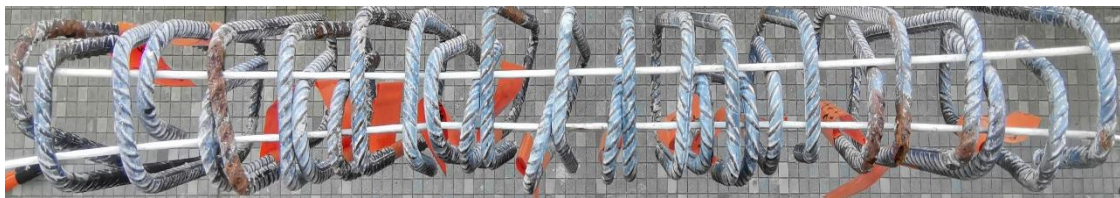
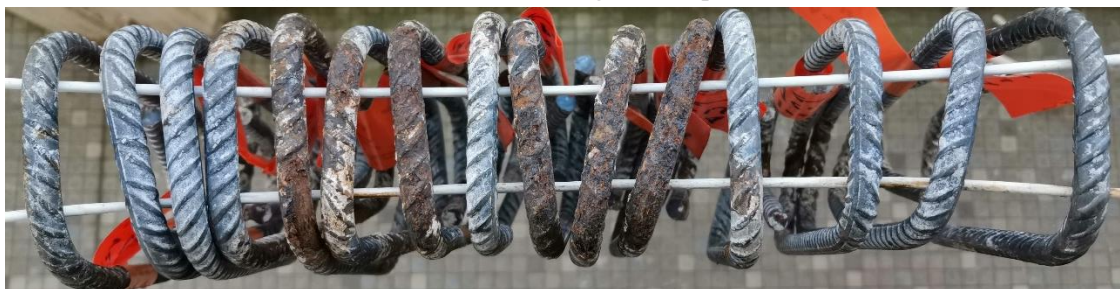
(a) Corrosion of horizontal legs in compressive zone

(b) Corrosion of horizontal legs in tensile zone

Figure IV-80 Horizontal legs of stirrups in beam As02
