En vue de l'obtention du DOCTORAT DE L'UNIVERSITÉ DE TOULOUSE

**Influence des défauts de mise en place du béton et des fissures
fonctionnelles transversales sur la corrosion des armatures des
structures en béton exposées aux chlorures**

LMDC - Laboratoire Matériaux et Durabilité des Constructions de Toulouse

Title: Effect of top-casting defects and cracks on the corrosion behavior of reinforcing steel in concrete under chloride environment

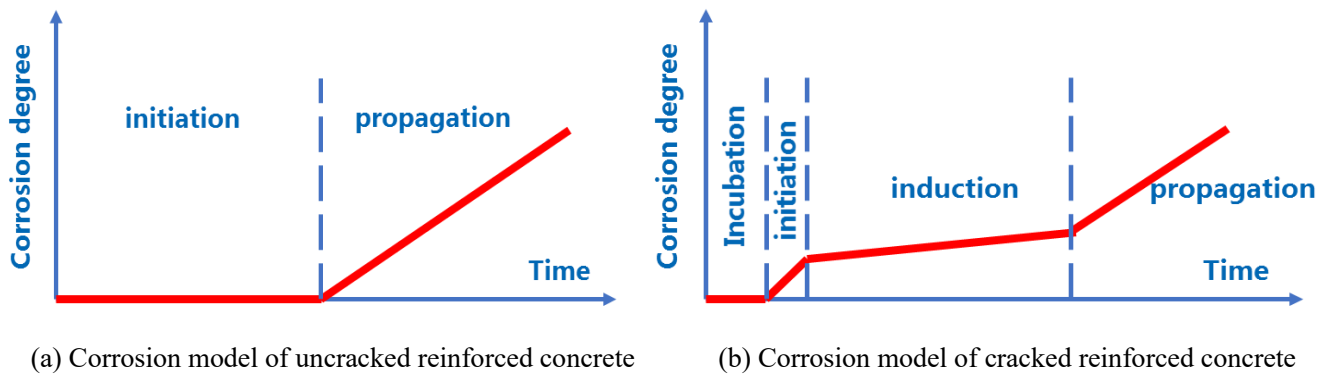
Figure 1 Modèles de corrosion du béton armé [7, 8]

pénètrent à travers les fissures primaires pour atteindre rapidement les barres d'armature en acier. Lors de l'initiation de la corrosion, les barres d'armature en acier situées au niveau des fissures primaires ont été dépassivées, tandis que les barres d'armature en acier entre les fissures primaires restent protégées par un revêtement en béton. Les barres d'armature en acier ont été corrodées sous la forme d'une corrosion par macro piles. Lors de l'induction de la corrosion, les produits de corrosion obturent les fissures primaires ce qui ralentit fortement le développement de la corrosion. La durée de cette période est liée au temps mis par les ions chlorure pour pénétrer à travers la structure poreuse de la couverture en béton. Dans la propagation de la corrosion, lorsque toute la couverture de béton est contaminée par des chlorures, la corrosion redémarre. Ensuite, le développement des produits de rouille induit une fissuration secondaire de la couverture en béton. Le modèle a été illustré à la Figure 1 (b).

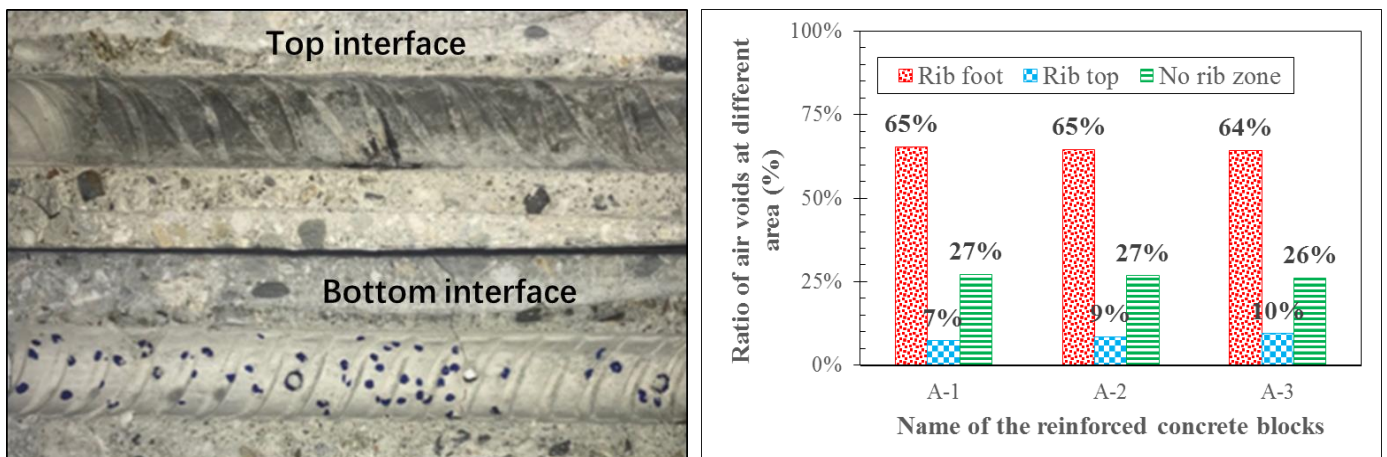
Figure 9 (a) Conditions of steel-concrete interface Figure 9 (b) Distribution of air bubbles in steel-concrete interface

Dans la Figure 9 (a), on peut constater que la couleur de l'interface supérieure était plus profonde que celle de l'interface inférieure. Cette différence est attribuée à la couche de produits d'hydratation du ciment plus dense ainsi qu'à la différence de microstructure entre l'interface supérieure et l'interface inférieure. La Figure 9 (b) présente la distribution des bulles d'air dans l'interface acier-béton. Il convient de noter qu'empreinte des armatures HA en acier sur le béton est divisée en trois zones différentes: sommet de la nervure, pied de nervure et zone entre deux nervures selon la forme de la barre d'armature en acier. Sur la figure, on peut observer que la plupart des bulles d'air sont apparues au pied des nervures, un quart des bulles d'air situées sur la zone sans nervures, pas plus de 10% ont été trouvées au sommet des nervures.

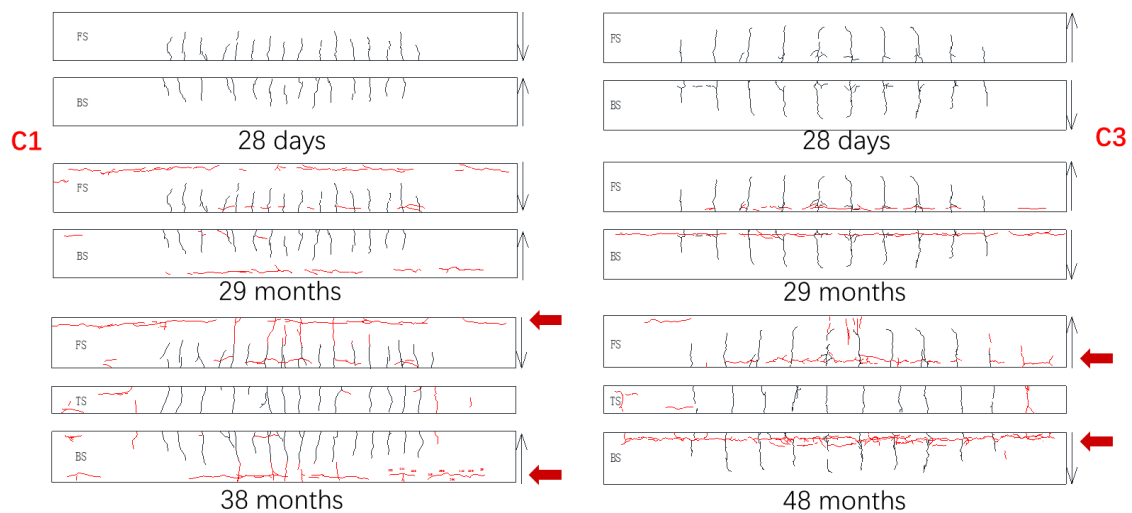
Figure 17 Carte de fissuration des poutres C1 et C3

La section 3 du chapitre IV présente l'impact des “top-casting defects” sur les caractéristiques de corrosion de la zone de compression de quatre poutres C pour un relativement long terme d'exposition dans un environnement de chlorures. Les cartes de fissuration, les profils de chlorures, la répartition des piqûres et la perte de section transversale des barres d'armature en acier ont été mesurés à 38 et 48 mois. La relation entre la corrosion par piqûres et les fissures induites par la corrosion a été discutée.

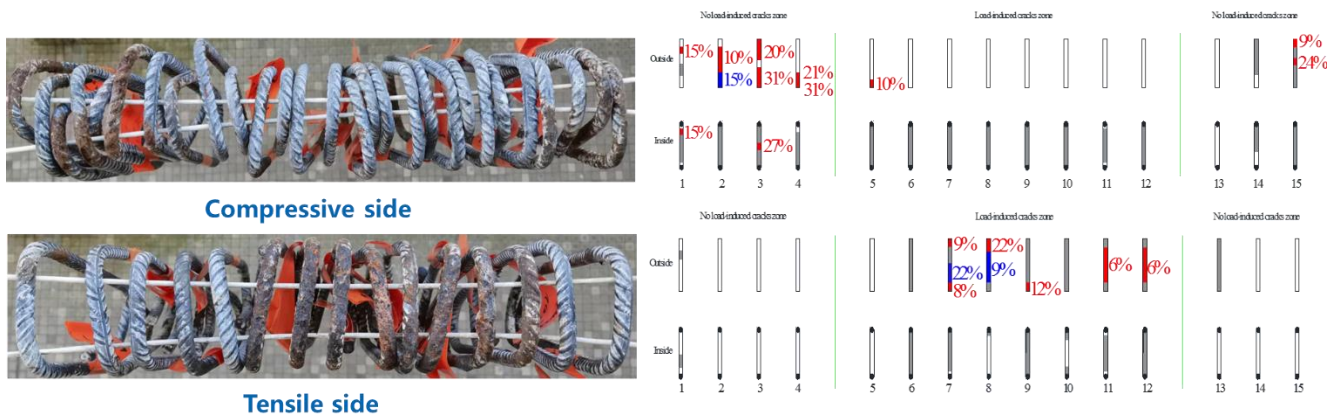
Figure 23 Corrosion des parties horizontales des étriers

extrémités de la poutre. Au contraire, du côté de la zone tendue, la corrosion par piqûres s'est principalement accumulée au milieu de la poutre (Figure 23). Le phénomène similaire peut également être observé sur les barres principales (Figure 24).

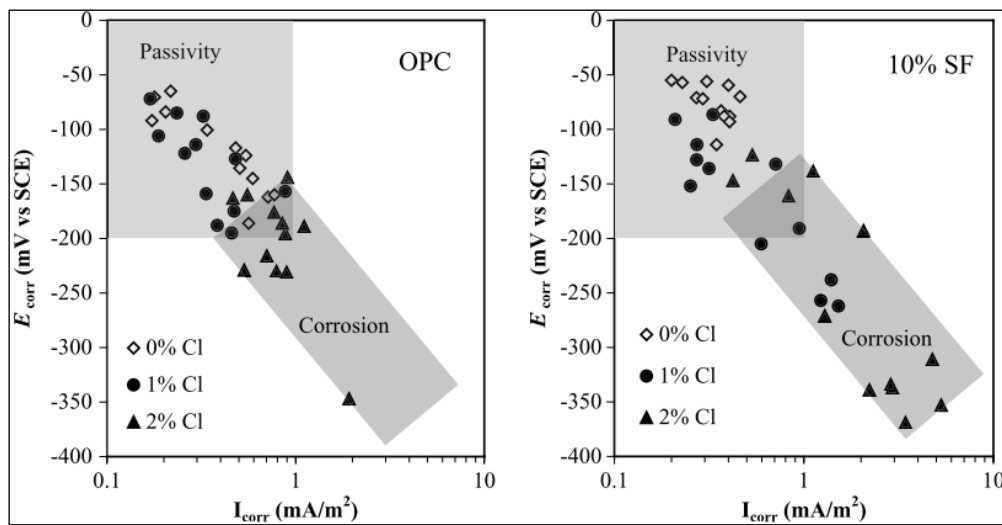
Figure II-42 Relationship between corrosion potential and corrosion current density of rebar[136]

experiment, cement was partly replaced by silica fume in 10% by mass of binder. The results are shown in Figure II-41 and Figure II-42. In concrete with 2% chloride by mass of binder (Figure II-41), a higher value of corrosion current was measured in concrete with silica fume. The results suggested that a higher susceptibility to pitting corrosion for the bars embedded in concrete with 10% silica fume. In Figure II-42, it can be found that the corrosion probability of rebars embedded in concrete with 10% silica fume is obvious higher than that of OPC under the same chloride concentration. It means that the use of silica fume in concrete would increase the risk of corrosion of steel bar.

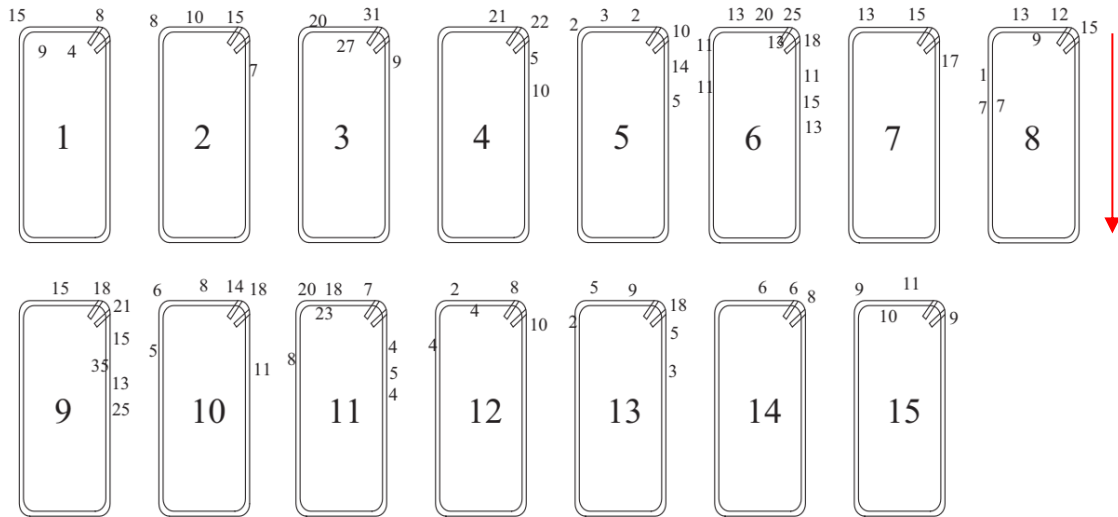
Figure II-73 Stirrup diameter loss (%) [62]

especially when the stirrups were located at the mid span of reinforced concrete beam. A few pitting corrossions, however, took place at the top half vertical legs, While, there were hardly any pitting corrosion spotted at the bottom horizontal legs of stirrups (Figure II-73).
