# Identification of initiation and propagation phases of steel corrosion in cracked and carbonated concrete

Rita Maria Ghantous. Identification of initiation and propagation phases of steel corrosion in cracked and carbonated concrete. Civil Engineering. INSA de Toulouse, 2016. English. NNT : 2016ISAT0031 . tel-02043212

Identification des phases d'initiation et de propagation de la corrosion  
des armatures enrobées dans un béton fissuré et carbonaté

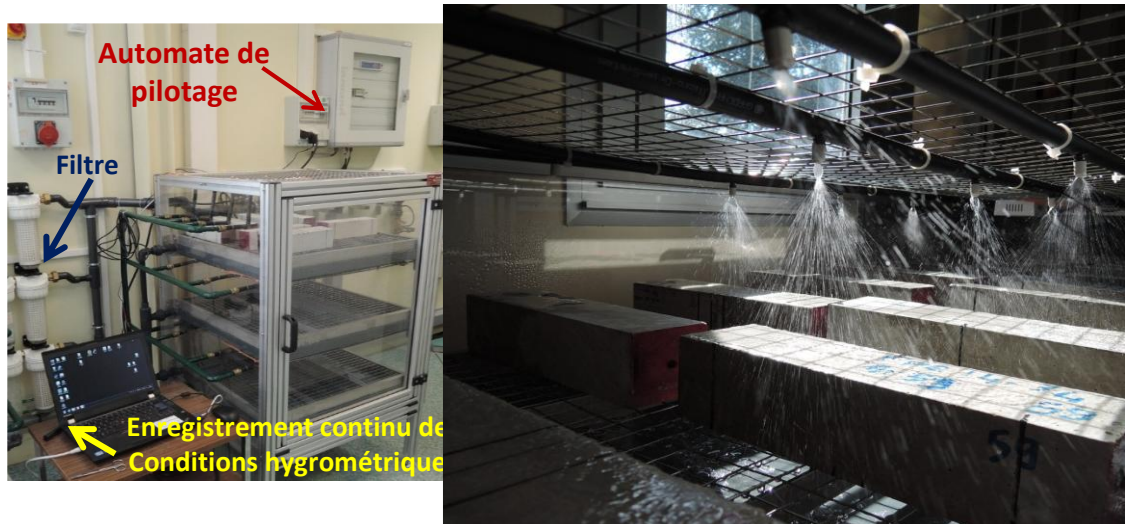
Figure 3: le dispositif ARIEL (simulAting RaInfall for concrEte durabiLity) pour corrosion accélérée par cycles de pluie en laboratoire

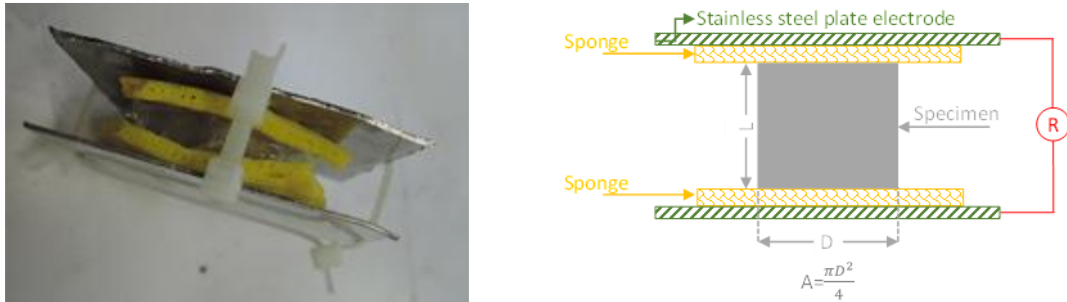
Figure 2-2: Uniaxial measurement of the specimen resistance

The electrical resistance (R) of the sample is equal to the average value of the real impedance values measured at high frequency (horizontal line). The domain of frequency used to calculate the electrolyte resistance is shown in Figure 2-3 by two vertical blue lines.

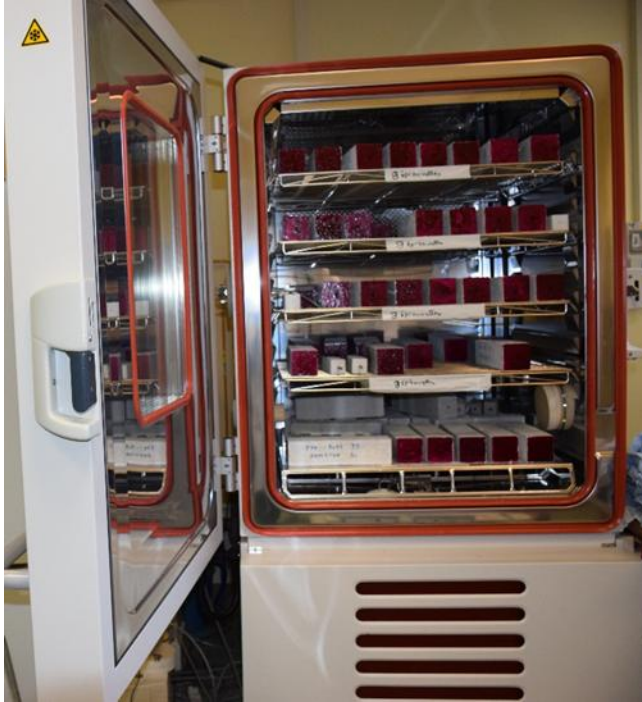
Figure 2-18: Carbonation climatic chamber

To ensure place for the huge number of specimens needed for this study, a new climatic chamber Vötsch VC<sup>3</sup> 0060 of 600 liters was adapted during this study for carbonation experiments (Figure 2-18) according to the plans of another carbonation chamber implemented by Drouet [20].

In this climatic chamber, the temperature and the relative humidity are continuously controlled. As indicated in the study [20], the standard deviations in the temperature and in the relative humidity are respectively equal to 0.05°C and 0.2%.

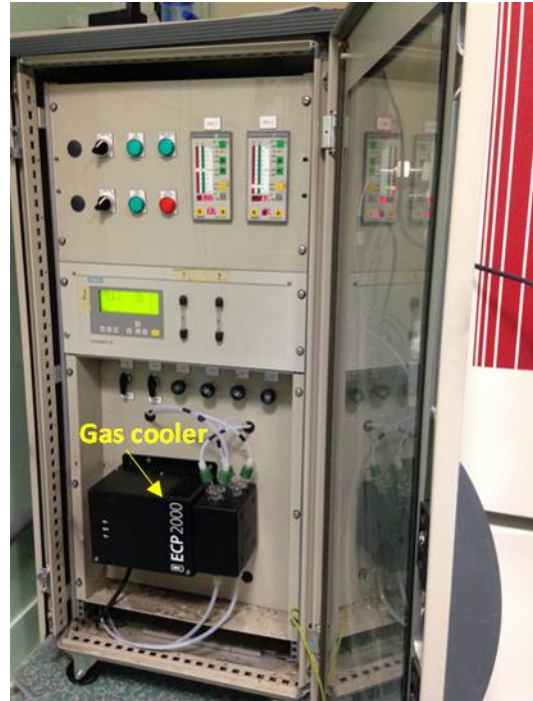
Figure 2-19: Siemens cabinet of CO<sub>2</sub> analysis and control

The carbon dioxide rate inside the climatic chamber is regulated using a SIEMENS cabinet of analysis and control (Figure 2-19). This cabinet contains a CO<sub>2</sub> analyzer (measure by absorption of infrared radiation) and a regulation system (pumps and servo-electro valves). Gas is continuously sampled from the climatic chamber and analyzed by the analyzer. Once the CO<sub>2</sub> concentration inside the climatic chamber drops below the set value, the regulation system inject CO<sub>2</sub> inside the climatic chamber in order to maintain the required carbon dioxide pressure. The standard deviation detected in the CO<sub>2</sub> pressure value is equal to 0.05% for an operating range from 0 to 100%.

The water vapor that may exist in the CO<sub>2</sub> may disturb the analysis. Moreover, its condensation in the measurement system may damage it. For these reasons, the CO<sub>2</sub> gas should be dry before its analysis. A gas cooler is added in order to drop down relative humidity when the analyzed gas is charged with water vapor (for experiments performed with a relative humidity higher than 50%) (Figure 2-19). This gas cooler maintain a temperature lower than 5°C. A peristaltic pump was also added to remove the condensate.

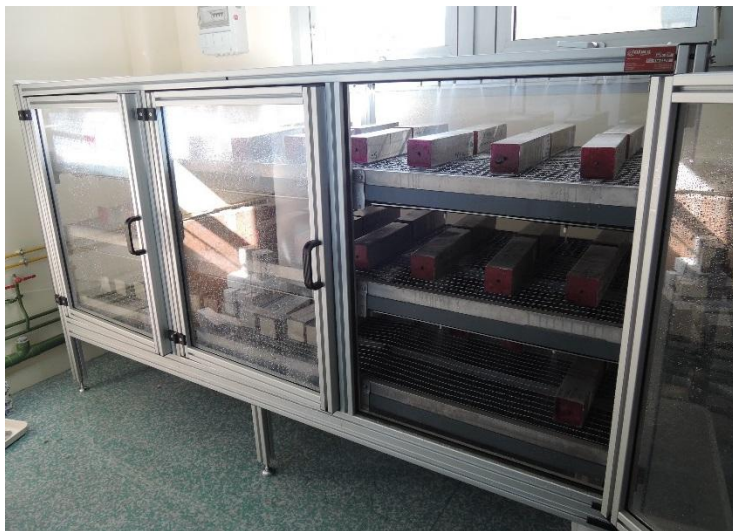
Figure 2-23: Real atomized device for humidification/drying cycles

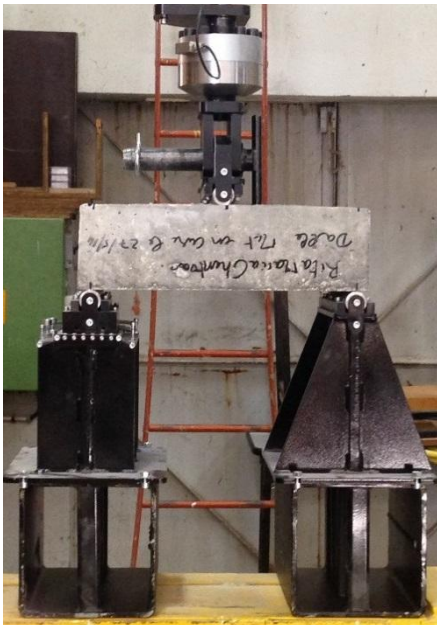
Figure 2-30: Cracking protocol of the concrete slabs

The three point bending test is also used to crack the metric specimens (concrete slabs) as shown in Figure 2-30. In this case, to measure the crack opening, a video microscope is used instead of the LVDT. The same cracking protocol is used for the 40 × 40 × 160 mm mortar specimen and the crack openings are monitored using an LVDT (Figure 2-31). For these prismatic specimens, one small crack opening (0.1 mm) is needed.

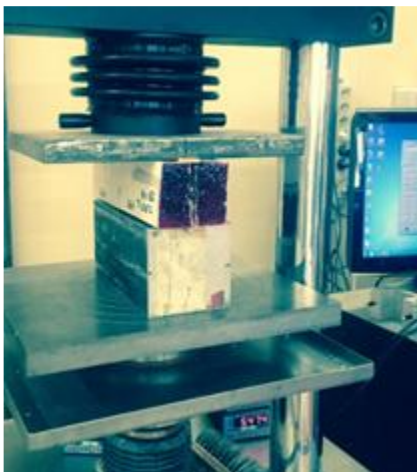
Figure 2-33: Splitting test

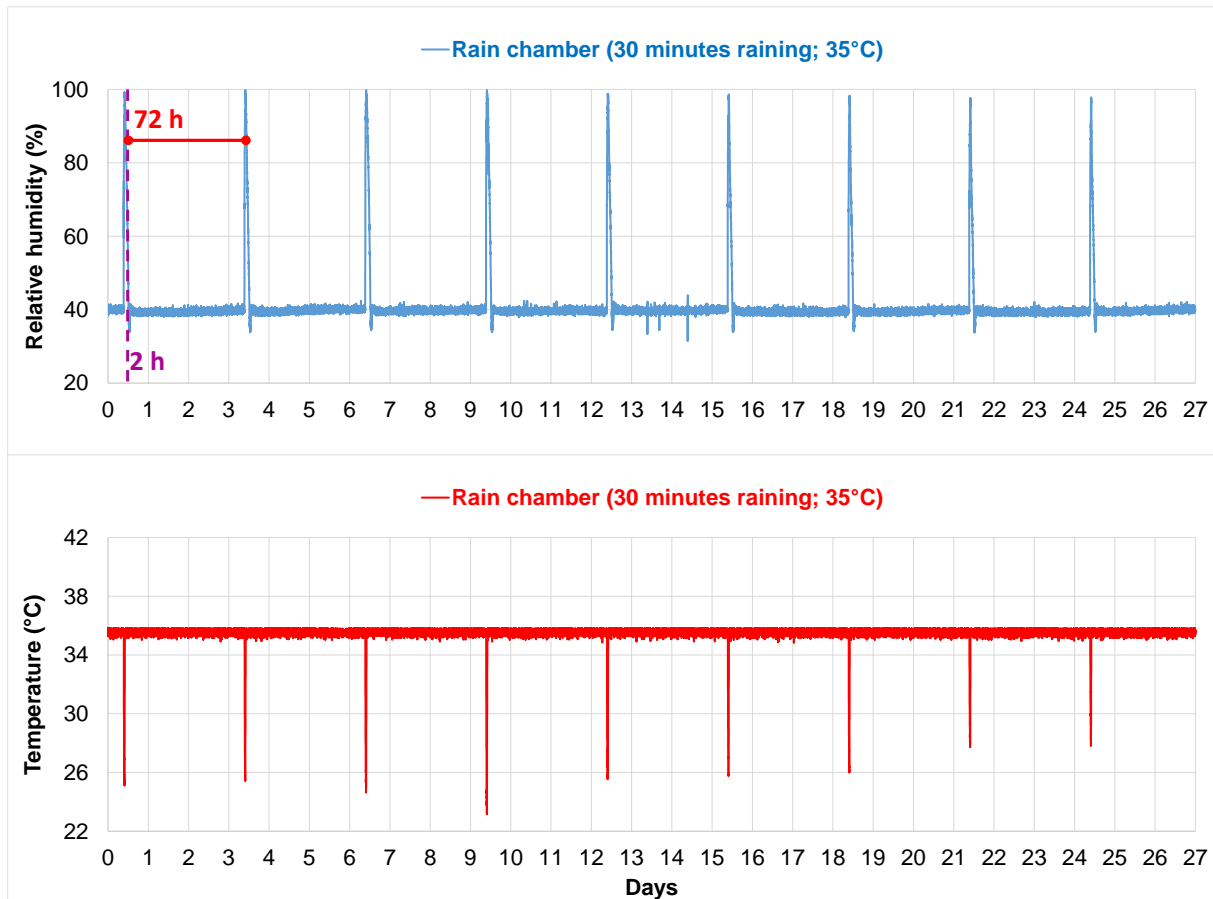
Figure 2-42: Relative humidity and temperature variation during raining/drying cycles in the 40°C temperature corrosion protocol

The effect of the temperature is tested by subjecting CEM I mortar specimens of 70 × 70 × 280 mm to the same raining/drying cycles of the reference protocol but the temperature is regulated at 40°C instead of 20°C. During the rainfall period, the relative humidity value increases to 100%. After the raining period, the drying phase starts and in this phase relative humidity value takes around 2 hours to drop down to approximately 40% (Figure 2-42). The temperature is regulated at 40°C but the one obtained is not more than 35°C. During the raining period temperature decreases from 8 to 10 degrees and this is also due to the lower temperature of water injected inside the rain chamber (Figure 2-42). Two residual crack opening are tested 100 μm and 300 μm. These cracks are oriented vertically with respect to rain.

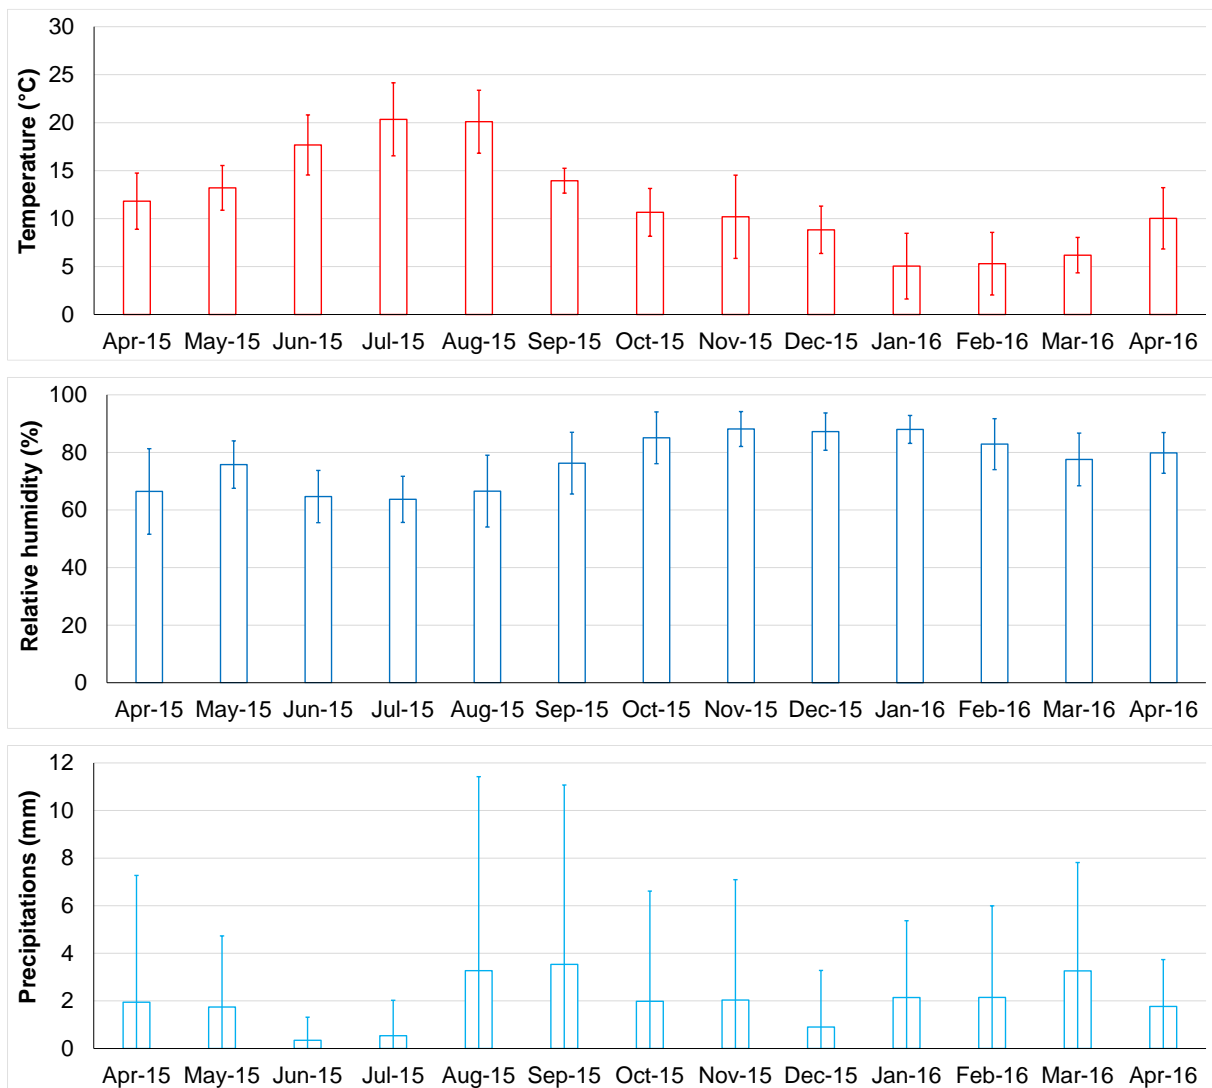
Figure 2-43: Hygrometric conditions in Saclay environment during experiments

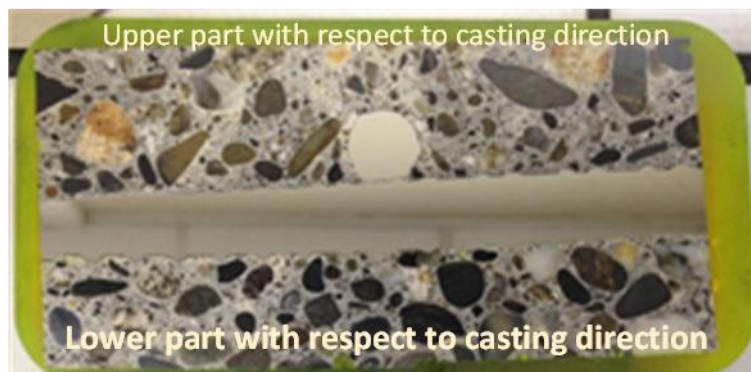
Figure 2-52: sample obtained from a concrete slab

The same protocol is applied to prepare samples from concrete slabs for the surface analysis. At each maturity date, a sample is cut from the concrete slab as shown in Figure 2-50. Then a prismatic sample of 550  $\times$  100  $\times$  150 mm containing two longitudinal steel rebars and 10 transversal steel rebars is obtained. From this sample, small samples should be cut according to the red lines in Figure 2-51. Then the obtained samples are covered by fluorescent epoxy resin before longitudinal polishing. A photo of a final sample ready to surface analysis is given in Figure 2-52.

The same analysis is performed thereafter for a higher number of cycles equal to 24. During this analysis, the cutting way of the small samples is not similar and is performed as shown in Figure 7-9. In this cutting way, after polishing, the obtained samples are shown in Figure 2-52.

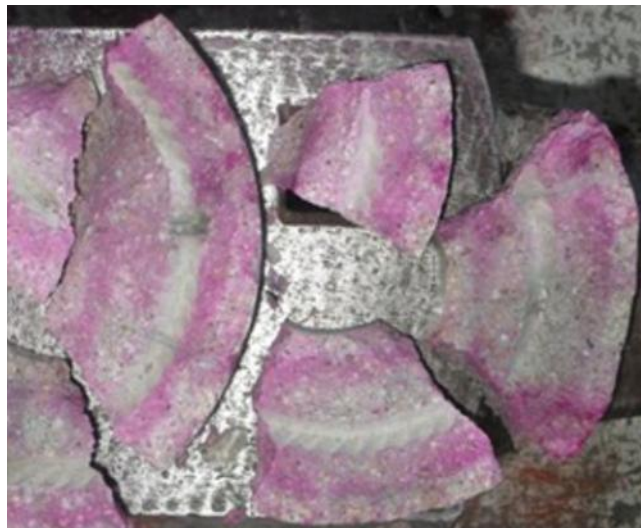
Figure 3-15: Phenolphthalein pH test on a ring shape mortar specimen carbonated at 50% CO<sub>2</sub> for 7 days [173]

The carbon dioxide concentration recommended in France [180] (50% CO<sub>2</sub>) may induce a carbonation shrinkage that may lead to progressive damage along the steel/mortar interface allowing the carbon dioxide to spread further than the mechanically damaged zone. This result may explain the total carbonation of the steel/mortar interface detected after exposing cracked ring shape mortar specimens to 50% CO<sub>2</sub>, 65% RH and 23°C temperature for 7 days in the study of Dang et al. [173] (Figure 3-15). However, cracks are close to each other in the case of ring shape mortar specimens and therefore an overlay of damaged zone may also occur and induce a spread of the CO<sub>2</sub> along the total steel/mortar interface.

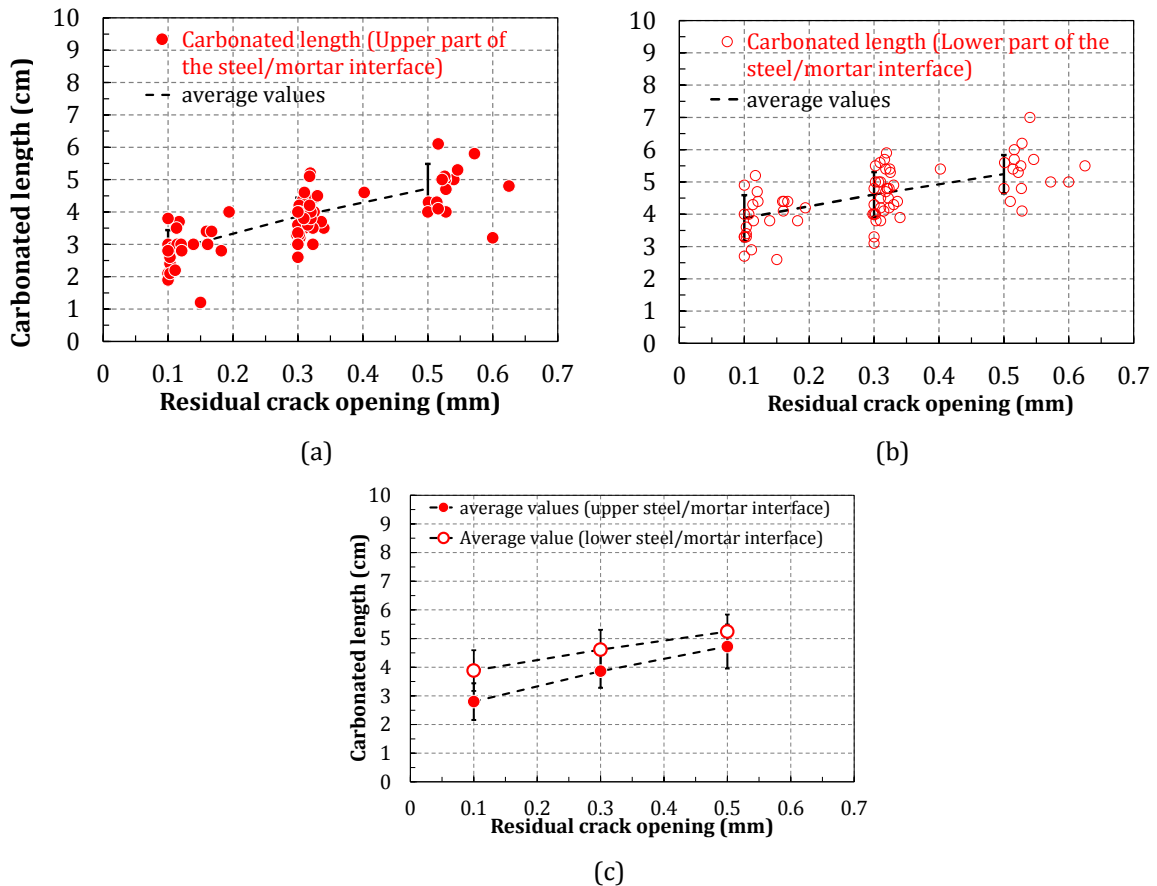
Figure 3-16: Experimental (79 samples) carbonated length of steel/mortar interface

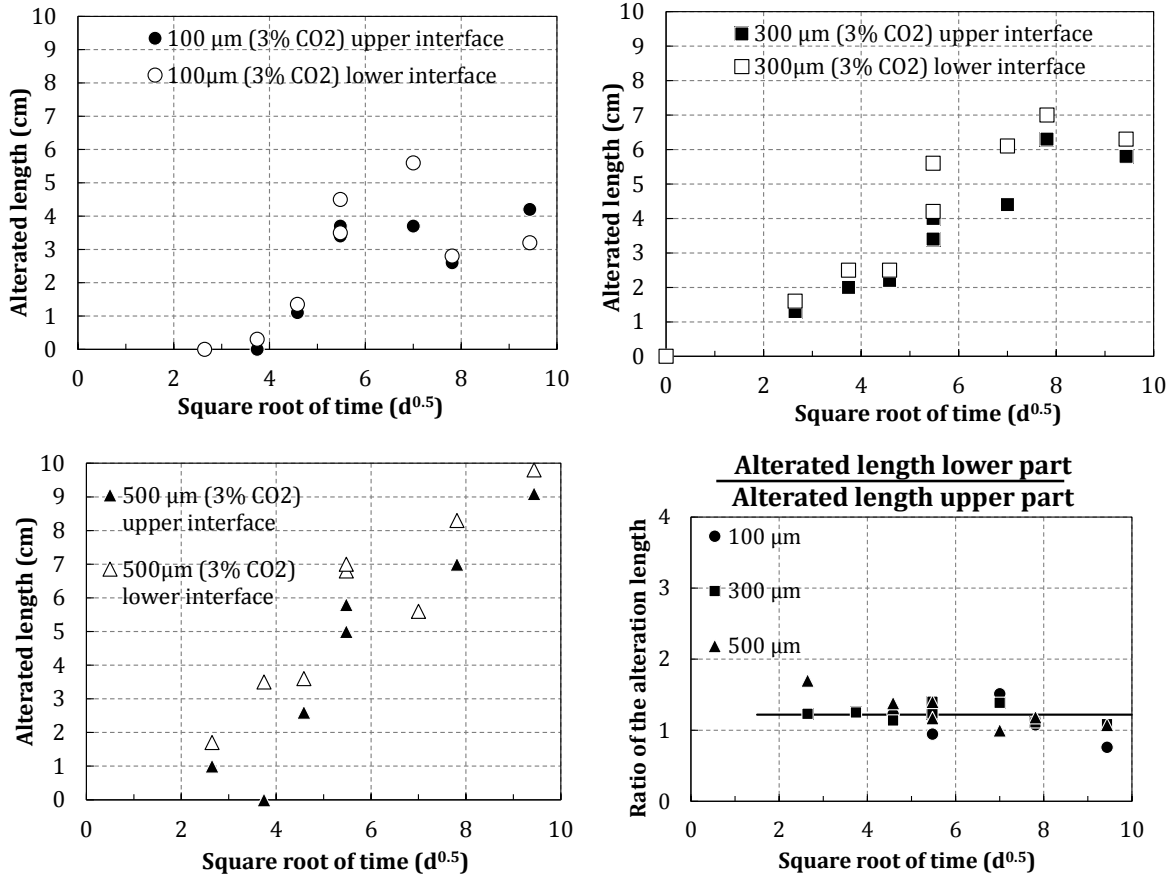
Figure 3-18: Comparison of the carbonated length between the upper and the lower part of the steel/mortar interface

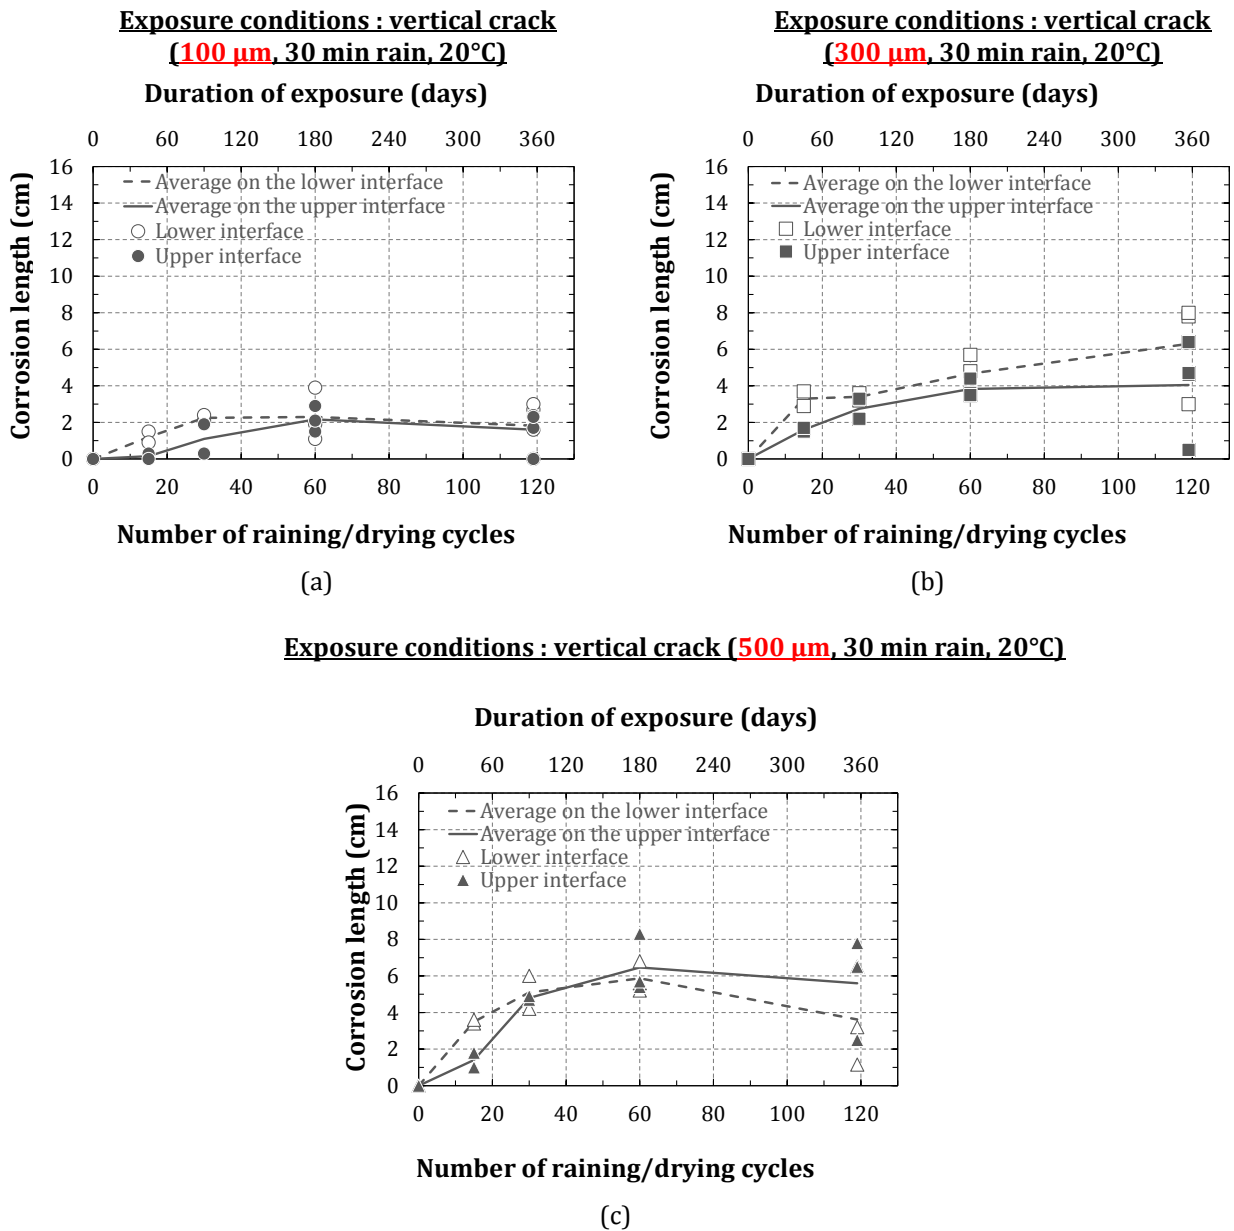
Figure 4-1 : Corrosion length along the upper and the lower steel/mortar interfaces measured during the visual inspection (naked eye)

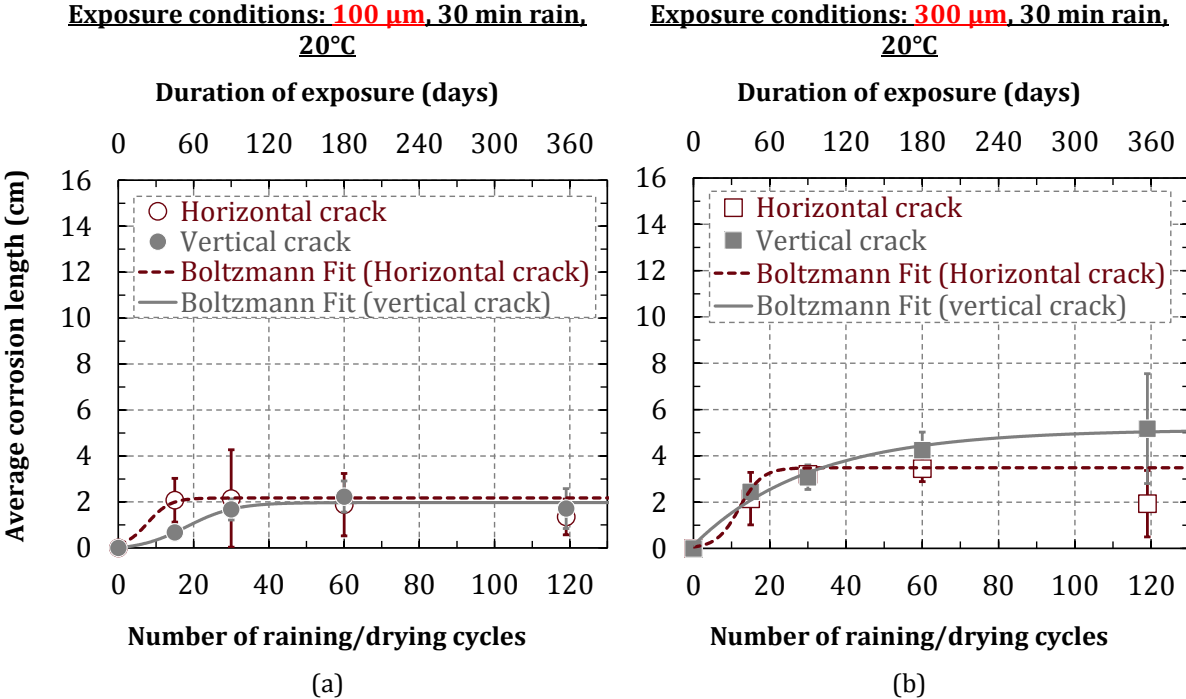
Figure 5-1: Corrosion length evolution with respect to raining/drying cycles and crack orientations (visual inspection)

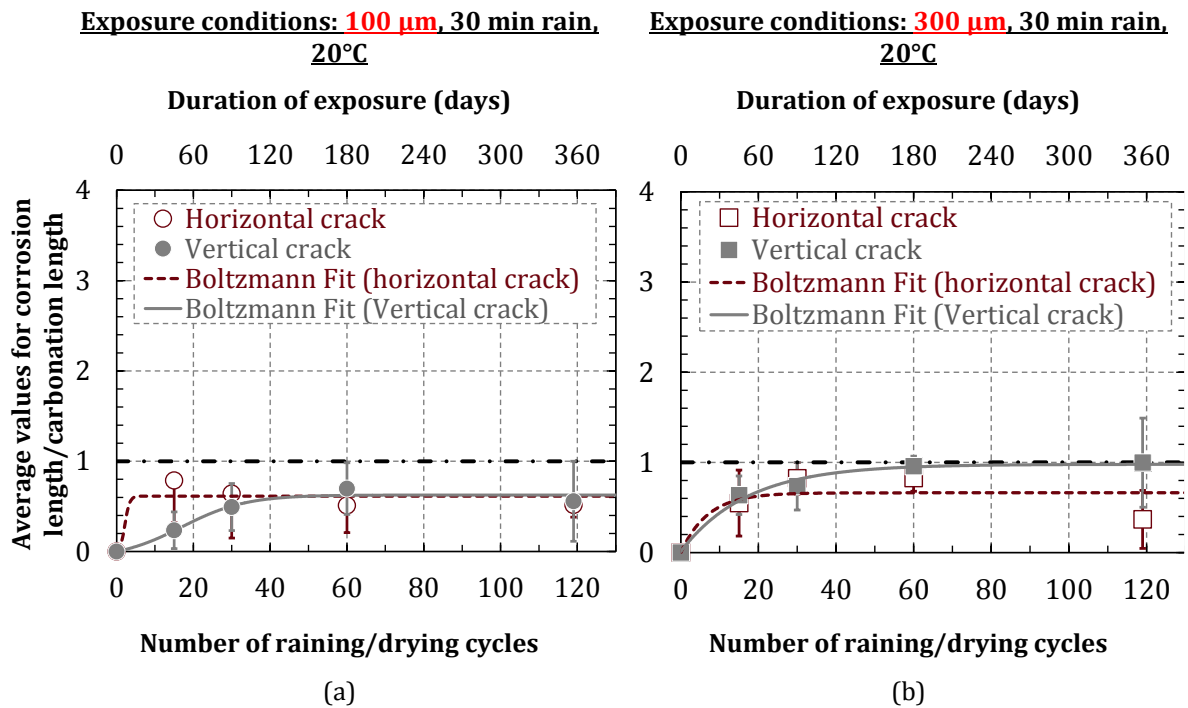
Figure 5-2: Evolution of the corrosion over carbonation length ratio with respect to raining/drying cycles and crack orientations (visual inspection)

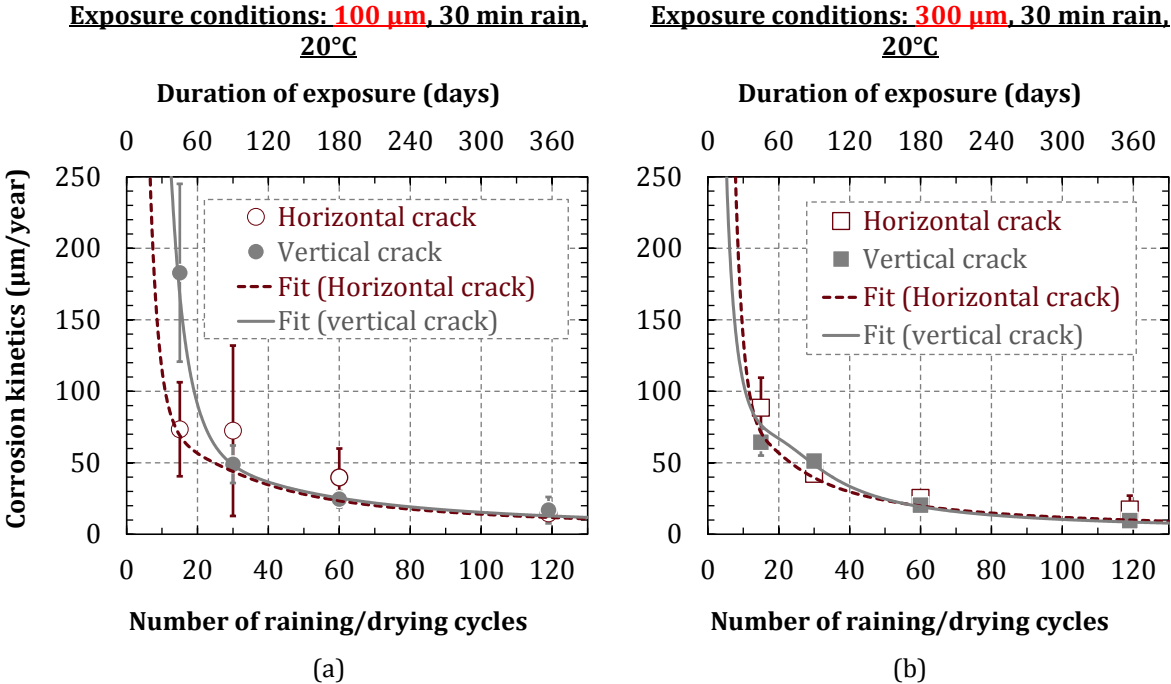
Figure 5-5: Corrosion rate evolution in specimens having different crack orientations with respect to raining/drying cycles.

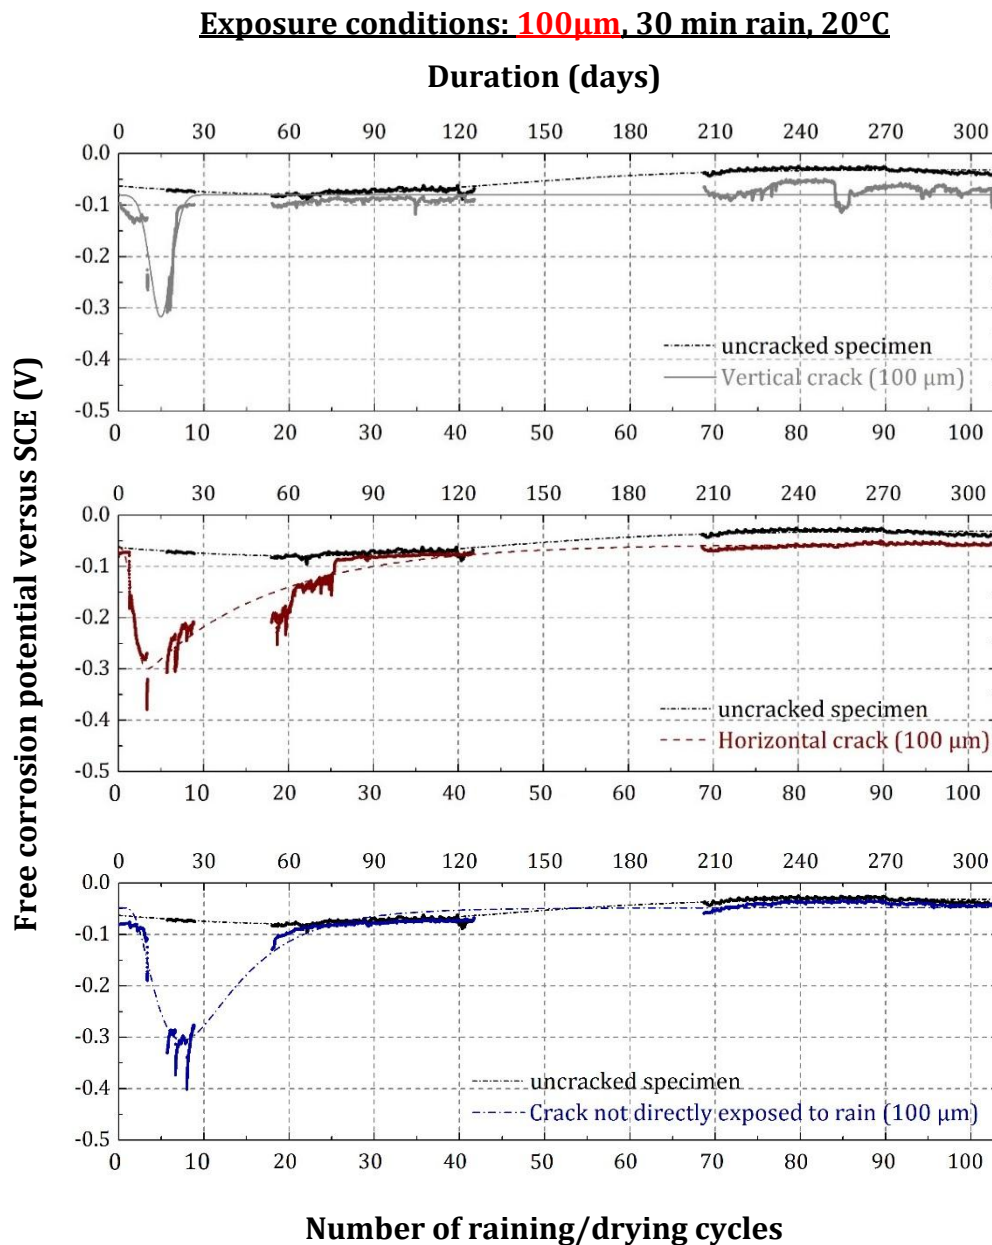
Figure 5-6: Free corrosion potential (versus SCE) measured in specimens showing 100  $\mu\text{m}$  residual crack exposed in different directions with respect to rain

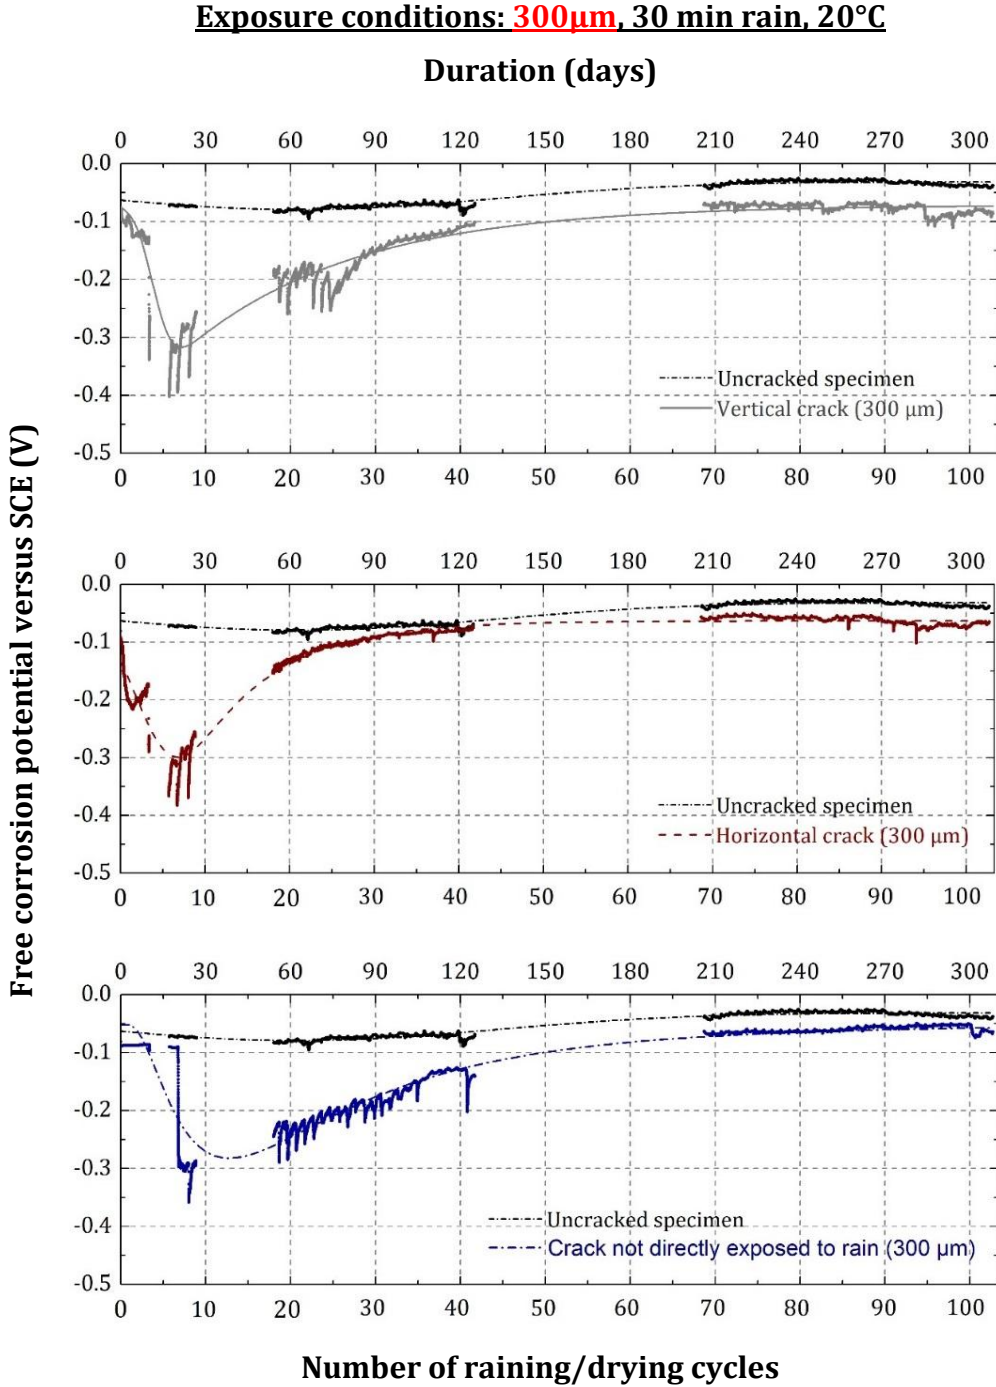
Figure 5-7: Free corrosion potential (versus SCE) measured in specimens showing 300 µm residual crack exposed in different directions with respect to rain

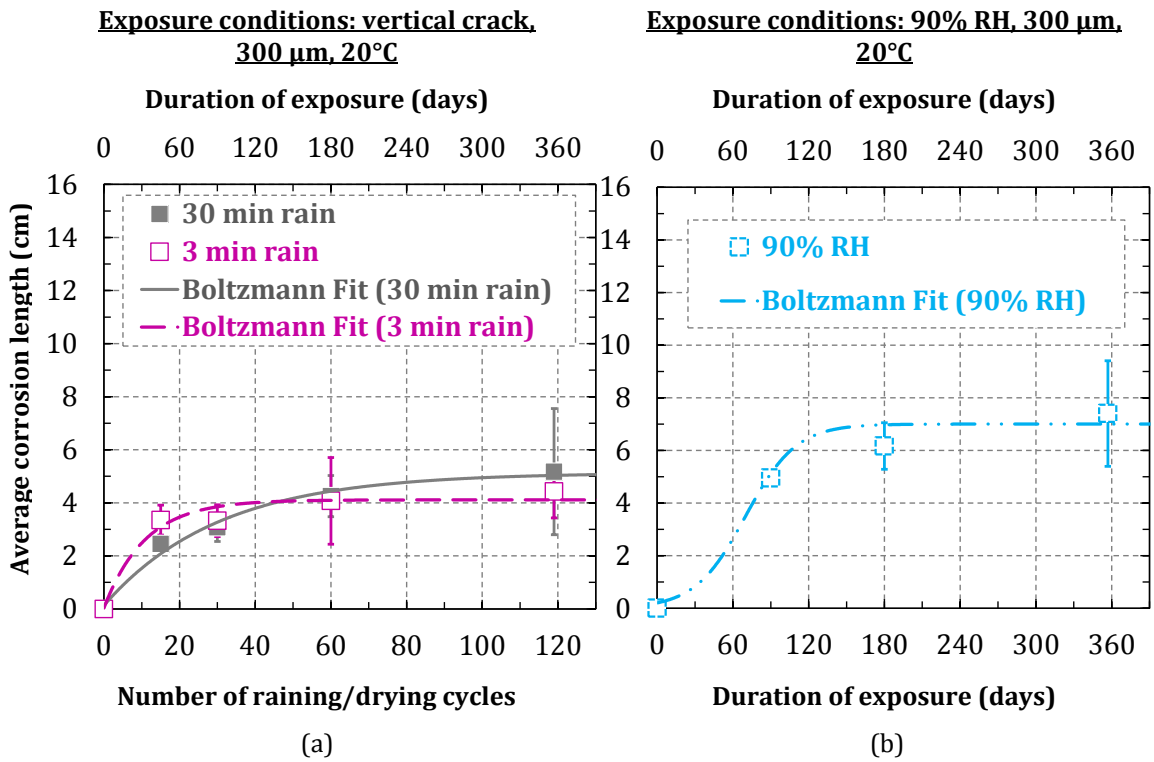
Figure 5-11: Corrosion length evolution with respect to raining/drying cycles and rain durations (visual inspection)

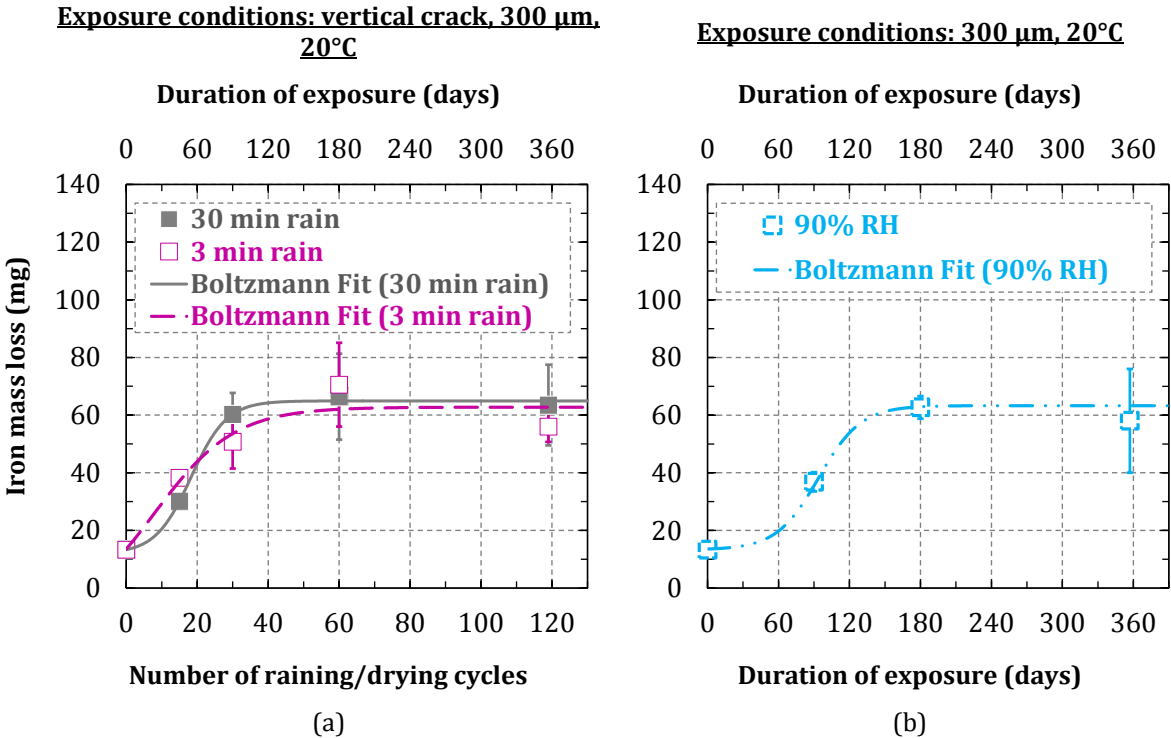
Figure 5-15: Iron mass losses in specimens subject to different durations of rainfall with respect to raining/drying cycles

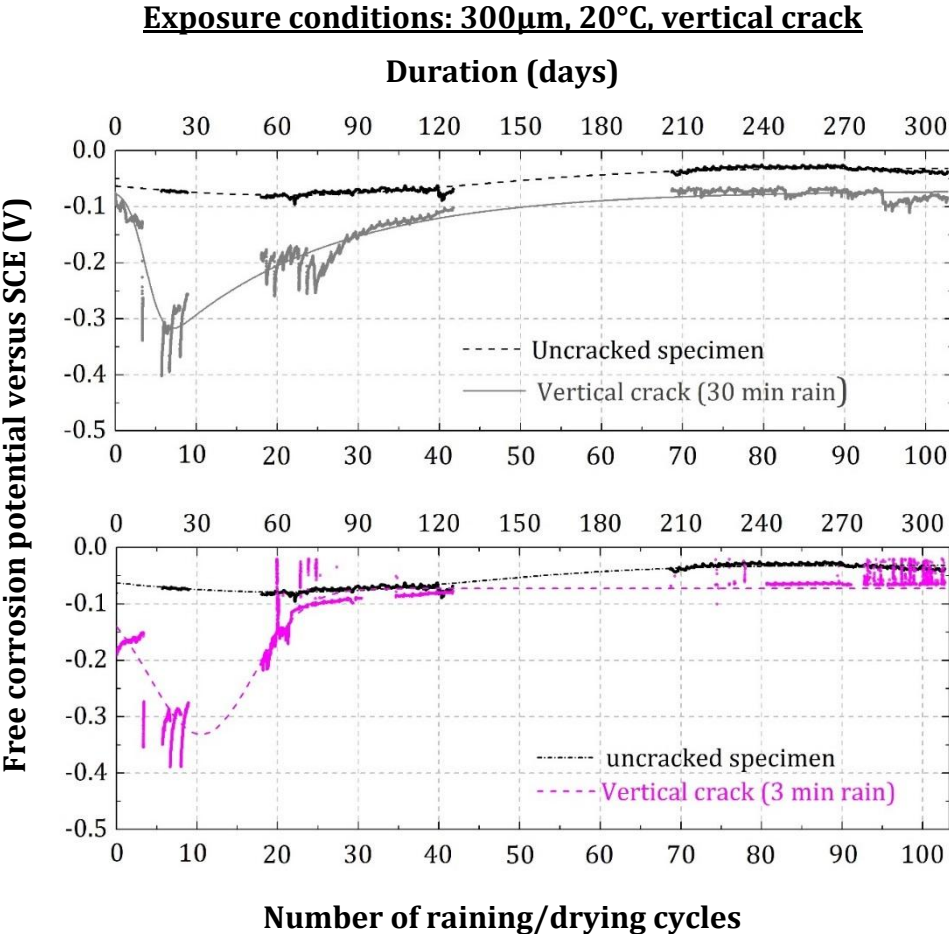
Figure 5-17: : Free corrosion potential (versus SCE) measured in specimens showing 300 µm residual crack width and exposed to different raining durations

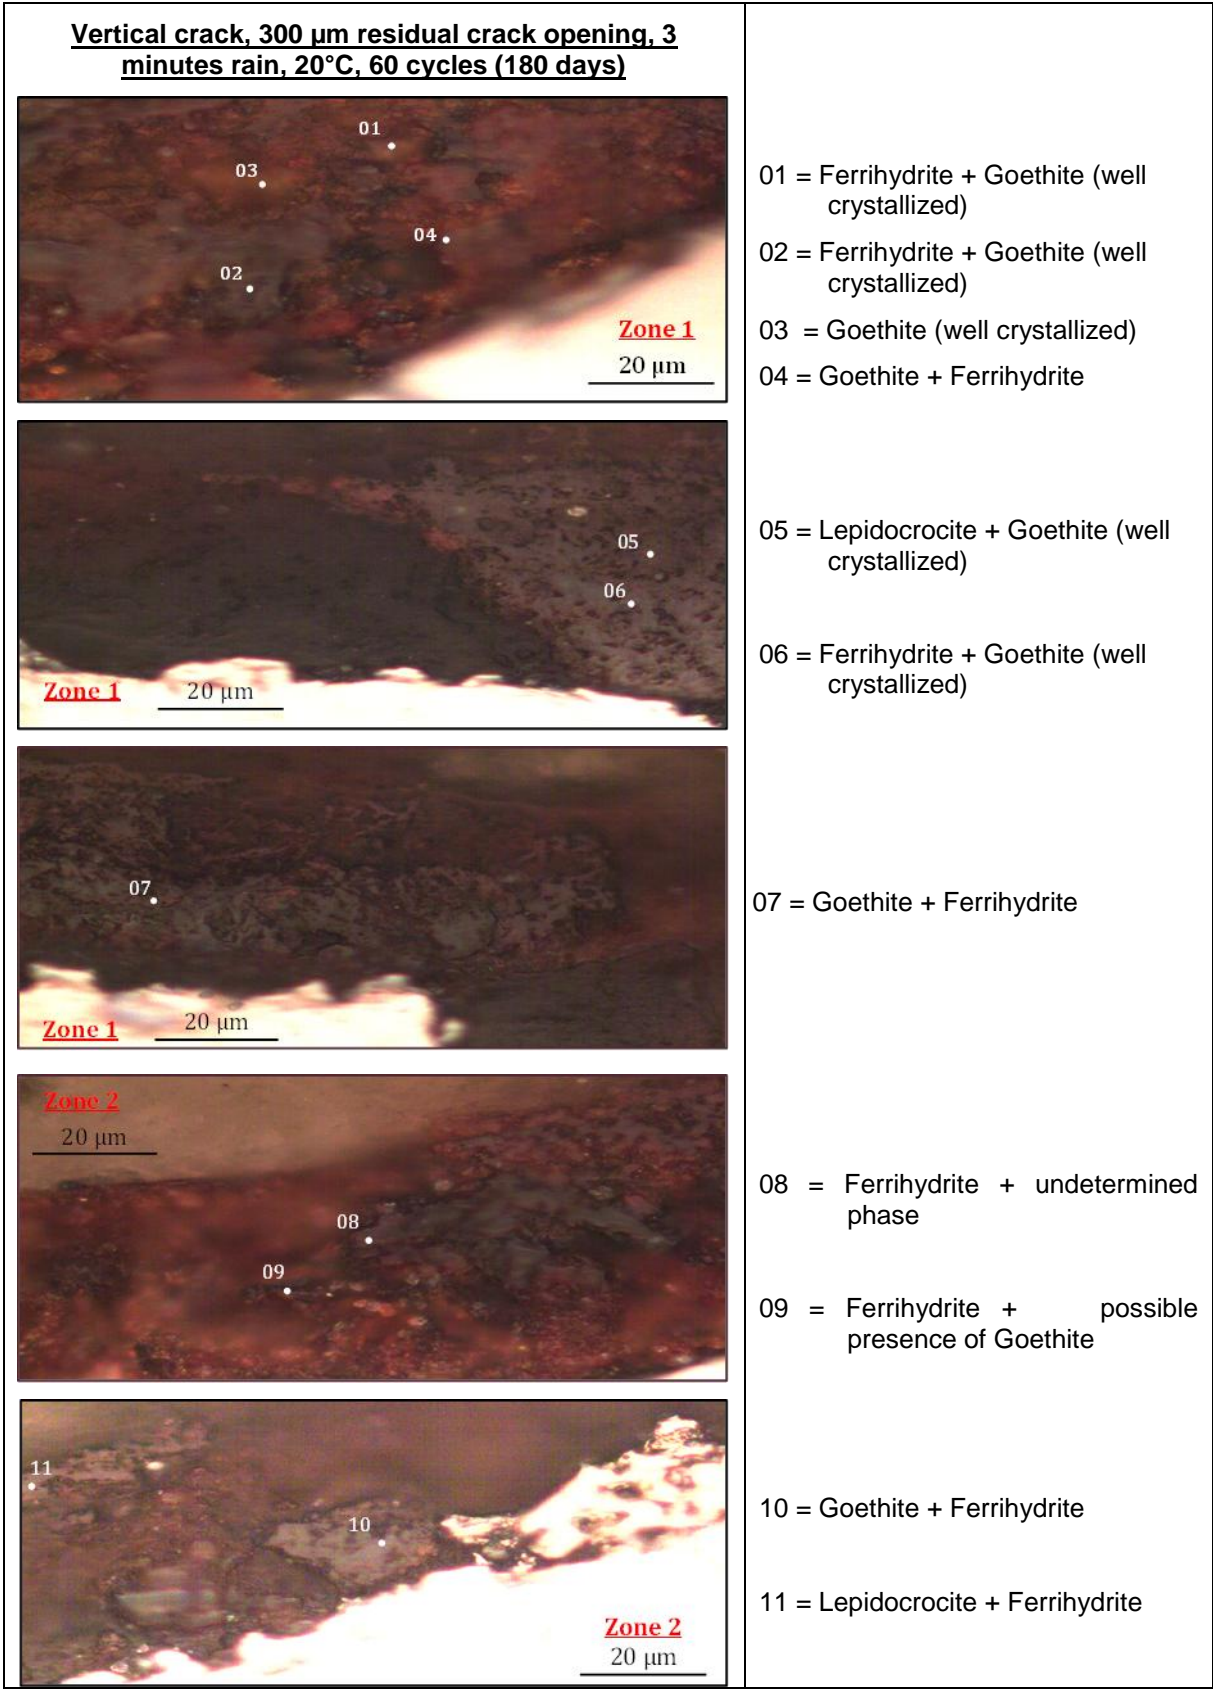
Figure 5-18: Corrosion layer observed at steel/mortar interfaces located far from the crack and deep in the crack in specimens having 300 μm residual crack width and exposed to 3 minutes rain in each raining/drying cycle.

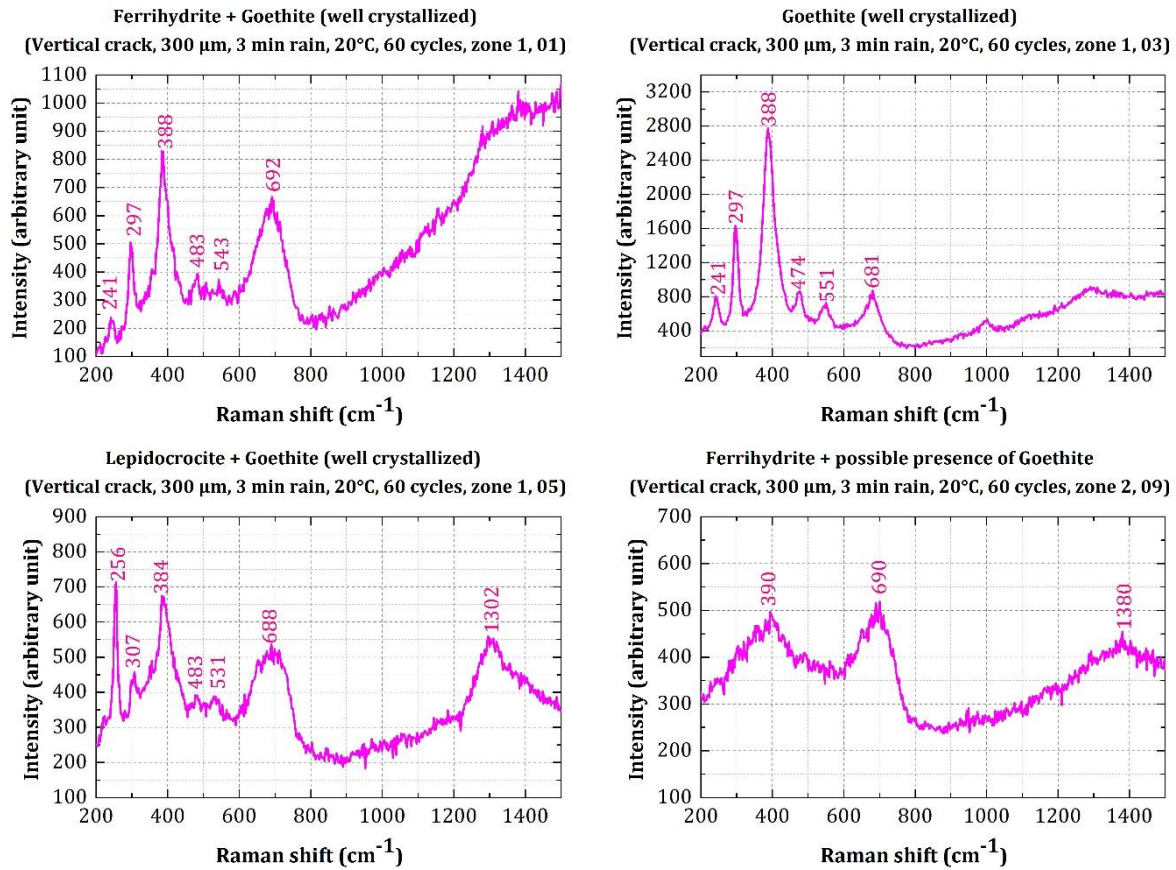
Figure 5-20: Raman spectra of corrosion products obtained on specimens having 300  $\mu\text{m}$  residual crack width and subjected to 3 minutes rain at each raining/drying cycle.
