# Identification of initiation and propagation phases of steel corrosion in cracked and carbonated concrete

Rita Maria Ghantous. Identification of initiation and propagation phases of steel corrosion in cracked and carbonated concrete. Civil Engineering. INSA de Toulouse, 2016. English. NNT : 2016ISAT0031 . tel-02043212

Identification des phases d'initiation et de propagation de la corrosion  
des armatures enrobées dans un béton fissuré et carbonaté

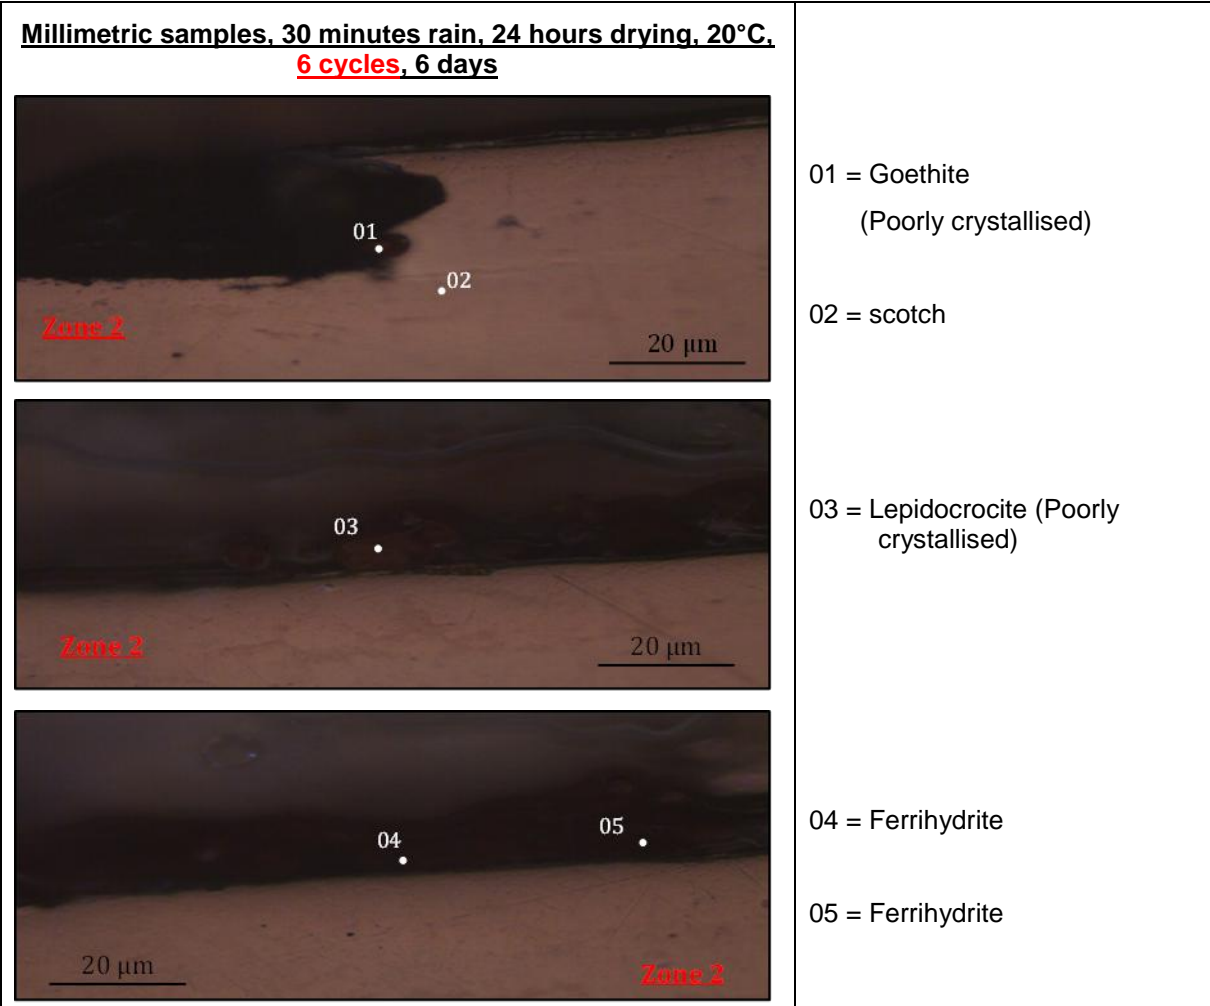
Figure 5-50: Corrosion layer observed at the upper part of the steel/mortar interface of millimetric sample subjected to 6 wetting/drying cycles

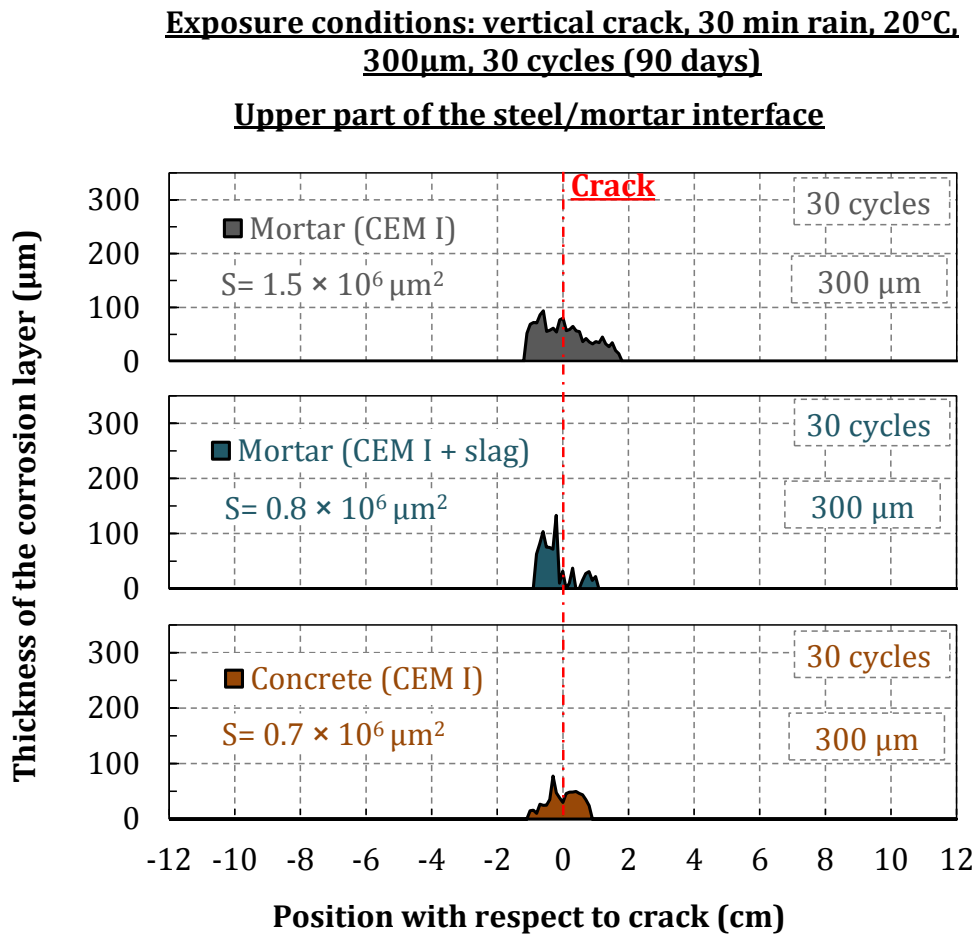
Figure 6-4: Corrosion products repartition obtained on specimens with different materials type (optical microscopy)

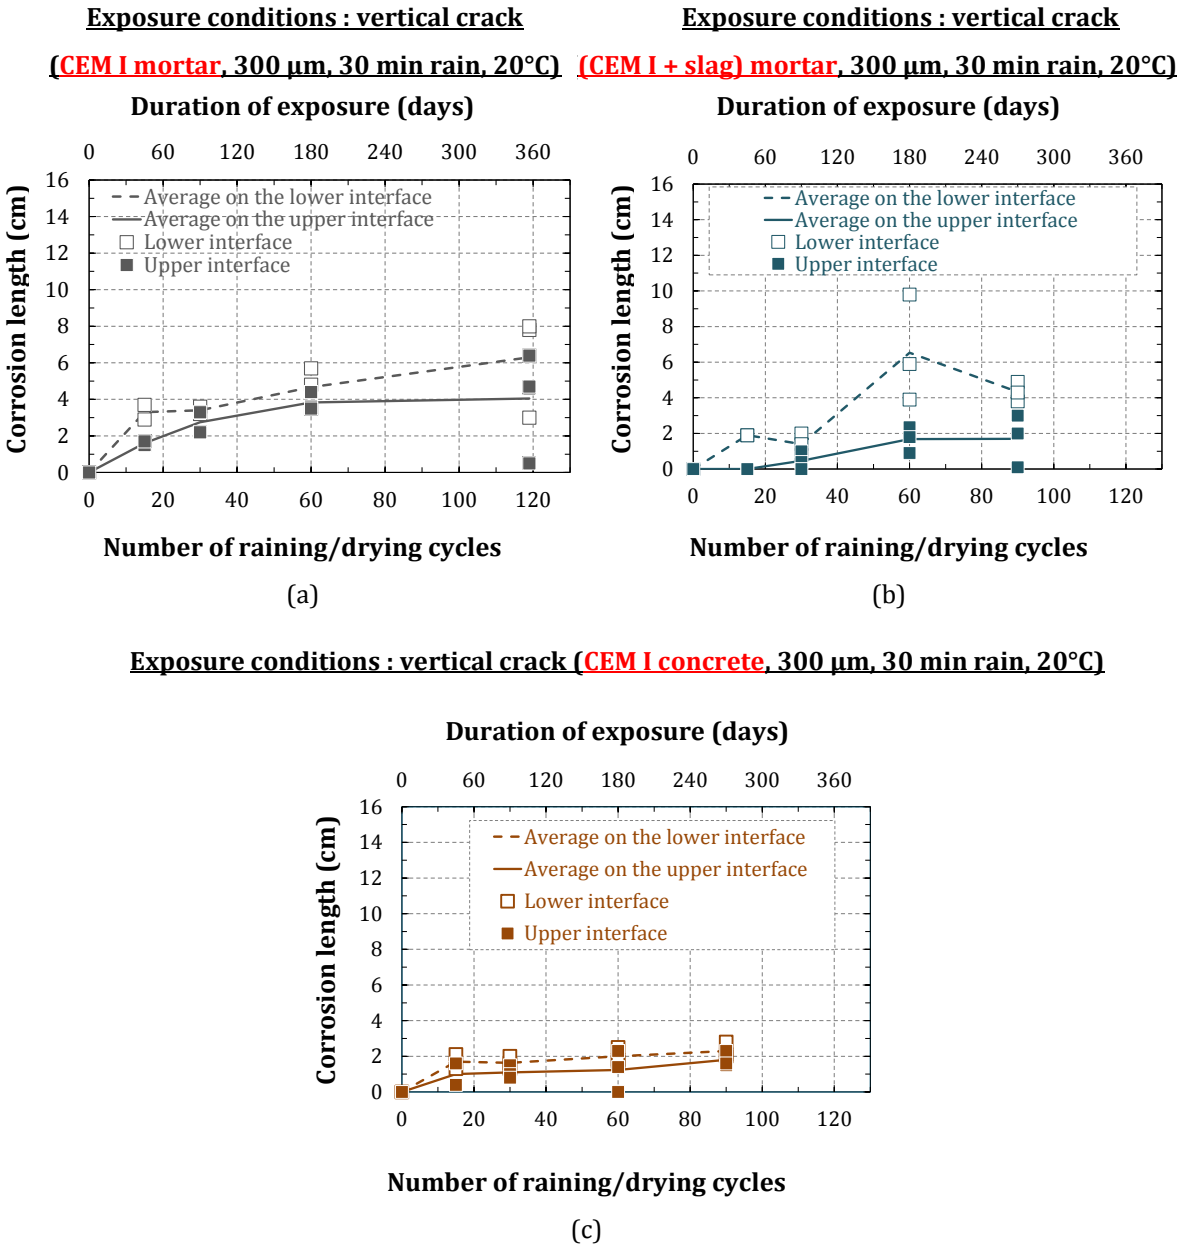
Figure 7-5 : Evolution of the corrosion length measured on the upper and the lower steel/mortar interfaces of specimens with different materials type (visual inspection)

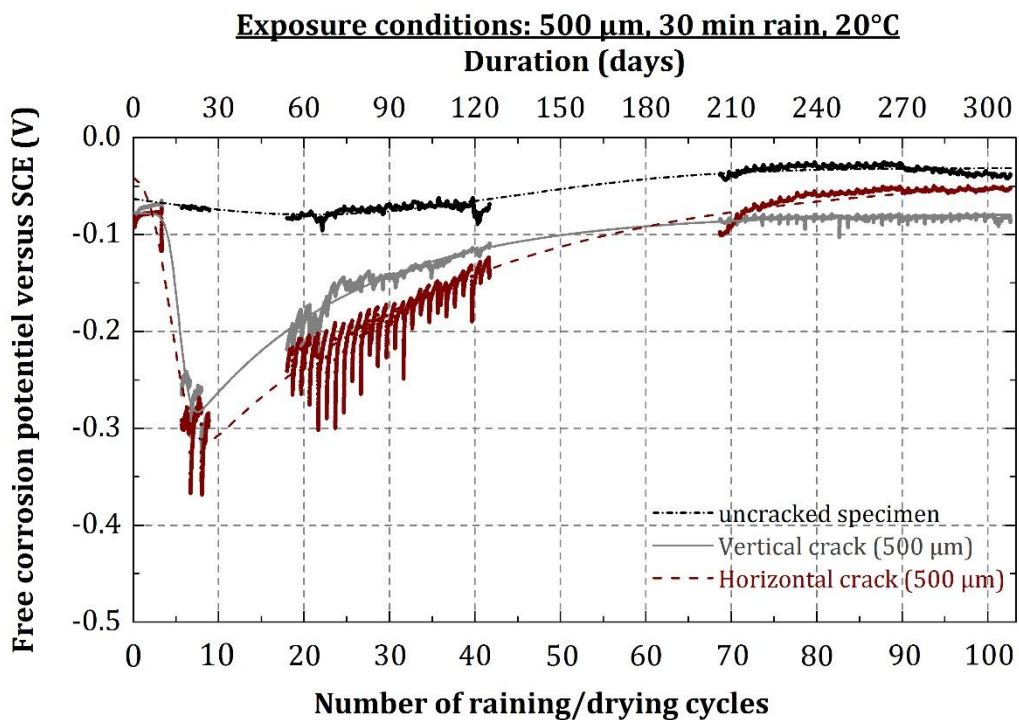
Figure I-35 : Free corrosion potential (versus SCE) measured in specimens showing 500  $\mu\text{m}$  residual crack exposed in different directions with respect to rain

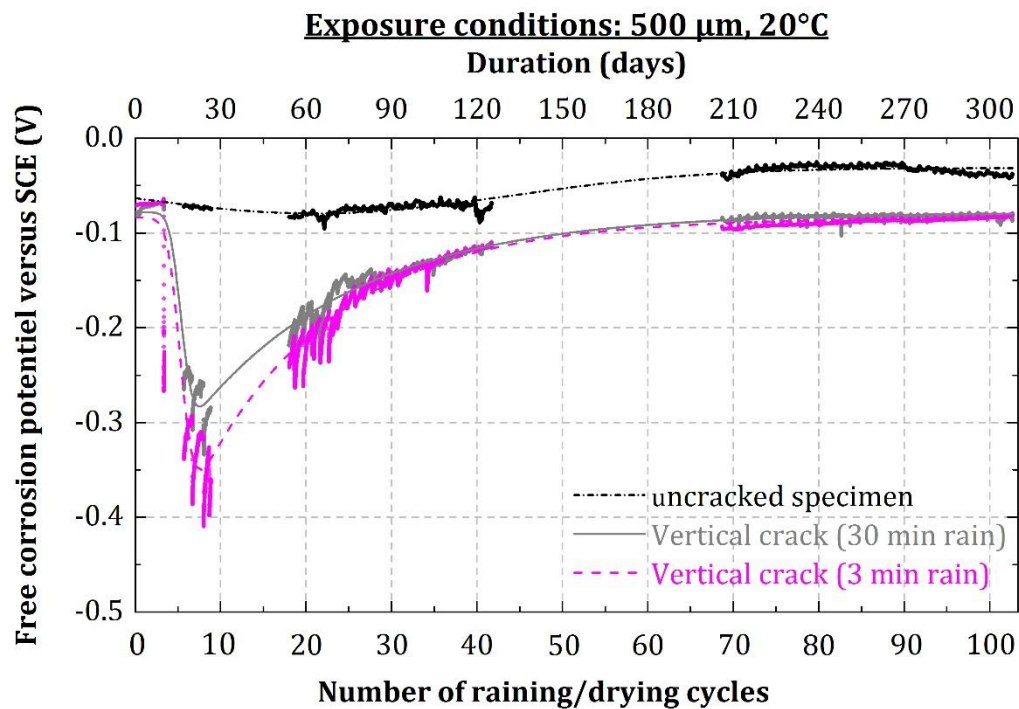
Figure I-37: Free corrosion potential (versus SCE) measured in specimens showing 500  $\mu\text{m}$  residual crack width exposed to different raining durations

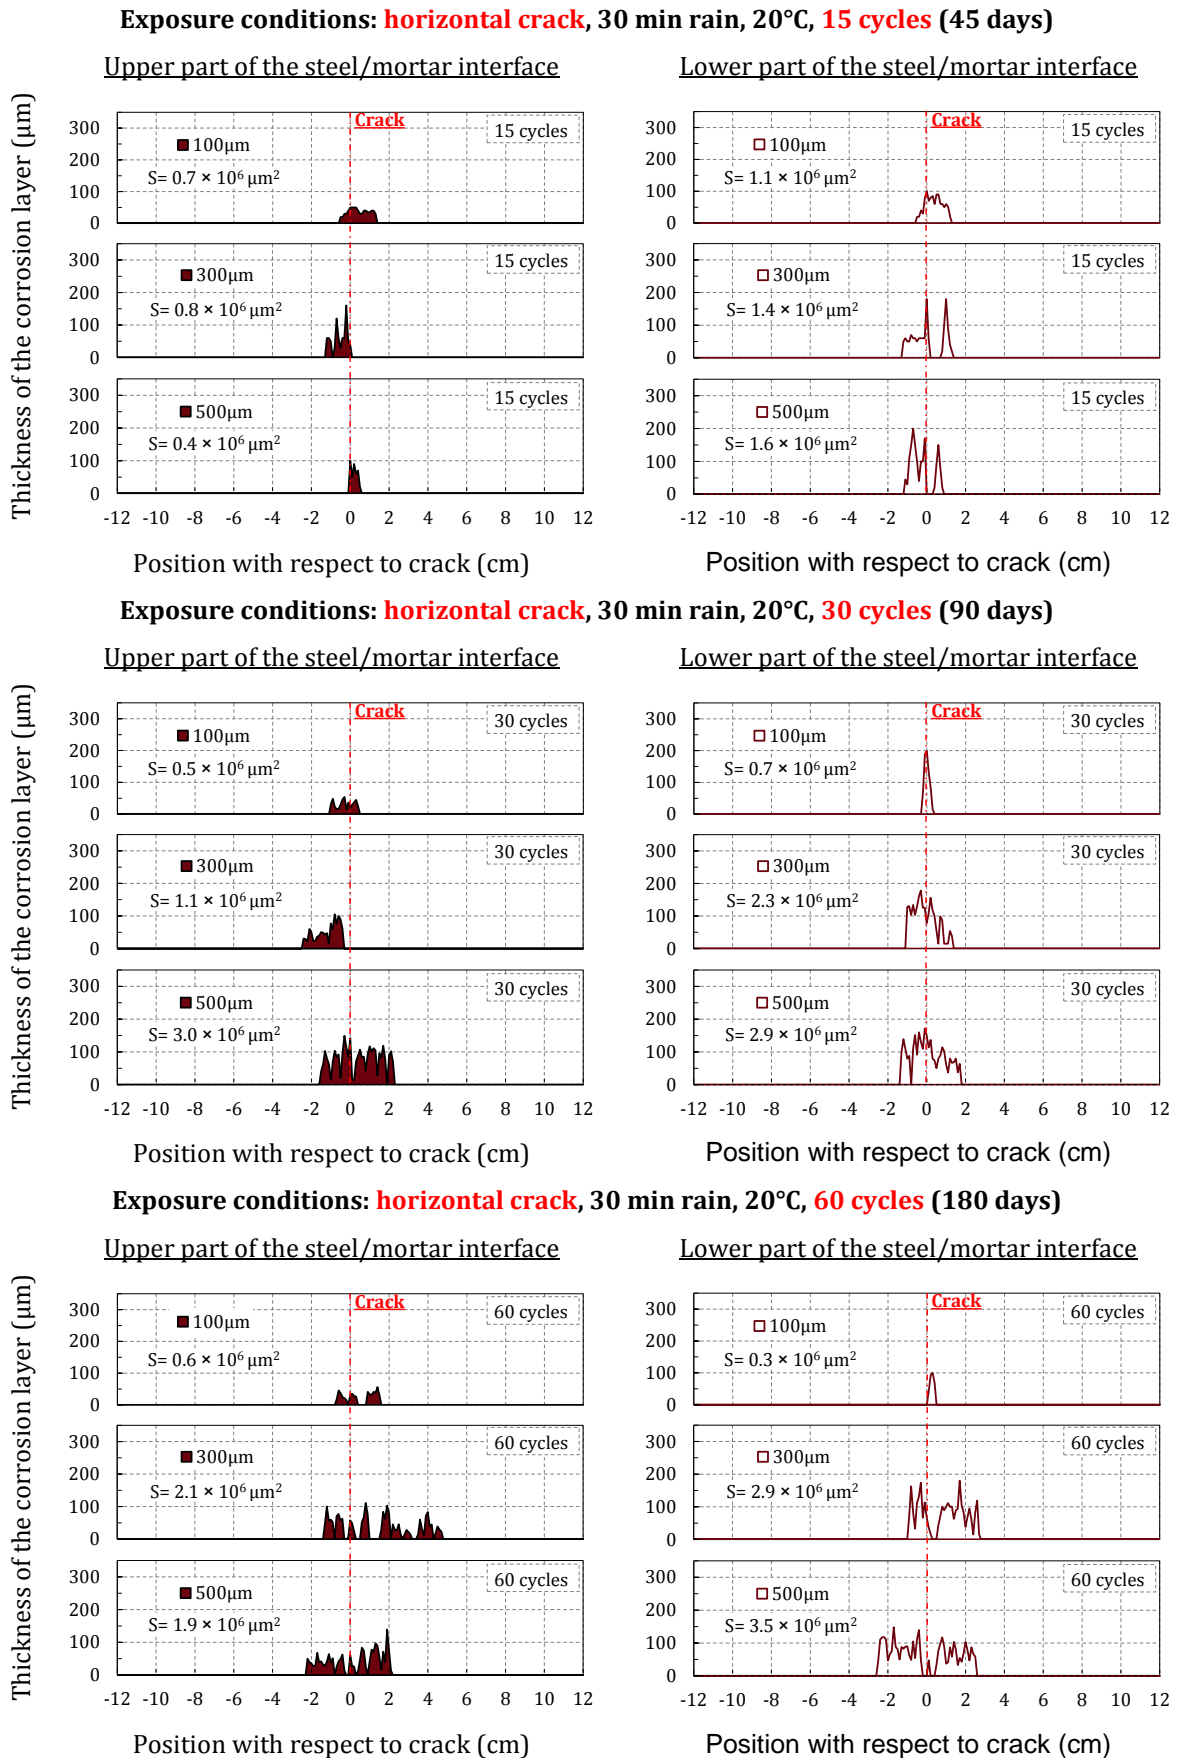
Figure I-39: Corrosion products repartition on the upper and the lower steel/mortar interfaces of specimens exposed horizontally with respect to rain (15, 30, 60 raining/drying cycles)

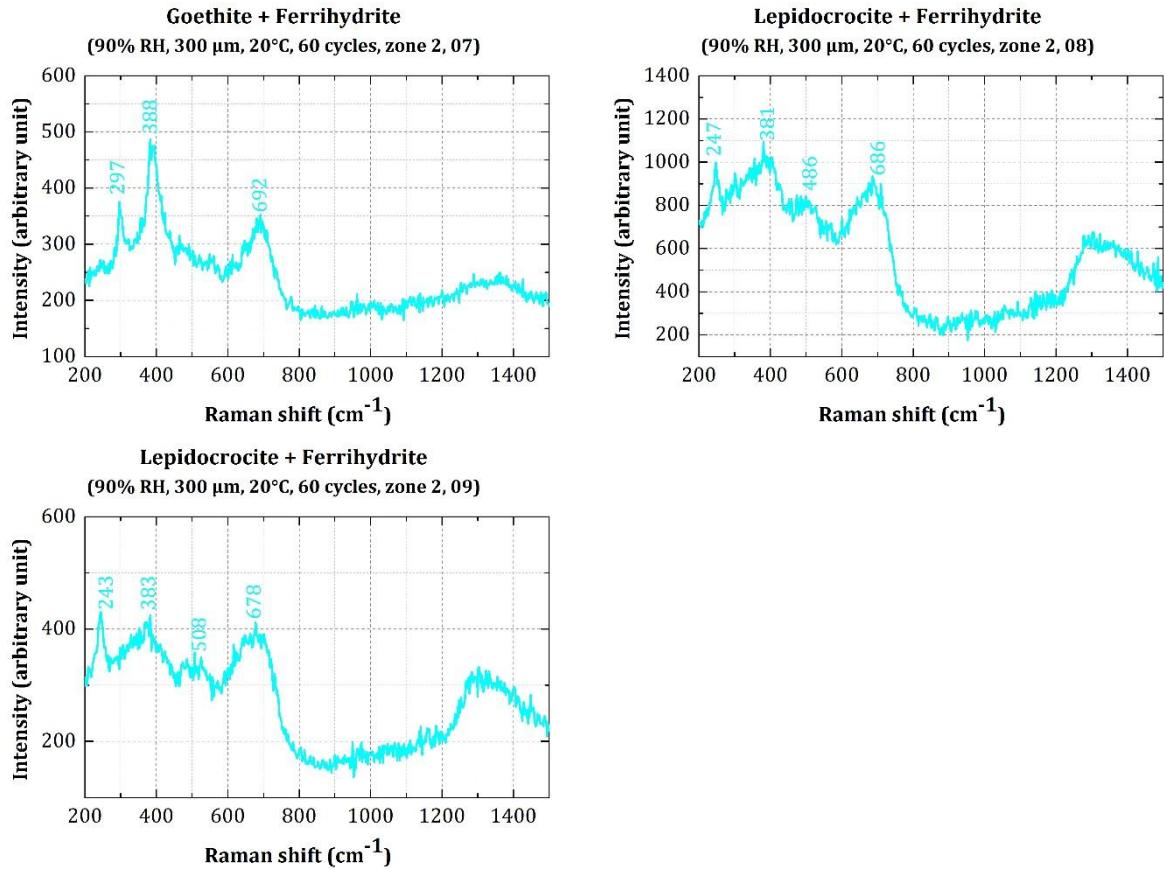
Figure I-54: All the Raman spectra of corrosion products obtained on specimens having 300 μm crack width and subjected continuously to 90% RH

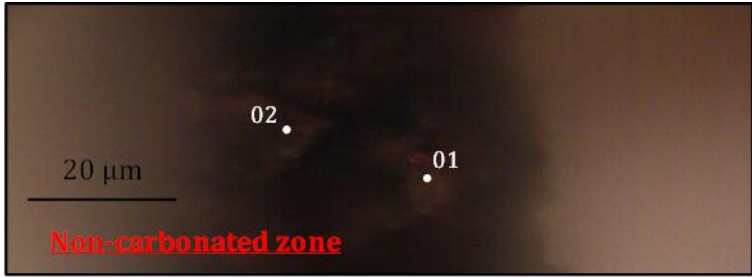
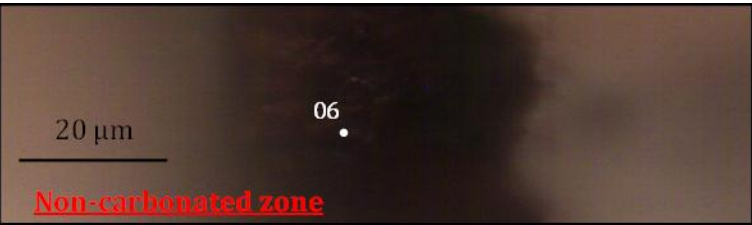
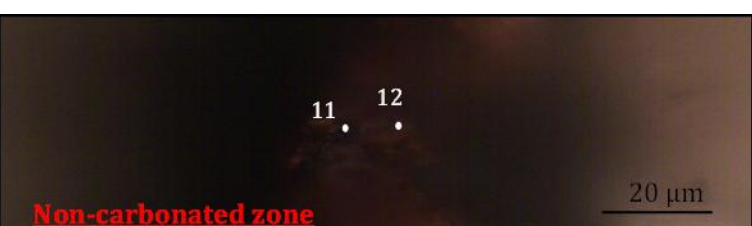
<u>Vertical crack, 300 <math>\mu\text{m}</math>, 30 min rain, 40°C, 60 cycles, non-carbonated zone</u>

<p>01 = Ferrihydrite</p> <p>02 = Lepidocrocite</p>

<p>06 = Ferrihydrite + Goethite (well crystallized)</p>

<p>11 = Lepidocrocite + Goethite + possible presence of Ferrihydrite</p> <p>12 = Lepidocrocite + Goethite + possible presence of Ferrihydrite</p>

Figure I-56: Corrosion layer observed at steel/mortar interface located in the non-carbonated zone of specimens having 300  $\mu\text{m}$  crack width and corroded under raining/drying cycles at 40°C

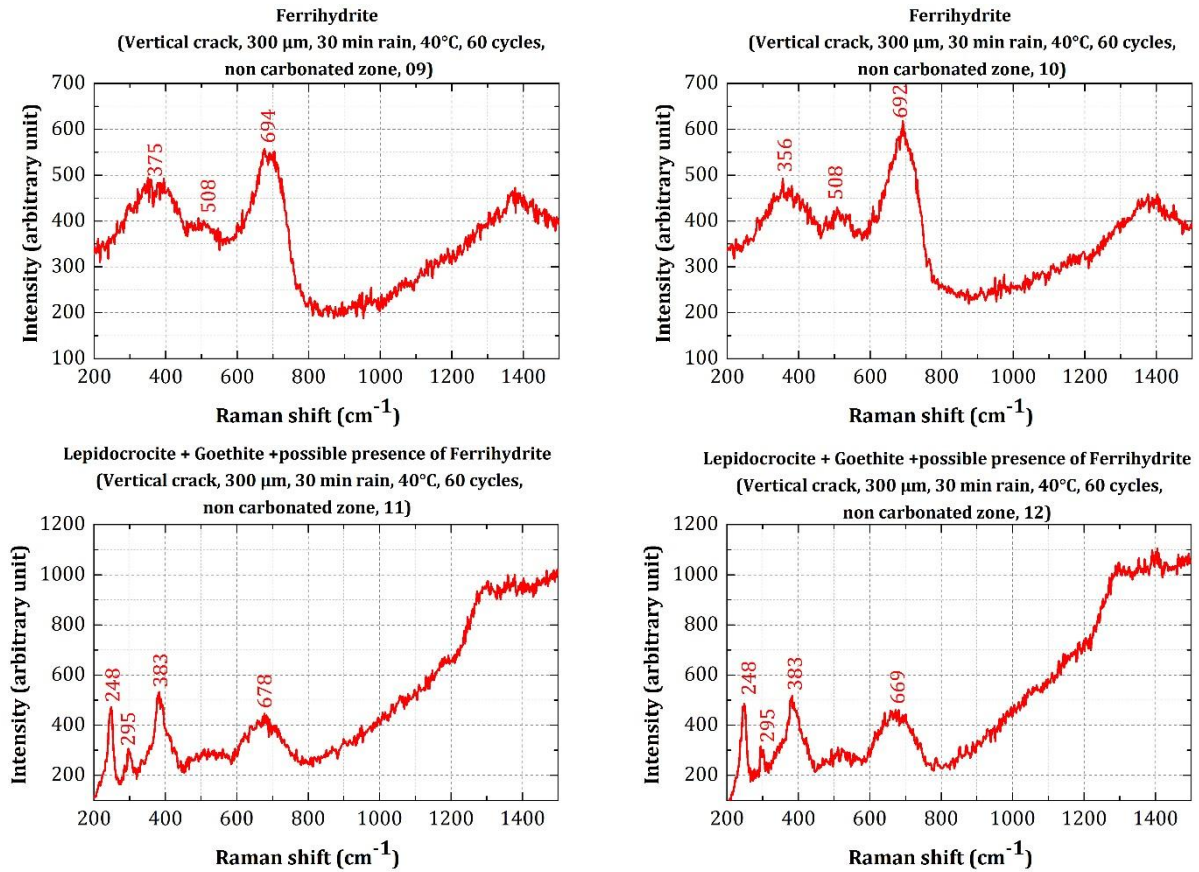
Figure I-57: All the Raman spectra of corrosion products obtained on specimens having 300  $\mu\text{m}$  crack width and corroded at 40°C under raining/drying cycles of 30 minutes rain each (in the non-carbonated area)
