# Advance on Non-Destructive Evaluation methodologies for the material characterization and damage monitoring of masonry structures

DOCTEUR DE L'UNIVERSITÉ DE BORDEAUX

**ADVANCE ON NON-DESTRUCTIVE  
EVALUATION METHODOLOGIES FOR THE  
MATERIAL CHARACTERIZATION AND DAMAGE  
MONITORING OF MASONRY STRUCTURES**

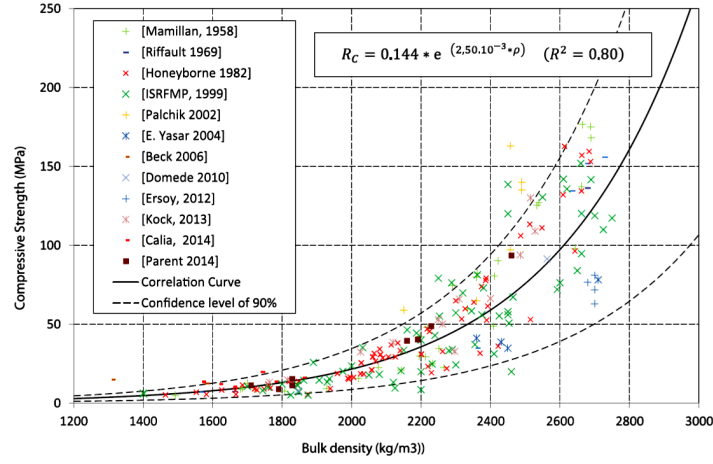
Figure 1.4: Compressive strength vs. bulk density [Parent et al., 2015]

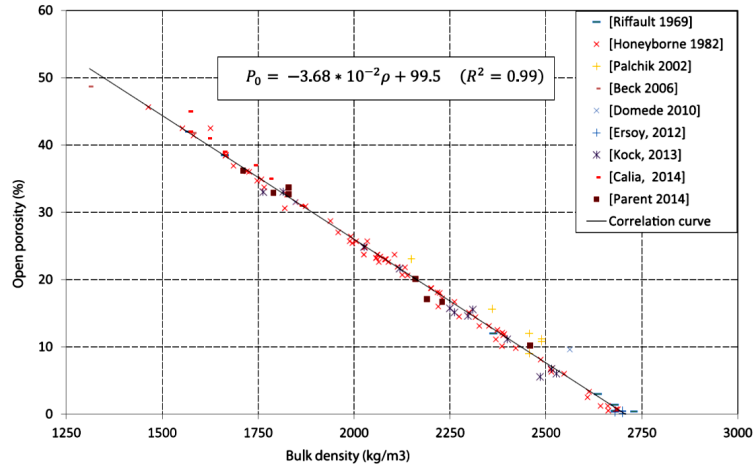
Figure 1.5: Open porosity vs. bulk density [Parent et al., 2015]

Fig 1.5 [Parent et al., 2015].

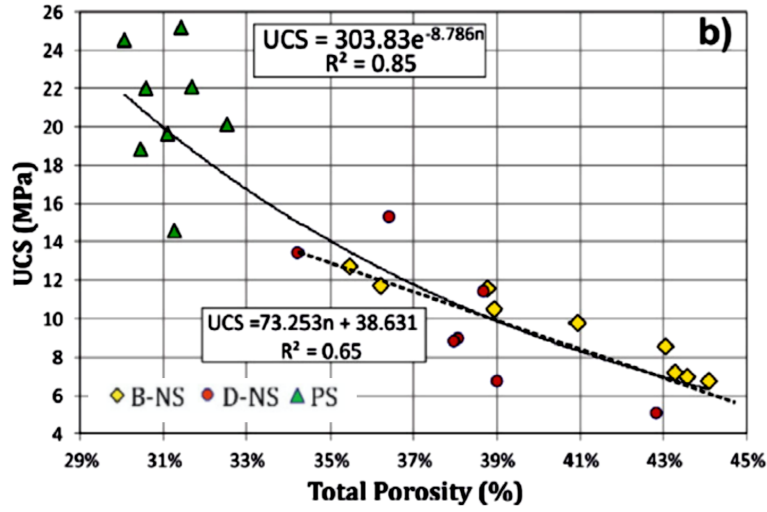
Figure 1.6: Evolution of UCS with porosity[Pappalardo et al., 2016]

the porosity of stone. In the Fig 1.6, an exponential law illustrates the decrease of the compressive strength with an increasing porosity, the similar tendency is observed in the modulus of elasticity (Fig 1.7). Meanwhile due to the heterogeneity of material and the non-uniform distribution of microfossils, the average value is not always representative, thus he suggested that the extreme value must be taken into consideration for the engineering characterization, in order to avoid either underestimation or overestimation of rock mechanical properties[Pappalardo et al., 2016].

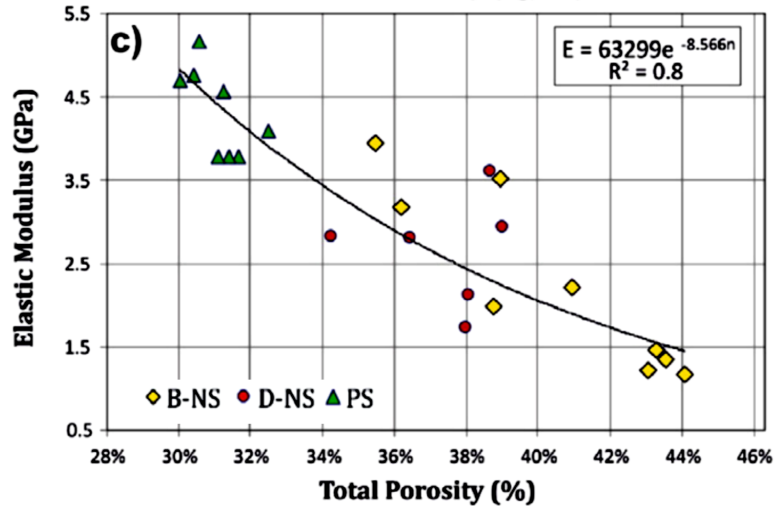
Figure 1.7: Elastic modulus vs. porosity[Pappalardo et al., 2016]

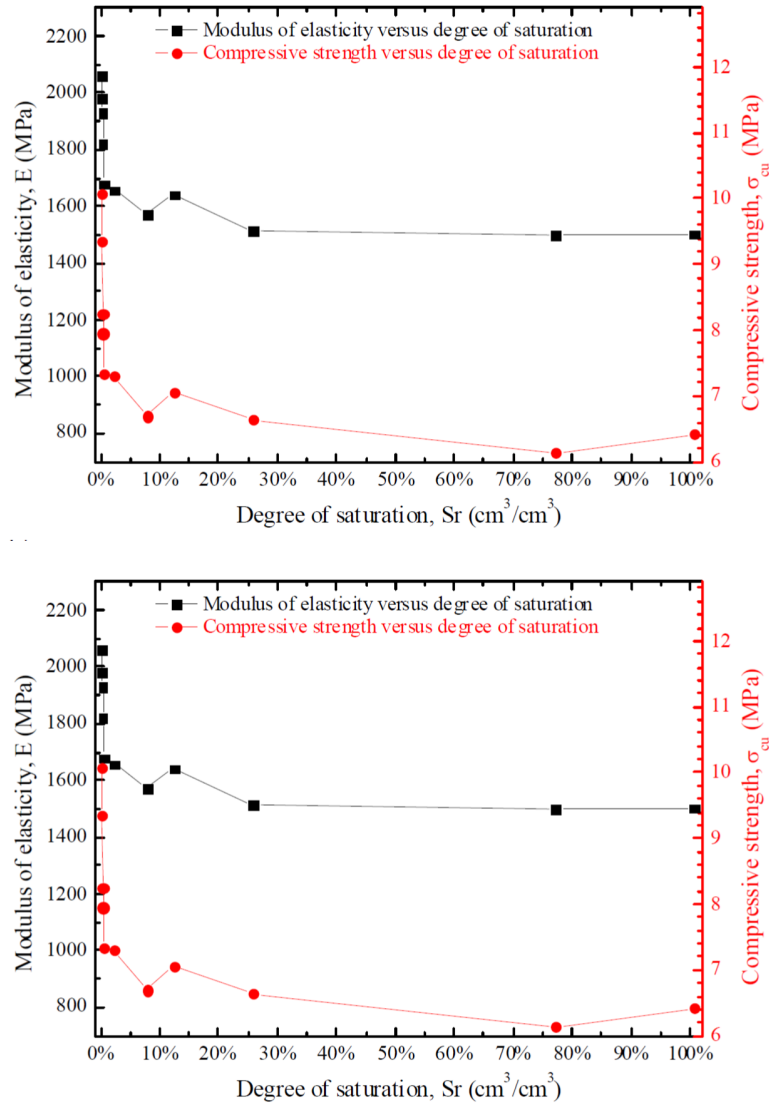
Figure 1.8: Compressive strength/modulus of elasticity vs. degree of saturation for (a) ‘White Tuffeau’ and (b) ‘Sébastopol’ stone[Beck et al., 2007]

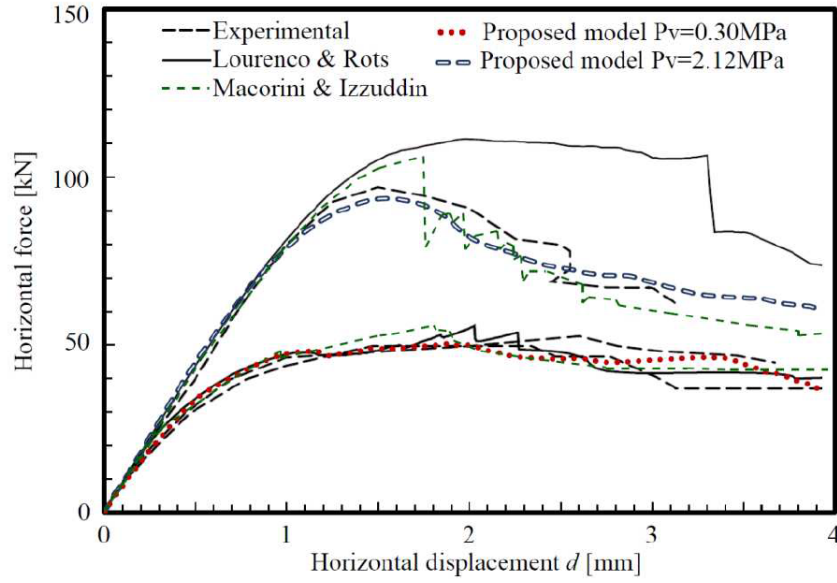
Figure 1.22: Experimental – numerical comparisons of the load – displacement curves for the masonry wall panels loaded in plane[D’Altri et al., 2018]

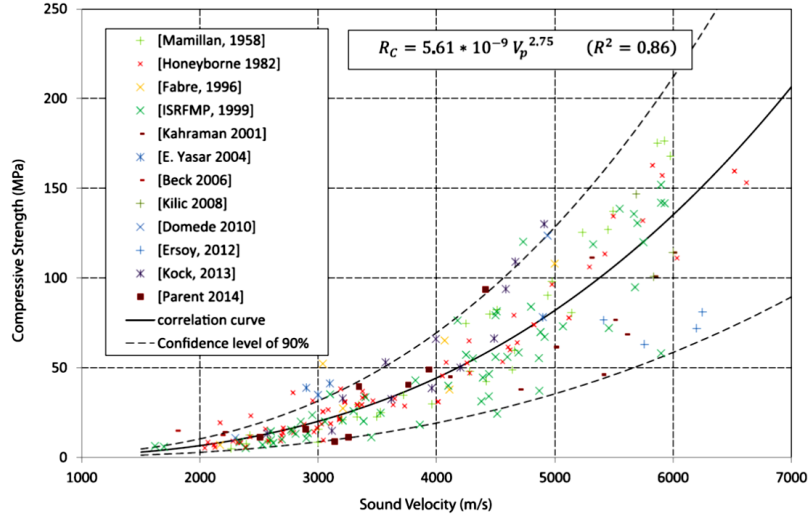
Figure 1.24: Compressive strength vs. sound velocity[Parent et al., 2015]
