# Do biotic and abiotic factors combine to affect the weathering of wood in use class 3 ?

# THESE DE DOCTORAT DE

**Les facteurs biotique et abiotique interagissent-ils pendant le vieillissement du bois utilisé en classe d'emploi 3 ?**

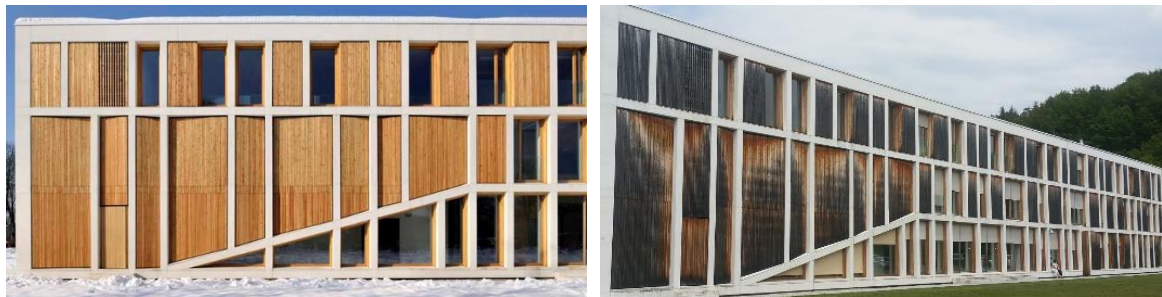
Figure 1: Façade of the Biotechnical faculty of the University of Ljubljana shortly after construction (Source: [https://www.e-architect.com/images/stories/slovenia/biotechnical\\_faculty\\_ljubljana\\_k260510\\_m4tb.jpg](https://www.e-architect.com/images/stories/slovenia/biotechnical_faculty_ljubljana_k260510_m4tb.jpg)) (left) and after 8 years of exposure (right)

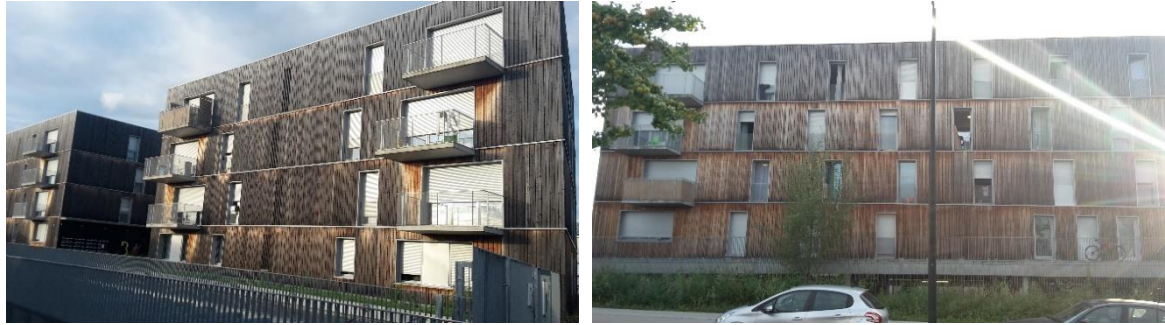
Figure 2: Wooden façades in Nantes. Exposure towards south-west (left) and north-east (right)

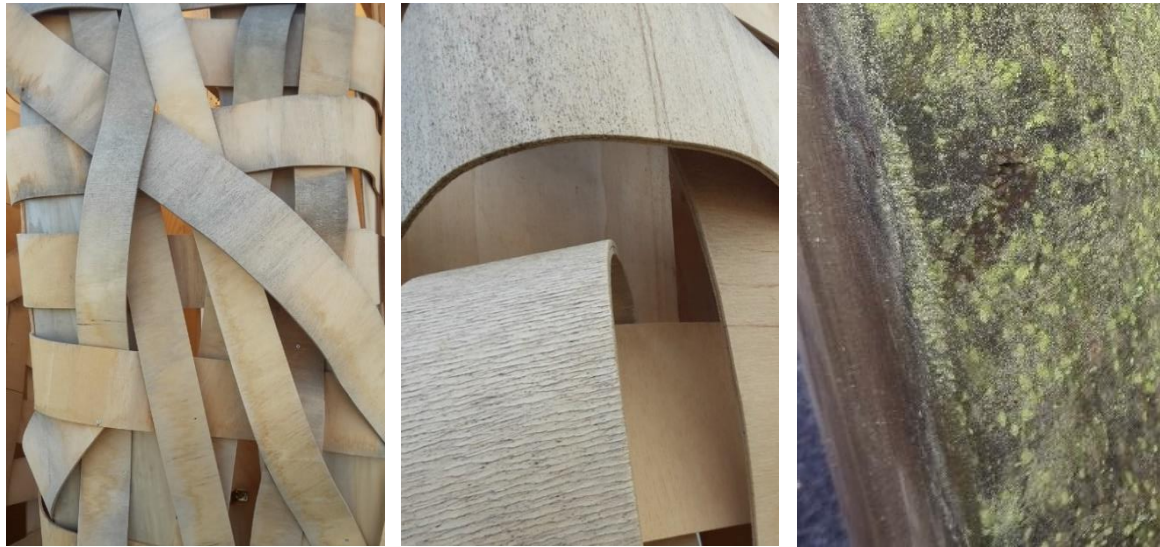
Figure 4: Wood exposed and attacked by fungi, visible to the naked eye

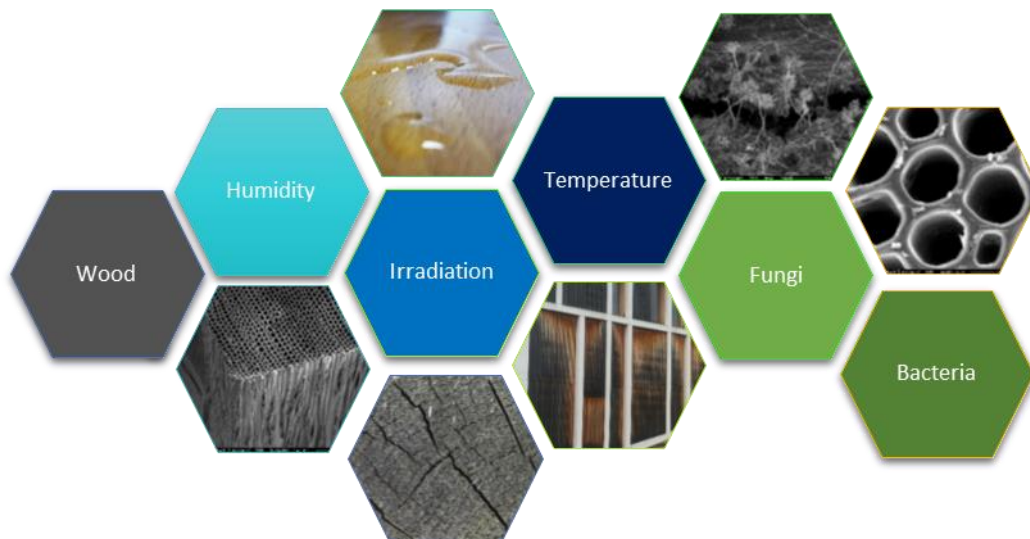
Factors that influence the degradation process of wood surfaces, and that are taken into account within this research, are the wood itself; with its specific anatomical and chemical features; the humidity, light irradiation, temperature and microorganisms such as fungi and bacteria (as shown in Figure 9).

Figure 9: Abiotic and biotic wood degrading factors studied within the research

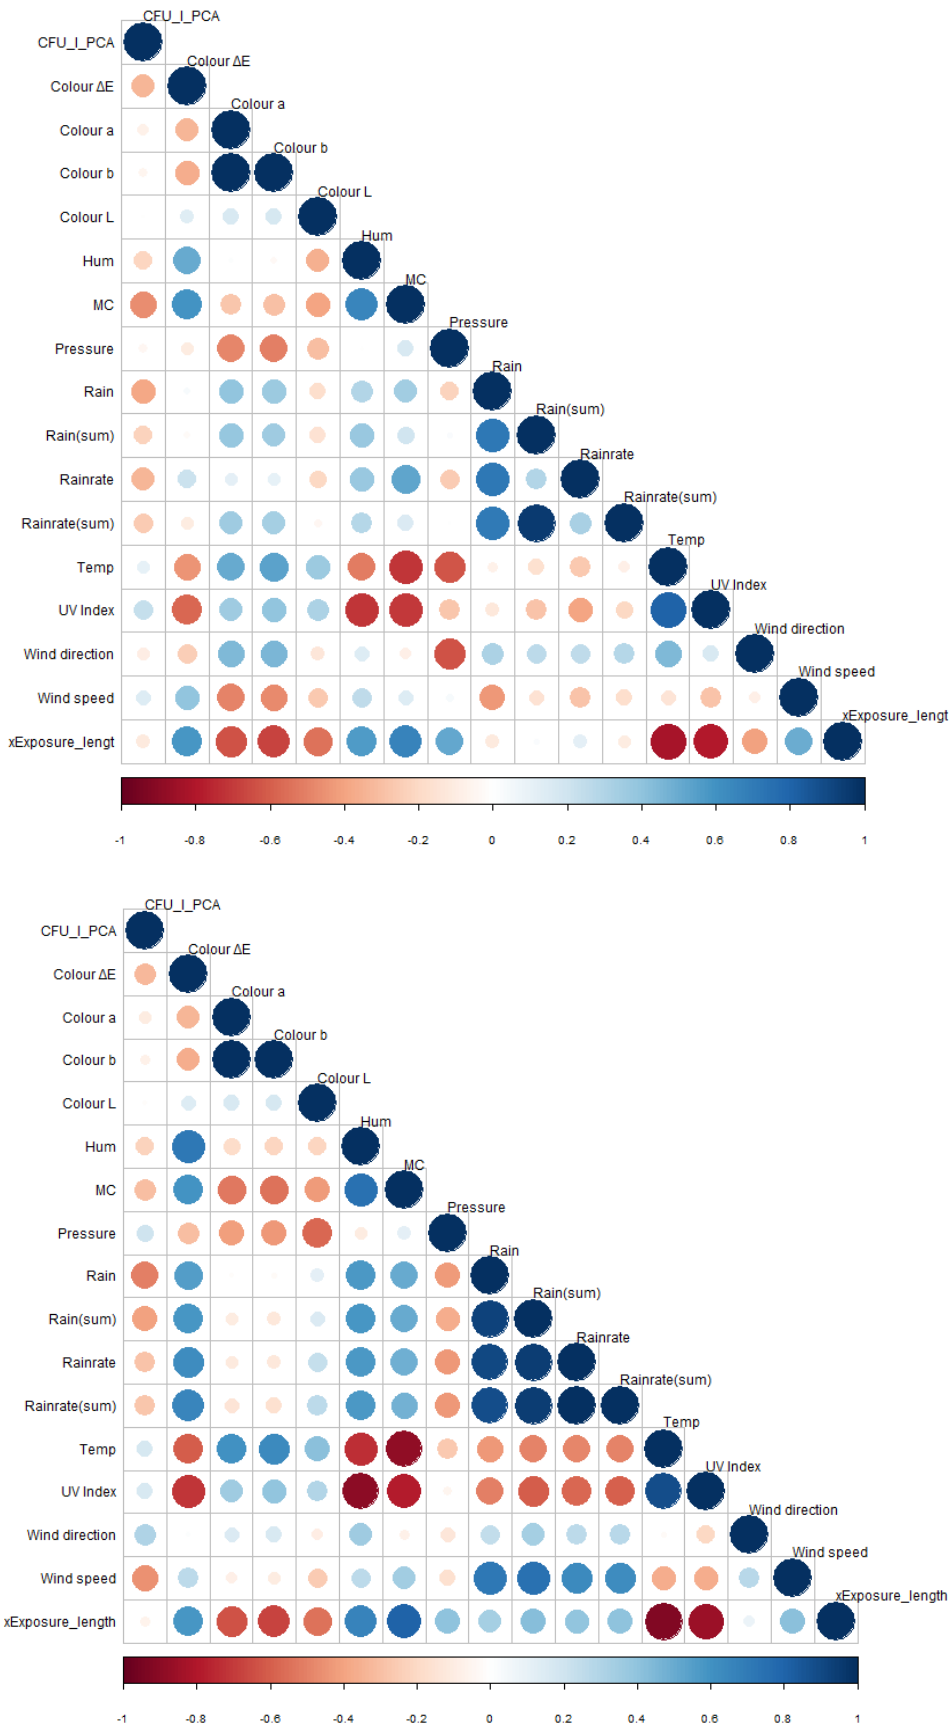
Figure 28: Heatmaps showing Pearson correlation of *df\_3h* (top) and *df\_weekly* (bottom) for Douglas fir. Legend: CFU\_I\_PCA: Number of CFU on PC-agar recovered from samples exposed from summer 2019 onwards, Hum: Air humidity, MC: Wood MC, Pressure: Atmospheric pressure, Temp: Temperature

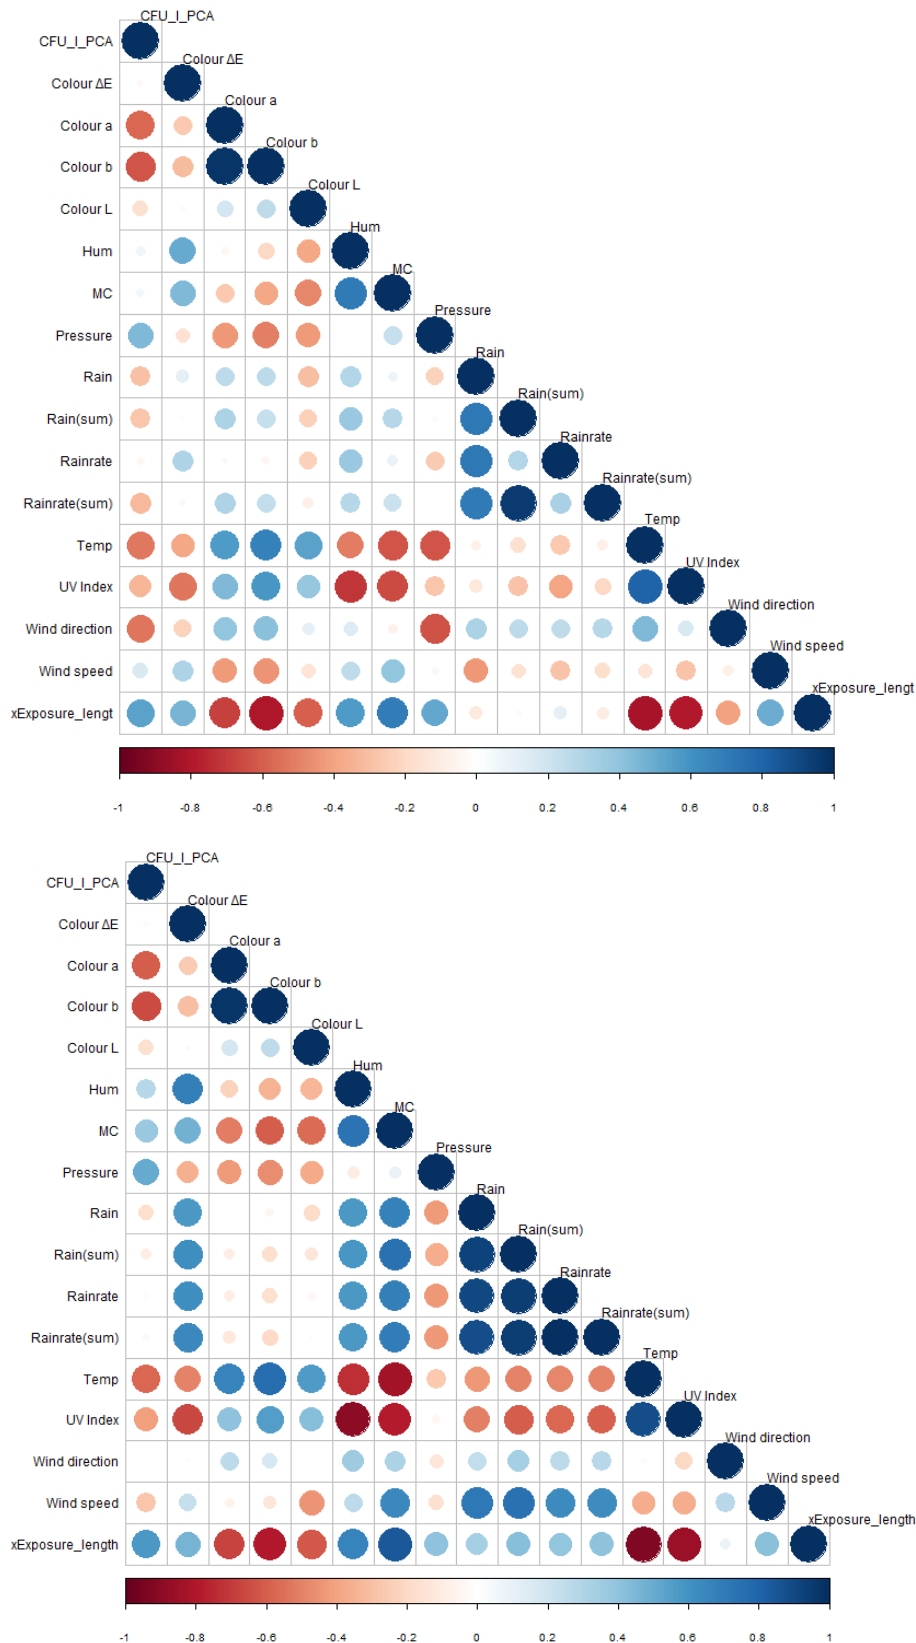
Figure 29: Heatmaps showing Pearson correlation of  $df_{3h}$  (top) and  $df_{weekly}$  (bottom) for oak wood. Legend: CFU\_I\_PCA: Number of CFU on PC-agar recovered from samples exposed from summer 2019 onwards, Hum: Air humidity, MC: Wood MC, Pressure: Atmospheric pressure, Temp: Temperature
