# Synthesis and tribocorrosion study of tungsten nitride thin films

# Thèse de Doctorat

***Elaboration et évaluation par tribocorrosion de couches minces de nitrure de tungstène***

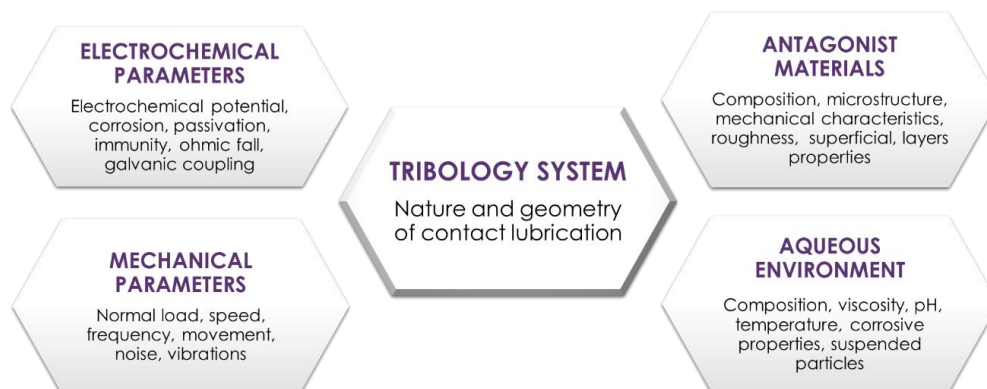
Figure 1.7 Representation of the elements parameters and system characteristics which can influence the response of tribocorrosion processes. Translated from [Richard and Geringer 2019].

The degradation of a surface by tribocorrosion depends on a wide range of parameters related to the corrosive environment and the materials in contact with it. Figure1.7 shows a scheme of such parameters. The details of the contact play a critical role in determining the effect of corrosion on the wastage rate, to understand the mixed contribution first we need to understand how each contribution works separately.

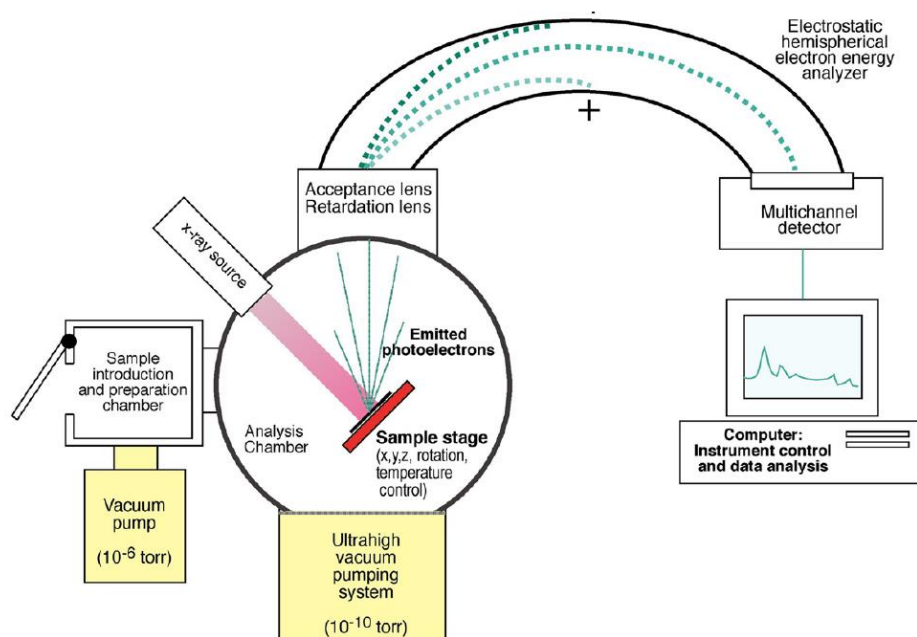
Figure 1.12 XPS device schema [Ratner 2007]

The resultant spectrum is a plot of the number of detected electrons per energy interval as a function of its kinetic energy. This characterization technique can identify the elements in the first 10 nm of the surface, on the assumption that the element of interest exists at >0,05atomic %. A schematic representation of an XPS device is shown in Figure 1.12.

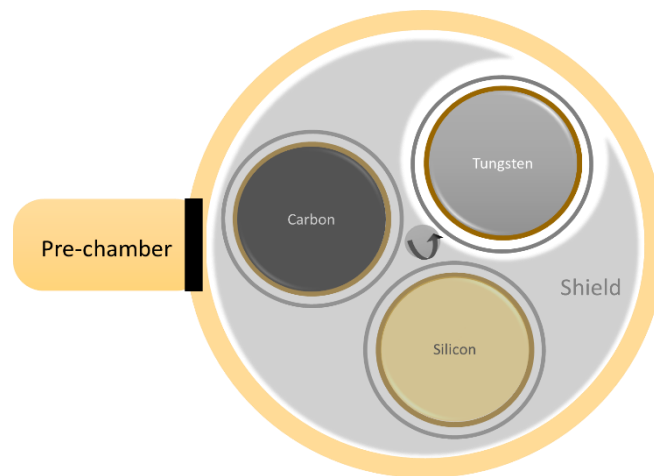
Figure 2.2 Top view of the vacuum chamber without lid

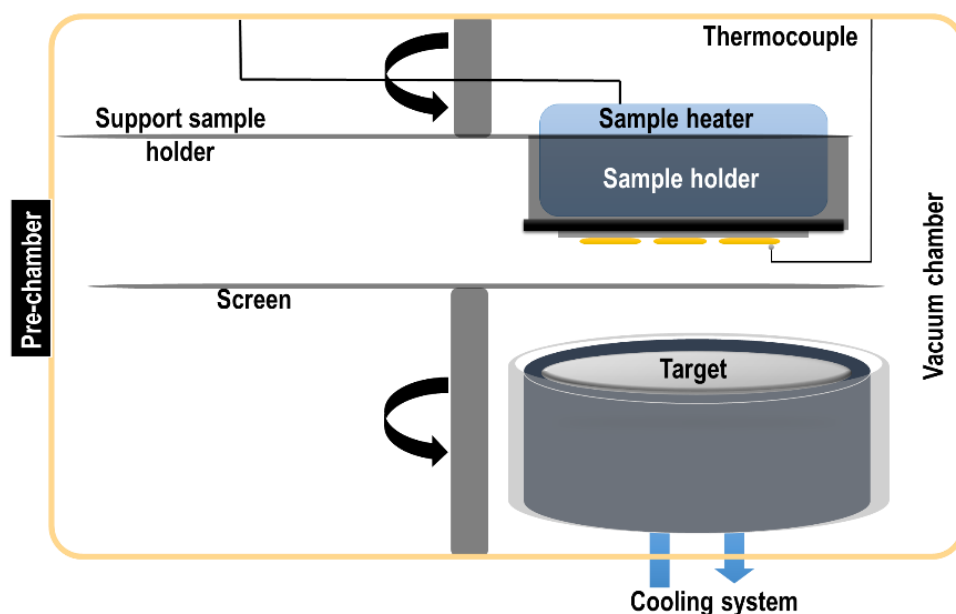
Figure 2.3 Transversal cut diagram of the vacuum chamber.

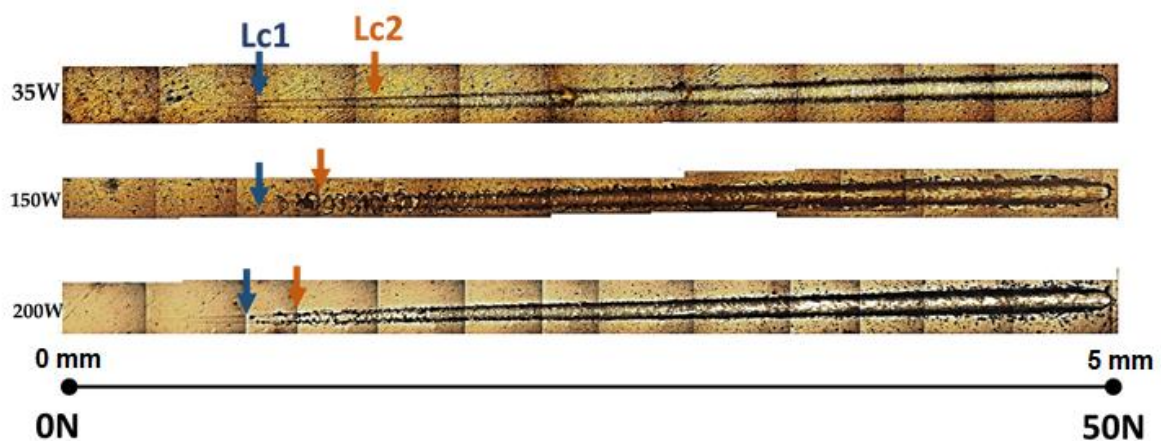
Figure 4.9 Resulting scratch track by increasing load scratch tests for tungsten nitride thin films deposited at different powers and 1 Pa of gas pressure.
